THE ALASKA EARTHQUAKE, MARCH 27, 1964:
EFFECTS ON COMMUNITIES

Effects of the Earthquake Of March 27, 1964, At Seward, Alaska

BY RICHARD W. LEMKE

GEOLOGICAL SURVEY PROFESSIONAL PAPER 542-E

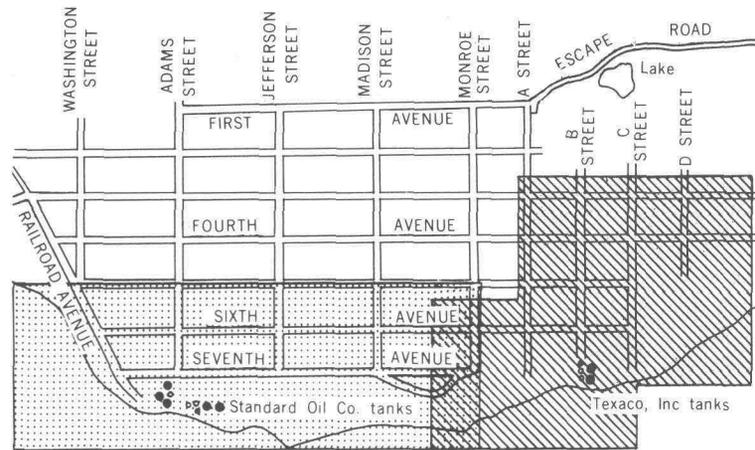
Index map showing relation of figures 3 and 4. Stippled area is figure 3, hachured area figure 4.

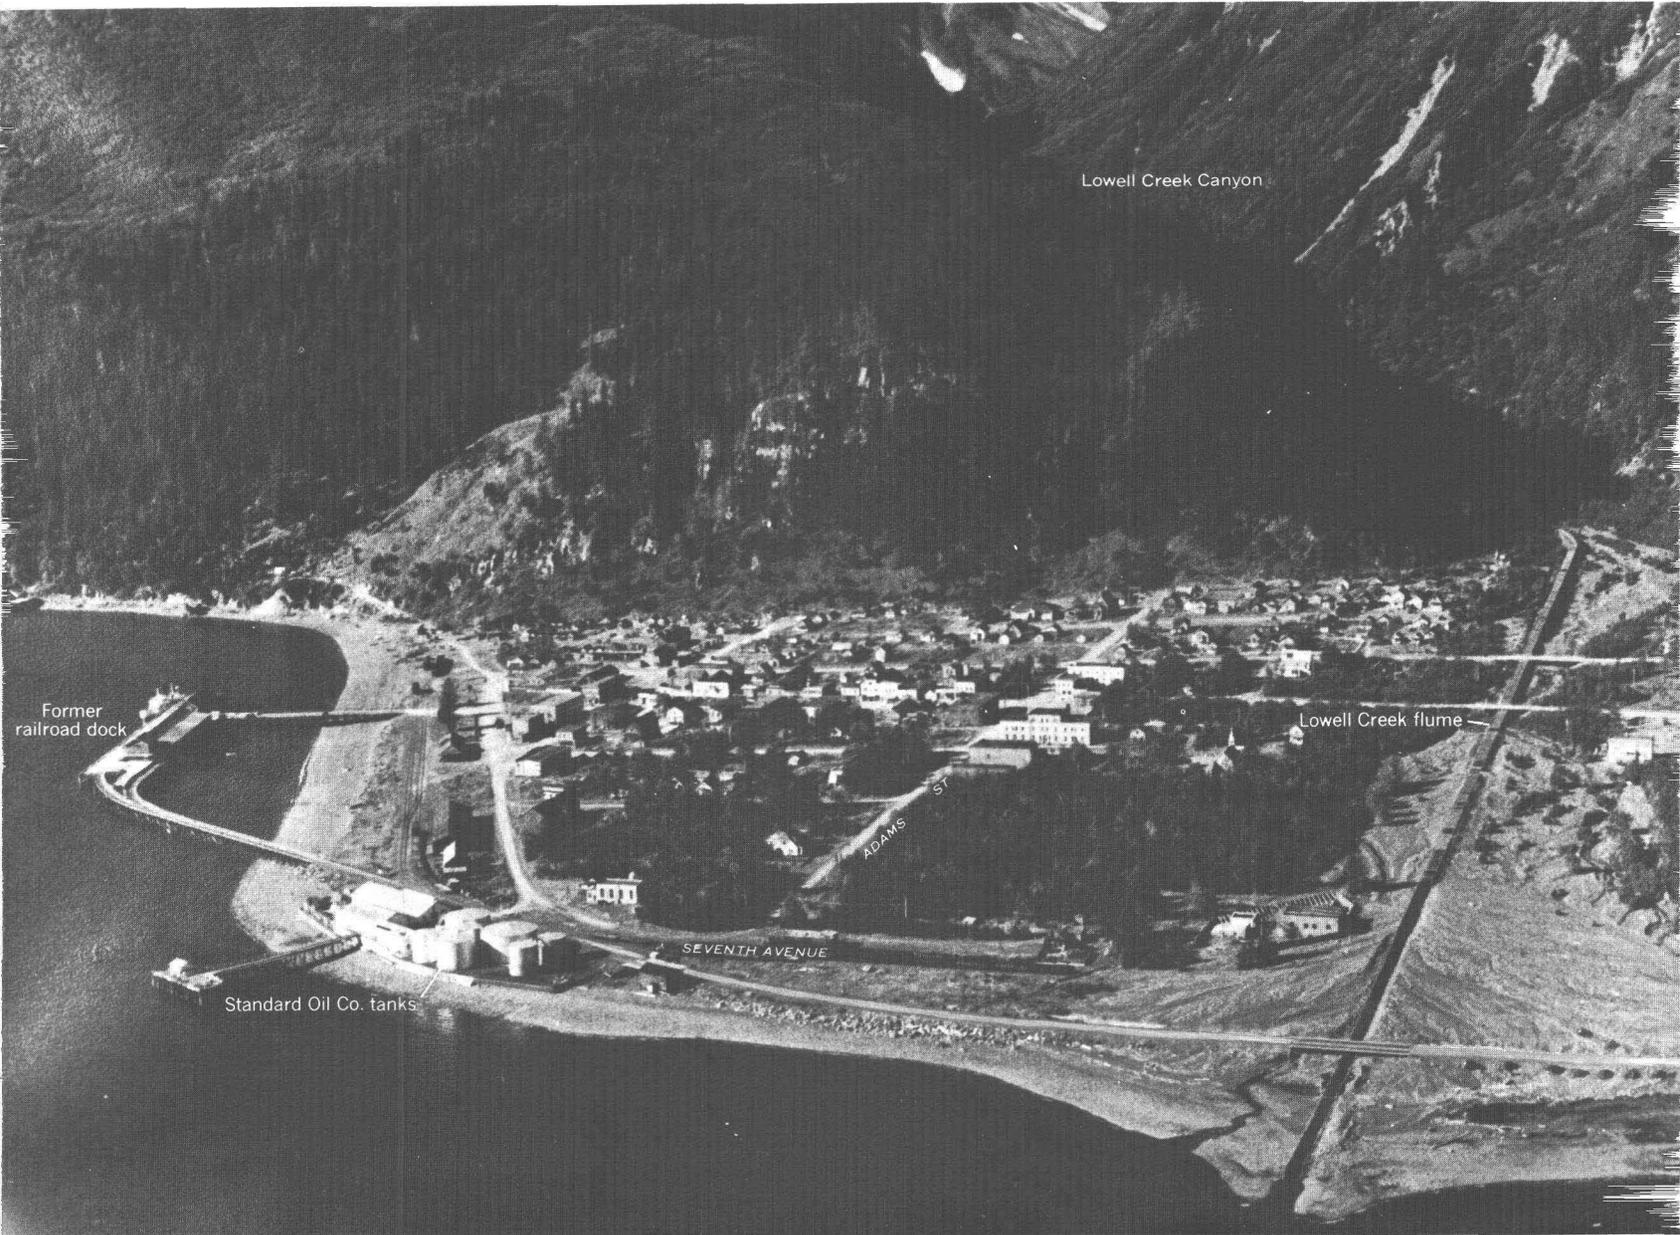
9.—Seward alluvial fan in 1939 showing torrential-type deposition from Lowell Creek after a flood. Photograph by Robert Zentmeyer.

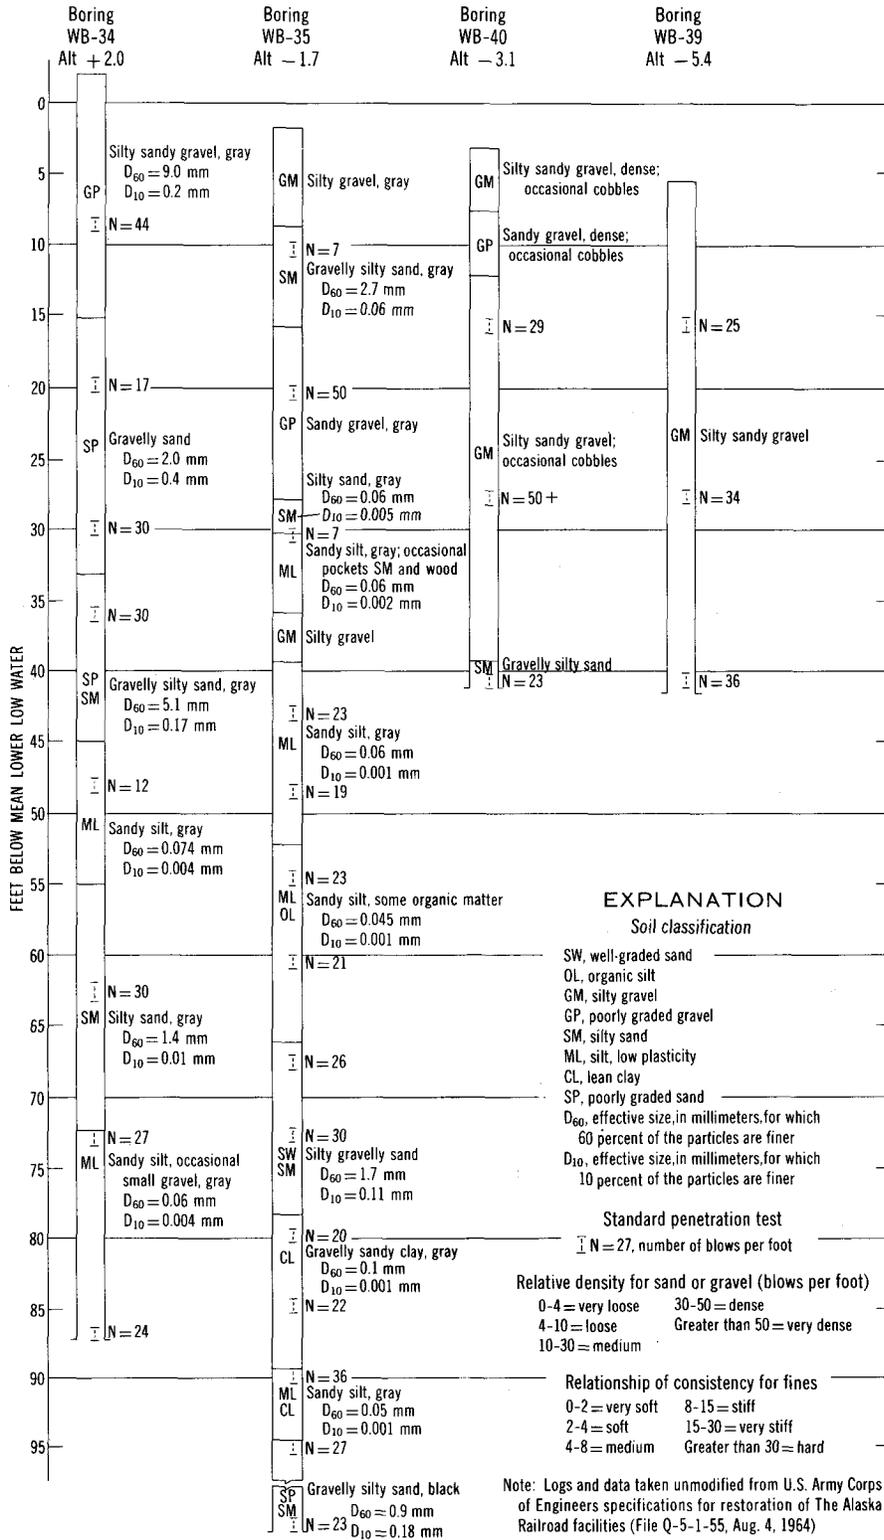
None of the bore holes were more than 100 feet deep and most were less than 50 feet deep. Those on land were 4–9 feet deep. The borings were water-jet holes made by using a pump that developed 450 psi (pounds per square inch) at approximately 20 gallons a minute (Robert H. Moran, U.S. Army, Corps of Engineers, written commun., 1964). The sampler was a 1-inch split spoon on a 2-inch drill rod inside a 4-inch casing. All work was done at the higher stages of the tide when the tidal flats were covered by water. Samples were classified in the field. According to Moran, this method of investigation is both economical and time proven and gives sufficiently accurate information for assessment of dredging character and design of structures. Logs and test data from four offshore borings (fig. 11, next page) show subsurface conditions in the area of the new Alaska Railroad dock.

11.—Offshore borings in the vicinity of the new Alaska Railroad dock. See plate 2 for locations.
