THE ALASKA EARTHQUAKE, MARCH 27, 1964:
REGIONAL EFFECTS

Surface Faults On Montague Island Associated with the 1964 Alaska Earthquake

By GEORGE PLAFKER

GEOLOGICAL SURVEY PROFESSIONAL PAPER 543-G

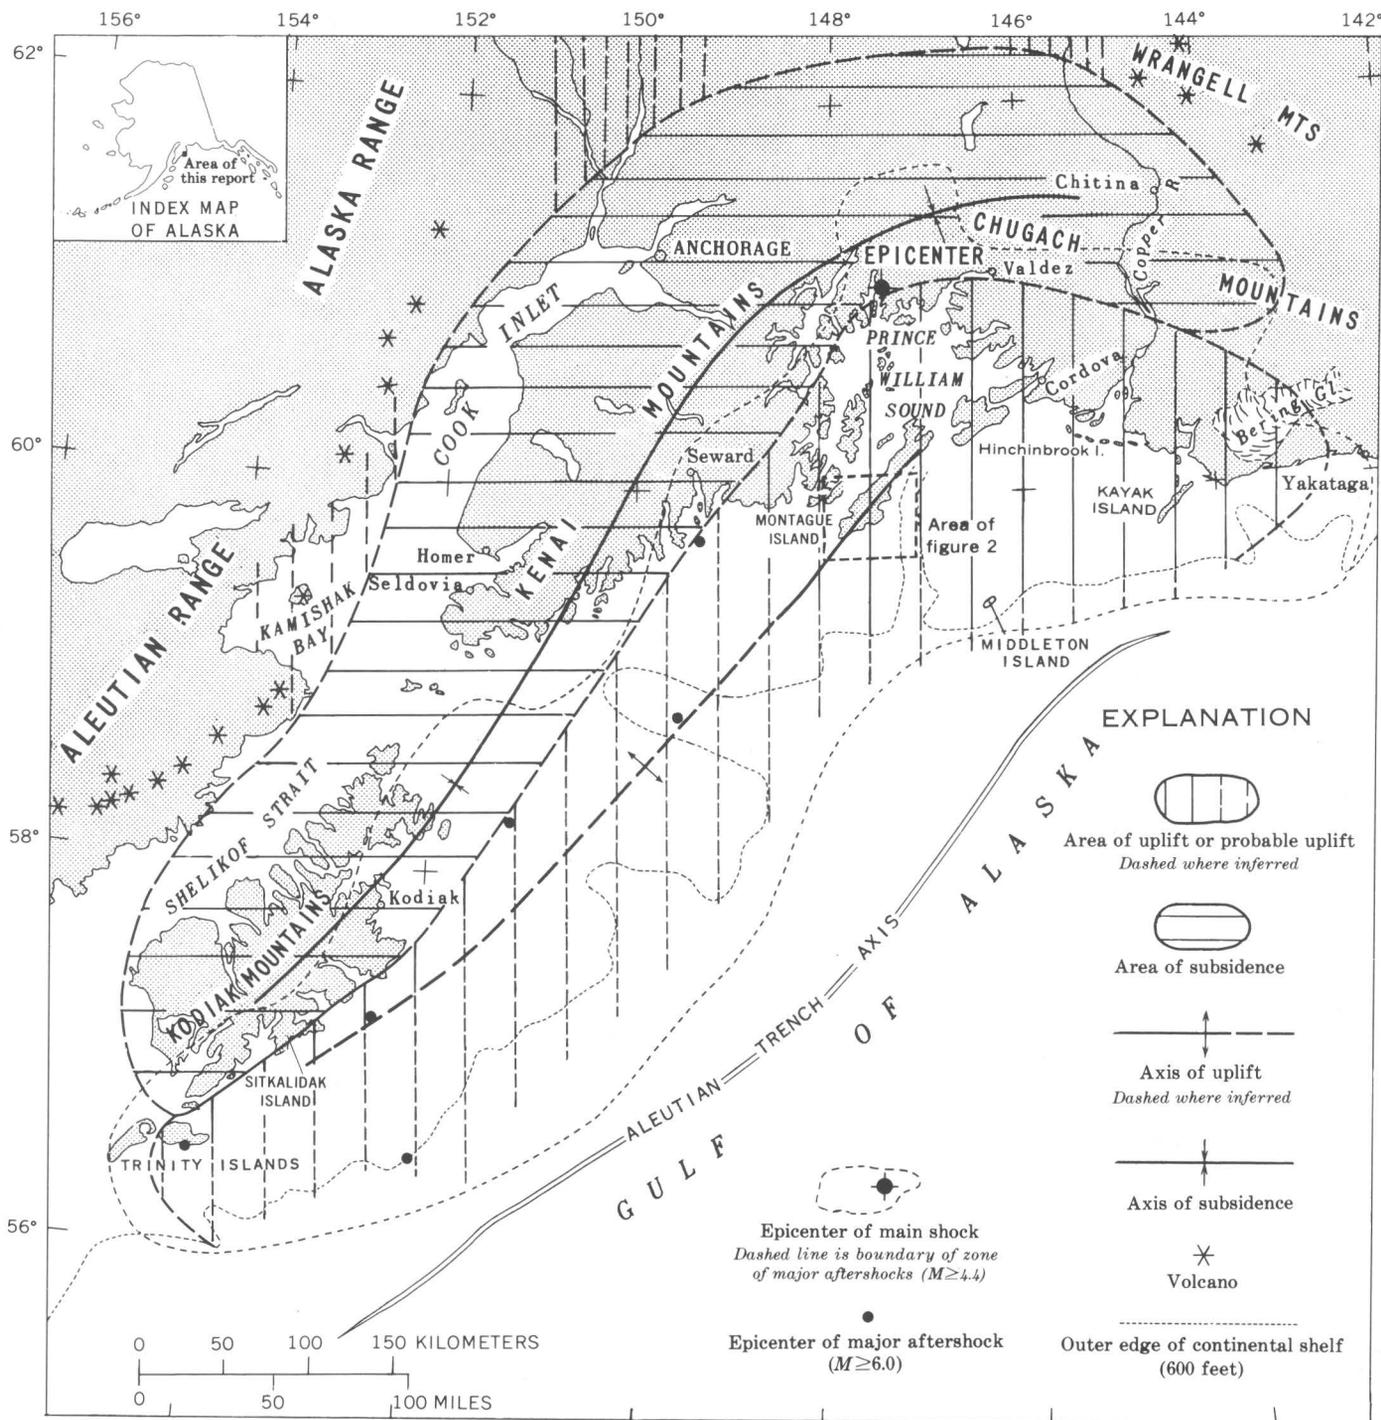
1.—Setting of Montague Island with respect to regional tectonic deformation and seismicity that accompanied the March 27, 1964, earthquake.

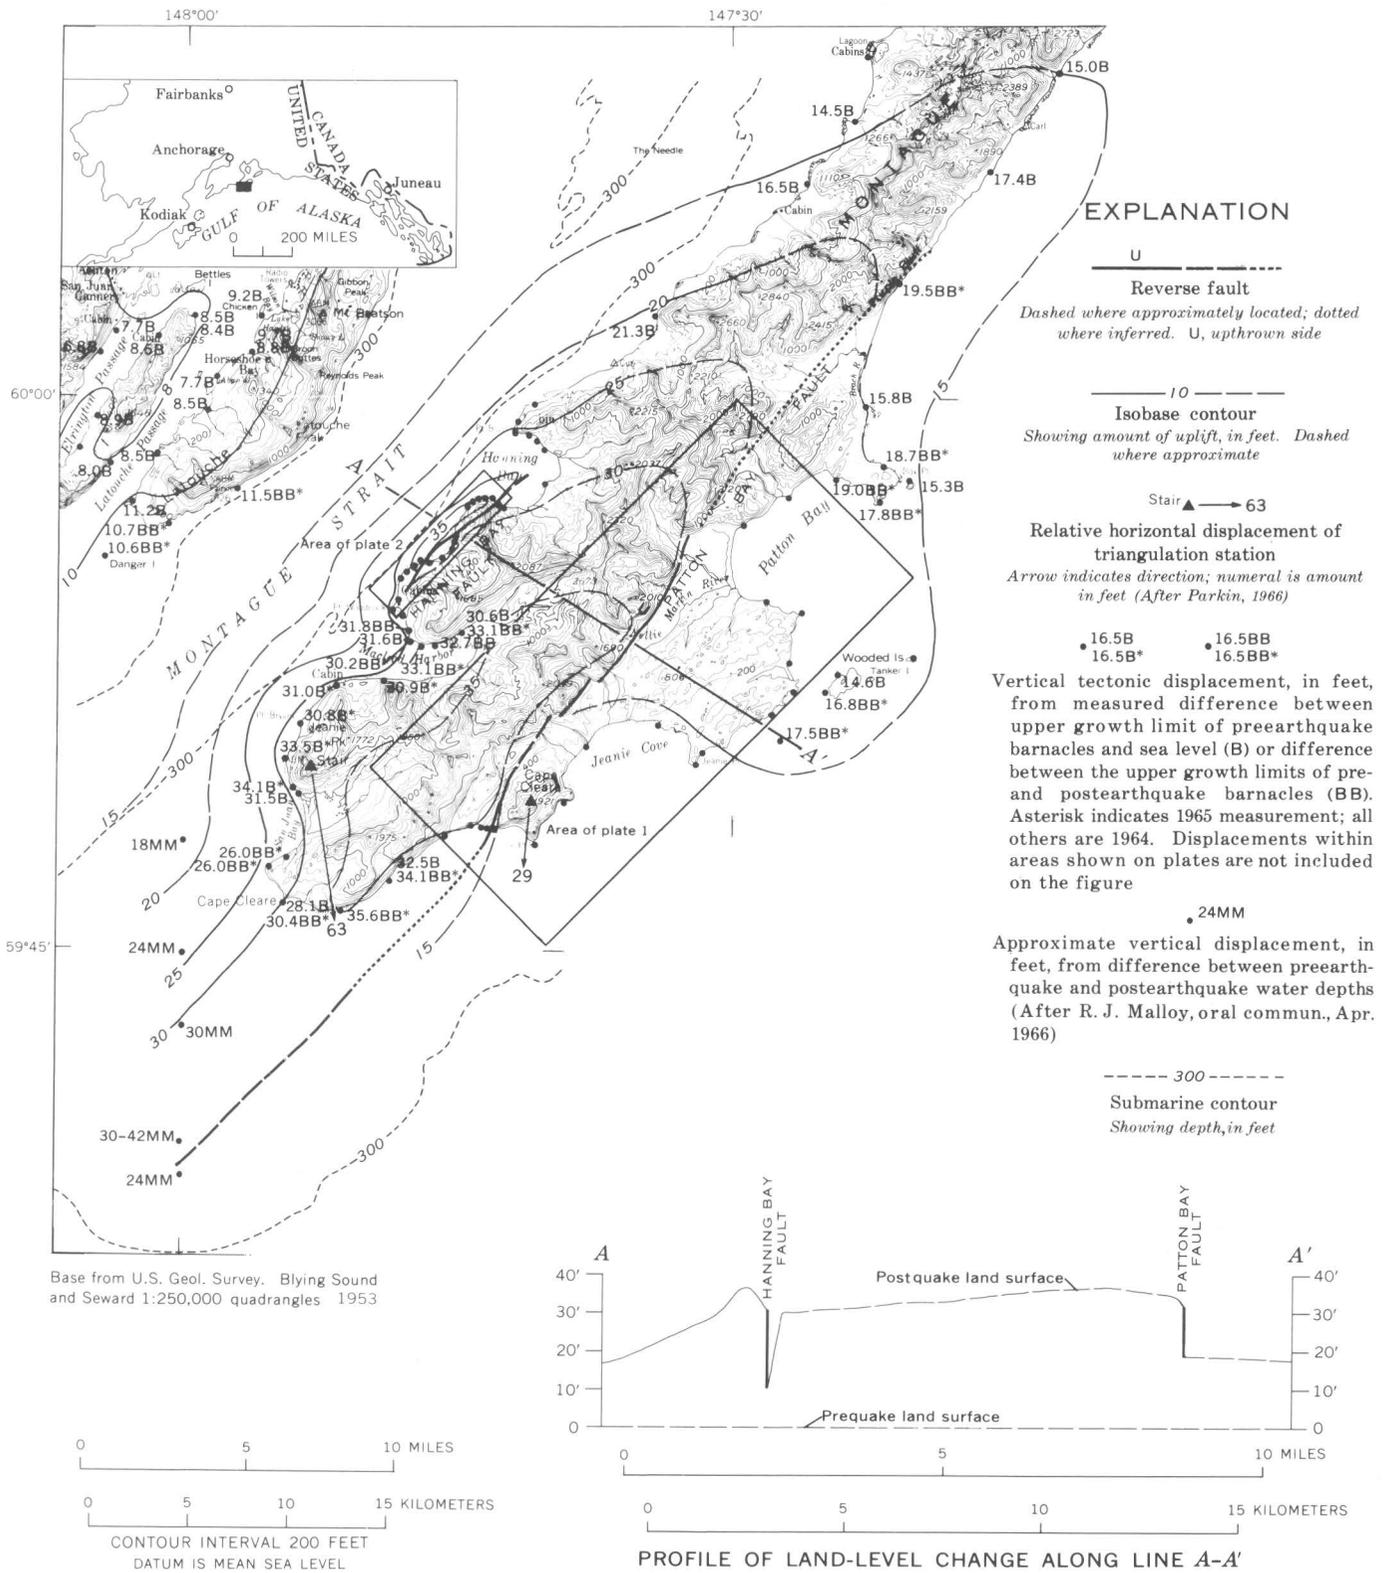
2.—Map and profile showing faults and horizontal and vertical tectonic displacements on southwestern Montague Island.

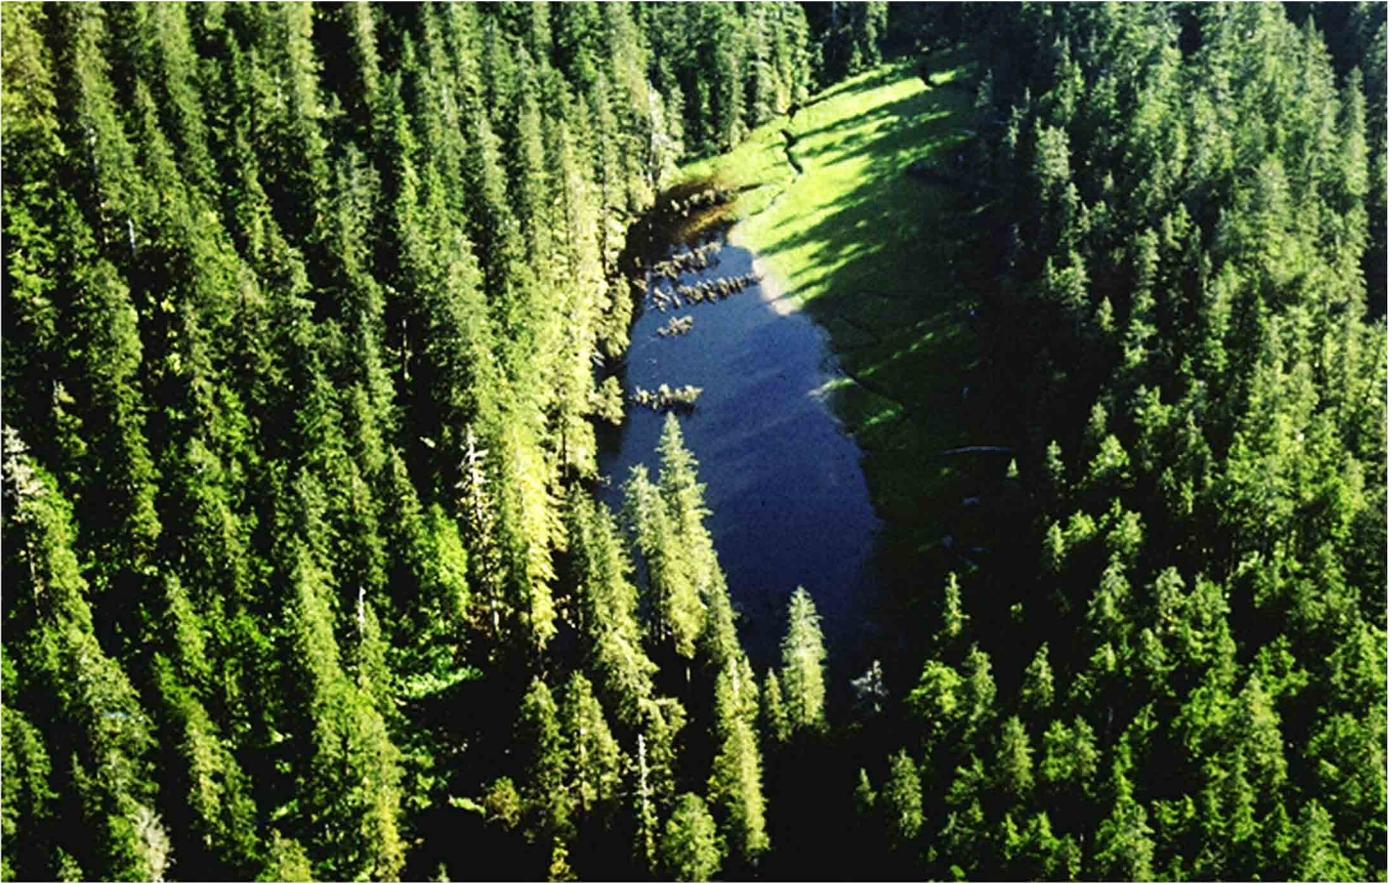
headwall scarps of enormous incipient landslide blocks that occur all along the upper part of the cliff. It reappears some 500 feet inland from the cliff where it coincides with the linear edge of a muskeg swamp. The fault trace here consists of a north-south trending zone of parallel surface fissures and flexures in glacial till and sphagnum peat. Individual fissures that parallel the trace are open as much as 3 feet (fig. 10) and have vertical offsets of as

much as 5 feet with the west (downhill) sides upthrown relative to the east sides. Net vertical displacement across the fissures is about 7 feet; the amount of vertical movement resulting from warping is not known. A possible left-lateral component of horizontal displacement is indicated by a 17-inch offset of segments of a log that had been frozen into the ground in a position almost normal to the trend of one of the larger surface breaks. A few gaping cracks that trend N. 15° W. at an oblique angle to the fault trace are also suggestive of some left-lateral strike-slip movement. No evidence for lateral offsets was found anywhere else along the fault trace.

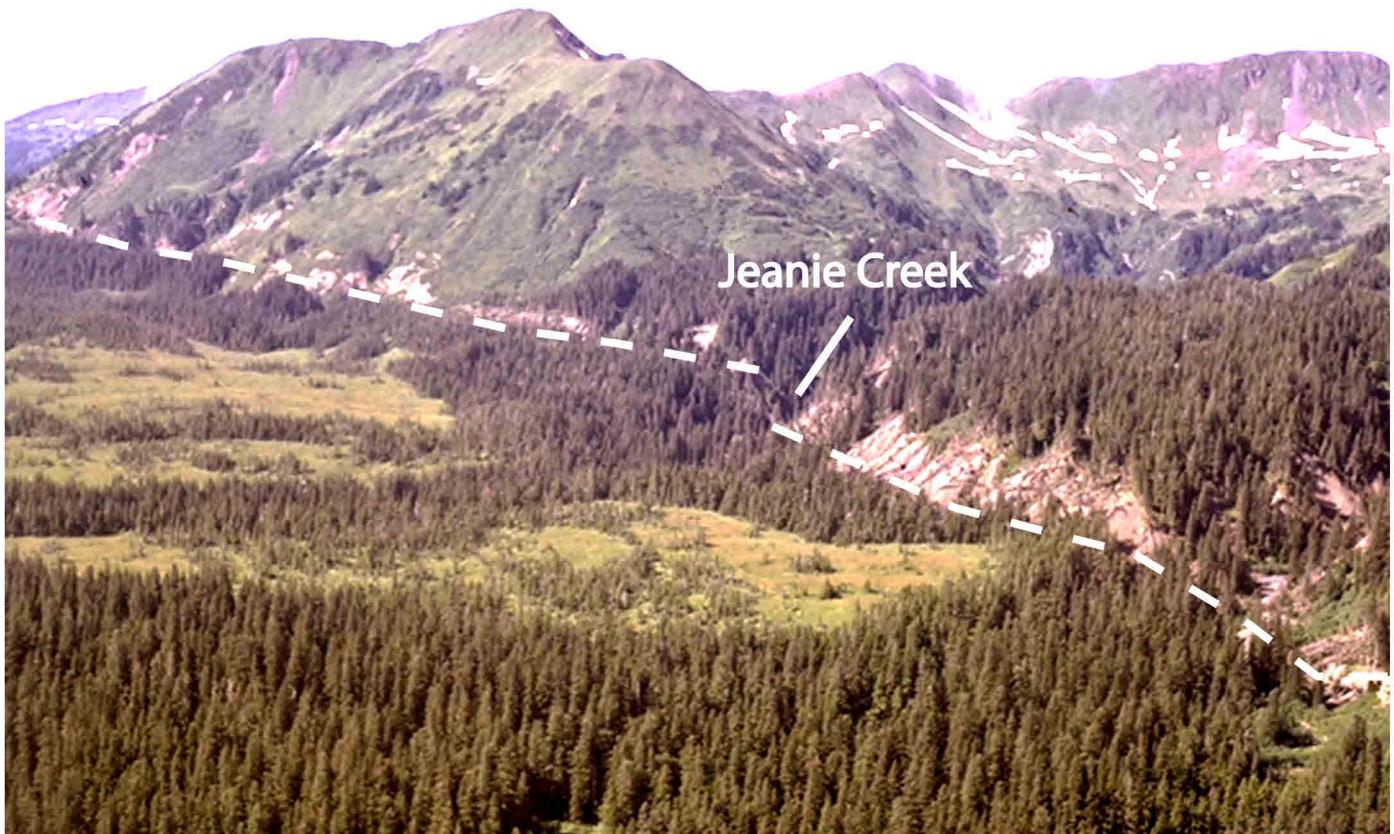
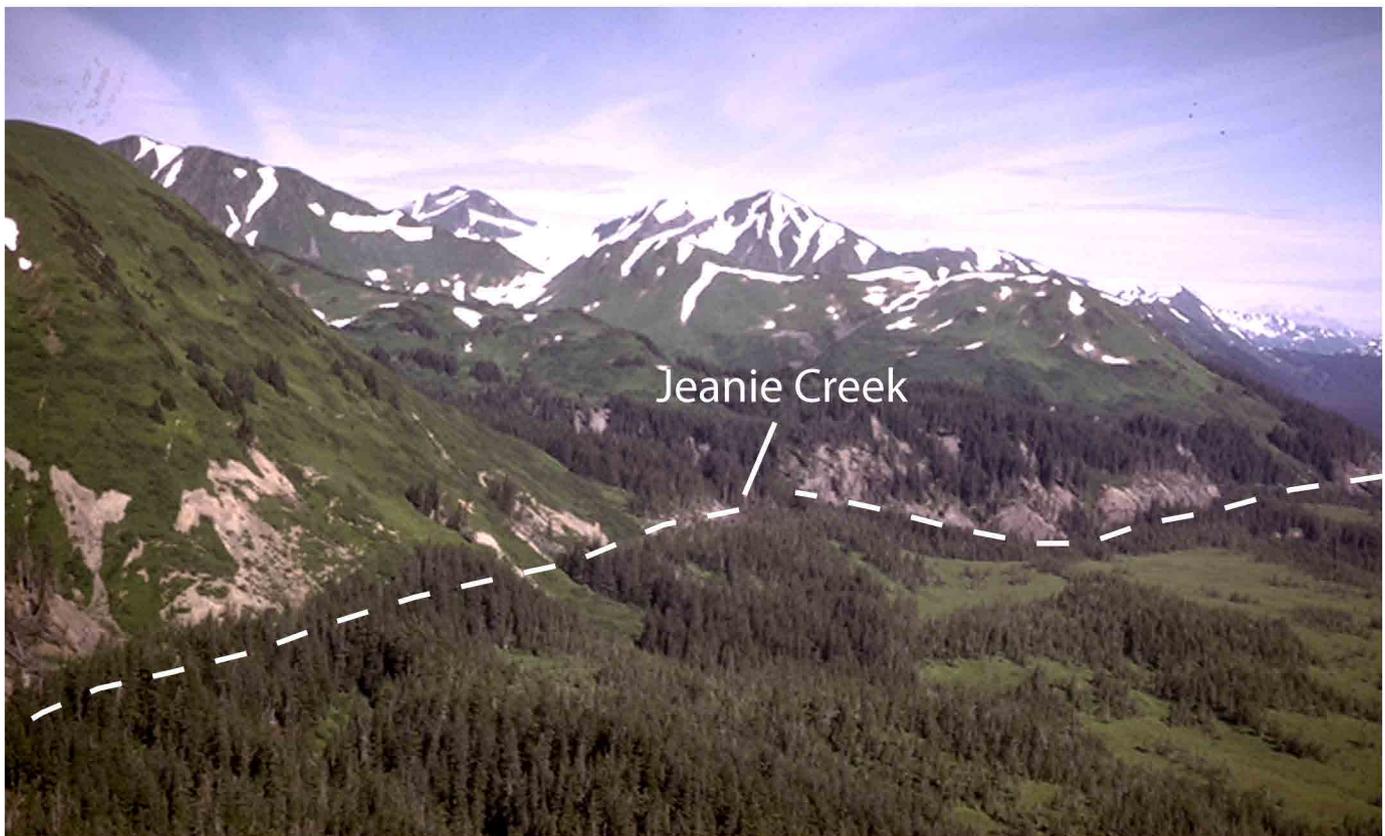
15.—Patton Bay fault (dashed) looking northeast toward Jeanie Creek. The segment of the fault north of Jeanie Creek is offset about 0.4 mile to the east relative to the segment south of the creek. →

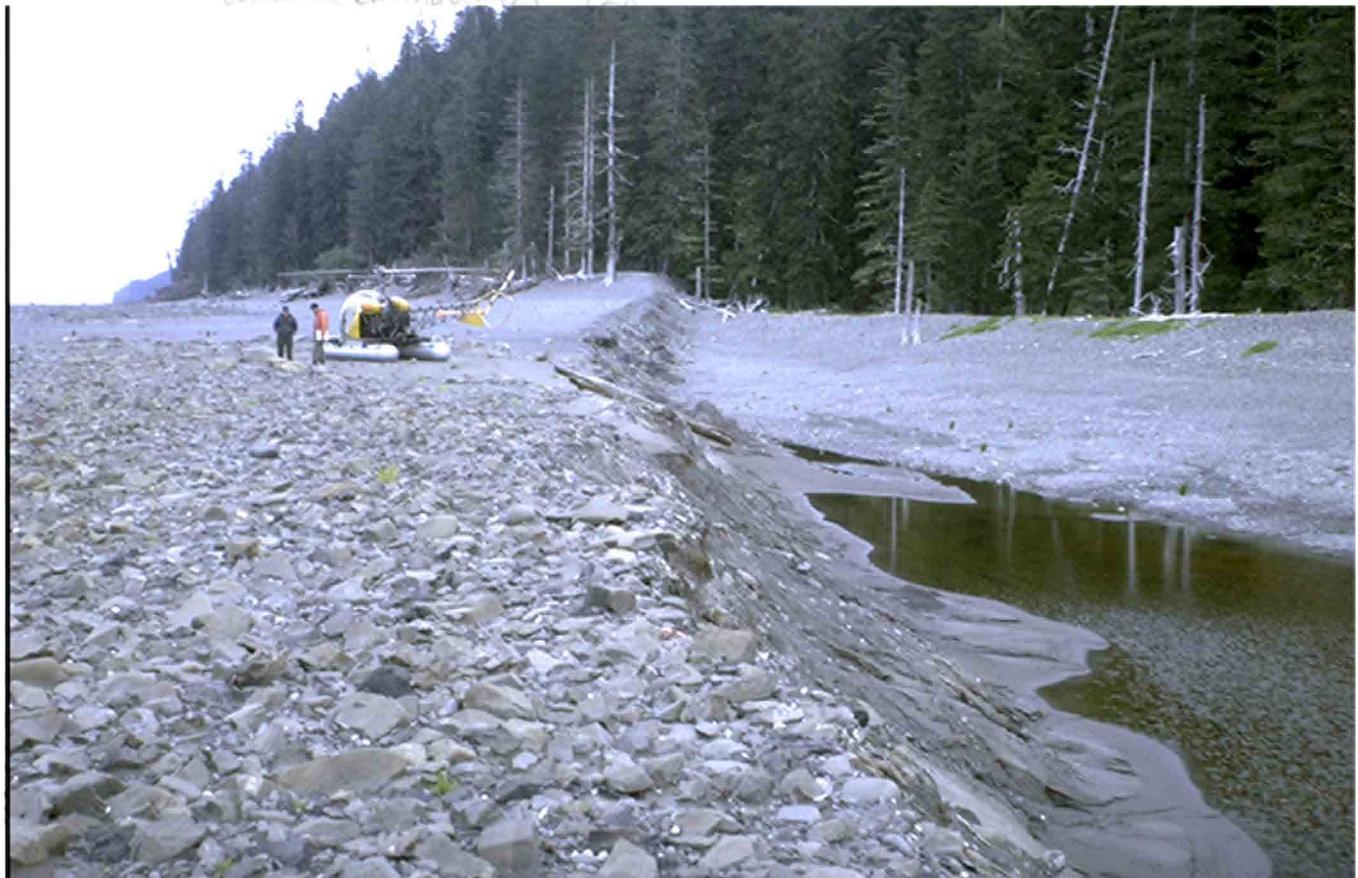
32.—View northwest toward cobble-gravel storm beach at north side of Fault Cove which was displaced $16\frac{1}{8}$ feet vertically across the Hanning Bay fault scarp. Pond at right occupies a shallow tectonic depression. Photograph by M. G. Bonilla.

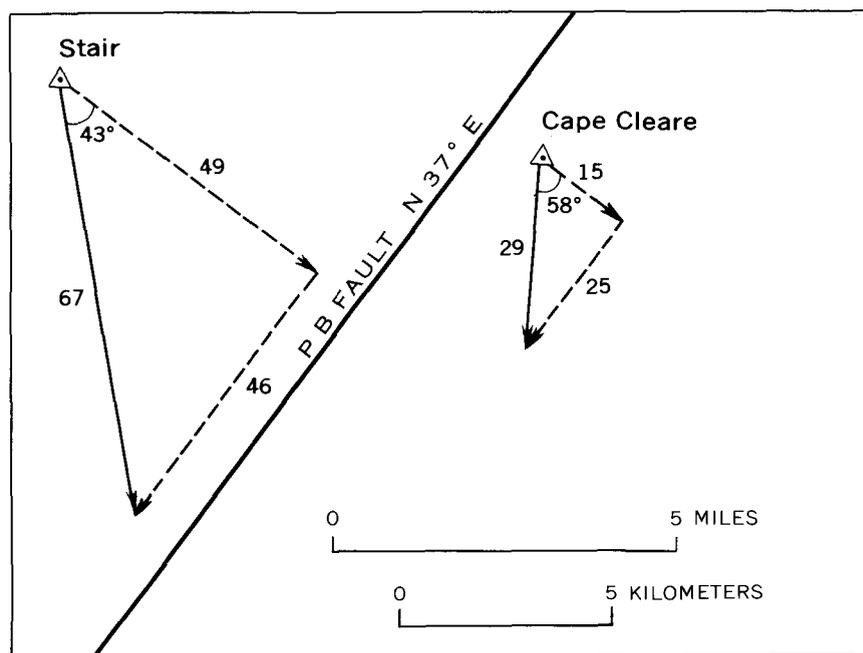
40.—Orientation of horizontal displacement vectors (solid arrows) at triangulation stations Stair and Cape Cleare relative to the average strike of the Patton Bay fault. Dashed arrows are the indicated components of horizontal displacement perpendicular to, and parallel to, the fault. Numerals are horizontal displacement in feet relative to station Fishhook (40 miles northeast of Anchorage), which was held fixed in the adjustment. Triangulation data from Parkin (1966, table 1).

principal vector of horizontal movement derived from the geodetic data is between N. 10° W. and N. 5° E. at an oblique angle to the fault system, whereas the direction indicated by the predominantly dip-slip displacements across the scarps is actually about N. 53° W., or approximately normal to the average strike of the faults. The re-triangulation data further indi-

cate that the two stations moved 34 feet relatively toward one another in the direction of fault dip and that they were relatively displaced 21 feet in a left-lateral sense (fig. 40). The dip-slip shortening could have been taken up by bending of the upthrown block in addition to the fault displacement. The strike-slip displacement, on the other hand, should have been
