The Alaska Earthquake

Eklutna
Power Project

Effect of the Earthquake
Of March 27, 1964, on
The Eklutna Hydroelectric
Project, Anchorage, Alaska

GEOLOGICAL SURVEY PROFESSIONAL PAPER 545-A

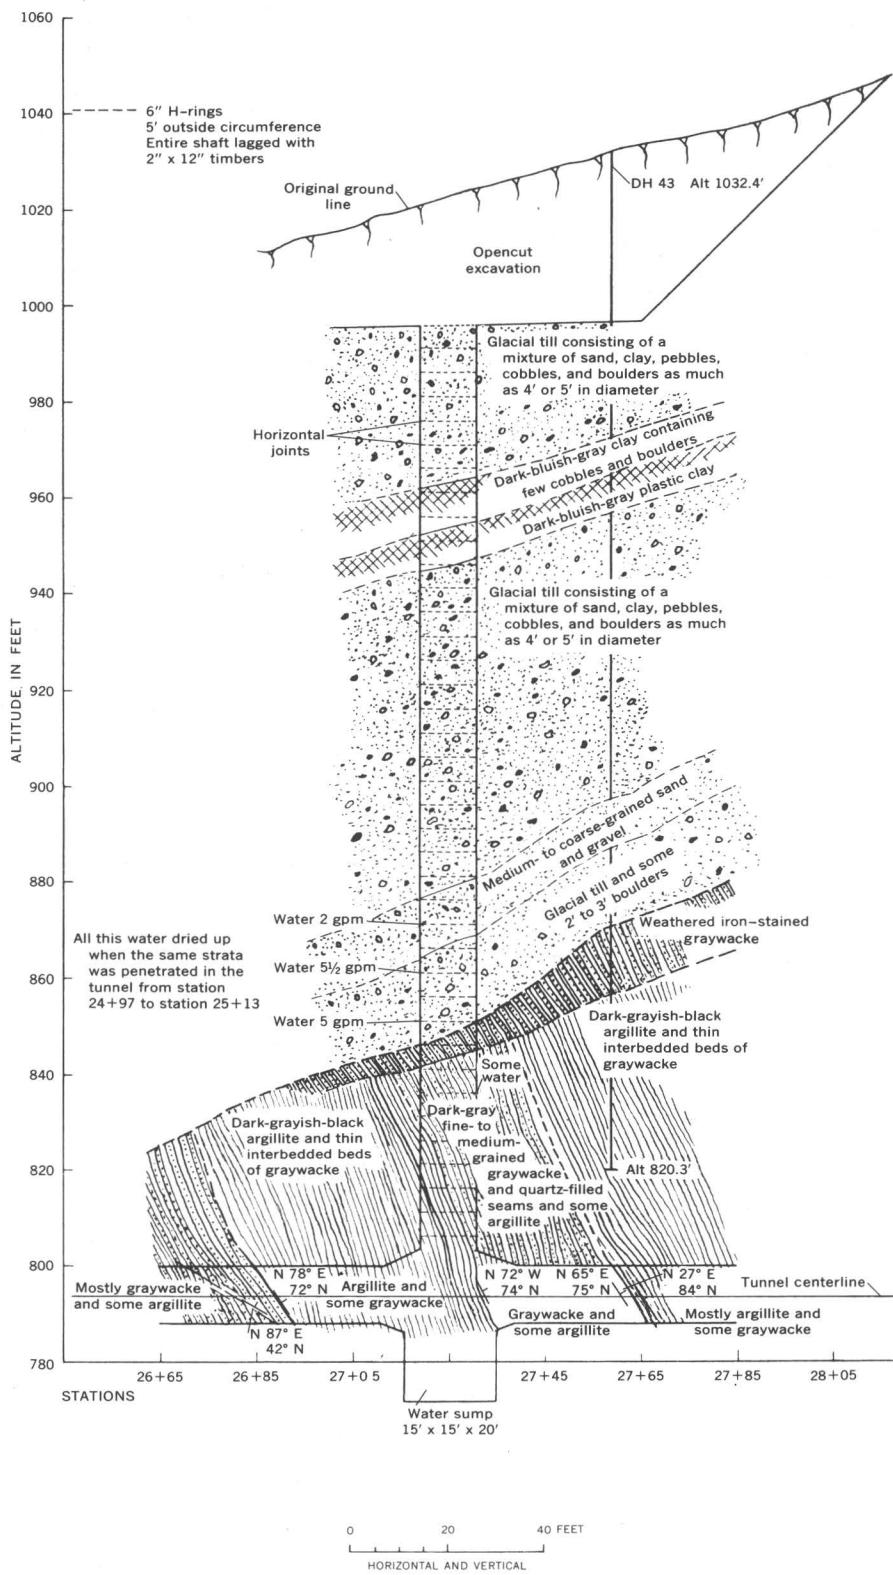
10.—Geologic section through gate shaft.

As part of the plan to design an earthquake-resistant structure, the gate shaft at station 27+25 was founded in competent rock (figs. 8, 10); it was reinforced to withstand internal bursting pressures. Horizontal joints in the shaft, indicated by dashed lines on figure 10, helped compensate for any possible vertical deflections during an earthquake. No damage to this structure was discernible.

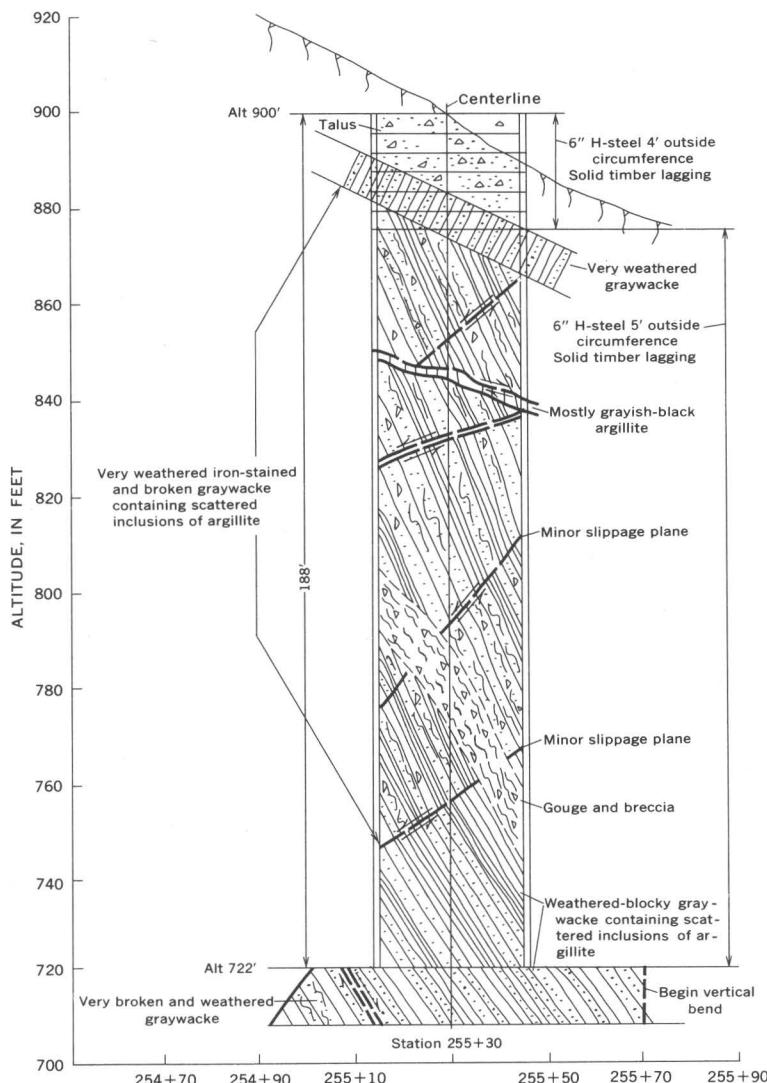
11.—Geologic section through surge tank.

The penstock, surge tank, pile-supported anchor block, and powerhouse evidently oscillated as an integral unit during the earthquake. Very little relative movement occurred between these features although backfill in the anchor-block area subsided (fig. 13).

A maximum residual separation of one-sixteenth to one-eighth inch was measured in the penstock ports of the powerhouse wall. The entire penstock from the tunnel to the units appeared to have sustained no permanent deformation. Fine line cracks in the overlapped painted surfaces at the coupled sleeve joints did, however, indicate unusual pipe vibration.
