THE ALASKA EARTHQUAKE, MARCH 27, 1964:
EFFECTS ON TRANSPORTATION, COMMUNICATIONS, AND UTILITIES

Effects of the Earthquake of March 27, 1964, on the Alaska Highway System

By REUBEN KACHADOORIAN

GEOLOGICAL SURVEY PROFESSIONAL PAPER 545-C

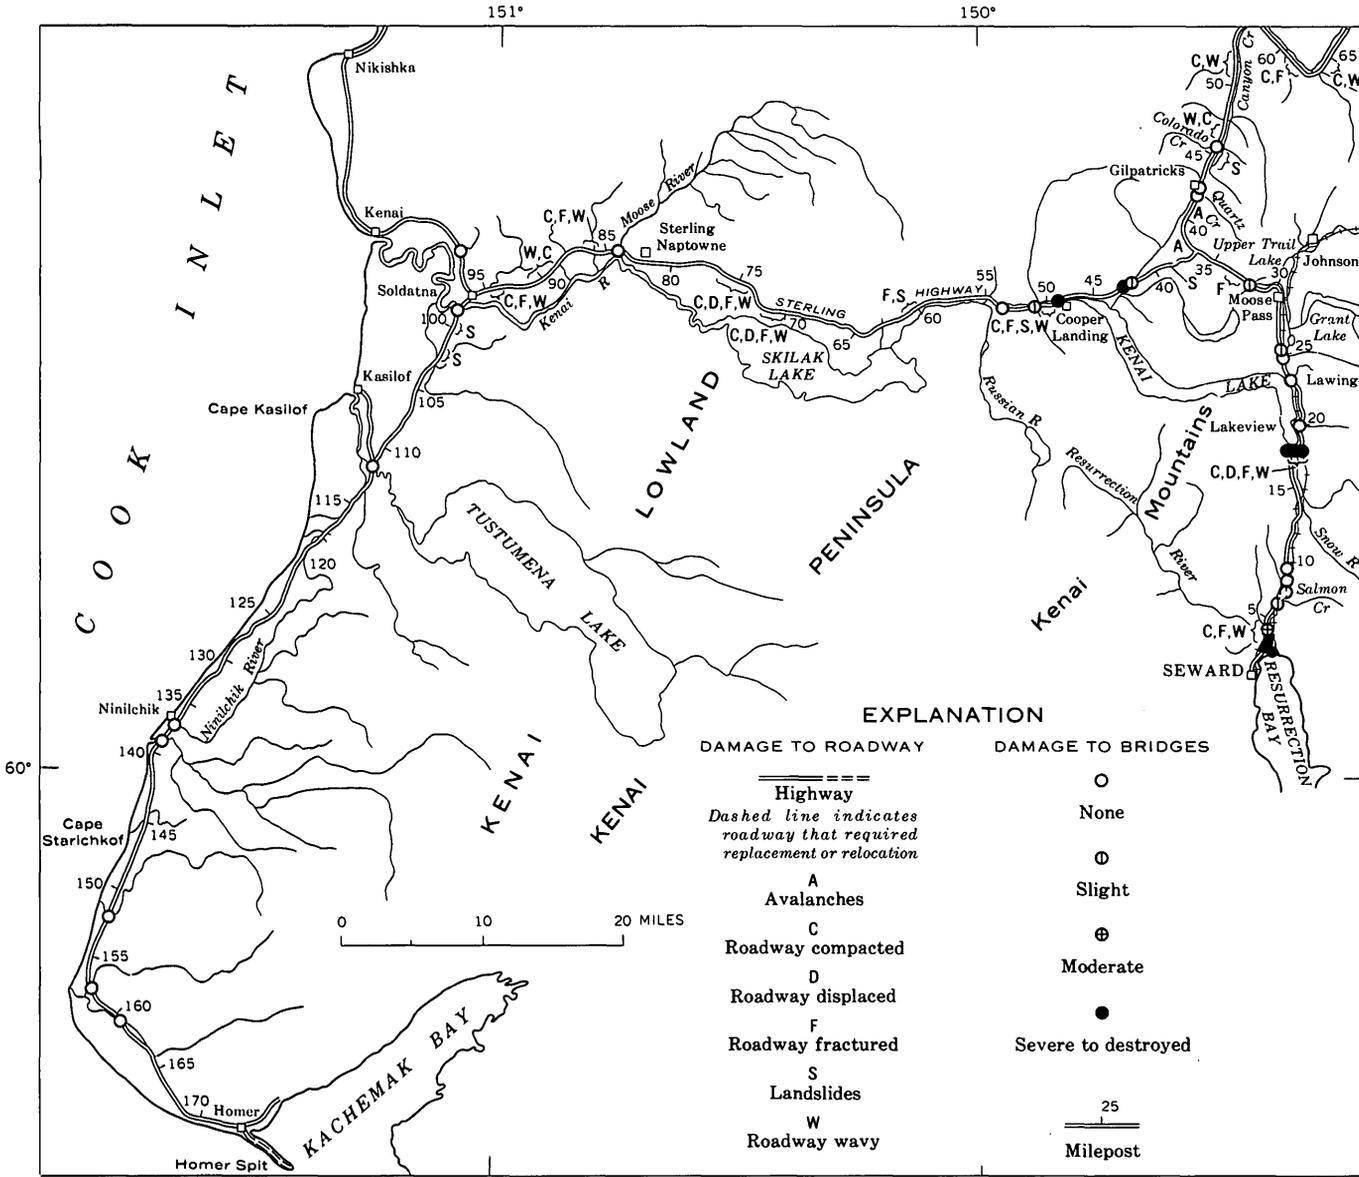
2.—Routes of Sterling Highway and part of Seward-Anchorage Highway, and effects of the earthquake upon the highways.

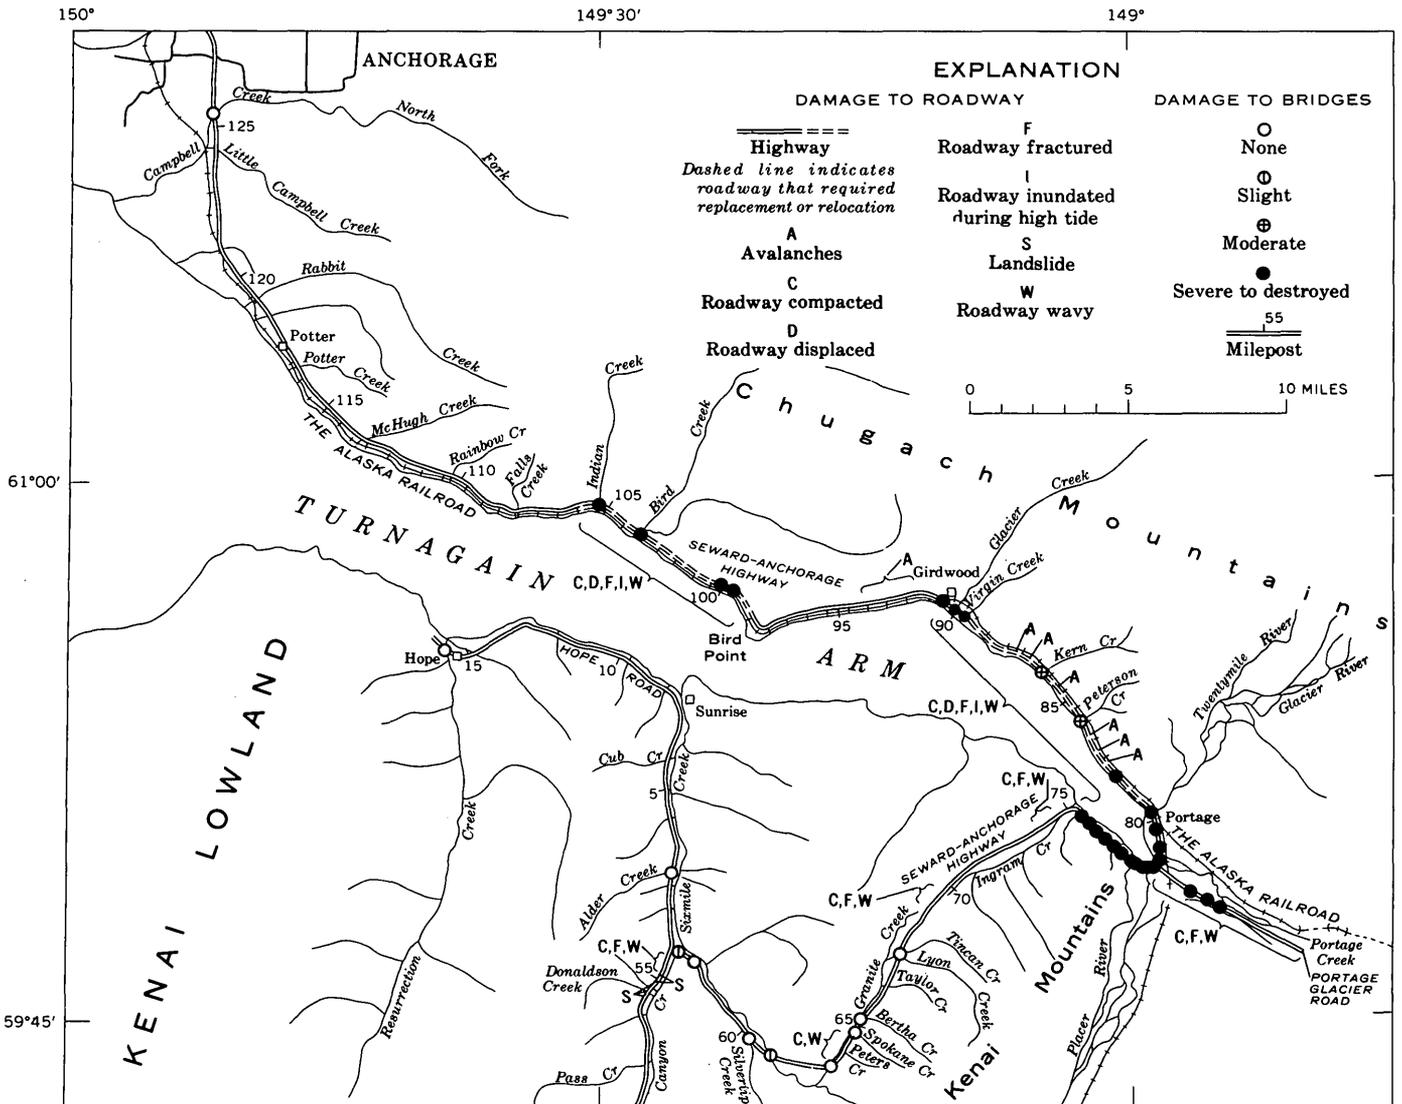
3.—Routes of part of Seward-Anchorage Highway, the Hope Road, the Portage Glacier Road, and effects of the earthquake upon the highways.

The most severe damage to roadways occurred at Snow River Crossing (fig. 2) and from mile 75.1 to about mile 90 (fig. 3) on the Seward-Anchorage Highway, on the Copper River Highway (fig. 6), and from mile 1 to mile 5 on the Richardson Highway (fig. 5). The Snow River Crossing is underlain by nonplastic silt and sand (fig. 8; table 7, p. C55). Here the groundwater table is generally within 1 foot of the surface. The Turnagain Arm section of the Seward - Anchorage Highway (mile 75.1 to mile 90) is primarily underlain by silt and sand with minor amounts of gravel (fig. 9). The sediments are nonplastic (tables 8, 9, p. C55, C56). Although not indicated on the graphic logs of the test holes, the water table lies generally within 3 feet of the surface; in the vicinity of the town of Portage the

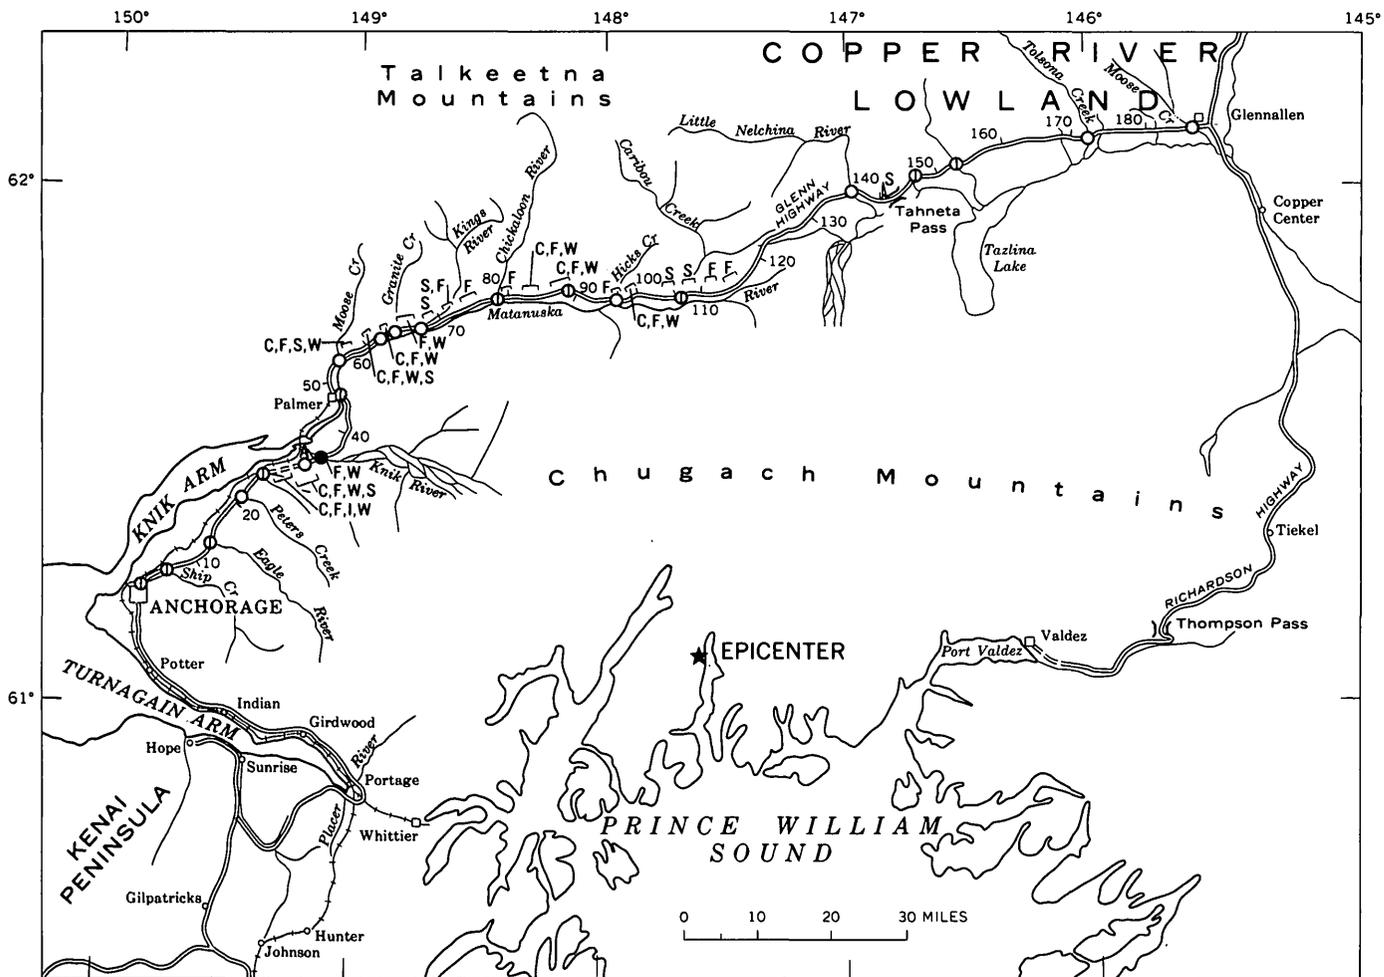
4.—Route of Glenn Highway and effects of the earthquake upon the highway.

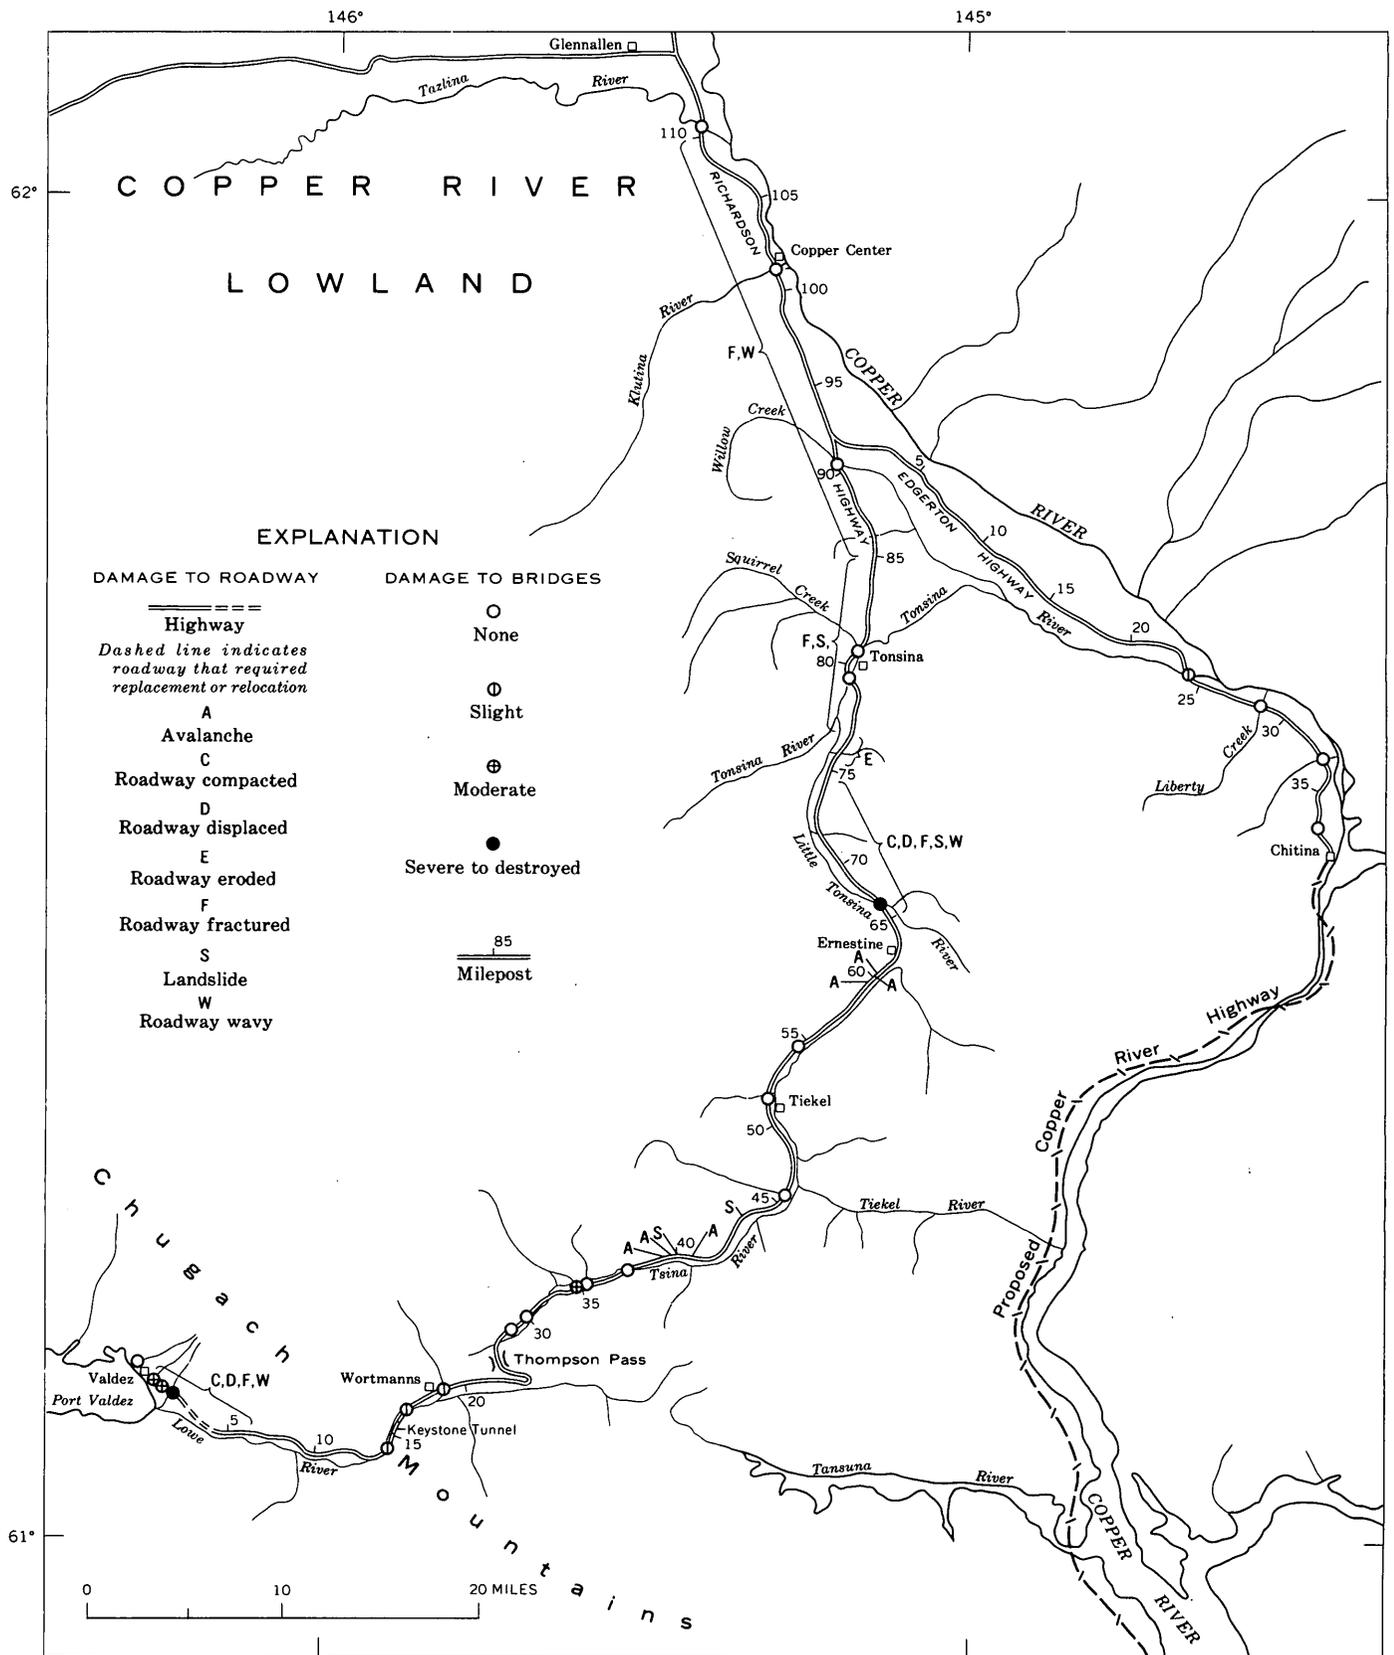
5.—Routes of the Edgerton Highway and part of the Richardson Highway, and effects of the earthquake on the highways.

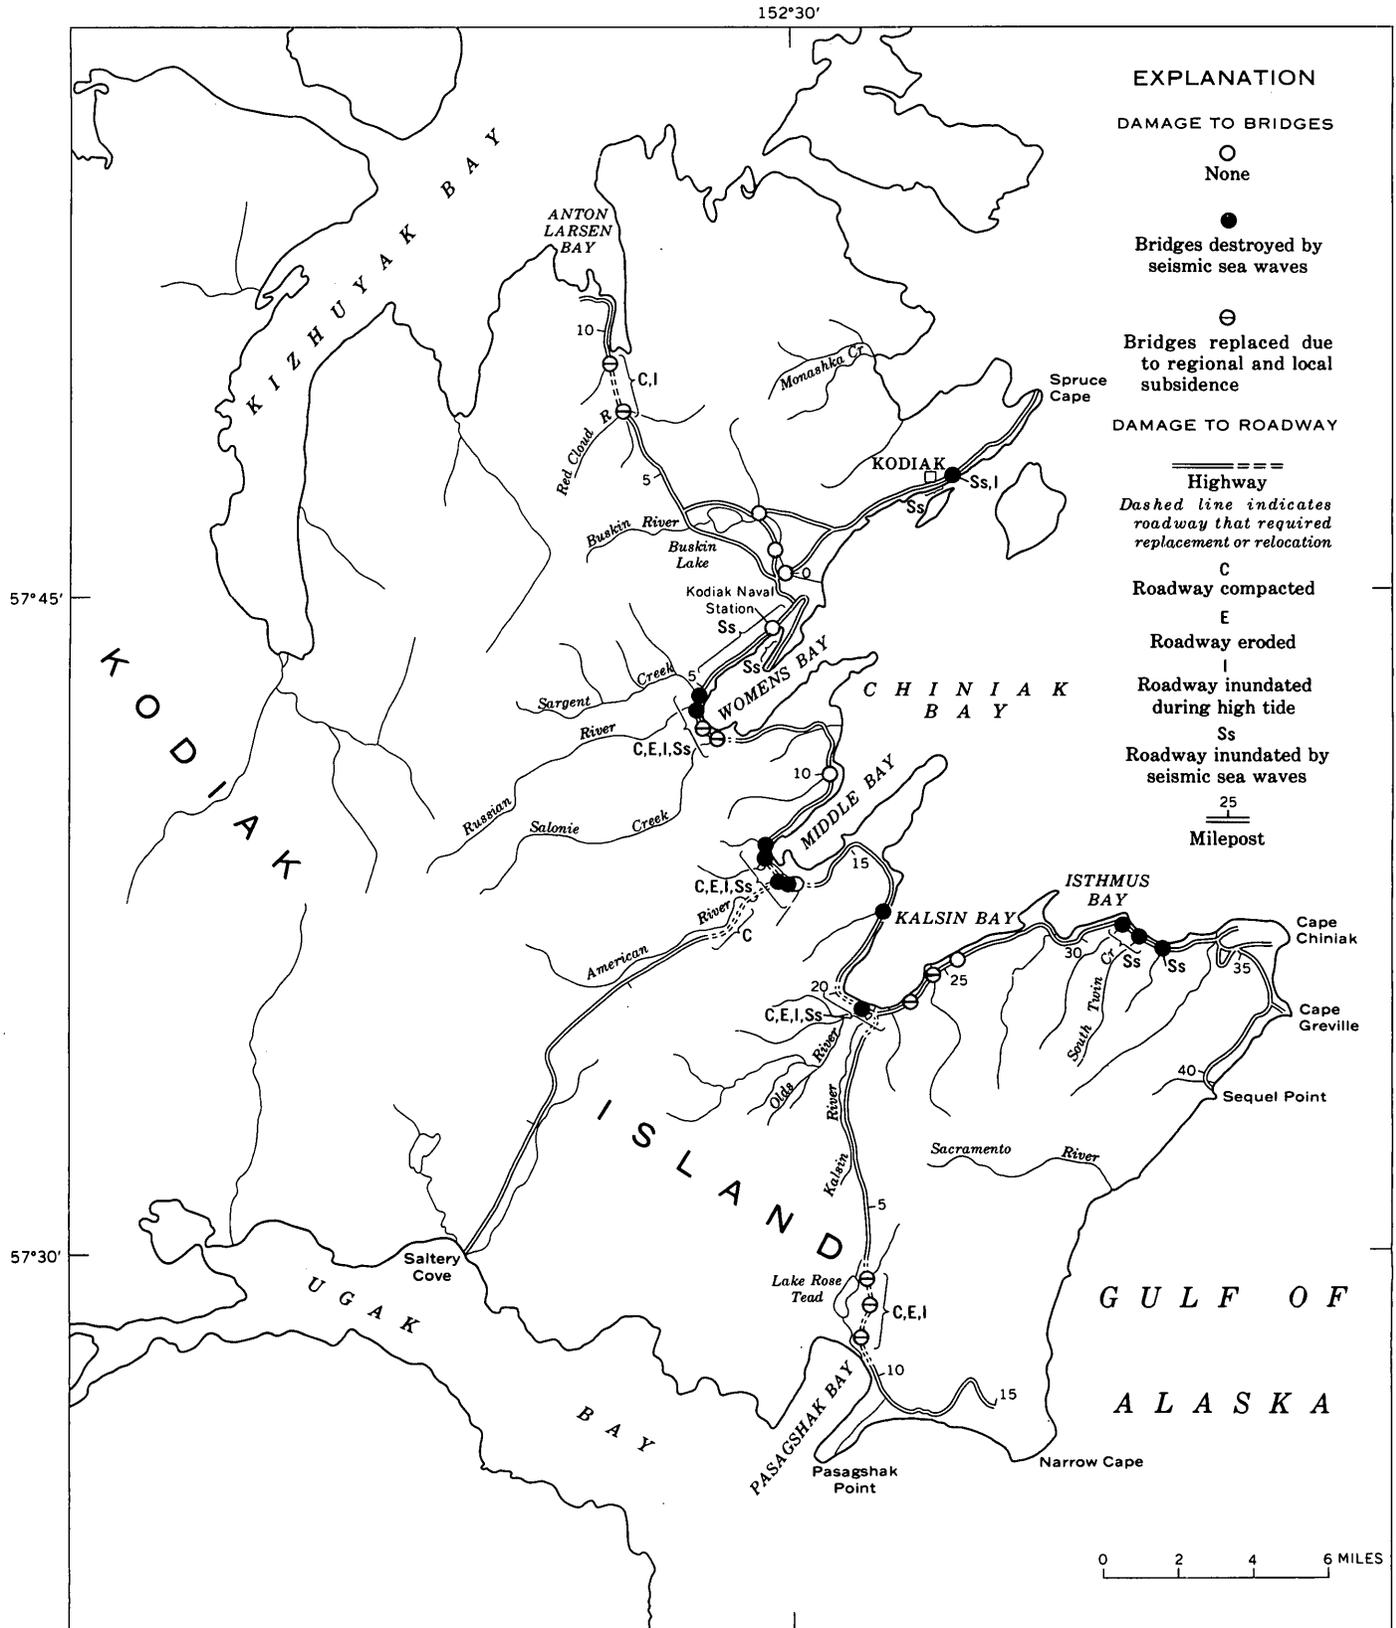
7.—Highway routes on Kodiak Island and effects of the earthquake upon the highways.

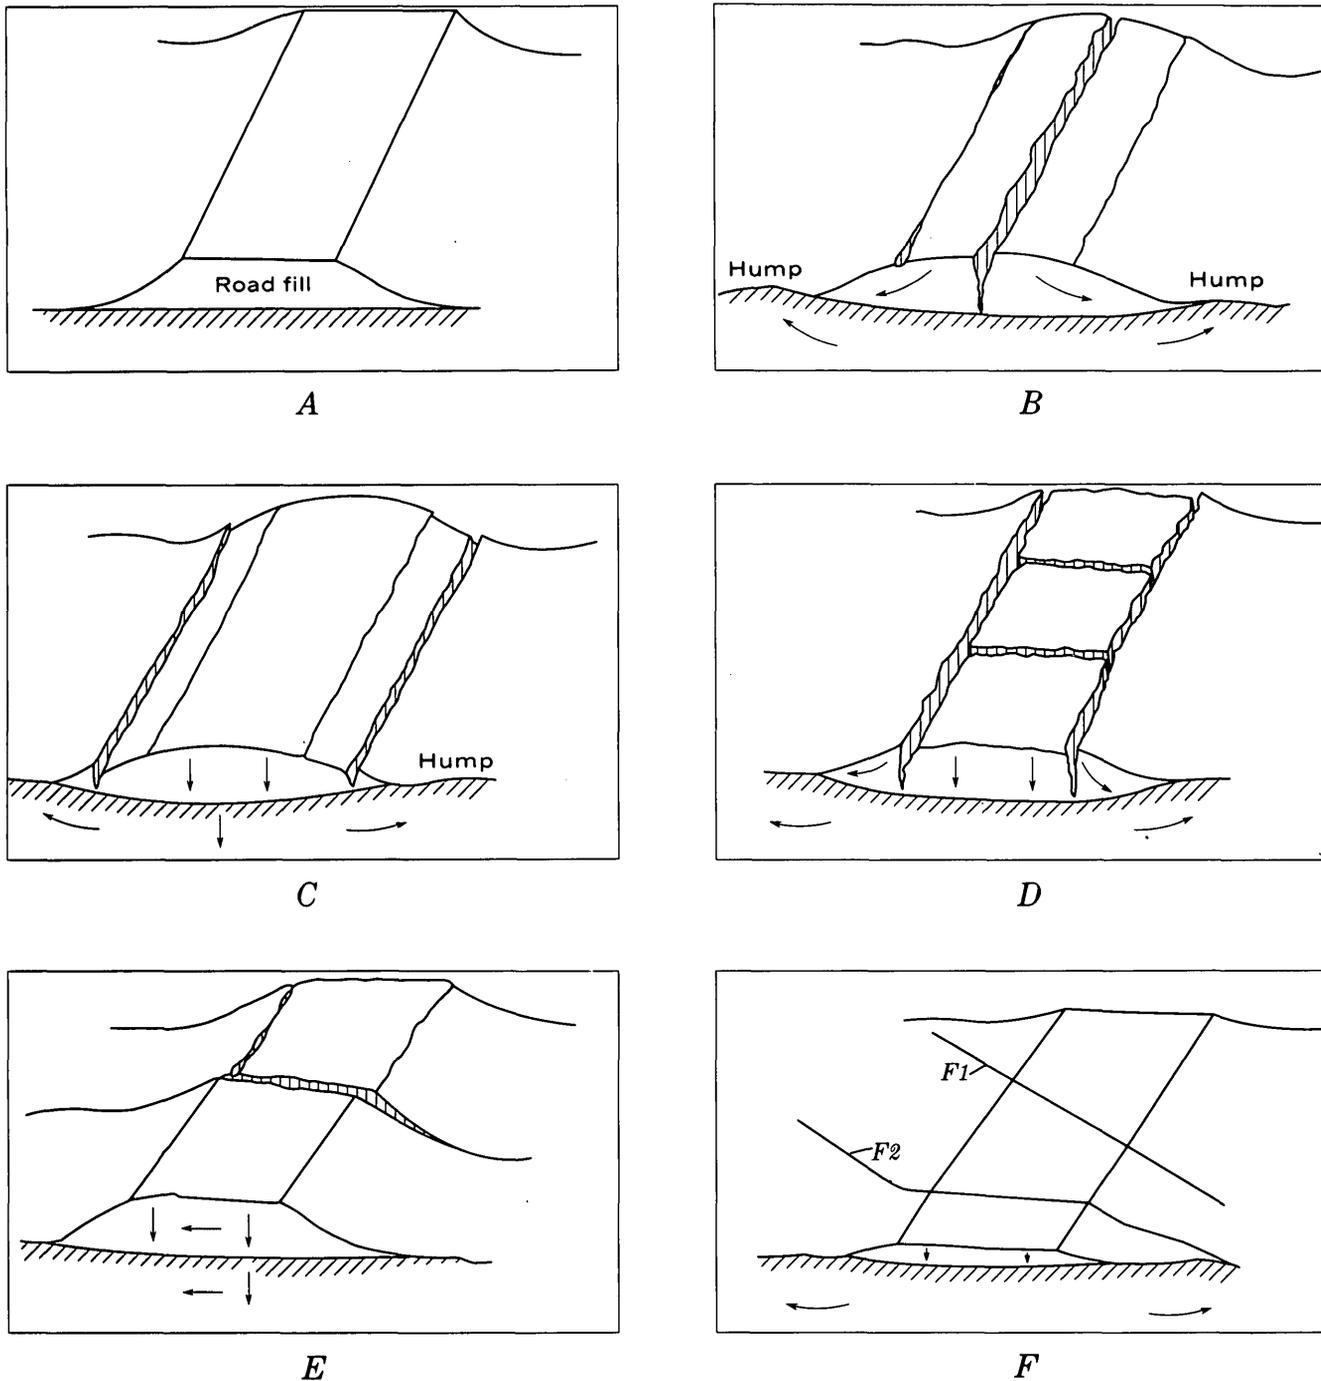
The most conspicuous fractures observed were those normal to the axis of the roadway (figs. 12E, 13); they were extensive along the Seward-Anchorage Highway and on the Richardson, Sterling, and Glenn Highways, particularly in paved sections. These fractures, plus the oblique type shown on figure 12F(2), represent about 90

12.—Schematic drawing of types of fracture generated by earthquake in roadways. *A*, Preearthquake. *B*, Underlying sediments compact and displace laterally. Roadway settles differentially and is moved laterally by underlying sediments; roadway fractures along centerline and is wavy; hump is formed off roadway. *C*, Underlying sediments compact and move laterally; roadway settles and longitudinal fractures develop along edges; roadway also wavy. *D*, Longitudinal fractures form as in *C*; as underlying sediments continue to compact and displace laterally, roadway settles differentially and transverse fractures develop. *E*, Fracture forms owing to horizontal displacement of roadway and underlying sediments; fracture generally originates off roadway. *F*, Fracture forms in original ground oblique to roadway; as it strikes roadway, it either continues at oblique angle (*F1*) or is refracted normal to roadway and, when past roadway, becomes oblique again (*F2*); these fractures occur chiefly in small roadway fills.

Fractures normal to the roadway are due to shear and tension (fig. 12*E*). The fractures due to shear first form in the ground because of mass displacement of the underlying sediments toward a

Failures along the centerline of the highway fill are due to tension (fig. 12*B*). As the roadway and underlying sediments are subjected to seismic shaking, the denser roadway subsides into the

Fractures along the edges and parallel to the roadway (fig. 12*C*,

D) are caused by compaction of the underlying sediments and lateral spreading of the ground. As seen in figure 12*C* the roadway, although wavy from differential compaction, has maintained its integrity. As the roadway is subsiding differentially, it is also being displaced along the axis owing to displacement of the underlying sediment. Thus, normal and longitudinal fractures are due to tension and are confined to the road fill.

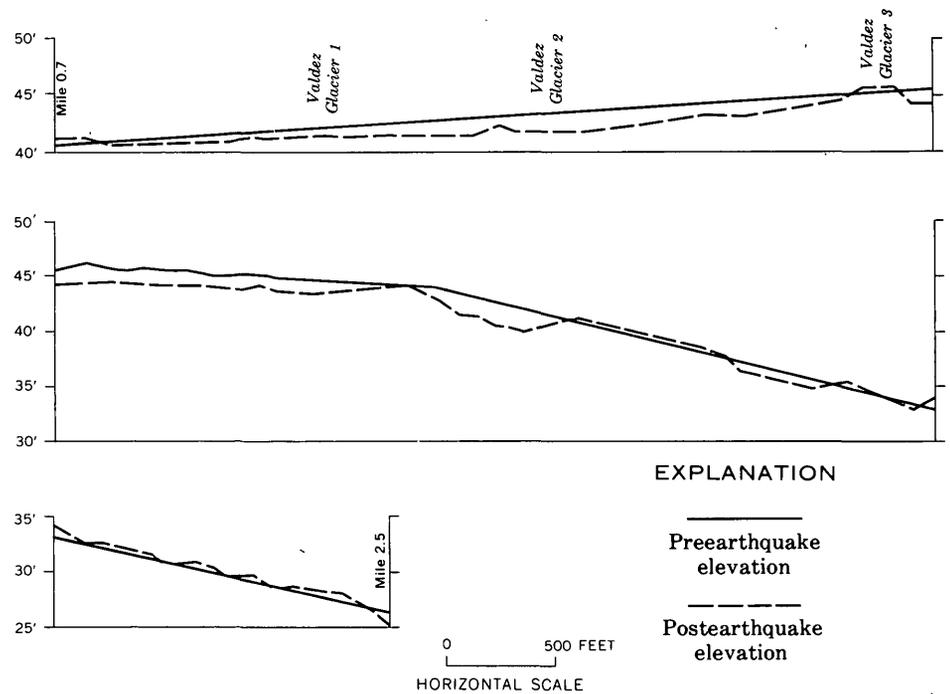
The most spectacular local subsidence occurred (1) on the Richardson Highway between mile 0.0 and mile 5.0, (2) on the Copper River Highway near mile 28.0, and (3) on the Seward-Anchorage Highway at Snow River Crossing and from mile 75.1 to mile 91.0. Figure 17 shows pre- and post-earthquake profiles from mile 0.7 to mile 2.5 of the Richardson Highway; figure 18, pre- and post-earthquake profiles from mile 5.9 to mile 11.0 of the Copper River Highway; figure 19, pre- and post-earthquake profiles from mile 75.1 to mile 85.0 of the Seward-Anchorage Highway; and figure 20, pre- and postearthquake profiles and pier elevations at the Snow River Crossing of the Seward-Anchorage Highway.

17.—Pre- and postearthquake profiles from mile 0.7 to mile 2.5, Richardson Highway. Data from Alaska Department of Highways.

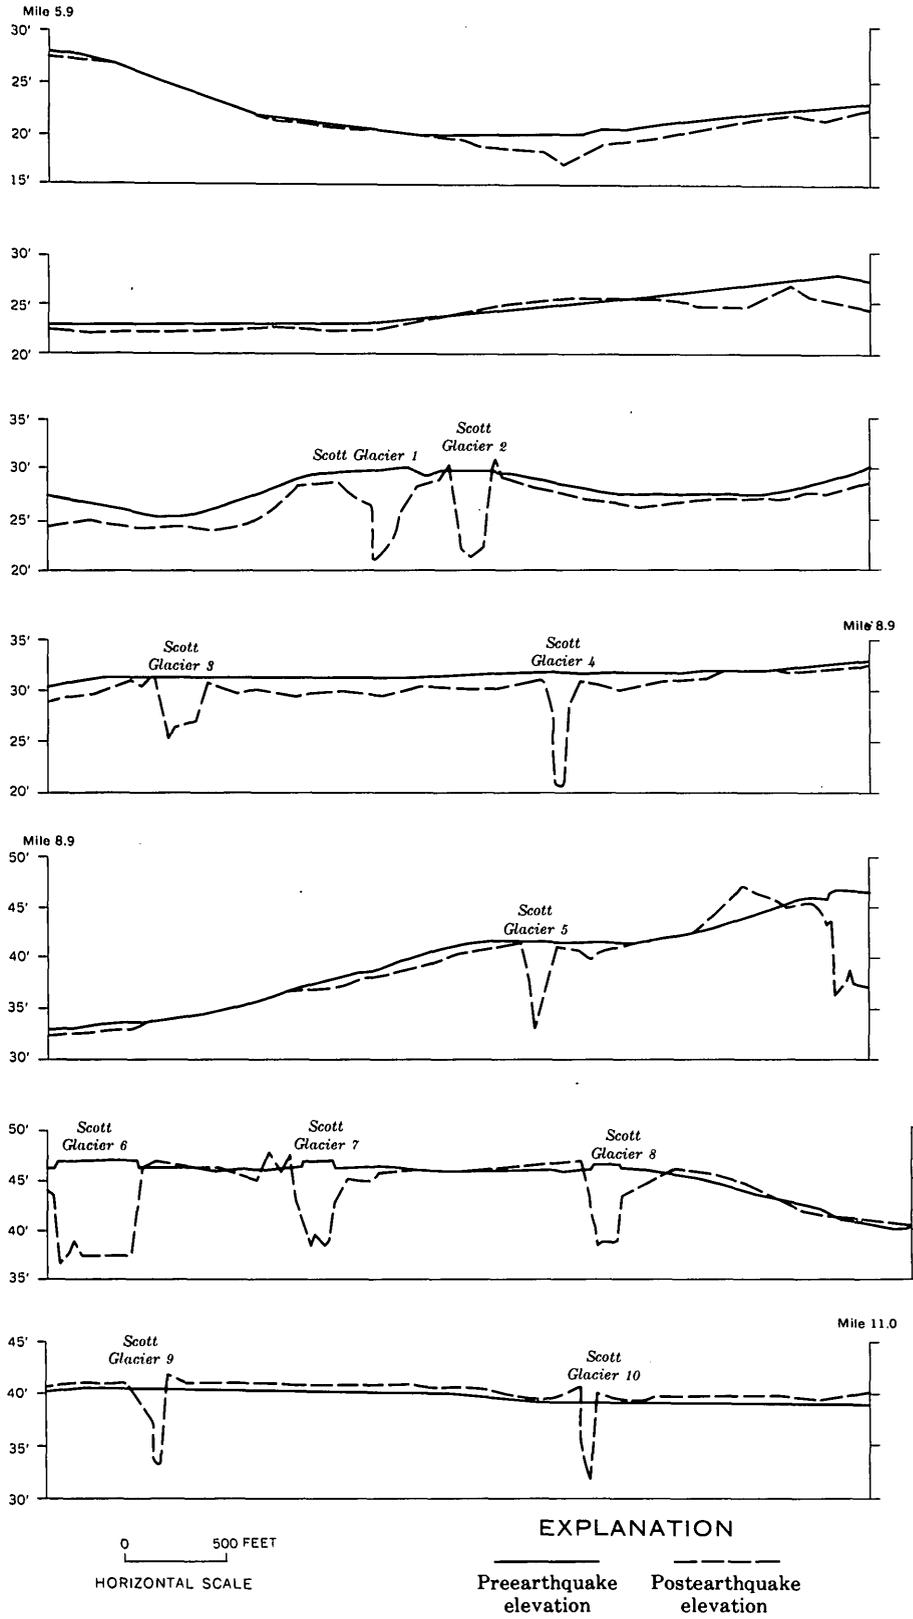
18.—Pre- and postearthquake profiles from mile 5.9 to mile 11.0, Copper River Highway. Data from Alaska Department of Highways.

Pre- and postearthquake profiles for the Copper River Highway are only available from mile 5.9 to mile 13. In this stretch of the highway a maximum local subsidence of 48 inches occurred at about mile 7.6. Here the roadway is underlain by clay, silt, sand, and organic debris (fig. 10). At mile 10.1, where the roadway is underlain by silty gravelly sand and silty

gravel, it did not subside. There was about 18 inches of subsidence at mile 11.0 where the highway is underlain chiefly by silty sandy gravel, sandy silt, and silty sand (all containing organic material; fig. 10); the water table there is about 2 feet from the surface.

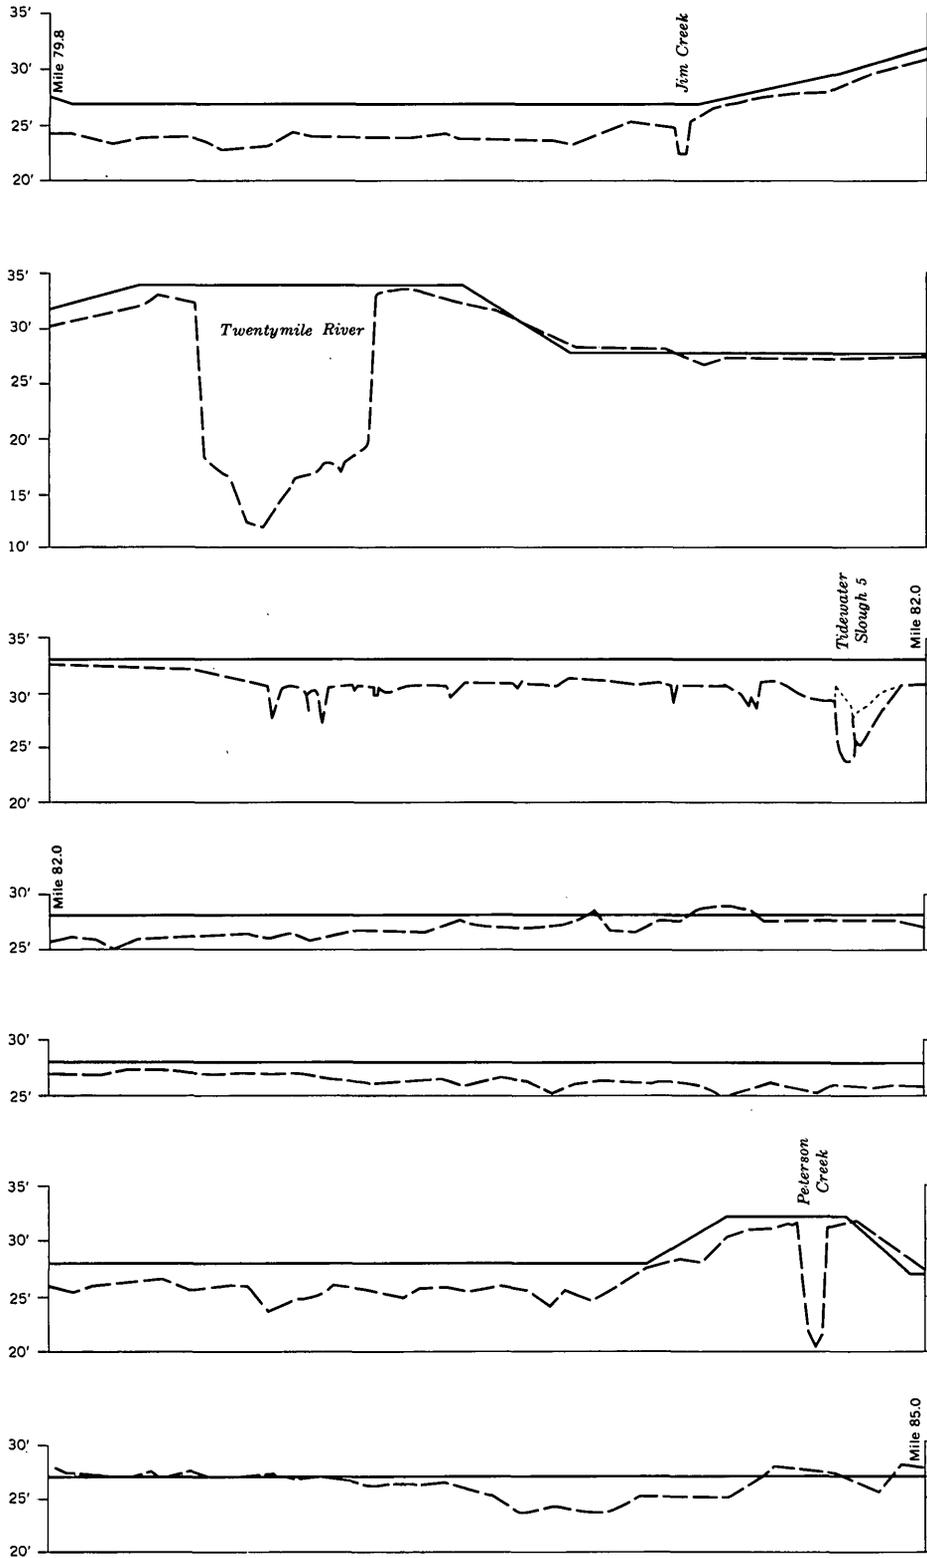
A large amount of local subsidence of the roadway occurred in the Portage area on the Seward-Anchorage Highway. Here a maximum subsidence of 54 inches was measured by the Alaska Department of Highways at mile 79.3 between Portage Creek 1 and

19. (Above and left)—Pre- and postearthquake profiles from mile 75.1 to mile 85.0, Seward-Anchorage Highway. Data from Alaska Department of Highways.

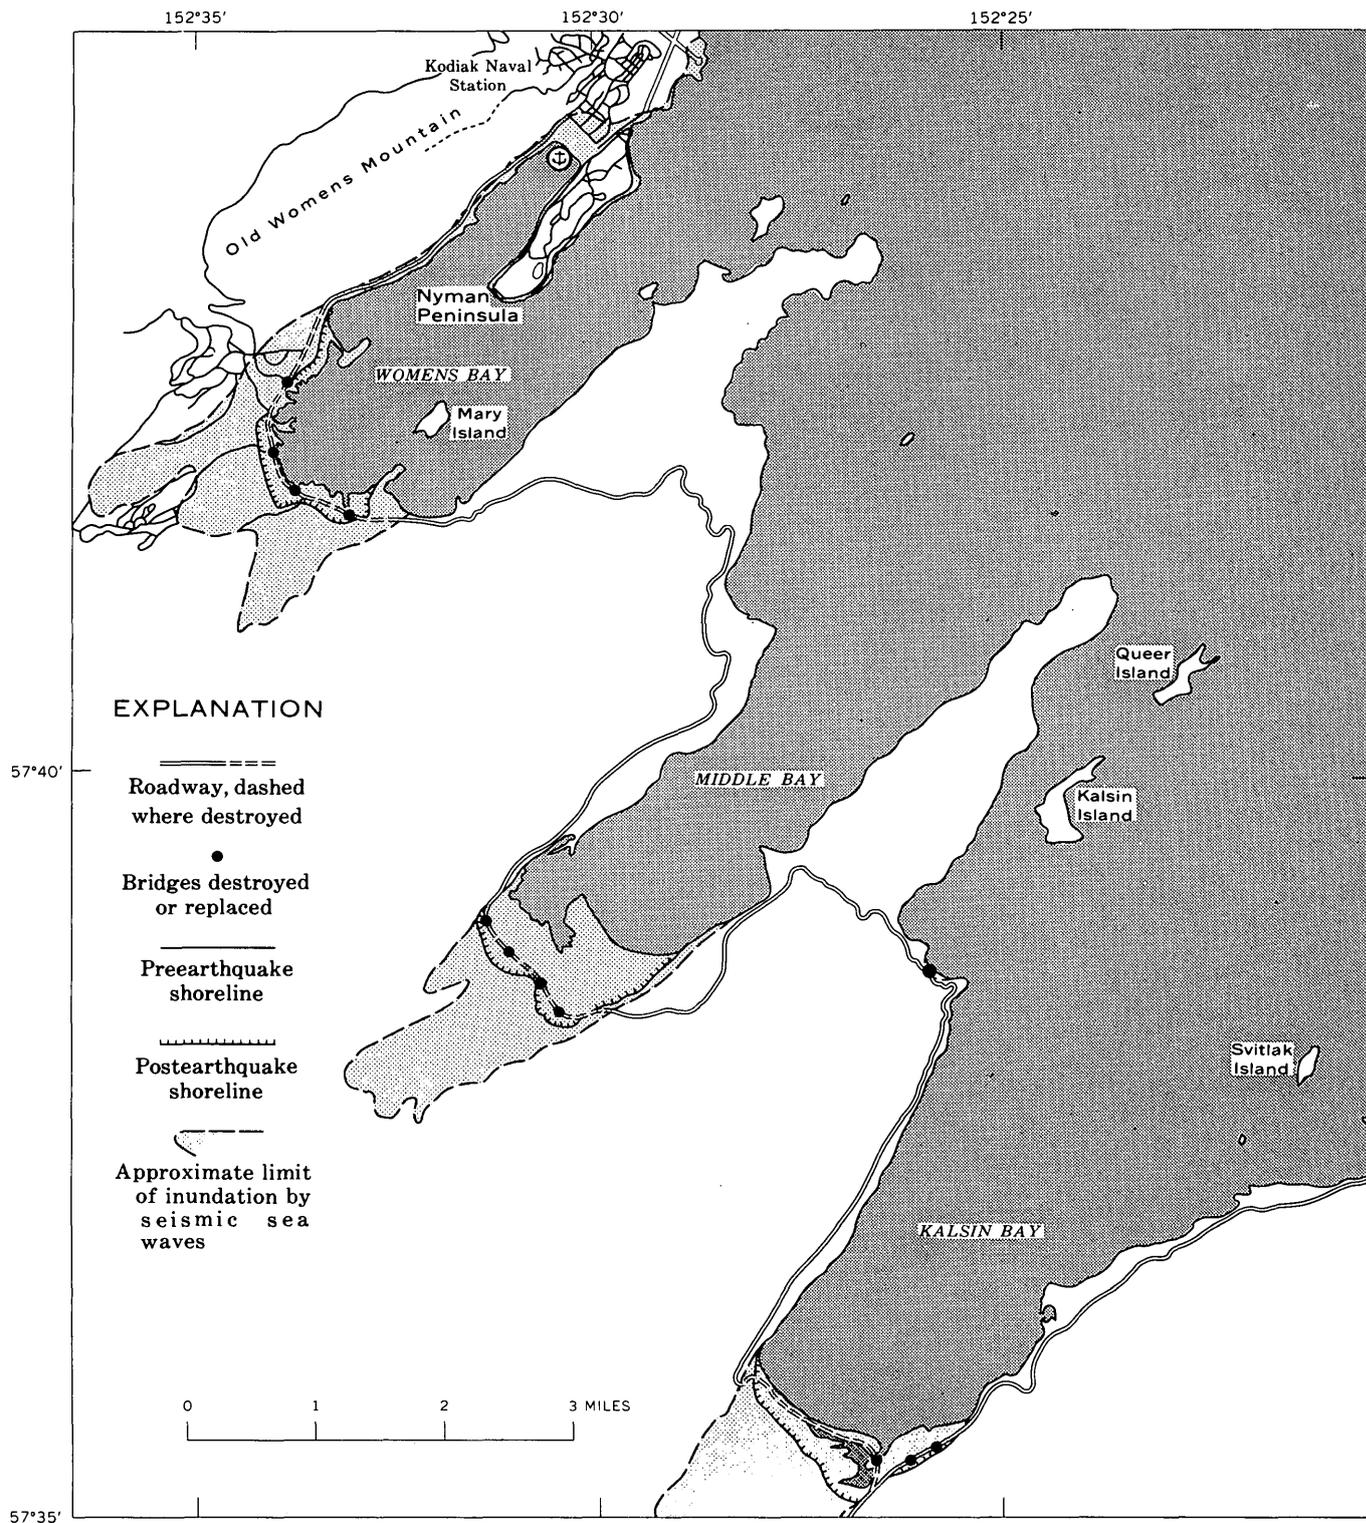
25.—Pre- and postearthquake shorelines and area of inundation by seismic sea waves on Kodiak Island.

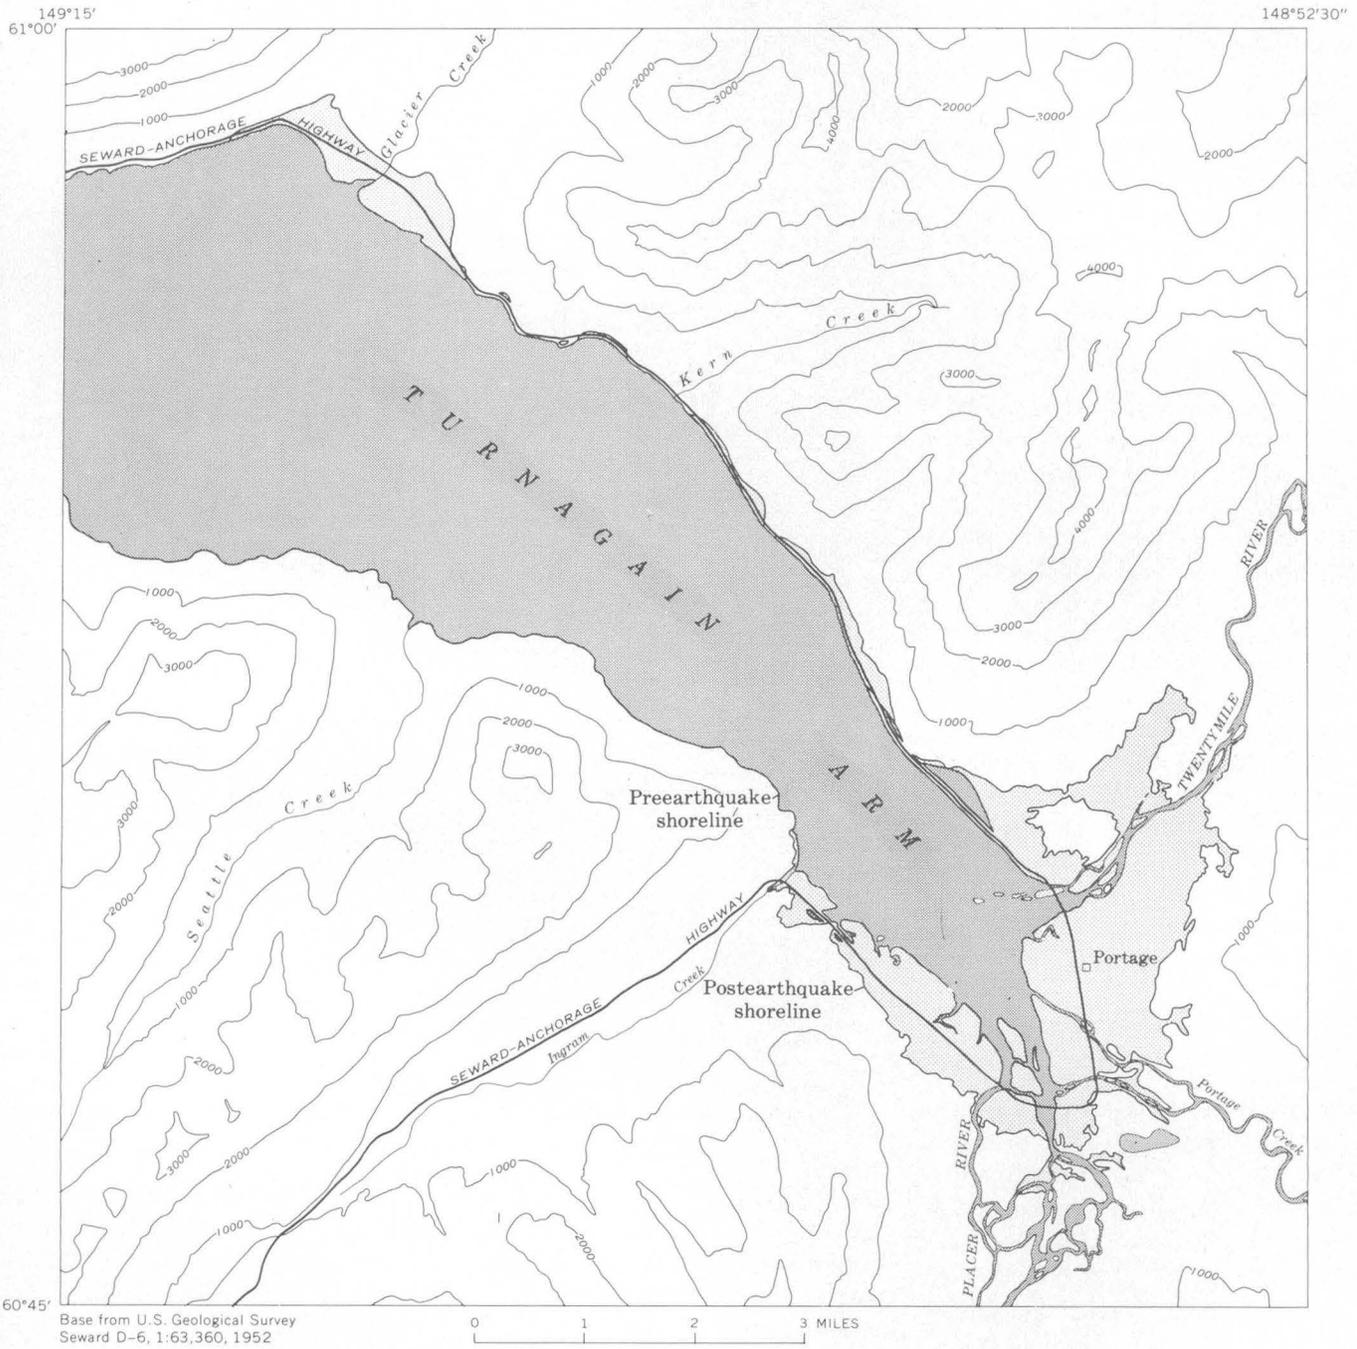
28.—Map of Turnagain Arm showing pre-earthquake shoreline based on mean high water and showing also the area inundated by the 33-foot tide of April 14, 1964. Tide height datum is mean lower low water.

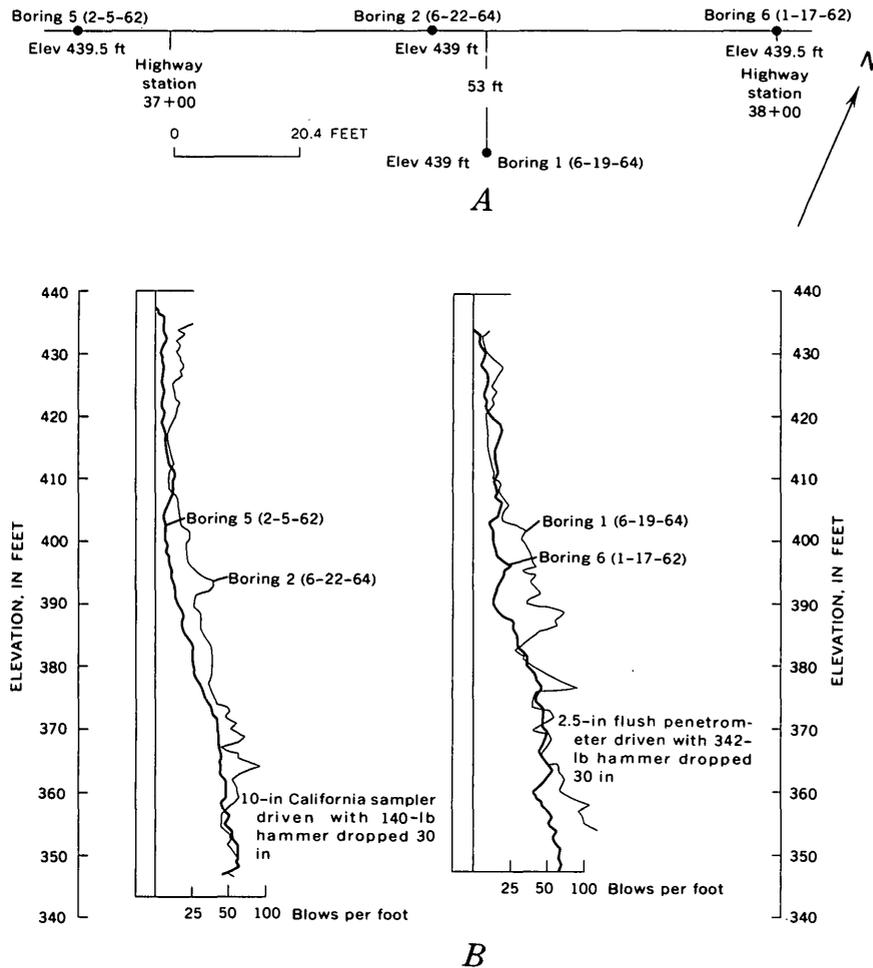
46.—Sketch of boring locations (A) and pre- and postearthquake penetrometer tests (B) at Snow River bridge 605, mile 17.7, Seward-Anchorage Highway. Data after George E. Utermole, Jr., Alaska Department of Highways.
