# The Alaska Earthquake

# Effects of the Earthquake Of March 27, 1964, on The Alaska Railroad

By DAVID S. McCULLOCH and MANUEL G. BONILLA

GEOLOGICAL SURVEY PROFESSIONAL PAPER 545-D

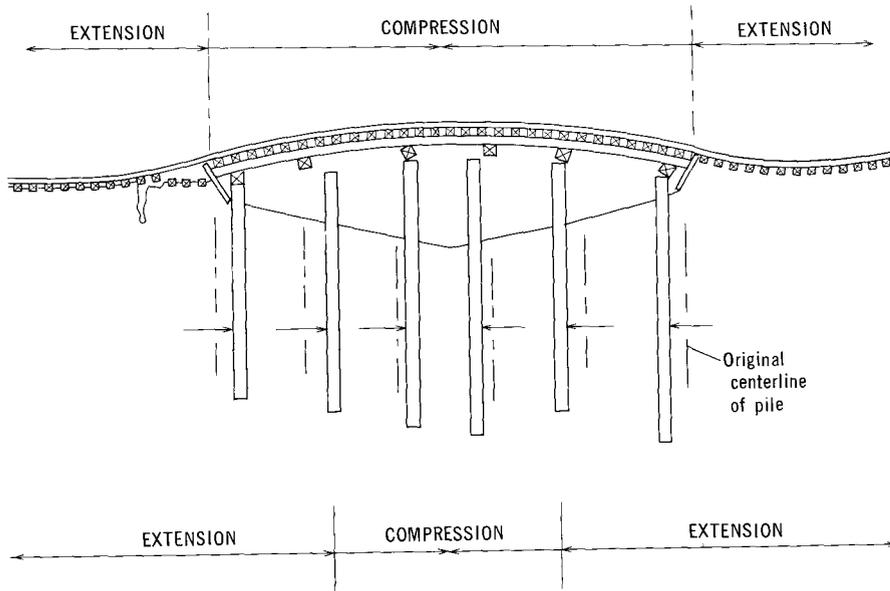
In nearly every damaged bridge, bents were shifted both horizontally and vertically, as shown diagrammatically in figure 5. Shifting occurred without vertical rotation; thus bents remained nearly vertical. Most horizontal displace-

Most displaced bents were torn free of the superstructure. Some pile caps remained attached to the piles and were pulled from the bolts that secured them to the stringers (fig. 5). Other pile caps remained secured to the stringers, but the piles pulled free of the drift pins that attach them to the pile cap and the sway braces were often split and detached from the caps. In other bridges, the pile caps were partially pulled from the stringers and the piles and were rotated between the shifting piles and the deck. Displacements of the bents probably very nearly reflect the movement of the foundation materials, because the connections between the piling and the superstructure appear to have offered little resistance to the horizontal displacement of the piles. If the connections at the tops of the bents had held, their bases would have rotated streamward, as were the bases of some of the piers

5.—Typical displacement of bridge piles. Most piles were crowded toward the center of the stream. The distance between piles increased at the bridge ends and decreased toward the bridge center. Piles in the center usually stood higher than at the ends.

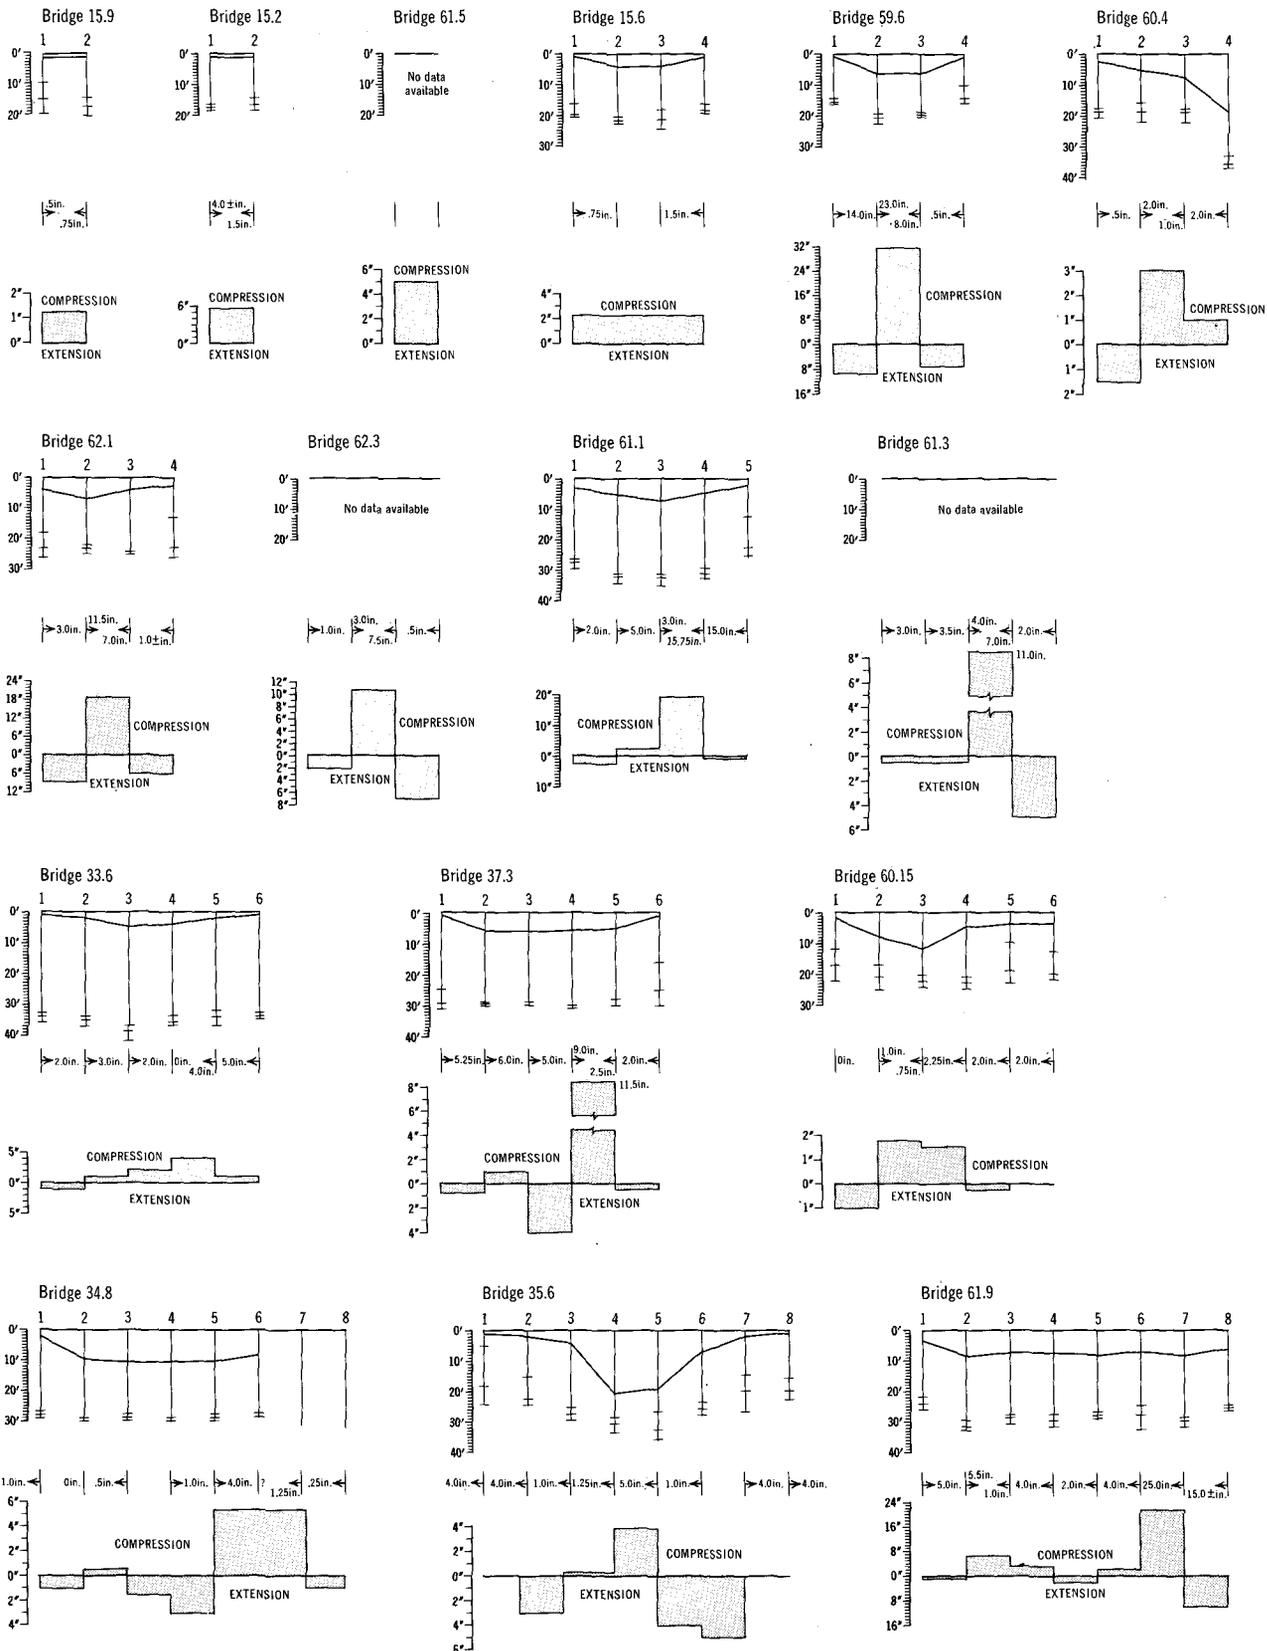
7.—Pile penetration length and relative horizontal displacement of bents of one- to seven-span open wood trestle bridges. The horizontal displacements are shown in terms of interpreted behavior of the foundation material: Extension, distance between bents increased; no change; and compression, distance between bents decreased. The shallowest, average, and greatest depths of penetration in each bent are indicated by horizontal lines.

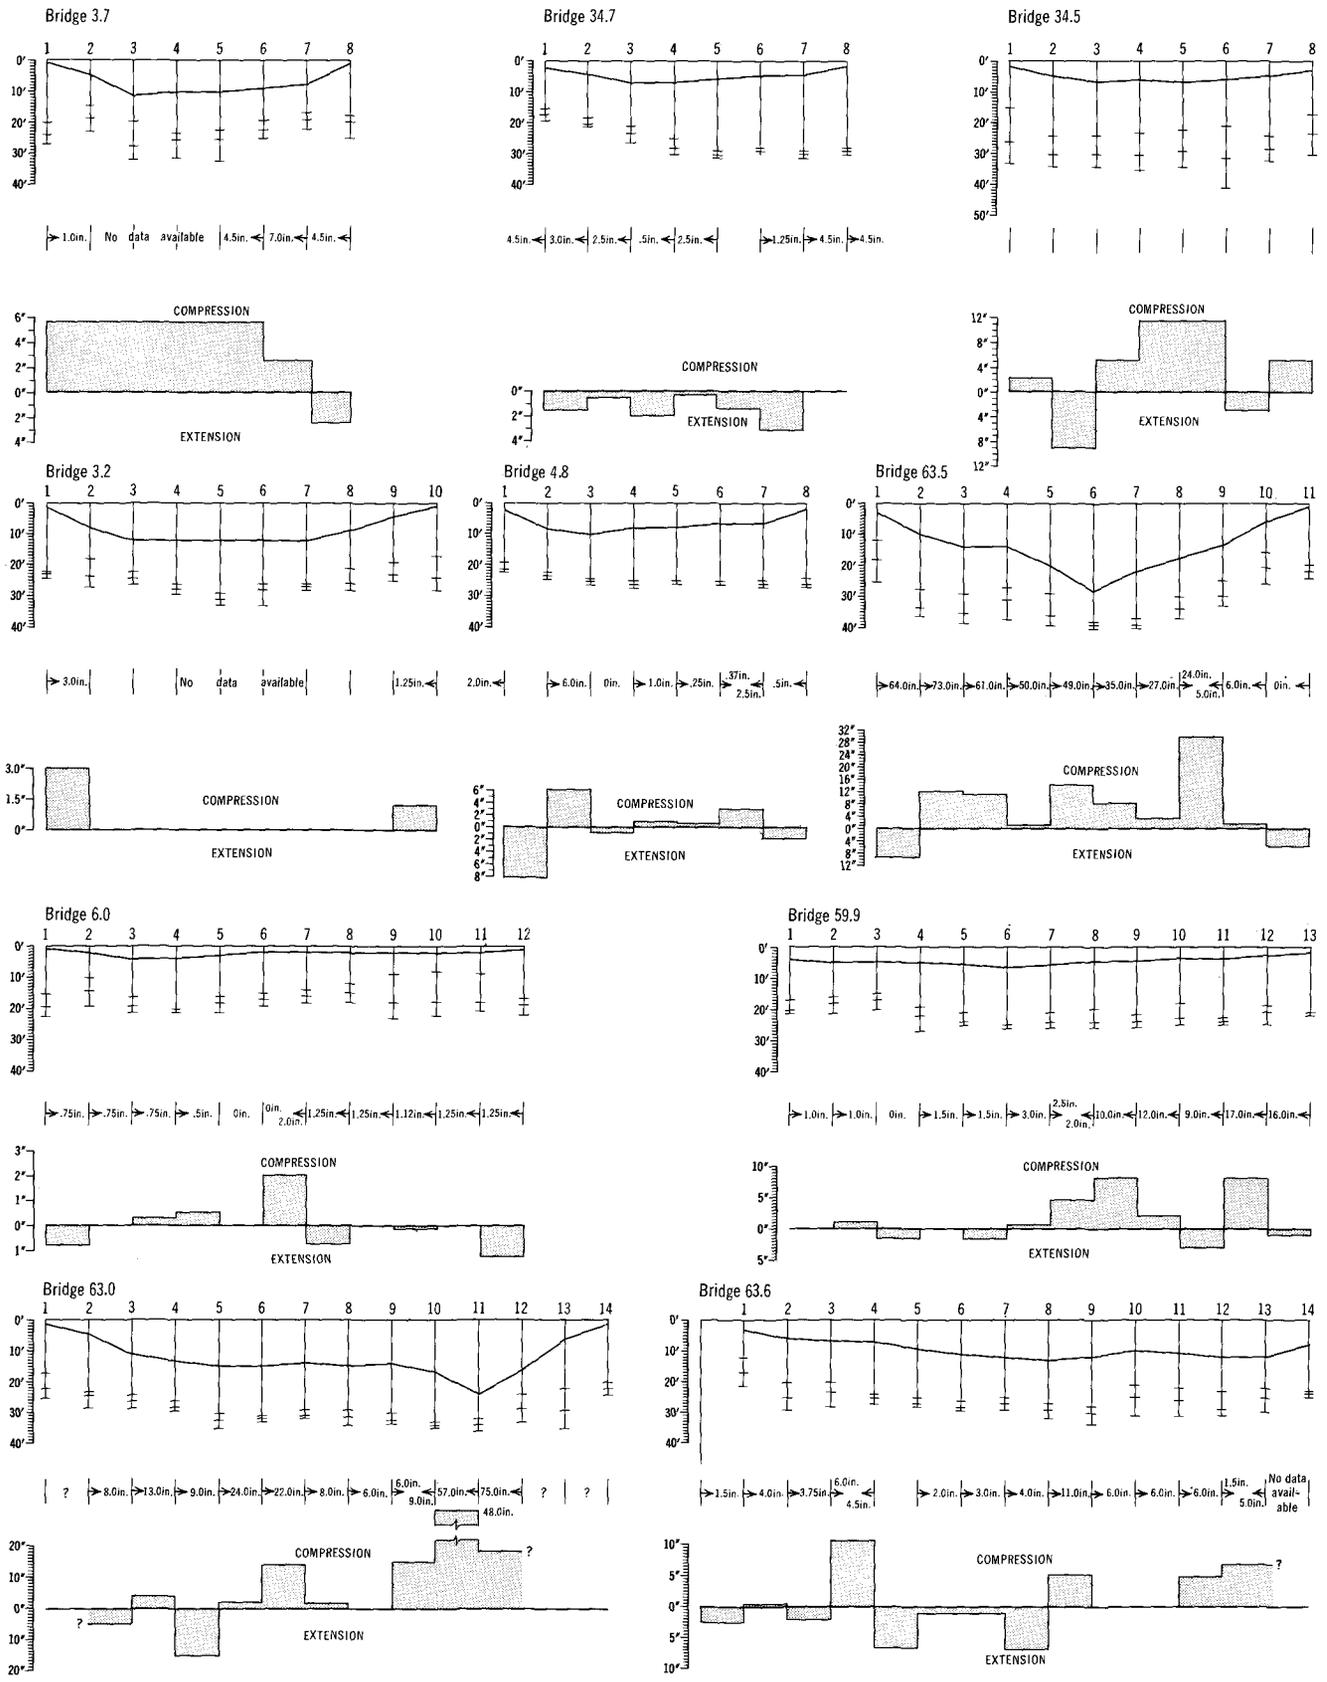
8.—Pile penetration length and relative horizontal displacement of bents of seven- to 14-span open wood trestle bridges. The horizontal displacements are shown in terms of interpreted behavior of the foundation material: Extension, distance between bents increased; no data; and compression, distance between bents decreased. The shallowest, average, and greatest depths of penetration in each bent are indicated by horizontal lines.

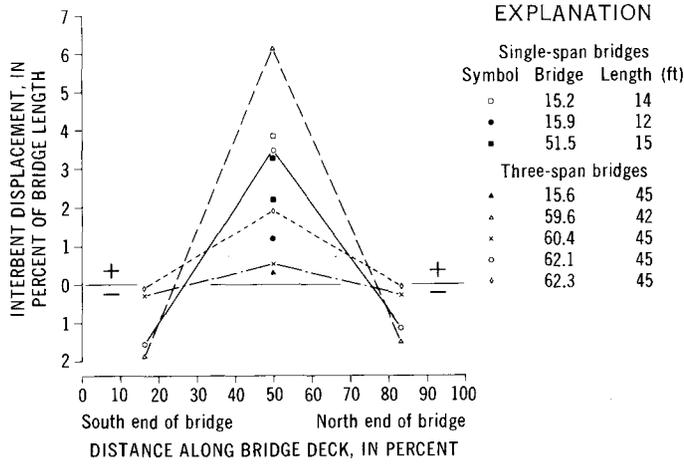
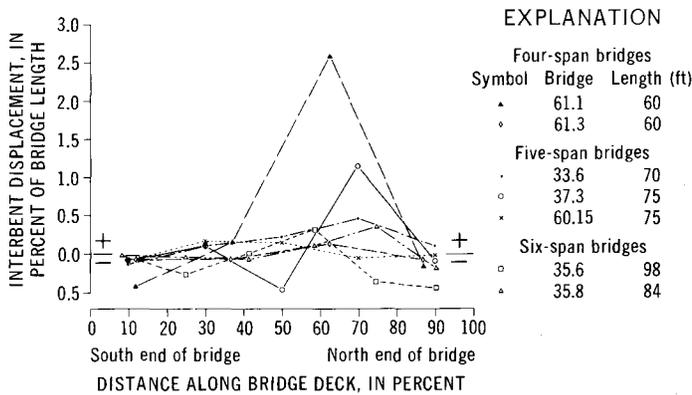
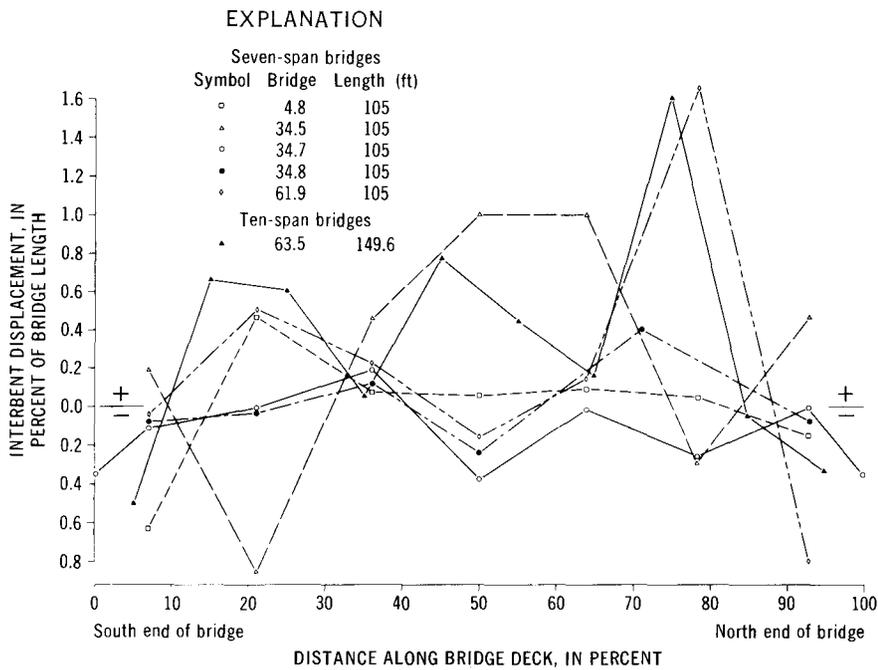
9.—Relative horizontal displacements between bents of open wood trestle bridges plotted as the percentage of the bridge length. Horizontal compression of foundation materials indicated by +, horizontal extension by —.

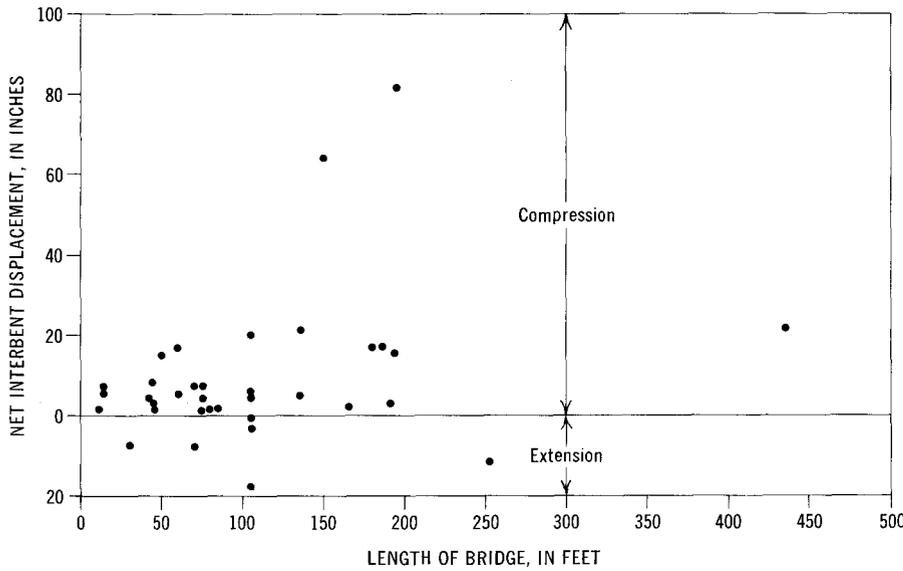
10.—Net horizontal compression or extension of bents, compared with the lengths of bridges.

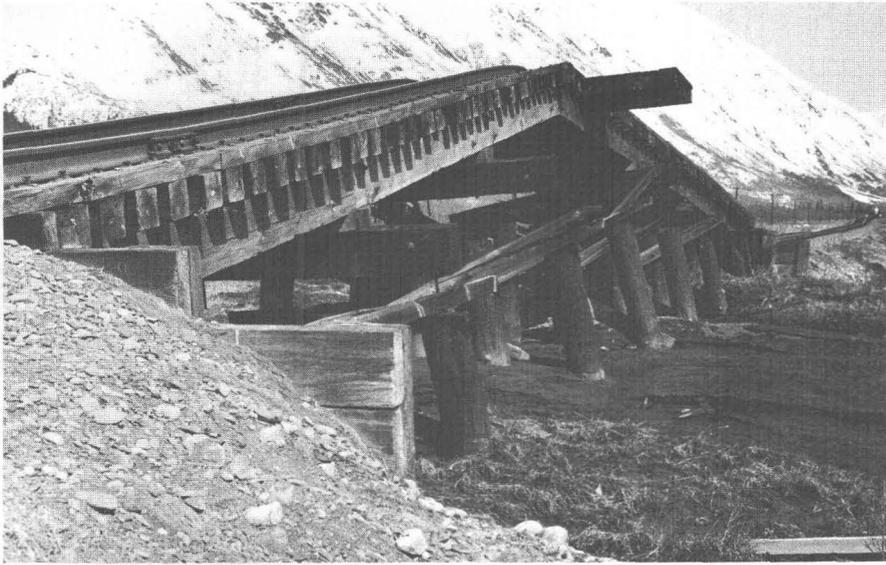
13.—Bridge 34.5 jackknifed upward by compression at the bulkheads. Note the mounds of fine-grained sediments ejected with ground water through cracks in the stream floor.

The 105-foot open wood trestle bridge at mile 34.5 was compressed so severely (2.2 ft) that the stringers jackknifed up off the piles and broke in the center of the span (figs. 13, 95). The piles were shifted toward the stream channel, and sand that had been ejected with ground water from cracks in the streambed covered the bed to a depth of several inches. Details of damage to this bridge are given on page D51.

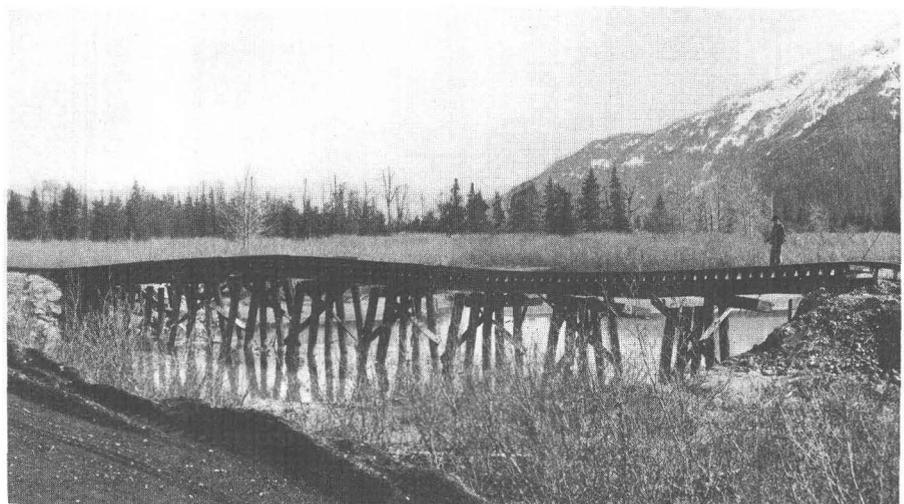
14.—Streambank closure of 64 inches drove the deck of bridge 63.5 through the south bulkhead up onto the top of the embankment. The tops of the piles beneath the deck describe an upward arch, and the deck sagged at the right until it encountered the piles. Photograph by The Alaska Railroad.

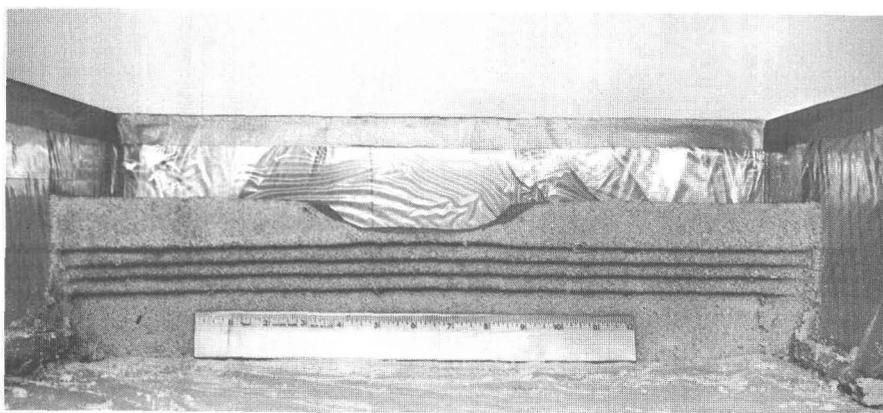
23.—A four-layer model showing upward arching of the carborundum layers beneath the channel. Note that the amplitude decreases in successively lower layers.

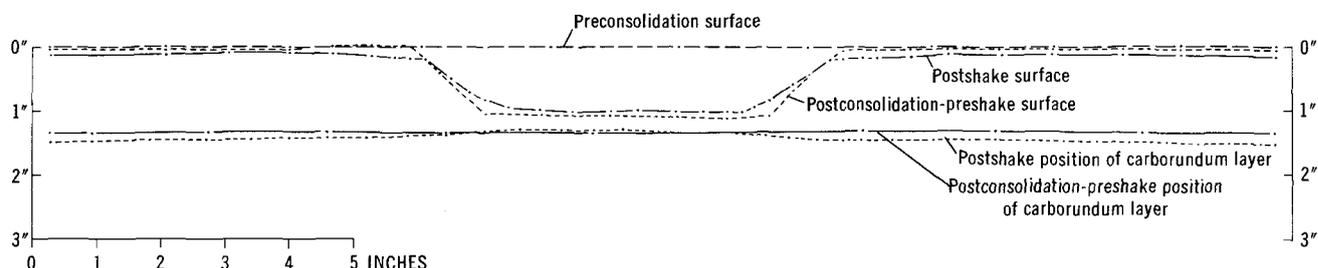
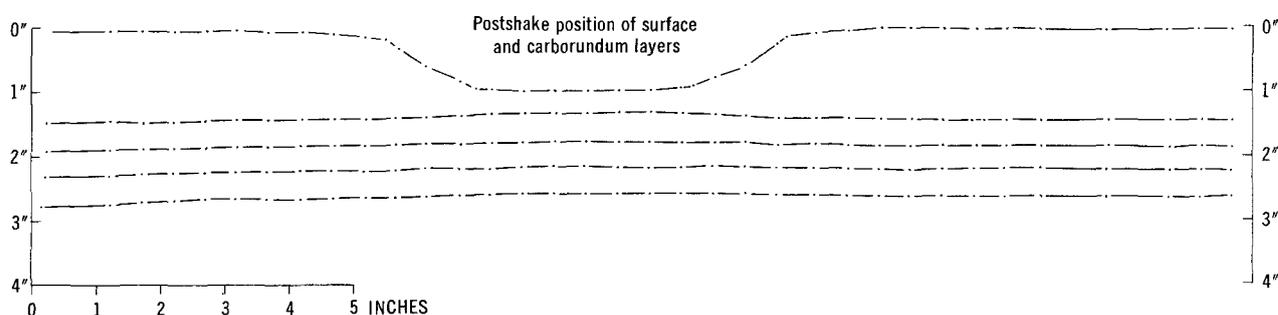
24.—*Upper*: A single-layer model showing the location of the carborundum layer and model surface before consolidation, the location of the surface and the channel cut after consolidation, and the final postshake position of the surface, channel, and carborundum layer. Note that the surface of the model was progressively lowered toward the channel. The edges of the channel were displaced toward the channel; the bottom of the channel rose to above its postconsolidation position, and the carborundum layer was arched above its original position. *Lower*: A four-layer model showing lowering of the surface toward the channel and arching of the carborundum layers beneath the channel.

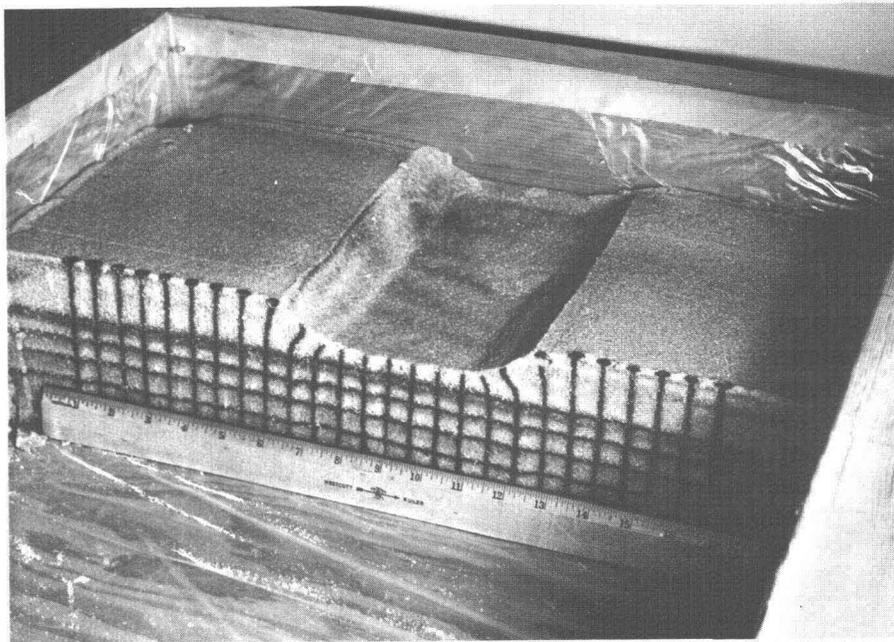
was built into which a vertical grid of carborundum was injected through a cannula (fig. 25). The pre- and postshake grids are compared in figure 26A. The preshake positions of the horizontal layers have been lowered, as described for previous models, to allow for consolidation.

25.—Postshake view of a four-layer model with a vertical carborundum grid shown in figure 26.

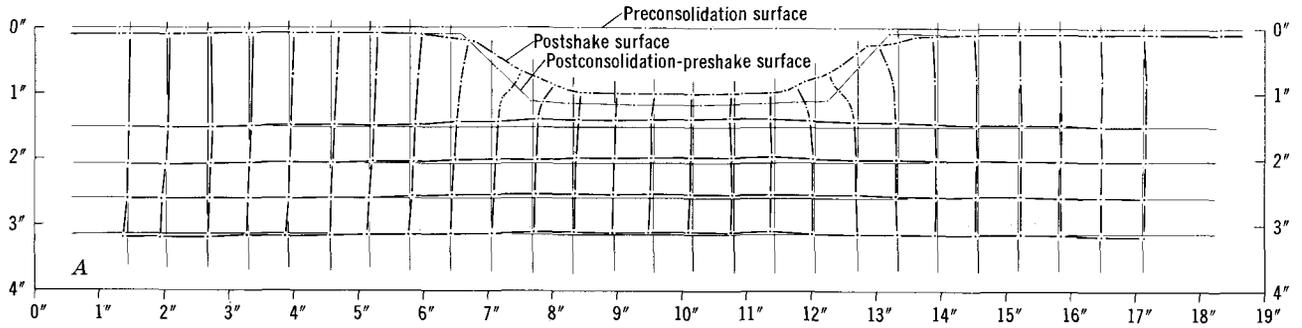
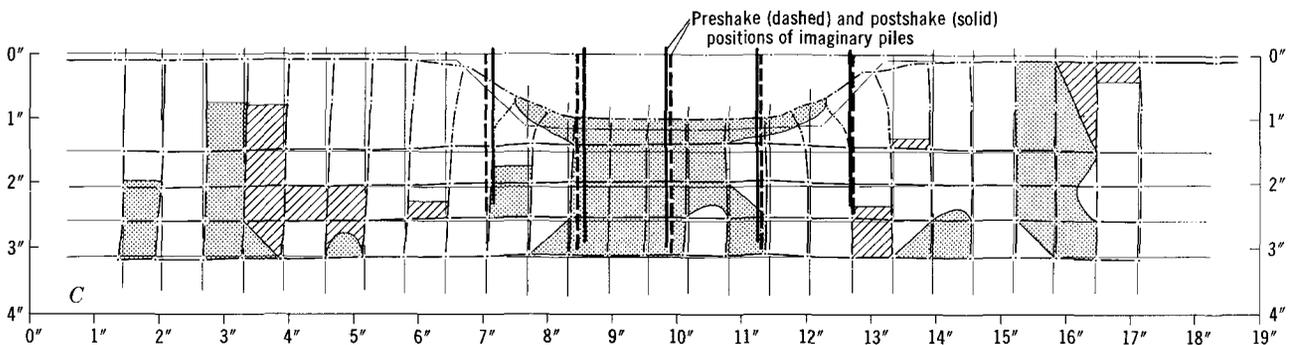
The distribution of particle movement throughout the model is shown by vectors that originate at the preshake positions of the grid intersections, and pass through the postshake positions (fig. 26B); the length of each vector is doubled in the figure to make small movements visible.

The particle displacement can also be treated quantitatively, and in figure 26B contours are drawn in which each contour interval is one-ninth of the length of the largest vector, and the value at any vector is taken to be located at the postshake position of the grid intersection. The large displacements at the channel sideslopes suggest that they are local failures not related directly to particle movement in other parts of the model. Distortion of the vertical lines at the sideslopes (fig.

Zones of horizontal compression and extension in the model are shown in figure 26C. If a properly scaled imaginary bridge (pile penetration of 20 ft and maximum unsupported pile length of 10 ft) were built across the model channel, with bents located as shown in figure 26C. Horizontal displacements of the sediments would have produced compression between central bents and extension, or no compression, between the outside bents. Assuming that the vertical displacement of each bent was the mean of the vertical displacements of the material at the bent, the

deck would have developed an upward arch of about 4 inches, with the crest of the arch at the central bent. Thus the horizontal and vertical displacements of the imaginary bents would have been quite similar to those observed in real bridges.

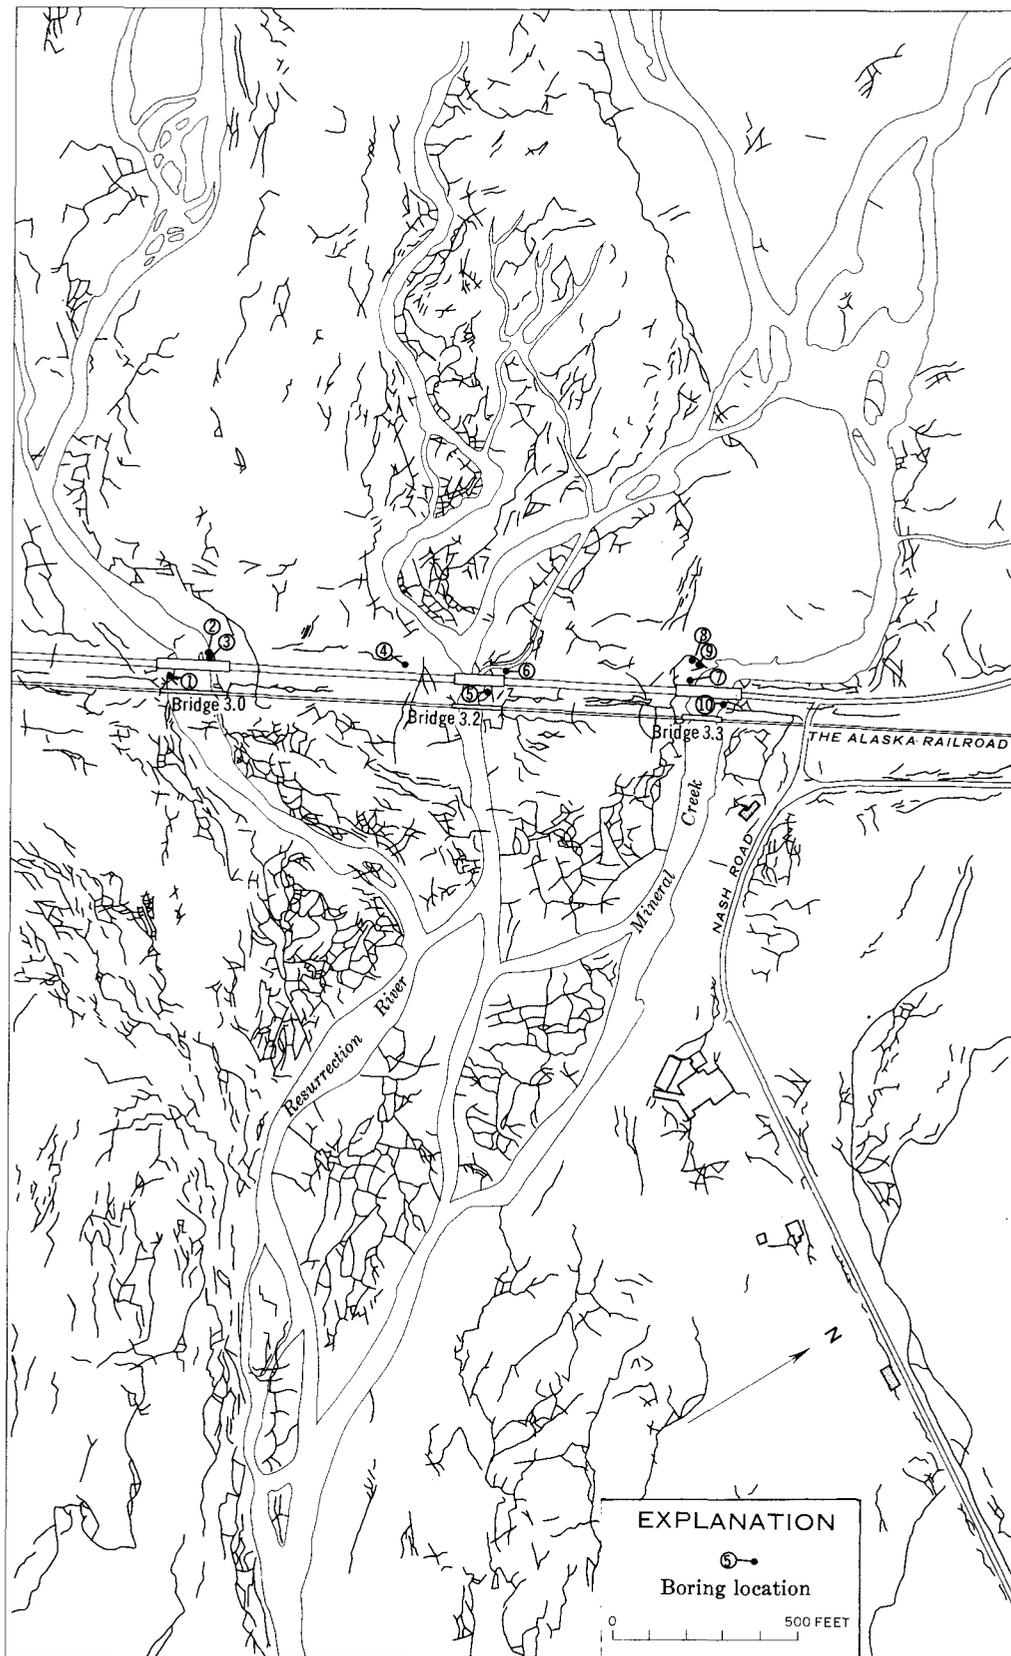
Three railroad and three adjacent highway bridges that cross the flood plain shared by Resurrection River and Mineral Creek just north of Seward were severely damaged. All three railroad bridges had to be replaced with entirely new structures. The low-relief flood-plain surface was severely fractured. Fracturing (figs. 27, 28) was accompanied by the ejection of a considerable amount of water.

27.—Ground cracking on the flood plains of Resurrection River and Mineral Creek. Numbers indicate borings, the logs of which are given on figures 29, 31, and 32. Cracks were mapped from aerial photographs taken by Air Photo Tech, Anchorage.

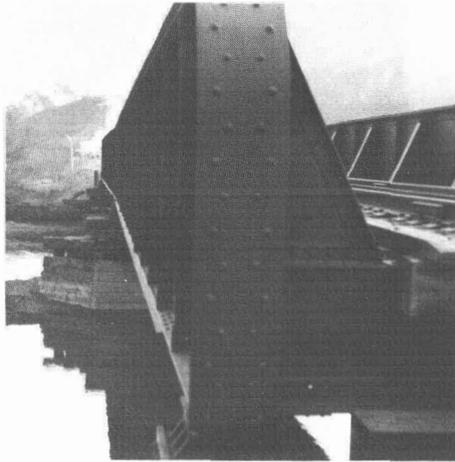
View south showing ends of bridge displaced downstream relative to its center

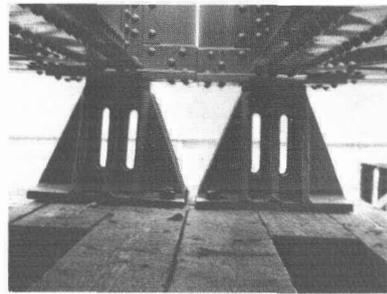
Fixed bridge shoes on the downstream side of the central pier were pried upward at their outward edges as the spans above were driven together

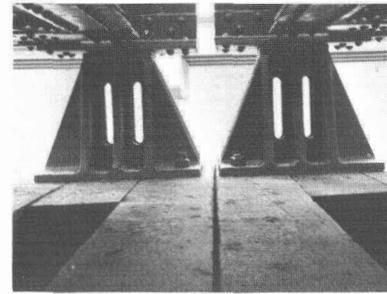
Fixed bridge shoes on upstream side of the central pier were not displaced

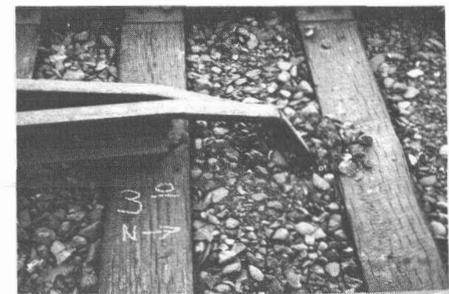
Central rail on bridge driven back into approach fill

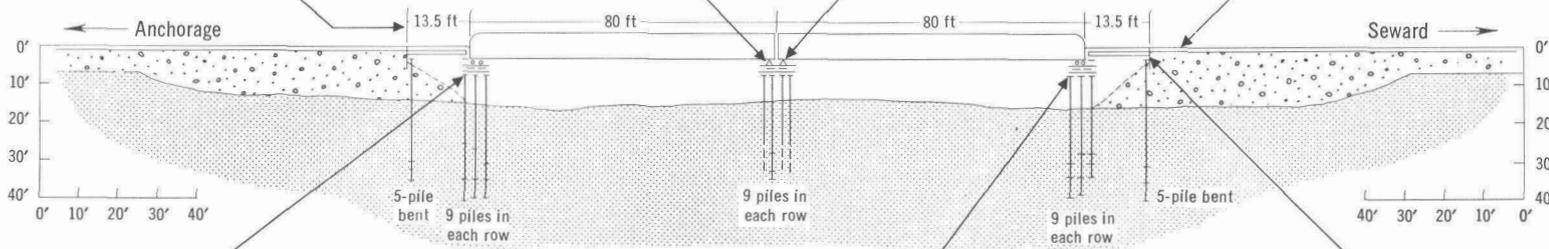
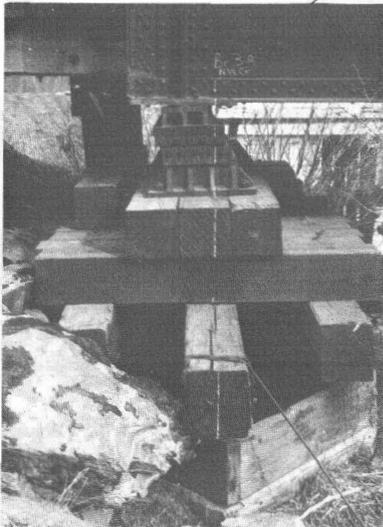
Piles at the bulkheads and piers were shifted streamward. All moved with no detected vertical rotation. The horizontal displacements ranged from 1½ to 11 inches; there was extension of the valley bottom sediments at the stream edges and compression in the center (fig. 29). The centers of the piers, originally under the bridge shoes, were displaced as shown by vertical chalk lines drawn up from the centerline of the central row of piles (fig. 29). As the piers shifted, rockers on the bridge shoes were driven to their extreme positions, and with continued movement of the piers, the cribbing was rotated, which placed more weight on the outside row of piles in each pier. The redistribution of the weight may have caused the vertical movements that occurred in piles under the piers. The tops of the piles in each row stood successively higher toward the streams. Despite the greater heights streamward, the cribbing was cantilevered off most

of the streamward row of piles. In the south pier, only three of the nine piles in the row were bearing; the rest ranged from three quarters of an inch to 6 inches below the cribbing. In the north pier all the streamward piles stood an inch or so below the cribbing. The transfer of the load to the outside piling and the decrease in skin friction which must have occurred during the movement of the sediments probably caused the outer row of piles to be driven downward into the sediments. Because these piers are closely spaced and depend primarily on skin friction for most of their bearing capacity, it also seems likely that downward movement of the overloaded piles may have produced a negative skin friction which pulled the unloaded streamward row of piles downward.

Piles shifted streamward, rotating the cribbing. Vertical chalk lines drawn upward from the pile cap at the pier center show the amount of horizontal displacement at the bridge shoes. Note that the nested rollers are driven into their extreme positions. Wooden stringers were driven 4 inches and 5½ inches into the central steel spans (shown by crowded ties in upper left of left photograph)

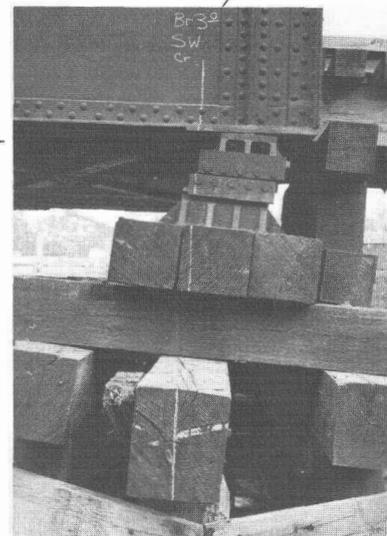
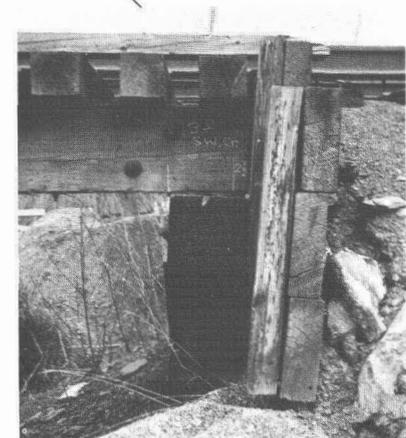
Deck stringers driven 2½ inches into the bulkhead. Rails pulled free at ties on the embankment. Bulkhead rotated back into the fill and guard timber driven over top at the bulkhead

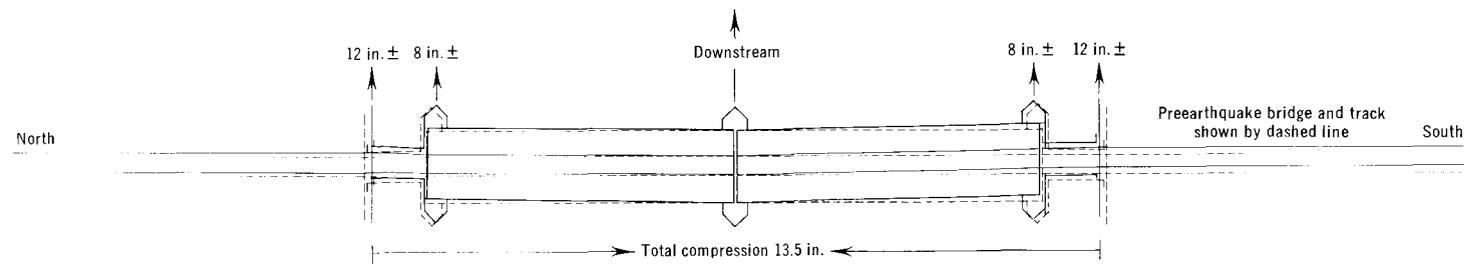
In addition to moving streamward, the outer piers shifted 8 inches downstream of the central pier, and the bulkheads and approach fills were carried 4 to 5 inches more; the central pier was thus left 12 to 13 inches upstream of the approaches. As shown in figure 29, the downstream edges of the steel girders were jammed together, and the metal shoes were rocked inward, their bases lifting ¾ and 1¾ inches off the cribbing. On the upstream side of the same pier the girders were pulled 3-3/16 inches apart. The compression of the steel spans at the downstream edge of this central pier may have exerted some downward force, for the top of the pier was tilted about 2 inches in the downstream direction.

Preearthquake bridge (dashed line) was compressed longitudinally and its ends carried in the downstream direction, while its center pier remained upstream

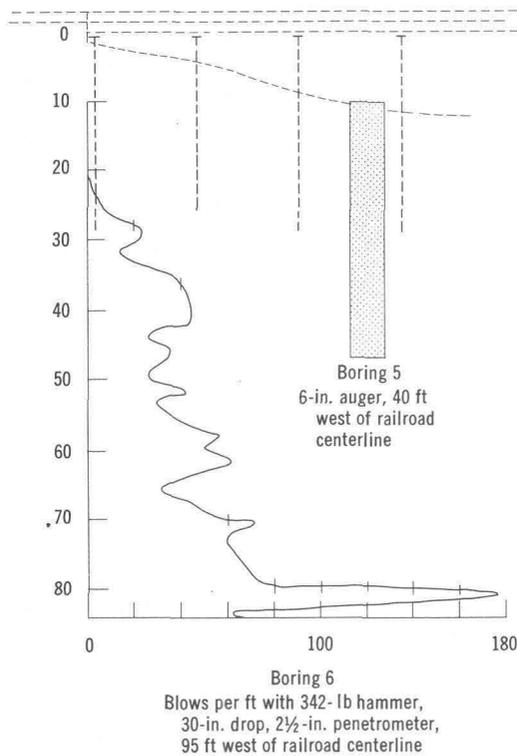
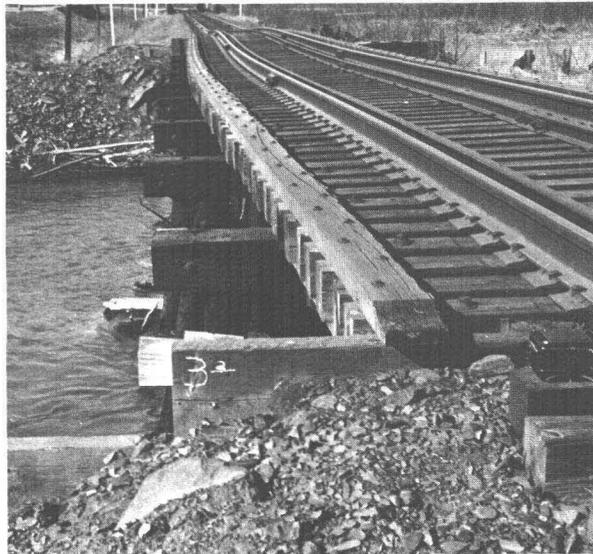
31.—Bridge 3.2; construction, damage, and subsurface information. Subsurface data projected to rail line at proper altitude.

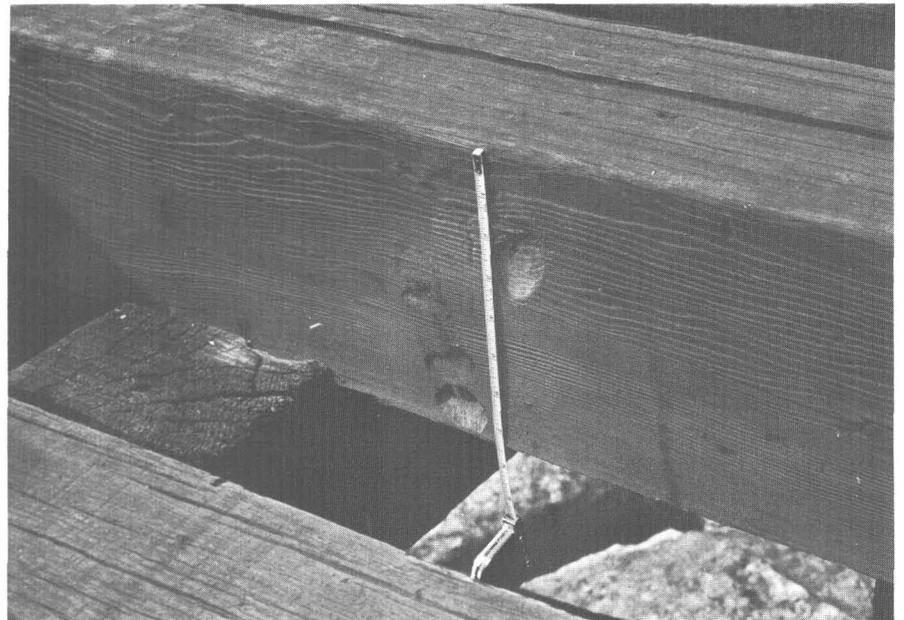
40.—Multiple dents on the end tie of a bridge deck made by a pebble that was caught as it fell between the filler (foreground) and tie during endways compression.

Using 0.07 to 0.09 seconds for the free-fall times making the assumption that the pounding was harmonic, a pounding rate can be estimated. If one assumes a wide range for the part of the compression-relaxation cycle during which the pebble was in free fall, the real rate should lie between the extremes. Assuming that the free-fall time was from  $1/5$  to  $1/2$  the cycle, the pounding rate should lie between 2.22 to 7.14 cycles per second. Clearly the assumptions make these figures questionable; furthermore they represent data from only one bridge. However, their magnitude suggests that this transient horizontal displacement is produced by considerably higher frequency ground displacements than those of observed surface waves, where periods are in the range of several seconds. (See, for example, Coulter and Magliacchio, 1966, p. C10.)

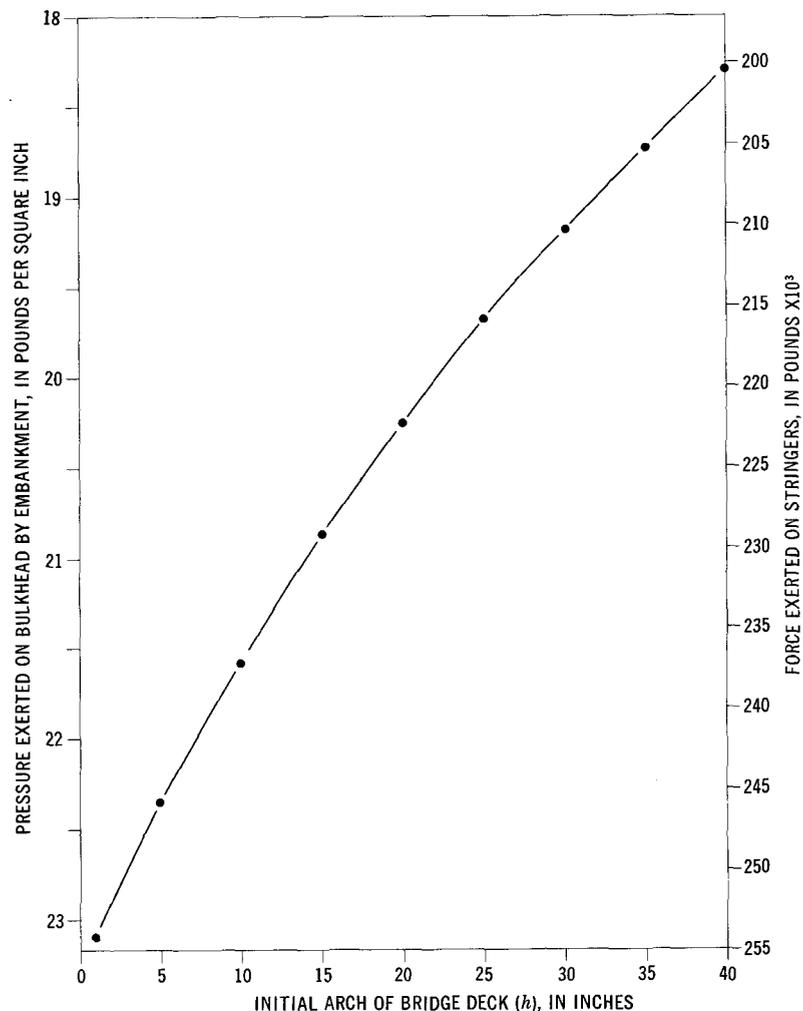
43.—Compressive force on the stringers of a 105-foot open wood trestle necessary to lift the superstructure just free of the piles, given some initial arch in the deck. The force exerted on the bulkhead by the embankment is also given.

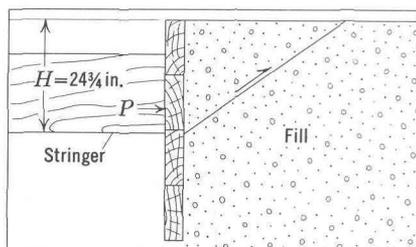
45.—Location of a possible Coulomb failure surface in an embankment due to force exerted on the embankment by bridge stringers.

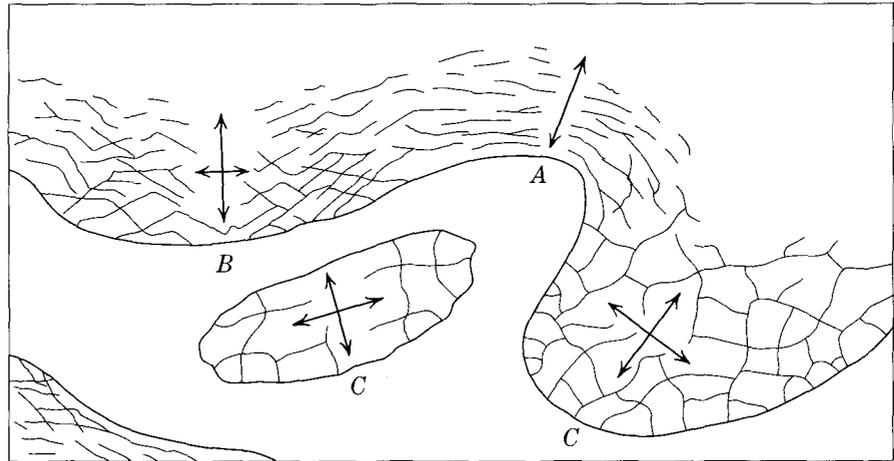
The probable relationship between the surface stress distribution and cracking adjacent to stream valleys is shown in figure 46, in which the inferred stress directions are shown by arrows. In areas affected by this kind of ground cracking that were bounded by straight or concave streambanks (*A*, fig. 46), the movement of the underlying sediment was somewhat convergent or unidirectional. Cracks that formed were generally parallel to the stream and normal to the stress, suggesting that they are tensional failures. Adjacent to convex streambanks (*B*, fig. 46), where the cracking resulting from streamward movement did not extend far

back from the stream edge, the spreading of the underlying sediments formed two perpendicular principal directions of stress, the major stress perpendicular and the minor stress parallel to the stream-bank. The resulting cracks formed at an intermediate position between the strain axes, and intersected at about  $45^\circ$  to  $70^\circ$ , suggesting that they were shear fractures. Cracks of this type were the most common kind on the distal edges of fans and deltas where the distortions of embankments and powerlines and the extension of bridges indicate that radial downhill spreading of the sediments occurred at some depth beneath the surface (see Sections 5, 6, 9, 10). In areas where the sediments spread in many directions, such as on the insides of meander bends and on small islands (*C*, fig. 46), the dominant crack pattern was an open network of curved or linear fractures that commonly intersected at right angles. The pattern of these cracks is similar in several respects to orthogonal thermal contraction cracks in frozen ground (Lachenbruch, 1962) that result from progressive tension failures. Where the stress in the surface layer is isotropic, orthogonal contraction cracks are curvilinear, intersecting at about  $90^\circ$ , and the crack-bounded blocks are randomly distributed. Where there is some preferred stress, the crack pattern can become highly rectilinear. In the formation of thermal contraction cracks, the preferred stress may result from a local heat source, such as a stream, whereas the rectilinear orthogonal fractures produced during the earthquake appear to have been due to the concentration of stress in the axes of abandoned channels that form small, elongate, generally parallel depressions in the surface.

46.—Relationship between probable stress and ground cracking produced by land-spreading toward a topographic depression. Arrows indicate directions of principal stress. Tension cracks form at right angles to the stress on straight and concave banks (*A*); shear fractures form on convex banks where the largest principal stress is perpendicular to the bank (*B*); cracks are orthogonal where stress is omnidirectional, as on islands or highly convex areas (*C*).

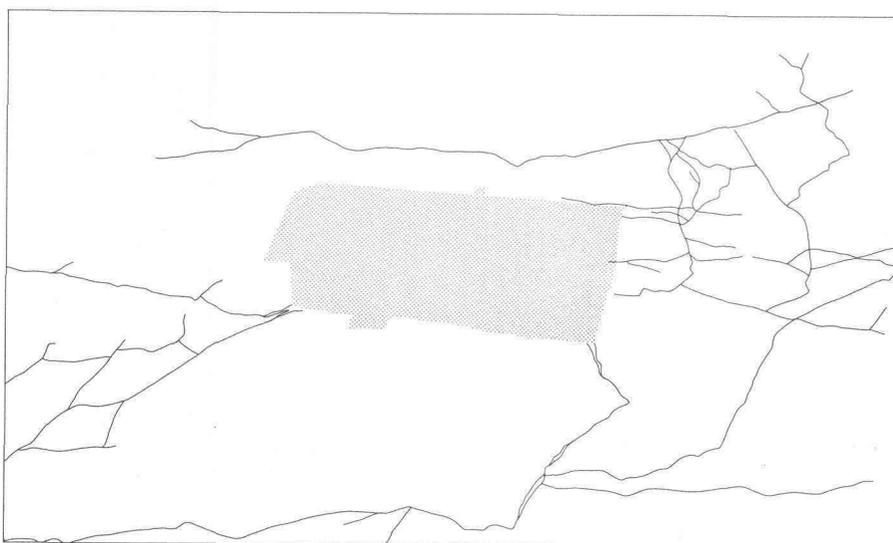
If, as suggested above, the surface materials were put in tension by lateral displacement of the underlying sediments, any sharp external angle in a hole through the frozen plate of surface sediments would concentrate the strain, and should be the site of a fracture. Once a fracture has been formed, the amount of force necessary to propagate the crack is reduced, because the sides of the fracture act as lever arms and increase the stress at the point of rupture; Inglis (1913) has shown that the stress at the apex of a crack in a plate is proportional to the square root of the length of the crack and inversely proportional to the radius of curvature of the angle at the apex of the crack. Because these cracks are initiated at weak

47.—Photograph and sketch of ground cracks localized at the corners of the U.S. Forest Service crew house on Portage Creek flood plain. Cracks broke the foundation and the building was moved to a new foundation. Photograph by Arthur Kennedy, U.S. Forest Service, Anchorage.

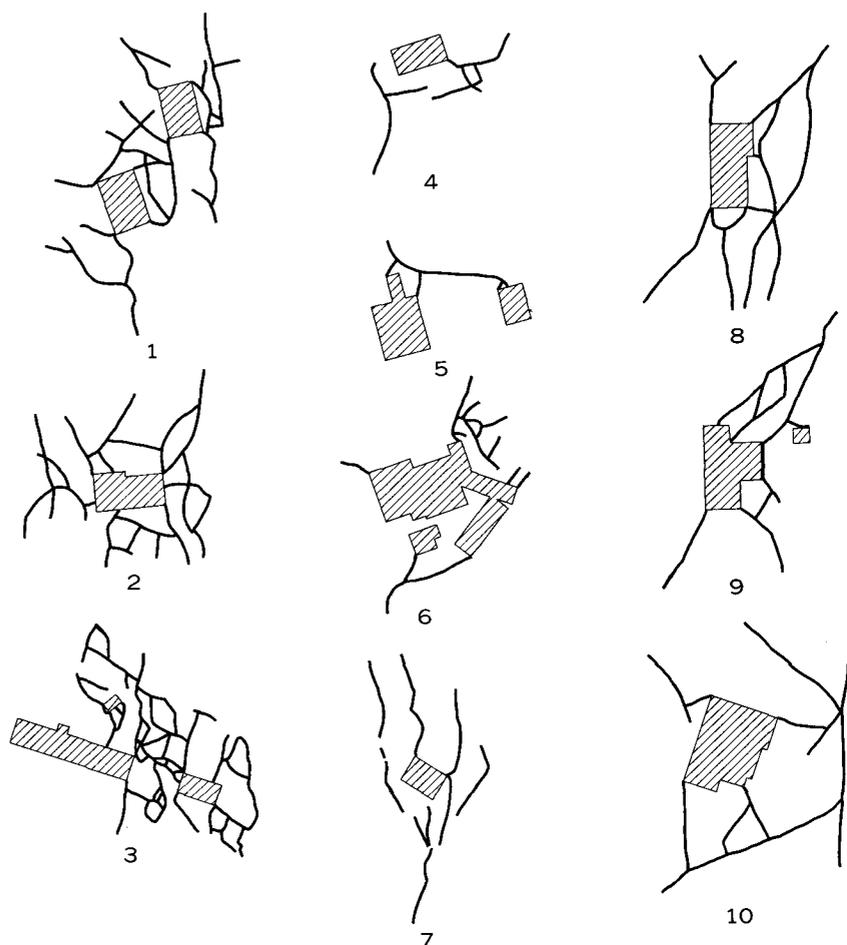
In summary: All the evidence— (1) the patterns of many ground cracks, (2) their location beside topographic depressions and on fans and deltas, where displaced embankments and bridge pilings indicate deep lateral displacement of underlying materials, (3) the concentrations of cracks at corners of buildings, (4) the increasing distances between fracture-bounded blocks toward topographic depressions, and (5) the evidence that lurching and landsliding were not important in producing these cracks—is consistent with the proposition that many ground cracks result from stress generated in the surface materials by lateral displacement and spreading of the underlying sediments. Although these cracks were important in causing damage to railroad and highway embankments, bridges, and buildings, possibly of even greater importance is the fact that they clearly indicate that even on relatively flat areas, where the only topographic relief is provided by a local depression, the depression may cause permanent lateral displacement of both the surface and underlying material for a distance of as much as sev-

48.—Ground cracks localized at the corners of houses on flood plains (1, 2, 4-6), on deltas (3, 7), and on alluvial fans (8-10). All houses oriented with the principal direction of landspreading to the right. Houses 1 and 2 on Portage Creek flood plain; 3, Lowell Creek delta; 4-6, Resurrection River flood plain; 7, Rocky Creek delta; 8-10 on Jap Creek fan (after Lemke, 1967, fig. 15).

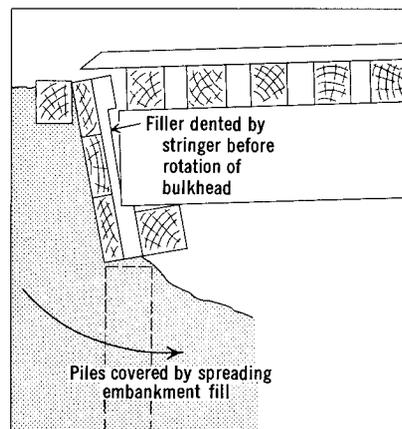
52.—A bulkhead filler that was rammed and dented by the stringer while it was still vertical. With continued shaking the base of the embankment fill spread over the bulkhead piles and the bulkhead was rotated.
