# The Alaska Earthquake

# Effects of the Earthquake Of March 27, 1964, on The Alaska Railroad

By DAVID S. McCULLOCH and MANUEL G. BONILLA

GEOLOGICAL SURVEY PROFESSIONAL PAPER 545-D

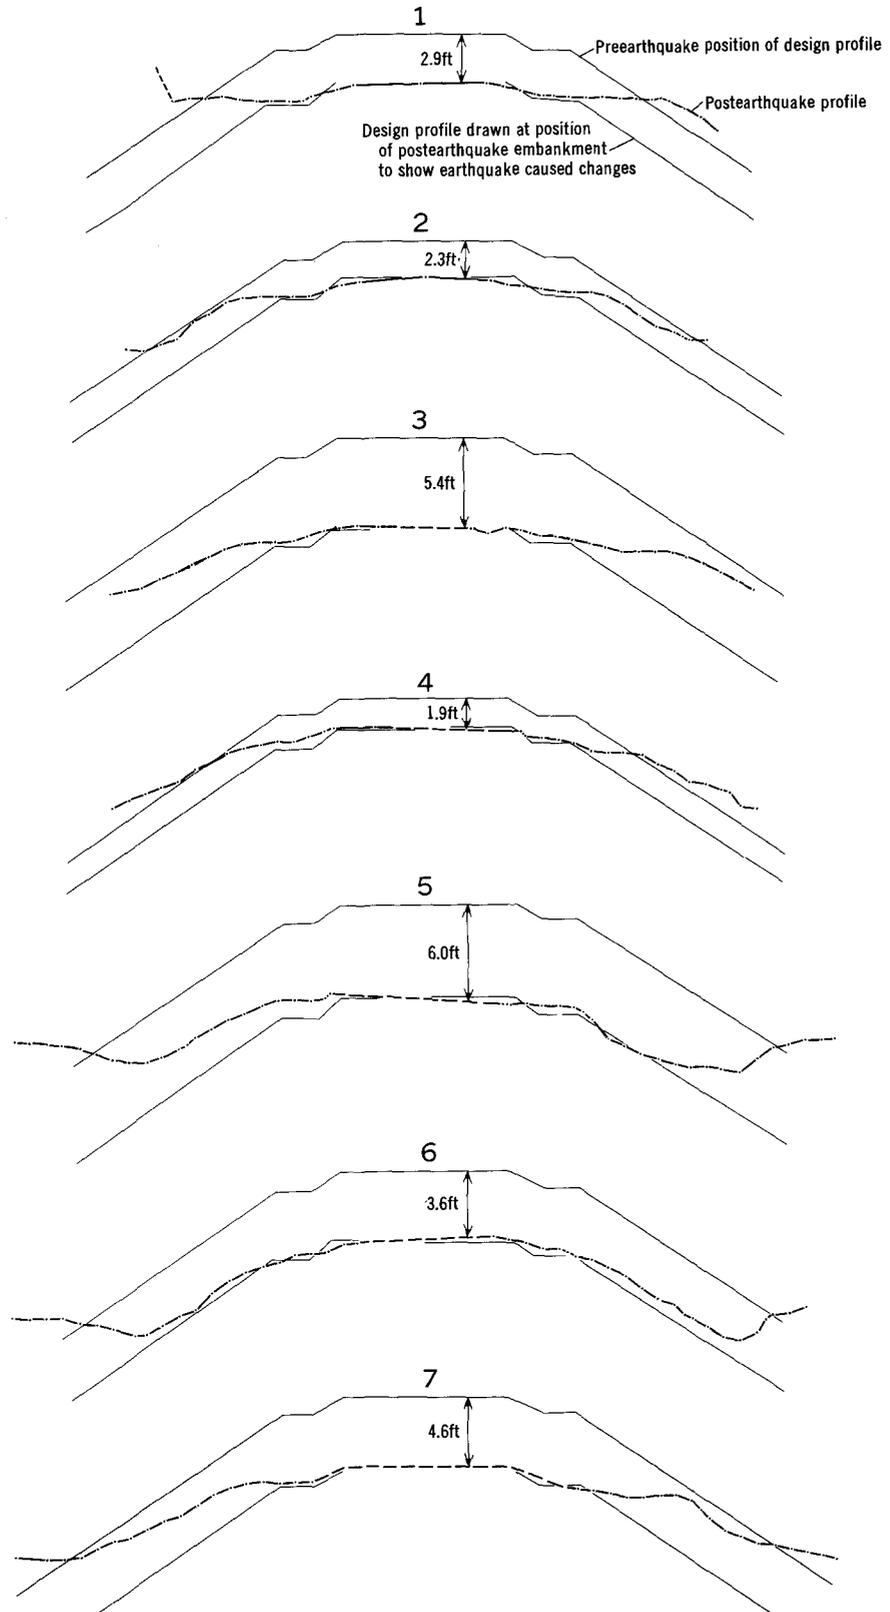
53.—Transverse profiles of settled railroad embankments in the Portage area measured by M. G. Bonilla and R. Kachadoorian. Each profile is compared with the design profile at the original and postearthquake height of the embankment. Profiles are located on figure 114.

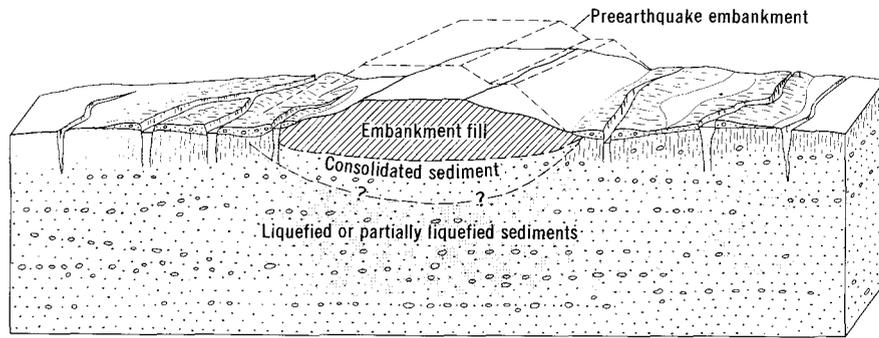
Figure 54 is a hypothetical sketch of liquefaction beneath an embankment. Although the field observations do not determine where liquefaction started, they strongly suggest that the embankments produced the liquefaction, and that sediments beneath the embankments became liquefied.

54.—Hypothetical sketch through an embankment underlain by liquefied sediments into which the embankment settled. Cracks formed by the embankment tapped the zone of high pore-water pressure, and sediments were carried to the surface by the escaping water.

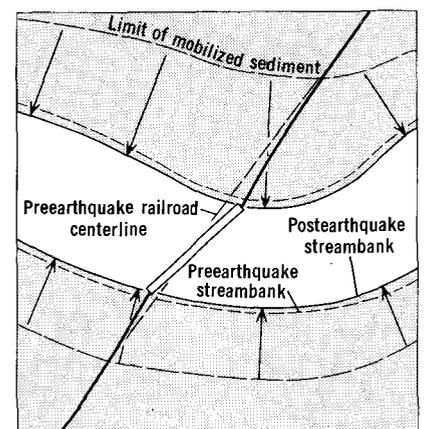
The most damaging passive failures of the embankments were at stream crossings, where landspreading was greatest. Because displacement was generally toward the stream valleys, embankments that approached valleys obliquely were offset horizontally in opposite directions on opposite sides of the streams (fig. 55) and the bridges were skewed horizontally. Horizontal offsets between embankment centerlines on opposite sides of stream channels measured at 27 bridges ranged from several inches to 10 feet (table 1). Twenty-one of these bridges are shown in figure 56; the offsetting of each bridge is described in pages D98–D157. As can be seen in figure 56, offsetting generally occurred as the result of movement toward the stream channels, but it also was produced by movement toward depressions

55.—Bridge skewed by streamward movement of sediments. Landspreading toward stream moved the banks closer together, and railroad grades that crossed streams at acute angles were carried sidewise in opposite directions on opposite sides of the stream, skewing the bridges.

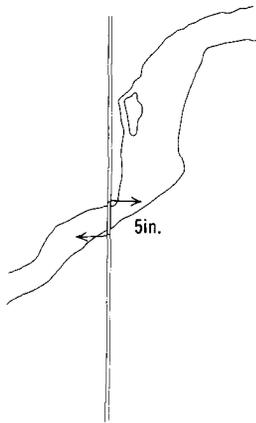
Bridge 4.8

56.—Bridges that were skewed horizontally by landspreading toward stream channels or topographically low areas. All figures oriented with increasing mileage from bottom to top.

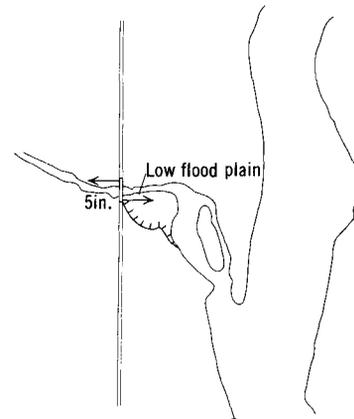
Bridge 33.6

(often wet) beside the embankments (bridges 33.6, 34.8, 37.0, 61.5). In one bridge (62.3), displacement was in the opposite sense, possibly because of local displacement of the high, narrow embankments of this bridge on the low active flood plain. In three large bridges (3.0, 3.2, and 3.3), the bridge ends and adjacent embankments were displaced laterally in the same directions parallel to the contours, offsetting them from the centers of the spans (figs. 29, 31, 32).

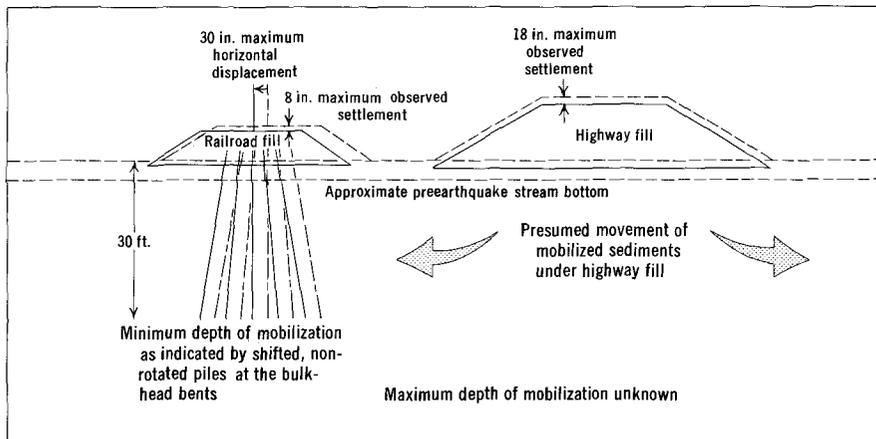
57.—Cross section of the railroad and highway fills at Resurrection River (fig. 27). Sediments displaced laterally beneath the sinking highway fill displaced the railroad fill and ends of bridges a maximum of 30 inches laterally, parallel to the contours. The lack of tilting in the bridge piling indicates that the depth of lateral displacement probably exceeded the pile depths. Dashed lines indicate preearthquake positions of embankments and piles.

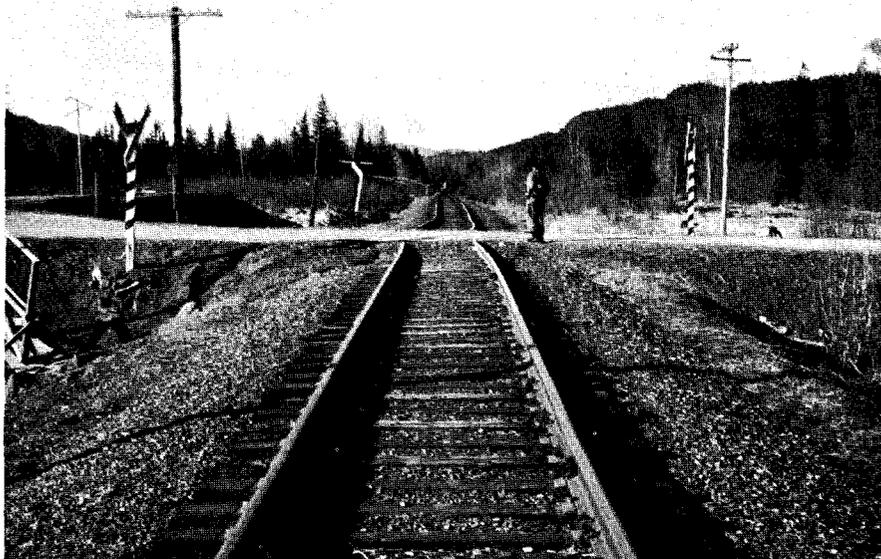
The absence of tilting in the displaced bridge piles driven largely through fill (bridges 3.0, 3.3) or the underlying sediments (bridges 3.0, 3.2) demonstrates that lateral shifting was not restricted to the fill, but that the fill was carried passively as the underlying material shifted. The minimal lateral displacement of the bridge centers suggests that movement parallel to the contours resulted from some force on the interstream areas. On the interstream areas the railroad lies adjacent to a large highway fill (fig. 27). Both the highway and railroad fills settled, and as shown by the extensive ground fracturing, expulsion of ground water, and streamward displacement of the foundation materials, the sediments were extensively mobilized by the shaking. The sinking of the large highway fill probably produced an outward flow of foundation materials that carried the adjacent railroad fill sidewise (fig. 57). This outward flow is also suggested by the fact that where the highway swings away from the railroad just north of bridge 3.3, the railroad fill was not displaced laterally (fig. 58). In the middle ground of this same figure, a lateral kink can be seen where the rails crossed a small road (Nash

Road, fig. 27). This road fill, lying at right angles to the railroad fill, appears to have resisted the lateral displacement, possibly because of its resistance to longitudinal compression.

58.—Sinking of large highway fill (at left) displaced adjacent sediments that carried the railroad embankment to the right and kinked the rails at smaller road fill (Nash Road, mile 3.4 figs. 27, 28) that was unaffected by the displacement, possibly because of its resistance to longitudinal compression. Lateral displacement decreased where the highway turns away from the railroad.

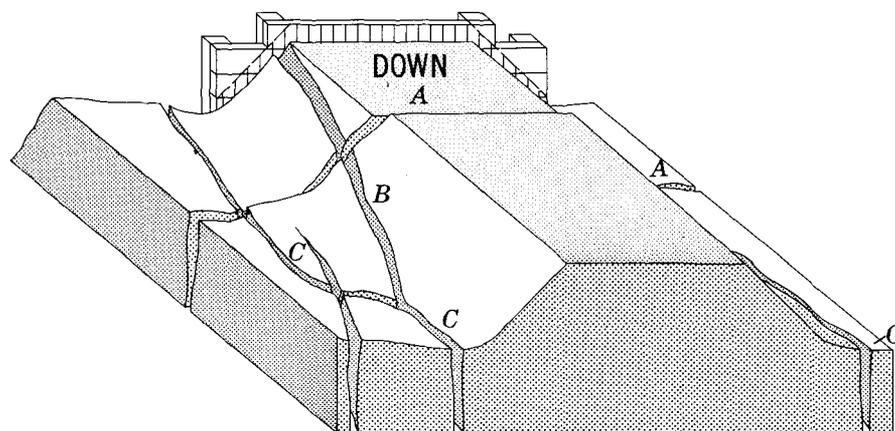
59.—Typical fractures at a bridge approach. A block of fill was lowered at the bulkhead and along a fracture (A) running perpendicular to the embankment. Fractures (B) formed on both sides of the embankment and ran diagonally back from the upper edge of the fill and joined fractures (C) that were approximately parallel to the fill in the adjacent ground.

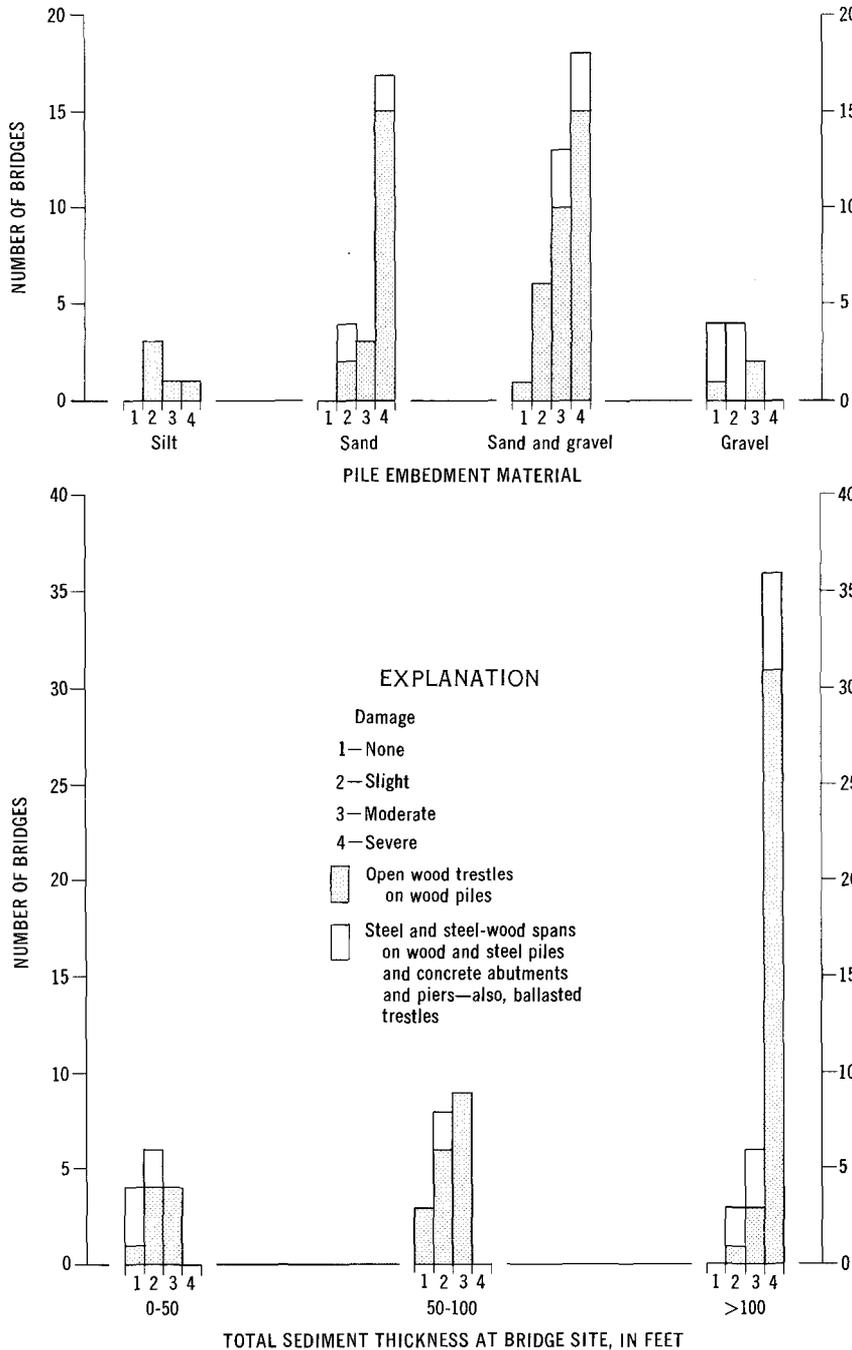
61.—The degree of damage to bridges compared with the grain size of the material in which the piles were embedded and the total thickness of all unconsolidated sediments at the bridge sites. As shown in table 3 and 4, the severity of the damage appears to be related most directly to the total sediment thickness.

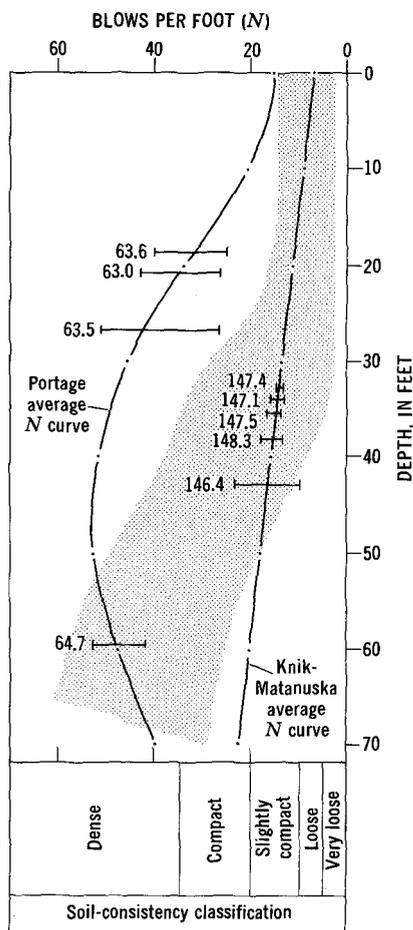
64.—Range of  $N$ -values (horizontal line) at tips of shallowest and deepest piles in damaged bridges in Portage and Knik-Matanuska areas, plotted on their respective average penetration resistance curves. Bridges in less dense sediments, far from the area of strain release at Knik-Matanuska area, were less severely damaged than those in denser sediments, nearer the area of greater strain release at Portage. The shaded area is the range of penetrometer values in sediments under severely damaged pile-supported structures in the 1964 Niigata earthquake in Japan (Seed and Idress, 1967).

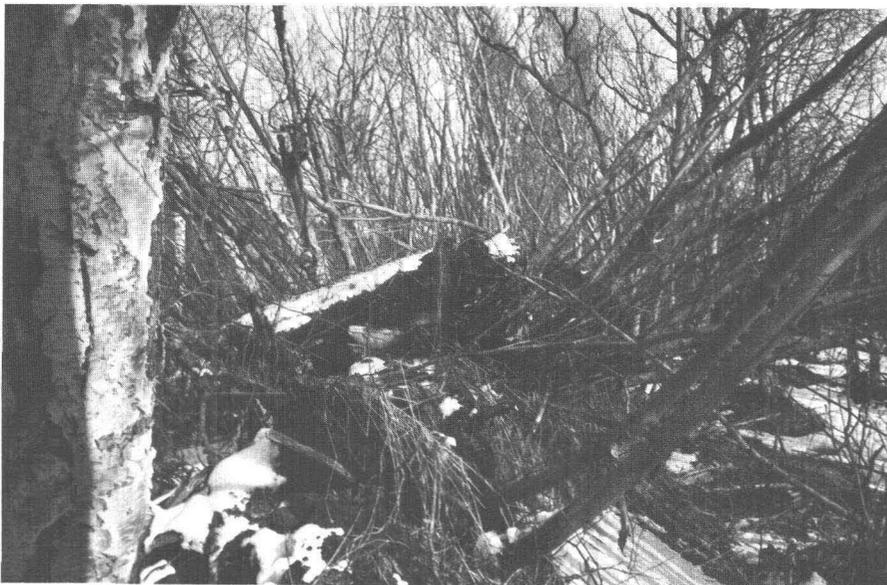
66.—Entirely detached block of frozen soil and uprooted trees that was thrust up over the adjacent tree-covered ground in a pressure ridge at the toe of Potter Hill slide.

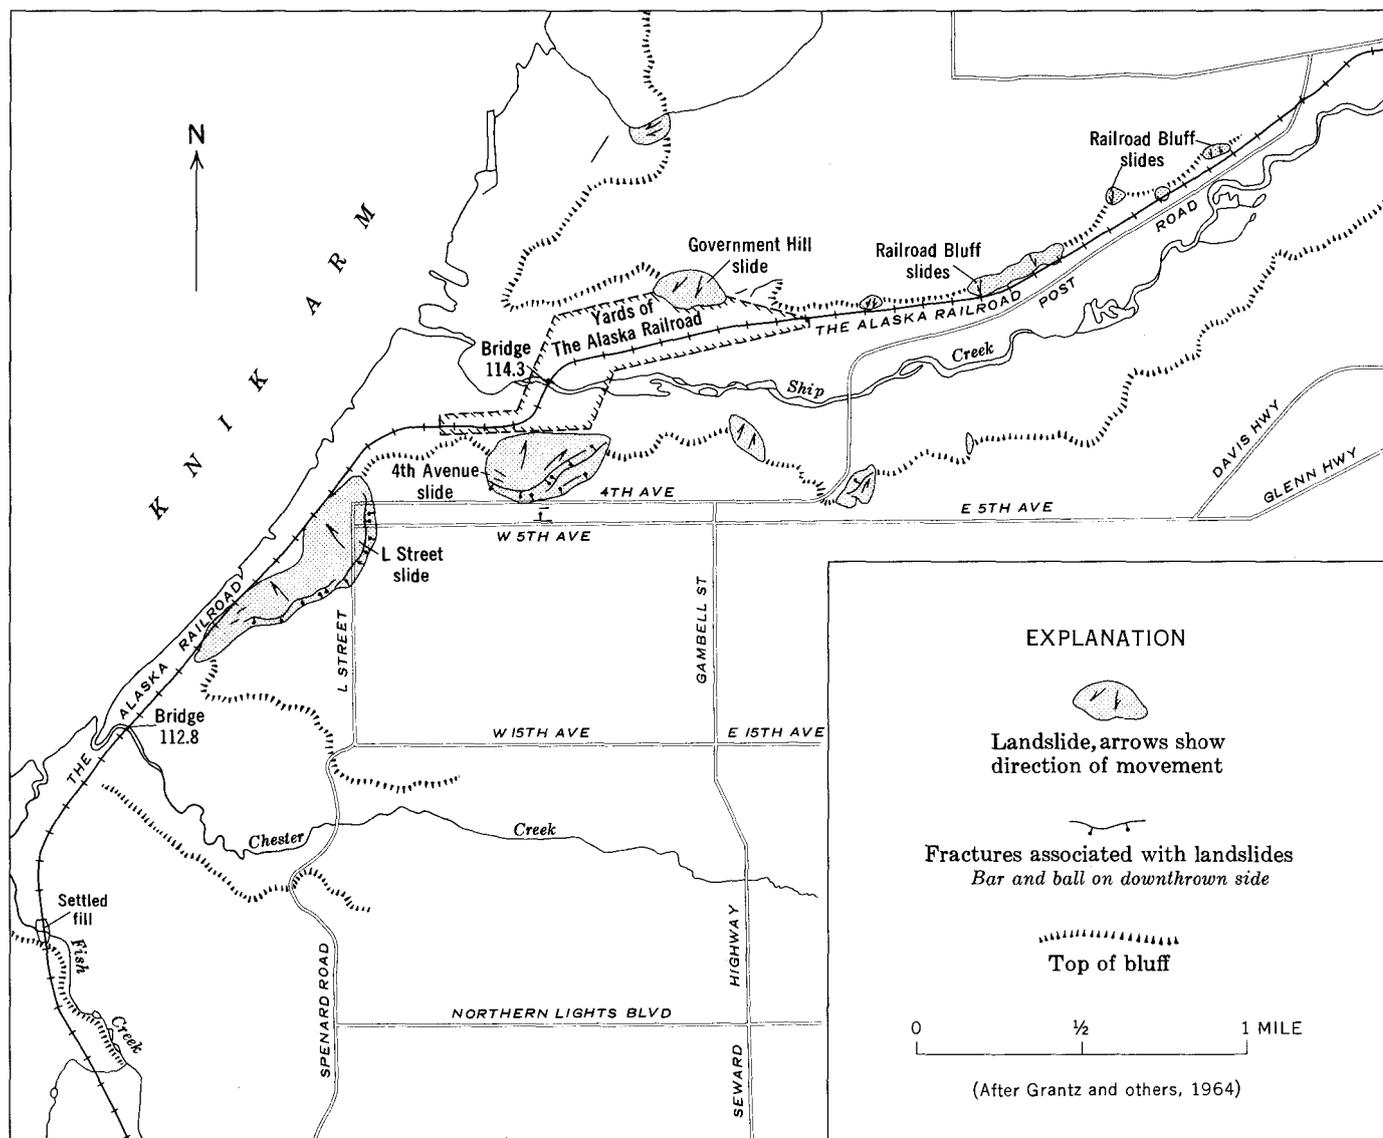
68.—Distribution of landslides in the Anchorage area and settled fill on Fish Creek (after Grantz and others, 1964).

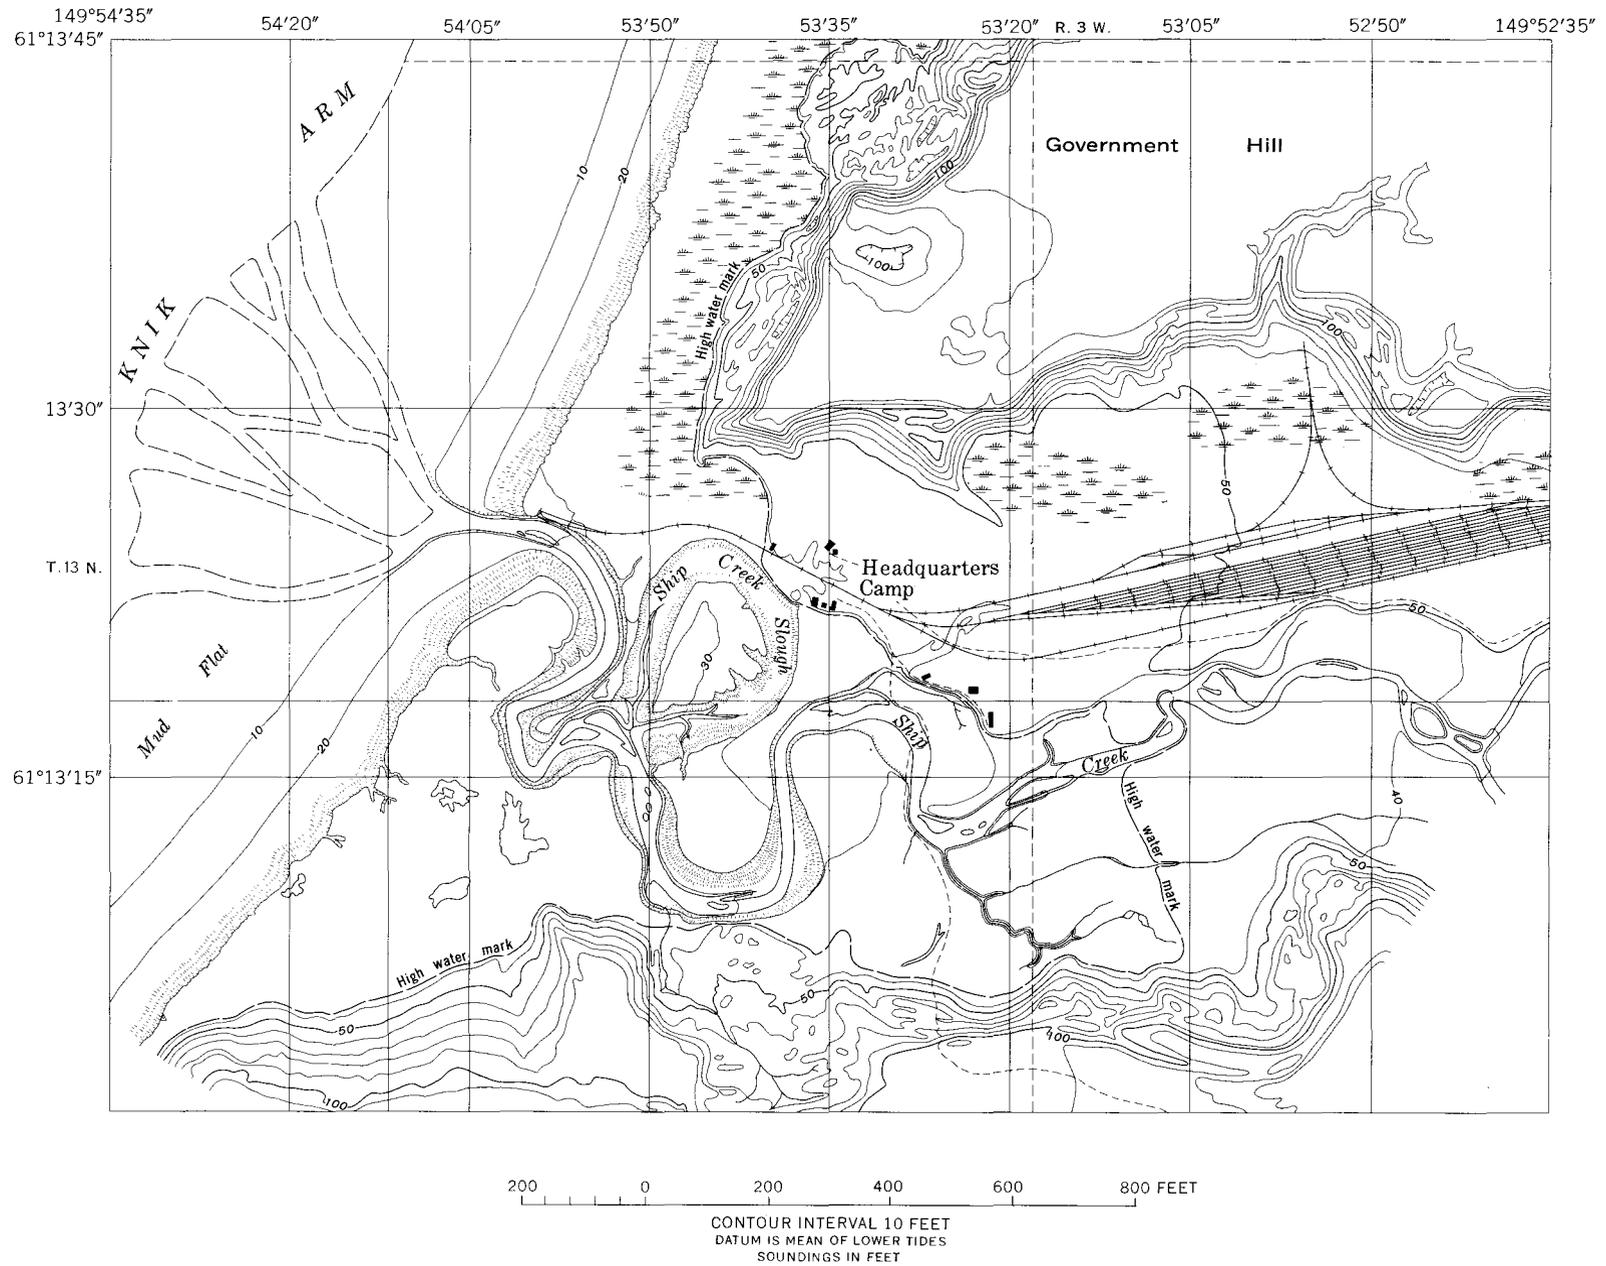
69.—Alaska Engineering Commission 1914 topographic map of Ship Creek valley, Anchorage. The landforms indicate two distinct slides backed by elongate grabens. These slides are on the west side of Government Hill, on either side of a topographic depression interpreted as being an ice-kettle hole. Two slides are also discernible on the south side of Government Hill, the easternmost in the position of the 1964 slide. On the south side of the creek, jumbled side-slope topography suggests extensive sliding from the area of the 1964 Fourth Avenue slide eastward for a distance of approximately 2,600 feet.

The topography shown on the 1914 map clearly confirms this conclusion. It also indicates that there was a flowing stream with several tributaries in the slide area. Although the topographer indicated small gullies up the face of the bluff, the fact that this is the only stream that he drew suggests that it was of some consequence. As drawn, the tributary pattern shows that the stream was largely fed from springs located in the slide mass and in the scarp at its head.

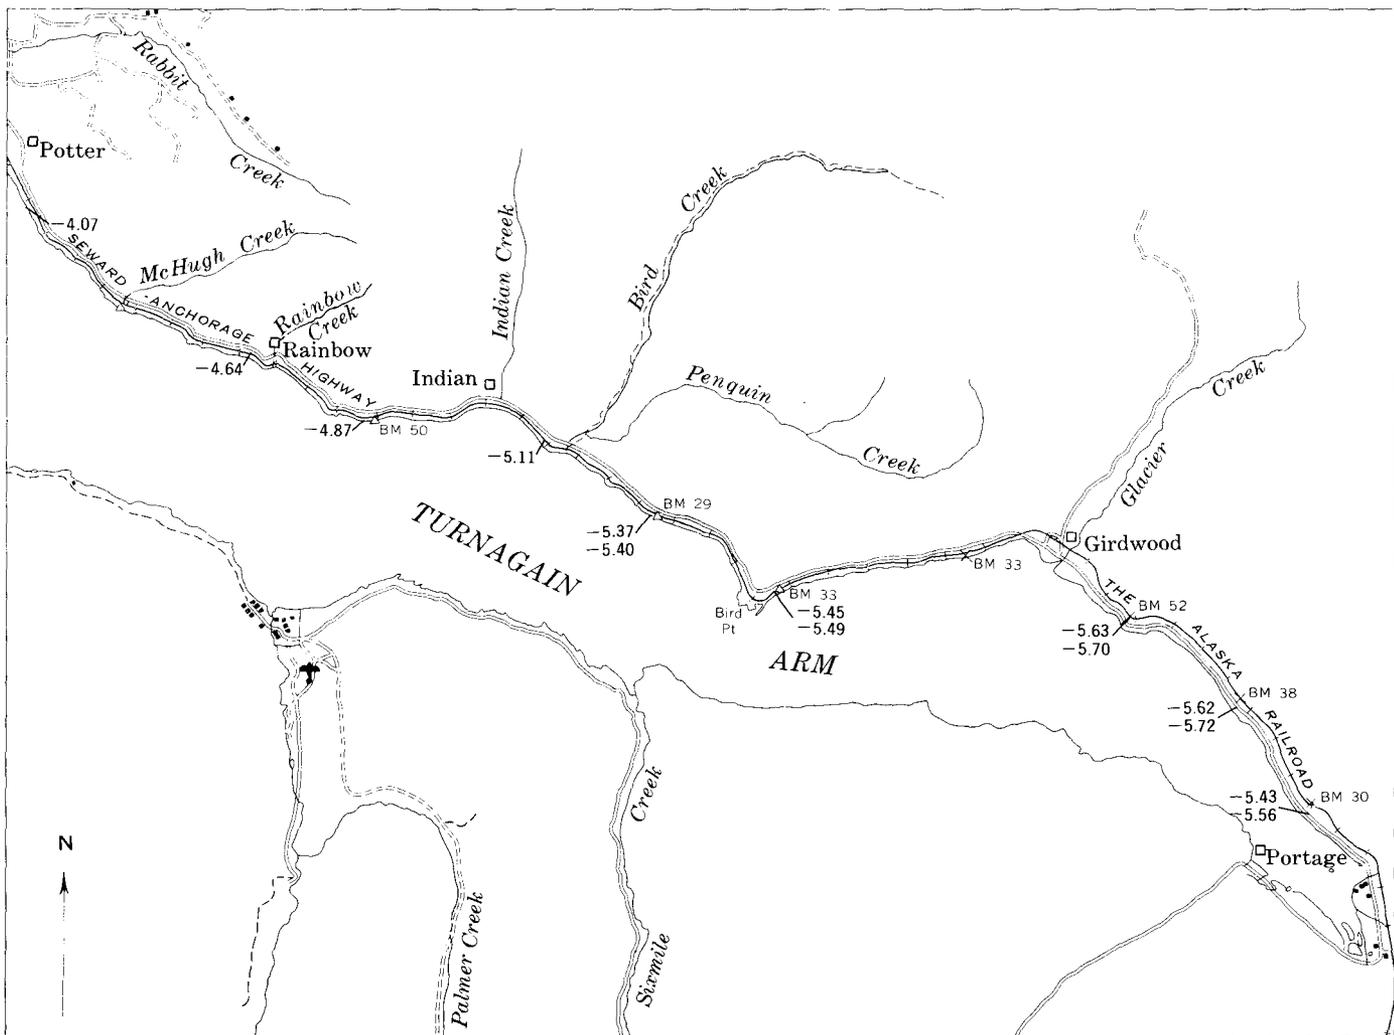
72.—The amount of lowering of bench marks on bedrock due to tectonic subsidence along Turnagain Arm, as determined by two U.S. Coast and Geodetic Survey level lines (Wood, 1966, p. 124). Single and top elevations were measured on a survey along the highway; bottom elevations east of Bird Creek were measured on a survey along the railroad.

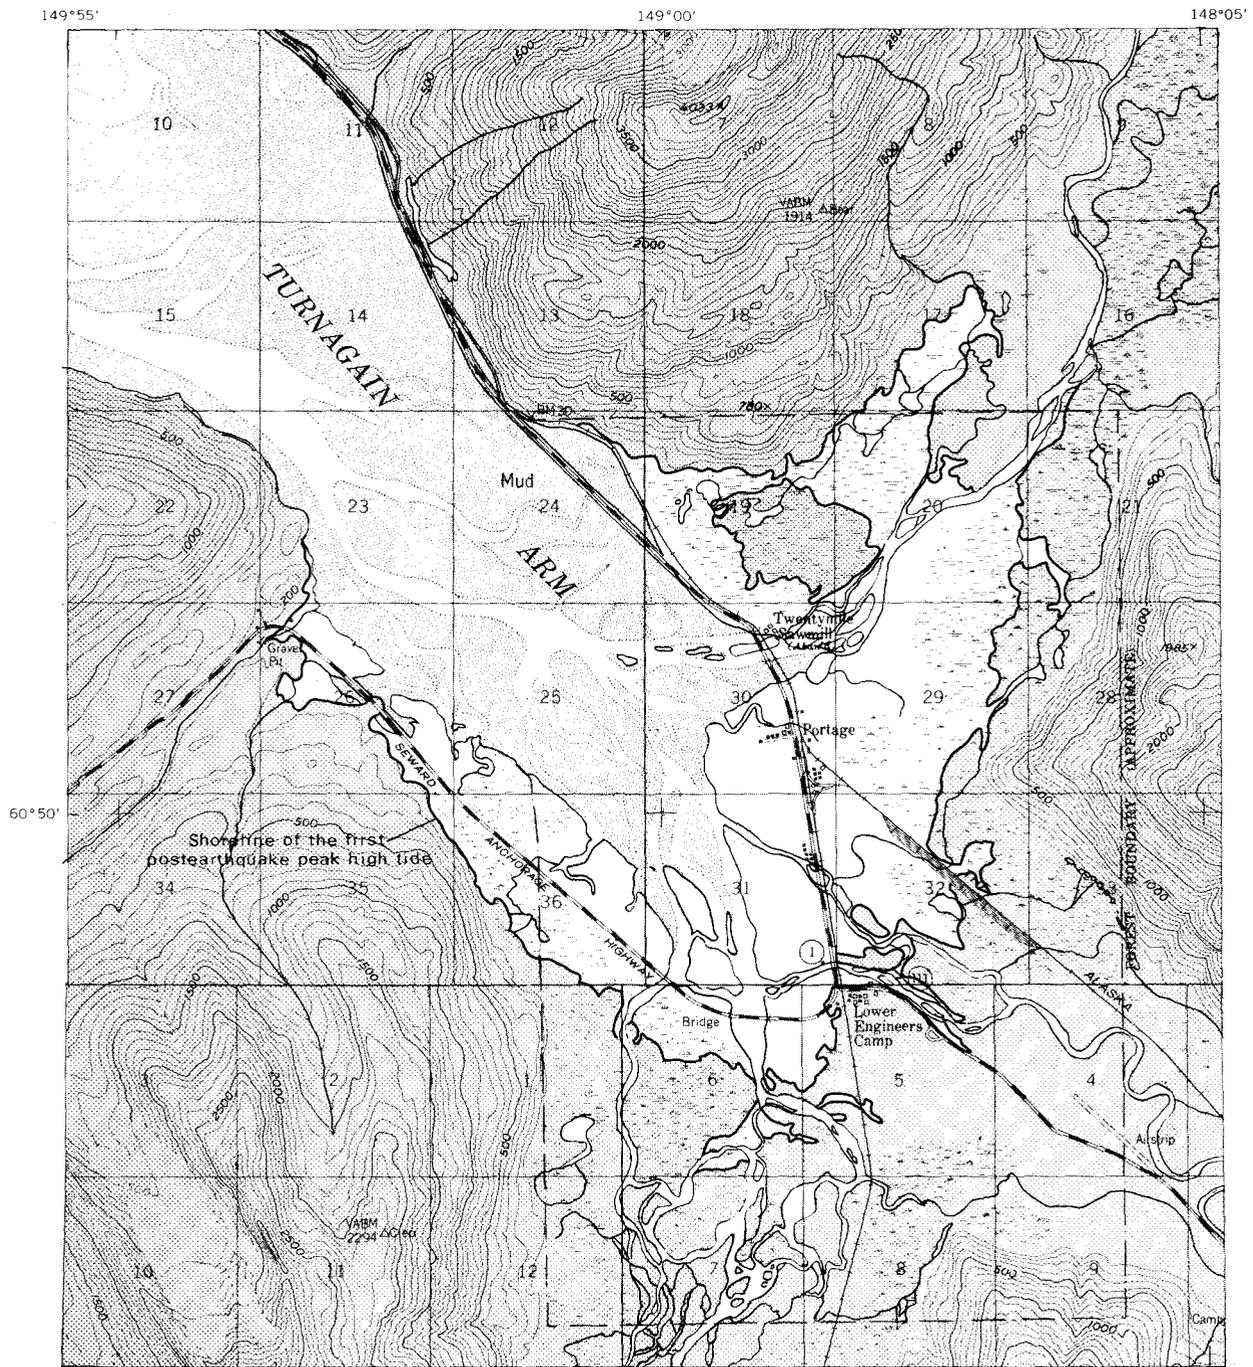
73.—Shorelines of the preearthquake mean high water and the first postearthquake peak high tides in the Portage area. The postearthquake high-tide limit is drawn from photographs by Air Photo Tech, Inc., Anchorage.

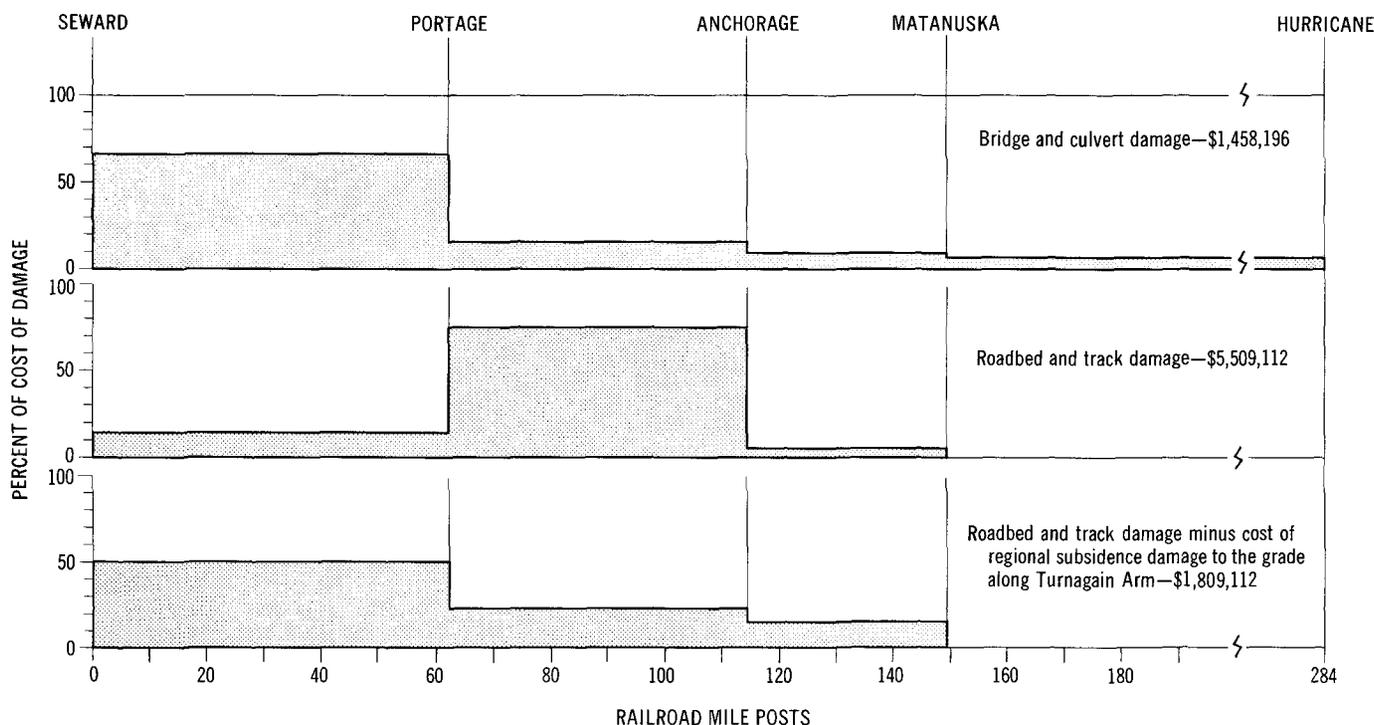
In figure 77, the distribution of some of the damage is shown diagrammatically to emphasize the geologic control. Bridge and culvert damage (the uppermost

Regional subsidence played the greatest role in controlling the cost of roadbed and track damage — 75 percent of all such damage occurred in the section along Turnagain Arm. Again, nearly all such damage (95 percent) lay south of Anchorage, and, where not caused by regional subsidence, it was due to the mobilization of foundation materials and their

attendant loss of bearing strength, surface cracking, and horizontal displacements. The lowermost graph (fig. 77) is an attempt to show the distribution of roadbed and track damage due solely to mobilization of foundation materials by eliminating that part of the cost resulting from regional subsidence of the roadbed along Turnagain Arm. In this graph the cost of armoring the grade with rock riprap and three-quarters of the cost of raising this 35-mile section of roadbed between 3 and 5 feet (total \$3,700,000) have been removed. One-quarter of the cost of raising the grade has been maintained to allow for local settling. With this estimated adjustment, the distribution of roadbed and track damage resembles that of bridges and culverts, and reflects the geologic control and the distribution of the seismic energy.

77.—Geographic distribution of the cost of the damage to bridges and culverts (top graph) and to roadbed and track (middle graph), Bridge and culvert damage increased to the south, toward the area of maximum strain release, but the cost of roadbed and track damage was greatest in the area of subsidence along Turnagain Arm. Eliminating costs due to regional subsidence (lower graph) shows that the roadbed and track damage also increased to the south, toward the area of maximum strain release.

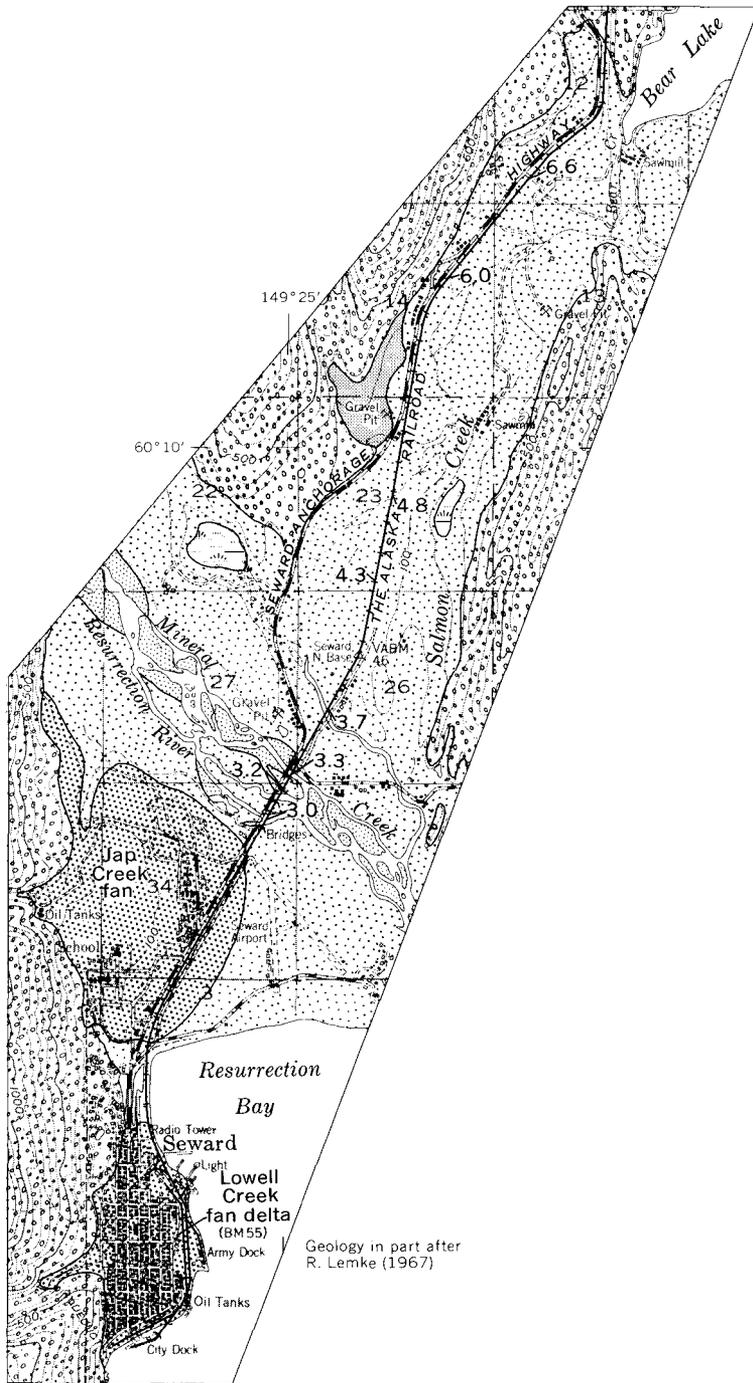
At Seward (fig. 78), the southern terminus of the rail line was at docking facilities and a switching and storage yard on the south side of the Lowell Creek fan delta. The rail line then passed north along the shoreline, being built largely on artificial fill placed along the east side of the fan delta. The fan delta is known from borings and seismic profiles (Lemke, 1967) to be composed of glacial drift (till and outwash) on bedrock covered by about 100 feet of fine gravel that intertongues with marine silt along the shoreline. Ground failures and damage to the city and rail facilities, previously described by Grantz and others (1964), Lemke (1967) and Chance (1966), is summarized below.

Landsliding started about 30 seconds after the shaking and took place as a series of slides that removed all the artificial fill beneath the rail line and some of the adjacent natural deltaic sediments from the eastern edge of the delta. These slides carried away most of the port facilities and some railroad line. At about the same time, sliding on the south edge of the delta carried away part of the two large railroad warehouses. During ground shaking, cracks developed, pro-

The composition of Jap Creek fan (fig. 78) and its surface cracking have been described by Lemke (1967). Cracking was restricted to the outer margin of the fan and was especially severe along the north edge (Forest Hills area). The fan is composed of bedded sand and gravel, coarser toward the head and finer toward the toe. In the severely fractured area, lenses or beds of sand 1 to 5 feet thick intertongue with poorly sorted sand and gravel. Occasional silt lenses as much as 2

Leaving Jap Creek fan, the rail line crosses the flood plains of Resurrection River and its northern channel, Mineral Creek, then passes on to the adjacent flood plain of Salmon River (fig. 78). The thickness of the flood-plain sediments on these valley floors and the composition of the underlying materials are not well known. At the north end of Resurrection Bay, seismic profiles and four bore holes indicate that the alluvium is about 350 feet thick, approximately half a mile west of the mouth of Resurrection River (Lemke, 1967, pl. 2). The alluvium thins eastward over a bedrock surface that emerges to the north; it also thins westward to about 100 feet and lies on compact glacial sediments that may be as much as 1,000 feet thick. At Resurrection River the deepest of borings for highway bridges reaches a depth of 95 feet and does not penetrate the base of the alluvium. (Logs of these wells are given in figs. 30-32).

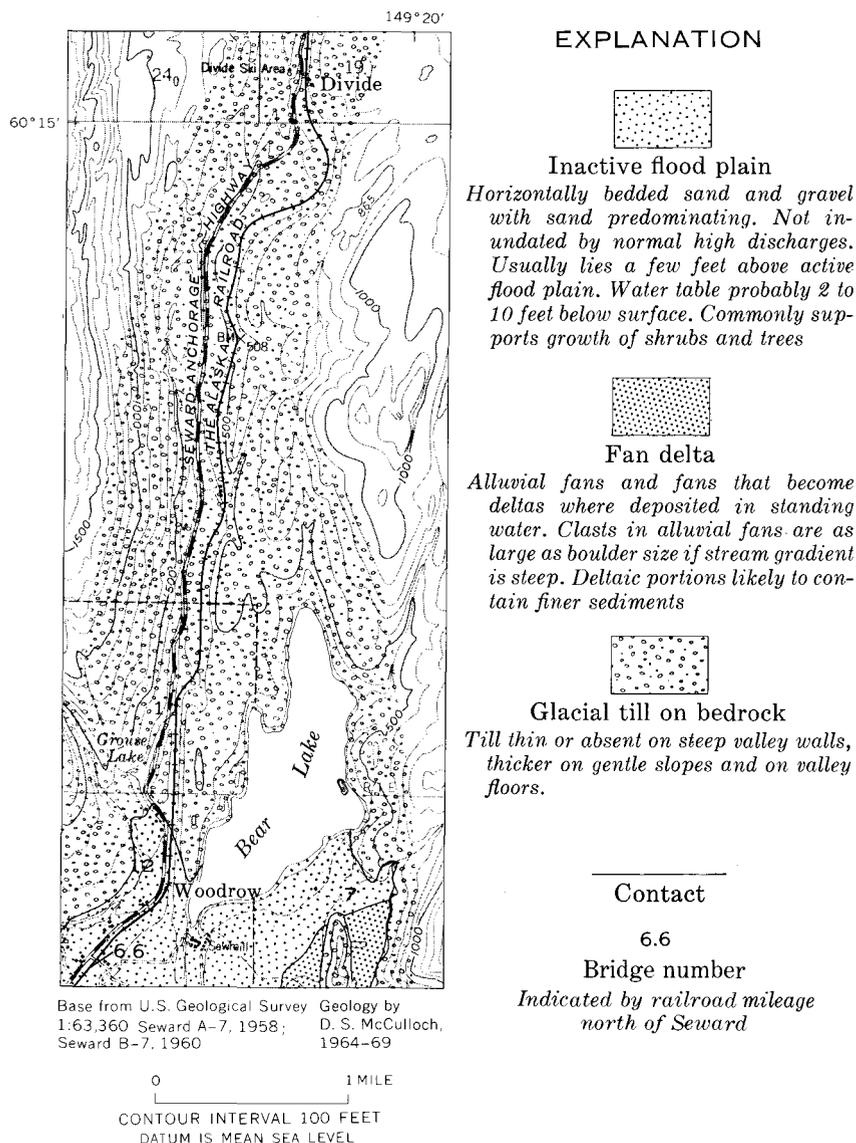
80.—Surficial geologic-physiographic map of the rail belt from Woodrow (mile 6.5) to Divide (mile 12).

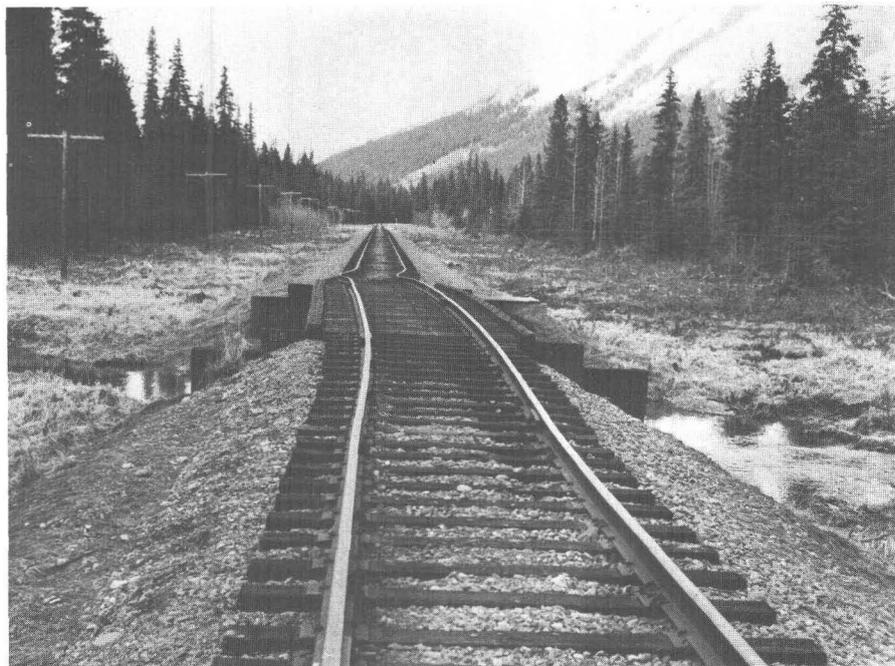
Bridge 15.6, a 45-foot open wood trestle, was also compressed, but only  $1\frac{3}{4}$  inches; its piles shifted streamward and the embankments were lowered slightly with respect to the bridge. As at bridge 15.2, long segments of the approaches were displaced horizontally. As shown in figure 56, the bridge crosses the creek obliquely. About 1,200 feet of the northern approach, to just beyond bridge 15.9,

was shifted westward toward the stream channel that approximately parallels the embankment (fig. 83). About 600 feet of the southern approach was displaced eastward toward a channel that lies between the rail line and the channel shown in figure 56. The straightness of the rails on the displaced segments north and south of the bridge indicates that the displacement was relatively uniform over the long segments. The resulting horizontal offset at the bridge was 20 inches.

83.—Bridge 15.6, a 45-foot wood trestle on the inactive floodplain of Snow River, showing long, horizontally offset embankments. A, View north; B, view south.

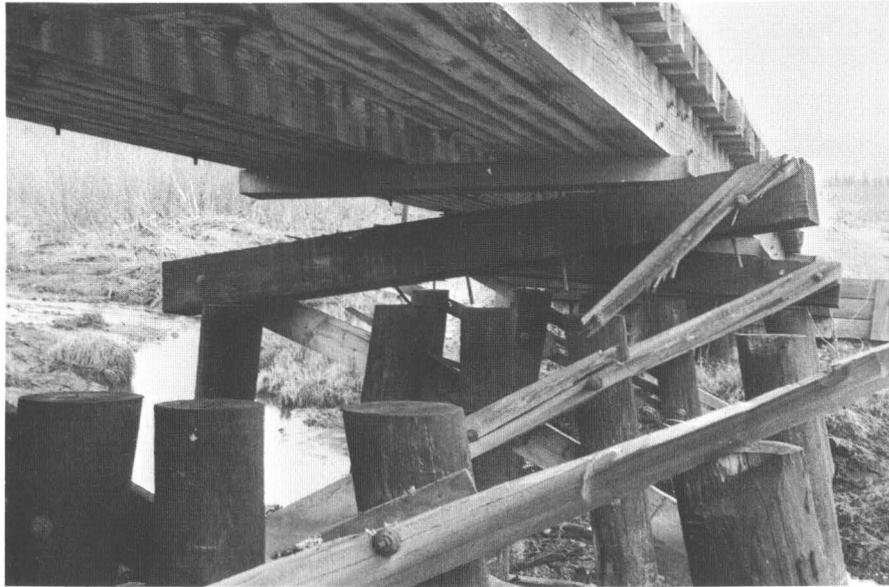
The 105-foot open wood trestle bridge at mile 34.5 was compressed so severely (2.2 ft) that the stringers jackknifed up off the piles and broke in the center of the span (figs. 13, 95). The piles were shifted toward the stream channel, and sand that had been ejected with ground water from cracks in the streambed covered the bed to a depth of several inches. Details of damage to this bridge are given on page D51.

95.—Caps pulled from bents and broken sway braces on the underside of the jackknifed deck of bridge 34.5.

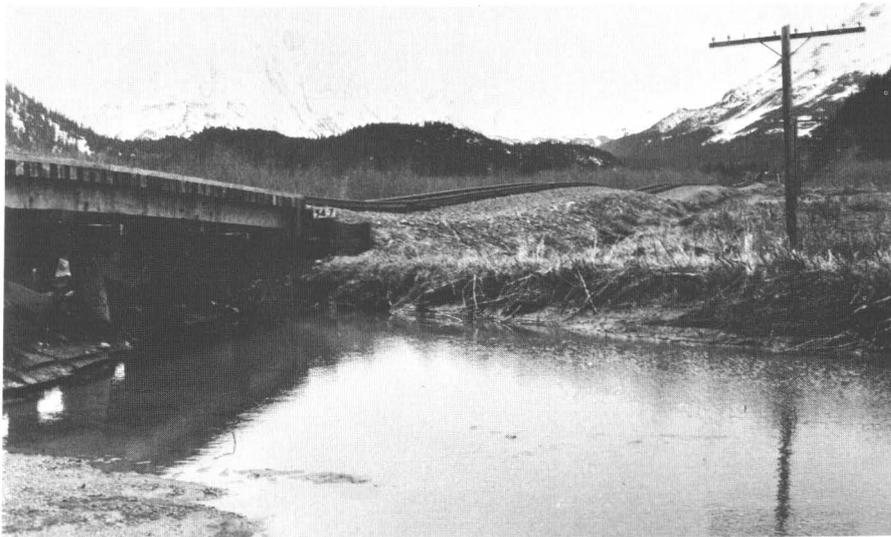
96.—Local settling of the railroad embankment between bridges 34.7 (foreground) and 34.5 on Hunter Flats.

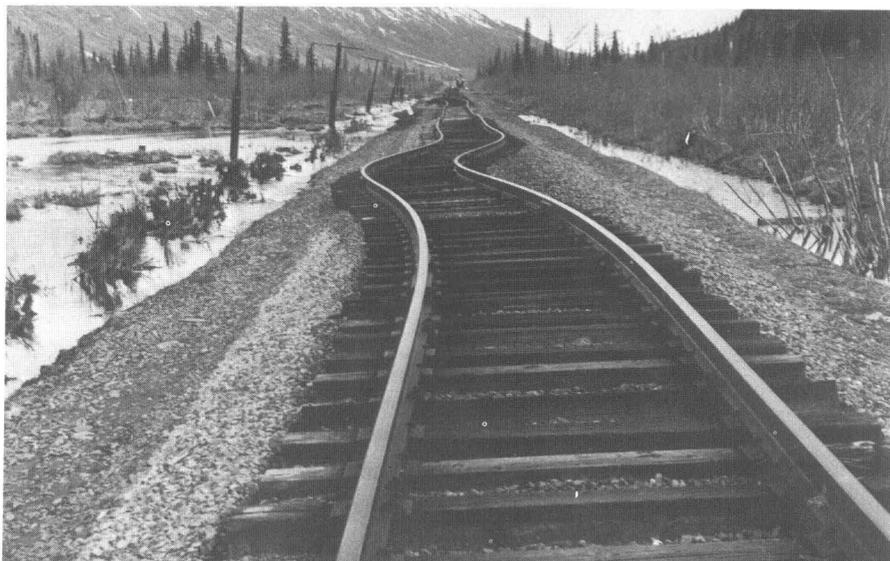
98.—Lateral kinks in the tracks, at mile 35 on Hunter Flats, which may have resulted from longitudinal compression of the embankment.

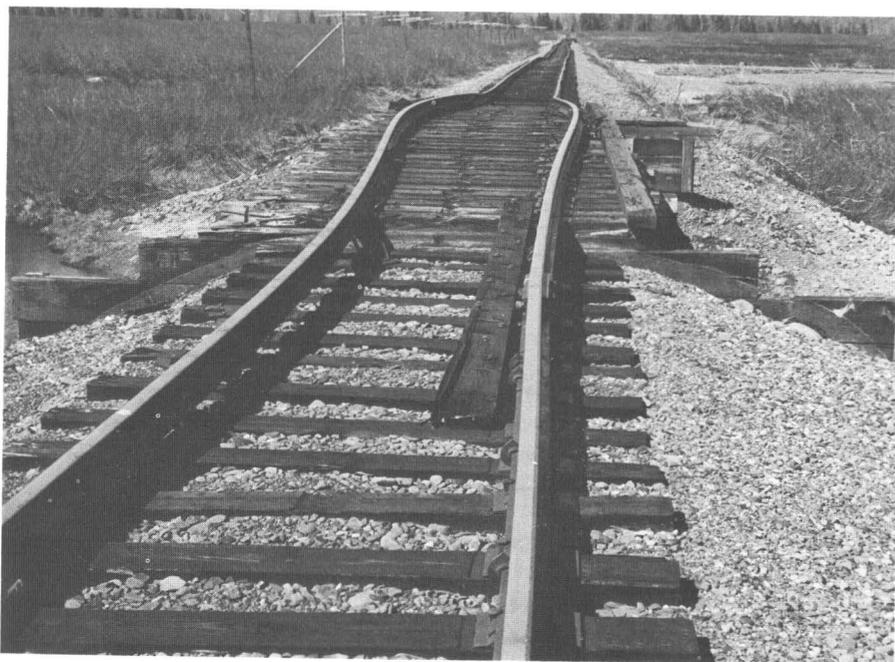
107.—View north over bridge 61.3 on the inactive flood plain of Placer River. The bridge was compressed and arched, and, as shown by the freshly exposed unweathered wood on the bulkhead, the embankment settled at the bulkheads. Approximately 200 feet of the embankment north of the bridge shifted to the left.

As at bridge 61.5, the approach fills were locally bulldozed up by the bulkheads that were held apart by the stringers. At the same time the sediments under the embankment moved streamward and carried the piling toward the stream. There was also considerable lateral movement of the sediments toward the major channel of Placer River to the west of the bridge. The embankments at both ends of the bridge were carried westward. The north embankment, which was somewhat closer to the main channel and bounded by lower ground, was carried farther; thus the north end of the bridge was skewed about 2 feet west relative to the south end. The piling was also carried laterally toward Placer River.
