# The Alaska Earthquake

# Effects of the Earthquake Of March 27, 1964, on The Alaska Railroad

By DAVID S. McCULLOCH and MANUEL G. BONILLA

GEOLOGICAL SURVEY PROFESSIONAL PAPER 545-D

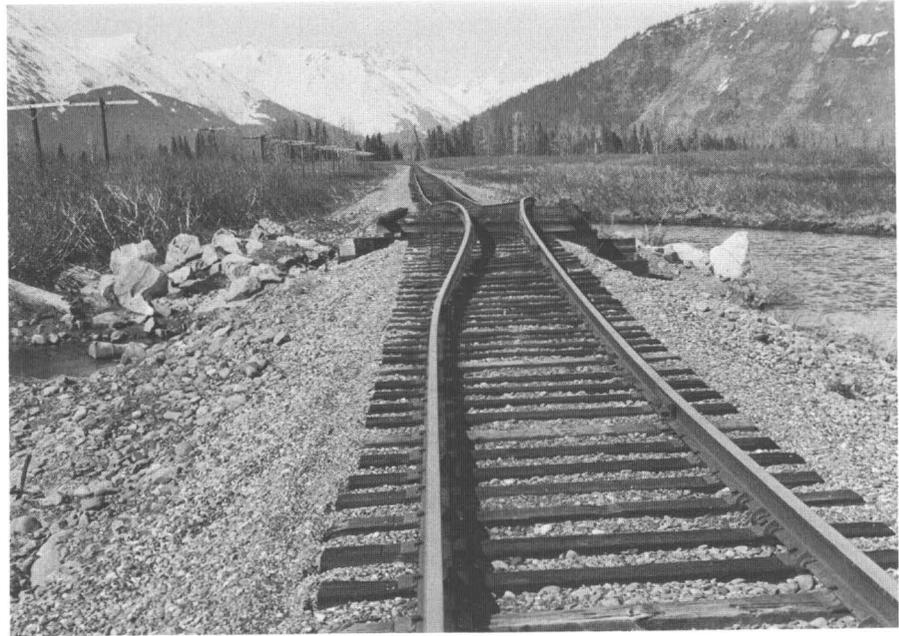
108.—View north over bridge 61.5 on the inactive flood plain of Portage Creek. The bridge was compressed and arched, and the rails pulled free of the fish plates. The north approach shifted to the right toward a small slough, and the south embankment shifted toward the topographically lower active flood plain of the adjacent creek, skewing the bridge 18 inches horizontally (see fig. 56).

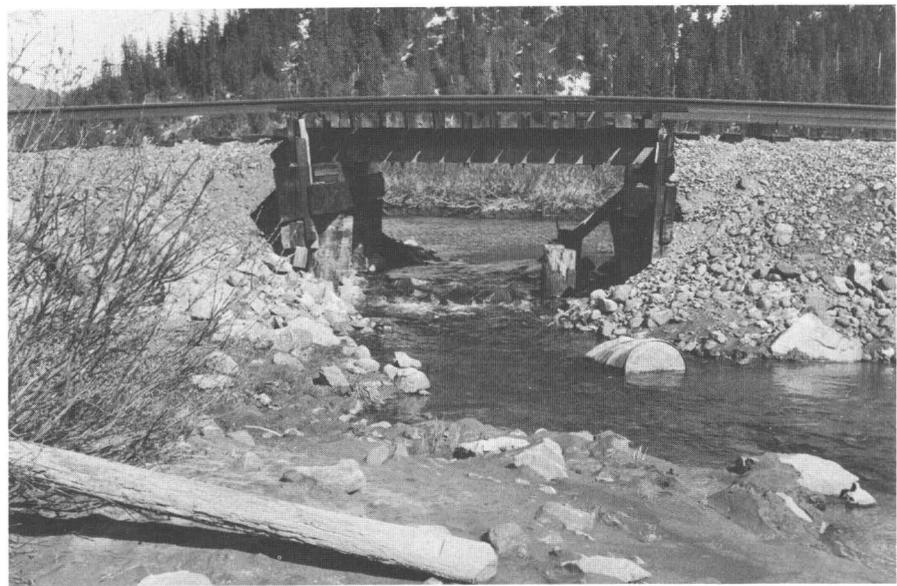
109.—View east at bridge 61.5 showing that the embankments were lowered relative to the bridge deck but had risen slightly toward the bridge.

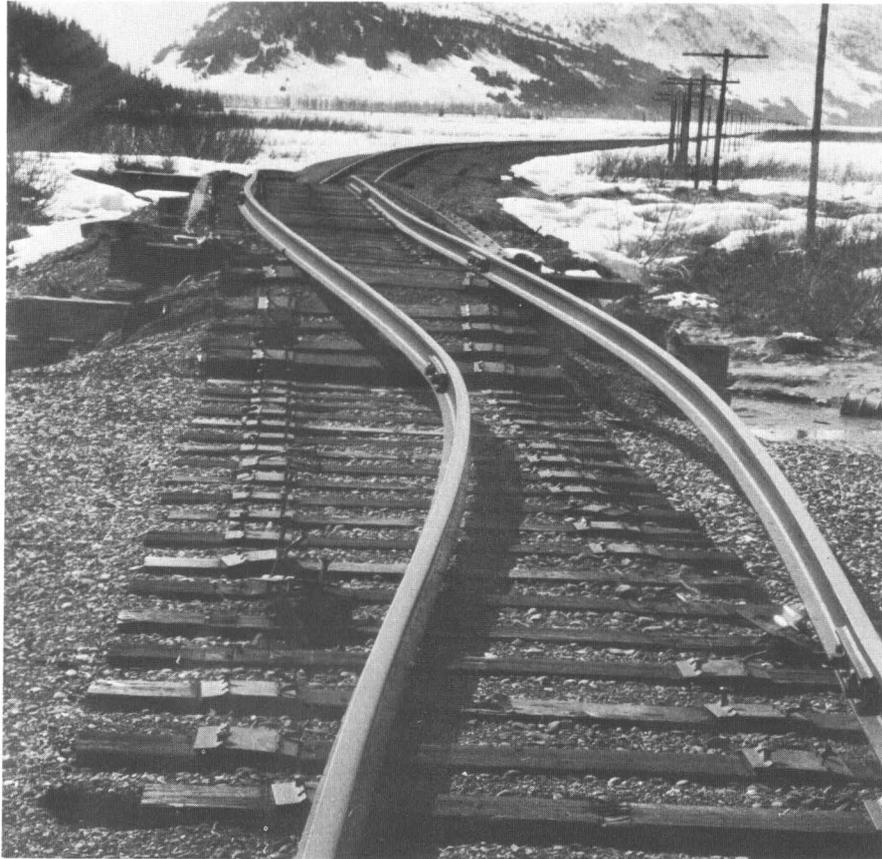
110.—Bridge 61.9 from the south, showing the lowering of the fills and the buckled compressed rails pulled free of the ties.

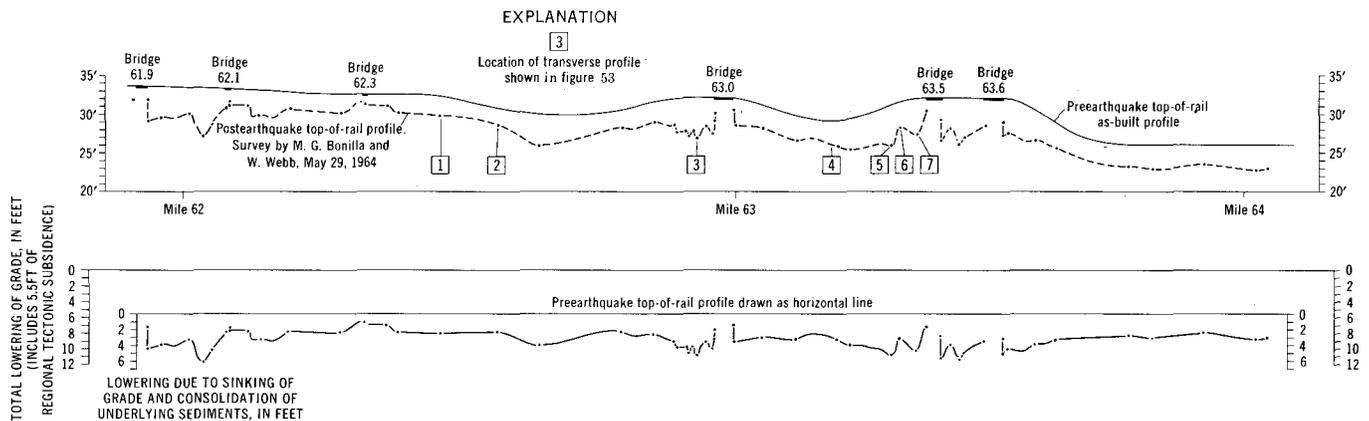
North from bridge 61.9 the embankment was generally lowered about 3 feet where it crosses the combined flood plains of Portage Creek and Twentymile River. The height of the postearthquake embankment is compared with the preearthquake embankment in figure 114, in which the heights of both are referred to the nearest bedrock bench mark (Q 12, U.S. Coast and Geod. Survey, 1929, at mile 66.5). Although there was ground cracking accompanied by the discharge of sediment-laden ground water along much of the embankment (pl. 3), the fact that local sags appeared to be related to larger discharges of sediment suggests that these sags resulted

114.—A comparison of the pre- and postearthquake top-of-rail profiles in the Portage area, neglecting the lowering due to tectonic subsidence, and a plot of the lowering as compared to the preearthquake position and the additional  $5.49 \pm$  feet of tectonic subsidence of the nearest bedrock bench mark (see fig. 72). Numbers indicate the stations at which transverse profiles were measured (see fig. 53).

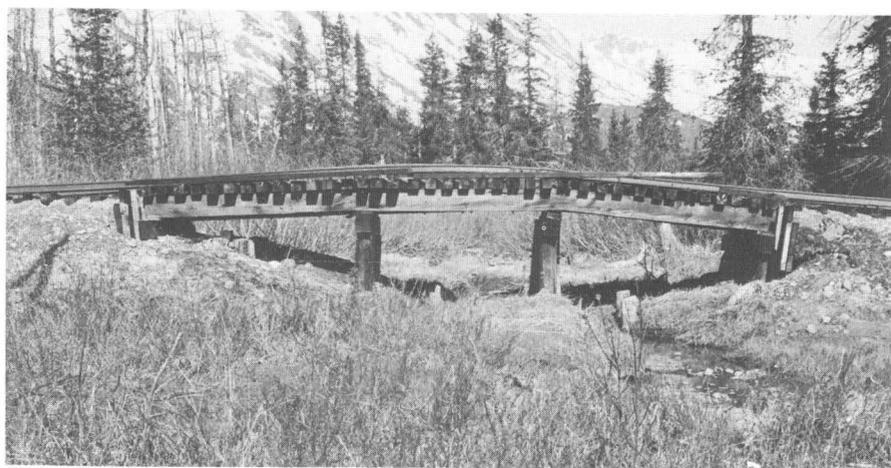
115.—Approach fills bulldozed against the bulkheads of bridge 62.1. Central bents were displaced horizontally without rotation, but the bulkhead bent was rotated as its base was carried farther toward the channel than its top. This sort of rotation was very uncommon.

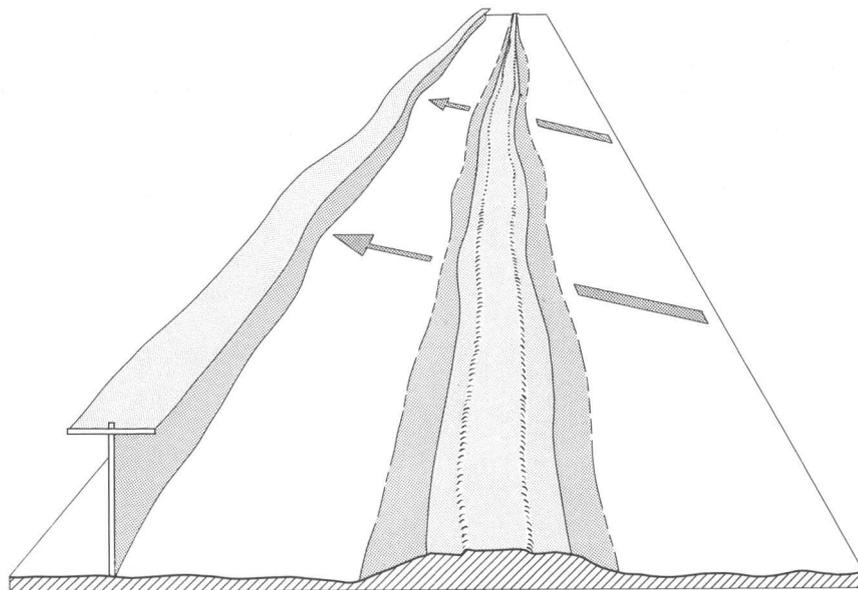
shows both the embankment and the adjacent pole line as drawn from a low-altitude aerial photograph that includes the embankment from just north of the buried structure to the Union Oil Co. tanks at about mile 62.8. The congruent sinuosity developed by both suggests that the lateral displacement resulted from horizontal shifting of the valley floor sediments beneath both the embankment and the pole line. As can be seen on plate 3, there was considerable ground cracking along the southern third of the embankment shown in figure 117. The pattern of the ground cracks and the numerous tension fractures that cross the embankment suggest an east-west spreading of unconsolidated materials beneath the flood-plain surface. The rails responded to the tension in this zone by forming 2-foot-wide pull-aparts, in the left rail 710 feet, and in the right rail 770 feet, north of the bridge (fig. 118). Actual movement of the valley floor sediment was predominantly to the east toward the major channel and the low area in which a small meandering stream flows.

117.—Congruent lateral displacement of the roadbed and pole line north of bridge 62.3 (drawn from fig. 116) showing that the roadbed and pole line were carried passively as the underlying flood-plain sediments moved laterally.

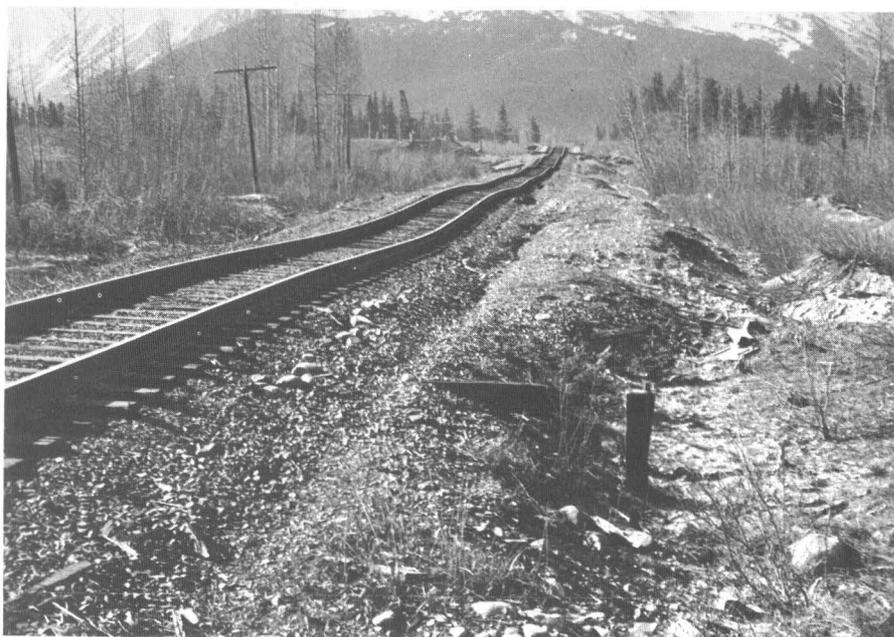
120.—Irregular settlement of the railroad embankment between the highway grade crossing at mile 62.9 and bridge 63.0 (see pl. 3).

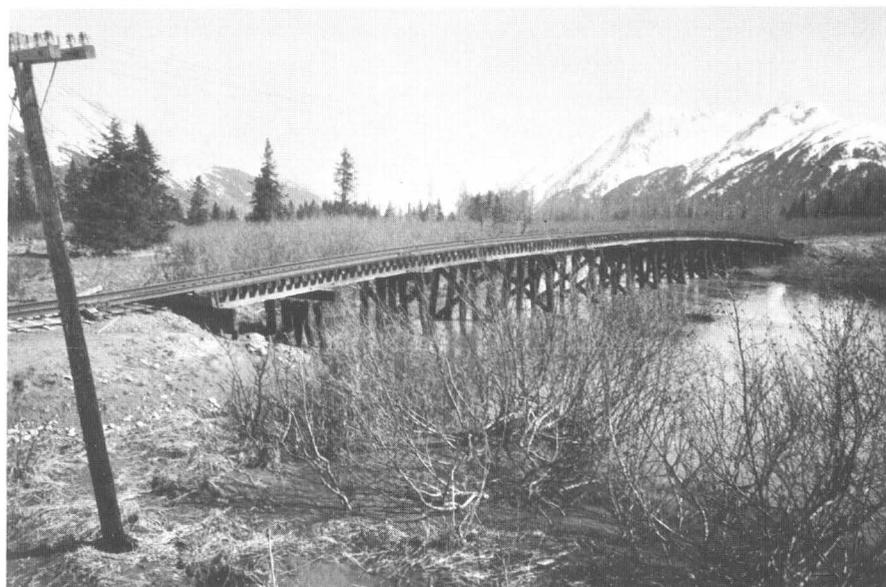
121.—A 2.6-foot arch in the deck of bridge 63.6 over Portage Creek. The deck was only slightly compressed, but was offset horizontally approximately 7 feet (see figs. 19, 56).

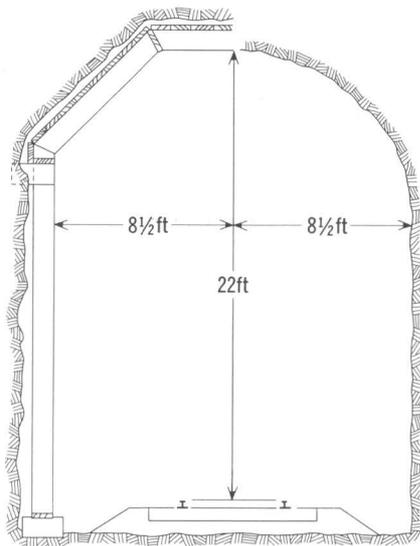
123.—Typical cross section of The Alaska Railroad tunnels, showing timbering used near portals.

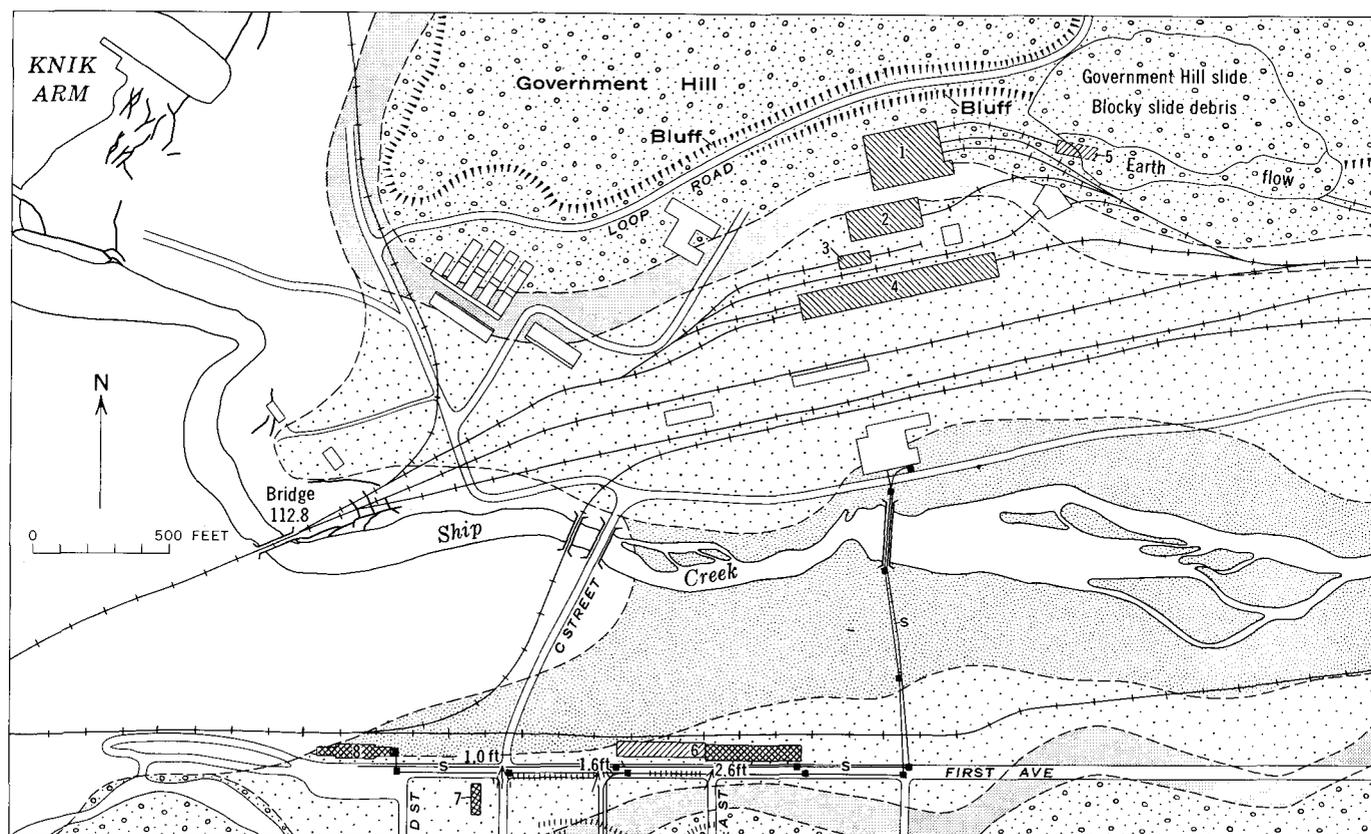
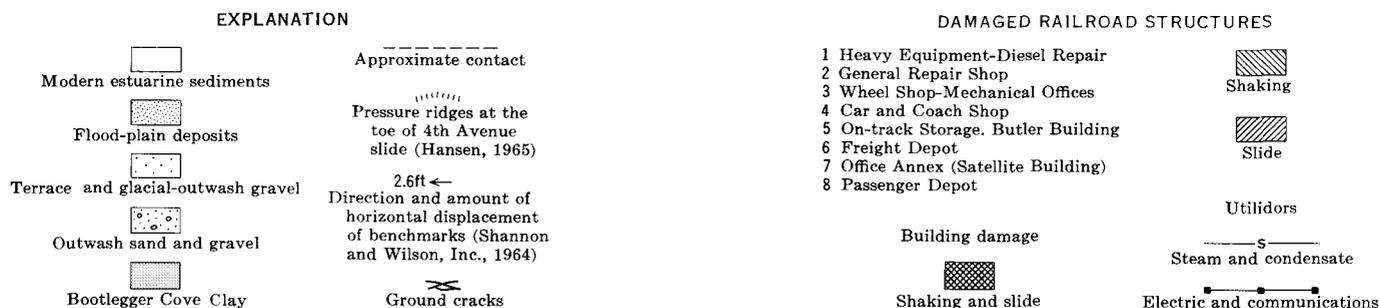
Shops and office buildings of The Alaska Railroad in the yards at Anchorage (fig. 126) were damaged by seismic shaking and compaction of underlying materials. In addition, buildings and utilities that lay in the path of landslides dislodged from the adjacent bluffs were also subjected to ground displacement, and one building was overrun by slide debris.

126.—Map of the railroad buildings and buried utilities, surficial geology, and landslide features in the Anchorage railroad yards in Ship Creek valley. Map of the railroad facilities after J. Morrison of The Alaska Railroad; geology modified after Miller and Dobrovlny (1959, pl. 1); landslide features after Shannon and Wilson, Inc. (1964b, pl. 8.2) and Hansen (1965, fig. 38).

Ground displacement at the toe of the Fourth Avenue slide also damaged about 1,800 feet of the steam, condensate, electrical, and communication lines of The Alaska Railroad that were carried in two buried utilidors (fig. 126). The utilidors consist of eight 4-inch-diameter fiber conduits (set in plastic separators) cast in a concrete envelope 17 inches high and 30 inches wide. Steam and condensate lines were cracked and electrical and communication lines sheared as the utilidors were displaced northward near the intersection of First Avenue and A Street. A break also occurred in the electrical-communications utilidor near the pressure ridge halfway between B and C Streets, and water had to be pumped continuously from this utilidor at the manhole southeast of the Depot. An abandoned section of the electrical-communications utilidor that ran up B Street was heaved upward and broken where it crossed a pressure ridge. Since the earthquake, all utilities previously carried by the utilidors along First Avenue have been installed above ground.

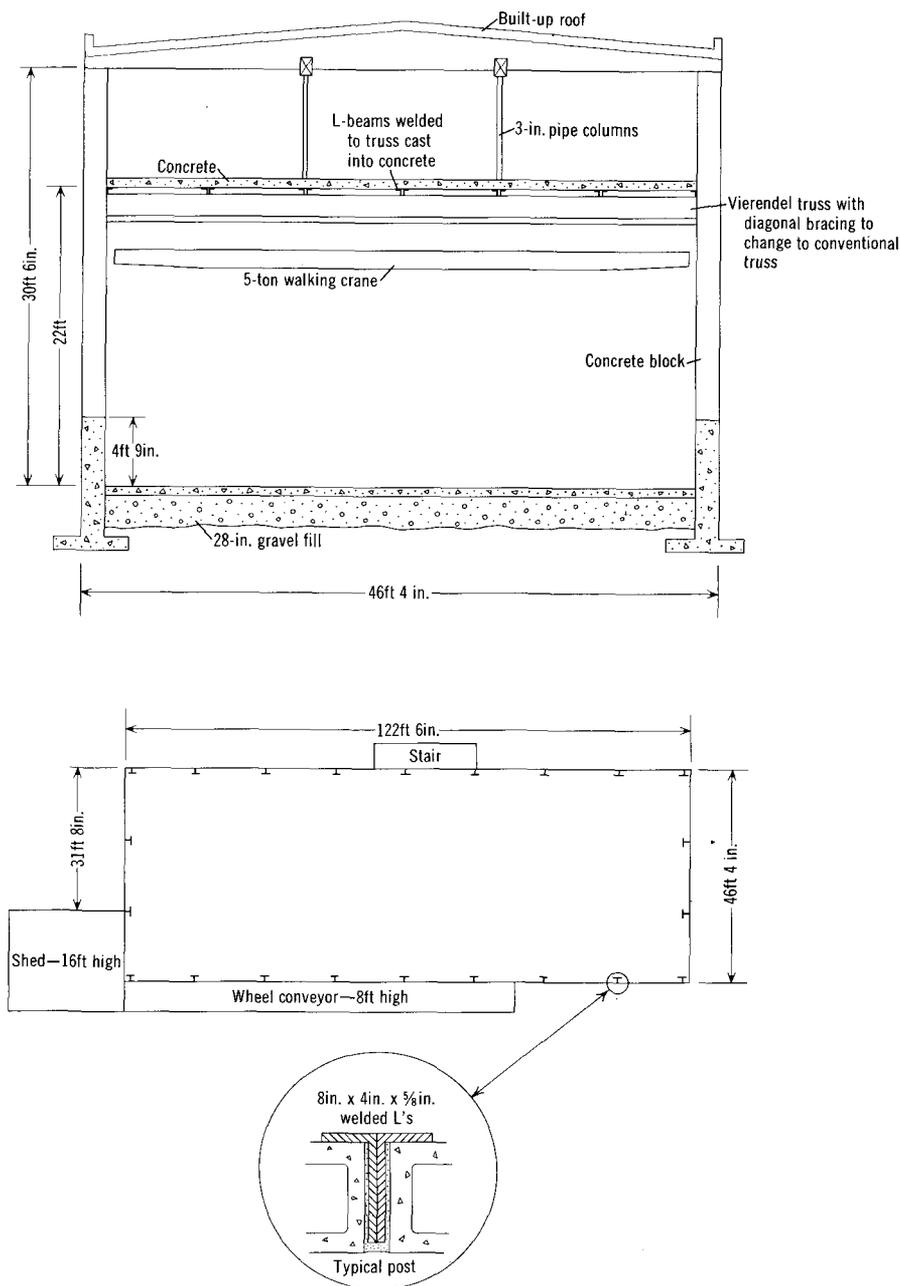
severely damaged that it had to be razed (fig. 127). The building, constructed during the Second World War when material was scarce, was built largely of salvaged materials. The steel frame consisted of columns of two welded L's cast into a high perimeter foundation wall (fig. 128). The columns were welded to modified Vierendeel trusses at the second

concrete second floor, to be delivered to the block walls. As a result, the unreinforced walls were shed from the sides of the building. The irregular roof-line and floor-line visible in figure 127 suggest that there were also some foundation failures.

128.—Construction of the Wheel Shop-Mechanical Offices building.

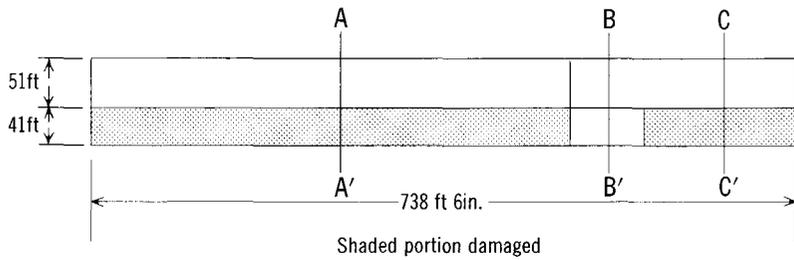
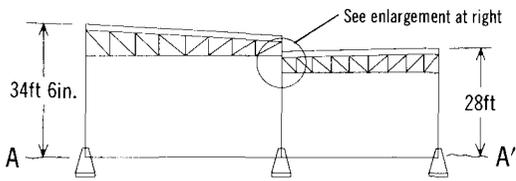
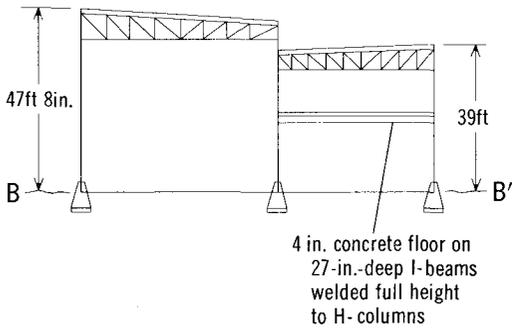
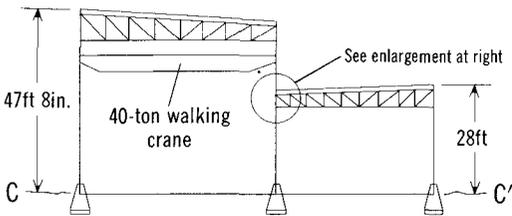
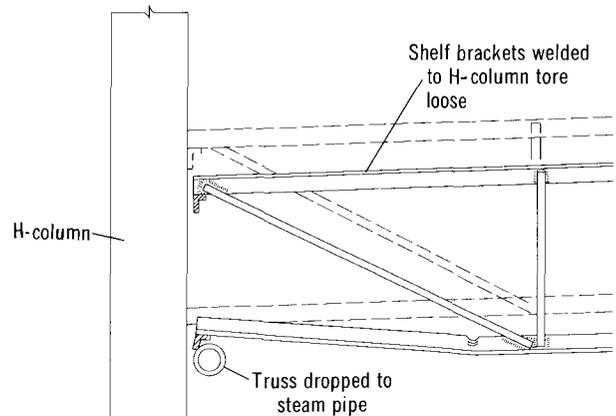
The Car and Coach Shop (No. 4, fig. 126) just south of the Wheel Shop was also damaged by shaking. The structure was 738.5 feet long, built with a steel frame of vertical H-columns to which were attached metal roof trusses supporting wood partitions and a wood roof deck (fig. 129). The building was sheathed with insulated metal sandwich panels (Robertson panels) welded to the

frame. During the shaking the roof trusses on the two long low bays on the south side of the building were torn from the H-column to which they had been attached by shelf brackets. The roof trusses dropped to a steampipe which then supported the roof. The two low bays were separated by a higher bay (section *B-B'*, fig. 129) in which there was an intermediate-level concrete floor supported on 27-inch-deep I-beams that were welded full height to the H-columns. There was no damage to the floor or to its supporting beams. In this section the central columns were made of two structural channels connected by welded diagonal round rods. The rods

buckled (fig. 130) as the building swayed. Swaying also stretched some of the bolts anchoring the H-columns to the concrete pedestals (Berg and Stratta, 1964).

129.—Construction of the Car and Coach Shop.

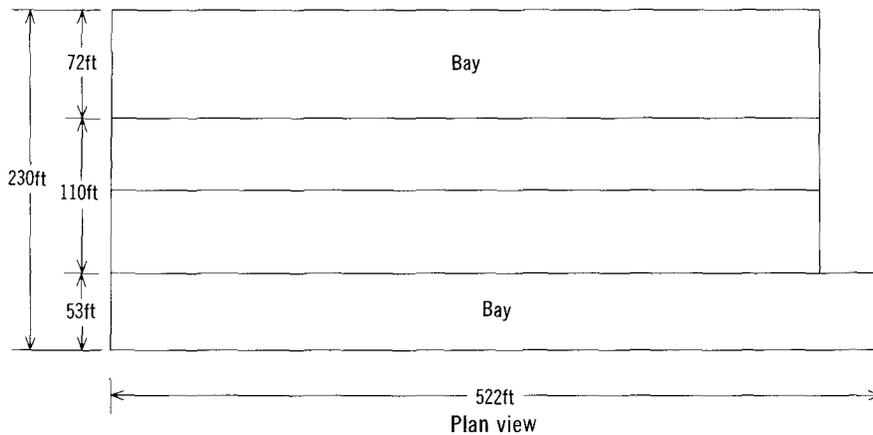
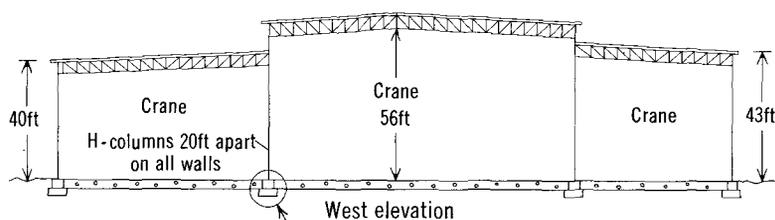
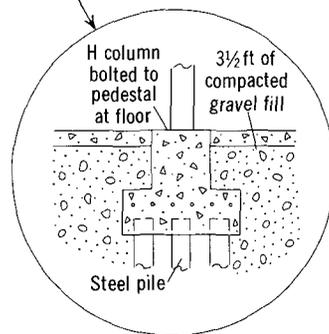
The Heavy Equipment and Diesel Repair Shop (No. 1, fig. 126), originally the Forge Building of the Denver Kaiser Steel Plant, Denver, Colo., had been reassembled in the rail yards with no structural changes. The building is 230 feet wide, 500 feet long, and 56 feet high at the central gable; it has two lower side bays, with outward-sloping shed roofs, that run the full length of the building (fig. 131). The steel frame consists of H-beam columns bolted to concrete pedestals at the floor

line, the pedestals being supported on steel piling. Metal trusses connected to the columns support a roof of welded-metal panels overlain by rigid insulation and a built-up surface. The exterior steel frame is diagonally braced by 3/4-inch tie rods between columns at the ends of the building and at four intermediate positions. It is

131.—Construction of the Heavy Equipment and Diesel Repair Shop.

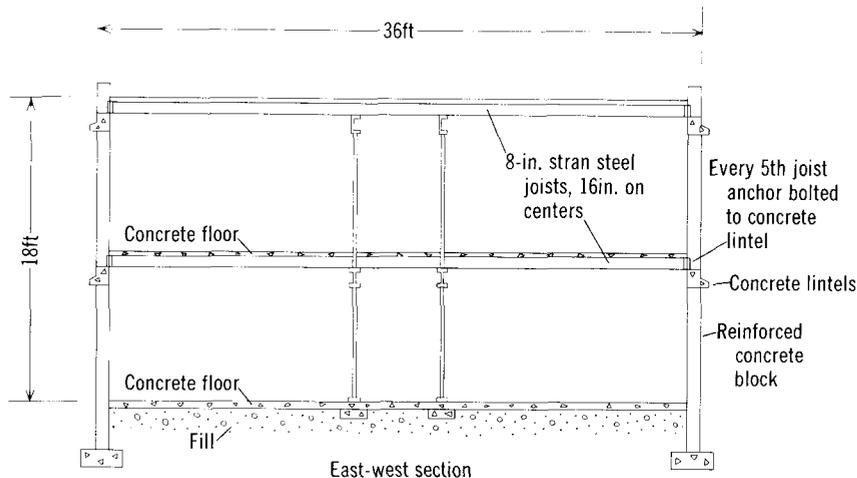
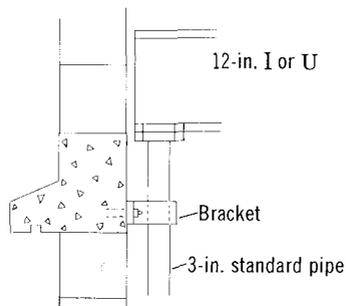
The Office Annex (Satellite) Building (No. 7, fig. 126) lay within the area affected by the Fourth Avenue slide. A pressure ridge formed at the nearby intersection of C Street and First Avenue, and a survey monument at this intersection was shifted 1 foot horizontally toward Ship Creek (fig. 126). The two-story building was 120 feet long, 36 feet wide, and 18 feet high (fig. 132). It had concrete floors, the second floor carried on 8-inch stran steel joists divided into three spans supported by 12-inch I-beams welded to columns of 3-inch standard iron pipe. Joists were 16 inches on center, and the end of every fifth joist was anchorbolted to reinforced concrete lintels in the side walls. The concrete block exterior was reinforced with vertical 3/4-inch iron in concrete-filled cells on a maximum 6-foot spacing and steel

concrete pour on a fill, was undamaged, but the second floor concrete slab was broken on an east-west crack. There was a vertical crack nearby in the west wall. The north and south end walls were badly broken by shear (C. L. Griffiths, oral commun., 1967). The top two courses of block of the parapet on a small bay on the

northwest side of the building were dislodged. Some damage that occurred at the south end of the building (fig. 133), where insufficiently reinforced blocks were pulled apart at mortar joints or ruptured, may have been produced by a pressure ridge. This building was razed and was replaced by a new building constructed across

132.—Construction of the Office Annex (Satellite) building.

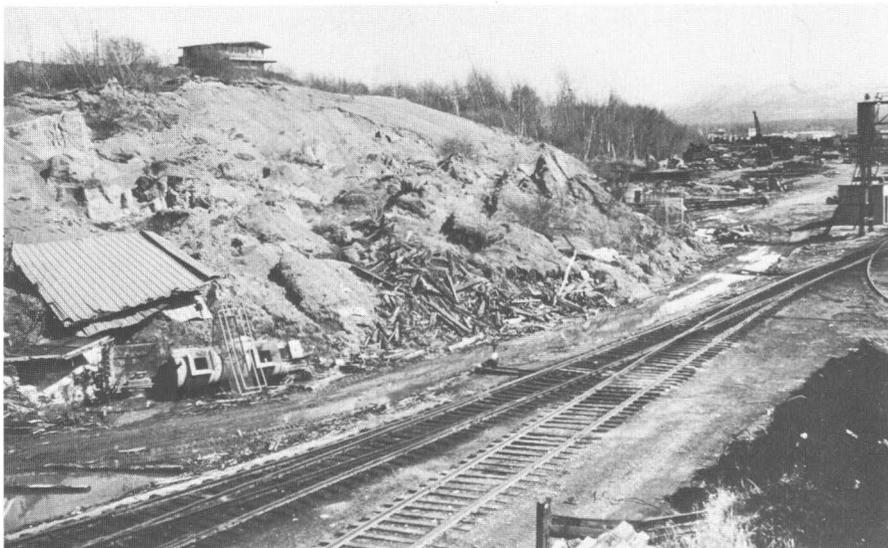
A steel-framed metal-sheathed Butler building (No. 5, fig. 126) used for on-track equipment storage was overrun by an earth flow that occurred at the toe of the Government Hill slide (fig. 135).

Some yard equipment and rolling stock were destroyed or damaged as the flowing earth covered about 850 feet of track. This slide is described by Hansen (1965).

135.—The toe of Government Hill slide that overran an on-track storage building and some rolling stock on the north side of Ship Creek valley

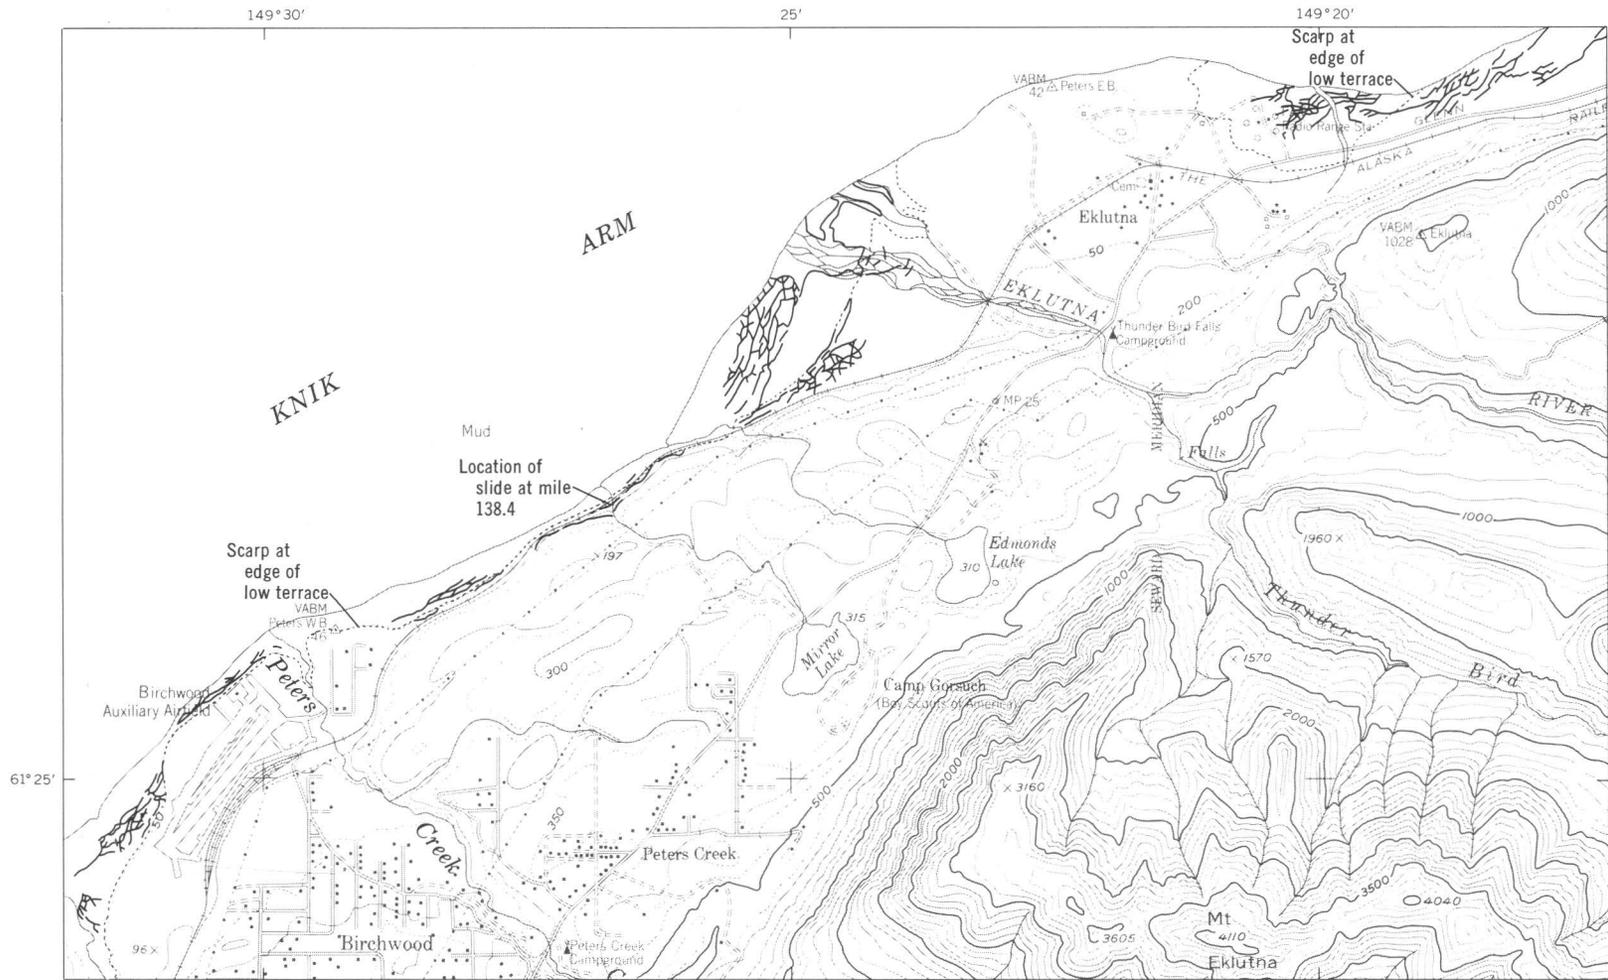
From Eagle River, the rail line runs northeast on a plain of ground moraine adjacent to the Elmendorf moraine, and near Birchwood (mile 136.4) it turns eastward and follows the shore of Knik Arm (fig. 136). The low ground-moraine plain is separated from Knik Arm by a low terrace. The sediments on the terrace are primarily estuarine, and the terrace is widened by deltas at the mouth of Peters Creek and the large delta of the Eklutna River, which crosses the rail line at mile 140.8. Northeast from the mouth of Fire Creek, south of Birchwood, the low terrace and delta surfaces were broken by cracks, many of which discharged sediment-laden water.

136.—Ground cracking in deltaic and estuarine sediments along the shore of Knik Arm. Cracks mapped from aerial photographs taken by Air Photo Tech, Inc., Anchorage.

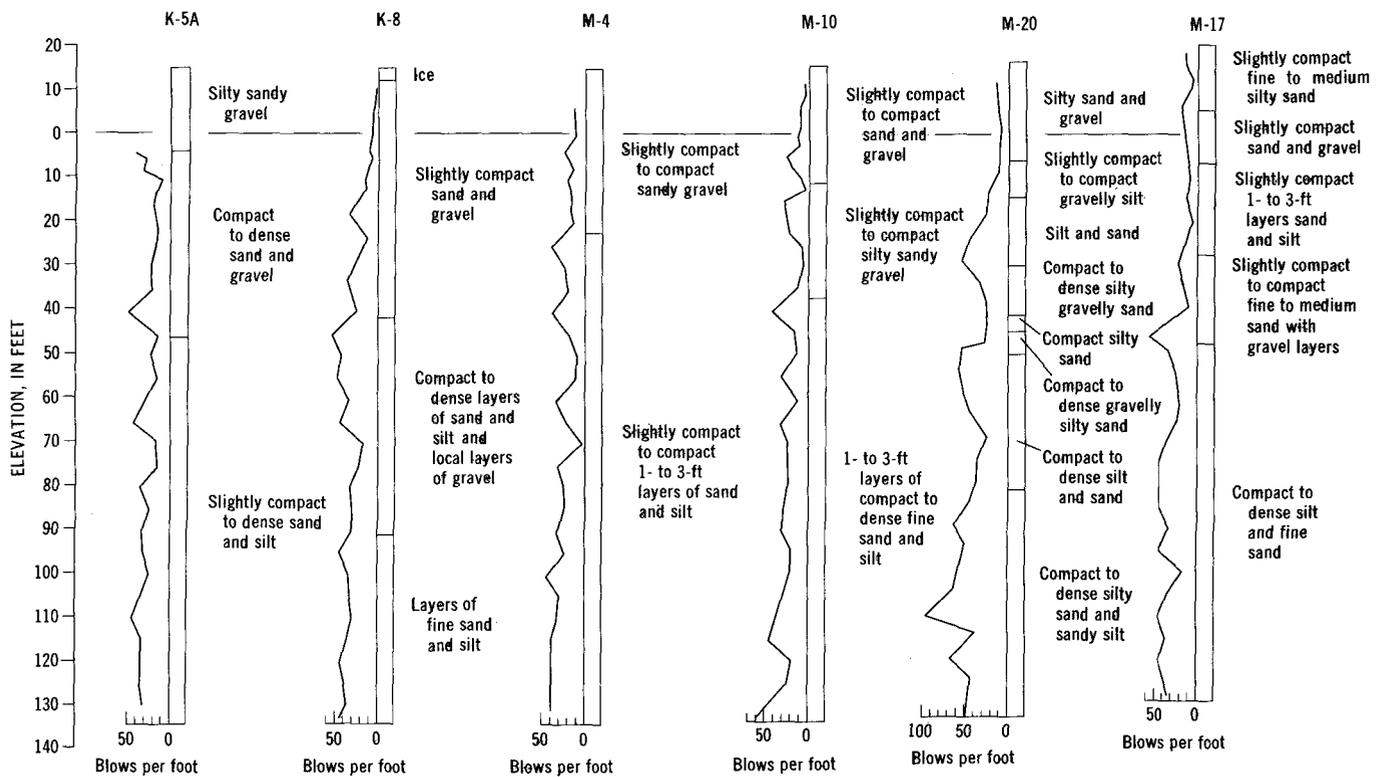
137.—Logs and penetration-resistance (blows per ft. 2-in. penetrometer, 140-lb hammer, 30-in. drop) of highway borings across Knik and Matanuska River flood plains. Borings located on plate 1. Data supplied by Alaska Department of Highways.

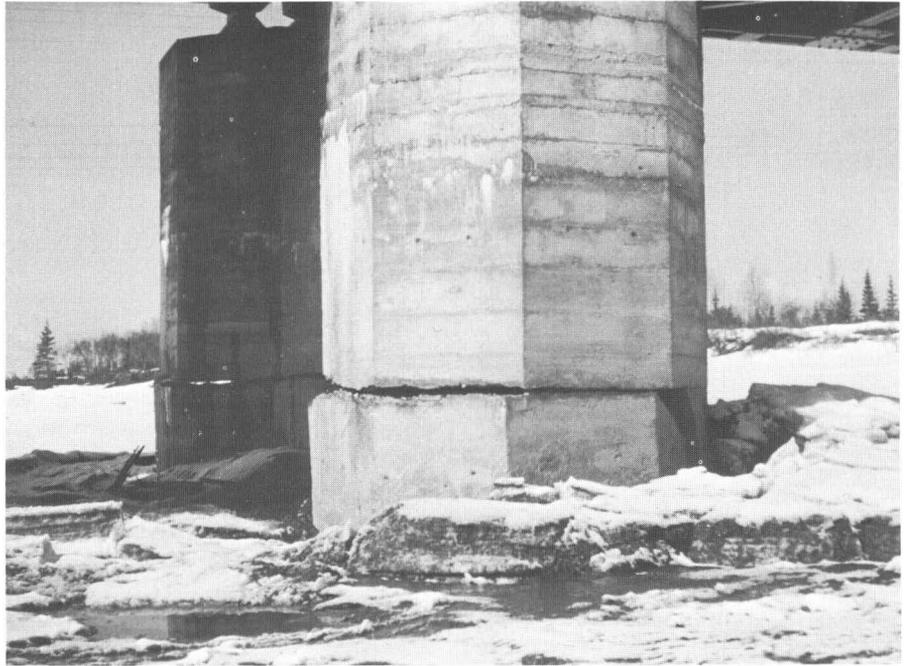
The next bridge to the north, built across another channel of Knik River at mile 147.1, is 420 feet long, with three central 125-foot steel through trusses and single 25-foot steel-beam spans at each end. All the spans are supported on concrete piers that were displaced toward the river during the earthquake. The anchor bolts in the short end spans tore free and spalled away the concrete, and the steel was jammed against the adjacent large steel spans. The third pier which, like the others, was reinforced with one-half-inch vertical bars 18 inches on centers was sheared off near its base along a fracture that followed a pour joint most of the way across the pier. The buried base of the pier was displaced about a foot south toward the river. The displacement tilted the upper part of the pier about 8 inches and produced an offset of about 4 inches at the break (fig. 138).

138.—Shearing at a pour joint of a concrete pier at bridge 147.1, Knik River.

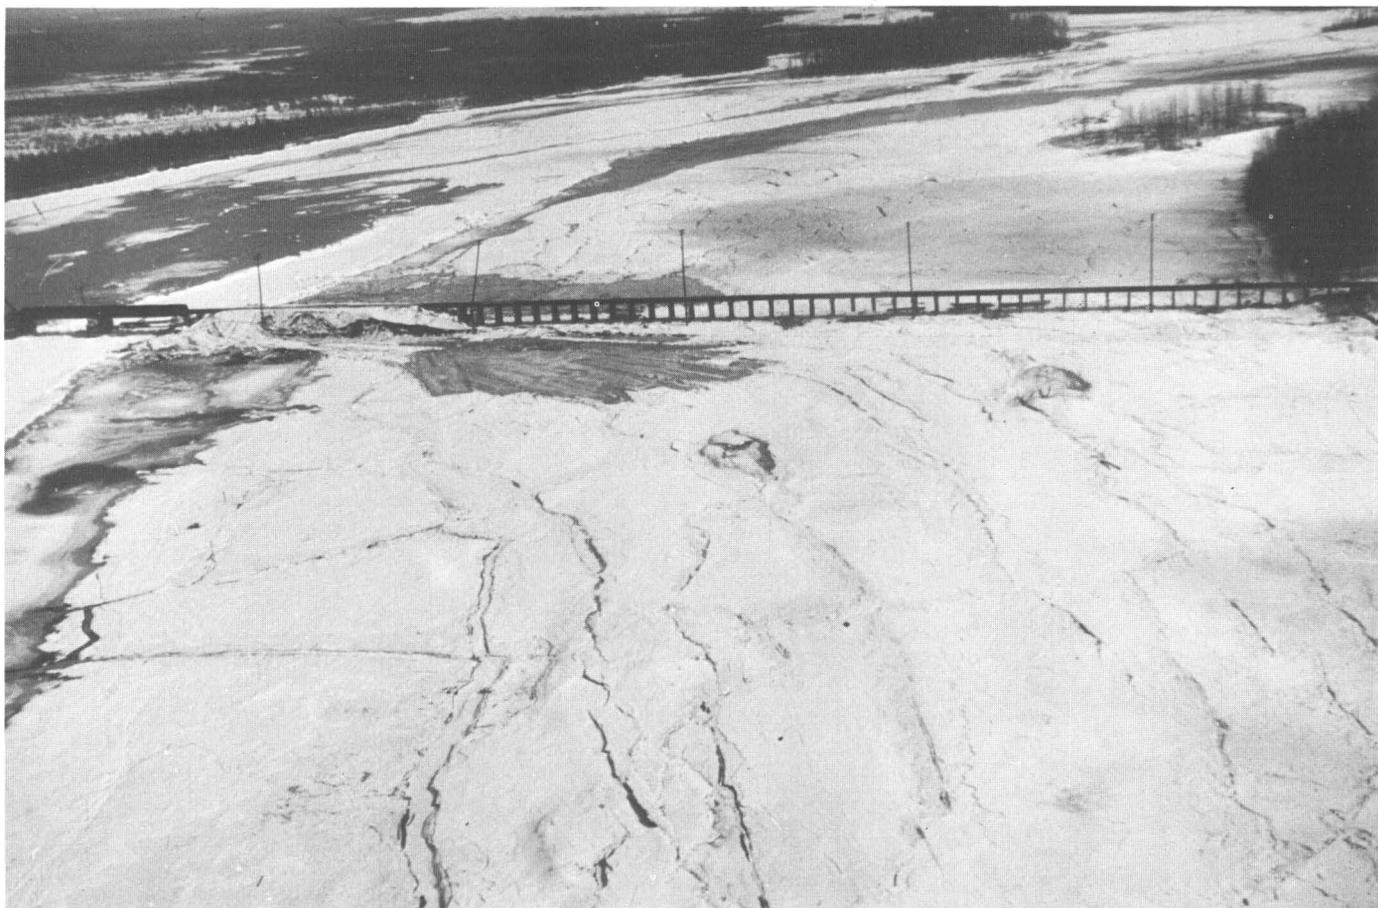
cracks. Figure 139, taken after channel deposits had been bulldozed to replace the destroyed bridge, shows that some of the cracks were several feet wide. Mr. Cannon also reports that the anchor bolts in the adjacent 70-foot through girders shown at the left of figure 140 were sheared.

139.—Cracks in the active flood-plain sediments at the south end of bridge 147.5 at Matanuska River. An earth fill has been bulldozed in to replace a section of trestle in which cracks sheared wood piles at the ground and offset the trestle.

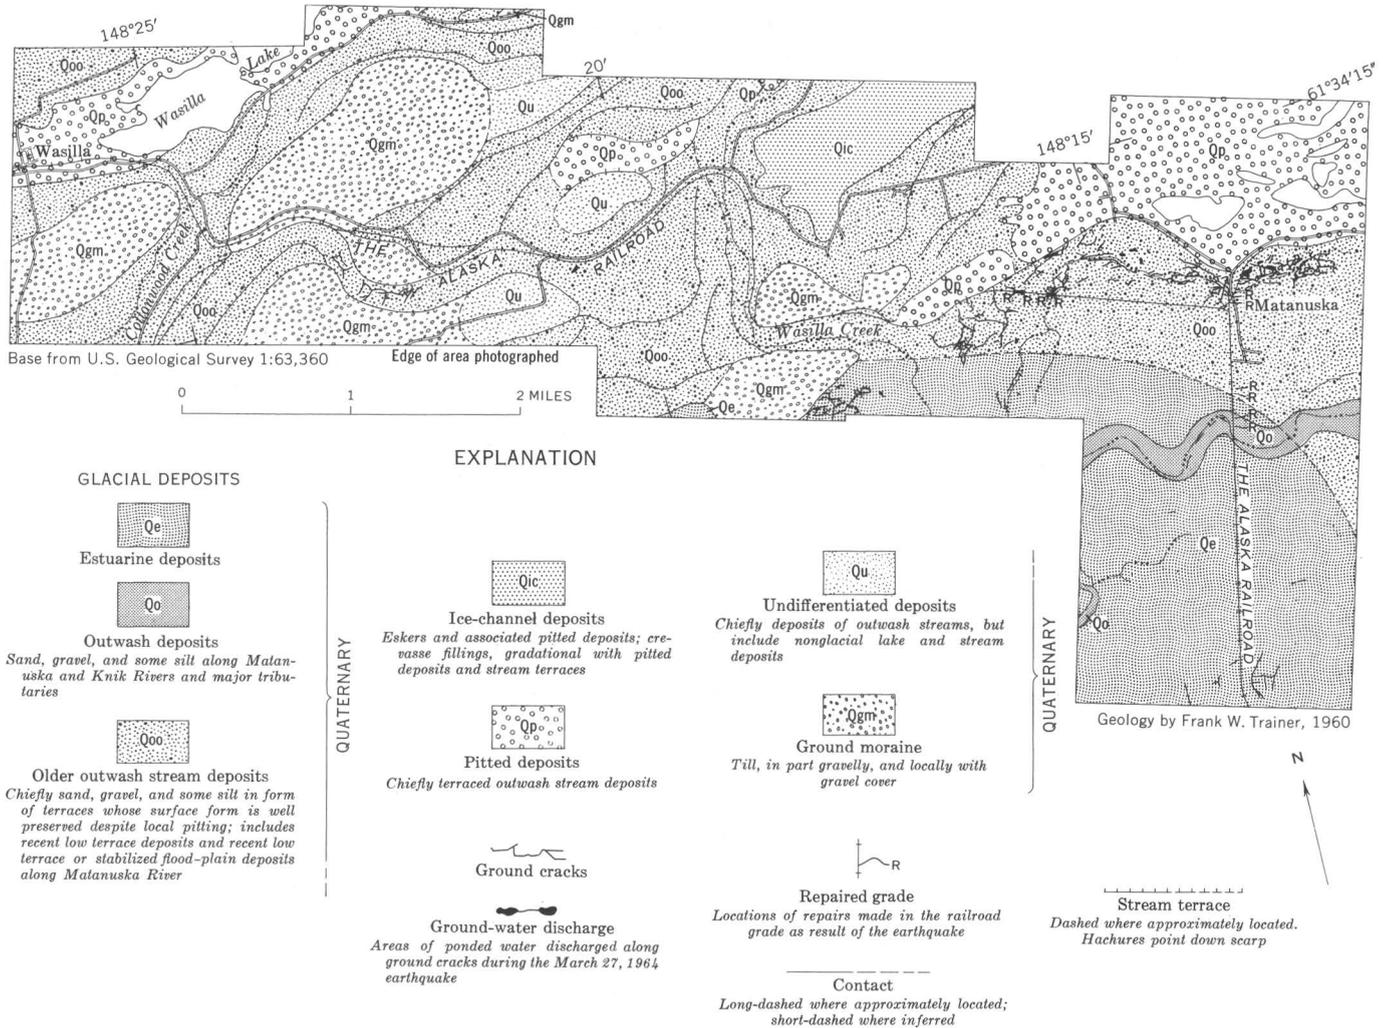
North of the Matanuska River the rail line leaves the highly fractured outwash and river-channel deposits and passes abruptly onto a nearly unfractured flat low-lying surface underlain by estuarine silt and clay (fig. 140). The estuarine deposits are relatively thick; Trainer (1960, p. 52) reports that a well drilled by The Alaska Railroad near Matanuska penetrated estuarine silt and clay to a total depth of 200 feet (175 ft below sea level) without reaching the base of the estuarine sediments. The estuarine sediments grade nearly imperceptibly into glacial-outwash

About a quarter of a mile north of Matanuska the rail line divides, the Sutton-Palmer branch swings off to the east and the main line turns west to Fairbanks (fig. 1). As shown on figure 140 the Fairbanks line proceeds west through deposits of glacial moraine and outwash sand and gravel; outwash in old ice-channel fillings, in terraced outwash stream deposits, or in older outwash deposits. Despite the wide variety of materials and the abrupt slopes shown by the scarps on figure 140, the only cracking that was visible on aerial photographs occurred in swampy areas along the modern streams

that lie in the older outwash and in the estuarine deposits. The selective cracking probably was related to a very shallow, or at-the-surface, water table.

140.—Ground cracking in the area of Matanuska. Most cracks are in young stream deposits lying in old glacial-outwash channels, where the water table is at, or just below, the ground surface.

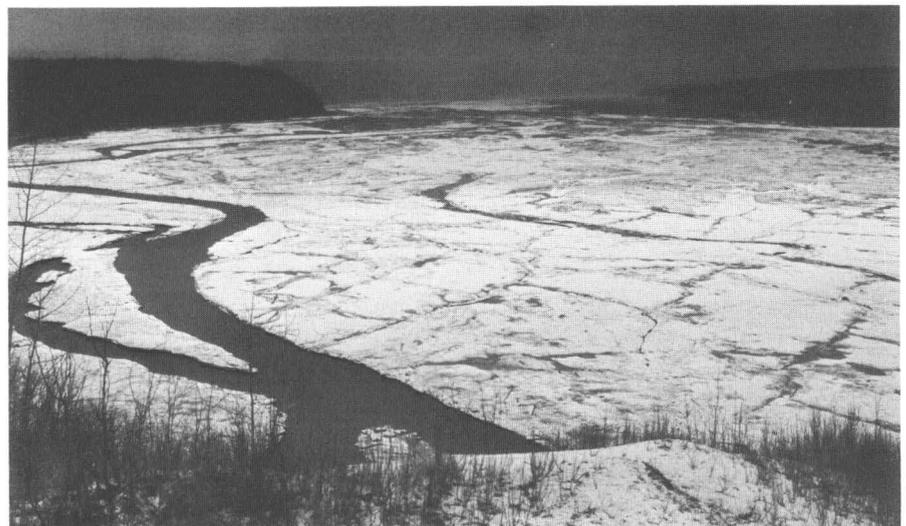
from the flood plain of the Matanuska River have accumulated on the outwash in a blanket that thickens to about 20 feet a mile or so north of Palmer (Trainer, 1961). Just beyond Palmer the rail line drops down across the steep river bluffs onto the flood plain of the Matanuska River and continues north on the flood plain at the toe of the bluffs to Sutton. The flood-plain sediments and the islands and low terraces composed of glacial outwash sand and gravel (Trainer, 1961) were as severely fractured here as at the mainline crossing to the southwest (fig. 141). The rail line is built at the

141.—Large and continuous ground cracks in low terraces of glacial outwash and flood-plain sediments in the Matanuska River valley.
