The Parkfield-Cholame California, Earthquakes of June-August 1966

GEOLOGICAL SURVEY
PROFESSIONAL PAPER 579

The Parkfield-Cholame California, Earthquakes of June-August 1966— Surface Geologic Effects Water-Resources Aspects, and Preliminary Seismic Data

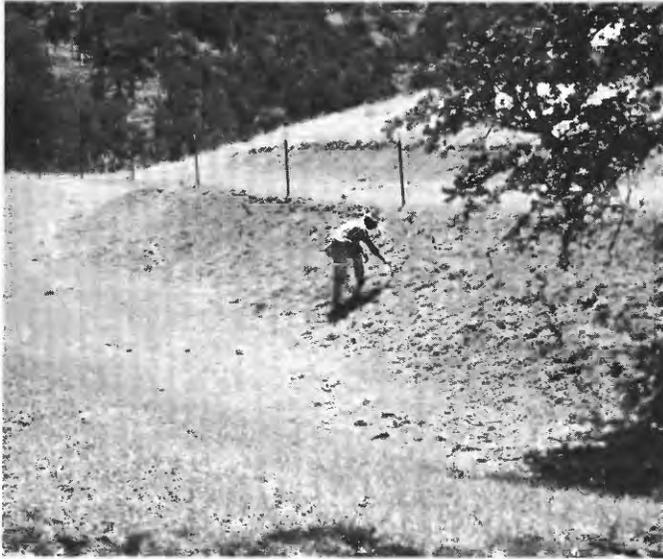
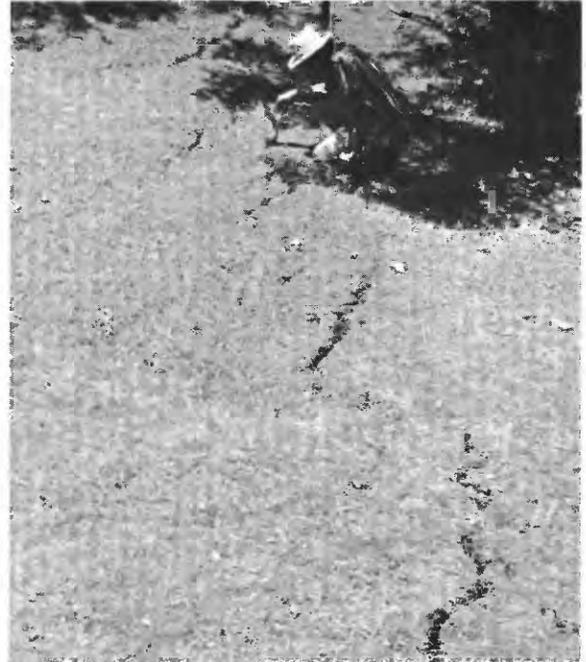
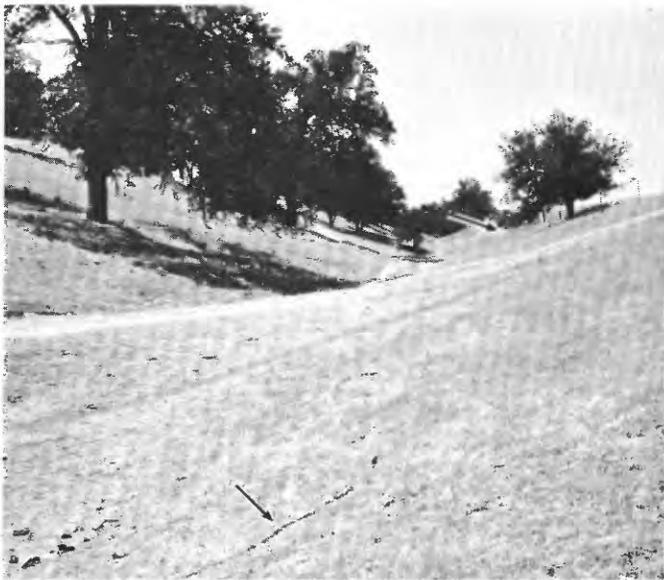
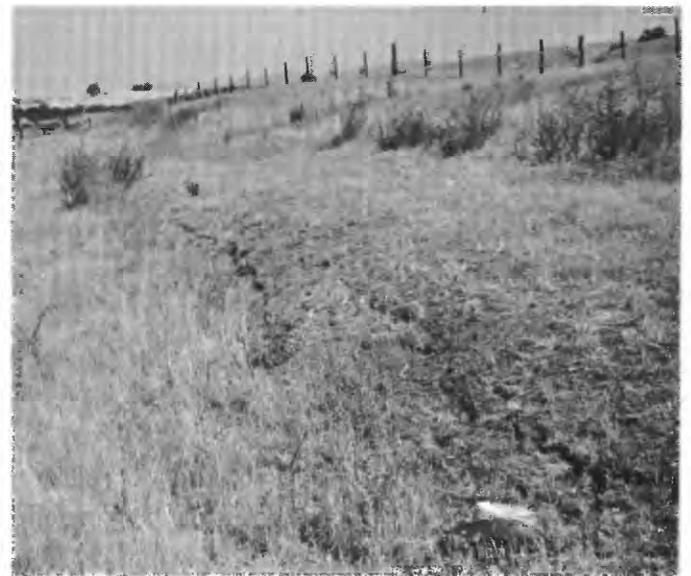
FIGURE 5.—Tectonic fractures, main fracture zone. *A.* Scarplet and dry sag pond (right foreground); en echelon fractures below fence trend obliquely across scarplet and are visible to right of figure. Middle Mountain near locality F3 (fig. 2 and table 2). *B.* En echelon fractures, Middle Mountain near locality F3. *C.* Low swale along San Andreas fault north of locality F7. Main fracture zone parallels swale but lies just east of its axis (arrows). One fracture of en echelon system is visible in foreground. *D.* Linear fractures near locality F15, showing about 1–2 inches of vertical movement, down to left (southwest). Fracture zone is at margin of flood-plain alluvium (to left) and closely follows contact with terrace deposits (to right).

From Middle Mountain southeast to California Flats Canyon, the main fracture zone is nearly straight and trends about N. 45° W. En echelon fractures are persistent and well defined, and the fracture zone closely follows a line of scarplets, benches, sag ponds, and other topographic faultline features (fig. 5C). There are very few gaps in the fracture zone, and most of them are in stubble fields or in freshly plowed ground, where tectonic fractures are probably present but are unidentifiable. One gap, between localities

The main fracture zone from California Flats Canyon to the southeastern end of Cholame Valley crosses an area of low relief where faultline topographic features are fewer and less obvious than to the north. The average trend of this segment of the fracture zone (about N. 30° W.) departs significantly from the trend farther north, but the local trend of the zone and the style of fracturing both vary considerably (table 2). En echelon fractures are the most common and are especially well formed on the southwest side of Cholame Valley; the trend of these varies with the orientation of the fracture-zone segment in which they occur. Linear cracks are common in some areas where en echelon fractures are absent (fig. 5D).

Linear or slightly arcuate fractures are less common than the en echelon type and are found locally between segments of an echelon fracturing. They are particularly well defined at two localities: one about a mile northwest of Cholame Ranch at locality F15 (fig. 5D), the other about $1\frac{1}{2}$ miles southeast of the ranch. At the locality southeast of the ranch linear fractures extend along the main fracture zone for about 1,200 feet. The linear fractures parallel or nearly parallel the fracture zone and vary from a nearly continuous single break to slightly en echelon discontinuous short strands. They average 20 feet long and 1 inch wide and have a maximum observed length of about 60 feet and a width of $3\frac{1}{2}$ inches. Most of them show a vertical component of movement and as much as 3 inches of displacement.

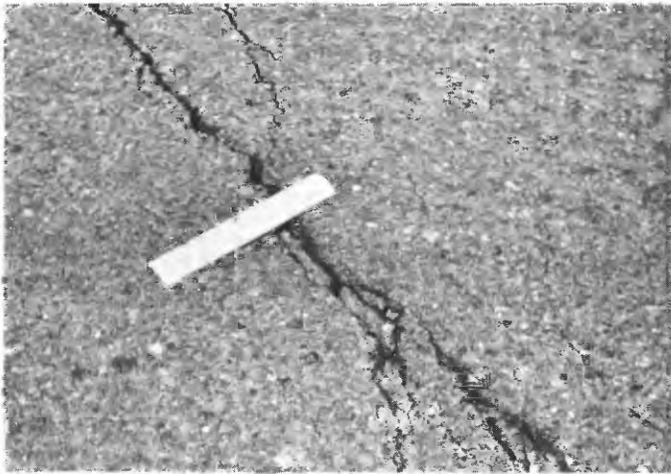
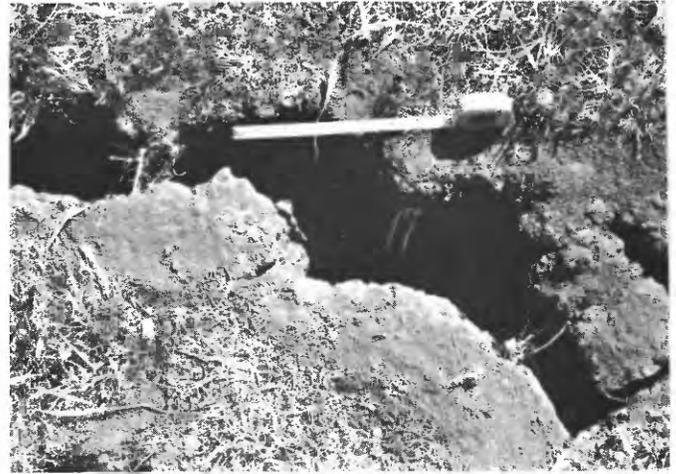
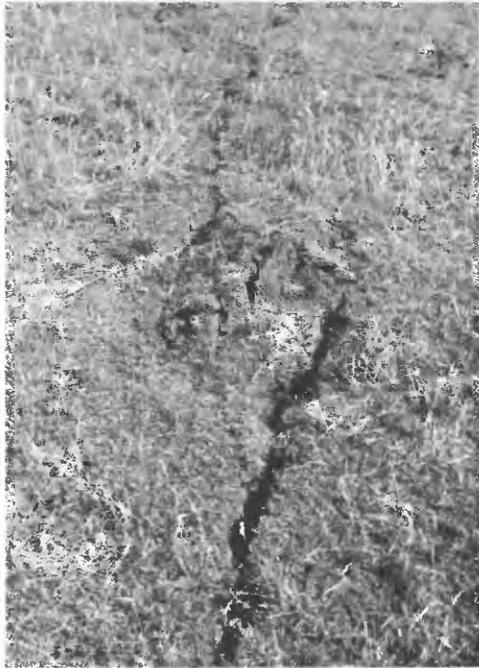
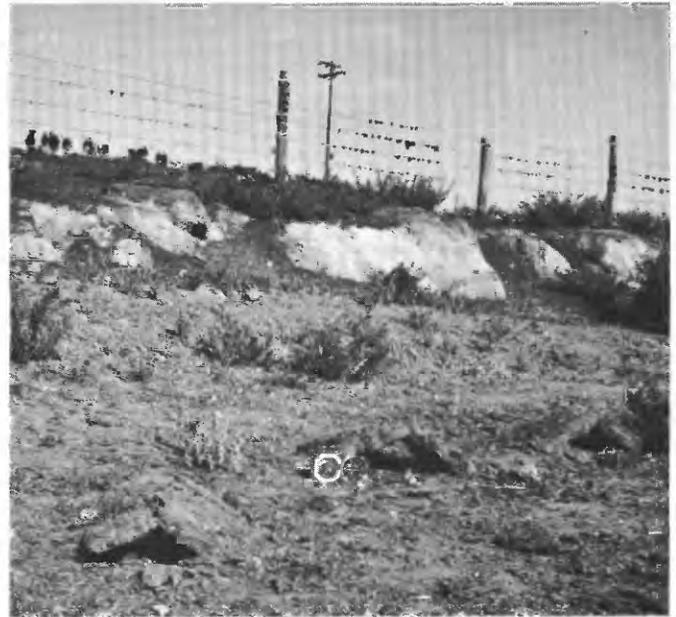
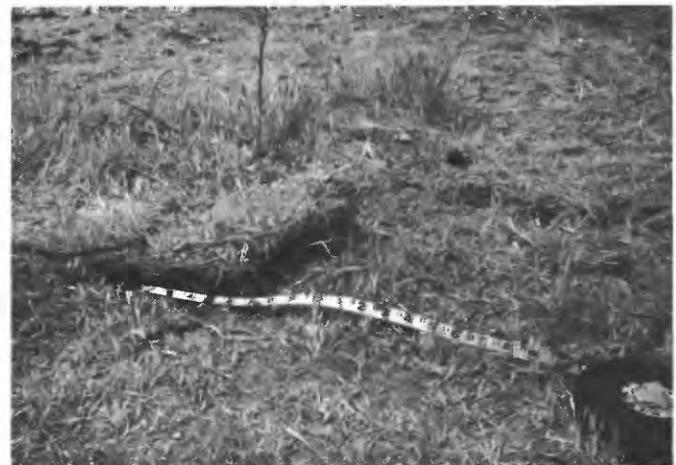
FIGURE 11.—Evidence of strike slip, main fracture zone
A. Strike slip exhibited along fracture wall in county road at locality F20. Matching points in fracture wall show about one-half inch of strike slip as shown near 6-inch rule. *B.* Strike slip exhibited along fracture wall in pastureland near locality F23. Approximately 4 inches of strike slip. *C.* Pressure ridge between adjacent en echelon fractures about one-half mile southeast of locality F23. Ridge is about 5 inches high. *D.* Pressure ridges formed along en echelon fractures in compact alluvium, bed of Cholame Creek at locality F18. *E.* Wedge of soil at end of en echelon fracture near locality F18 is raised and thrust to the right about 4 inches.

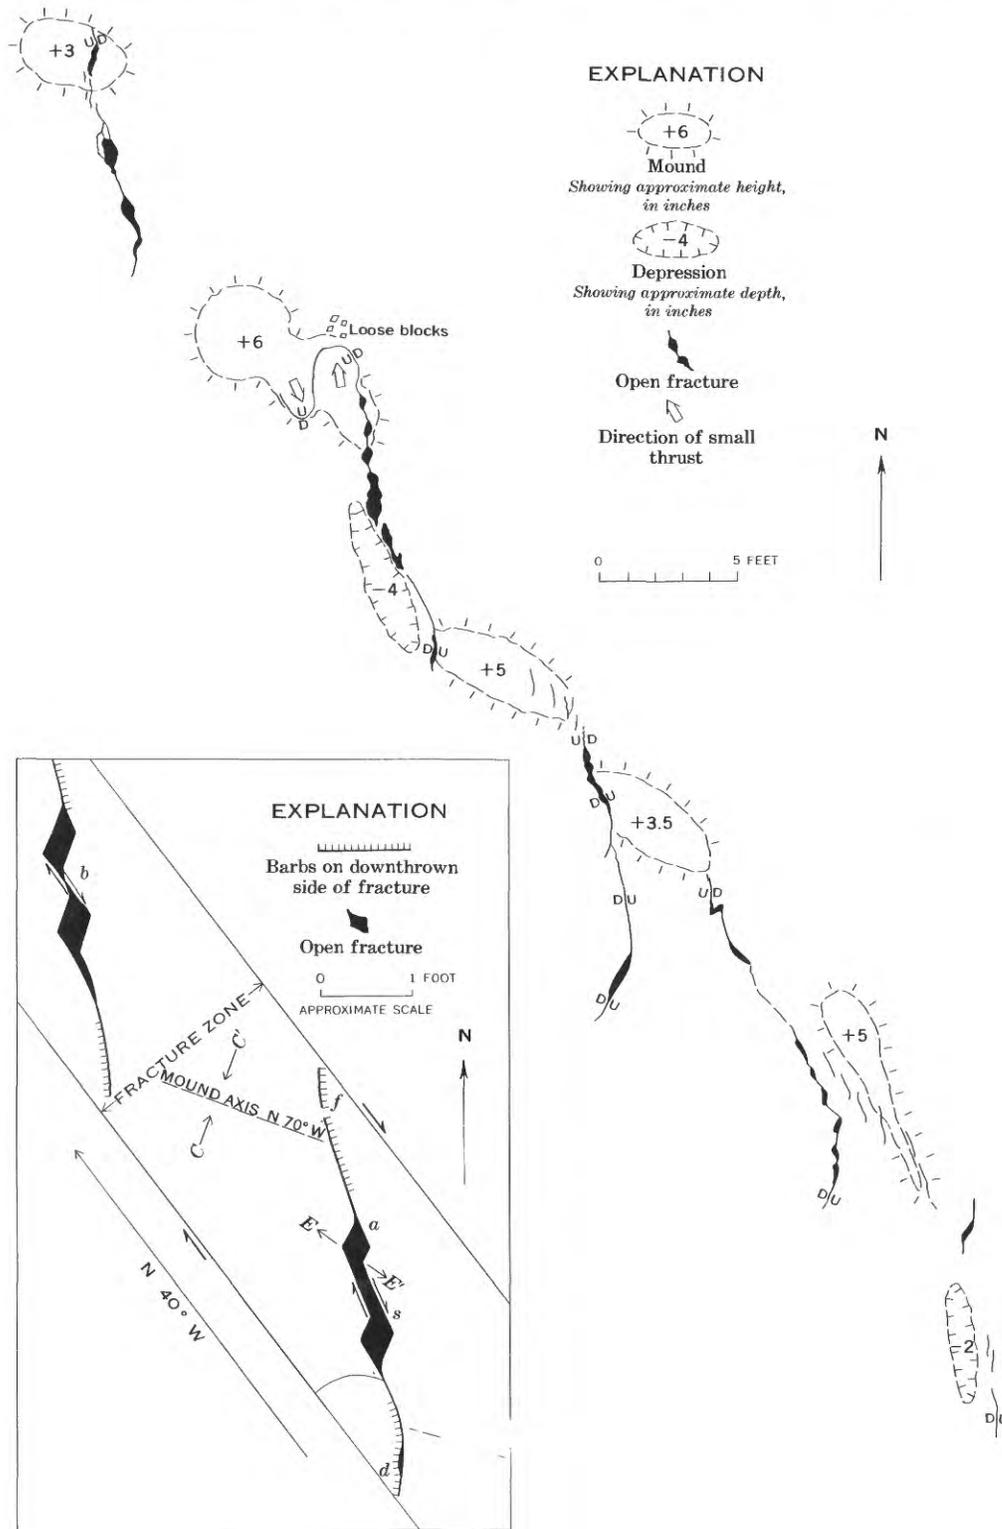
FIGURE 12.—Sketch map of an echelon fractures and accompanying mounds or pressure ridges, which together make up mole tracks 640–700 feet southeast of F23 (fig. 2). Fractures mapped by R. E. Wallace on July 21, 1966. U, upthrown; D, downthrown. Inset is a diagram of the fracture system and related pressure ridges where individual fractures result from a composite of shear and extension movement, alternating in a steplike arrangement as at *a*, *s*, and *b*. Note the sigmoid pattern formed by the bowed ends at *d* and *f*. Mound relief is compensated by vertical displacement indicated at *d* and *f*. Greatest extension is between *E-E'* nearly parallel to the mound axes or normal to the shortening direction *C-C'*.

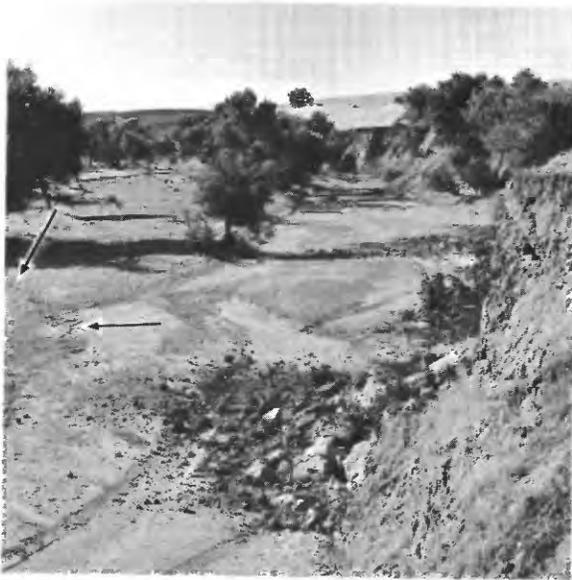
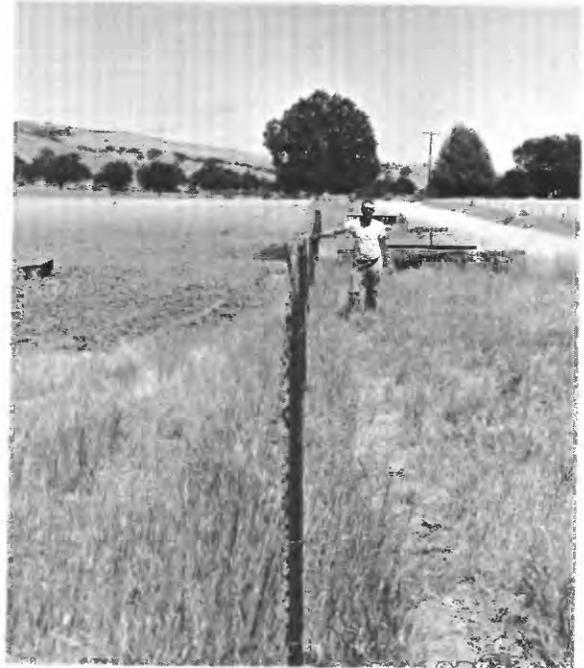
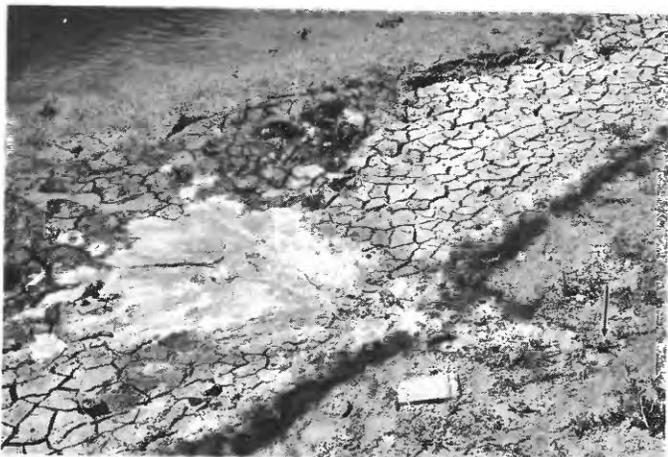
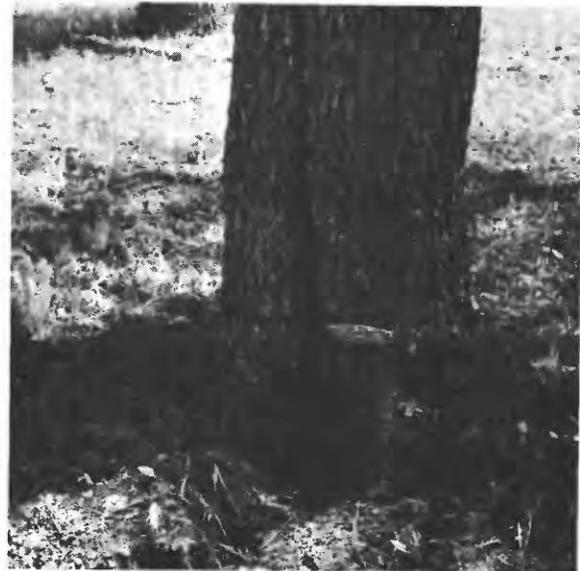
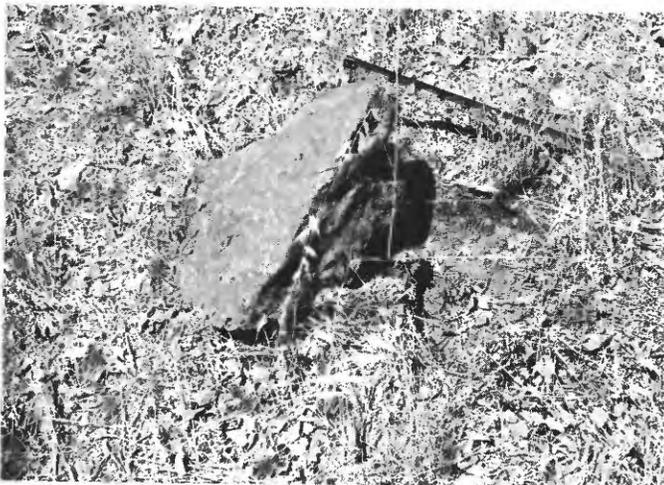
In two areas of flat to gently sloping (5°) ground, dislodged boulders, cobbles, and pebbles were noted within the main fracture zone or within a few feet of it. Most of the dislodged stones were shifted only slightly from their earlier positions (as shown by impressions in soil and grass), but a few were moved entirely out of their former sites to places several inches away. Some of the stones left skid marks (fig. 14E), others that moved under apparently identical conditions did not.

FIGURE 14.—Features associated with tectonic fracture zones. *A*. Debris slide at intersection of main fracture zone (arrows) with left bank of Cholame Creek, locality F14. Note other debris slides upstream along creek bed. *B*. Steel-stake and barbed-wire fence at locality F31. Extension resulting from strike slip has tightened top strand of wire pulling one stake out of alignment. *C*. Sand flow north of locality F25 formed by the extrusion of water saturated sand and silt. Orifice for flow indicated by arrow. *D*. Oak tree, split vertically by tectonic fracture visible in left foreground. Handle of knife is 3 inches long. *E*. Dislodged angular cobble at locality F8, showing original "nest" in which cobble rested and skid mark formed during movement.

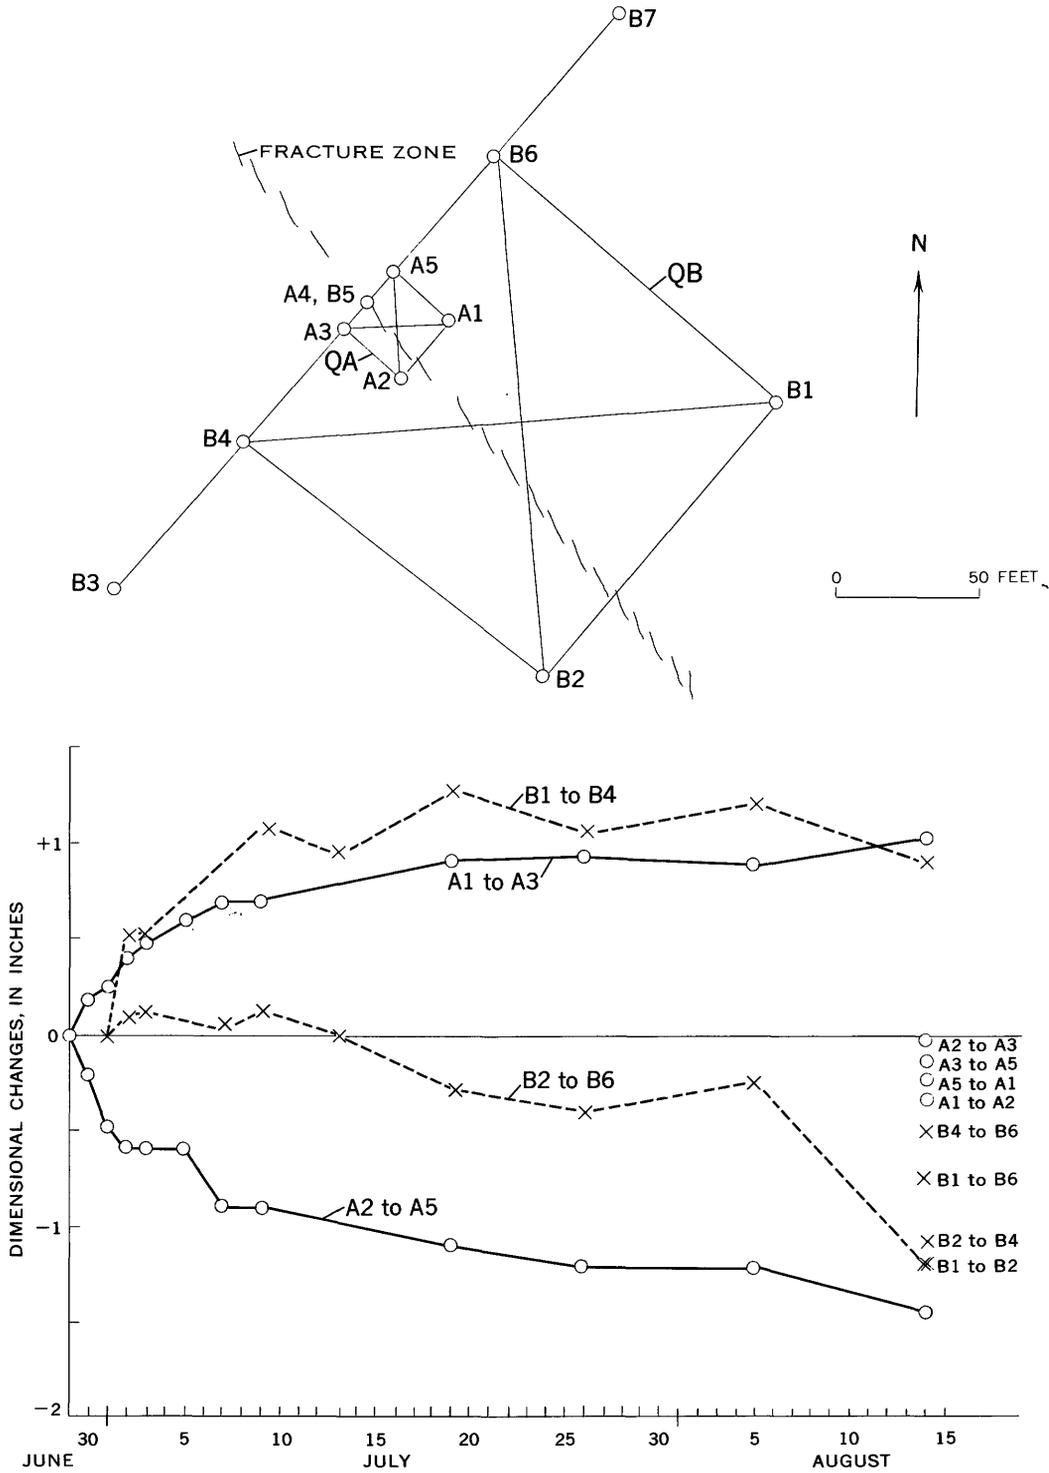
Measurements of quadrilaterals QA and QB (fig. 16) show continuing deformation up to the last time recorded here although the rate has decreased. (See also fig. 17 for map of fracture zone at this locality.) By

FIGURE 16.—Plan of quadrilaterals QA and QB and graph of dimensional changes with time. See figure 17 for detailed map of fractures.

August 14 only the two diagonals B1-B4 and A1-A3 showed extension; the remaining two diagonals and eight sides all showed shortening.

An approximation of strike slip suggested by the lengthening of B1-B4, after correcting for shortening of B1-B2 and B2-B4, is 3.4 inches. An amount almost equal to this may have taken place before measurements were started because estimates based on fracture dimensions (fig. 17) suggest 6 or 7 inches of strike slip at this locality.

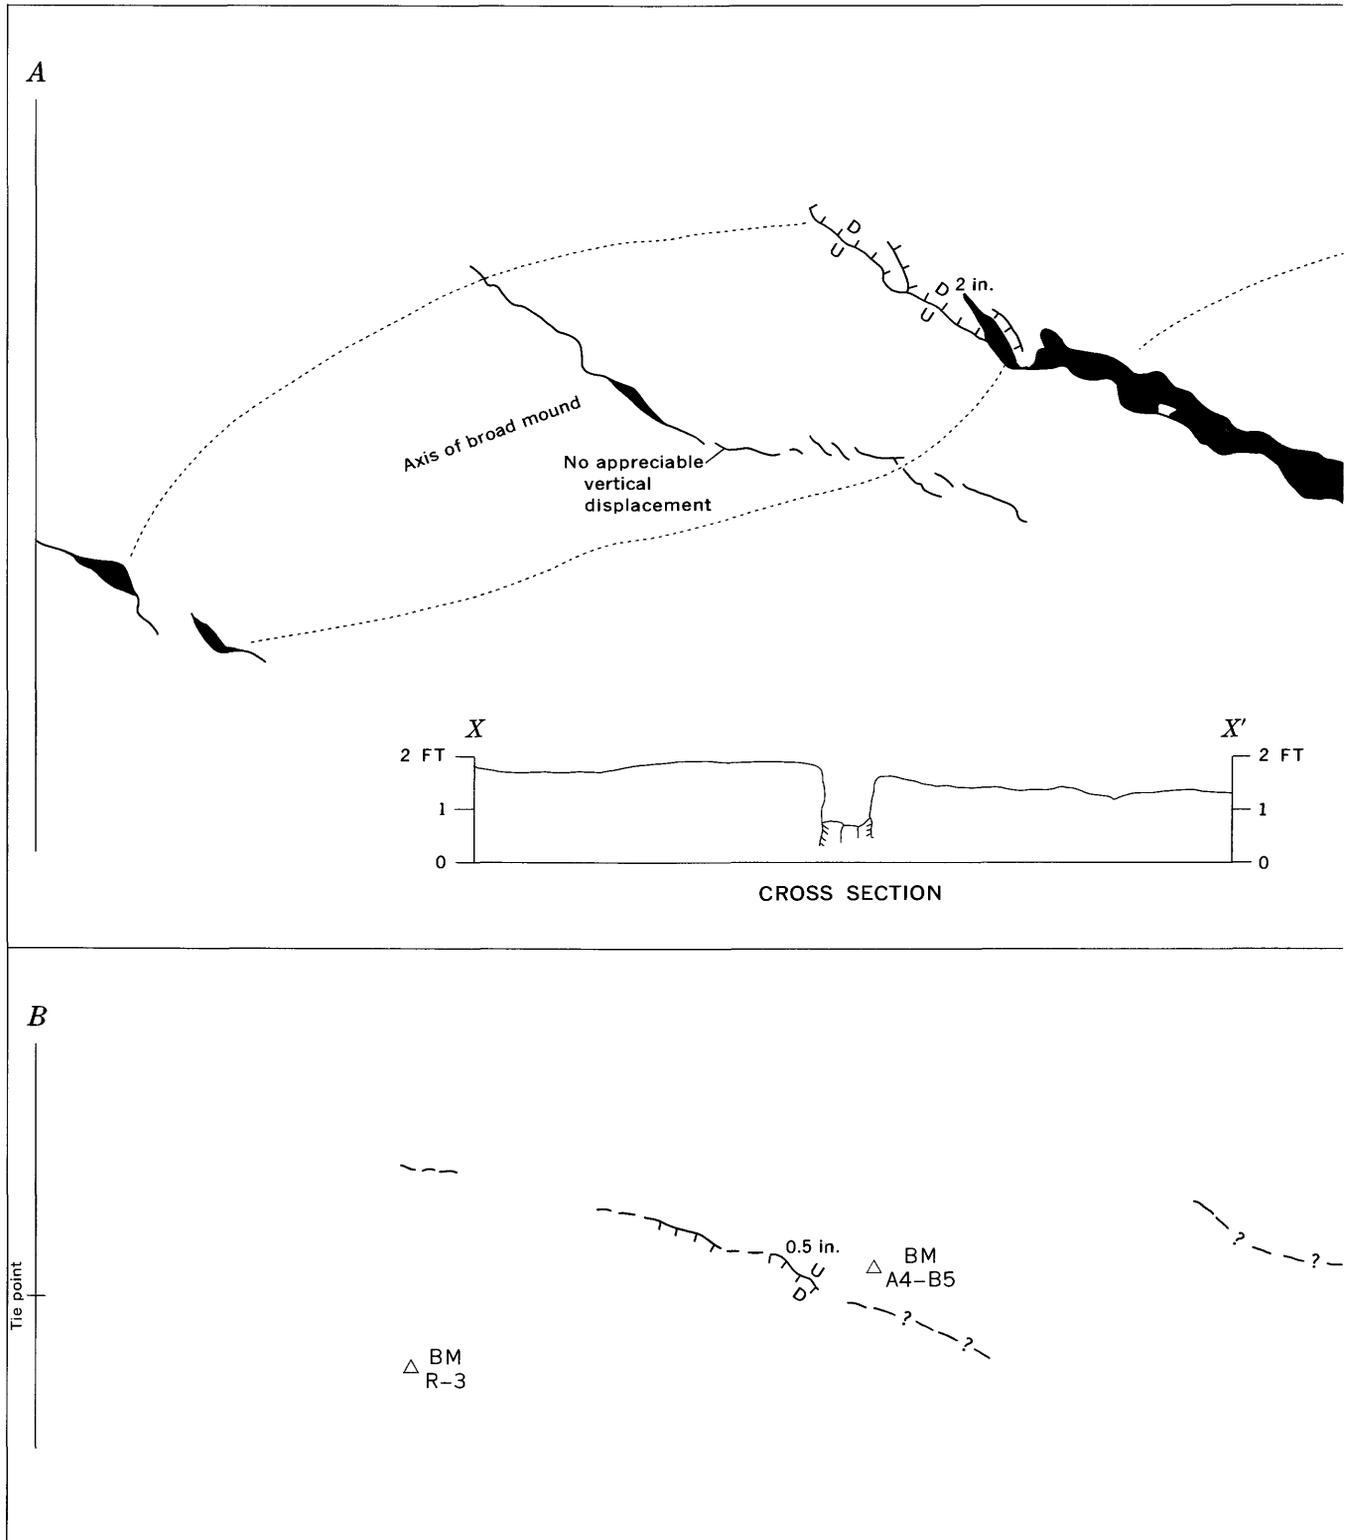
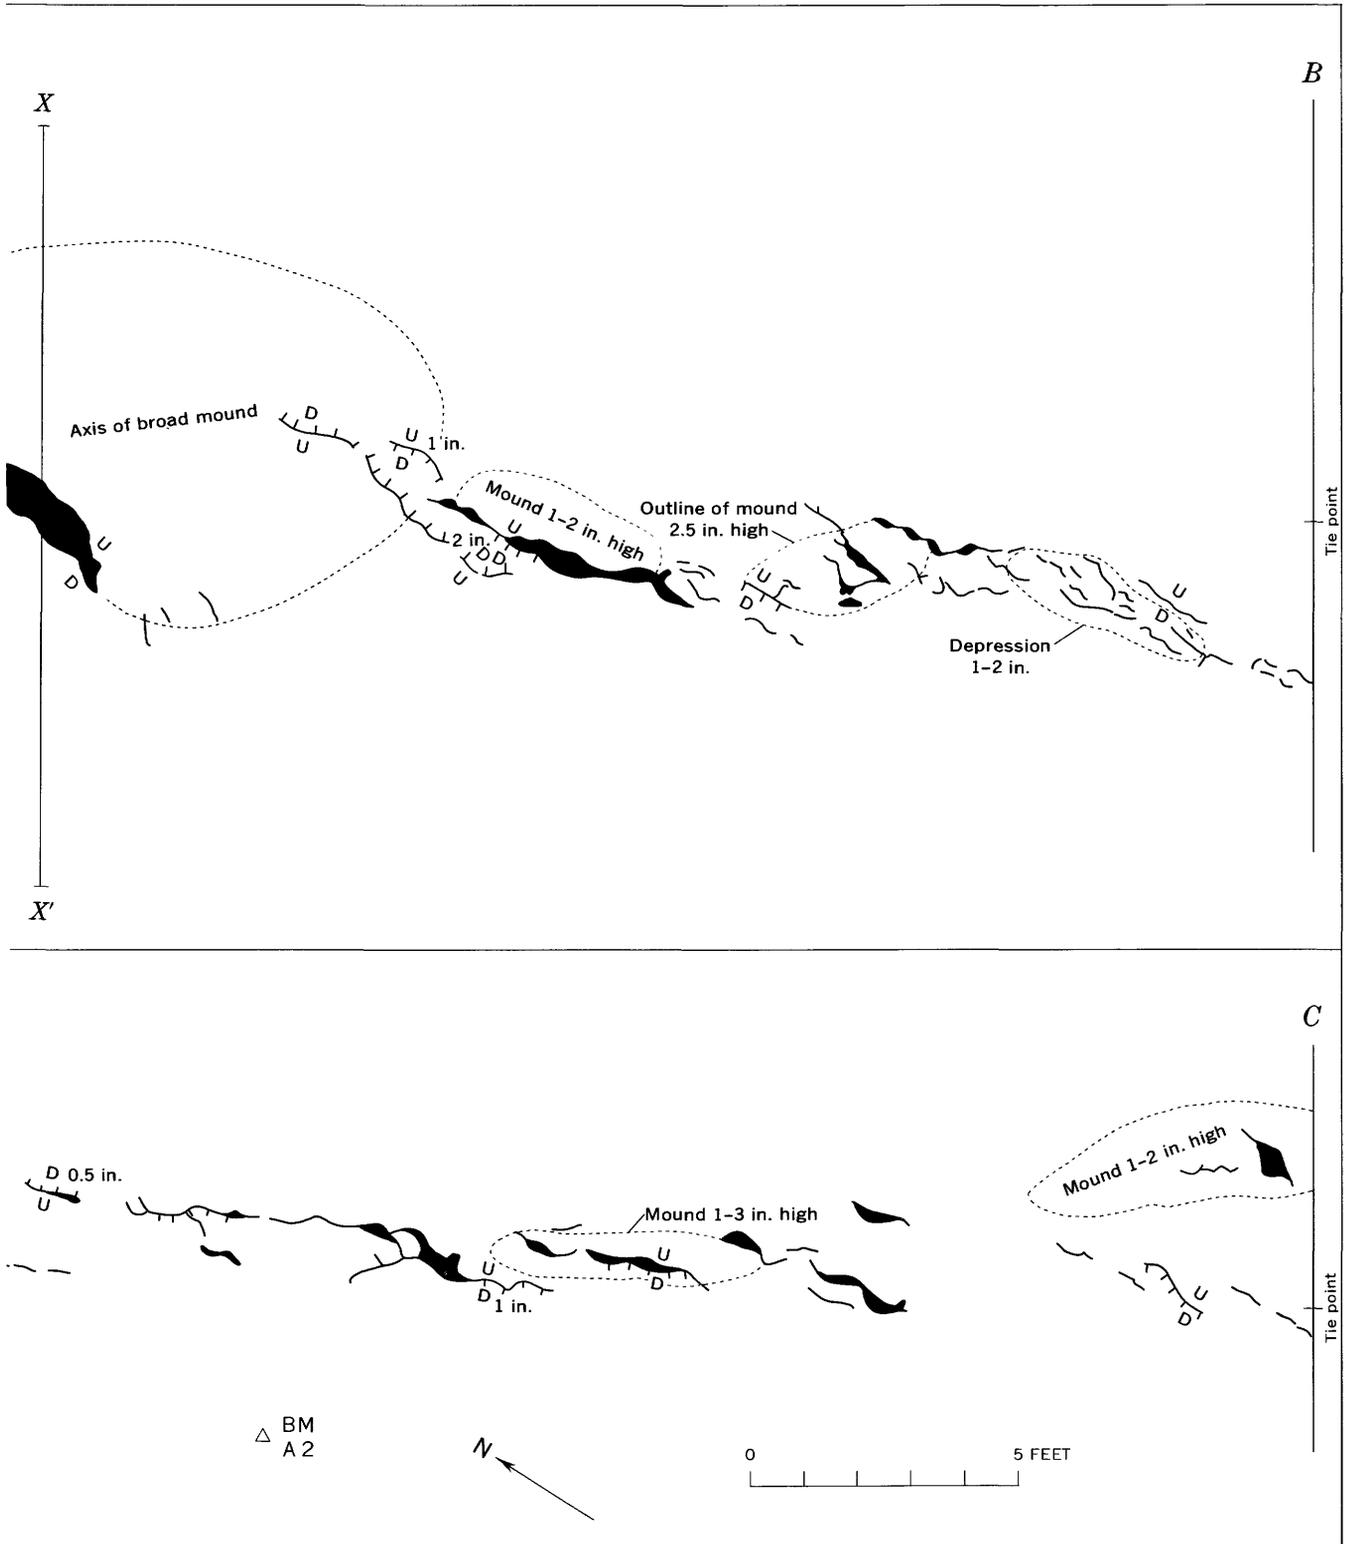
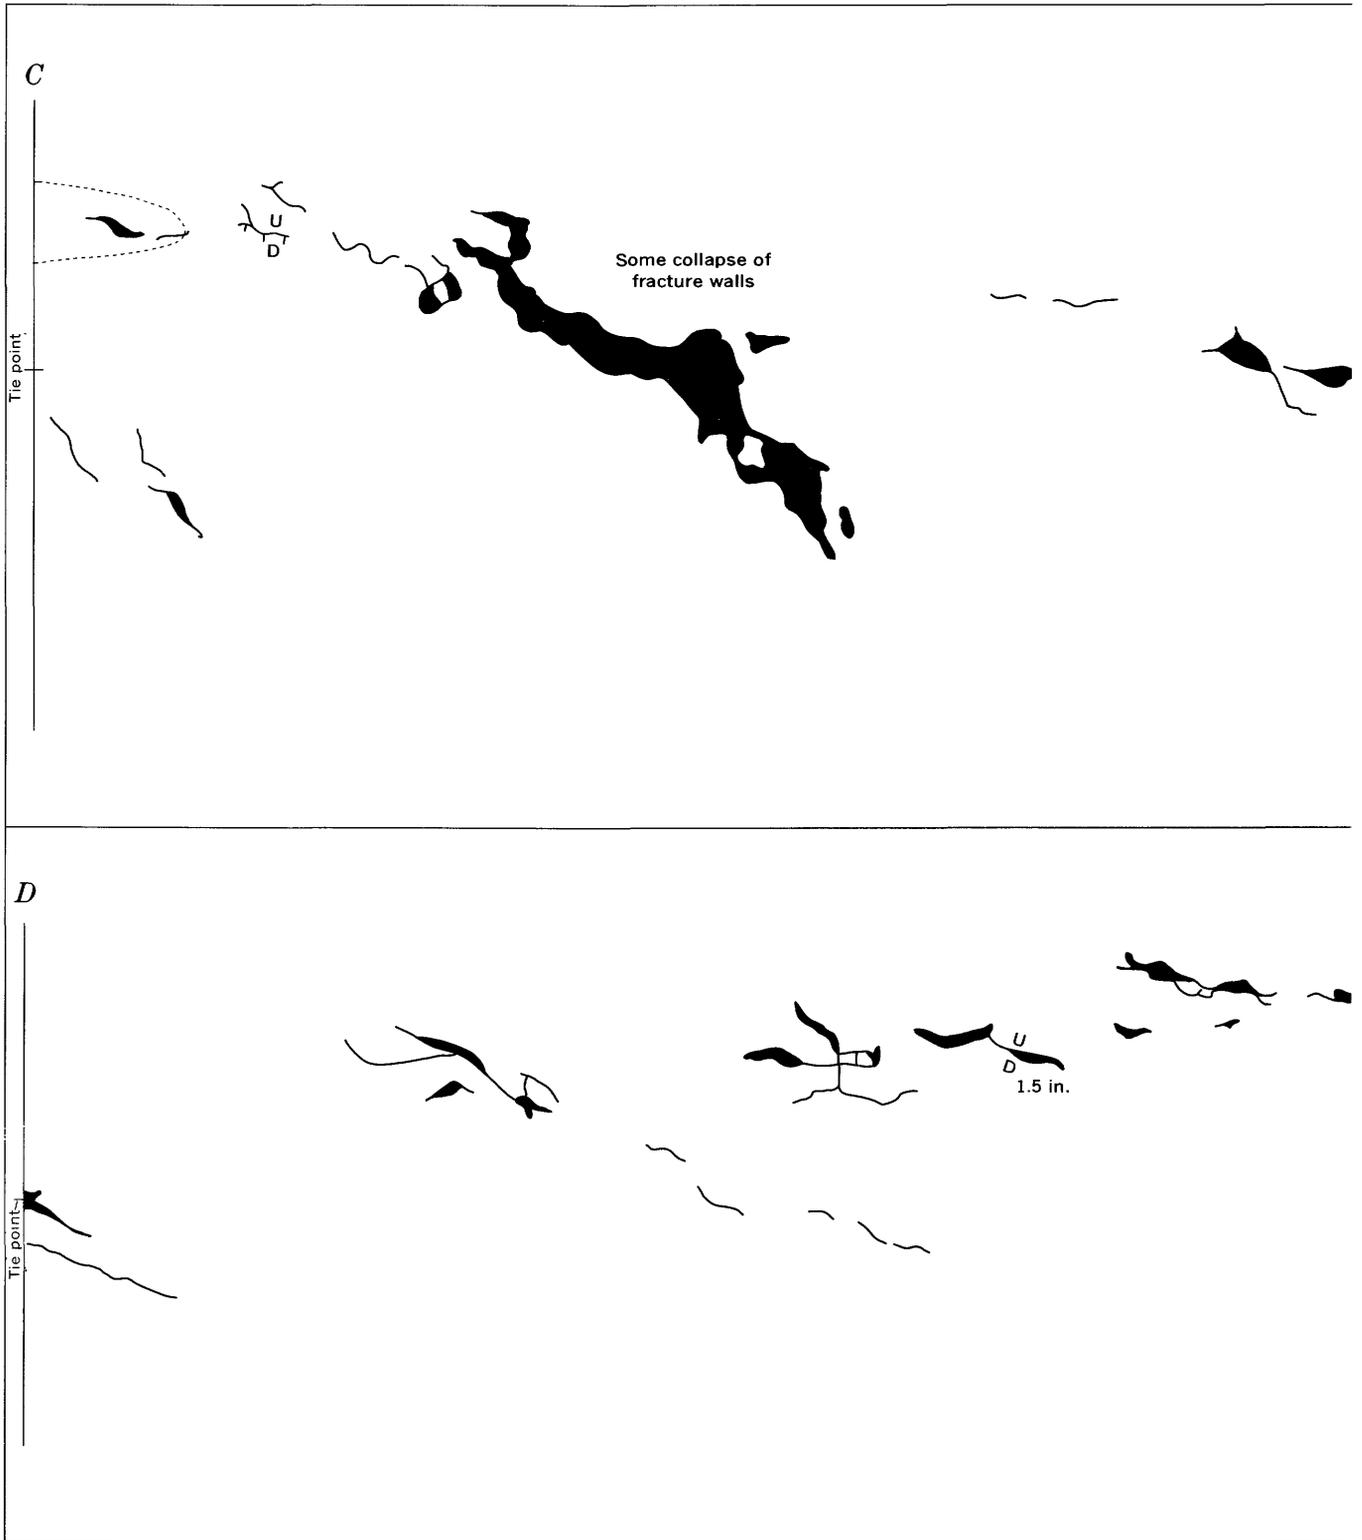
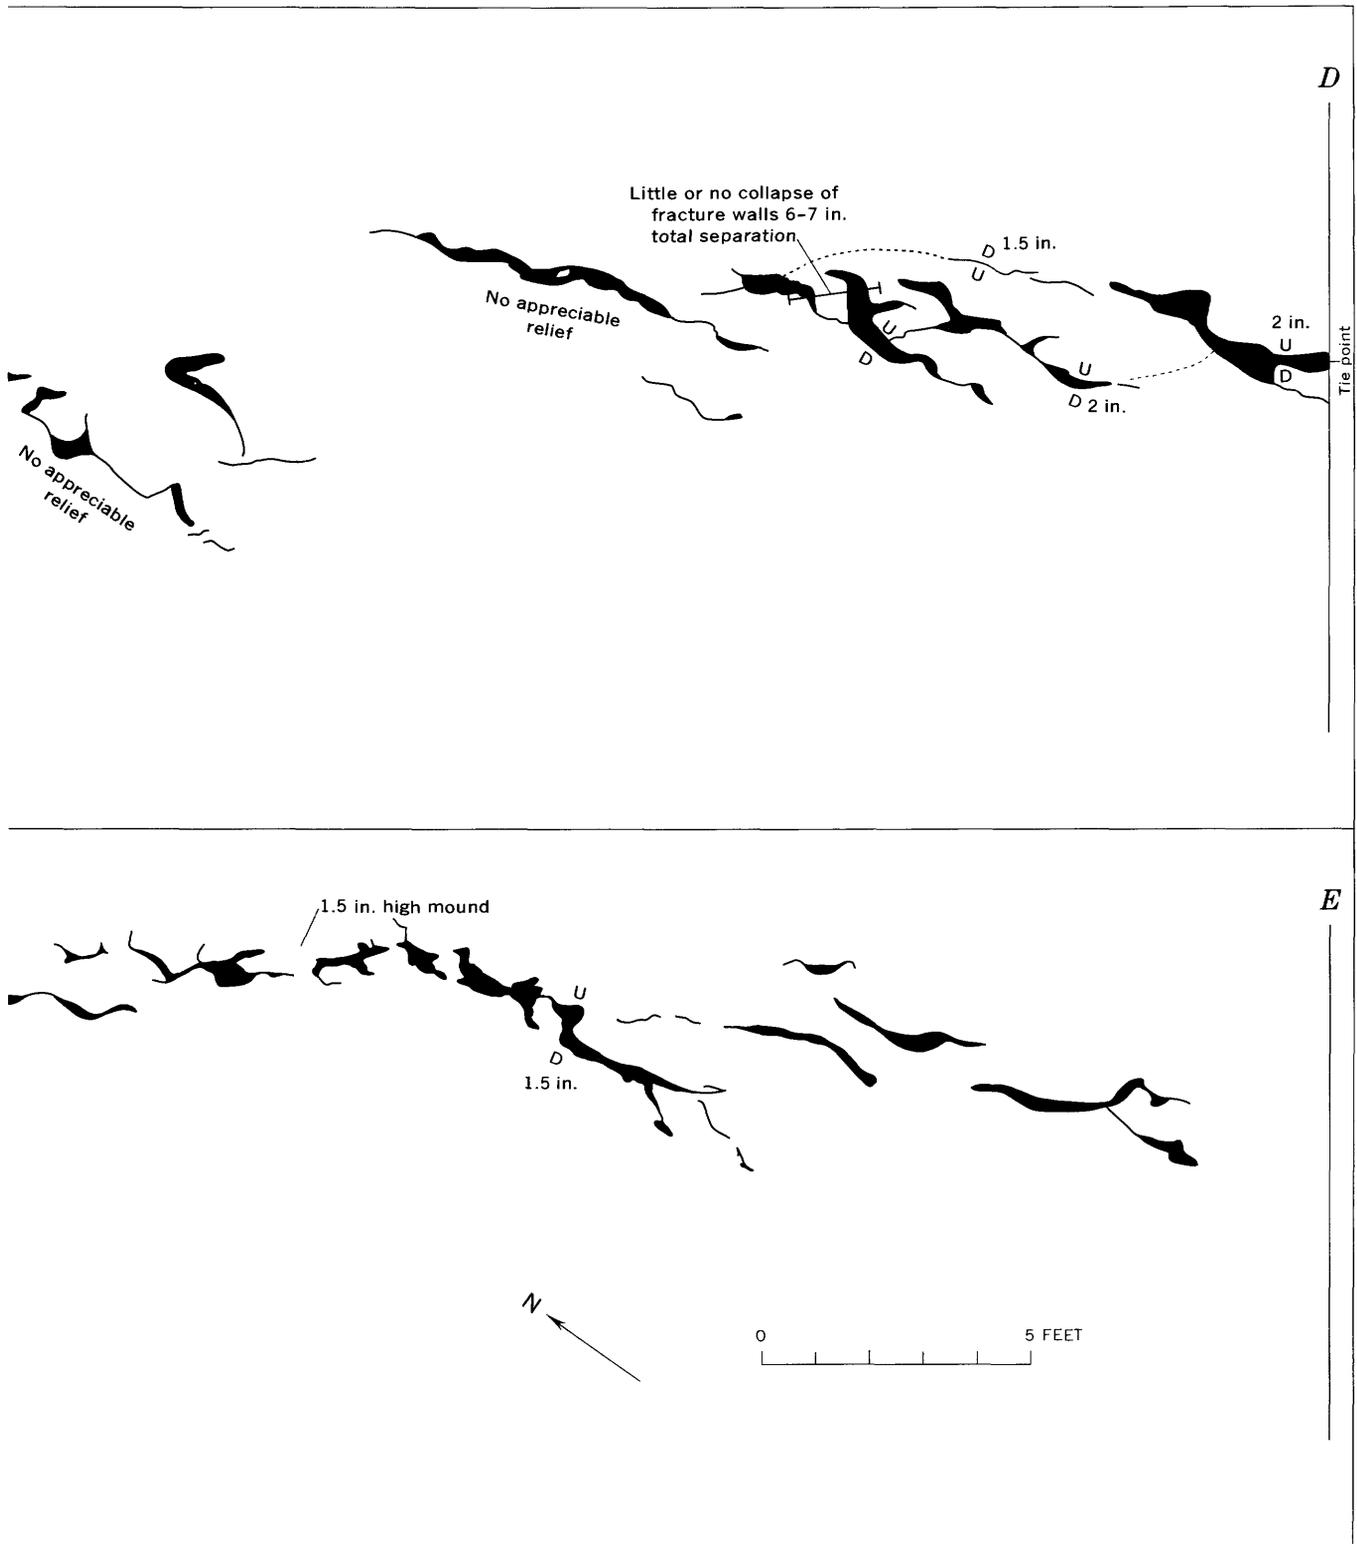
FIGURE 17.—Detailed map of tectonic fracture zone at quadrilaterals QA and QB. Bench marks A4, B5, and A2 mark quadrilateral downthrown side of fractures with vertical displacement.

reference points shown in figure 16. Dark areas indicate open fractures; dashes show mound outlines; hachures indicate the (For map sections C and D see p. 28-29.)

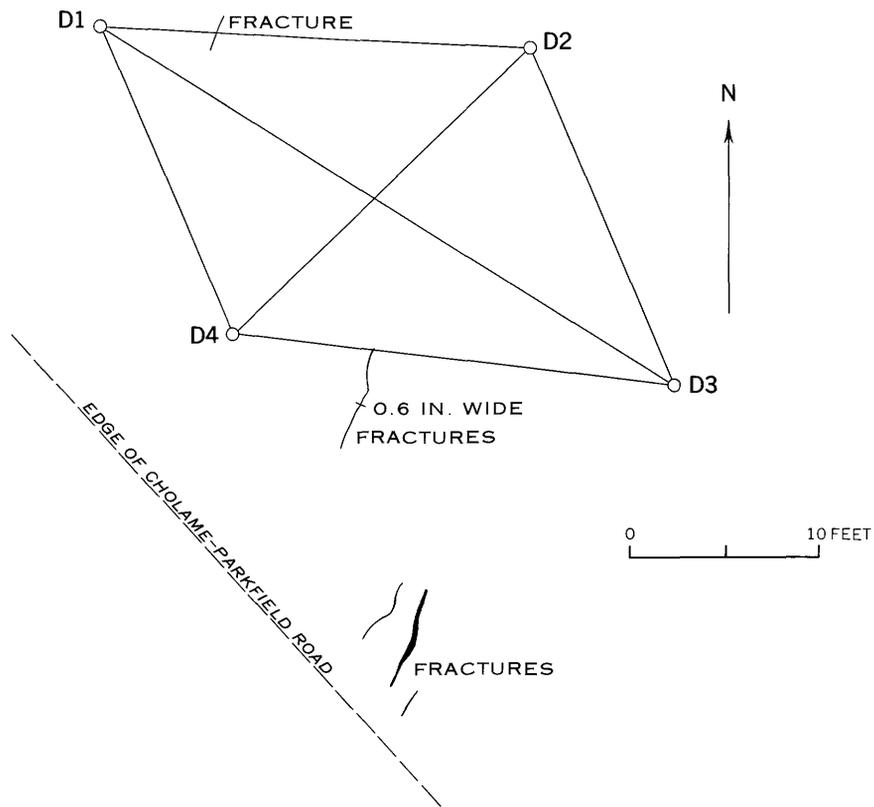
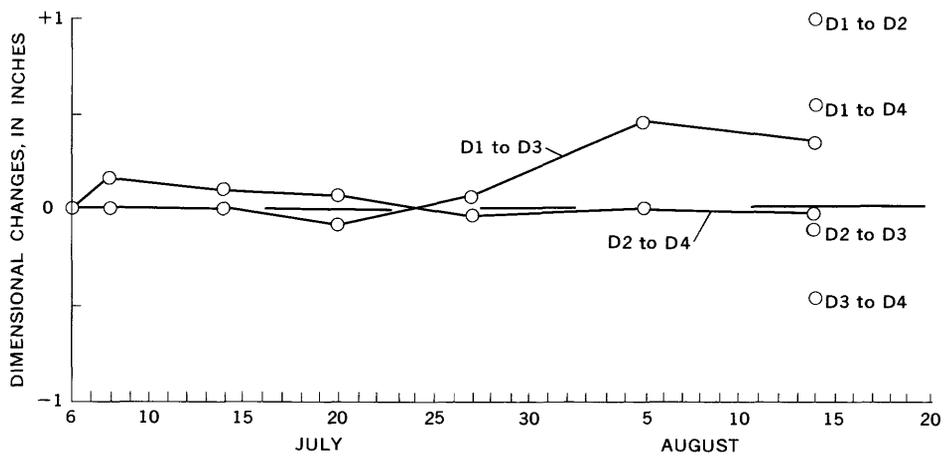
Measurements of quadrilateral QD (fig. 18) show relatively little change in the length of the diagonals during the period July 6 to July 30; however, on August 5, following the aftershock of August 3, D1-D3, which would be expected to increase in length during right-lateral strike-slip strain, did indeed show an extension of about 0.5 inch. Similarly, during the

FIGURE 18.—Plan of quadrilateral QD (showing fractures in ground) and graph of dimensional changes with time.

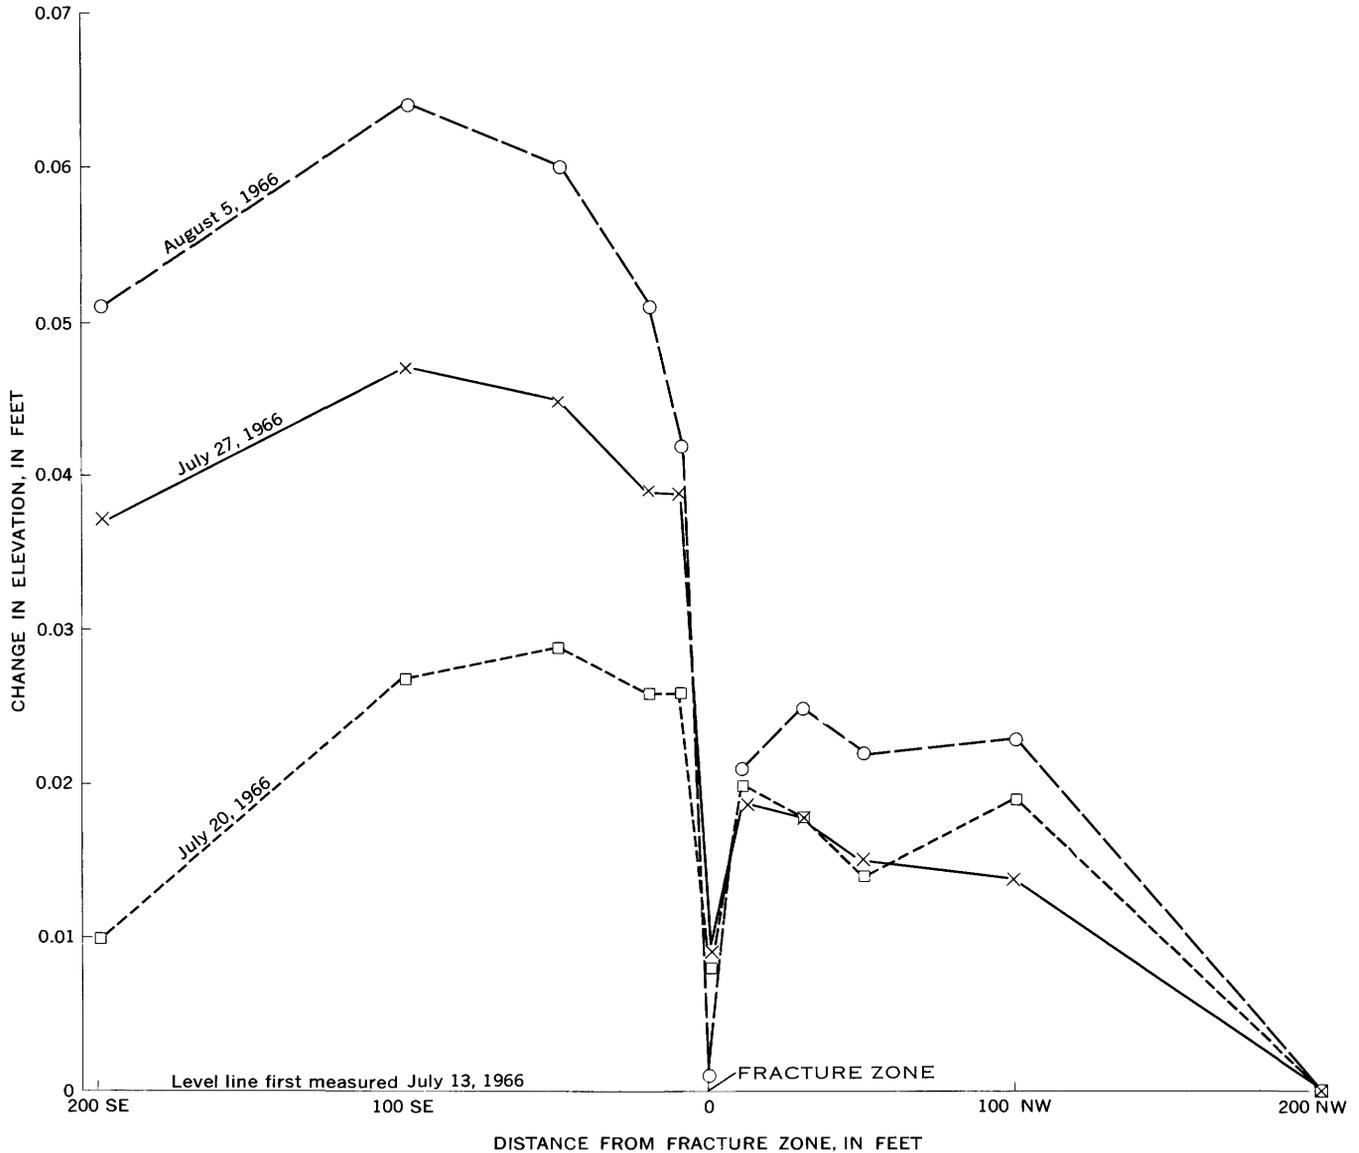
A comparison of vertical displacement (fig. 20) and horizontal displacements at this locality (F20) reveals that vertical displacement is as great as horizontal displacement during the period in which measurements were made and possibly was greater than the horizontal displacement. Apparently strike slip, which reaches a maximum of about 6 or 7 inches at locality F23 a mile southeast, dies out toward locality F20; as the trend of the fracture zone bends from N. 40° W. to N. 10° W. toward the en echelon segment to the north, vertical displacement becomes more important.

FIGURE 20.—Relative change in elevation with time of points along centerline of Cholame-Parkfield road where fracture zone crosses 3.2 miles northwest of Highway 46. Northwesternmost point arbitrarily considered constant.

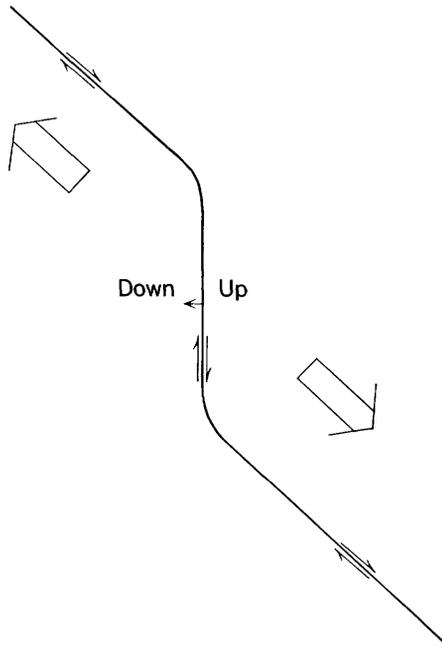
The problem of linkage of en echelon fractures has attracted attention over the years; for example, McKinstry (1948, p. 314) diagrams nine different types of linkages. The pattern displayed here appears to be one in which two en echelon fault segments displaying principally strike slip are linked by a structure in which vertical displacement is important. Figure 21 illustrates a model in which vertical displacement represented by normal faulting could accommodate tensional stresses across the north-trending segment which links the two northwest-trending segments. The greater thickness of alluvium in the valley under which the north-trending segment passes also may modify the style of strain at the ground surface; for example, the vertical displacement may be in part accommodated by a sharp monoclinical flexure at the surface even though faulting may exist at depth.

FIGURE 21.—Diagram of suggested linkage between two en echelon segments of San Andreas fault.
