The Parkfield-Cholame California, Earthquakes of June-August 1966

GEOLOGICAL SURVEY
PROFESSIONAL PAPER 579

The Parkfield-Cholame California, Earthquakes of June-August 1966— Surface Geologic Effects Water-Resources Aspects, and Preliminary Seismic Data

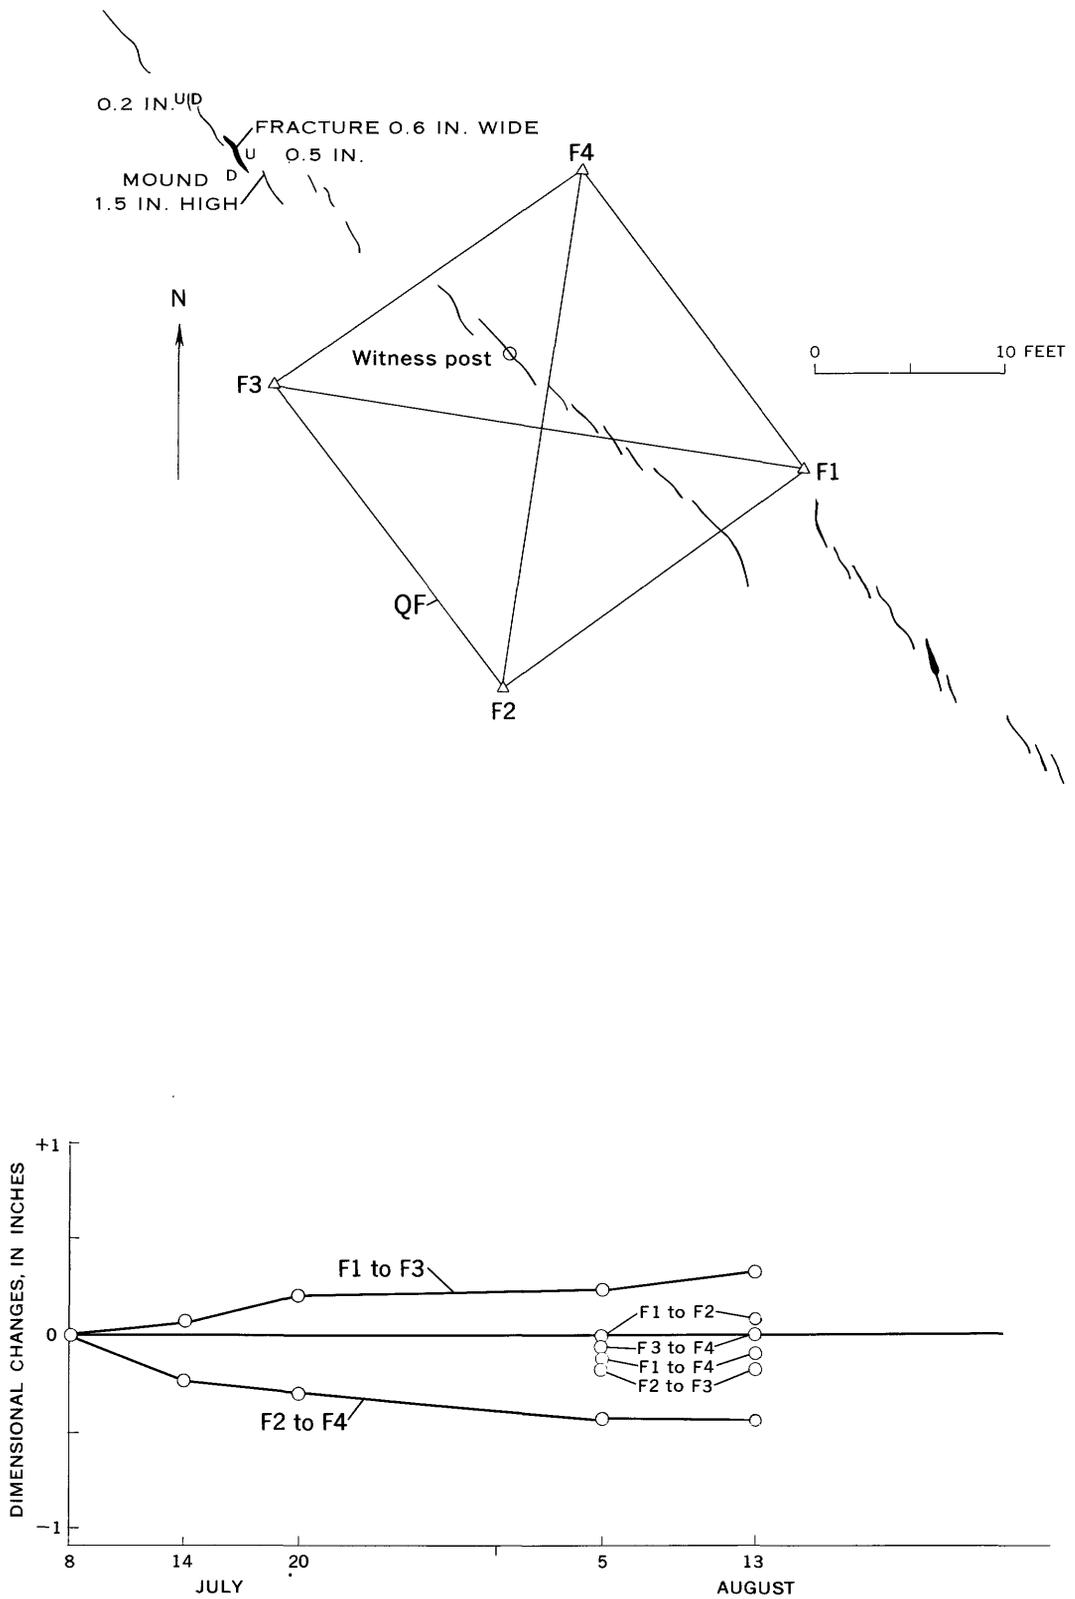
Measurements of quadrilateral QF (fig. 22) show continuing deformation up to the last time recorded here. Of the six dimensions measured, only two, F1-F3 and F1-F2, showed extension. The pattern of strain is consistent with right-lateral strike slip ac-

FIGURE 22.—Plan of quadrilateral QF (showing fracture pattern) and graph of dimensional changes with time.

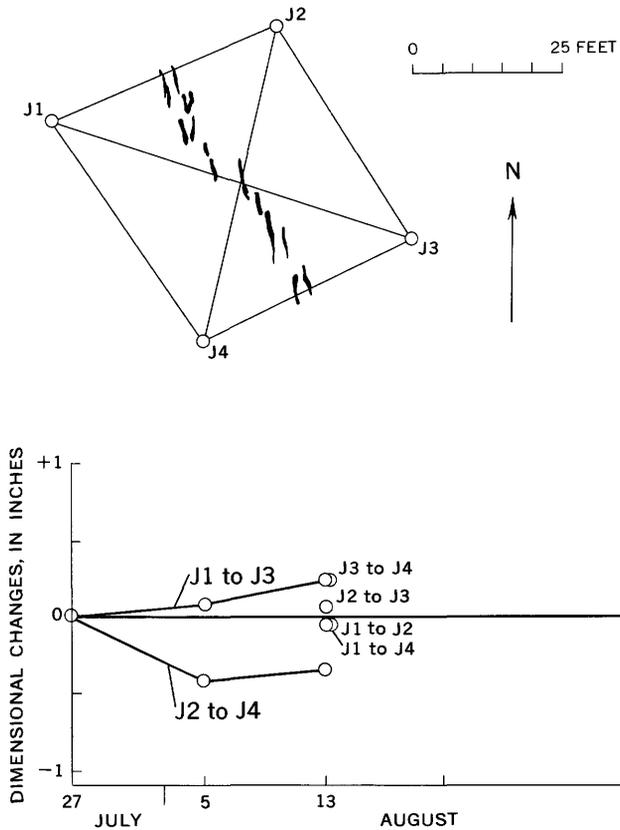
FIGURE 23.—Plan of quadrilateral QJ and graph of dimensional changes with time.

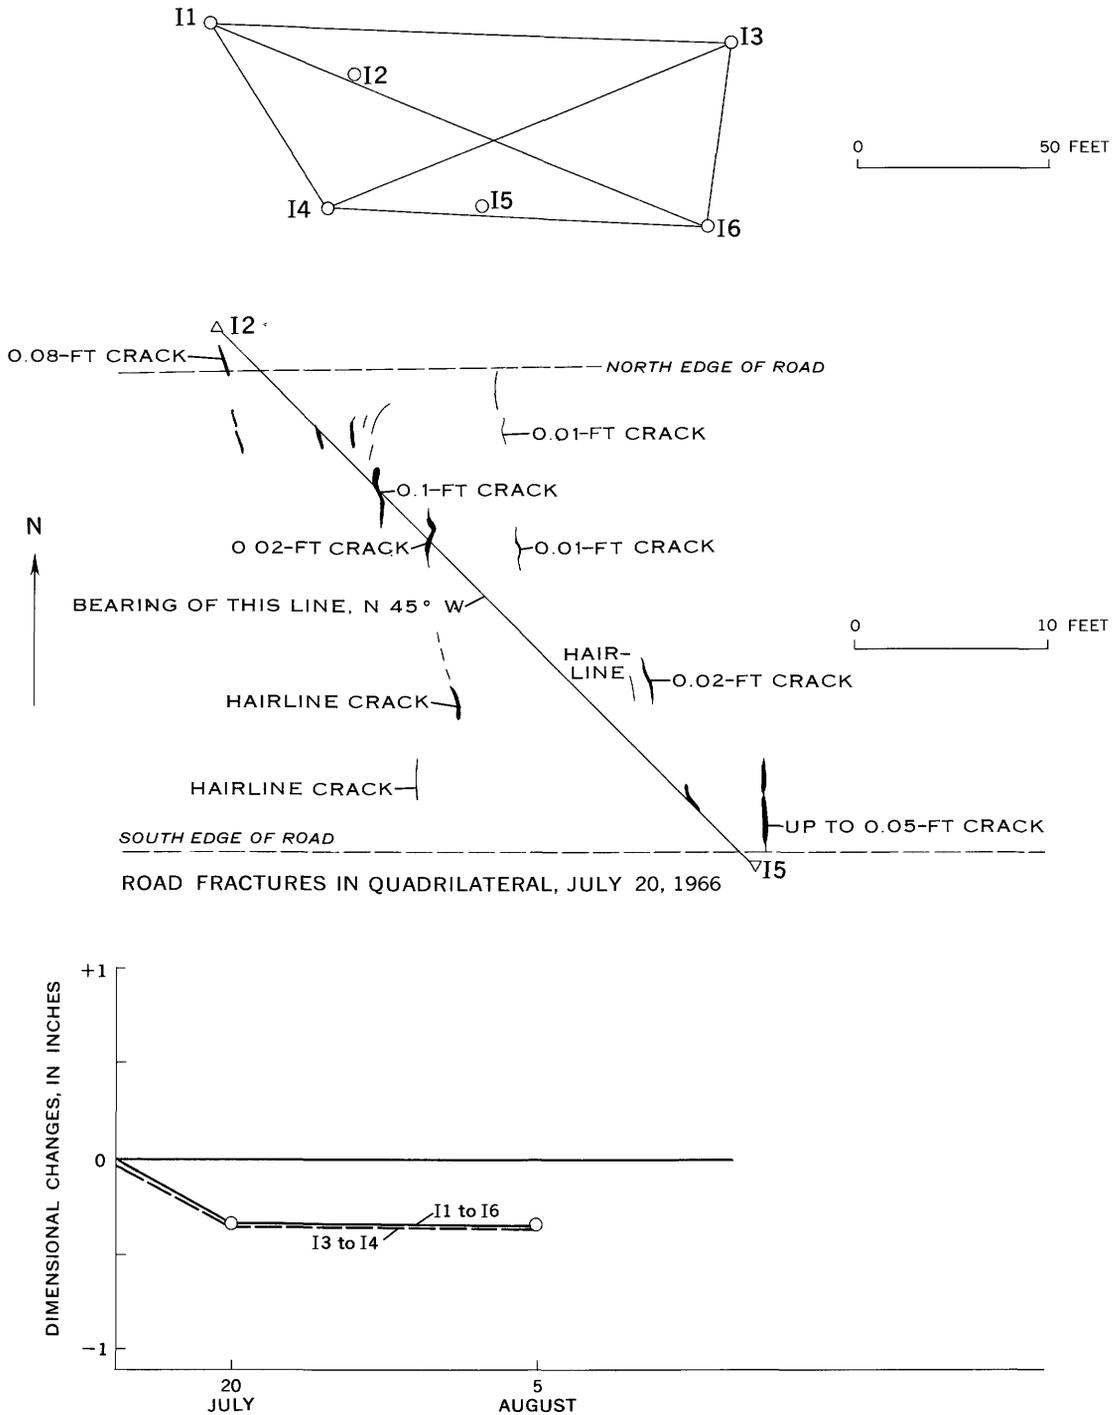
FIGURE 24.—Plan of quadrilateral QI and graph of dimensional changes with time.

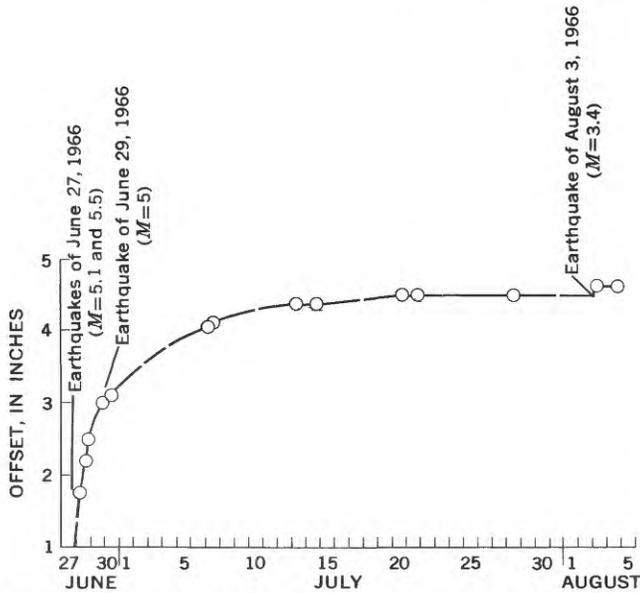
FIGURE 25.—Graph of offset of center white line on Highway 46, 0.85 mile northeast of Cholame. *M*=magnitude.

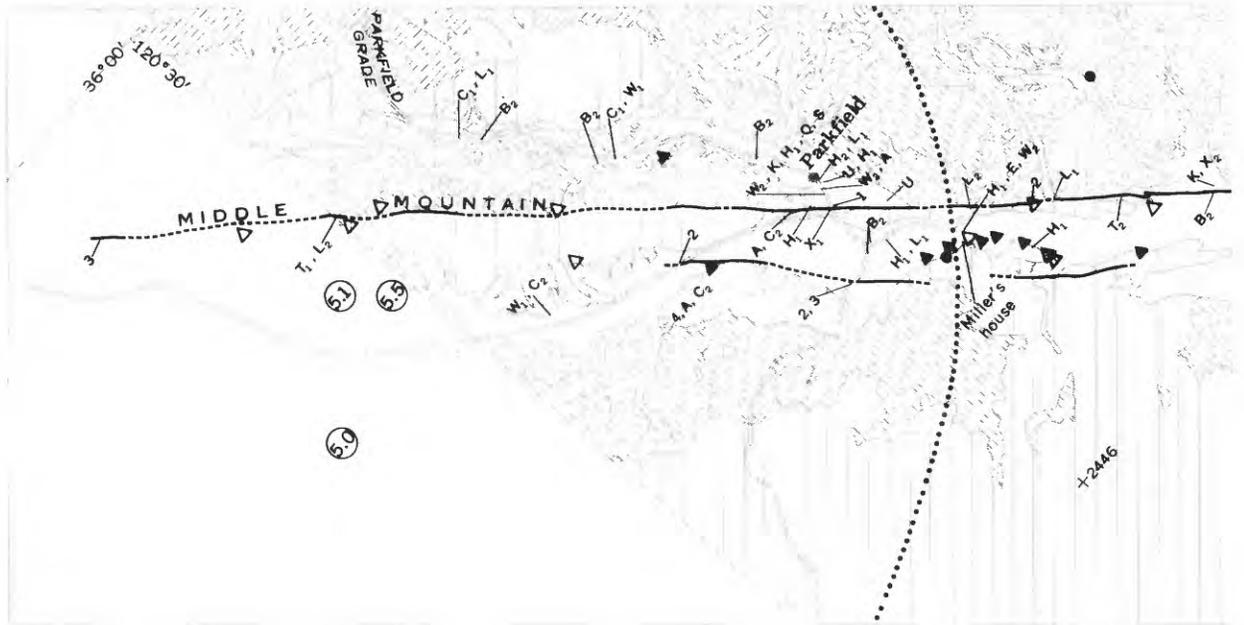
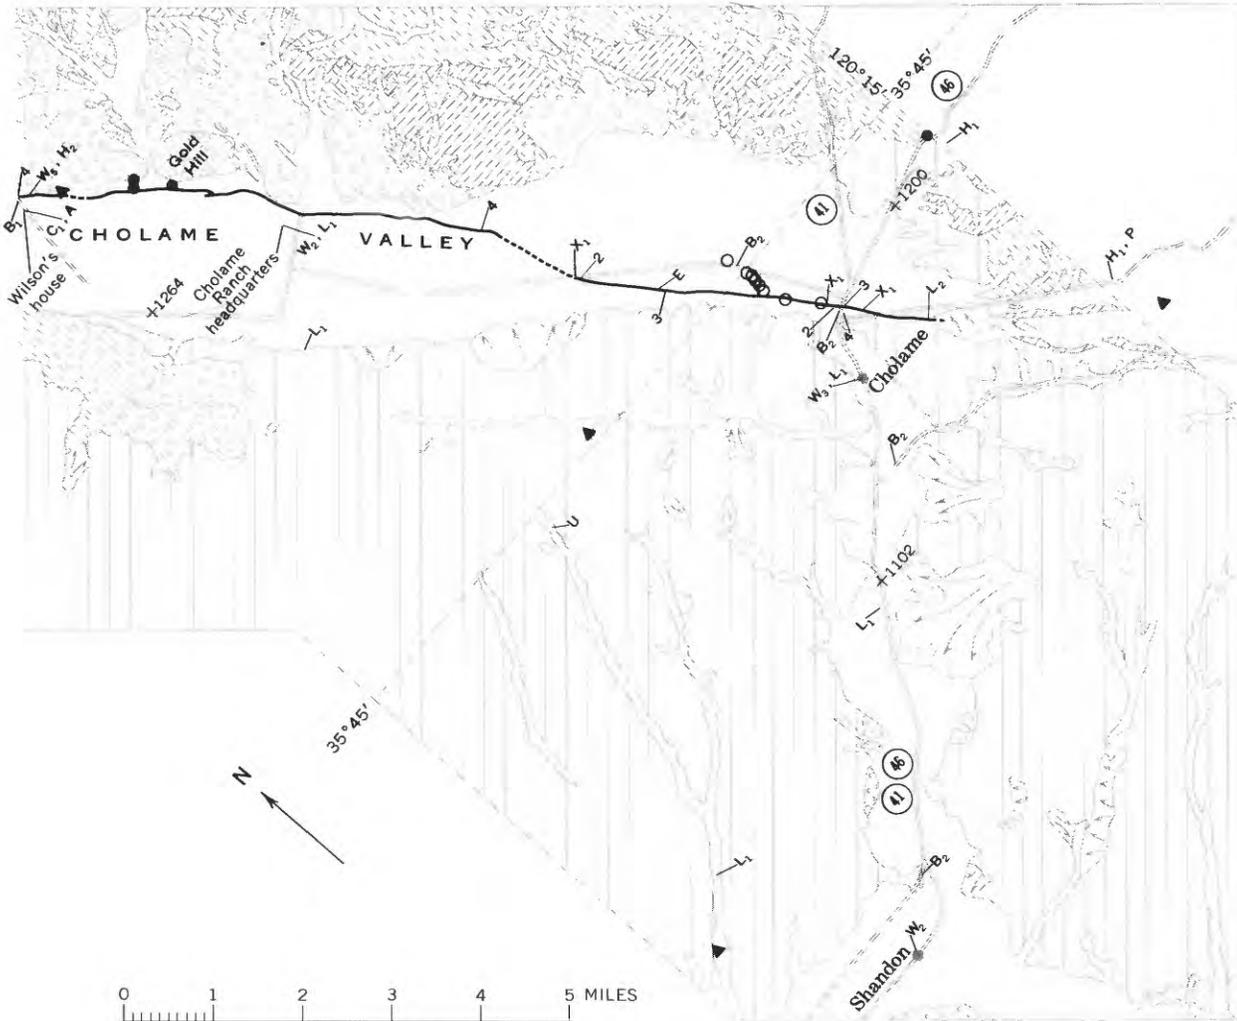
FIGURE 35.—Distribution and types of effects that accompanied the Parkfield-Cholame

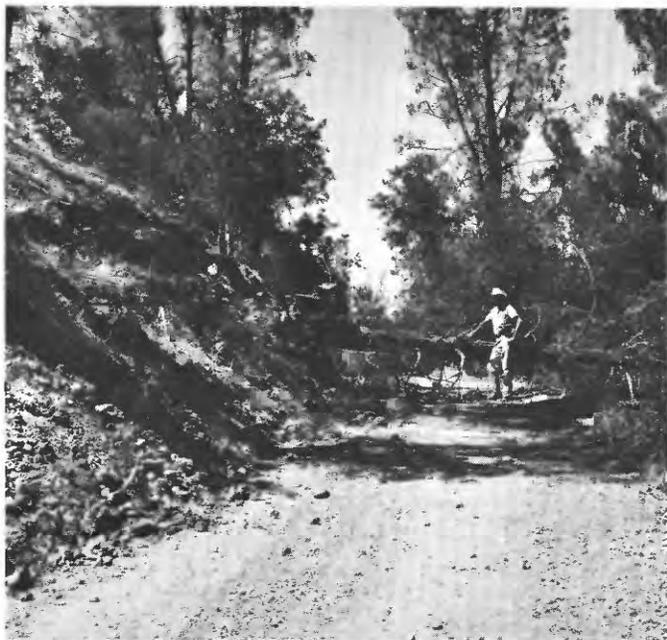
A

Debris slides occurred in gently dipping, clayey, silty, or sandy semiconsolidated sedimentary rocks of the Paso Robles Formation, as well as in soils developed on these materials. Most such slides in the Paso Robles are in steep roadcuts or streamcuts 15–40 feet high that had original slopes of 70° – 75° (fig. 37).

FIGURE 37.—Debris slides. A. Slide and toppled tree in Paso Robles Formation along west cut of road just northwest of Parkfield cemetery, half a mile southeast of Miller's house, and about midway between the fracture zones. Original cut slope was about 15 feet high at an angle of 70° – 75° . B. Headwall fissures of small debris slide in alluvial deposits along north bank of Cholame Creek, near north end of southwest fracture zone.

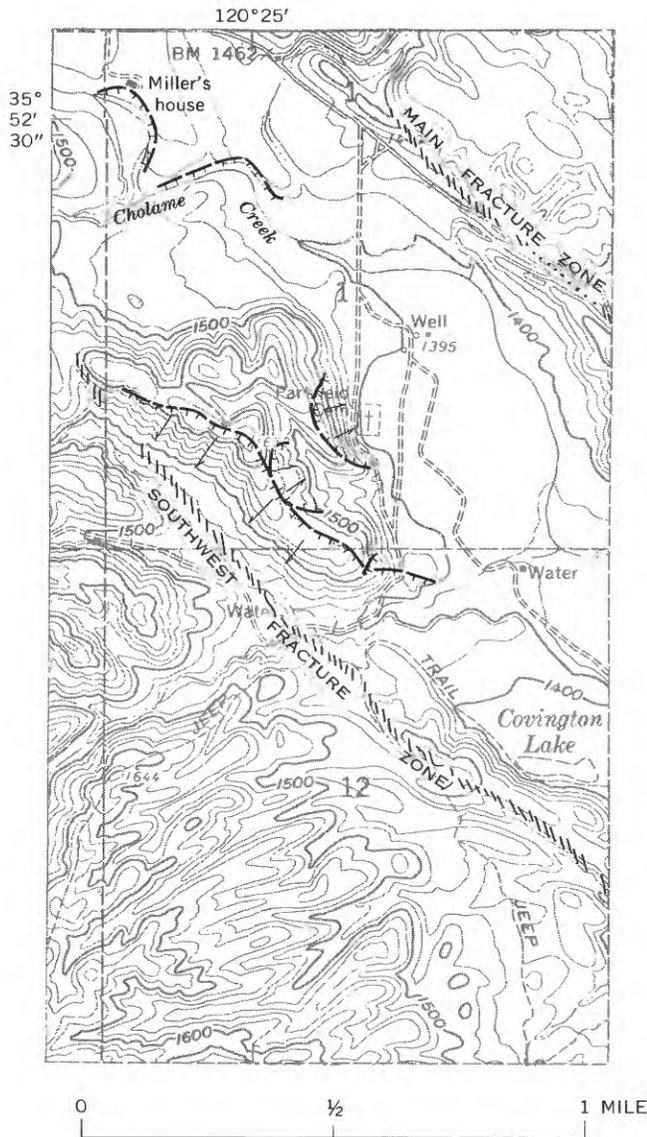
FIGURE 38.—Area between fracture zones about 2 miles south of Parkfield, showing distribution of fresh fissures at heads of new debris slides in alluvial deposits along Cholame Creek and at heads of slightly reactivated slumps in the Paso Robles Formation southwest of the creek. Mapped during July 1966; base from Cholame Hills and Parkfield 1:24,000 topographic quadrangles; area in northeast corner of T. 24 S., R. 14 E., Mount Diablo base and meridian; contour interval is 20 feet.

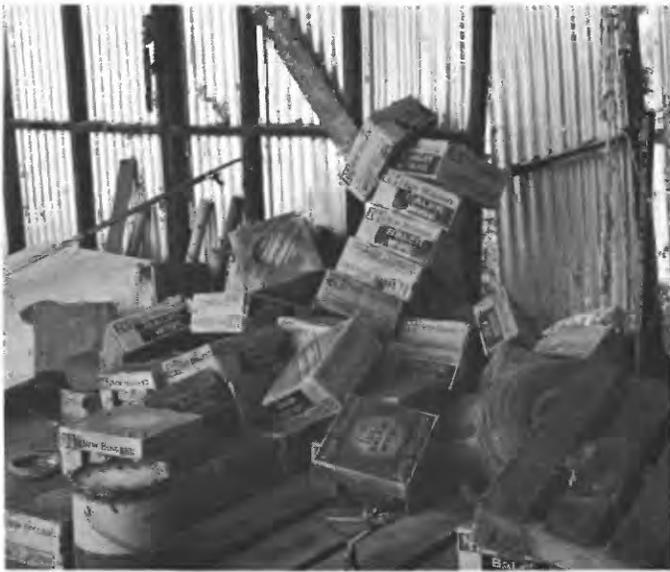
A

An unfloored barn immediately southwest of the main fracture zone and about midway along its length near the Wilson house contained an elongate stack of heavy boxes of wire; the stack was not in contact with the building. The stack tumbled northeastward during the earthquake, directly toward the fracture zone and parallel to the long dimension of the stack (fig. 47A). Near the same locality, a heavy wood box of hardware was projected southeastward about 4 feet from its

FIGURE 47.—Collapsed or projected heavy objects, just southwest of the main fracture zone near Wilson's house. A. Collapsed stack of 120-pound boxes that rest on wood pallet set on dirt floor of barn. Stack was not in contact with walls before earthquakes and collapsed directly toward the main fracture zone, which is about 200 feet to northeast. B. Heavy box of hardware at lower left was projected southeastward from within empty box still in contact with empty overturned steel drum. Drum was upright, with nested boxes resting on top, before earthquakes.

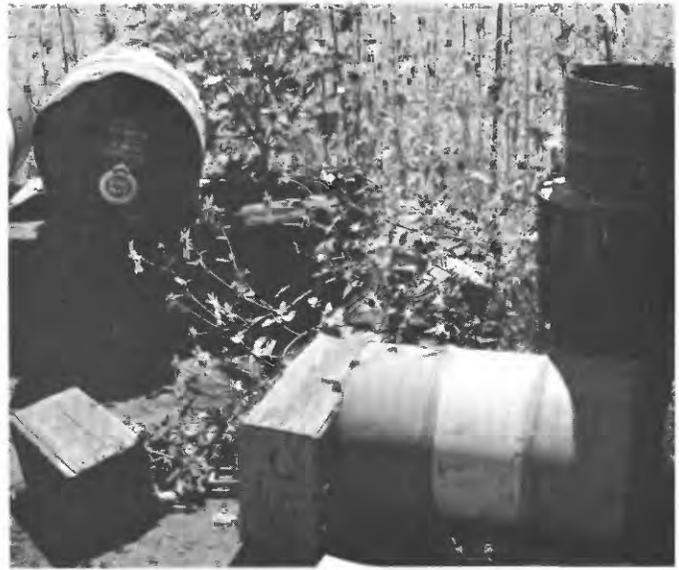
B

initial position inside a second wooden box that had rested on top of an upright empty steel drum (fig. 47B). The drum and empty box were overturned along the line the box of hardware was projected; however, the drum and empty box were neither projected nor separated from each other.

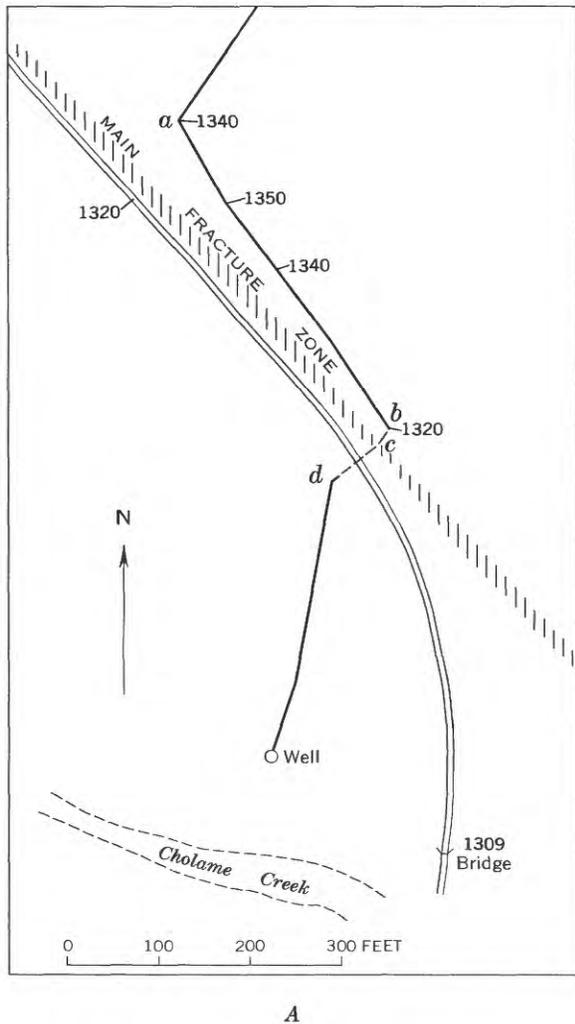
A

An irrigation pipeline that crosses the main fracture zone near the Wilson house was in use on June 27 but was ruptured and separated about 9 hours before the sequence of main shocks. The rupture occurred near an elbow that connects a 400-foot-long exposed segment of pipe that is parallel to and about 20 feet east of the main fracture zone with a short segment that is buried where it crosses the fracture zone and the Parkfield road (fig. 48). The rupture was caused by about 2 feet of southeastward shifting of the long segment of the pipe parallel to its trend and relative to the elbow, which is constrained by the rigid support of the buried segment. The cause of the shifting has not been determined, but two possibly contributory factors should be noted: (1) The long segment drops in latitude between 20–30 feet from northwest to southeast along its length, and (2) according to Allen and Smith (1966), en echelon fractures existed along the trend of the main fracture zone about 1.8 miles southeast of Parkfield on June 16, 11 days before the main shocks. Further-

FIGURE 48.—Irrigation pipeline that crosses the main fracture zone and Monterey County road between Cholame and Parkfield, about 0.1 mile northwest of Wilson's house. A. Plan view of pipeline. Pipe is buried between points *c* and *d* where it crosses the fracture zone and the road, and exposed elsewhere. The pipeline ruptured and separated near elbow (*b*) about 9 hours before main earthquakes of June 27, owing to 1-2 feet of southeastward movement of long segment (*a-b*) relative to buried segment (*c-d*). Figures show approximate spot altitudes in feet as interpolated from Cholame Hills 1:24,000 topographic quadrangle; plot traced directly from vertical aerial photograph. B. View eastward of part near elbow (arrow corresponds to point *b* of map) that ruptured.

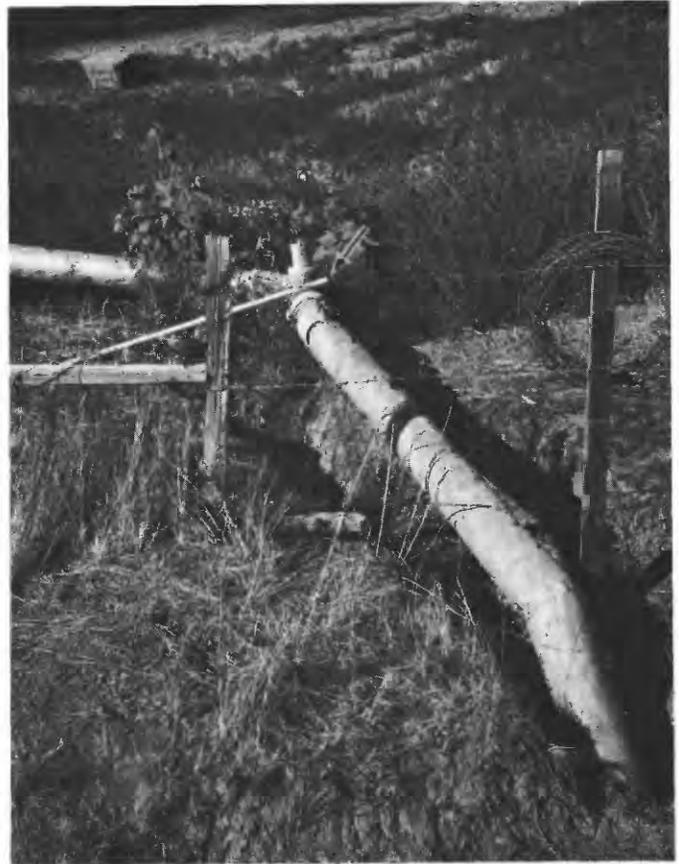
B

Another piece of evidence, although questionably related to tectonic strain, bears reporting. An irrigation pipe (fig. 48B) broke about 9 hours before the earthquakes of June 27. The details are reported in the section on "Engineering geology aspects." We have formulated no certain interpretation of the cause of the break, but its proximity to the fracture zone—although all sections of the pipe affected lie east of the zone—and the precursory timing make the event of particular interest. If the break was a result of strain in the block immediately east of the fracture zone, it produced no obvious effects in the ground surface. At several places along the east side of the main fracture zone, however, as at locality F23, a broad arch 50 or more feet wide represents distinct tectonic strain, possibly including shortening in plan. Progressive shortening of the sides of quadrilaterals, for example, of QA and QB (fig. 16), following the earthquakes

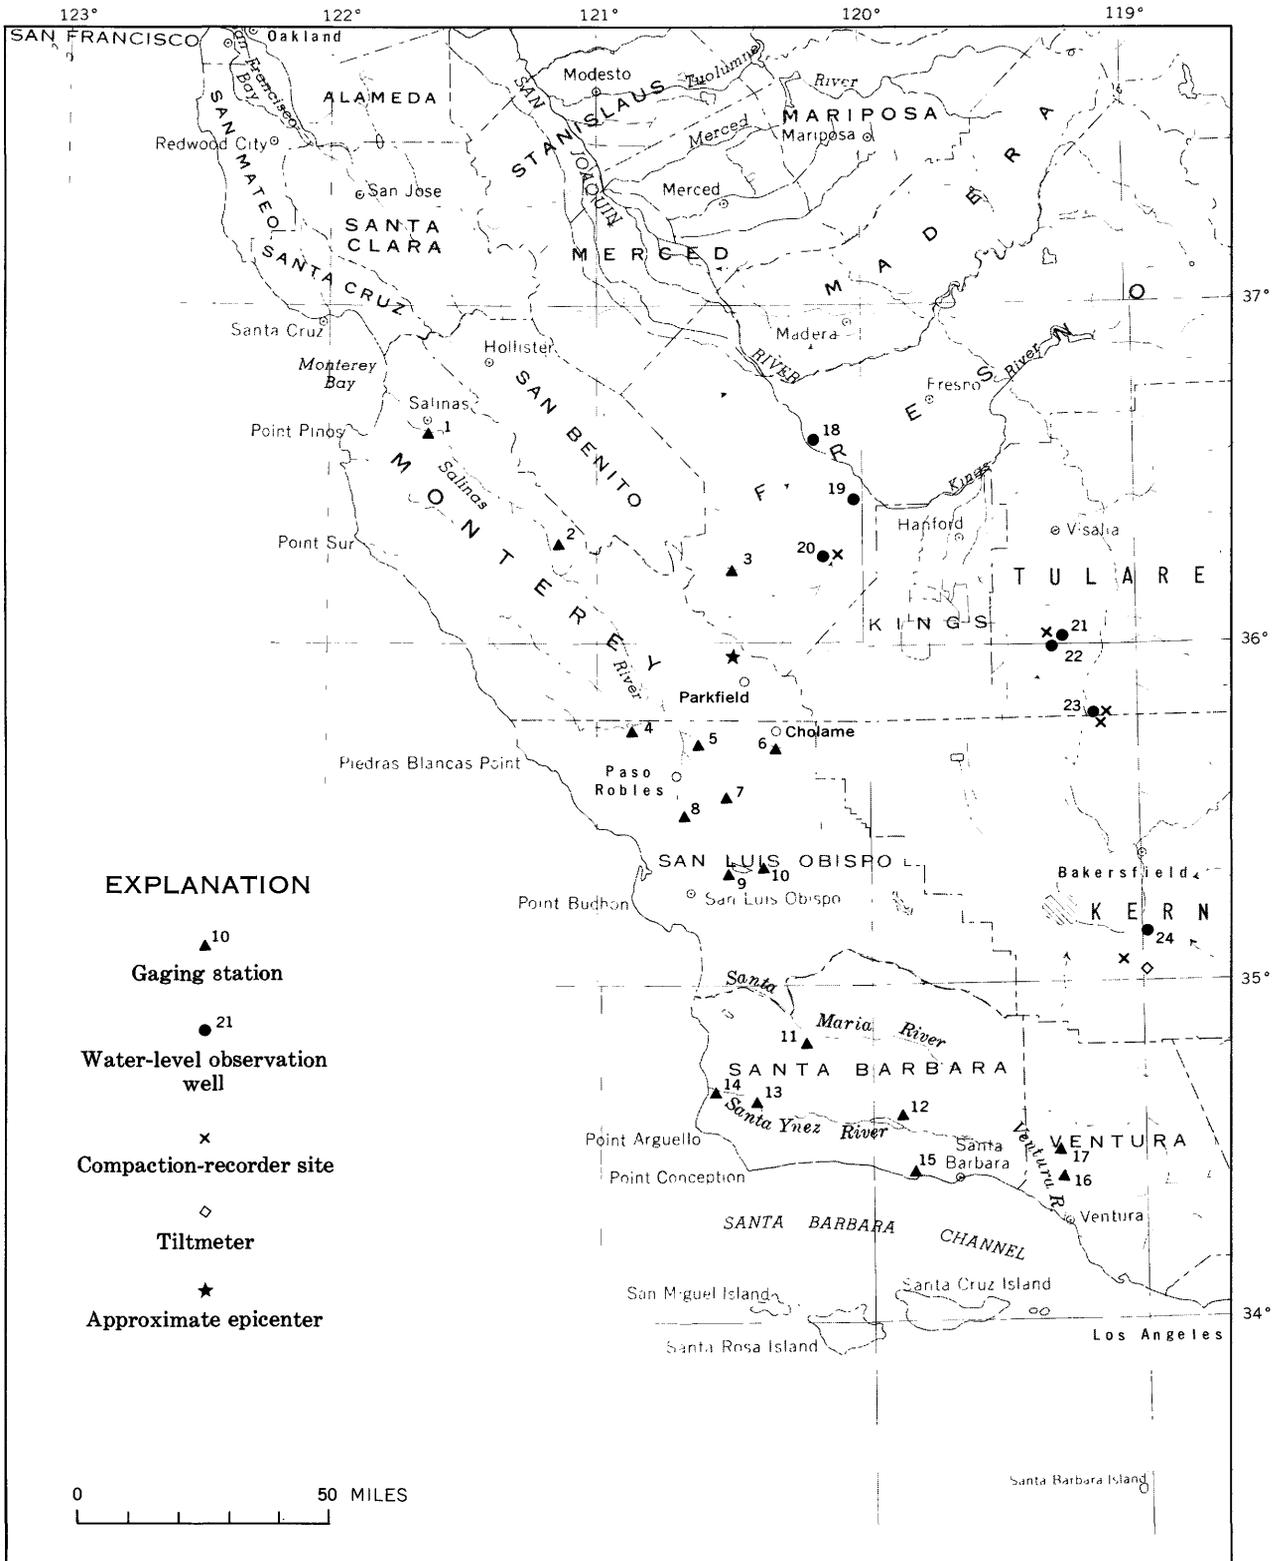
Compaction recorders in Fresno, Tulare, and Kern Counties, installed at or near observation-well sites (fig. 49), showed movements at the approximate time of the principal shock on June 27. These movements seem to be attributable to the earthquake. A tiltmeter installed near Mettler in Kern County, about 24 miles south of Bakersfield, also reflected the major shocks.

FIGURE 49.—Selected gaging stations, observation wells, and compaction-recorder sites that showed effects of Parkfield-Cholame earthquakes, June 27, 1966. Gaging stations and observation wells are given in tables 4 and 5, respectively.

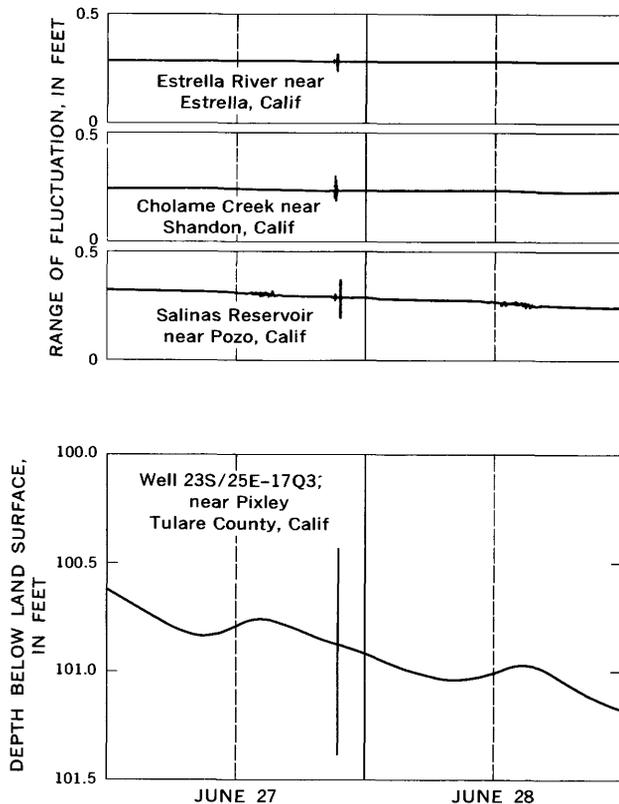
FIGURE 50.—Fluctuations recorded at gaging stations and an observation well during Parkfield-Cholame earthquakes, June 27-28, 1966.

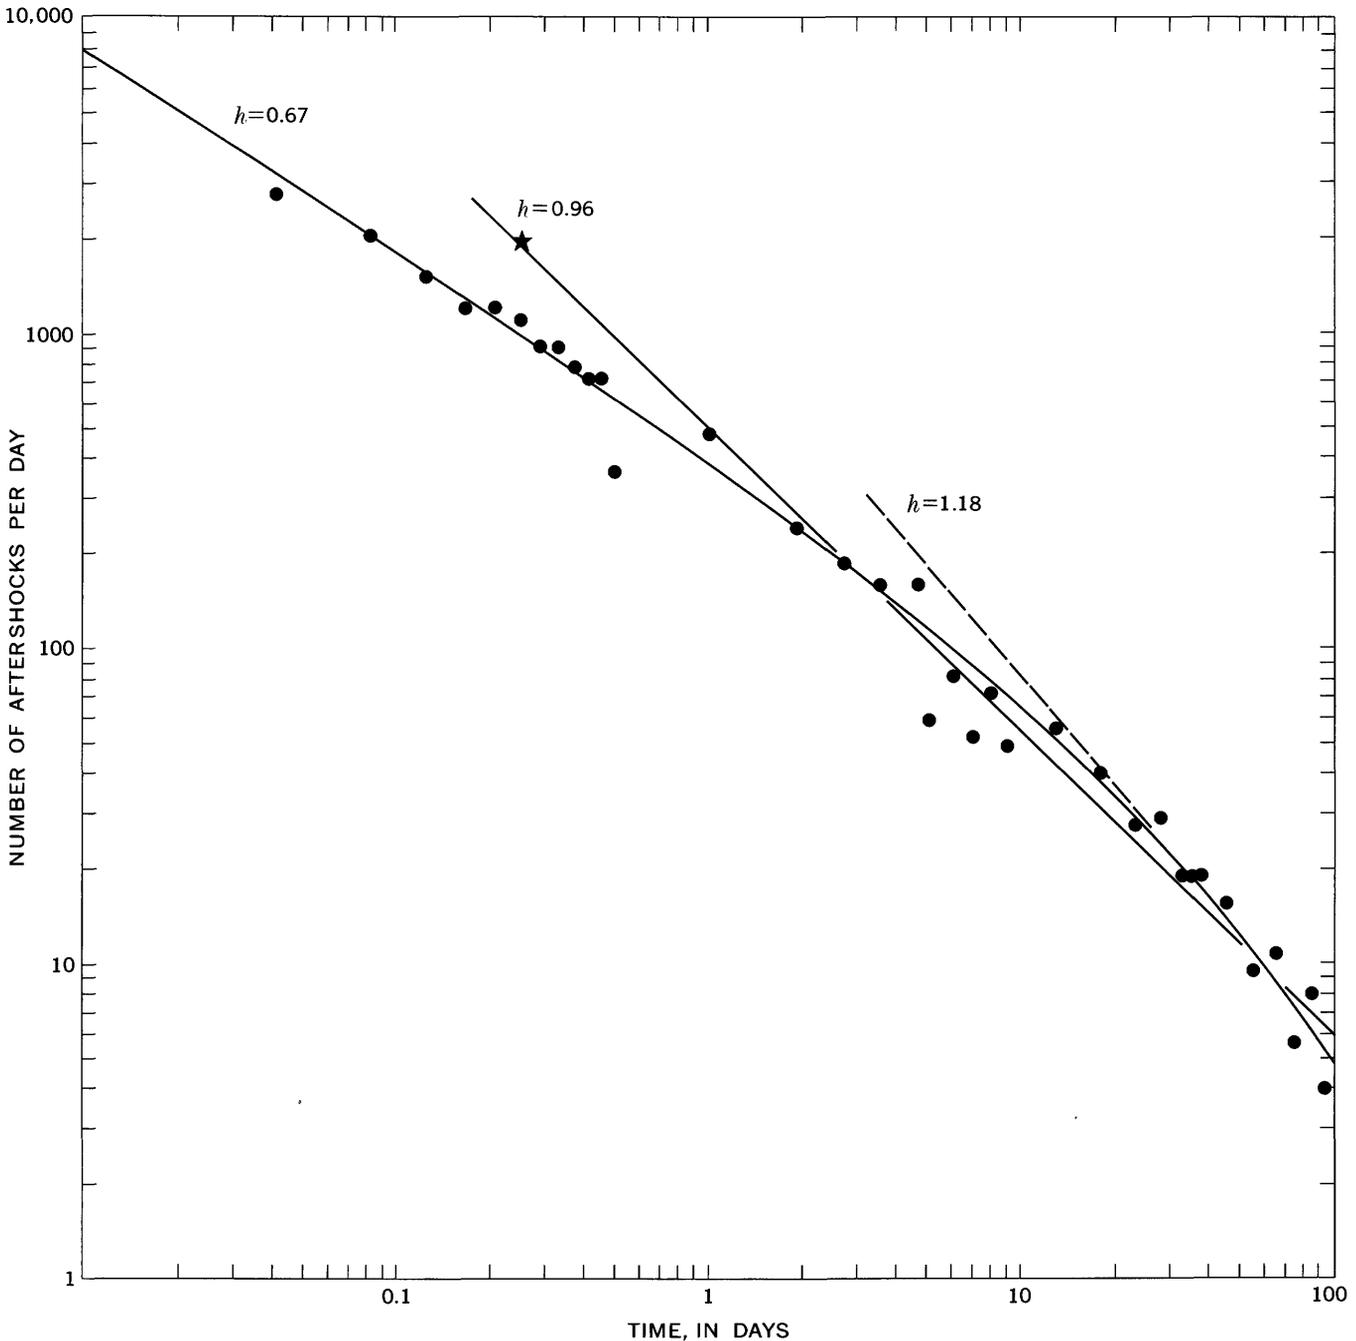
FIGURE 51.—Frequency of aftershocks at Gold Hill as a function of time for 96 days after the main shock. Solid circles represent hourly averages for the first 12 hours, daily averages for the next 5 days, 5-day averages for the next 30 days, and 10-day averages thereafter. The star represents events during the first 12 hours when they are lumped into a single interval. The h 's refer to the rate of decay of the aftershock sequence according to the empirical equation $R(t) = R_0 t^{-h}$.

A similar plot of data for the Parkfield-Cholame earthquake (fig. 51) appears to be best fit by a curve that deflects downward with respect to a straight line as time increases. Tangents to this curve which fit the plotted points from 0 to 4+ days and from 10 to 96 days have h equal to 0.67 and 1.18, respectively. The apparent differences between these data and those reported by Mogi may result from differences in the time intervals over which aftershocks were counted for the purpose of determining the aftershock frequencies. For example, if aftershocks during the first 12 hours of the Parkfield-Cholame sequence were added together and plotted at $t=0.27$ day (star on fig. 51), it would be

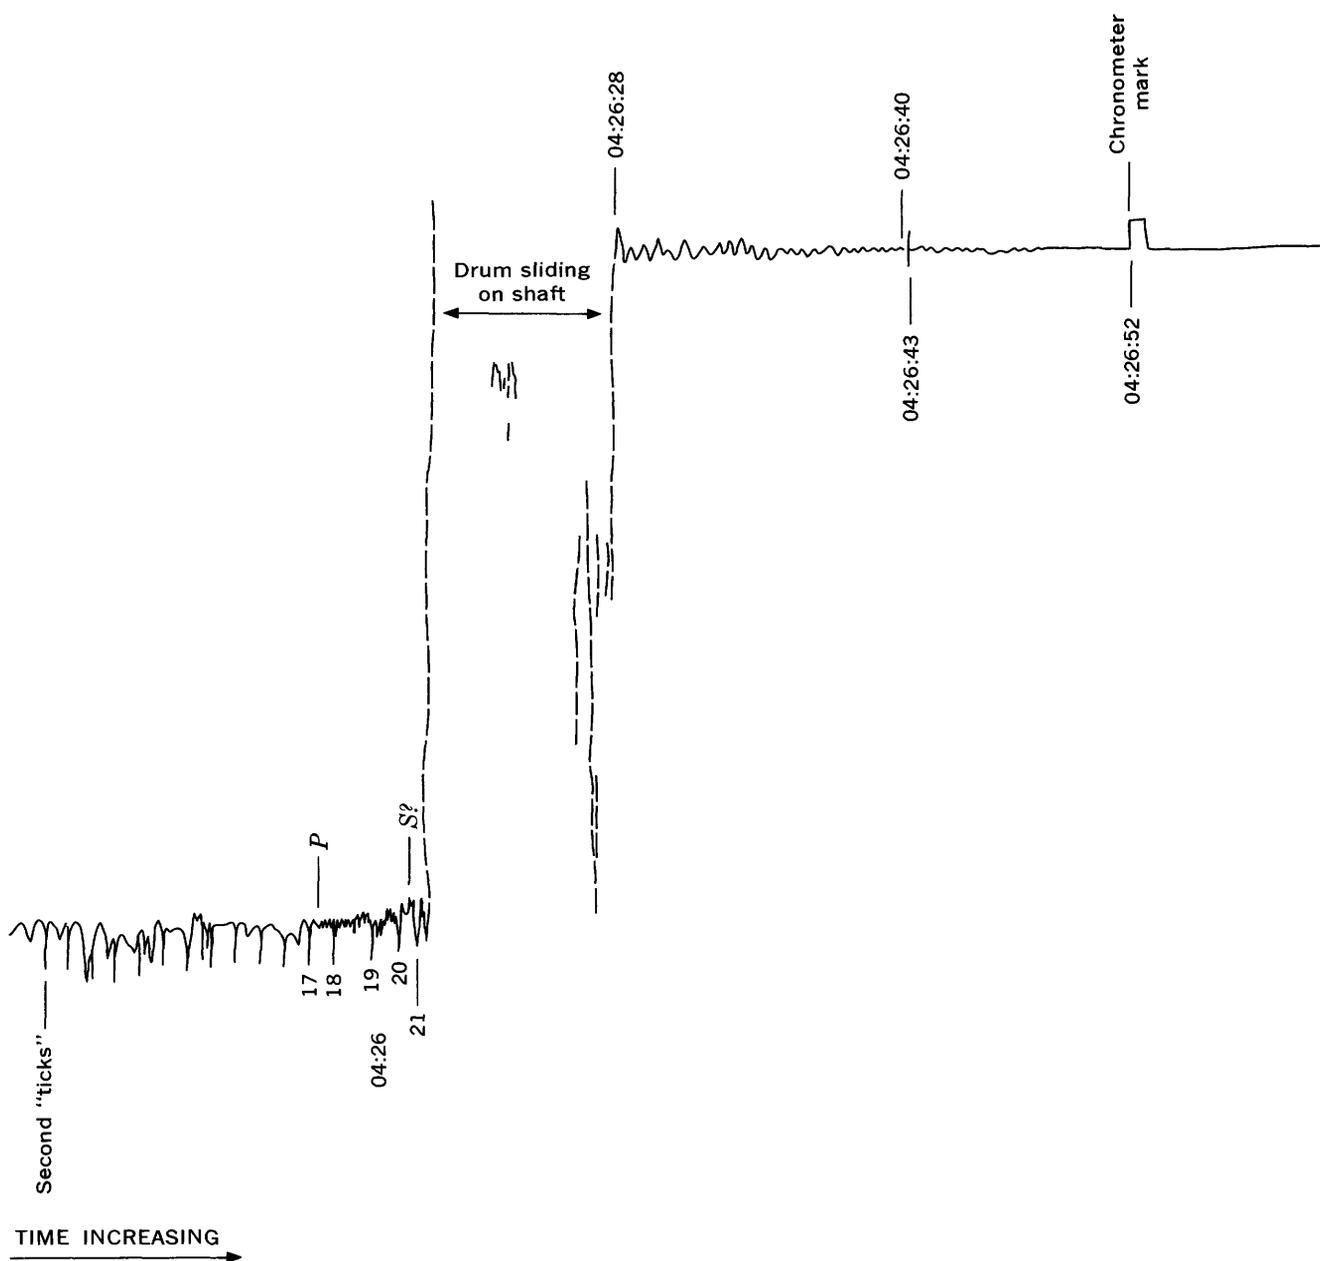
Immediately before the quake the radio trace was recording a slowly varying audio WWV "tone" punctuated by the 40-millisecond interruptions that mark individual seconds. These "second ticks" can be seen clearly in figure 52, a sketch of the critical part of the record, before and during the first few seconds of the earthquake. The actual times of several of the second marks are indicated on the sketch, where an irregular advance of the drum during the earthquake is evidenced by the uneven spacing of the second marks. The arrival of the P waves is marked by a slight widening of the trace at 04:26:17.4, and a moderate increase in shaking occurred about 1 second later. Still stronger longer period motion (possibly S) began just before 04:26:21. At about 04:26:22 the inertial forces acting

FIGURE 52.—Abnormal behavior of the radio time trace on the 35-mm film recorder produced by strong ground motion at the Gold Hill van. Indicated times are Greenwich. Dash lines indicate very faint parts of the trace that were written while the drum was sliding to and fro on its shaft.

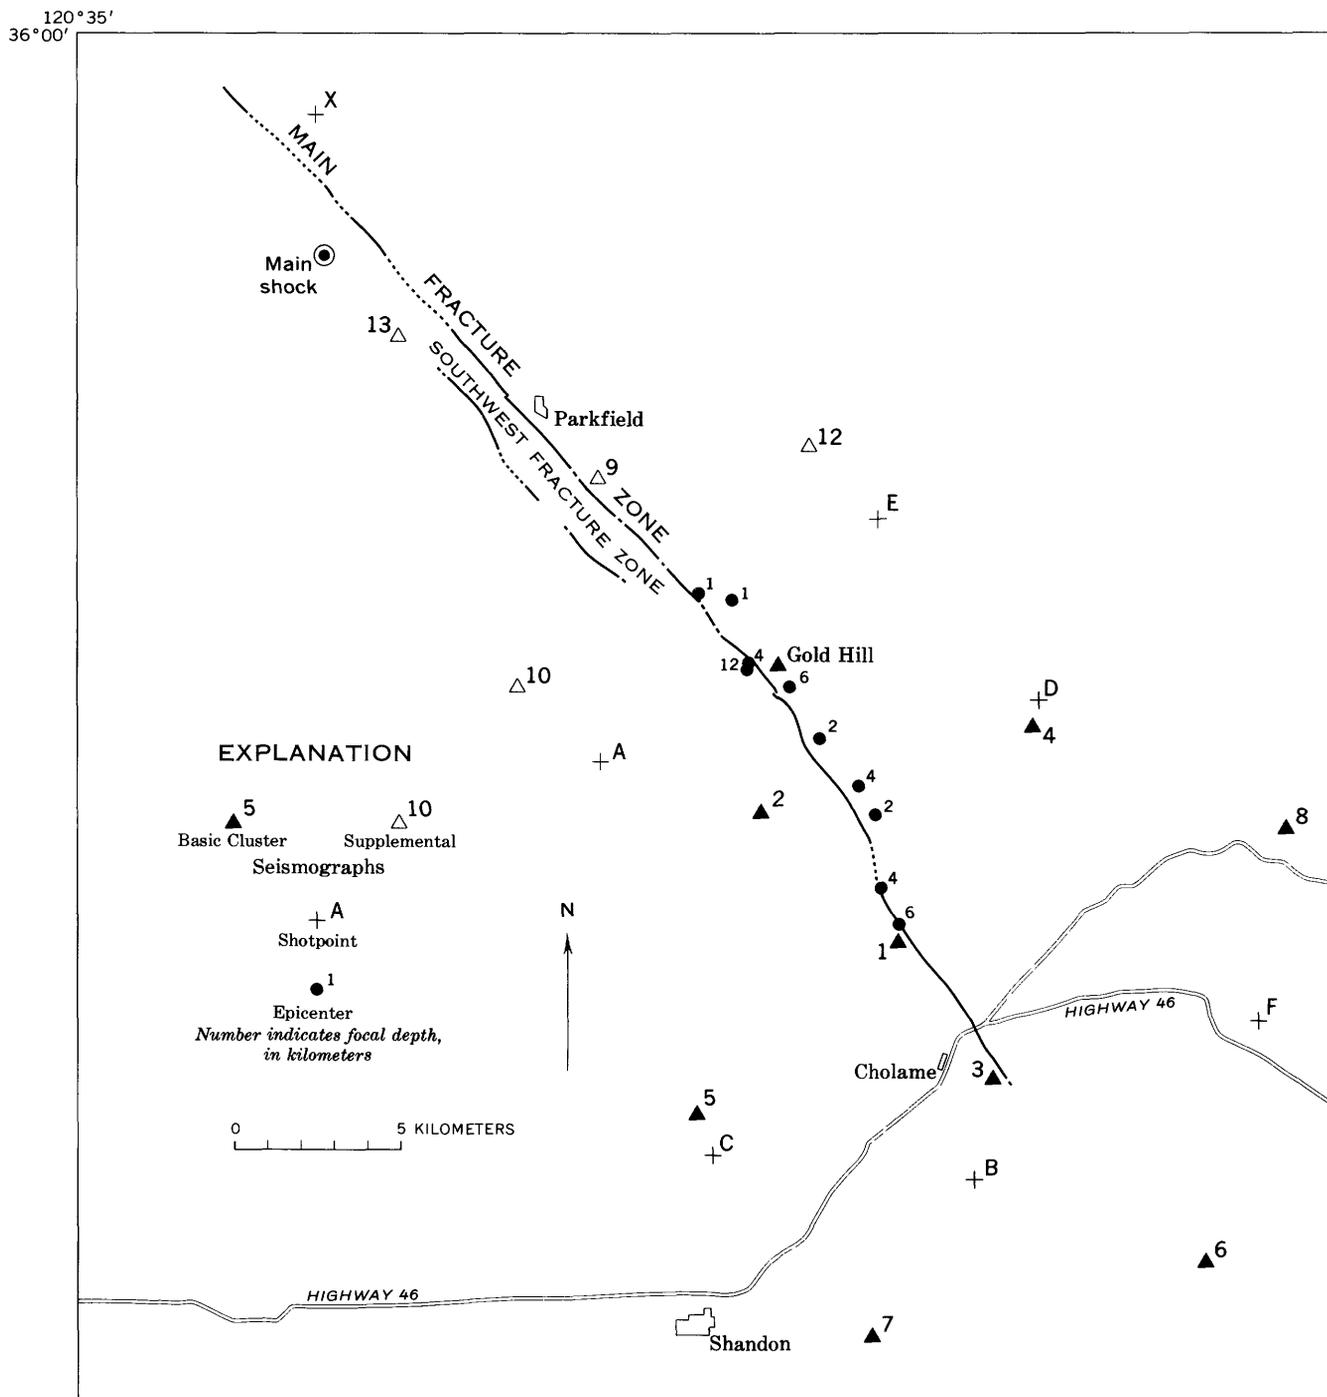
Epicenters and focal depths of the 10 "located" aftershocks in table 9 are indicated in figure 53. The epicenters lie very close to the trace of the main fracture zone, and there appears to be no sorting of earthquakes with respect to distance from the surface break as a function of focal depth. Thus, it seems that the aftershocks included in this small sample occurred on or very near a fault surface that extends vertically downward from the surface break to a depth of about 12 km.

FIGURE 53.—Parkfield-Cholame region. U.S. Geological Survey seismograph stations, epicenters of July 17, 1966, aftershocks, refraction and calibration shot locations, and the surface fracture zones associated with the 1966 earthquake sequence (from fig. 2). The epicenter of the main shock was provided by Prof. T. V. McEvelly, University of California at Berkeley.

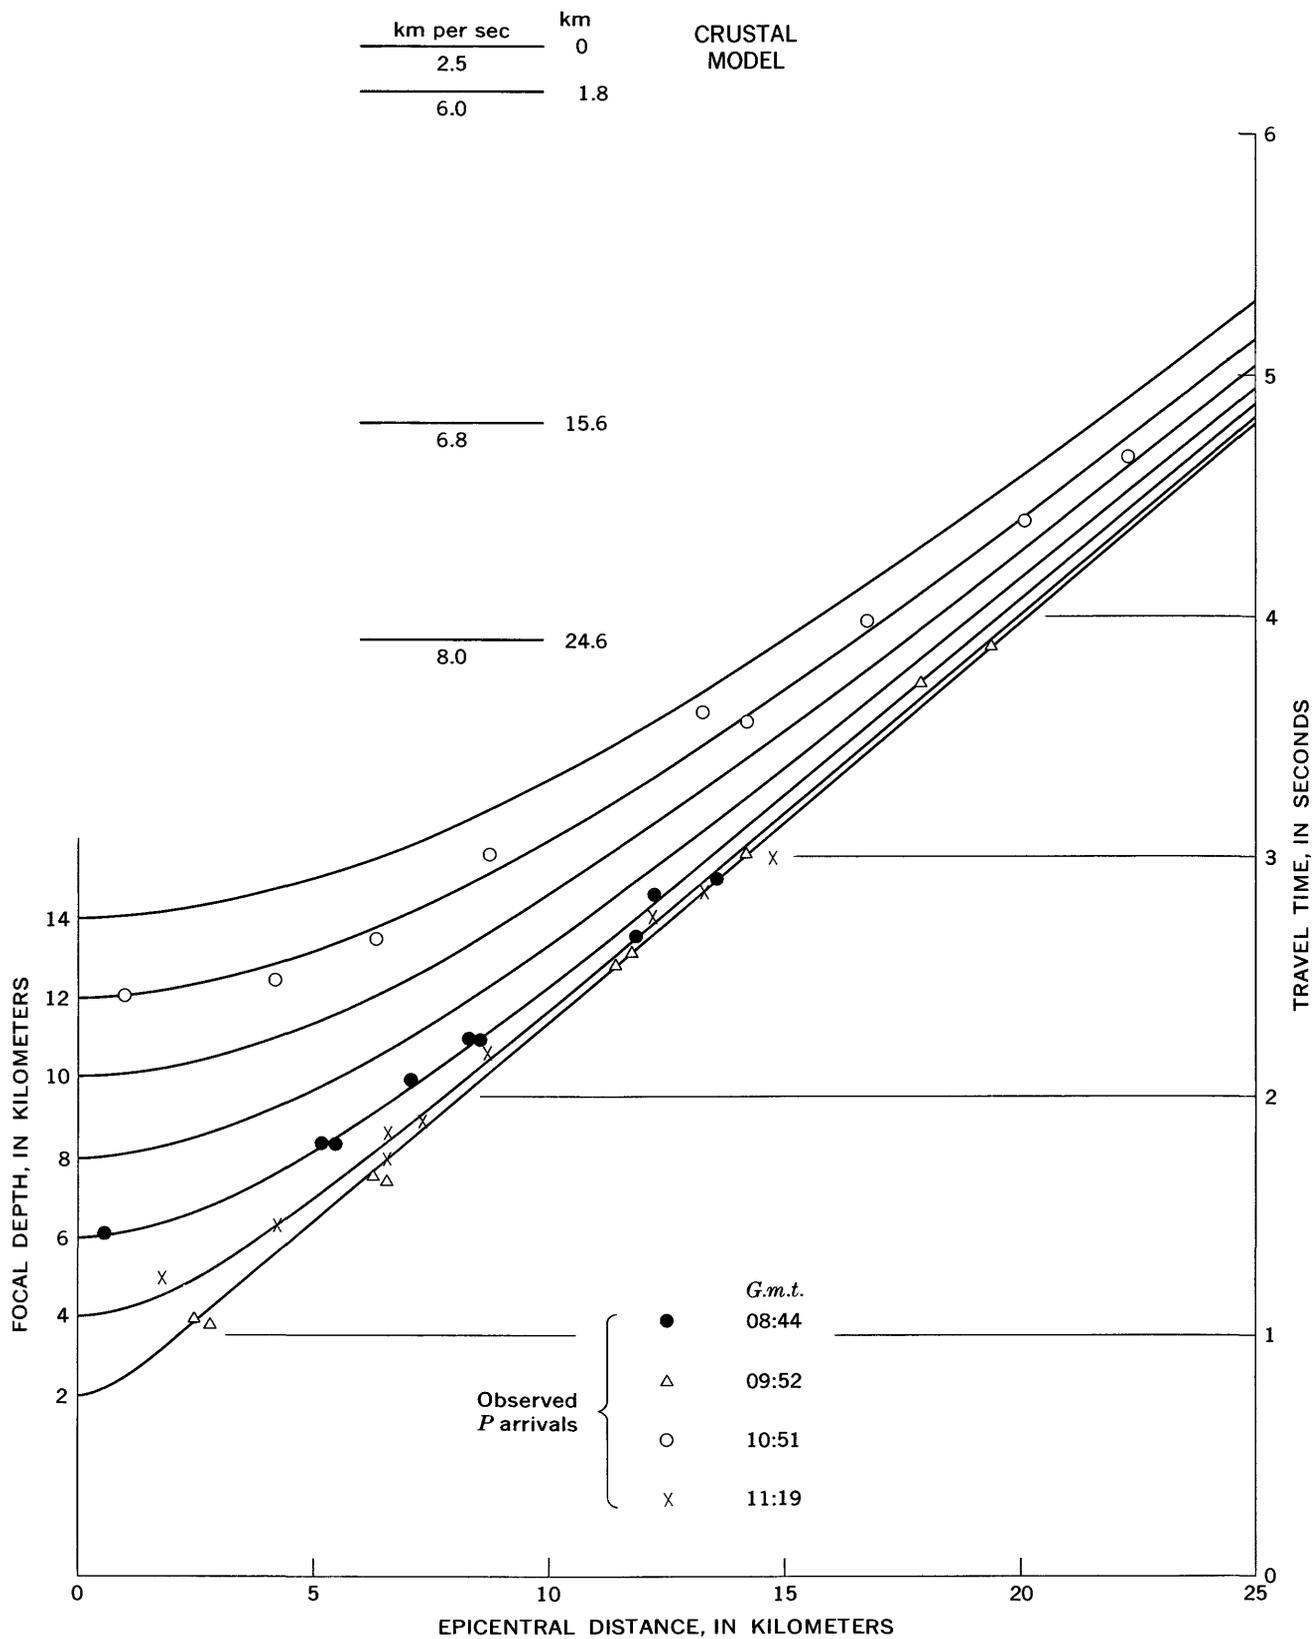
To indicate the sensitivity of the cluster to variations in focal depth, *P*-wave traveltime curves for earthquakes at various depths between 2 and 14 km are given in figure 54. Observed arrivals from four aftershocks with different focal depths are plotted in figure 54 for comparison. This comparison illustrates how the range

in recording distance, and scatter in arrival times, of observations from individual earthquakes limit the precision with which focal depths can be determined. If ± 1 km precision is sought, some observations at epicentral distances as small as the focal depth are required.

FIGURE 54.—Theoretical traveltime curves for earthquakes with focal depths from 2 to 14 km and the crustal model from which they were calculated. Observations from four July 17 aftershocks (see table 9) are plotted on the diagram for comparison with the theoretical curves.
