Landslides of Rio de Janeiro and the Serra das Araras Escarpment, Brazil

By FRED O. JONES

GEOLOGICAL SURVEY PROFESSIONAL PAPER 697

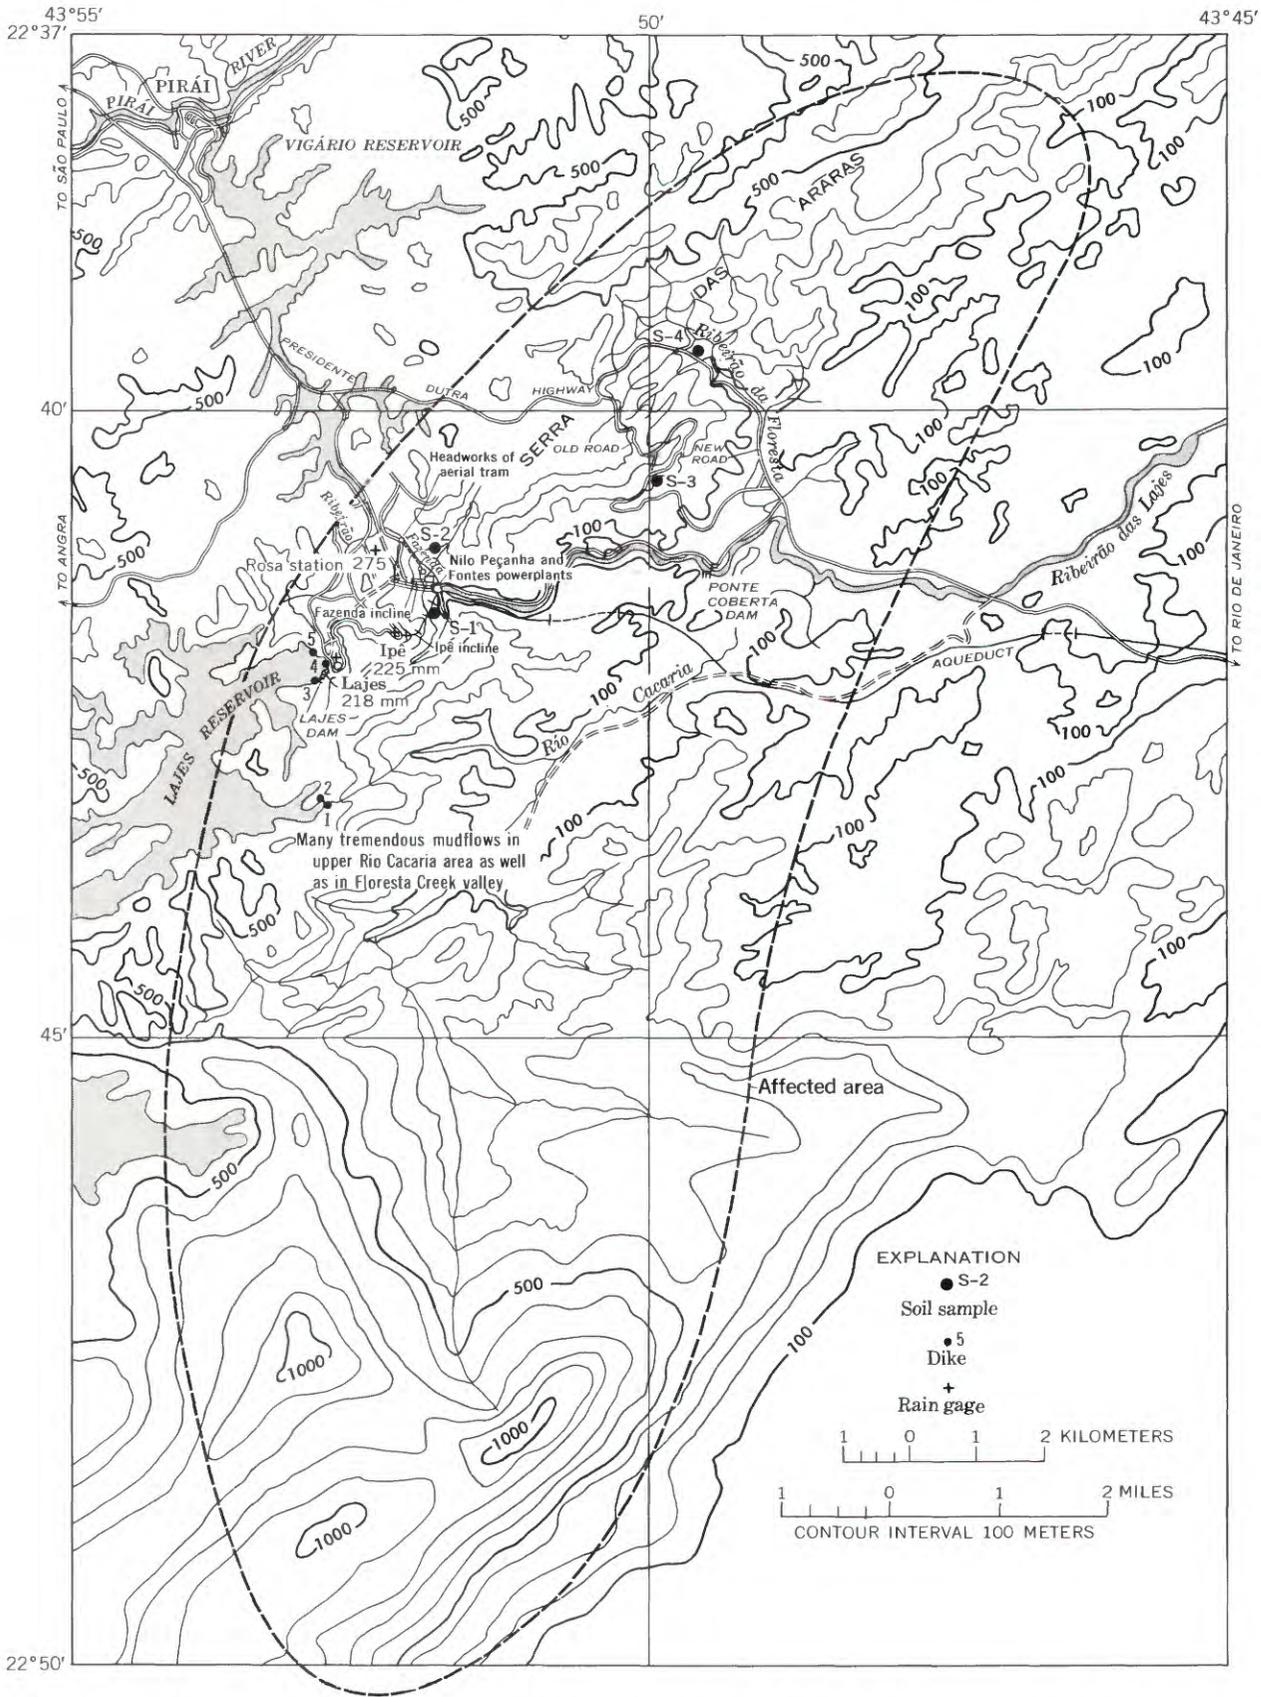
FIGURE 15.—Map of Serra das Araras landslide disaster area showing areas of destruction after the rainstorm of January 22 and 23, 1967. Rainfall recorded at selected points is shown in millimeters.

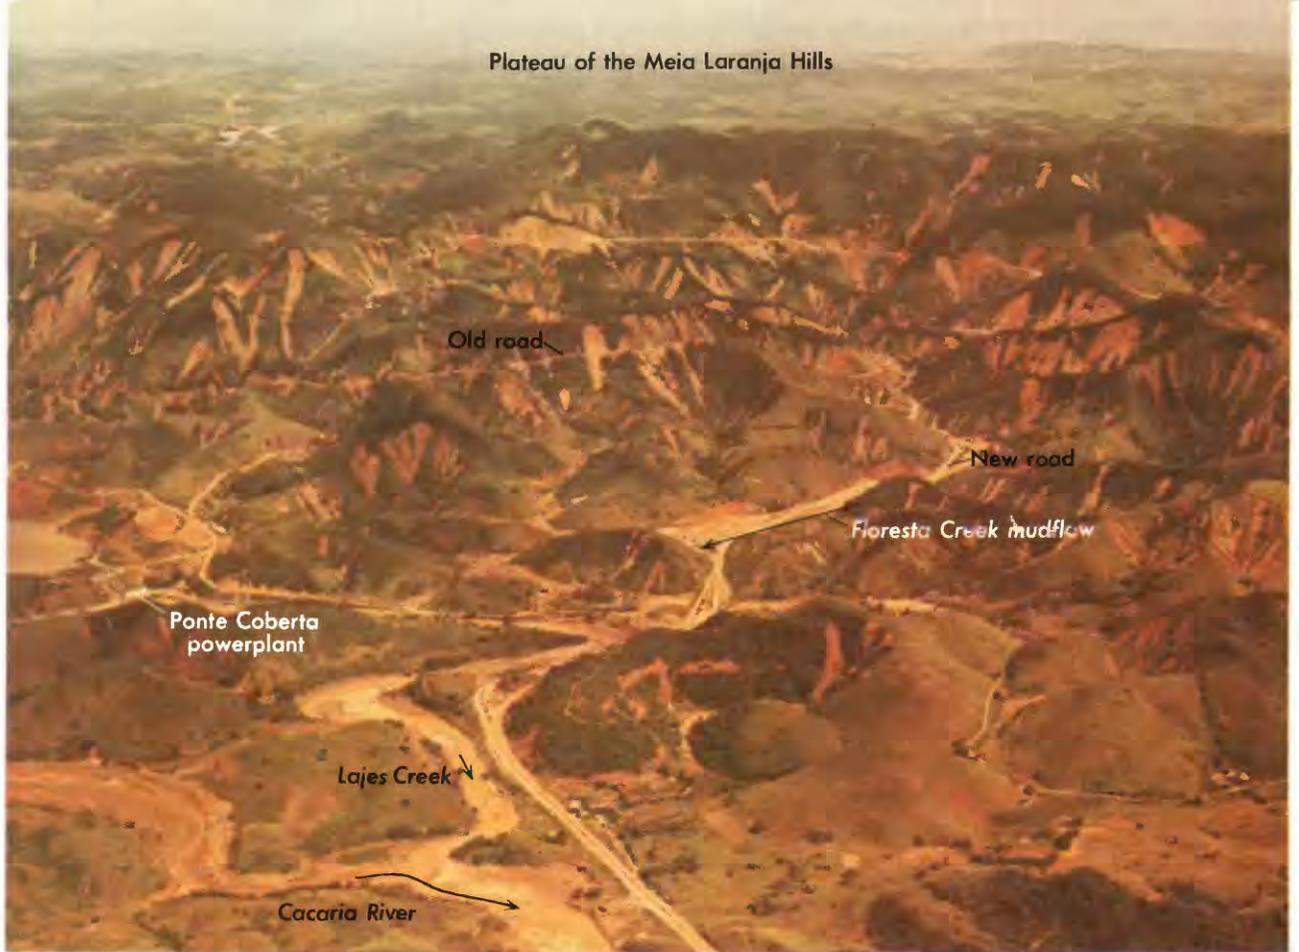
FIGURE 16 (above).—High level view of São Paulo-Rio de Janeiro highways across the Serra das Araras escarpment. Plateau of the Meia Laranja Hills above escarpment. Confluence of Rio Cacaria and Ribeirão das Lajes in lower foreground. The Rio Cacaria drains a large part of the area of heavy landslide destruction. Ponte Coberta powerplant on Ribeirão das Lajes in lower left.

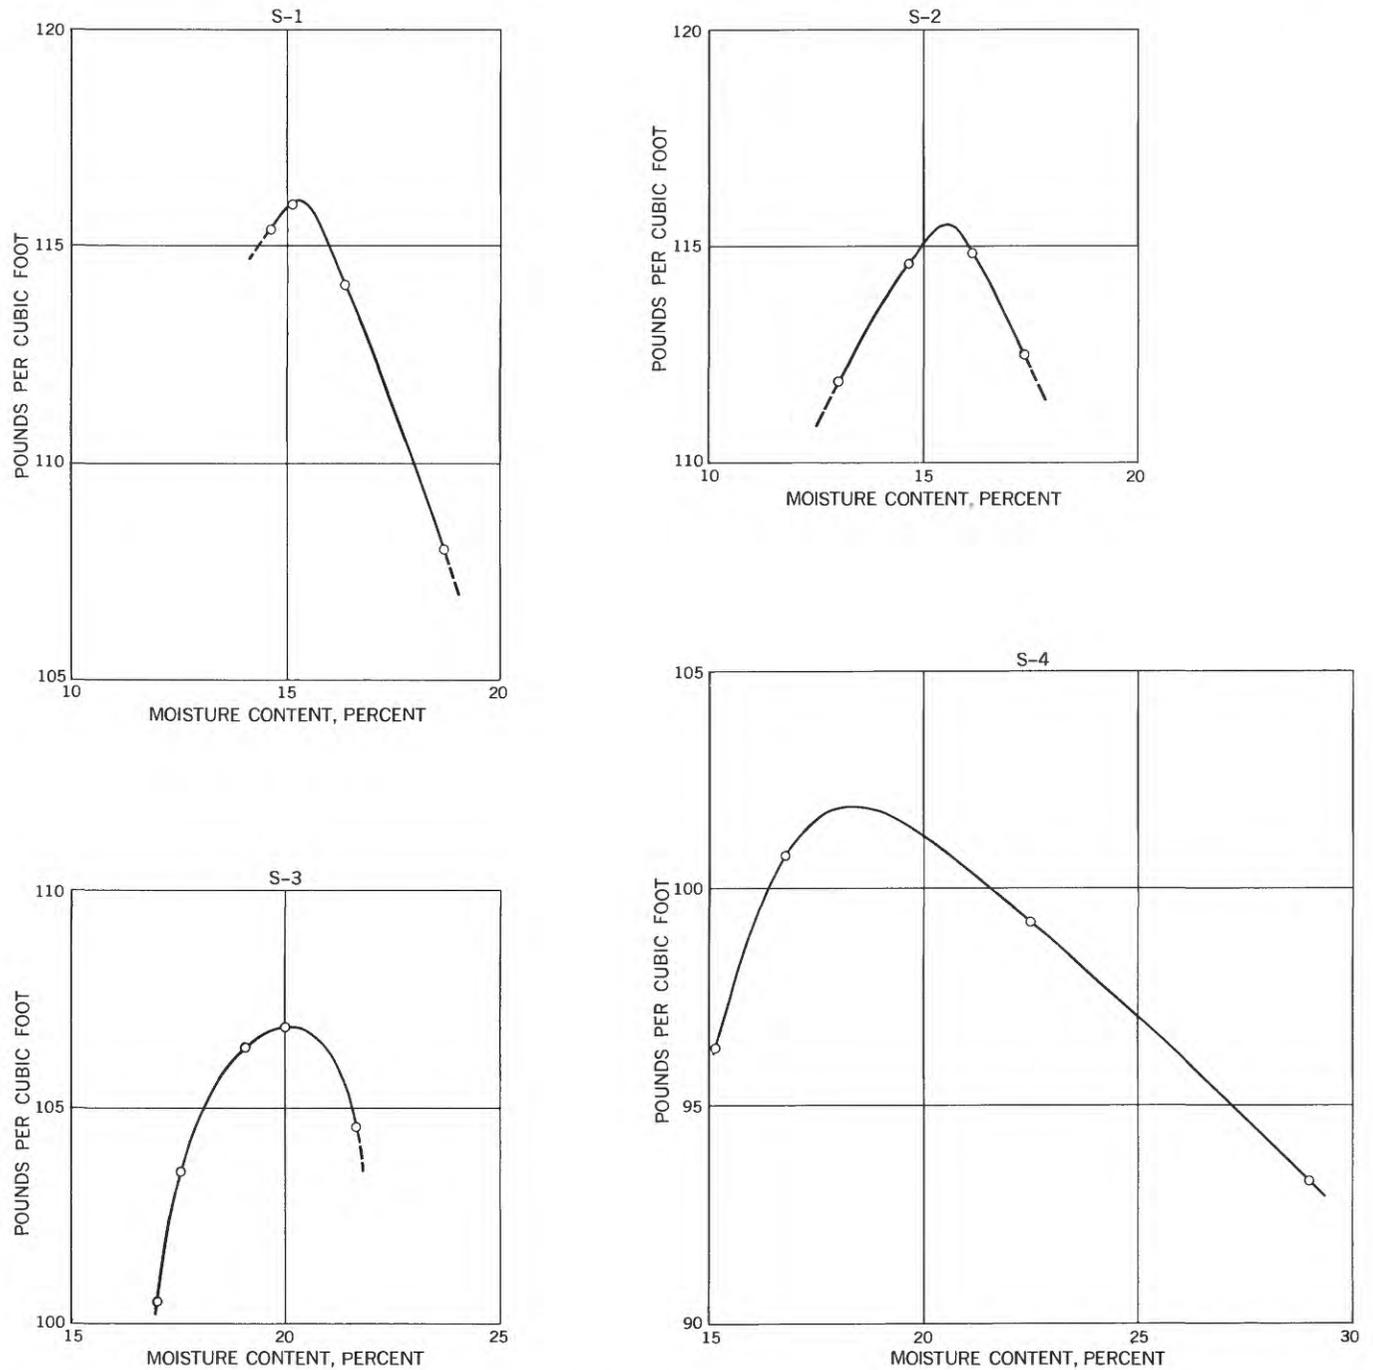
FIGURE 29.—Moisture-density curves for soil samples S-1 to S-4 using the Harvard compaction apparatus. Natural-state moisture content could not be determined on the samples as they were received in a dry condition with a moisture content of only a few percent. It was assumed that the natural-state moisture content was much greater. Compactive effort: five layers, fifteen 40-pound tamps per layer. Analyses by E. E. McGregor, U.S. Geological Survey.

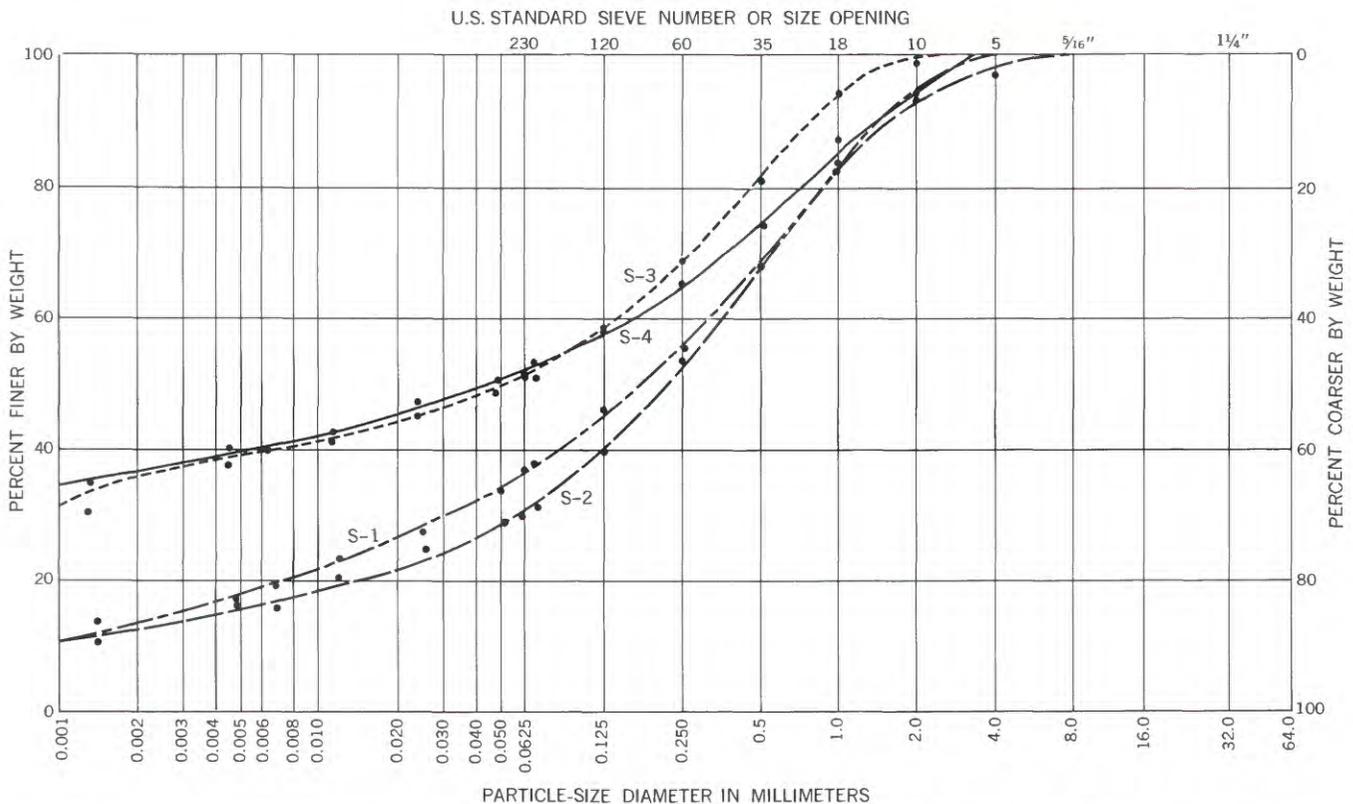
FIGURE 30.—Particle-size distribution of four soil samples, S-1 to S-4. Analyses by E. E. McGregor, U.S. Geological Survey.

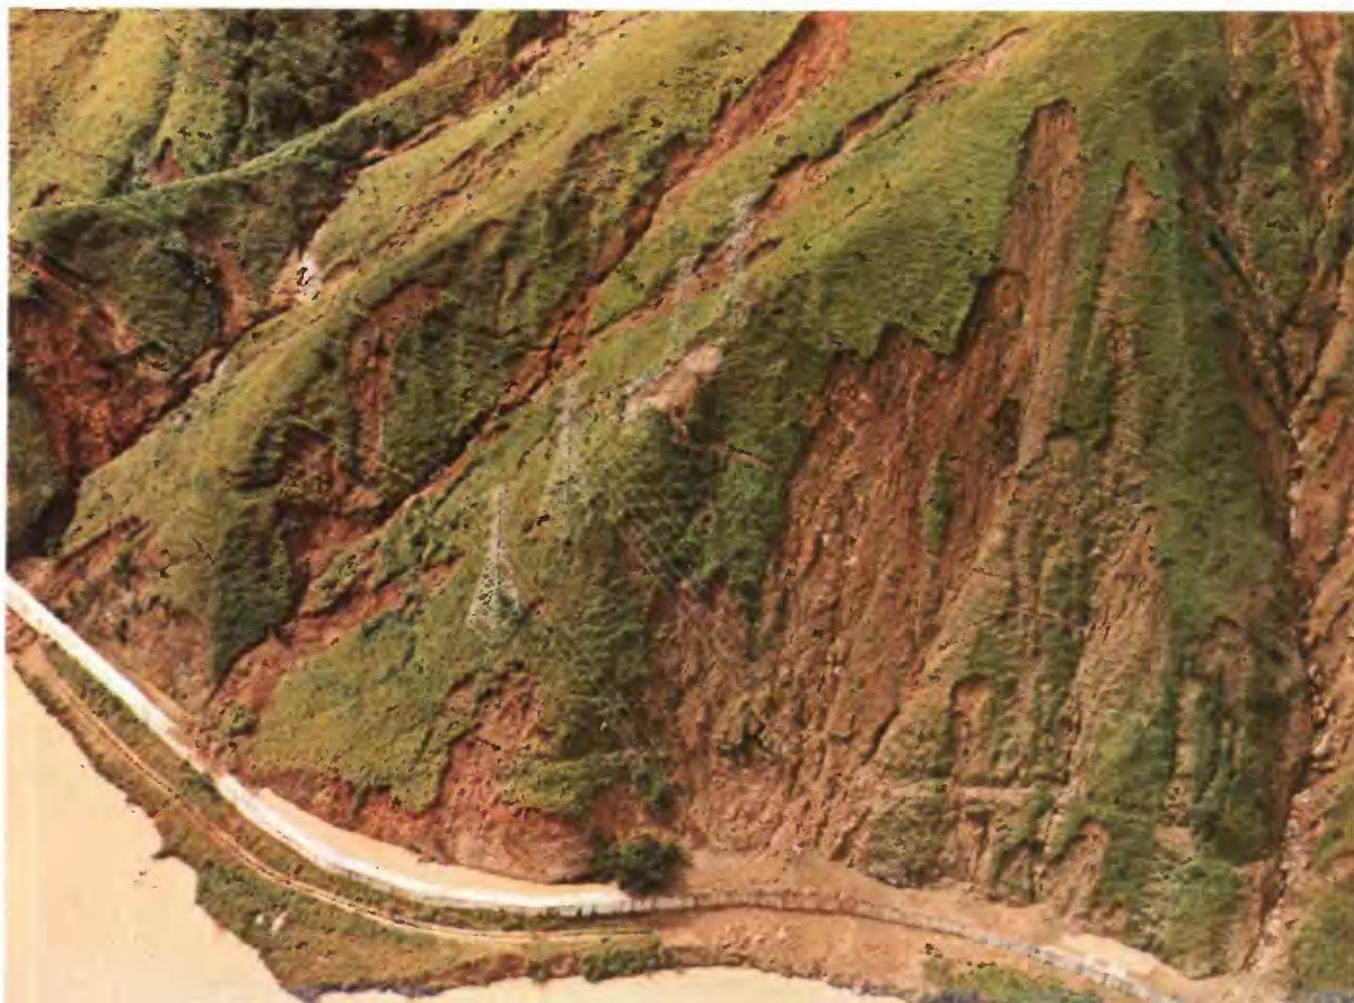
FIGURE 38 (below).—Landslides above Rio de Janeiro water conduit and near transmission towers just downstream from powerplants. Ponte Coberta Reservoir in foreground.
