# THE SAN FERNANDO, CALIFORNIA, EARTHQUAKE OF FEBRUARY 9, 1971:

*A preliminary report published jointly by the U.S. Geological Survey  
and the National Oceanic and Atmospheric Administration*

GEOLOGICAL SURVEY PROFESSIONAL PAPER 733

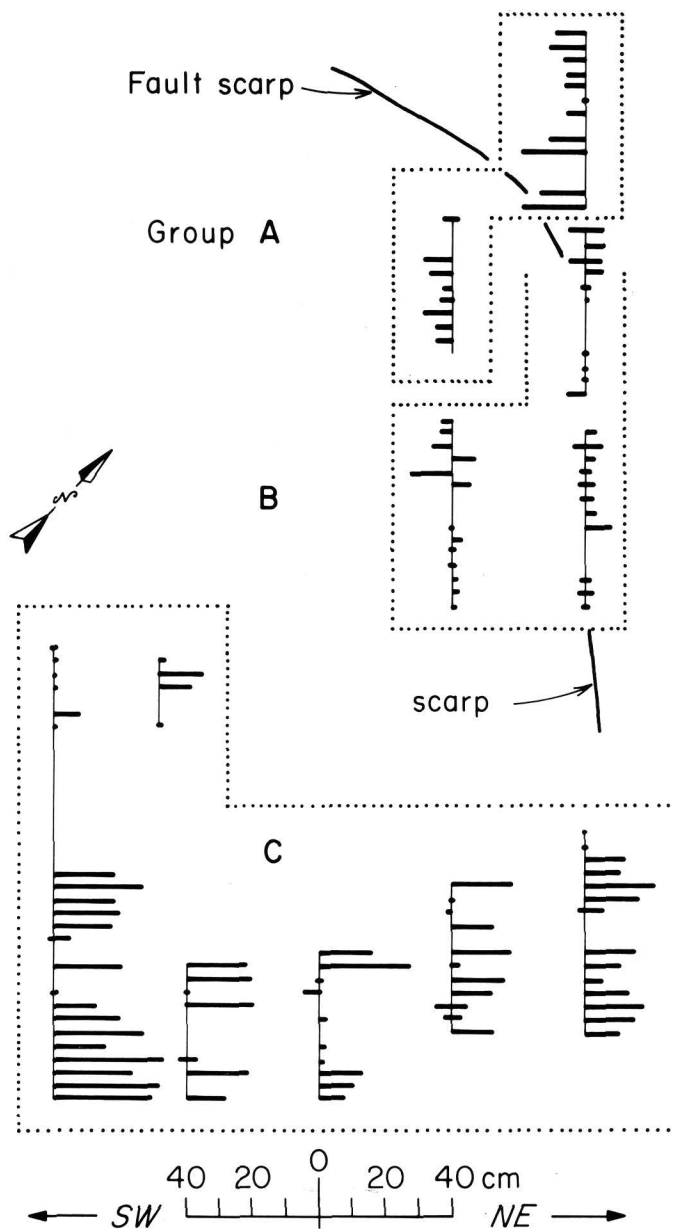
Some unique evidence as to ground displacements in the vicinity of the Power Line scarp is provided by an array of 173 large cable spools, each weighing about 6 tons, which stood in neat rows in the transmission-line right of way as outlined by the dotted rectangles in figure 3. The spools stood on their rims, like wheels, with the spool axes oriented northeast. The rims had pressed down as much as 10 cm into the sandy soil. Although the spools were oriented so as to roll northwest-southeast, during the earthquake very few of them rolled. Instead, most of them shifted 10–20 cm sideways, gouging out a track in the soil. The sideways (NE-SW) motions are plotted in figure 4, in a format which shows schematically both the displacement of each spool and also the position of the spool in the entire array. Figure 4 shows that some of the spools did not move and that some oscillated back and forth, but many moved in a consistent pattern to one side or the other. As a whole, the spools outlined in group A moved consistently toward the southwest, and those in group C moved toward the northeast, while those in group B showed no preferred direction of motion and represent a transition group between A and C. The actual positions of these groups on the ground are shown in figure 3.

FIGURE 4.—Displacements of cable reels that moved in the earthquake. Fine lines represent rows of reels in their approximate original position on the ground, but foreshortened in the NW-SE direction. Heavy lines represent the amount of sideward displacement of individual reels northeastward or southwestward from their original positions, according to the scale at bottom. The actual position on the ground of the groups of reels, as outlined with dotted lines, is shown in figure 3. The location of the Power Line fault scarp is shown schematically in relation to the rows of reels.

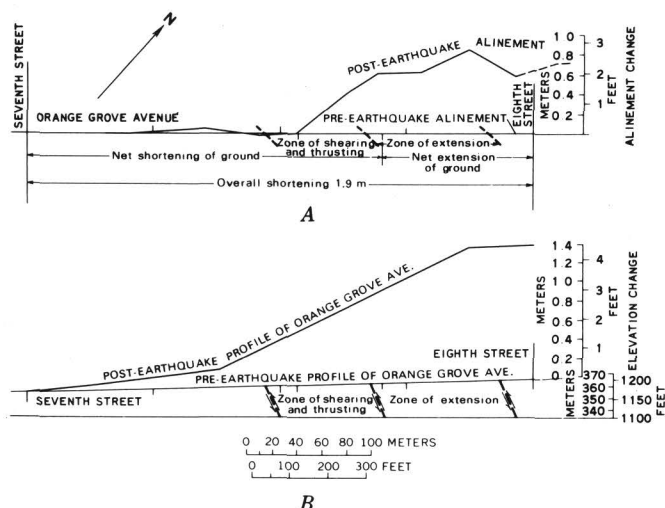
FIGURE 4.—Changes in level, length, and horizontal alinement along Orange Grove Avenue between Seventh and Eighth Streets, city of San Fernando. A. Changes in length and alinement (plan view). Left-lateral displacement of the street from the original alinement was measured by sighting along the northeast curb February 19, 1971. Change in length of the street was measured February 20, 1971, by R. T. Ruthven, U.S. Geological Survey. Localization of horizontal movement was determined by measuring compression and extension of curbs and sidewalks on both sides of Orange Grove Avenue. This figure shows that most of the shearing and thrusting is concentrated in the shear-thrust zone near the southern boundary of the break zone. B. Changes in elevation relative to leveling done in January 1962. The elevation of the intersection of Orange Grove Avenue and Seventh Street is assumed to have remained unchanged. Measured February 15, 1971, by R. E. Munn, Engineering Department, city of San Fernando. This profile shows that vertical displacement is distributed across the entire zone of breakage.

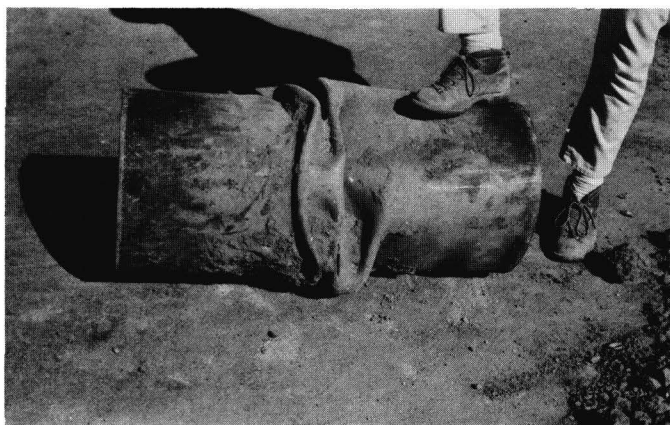
FIGURE 5.—Shortened section of gas pipe taken from the shear-thrust zone across Glenoaks Boulevard. This piece was shortened more than 0.1 m (4 in.); at least one other shortened section of the same pipe was removed from another place in this shear zone. Immediately north of the shear zone across Glenoaks Boulevard, but still in the fault zone, this pipe and adjacent water pipes were each broken in several places by extension of the ground combined with downward movement to the south. Despite the shortening in the shear zone shown by this photograph, the net change in the length of Glenoaks Boulevard and the pipes buried beneath it was an extension of 0.6 m between Hubbard and Orange Grove Avenues (measured February 20, 1971, by R. T. Ruthven).

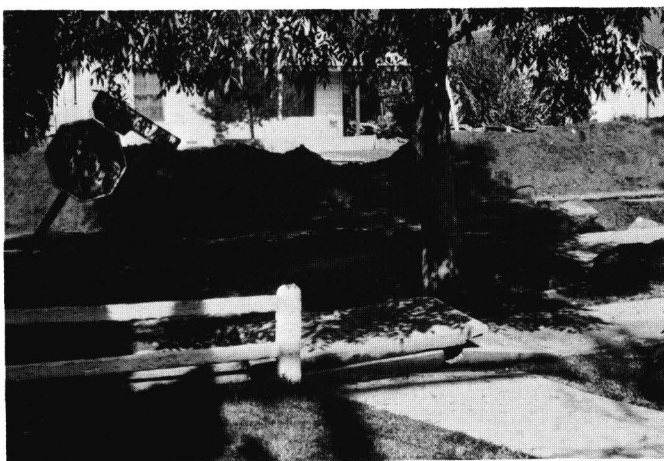
FIGURE 6.—Shortened sidewalk. The slab resting on top of this sidewalk on the southeast side of Orange Grove Avenue near Phillippi Street has been thrust from left to right. Thrusting between Phillippi and Knox Streets shortened Orange Grove about 1.3 m (about 4 ft) and ejected the slab. The two corners at the ends of the block yielded little, forcing the sidewalk to buckle at this point.

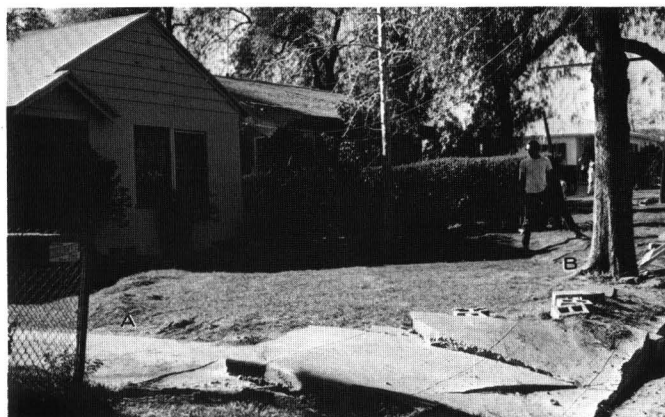
FIGURE 8.—Shear-thrust zone at Cometa Avenue (parallel to and northeast of Eighth Street). The two larger thrust faults (A and B) account for most of the strike slip and shortening of the shear-thrust zone, which is less than about 10 m wide at this location. The overthrust driveway and adjoining street span the shear-thrust zone and indicate roughly 1 m of shortening. The curb at the right is offset nearly 2 m left-laterally across these two breaks. Vertical displacement is about 0.5 m. The closest house has broken free of its foundation and shifted nearly 0.5 m to the right (north).

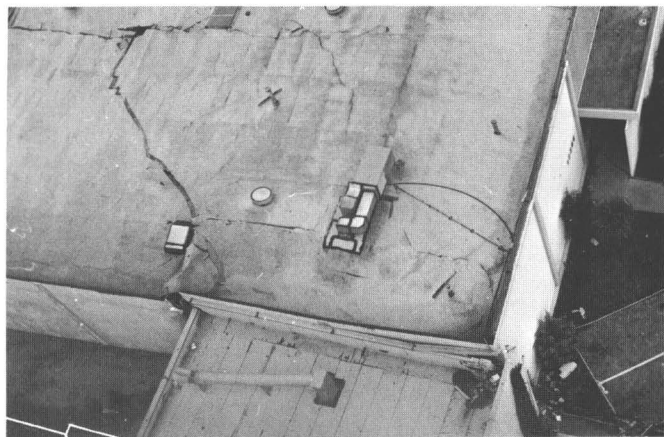
FIGURE 10.—Detail of interpenetration of two buildings caused by ground rupture. Edges of asphalt paving, outlined in lower left corner of photograph, overlap by 0.49 m. Near southeast end of Gladstone Avenue, near San Fernando Ranger Station.

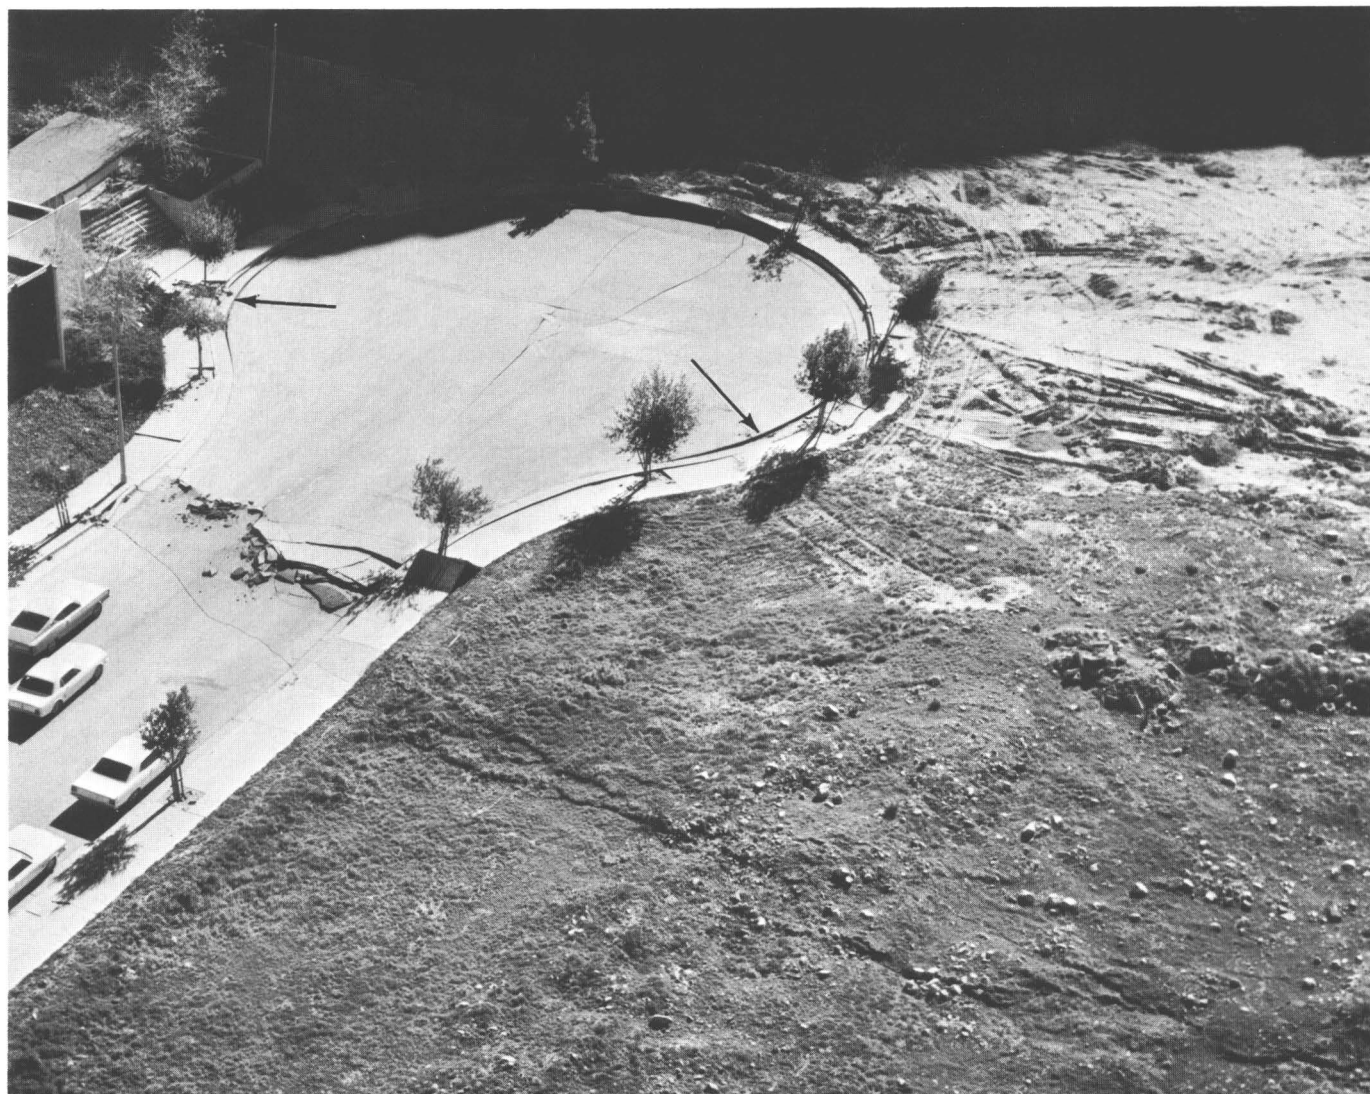
east of the end of the street, was shifted about 0.2 m southwest of the centerline. The shortening buckled the sidewalk and flattened the circle at the end of the street and produced crescent-shaped openings between the curb and the sidewalk (figs. 11 and 12). The form of the ruptures both in the streets and in vacant lots indicates strong compression in the northwest-southeast direction and uplift of the southeast side, possibly combined with a minor right-slip component. Numerous landslide scarps up to 1 m high cut the flanks and ridges of the hill immediately to the east. Their presence suggests the possibility that settling and spreading of the bedded and jointed rock that constitutes the hill may have forced out a wedge of alluvium at the base of the hill, produced most of the compressional effects, and masked whatever tectonic displacements may have occurred.

FIGURE 11.—Oblique aerial photograph of ground breakage on Montero Avenue near San Fernando Ranger Station. Note thrusting in open ground, compression of sidewalk and asphalt street, and crescent shaped openings near curbs (arrows).

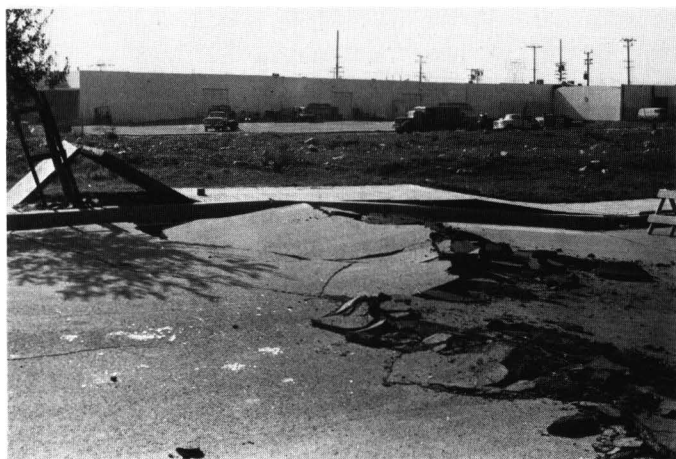
FIGURE 12.—Detail of compression of sidewalk and asphalt street. The compressed sidewalk at left shortened 0.3 m. Note tree tilting southeast.

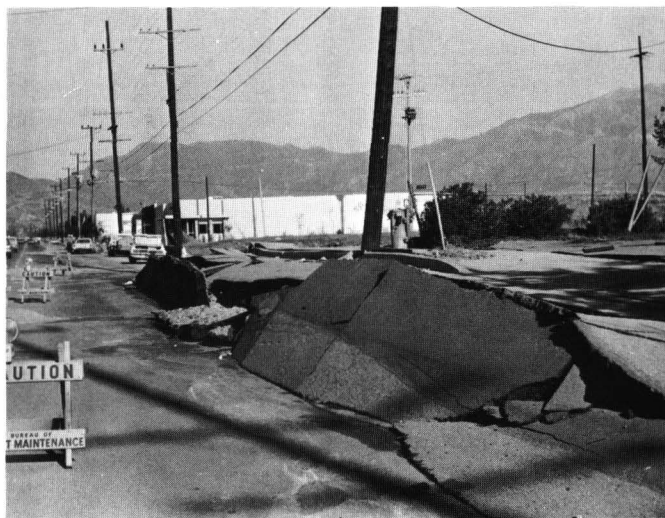
In front of the nursing home the curb is raised about 1 m above the street level (fig. 13). A transverse component of movement, shown by about 0.9 m of shortening, was measured along a fence trending N. 50° E. on the east side of the nursing home. East of the nursing home, a low, but well-defined fault trace continues with only a few interruptions to the mouth of Lopez Canyon. Where the surface ruptures transect the lower slopes of the hills just

FIGURE 13.—Scarp formed near curb in front of Foothill Nursing Home. Scarp is about 1 m high here but is more subdued where it developed in unconsolidated sandy soil on either side of the nursing home. View looks northwest on Foothill Boulevard.

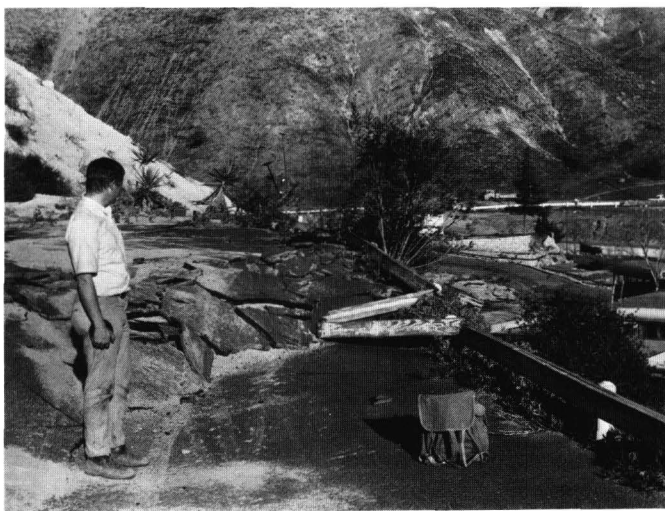
east of the nursing home, the scarps are low, but well defined. A conspicuous zone of tension cracks about 2–3 m wide formed about 10 m upslope from the base of the scarps. On the west side of Lopez Canyon, the scarp, which is about 0.85 m in height (fig. 14), is a hummocky, multistranded bulge at the leading edge of the overriding northern block. In a trailer park immediately west of Lopez Canyon, the fault appears to follow a shallow-dipping plane in Tertiary marine deposits. About 0.4 km west of Lopez Canyon and for approximately 200 m along strike, the fault plane has a rather uniform dip of about 55° N. Just east of the canyon, the fault zone is defined by many subparallel imbricate breaks.

FIGURE 14.—Scarp in trailer court just west of the mouth of Lopez Canyon. Buckling of wood guardrail indicates considerable shortening, but the amount of shortening could not be precisely measured because guardrail posts on upper part of scarp detached from the ground. Height of scarp is about 0.85 m. View towards northeast. Mouth of Lopez Canyon in background.

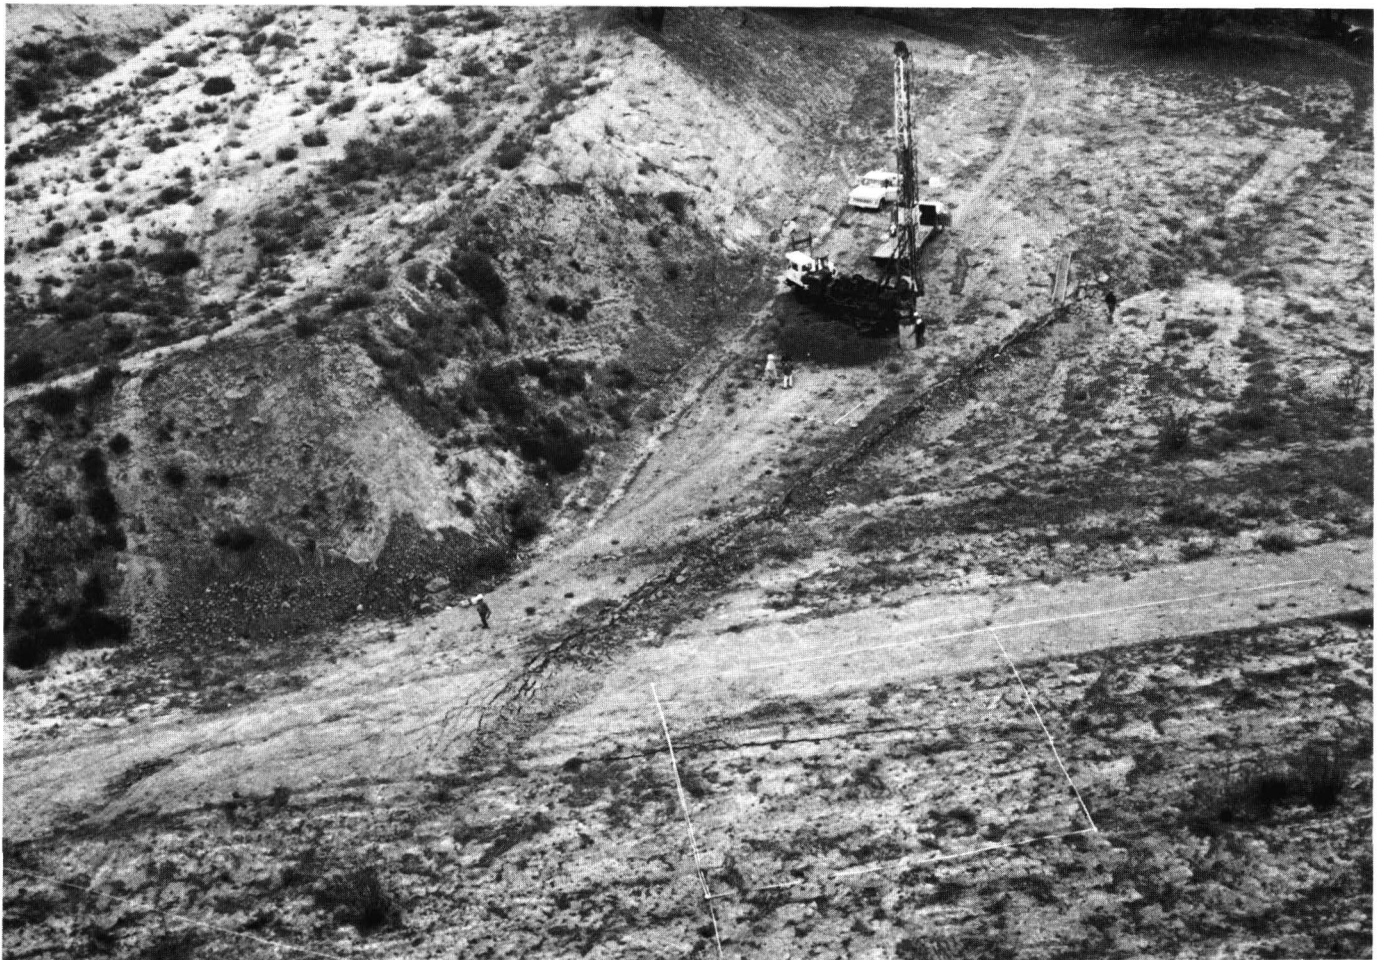
in figure 16, drilled to install a wire extensometer. The gentle monocline that marks the fault in the alluvium is some 30–35 m wide (profile *B–B'* in fig. 17). Although the difference in height across the monocline is about the same as across the scarp, it would be difficult to identify this as a structural warp from the profile alone. Between S36 and S39

FIGURE 16.—Oblique aerial photograph of fault scarp 0.9 km north of mouth of Lopez Canyon. Note gradation to monoclines at each end of scarp. Drill rig is setting casing in borehole that confirmed 65° dip of fault.

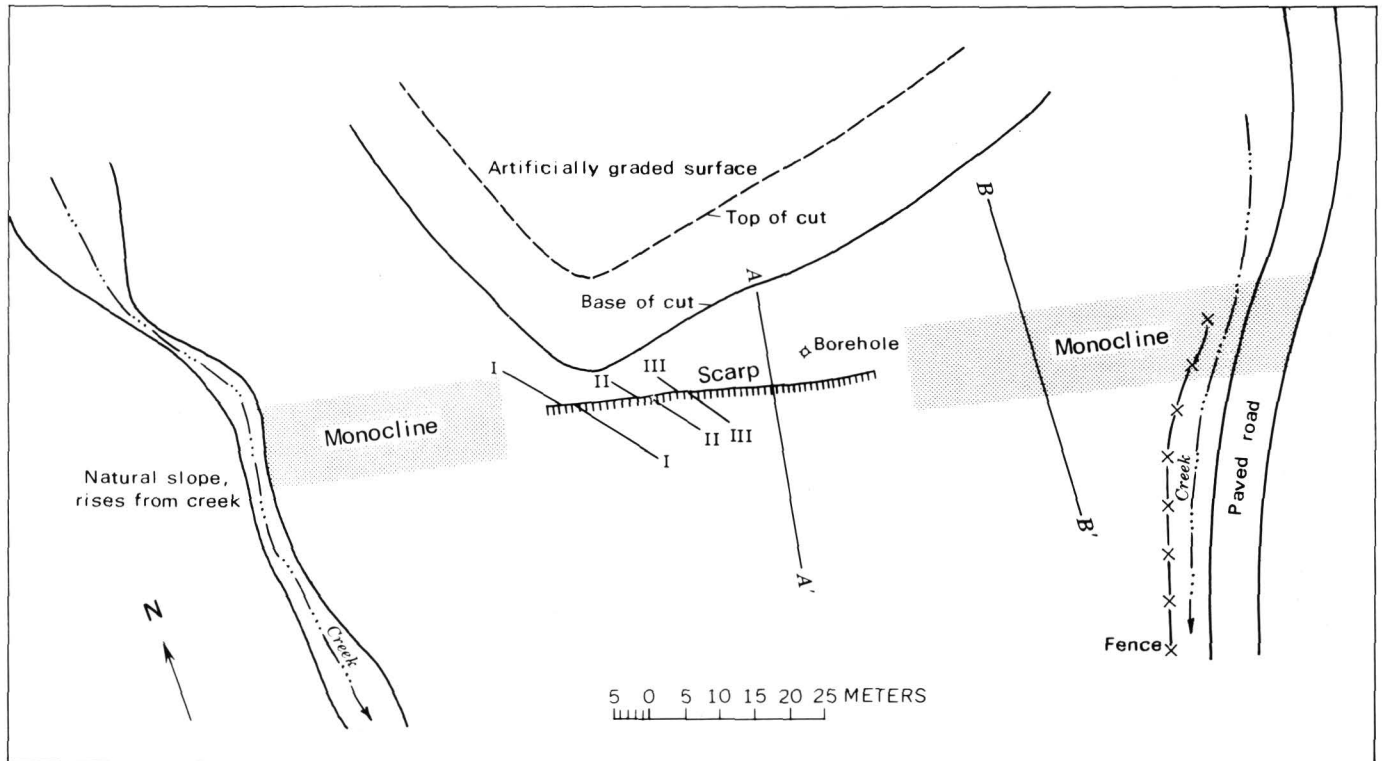
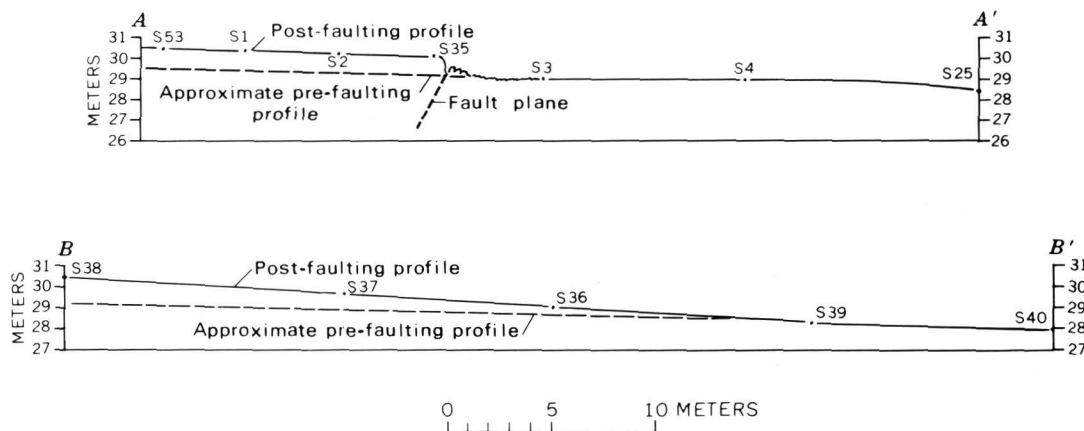
on profile *B-B'*, the monocline is marked by a series of weakly developed pressure ridges trending east-southeast and tension fractures trending north-northeast. Some of the fractures show minor left-lateral displacement. Between S36 and S38, the monocline is characterized by generally east- or east-northeast-trending tension fractures that display small vertical movements (down on the south). These movements are accompanied by small left-lateral displacements between S36 and S37 and by small right-lateral displacements between S37 and S38.

Three linear features that were used to calculate the fault displacement in Lopez Canyon are marked I, II, and III in figure 17. These features, which were probably made by a bulldozer, consist of two ridges (I and II) and the edge of a shallow cut (III). The reverse-slip and left lateral slip components calculated from the field measurements are, respectively, 1.05 m and 0.80 m for I; 1.26 m and 0.85 m for II; and 0.88 m and 0.70 m for III. The average values of the components are about 1.05 m

FIGURE 17.—Plan and profiles of trace of fault 0.9 km north of mouth of Lopez Canyon, based on planetable mapping. For location see figure 2. Elevations on profiles referred to local assumed datum. Numbers preceded by S are field survey stations. See text for details.

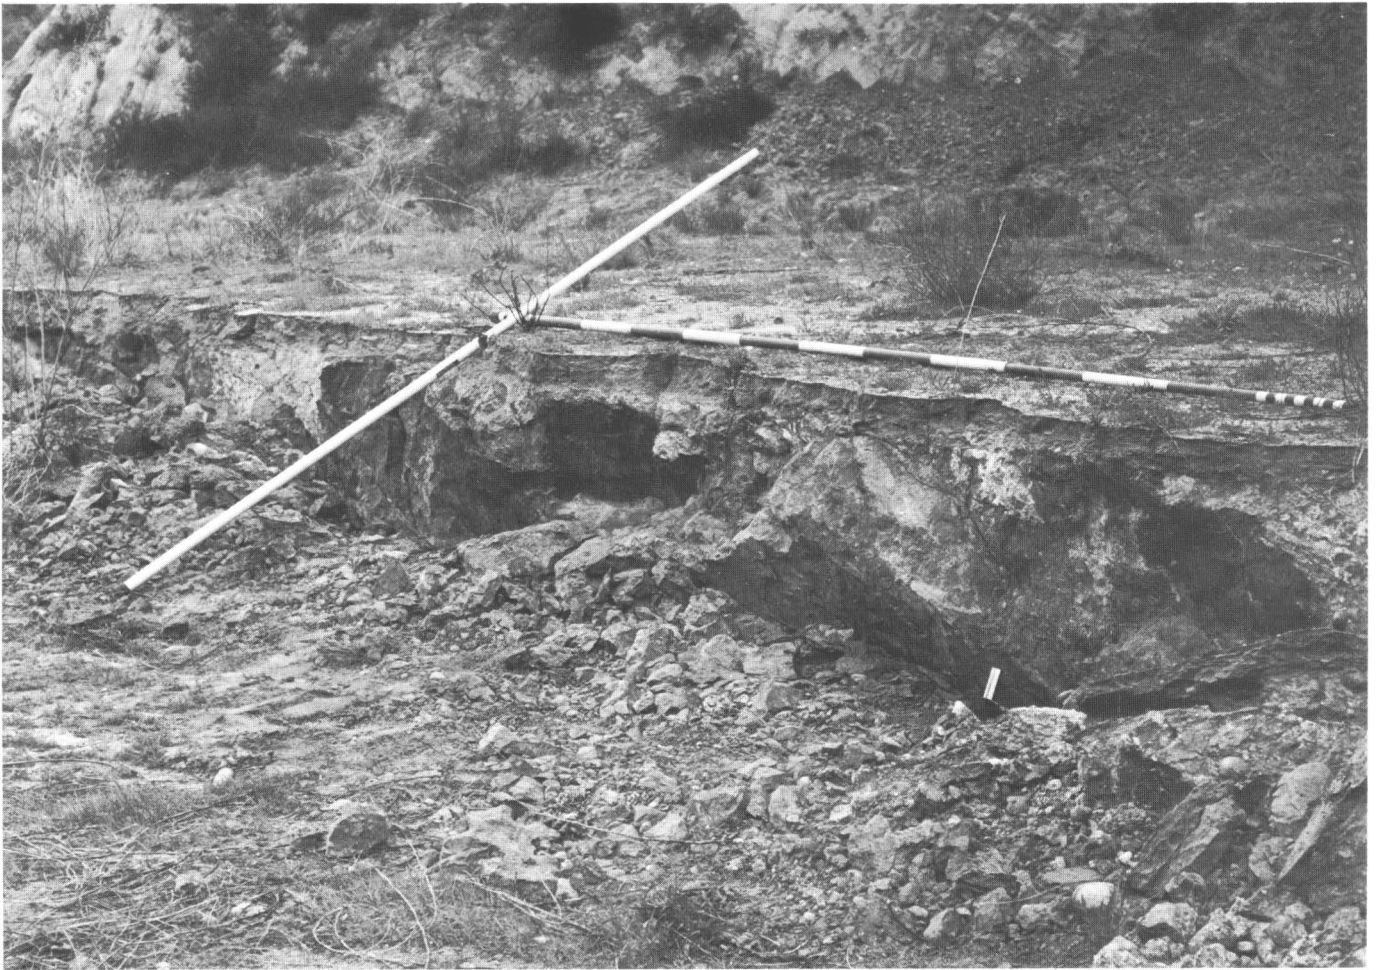
FIGURE 18.—Fault scarp in bedrock, Lopez Canyon. Note fault surface dipping under scarp, debris from collapsed hanging wall of fault, and thin layer of unconsolidated material over bedrock. Large divisions on horizontal rod are 12 inches (0.3 m).

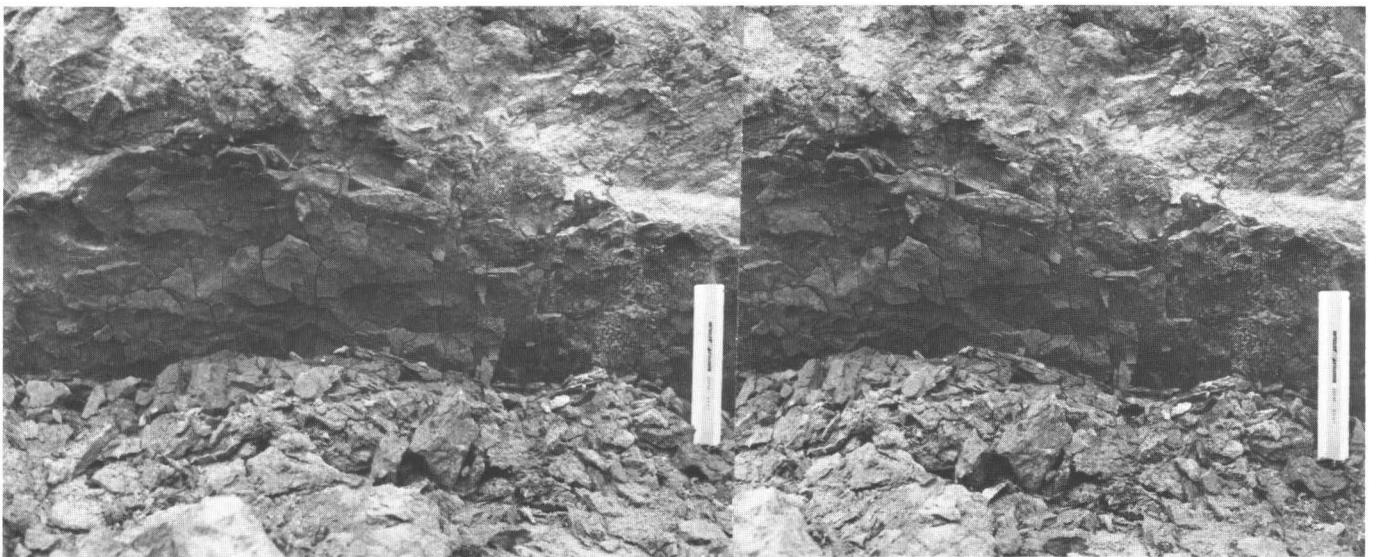
FIGURE 19.—Detail of dipping fault plane shown in figure 18, showing sloughing gouge; photographs mounted as a stereoscopic pair. The scale in the lower right, which is 170 mm long, is also shown at the same spot in figure 18.

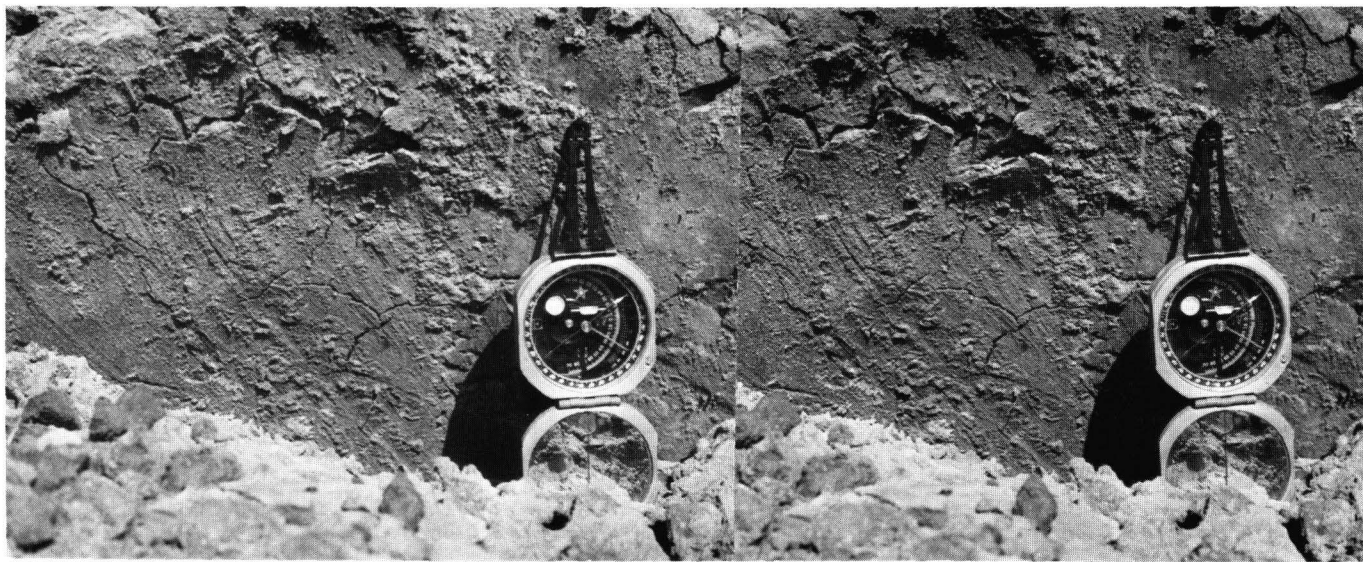
Near the east end of the scarp, slickensides in the gouge are inclined  $58^\circ$  from the horizontal (fig. 20) which indicates a somewhat lower ratio (0.635) of strike slip to dip slip than was obtained from the displaced bulldozer features (0.76). It is uncertain, however, whether these slickensides formed on February 9 or during an earlier movement on the same

FIGURE 20.—Detail of fault plane showing slickensides inclined  $58^\circ$  from horizontal; photographs mounted as a stereoscopic pair. Note apparent change of inclination of the striations over this length. Vertical groove near compass is artificial. These slickensides may have been produced by a fault movement previous to the one on February 9.

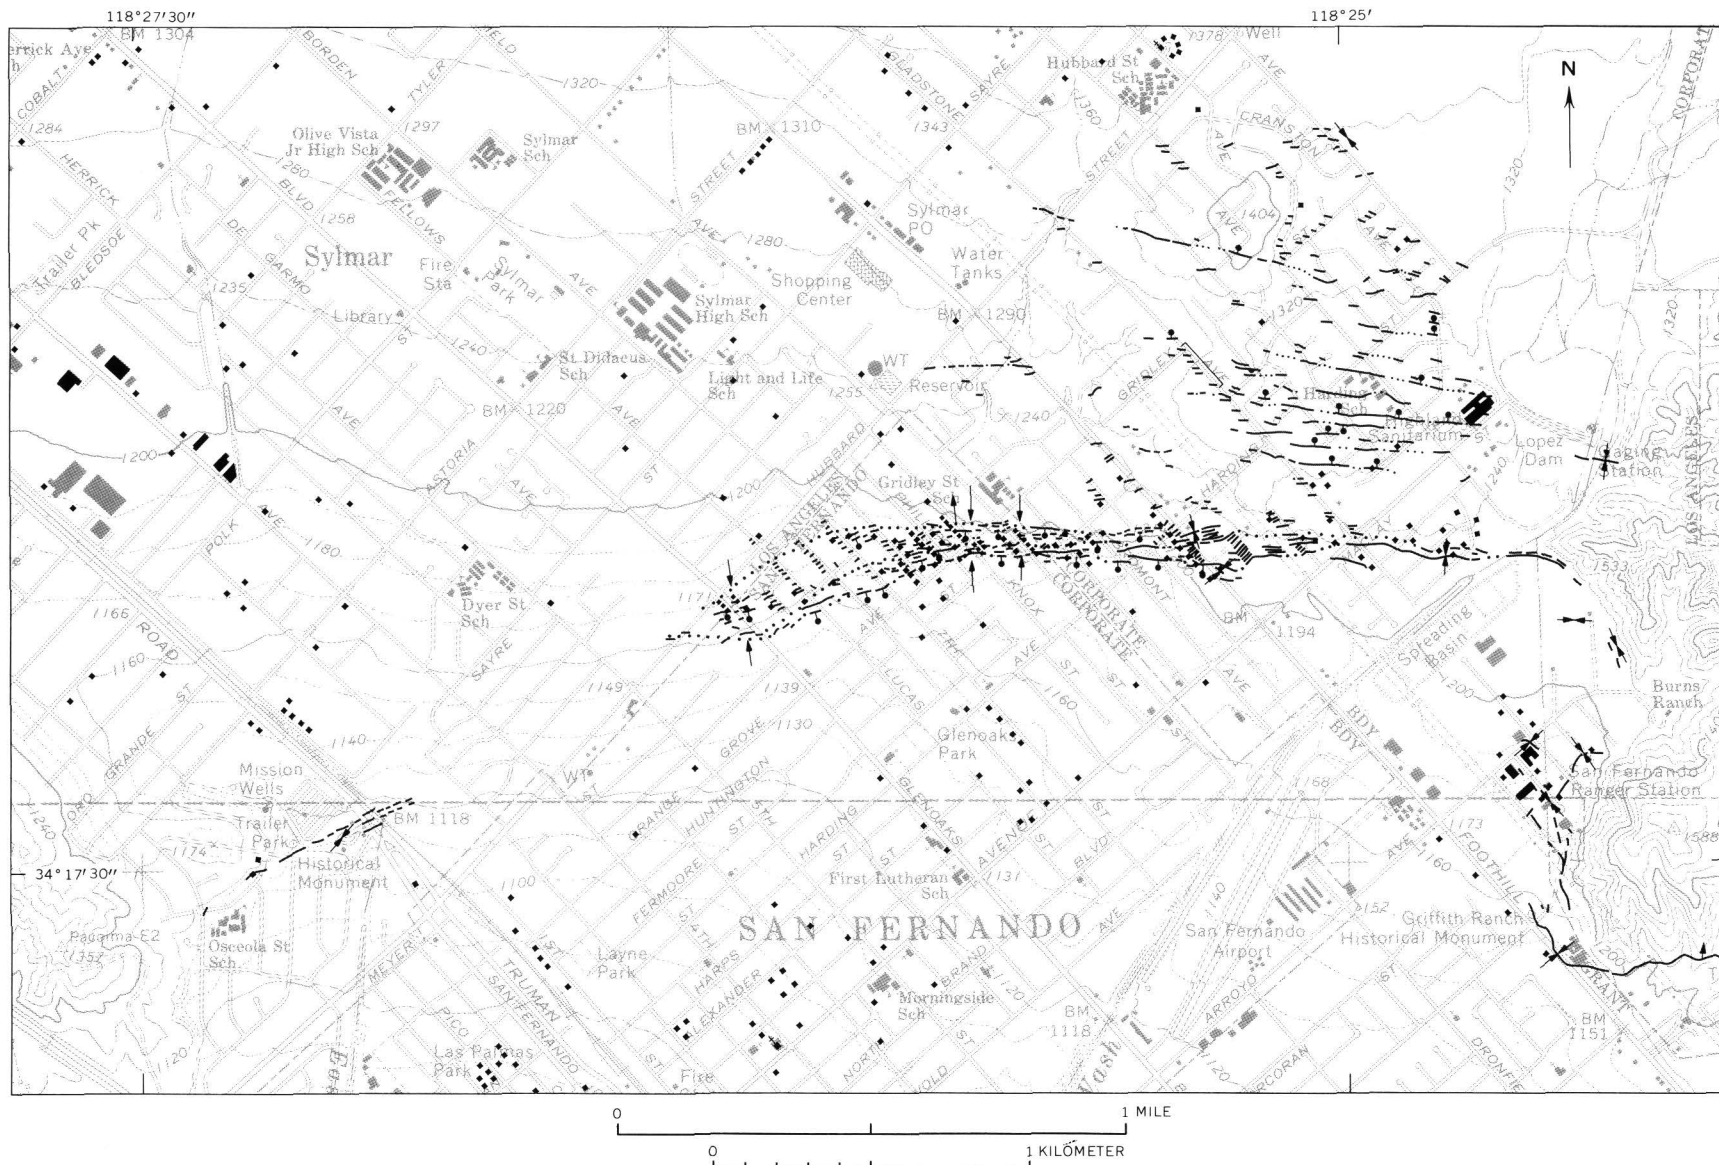
The Sylmar segment of the San Fernando fault is a zone of concentrated major damage to buildings. This fact is indicated by figure 21, which shows the location of buildings in parts of San Fernando and Los Angeles that were posted as unsafe as of February 24–March 1, 1971. Not only is there a greater concentration of such buildings within the mapped fault zone than in any other comparable area in the figure, but east of Seventh Street the

FIGURE 21.—Relation of surface faulting to the location of damaged buildings posted as unsafe (black squares) by officials of the cities of Los Angeles and San Fernando. From preliminary lists supplied by the Los Angeles Department of Building and Safety on February 24, 1971, and by the San Fernando Department of Building and Planning on February 24 and March 1, 1971. The lists were not necessarily complete and were subject to daily additions and deletions at the time they were sent. Many unsafe commercial buildings in the vicinity of San Fernando Road in San Fernando were not plotted because no street address was supplied. Most houses plotted along the Sylmar segment west of Foothill Boulevard are within 25 m of their correct position; elsewhere in San Fernando most houses are plotted within 50 m of their correct position; most of those on the remainder of the map are within 200 m of their correct position. Surface fault traces are from figure 2.

pattern of posted buildings closely conforms to the narrowing limits of the zone of breaks. Many additional buildings in the fault zone suffered severe structural damage, but were not classified as unsafe.

Concentrations of "unsafe" houses shown in figure 21 beyond the limits of significant faulting may result from such causes as locally amplified seismic shaking, local surficial ground movement, undiscovered tectonic movement, or design and construction.

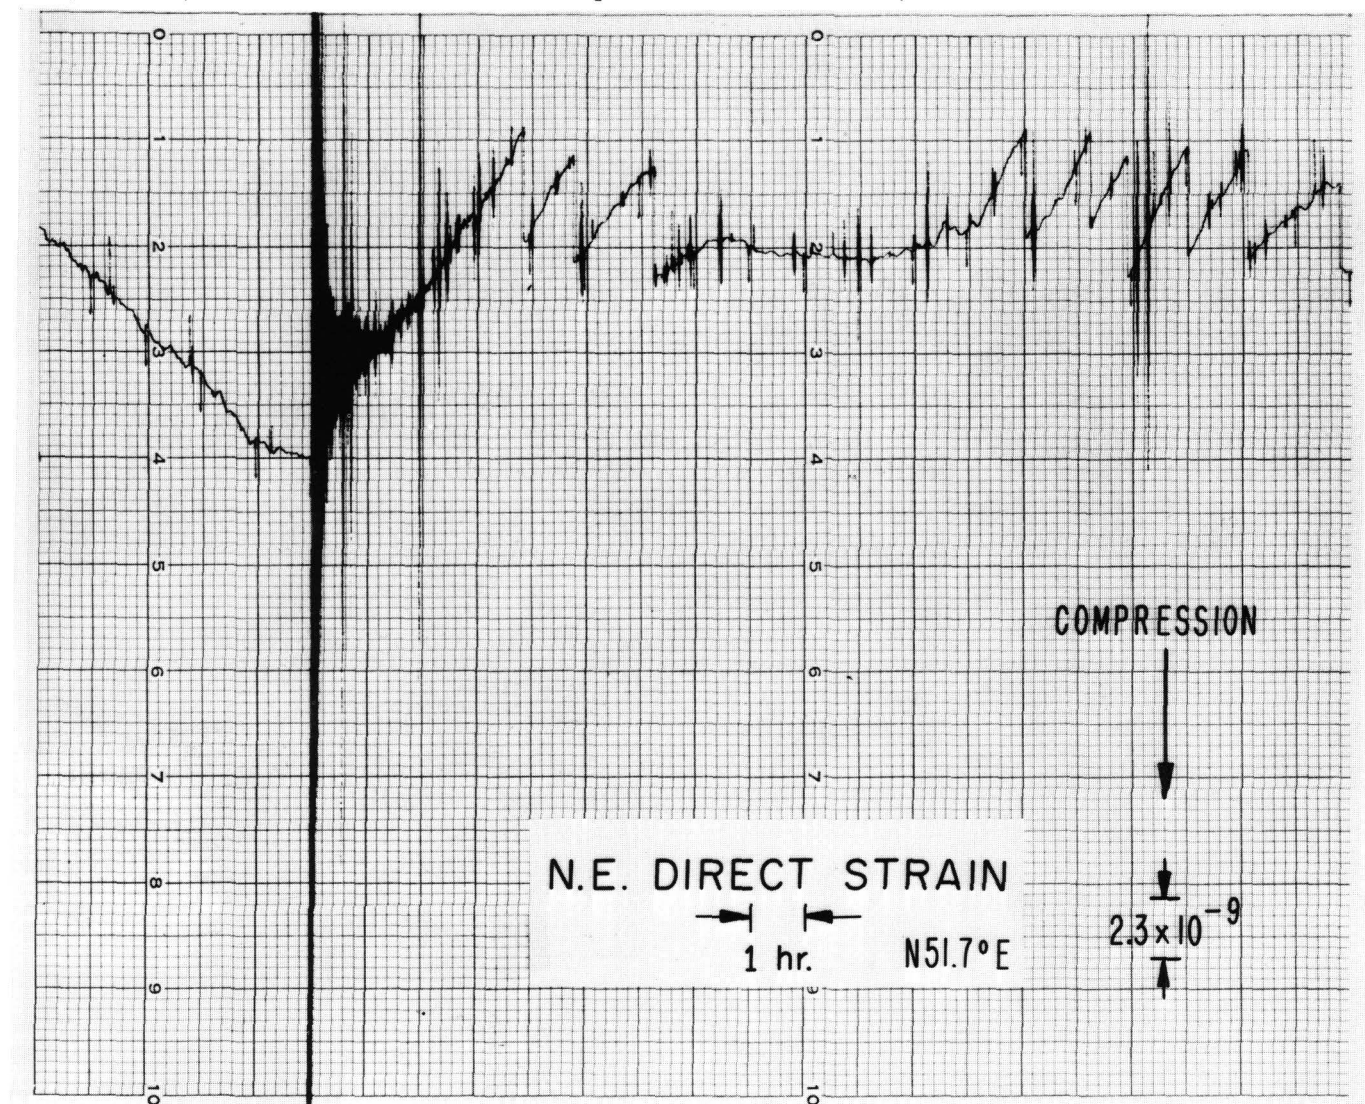
FIGURE 1.—Strain seismogram for the N.  $51.7^\circ$  E. component at Isabella from 0100 February 9 (left side of record) to 0100 February 10, 1971 (PST.). Note the “permanent” offset on the record at the superimposed very large amplitude deflections that mark the main shock at approximately 0601 February 9, 1971 (PST.). The vertical offsets, or steps, in the seismogram following (to the right of) the main shock are the result of automatic recentering of the trace.

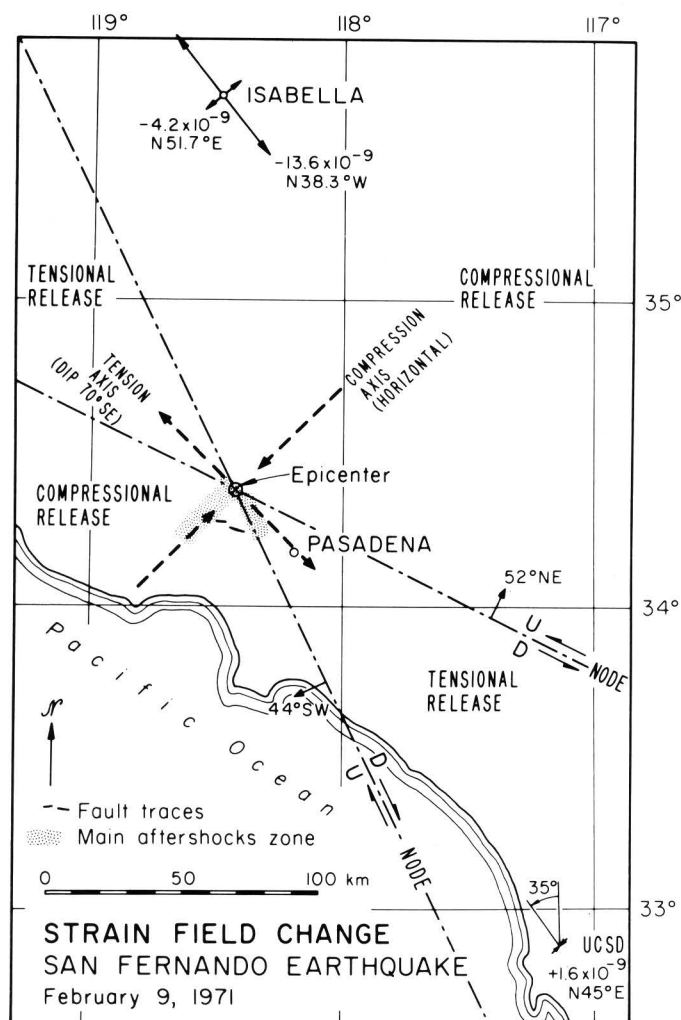
FIGURE 2.—Strain field changes associated with the San Fernando earthquake.

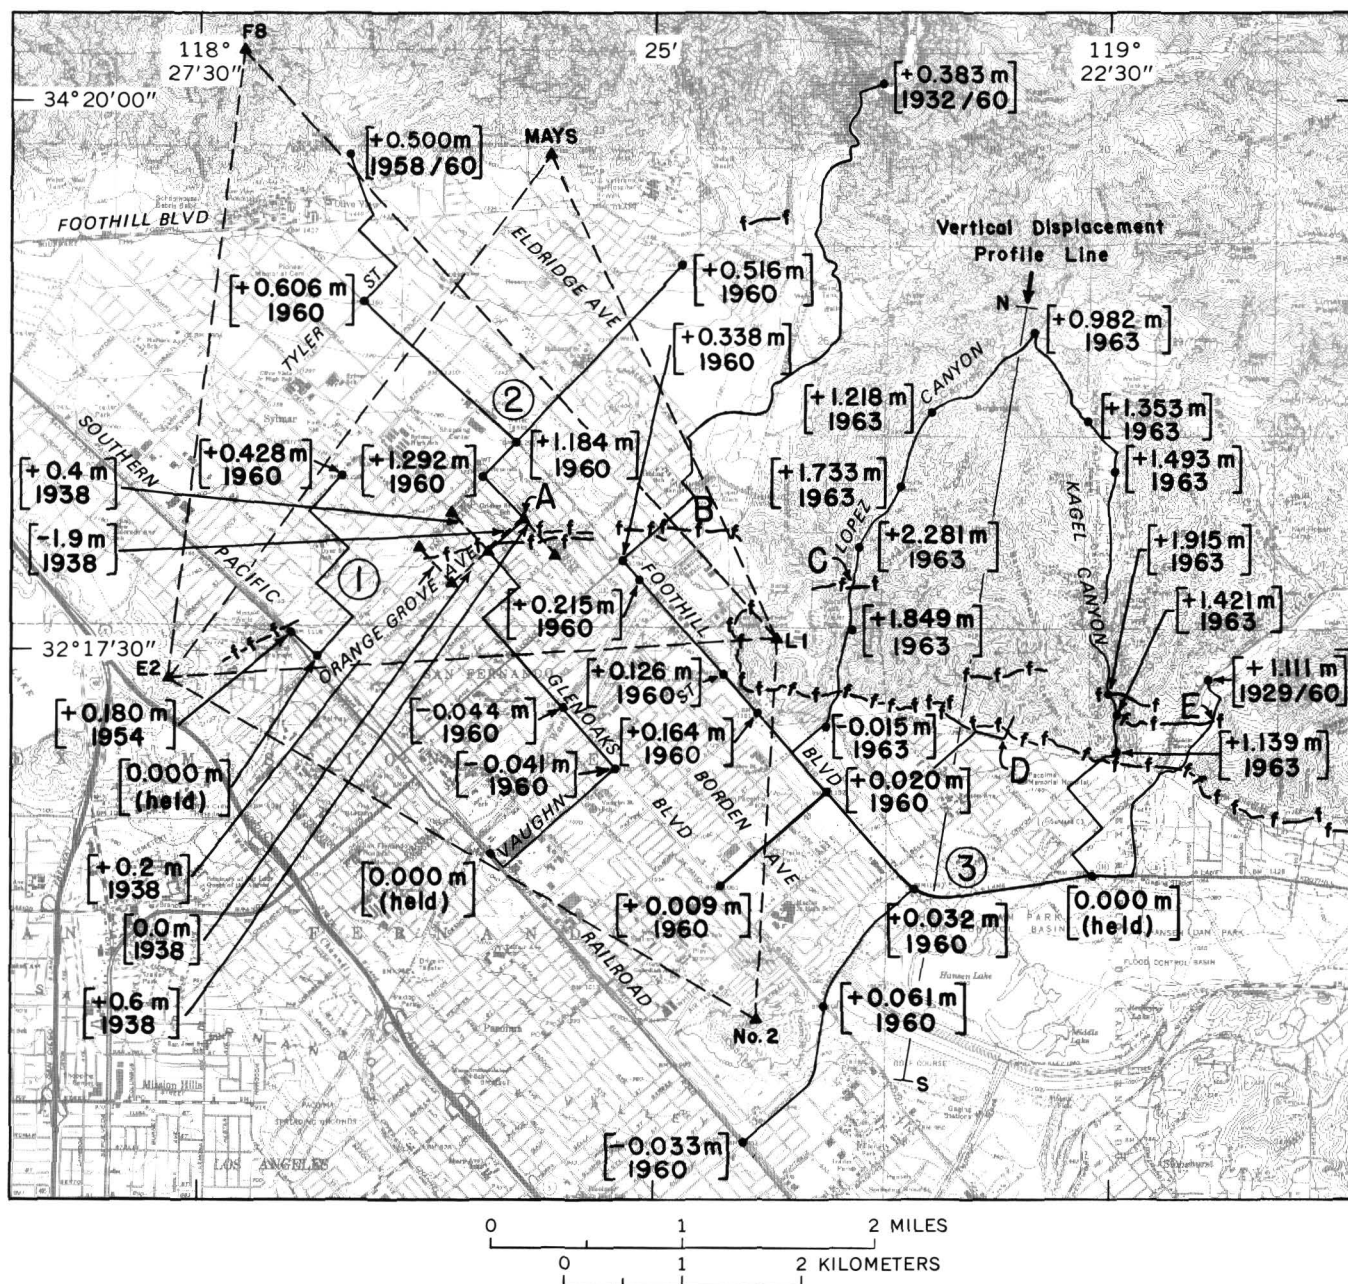
Comparison of the elevation changes among the five or six bench marks clearly south of the fracture zone indicates a relatively slight northward tilt of the southern block compared to the prominent northward tilt of the upper (north) block from the point of maximum uplift up to Pacoima Reservoir. The leading edge of the upper plate was sharply arched or buckled in a similar manner to the upper plate north of the break in San Fernando. The south-facing flank of the upward warp contains at least three locally prominent but apparently discontinuous scarps. Total accumulated displacement across the known scarps accounts for only about 1.5 m of the uplift; the remaining 0.8 m could be distributed among smaller scarps or perhaps could be more smoothly distributed as a flexure in surface material overlying a cleaner break at some unknown depth.

FIGURE 1.—Map showing elevation and length changes in meters derived through comparison of preearthquake and post-earthquake measurements. Elevation changes along each of the three identified circuits are relative to arbitrarily selected control points to the south of main fracture zone. Based on unpublished data of the Geological Survey, Los Angeles County Department of County Engineer, Los Angeles County Flood Control District, City of Los Angeles Bureau of Engineering, and City of San Fernando.

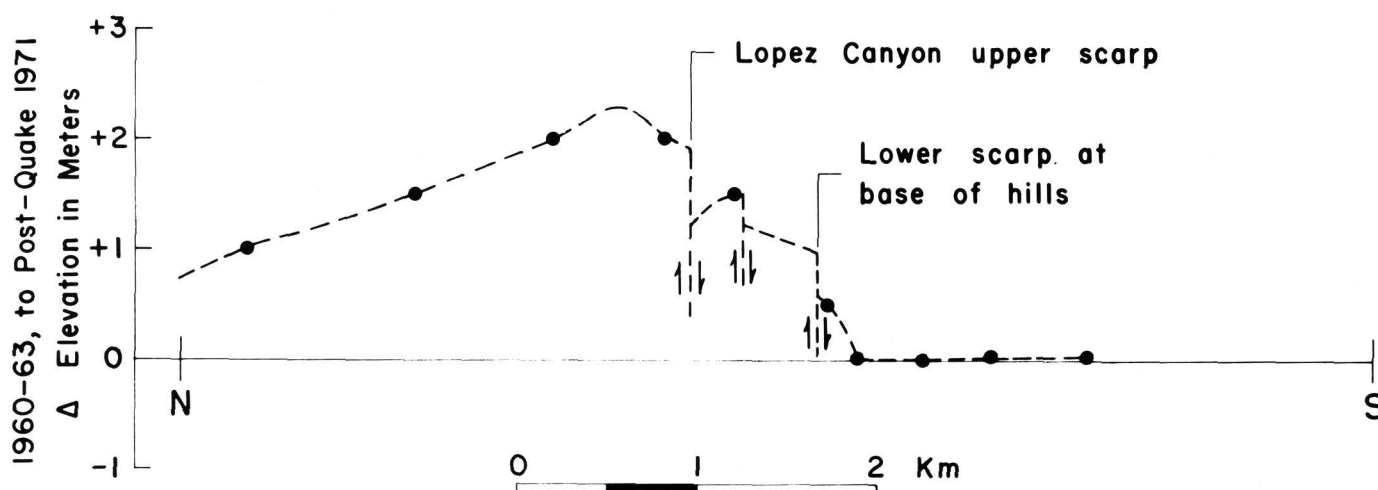
FIGURE 2.—Profile of interpolated relative vertical displacement along a line crossing the zone of surface breaks between Hansen Lake and Kagel Mountain. See figure 1 for location of profile line.

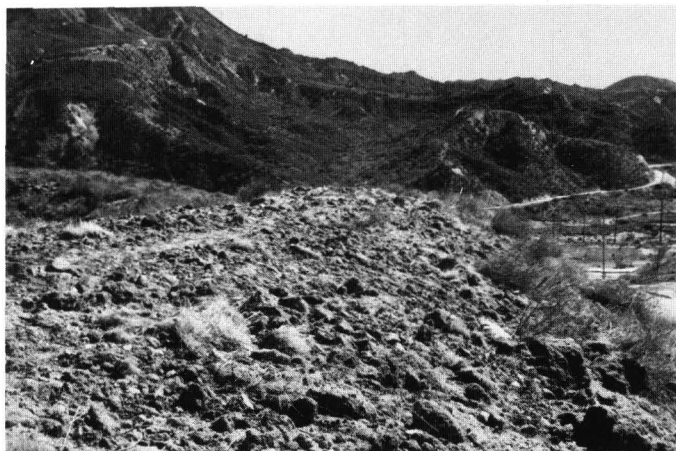
For 200 feet along flat ground at the top of the ridge, the soil was thoroughly broken and overturned by shaking during the earthquake, giving an impression of well-plowed land (figs. 2, 3, 4). Soil clods are shattered and overturned such that 90 percent of the surface is fresh mineral soil. The

FIGURE 2.—View of shattered earth on flat ridge-top, looking southeast. Wallaby Street on right.

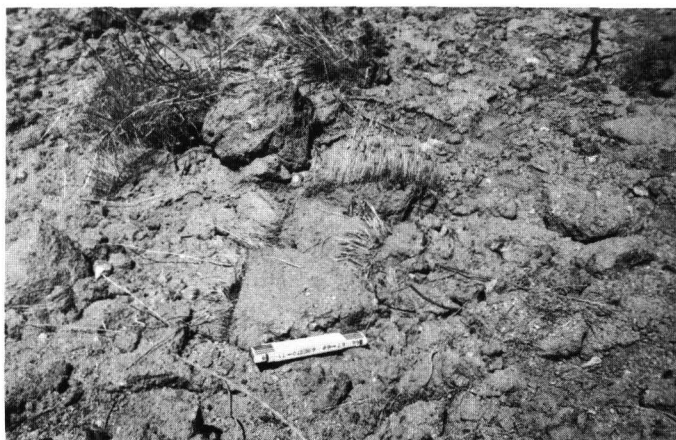
FIGURE 3.—Detail of shattered earth, with 6-inch folding rule for scale. Fine-grained material has been partially consolidated by a postearthquake rainstorm.

verized into particles of sand-grain size. The surface was soft enough so that one would sink about 3 inches into the loose soil when the site was first observed 4 days after the earthquake. The soil had undoubtedly been hardpacked like nearby areas before the earthquake. A 30-inch-deep trench and probings with a stick showed that the soil is loose to a depth of 1 to 2 feet, becoming gradationally harder like the original soil with increased depth. No discontinuities or layers were evident in the trench.

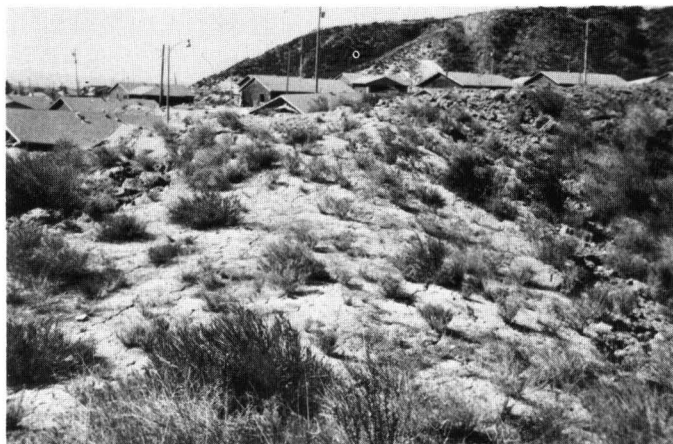
FIGURE 4.—View of fractured ground immediately southeast of shattered earth, which is on the ridge-top in upper right. Collapsed frames of uncompleted houses on far side of Wallaby Street.
