# THE SAN FERNANDO, CALIFORNIA, EARTHQUAKE OF FEBRUARY 9, 1971:

*A preliminary report published jointly by the U.S. Geological Survey  
and the National Oceanic and Atmospheric Administration*

GEOLOGICAL SURVEY PROFESSIONAL PAPER 733

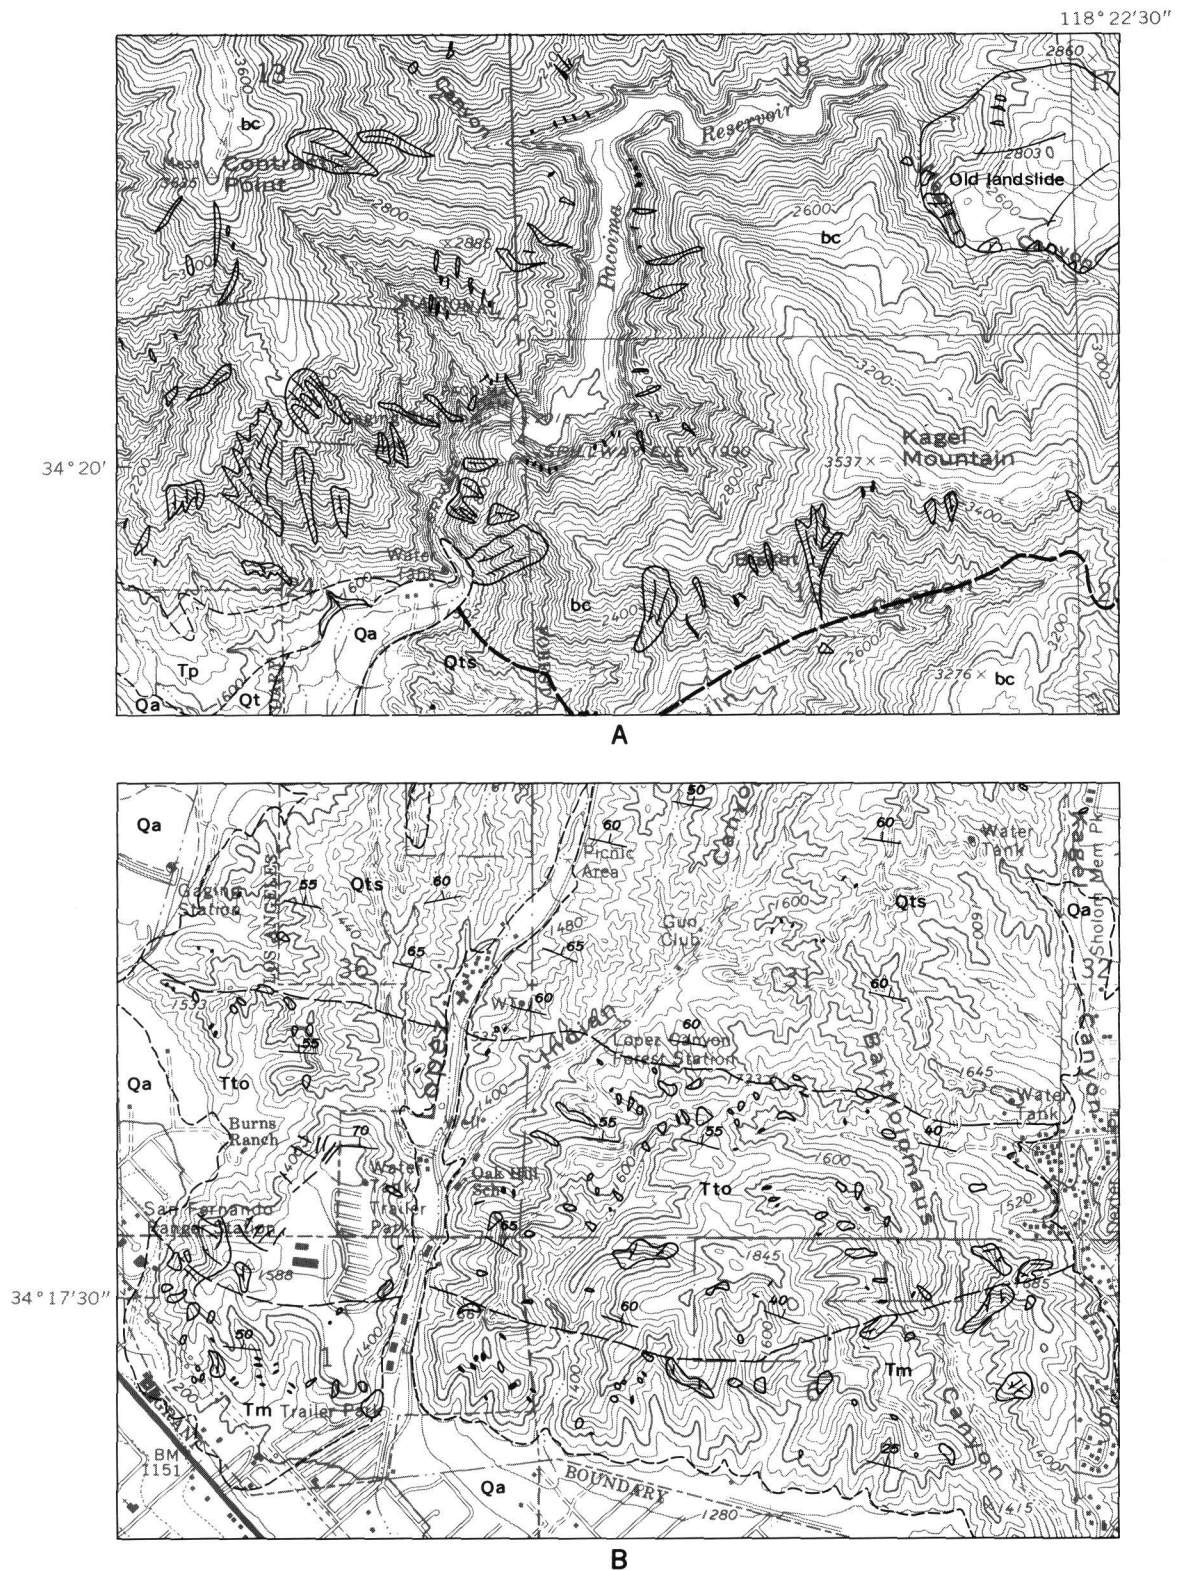
Landslide distribution controlled by rock type is best seen in the vicinity of Lopez and Bartholomaeus Canyons (fig. 4B). Here, numerous landslides formed on outcrops of the Modelo and Towsley Formations, while relatively few formed on the immediately adjacent Saugus Formation. Free faces of stream terrace deposits were also especially slide

prone, giving rise to small soil falls over a considerably larger area than that of figure 1. Numerous rock falls also occurred where highly fractured basement rock is exposed on steep slopes, especially along the major drainages—Pacoima, Little Tujunga, and Big Tujunga Canyons. Rock falls at the mouth of Pacoima Canyon (fig. 4A) covered sizable areas, but apparently consisted only of surficial material.

FIGURE 4.—A, Landslides in lower Pacoima Canyon area, San Fernando quadrangle, showing topographic control of some landslides and landsliding within older landslide deposits. B, Landslides in the Lopez Canyon area, San Fernando quadrangle, showing lithologic control of landslide distribution. See figure 5 for explanation of symbols.

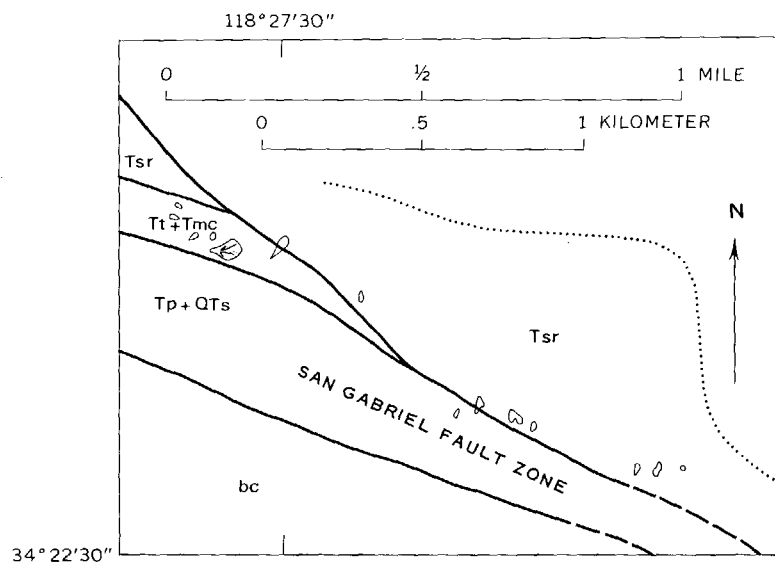
Previously weakened rock showed a common tendency to fail. A number of old landslides were reactivated, as shown by fresh scarps from 0.25 to about 1 m high. Some small old scarps failed as debris slides. Parts of other large old slides failed as a number of small discrete new slides generally concentrated along the toe of the old slide (for example, in Pacoima Canyon, fig. 4A). Some landslides were localized by crushed rock along fault zones. Thus, the San Gabriel fault zone was the locus of a narrow band of landslides north of Placerita Canyon (fig. 5).

FIGURE 5.—Landslides in the Placerita Canyon area, Mint Canyon quadrangle, showing localization of landslides along the San Gabriel fault.

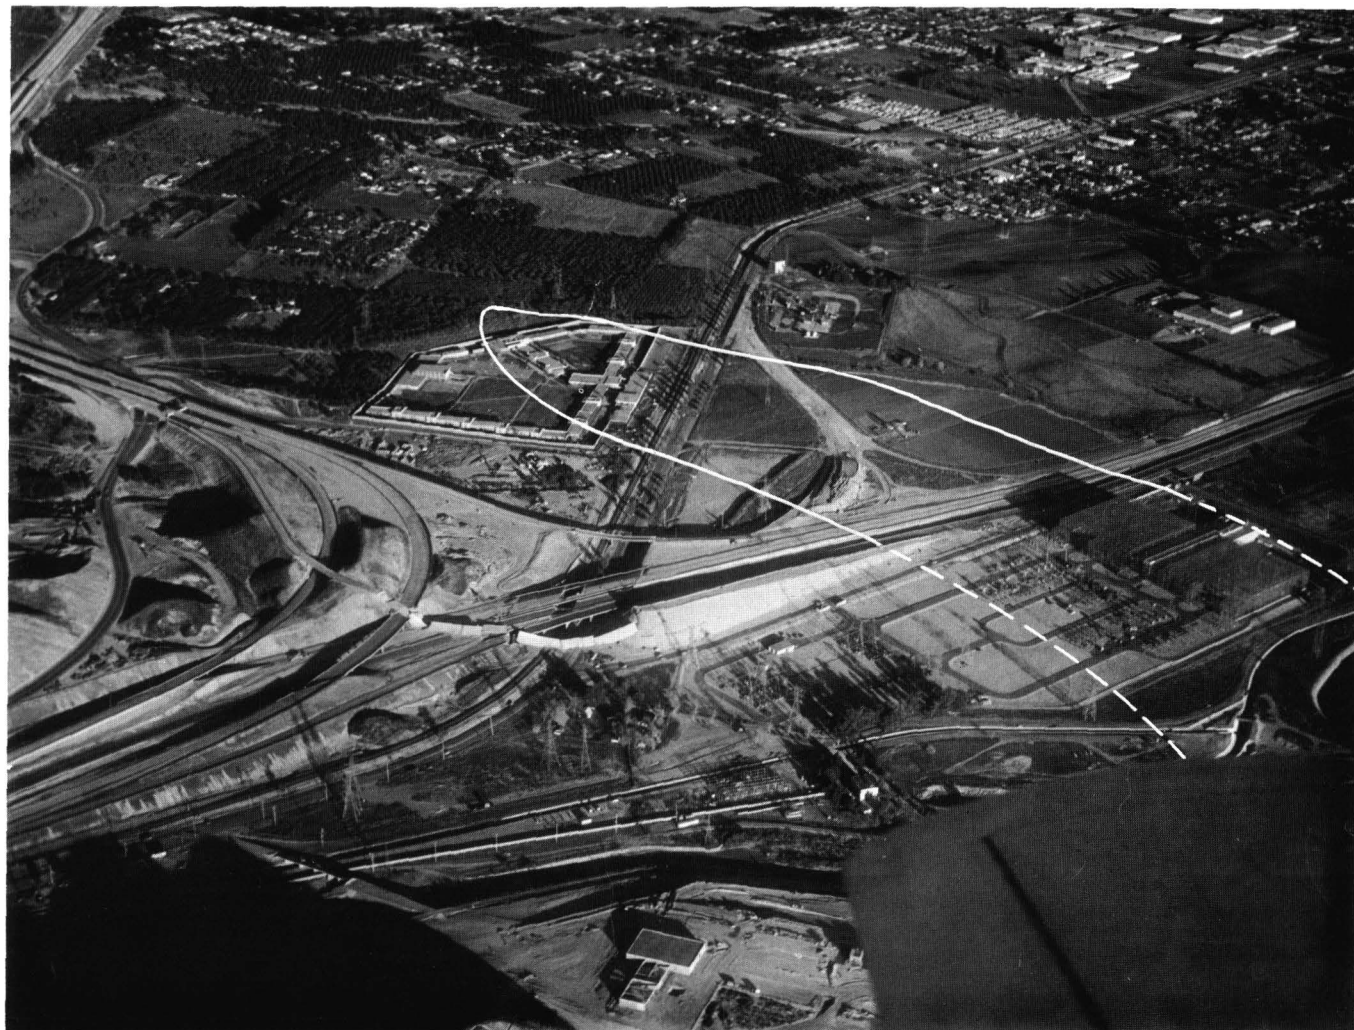
ing northeastward from the upper lake for a distance of 1.2 km. Located on or crossing this slide, hereafter called the Juvenile Hall slide (fig. 2), are a major part of the San Fernando Valley Juvenile Hall, trunk lines of the Southern Pacific Railroad, San Fernando Boulevard, Interstate Highway 5, the Sylmar electrical converter station, and several pipelines and canals. (See Youd and Olsen, this report). Earthquake damage to these facilities will likely exceed \$30 million.

The available evidence indicates that the displacements associated with this feature are of landslide rather than tectonic origin. The evidence includes: (1) the tonguelike shape of the feature and the fact that the rupture pattern did not extend beyond the bounds of the feature; (2) fissures with right-lateral displacements formed on the north margin, fis-

FIGURE 2.—Oblique photograph of San Fernando Valley Juvenile Hall area and approximate boundaries of the Juvenile Hall slide. View to east.

The most reasonable explanation for slippage of the Juvenile Hall slide on a slope of such low gradient is that the underlying soils were partially or completely liquefied during the earthquake. The many sand boils observed on or near the slide are evidence that this occurred.

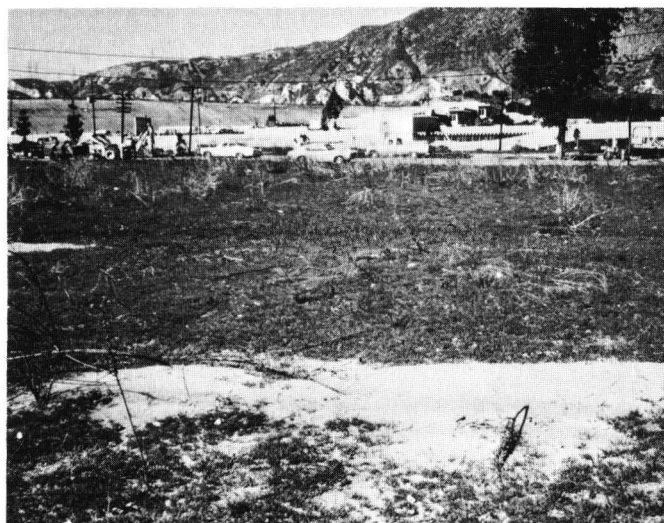
Numerous sand boils erupted on the lake floor, presumably near the toe of the slide. These were exposed after the water level was lowered. Sand boils were also found at the following locations: Behind the converter station near the base of the graded fill, in a field south of Juvenile Hall (fig. 3), and along the north edge of the railroad grade in front of the Juvenile Hall Administration Building.

FIGURE 3.—Sand boils on Juvenile Hall slide. A damaged part of the Juvenile Hall is in the background.

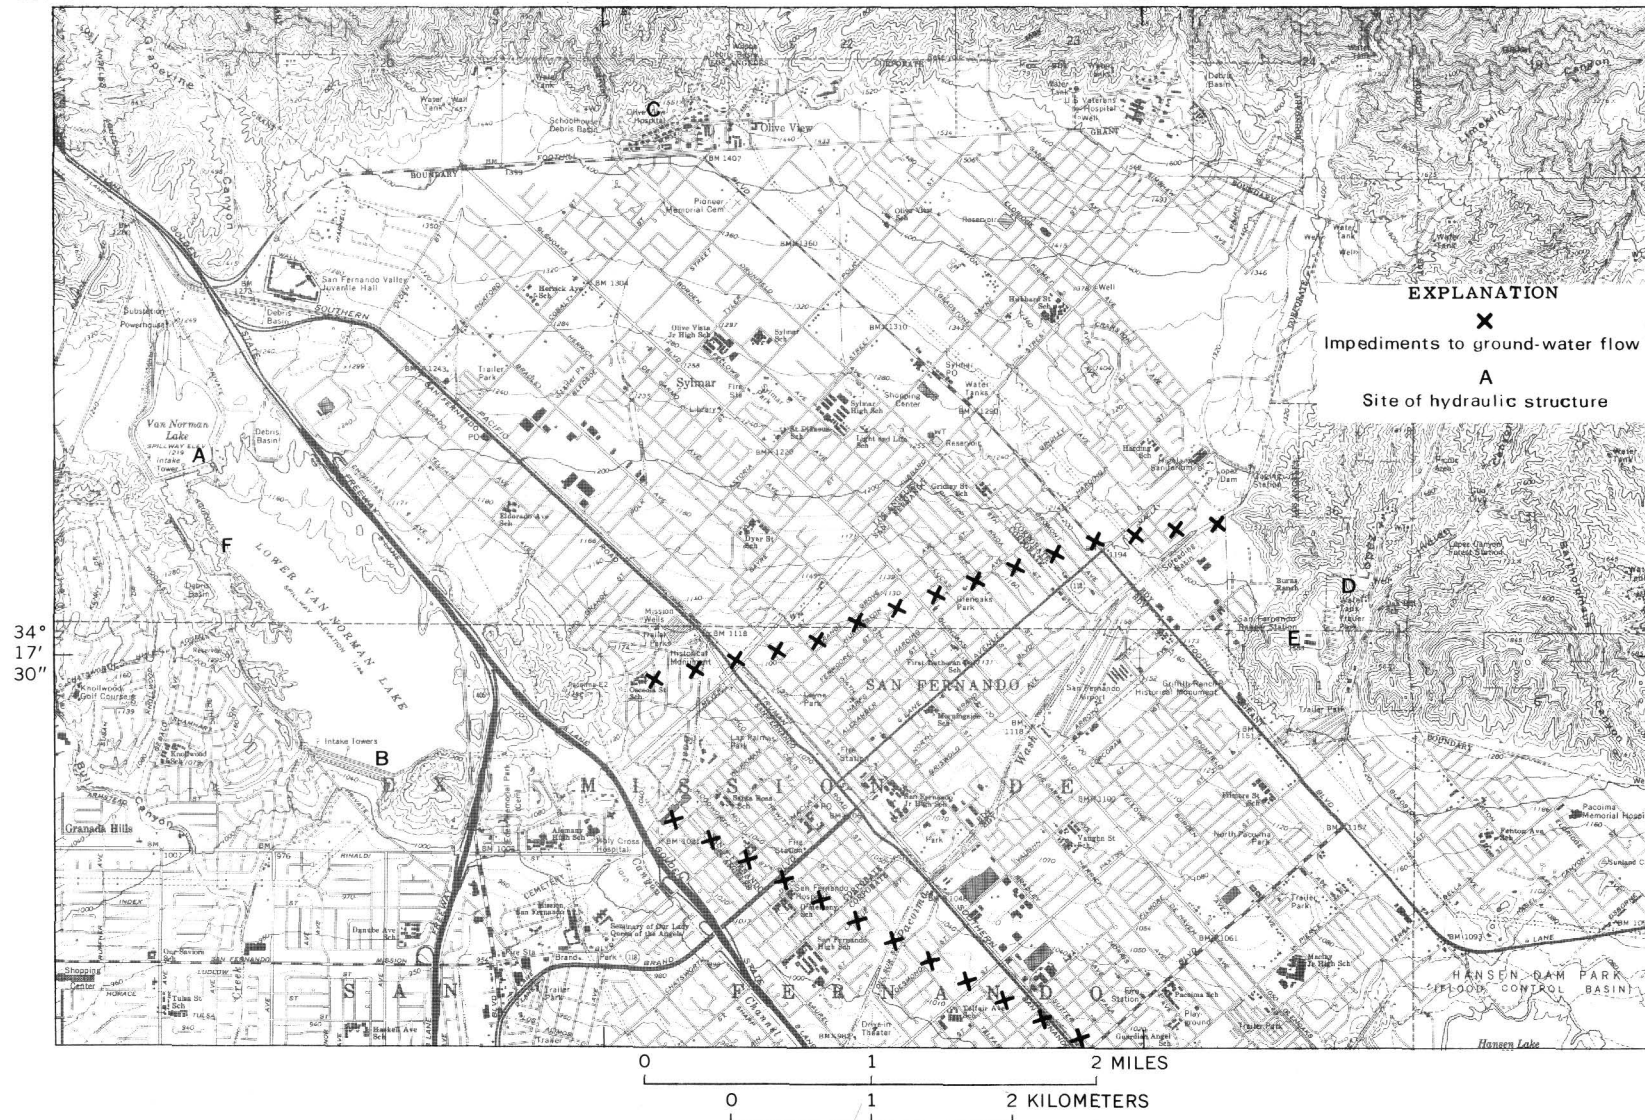
The earthfill dams on both the Upper and the Lower Van Norman Lakes (sites A and B, fig. 3) were severely damaged by the earthquake. The dam at the upper lake moved about 2 m downstream and the crest slumped substantially. The dam on Lower Van Norman Lake, initially completed in 1918, was fractured, the crest slumped, and a large part of the upstream concrete facing of the dam slid into the reservoir. (See section by Youd and Olsen.) One of the two intake towers was destroyed. Fortunately the dam was not breached. At the time of the earthquake Lower Van Norman Lake (capacity, 20,500 acre-ft)

FIGURE 3.—Map showing location of hydraulic structures damaged by the San Fernando earthquake and of impediments to ground-water flow.

Many water tanks were destroyed by the earthquake. Elevated tanks appeared to be particularly susceptible to damage. A short northwest-trending break of uncertain origin north of the Olive View Hospital at Sylmar passed under and apparently caused rupture of a large steel water tank (site C, fig. 3). An elevated water tank at a trailer park in Lopez Canyon (site D, fig. 3) was destroyed; in the process the tank was moved about 30 m northwest

from its pad. The top and sides of a steel above-ground tank near the mouth of Lopez Canyon (site E, fig. 3) were severely battered by wave motion in the tank. An elevated fiberglass tank near the northwest shore of Lower Van Norman Lake (site F, fig. 3) literally exploded when it struck the ground, as shown by the shredding of the fibers. In contrast, a concrete tank set in the ground near the Sylmar Post Office (site G, fig. 3) was not damaged.

Prompt opening of the available discharge facilities at Lower Van Norman Dam started lake-lowering operations necessary to reduce the hazard of breaching the dam; by February 15 the levels had been lowered more than 6 m. The record for Los Angeles River below Sepulveda Dam (fig. 2), at a point 15 km downstream from Lower Van Norman Dam, illustrates the manner in which water discharged from Lower Van Norman Lake reached the Los Angeles River on February 9. Effective operations at the dam were expedited by prompt decisions by local authorities. The speedy evacuation of residents from the area downstream from Lower Van Norman Lake was based on the awareness of personnel of the city of Los Angeles of the potential extent of flooding if the dam were breached.

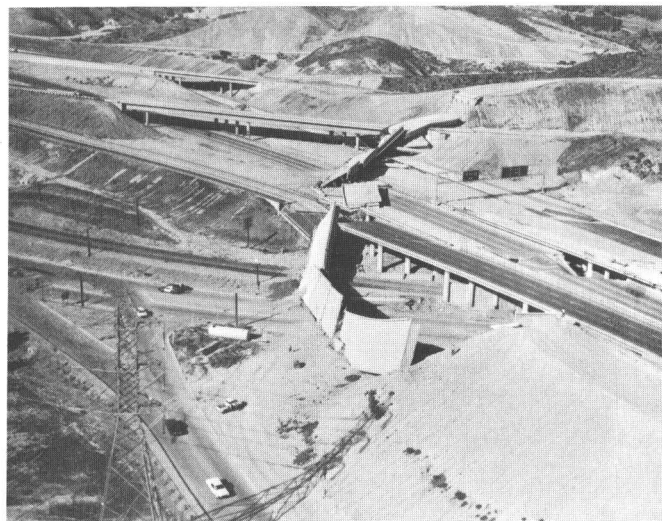
Earthquake damage blocked several major transportation routes through the northern San Fernando Valley and severely disrupted many others. Interstate Highway 5 was blocked in both directions by collapsed bridges, as were also the main lines of the Southern Pacific Railroad, at the Foothill Interchange complex (fig. 3). A number of other high-

FIGURE 3.—Collapsed structures at the Foothill and Golden State Freeway interchange.

way bridges also collapsed or were damaged beyond use. Slope failures, subsidence at bridge approaches, and buckled and displaced pavements left other sections of freeway, main roads, and city streets disrupted in varying degrees.

Seismic shaking rather than tectonic ground movement, landslides, or local bearing-capacity failures appeared to be the primary causes of the bridge damage we observed.

Substantial repairs had to be made to both the highways and to the railroad before normal traffic could resume.

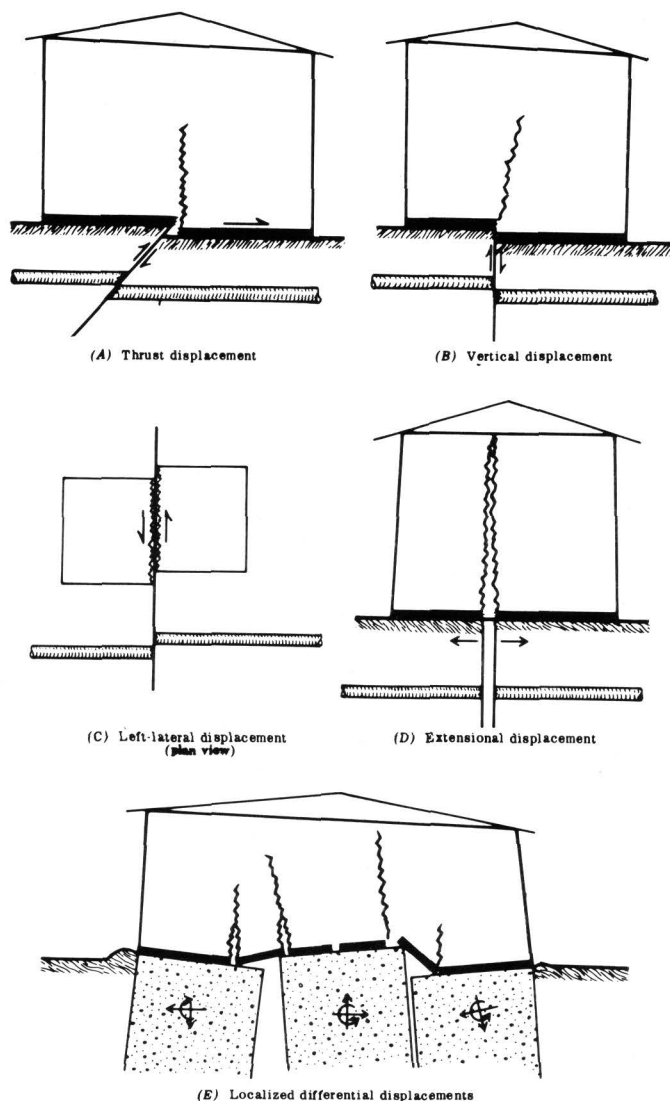
The extensive damage to underground pipelines was due in large part to the location, size, and distributed nature of the surface ruptures generated by the tectonic movements in the San Fernando fault zone. The largest fault displacements had both thrust and left-lateral components. Nearly every pipeline crossing such ruptures was either fractured or badly distorted. Sketches illustrating thrust and left-lateral movements and their effects on pipelines and buildings are diagramed in figure 6. Zones of

FIGURE 6.—Basic types of ground ruptures and associated pipeline and building damage in the northern San Fernando Valley.

extensional cracking and zones of compression were associated with the tectonic ruptures. Extensional displacements were frequently large enough to pull apart or fracture pipelines. Displacements of this type are diagramed in figure 6D. In the compressed

A substantial part of the building damage observed in our reconnaissance was directly related to ground rupture beneath structures. Sketches of the basic types of ground ruptures observed, and simplified diagrams depicting the types of damage inflicted to buildings located athwart these ruptures, are illustrated in figure 6.

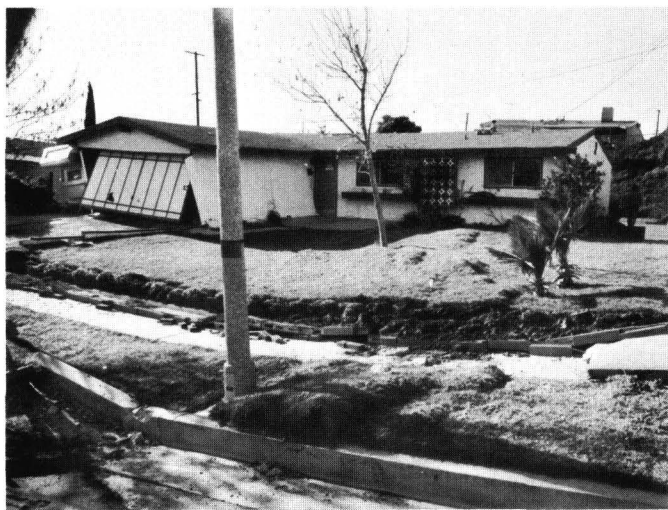
Almost all buildings overlying thrust faults, with or without accompanying lateral displacements, suffered severely. Figure 6A illustrates the type of distress such displacements induced in overlying structures. A house wrecked by a thrust fault is shown in figure 7. Commonly, buildings undercut by such rup-

FIGURE 7.—House damaged by thrust-fault displacement.

tures were thrust horizontally, in some places being forced against adjacent buildings. (See photograph in section on "Surface faulting," by U.S. Geological Survey staff, this report.)

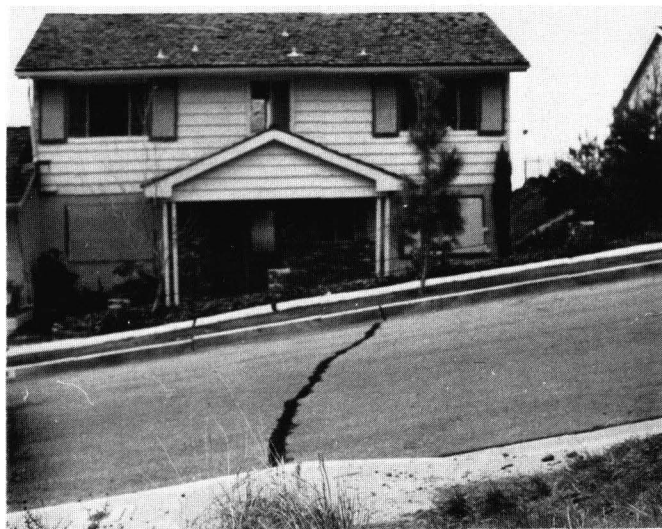
components of fault displacement, were common throughout the San Fernando fault zone. Similar cracks were also formed on slopes by weakly developed landslide movements. Where cracks of this character passed beneath light buildings, their foundations often fractured in tension, which in turn opened up cracks in the overlying structures (fig. 6D). An example of this type of damage was observed in a house on Tucker Avenue east of Rajah Street in the area sloping down toward Pacoima Wash. Downhill displacement of no more than a few tenths of a meter opened up a crack which broke through the street and walks, passed beneath the house (fig. 8), and continued on down the slope

FIGURE 8.—House damaged by tension crack.

behind. The slab foundation of the house was fractured by tension cracks as was the house itself. Damage was severe, and the house was designated as unsafe. Weakening of this house by foundation failure probably made the house more vulnerable to additional shaking damage.

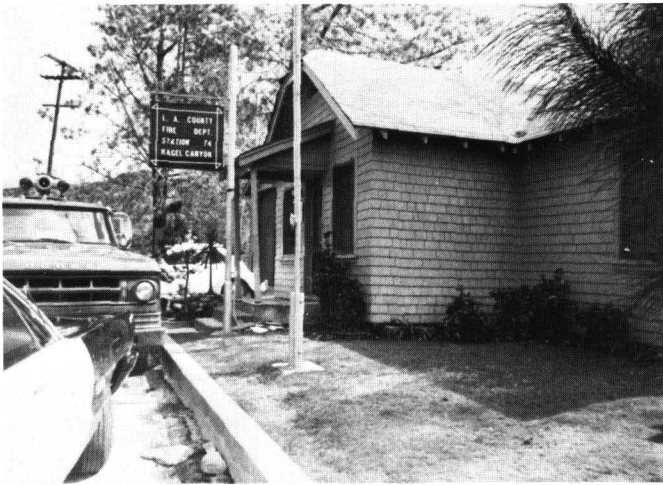
Firemen were resting in the wood-frame quarters building shown in figure 2. Mr. J. White, duty fireman, stated that he was tossed out of bed onto the floor, and the bed landed on top of him. Every object in the building was upset. Even the handset of a standard wall phone came off its hook. Loud cracking and thunderlike noises added to the general confusion. The building was shifted off its foundation. Outside, rocks were thrown off the ground, and large cracks appeared in both soil and rock. The rear view of the quarters building in figure 3 shows one of the many ground cracks that appeared throughout the area. The surface of a hill adjacent to the building exhibited the "shattered earth" effect reported (see section by R. Nason, this report) a few miles to the west. A nearby rock roadcut appeared

FIGURE 2.—Quarters building of Los Angeles County Fire Station No. 74 (Kagel Canyon).

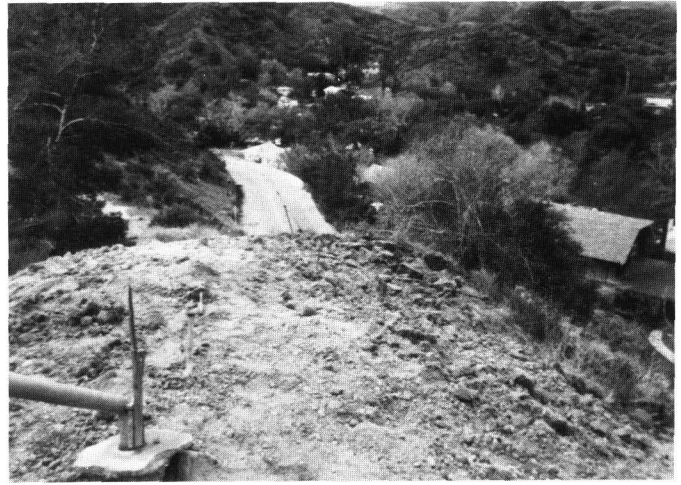
FIGURE 4.—Tossed-earth effect noted at top of rock hill beside quarters building.

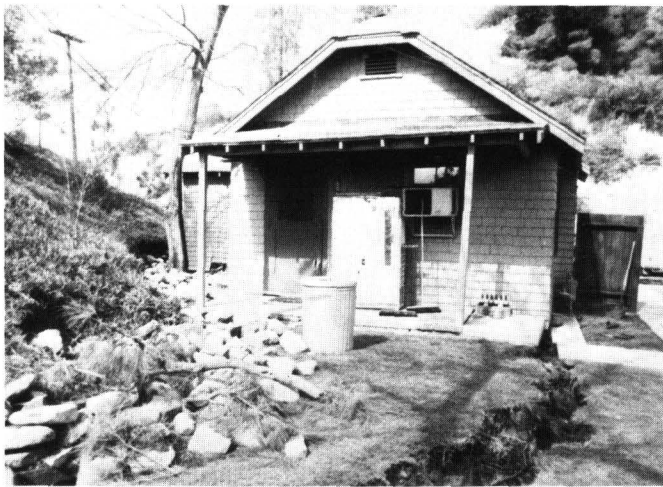
FIGURE 3.—Rear view of figure 2, showing one of the many ground cracks in the area.

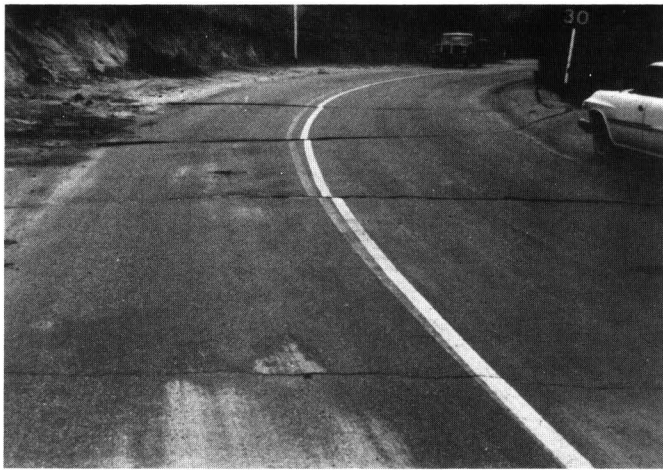
FIGURE 6.—Highway cracks and offsets. Rocks in face of road cut shattered with explosive intensity.

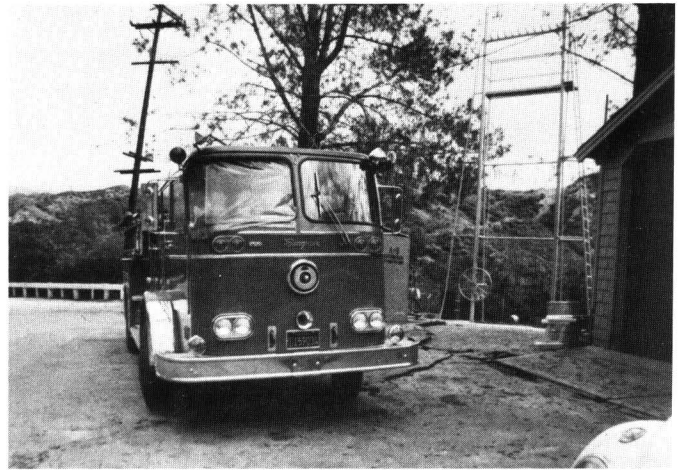
A 20-ton fire truck enclosed in the garage (figs. 7 and 8) moved 6 to 8 feet fore and aft, 2 to 3 feet sideways without leaving visible skid marks on the garage floor. The truck was in gear, and the brakes were set. Damage to the truck was a bent rear step, broken windshield, shattered red light, and siren broken off. Also, a ladder and a hook were broken. Marks which appear to have been made by the right rear tire were found on the door frame (fig. 9) 3 feet above the floor, while the metal fender was not damaged. The fender extends several inches out beyond the upper portion of the tire. Four feet above the floor the hose rack was broken by the rear step of the truck. The step was bent up while the hose rack was broken downward. The rear of the garage was pushed outward 6 to 8 inches, and the final position of the truck was about 4 feet out the front of the garage, with the garage door resting on the cab.

FIGURE 8.—Front view of fire truck shows broken windshield, damaged red light, and siren

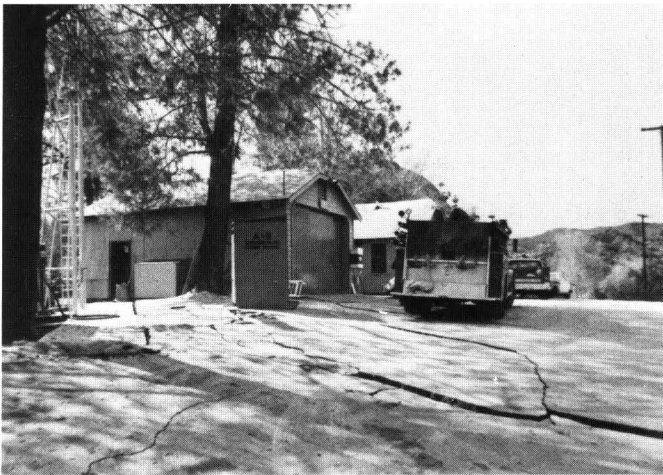
FIGURE 7.—Twenty-ton fire truck, located in garage at left, was moved several feet forward, backward, and sideways, without leaving visible skid marks on floor.

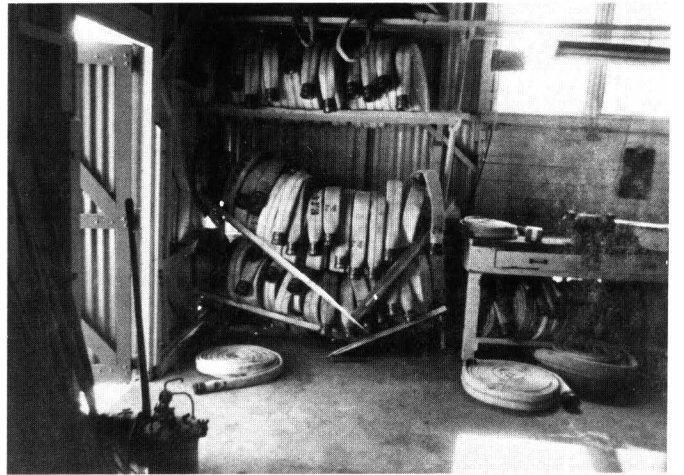
FIGURE 9.—Damage to garage interior. Rubber marks on door frame appear to have been made by rear tire of truck.

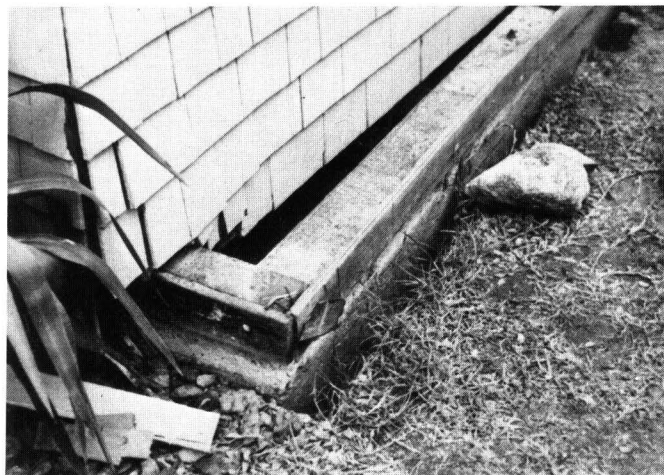
Figure 10 shows the northwest corner of the quarters building. Note that the bottom row of shingles is undisturbed. These shingles prior to the quake overlapped the foundation  $4\frac{3}{8}$  inches. Figures 11 and 12 show a plan and an elevation view of figure 10 with appropriate measurements taken shortly after the quake.

FIGURE 10.—Northwest corner of quarters building showing shingles which overlapped foundation. Shingles on opposite side of building also undamaged.

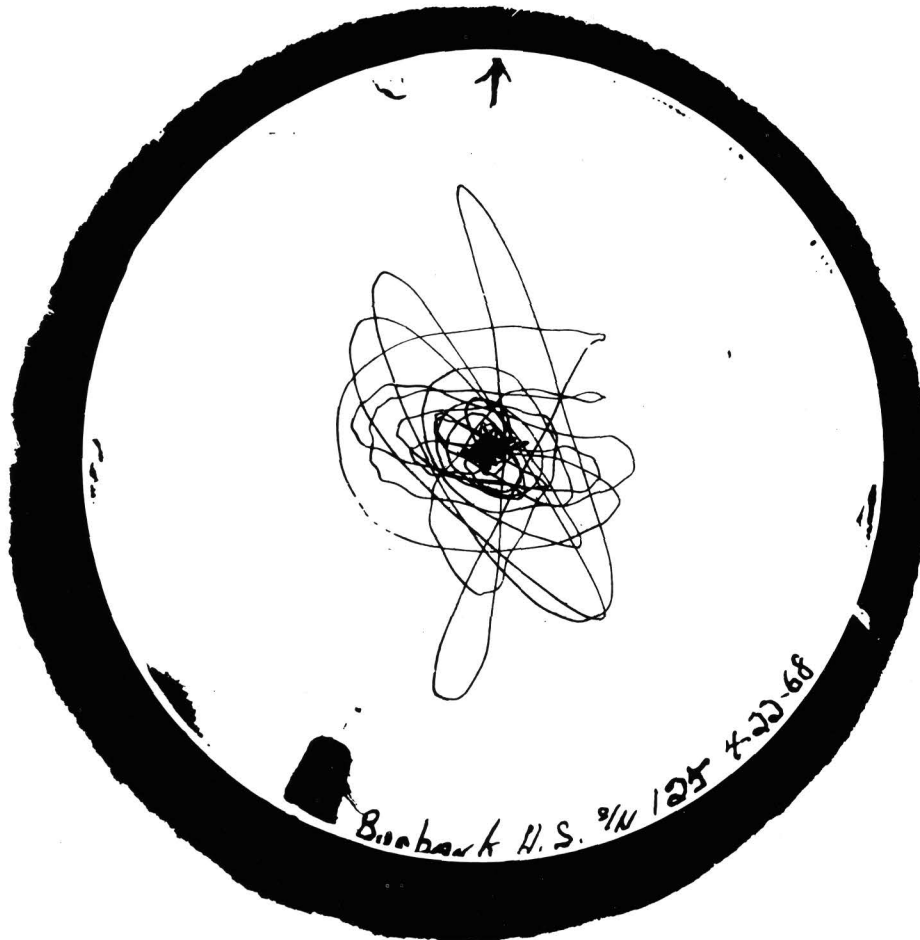
many places transformers were lifted out of their brackets. Seismoscope records in some locations showed interruptions in their traces, which suggest that the styli left the smoke glass plates. Figure 13 shows one of these records.

FIGURE 13.—Burbank High School seismoscope record. Vertical motion lifted stylus arm and interrupted trace.

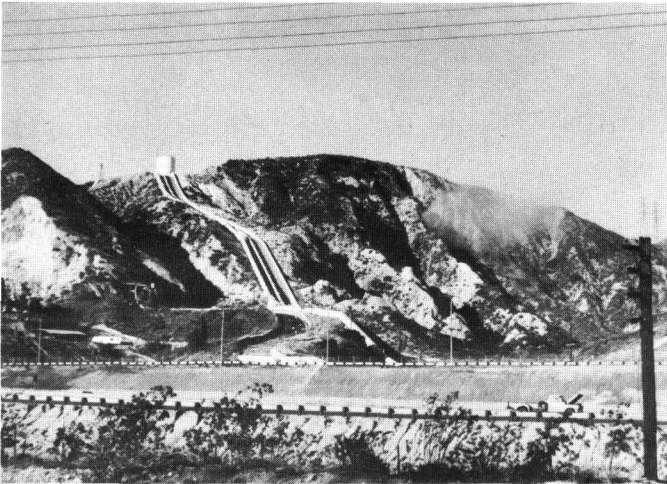
FIGURE 1.—Earthslide, afternoon of February 9, 1971, near intersection of Routes 5 and 14. J. F. Meehan, OAC photograph.

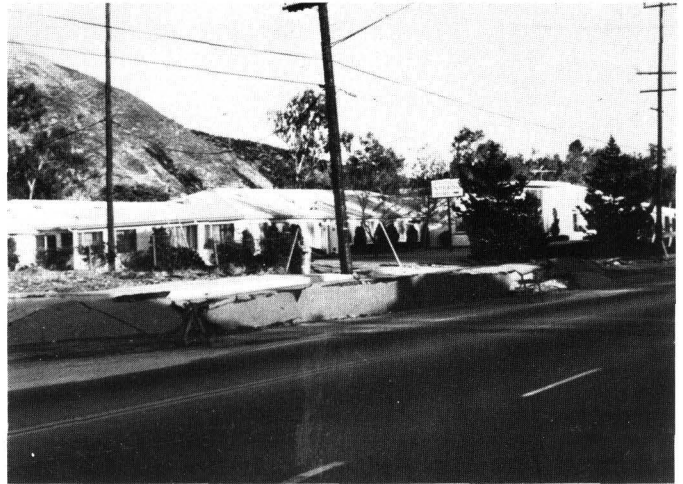
FIGURE 3.—Foothill Boulevard, east of Arroyo. Compression ridge in street, J. F. Meehan, OAC photograph.

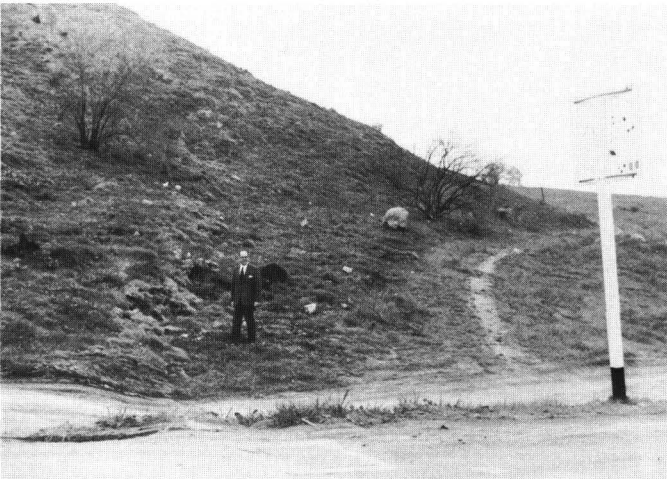
FIGURE 2.—Surface expression of movement  $2\frac{1}{2}$  feet vertically, Lopez Canyon and Foothill Boulevard, J. F. Meehan, OAC photograph.

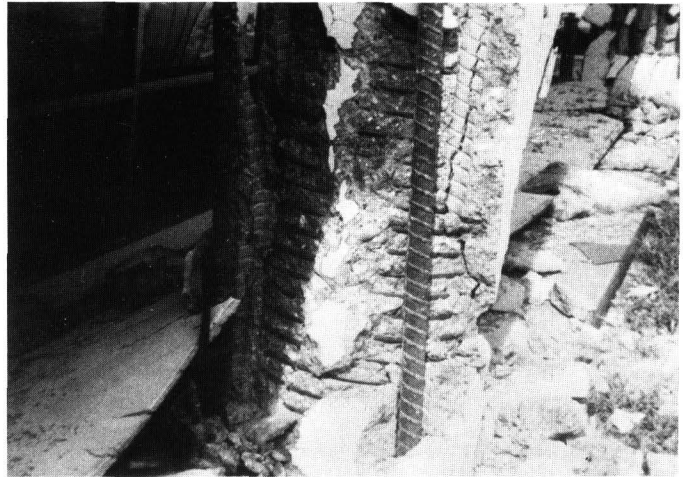
FIGURE 4.—Olive View, Medical Care Facility. Spirally-wrapped column with number 18 corner bars.

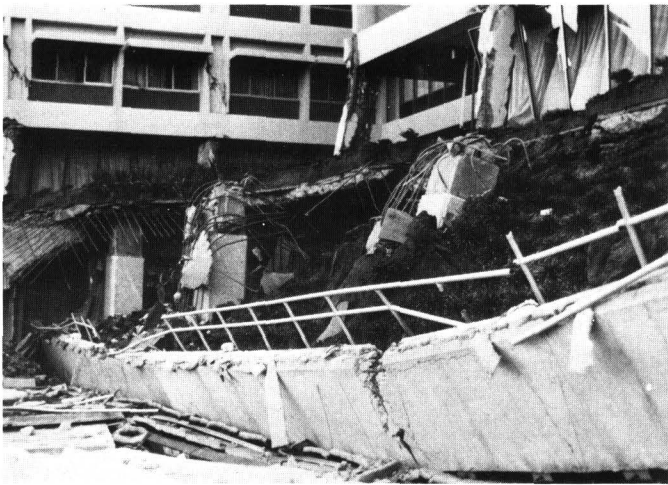
FIGURE 2.—Olive View. South side of Medical Care Building. Columns punched through basement roof slab.

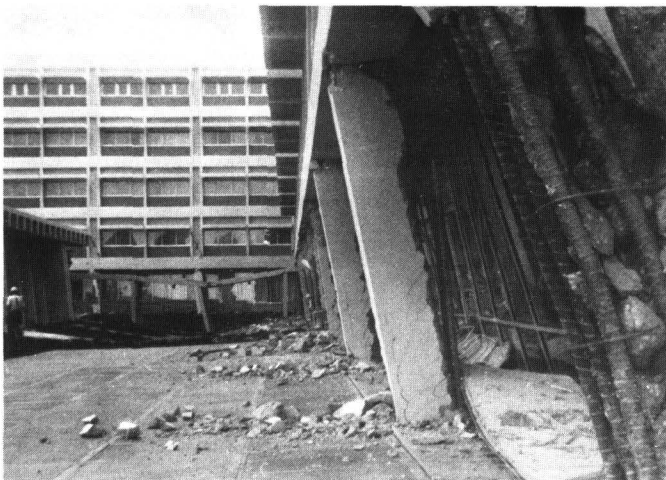
FIGURE 3.—Olive View, Medical Care Facility, north wall. Note shattered concrete in corner column.

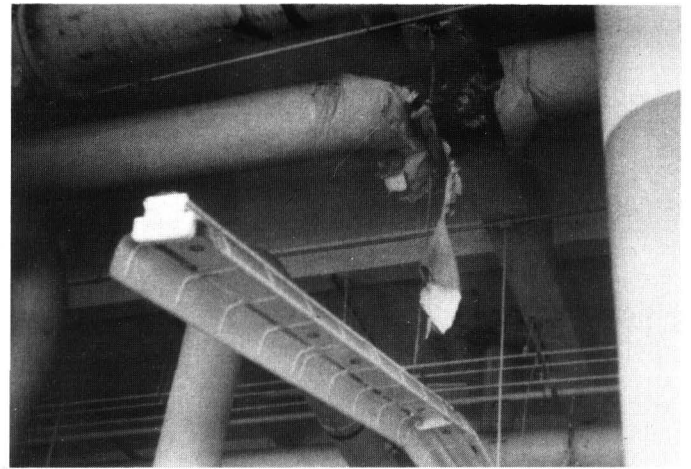
The power station suffered severe damage to contents. Boilers were shifted as much as 4 feet. Piping and electrical and mechanical equipment were badly damaged (fig. 10). Steel flat-bar bracing in the north wall was stretched and broken (fig. 11). However, the reinforced-masonry shear wall at the south side was only slightly cracked.

FIGURE 10.—Olive View Power Building. Bent pipe hanger.

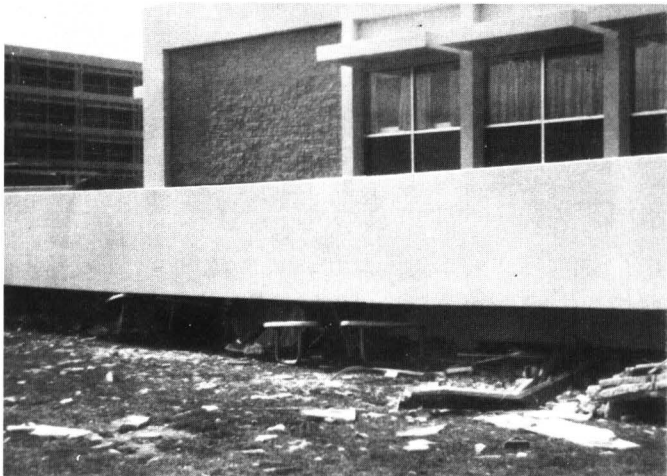
FIGURE 8.—Olive View Psychiatric Unit. Second floor rests on tables and chairs.

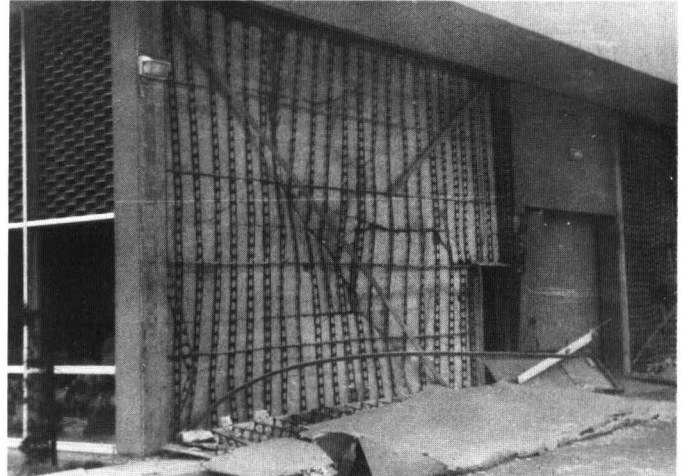
FIGURE 11.—Olive View Power Building. Flat-bar bracing broken in north wall.

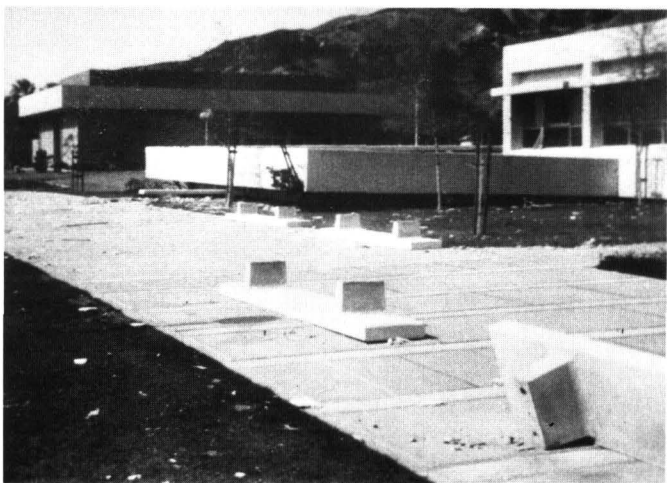
FIGURE 9.—Olive View Hospital. Overturned concrete benches. Psychiatric Unit in background.

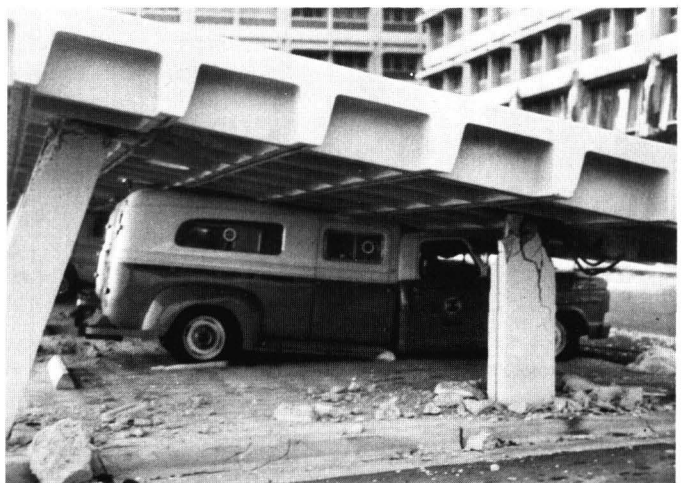
FIGURE 12.—Olive View Parking Shelter.

The one-story parking shelter has a reinforced-concrete roof slab supported on columns. There are no walls. Columns failed, generally at the top, and the roof fell on several vehicles (fig. 12).

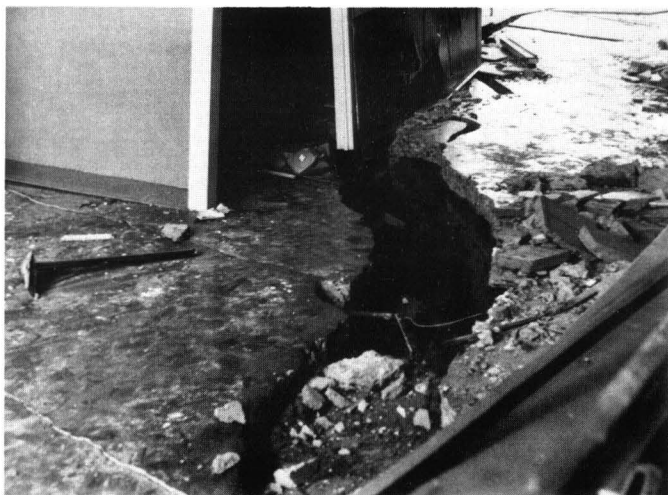
FIGURE 1.—Juvenile Hall. Ground crack opening in girls dormitory. J. F. Meehan, photograph.

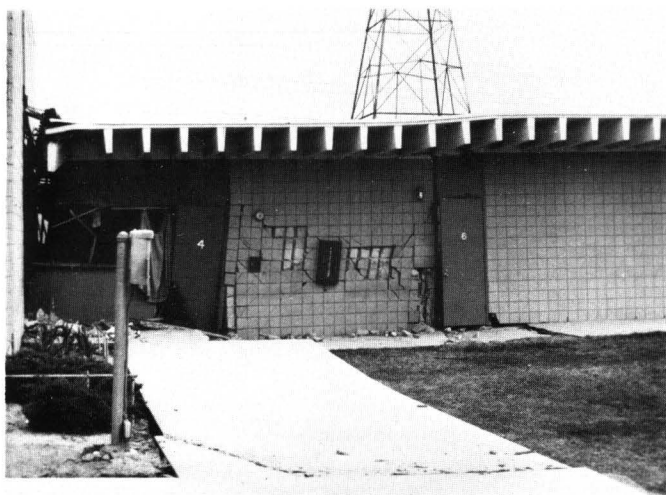
FIGURE 2.—Juvenile Hall. Detail of wall failure. J. F. Meehan, OAC photograph.

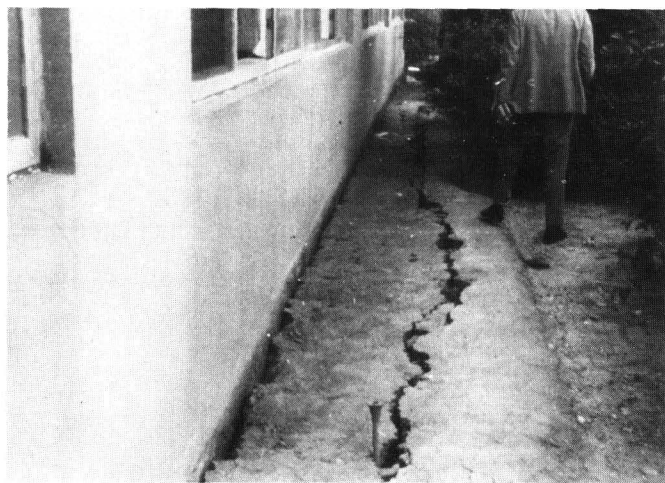
FIGURE 2.—Pacoima Memorial Lutheran Hospital ground cracks at north wall. Building raised about five inches relative to ground. D. F. Moran photograph.

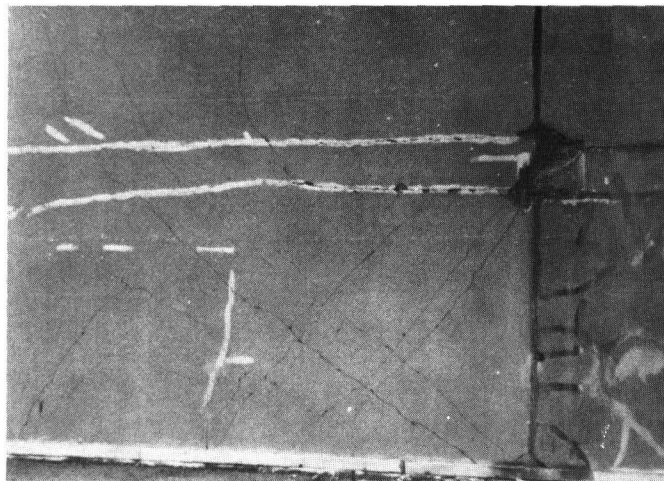
FIGURE 3.—Pacoima Memorial Lutheran Hospital, east shear wall diagonal cracks. White lines are patching before earthquake. D. F. Moran photograph.

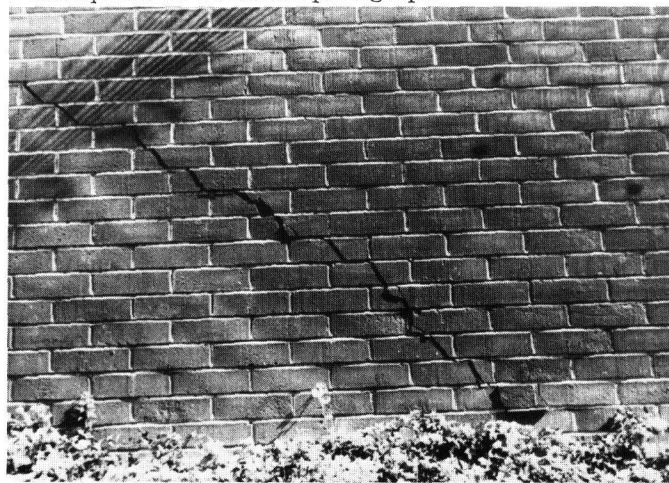
FIGURE 4.—Pacoima Memorial Lutheran Hospital cracked brick wall at west side of south section.

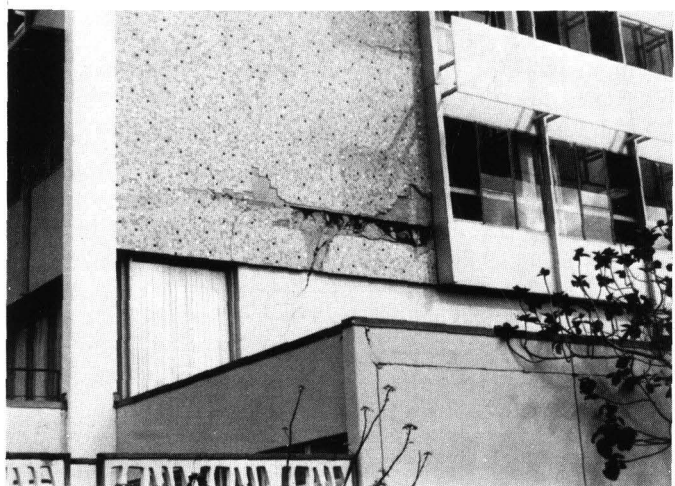
FIGURE 3.—Holy Cross Hospital, west wall. J. F. Meehan OAC photograph.

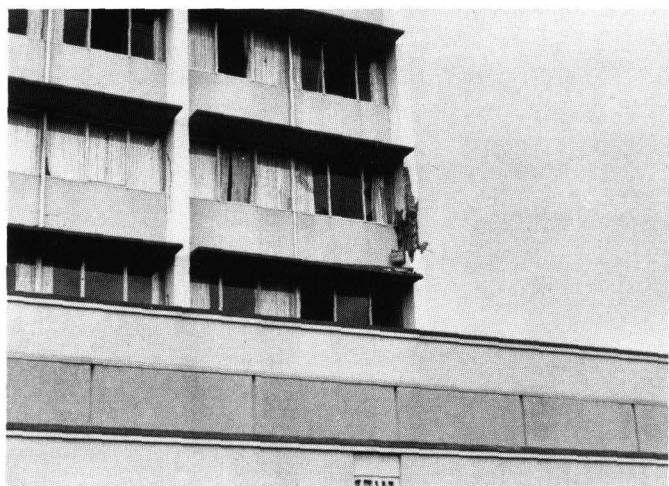
FIGURE 5.—Holy Cross Hospital, southeast corner column. J. F. Meehan OAC photograph.

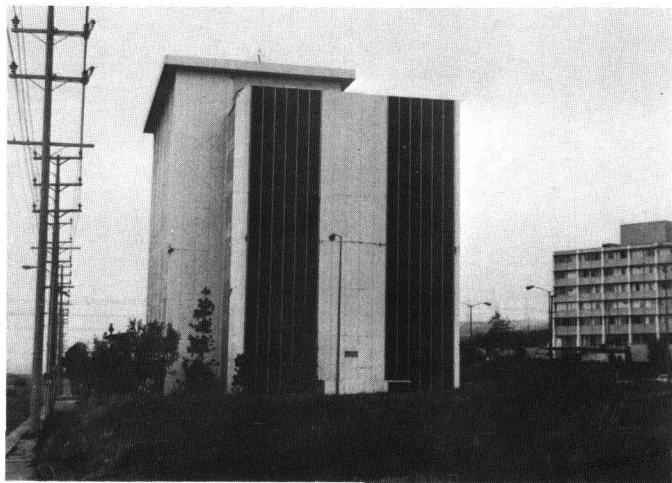
The medical building is a six-story reinforced concrete structure, 64 feet by 172 feet in plan with a 17- by 85-foot projection on the south side. First-story height is 17 feet 6 inches, and the stories above are 13 feet 3 inches high. It has a reinforced concrete pile foundation and a light steel frame penthouse (fig. 1).

FIGURE 1.—Indian Hills Medical Center. Note horizontal crack in center shear wall. J. F. Meehan, OAC Photograph.

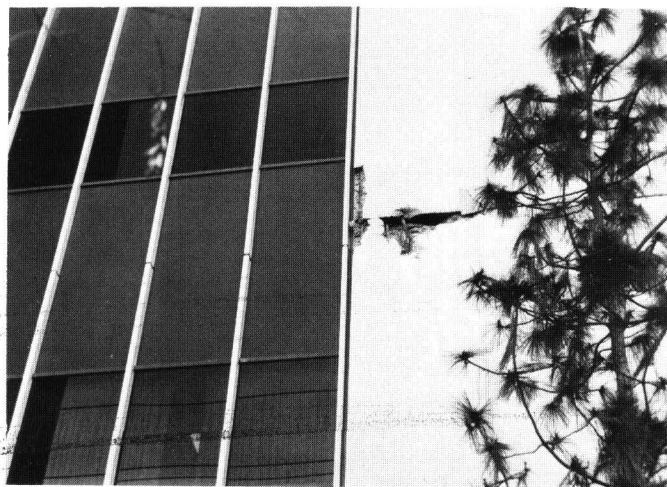
Shear walls parallel to each of the main axes of the building had multiple diagonal cracks (fig. 2), and the concrete spalled along the vertical edges of the walls at the second, third, and fourth floors. Vertical reinforcing buckled in some instances.

FIGURE 2.—Indian Hills Medical Center. Cracks in north wall. J. F. Meehan, OAC photograph.
