# THE SAN FERNANDO, CALIFORNIA, EARTHQUAKE OF FEBRUARY 9, 1971:

*A preliminary report published jointly by the U.S. Geological Survey  
and the National Oceanic and Atmospheric Administration*

GEOLOGICAL SURVEY PROFESSIONAL PAPER 733

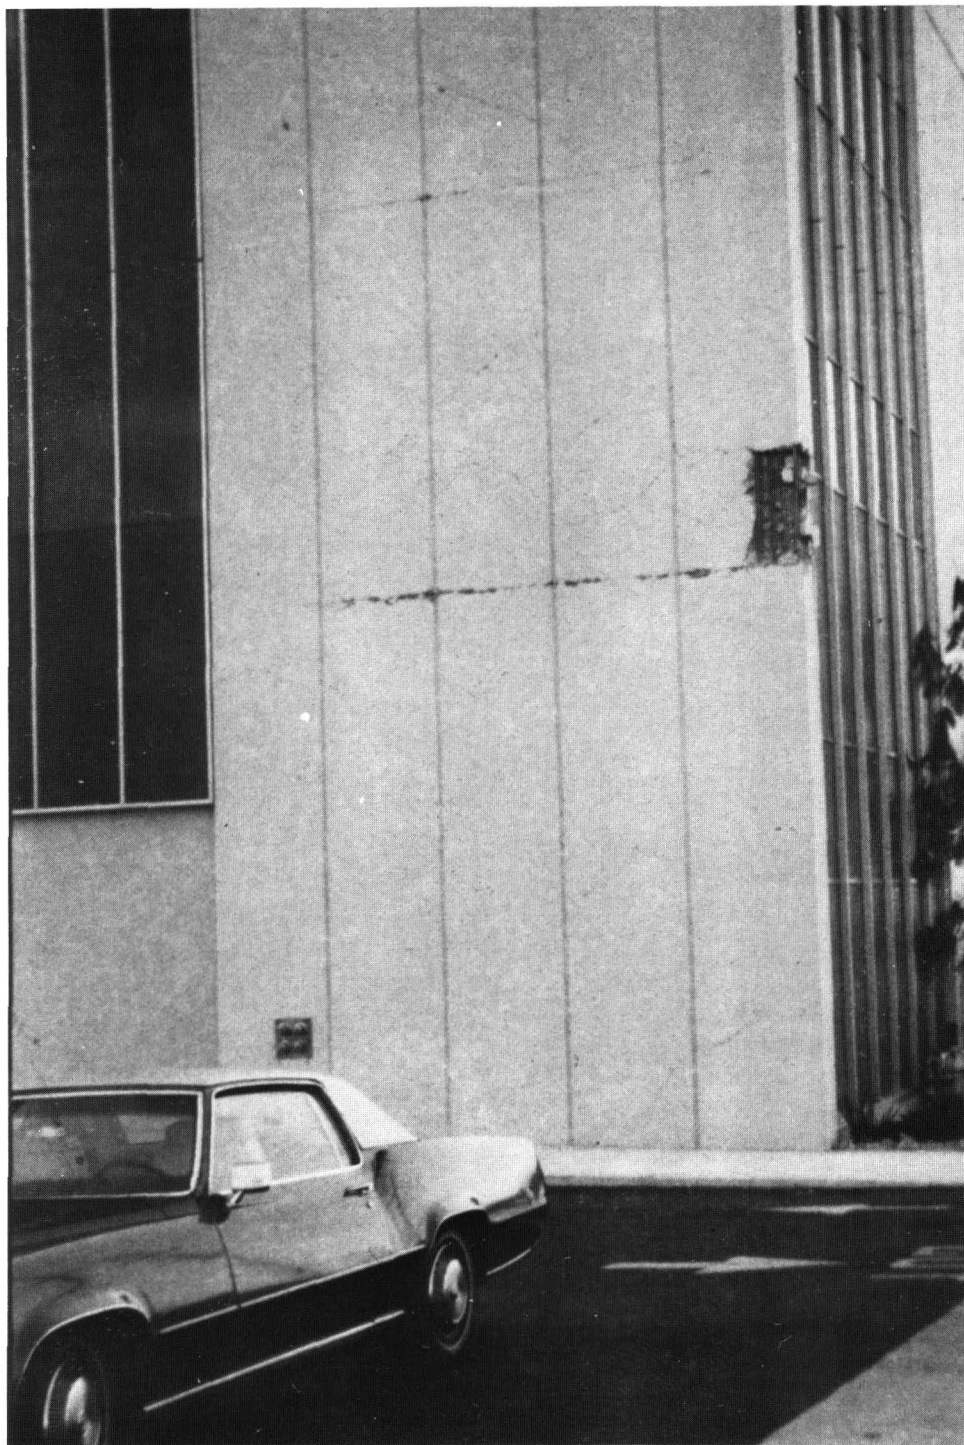
Cracks also occurred at the beam and column connections (fig. 3). The ceilings, stairways, elevators, and mechanical equipment supports in the penthouse also suffered damage.

FIGURE 3.—Indian Hills Medical Center. Northwest corner. J. J. Kesler, photograph.

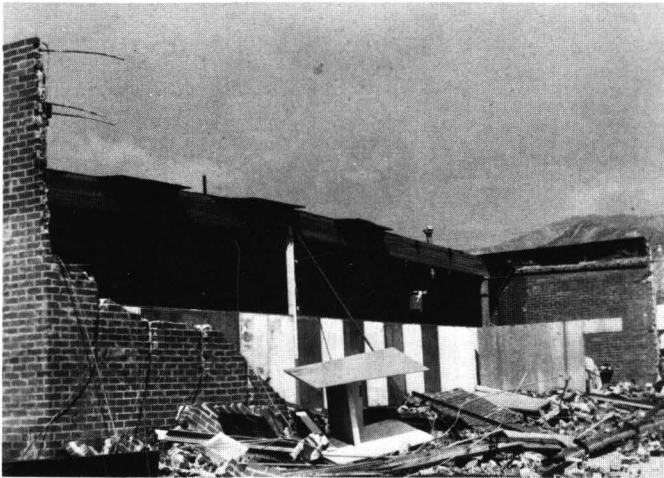
FIGURE 1.—12836 West Arroyo. South wall collapse. J. F. Meehan, OAC photograph.

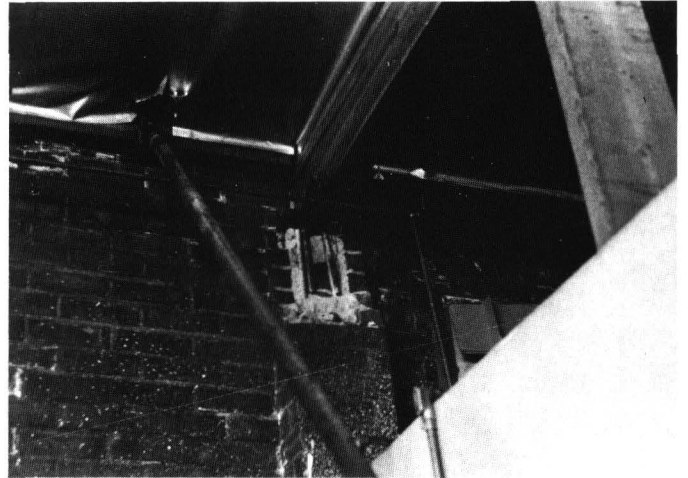
nails pulled out of the ledgers. Brick pilasters were spalled at beam seats (fig. 3).

FIGURE 3.—12836 West Arroyo. Damaged pilaster. J. F. Meehan, OAC photograph.

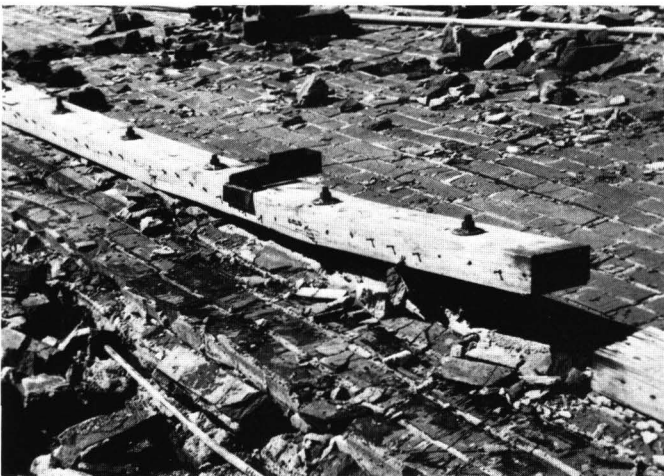
Most plywood diaphragm failures seemed to be by tension, causing nails to pull out of plywood or out of supporting ledgers and joists. The ledgers split horizontally along the bolt line, in some cases.

FIGURE 2.—12836 West Arroyo. Ledger on walls. Nails pulled through plywood sheathing. J. F. Meehan, OAC photograph.

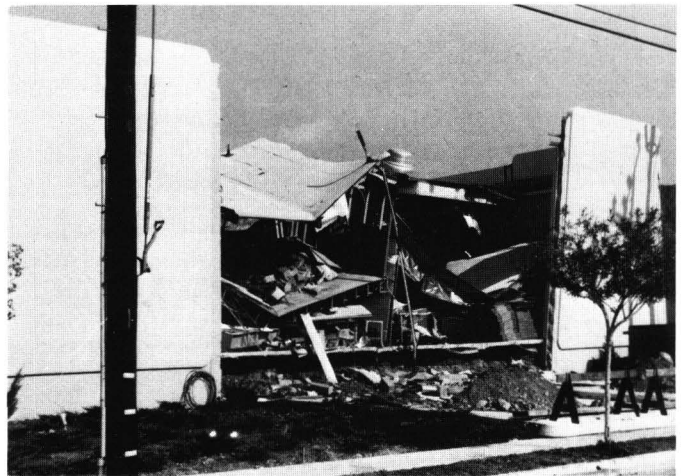
At 12460 Gladstone, a portion of the west wall collapsed (fig. 4). Walls are reinforced-concrete tilt-up construction. Roof sheathing is 1½-inch plywood. Other walls were leaning out and cracked, and the east end roof bay collapsed. An interior portion of the roof also fell in this structure. This structure has a dock-height floor.

FIGURE 4.—San Fernando Industrial Tract. 12460 Gladstone. Collapsed front wall. J. F. Meehan, OAC photograph.

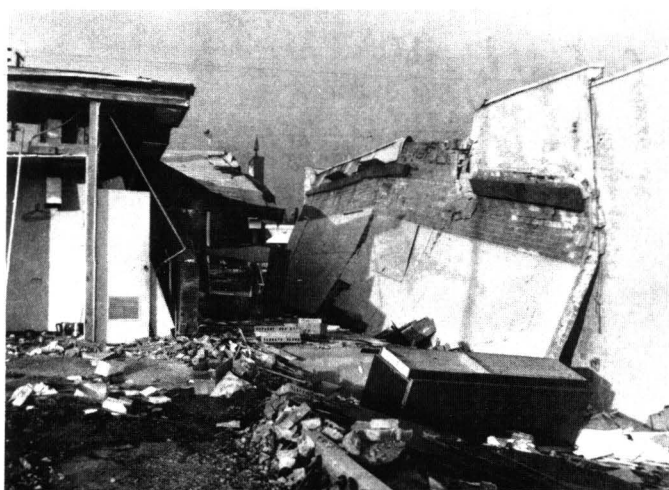
FIGURE 1.—Market, Hubbard and Glenoaks. J. F. Meehan, OAS photograph.

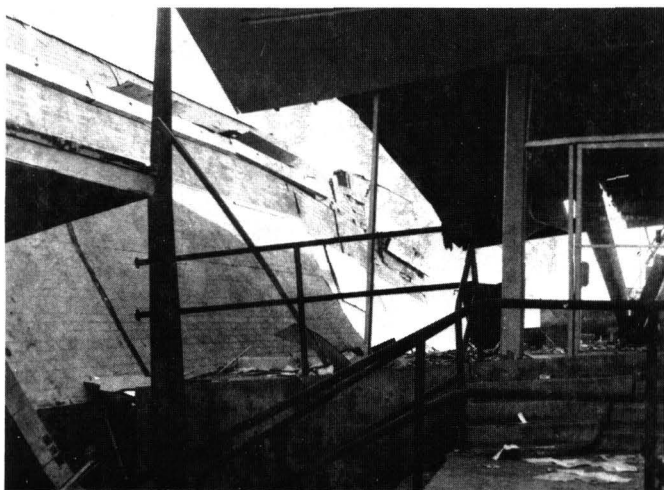
FIGURE 2.—Market. East wall. J. F. Meehan, OAC photograph.

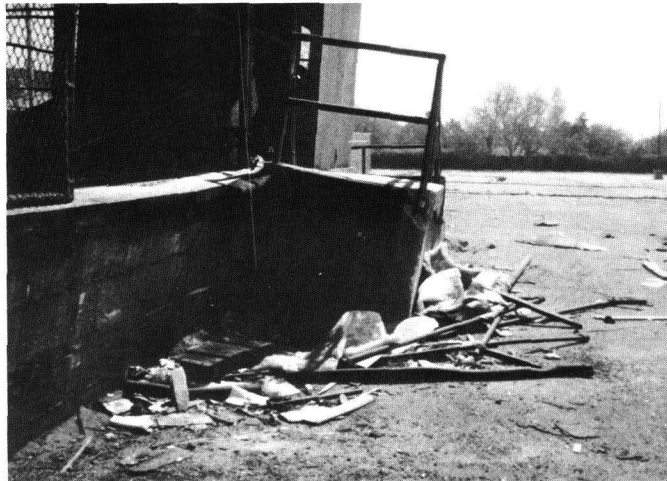
The failure of the ties had probably been due to the great amount of ground movement, slippage, and cracking through the area.

FIGURE 3.—Market. This portion of building moved southerly tilting the dock wall and fracturing the landing. Note the random cracks in paving in the background. Walter Dickey photograph.

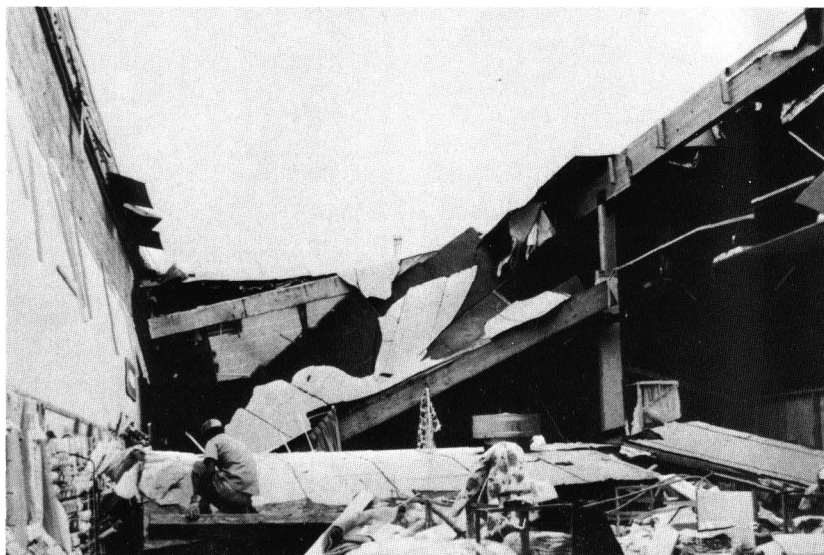
FIGURE 1.—North Oaks Shopping Center, 19419 Soledad Canyon Road.

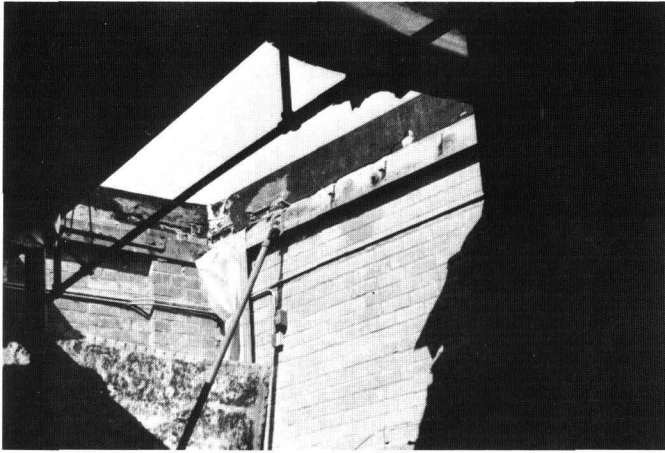
FIGURE 2.—North Oaks. Roof collapse. 19419 Soledad Canyon Road.

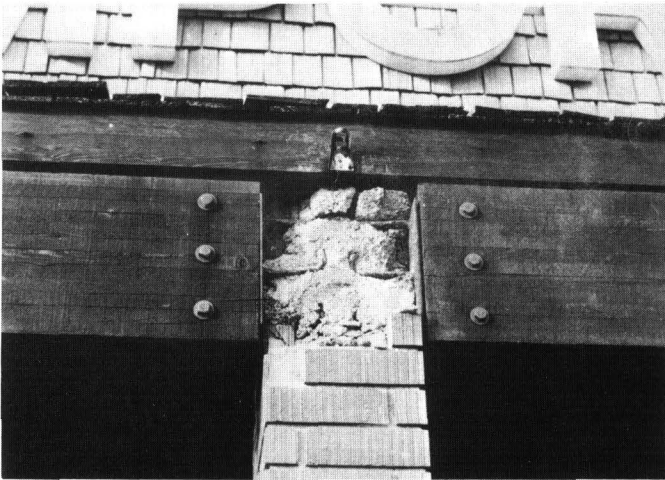
FIGURE 3.—North Oaks Shopping Center, 19407 Soledad Canyon Road. Front wall columns.

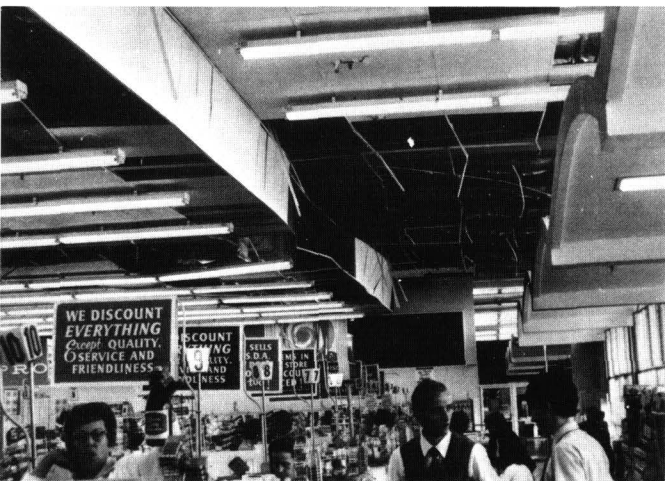
FIGURE 4.—North Oaks, Market. T-bar ceiling damage.

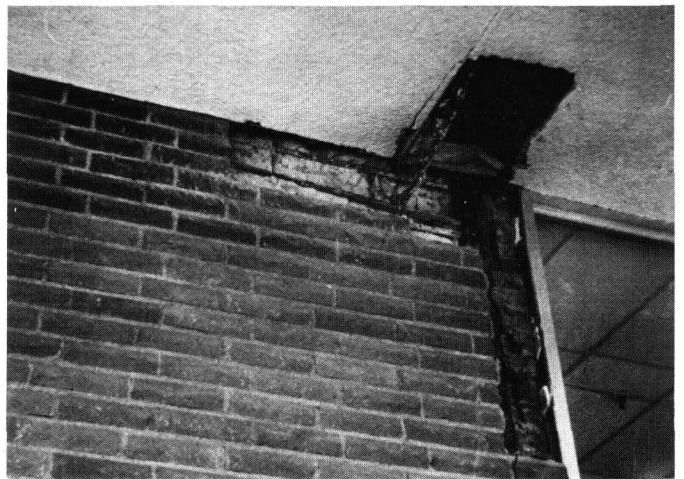
Large sections of the suspended ceiling collapsed; almost all the glass in the front wall broke. The brick walls at the front (fig. 6) spalled at ceiling level, and additional spalling occurred near ceiling level at the sign support.

FIGURE 6.—Store building, 24200 Lyons Avenue. Damage to front shear wall.

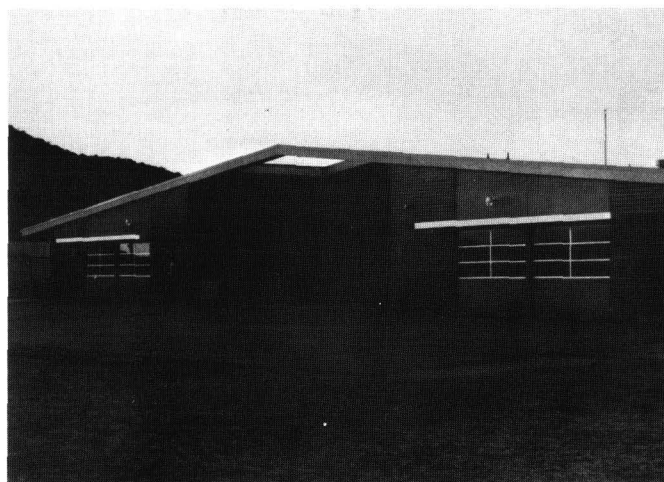
FIGURE 1.—Agua Dulce School, about 1½ miles from epicenter. Plastic lenses from several light fixtures fell to floor. J. F. Meehan, OAC photograph.

1. T-bar ceilings require engineering considerations to resist the dynamic forces of earthquakes.
2. All parts, including the anchorage, of light fixtures require engineering considerations to resist the dynamic forces of earthquakes.
3. All overhead objects such as grilles and fixtures, require particular attention to details and positive mechanical anchorage to prevent displacement during earthquakes.
4. Strong-motion earthquake records show the lateral loads experienced in many structures greatly exceed those required by present codes. Consideration will be given to this information as it applies to low, intermediate, and high buildings.

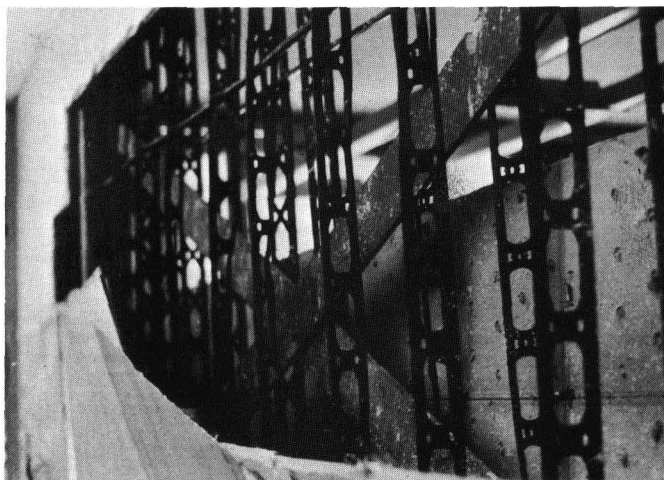
FIGURE 2.—Clark Junior High School. Steel flat bar diagonal bracing buckled and damaged plastered partitions. J. F. Meehan, OAC photograph.

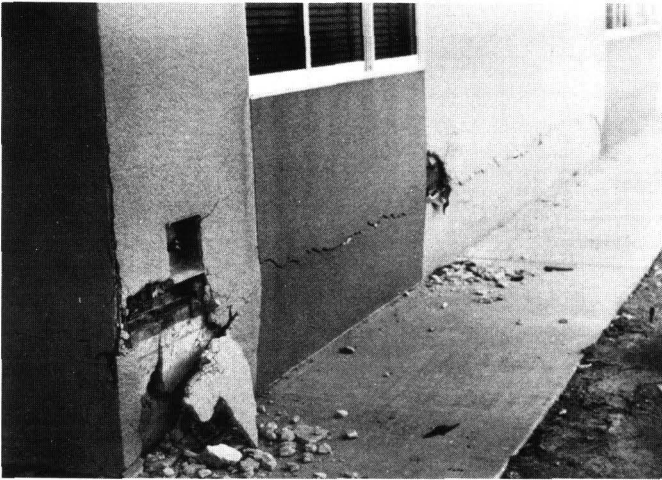
FIGURE 3.—Van Gogh School. Damage at junction of foundation and wood stud wall. J. F. Meehan, OAC photograph.

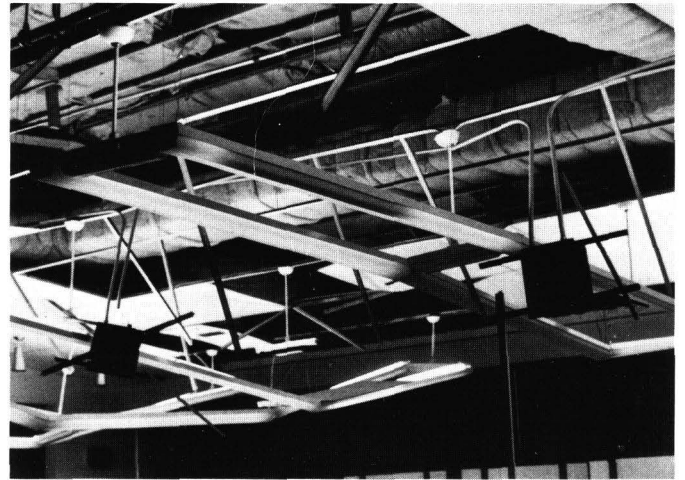
FIGURE 5.—Soledad Canyon School, T-bar ceiling, and light fixtures. J. F. Meehan, photograph.

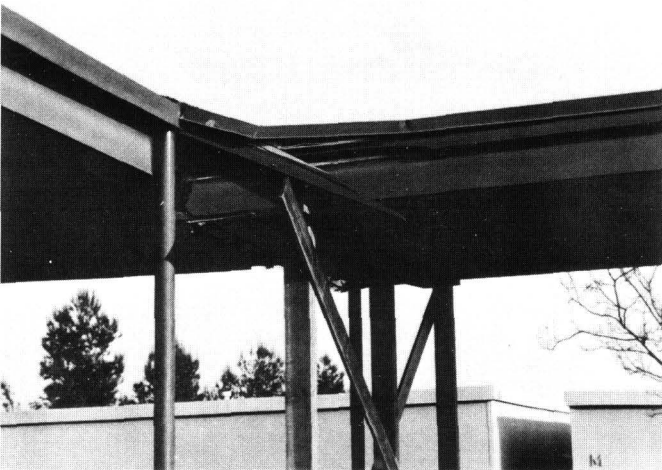
FIGURE 4.—Sylmar High School. Arcade roof joints pounded. J. F. Meehan, OAC photograph.

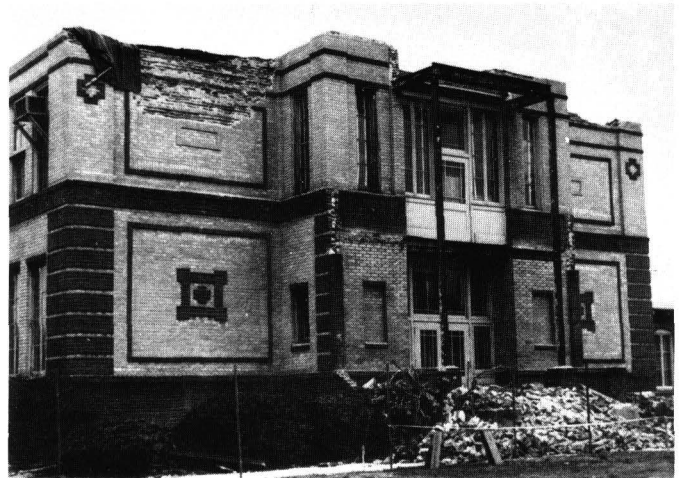
FIGURE 6.—Administration Center, Glendale. This pre-Field Act School was being rehabilitated. Brick work over the entry fell. J. F. Meehan, OAC photograph.

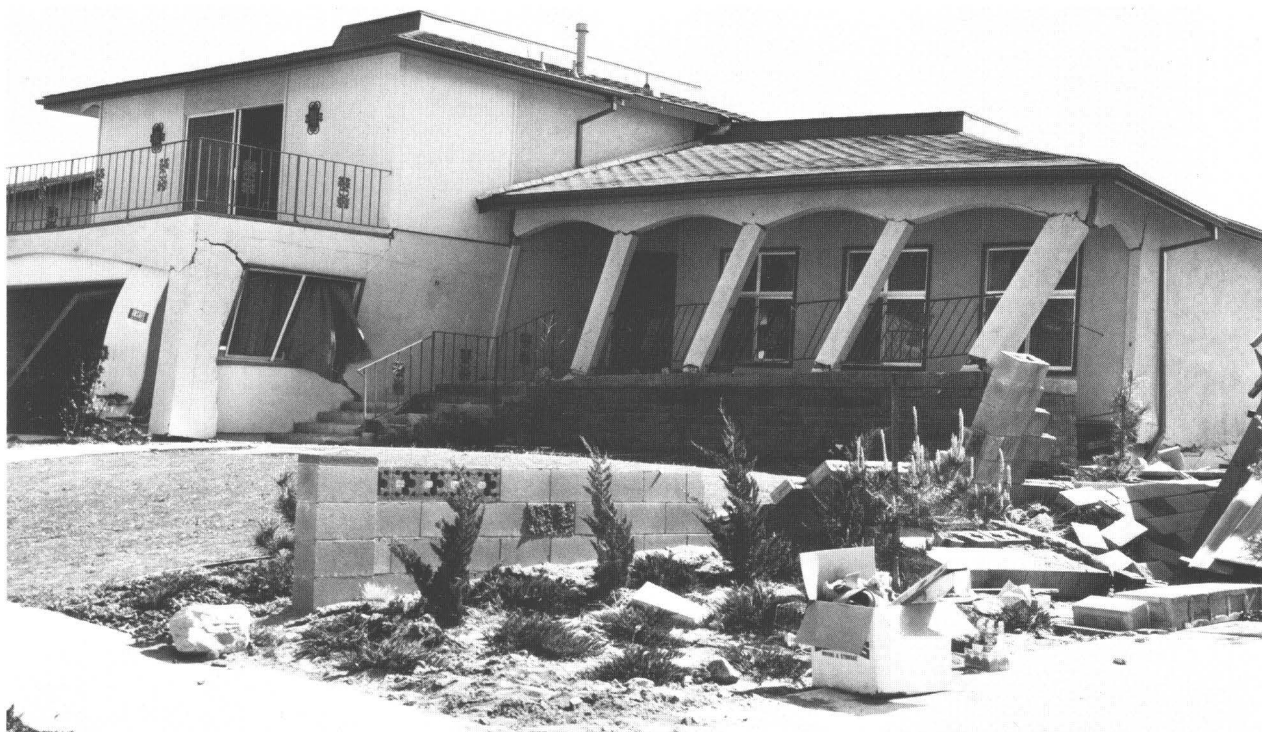
FIGURE 1.—Almetz Street, between VA Hospital and Olive View. Los Angeles City Department of Building and Safety photograph.

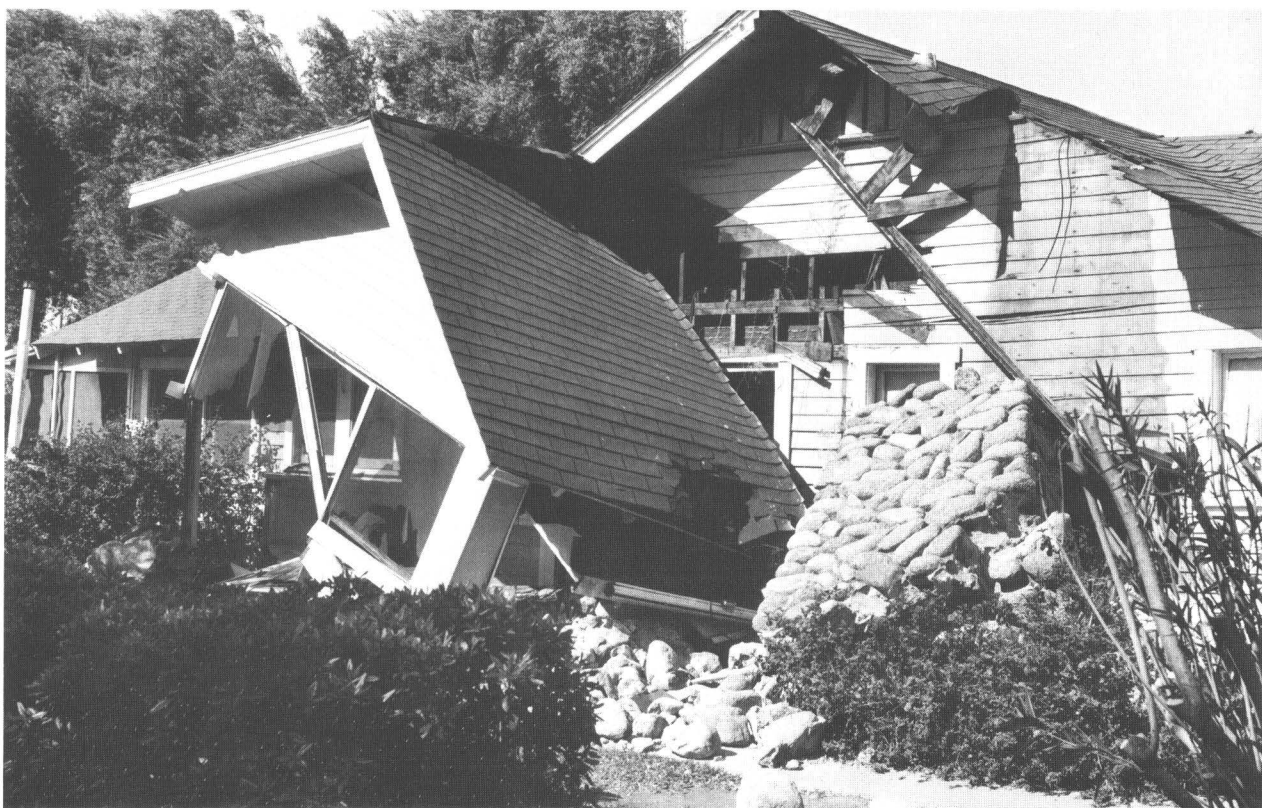
FIGURE 2.—Older dwelling in the vicinity of 8th Street and Fernmont in San Fernando. Los Angeles City Department of Building and Safety photograph.

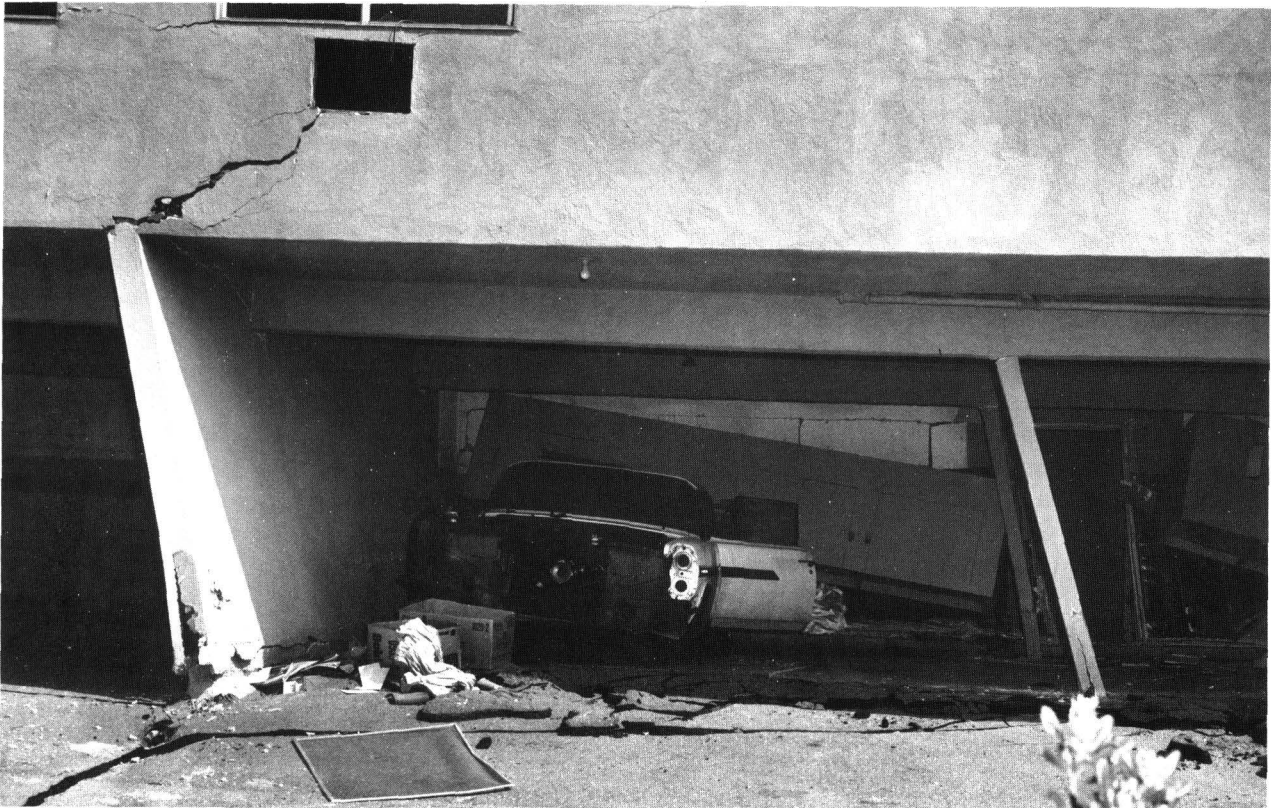
FIGURE 6.—Rear of apartment at Foothill Boulevard and Harding. Los Angeles City Department of Building and Safety photograph.

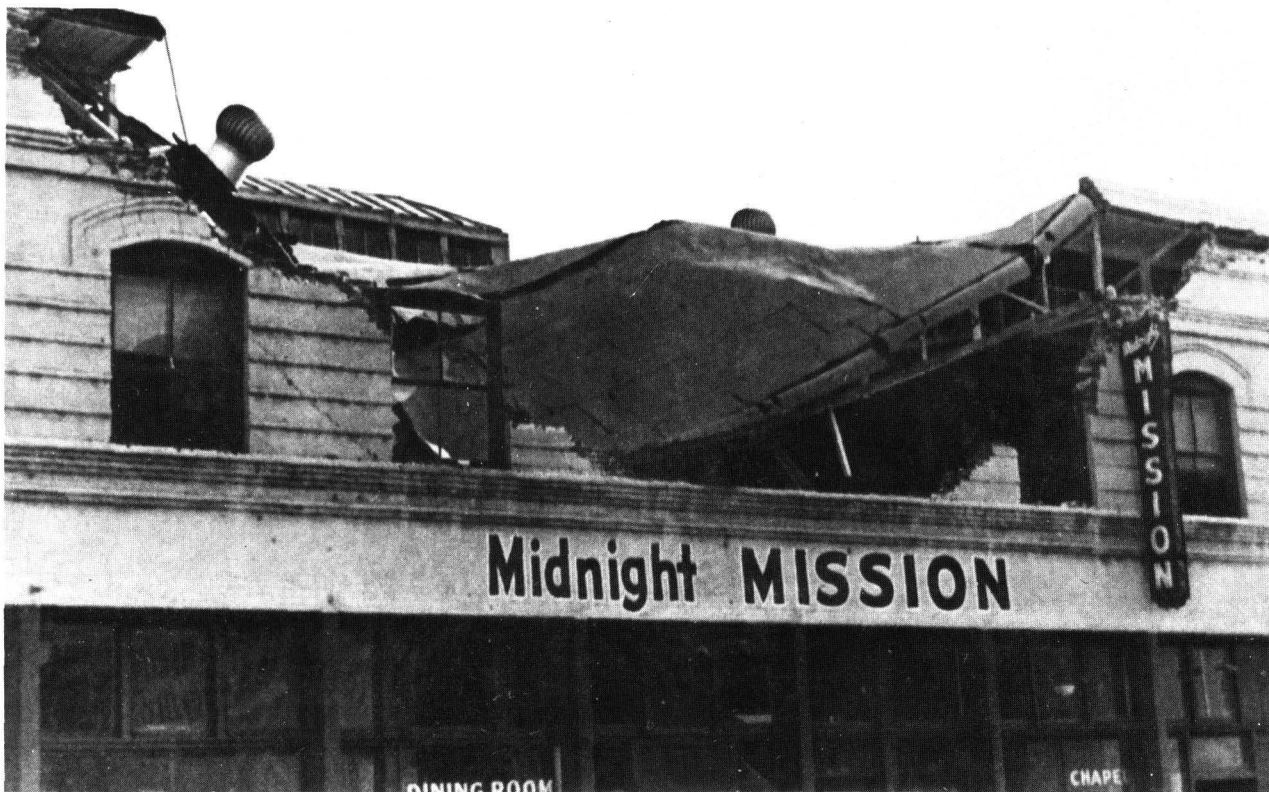
FIGURE 7.—Midnight Mission in downtown Los Angeles. Los Angeles City Department of Building and Safety photograph.

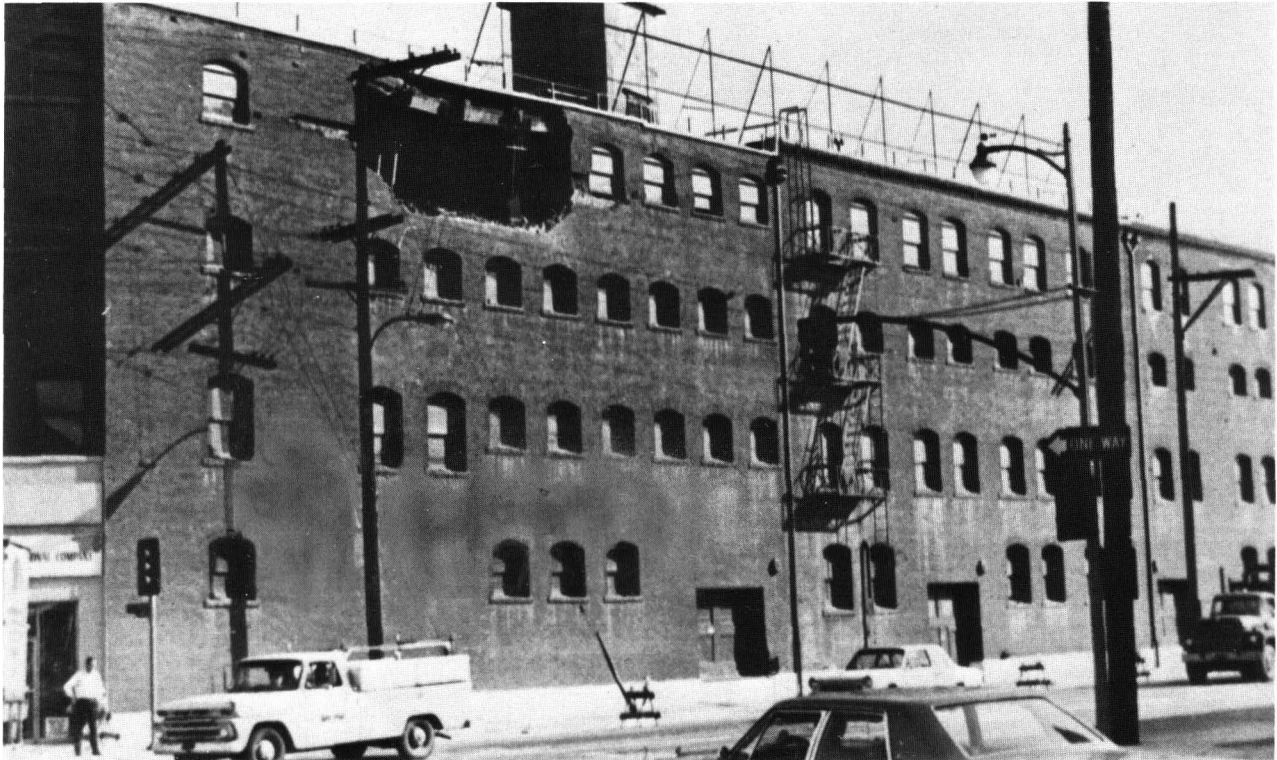
FIGURE 8.—Near 4th Street and Alameda, Los Angeles. Los Angeles City Department of Building and Safety photograph.

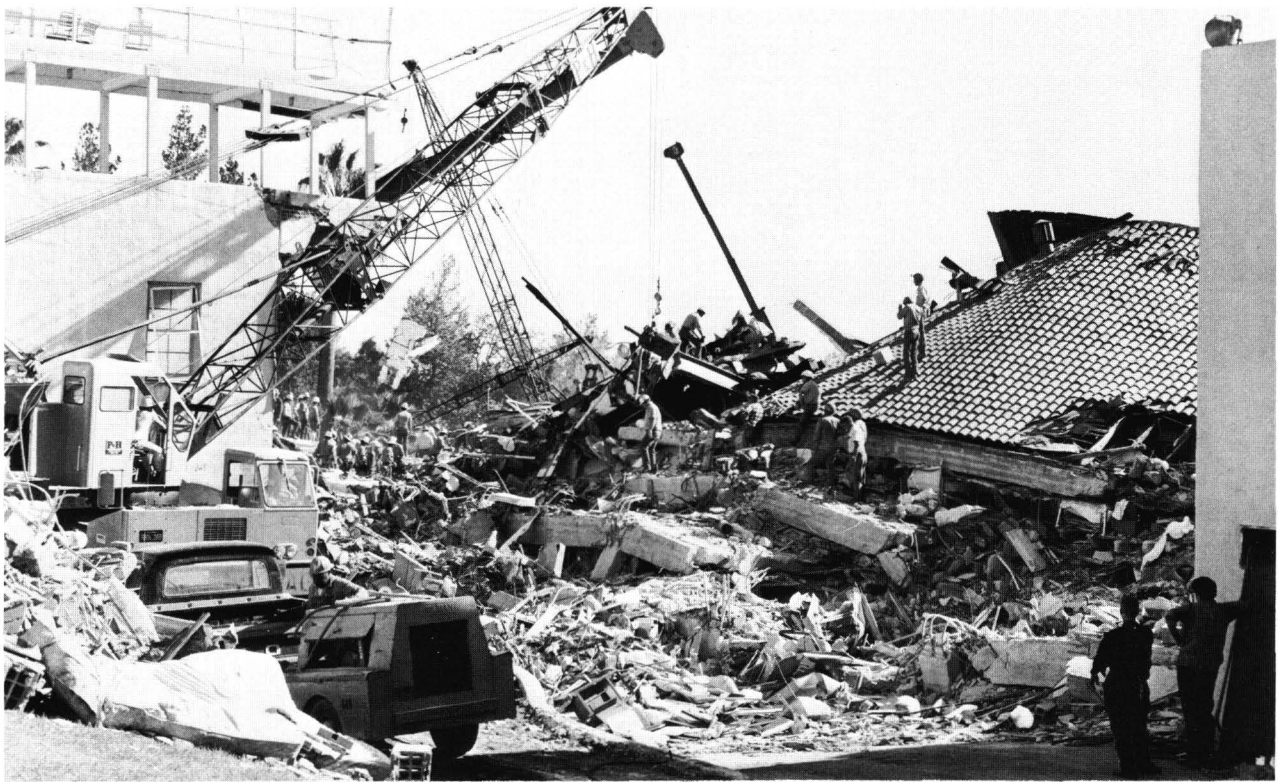
FIGURE 9.—Veterans Hospital rescue operations. Los Angeles City Department of Building and Safety photograph.

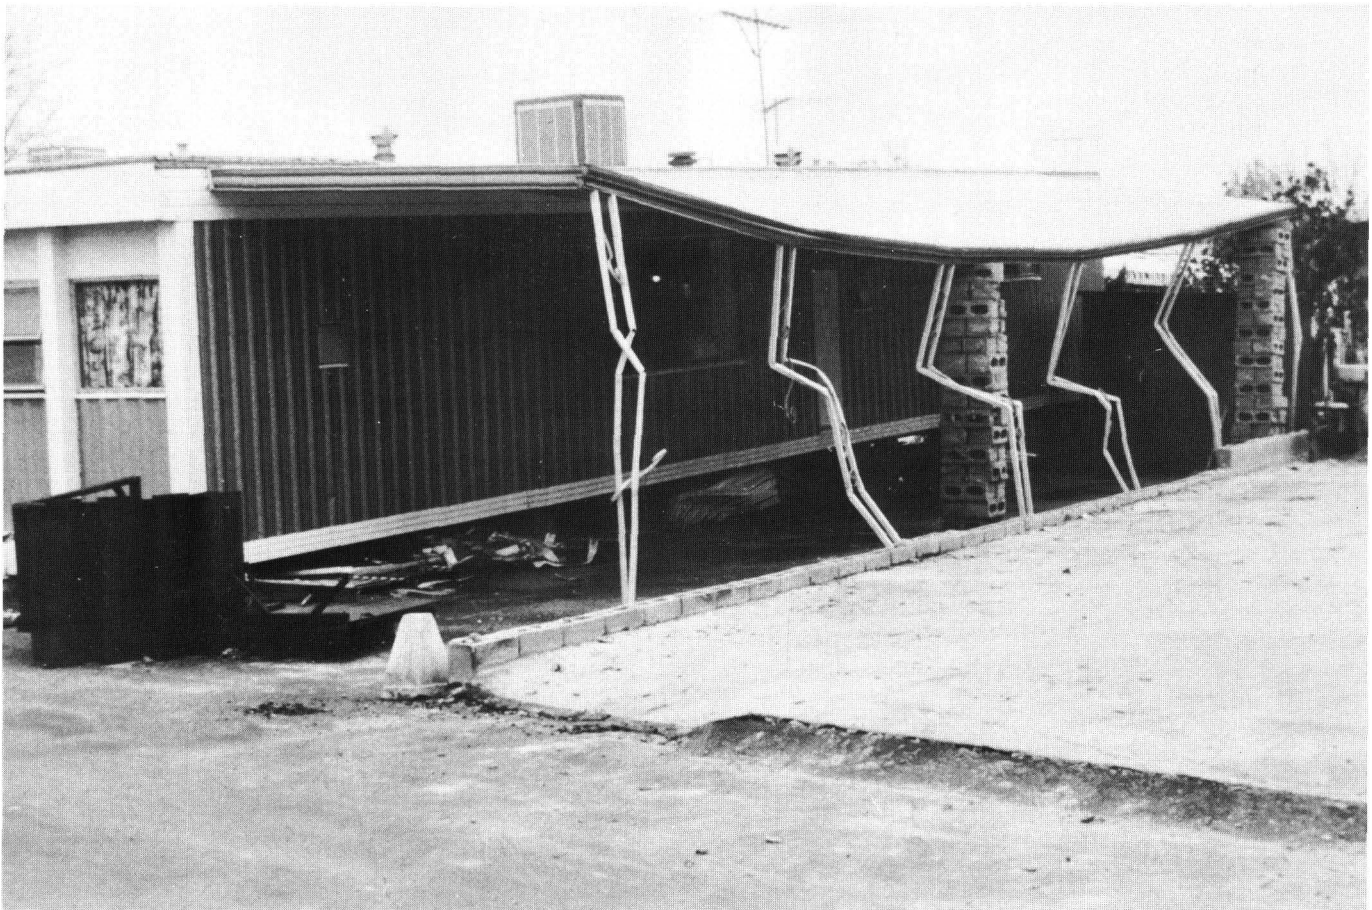
FIGURE 10.—House trailer off supports. J. F. Meehan, OAC photograph.

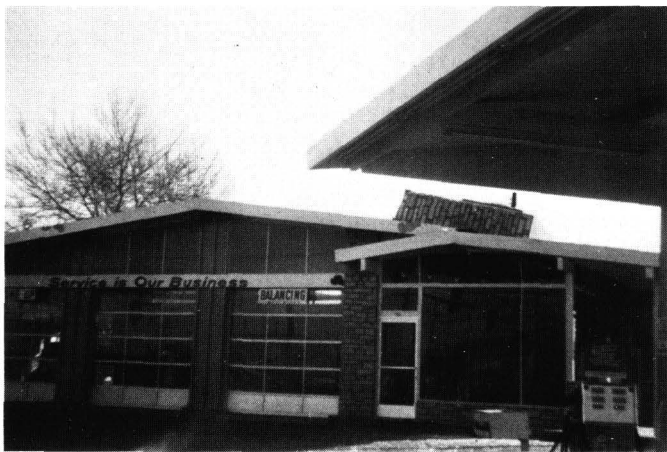
Generally, gasoline stations performed well. At one modern station a decorative masonry chimney fell (fig. 11), and large rocks on the roof of canopies were thrown off (fig. 12).

FIGURE 11.—Gasoline station, collapsed masonry chimney. Foothill and Van Nuys Boulevard. D. F. Moran, photograph.

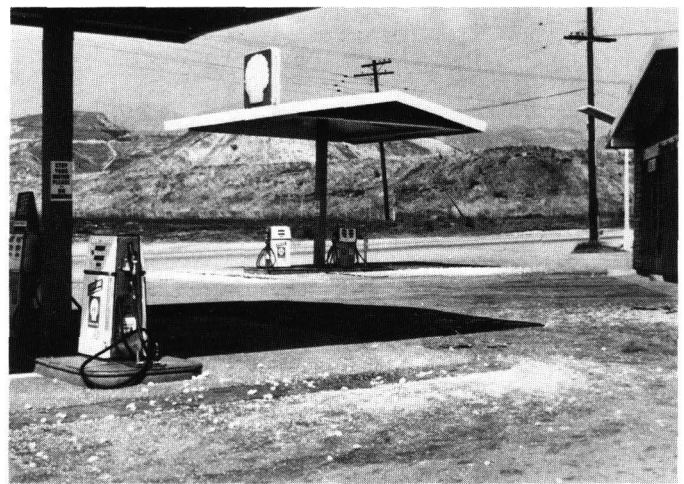
FIGURE 12.—Gasoline station. Rocks shaken off canopies. J. F. Meehan, OAC photograph.

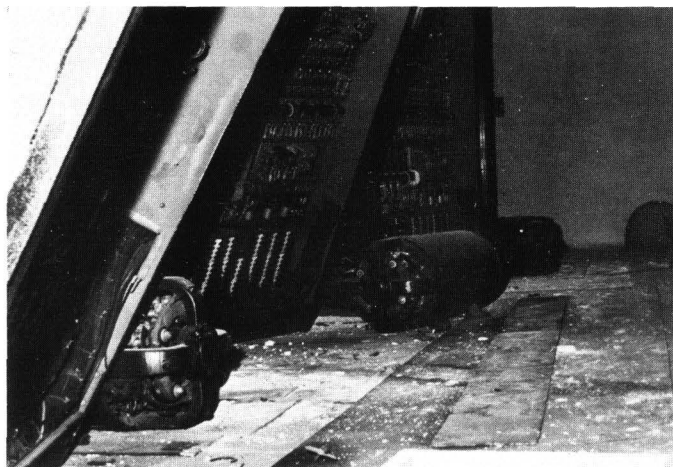
FIGURE 1.—Holy Cross Hospital. Elevator machinery-room generator sets were thrown off their mounts, and control panels were damaged. J. M. Ayres, photograph.

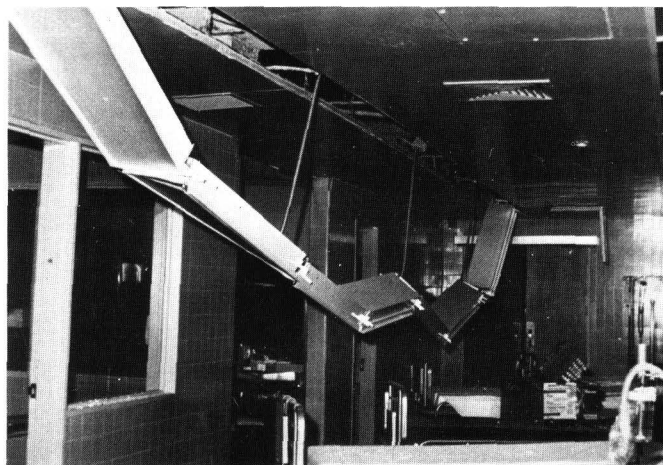
FIGURE 4.—Olive View Hospital. Light fixtures slipped from support brackets as plaster ceiling moved. J. M. Ayres, photograph.

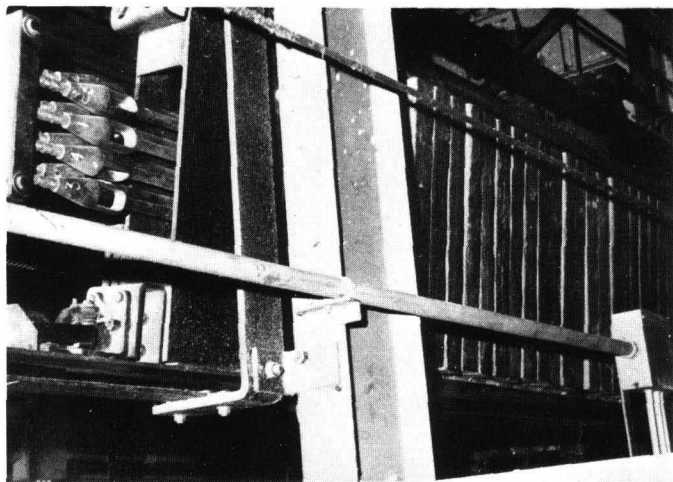
FIGURE 2.—Holy Cross Hospital. Elevator counterweights slipped out of their guide rails. J. M. Ayres, photograph.

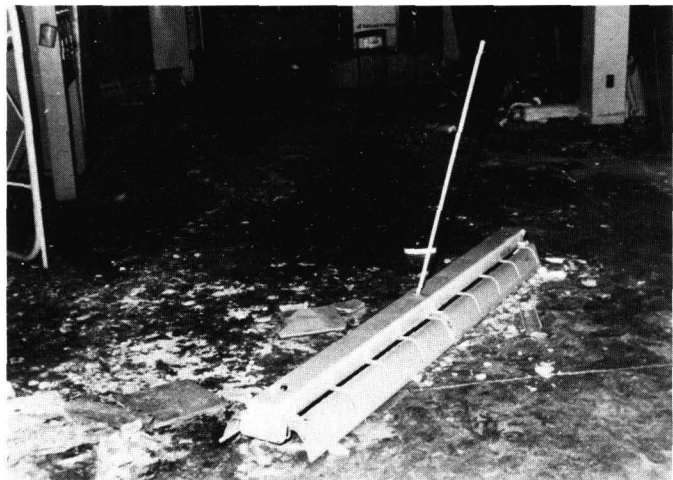
FIGURE 3.—Olive View Power Plant. Light-fixture pendant mounts failed. J. M. Ayres, photograph.

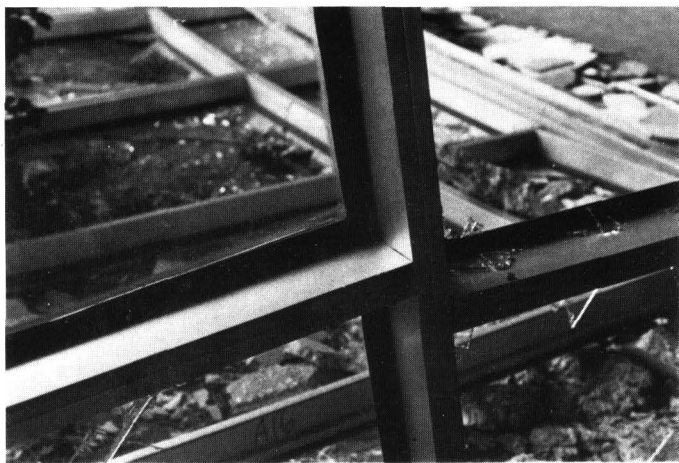
FIGURE 6.—Olive View Hospital. Glass light in rubber mount did not fail even though excessive frame deformation broke three adjacent lites. J. M. Ayres, photograph.

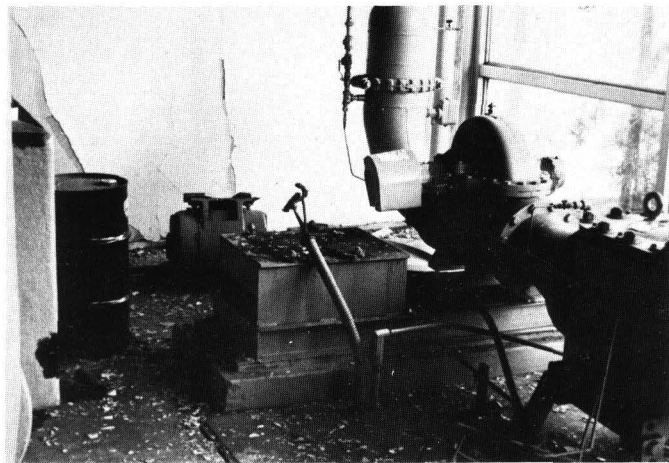
*Mechanical Systems.*—Pump motors were thrown from their pedestal mounts (fig. 8), and water chillers were torn from their tube bundles because they were not properly secured and tied together and to the floor (fig. 9). Heavy tanks not secured to floors shifted, and improperly designed legs collapsed (fig. 10). Central-station air-conditioning systems mounted on large unrestrained vibration-isolation springs shifted off their mounts (fig. 11). Large steam boilers shifted 3½ feet (fig. 12), damaging stacks, pipes, control panels and adjacent walls, because the boilers were not properly secured to the floor (figs. 13 and 14).

FIGURE 8.—Olive View Power Plant. Condenser water-pump motors were thrown from their pedestal mounts. J. M. Ayres, photograph.

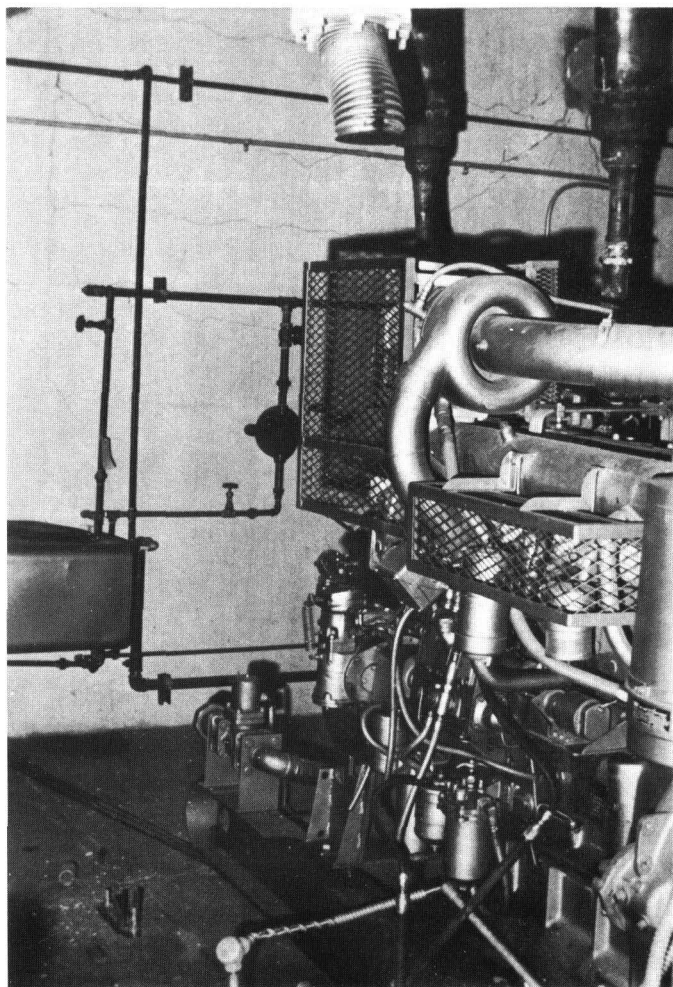
FIGURE 7.—Olive View Hospital. Emergency generators moved off of their vibration-isolation spring mounts. J. M. Ayres, photograph.

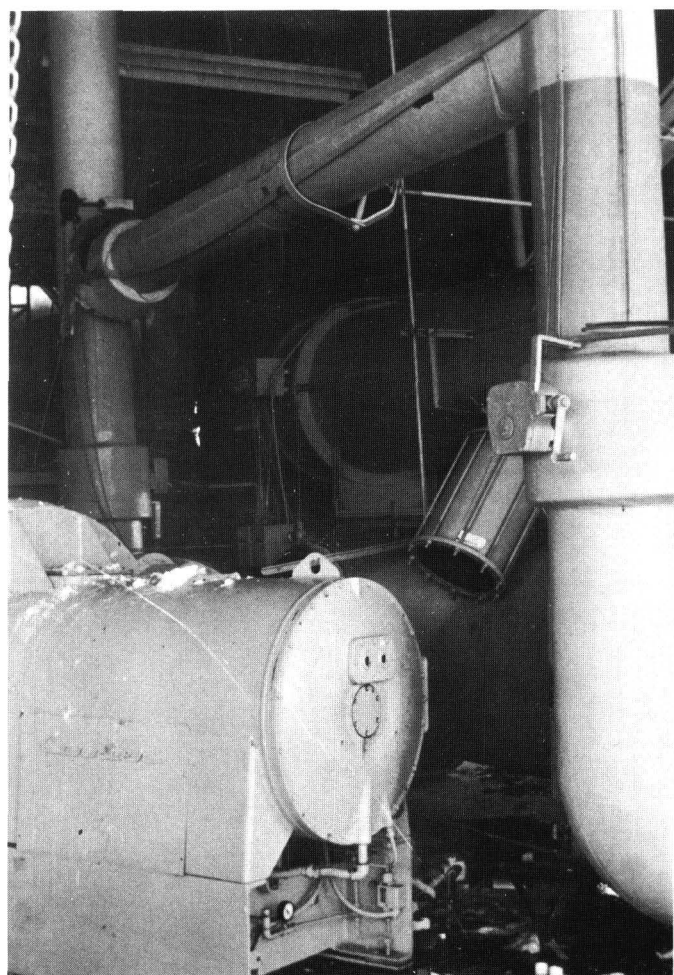
FIGURE 9.—Olive View Power Plant. Water chillers were torn from their adjacent tube bundles. J. M. Ayres, photograph.

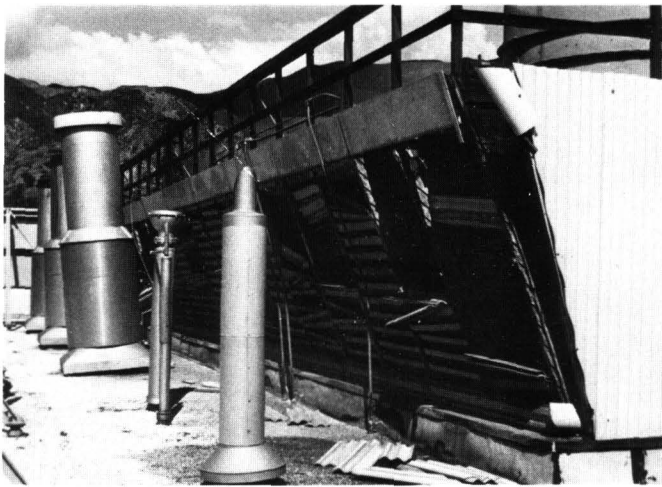
FIGURE 14.—Olive View Power Plant. Roof-mounted cooling-tower intake louver damaged by racking, and adjacent boiler stacks twisted when boilers moved. J. M. Ayres, photograph.

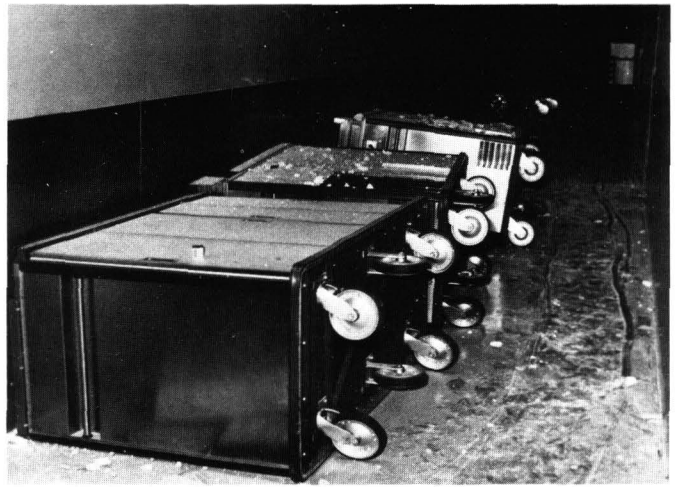
*Storage Racks and Loose Objects.*—Markets found their aisles filled with materials thrown from shelves. Library books were thrown to the floor (fig. 15), and in some instances, the book racks collapsed. Loose objects and carts blocked exits (fig. 16).

FIGURE 16.—Olive View Hospital. Corridor blocked by overturned carts. J. M. Ayres, photograph.

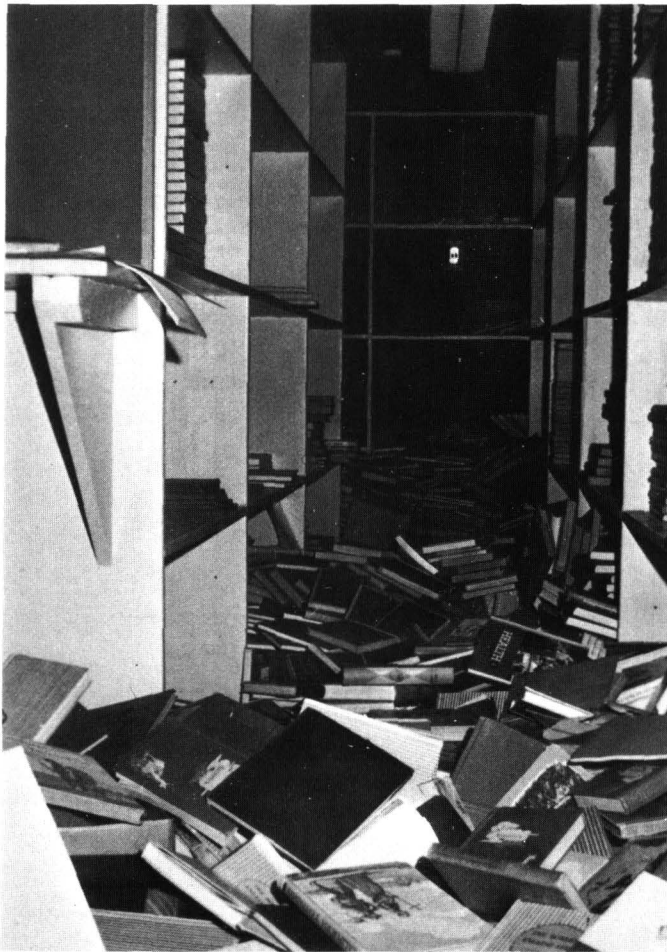
FIGURE 15.—Sylmar Elementary School. Books thrown from shelves. J. M. Ayres, photograph.

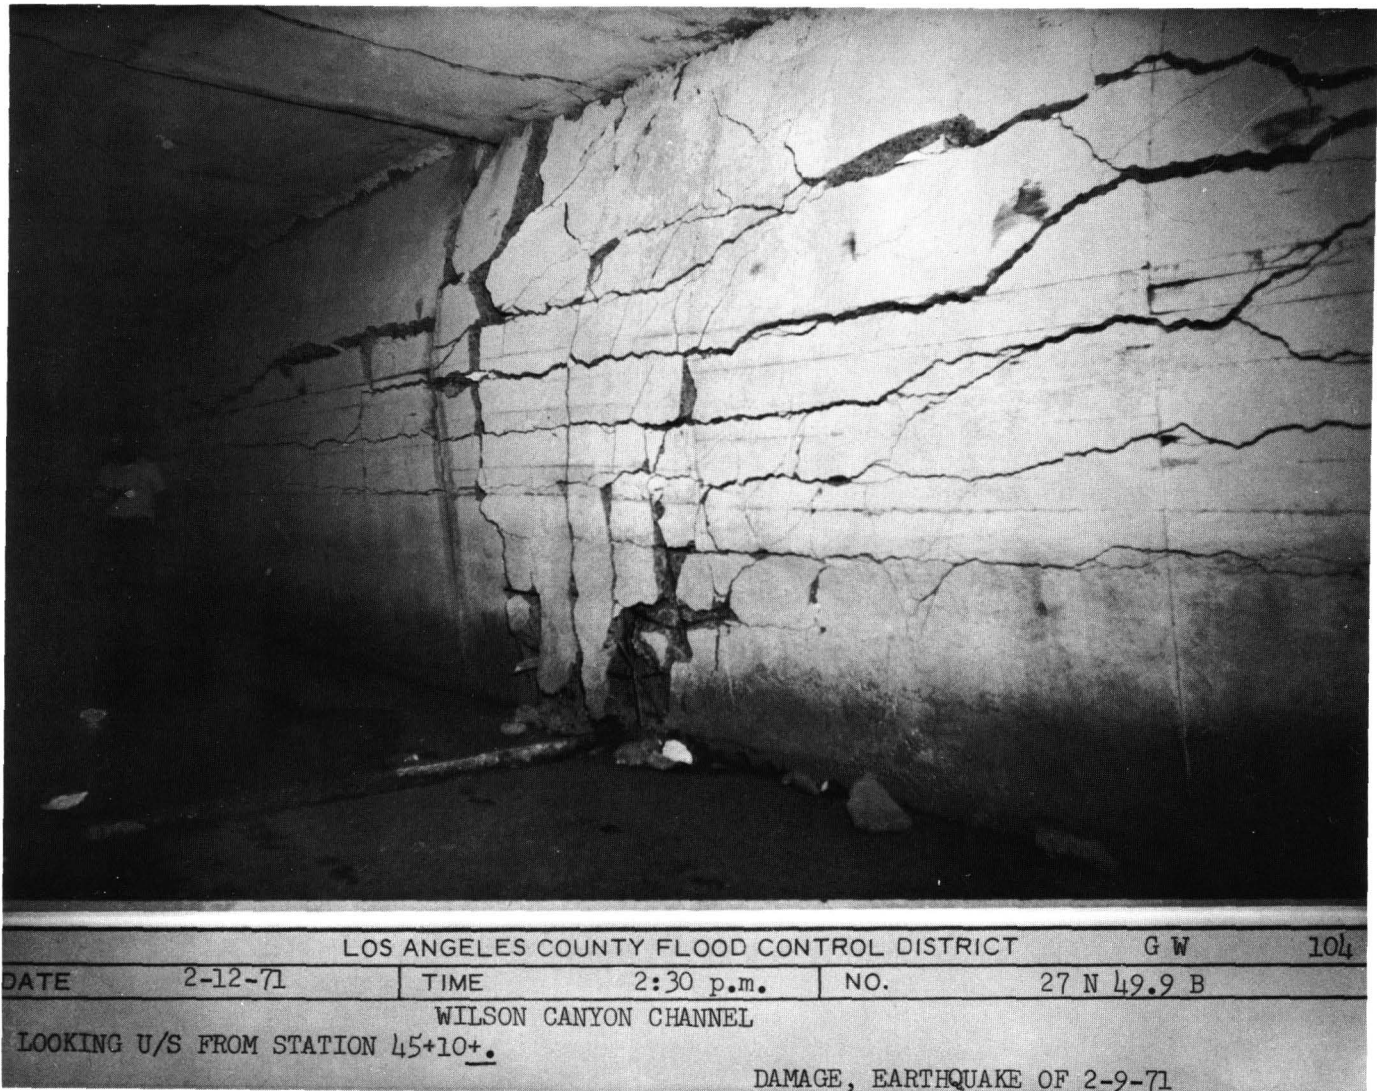
FIGURE 1.—Inside of Box Culvert at Wilson Canyon Channel. Los Angeles County Flood Control District photograph.
