# THE SAN FERNANDO, CALIFORNIA, EARTHQUAKE OF FEBRUARY 9, 1971:

*A preliminary report published jointly by the U.S. Geological Survey  
and the National Oceanic and Atmospheric Administration*

GEOLOGICAL SURVEY PROFESSIONAL PAPER 733

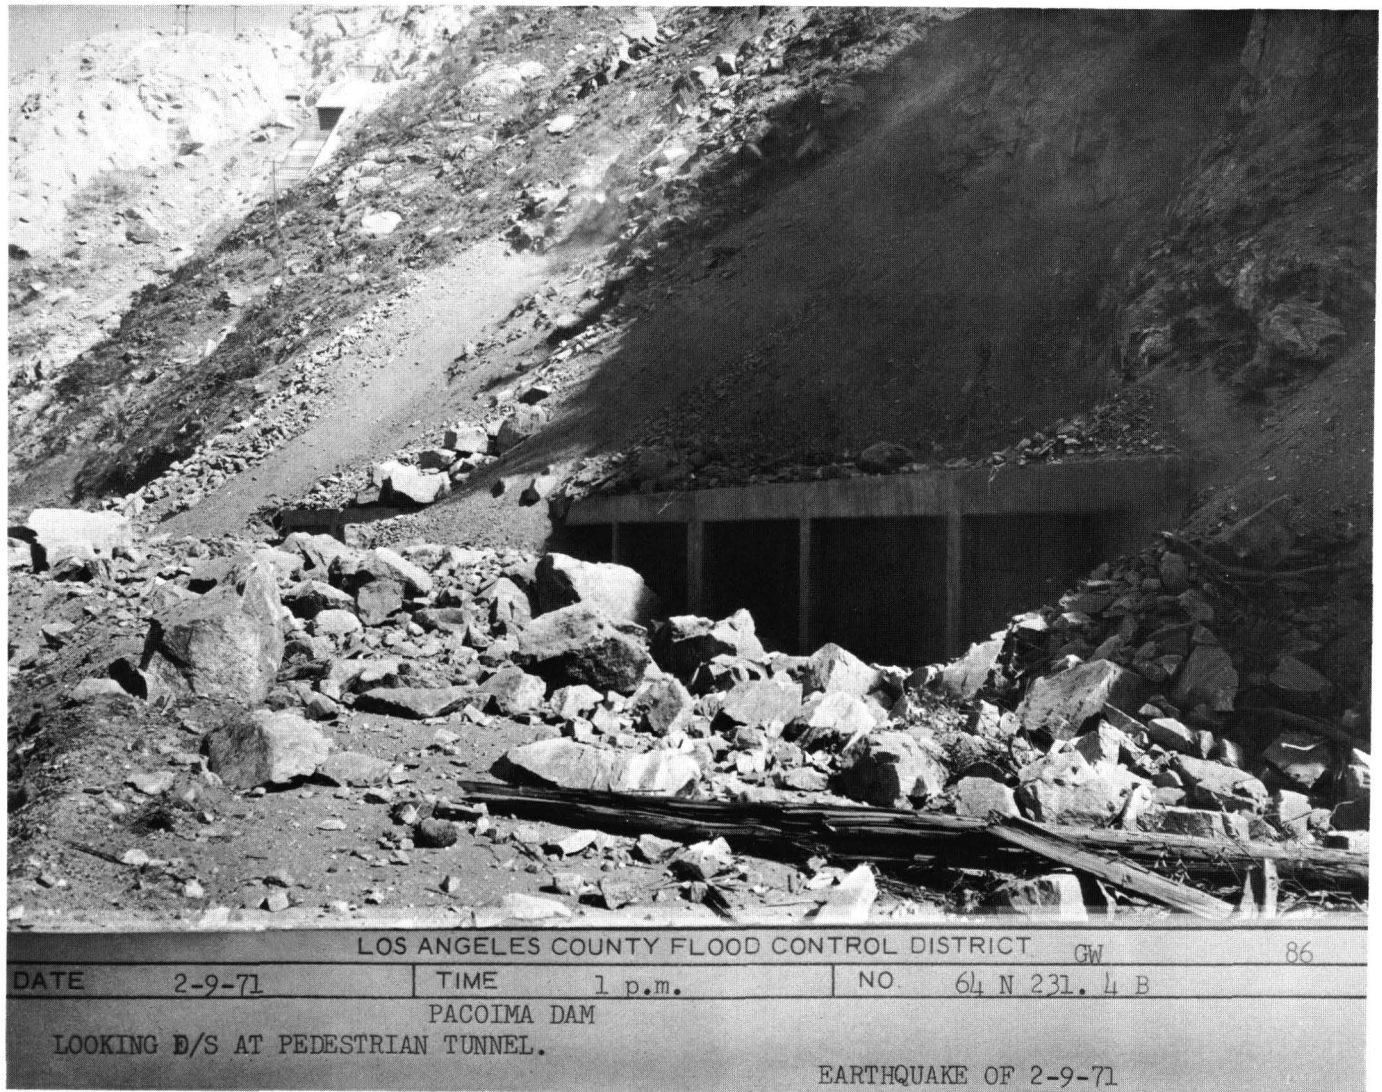
FIGURE 2.—Rockslides at west abutment of Pacoima Dam. LACFCD photograph.

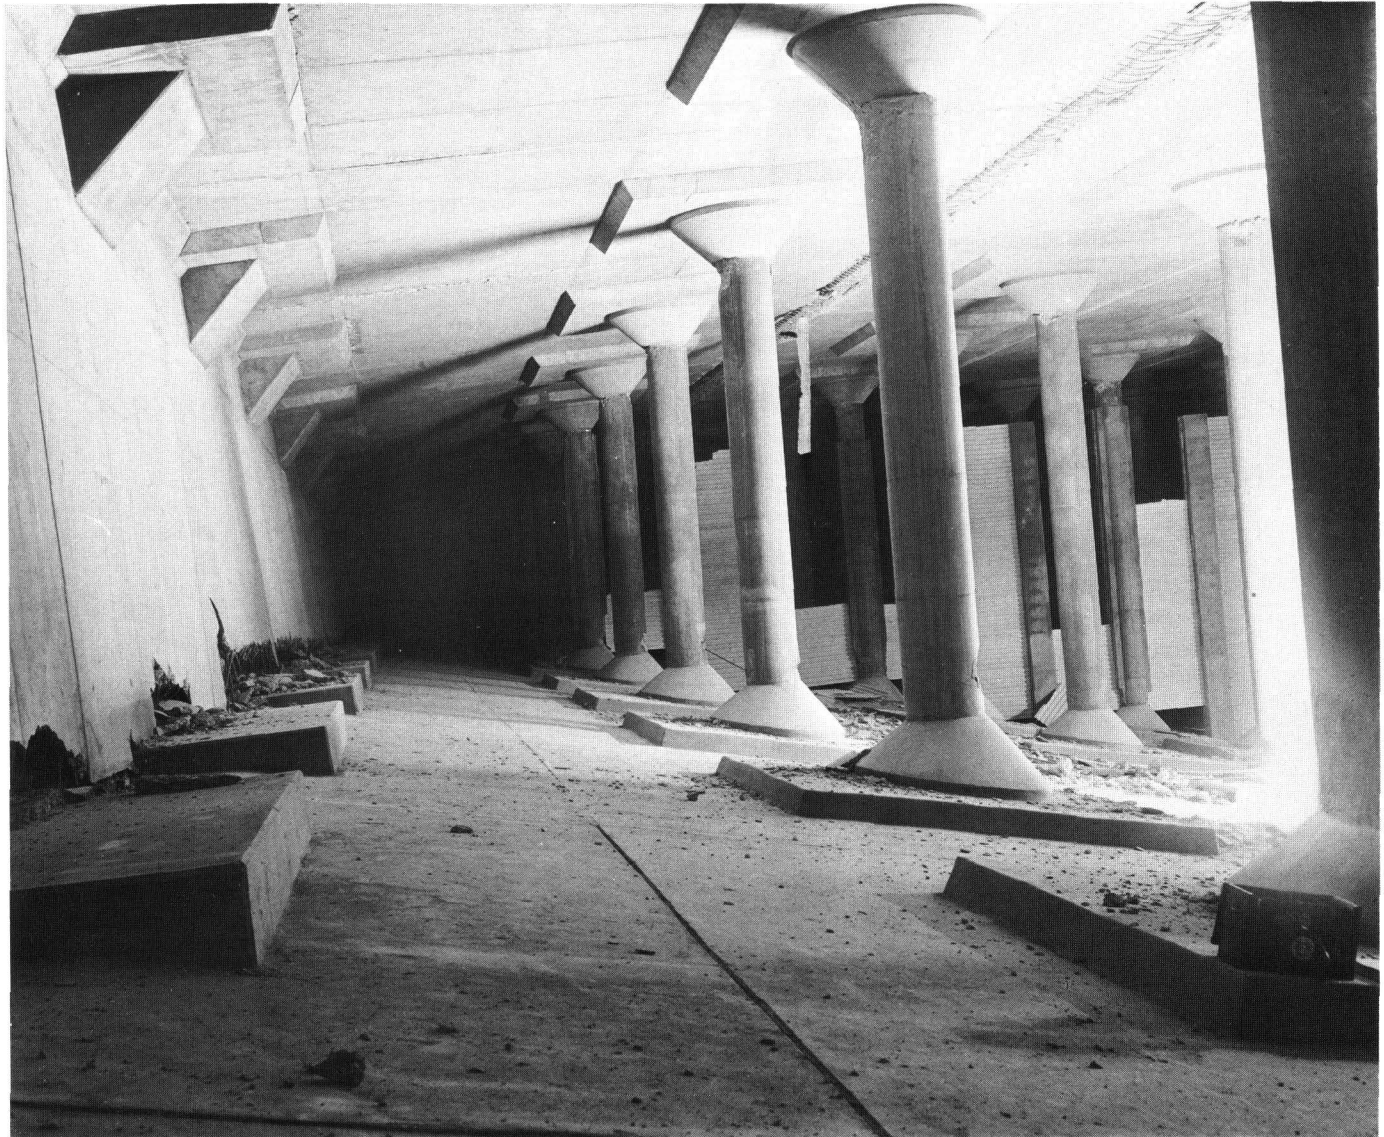
FIGURE 3.—Metropolitan Water District, Joseph Jensen Filtration Plant, Interior of finished water reservoir. MWD photographs.

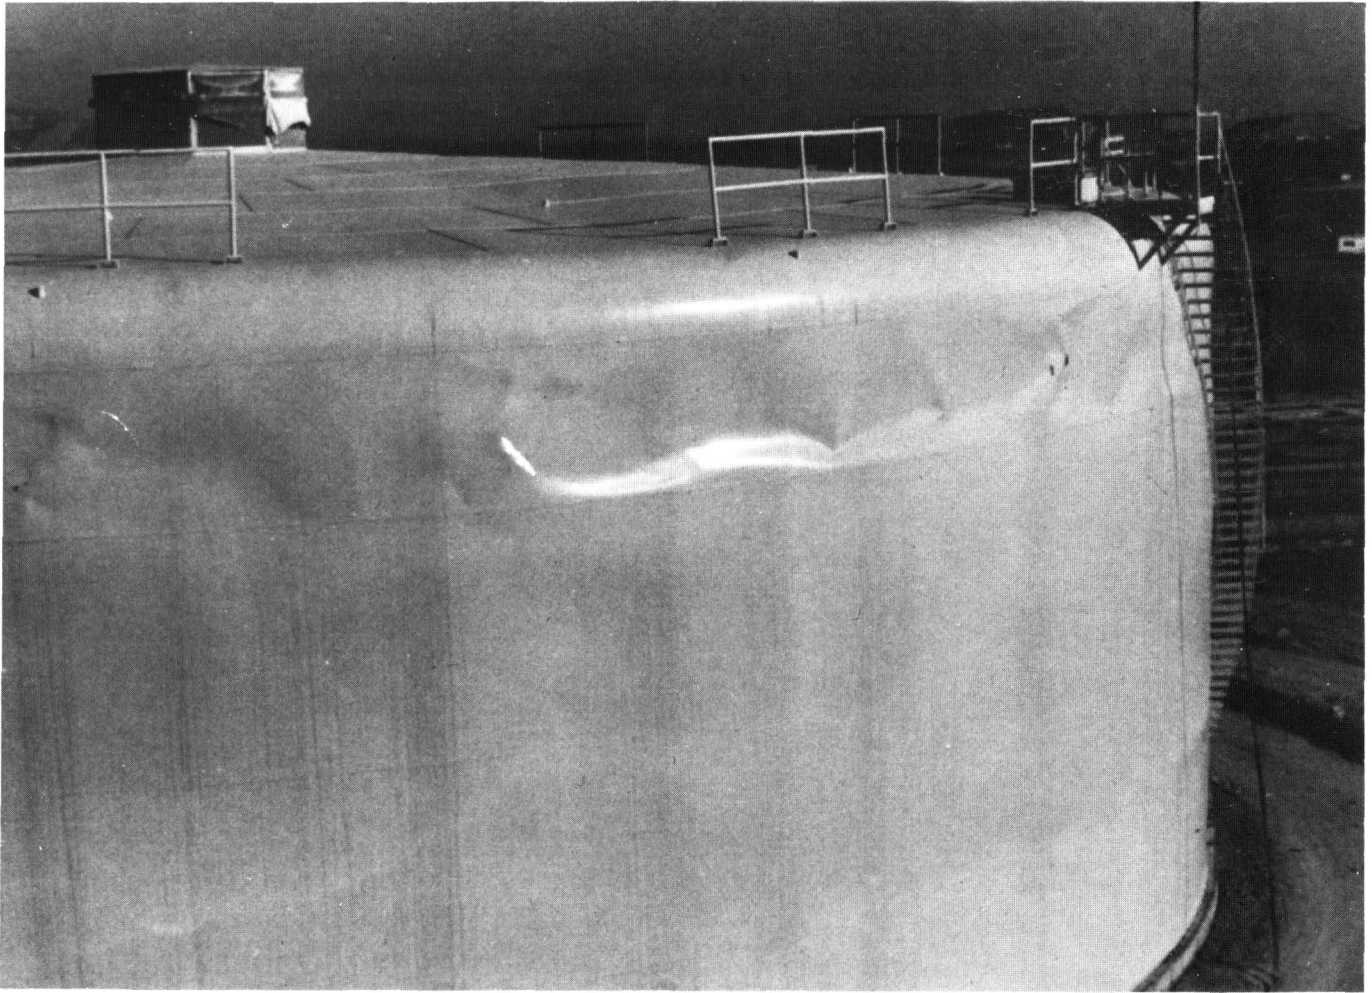
FIGURE 5.—1,750,000 gallon wash water tank, Jensen Filtration Plant. J. F. Meehan, OAC photograph.

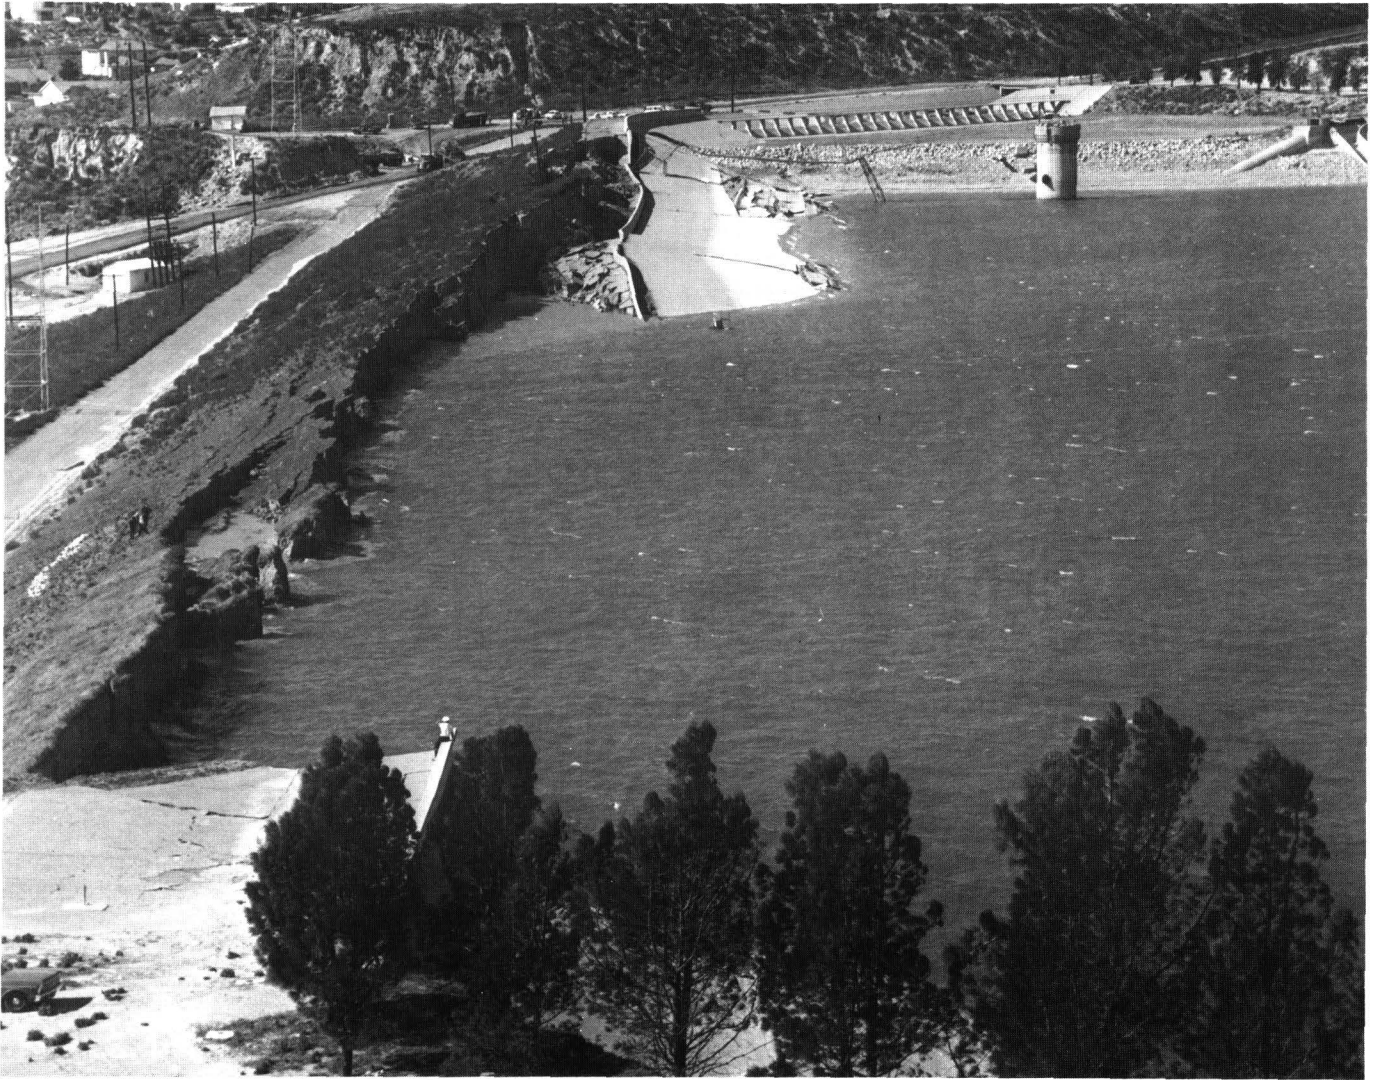
FIGURE 9.—Lower San Fernando Dam. February 9, 1971. DWP photograph by Max Gould.

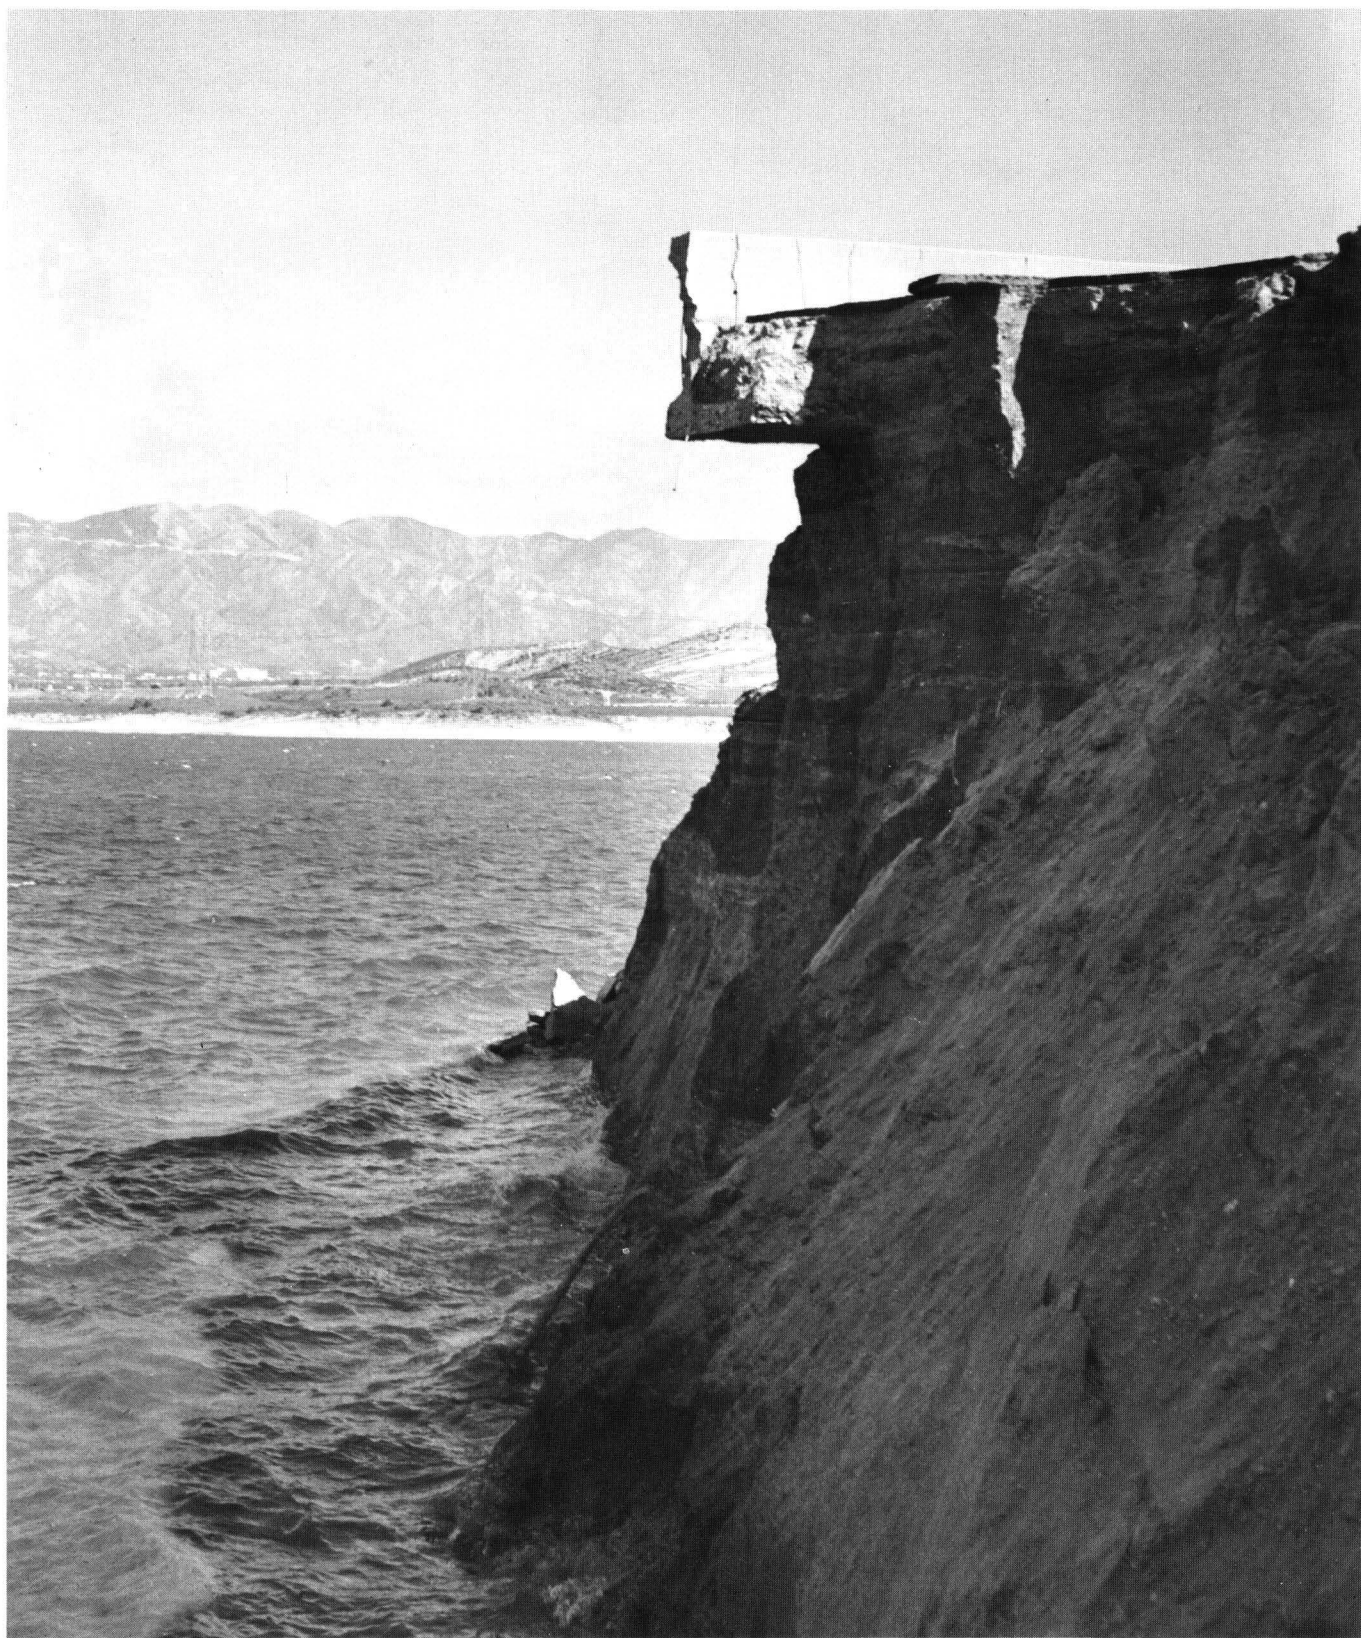
FIGURE 10.—Lower San Fernando Dam, near east abutment, February 9, 1971. DWP photograph by Max Gould.

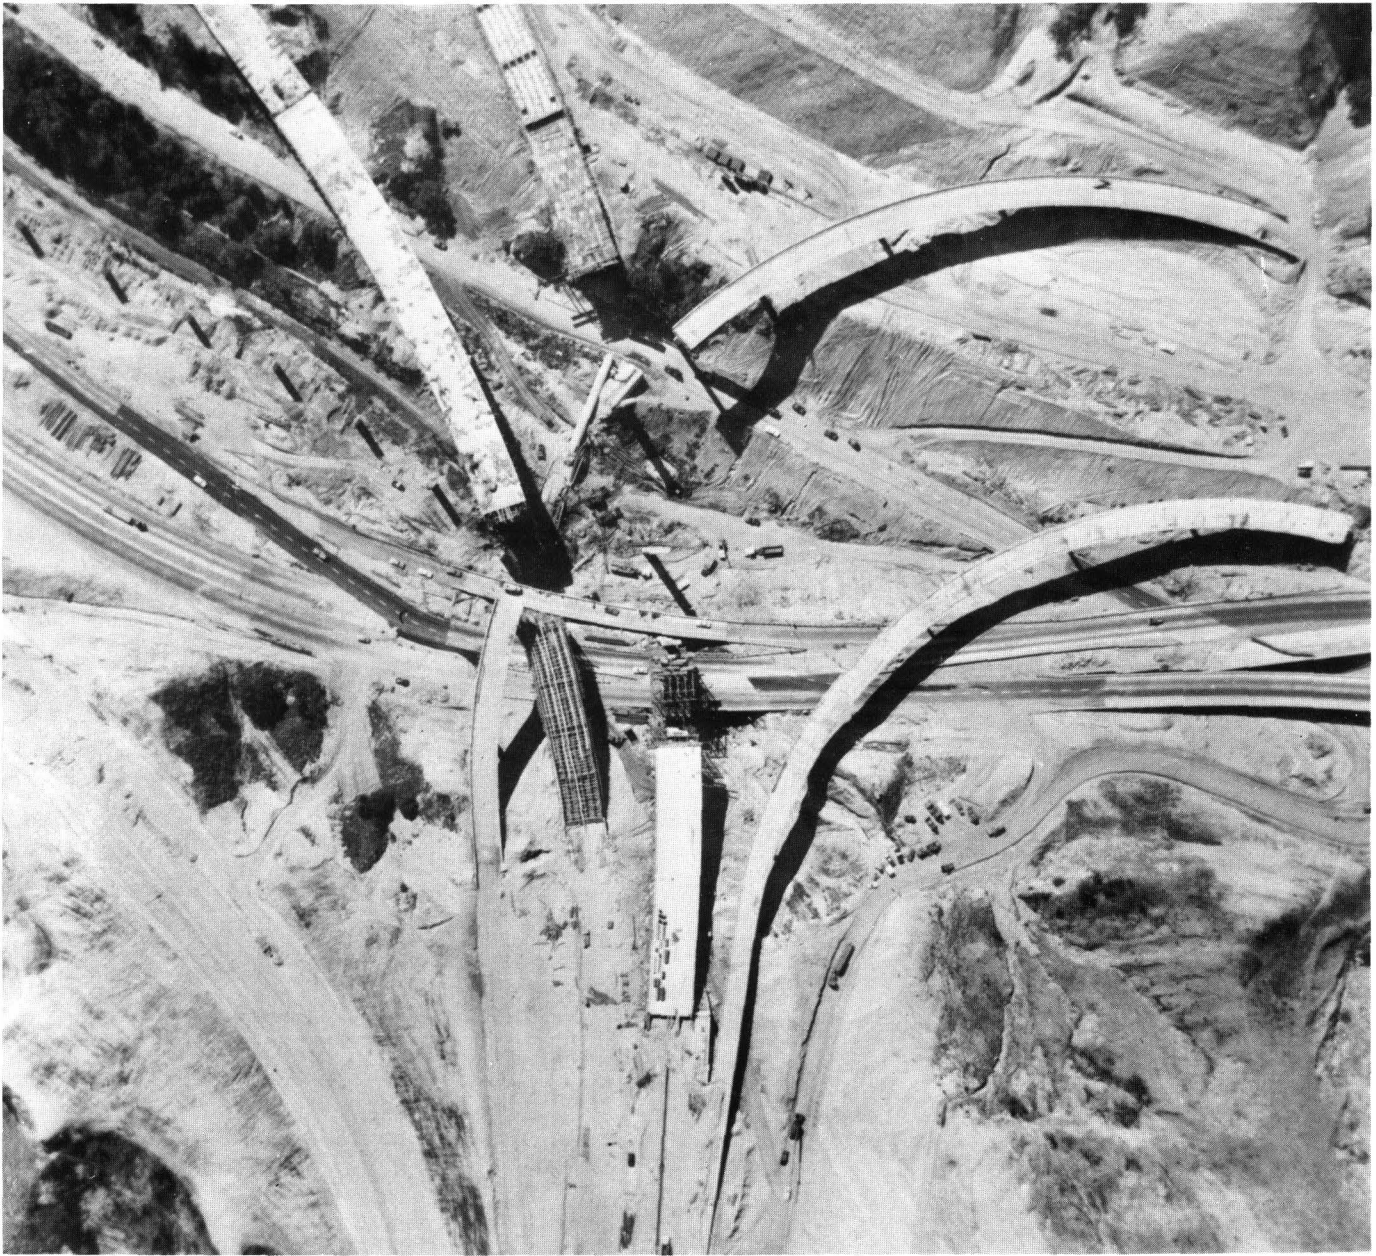
FIGURE 2.—Interchange at Routes 5/14. Looking north. Overpasses under construction collapsed. California Division of Highways photograph.

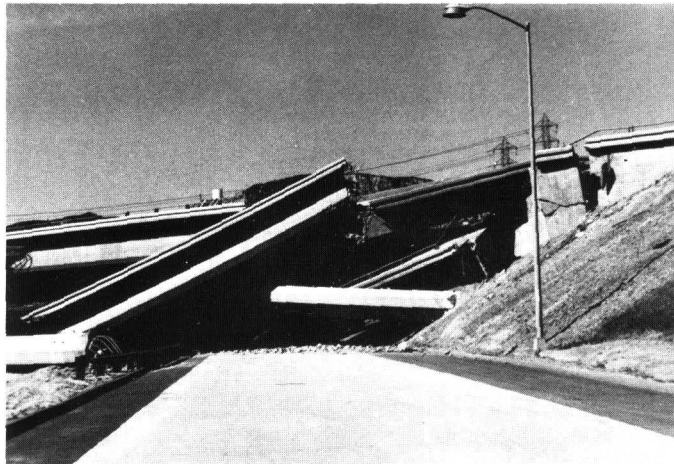
FIGURE 3.—Freeway overpass collapse. At interchange of Routes 5/210. J. F. Meehan, OAC photograph.

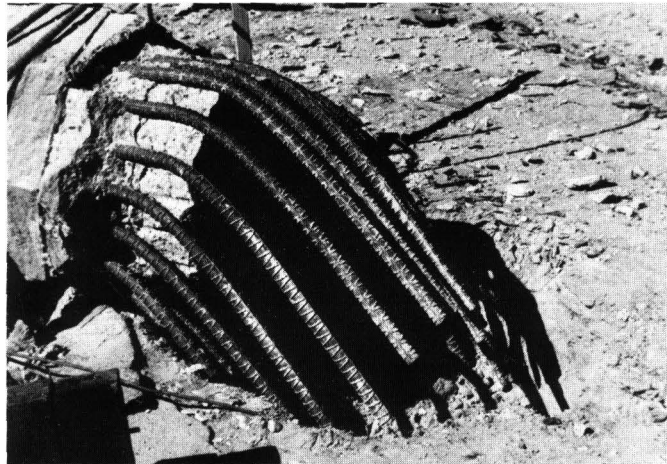
FIGURE 5.—Freeway overpass collapse. Routes 5/210. Column bores pulled from footing. J. F. Meehan, OAC photograph.

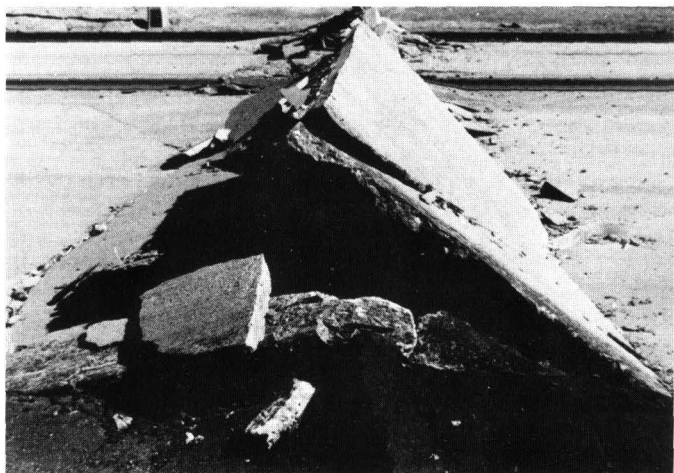
FIGURE 4.—Freeway compression, about 27 inches. South of interchange of Routes 5/210. J. F. Meehan, photograph.

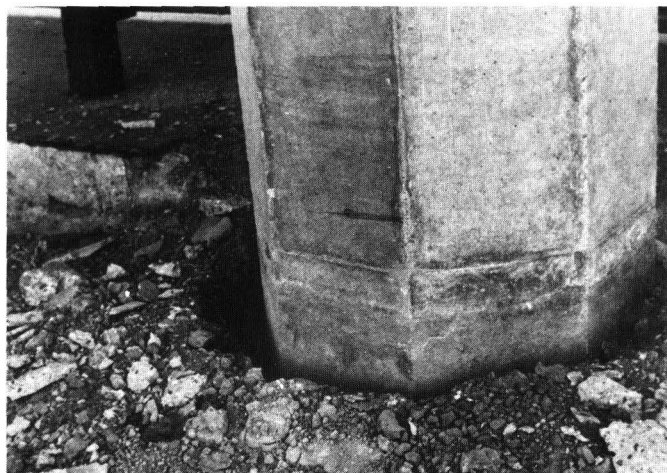
FIGURE 6.—Freeway Interchange 5/210. Column movement in soil. J. F. Meehan, OAC photograph.

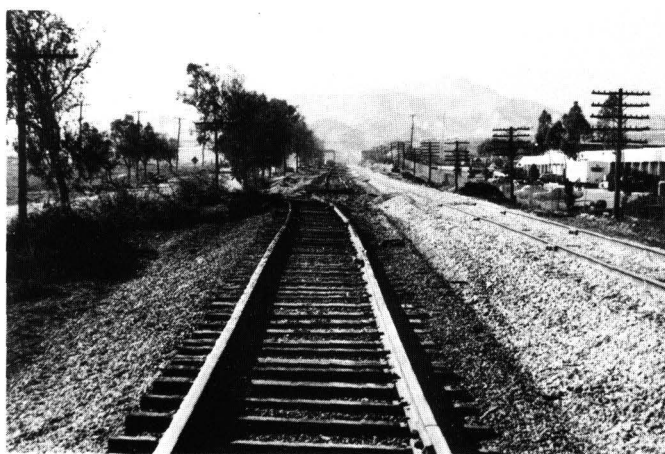
FIGURE 7.—Railroad west of Juvenile Facility. J. F. Meehan, OAC photograph.

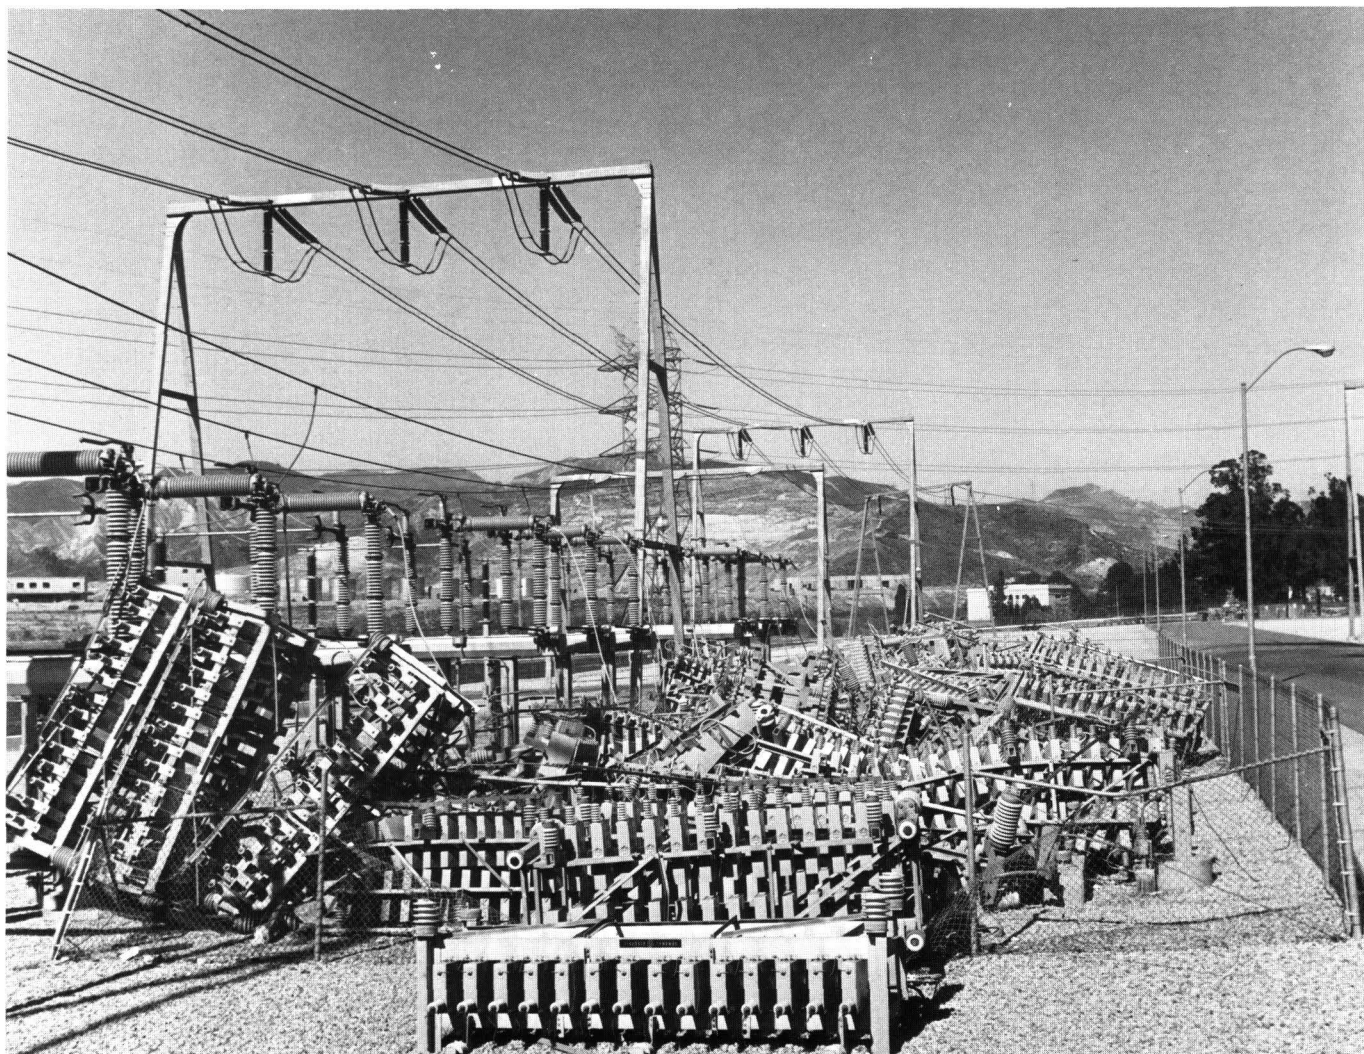
FIGURE 1.—Sylmar Converter Station collapsed condenser banks. DWP photograph.

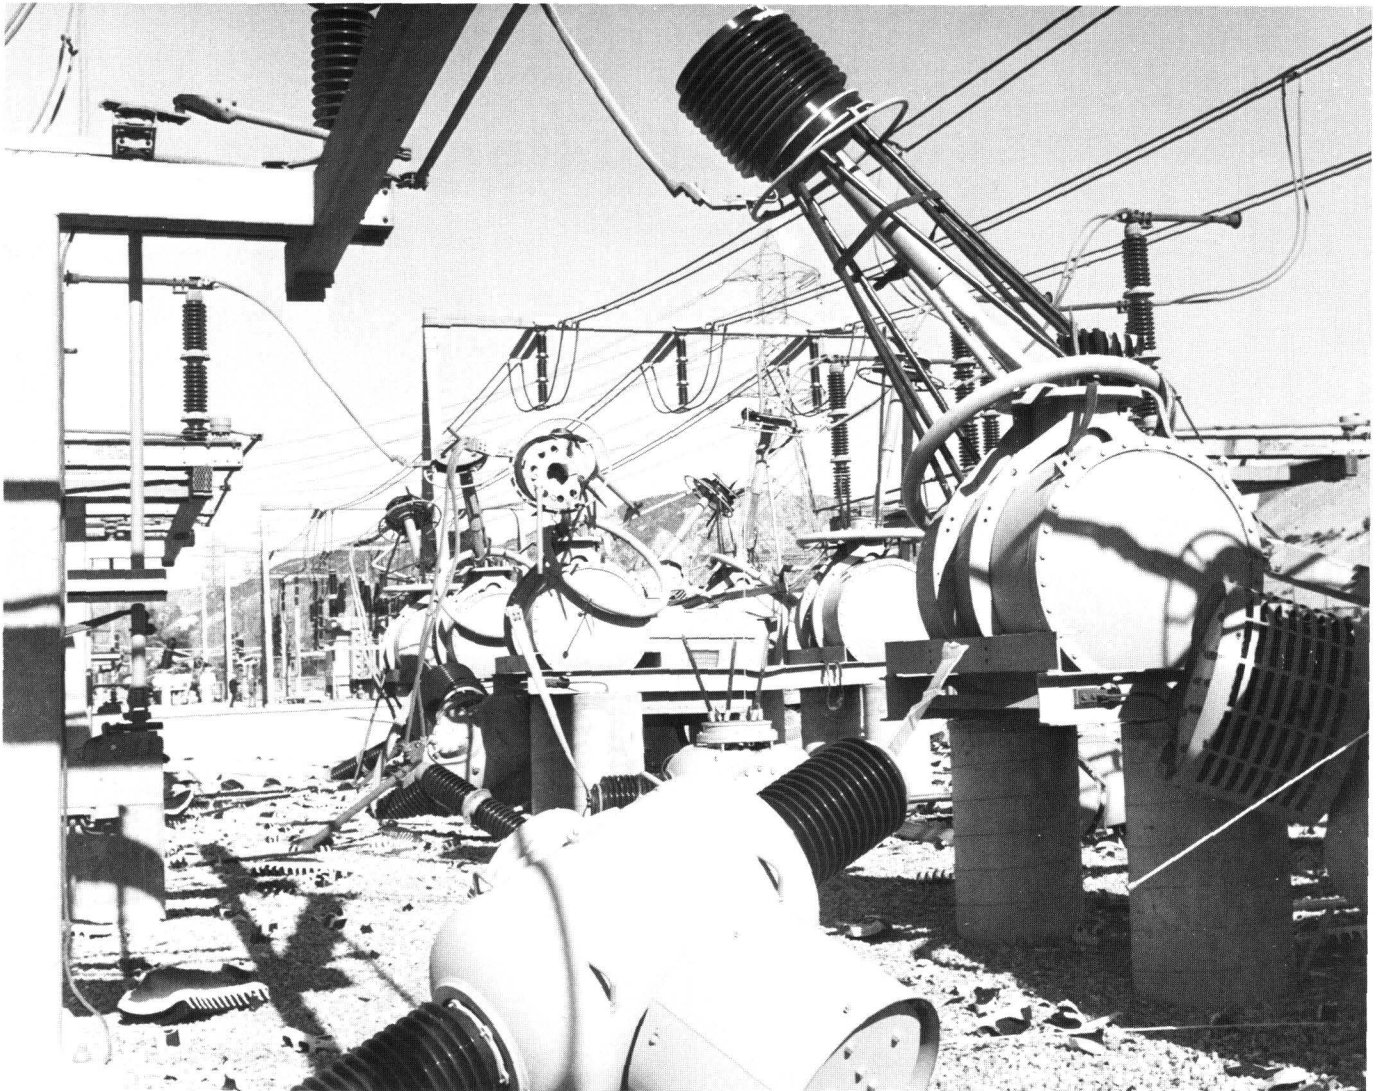
FIGURE 2.—Sylmar Converter Station air switches. DWP photograph.

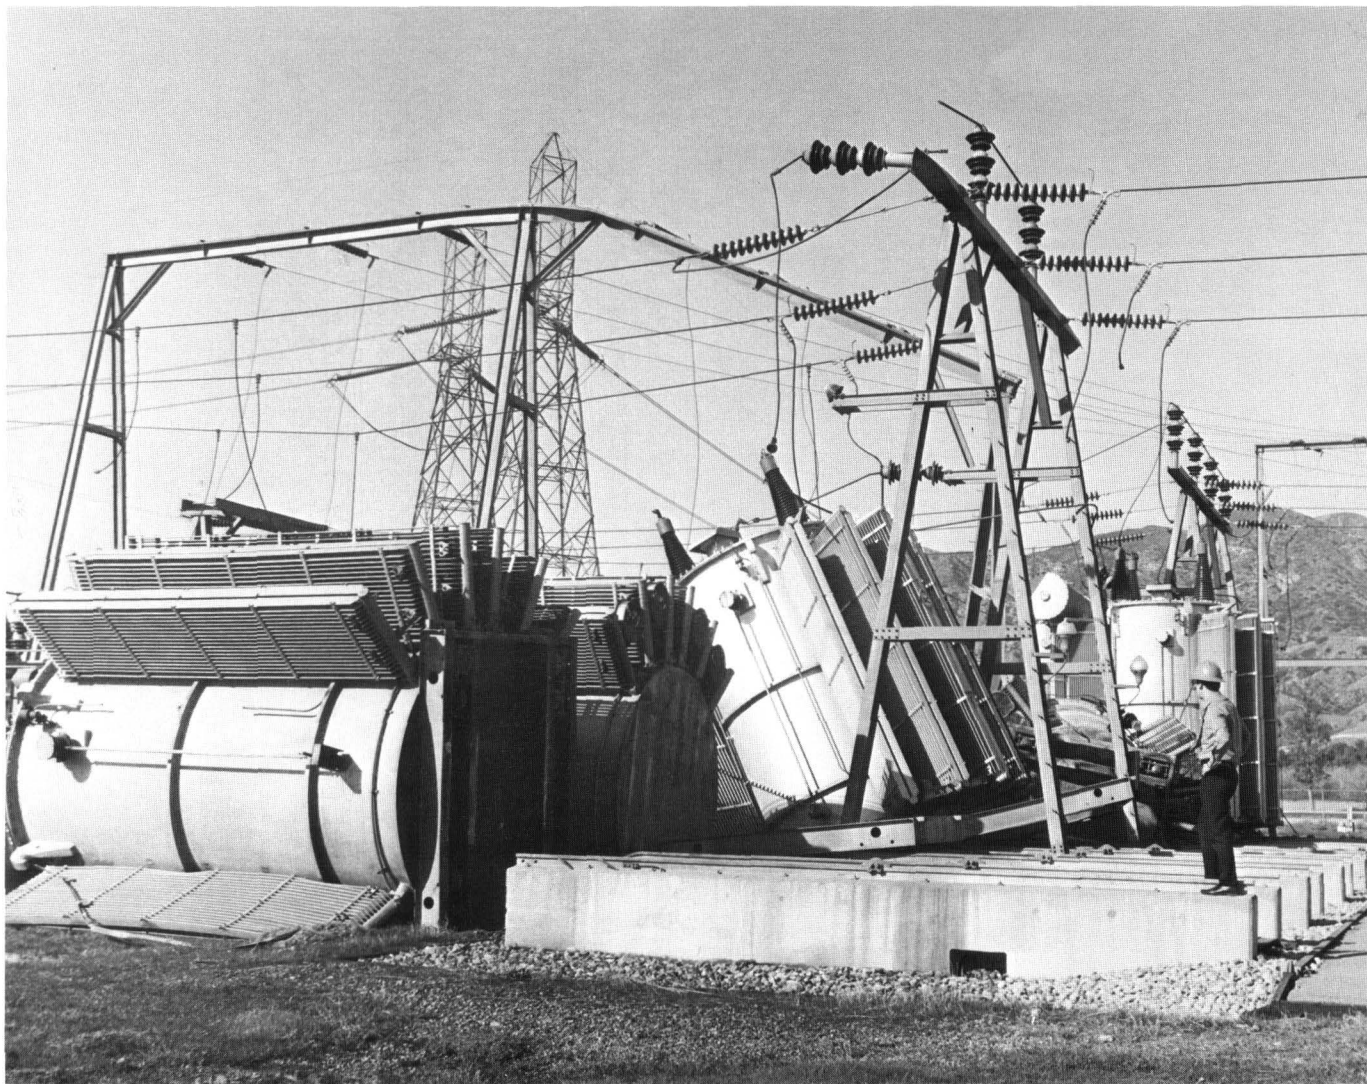
FIGURE 3.—Olive Switching Station overturned transformers. DWP photograph
