Geologic and Seismologic Aspects of the  
Managua, Nicaragua, Earthquakes of  
December 23, 1972

GEOLOGICAL SURVEY PROFESSIONAL PAPER 838

By R. D. Brown, Jr., P. L. Ward, and George Plafker

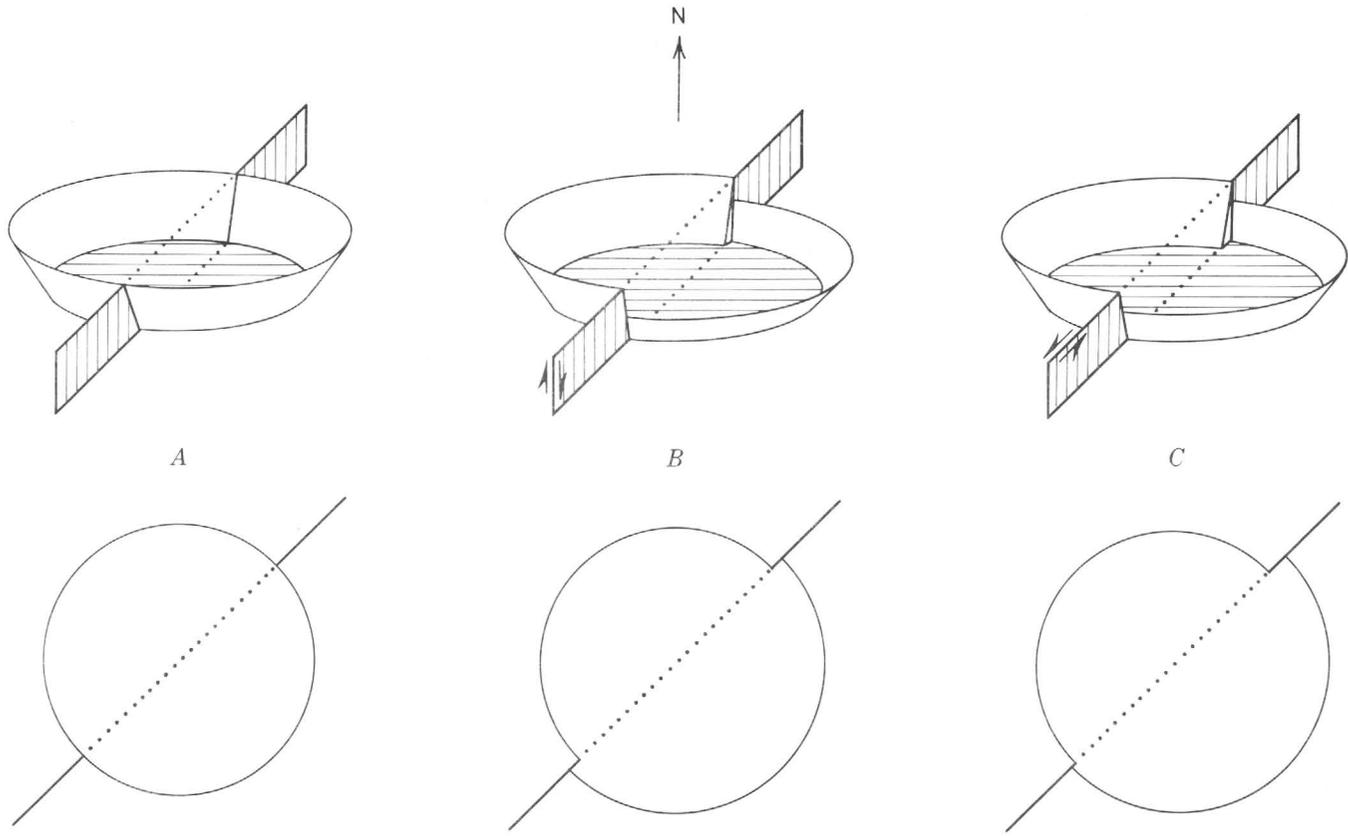
shore is illustrated diagrammatically in figure 16. The amount of inferred vertical and lateral displacement on the fault is subject to large uncertainties regarding the original crater shape and the extent to which that shape was modified by landslides along the crater walls. The most direct geometric reconstruction indicates that on the order of 30 m vertical and 10 m sinistral displacement provides the best fit for the lakeshore. Although the calculated amount of vertical slip is nearly double that which is indicated by scarp heights at the crater rim or further south along the fault trace, it is clear that any reasonable model requires a vertical component that is larger than the horizontal component. This is at variance with the predominantly strike-slip sense of displacement observed after the 1972 earthquakes, and may indicate a late Holocene change in style of tectonic deformation. The Tiscapa data, and other evidence for young faulting cited previously, indicate an extremely complex and active Holocene tectonic history in the Managua area involving recurrent horizontal and vertical movements over a broad zone of faulting. It is noteworthy that about 30 fault movements, equivalent in displacement to that which occurred during the 1972 event would be required to produce just the 10 m of sinistral displacement that has offset the shores of Lake Tiscapa—an indication that there must have been many repeated displacements on the fault since the Tiscapa crater was formed.

FIGURE 16.—Schematic diagrams illustrating possible fault-controlled topographic modifications at the Tiscapa pit crater (oblique views above) and Lake Tiscapa (plan views below). For clarity, the vertical and horizontal displacements are shown sequentially, although it is likely that they were at least in part simultaneous. *A*, Inferred initial shape; *B*, Formation of rim scarp and symmetrically offset lake shore due to vertical fault slip; *C*, asymmetrical offset of lake shore due to sinistral slip. Diagrams are not to scale.

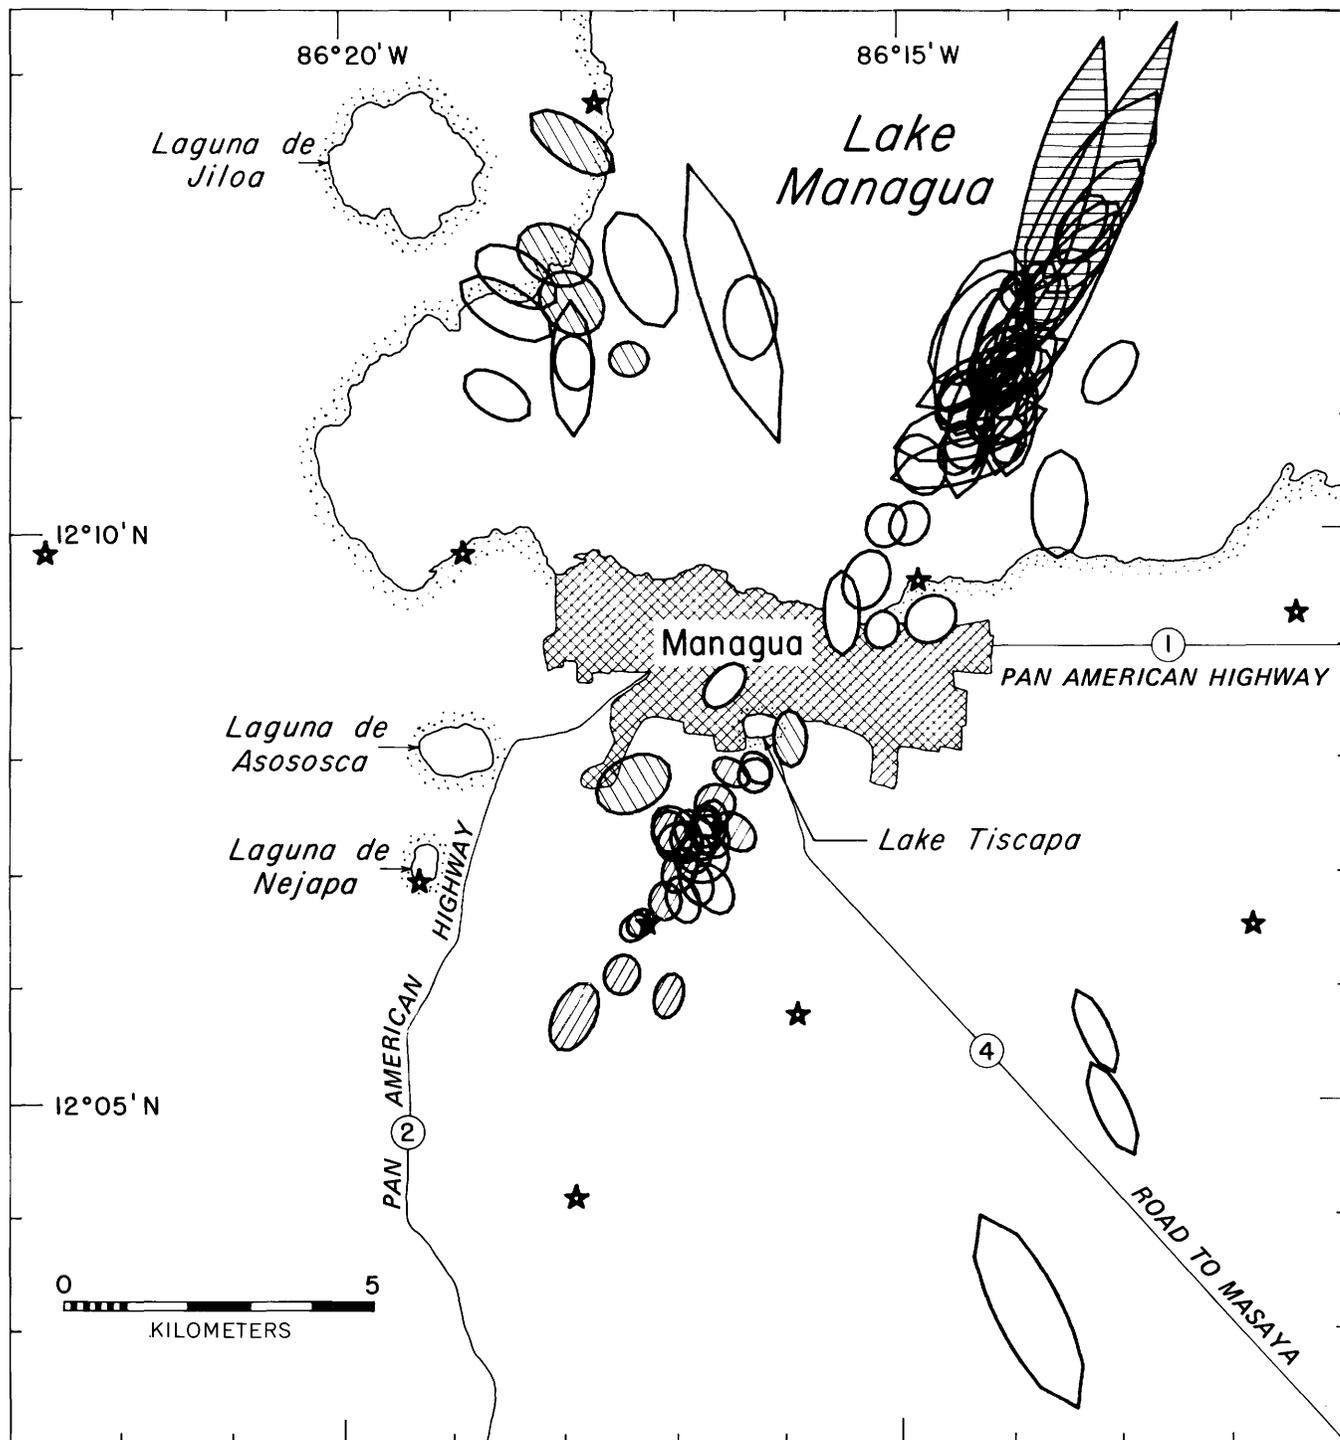
The locations of the aftershocks are shown in figure 20. The polygons represent the error in location, assuming a possible error in reading the arrival times at each station of 0.1 second. This standard error, which is statistically the 68-percent confidence limit, is calculated as an ellipsoid. Each polygon plotted is the shadow of an ellipsoid on the plane of the map projection where, to save computer time, the shadow is plotted as an 18-sided polygon rather than as a smooth ellipse. Thus we are 68 percent certain that the epicenter for each earthquake lies within the polygon plotted on the map. The largest symbols represent the least accurate locations. These error limits do not include the possible errors in location caused by incomplete understanding of the crustal structure. As discussed above, those errors are small and would cause a systematic shift in the locations.

FIGURE 20.—Locations of 94 aftershocks for the period from January 4 to January 17, 1973. The polygons represent the error in location assuming a possible error in reading the arrival times at each station of 0.1 second. Station locations are designated by stars. Polygons for earthquakes with nodal plane solutions other than type A (fig. 22) are crosshatched as follows: type B, east-west trending lines; type C, southwest-trending lines; D, southeast-trending lines.

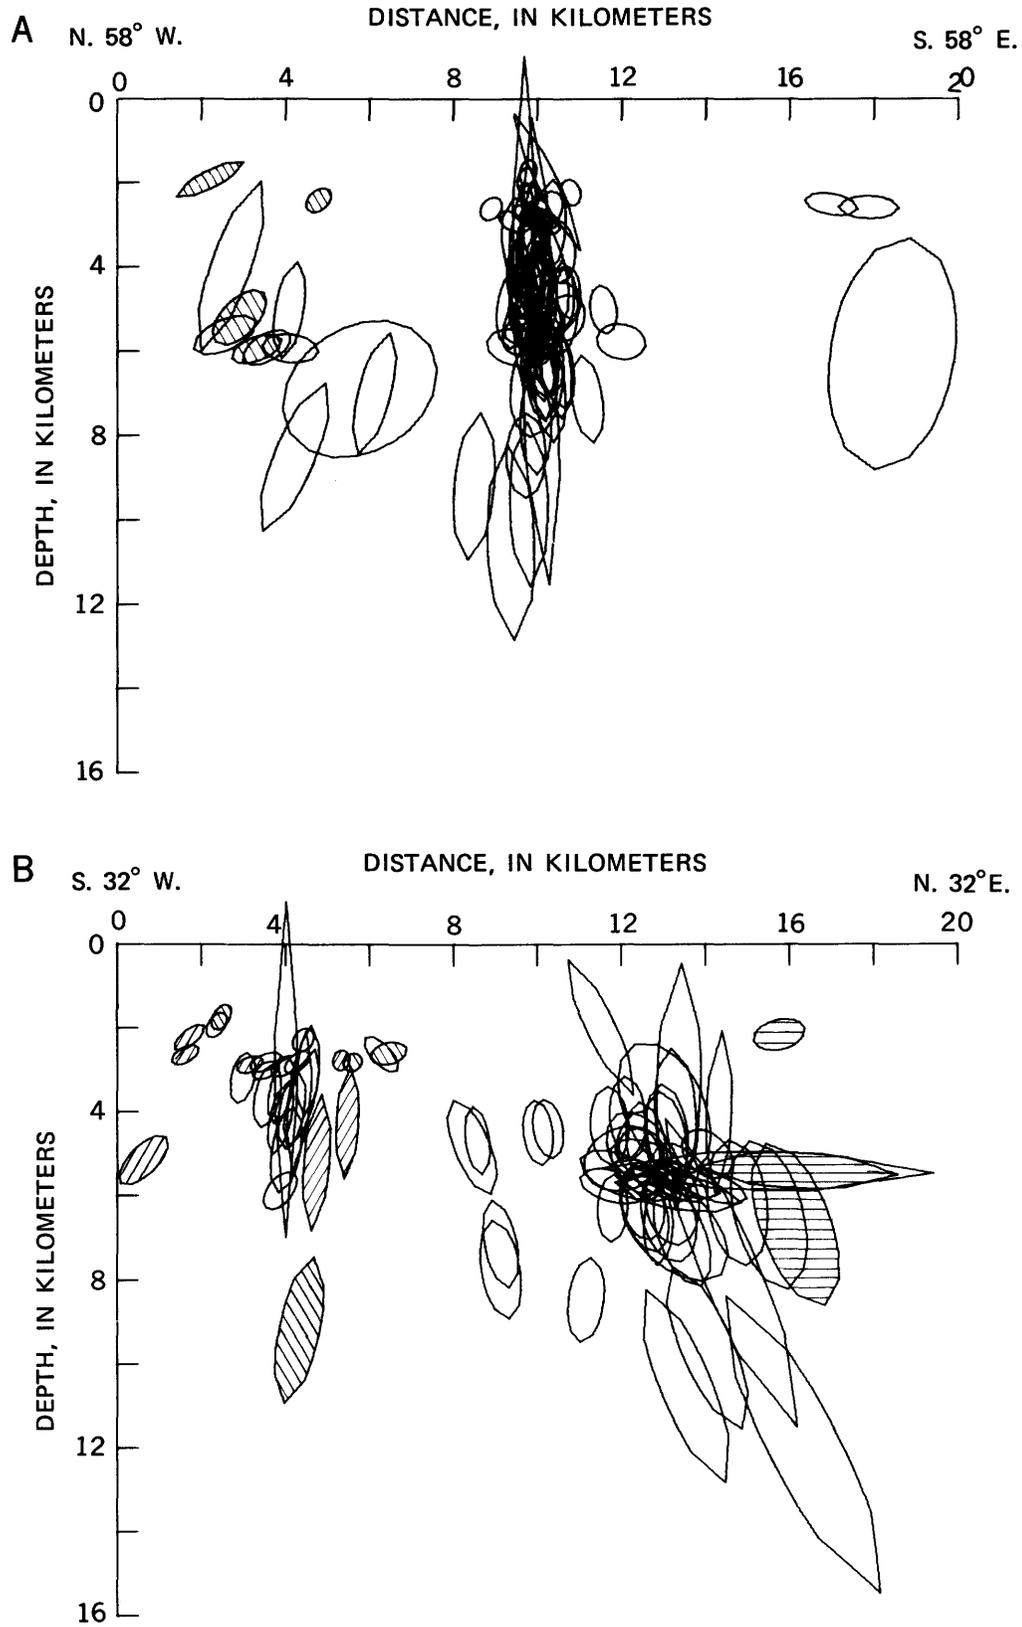
The depths of these events clearly range from about 2 km to about 8 or 10 km, or at most 16 km. All earthquakes are shown in figure 21A where they are projected onto a vertical plane striking  $N. 58^{\circ} W.$  through the area and perpendicular to the main epicentral trend. The locations of the earthquakes in this northeast-trending zone are shown in figure 21B where they are projected onto a vertical plane passing along the zone. Note that most locations define a narrow vertical zone of seismic activity. Thus, aftershock locations considered with the observed surface faulting clearly imply that the fault that broke during the main earthquake on December 23, 1972, is 10 to 15 km long, extends to a depth of 8 or 10 km, and strikes approximately  $N. 30^{\circ}$  to  $35^{\circ} E.$

FIGURE 21.—Hypocenters of the aftershocks projected onto vertical planes. The strike of plane A is N. 58° W., and for plane B, the strike is N. 32° E. The polygons and crosshatching are the same symbols used in figure 20.

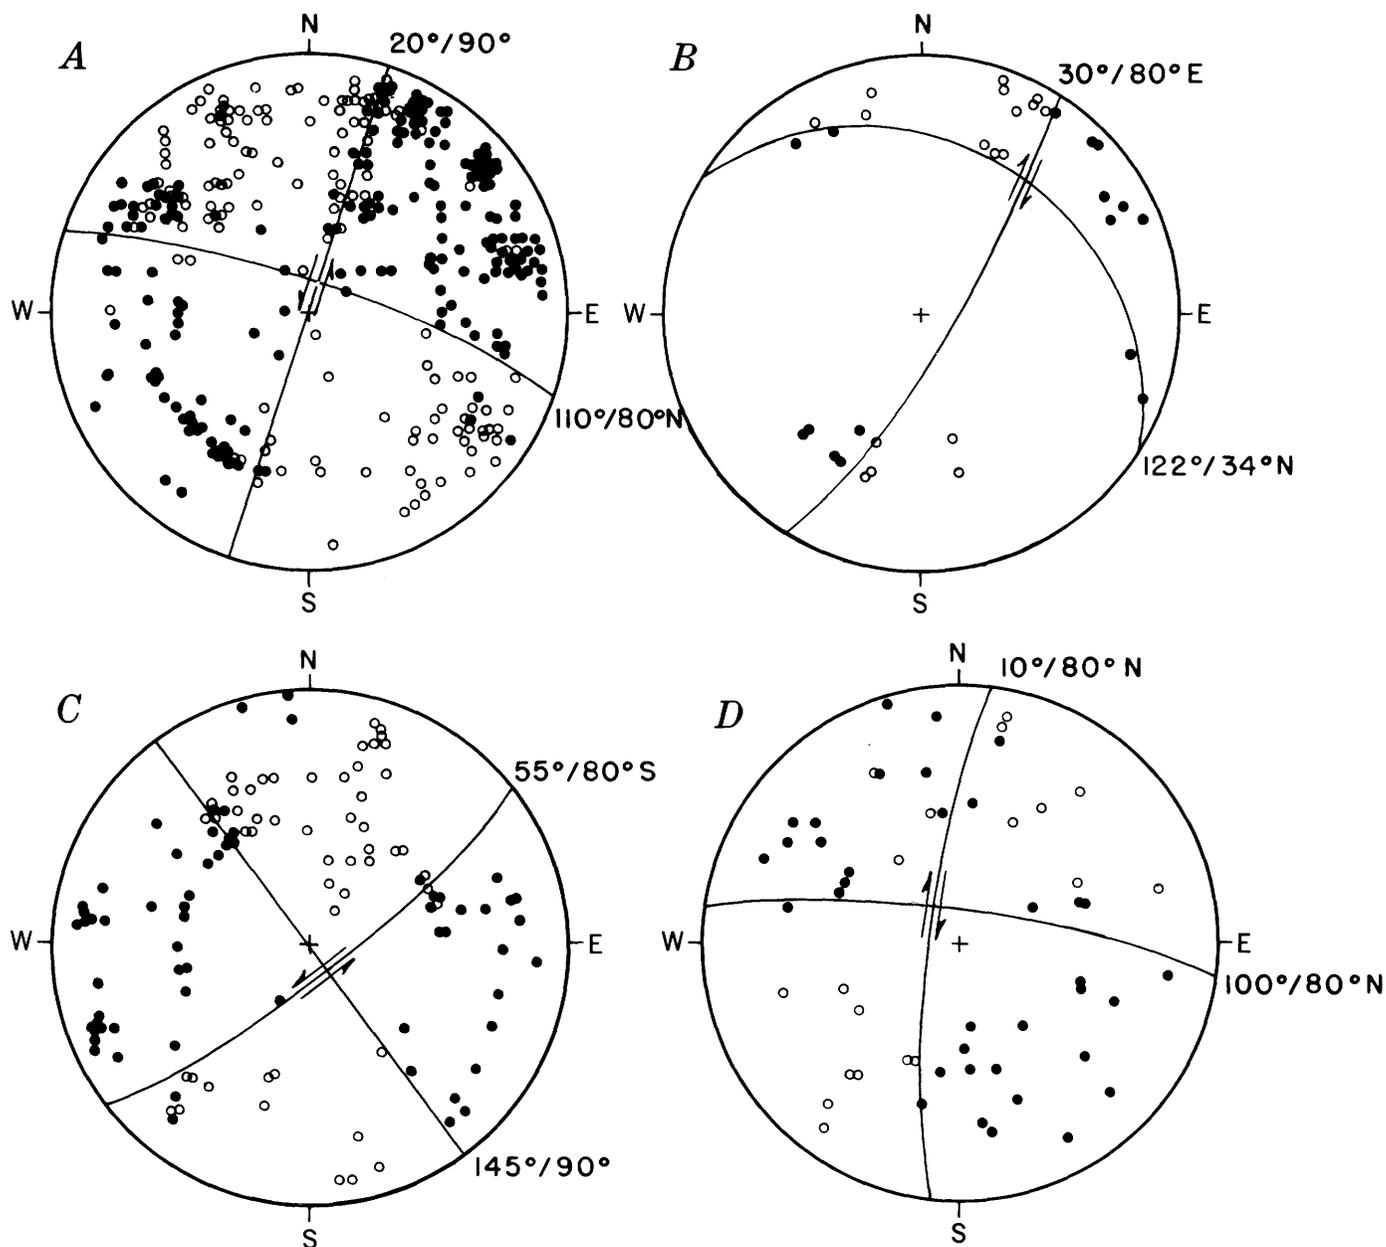
FIGURE 22.—Composite nodal plane solution for 59 type *A* events, 5 type *B* events, 19 type *C* events, and 9 type *D* events. The plots are an equal area stereographic projection of the lower half of an imaginary sphere around the focus of the earthquake. Waves traveling up directly through the upper half of the sphere are projected through the center of the sphere onto the lower half. Compressions or upward motions of the ground are represented by solid circles; dilatations or downward motions of the ground are represented by open circles. Arrows designate the direction of motion on the most likely nodal plane chosen because of the trend of the zone of aftershocks and the trend of the surface faulting.

- A. Fifty-nine earthquakes show sinistral slip along a vertical plane roughly parallel to the main zone of seismic activity. These events are located predominantly on the northeast half of the main seismic zone and in the cluster of events to the northwest. Some are located to the southwest.
- B. Five earthquakes near the northeast end of the seismic zone have sinistral slip but with a major component of normal faulting down to the southeast.
- C. Nineteen events in the cluster of activity near the southwest end of the fault show sinistral slip along a nearly vertical fault striking N. 55° E.

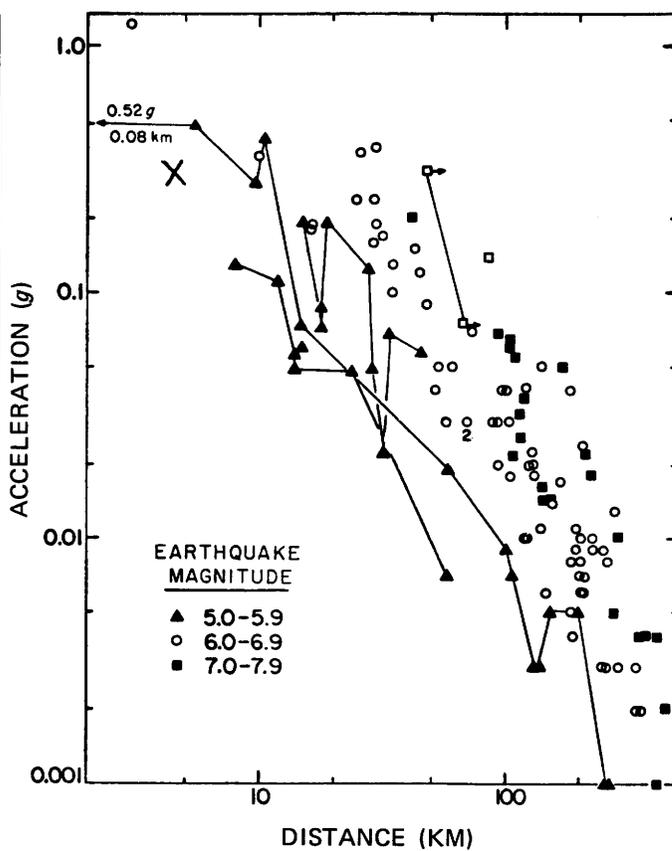
FIGURE 23.—Peak horizontal acceleration versus distance to the slipped fault as a function of magnitude (after Page and others, 1972). The X is the peak acceleration of 0.31g observed at the ESSO refinery for the Managua earthquake.
