# Soil Slips, Debris Flows, and Rainstorms in the Santa Monica Mountains and Vicinity, Southern California

U.S. GEOLOGICAL SURVEY PROFESSIONAL PAPER 851

By RUSSELL H. CAMPBELL

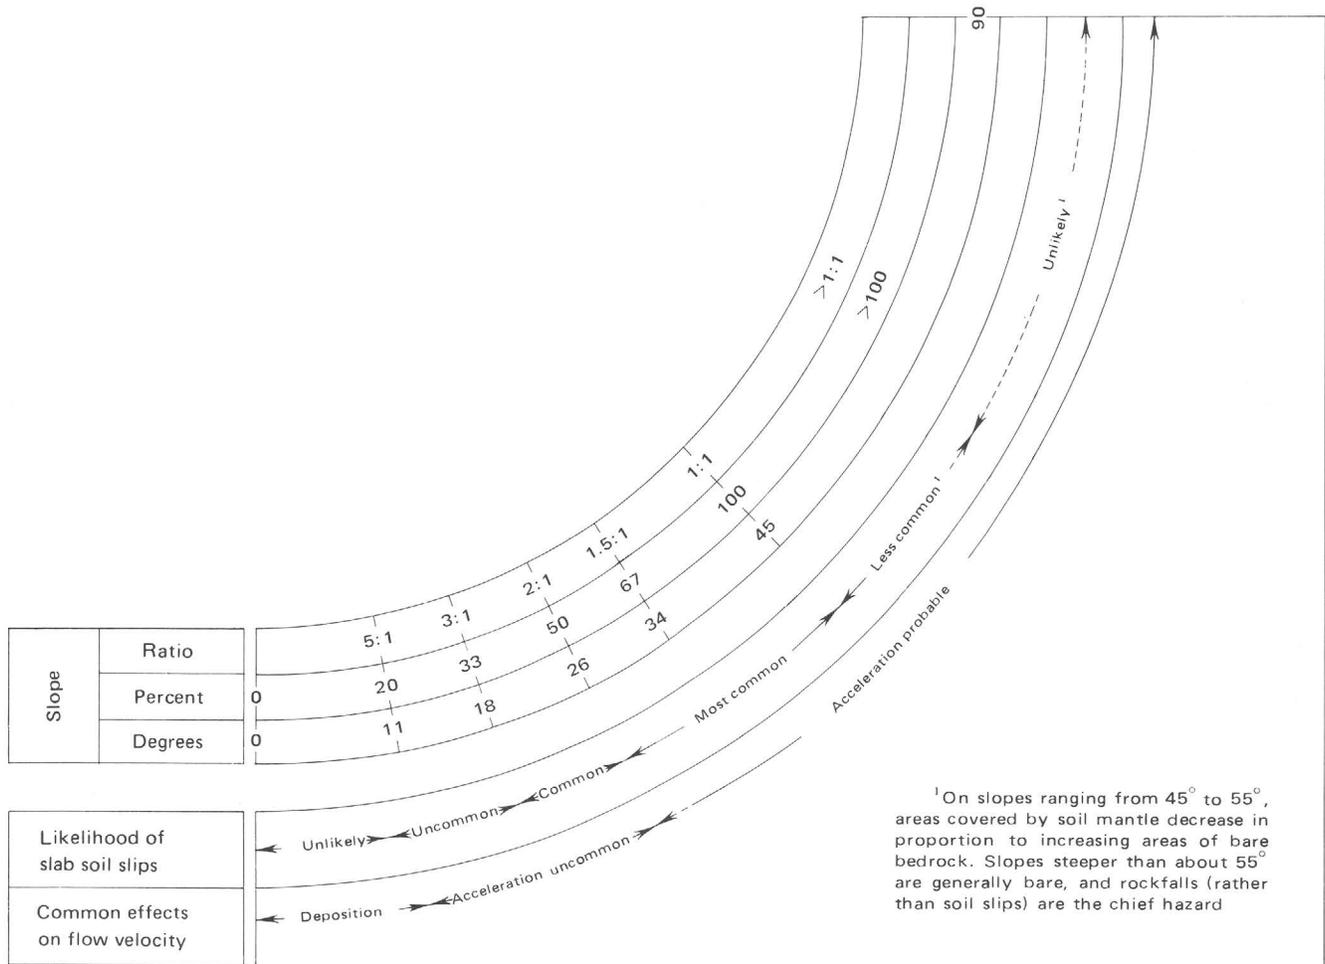
Soil slips were common in the Santa Monica Mountains on slopes from about  $25^\circ$  to about  $45^\circ$  during the storm of January 18–26, 1969, and the lowest slope that failed was about  $22^\circ$ . For comparison, after the storm of November 21–25, 1965, Corbett and Rice (1966, p. 6) found that in the San Dimas Experimental Forest, in

FIGURE 8.—Approximate relations of natural slopes to soil-slip failures.

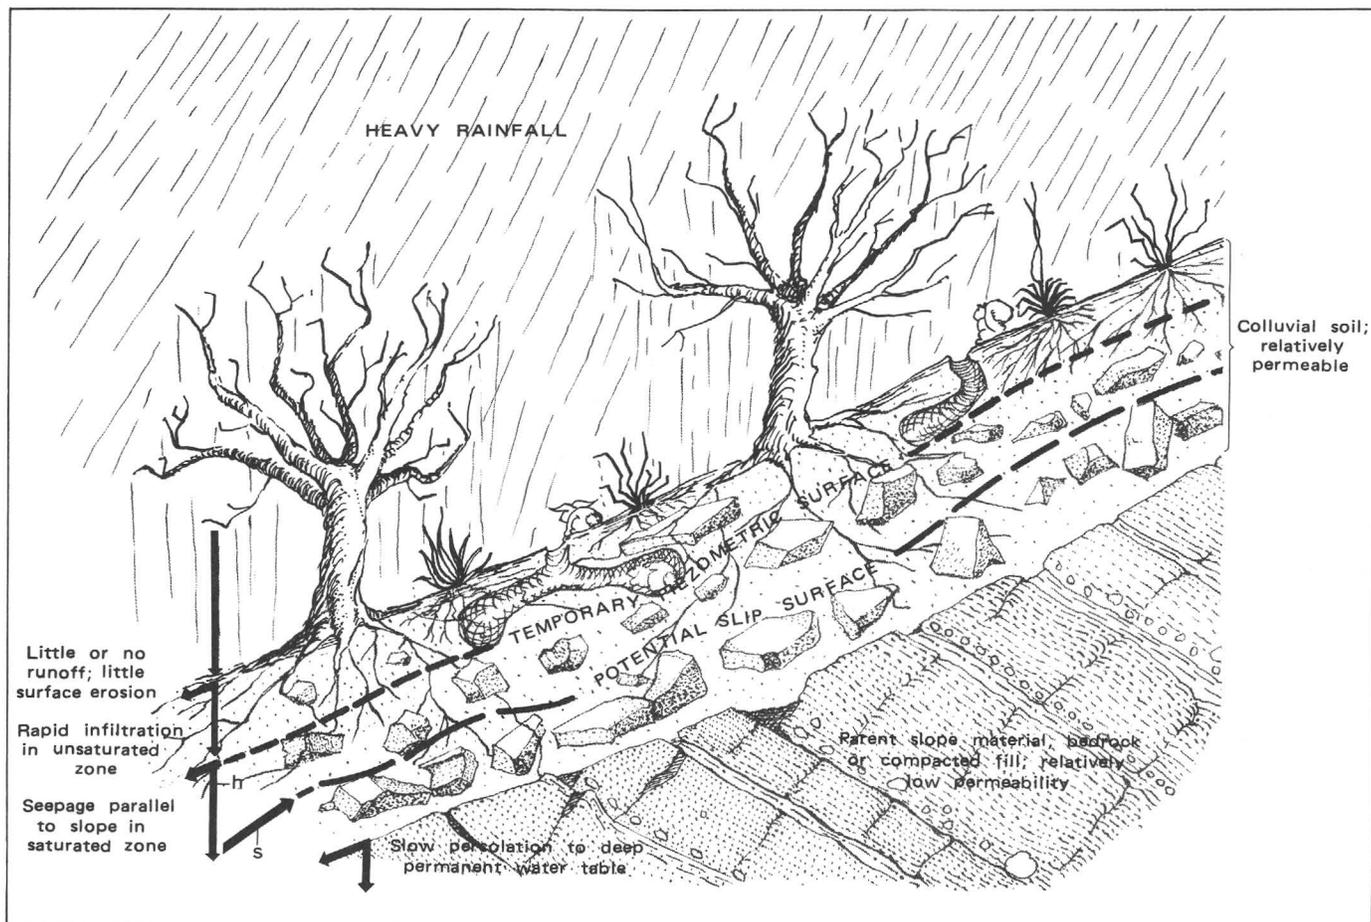
FIGURE 16.—Diagram showing buildup of perched water table in colluvial soil during heavy rainfall. Bedrock subsoil is shown here; however, soil slips also occurred over compacted fill slopes where the transition from parent material to colluvial soil is more obviously gradational. The significance of the piezometric head ( $h$ ) in reducing the shearing resistance ( $S$ ) is discussed in the text, with regard to the formula  $S = c + (p - hw) \tan \phi$  (Terzaghi, 1950).

The mechanism is illustrated by figure 16, which shows shallow-rooted vegetation with a thin mulch of dead leaves and grass growing in a regolith of colluvial soil, the upper part of which contains abundant living and dead roots as well as animal burrows. When the

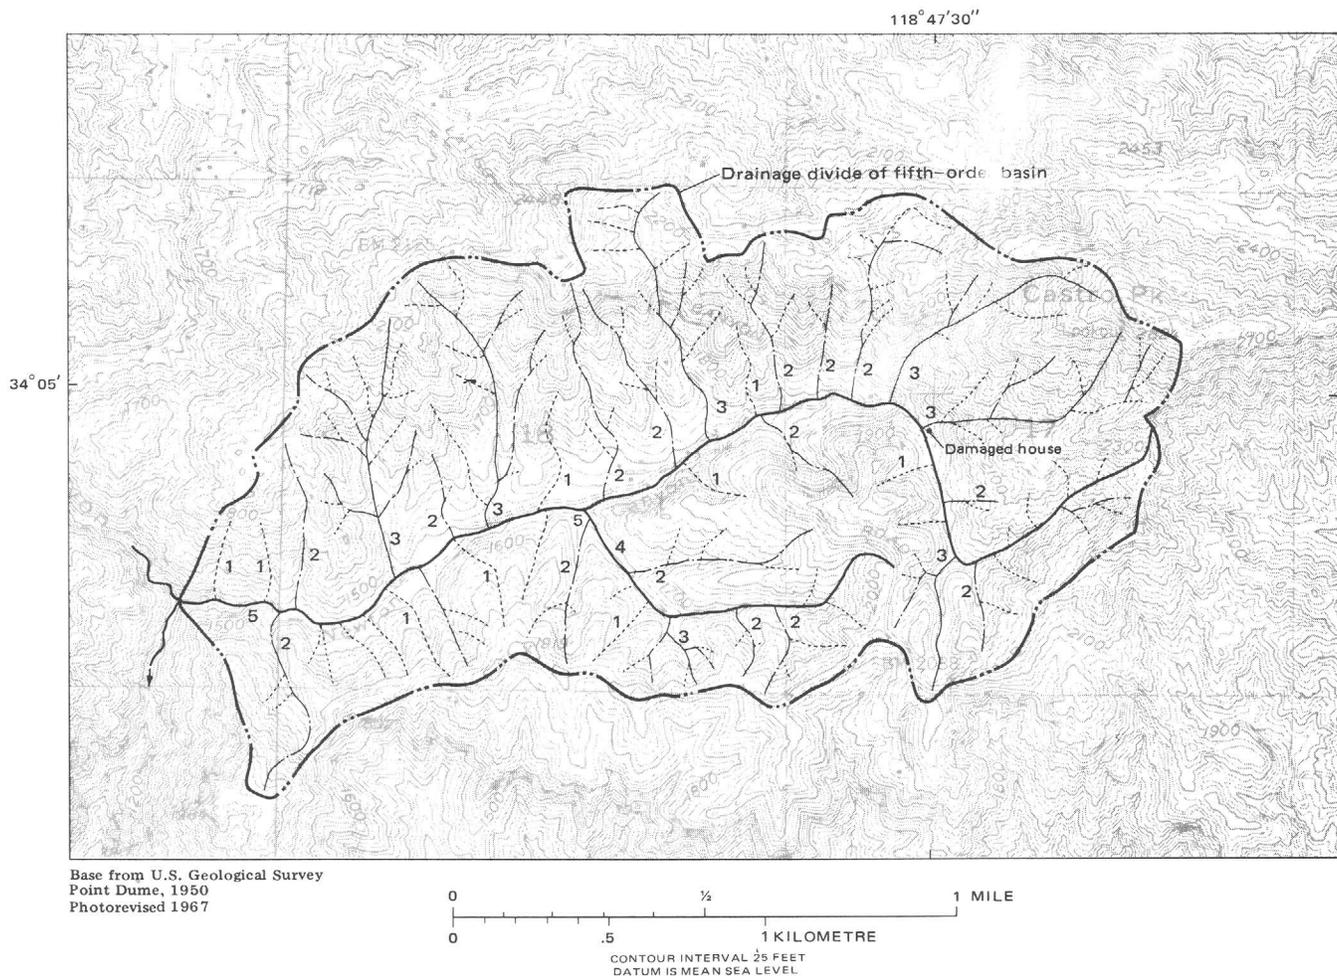
FIGURE 29.—Drainage basin of Newton Canyon, showing location of house destroyed by debris flow of December 29, 1965, at junction of third-order tributary with fifth-order trunk stream. Rank of tributary shown by number.

- 15. *Treatment:* Event not predicted and proceeded too rapidly to permit erection of defenses. Recognition of potential for event and evacuation during high-intensity rainfall would have saved resident

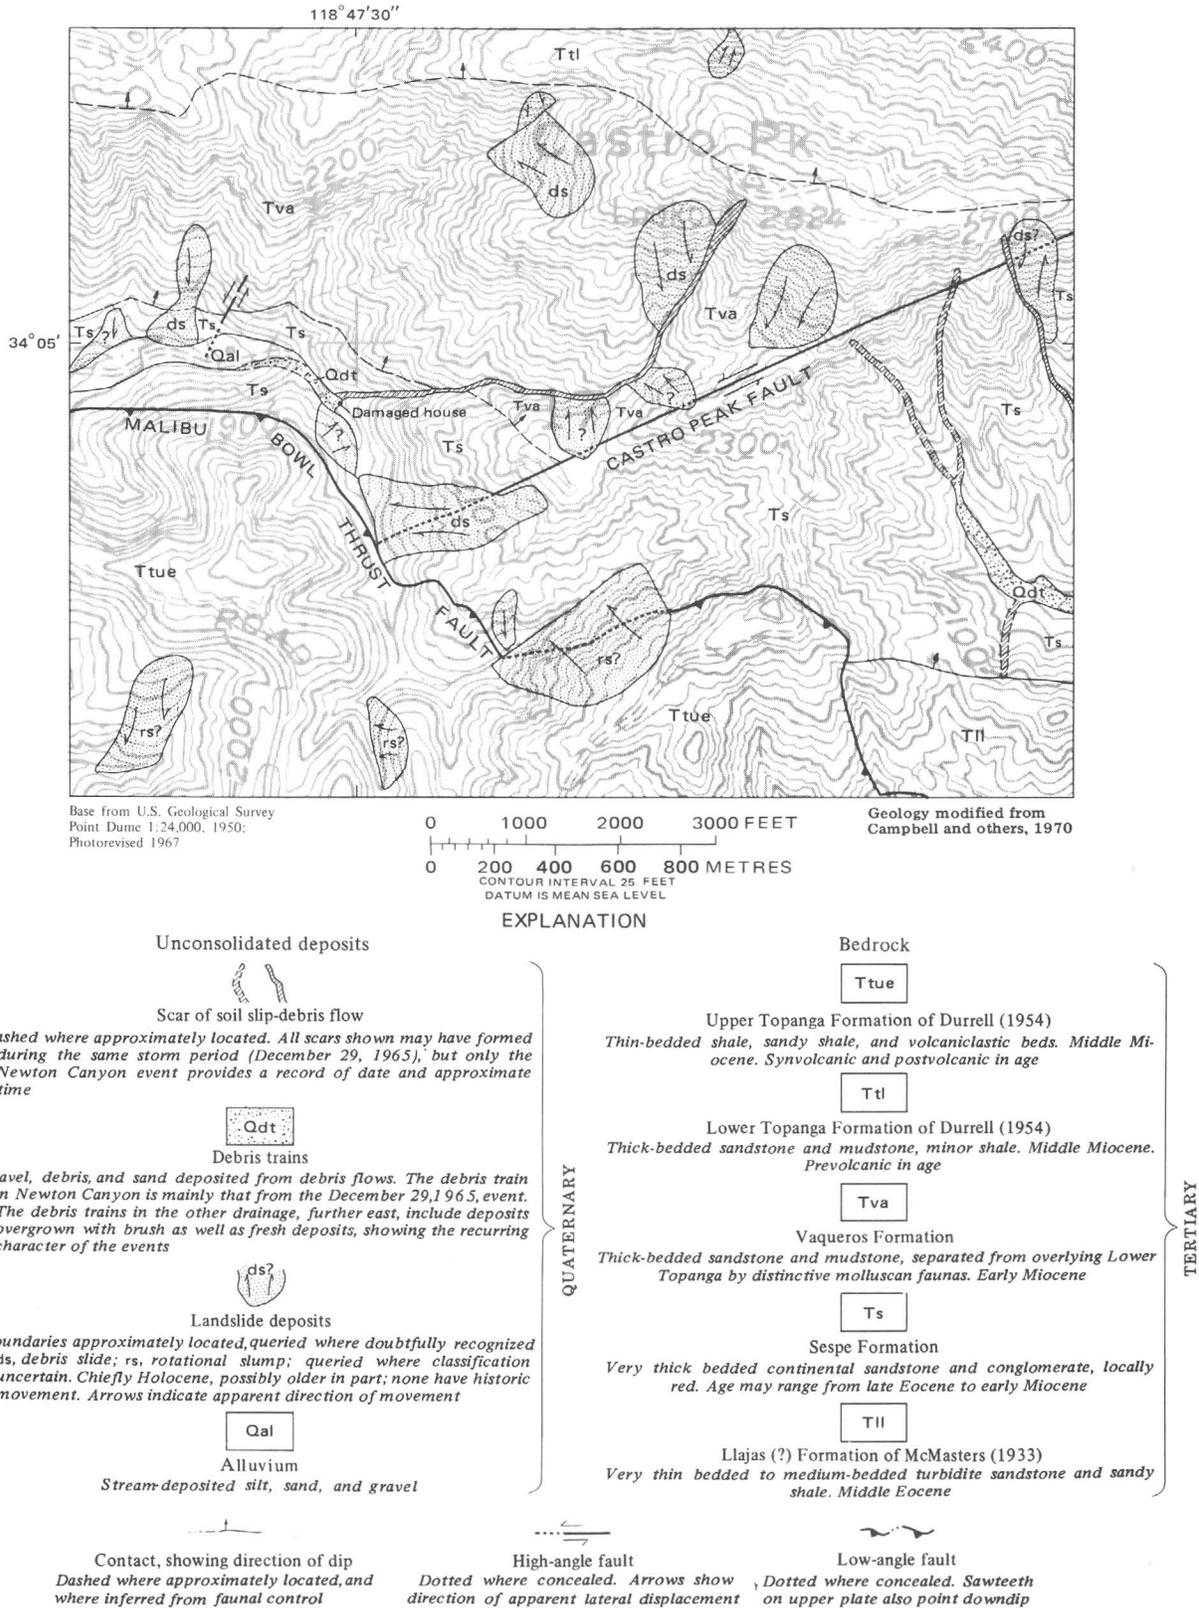
- c. *Thickness:* Scar.—Judging from thickness of material remaining adjacent to scar, colluvium was 1–3 feet thick in headwall and on flanks of channel. May have been as much as 15 feet thick in the bottom of a few parts of the gentler reaches of the ravine, but was probably generally less than 5 feet thick; Deposit.—Highly irregular piles of boulders and brush from a few inches to as much as 6 feet (mostly brushy), but mostly less than 4 feet high. Much of deposit reworked by bulldozer during search for the missing resident. Much of silt and fine sand probably continued downstream as muddy floodflow.

FIGURE 30—Geologic map of upper Newton Canyon, showing path of debris flow of December 29, 1965, and similar scars in nearby uninhabited areas.

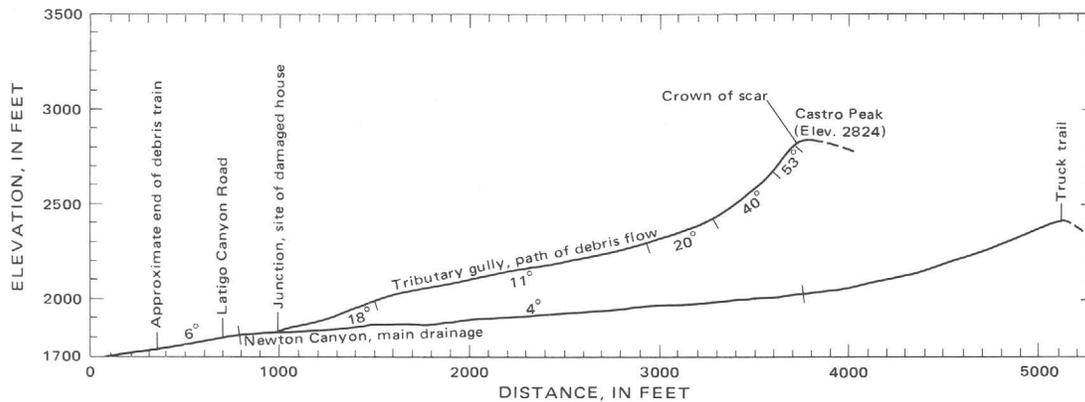
- 6. *Distance moved:* Material from the head of the scar moved at least 3,100 feet.
- 7. *Original slope at failure:* Steepest gradient in headwall about 50 degrees. Gentlest reach 11° (fig. 32).
- 8. *Estimated rate of movement:* Very rapid to extremely rapid—probably greater than 10 ft/s. The impact damage at the head of the debris train indicates momentum from high velocity of debris.
- 9. *Precipitation conditions:* Prolonged heavy rains preceded and accompanied the failure.
- 10. *Subsurface water:* Prior to seasonal rains, there were no springs or other indications that a permanent water table in the bedrock intersected the ground surface in the drainage that failed,

FIGURE 32.—Profile of Newton Canyon debris flow of December 29, 1965, comparing gradients of trunk canyon and tributary. Note that there is no vertical exaggeration.

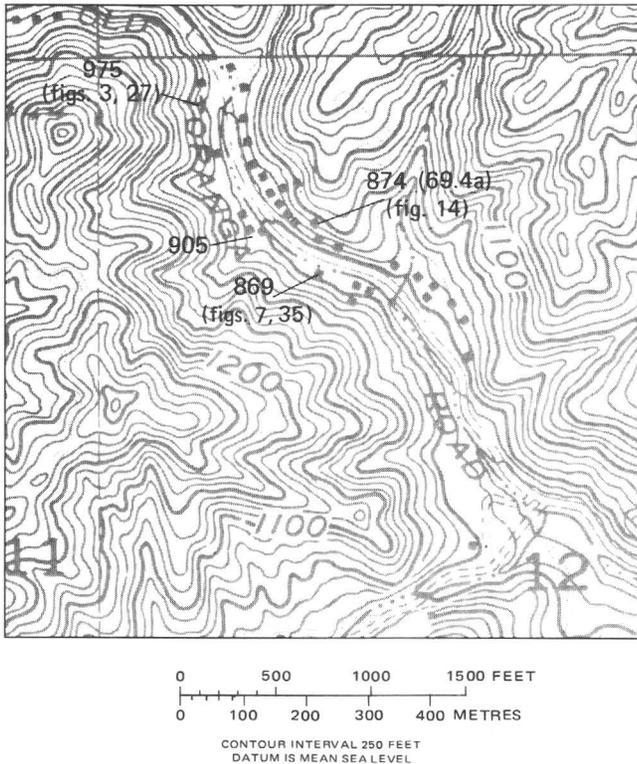
FIGURE 34.—Map of NW $\frac{1}{4}$  sec. 12, T. 1 S., R. 16 W., Topanga 7.5' quadrangle, showing location of several damaging debris flows in Old Topanga Canyon. Numbers refer to street addresses.
