# THE GUATEMALAN EARTHQUAKE OF FEBRUARY 4, 1976, A PRELIMINARY REPORT

GEOLOGICAL SURVEY PROFESSIONAL PAPER 1002

A. F. ESPINOSA, EDITOR

*A preliminary report of a series of  
closely related studies of the  
destructive Guatemalan earthquake of  
February 4, 1976*

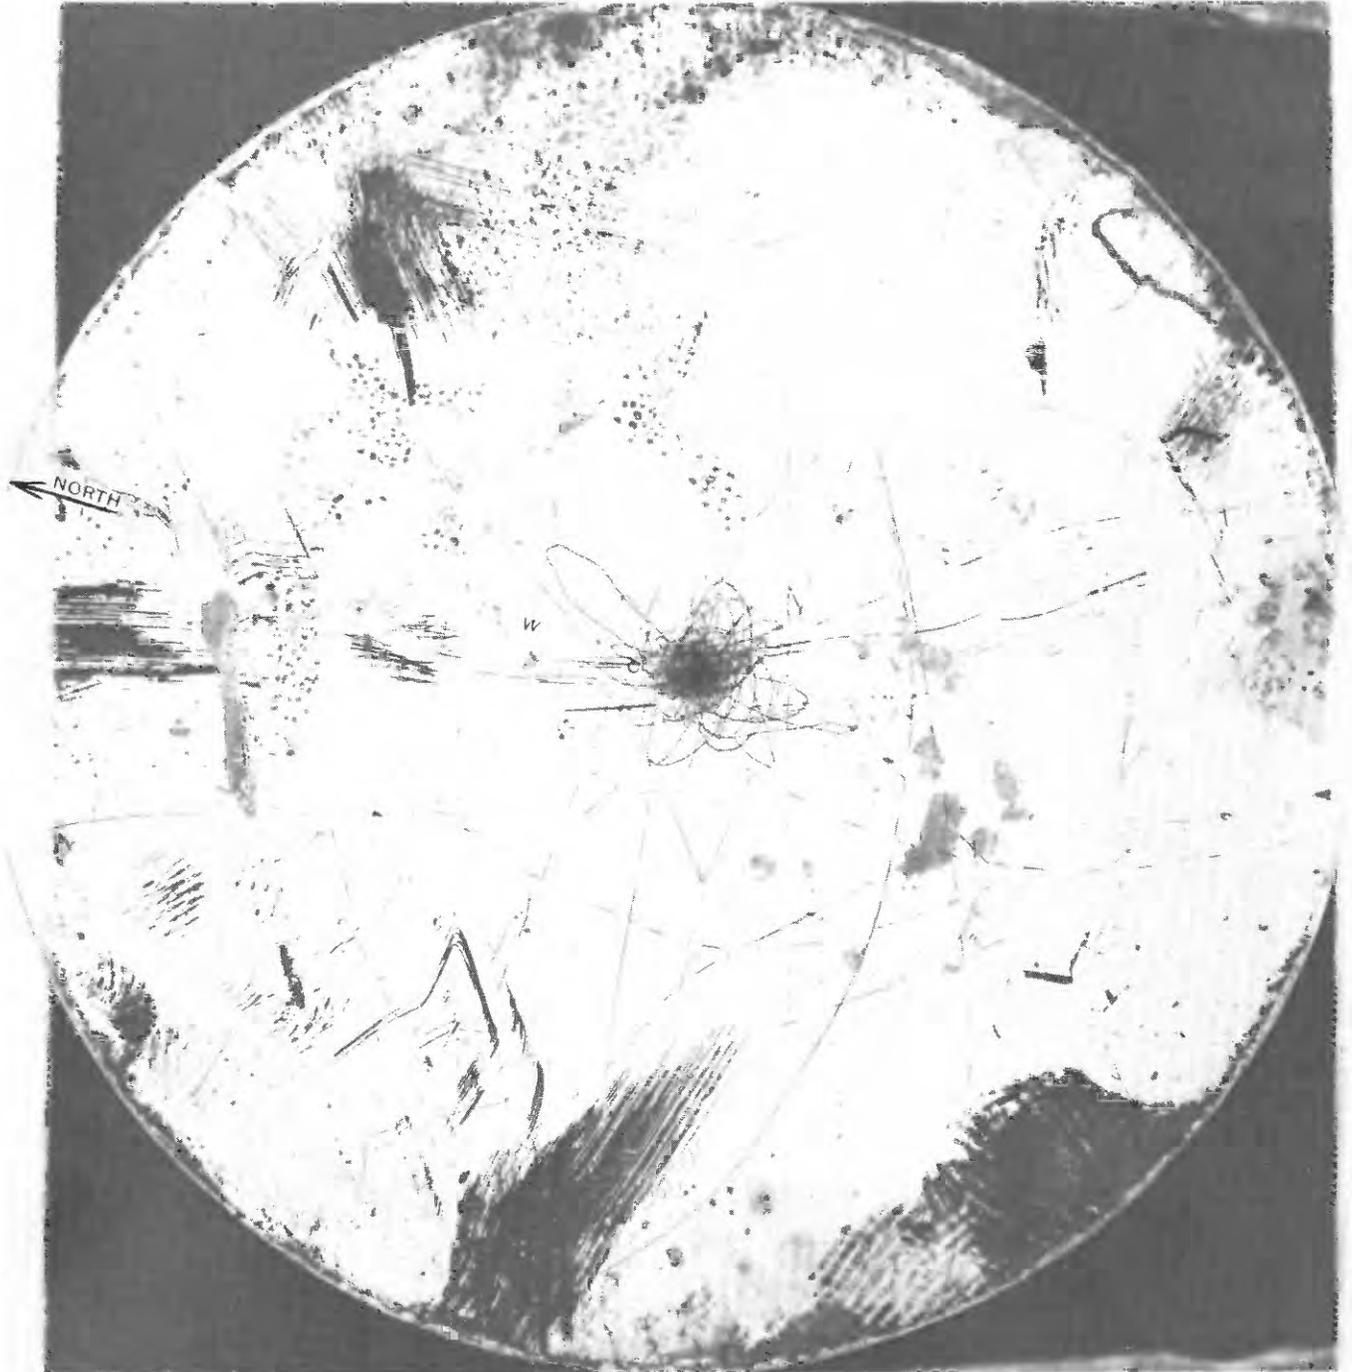
had been dislodged. The ground motion on this record exceeded the maximum radius of the plate before it was dislodged. The trace on the seismoscope plate of the ground floor (fig. 17) had a maximum relative displacement of  $S_0=5.3$  cm for  $T_1=0.78$  s, and a 10-percent damping.

FIGURE 16.—Seismoscope plate of main event located on a rooftop instrument at the administration building of the Universidad de San Carlos, Guatemala City. Instrument was about 30 km south of Motagua fault surface breakage. Arrow indicates north. The plate is scratched all over. Recording of main event is shown in the middle part of plate and to the sides before dislodging.

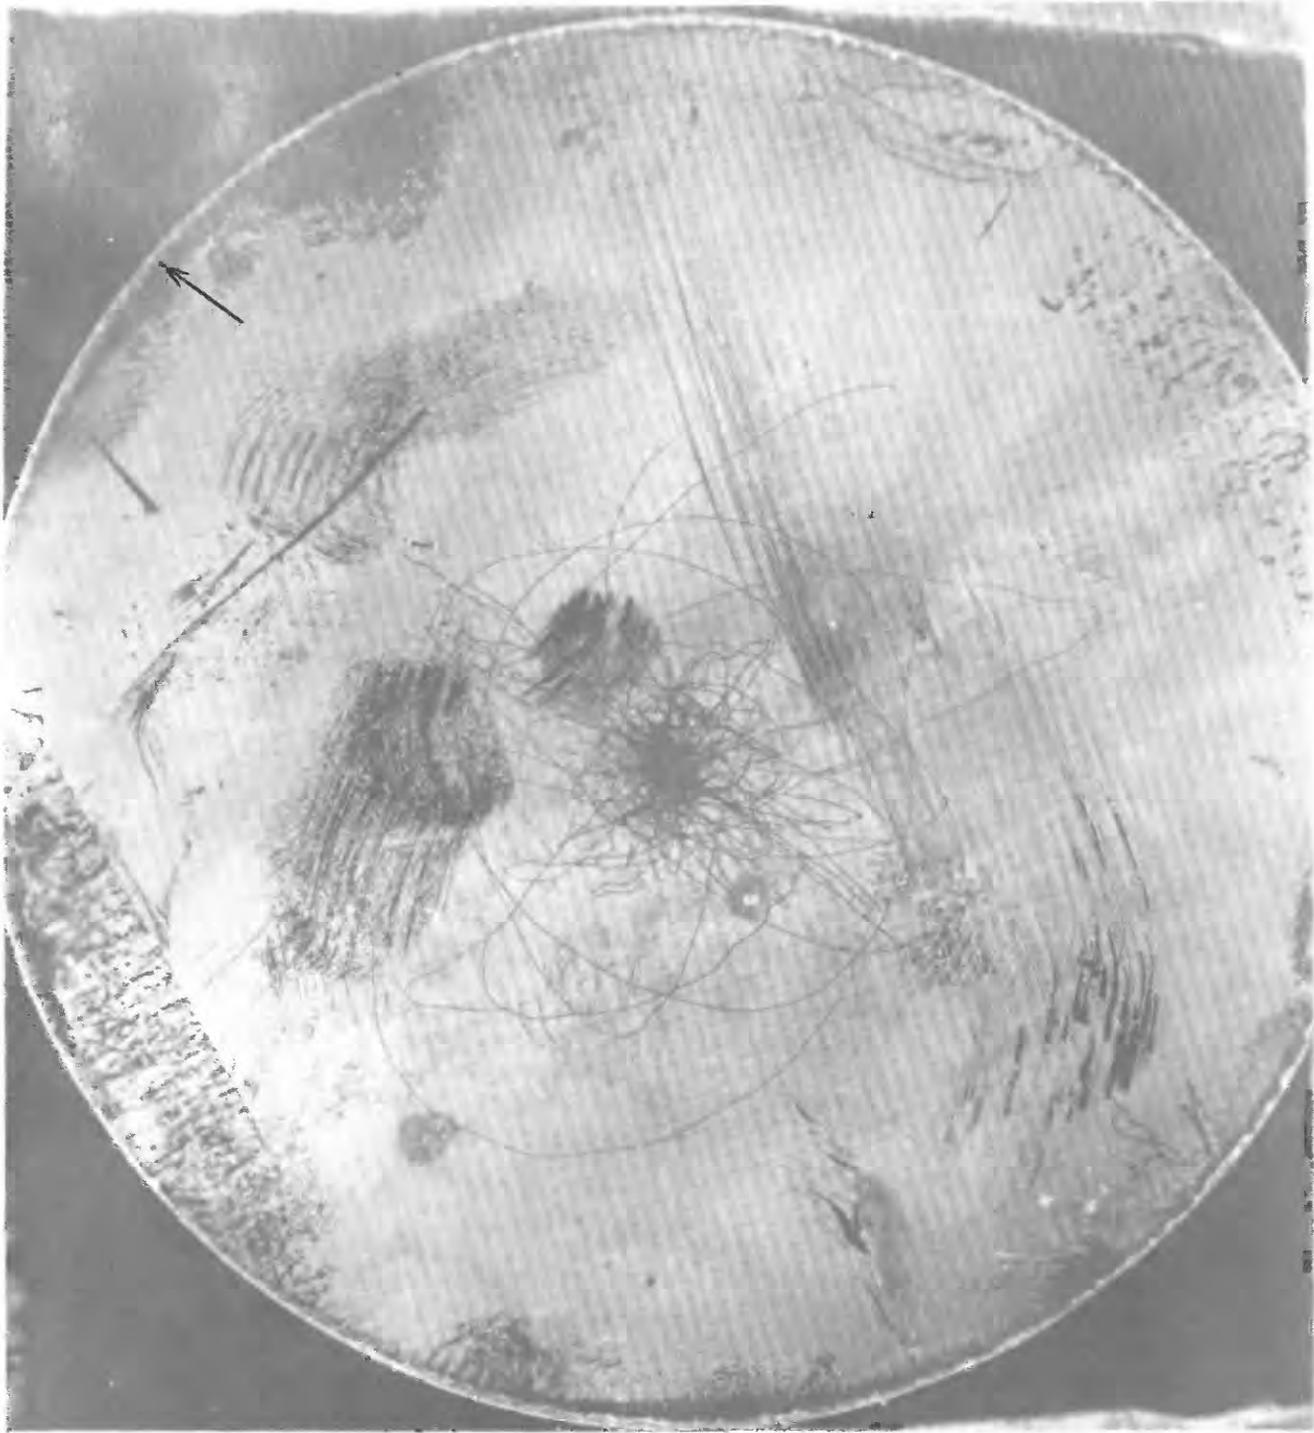
FIGURE 17.—Seismoscope plate of main event located on a ground-floor instrument at the administration building of the Universidad de San Carlos, Guatemala City. Instrument was about 30 km south of Motagua fault surface breakage. Arrow indicates north. The plate is scratched all over. Recording of main event is shown in middle part of plate.

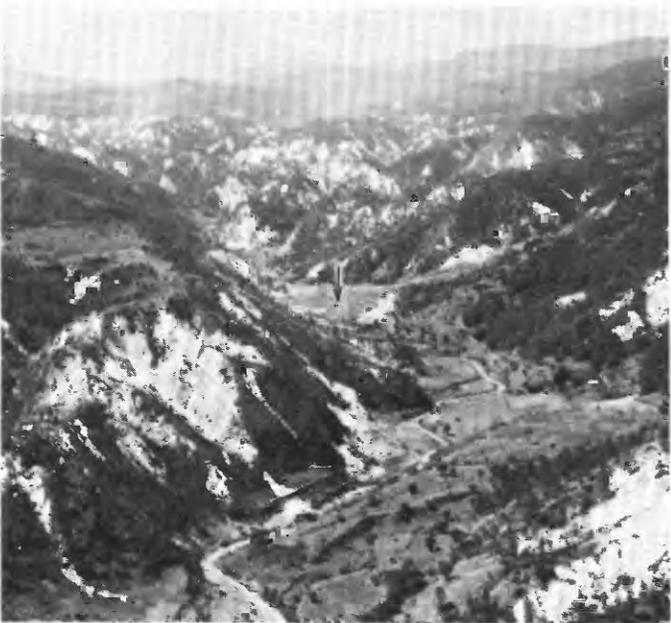
Some of the larger slump blocks and rotational slumps observed contain several million cubic metres of material. A number of these larger slides (indicated in fig. 33) have formed natural dams behind which lakes are developing (fig. 37). Such lakes are potentially hazardous because, when the dams are overtopped, rapid erosion and relatively sudden breakout could cause catastrophic flooding of inhabited areas and communication routes downstream.

FIGURE 35.—Aerial view looking northeastward along Río Pixcayá, due north of Chimaltenango, showing numerous landslides in pyroclastic deposits. The river was partially dammed by a major landslide, shown by arrow in the middle distance. (Also see fig. 37.)

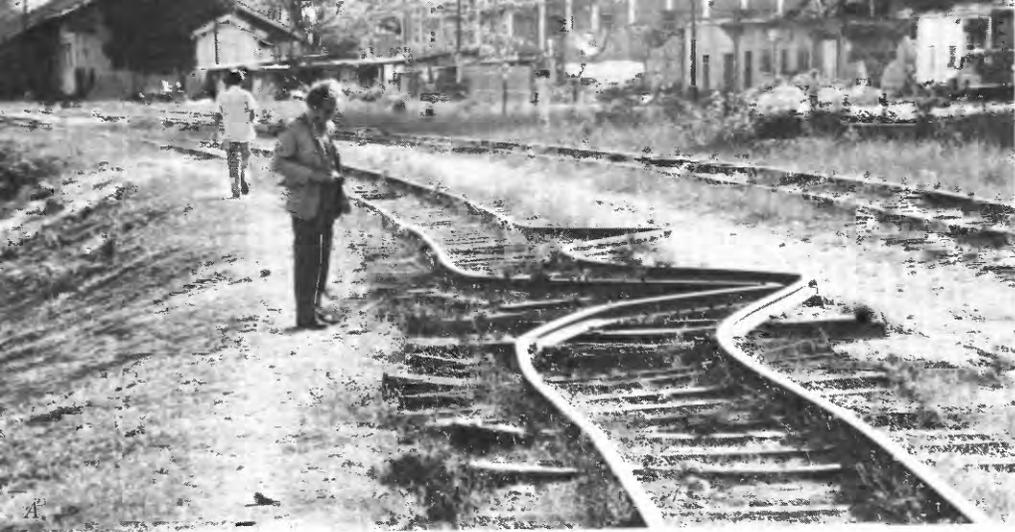
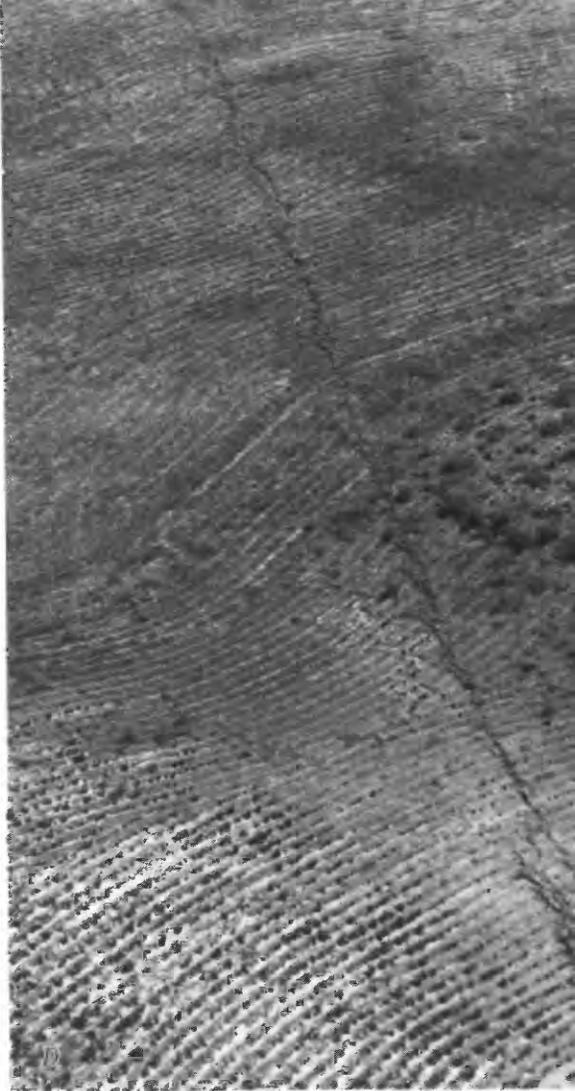
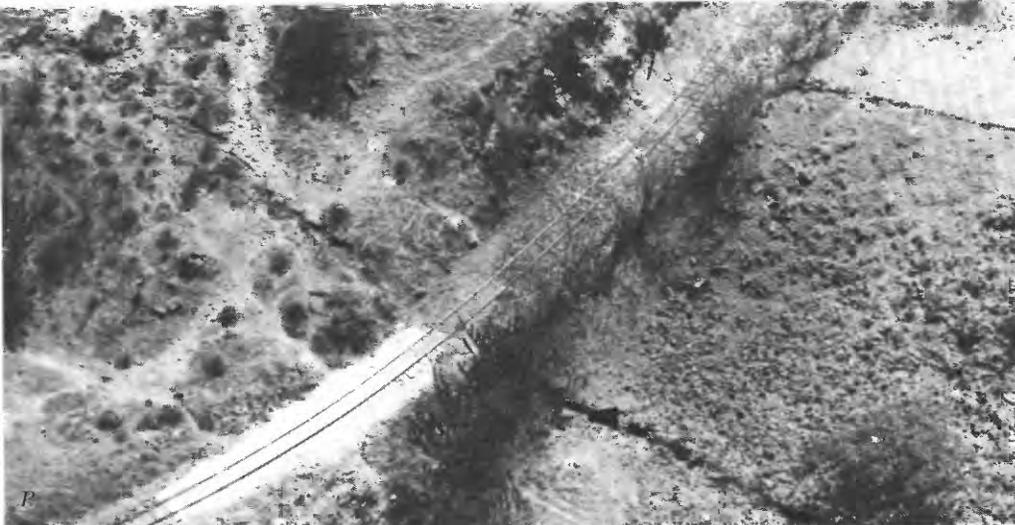
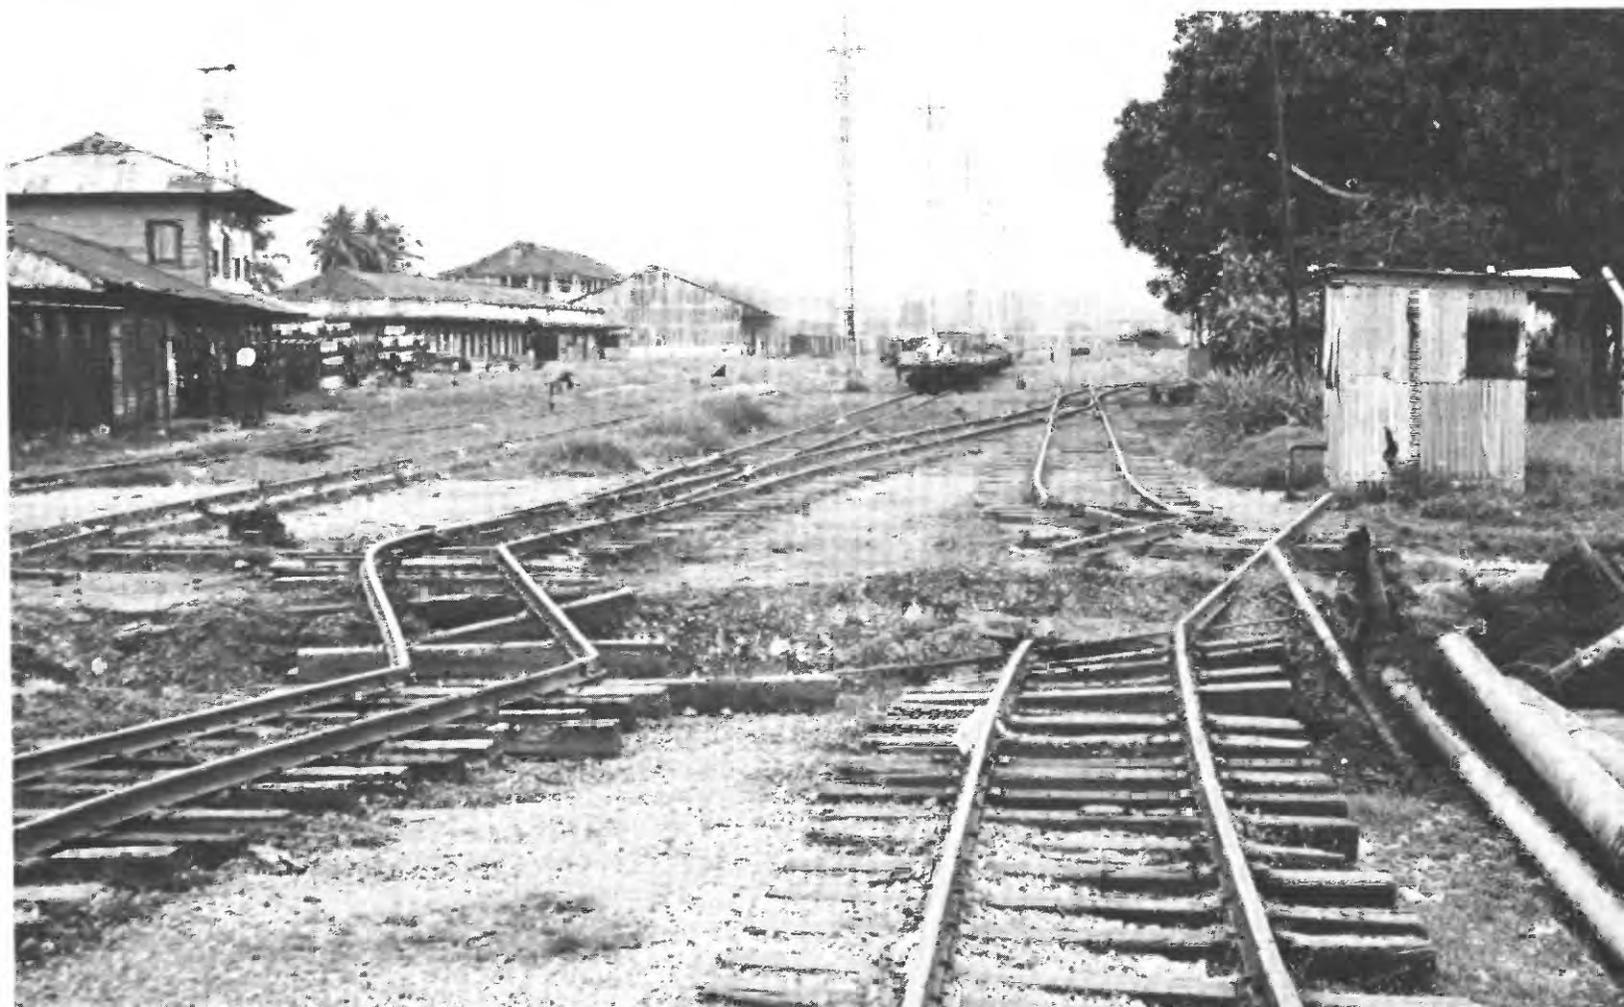
Rails bent greatly are not related directly to ground shaking, but this effect is related to ground movement due to faulting, as seen in Gualán (fig. 42A) and near El Jicaro (fig. 42B), or to ground compaction, as observed in Puerto Barrios (fig. 42C). Another factor that yields higher intensities

is surface faulting, examples of which are observed in Gualán (see cover photograph) and along the Motagua fault, near Las Ovejas (fig. 42D).

FIGURE 42.—A, Rails bent in Gualán, Department of Zacapa. B, Rails repaired between El Jicaro and Las Ovejas, Department of El Progreso; also shown in B is the surface faulting with an east-west trend. This photograph was taken from a helicopter in a eastward direction. C, Rails bent on the Puerto Barrios wharf. D, Aerial view of fault trace near Las Ovejas. See figure 40 for town locations. ▶

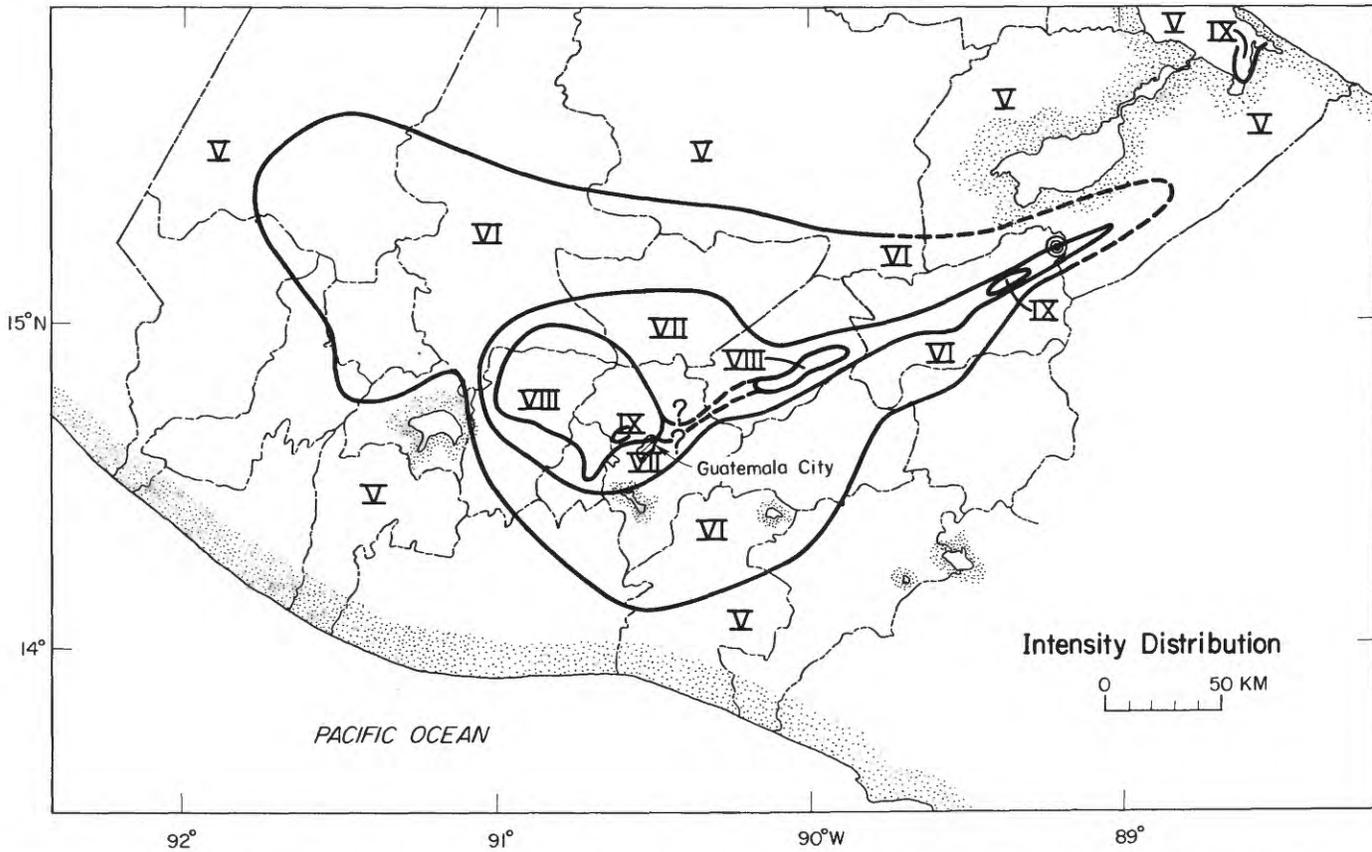
The possibility of a fault rupture traveling from east to west (suggested in fig. 43) could be verified with teleseismic data at western azimuths. Also, the suggestion of a double rupture or a multiple earthquake from the isoseismal distribution is plausible. If this second alternative is adopted, the first earthquake will be constrained to the observed surface faulting from Los Amates to Kilometre 15 southwest of El Progreso. The second event could be associated with the secondary faulting observed in the Mixco area.

Other factors that may enter into the intensity distribution pattern shown in figure 43 are seismic-wave amplification effects, topographic seismic-wave amplification, influence of the surficial soil conditions, and depth of the water table.

FIGURE 43.—Modified Mercalli intensity distribution in Guatemala from the main event. Circle indicates epicenter location of the February 4 earthquake; dashed line indicates approximate isoseismal. (Base map modified from Guatemala Instituto Geográfico Nacional, 1974, 1:500,000.)

The pattern of adobe damage (fig. 45) is similar to the intensity distribution shown in figure 43. The similarity suggests that more energy was released to the west than to the east. It also suggests that seismic energy was released along and near the known fault zone of the Motagua fault. The maximum concentration of damage, mostly in the Department of Chimaltenango, is suggestive of a constructive interference of seismic waves due to a moving dislocation.

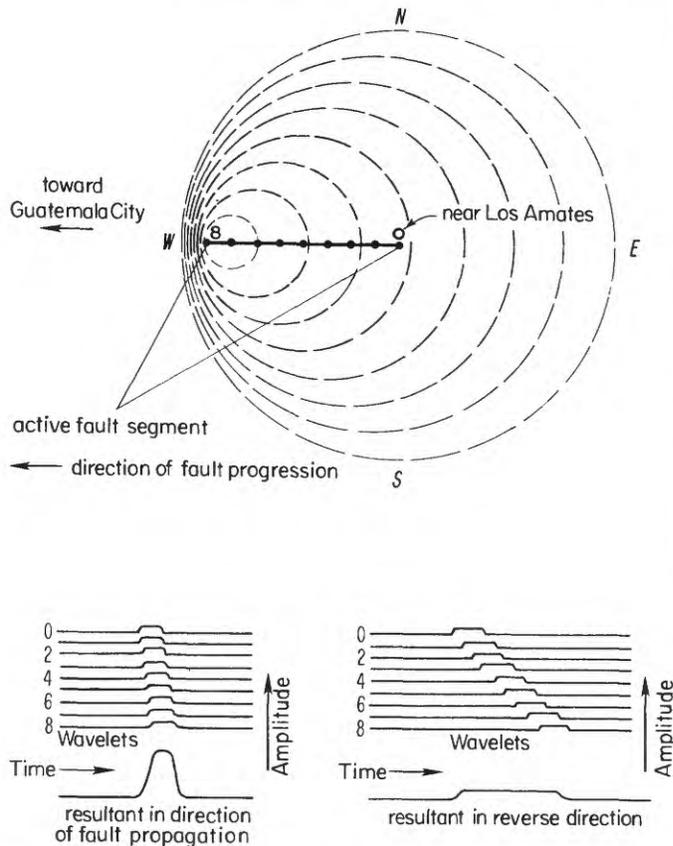
lower left in figure 44, has a larger concentration of energy than the slightly dispersed wavelet traveling in the opposite direction.

FIGURE 44.—Schematic of slip progression and its effect on wave amplitudes and shapes due to a moving source (modified from Benioff, 1955). Fault propagation from east, near Los Amates, to west, toward Guatemala City.

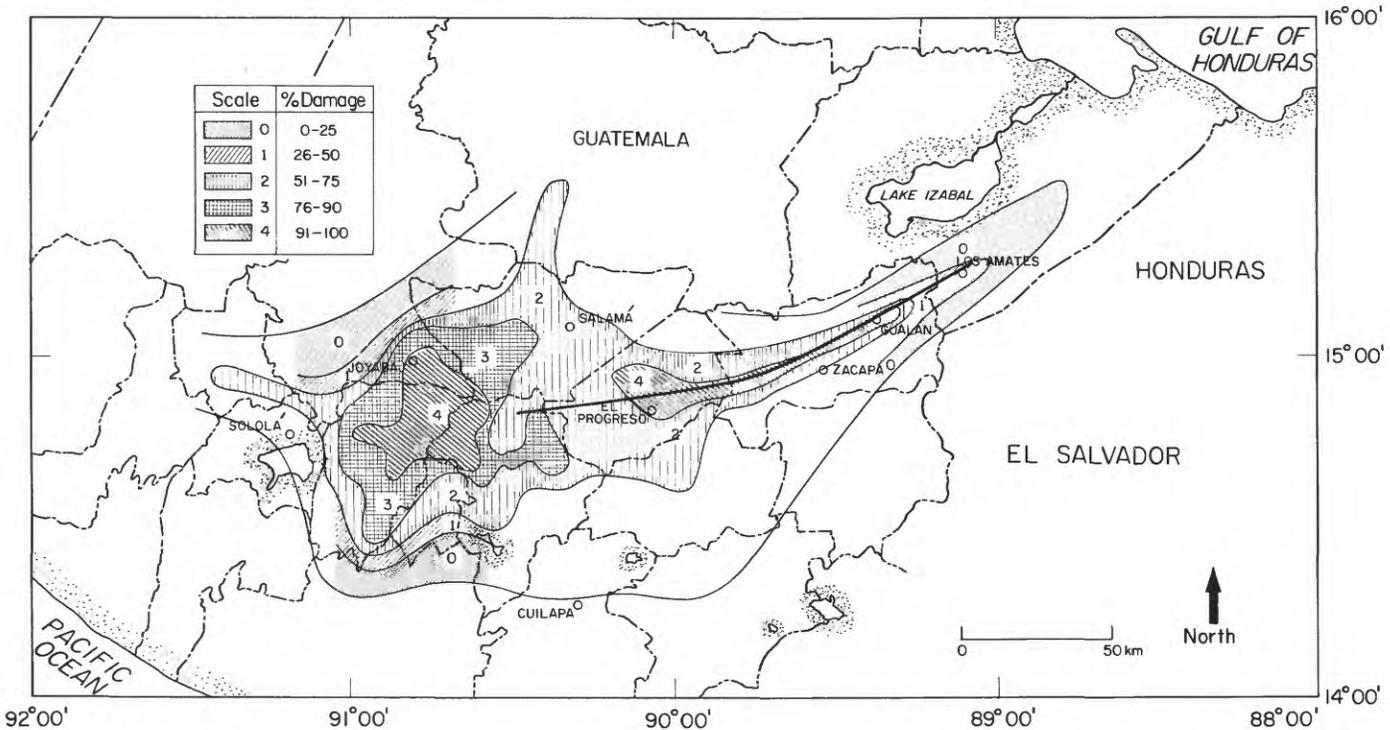
The map shown in figure 45 represents the overall distribution of adobe damage in the Republic of Guatemala. This map was prepared with information from a variety of sources. First, we studied reports from the Comité Nacional de Emergencia, which gathered a large amount of information through the local committees. These reports were supplemented by detailed lists of damage and by our assessment of the sustained damage in the field. Newspaper clippings from the national press were

the Departments of Chimaltenango, Guatemala, and lower Quiché. These regions of the country are the highlands of Guatemala. The affected region of 51- to 100-percent damage covers a surface area of approximately 8,725 km<sup>2</sup>. There are two well-defined areas of maximum damage; one follows a trend parallel to the Motagua fault located in the Departments of Izabal, Zacapa, and El Progreso. A gap is found between the 4 and 2 contours for nearly 40 km. Within the next 35 km there is another concentration of high damage (fig. 45). The damage pattern diminished rapidly to the west into the state of Tonicapán.

FIGURE 45.—Contour map showing damage to adobe-type structures in Guatemala owing to the February 4 earthquake. See figure 1 for Department names. (Base map modified from Guatemala Instituto Geográfico Nacional, 1974, 1:500,000.)

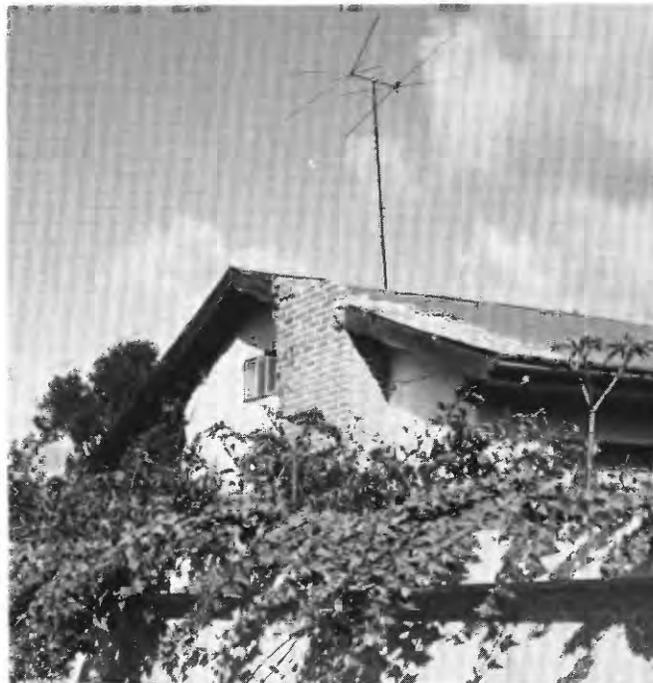
A number of chimneys cracked and collapsed in different suburbs of the city (fig. 48). The variations of the intensity ratings in the city proper varied from VI to IX. A number of wells showed an increase in temperature of more than  $2^{\circ}$  C, and their water level changed drastically, sometimes more than 60 cm, due to the February 4 earthquake. In the northern part of the city, damage to adobe-type construction was intense. Also, throughout the city, there were a number of damaged reinforced-concrete structures (Husid and others, this report). A number of landslides occurred to the northwest in the Colonia 1<sup>o</sup> de Julio, Zone 19, on the Barranco de las Guacamayas. The barrancos have an almost vertical drop of nearly 90 m. Figure 49 shows the head of a landslide in the area, at approximately long  $90^{\circ}33.5'$  W., lat  $14^{\circ}40.6'$  N.

FIGURE 48.—Chimney collapse from a one-story house in Guatemala City, Zone 11.

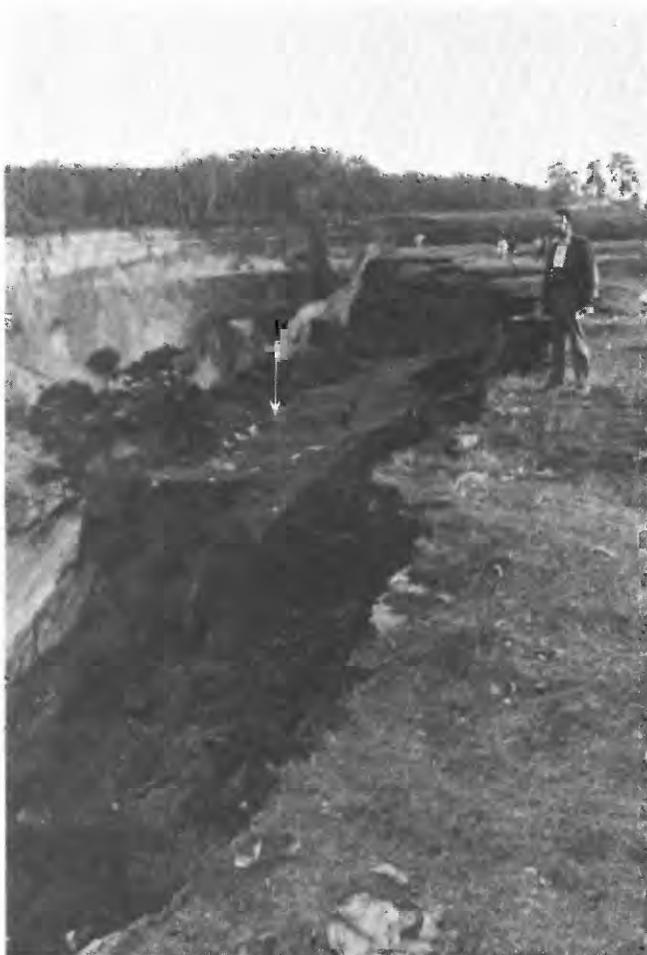
FIGURE 49.—Head of large landslide (shown by arrow) in the Barranco de las Guacamayas, Guatemala City.

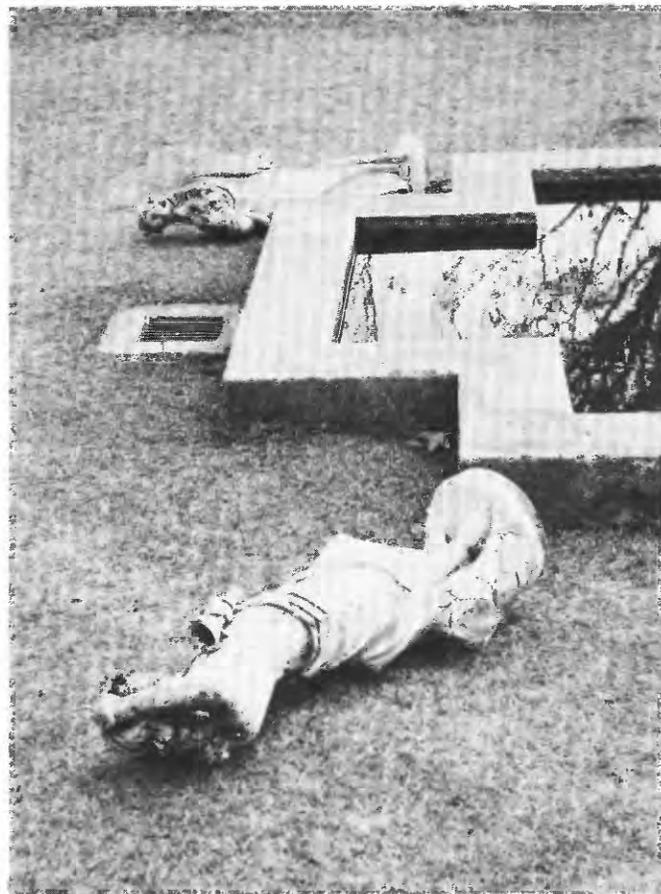
In Guatemala City, in the chemistry building of the ICAITI (see Glossary) complex, a large machine weighing 1,298 kg was displaced 7 cm horizontally. To the southeast of the city in Zone 10, in the Herrera's grounds, four medium-sized marble statues were thrown 40 cm from their stands (fig. 50). There were some reports that hanging lamps dented the ceilings of homes and that outside hanging lamps left a fan of dents on the walls.

FIGURE 50.—A marble statue thrown 40 cm from its pedestal; it is 120 cm high, weighs approximately 200 kg, and is located in Zone 10 in Guatemala City.

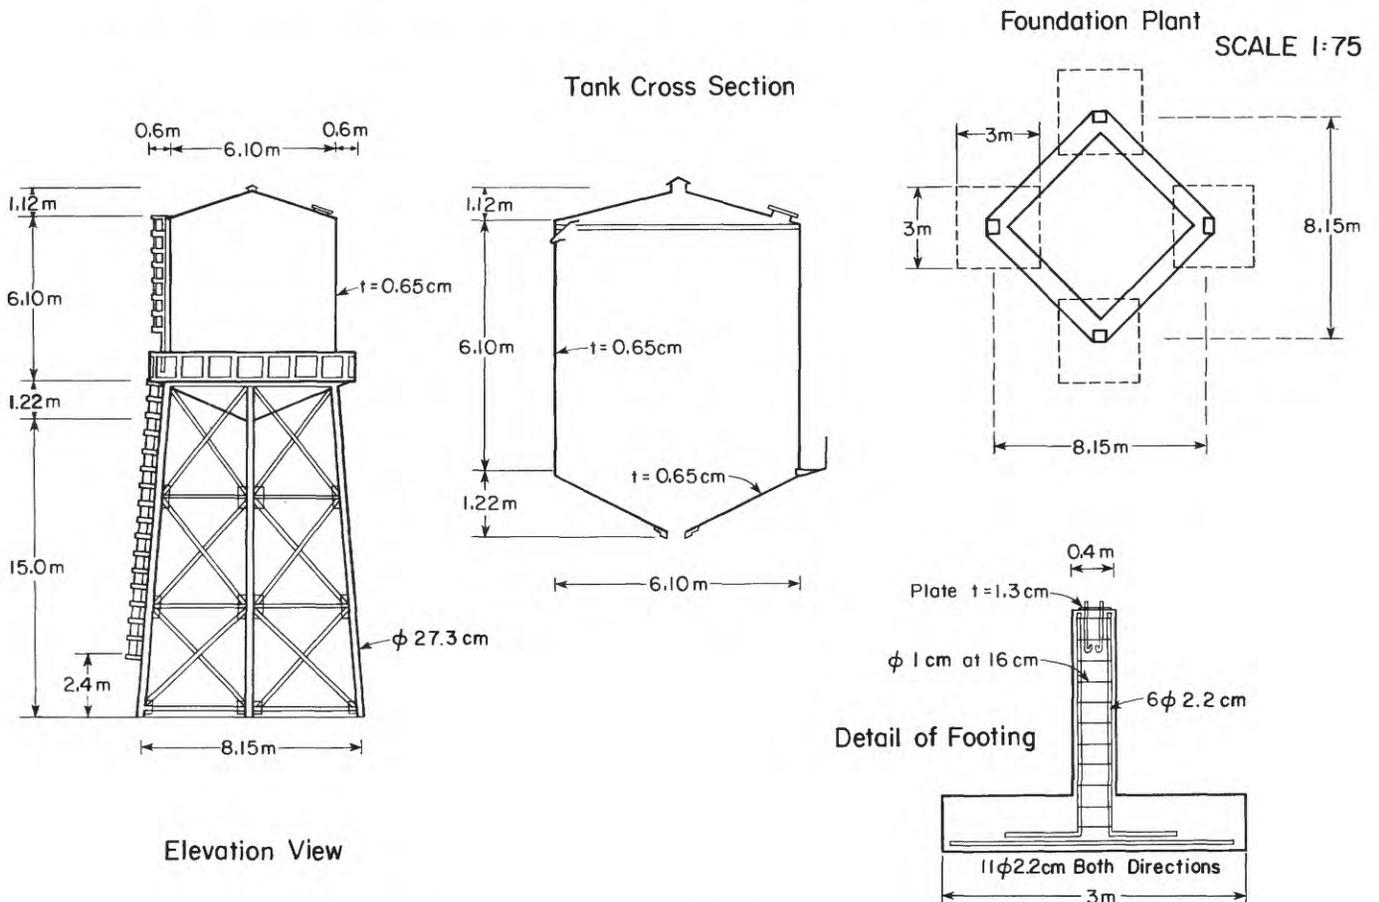
Various elevated steel water tanks collapsed in Guatemala City and vicinity. Figure 57 shows one type of tank that suffered complete failure. Figure 58 shows the engineering plan of another type of elevated steel water tank (50,000-gallon capacity) that was used extensively throughout the city and failed in several locations. Three water tanks of this design that were full of water at the time of the earthquake collapsed (fig. 59). Two other tanks of this design that were empty sustained extensive damage; the anchor bolts had sheared, and most of the diagonal bracing failed.

FIGURE 58.—Engineering plans of an elevated water tank shown in figure 59. ( $\phi$ , diameter.)

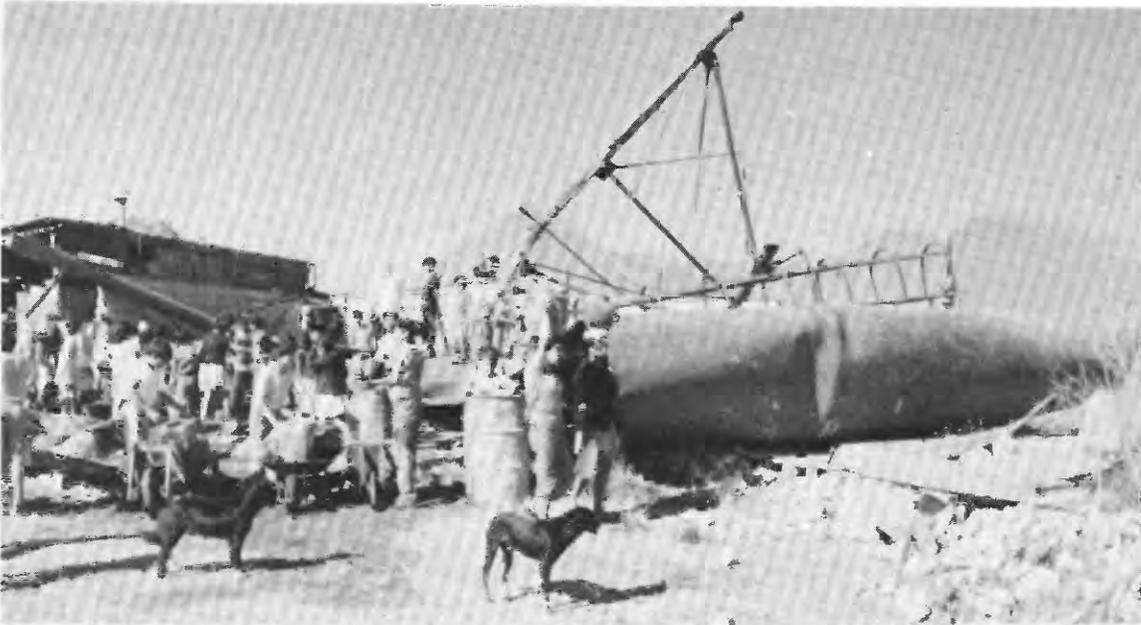
FIGURE 59.—Collapse of an elevated steel water tank in Villanueva, Colonia de los Planes, 22 km south of Guatemala City.

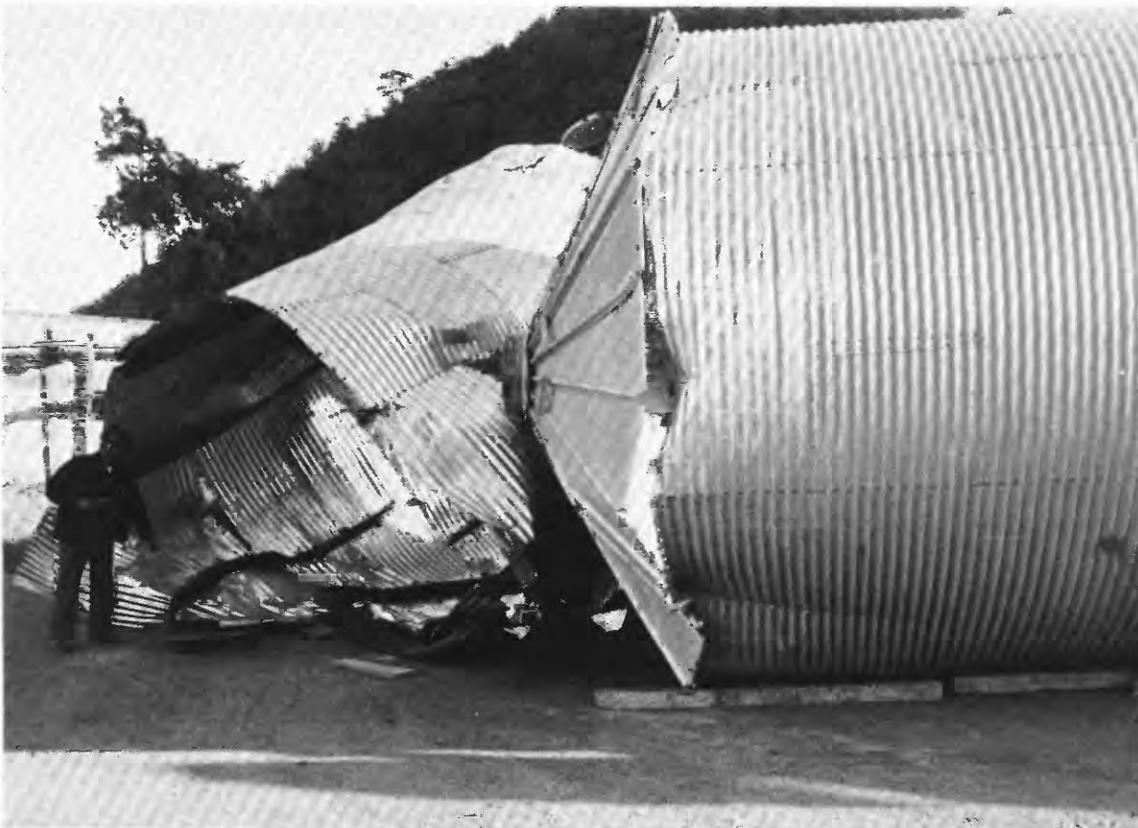
A few corrugated-steel grain silos collapsed (fig. 60), and some that remained standing sustained extensive damage where they were connected to the foundation.

FIGURE 60.—Collapse of a corrugated-steel grain silo in Villalobos, 5 km southeast of Guatemala City.

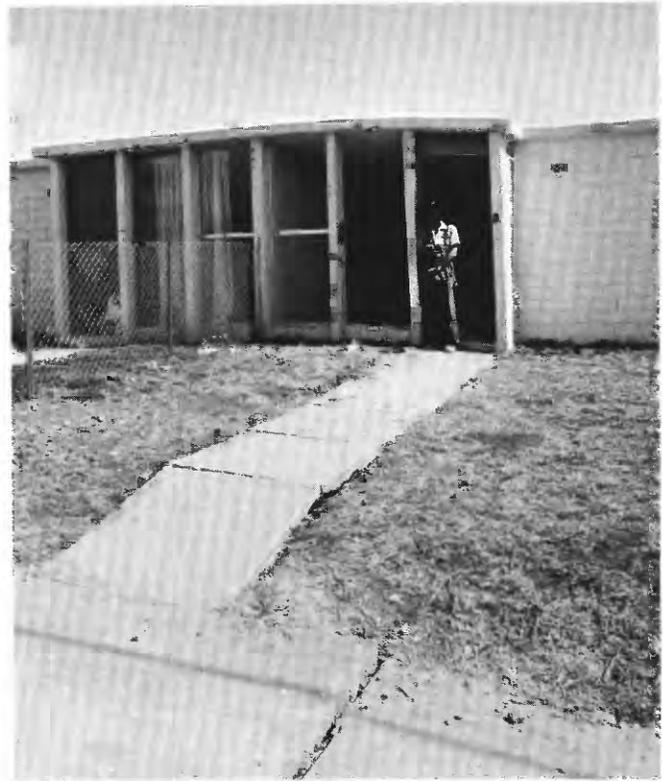
Surface breakage on north- to northeast-striking secondary faulting (Zone 19) in Colonia San Francisco locally generated extensive damage to local residences (fig. 62).

▶ FIGURE 62.—Severe damage to reinforced-masonry construction caused by secondary faulting in Colonia San Francisco (Zone 19). The fault strikes north to northeast.

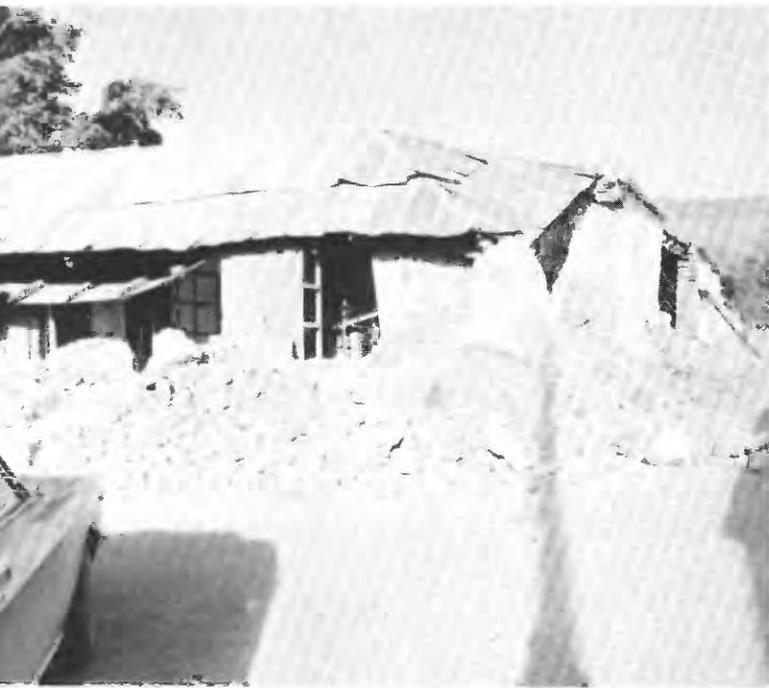
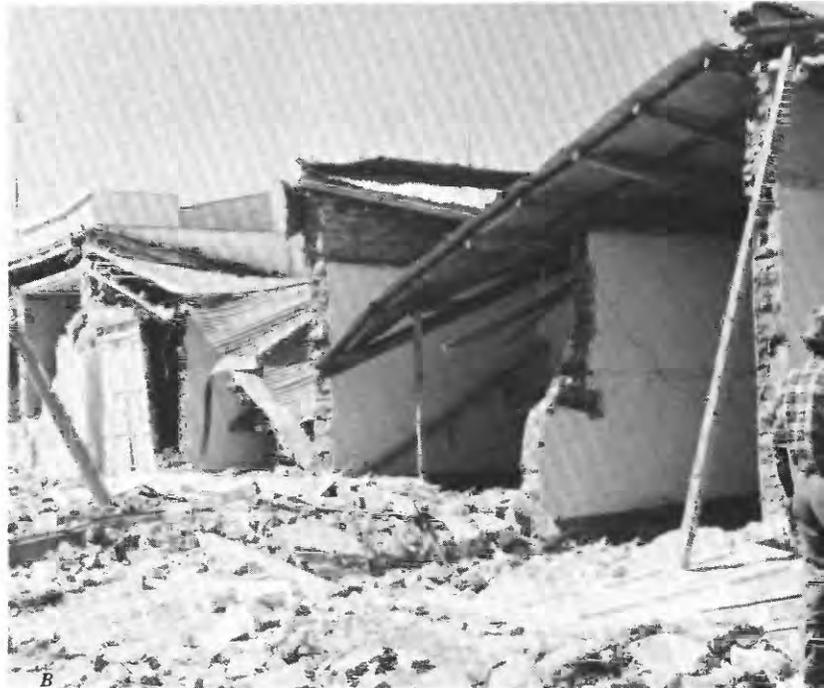
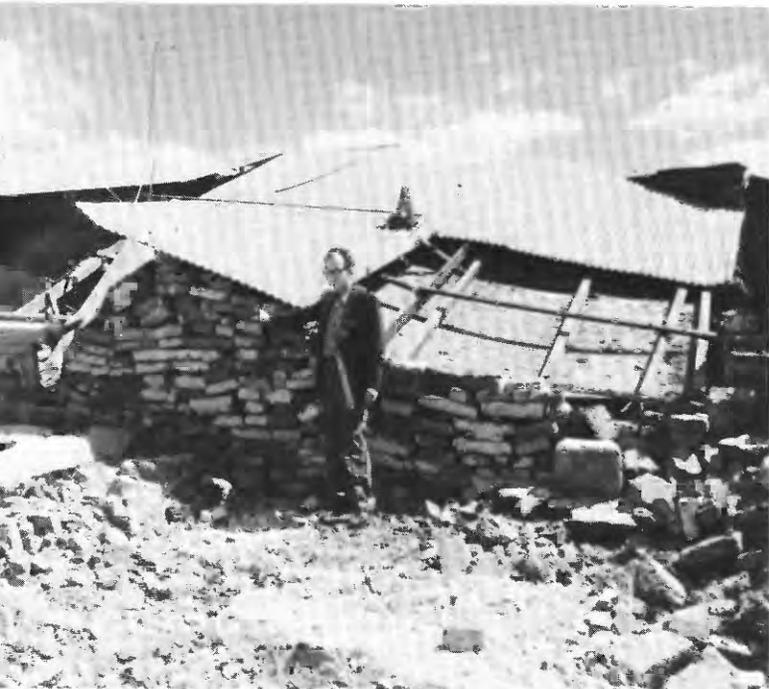
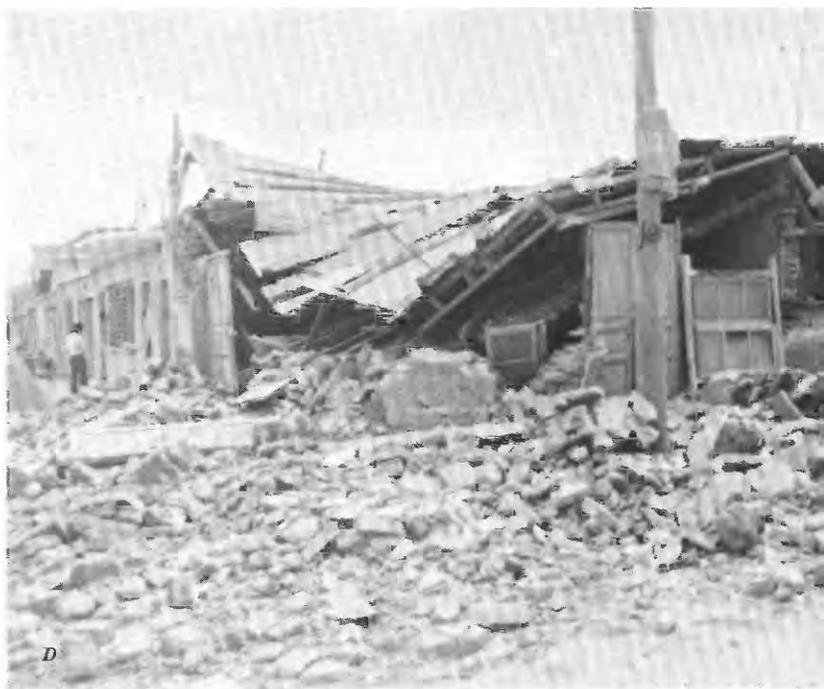
Adobe construction is not earthquake resistant; some examples of the unsatisfactory performance of adobe is shown in figures 69A, B, C, and D. Considering the fact that it is not economically feasible to eliminate adobe construction in Guatemala, it would be desirable to make an inventory of the different types of adobe used countrywide and prepare recommendations for simple modifications that might improve the strength of adobe houses subjected to earthquakes.

FIGURE 69.—A, Massive destruction of some adobe houses in Antigua, Guatemala, near the center of town. B, Large-scale destruction of adobe houses in Guatemala City, Calle 2 and Avenida 9A (Zone 2). C, Collapse of adobe houses in Guatemala City, Calle 22A and 34 Avenida (Zone 5). D, Collapse of adobe houses in Guatemala City, Calle 22 and Avenida 32 (Zone 5).

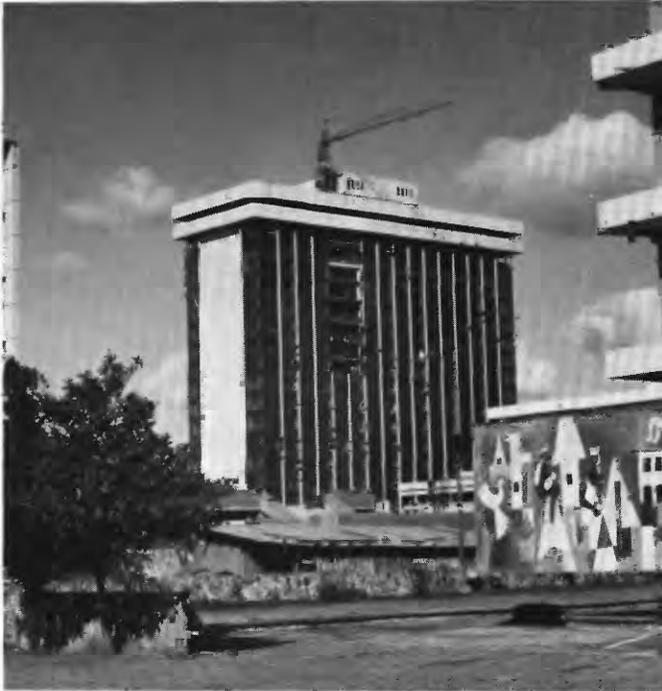
There apparently are only two structural-steel multistory buildings in Guatemala City, the Finance Ministry Building (fig. 71) and the National Theater (which is only partially steel frame). In these two known instances, special quality-control efforts were made during fabrication and erection, and no significant damage occurred to them.

FIGURE 71.—The Finance Ministry Building (in Guatemala City) has 19 stories above ground plus 3 below. The undamaged steel-frame building is in the final stages of construction. (Photograph by W. H. Smith, American Iron and Steel Institute.)
