THE GUATEMALA EARTHQUAKE OF FEBRUARY 4, 1976

LANDSLIDES FROM THE FEBRUARY 4, 1976, GUATEMALA EARTHQUAKE

GEOLOGICAL SURVEY PROFESSIONAL PAPER 1204-A

*A description of the largest landslides,
a discussion of failure mechanisms, a
mapping of landslides throughout most of
the landslide-affected area, and a
mapping of landslide concentration in
the Guatemala City area*

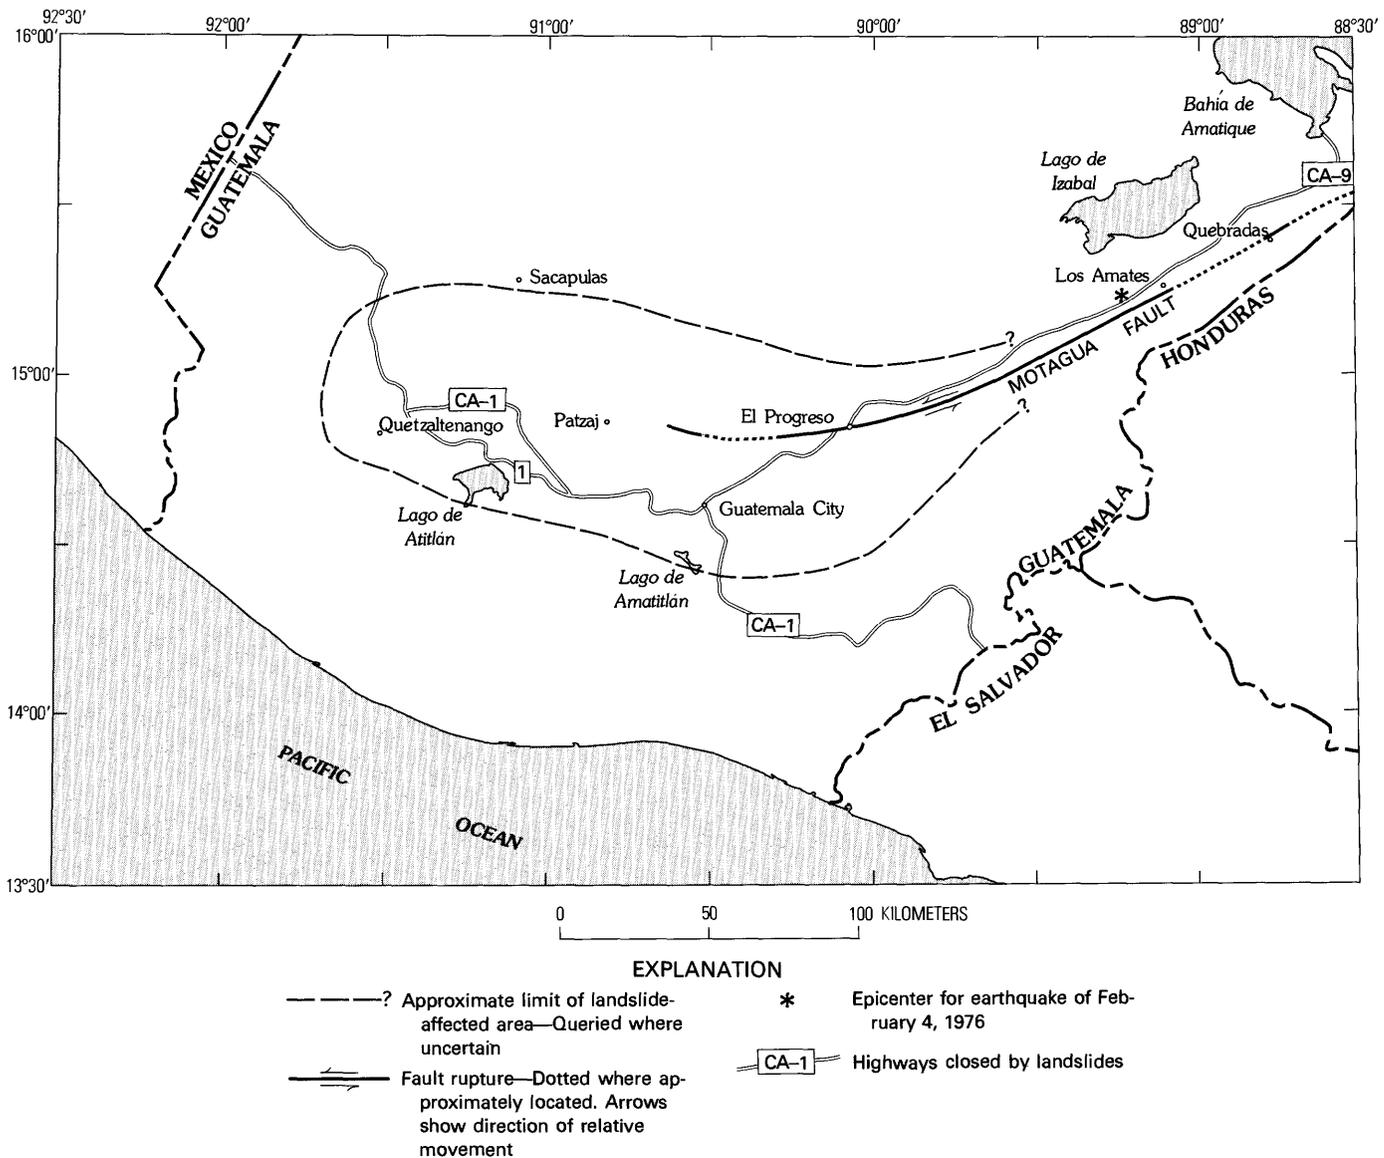
FIGURE 1.—Epicenter (Person and others, 1976), fault rupture (Plafker and others, 1976), and approximate limits of landslide-affected area in the February 4, 1976, Guatemala earthquake, and highways closed by landslides.

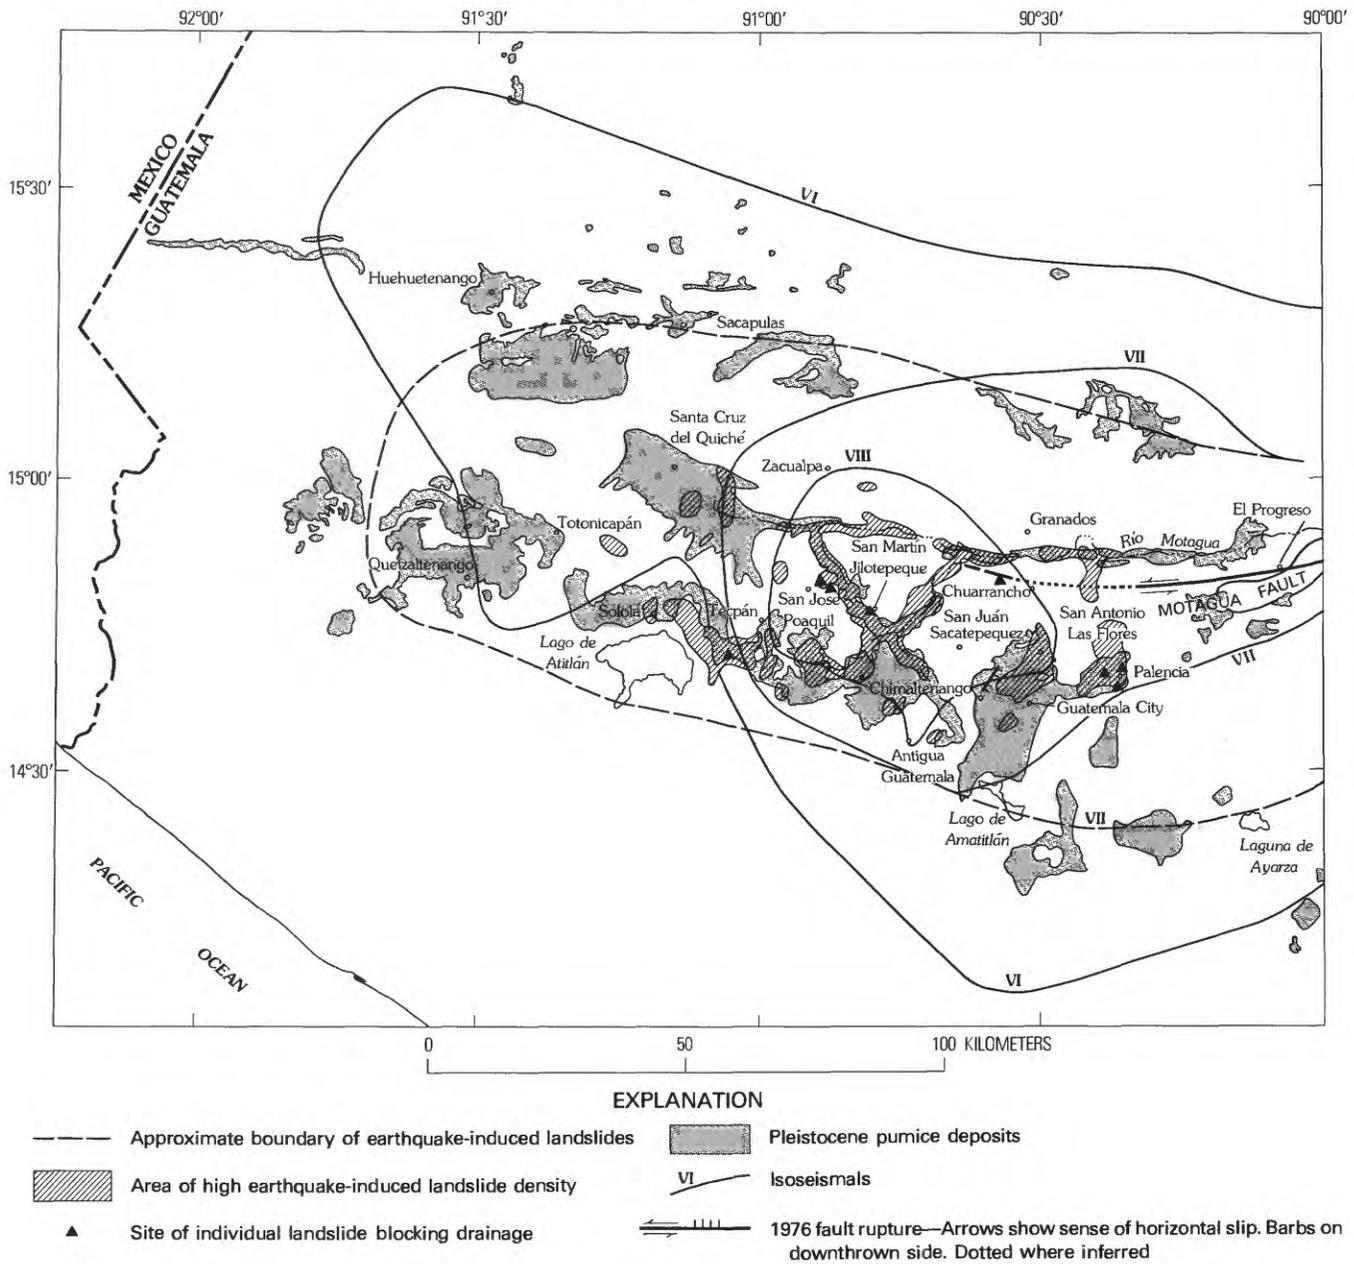
FIGURE 2.—Southwestern Guatemala, showing areas of high density of earthquake-induced landslides, distribution of Pleistocene pumice deposits (Bonis and others, 1970; Koch and McLean, 1975), isoseismals (Espinosa and others, 1976), fault rupture (Plafker and others, 1976), and approximate limits of landslide-affected area.

A comparison of our map of the areas of highest landslide density with the isoseismal map by Espinosa, Husid, and Quesada indicates that landslides occurred mostly within the modified Mercalli intensity (MMI) VI contour and that areas of high landslide density are largely within the MMI VII isoseismal (fig. 2). The MMI scale assigns a high seismic intensity to areas with pronounced ground failures, and areas of heavy landsliding generally receive a scale value of X (Wood and Neumann, 1931). Espinosa, Husid, and Quesada based their intensity survey largely on the degree of shaking damage to adobe dwellings and excluded landslides and other ground failures as secondary effects of seismic shaking. They also noted that adobe houses were relatively undamaged in several areas of heavy landslide activity and concluded that "landsliding implies intensity X, but undamaged adobe houses suggest much lower intensities" (Espinosa and others, 1976, p. 53). Our field observations of the degree of structural damage in many landslide-affected areas suggest that the threshold shaking intensity for triggering landslides in the most susceptible localities corresponded to an MMI of VI.

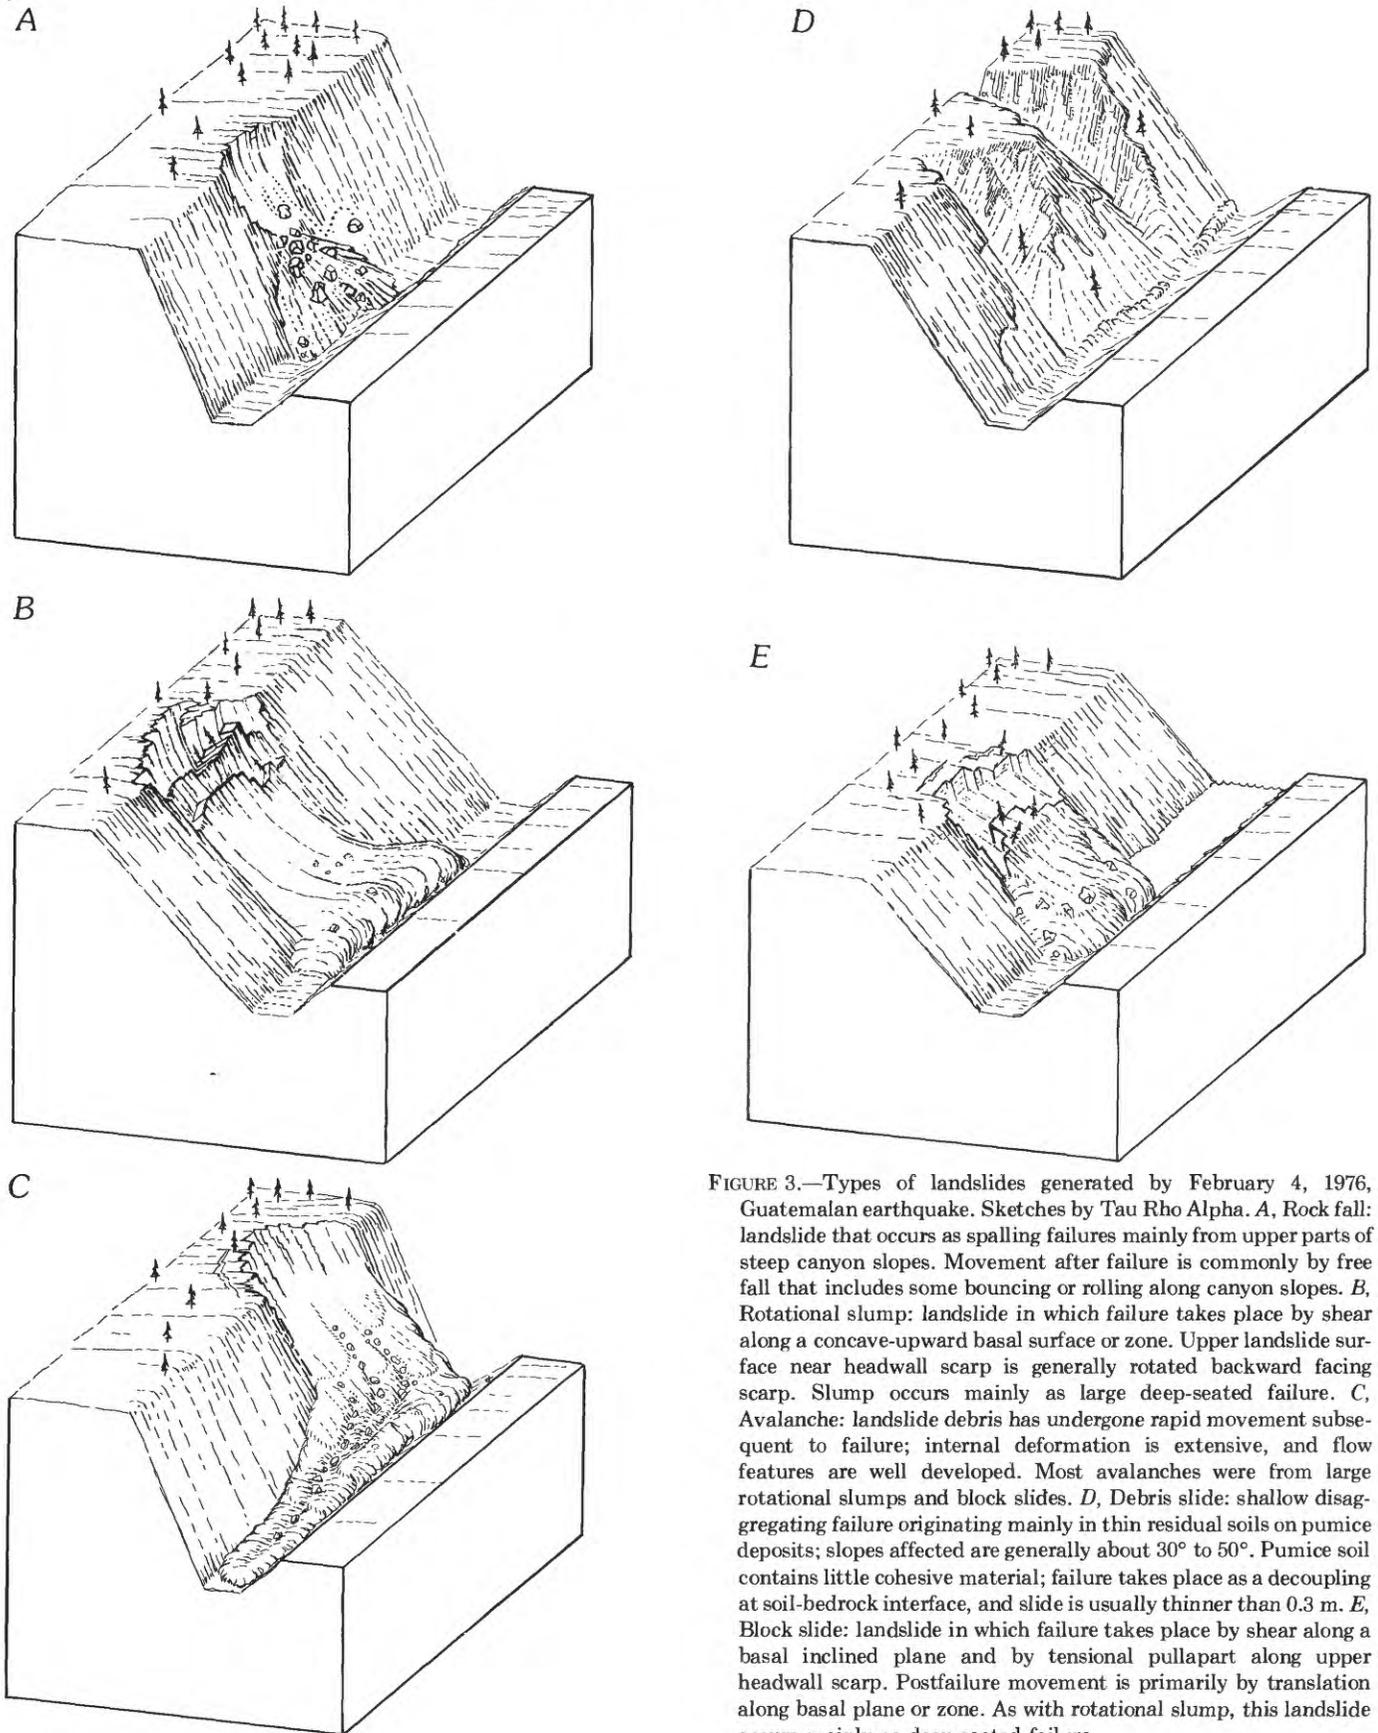
The predominant types of landslides¹ induced by this earthquake (fig. 3) were rock falls and debris slides of less than 15,000 m³ volume. In some areas, however, landslides coalesced so extensively that as much as 80 percent of slopes were denuded (fig. 4).

FIGURE 3.—Types of landslides generated by February 4, 1976, Guatemalan earthquake. Sketches by Tau Rho Alpha. *A*, Rock fall: landslide that occurs as spalling failures mainly from upper parts of steep canyon slopes. Movement after failure is commonly by free fall that includes some bouncing or rolling along canyon slopes. *B*, Rotational slump: landslide in which failure takes place by shear along a concave-upward basal surface or zone. Upper landslide surface near headwall scarp is generally rotated backward facing scarp. Slump occurs mainly as large deep-seated failure. *C*, Avalanche: landslide debris has undergone rapid movement subsequent to failure; internal deformation is extensive, and flow features are well developed. Most avalanches were from large rotational slumps and block slides. *D*, Debris slide: shallow disaggregating failure originating mainly in thin residual soils on pumice deposits; slopes affected are generally about 30° to 50° . Pumice soil contains little cohesive material; failure takes place as a decoupling at soil-bedrock interface, and slide is usually thinner than 0.3 m. *E*, Block slide: landslide in which failure takes place by shear along a basal inclined plane and by tensional pullapart along upper headwall scarp. Postfailure movement is primarily by translation along basal plane or zone. As with rotational slump, this landslide occurs mainly as deep-seated failure.

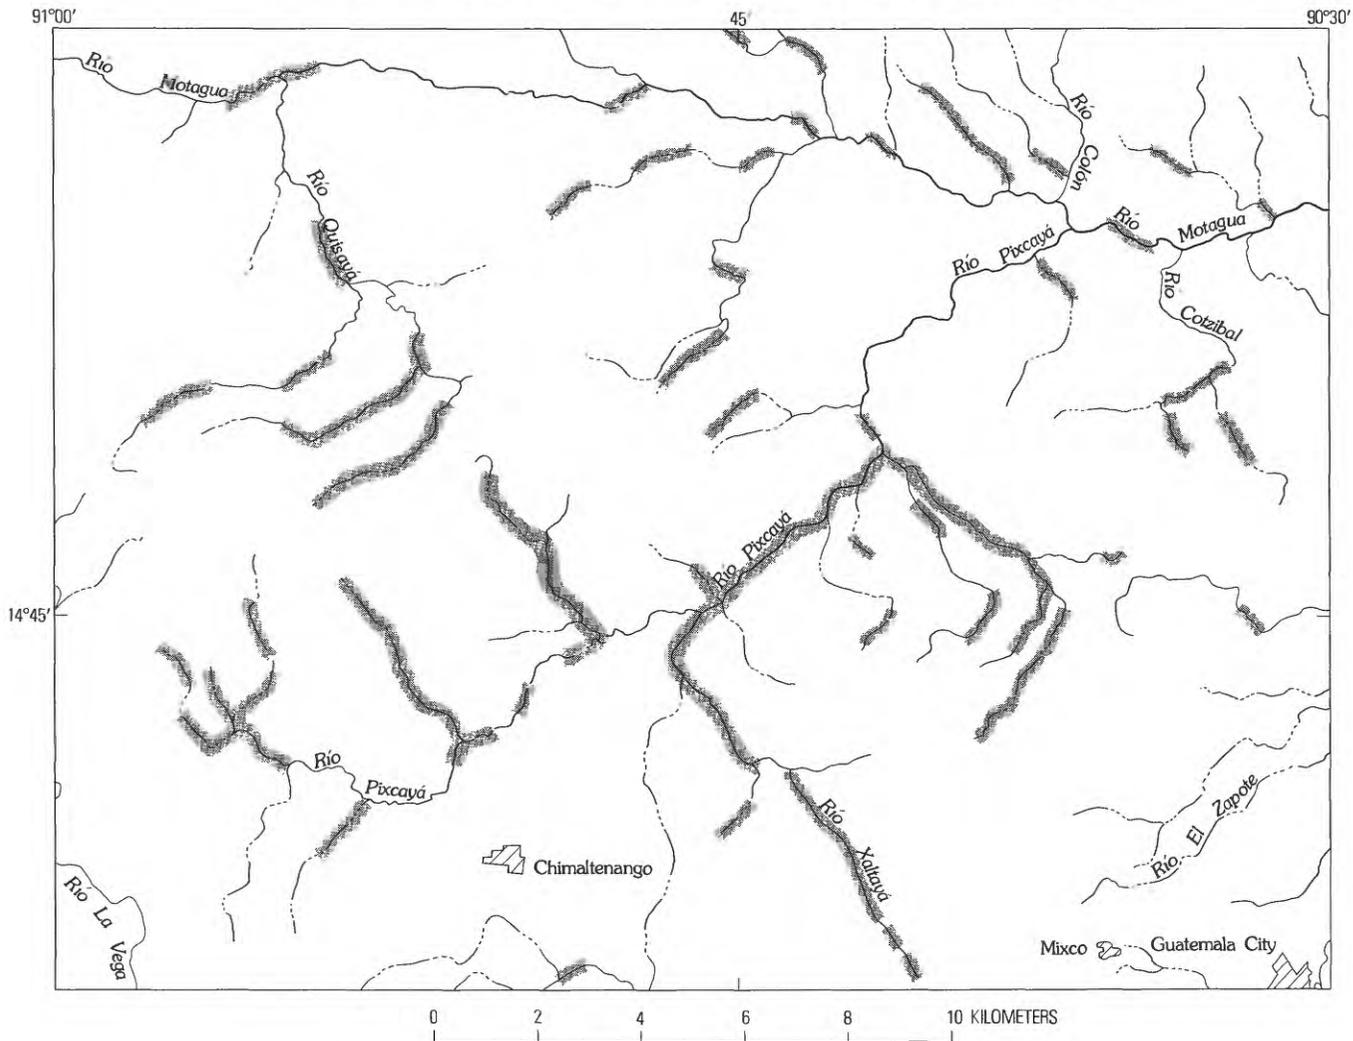
A well-defined system of regional lineaments exists in the highlands west of Guatemala City (fig. 13). This system, probably related to regional fractures, is noticeable on the U-2 photographs and the 1:50,000-scale topographic maps. The system is dominated by orthogonal elements trending N. 45° E. and N. 45° W. The origin of these lineaments is unclear; however, they have apparently provided a structural control on the major stream drainages in that area. This system of lineaments has also exerted an important, though indirect, control on the distribution of earthquake-induced landslides. These drainages have been filled with pumice during periods of volcanic activity and then reexcavated into canyons by erosion during periods of quiescence. The canyons now form optimal sites for rock falls and debris slides, as is evident from the landslide incidence in these canyons in response to the 1976 earthquake. One N. 45° E.-trending lineament near Tecpán and another near Chimaltenango, both of which showed a high level of aftershock activity, were interpreted by Langer, Whitcomb, and Aburto Q. (1976) to be secondary faults.

FIGURE 13.—Regional system of orthogonal lineaments (fractures?) in highlands west of Guatemala City. Shaded lines denote areas where lineaments apparently exert structural control on stream drainages.

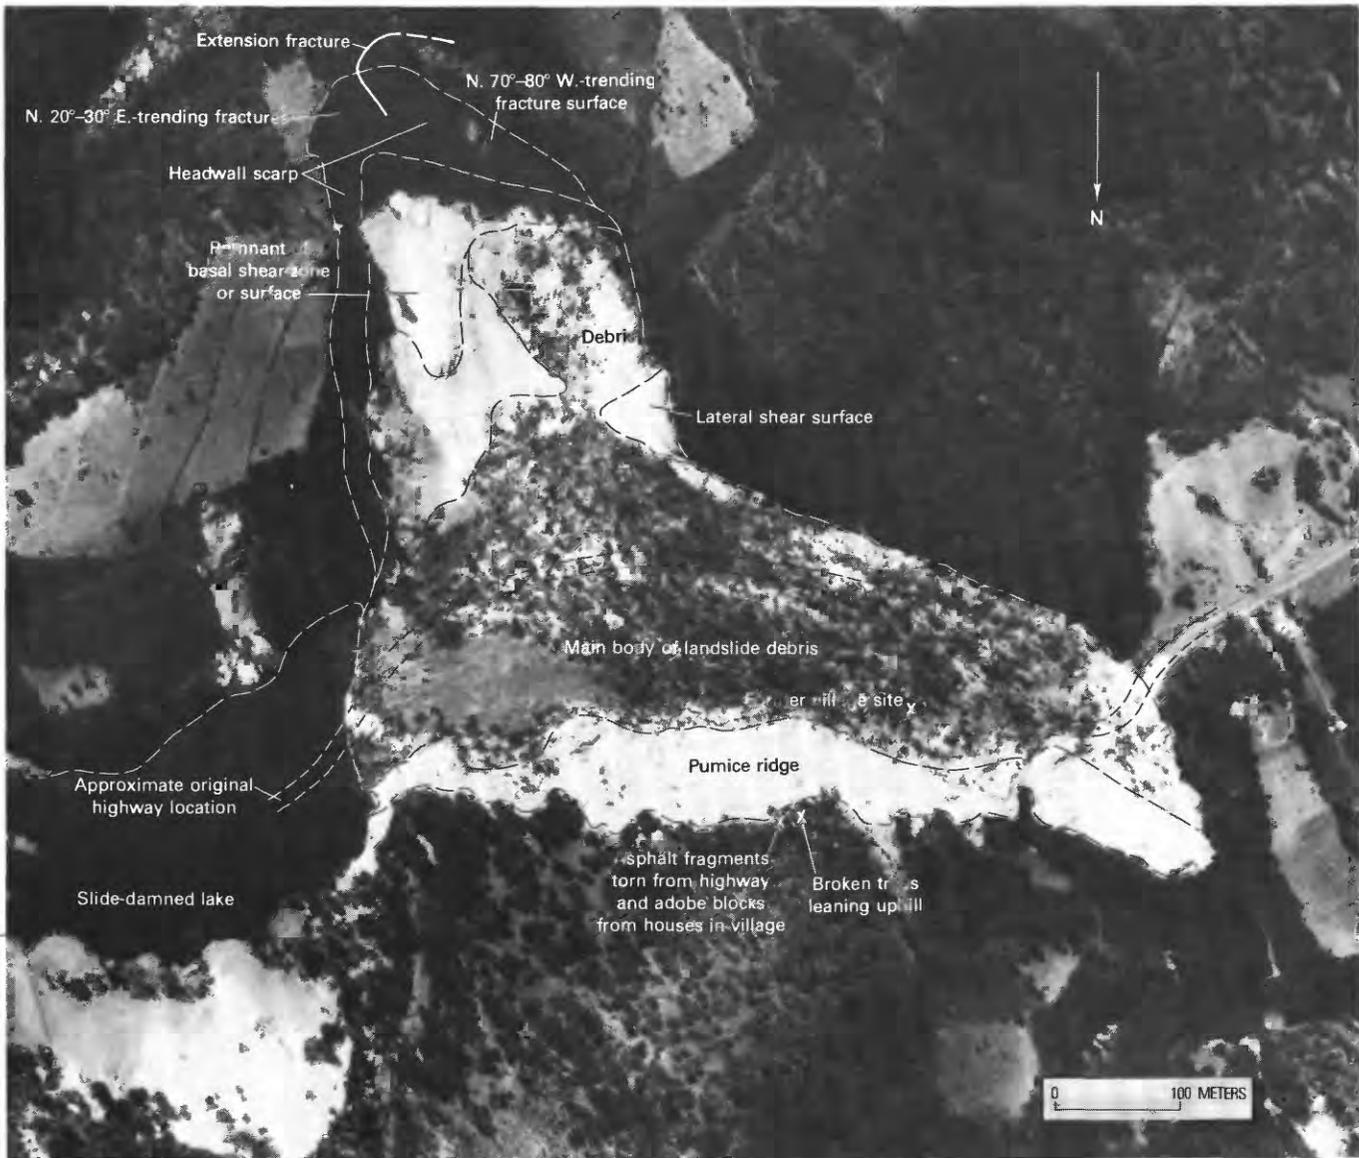
The Los Chocoyos landslide (figs. 16, 17; site 1, table 1) occurred about 15 km southwest of Tecpán, along the steep south wall of the valley of the Río Los Chocoyos. The slide buried two houses and killed six people. The slide mass contained between 0.75×10^6 and 1.0×10^6 m³ of debris, all derived from Pleistocene pumice deposits, primarily the tephra H and the H ash-flow tuff of Koch and McLean (1975). Witnesses to the landslide reported that they heard only one period of loud noise at the same time as the main earthquake shock. This report indicates that movement on the slide was rapid and that nearly all the slide material came down during the main shock.

Judging from the morphology of the headwall scarp and of the basal failure surface, the Los Chocoyos landslide probably began as a block slide and disintegrated into a debris avalanche that plummeted down the canyon wall to the river and then traveled some 600 m downstream before coming to rest. The slide debris filled the valley to a depth of 20 to 50 m over a length of about 800 m and a width of 300 to 400 m. The debris blocked the main river drainage and formed a lake that extended about 300 m upstream at its maximum (fig. 18). To avoid a sudden breaching of the debris dam and a consequent flood that could have endangered the villages and farms downstream along the Río Madre Vieja, volunteers from the Mexico Department of Transportation excavated a channel through the slide mass during the early stages of lake filling. The channel, however, did not initially accommodate a flow sufficient to drain the

FIGURE 16.—U-2 photograph of Los Chocoyos landslide, showing main features outlined against countryside.

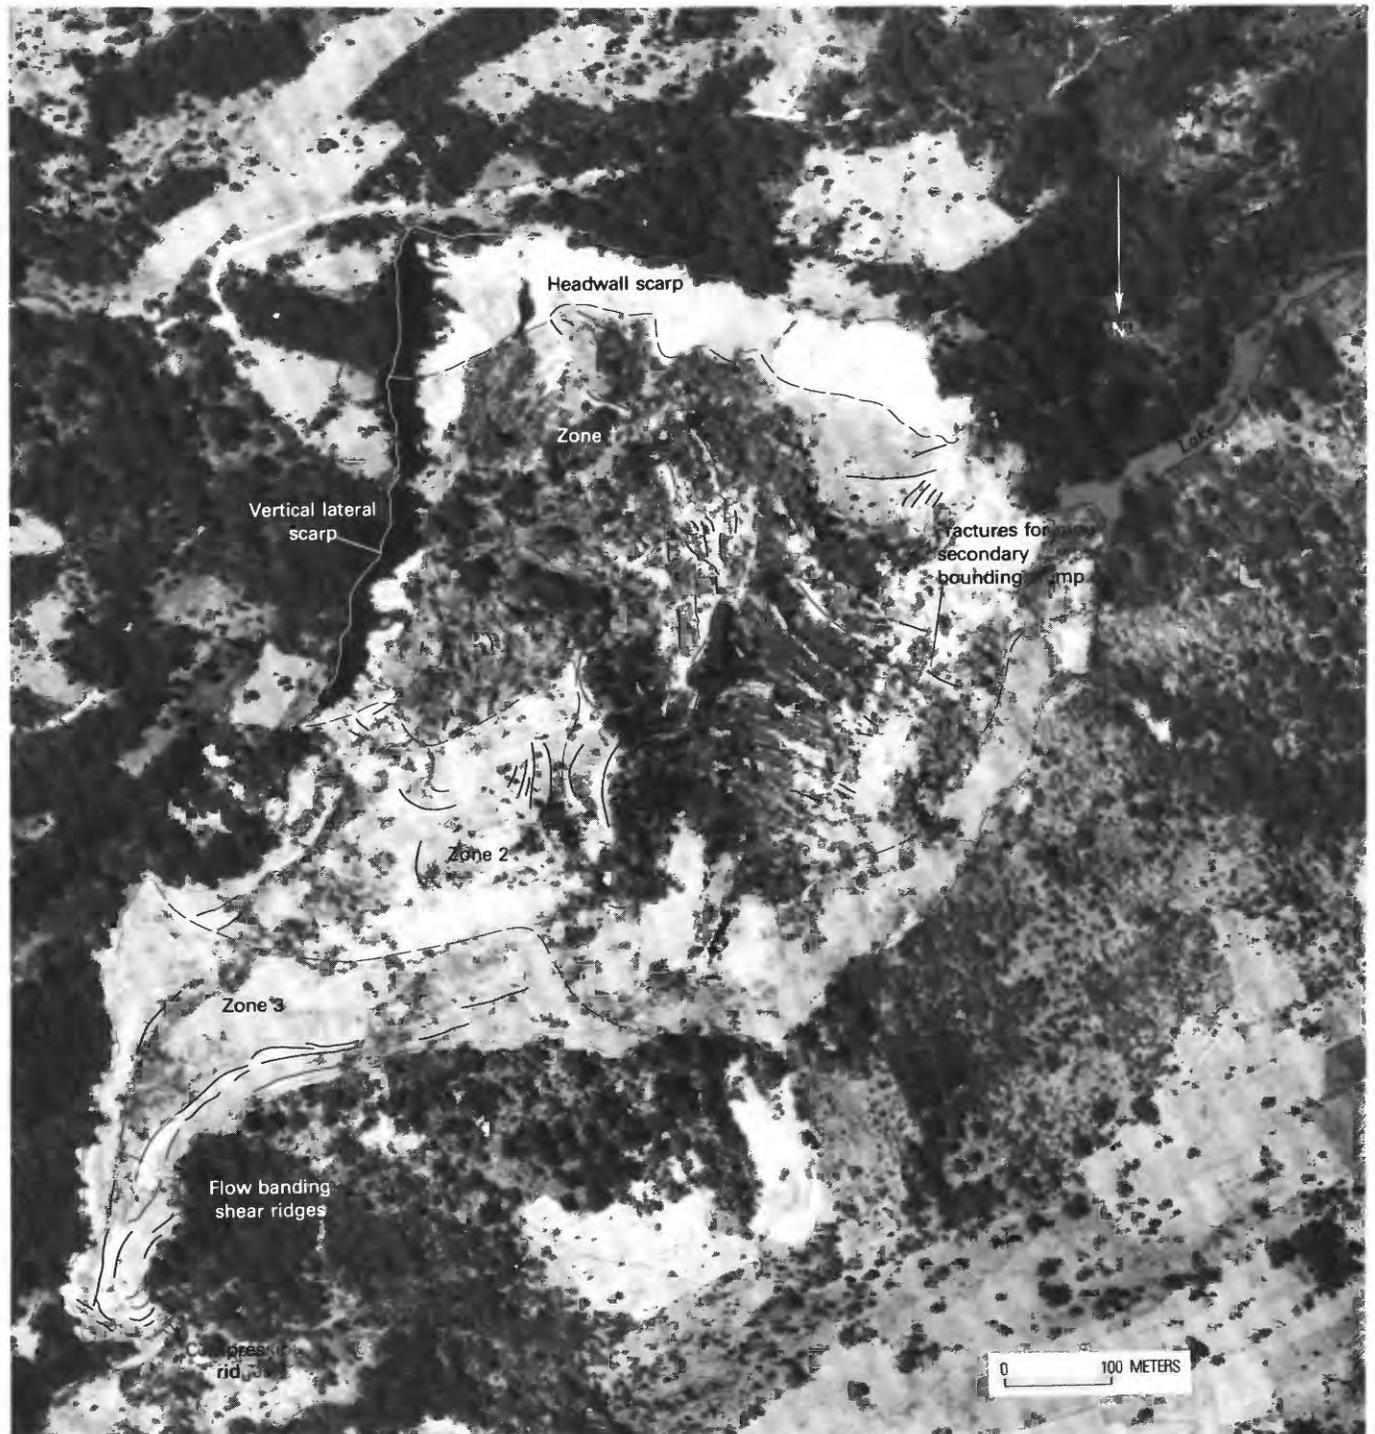
The headwall scarp (fig. 27) is about 35 m high and about 500 m long and strikes approximately N. 75° W. The planar surface of the scarp dips about 45° N. for 50 m downward from the top and then flattens to about 25° near the base (fig. 28). The scarp surface has two prominent sets of slickensides, the most prominent set plunging directly downdip and the other plunging northwest in the plane of the scarp, at about 30° to the first. A lateral scarp, intersecting the east end of the headwall scarp at nearly a right angle (fig. 29), is nearly vertical, trends N. 15° E., and extends along the slide margin for approximately 600 m (see fig. 23).

The landslide debris, about 50 m in maximum thickness, extends about 1 km northeastward from the foot of the headwall scarp. The landslide mass is a complex rotational slump/rock avalanche (see fig. 3) divided into three distinct zones (1-3, fig. 23). The material in zone 1 next to the headwall scarp (fig. 30) contains many secondary slumps spaced from 1 to 20 m apart. Most of this material remained relatively coherent despite at least 100 m of downscarp movement and about 20° of backward rotation. The original ground surface throughout most of this zone remained sufficiently intact during movement for the trees to continue to grow (as of July 1976), whereas trees in the slide debris further downslope in zone 2 (fig. 31) died. The slide material in zone 2 is much more internally deformed than the debris in zone 1; rock in zone 2 is extensively exposed on many secondary scarps. Still further downslope, the slide material in zone 3 exhibits flow features—for example, lateral ridges (shear surfaces along which landslide material has overridden adjacent intact material), longitudinal banding, and sinuosity conforming to the narrow valley walls. These features indicate that the debris in the toe (fig. 32) was sufficiently disaggregated to exhibit fluidlike flow.

FIGURE 23.—U-2 photograph of large landslide 2 km northeast of San José Poaquil. Photograph taken February 13, 1976.

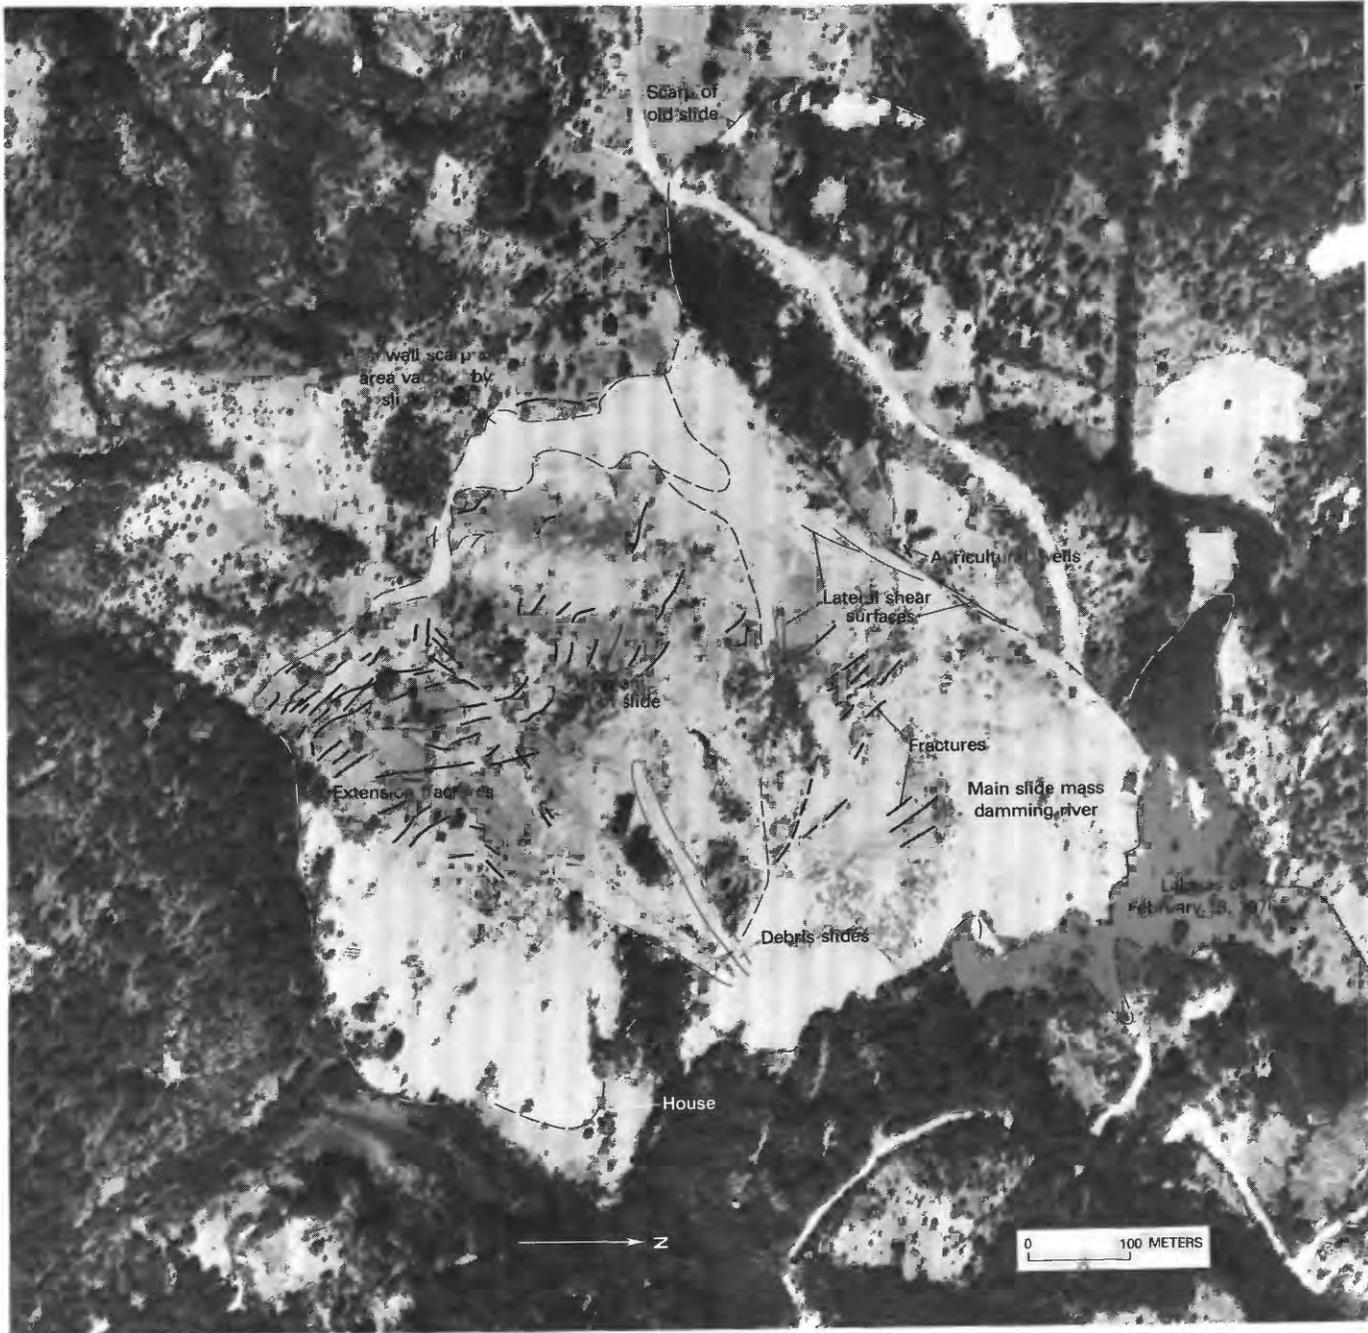
FIGURE 33.—U-2 photograph of large landslide 1 km southwest of San Martín Jilotepeque. Photograph taken February 13, 1976.

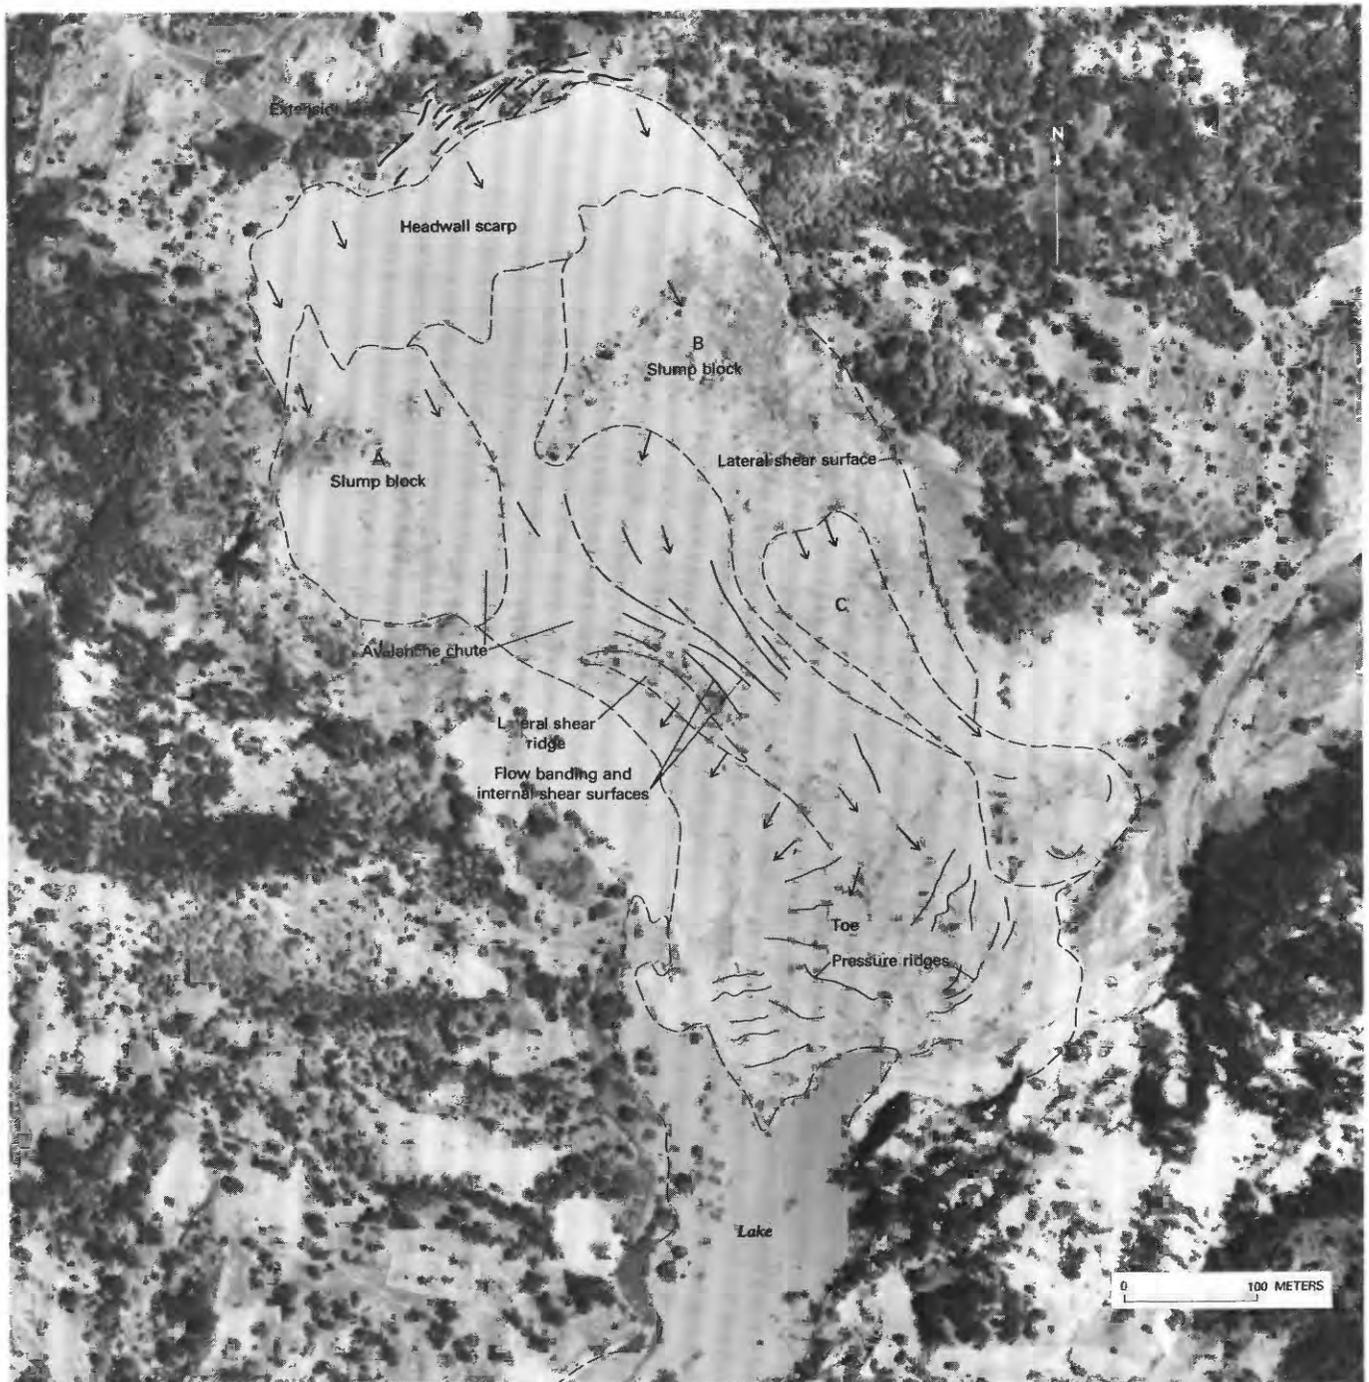
Blocks A and B of the landslide mass remained relatively intact despite a descent of more than 100 m. However, a tongue of debris (C, figs. 37, 38), which showed secondary slumping from the edges of block B, avalanched out onto the river flood plain and merged with the rest of the debris forming the landslide toe. The toe (figs. 37, 38) exhibited several distinct curvilinear lobes of debris that mark different flow fronts. These lobes may not indicate separate episodes of movement but rather changes in the flow direction of the debris during sliding.

Extension cracks (fig. 37, 39) were visible behind the headwall scarp for a distance of about 100 m (fig. 41). In late June 1976, slump movement was taking place along several of these fractures, probably as a result of precipitation during the rainy season. Several fracture-bounded blocks were reported to have slid down the scarp face in response to heavy afternoon rainfall. During this part of the rainy season, two ponds formed: one midway along the left margin of the landslide (looking upslope), and one near the base of the headwall scarp.

FIGURE 37.—U-2 photograph of large landslide near Estancia de la Virgen. Photograph taken February 13, 1976. Arrows show direction of slide movement.

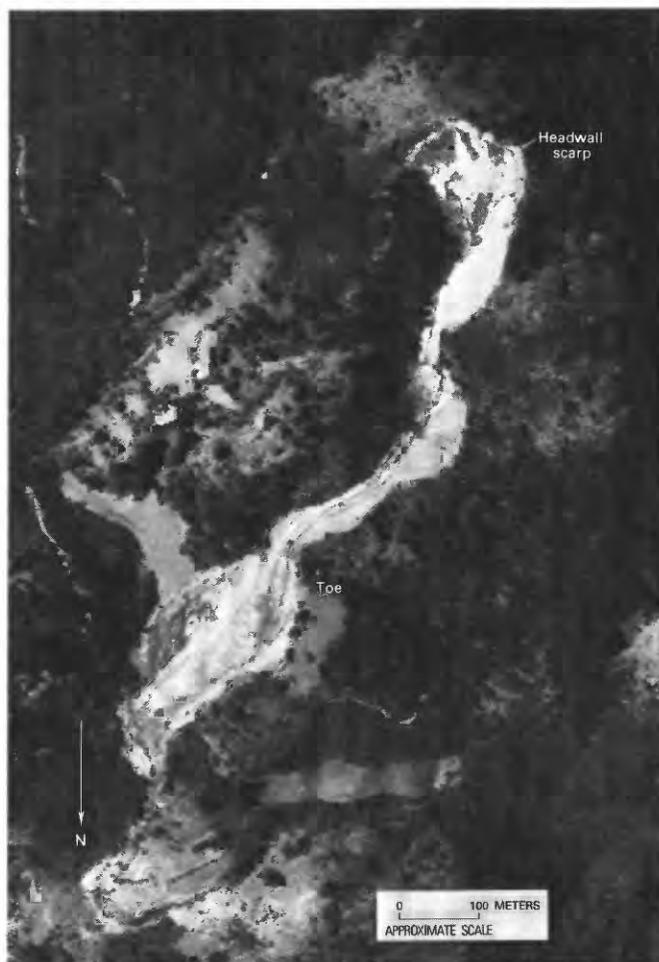
Several other landslides were not voluminous enough (20,000–100,000 m³) to dam stream drainages or otherwise to affect people or property. Three flow landslides occurred about 6 km north of Tecpán (pl. 1) in what appeared to be dark-brown soil overlying andesite. These landslides were observed only from the air, and the slide debris appeared to be wet soil that had flowed a great deal. The largest of these landslides is a long narrow feature (fig. 43) similar to the flows caused by liquefaction in the 1906 San Francisco, Calif., earthquake (Youd and Hoose, 1977). We have no data on the moisture content of this landslide, however, and therefore no evidence of whether liquefaction occurred there.

FIGURE 43.—U-2 photograph of flow landslide north of Tecpán.

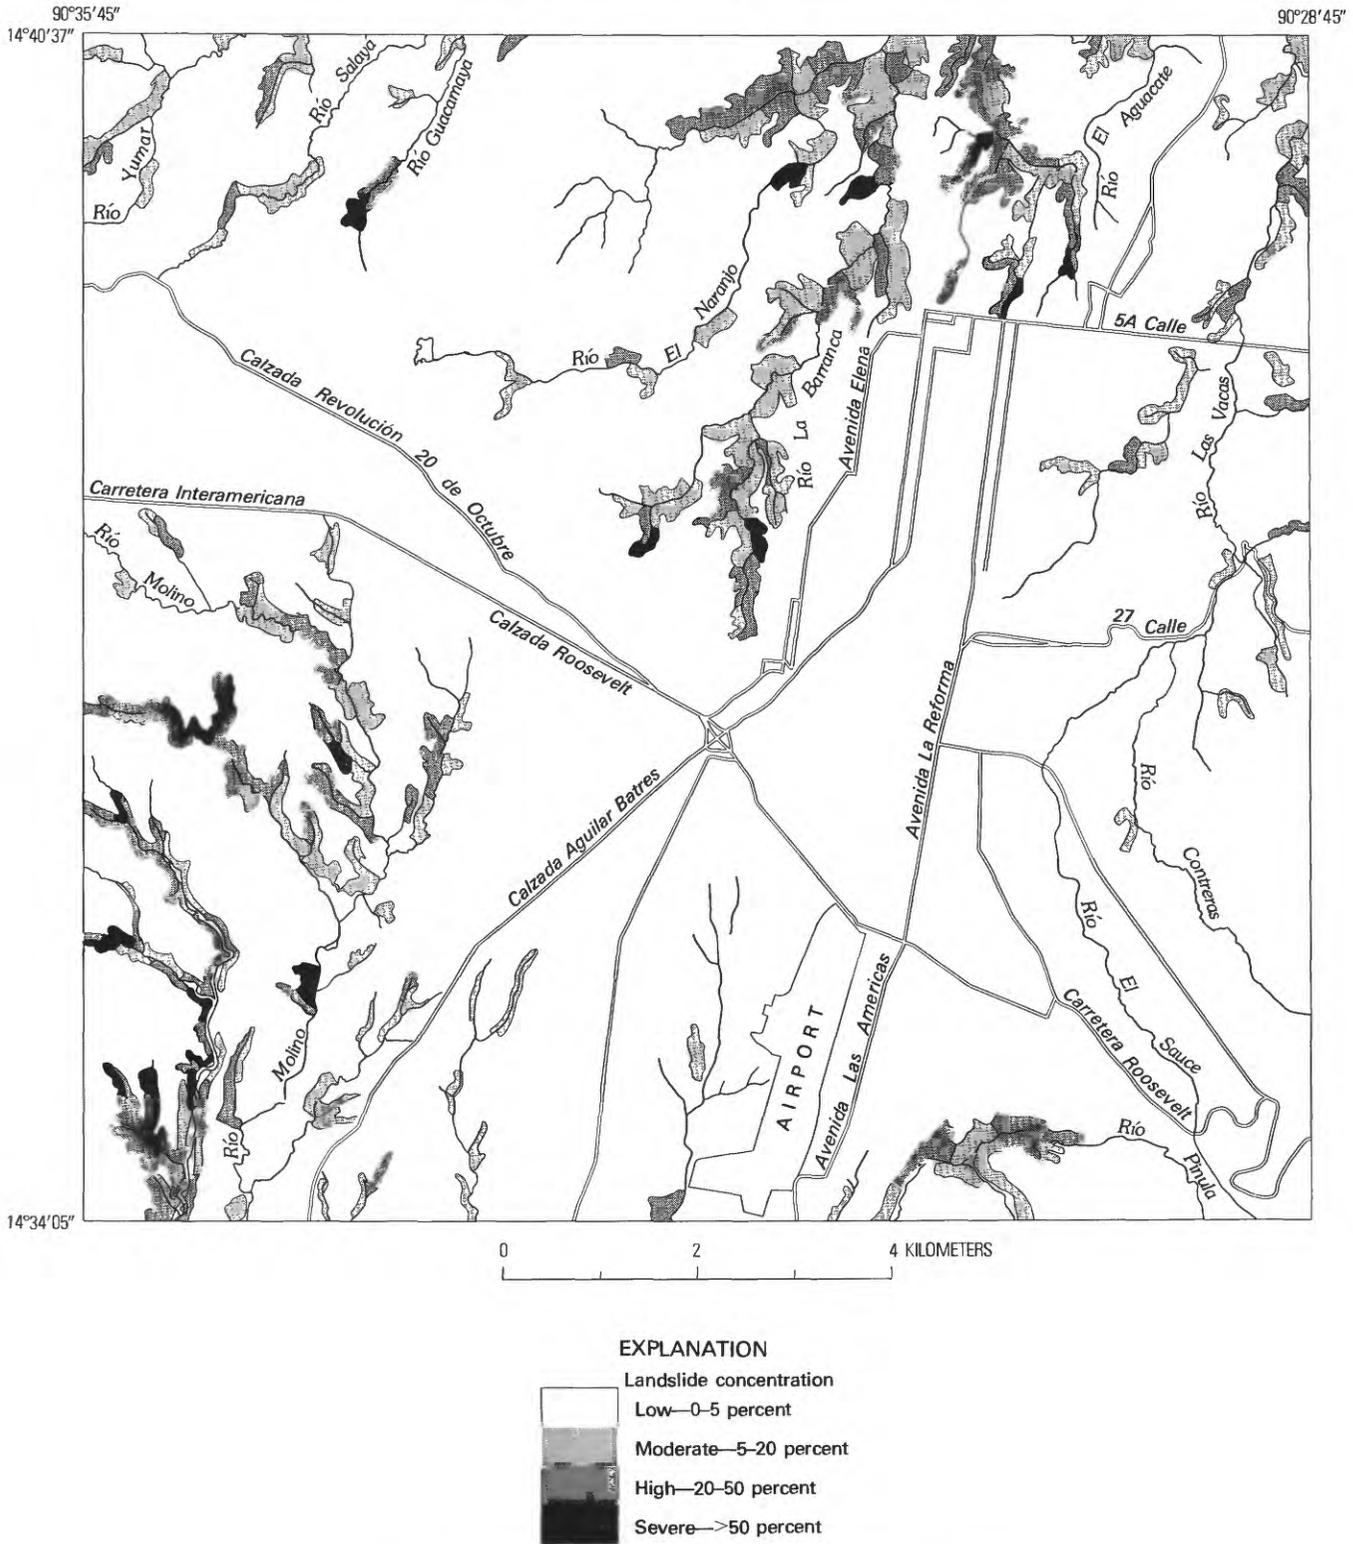
Our map (fig. 46), which depicts the relative abundance or concentration of landslides generated in the Guatemala City area by the 1976 earthquake, is a generalization of an unpublished 1:12,500-scale landslide inventory prepared from aerial photography and field reconnaissance. Thus, this landslide concentration map is a second-generation map that quantifies and categorizes the concentration of landslides along discrete areas of the canyon margins to which earthquake-

As can be seen on our landslide concentration map (fig. 46), canyon slopes were not uniformly affected by seismically induced landslides. For example, in the central part of the map area along the Río La Barranca, landslide concentration zones classified as moderate and severe are juxtaposed. Immediately to the north, severe concentrations are adjacent to low and moderate concentrations along the Río El Naranjo. The canyon slopes of the Río El Naranjo were markedly unaffected by landslides, although the slopes are in an area practically surrounded by canyons with high and severe landslide concentrations. Landslide concentration also varies greatly in the area north of Guatemala City as well as

FIGURE 46.—Landslide concentration map of Guatemala City area.

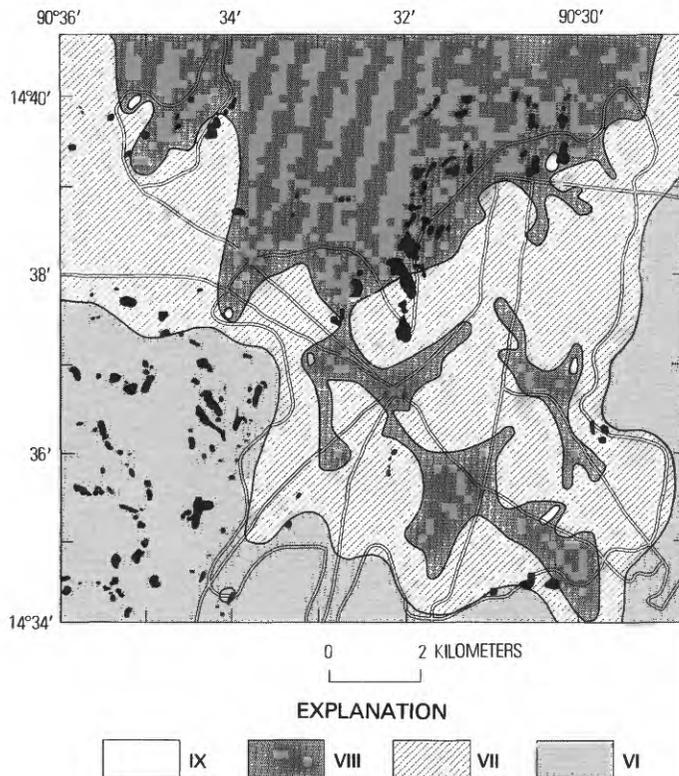
FIGURE 49.—Distribution of seismic intensities and landslides (black areas) from 1976 Guatemala earthquake in Guatemala City area. Note scatter of landslides throughout areas within zones of MMI VI, through VII (after Espinosa and others, 1978, fig. 25).
