# The Loma Prieta, California, Earthquake of October 17, 1989— Landslides

DAVID K. KEEFER, *Editor*

STRONG GROUND MOTION AND GROUND FAILURE  
THOMAS L. HOLZER, *Coordinator*

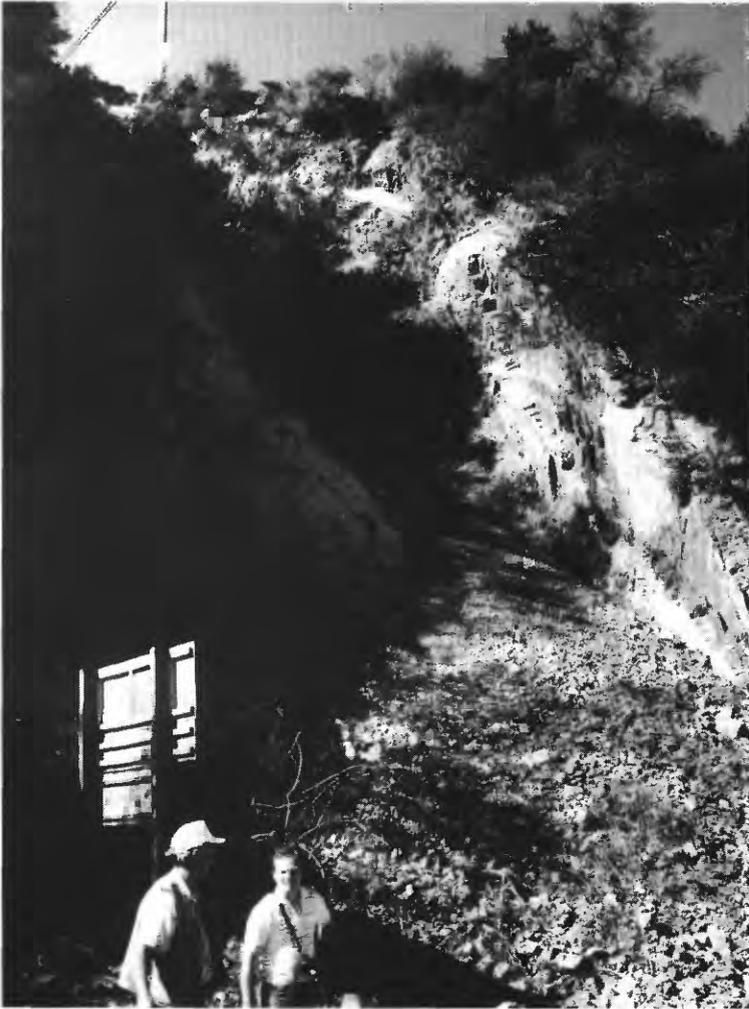
Another complex of rock falls and rock slides, which resulted from failures of cut slopes on both sides of California Highway 17, temporarily blocked that highway at the Santa Cruz-Santa Clara County line (fig. 2). The landslide source was a sequence of steeply dipping beds of sandstone and shale of the Vaqueros Sandstone, which were massive but locally closely fractured. Rock falls were generated only within the shale beds, and open fissures on the ridgecrest above the source west of the highway indicated that these rock falls were related to an incipient slope failure which was much larger and deeper. Together, the rock falls and rock slides at this locality contained an estimated several hundred cubic meters of material.

Figure 2.—Part of deposit from complex of rock falls and rock slides along California Highway 17 at Santa Cruz-Santa Clara County line (see pl. 1 for location). Landslide source was in intensely fractured rock.

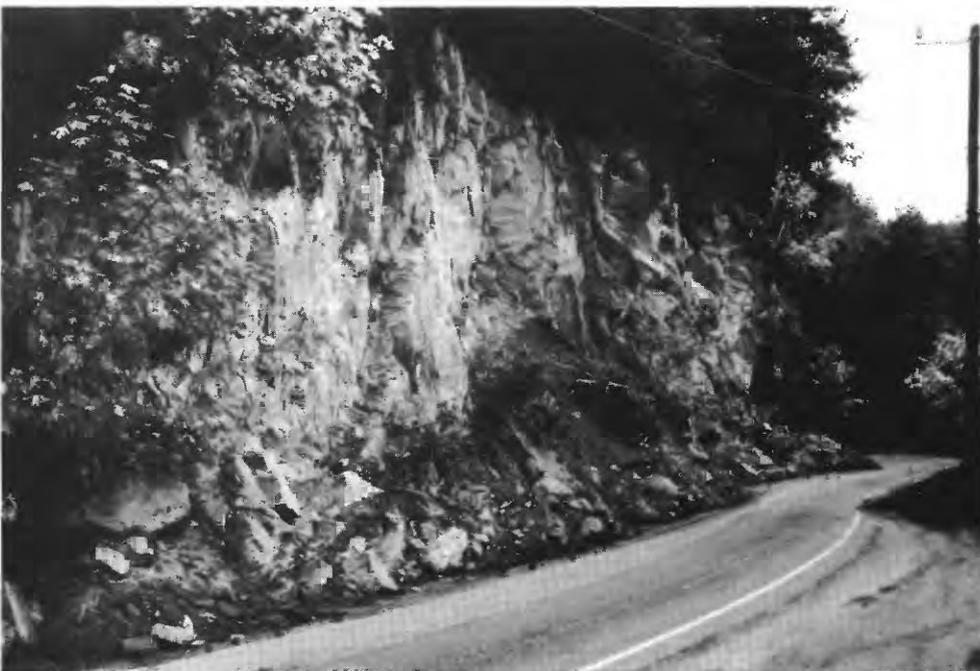
Figure 3.—Rock fall from near-vertical cut along Old San Jose Road, about 0.9 km northwest of Sugarloaf Mountain (see pl. 2 for location). Source rock is weakly to moderately cemented sandstone, broken by conspicuous, through-going joints. Estimated volume of deposit is 500 to 1,000 m<sup>3</sup>.

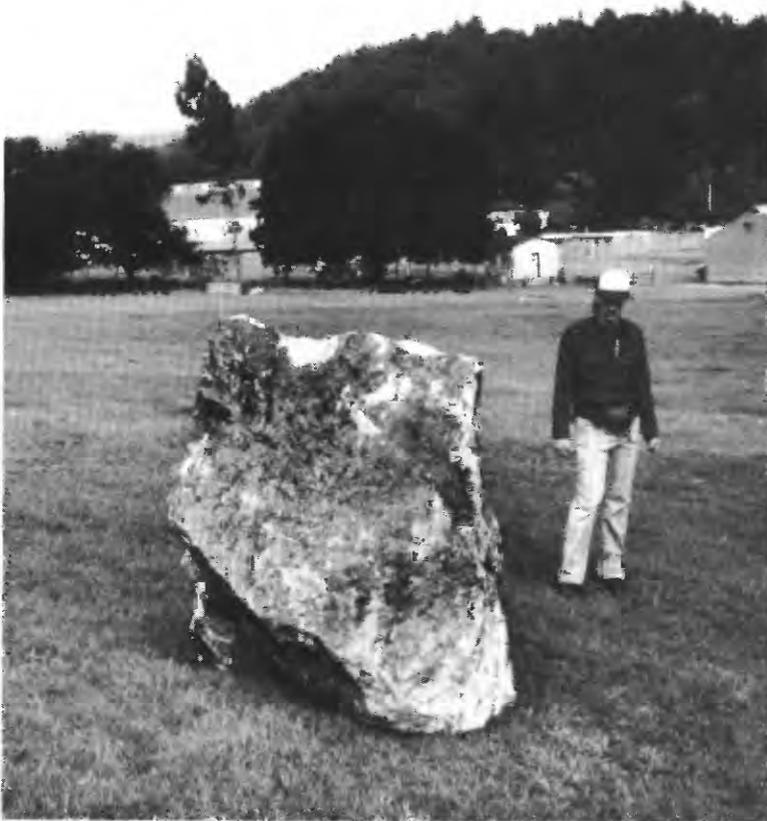
Figure 4.—Boulder, approximately 1.5 m in maximum diameter, from earthquake-induced rock fall near conference ground about 2.5 km north of Soquel (see pl. 2 for location). Several boulders of nearly comparable size bounced and rolled into gently sloping field from steep slope above.

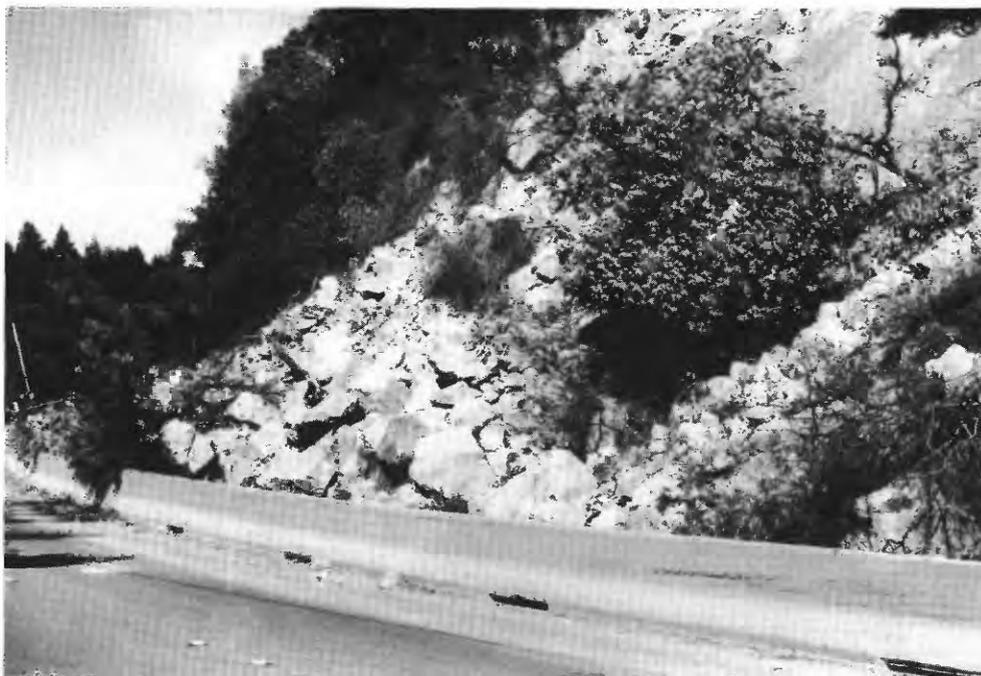
Figure 5.—Part of rock-fall deposit from cut slope above California Highway 17 in Glenwood area (see pl. 2 for location).

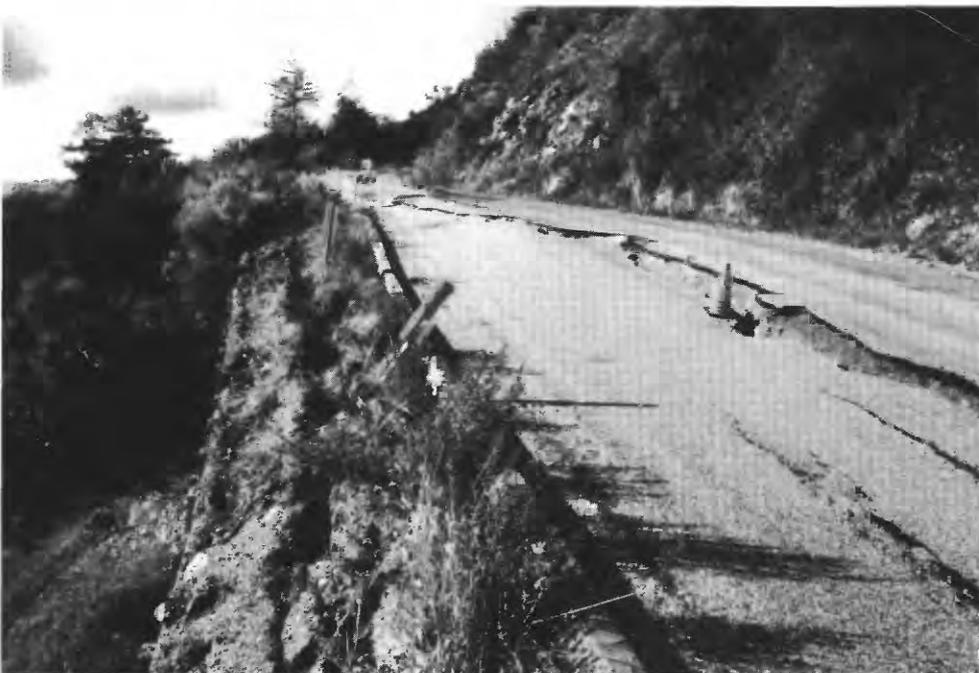
Figure 7.—Small slump in road fill near Bean Hill (see pl. 2 for location). Note arcuate, concave-downslope main scarp nearly parallel to long axis of road. Slumps in fill were most common type of category II landslides in the southern Santa Cruz Mountains. Photograph by David M. Peterson, U.S. Geological Survey.

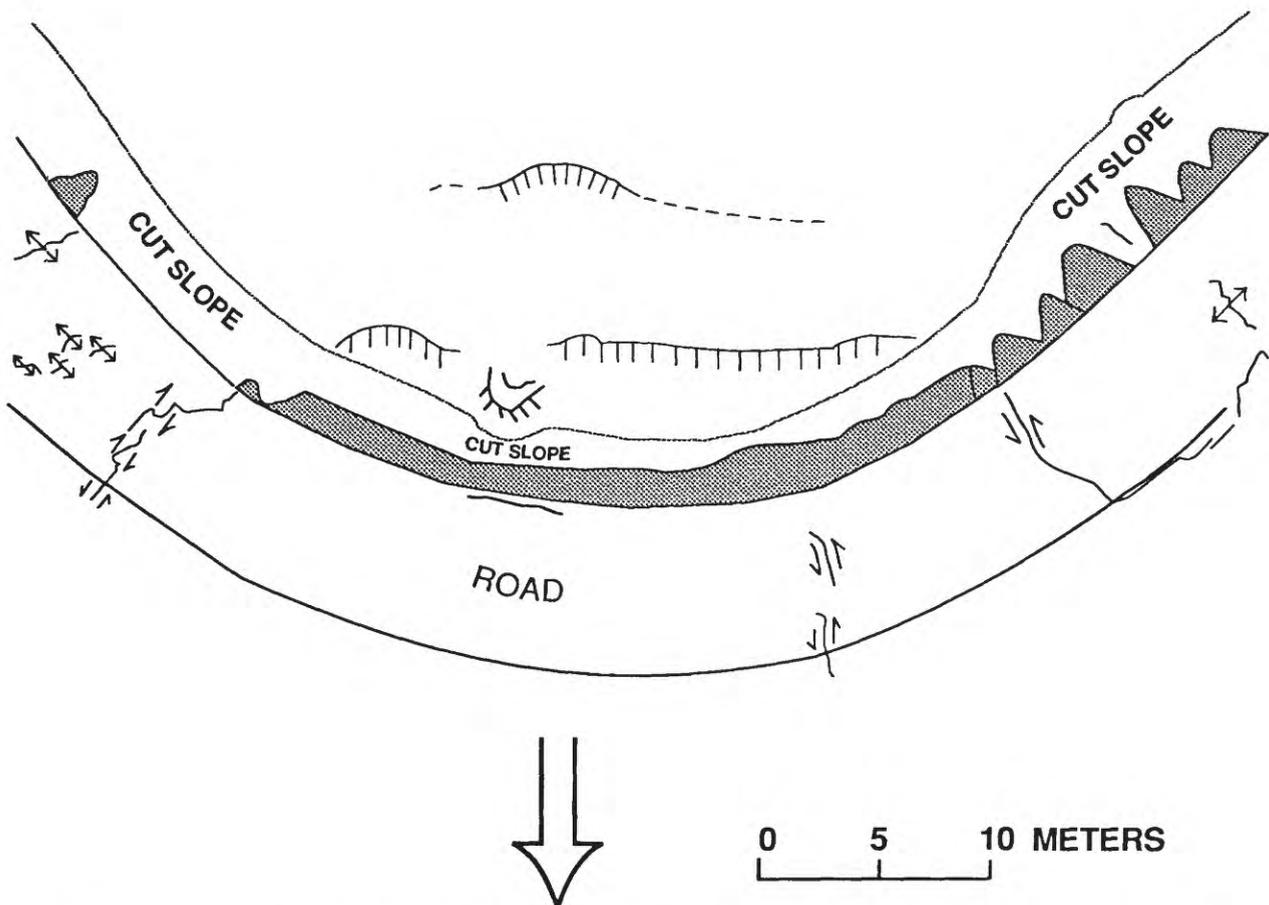
Figure 10.—Sketch map showing rock fall and block slide from end of ridge in Big Basin Redwoods State Park (see pl. 1 for location). Road curves around end of ridge in midslope position. Prominent scarps on ridgecrest above road (hachured on down-dropped side, dashed where approximately located) showed as much as 6 cm of downslope displacement. Small arrows denote relative senses of motion on cracks in road, which typically trend perpendicular to long axis of roadway. Maximum local lateral displacement was 1.5 cm. Large arrow indicates approximate, inferred direction of movement of slide. No compressional features were found in heavily vegetated area downslope from road. Rock and soil falls (shaded areas) occurred on cut slope above road.

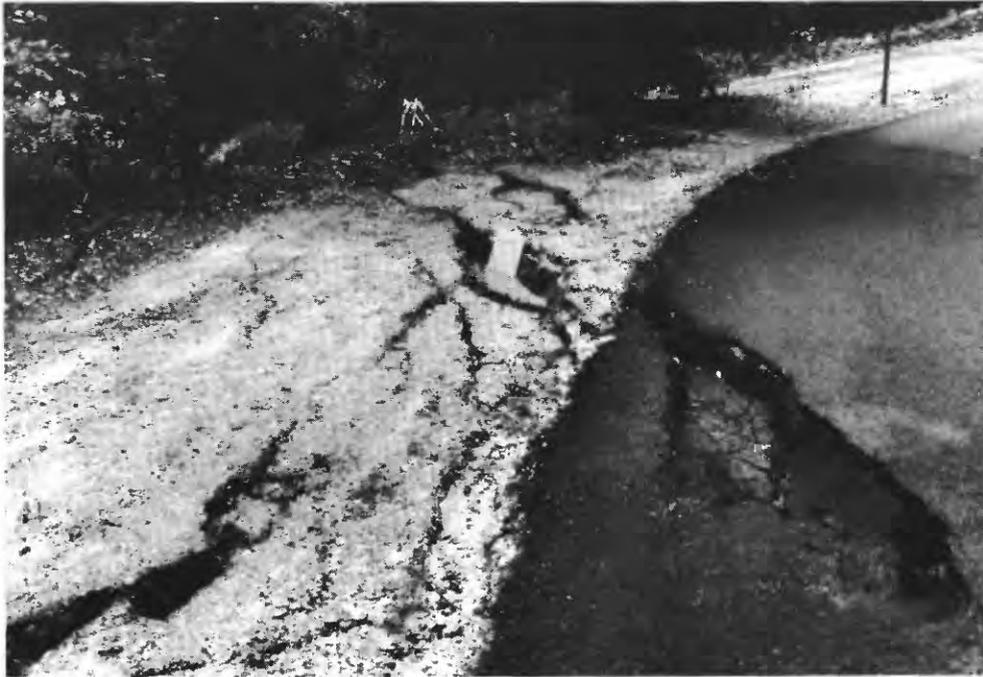
Figure 11.—Part of main scarp of rock block slide on end of ridge near Laurel (see pl. 2 for location). Notebook is 20 by 27 cm.

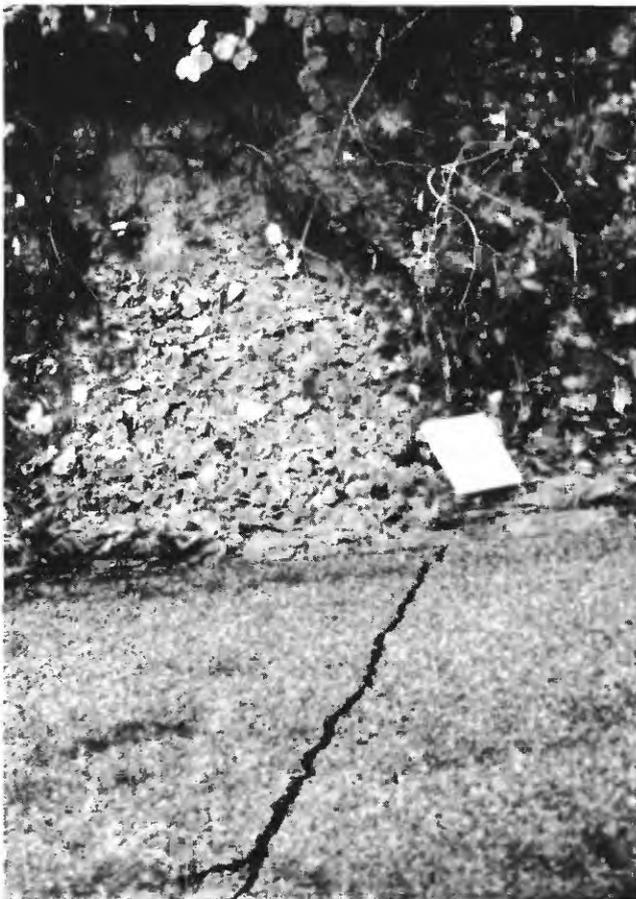
Figure 12.—Lateral margin (left flank) of block slide near Laurel (see pl. 2 for location) defined by crack across road, showing left-lateral movement. Note small rock fall where crack intersects steep cut slope across road.

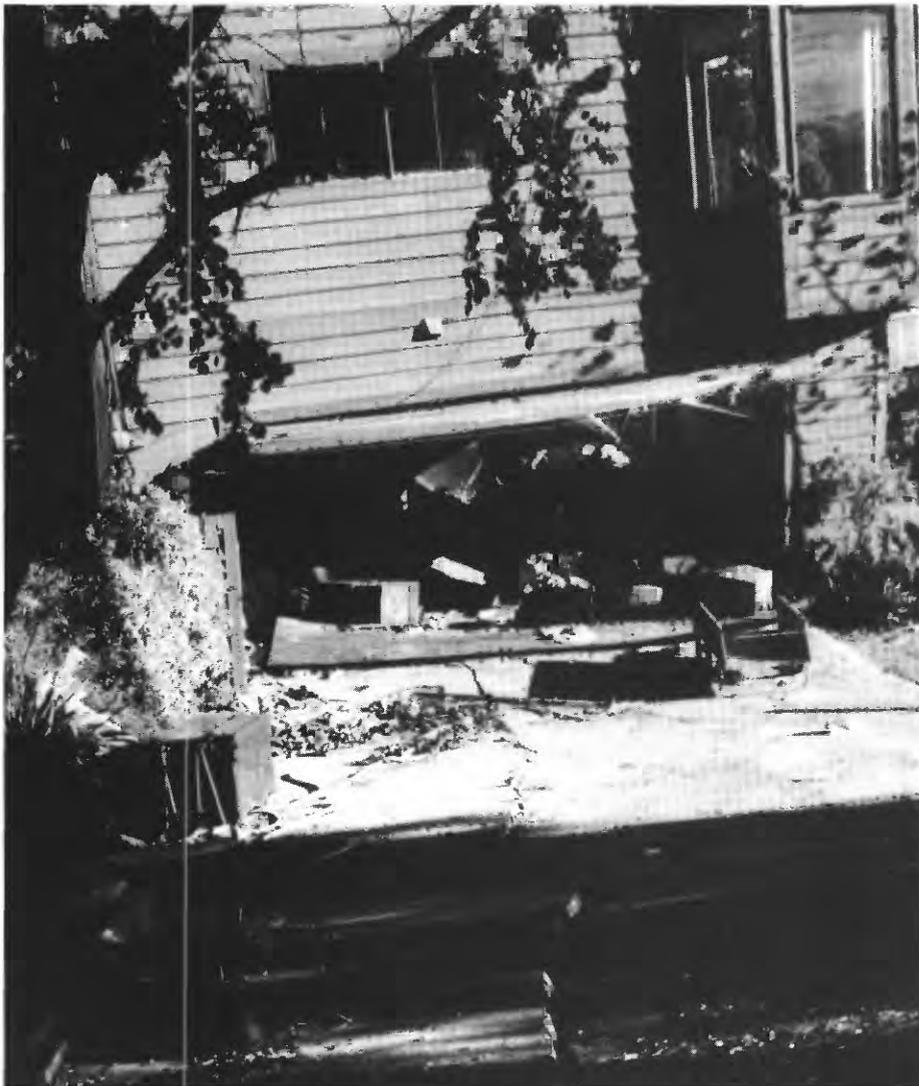
A

Figure 13.—Ridgecrest fissure and associated landslide along Robinwood Way (see pl. 2 for location). *A*, Ground crack, also breaking pavement and foundation slab. Crack is nearly linear, trends parallel to long axis of steep, high, narrow ridge, and is immediately upslope from slump shown in figure 13*B*. Downslope direction is toward right. *B*, Rotational slump originating on edge of ridgecrest, immediately below ground crack shown in figure 13*A*. Position and orientation of crack and relation to slump indicate that crack is an incipient landslide feature.

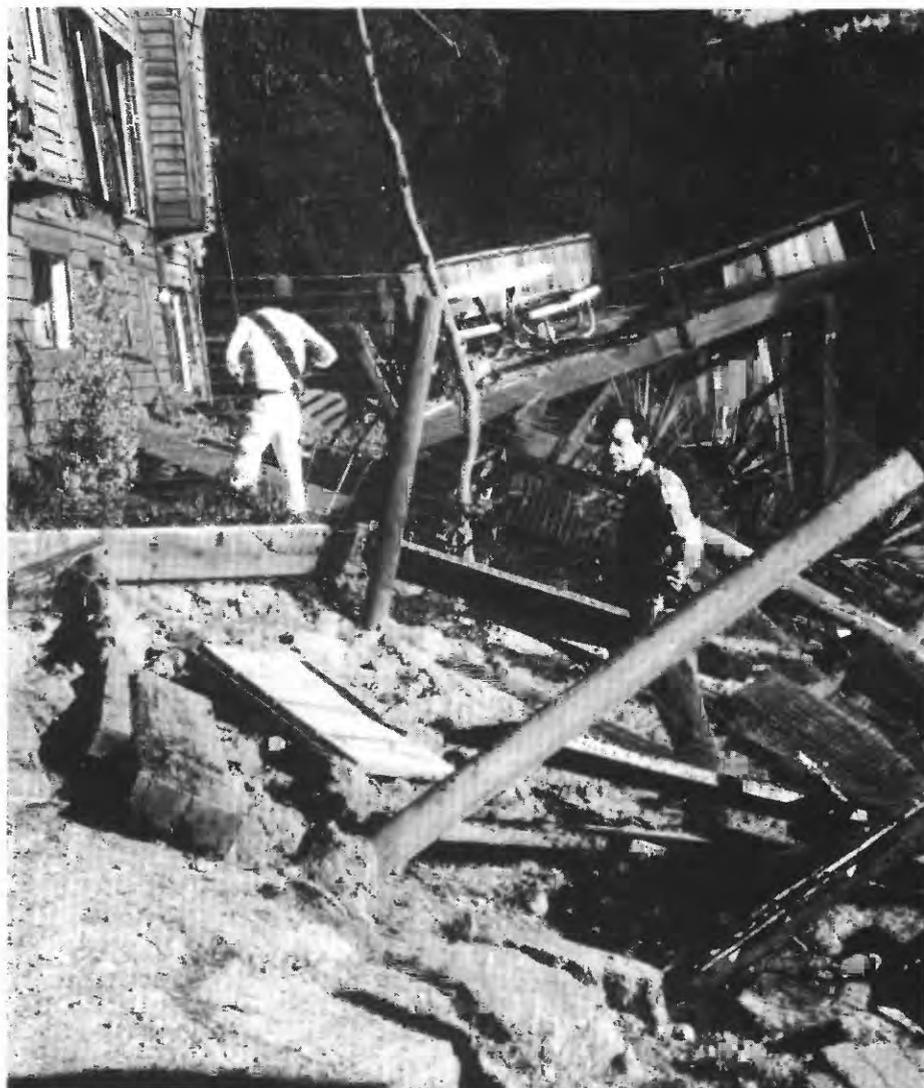
B

Figure 13.—Continued.

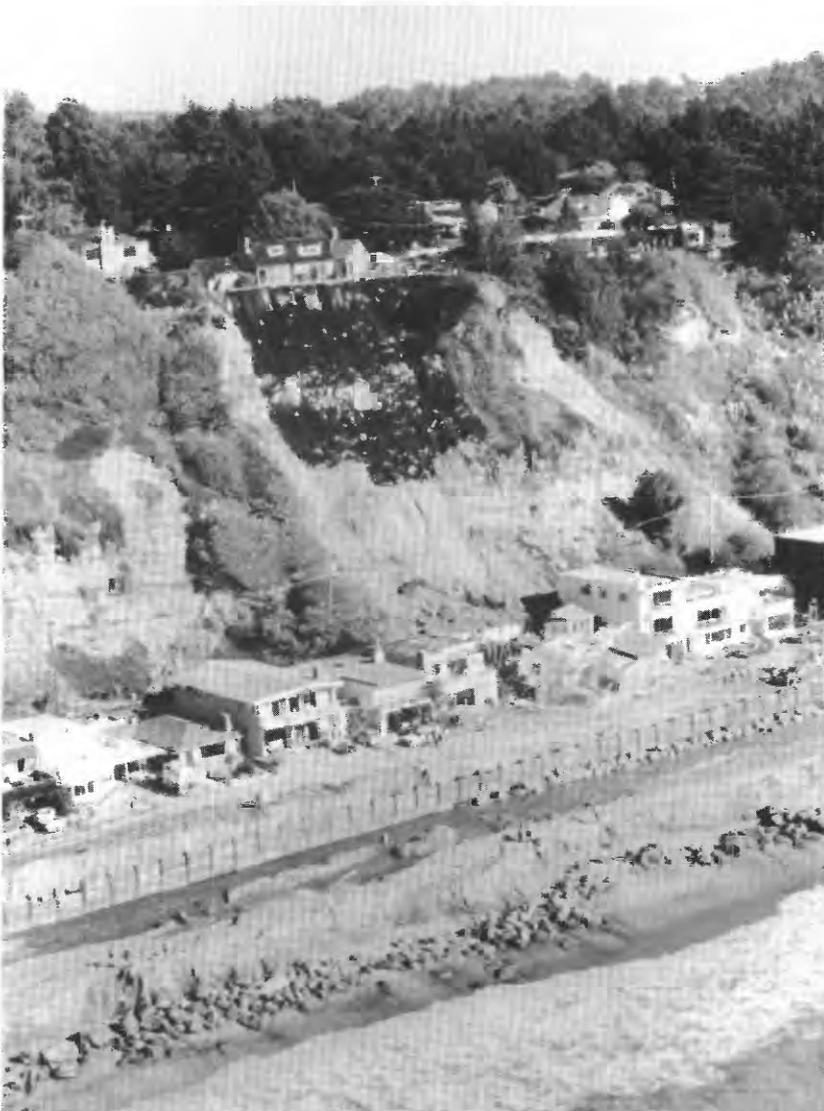
Figure 1.—Coastal-bluff failure in Rio Del Mar (see fig. 4 for location) during a 100-yr 24-hour rainstorm in January 1982.

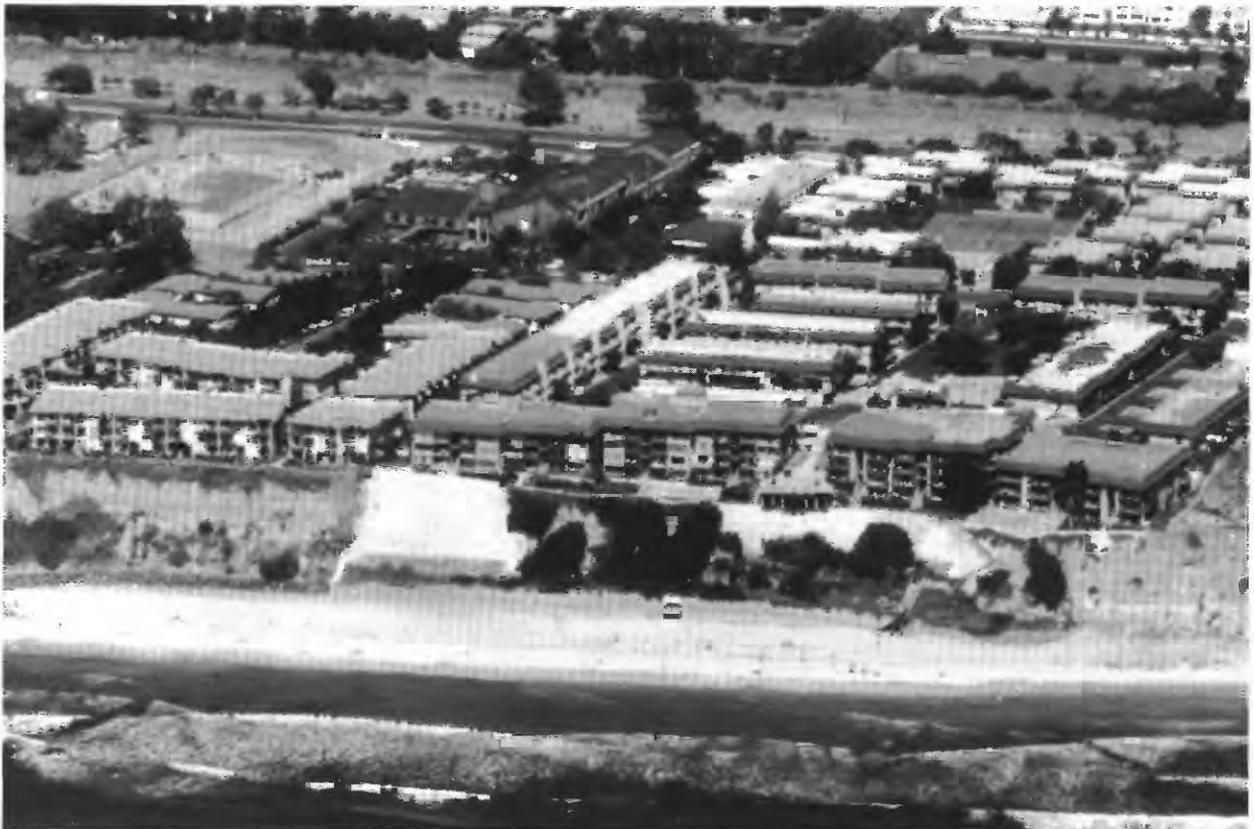
Figure 3.—Intense blufftop development along coast of San Diego County, showing use of seawalls and gunitite to reduce bluff failure.

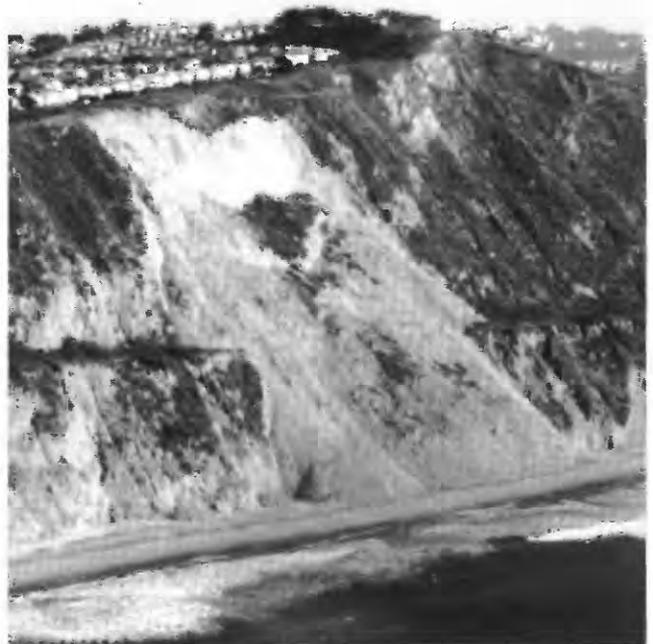
The bluff failures at Daly City, south of San Francisco (fig. 6), are significant because of their size, the proxim-

Figure 6.—Large coastal landslide near Daly City (fig. 4) resulting from 1989 Loma Prieta earthquake. Note proximity of cliff-top houses to headscarp.

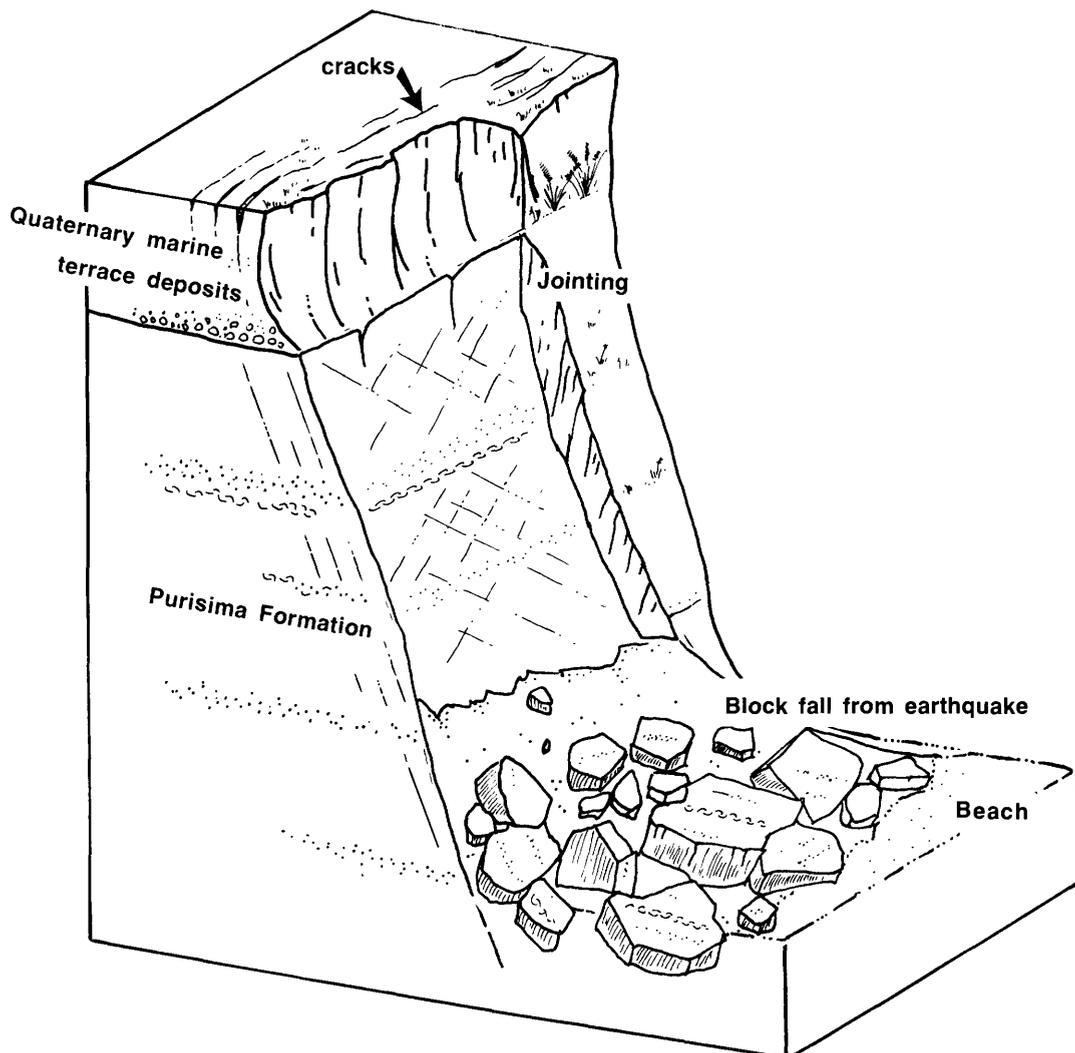
ries toppled downslope, blufftop terrace deposits collapsed, and weakened bedrock failed. Horizontal and downslope separation along joint surfaces allowed large blocks to separate from more intact rock (fig. 7). The size of these failures was a function of joint spacing and orientation, frictional or cohesive strength along the joint surface, cliff height, and toe support. High cliffs with widely spaced, subvertical joints and poor toe support sustained the largest instantaneous and incipient failures in weakened or undercut sedimentary rocks.

Figure 7.—Geologic structure and style of typical rockfall in seacliffs underlain by well-jointed siltstone of the Purisima Formation. Note undercut cliff and tension cracks in Pleistocene terrace deposits.

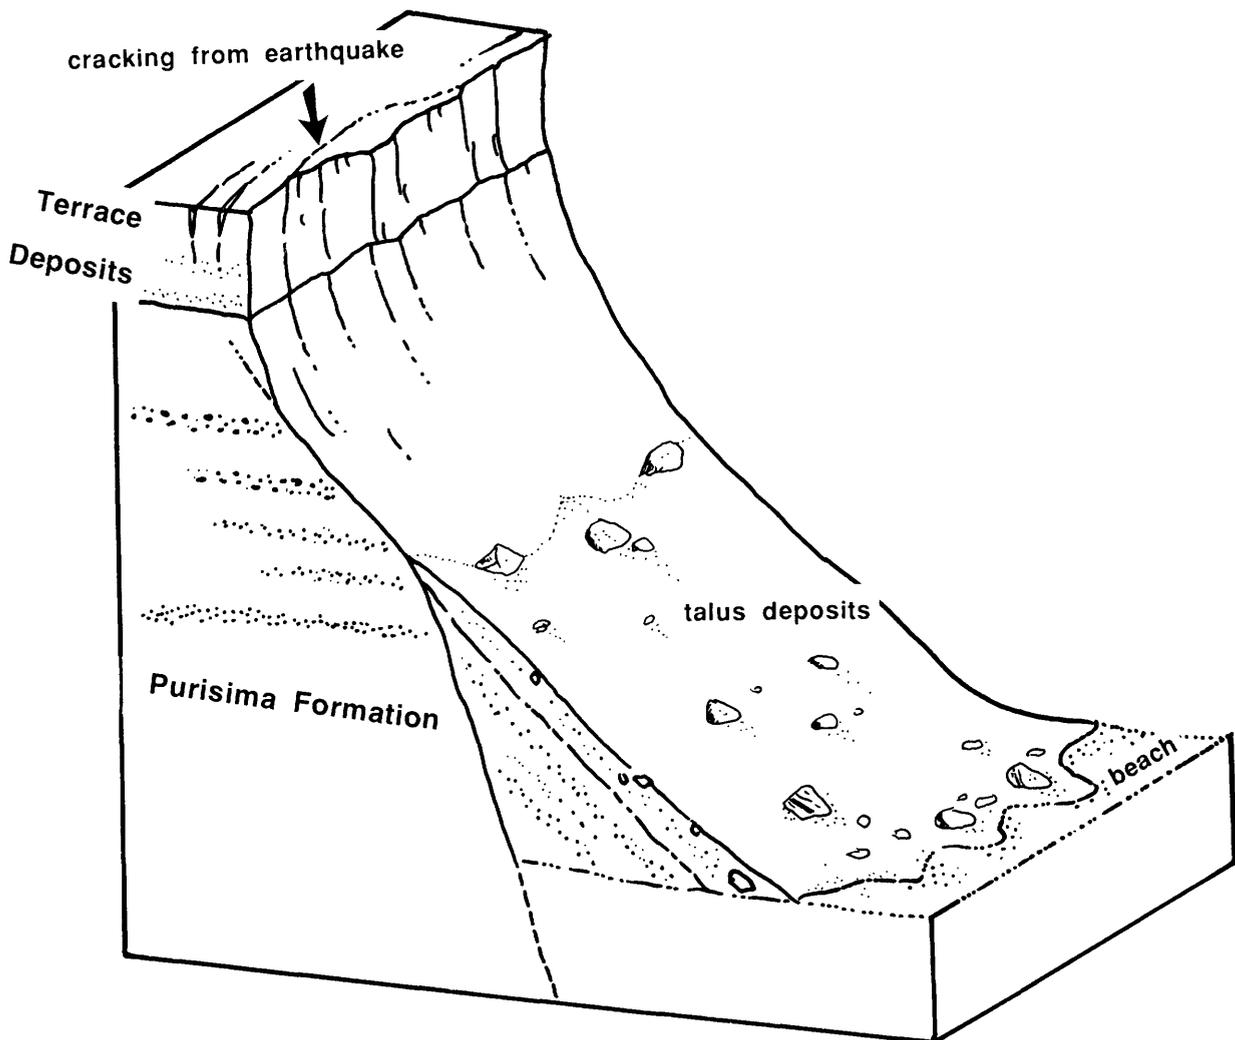
Figure 8.—Geologic structure and typical debris slide in seacliffs underlain by sandstone of the Purisima Formation.

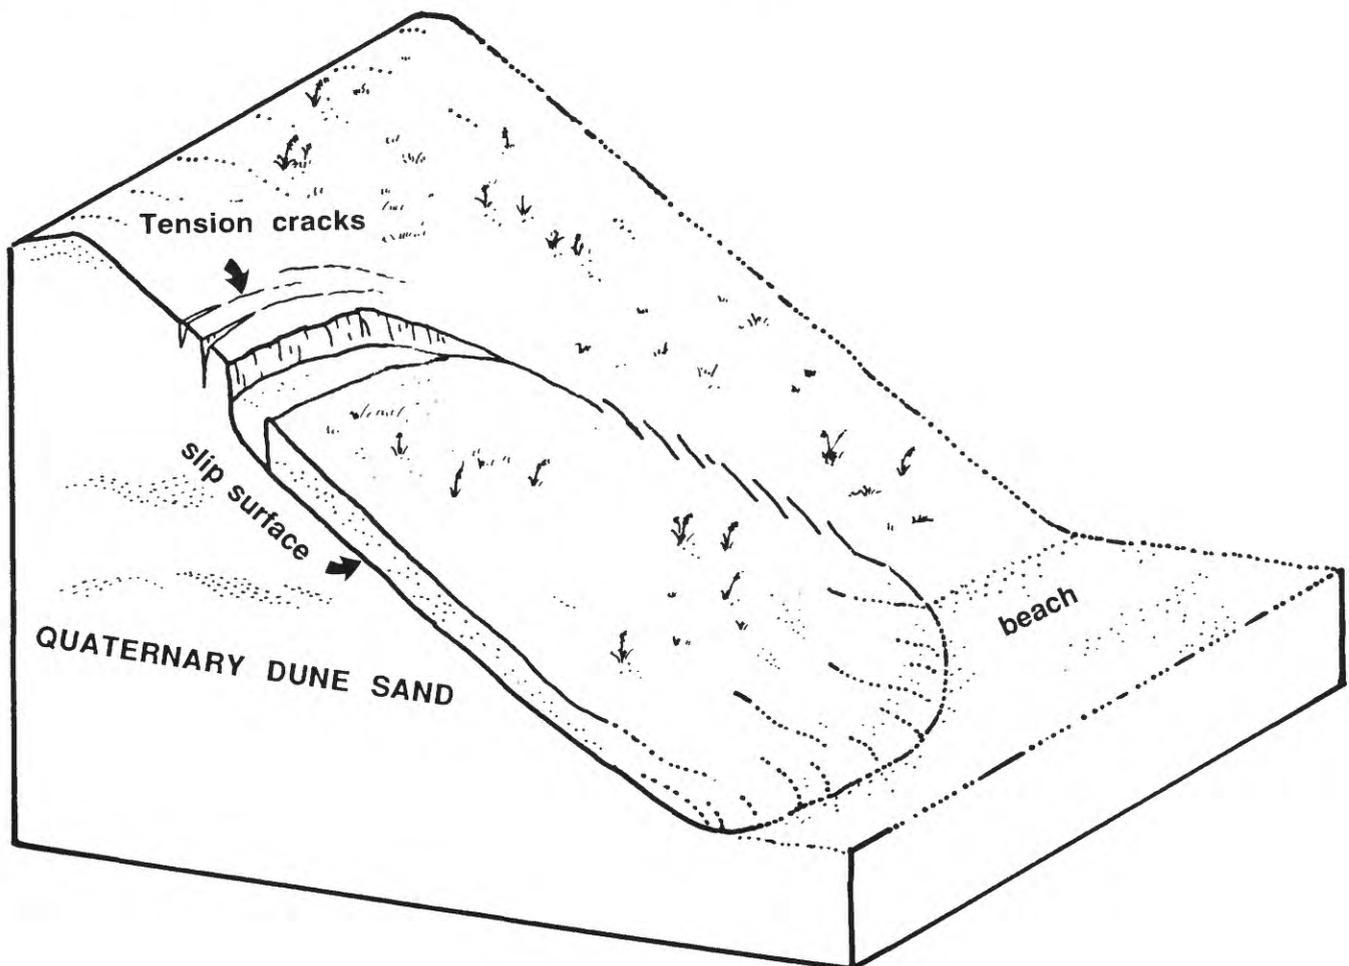
Another type of failure occurred in weakly consolidated Pleistocene dune sand near Sunset Beach (fig. 4) that has been partially stabilized by vegetation. Homes have been built on the edge of this ancient, partially vegetated dune complex. Slope failure took the form of shallow (max 1 m thick), dry sandflows that initiated well below the blufftop (figs. 9, 19). A vertical scarp cut through a thin, cohesive soil layer to a failure surface that paralleled the bluff face. Loose sand or small blocks of more cohesive material, commonly held together by roots, slid downslope along this surface and then ramped over the less steep talus deposits at the base of the bluff. The foundations of several homes were threatened, and one home was relocated.

Figure 9.—Dry sandflow in uncemented eolian deposits. Note tension cracks in overlying, more cohesive surficial soils.

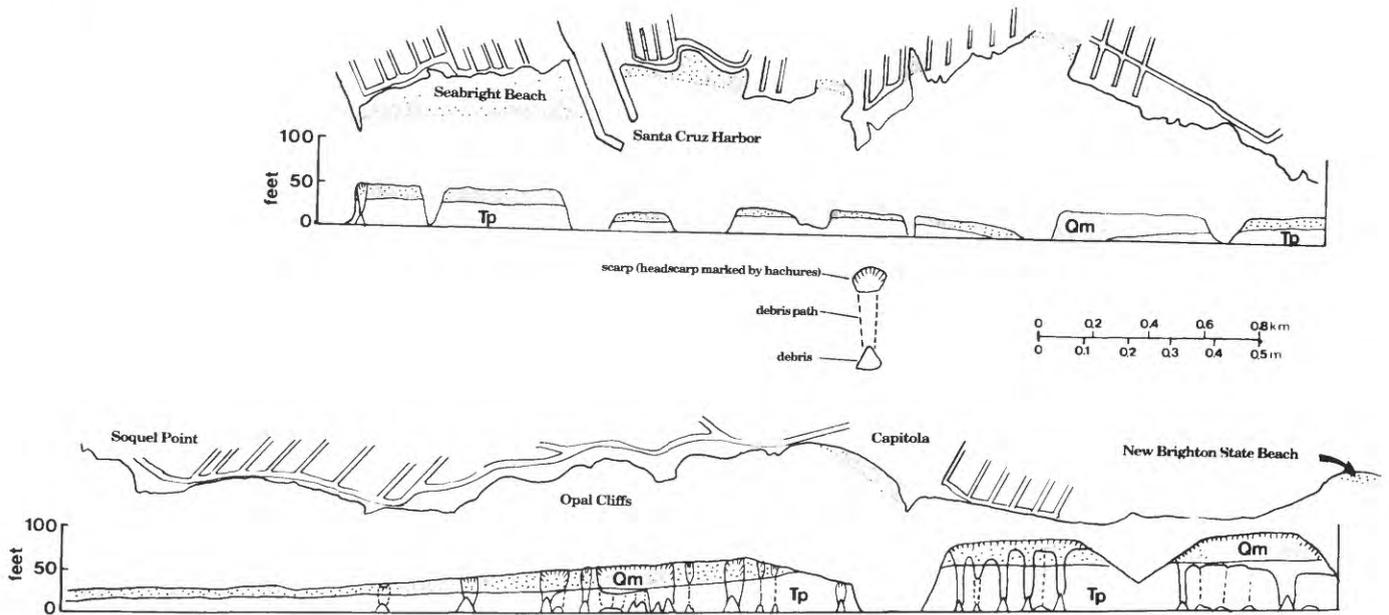
Seismic shaking during the earthquake initiated numerous rockfalls and block slides along this section of the coast (fig. 10). Undercut bedrock and fractured promonto-

Figure 10.—Plan view and longitudinal section showing locations and sizes of earthquake-induced seacliff failures and geology between Seabright Beach and Soquel Point (A) and between Soquel Point and New Brighton State Beach (B) (see fig. 5 for locations). Units: Qm, marine-terrace deposits (Quaternary); Tp, Purisima Formation (late Miocene and Pliocene).

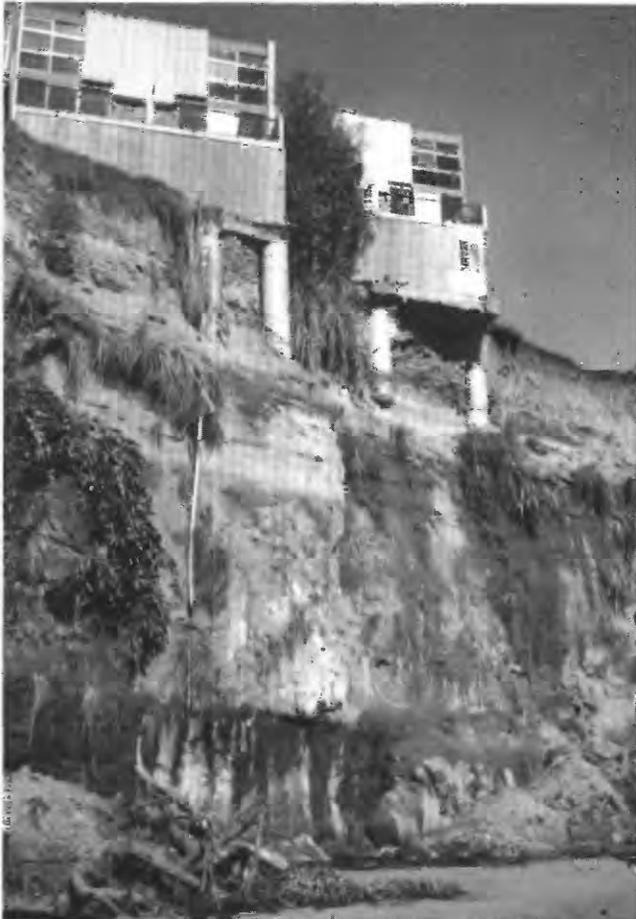
Damage to private property and public infrastructure was minimal along the cliffs in this area, except for those immediately east of Capitola (fig. 4). An apartment complex that was already overhanging the seacliff was additionally undermined as both bedrock and terrace deposits toppled to the beach below (fig. 11). Earthquake-induced failure led to partial loss of concrete caisson support and cracking of the foundation slab and perimeter wall of six apartments. Tension cracks were visible as far as 10 m inland of the cliff edge.

Figure 11.—Collapse of terrace deposits and underlying jointed bedrock of the Purisima Formation at Capitola (fig. 5) as a result of the 1989 Loma Prieta earthquake. These six apartment units were subsequently demolished, owing to blufftop cracking and loss of foundation support.

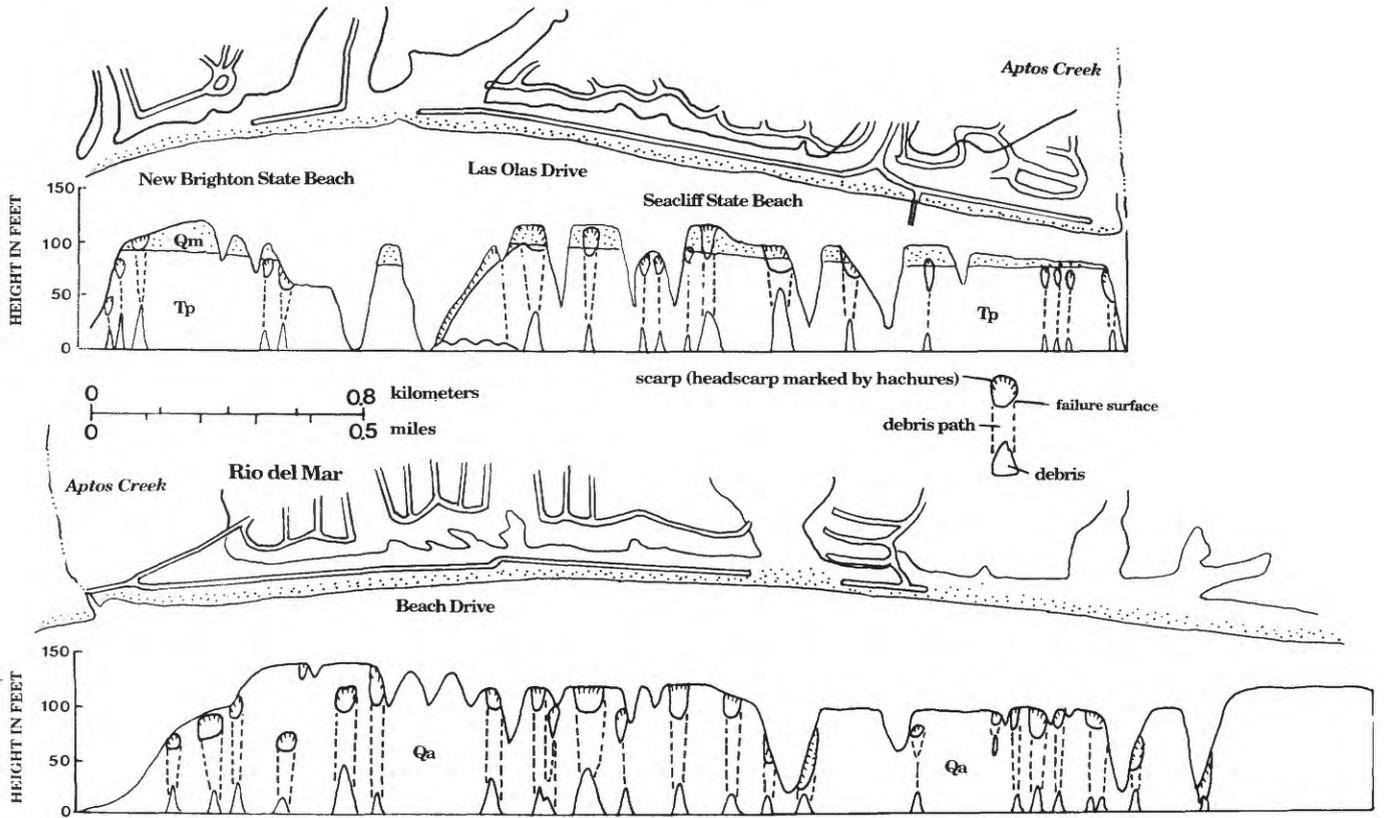
Figure 13.—Plan view and longitudinal section showing locations and sizes of seacliff failures and geology between New Brighton State Beach and Aptos Creek (A), and between Aptos Creek and Rio Del Mar (B) (see fig. 5 for locations). Units: Qa, Aromas Sand (Pleistocene); Qd, dune sand (Quaternary); Qm, marine terrace deposits (Quaternary); Tp, Purisima Formation (late Miocene and Pliocene).

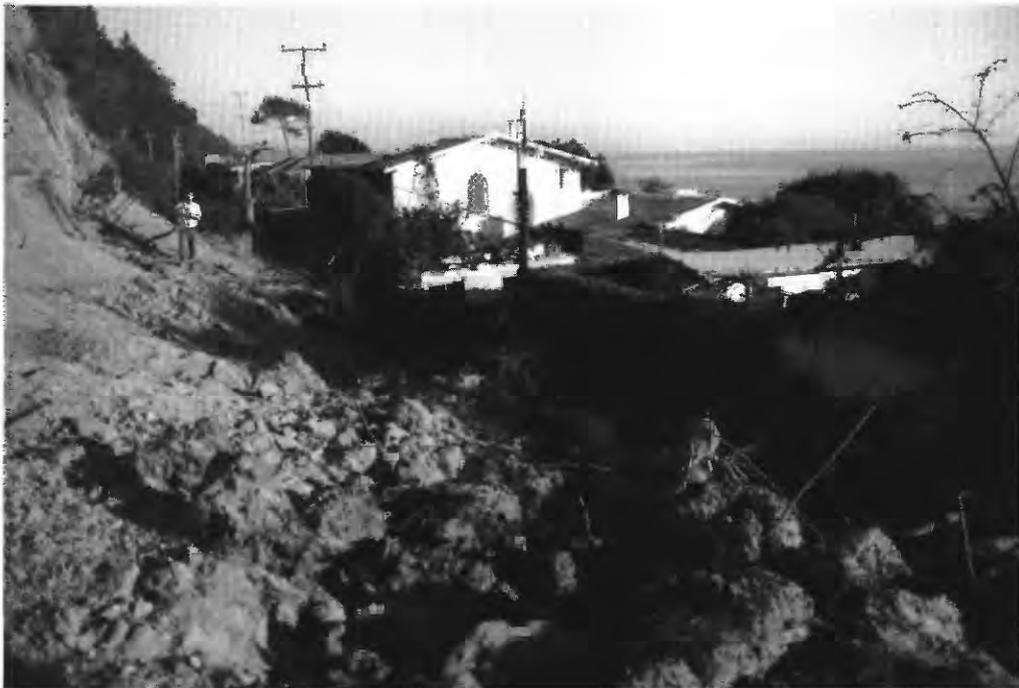
Figure 14.—Base of seacliff in area of figure 12 where material from bluff failure has blocked access to beach-front homes.

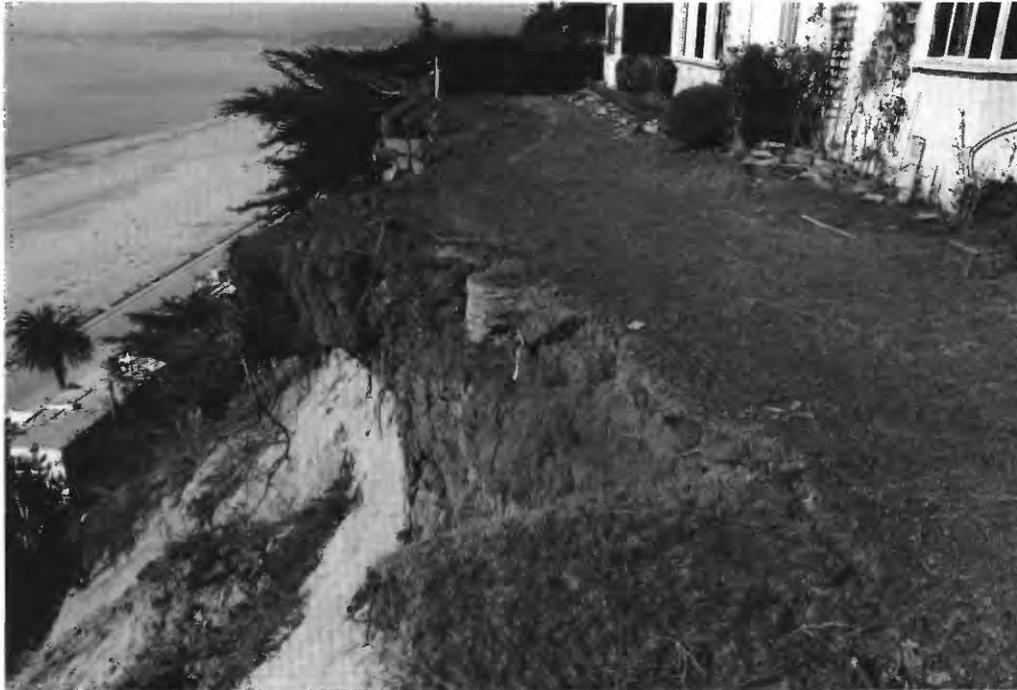
Translational failure along joints or weathering surfaces produced many large (30–60 m wide) concave upward scarps in the upper 12 to 15 m of the cliff in this area (figs. 8, 12). These scarps tended to cut vertically through the terrace deposits and then flatten to parallel the slope as they approached the Purisima Formation. Deep tension cracks cut through the upper terrace deposits and soils as far as 6 m landward of many of the scarps; this distance tended to increase with the size of the scarp and the height of the cliff. Coherent blocks overlying loose soil disintegrated as they cascaded down the cliff face. Talus piles, as much as 12 m high, blocked access to homes (fig. 14) and partly buried automobiles. Two blufftop homes ultimately were demolished because of such failures, which produced deep tension cracks through the building sites

(fig. 15). Both homesites were on narrow, steep-sided peninsulas along the crest of the coastal bluff, locations where seismic shaking appears to have been particularly severe.

Figure 15.—Deep tension cracks (arrows) in terrace deposits in Rio Del Mar (fig. 5). Cracks cut through house foundation and indicate potential extent of future failure. At this site, house was demolished, and unstable material was removed to stabilize site.

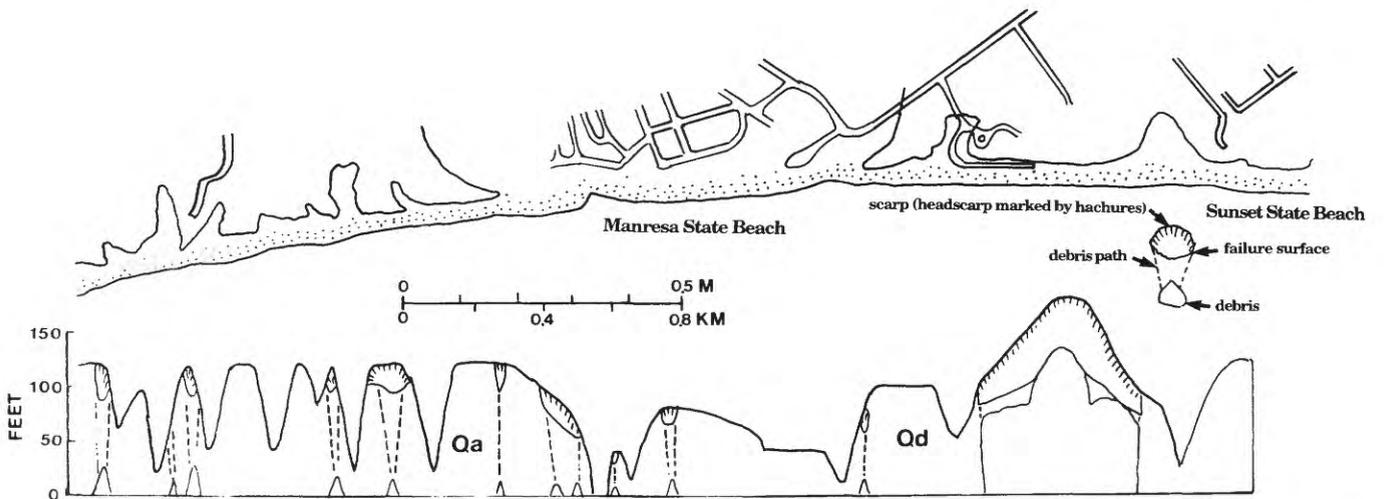
Figure 16.—Plan view and longitudinal section showing locations and sizes of seacliff failures and geology between Rio Del Mar and Sunset State Beach (see fig. 5 for locations). Units: Qa, Aromas Sand (Pleistocene); Qd, dune sand (Quaternary).

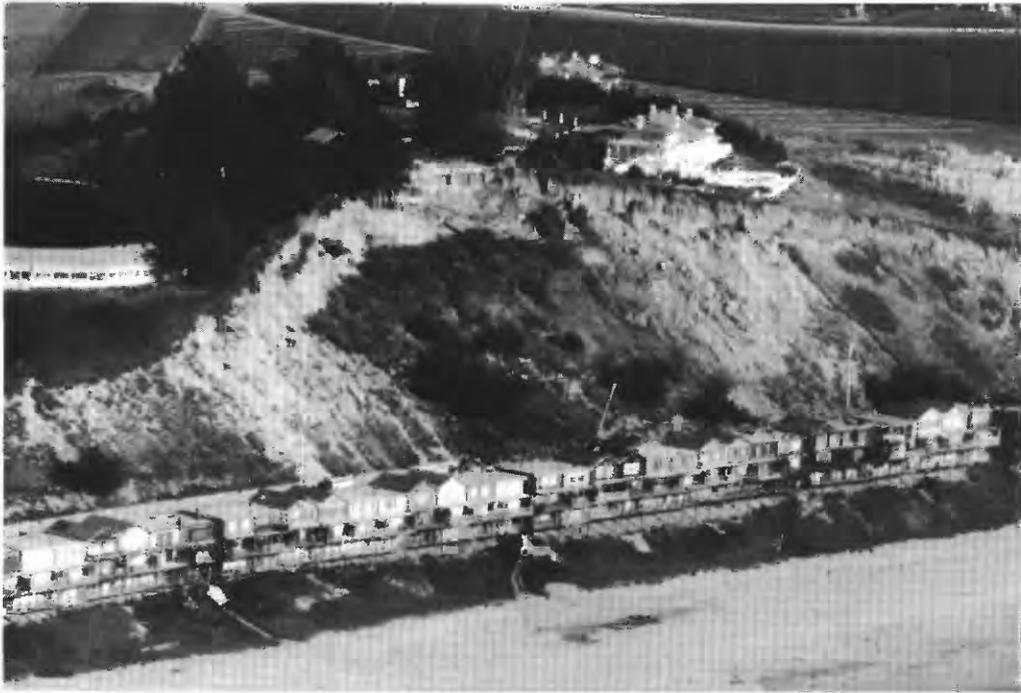
Several types of earthquake-induced failures were typical along this stretch of coastal bluffs. The first type consisted of shallow (1–3 m deep), large (max 100 m wide) translational slides (figs. 8, 16, 17). At one site, such a failure undermined 5 to 10 m of the cliff top, leading to collapse and toppling of large cohesive blocks of soil. These detached masses rolled downslope and blocked access to condominiums built on the talus slope at the base of the bluff (fig. 18). This same failure also undermined a blufftop home that was subsequently demolished.

Figure 17.—Large translational slide above condominium development south of Rio Del Mar (fig. 5). One house at top of bluff had to be demolished; homes at base of bluff were threatened, and access partly blocked (see fig. 18).

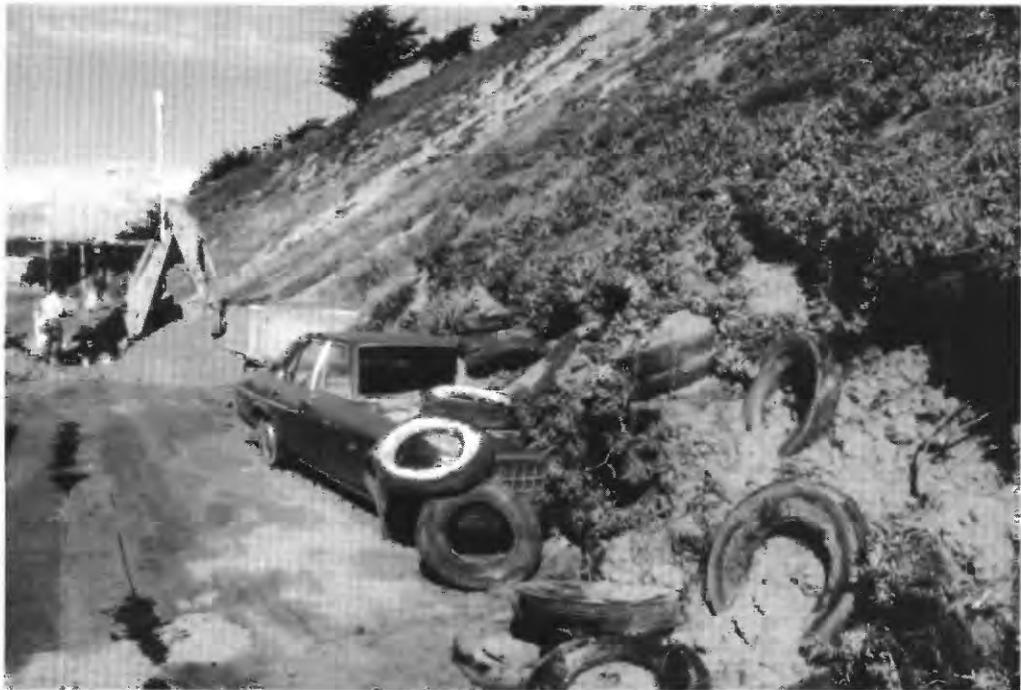
Figure 18.—Weakly consolidated sand of the Aromas Sand disintegrated and flowed downhill to block access and threaten condominiums at base of bluff (see fig. 16). Tires had been placed on slope in an attempt to control erosion.
