# The Loma Prieta, California, Earthquake of October 17, 1989— Landslides

DAVID K. KEEFER, *Editor*

STRONG GROUND MOTION AND GROUND FAILURE  
THOMAS L. HOLZER, *Coordinator*

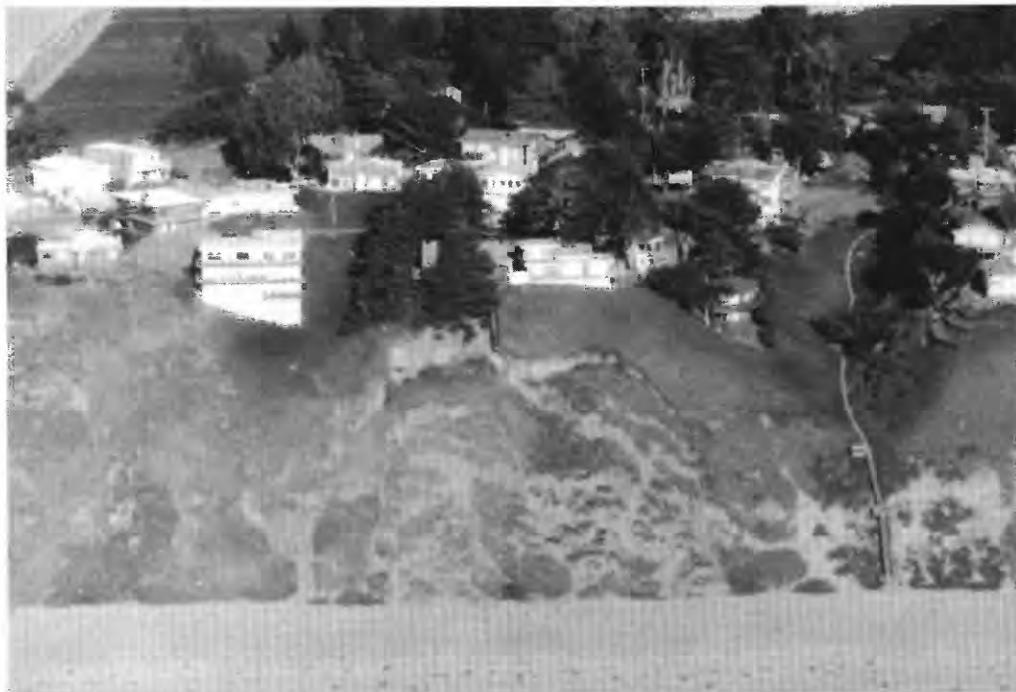
Figure 19.—Large sandflows above Sunset State Beach (fig. 5). One blufftop house was to be relocated.

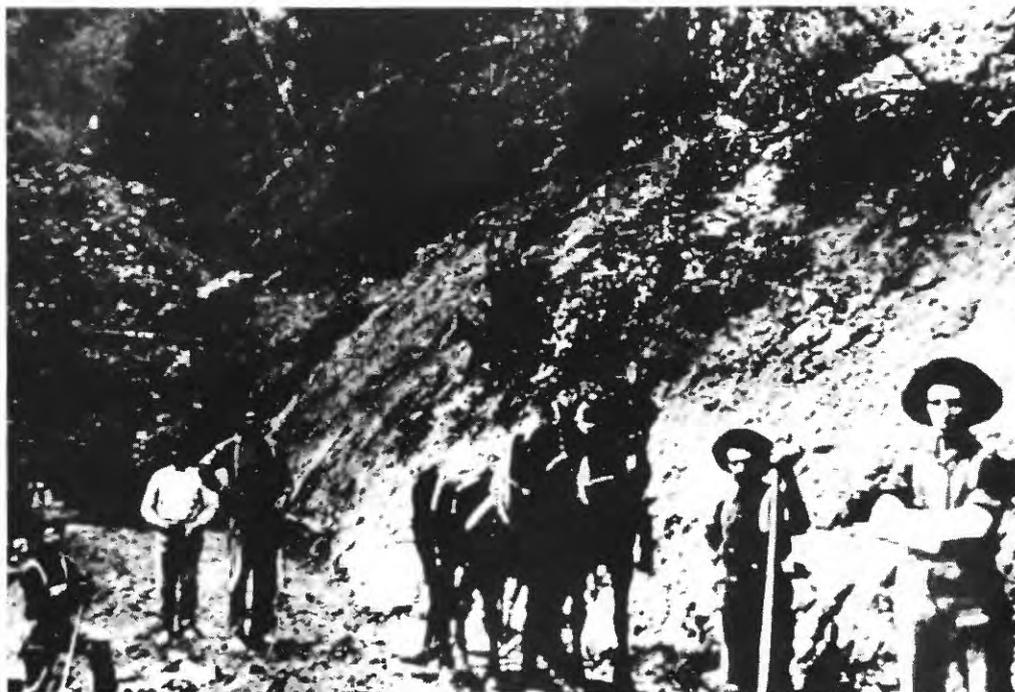
Figure 3.—Workers removing toe of earthquake-induced landslide that dammed Hinckley Creek at Olive Springs sawmill in 1906 (see fig. 4 for location). Landslide killed nine workers at Olive Springs and formed a 20-m-deep impoundment where it dammed the creek. Photograph courtesy of California Department of Parks and Recreation.

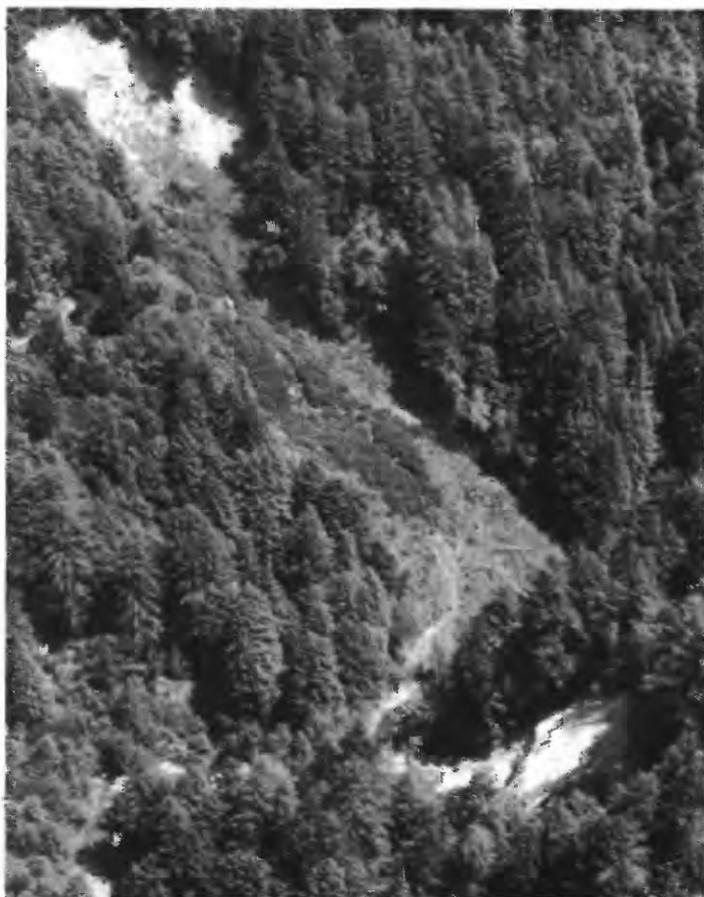
The rockslide on West Branch Soquel Creek (fig. 6), which occurred on a rather remote stretch of the creek (fig. 4), is the largest of the five 1989 landslides discussed in this paper. This slide was approximately 250 m long, averaged 50 m in width, and had an estimated maximum thickness of 6 m and a volume of  $50,000 \text{ m}^3$ . The slide began in Purisima Formation sandstone, siltstone,

Figure 6.—Toe of this 50,000-m<sup>3</sup>-volume earthquake-induced slide dammed West Branch Soquel Creek (see fig. 4 for location). Dam failed in December 1989, 61 days after 1989 Loma Prieta earthquake. Photograph taken in May 1992.

and mudstone at the site of a spring on the valley wall. Initial failure probably occurred in a weak layer of silt or clay in the Purisima Formation. The slide crosses the Zayante fault (Clark and others, 1989) on a slope averaging  $26^\circ$ , and its toe lies on rocks of the Eocene Butano sandstone in the valley bottom. The existing, nearly vertical headscarp in Purisima Formation rocks is 12 m high and 30 m long and has a spring issuing from its base. As indicated by Clark and others, the strike of the Purisima Formation beds at this site approximately parallels West Branch Soquel Creek, and the dip is back into the valley wall. Thus, this slide was not a dip-slope failure; instead, failure probably was related to the low shear strength of mudstone and siltstone that had been saturated locally by ground water from the spring.

Then, 61 days after the earthquake, the dam failed, causing minor downstream flooding in the channels of West Branch Soquel Creek and Soquel Creek. Channel capacity was not exceeded; thus, no damage occurred as a result of flooding.

On the day after the earthquake, the landslide dam on West Branch Soquel Creek (fig. 6) was noted from the air (Capt. Dennis Smith, Santa Cruz County Sheriff's Office, oral commun., 1989). However, because this landslide dam was in an unpopulated, untraveled area and its impoundment was small, no mitigative measures were undertaken.

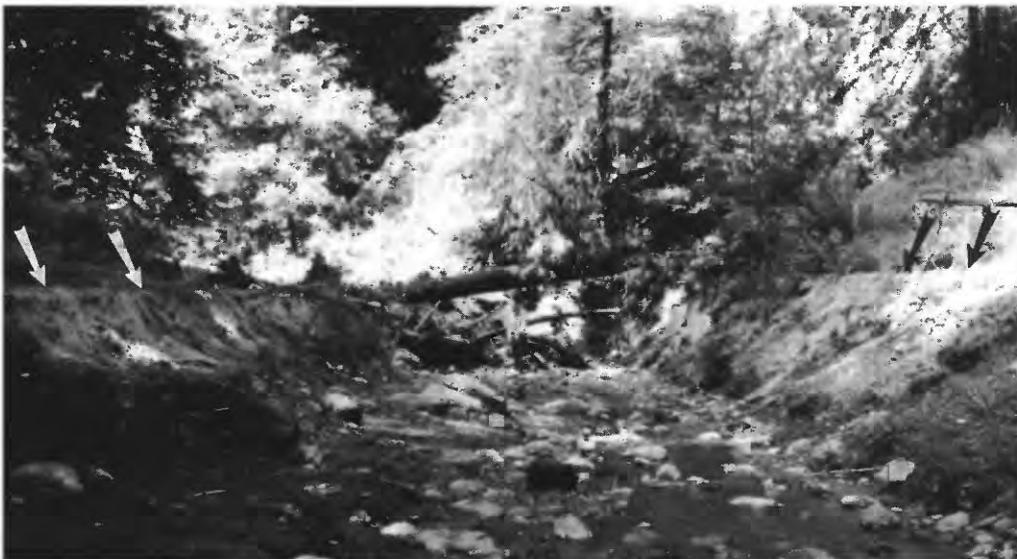
Figure 9.—Downstream view of remnants of 1989 Hinckley Creek landslide dam after it had failed in February 1992. Arrows denote previous shoreline of now-drained 4-m-deep impoundment. Photograph taken May 1992.

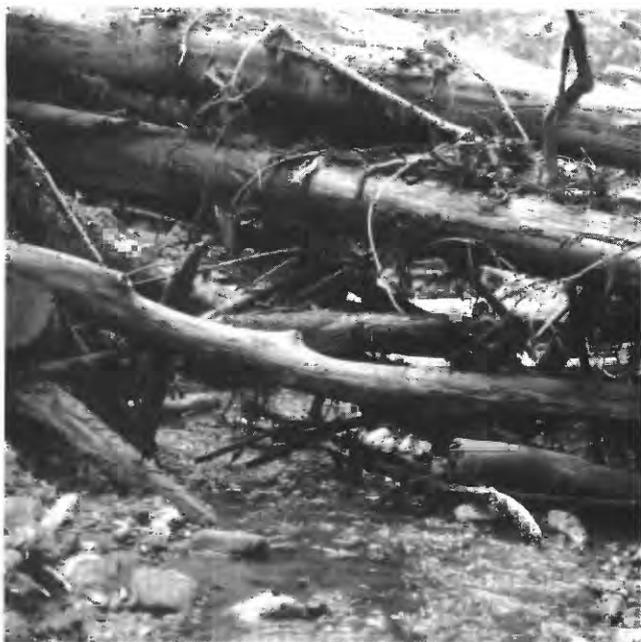
Figure 10.—Closeup of log/brush remnant of 1989 Hinckley Creek landslide dam after soil matrix of dam had eroded away in February 1992. Photograph taken May 1992.

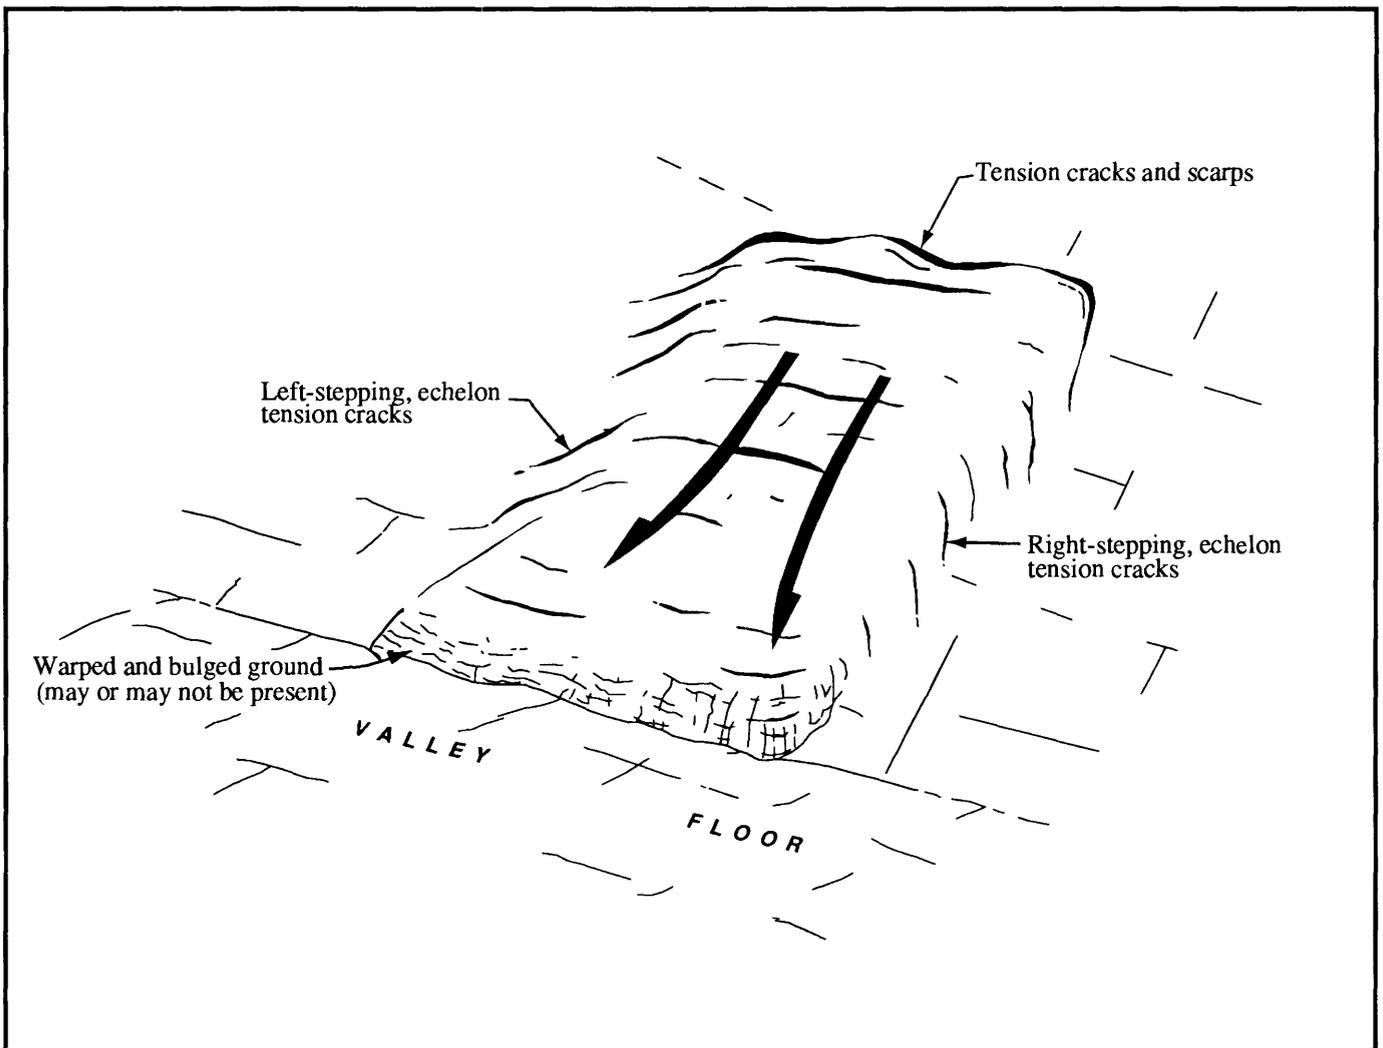
Figure 6.—Idealized landslide bounded by discontinuous surface features, as was typical for large landslides in Summit Ridge area (modified from William Cotton and Associates, Inc., 1990).

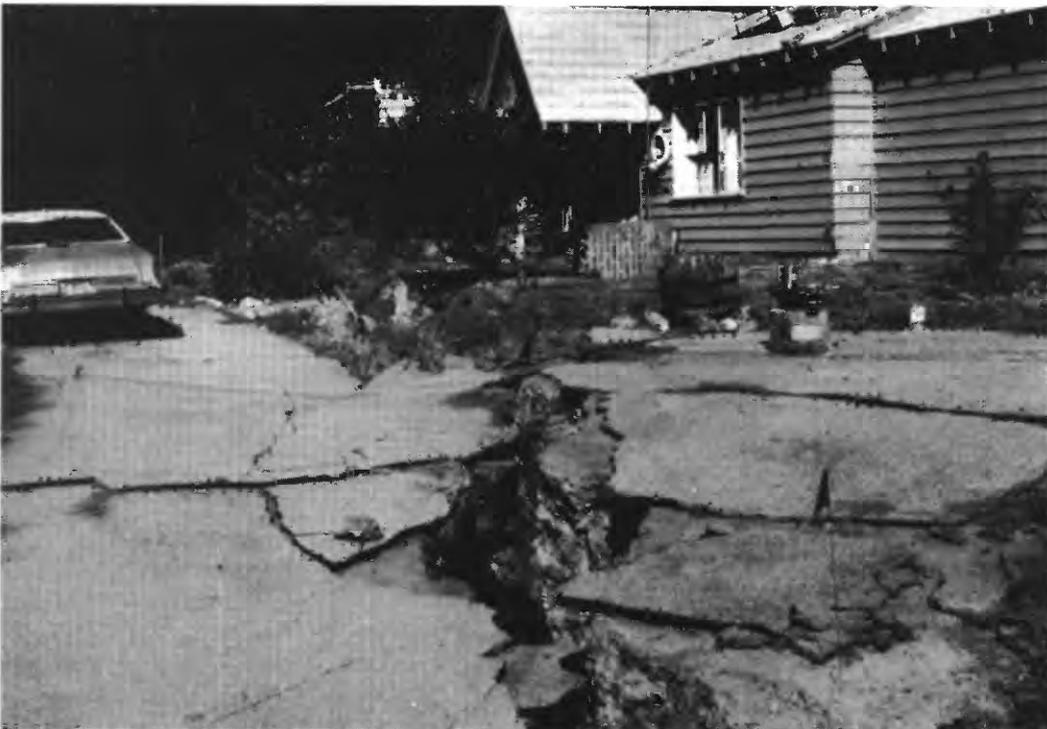
The longest ground-cracking feature within this area is a nearly continuous, southeast-trending line of cracks and scarps (fig. 8), approximately 1,200 m long (leg A-A', fig. 7A). Displacements across this feature vary along its length; maximum displacement components are about 60 cm vertical (down to the southwest), 75 cm left lateral, and 15 cm extensional.

Figure 8.—Segment of Tranbarger fracture (leg A–A', fig. 7A), a 1,200-m-long zone of scarps and cracks in Old Santa Cruz Highway landslide complex. View northwestward from north edge of Summit Road (loc. D, fig. 7A).

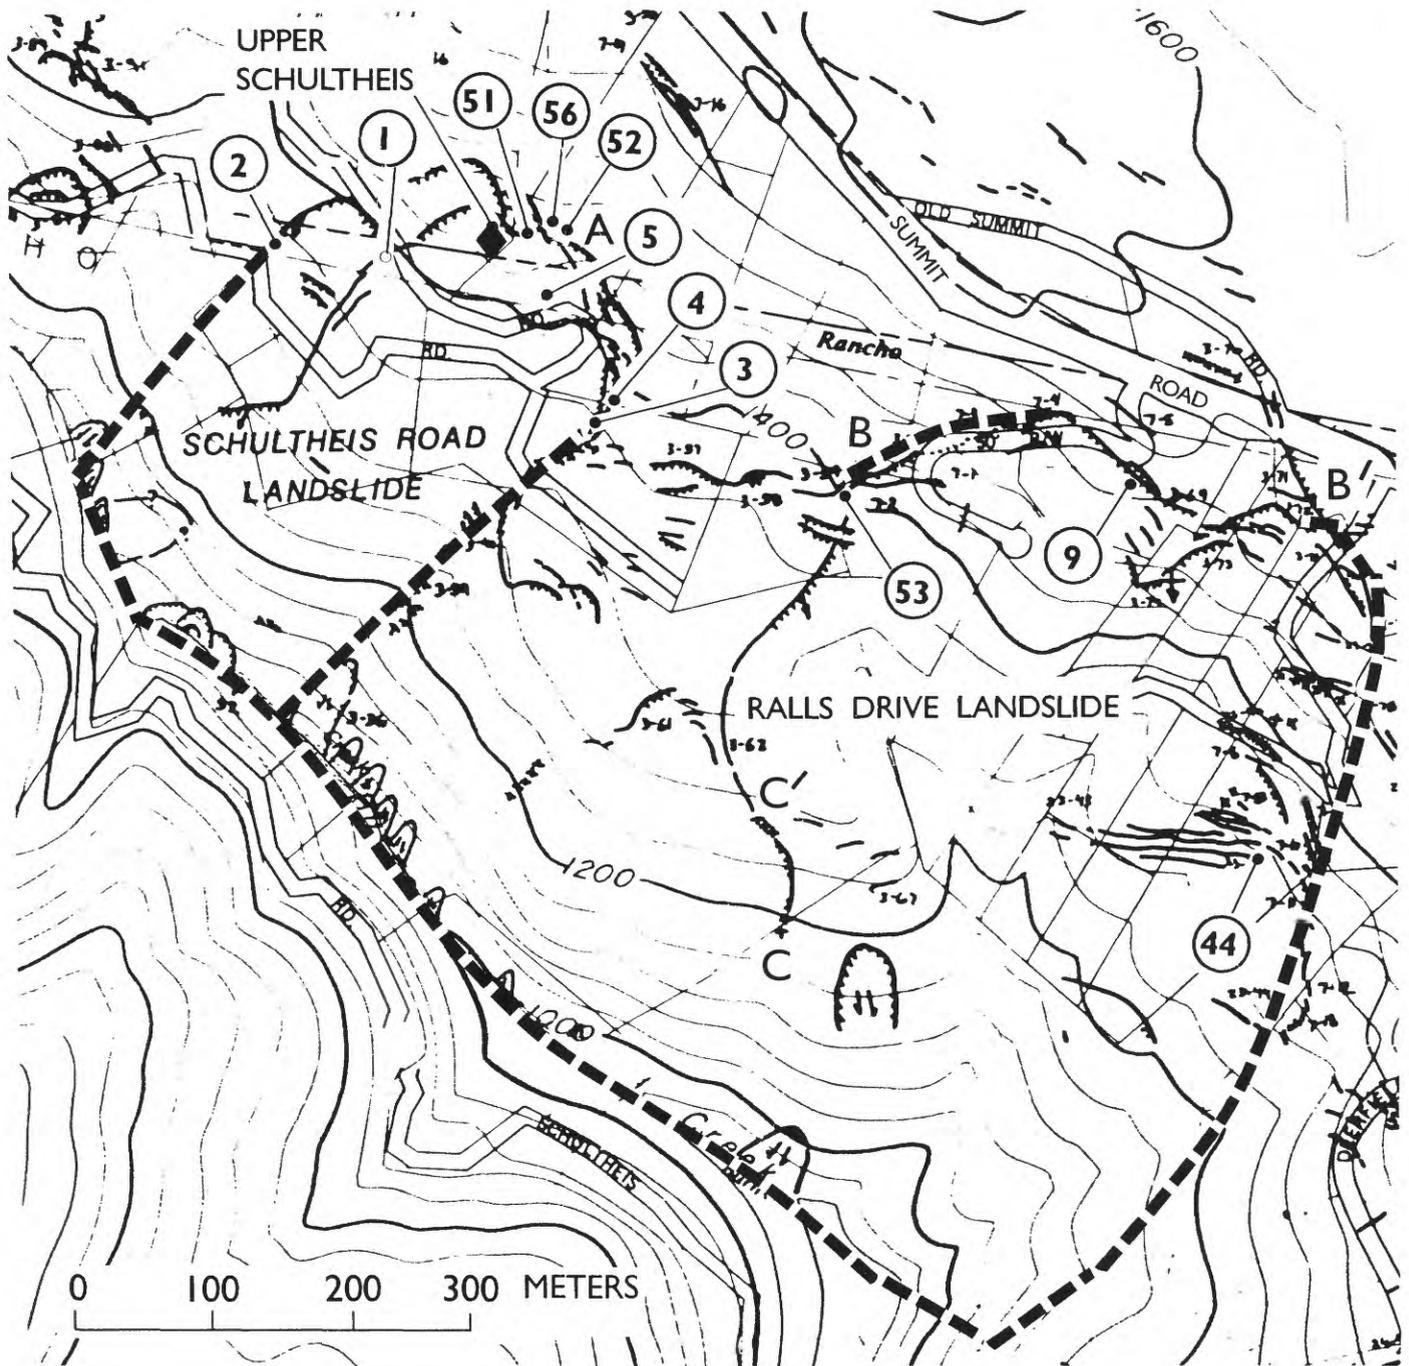
Displacements measured along a transect across the main scarp indicate that the head of the landslide moved 1.16 m downslope. An additional 1.28 m of downslope displacement was measured across a series of internal fissures and scarps that extended for 62 m downslope from the main scarp. The total measured displacement of the landslide along that transect was thus 2.44 m.

Particularly conspicuous shear zones were penetrated in borehole SR-2 at a depth of 27.1 to 27.4 m, and in the larger-diameter boreholes SR-5, SR-6, and SR-7 at depths of 6.7, 5.3 to 6.7, and 10.4 m, respectively (figs. 9B, 11). The deeper shear zone contained a sheared mixture of highly plastic clay, silty clay, sandstone, and fractured shale overlying 0.5 to 1.3 cm of sheared, mixed silty clay and clayey silt of varying plasticity (William Cotton and Associates, Inc., 1990); the shallower shear zone separated intensely weathered and oxidized materials from unoxidized rocks (Cole and others, 1991). In borehole SR-5, this shallower shear zone consisted of 3 to 13 cm of sheared siltstone and clay with polished surfaces; in borehole SR-6, the zone contained three separate faulted and sheared contacts; and in borehole SR-7, the zone was a 5- to 10-cm-thick layer of swelling clayey siltstone, which separated an overlying brecciated and fractured siltstone from an underlying sandstone (Cole and others, 1991).

Two of three known water wells within the landslide were reportedly damaged during the earthquake. In well 141 (fig. 9B), located less than 30 m from borehole SR-2, the well-pump motor was reportedly broken off, and the motor shaft bent to a 45° angle at 30-m depth, corresponding closely to the 27-m depth of the shear zone in borehole SR-2. In well 218, about 3 m from borehole SR-6 (fig. 9B), an offset of 20 to 30 cm was reported to have occurred at about 4.5-m depth in a 76-cm-diameter casing. This offset corresponds closely in depth to the shallower shear zone. These correspondences indicate that landslide displacements during the earthquake probably occurred in both the shallower and deeper shear zones. A cross section showing the inferred landslide basal shear surfaces is shown in figure 11. If the average landslide thickness is assumed to be half of the maximum thickness shown on this cross section, the total volume of the landslide is  $4.3 \times 10^6 \text{ m}^3$ .

Figure 9.—Upper Schultheis Road and Ralls Drive landslides, showing boundary of landslides and locations of (A) surficial features, surface-monitoring stations, and localities discussed in text and of (B) boreholes (from William Cotton and Associates, 1990, and Cole and others, 1991),

cross section in figure 11, and water wells (from Brumbaugh, 1990). Ground cracks and compressional features from Spittler and Harp (1990); landslide boundaries from Keefer (1991). See figure 7 for explanation and base-map information.

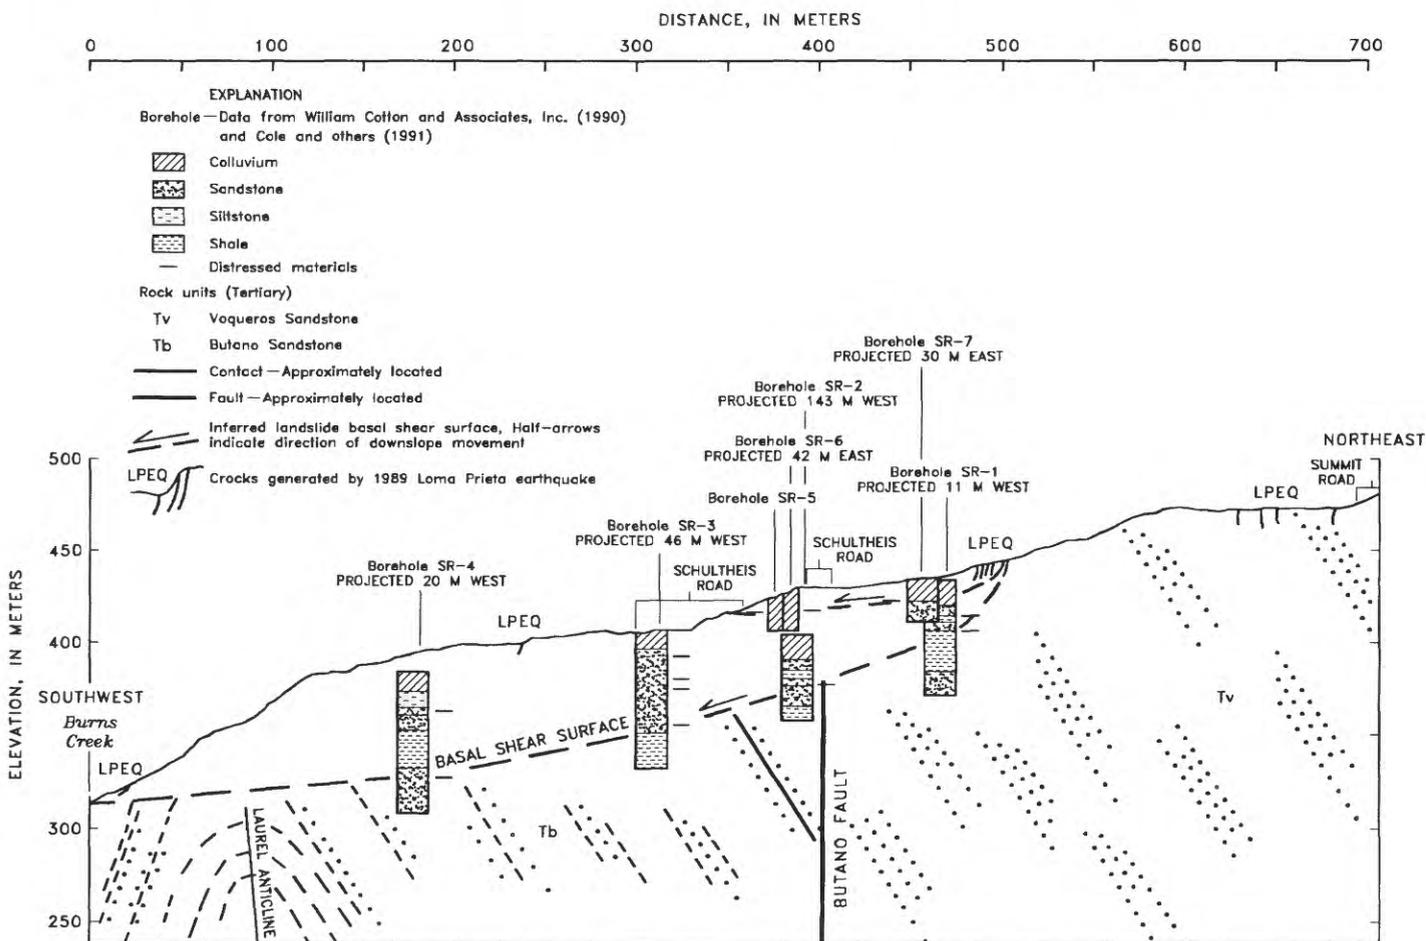
Figure 11.—Geologic cross section through Upper Schultheis Road landslide (fig. 9B). Locations of landslide basal shear surfaces inferred from borehole data of William Cotton and Associates, Inc. (1990), and Cole and others (1991).

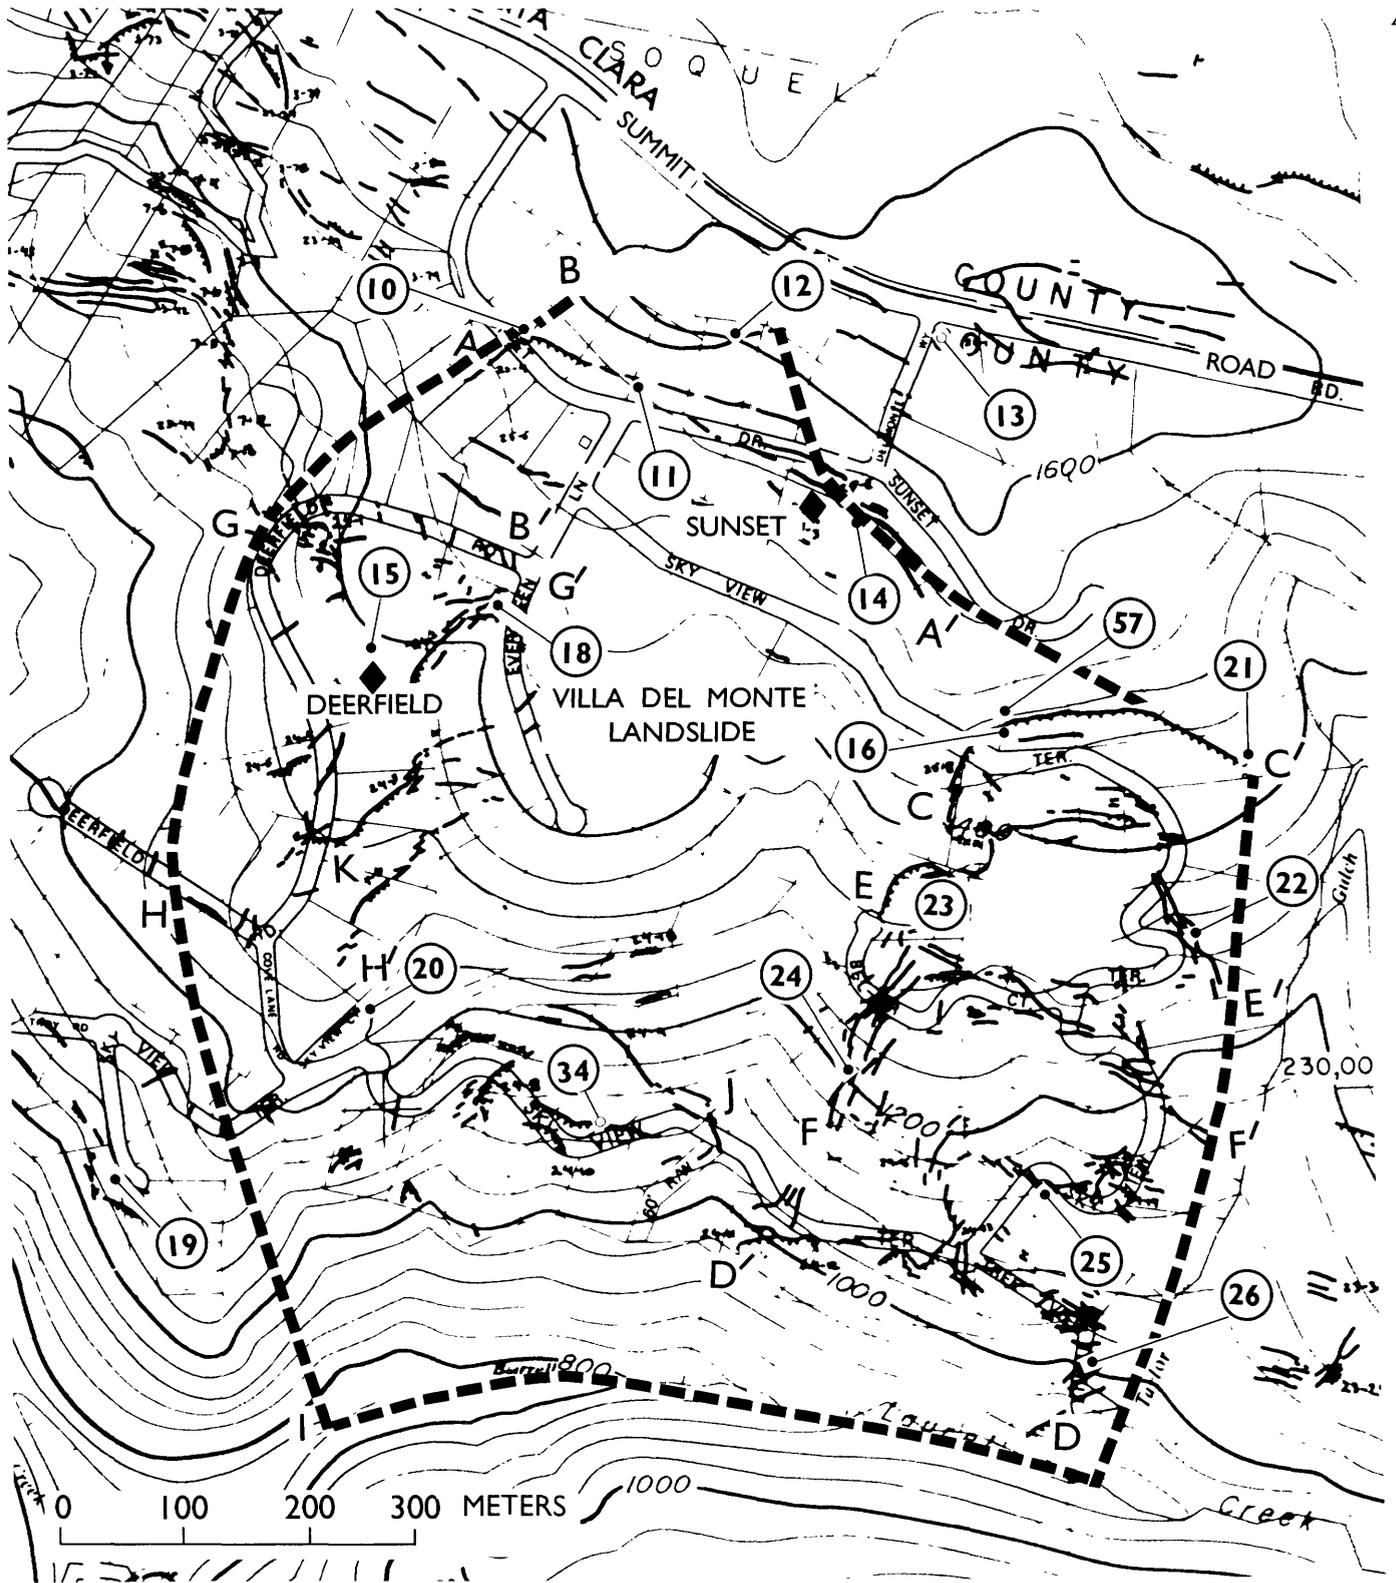
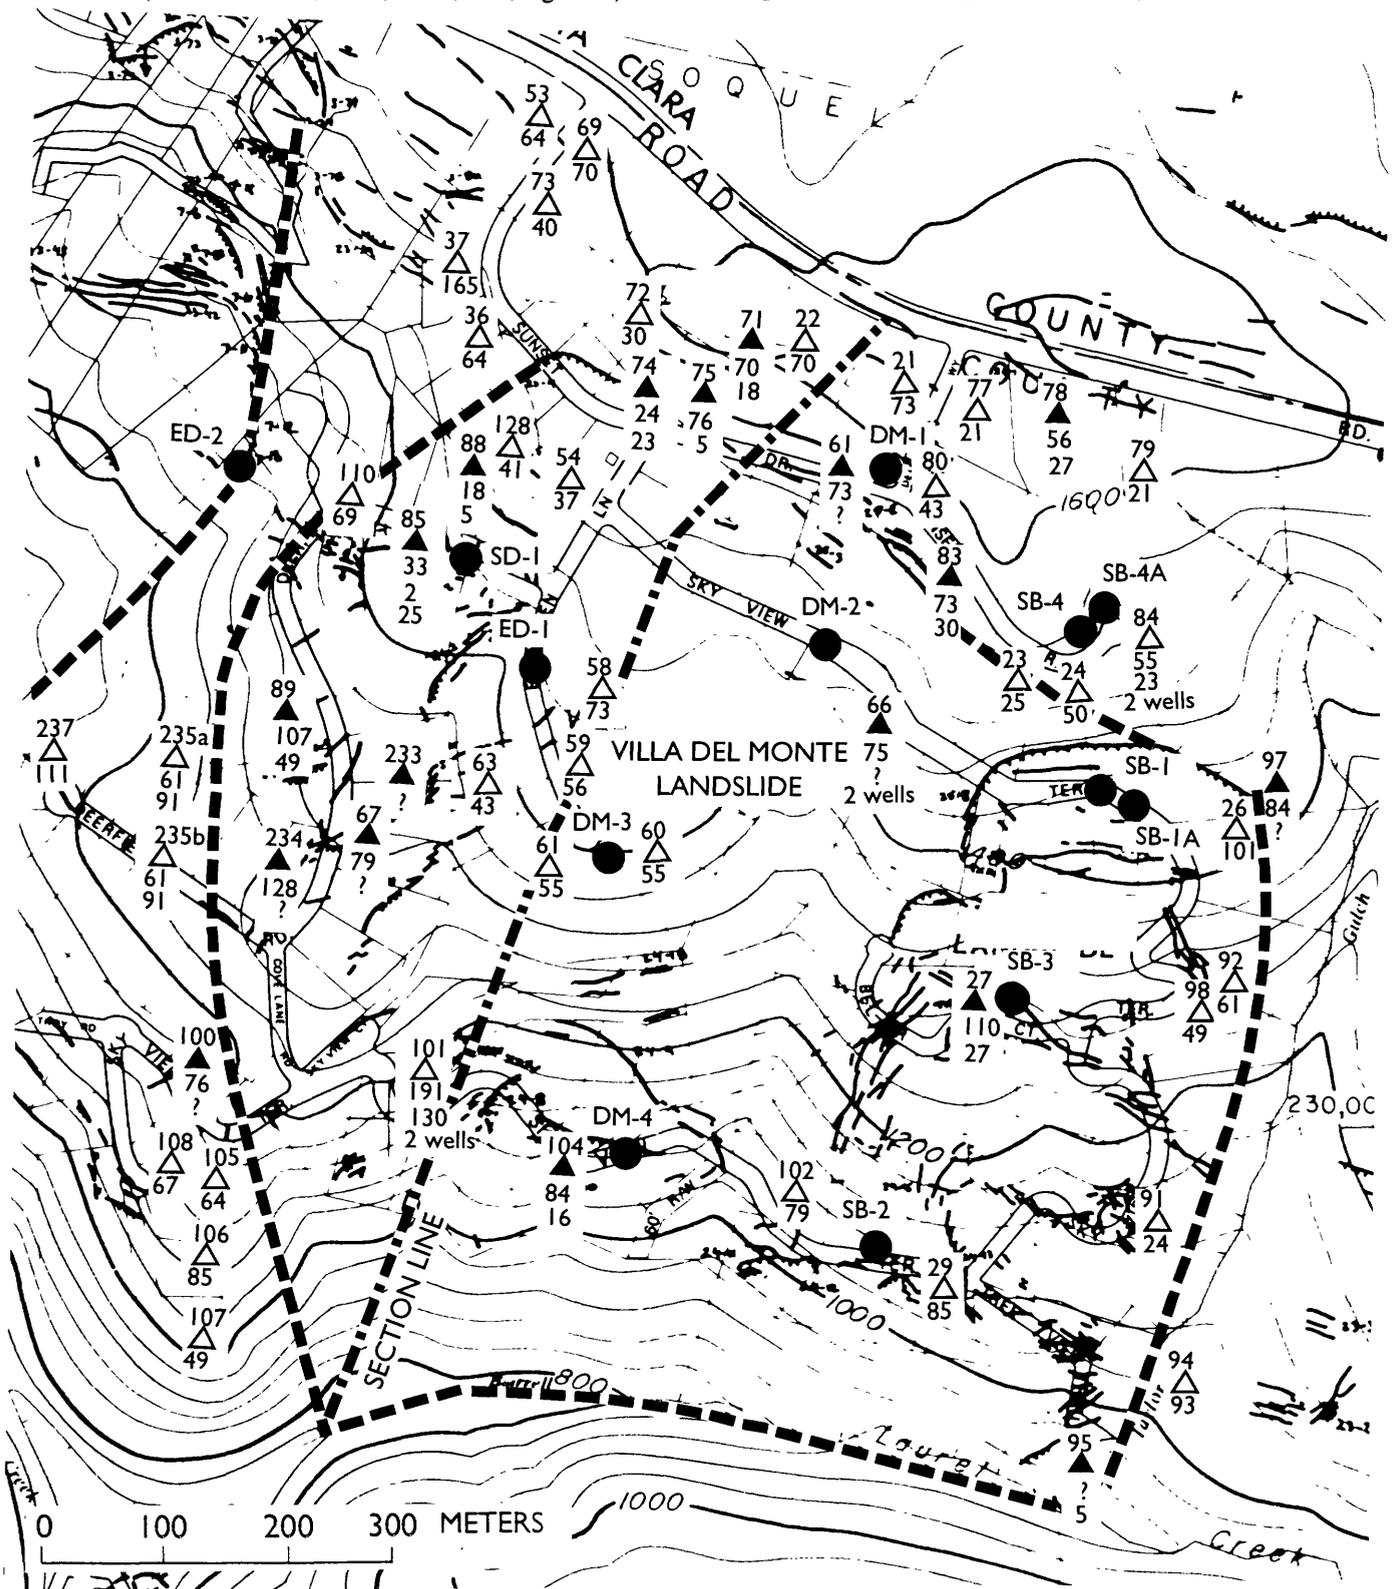
In the western part of the Villa Del Monte area, another major zone of ground cracks, scarps, and pressure ridges occurs along Deerfield Road and between Deerfield Road and Evergreen Lane (area G-G'-H-H', fig. 12A). This zone extends approximately 240 m from west to east and 370 m downslope (fig. 12). The cracks and scarps (fig. 15) in the zone strike predominantly northeast, oblique to the main structural elements in the bedrock (see pl. 3). Displacement measurements show predominantly southeastward to locally southwestward movement of 5 to 41 cm. Both the strike of the main ground cracks and the predominantly southeastward direction of displacements indicate that this zone forms the west (or right) flank of the landslide.

All five wells in this zone, along Deerfield Road (wells 85, 88, 89, 233, 234, fig. 12B), were reportedly damaged

Figure 12.—Villa Del Monte landslide, showing boundary of landslide and locations of (A) surficial features, surface-monitoring stations, and localities discussed in text and of (B) boreholes (from William Cotton and Associates, 1990, and Cole and others, 1991), cross section in figure 16, and water wells (from Brumbaugh, 1990). Ground cracks and compressional features from Spittler and Harp (1990); landslide boundaries modi-

by the earthquake. However, seven of the eight wells along westernmost Deerfield Road and westernmost Skyview Terrace (wells 105-108, 235a, 235b, 237, fig. 12B) were

reportedly undamaged. This zone of undamaged wells suggests that the smaller zones of ground cracks farther west (fig. 12) were not part of the larger landslide. These

westernmost ground cracks were almost certainly associated with smaller landslides. Although the boundary of the large landslide is inferred to lie generally in the area between locs. H and I, fig. 12A), the landslide limits in this area were poorly defined by the available data.

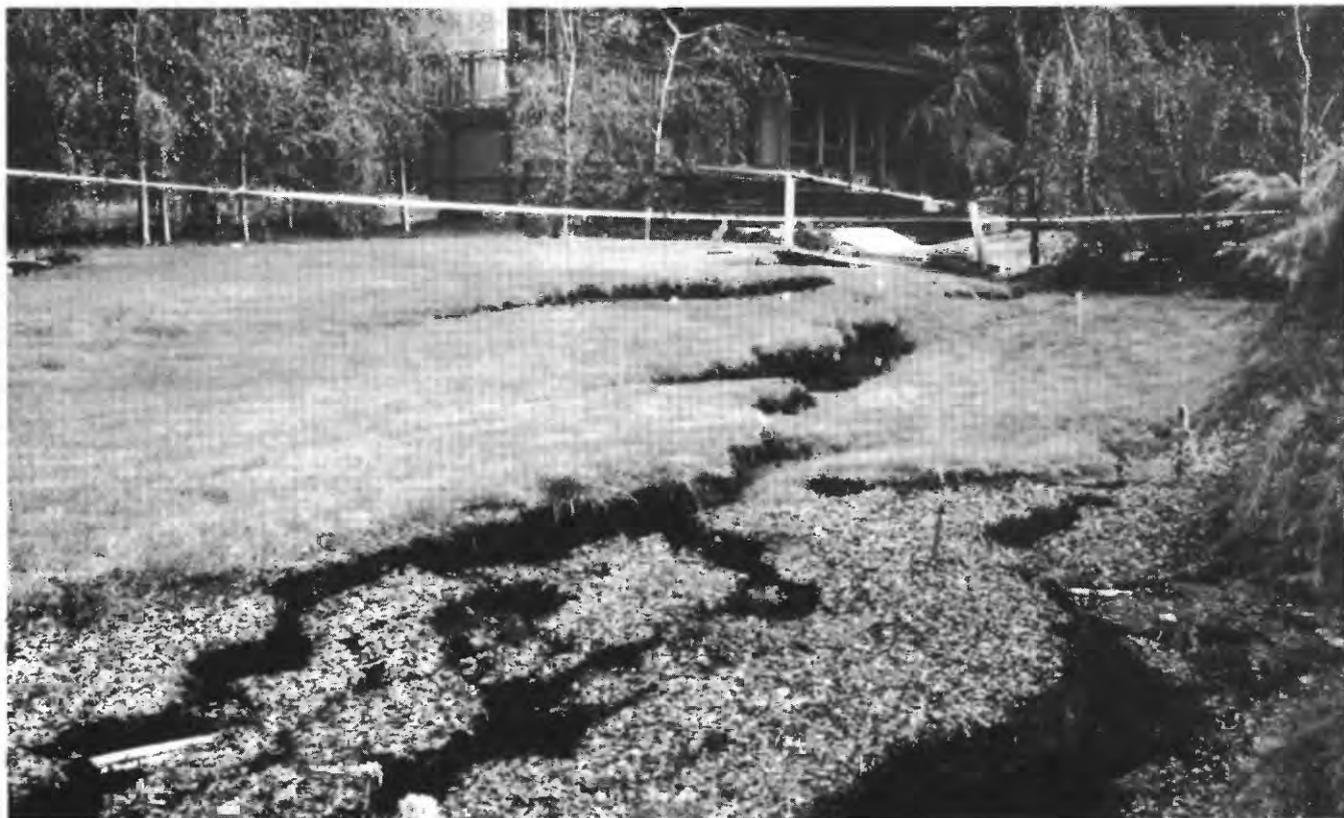
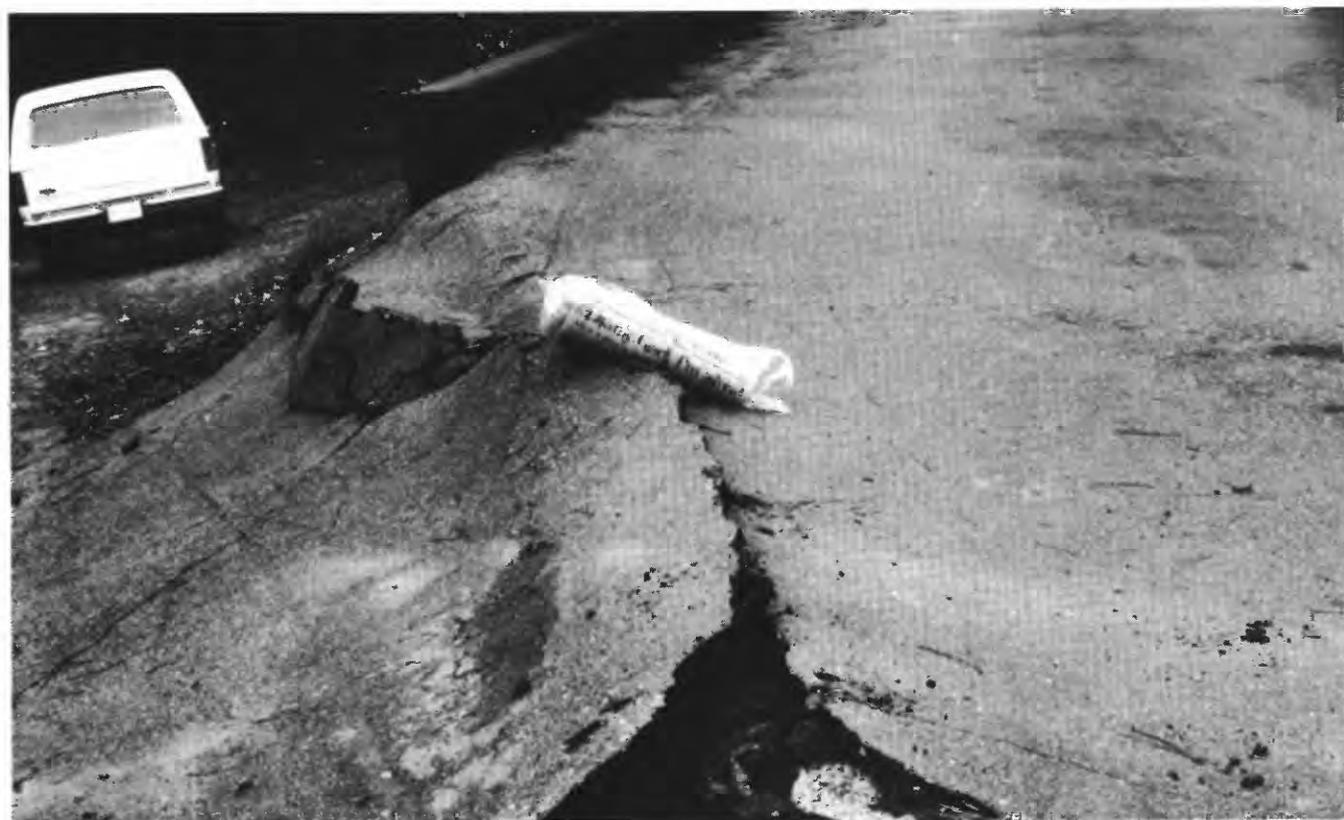
Figure 15.—Internal scarps and compressional features of Villa Del Monte landslide in Deerfield Road area. *A*, Internal scarps, which are part of a zone about 200 m long. View northeastward from just east of Deerfield Road (loc. K, fig. 12A). *B*, Internal ridge, consisting of compressed ground, marked by broken and buckled pavement. View northwestward from near east end of Deerfield Road (loc. B' on fig. 12A).

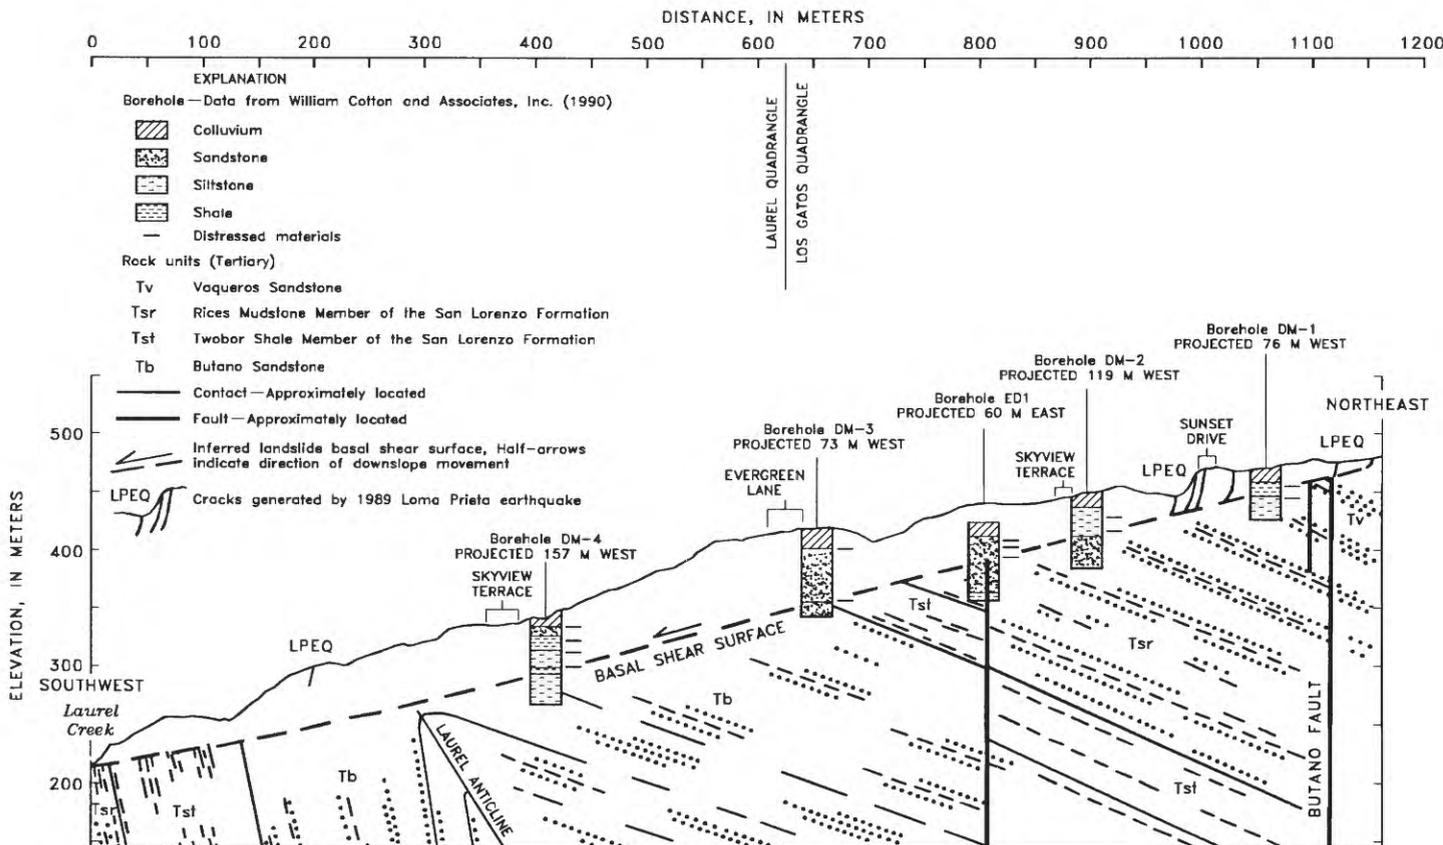
The soil, weathered rock, and bedrock contained approximately 45 intervals in the boreholes with indications of distressed materials—sheared, intensely fractured, or faulted rocks; very soft zones; crushed materials; intervals of collapsing or caving of the boreholes; or zones of lost circulation (fig. 16; William Cotton and Associates, Inc., 1990). These zones occurred in all rock types at depths from near the surface to near the maximum depth of drilling. However, the small diameters, discontinuous sampling, and absence of geophysical logging of the boreholes made identification of landslide shear surfaces within the boreholes uncertain. The numerous zones with indications of disturbance and reports of water well damage at various depths (fig. 12B) indicate that localized internal shearing occurred at several depths during landslide movement. An inferred deep basal shear surface, which is compatible with the drilling and surface data, is shown in figure 16. If the average landslide thickness is assumed to be half of the maximum thickness shown on this cross section, the landslide volume is  $27 \times 10^6 \text{ m}^3$ .

Figure 16.—Geologic cross section through Villa Del Monte landslide (see fig. 12B for location). Basal shear surface inferred from borehole data of William Cotton and Associates, Inc. (1990). See figure 11 for explanation.

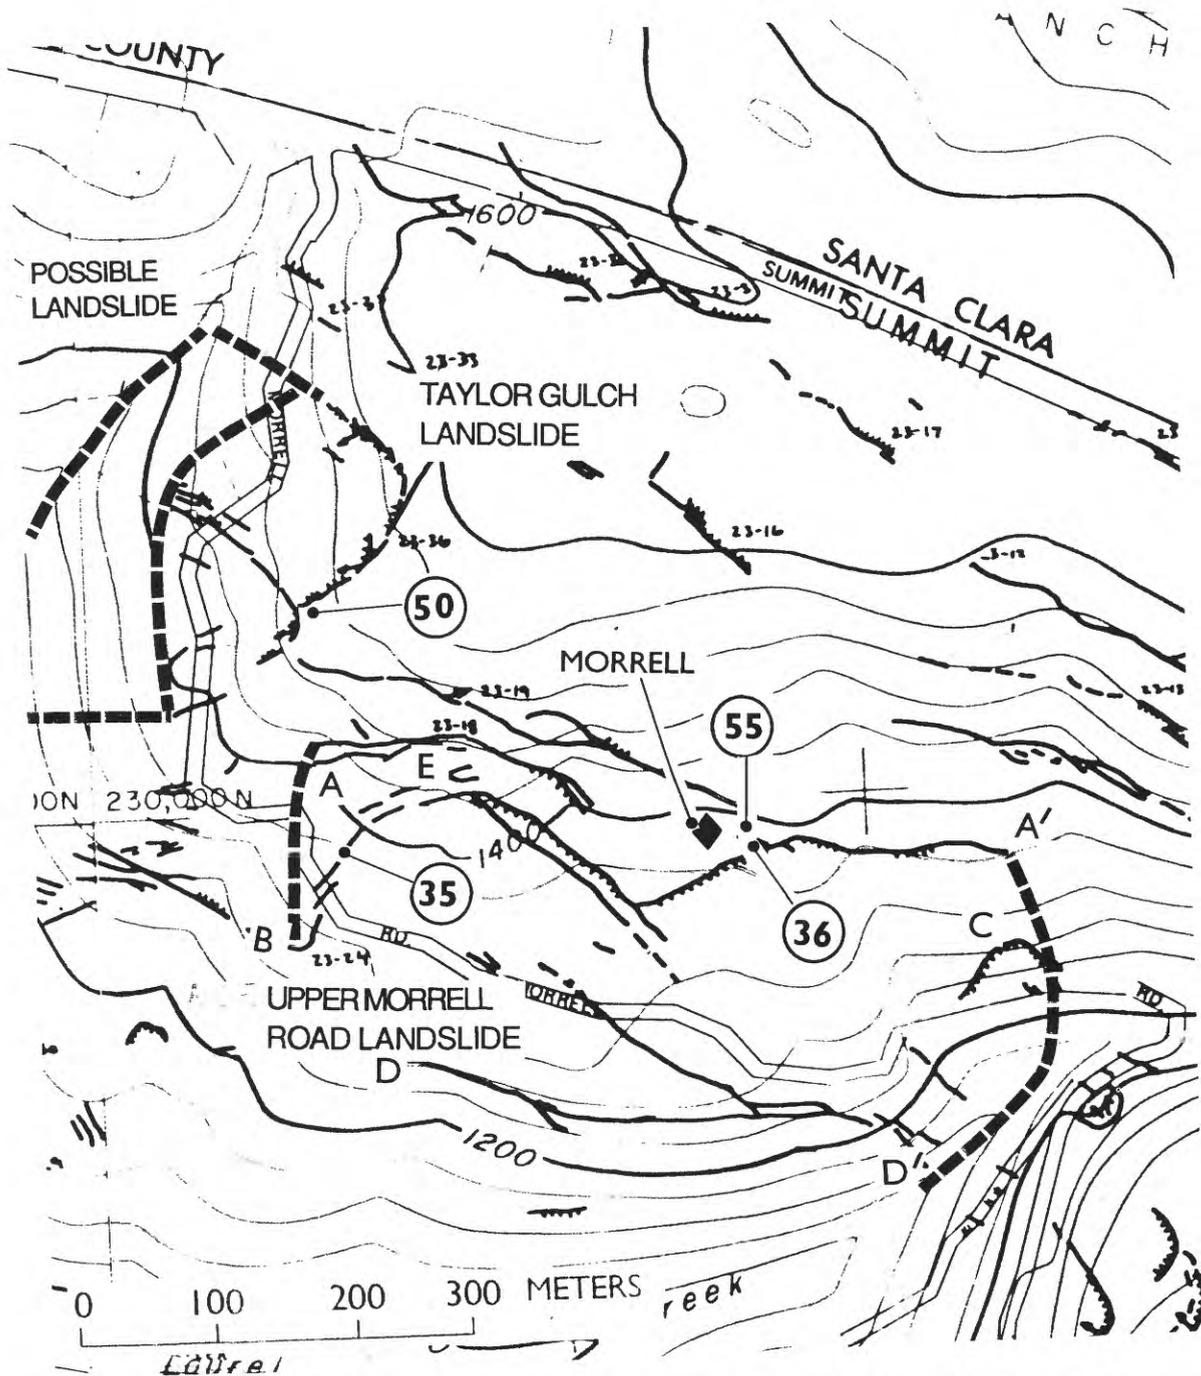
The Upper Morrell Road landslide is on the south flank of Summit Ridge east of Taylor Gulch (area 7, pl. 3). The main scarp of the landslide is made up of two adjoining zones of ground cracks and scarps, each of which is arcuate, concave downslope in plan view (leg A-A', fig. 17). Together, these zones extend approximately 550 m across the slope. The orientation of ground cracks in these zones

and the relation of these cracks to other northwest-striking cracks nearby (leg B-B', fig. 17) suggest significant control by bedrock structures. Displacement measurements across the main zones of cracks (fig. 18) indicate downslope movement of as much as 2.01 m. Southeast of the main scarp, a shorter scarp is inferred to mark part of the east flank of the landslide (loc. C, fig. 17).

Figure 17.—Taylor Gulch and Upper Morrell Road landslides. Ground cracks and compressional features from Spittler and Harp (1990); landslide boundaries from Keefer (1991). See figure 7 for explanation and figure 12 for base-map information.

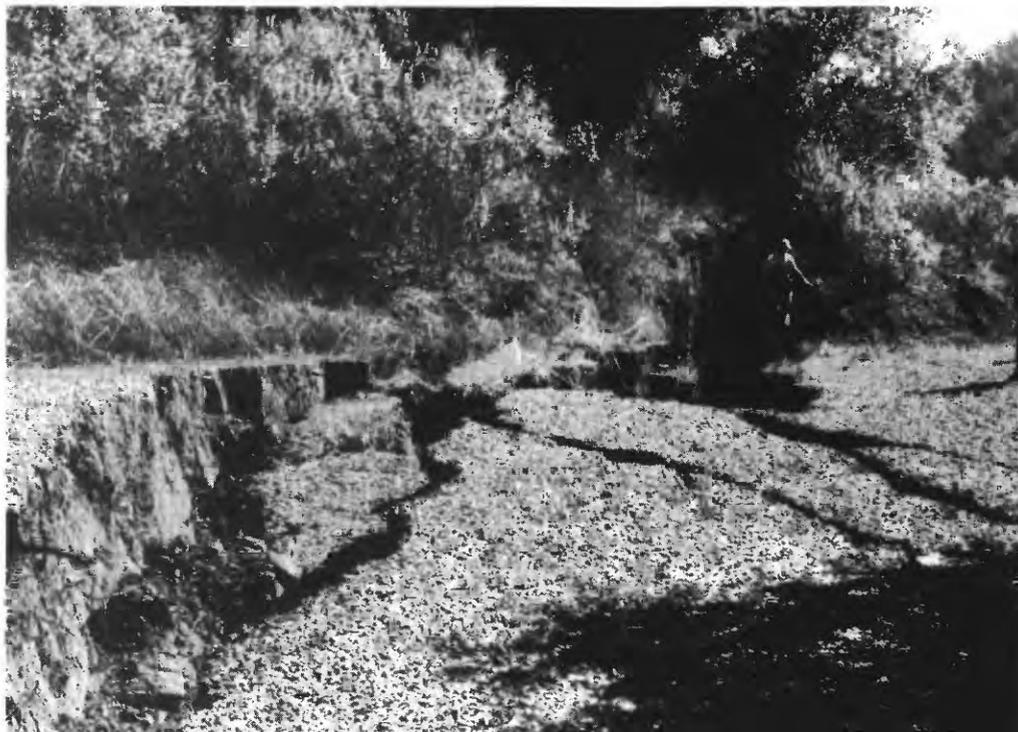
Figure 18.—Part of main scarp of Upper Morrell Road landslide where scarp crosses gravel road. View northeastward from just east of Morrell Road (loc. E, fig. 17).
