# The Loma Prieta, California, Earthquake of October 17, 1989— Landslides

DAVID K. KEEFER, *Editor*

STRONG GROUND MOTION AND GROUND FAILURE  
THOMAS L. HOLZER, *Coordinator*

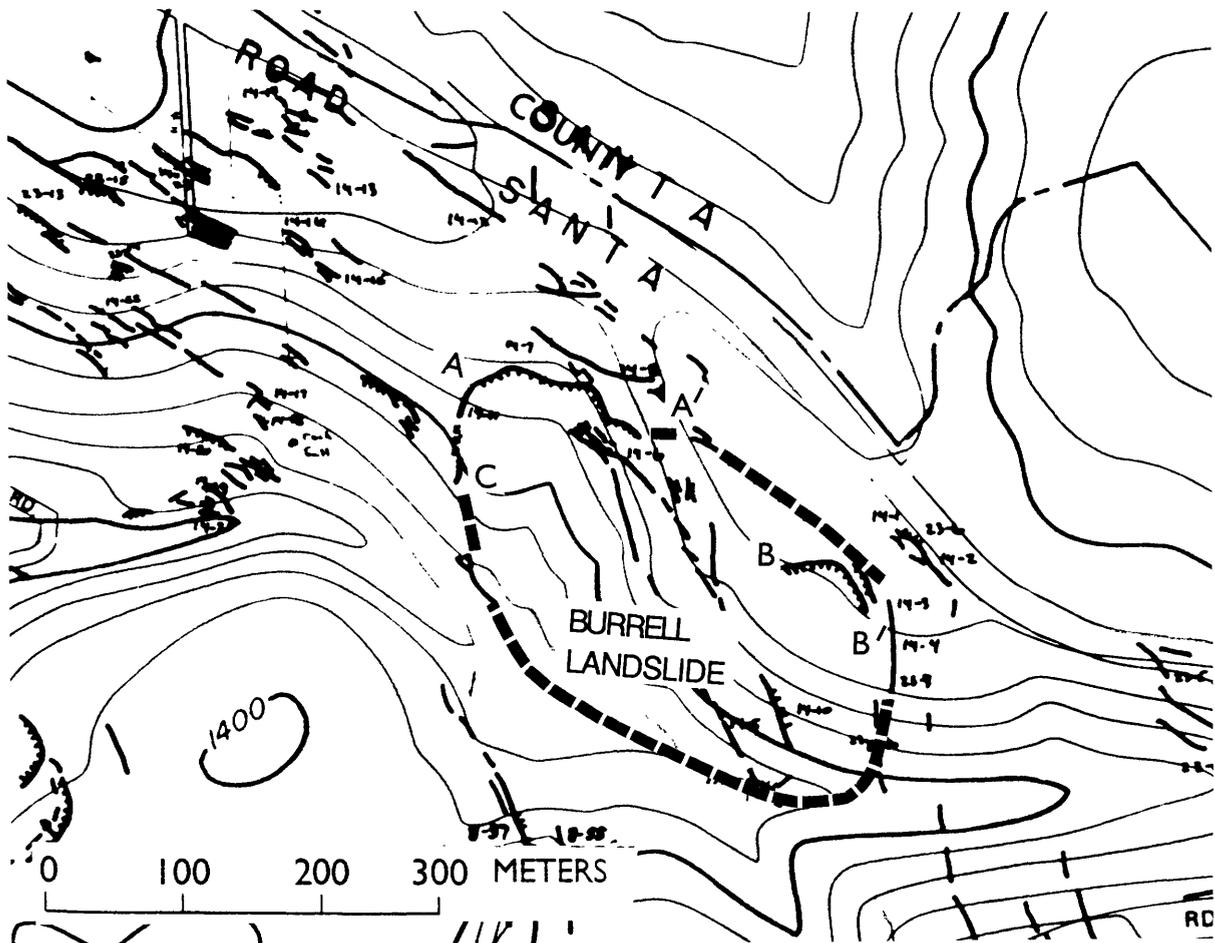
of two landslide blocks (legs A–A', B–B', fig. 19) were differentiated from other ground cracks in the area on the basis of their arcuate forms, their location at the upslope margin of a gently sloping topographic bench, and the occurrence of a pressure ridge downslope from one of them, which partly delineates the landslide toe (loc. C, fig. 19). These two main scarps were separated by a zone of discontinuous cracks. The landslide is approximately 230 m long by 460 m wide and encompasses an area of about 9 ha. Downslope displacements measured across the main scarps were from 28 to 71 cm. The slope averages  $15^\circ$ – $20^\circ$ , and bedrock is the Butano Sandstone (see pl. 3), which dips east to northeast, oblique to the slope direction.

Figure 19.—Burrell landslide. Ground cracks and compressional features from Spittler and Harp (1990); landslide boundaries from Keefer (1991). Base from Towill, Inc., prepared using topography from U.S. Geological Survey Laurel, Calif., 7.5-minute quadrangle and culture from County of Santa Cruz planimetric base and interpretation of aerial photographs flown July 24, 1990. See figure 7 for explanation. Contour interval, 40 ft.

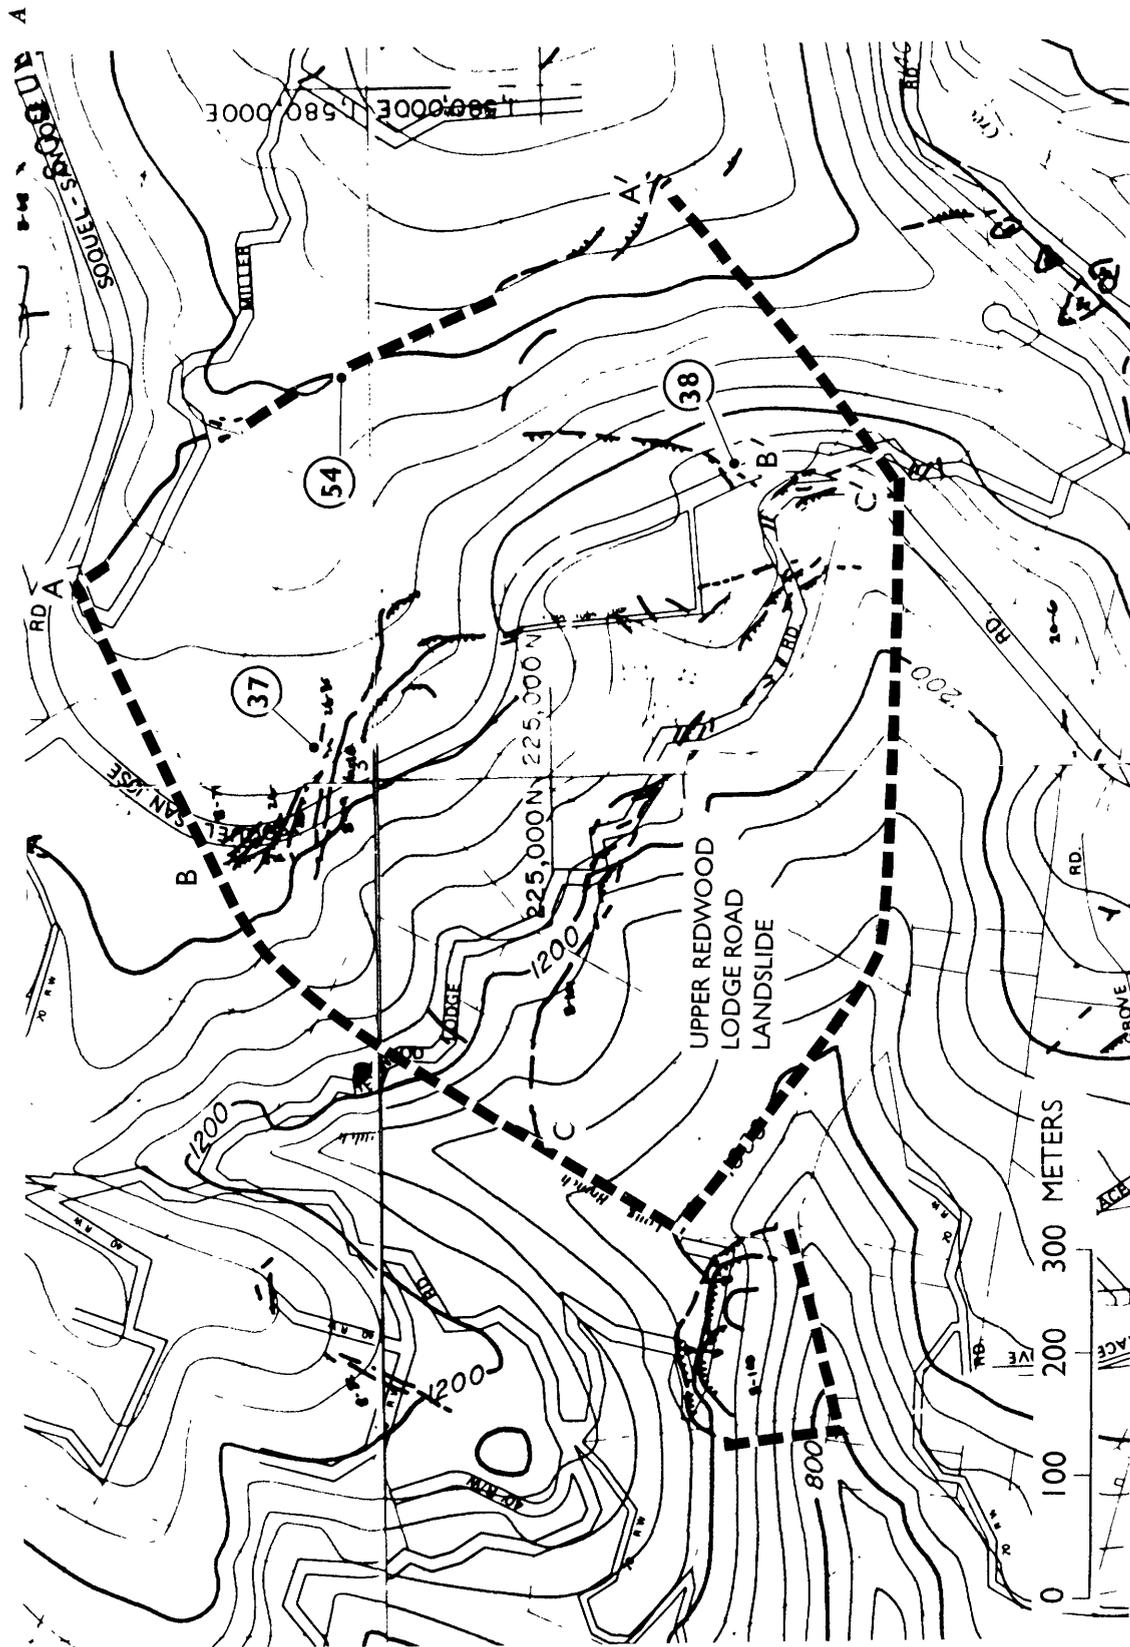
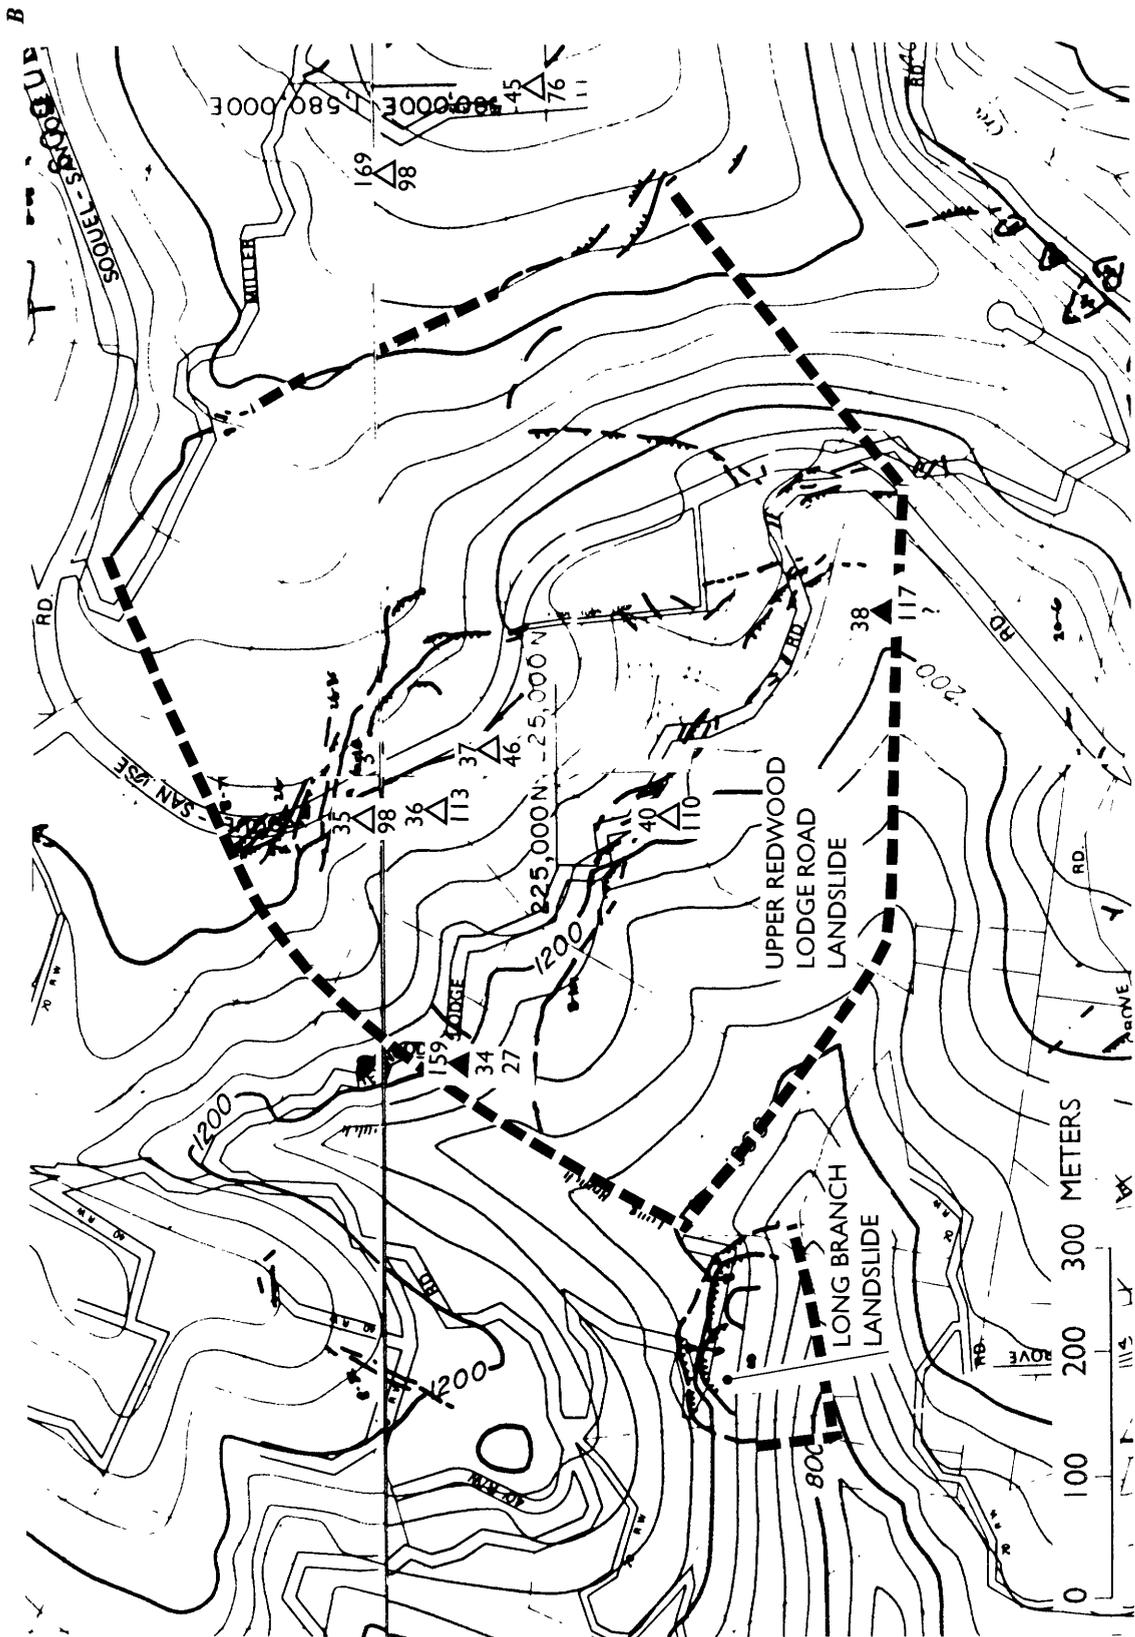
main scarp of the landslide is a series of discontinuous, straight to slightly arcuate cracks and scarps approximately 580 m long, that strikes about N. 30° W. (leg A–A', fig. 20A). The linearity and strike direction suggest that crack formation was controlled by bedrock structures (Keefer, 1991; Harp, this chapter). The most conspicuous ground cracks and scarps are in a nearly flat meadow, at the base of a steep stretch of slope; for part of their length, they are associated with a preexisting graben, about 30 m long, a few meters wide, and about 1 m deep. These relations indicate that the area is the head both of a large landslide that moved during the 1989 Loma Prieta earthquake and of a large preexisting landslide. Earthquake-induced displacements across the ground cracks and scarps were as great as 25 cm.

Figure 20.—Upper Redwood Lodge Road and Long Branch landslides, showing locations of (A) surficial features, surface-monitoring stations, and localities discussed in text and of (B) water wells (from Brumbaugh, 1990). Ground cracks and compressional features from Spittler and Harp (1990); landslide boundaries from Keefer (1991). See figure 7 for explanation and figure 19 for base-map information.

cracks and scarps (fig. 20); the landslide is thus at least 640 m wide. The southwest (downslope) boundary is likewise not marked by any surface features, but the position and pattern of the westernmost cracks and scarps suggest that the landslide extends to the creek at the base of the slope (fig. 20). The landslide is thus about 820 m long and at least 37 ha in area. The slope through the landslide averages 15°–20°.

Two wells within the landslide were reportedly damaged by the earthquake—well 159, at a depth of 27 m and well 38, at undetermined depth—and four wells (35–37, 40, fig. 20B), with depths of 45 to 113 m, were reportedly undamaged (Brumbaugh, 1990). The two damaged wells are both located near the margins of the landslide. The four reportedly undamaged wells are farther from these margins, and the absence of reported damage could indicate either a basal shear surface locally deeper than the wells or local displacements too small to cause damage.

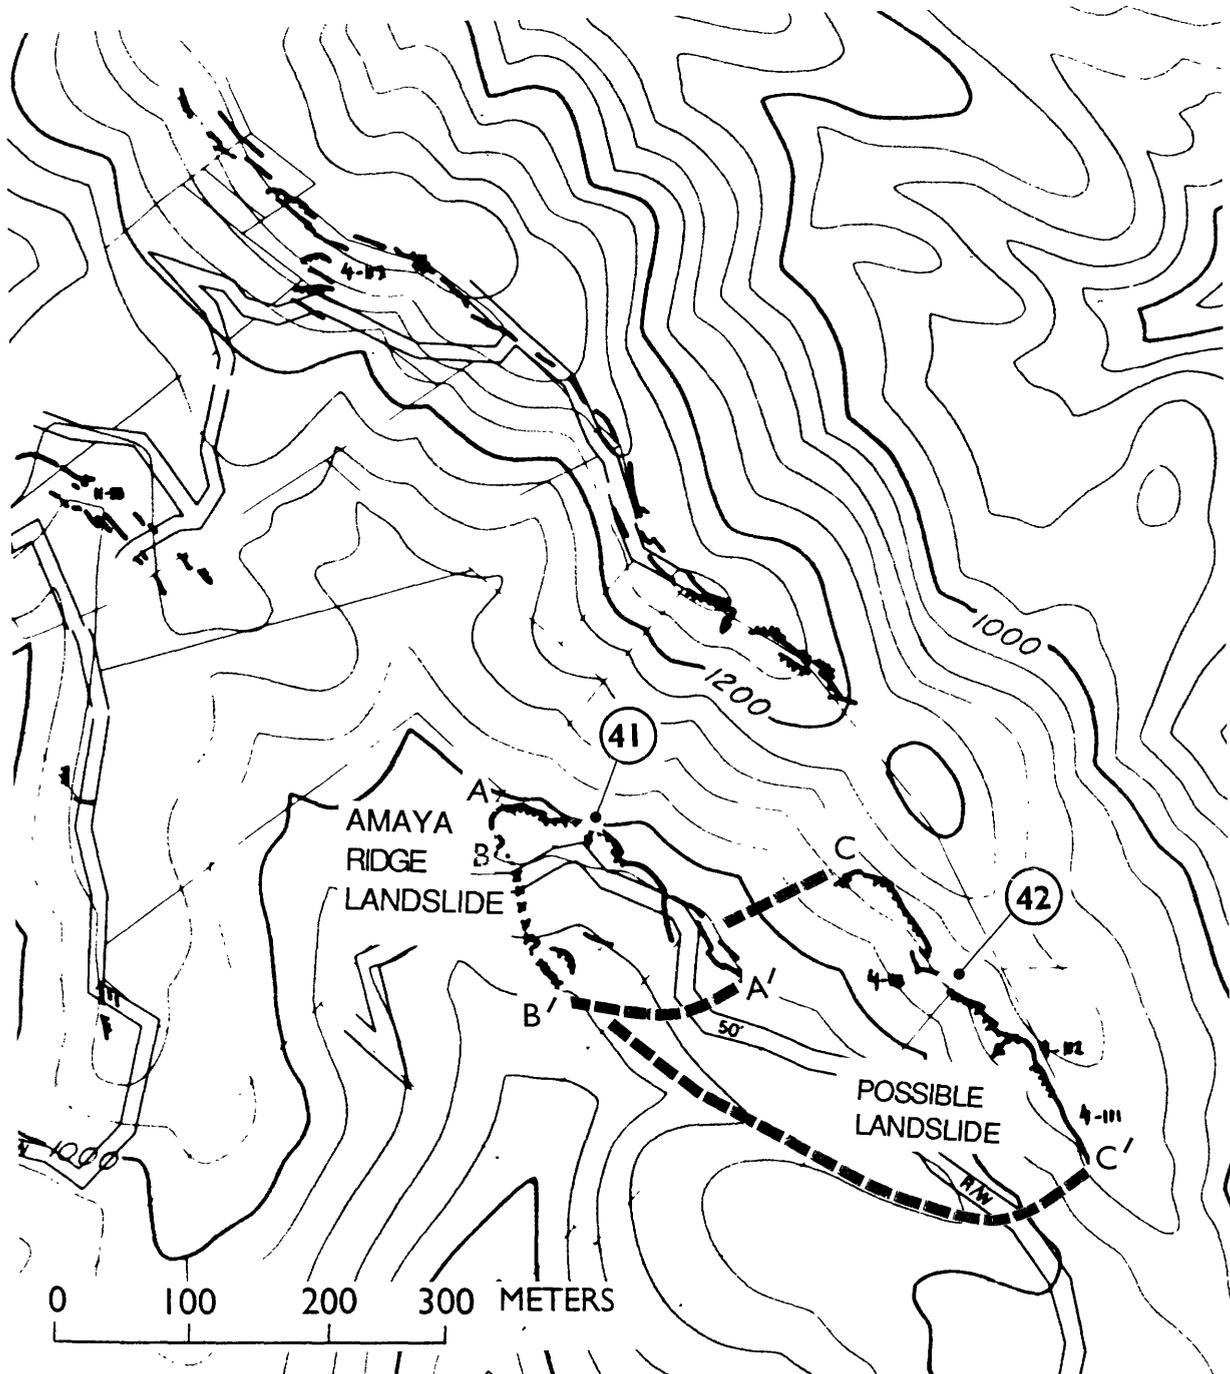
The Amaya Ridge landslide is on the southwest flank of Amaya Ridge, in the southern part of the study area (area 13, pl. 3). Two sets of ground cracks and associated features are present (fig. 21). The northwestern set consists of a relatively continuous, arcuate zone of ground cracks that are concave downslope in plan view (leg A–A', fig. 21), and a nearly straight compression feature farther downslope (leg B–B', fig. 21). These features are interpreted to be, respectively, the main scarp and toe of a landslide, approximately 120 m long, 240 m wide, and 1.6 ha in area. Measurements across the main scarp indicated local downslope displacements of 8 to 100 cm or more.

Southeast of the landslide is a 300-m-long zone of ground cracks and scarps (line C–C', fig. 21) that is linear to slightly arcuate, parallel, and echelon to the main scarp to the northwest. This southeastern set of ground cracks and scarps may represent the main scarp of a separate landslide, an easterly and upslope extension of the other landslide, or cracks produced by some other process. One displacement measurement across a ground crack in this set indicated movement of 15 to 20 cm downslope, to the

Both sets of ground cracks and scarps (legs A–A', C–C', fig. 21) are near breaks in slope; the slope above them is relatively steep, and the slope below them is a broad, gently sloping bench, 90 m wide. A topographic profile surveyed through the northwestern set of ground cracks and scarps shows an average slope inclination of 22° and an inclination of the steep segment above the scarps of 24°. Marshy areas just below the base of the steep stretch of slope indicate a local water table near the surface.

Figure 21.—Amaya Ridge landslide. Ground cracks and compressional features from Spittler and Harp (1990); landslide boundaries from Keefer (1991). See figure 7 for explanation and figure 19 for base-map information.

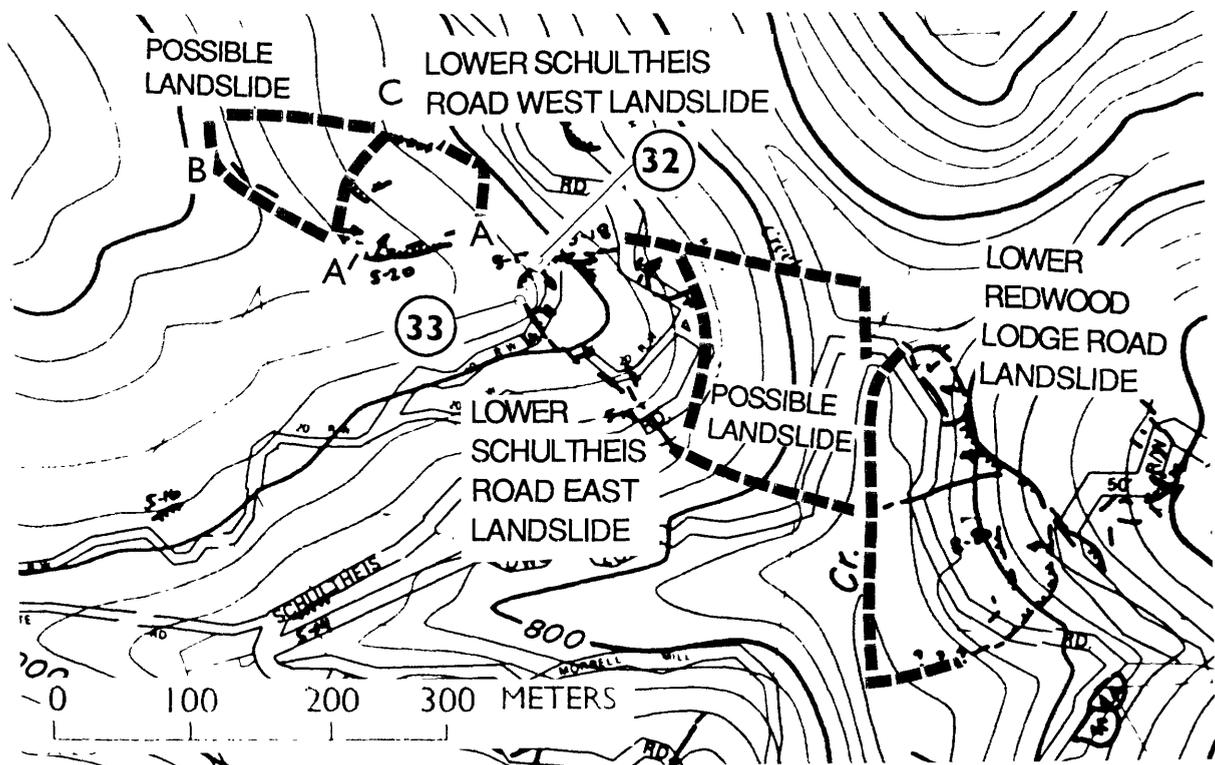
The Lower Schultheis Road West landslide is near Laurel, on a short ridge immediately south of Summit Ridge (area 18, pl. 3). The main scarp of the landslide is a 90-m-long series of slightly arcuate cracks and a graben (leg A–A', fig. 22). For part of its length, this main scarp is south of the ridge crest (fig. 23), and so part of the ridge crest is involved in the landslide, having been displaced to the north. Measurements along the scarp showed 30 to 65 cm of northward displacement.

A set of discontinuous ground cracks (leg A'–B, fig. 22) west of the scarp indicates that the landslide may extend an additional 90 m in that direction. These ground cracks also nearly parallel the bedrock strike (see pl. 3), suggesting that they and, by extension, the better developed main scarp to the east probably are structurally controlled. An elongate bulge in the ground about 110 m downslope from the main scarp marks part of the landslide toe (loc. C, fig. 22). The landslide defined by this bulge and the main scarp is at least 110 m long, 110 m wide, and 1.2 ha in area; if the landslide also encompasses the zone of ground cracking to the north and also extends there as far downslope as the bulge, its area may be as large as 2 ha. The slope through the landslide averages 15°–20°.

Figure 22.—Lower Redwood Lodge Road, Lower Schultheis Road East, and Lower Schultheis Road West landslides. Ground cracks and compressional features from Spittler and Harp (1990); landslide boundaries from Keefer and others (1991). See figure 7 for explanation and figure 19 for base-map information.

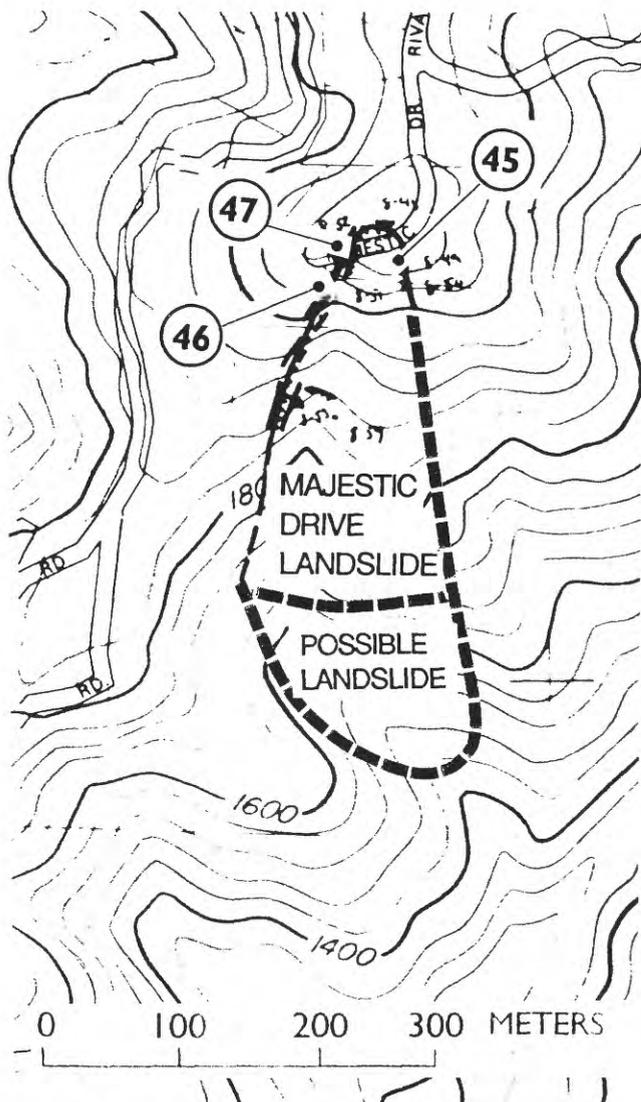
Figure 24.—Majestic Drive landslide. Ground cracks and compressional features from Spittler and Harp (1990); landslide boundaries from Keefer (1991). See figure 7 for explanation and base-map information.

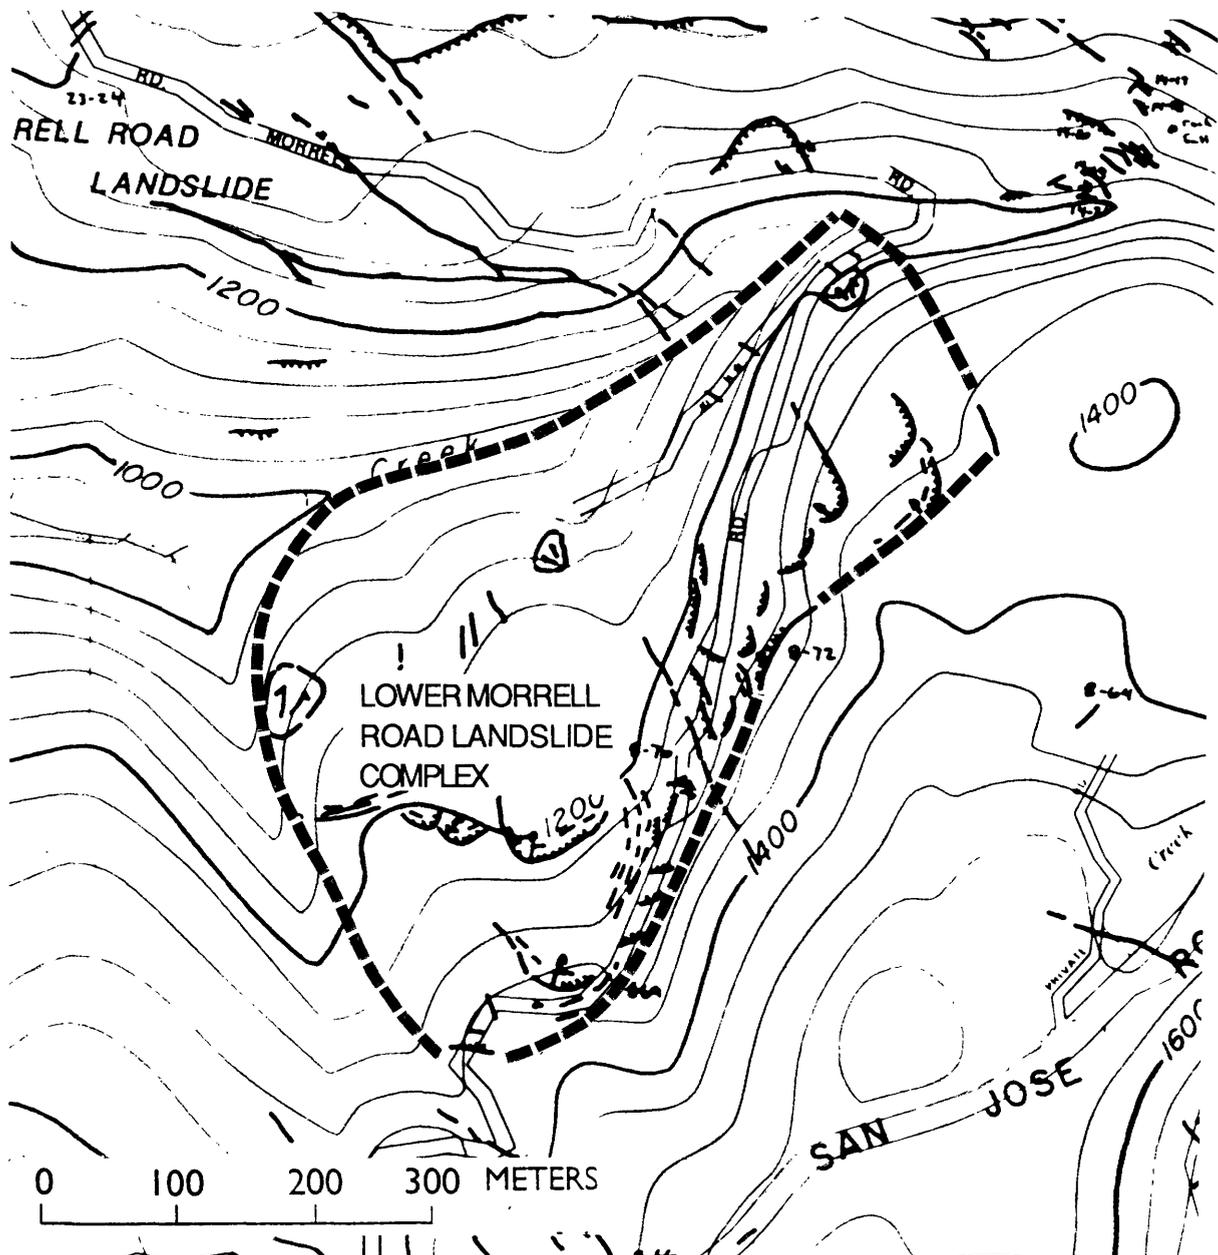
Figure 25.—Lower Morrell Road landslide complex. Ground cracks and compressional features from Spittler and Harp (1990); landslide boundaries from Keefer (1991). See figure 7 for explanation and figure 19 for base-map information.

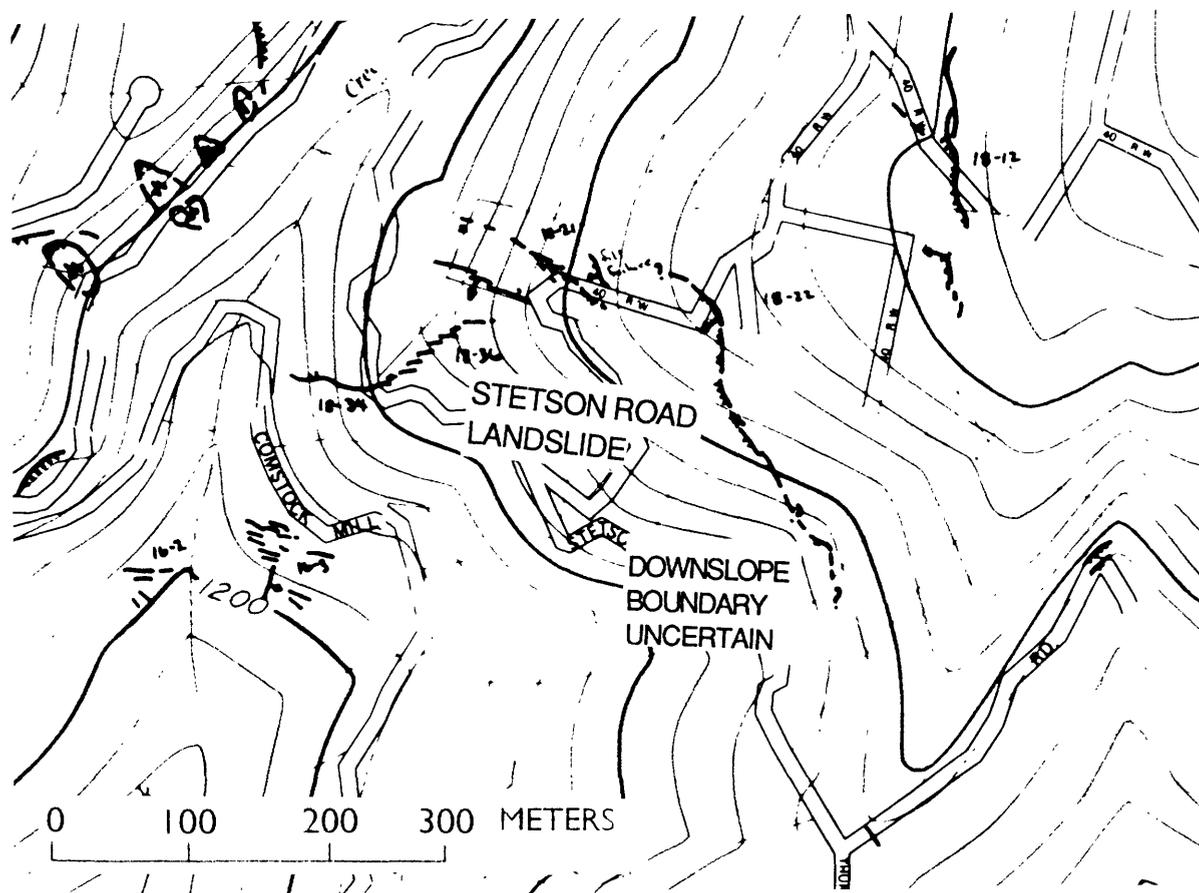
Figure 26.—Stetson Road landslide. Ground cracks and compressional features from Spittler and Harp (1990); landslide boundaries from Keefer (1991). See figure 7 for explanation and figure 19 for base-map information.

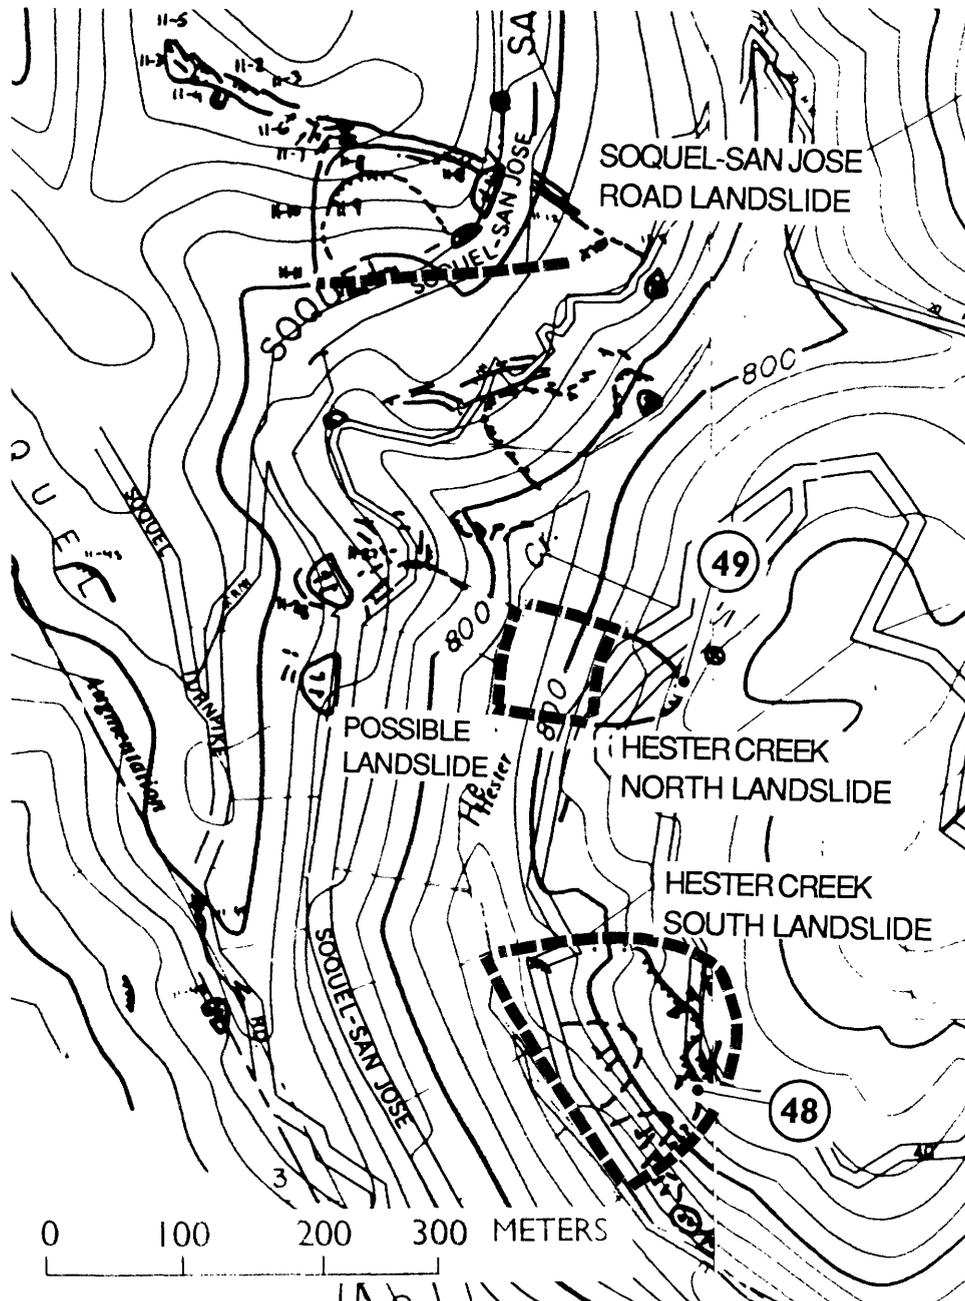
Renewed displacement was first detected along the main scarp of the Hester Creek North landslide on March 19, 1991. Measurements at quadrilateral array 49 (fig. 27) indicated 2 cm of extension between March 15 and 19,

and on March 25, measurements at the site revealed an additional 2 cm of extension. During the March 25 survey, renewed minor cracking was also observed across the unpaved access road, downslope from quadrilateral array 49 (fig. 27), at both localities where the road crossed the main scarp. Those cracks were 1 to 2 cm wide and showed slight vertical displacements.

Figure 27.—Hester Creek North, Hester Creek South, and Soquel-San Jose Road landslides. Ground cracks and compressional features from Spittler and Harp (1990); boundaries of Hester Creek North and South landslides from Keefer (1991). See figure 7 for explanation and figure 19 for base-map information.

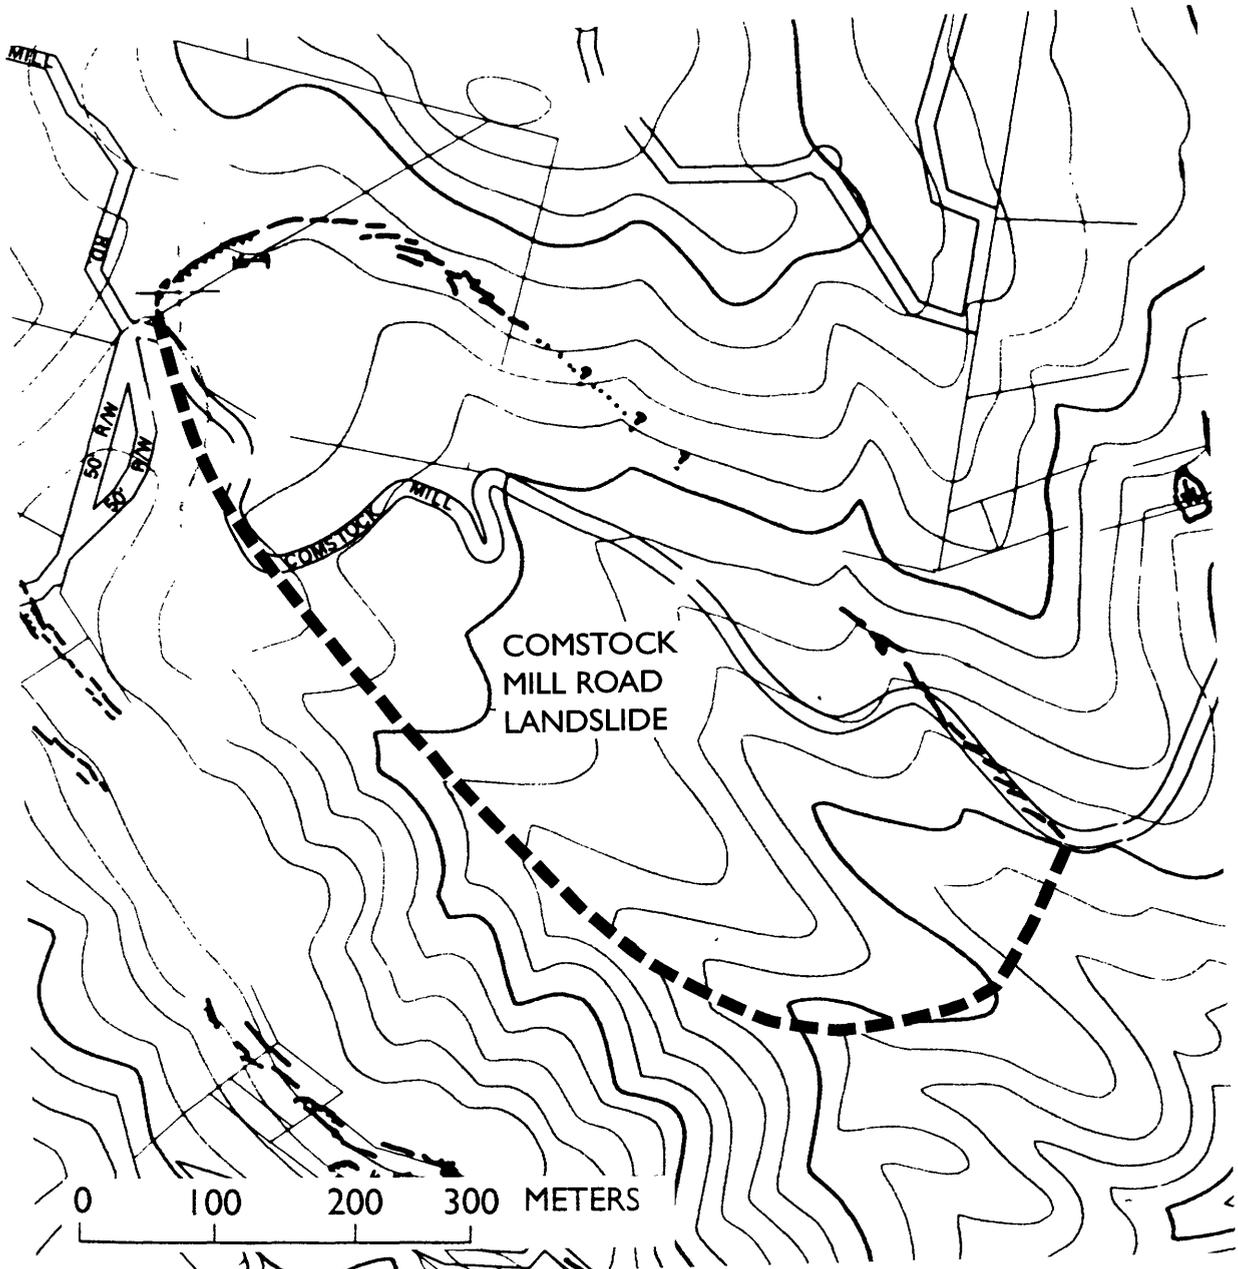
Figure 28.—Comstock Mill Road landslide. Ground cracks and compressional features from Spittler and Harp (1990). See figure 7 for explanation and figure 19 for base-map information.

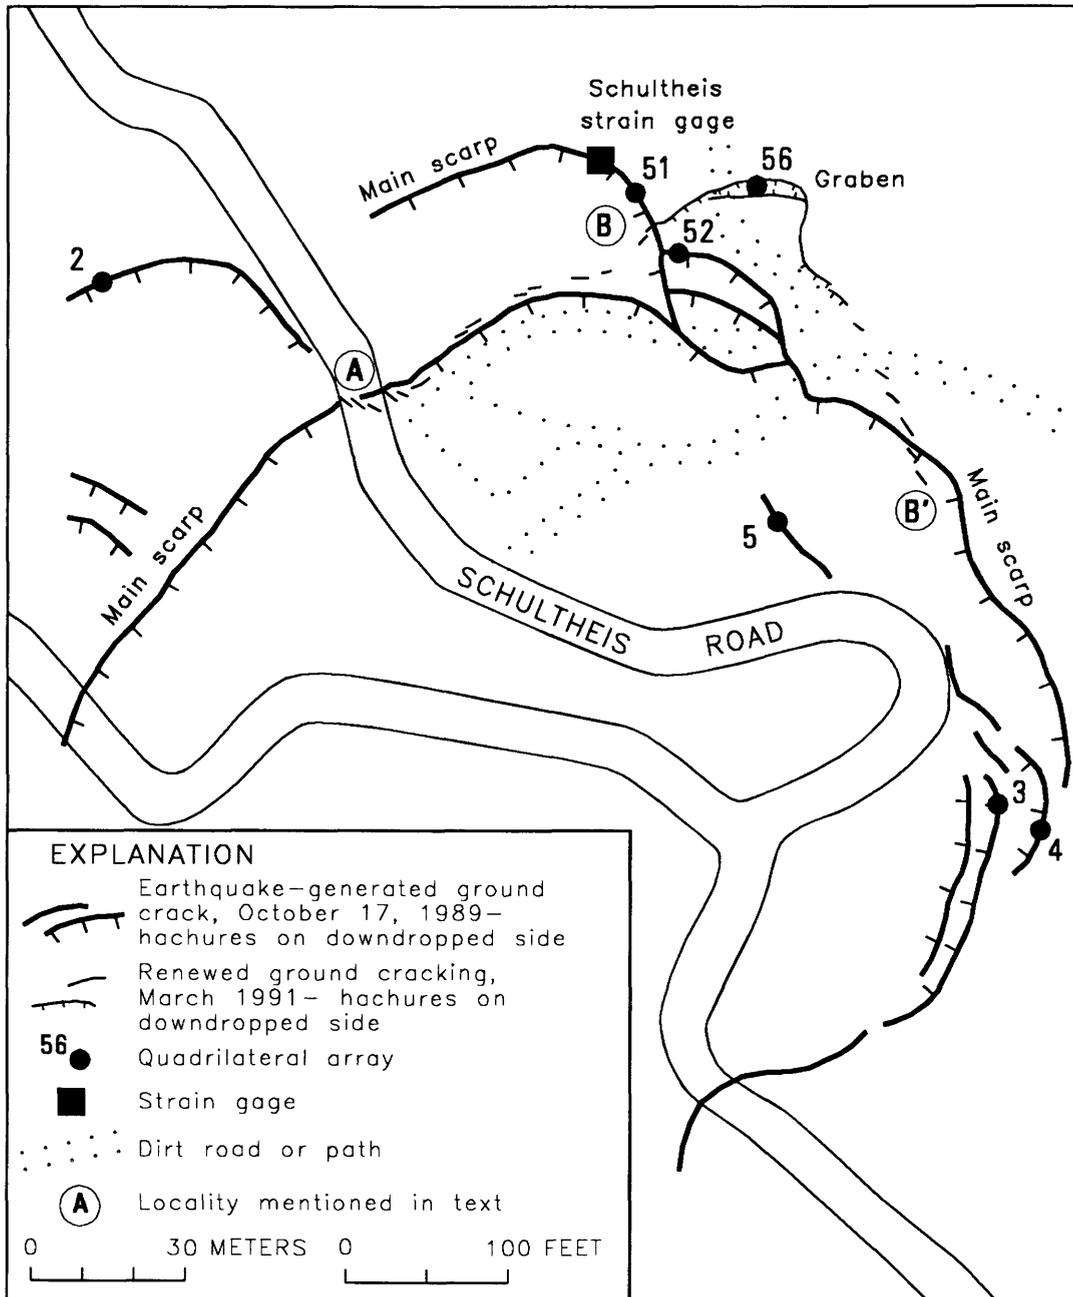
The first evidence of postearthquake ground cracking related to landslide movement was discovered on March 5, 1991, when new echelon cracks were observed on repaired pavement where Schultheis Road crosses the main scarp of the Upper Schultheis Road landslide (loc. A, fig. 29). The cracks were 1.5 to 3 m long and 1 to 2 cm wide, and showed as much as 2 cm of downslope vertical displacement. Observations on March 15 and 19, after additional rain, revealed increases of 1 to 2 cm in crack widths and vertical displacements, and increases of 0.5 to 1 m in crack lengths (Marshall and Griggs, 1991).

On March 25, a new set of cracks was observed upslope from the main scarp that formed during the earthquake (leg B–B', fig. 29). Because these new cracks did not occur along the traces of the preexisting, earthquake-induced cracks, associated displacements were not detected at nearby quadrilateral arrays 51 or 52 or by the adjacent

Schultheis strain gage (fig. 29). The new set of cracks extended eastward and southeastward from a point (B, fig. 29) on the earthquake-generated main scarp. From there eastward, a new crack was virtually continuous for about 50 m. This crack was arcuate and concave downslope in plan view, and along part of the crack was a graben, 15 m long, 2 to 3 m wide, and 0.5 m deep, that showed 20 to 30 cm of net vertical displacement between its upslope and downslope margins. Elsewhere, the crack was 5 to 10 cm wide and showed 5 to 10 cm of vertical displacement. Southeast of the continuous crack, shorter echelon cracks continued for an additional 50 m (to loc. B', fig. 29). These shorter cracks were 10 to 20 cm wide and showed

as much as 10 cm of vertical displacement. At several localities upslope from the main scarp, storm runoff was observed flowing into the newly formed cracks on March 25 (Marshall and Griggs, 1991).

A new quadrilateral array (56, figs. 9A, 29) was installed on March 27, 1991, across the newly formed graben. Measurement of this array 2 weeks later, on April 11, showed 3 cm of additional downslope displacement. Subsequent measurements on April 18, 23, and 30, May 8, and July 17 indicated no additional displacements, but field observations during those surveys showed that minor ground cracking had occurred in several places along the main scarp (between locs. A and B, fig. 29).

Figure 29.—Area around main scarp of Upper Schultheis Road landslide, showing ground cracks and scarps that resulted from earthquake; ground cracks, scarps, and grabens formed during period of heavy rainfall in March 1991; and locations of quadrilateral arrays and strain gage.

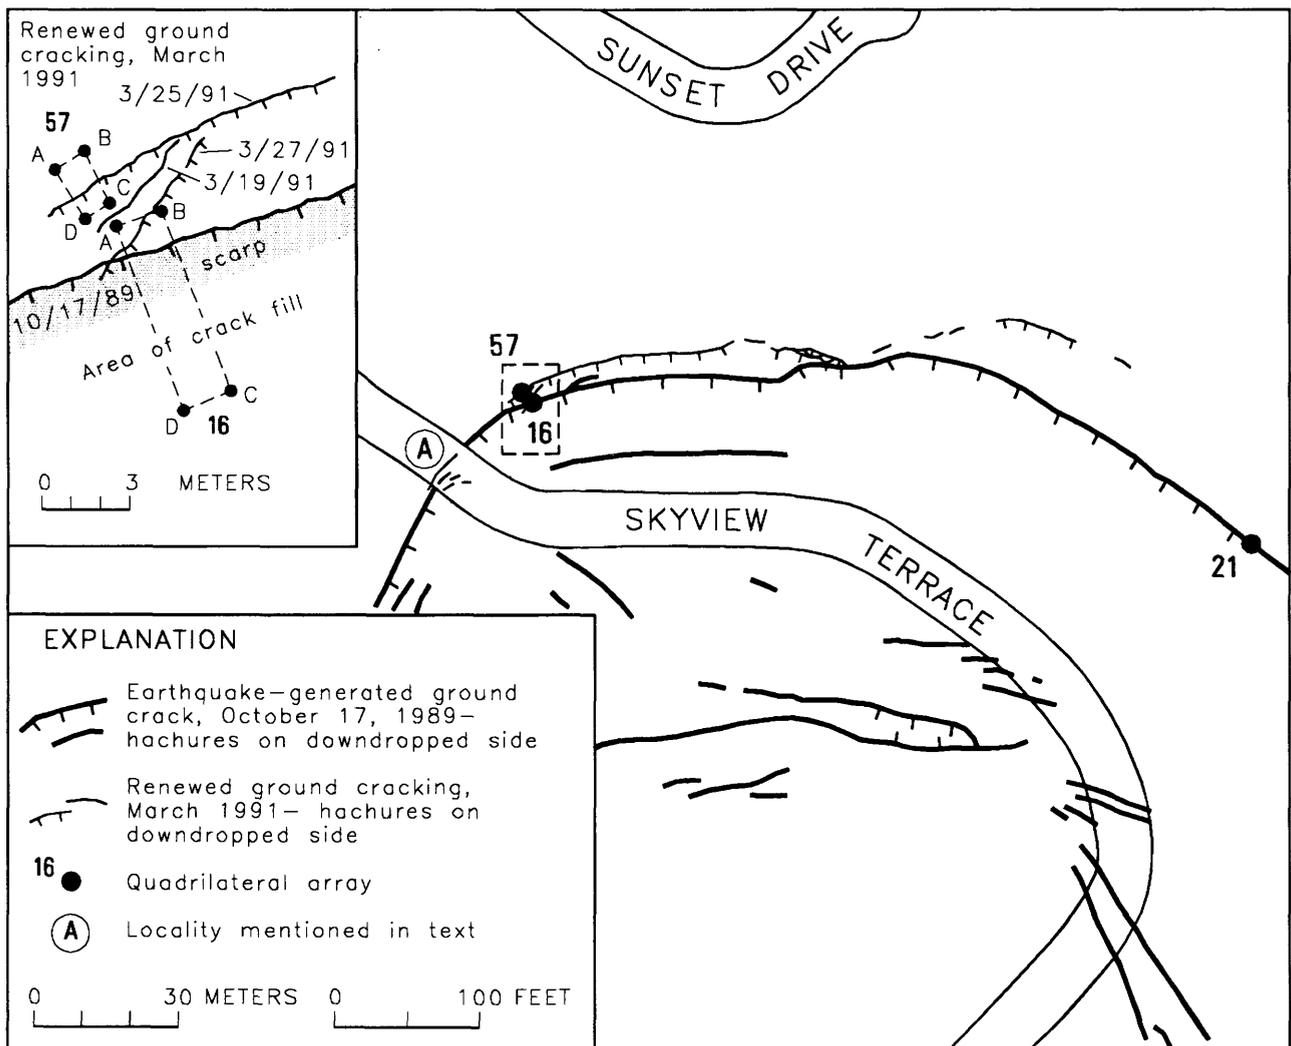
Renewed ground cracking and displacement along the major scarp near upper Skyview Terrace was detected on March 19, 1991, when a survey of quadrilateral array 16 (figs. 12, 30), showed 1 to 2 cm of contraction. Field inspection revealed that the contraction was associated with extension across a new crack, less than 1 m upslope from the site (inset, fig. 30). This crack, which formed sometime between March 15 and 19, was 2 to 5 cm wide and showed no vertical displacement. The crack was traceable 10 m eastward from the array, until lost beneath thick vegetation. Small cracks, less than 1 cm wide, also broke the pavement of upper Skyview Terrace near quadrilateral array 16 (point A, fig. 30).

Measurements at quadrilateral array 16 on March 25 revealed additional contractions of 11 to 19 cm. The new crack noted on March 19 appeared to be unchanged, but a larger crack, about 1 m farther upslope, had formed between March 19 and 25. This new crack, 5 to 15 cm wide and showing 5 to 15 cm of downslope vertical displacement, was subparallel to the preexisting scarp

and traceable continuously approximately 40 m eastward. From that point east, a series of shorter cracks were traceable an additional 70 to 80 m. These shorter cracks were 5 to 15 cm wide and showed vertical displacements of as much as 15 cm. The cracks in Skyview Terrace (loc. A, fig. 30) had also become larger by March 25.

On March 27, another new crack was observed, trending obliquely upslope, northeast from the earthquake-generated scarp (inset, fig. 30). This crack, which averaged 5 cm in width and showed as much as 5 cm of vertical displacement, was traceable for 4 m and passed between two of the stakes in quadrilateral array 16 (stakes A, B, inset, fig. 30). The March 27 survey showed 11 cm of cross-crack contraction on the two legs involving stake B (that is, legs B-C, B-D) and no significant change on the two legs involving stake A (that is, legs A-C, A-D). On March 27, a new quadrilateral array (57, figs. 12A, 30) was installed across the new crack observed on March 25 (fig. 30). Subsequent measurements made at both quadrilateral arrays 16 and 57 on April 11, 18, and 23 and May 8, 1991, showed that no additional displacements had occurred.

Figure 30.—Area around part of upper Skyview Terrace on Villa Del Monte landslide, showing ground cracks and scarps that resulted from earthquake; ground cracks and scarps formed during period of heavy rainfall in March 1991; and locations of quadrilateral arrays.

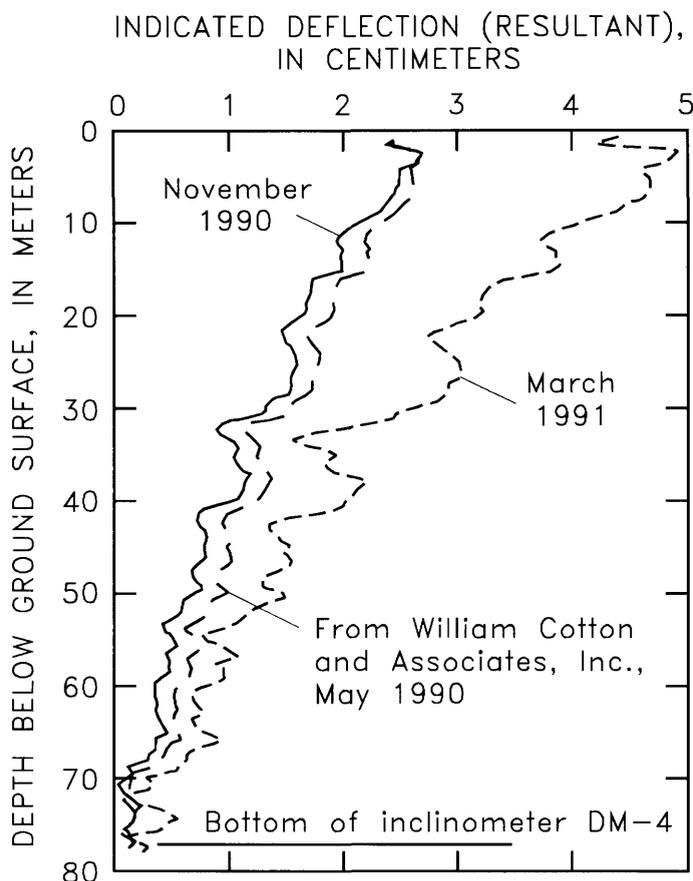
Figure 31.—Deflections measured by inclinometer in borehole DM-4 on Villa Del Monte landslide (see fig. 12B for location).

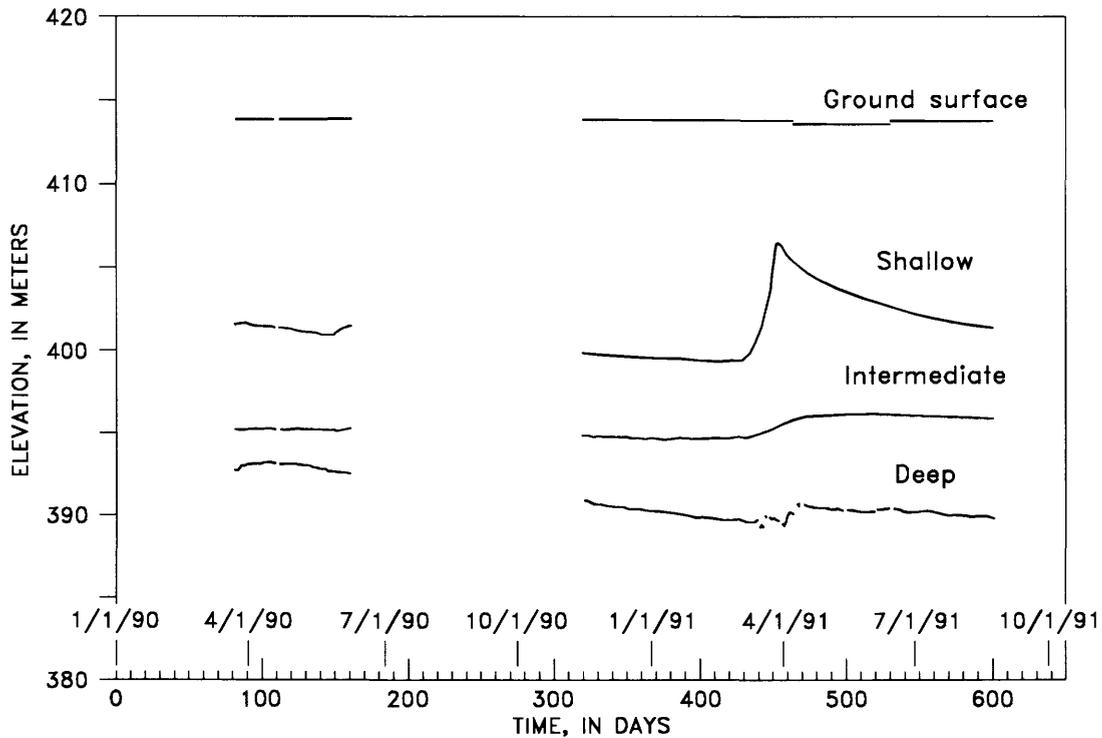
Figure 32.—Elevation of piezometric surface versus time for piezometers in borehole SR-3 on Upper Schultheis Road landslide (see fig. 9B for location).

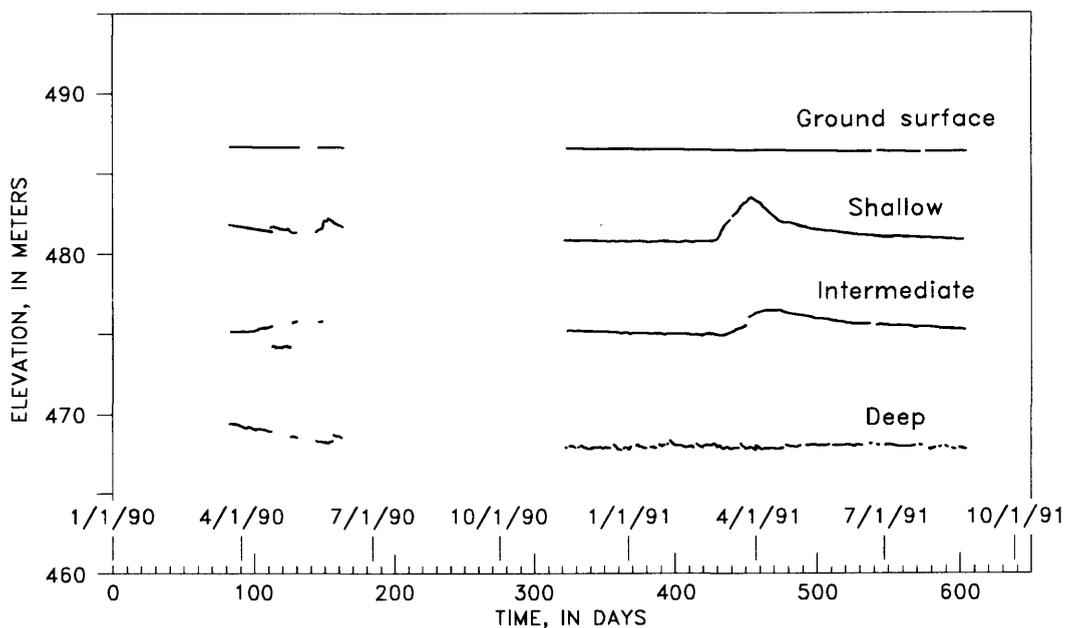
Figure 33.—Elevation of piezometric surface versus time for piezometers in borehole DM-1 on Villa Del Monte landslide (see fig. 12B for location).
