# The Loma Prieta, California, Earthquake of October 17, 1989— Landslides

DAVID K. KEEFER, *Editor*

STRONG GROUND MOTION AND GROUND FAILURE  
THOMAS L. HOLZER, *Coordinator*

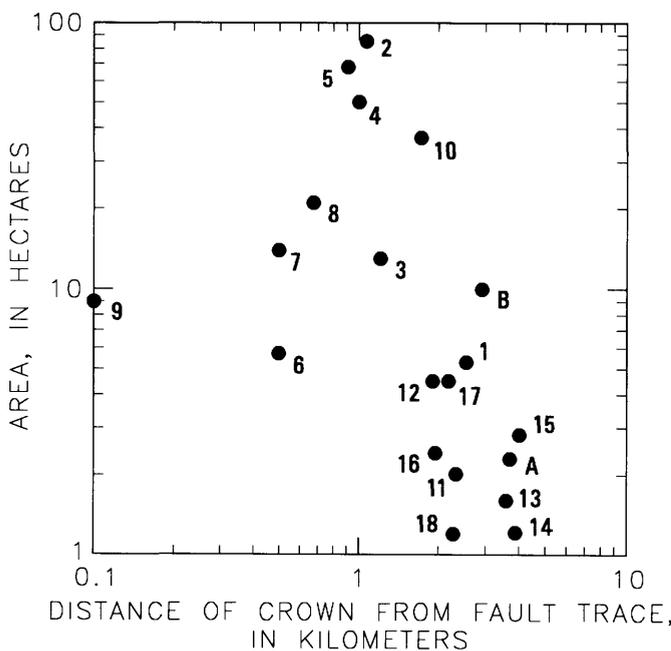
of these landslides only in the Summit Ridge area indicates that their formation was related to specific seismic and (or) geologic conditions there. Among those conditions is the proximity of the landslides to the trace of the San Andreas fault. All of these landslides are within 4.1 km of the fault trace, and all of those larger than 10 ha in area are within 1.8 km of the fault trace (fig. 34). In addition, although the data plotted in figure 34 show considerable scatter, a generally inverse relation between landslide area and distance from the fault trace is evident.

Figure 34.—Area of landslide versus distance from landslide crowns to surface trace of San Andreas fault. Letters and numbers refer to landslides mapped on plate 3 and listed in table 3.

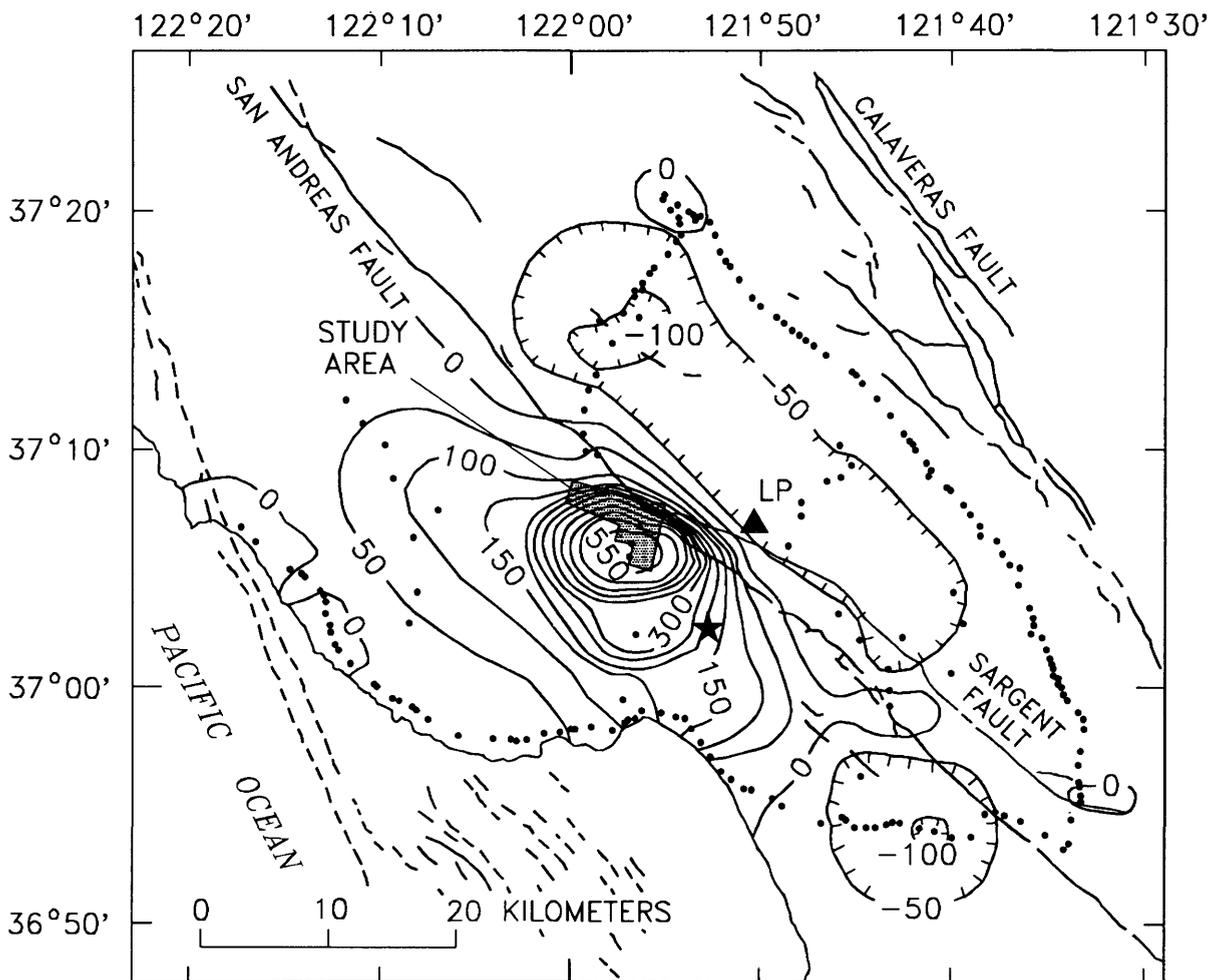
The Summit Ridge area was also in the region of maximum tectonic ground deformation, as determined by geodetic analysis of surface uplift and mapping of off-fault ground cracking. The maximum measured coseismic uplift of 592 mm was near the south boundary of the study area, and uplift within the study area itself ranged from

about 100 to slightly less than 592 mm (fig. 35; Marshall and others, 1991). The Summit Ridge area also had the highest concentration of ground cracks produced by the earthquake (see pl. 3; Spittler and Harp, 1990; Ponti and Wells, 1991). Within the area, ground cracks were most abundant along the south flank of Summit Ridge, where most of the largest landslides occurred.

Figure 35.—Loma Prieta area, showing contours of coseismic uplift and subsidence caused by 1989 earthquake (from Marshall and others, 1991). Star, earthquake epicenter; triangle LP, geodetic station on Loma Prieta; dots, bench-mark locations; irregular thin lines, faults (dashed where approximately located, dotted where concealed). Contour interval, 50 mm; subsidence contours hachured.

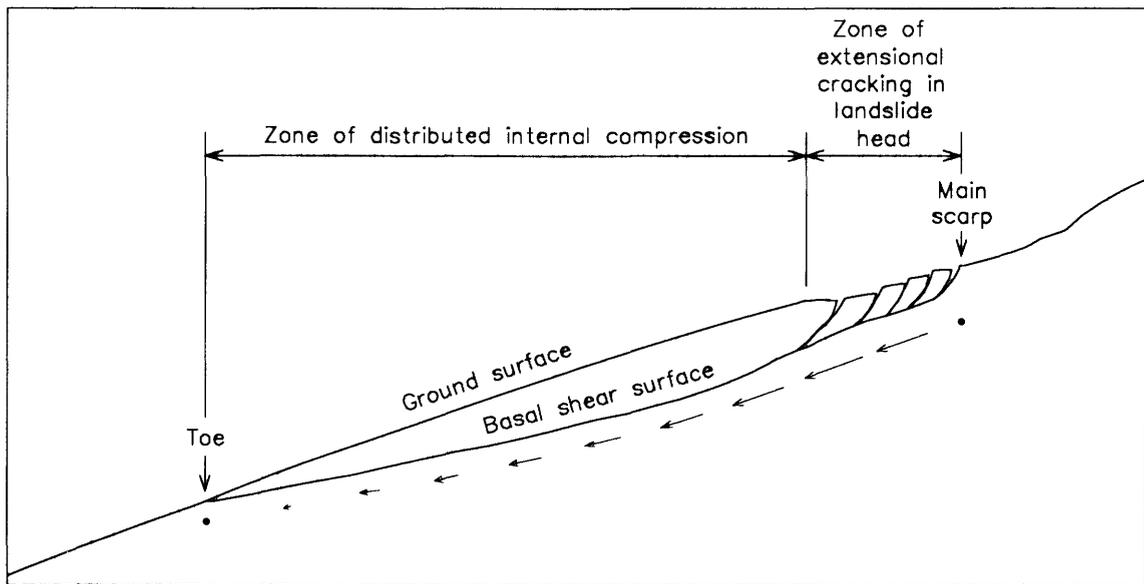
Figure 36.—Idealized landslide cross section, illustrating accommodation of extensional displacement in head by distributed internal compression of rest of landslide, with no bulging of ground surface at landslide toe. Lengths of arrows along basal shear surface represent relative downslope displacement of points along basal shear surface; dots, no displacement. For example, within a landslide 1,000 m long, 2 m of extensional displacement across main scarp could be accommodated by 0.2 percent of distributed longitudinal compressive strain within landslide material, with no movement at toe and no bulging of ground surface (assuming a constant thickness of landslide material).

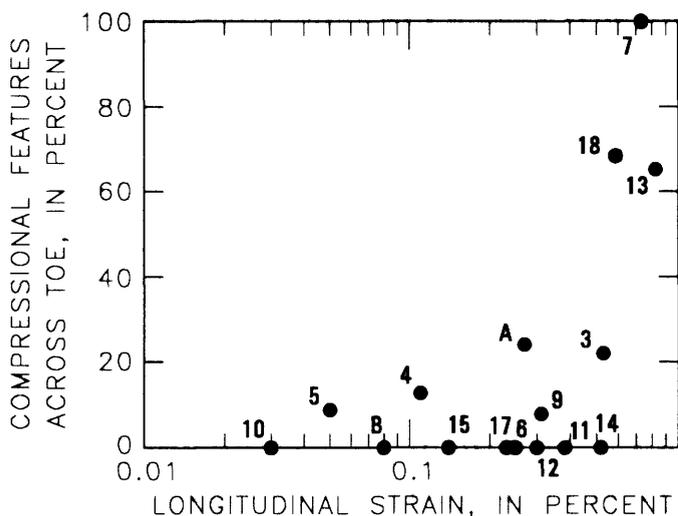
With increasing longitudinal strain, landslide features, particularly those in the landslide toes, should be more fully formed. The relation between longitudinal strain and the formation of surface features across toes for the landslides in the Summit Ridge area is plotted in figure 37. Half of the landslides exhibited no mapped pressure ridges or other features marking the toes; however, the toe features observed on other landslides were typically small, and so many toe features could have been hidden in heavily vegetated terrain. For those landslides where toe features were mapped, the data show a trend of increasing development of toe features with increasing longitudinal strain.

Figure 37.—Percentage of landslide toes marked by compressional features (calculated from ratio of total length of compressional features in landslide toe to width of toe) versus longitudinal strain (calculated from ratio of displacement to landslide length) for landslides in Summit Ridge area. Letters and numbers refer to landslides mapped on plate 3 and listed in table 3.

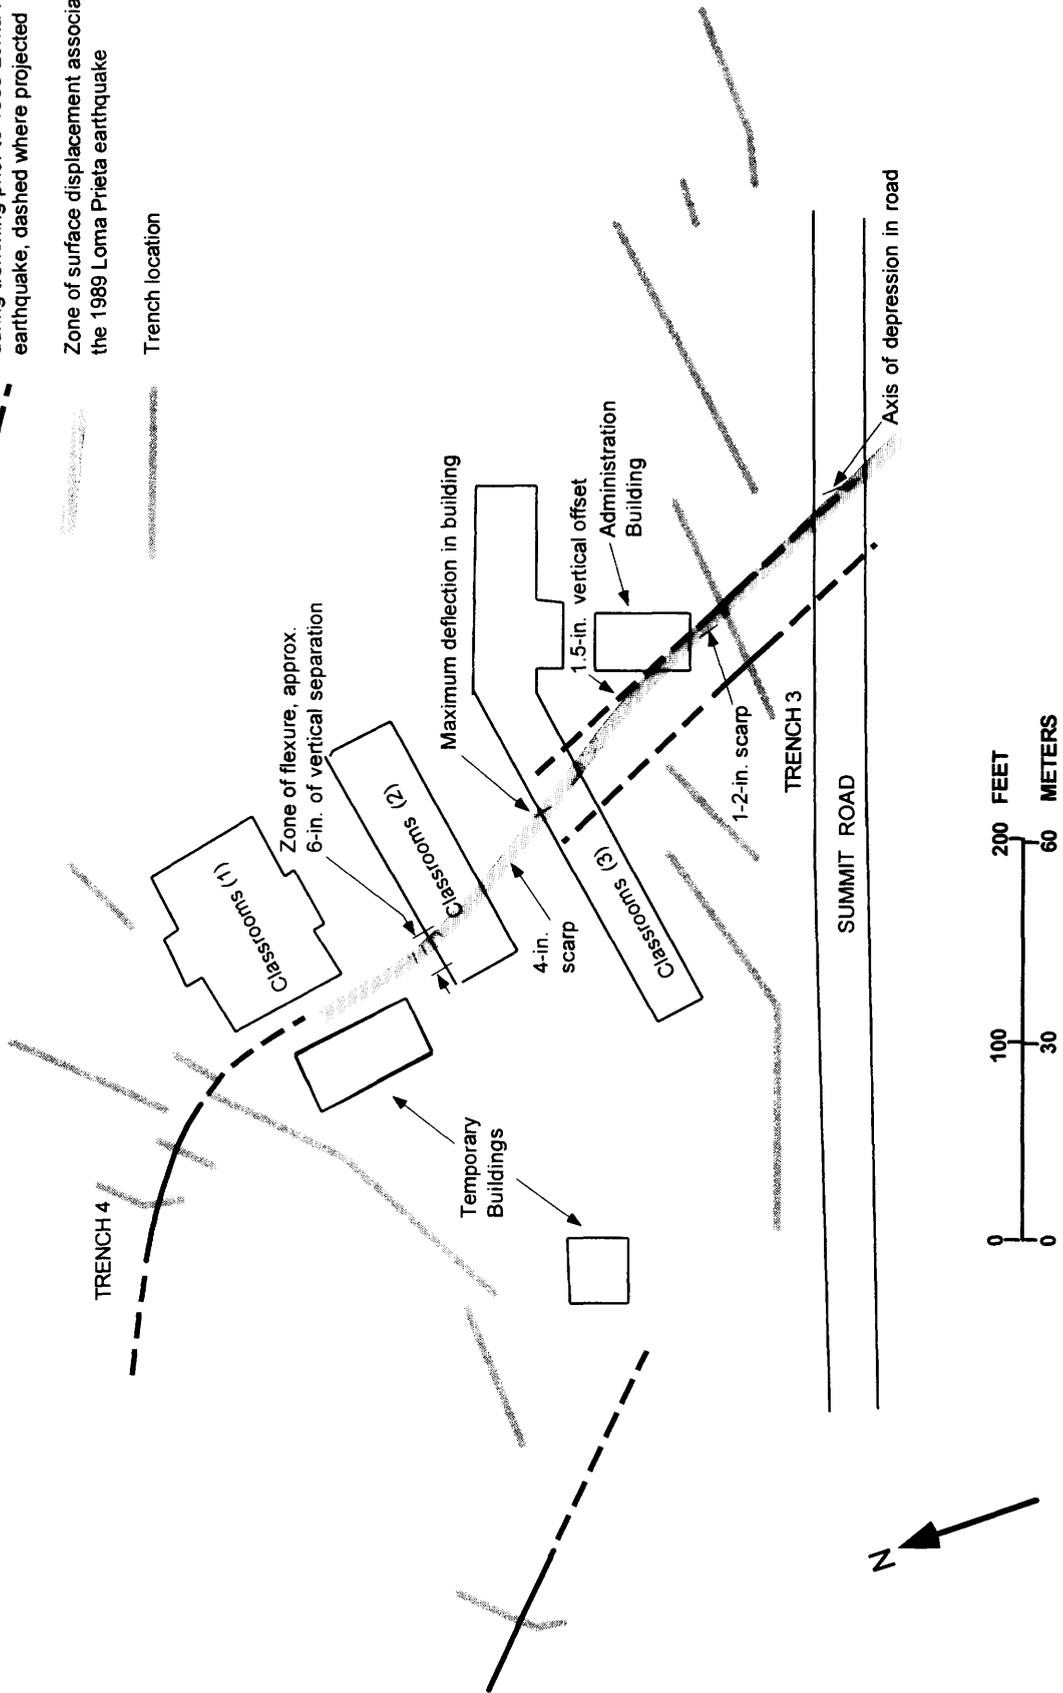
Figure 4.—Simplified site plan for Loma Prieta Elementary School, showing locations of paleoseismic trenches excavated before 1989 Loma Prieta earthquake, suspected active faults identified in trenches, and ground displacement that occurred during the earthquake. Modified from Rogers E. Johnson and Associates (1989).

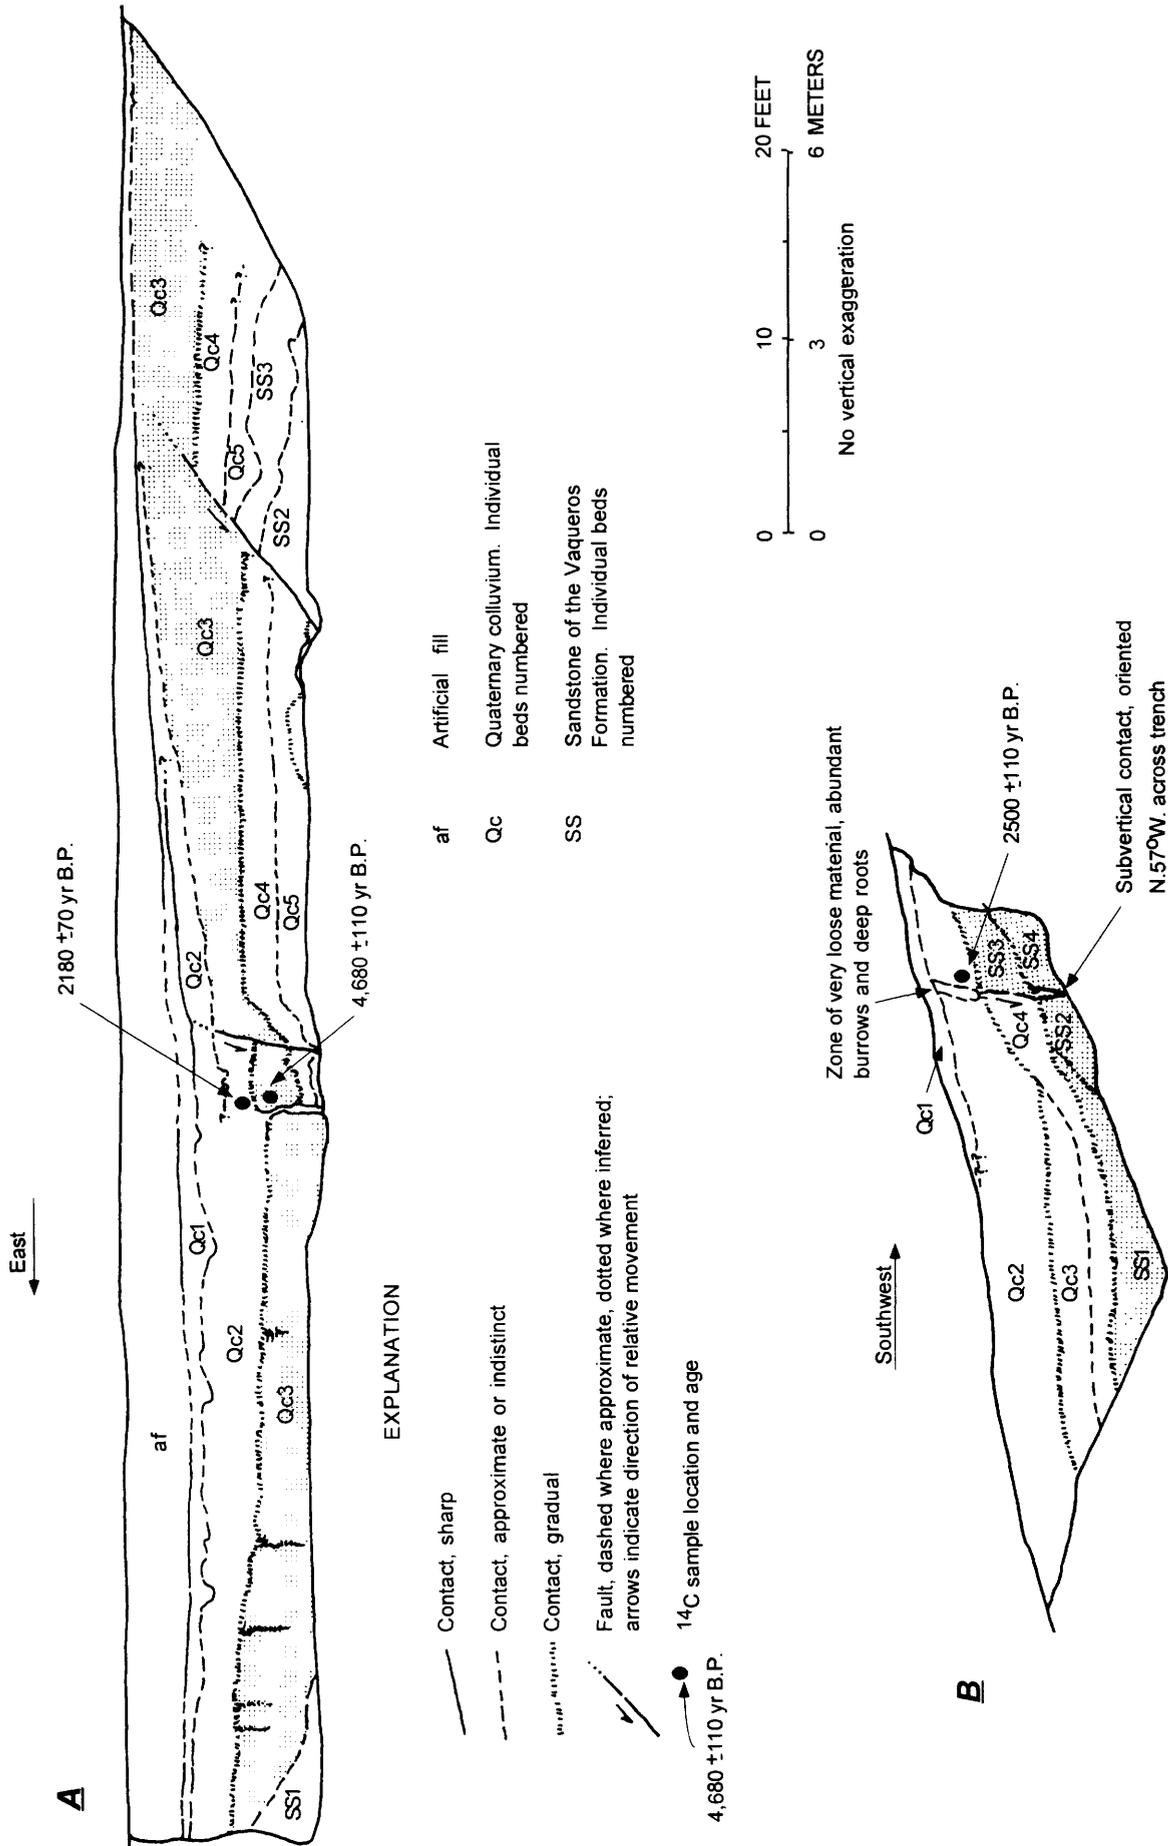
Figure 5.—Logs of trenches 3 (A) and 4 (B), showing evidence for active faulting found during preearthquake trenching investigation. Fault in center of trench 3 was reactivated during 1989 Loma Prieta earthquake, causing as much as 15 cm of down-to-the-northeast displacement under classroom unit 2. Modified from Rogers E. Johnson and Associates (1989).

room building 2 and decreased to the northwest and southeast. The deformation occurred as flexure of the ground surface, northeast side down, probably as a result of normal slip at depth. Maximum vertical displacement was approximately 15 cm across a zone of flexure about 3 m wide.

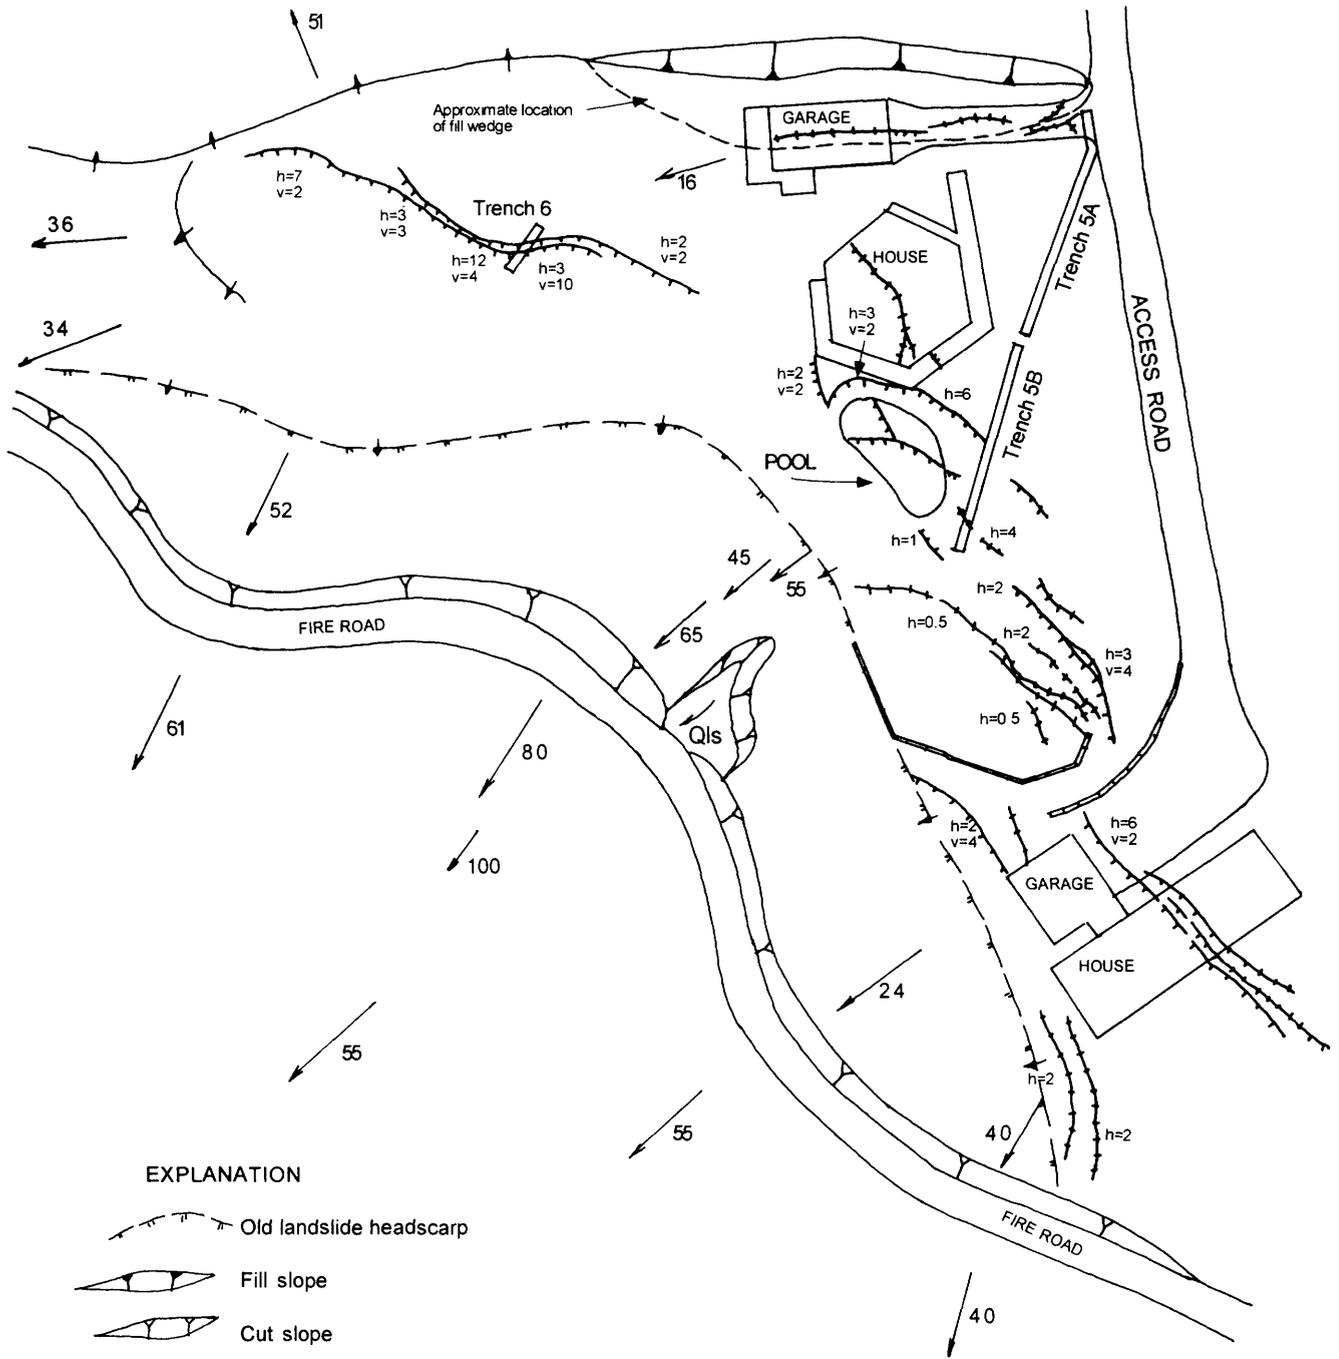
Figure 6.—Area of case history 2 (see pl. 5 for location), showing pattern and dimensions of ground cracking that occurred during 1989 Loma Prieta earthquake. Trenches across ground-cracks showed evidence for many previous episodes of ground cracking in the same places. From G.E. Weber and Associates (1990a).

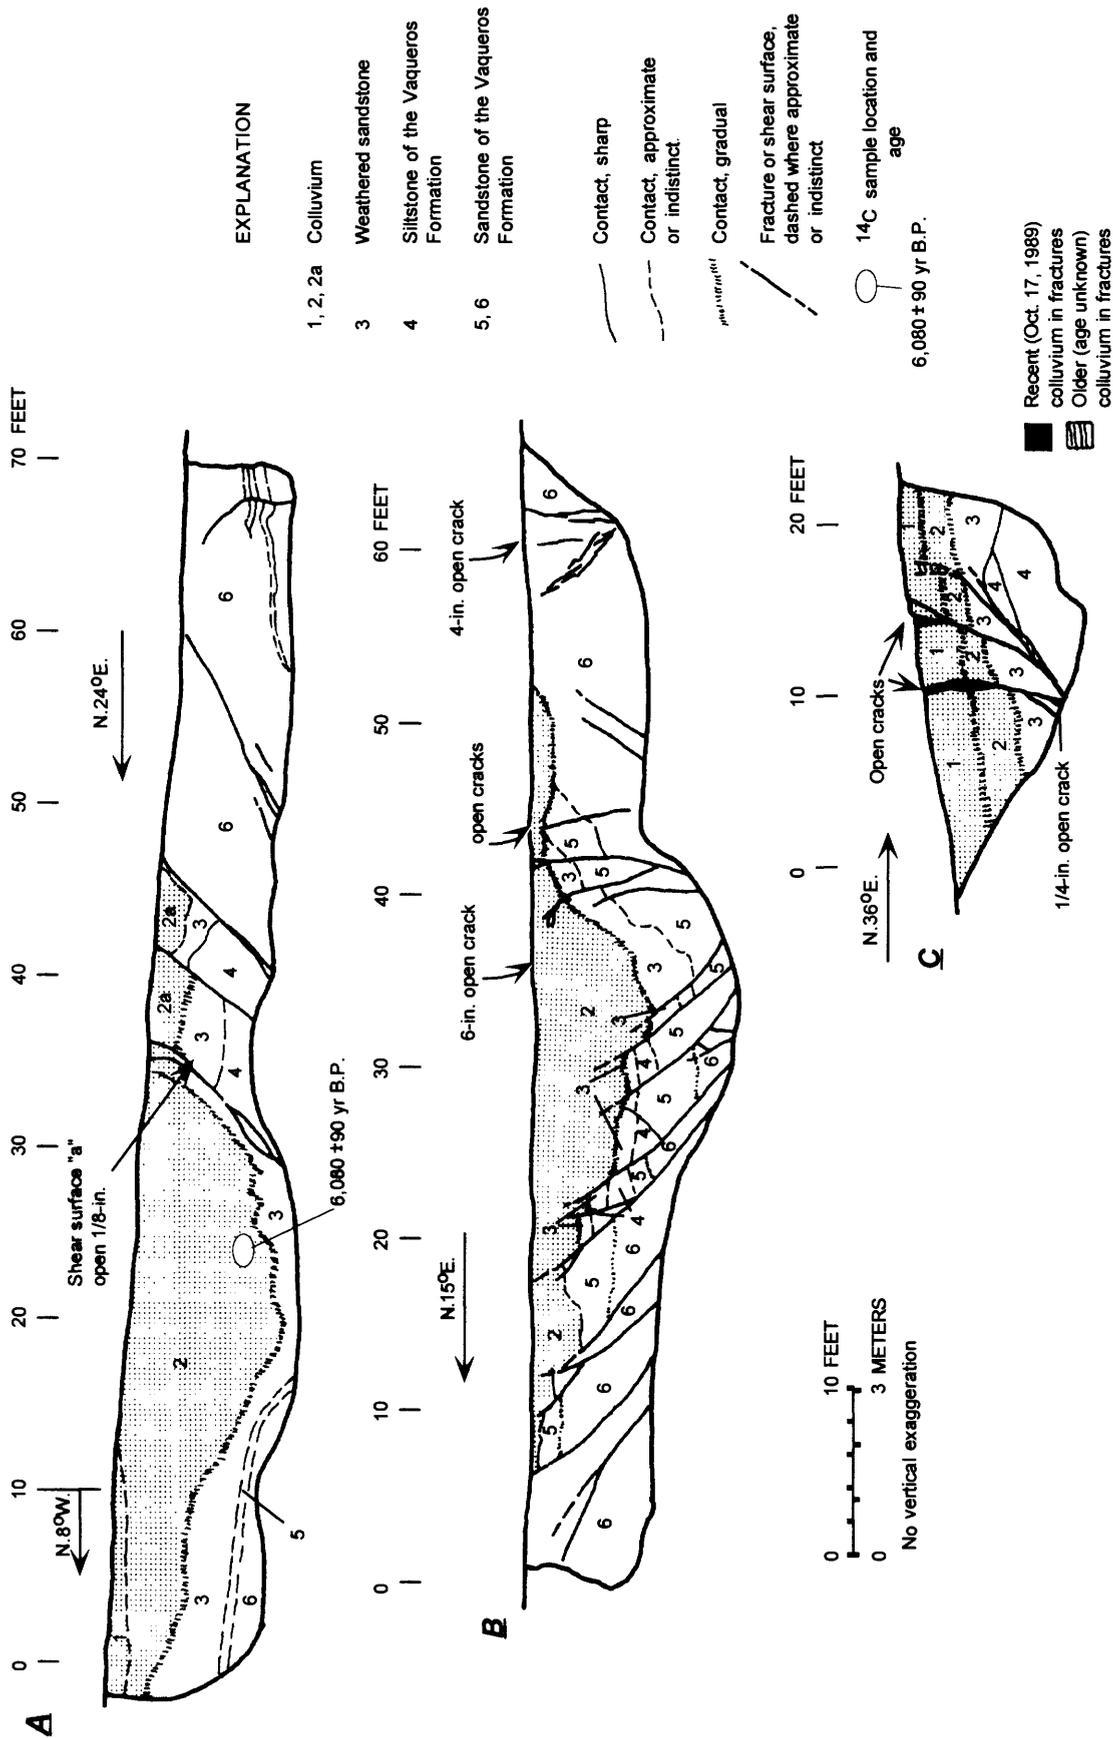
Figure 7.—Logs of trenches 5A (A), 5B (B), and 6 (C) across area of major ground cracks. A, Trench 5A crosses a colluvium-filled graben that was not perceptibly reactivated in 1989. B, Trench 5B shows a second colluvium-filled graben where ground cracks cross trench, indicating many previous episodes of ground cracking in the same place. C, Trench 6 shows bedrock and soil offsets much larger than 1989 displacements, clear evidence for earlier episodes of movement. From G.E. Weber and Associates (1990a).

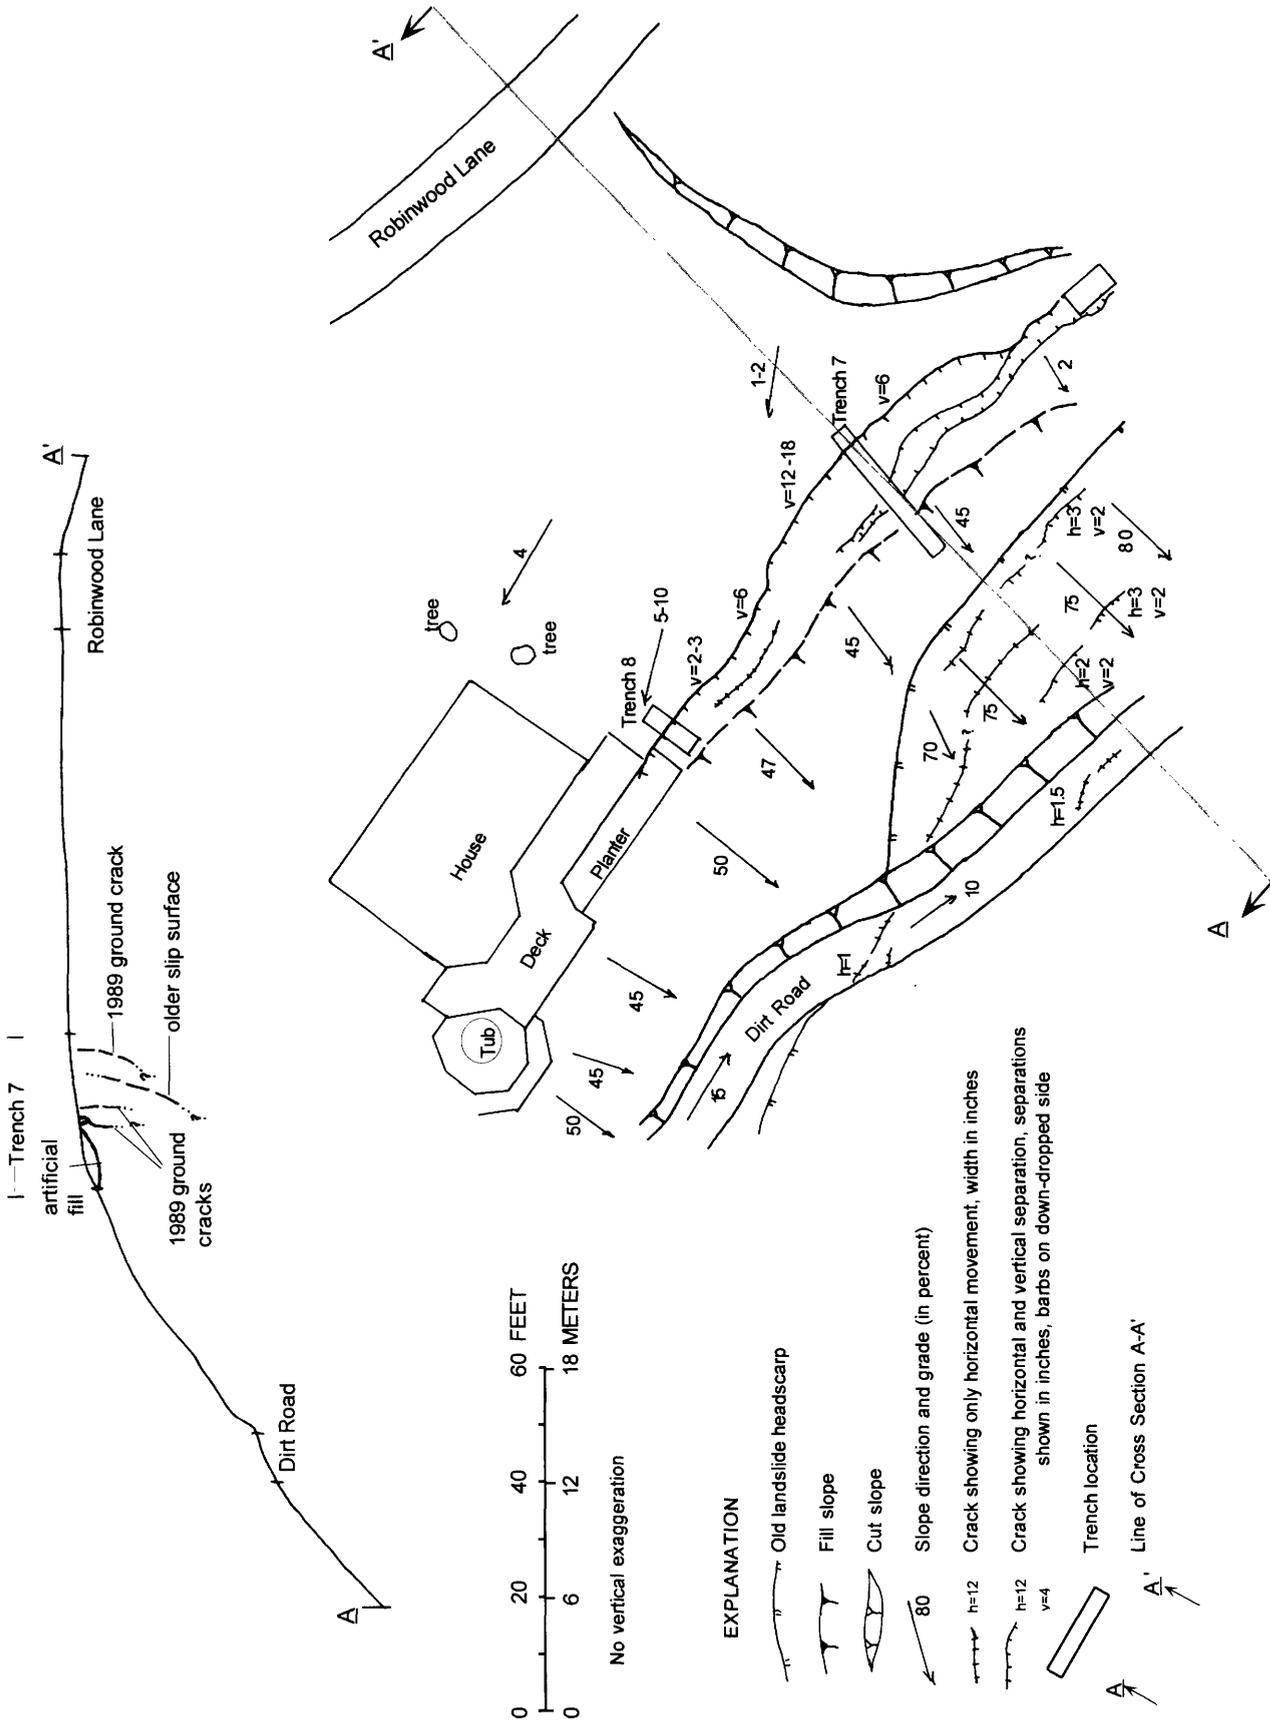
Figure 8.—Area of case history 3 (see pl. 5 for location), at the crest of a narrow, steep-sided ridge, and cross section A-A'. Ground cracking occurred continuously along crest and southwest facing flank of ridge for a distance of more than 0.5 km. A total of 12 trenches across this series of cracks revealed evidence for multiple earlier movements on 1989 ground cracks but also several previous ground cracks that were not reactivated by 1989 Loma Prieta earthquake. From G.E. Weber and Associates (1990b).

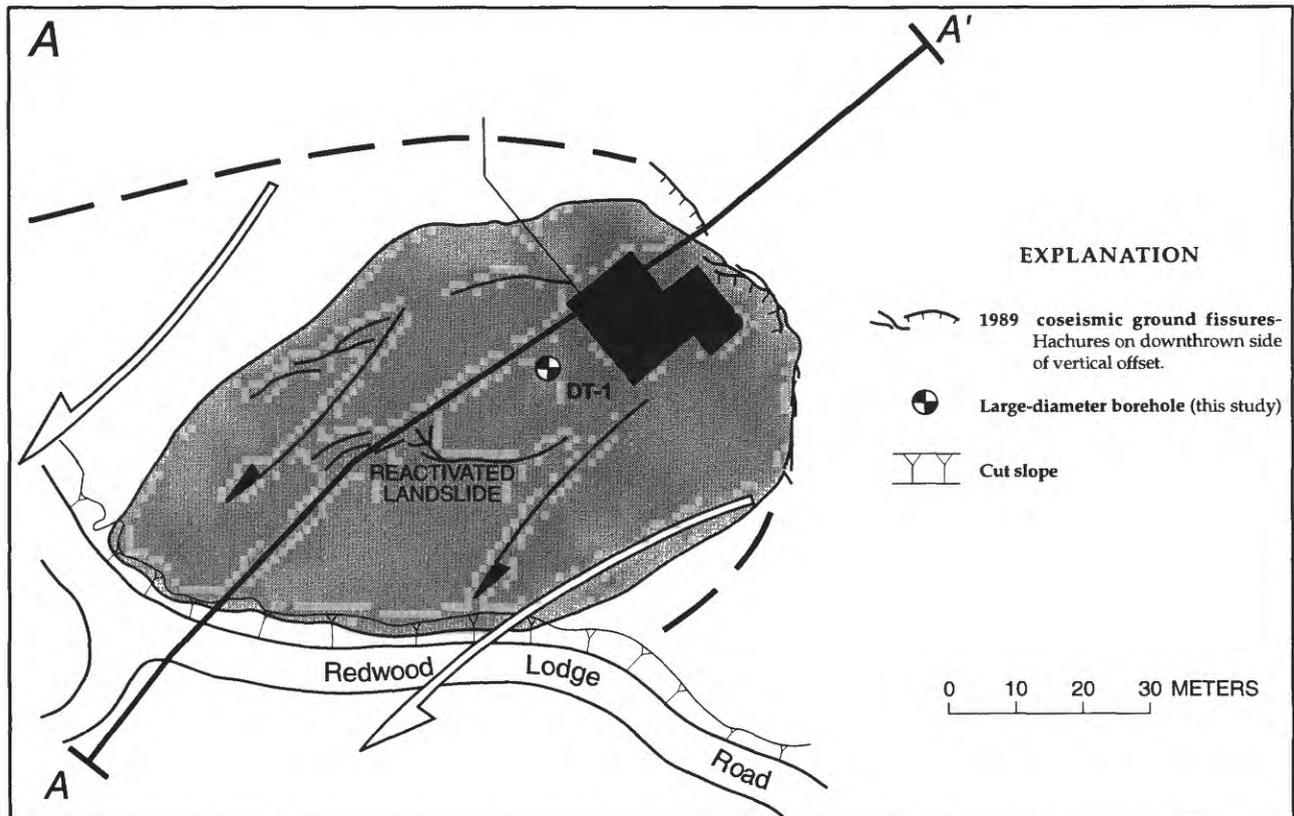
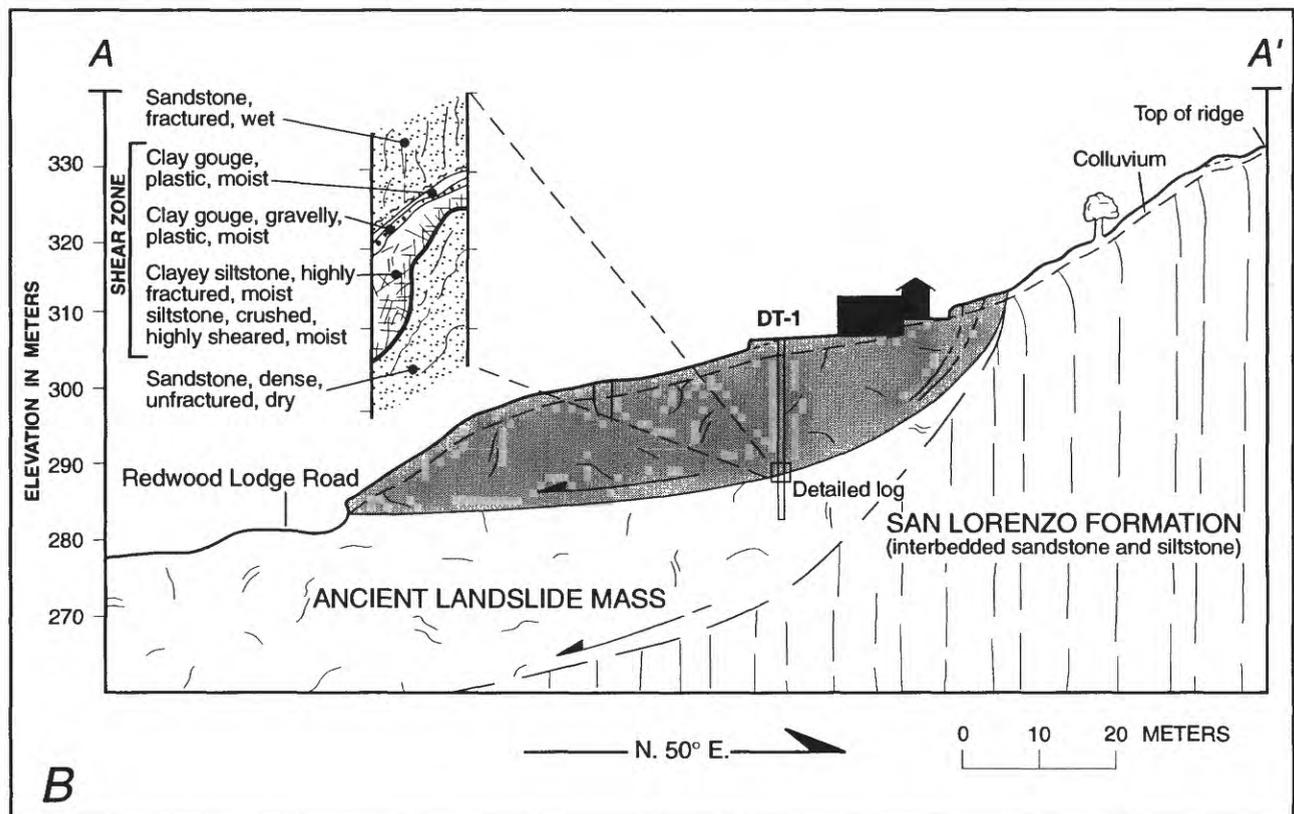
Figure 4.—Simplified geologic map (A) and cross section (B) of Ditullio landslide (see fig. 2 for location). Half-arrows indicate direction of downslope movement.

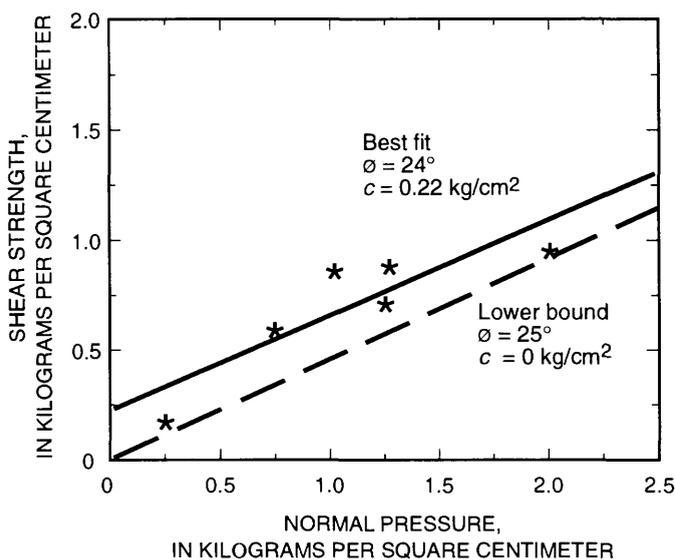
The residual shear strengths measured in direct shear tests are approximately 70 to 75 percent of the peak values. This result approximates the reduction to 80 percent of peak shear strength estimated by Makdisi and Seed (1977) and recommended by Hynes-Griffin and Franklin (1984), owing to cyclic-loading effects. Therefore, we used the residual shear strengths to characterize the cyclic strength of the basal rupture surfaces. Two measures of residual shear strength, lower-bound and average or "best fit" curves, were drawn by linear regression through the data points (fig. 6). The shear-strength parameters, in terms of angle of internal friction ( $\phi$ ) and cohesion ( $c$ ), that describe the lower-bound and best-fit values are  $\phi=25^\circ$ ,  $c=0 \text{ kg/cm}^2$  and  $\phi=24^\circ$ ,  $c=0.22 \text{ kg/cm}^2$ , respectively.

Figure 6.—Residual shear strength versus normal pressure in laboratory consolidated-undrained tests on landslide rupture surface material.

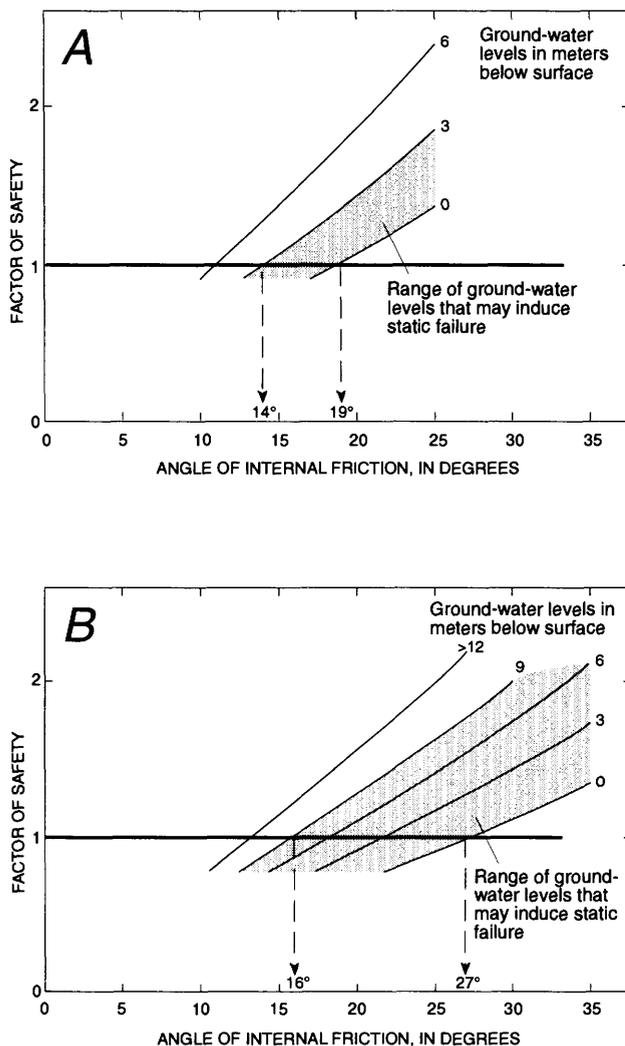
analysis would not have predicted the slope failures even if the lower-bound values were used. However, the FS value drops below 1.0 when a  $k_y$  value of about 0.25 g is used.

Figure 7.—Factor of safety versus shear strength (expressed as angle of internal friction) at various ground-water levels in Lower Schultheis Road West (A) and Ditullio (B) landslides (see fig. 2 for locations).

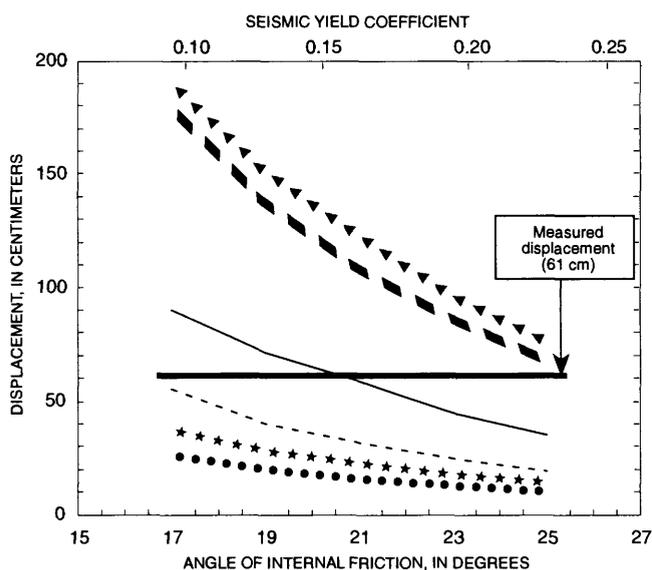
The displacements that can be calculated for an  $M=7.0$  earthquake, using the three curves of Makdisi and Seed (1977) and Hynes-Griffin and Franklin (1984) for the Lower Schultheis Road West landslide, are plotted in figure 10. Because of the bilateral rupture, the 1989 Loma Prieta earthquake was of considerably shorter duration than most other earthquakes of similar magnitude. Therefore, we might expect the measured displacements to fall in the lower part of the range of calculated displacements. Figure 10 shows, however, that they do so only for the smallest  $\phi$  values. If we assume that the appropriate  $\phi$  value should be about  $21^\circ$ , then the measured displacements fall in the middle of the range of displacements in the data sets of both Makdisi and Seed (1977) and Hynes-Griffin and Franklin (1984).

Figure 10.—Predicted displacement versus shear strength (expressed as angle of internal friction) calculated by two cumulative-displacement methods for Lower Schultheis Road West landslide (see fig. 2 for location).
