The Loma Prieta, California, Earthquake of October 17, 1989— Highway Systems

Professional Paper 1552-B

This paper summarizes the impact of the Loma Prieta earthquake on highway systems. City streets, urban freeways, county roads, state routes, and the national highway system were all affected. There was damage to bridges, roads, tunnels, and other highway structures. The most serious damage occurred in the cities of San Francisco and Oakland, 60 miles from the fault rupture. The cost to repair and replace highways damaged by this earthquake was \$2 billion. About half of this cost was to replace the Cypress Viaduct, a long, elevated double-deck expressway that had a devastating collapse which resulted in 42 deaths and 108 injuries.

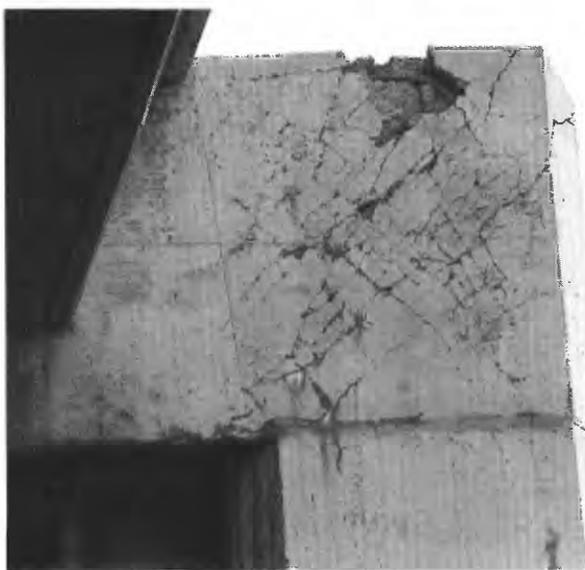
Almost all of the serious bridge damage was the result of problems in transferring forces between vertical and horizontal elements. This was a problem for both steel and reinforced concrete members. Outrigger joints cracked, pinned connections shattered, moment connections sheared, bolted connections broke, and development rebar pulled out (fig.

Figure 4.—Damage to outrigger knee-joint on Route 980 Southbound Connector.

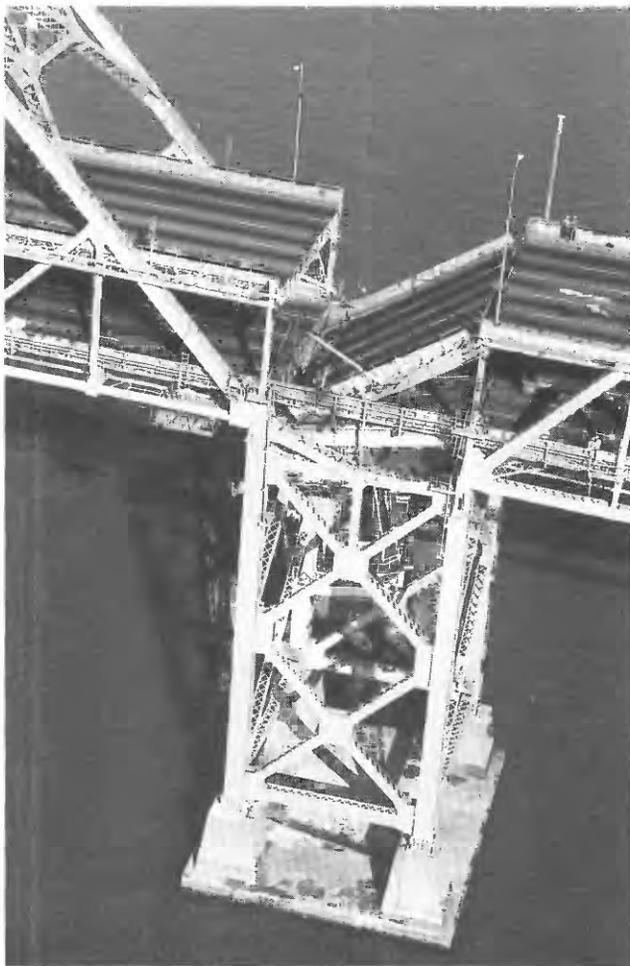
Except for a few minor problems on the West Bay Crossing, all of the earthquake damage occurred on the East Bay Crossing. The most significant damage was at Pier E9 where the top and bottom decks were pulled off their seats, causing them to fall onto a platform and electrical building near the top of the pier (fig. 12). The rest of the damage occurred from Piers E17 to E23 where anchor bolts failed, earthquake restrainers were damaged, stringers moved on their seats, the concrete pedestal at E17 rocked, and expansion joints spalled.

Figure 12.—Fallen decks at Pier E9 of the East Bay Crossing.

age was the dropping of the 50-foot span at Pier E9, which resulted in an unfortunate loss of life. Since the peak ground acceleration from the maximum credible earthquake at this bridge is at least 0.5 g, a substantial retrofit is required to prevent severe bridge damage from a rupture on the San Andreas or Hayward faults, which are near this site.

After the earthquake, an emergency contract was given to the Smith-Rice Company, who had the biggest derrick barge in the area to repair the bridge. Rigging International was the prime subcontractor. The fallen decks at Pier E9 were removed, new girders put in place, and precast concrete deck sections (fig. 19)

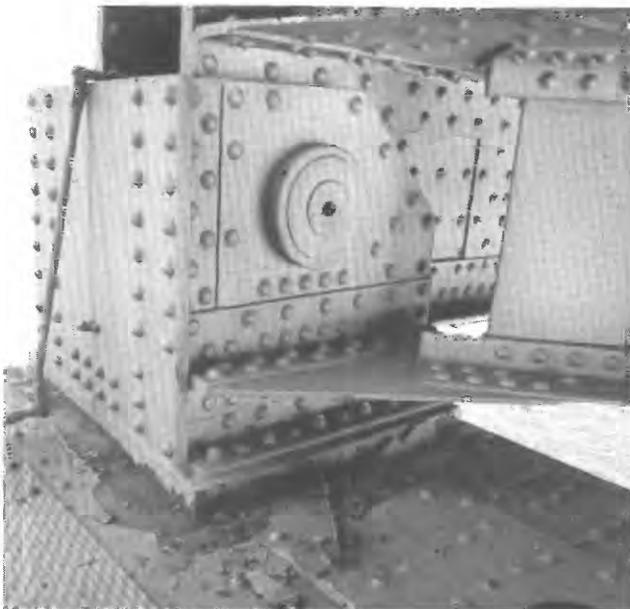
The movement of the decks at Pier E9 was the result of all 20 high-strength bolts at each of the east truss shoes breaking (fig. 13). This allowed the superstructure trusses on the east side of Pier E9 to move approximately 10 inches to the east and 5 inches to the north. The decks at Pier E9 are supported on steel stringers that rest on 6-inch steel angles bolted to large floor beams. When the trusses moved to the east, the stringers were pulled off the angles on the west end. The stringers remained on the bearing seats at the east end, which were bent as the west side fell.

Figure 13.—Truss shoe at Pier E9 of the East Bay Crossing showing broken bolts and shoe movement after earthquake.

laid on top. All the truss sections were jacked back into place, new high-strength bolts were used, and new joint seals were laid.

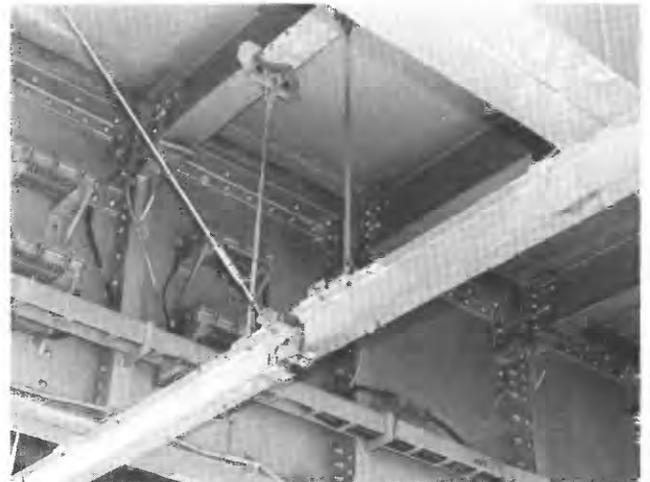
At Pier E23 the rivets connecting the bottom flange of the floor beam (fig. 15) to the concrete pier were sheared off, allowing the span between Pier E23 and E24 to move. A 9-foot drop-in span for the top deck at Pier E23 (figs. 16 and 17) rested on seats attached to this floor beam in a manner similar to that described for Pier E9 (fig. 18). When the floor beam moved, the steel stringer webs were pulled out of the guide angles at Pier E23 (similar to Pier E9) and to within one-quarter inch of the edge of the bearing seat.

Figure 15.—Pier E23 floor beam with small girder seat that almost dropped this span during the earthquake (photograph by Erik Zechlin).

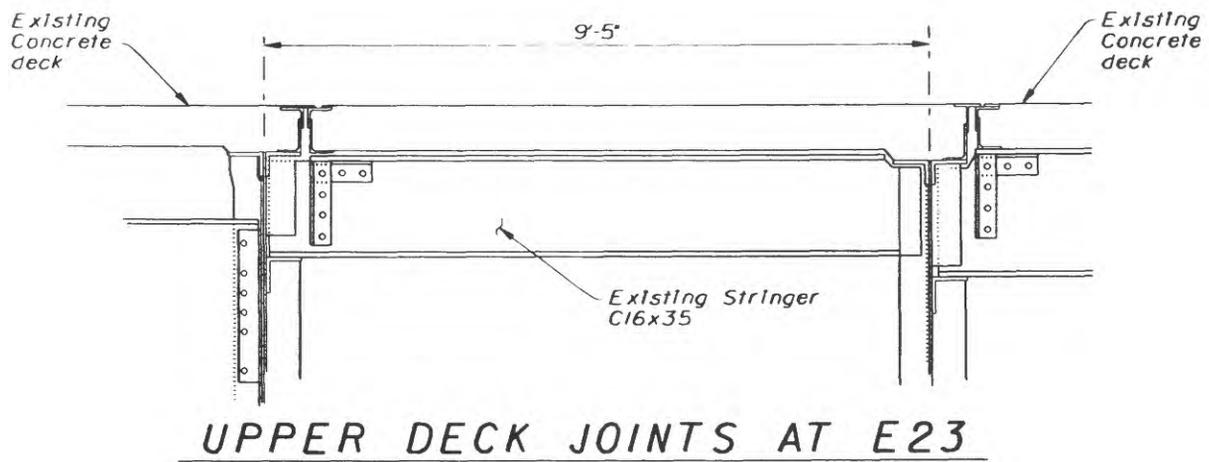
Figure 16.—Plan drawing of steel girders, floor beams, and girder seats at Pier E23 of the East Bay Crossing.

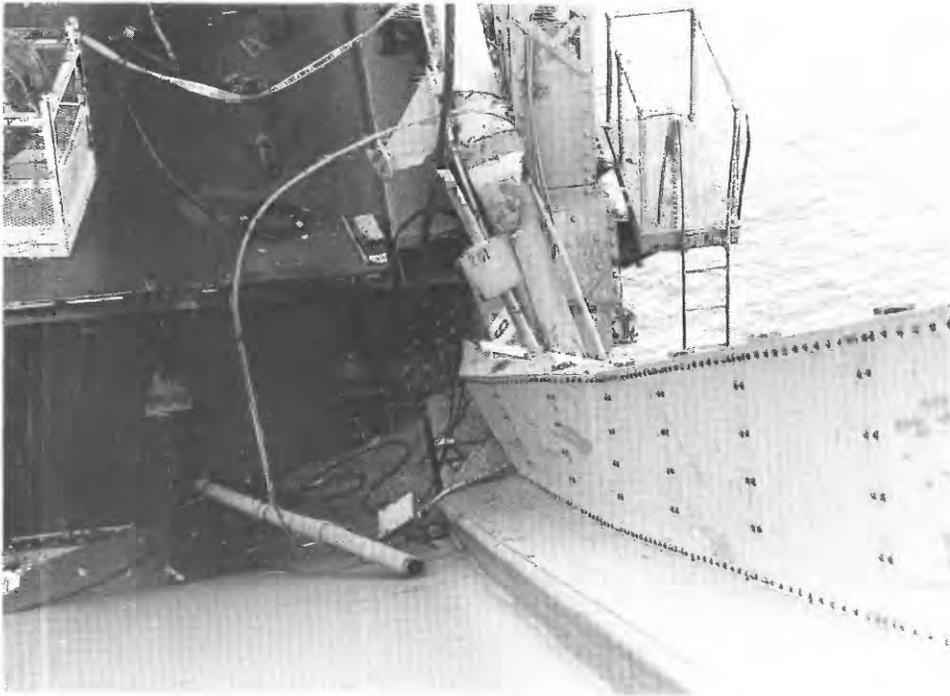
Figure 18.—Collapsed lower deck at Pier E9 of the East Bay Crossing showing short girder seats attached to floor beam.

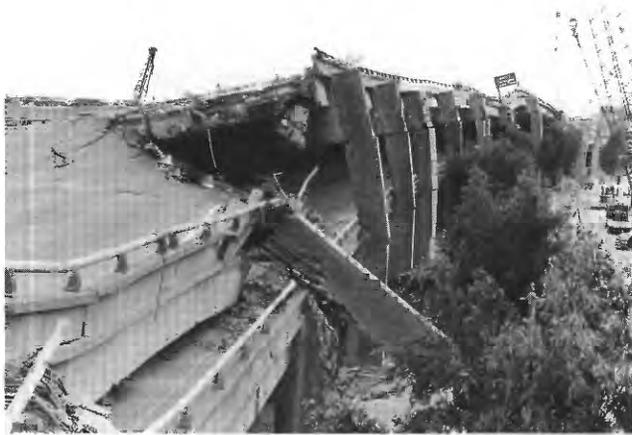
Figure 27.—Pin connection failure at Cypress Viaduct.

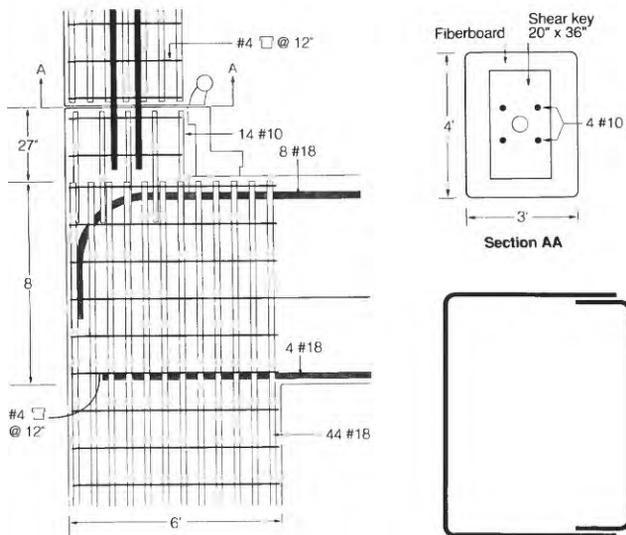
Figure 28.—Pin reinforcement details for Cypress Viaduct.

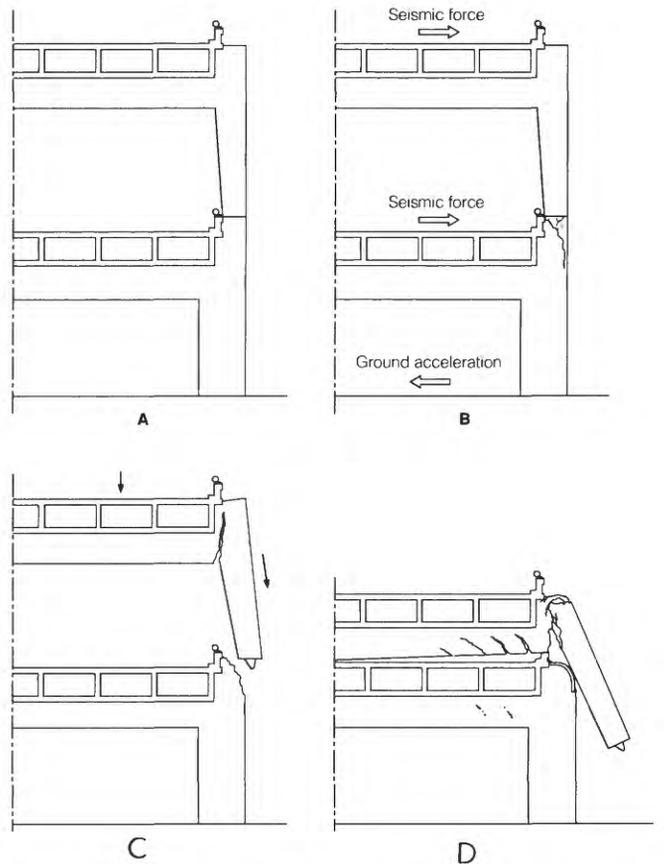
Figure 29.—Cypress Viaduct collapse sequence for bent type B1 (from Thiel, 1990).

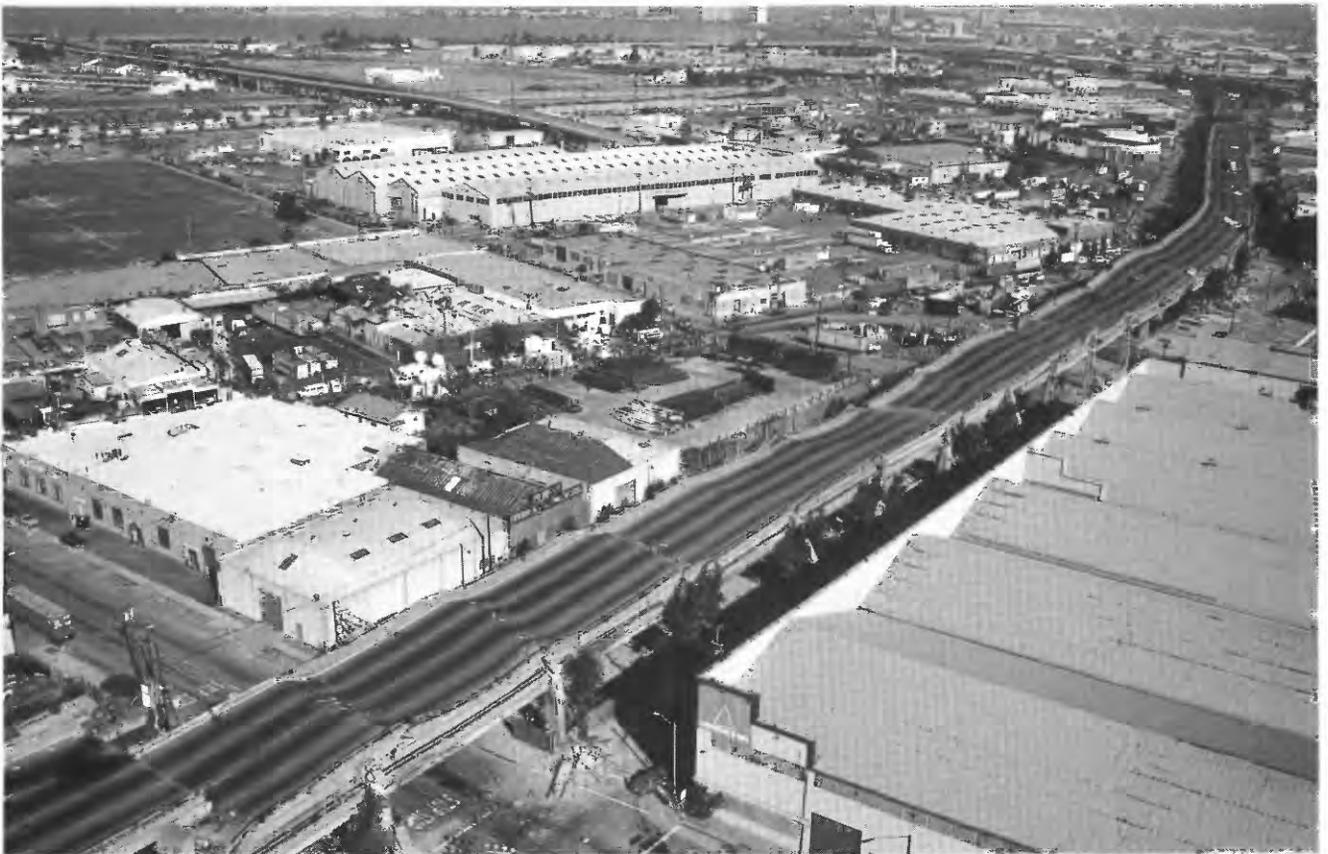
Figure 30.—Collapse of Cypress Viaduct between Bent 62 and Bent 113.

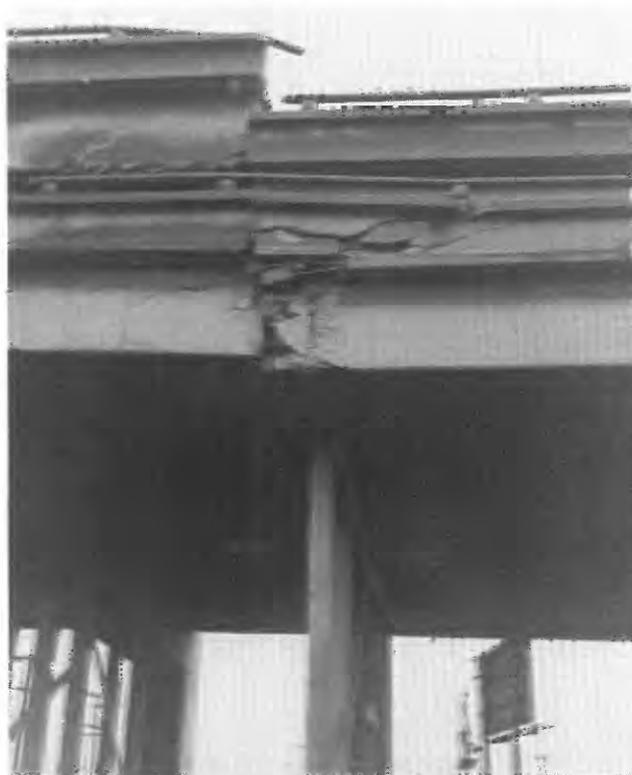
Figure 31.—Hinge damage at Cypress Viaduct.

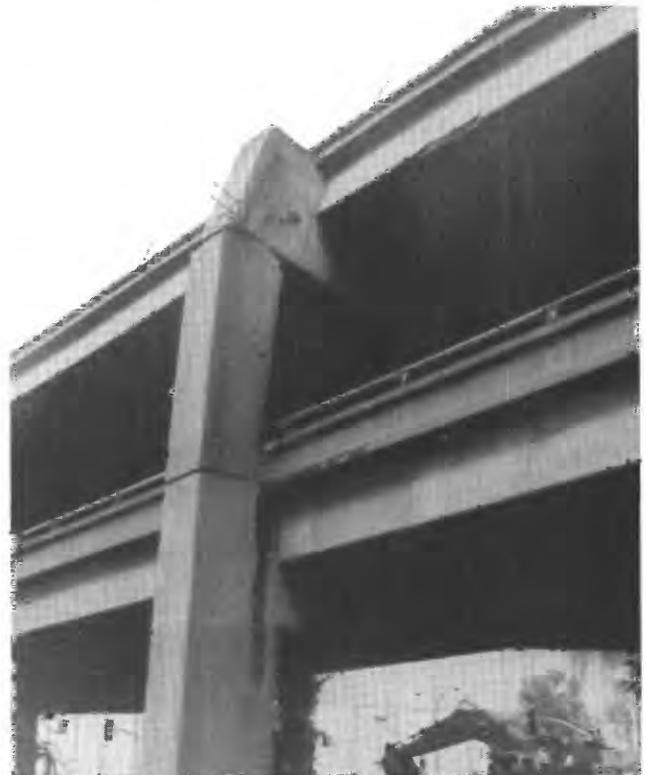
Figure 32.—Rotation at Bent 76 of Cypress Viaduct (note prestressing tendons).

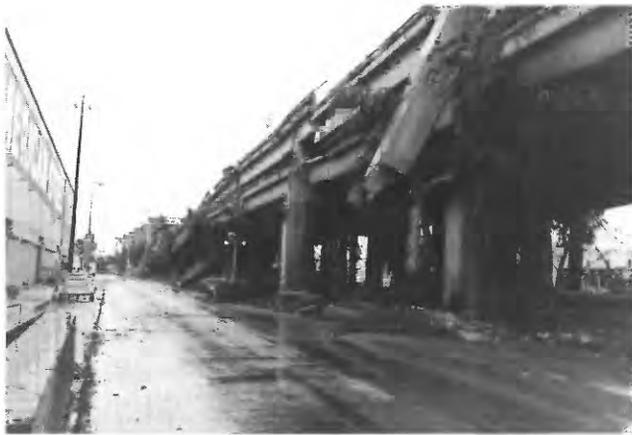
Figure 33.—Bent 70 of the Cypress Viaduct (view to south).

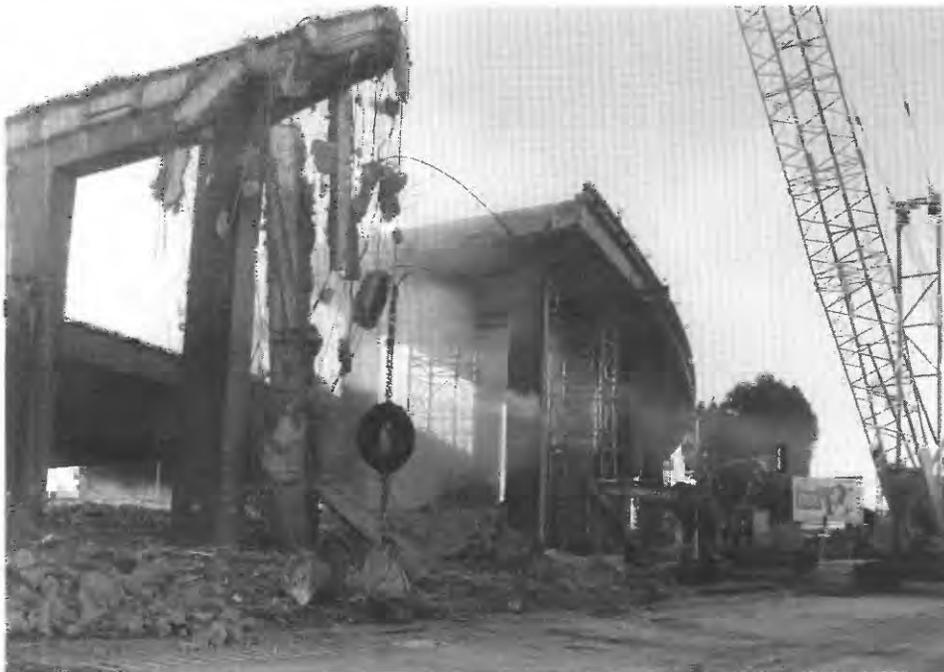
After the last human remains and vehicles were removed from the site, the task switched to the expeditious removal of the freeway (fig. 37). The biggest problem was finding a place to dispose of the debris. The city of Oakland passed an ordinance prohibiting disposal of the rubble in the city. It was hoped that the debris could be recycled and used as construction material. However, there were difficulties in removing the reinforcement from the concrete and obtaining the necessary permits; in the end, almost all the material was hauled by trucks and disposed of along the Route 580 right of way in Castro Valley.

Figure 37.—Removal of the Cypress Viaduct.

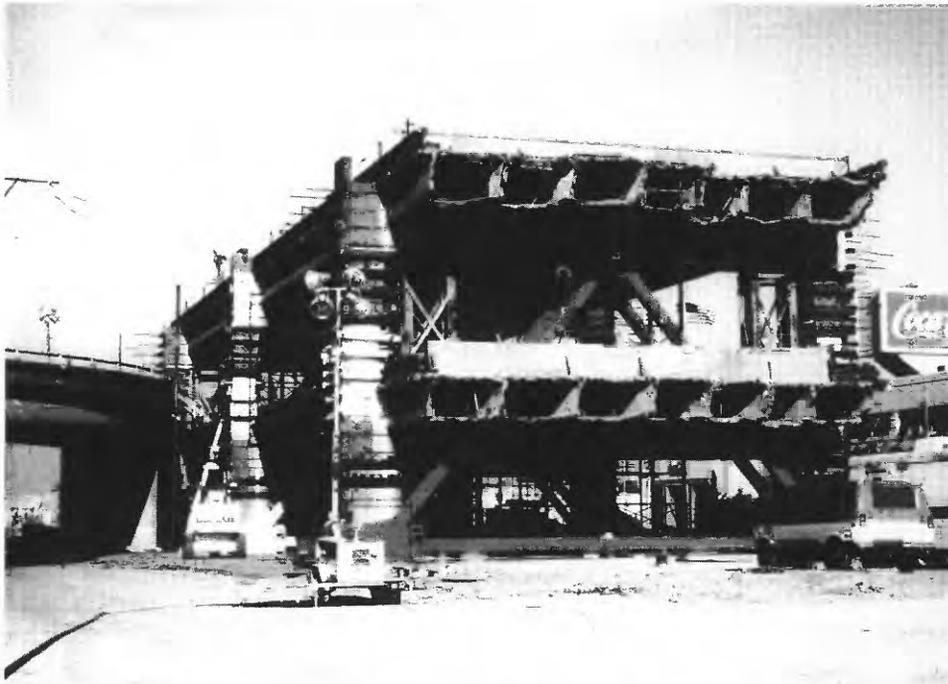
Finally, the portion of this viaduct that was still standing afforded researchers a rare opportunity to do (1) destructive testing to help understand the collapse, the behavior of pile groups to failure, and new retrofit schemes and (2) testing to compare computed deflection and damage to actual bridge behavior. These tests were carried out by the University of California at Berkeley and Caltrans' Division of Structures. Steel jacking platforms were built (fig. 38). The bents were modified with different retrofits to provide confinement to vulnerable members. Then vibration tests were done as well as transverse loading to failure. However, due to time constraints to complete the testing, most of these confinement retrofit schemes were of limited value. Of more importance was the pipe seat extender testing. High-strength pipes were inserted in hinges to pre-

Figure 38.—Retrofit strategy being tested with jacking frame on section of the Cypress Viaduct.

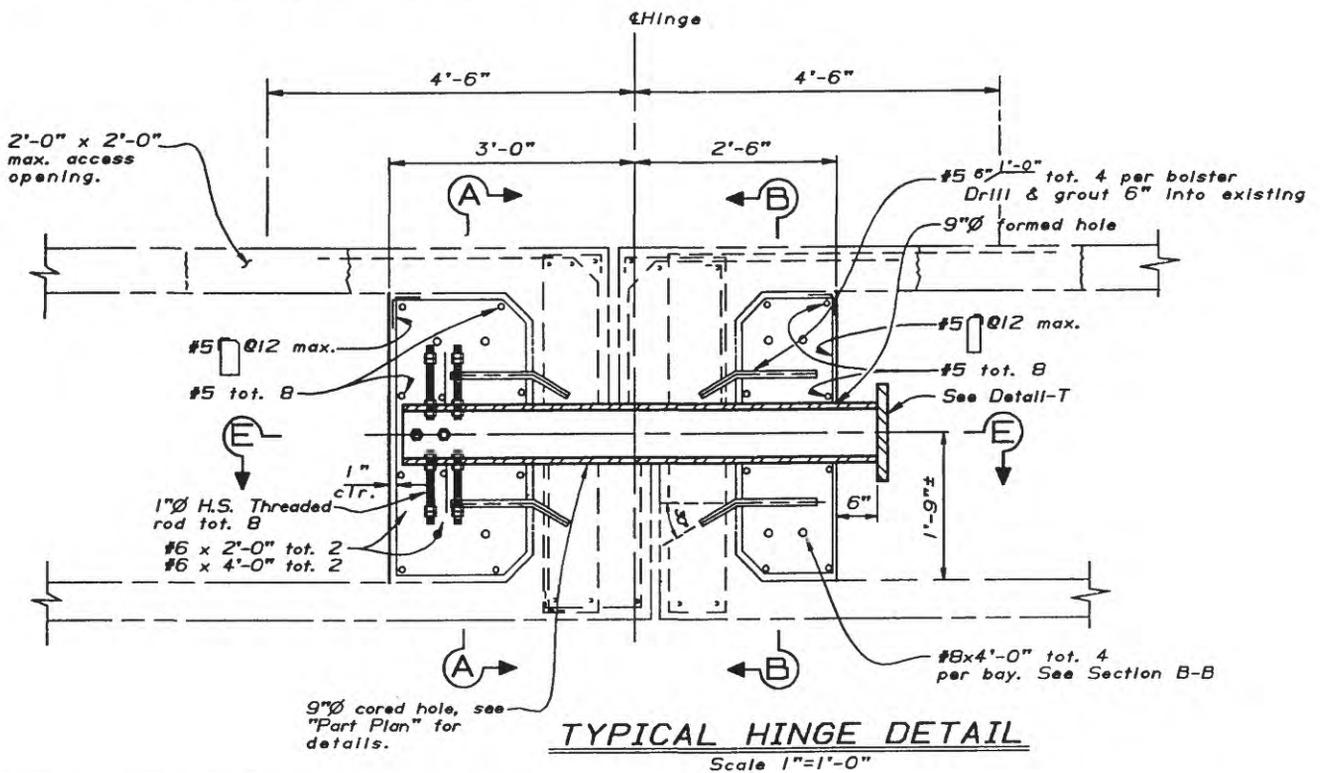
vent unseating (fig. 39). This retrofit scheme has since become very popular.

Figure 39.—Pipe seat extender test for the Cypress Viaduct

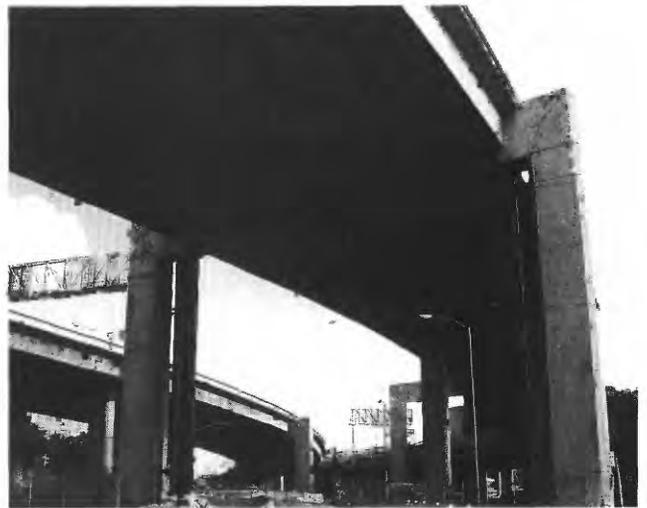
moved transversely, the main restraints were the moment-resisting cap/column joints at Bent 38. Both joints were cracked, the west joint most severely, with the cracks, more severe on the hinge side of the bent. Also, the bridge deck over the bent sustained some cracks suggesting high stresses to the extreme fibers of the bent cap in bending.

Figure 45.—Bent 38 of Route 980 Southbound Connector after the earthquake.

shifted to the east half of the roadway, and work was begun to strengthen the cap/column joints on the west side by adding reinforcement and increasing the size of the joints. After the concrete was cured, traffic was shifted to the west side, and the same procedure was done to the east side of the bridge. Then the falsework was removed, the surface streets below the connector were given minor repairs, and traffic was allowed back on the streets below the bridge. All the work was completed as of November 7, 1989. The total cost of this repair was just under \$100,000. Since the only deficiencies to this modern structure were the weak cap/column joints, this repair was considered sufficient to protect the bridge from the maximum credible earthquake.

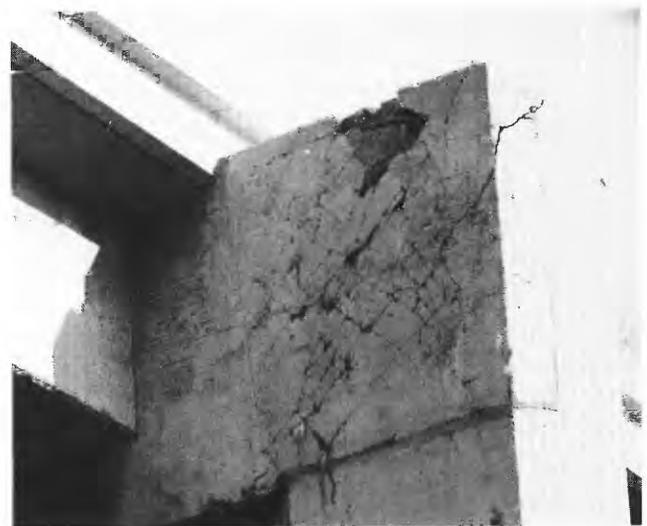
Bent 38's west outrigger knee joint was confined with W5 spiral wire which broke along with a #18 vertical reinforcing bar in the joint. Whatever moment capacity this joint had was severely reduced by cracking and spalling of the concrete after the confinement reinforcement broke. The #18 "X" reinforcement in this joint was tested in the materials lab after the quake. It was found that the broken rebar was of grade 75 steel, while the other bars were grade 60 steel. Moreover, the broken rebar had a curve radius of 11 3/8 inches, while the plans showed a bend radius of 18 inches. It is believed that the difference in grade and the sharp bend in the bar caused the failure. The difference in grade made the rebar much stronger, causing most of the load to be transferred to the stiffer bar. Other bridge damage including spalling of concrete at the wingwall and shear keys of the north abutment. There were column cracks at Bents 35 to 37 that appear to have occurred prior to but were widened by the earthquake. There was damage to the sidewalk, asphalt, and soil around the base of these columns, indicating that they experienced a lot of movement during the earthquake. The expansion joints at the abutment and hinges all showed signs of banging and large movements.

Figure 46.—Closer view of knee joint damage to Bent 38 of Route 980 Southbound Connector.

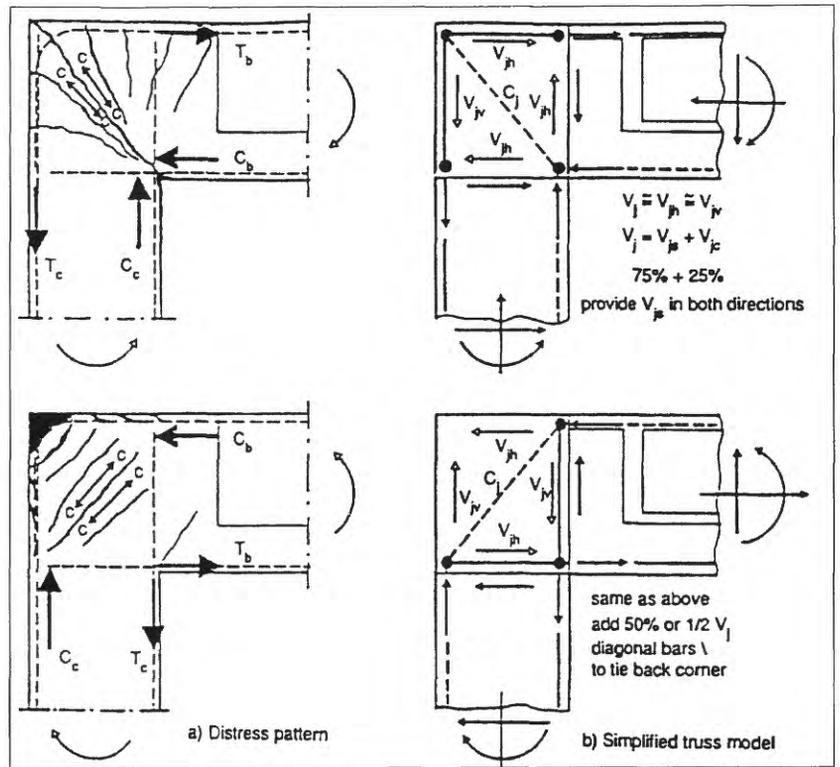
The vulnerability of knee joints from opening and closing moments had been studied before this bridge was built (Park and Paulay, 1975). Caltrans' philosophy has been to design very strong joints and bent caps that force the damage to occur in the ductile columns. This bridge had very ductile columns, but the joints were underdesigned. Joint damage to this and other bridges has resulted in a major research and testing effort at the University of California, San Diego, to come up with better joint details and a coherent philosophy for joint design.

Figure 47.—Distress pattern for closing and opening of knee joints (Seible and Priestley, 1991).

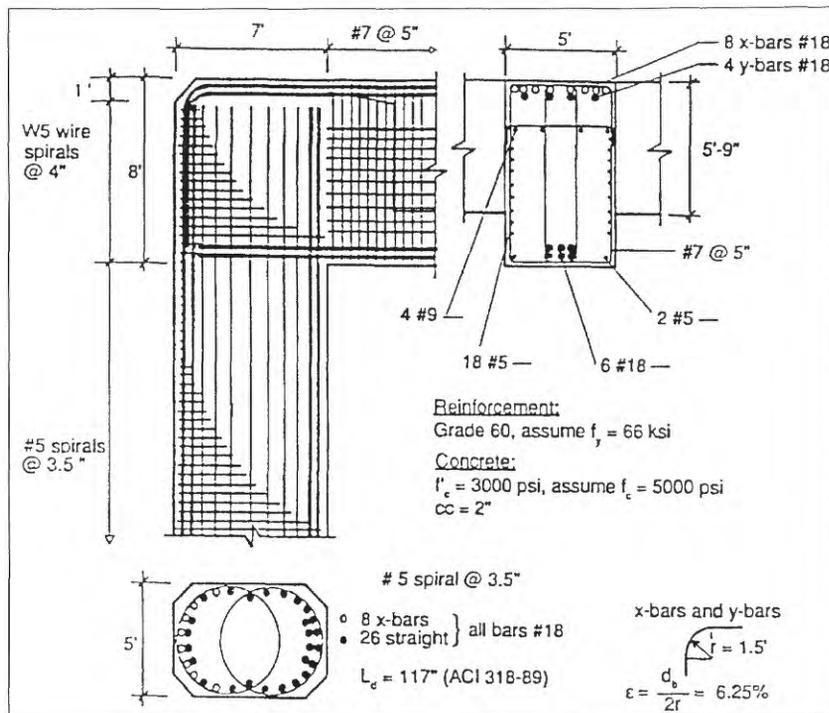
Figure 48.—Drawing of knee joint reinforcement for Bent 38 of Route 980 Southbound Connector.

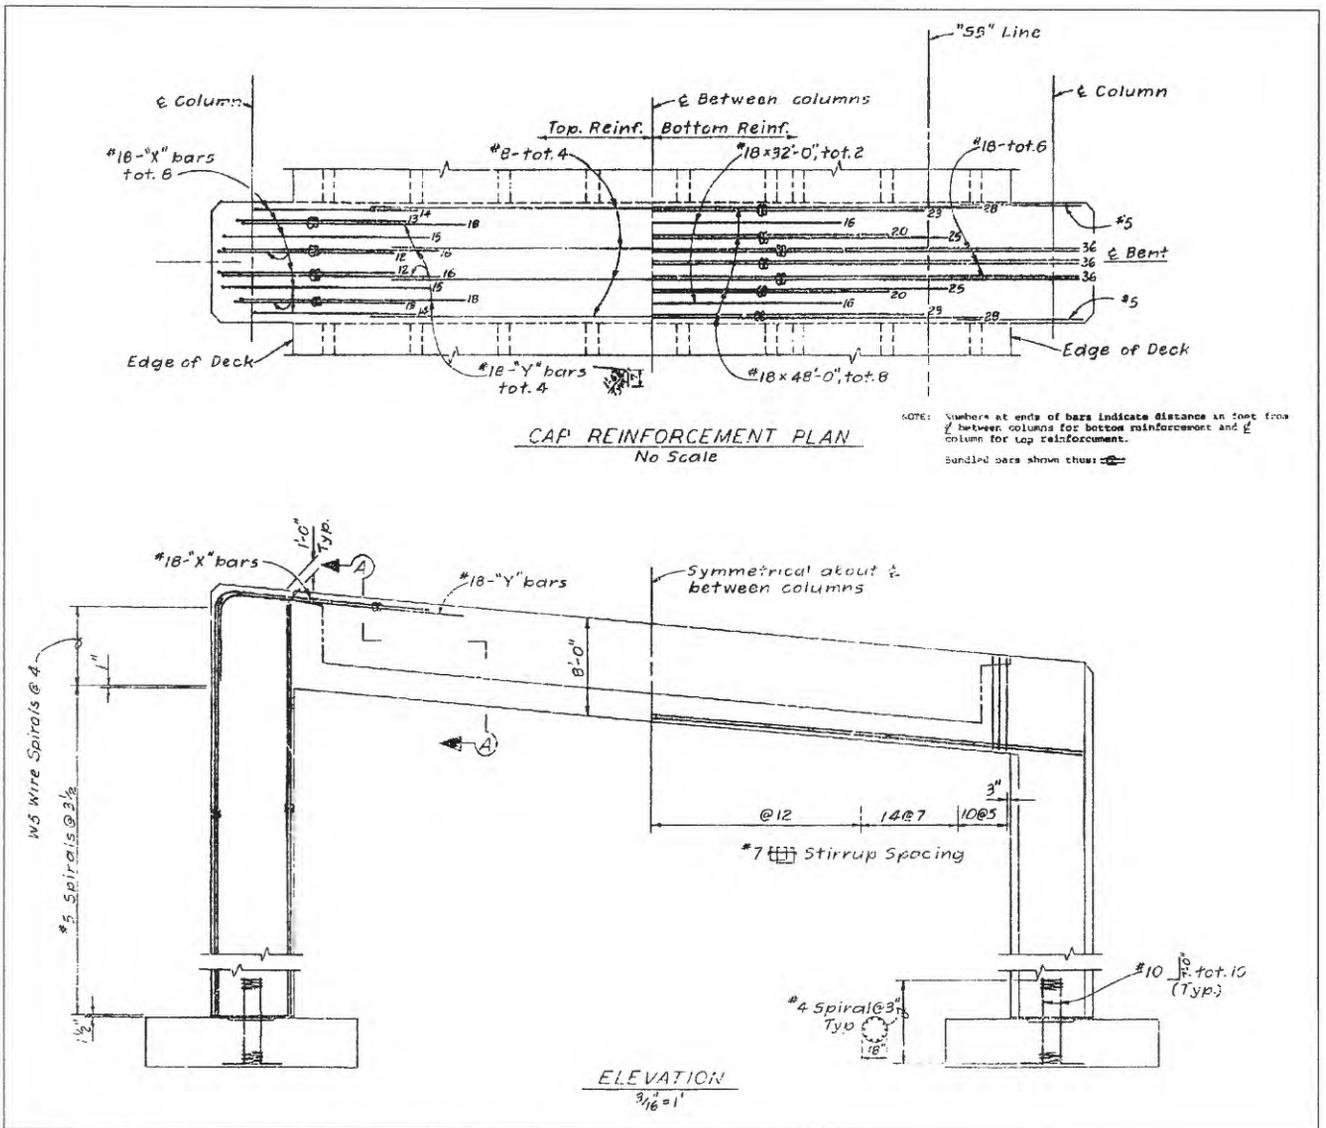
Figure 49.—Reinforcement details for Bent 38 of Route 980 Southbound Connector.

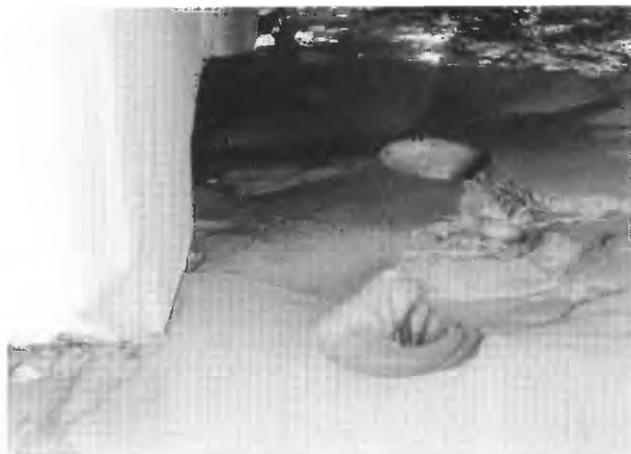
The most noticeable evidence that a strong earthquake had occurred was the quantity of ejected sand around the columns at the north end of the bridge (fig. 53). There was substantial minor damage to this bridge during the earthquake. Anchor bolts that held the bottom steel girder flange to the bent cap were broken at a few locations. Also, some anchor bolts that held the steel bent caps to the columns were damaged. Mortar pads under girders had been broken. Keeper plates that held the steel bearings in place had been knocked loose at many locations. Some girders had moved sideways up to 14 inches, buckling the crossbracing. Surprisingly, cable restrainers had yielded at several locations (fig. 54). Steel girder flanges had buckled at two locations. There was also some concrete damage. The deck overhang had spalled from banging at expansion joints. There was some shear cracking at bent caps. The most serious damage was spalling at the base of some of the reinforced concrete single column bents (fig. 55). Table 11 summarizes the visual inspection of damage for each alignment. All the evidence suggests that the bridge moved primarily in an east-west (transverse) direction during the earthquake. After the earthquake, this bridge was used to haul heavy timber for shoring at the nearby Cypress Street Viaduct. However, it was later decided to close the structure for a few days while some repairs were made.

Figure 53.—Sand boil at Bent 3 of the O line at Port of Oakland Overcrossing (view to south) (photograph by Li Hong Sheng).

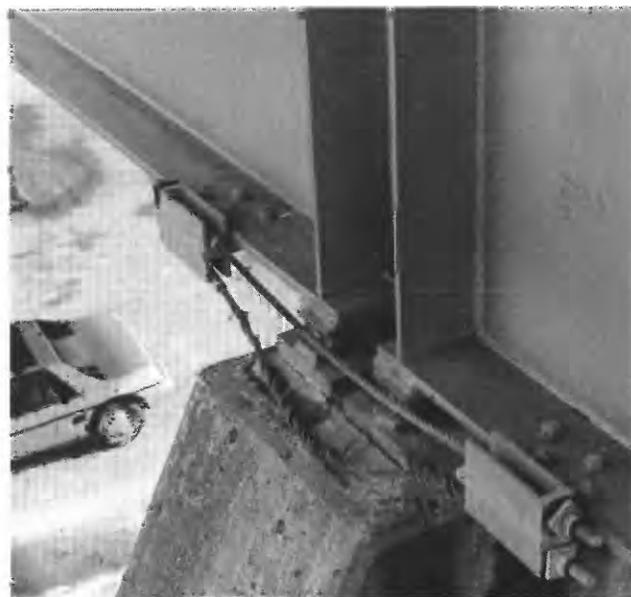
Figure 54.—Restrainer damage at Port of Oakland Overcrossing (Photograph by Philip Stolarski).

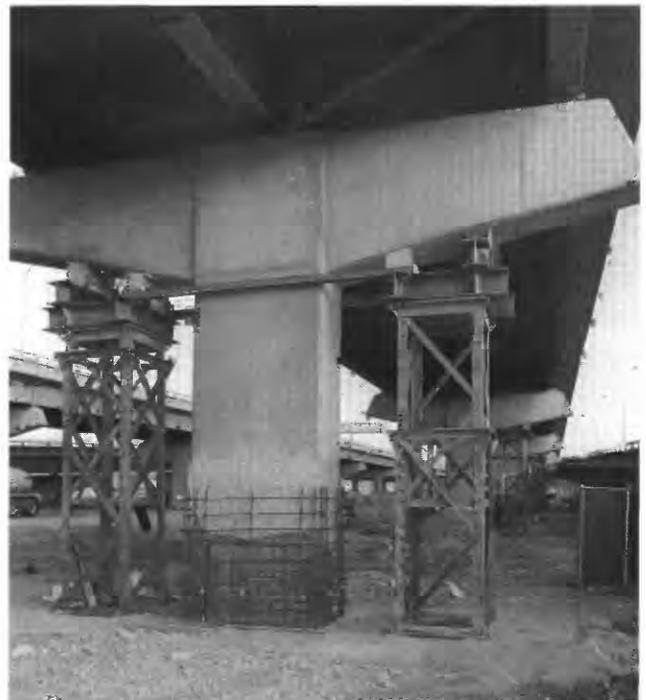
JR line	Bents JR28 to JR34 have soil cracks around footings and concrete spalls at column bottoms, indicative of flexural yielding in east-west direction.

Figure 56.—Column damage and repair at Port of Oakland Overcrossing.

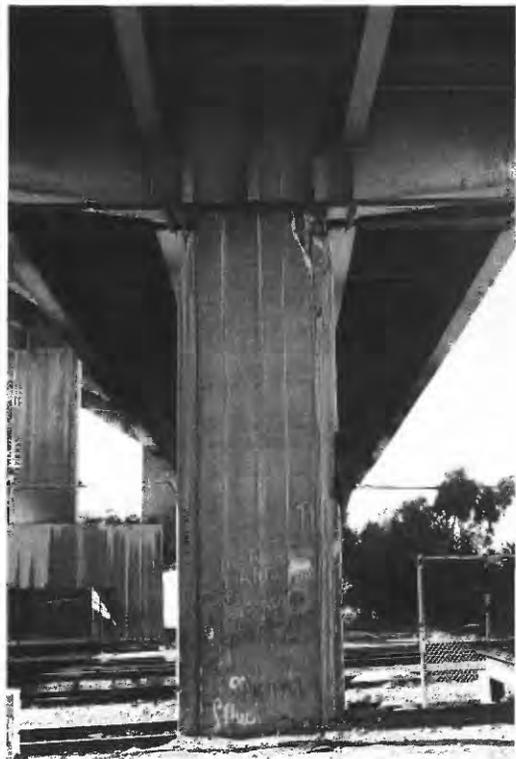
There was a great deal of minor and moderate damage to this structure. There was substantial damage to keeper plates, anchor bolts, and other steel hardware that kept the bearings in place. There was some minor cracking at the bottom of columns. Figures 61 and 62 show the results of transverse rocking of bents which caused concrete to spall and anchor bolts to deform at the column-to-steel-bent-cap connection. The MB alignment had the most damage. The backwall for Abutment MB1 was severely cracked. The most significant damage was at Bent MB25, where there were many cracks at the bottom of the column, the bearing keeper plates were knocked off, the girder ends were bent, the bent cap web had a bow, and the superstructure shifted 3 inches to the north. Figure 63 shows the keeper plate damage. Table 13 summarizes the structural damage.

Figure 61.—Spalls and anchor bolt damage at Bent BC8 of the Distribution Structure.

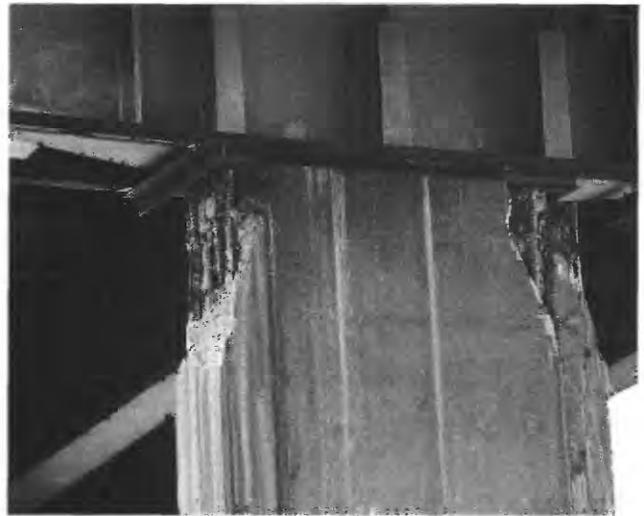
Figure 62.—Closer view of damage at top of Bent BC8 of the Distribution Structure.

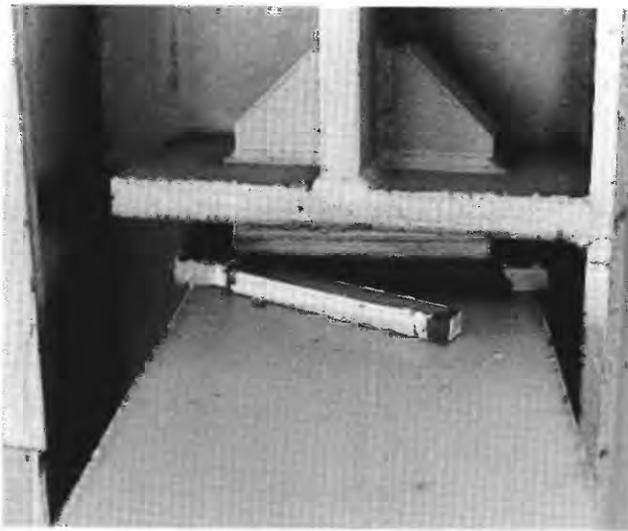
Figure 63.—Keeper Plate Damage on the Distribution Structure (photograph by Li Hong Sheng).

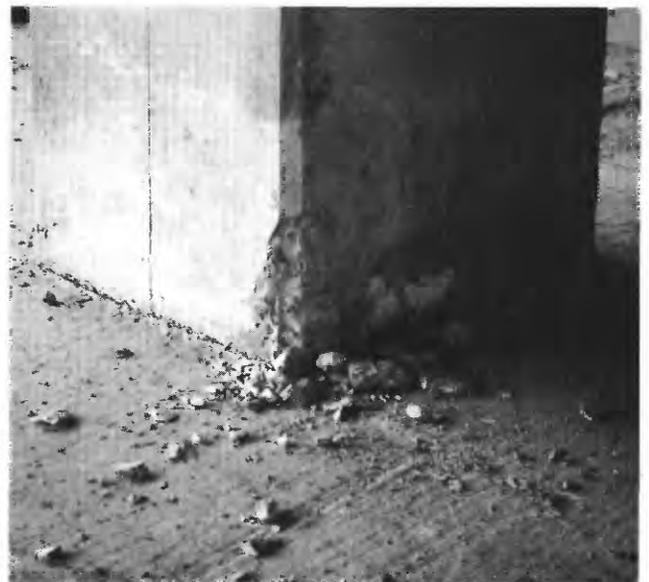
Figure 71.—Spall at column base for Bent 35 of Fifth Avenue Overhead (courtesy of Earthquake Engineering Research Institute).

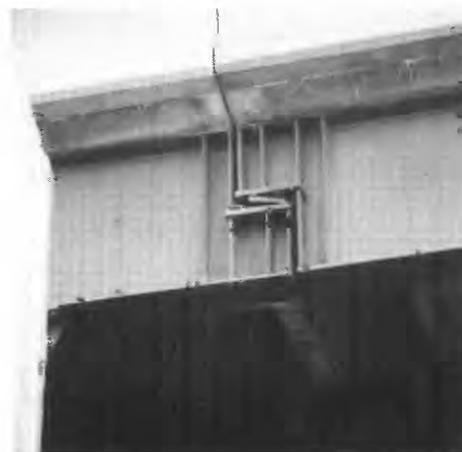
Figure 74.—Damaged hinge at Bent 36 of Fifth Avenue Overhead (courtesy of Earthquake Engineering Research Institute).

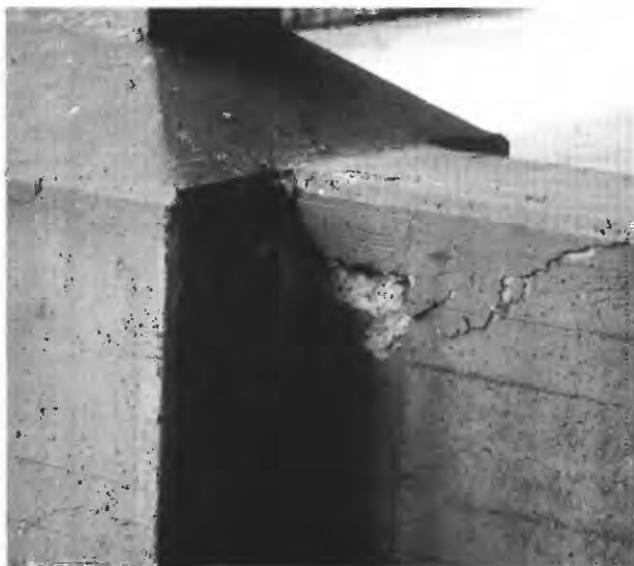
Figure 72.—Damage to railroad collision wall of Fifth Avenue Overhead (courtesy of Earthquake Engineering Research Institute).

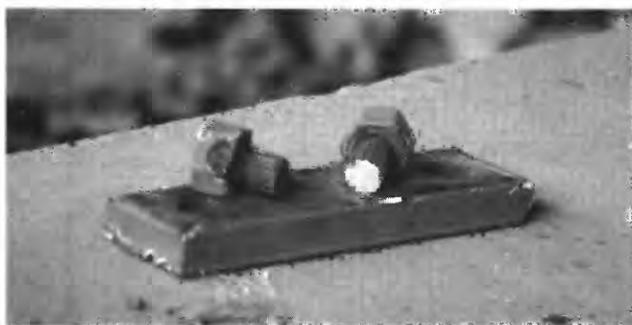
Figure 73.—Broken keeper plate at Bent 35 of Fifth Avenue Overhead (courtesy of Earthquake Engineering Research Institute).

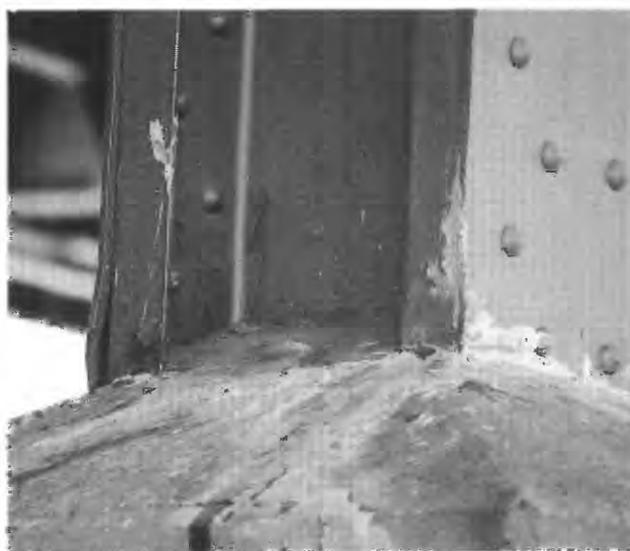
Figure 76.—Steel column damage at Fifth Avenue Overhead (courtesy of Abolhassan Astaneh-Asl).

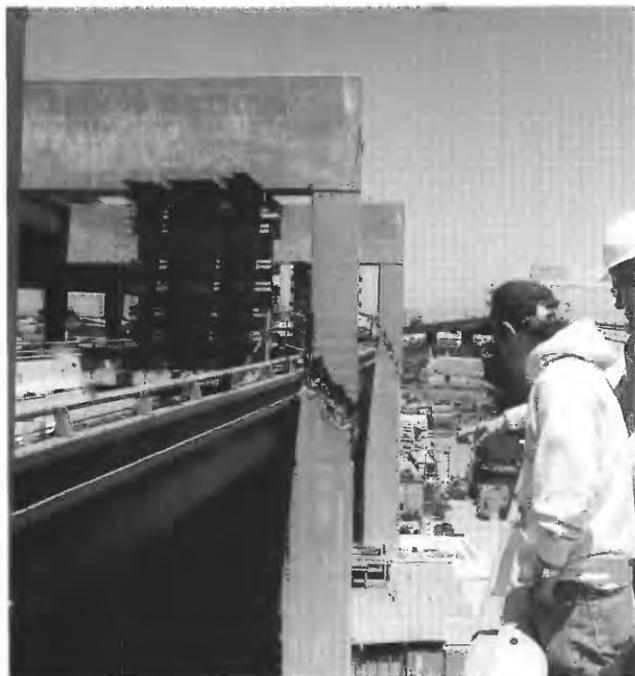
Bent 51 Right Column.—Diagonal cracks formed where the column frames into the bent caps (fig. 80, 86).

Bent 52 Right Column.—Similar to Bent 51, a shear transfer crack formed at the bottom bent cap.

Figure 80.—Damage to Bents 51 and 52 of Southern Freeway Viaduct.

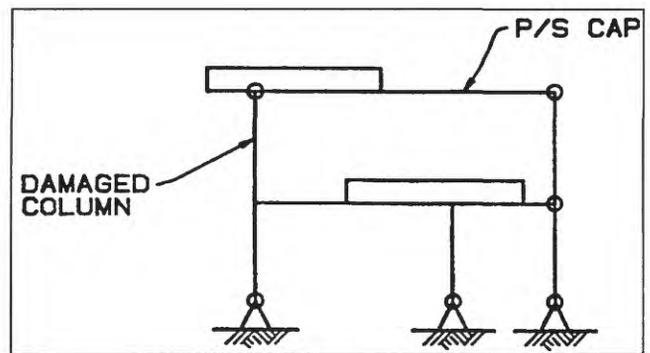
Bent 48 Left Column.—A large crack occurred all the way though the top of the left column (fig. 83). The top of the column is not monolithic with the outrigger bent cap. This pin connection clearly began to fail due to movement of the top deck. The framing diagram (fig. 84, 85) shows how the left column must carry the upper deck transversely.

Figure 84.—Section drawing of Bent 48 at Southern Freeway Viaduct.

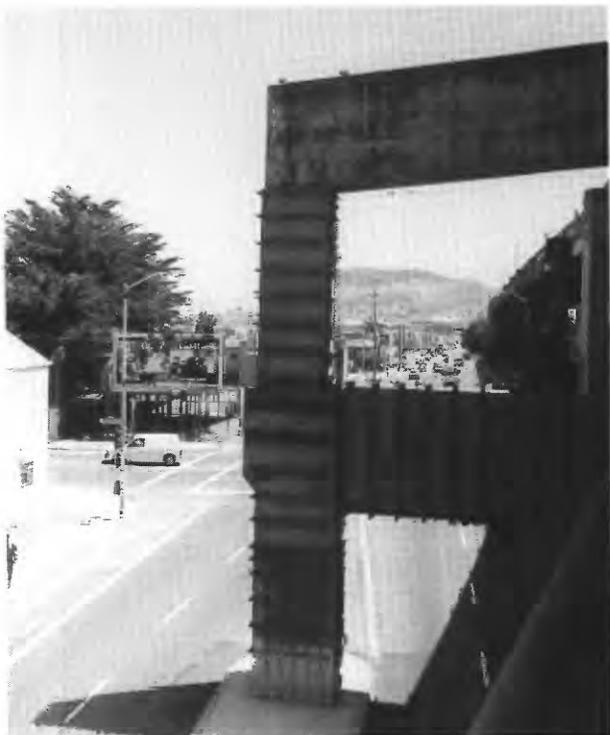
After the earthquake, temporary supports were placed at the damaged bents. Then a temporary retrofit was completed on vulnerable columns (fig. 87). However, it was rejected by the Peer Review Panel as not providing sufficient ductility, especially at the column to cap connections (the Governor's Board of Inquiry recommended that major bridge projects should be peer reviewed). The eventual retrofit (fig. 88) includes edge beams to pick up flexural moments that otherwise would be carried as torsion in the bottom bent cap, oversized joints for shear transfer, prestressed top bent caps on pinned connections, and new, very ductile columns and footings.

Figure 87.—Retrofit of the Southern Freeway Viaduct later rejected by the Peer Review Panel.

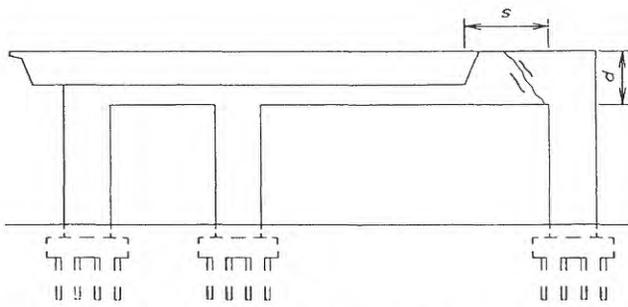
Bent A-32.—This bent is similar to A-31 except that the right column here supports an outrigger bent cap. The outrigger cap had significant diagonal cracks that extended

from the column up to bridge deck, possibly due to longitudinal movement of the superstructure (fig. 94).

Figure 94.—Damage to Bent A-32 of China Basin Viaduct.

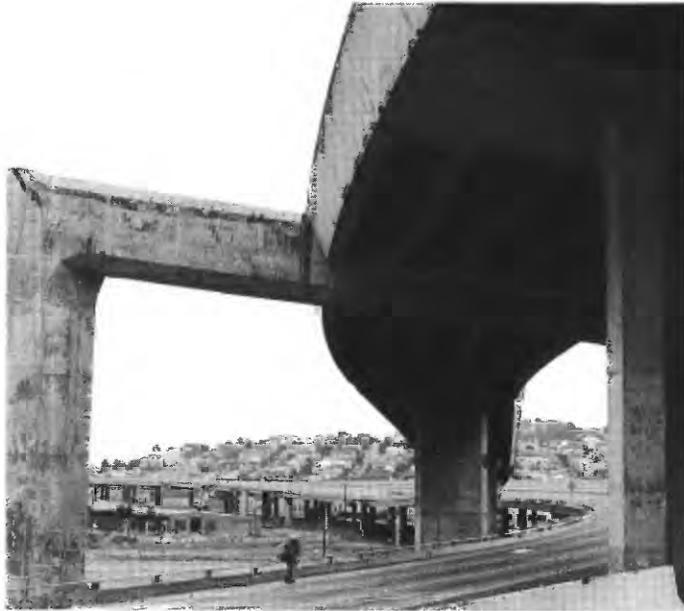
Bent N-35.—This outrigger bent had significant diagonal cracks where the columns frame into the cap and where the cap frames into the superstructure. It is reported that the cracks from the superstructure to the cap had existed since construction but may have worsened due to the earthquake. The cracks around the columns were the result of transverse movement during the earthquake. There were 2 inches of longitudinal movement to the hinge just north of this bent. Also one could see the outline of the column footings in the soil and pavement around these columns (fig. 95).

Figure 95.—Damage to knee joints at Bent N1-35 of China Basin Viaduct.

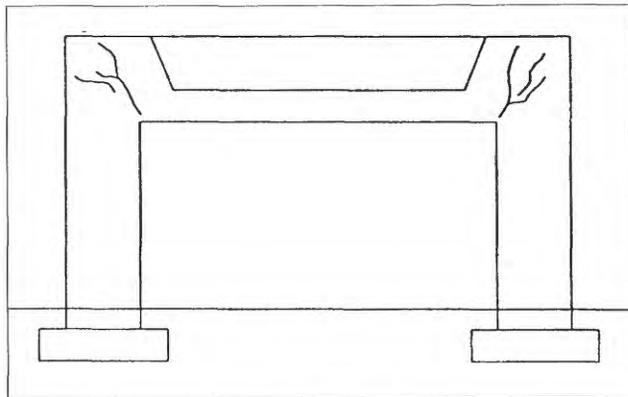
Bent S2-41.—This bent has a shorter outrigger cap with two fixed columns and precast I-girders framed to the cap. Again, there was cracking that began where the bottom of the cap joined the column and extended to the bottom of the exterior girder (fig. 96).

Figure 96.—Damage at Bent S2-41 of China Basin Viaduct.

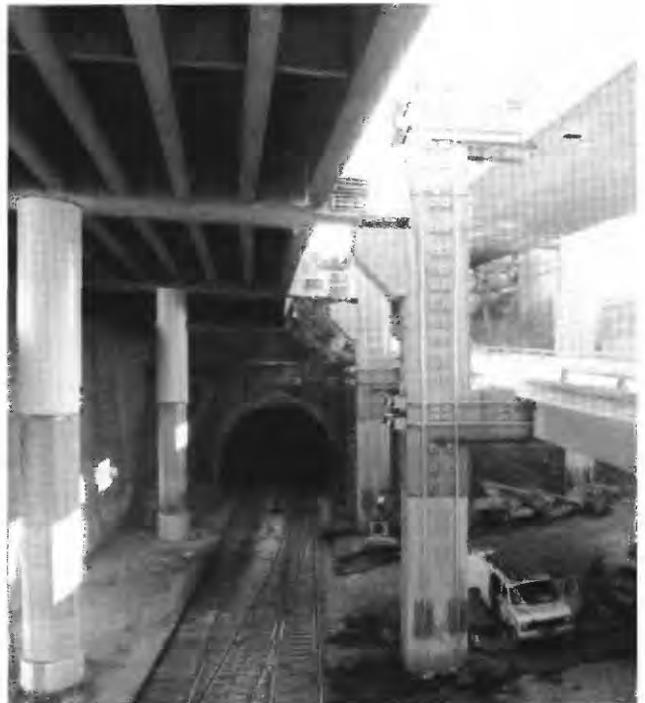
Figure 98.—Similar to the retrofit that was done to Southern Freeway Viaduct immediately after the earthquake, this retrofit to China Basin Viaduct was also rejected because it could not provide a high enough level of serviceability after the maximum credible earthquake.
