The Loma Prieta, California, Earthquake of October 17, 1989— Highway Systems

Professional Paper 1552-B

This paper summarizes the impact of the Loma Prieta earthquake on highway systems. City streets, urban freeways, county roads, state routes, and the national highway system were all affected. There was damage to bridges, roads, tunnels, and other highway structures. The most serious damage occurred in the cities of San Francisco and Oakland, 60 miles from the fault rupture. The cost to repair and replace highways damaged by this earthquake was \$2 billion. About half of this cost was to replace the Cypress Viaduct, a long, elevated double-deck expressway that had a devastating collapse which resulted in 42 deaths and 108 injuries.

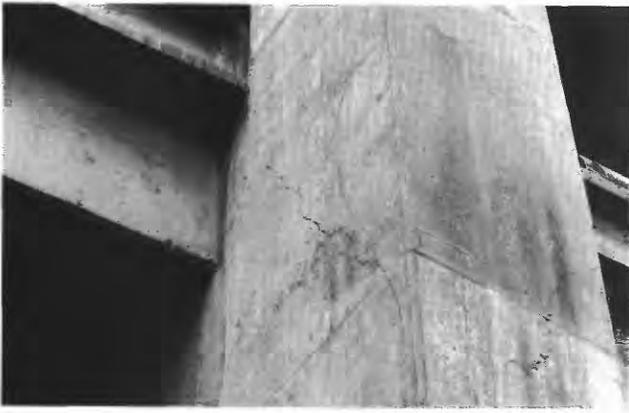
Figure 114.—Column damage to west side of Bent 75 at Embarcadero Viaduct.

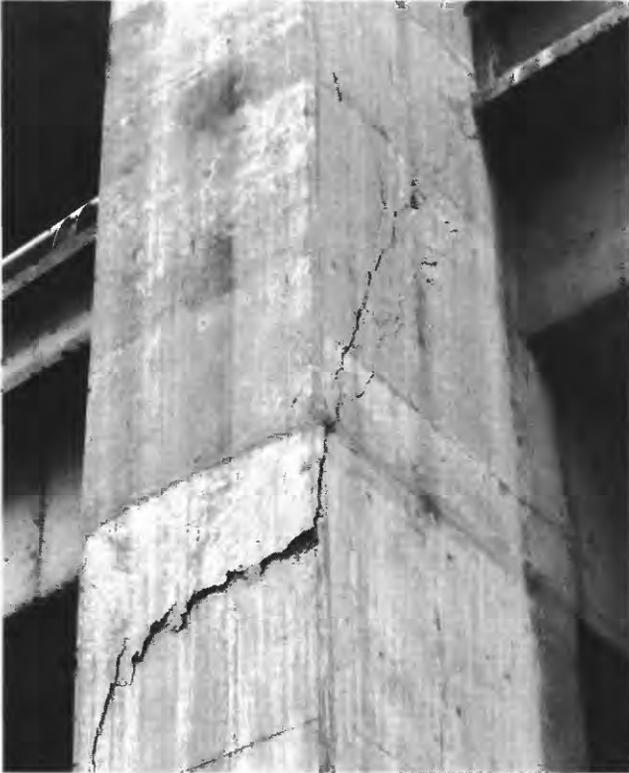
Figure 115.—Column damage to west side of Bent 76 at Embarcadero Viaduct.

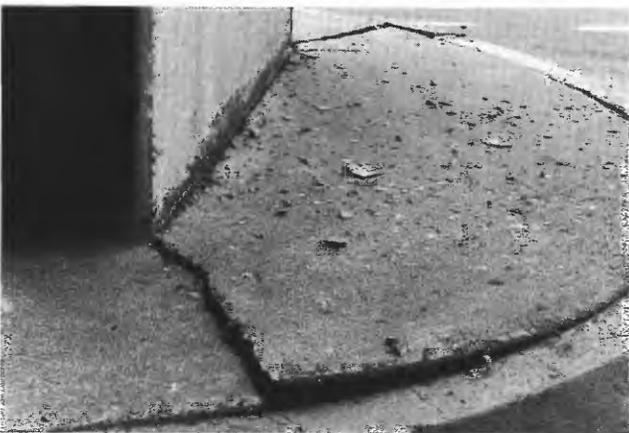
Figure 116.—Damage to sidewalk under Bent 77 of Embarcadero Viaduct.

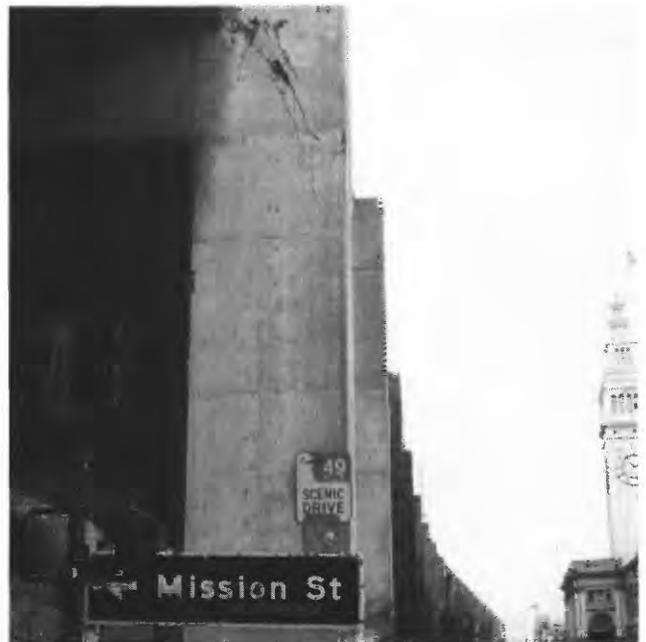
Figure 118.—Column damage on east side of Bent 79 at Embarcadero Viaduct.

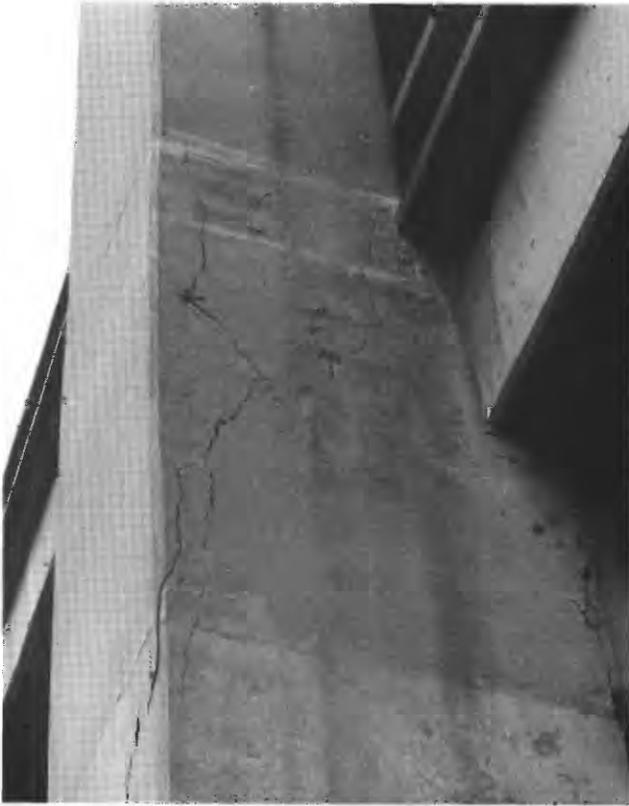
Figure 119.—Column damage to west side of Bent 79 at Embarcadero Viaduct.

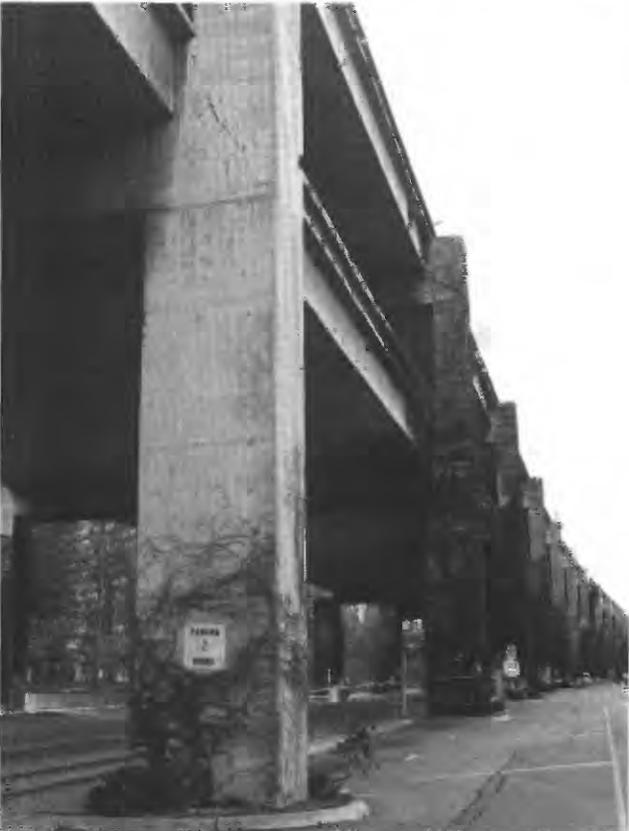
Figure 120.—Damage to west side of Bent 80 at Embarcadero Viaduct.

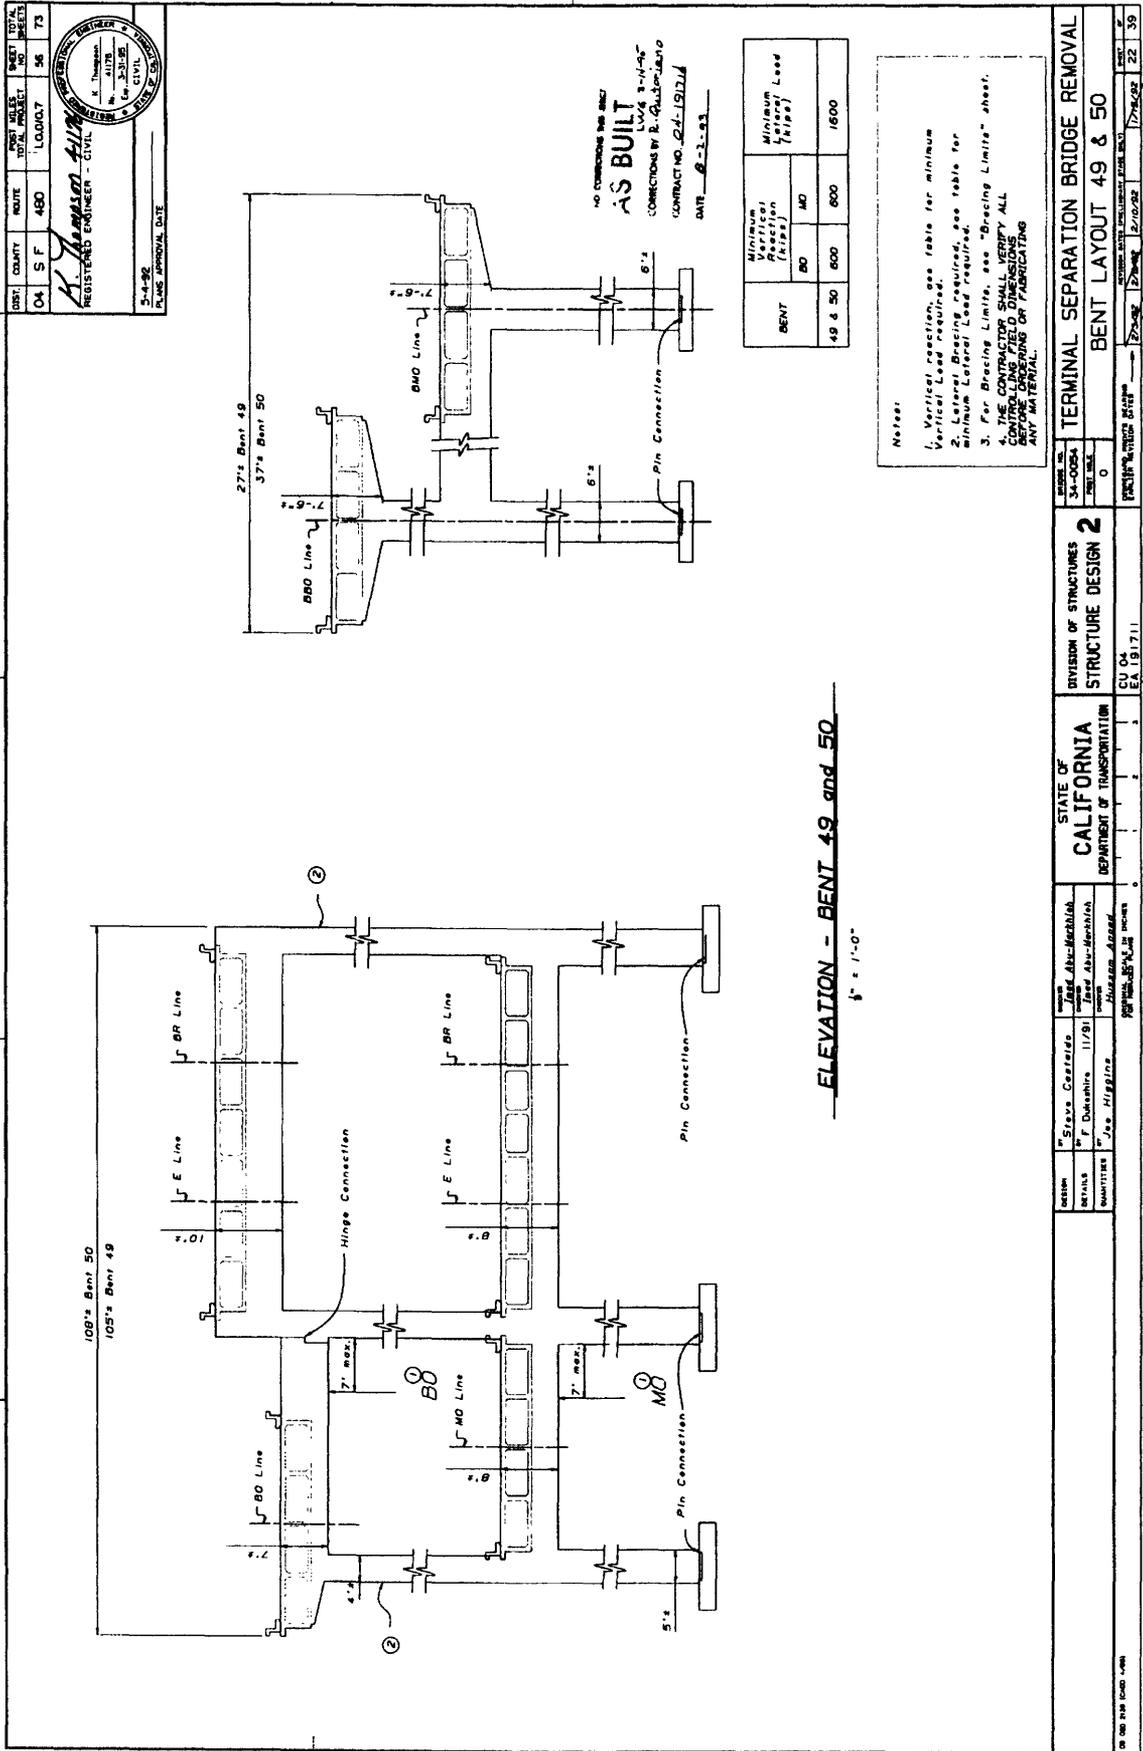
Figure 129.—Elevation drawing of Bent 49 and 50 at Terminal Separation.

Bent 49.—No earthquake damage (fig. 129).

Bent 50.—No earthquake damage (fig. 129).

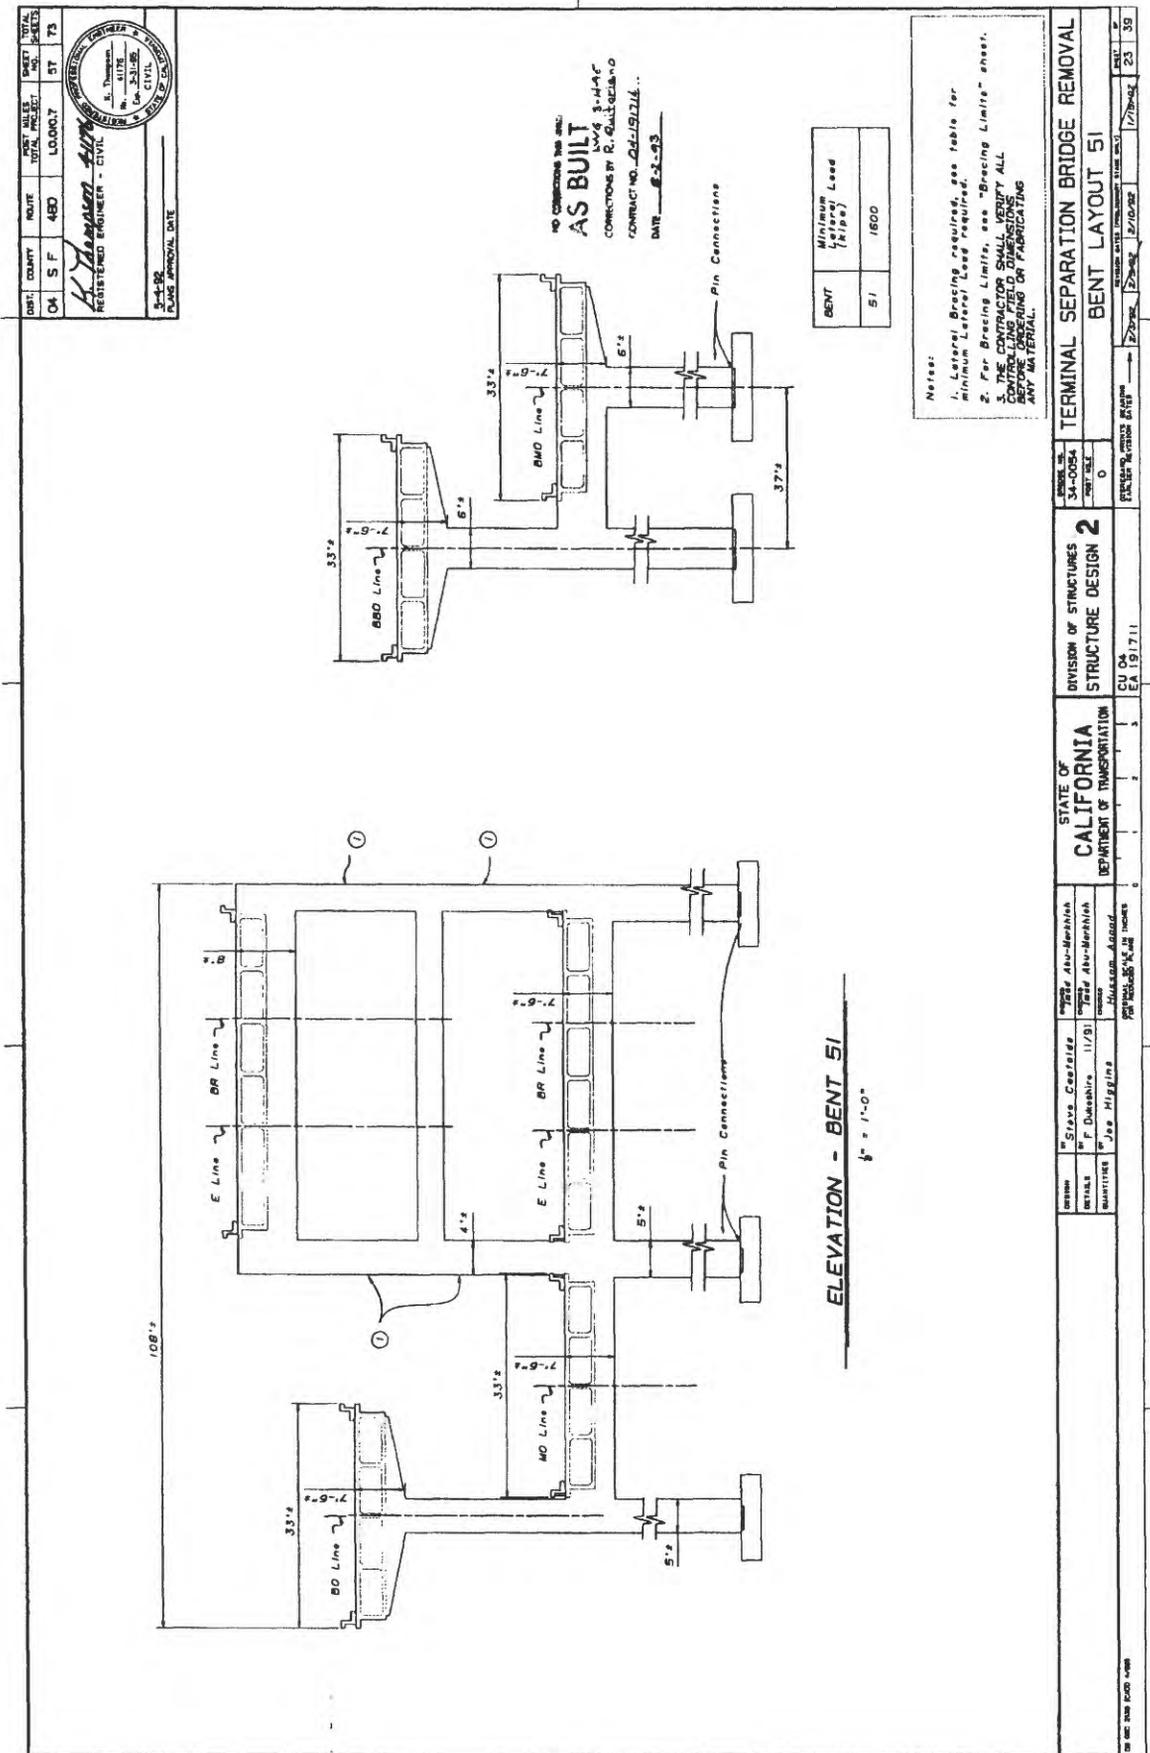
Figure 130.—Elevation drawing of Bent 51 at Terminal Separation.

Bent 51.—The bent cap at Column 1 was vertically cracked at the column face, with exposed rebar (fig. 130). Total estimated cost of repair for this bent was estimated as \$50,000.

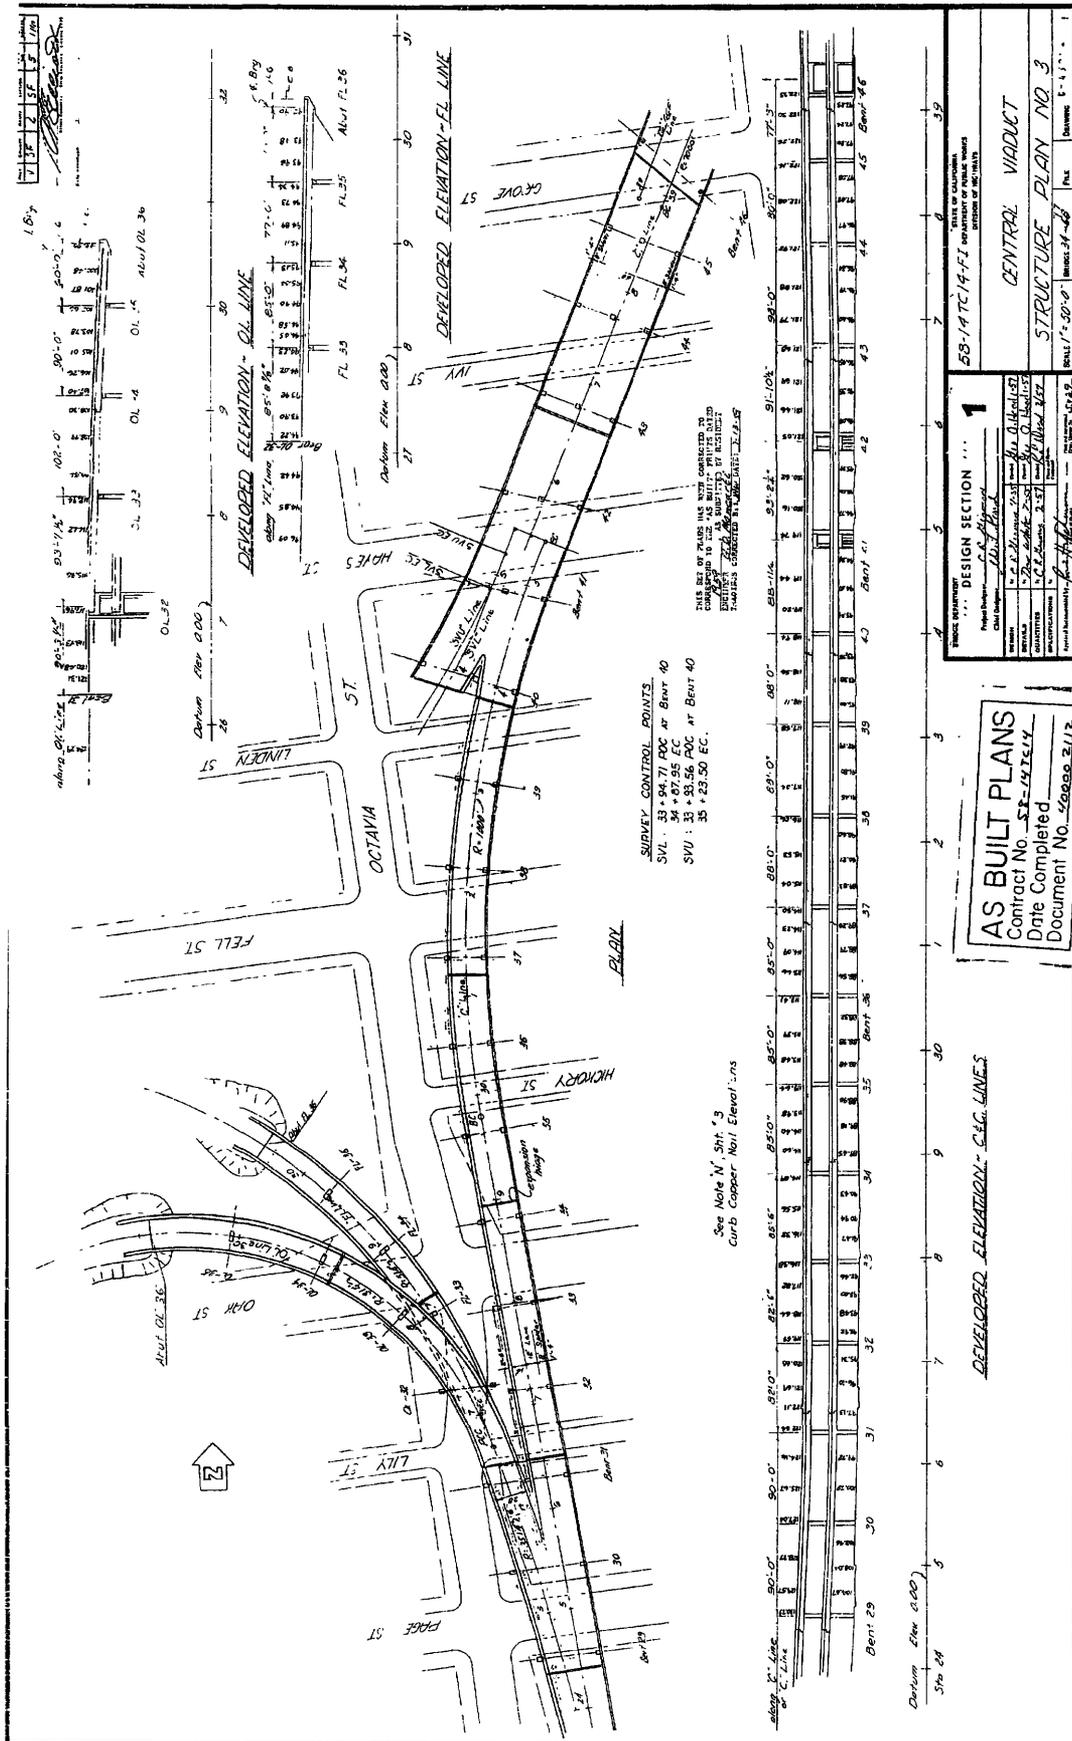
Figure 137.—Structural Plan drawing of damaged area at Central Freeway Viaduct.

Figures 137 and 138 show plan views of portions of this structure that sustained damage during the earthquake. Figure 142 (Thiel, 1990) is a schematic diagram of the bents that sustained damage to this structure. The bridge was inspected by Structures Maintenance on October 26, 1989, with the following findings:

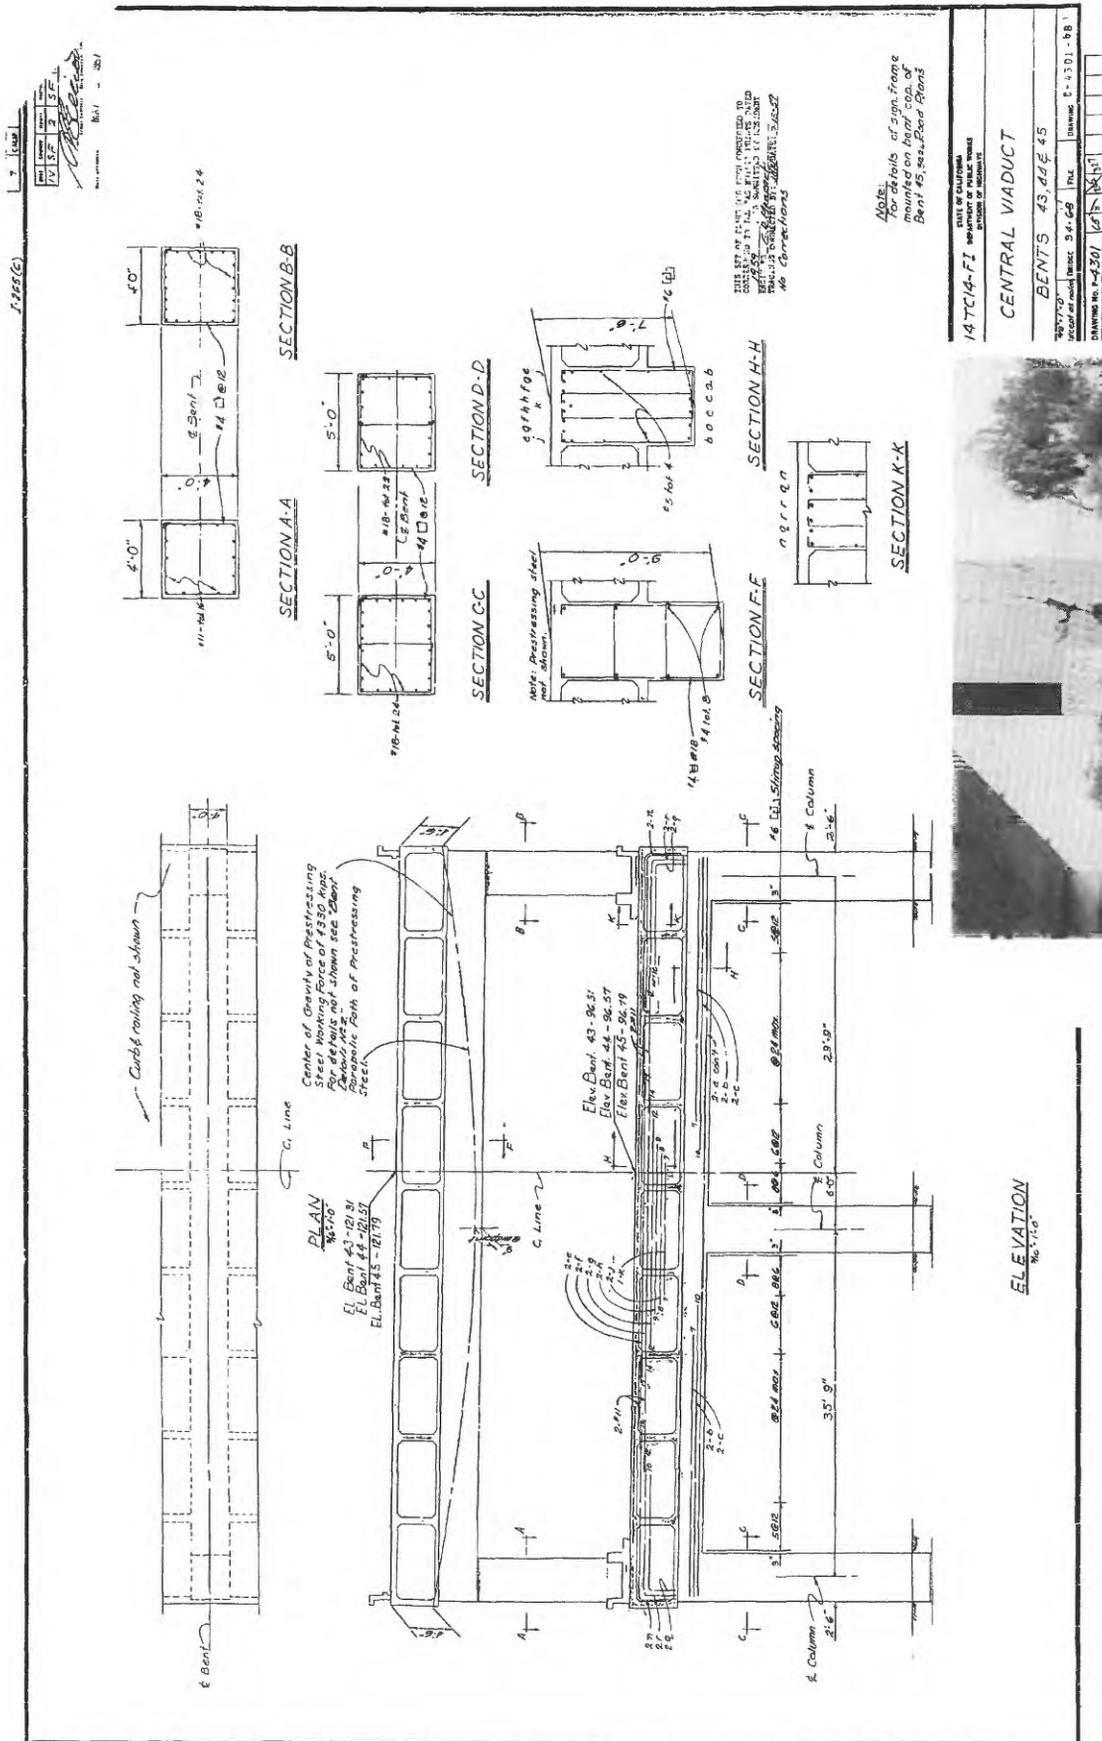
Figure 139.—Elevation drawing of Bent 43 at Central Freeway Viaduct.

Bents 42, 43, 44, 45, 46, and 48.—Column 2 (and Column 3 for three column bents) had a similar cracking pattern, which consisted of mostly heavy and medium cracks proceeding through the center (of the sides of the columns facing up and down station) and terminating at the opposite sides of each column after following on approximately diagonal path. These cracks, starting at the base on the lower deck, proceeded up from 10 to 14 feet toward the upper deck. They appeared to be of a compression failure nature. In Column 2 of Bent 43 and in Column 3 of Bent 48, this cracking was advanced enough to form an "X" pattern and to induce significant spalling and incipient spalling at Bent 43 with exposure of main and tie rein-

forcement (figs 139 to 141). In all cases the cracks appeared to extend through the entire column cross section. At street level, Column 3 of Bent 48 and Column 2 of Bent 49 had the same damage as mentioned above, indicating it was distressed and only partially functional. Figure 142 shows all the significant damage that occurred at Central Viaduct during the earthquake.

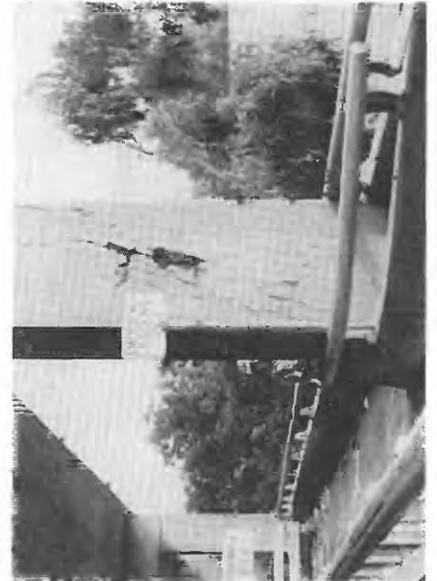
Figure 140.—Damage to Column 2 of Bent 43 at Central Freeway Viaduct (photograph by Mike Van de Pol).

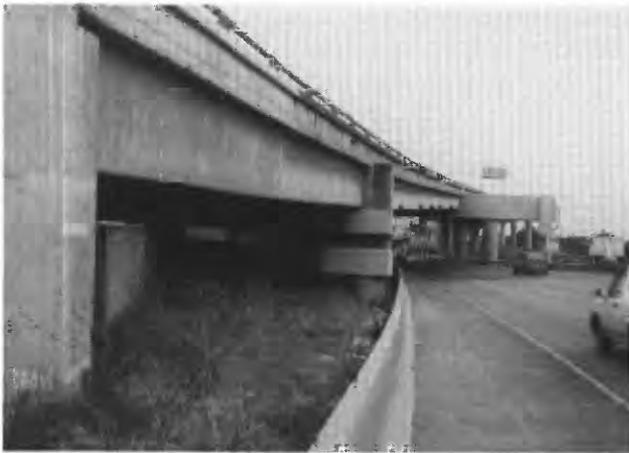
Figure 145.—Completed retrofit for Alemany Interchange.

This viaduct also had a proposed retrofit that was rejected by the Peer Review Panel. However, a very innovative retrofit was done in 1992. This structure, like so many bridges, begins on very short bents and gradually ascends on very tall columns. To prevent substructure damage on the short, stiff bents and to prevent superstructure damage on the tall, strong bents, isolators were installed to give the substructure a uniform response along its entire length and to prevent large plastic moments from forming on the tall columns (fig. 145).

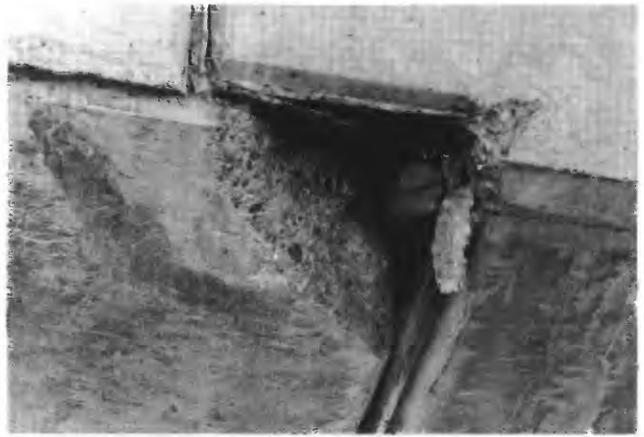
The hinge at the center frame suffered serious damage due to relative movement between the three frames during the earthquake (fig. 155). The elastomeric bearing pads did not delaminate, but certain layers were compressed and worn down. Inspection of the joints showed that the suspended side of the Span 19 hinge was 1.5 inches lower than the support side. On October 25, 1989, work began to replace the elastomeric pads at Span 19. The superstructure was jacked up, new elastomeric pads and restrainers were placed in the hinge, and the bridge was reopened to traffic on November 2, 1989. The Span 16

Figure 155.—Spall at Northwest Connector of Route 92/101 Interchange.

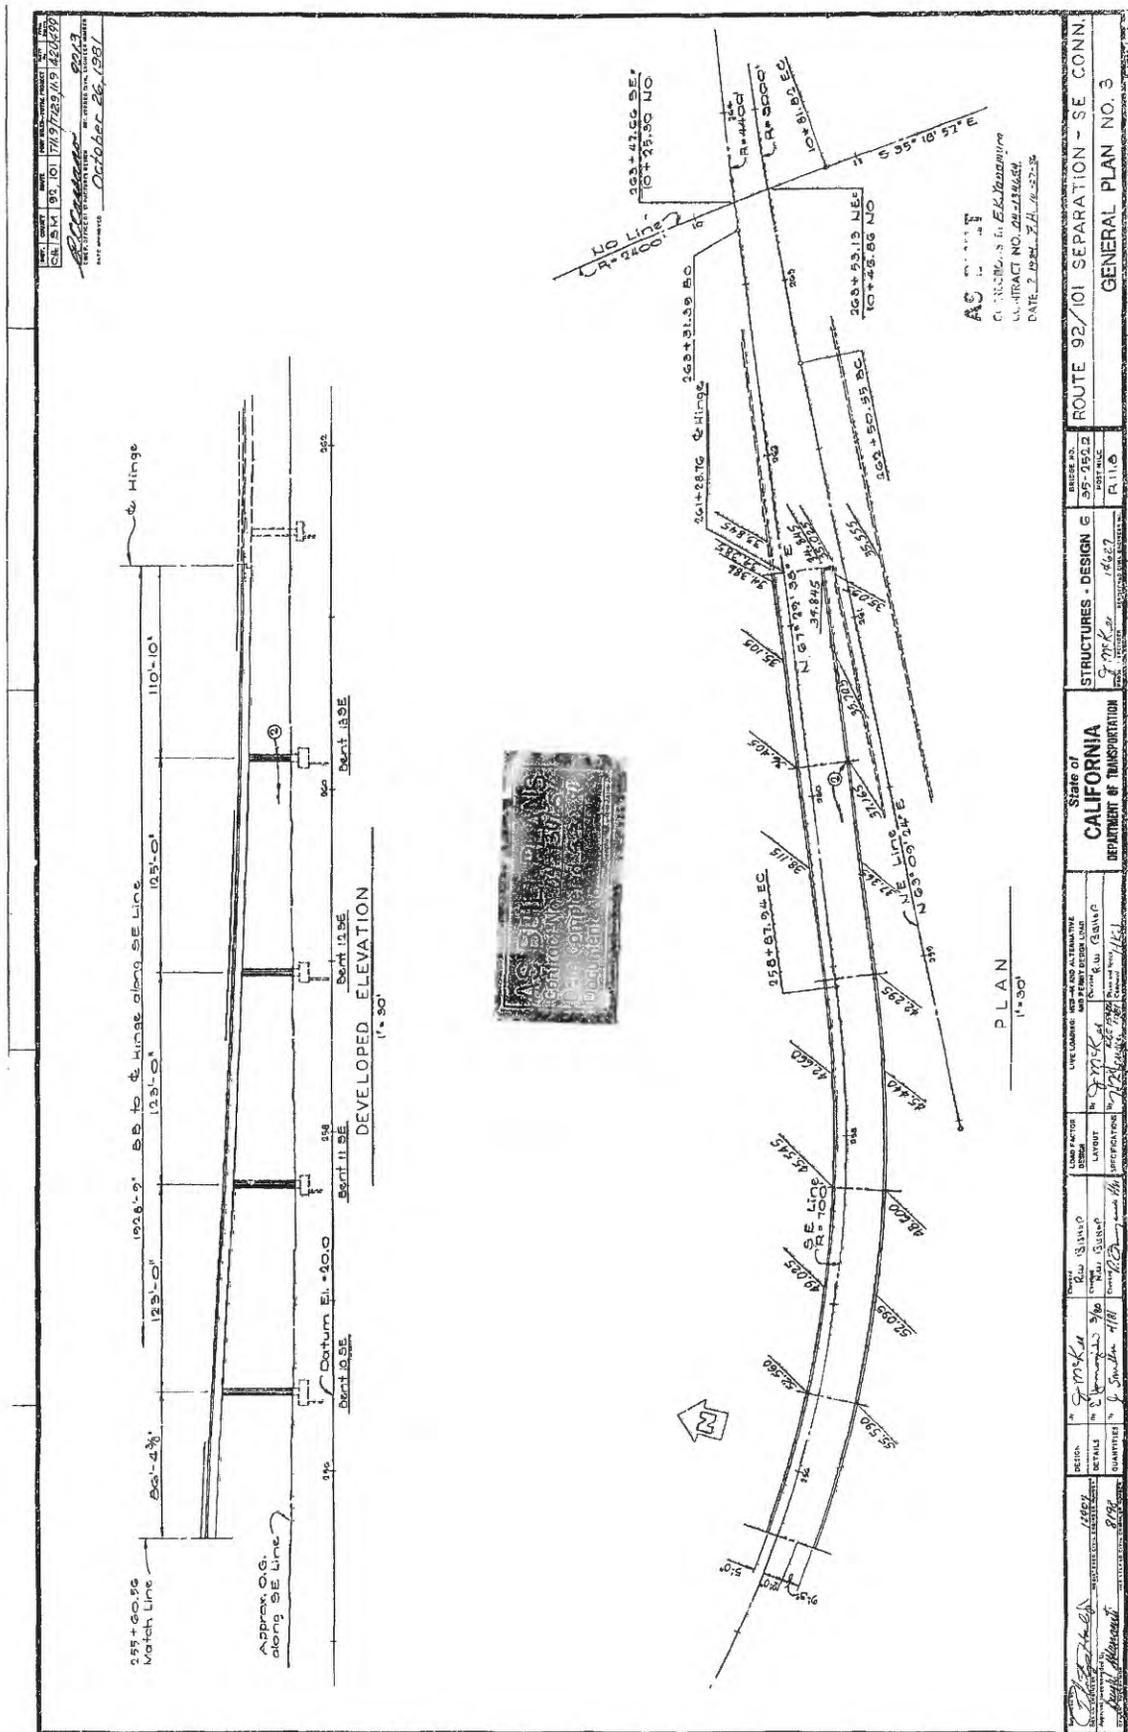
Figure 156.—General Plan drawing for the eastern portion (including Bents 12SE and 13SE) of Southeast Connector of Route 92/101 Interchange.

Figure 156 shows the geometry of the eastern portion of the Southeast Connector. At the 2-year inspection of this interchange (on February 1, 1990), two spalls were noticed at the column of Bent 12SE. The spall in the south side of the column is just above the collar around the base of the column. This spall is oblong in shape, measuring about 2 feet vertically, and about 1 foot horizontally. It is very shallow, only in the surface of the column concrete. The other spall is very small, located on the opposite side of the column, also at the base of the column, just above the collar.

Because the column of Bent 12SE was spalled near the bottom of the column, it was decided to investigate the condition of the footing block concrete and the supporting piling. It was decided also to investigate the condition of the footing of Bent 13SE as well, although there were no spalls at that column.

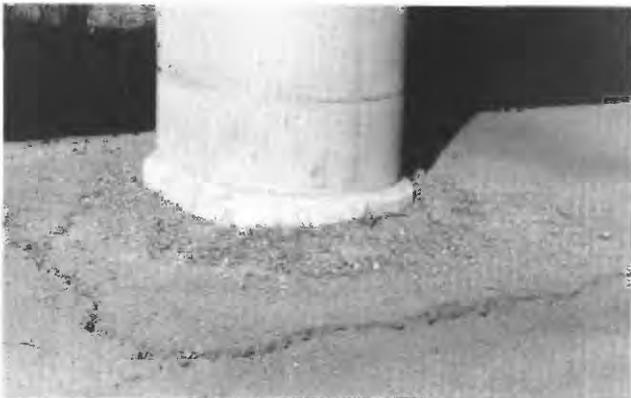
The soil around the base of most of the columns of this structure in the vicinity of Bent 12SE and 13SE had consolidated because of the October earthquake. There is a small crack in the soil around these single column bents, outlining the shape of the footing (fig. 157). The consolidation is not severe, only an inch or two in some locations. At other locations, only a small crack is visible in the soil, outlining the edges of the footing. In most locations, the cover over the footing block concrete is only 2 to 3 inches.

Figure 157.—Foundation movement at Southeast Connector of Route 92/101 Interchange.

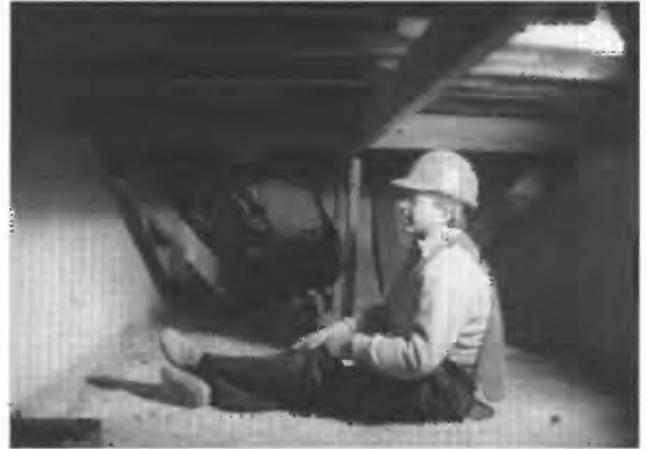
In 1991, Professors Saidi and Maragakis from the University of Nevada at Reno made a study of several wide soffit cracks near the hinge of the Northeast Connector (figs. 158 and 159). These cracks were reported after the earthquake, but an investigation had to wait until access holes were cut into the soffit (November 21, 1991). The cracks, along with some damage to the barrier rails at the hinge, suggested that they were caused by the earthquake (figs. 160 to 162). Because the cracks were vertical along the webs, they could not have been caused by shear. Because the cracks were near the hinge, they could not be caused by flexure. Therefore, it was felt that the cracks were caused by tension. The eccentric location of the restrainers could possibly have produced a flexural moment which may have caused these cracks. Also, the role of prestressing tendons combined with cable restrainers needs more study.

Figure 161.—M. "Saiid" Saidi investigating cracks in interior bay of Northeast Connector of Route 92/101 Interchange.

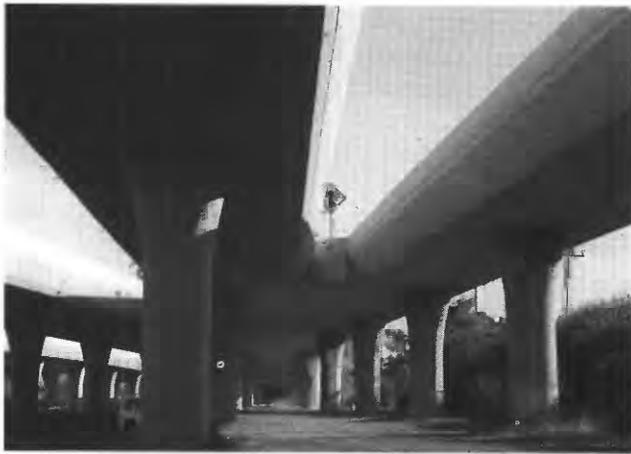
Figure 159.—Portion of Northeast Connector of Route 92/101 Interchange where soffit cracks were investigated.

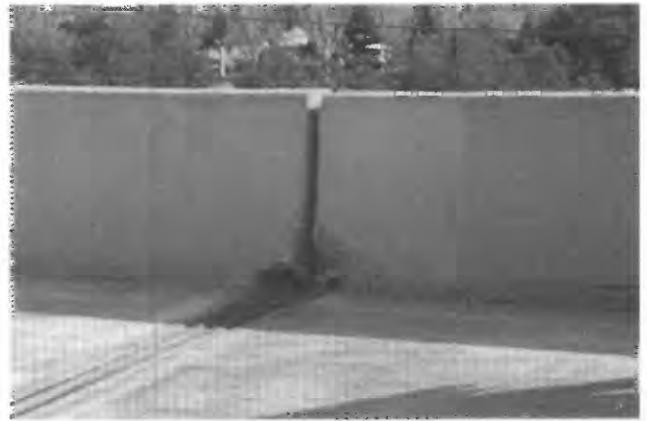
Figure 162.—Barrier rail damage at hinge of Northeast Connector of the Route 92/101 Interchange.

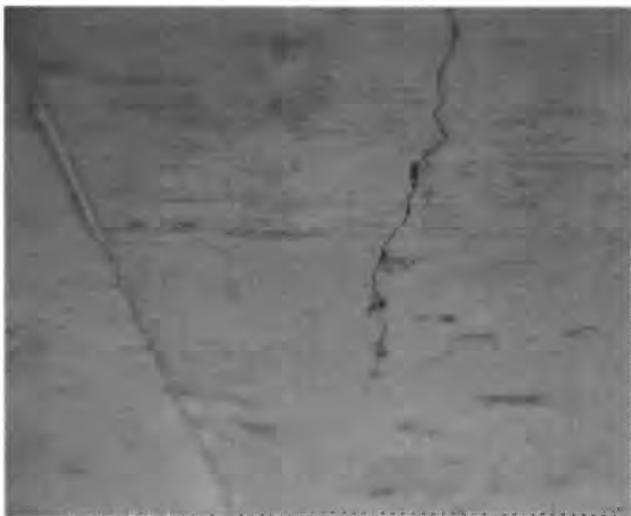
Figure 160.—Soffit cracks on Northeast Connector of Route 92/101 Interchange.

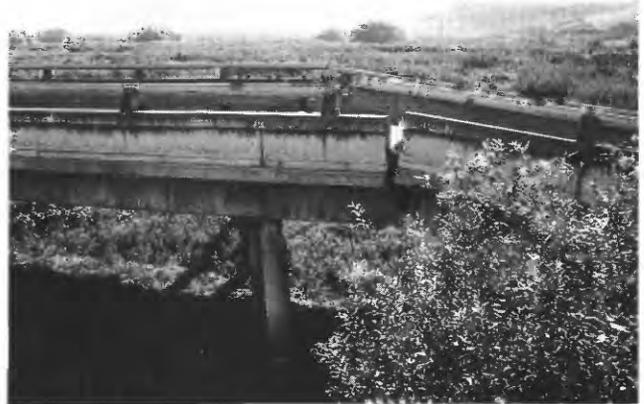
The restrainers performed surprisingly well during the earthquake, holding the hinges together even on the collapsed portion of the bridge. There was a great deal of displacement. Abutment 1 of the left bridge moved 6 inches longitudinally, and the approach fill settled 3 inches behind the abutment. The bridge superstructure displaced up to 2 feet at midspan. Almost all the pile extensions were damaged. There

Figure 168.—Cable restrainers holding hinge together on Struve Slough Bridges (superstructure was unsupported beyond this point).

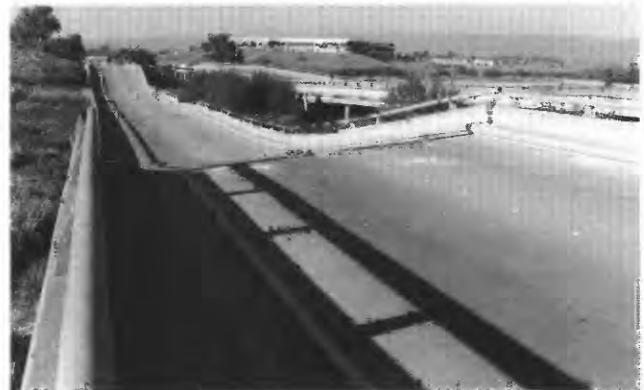
Figure 169.—South abutment of left Struve Slough Bridge (view to north).

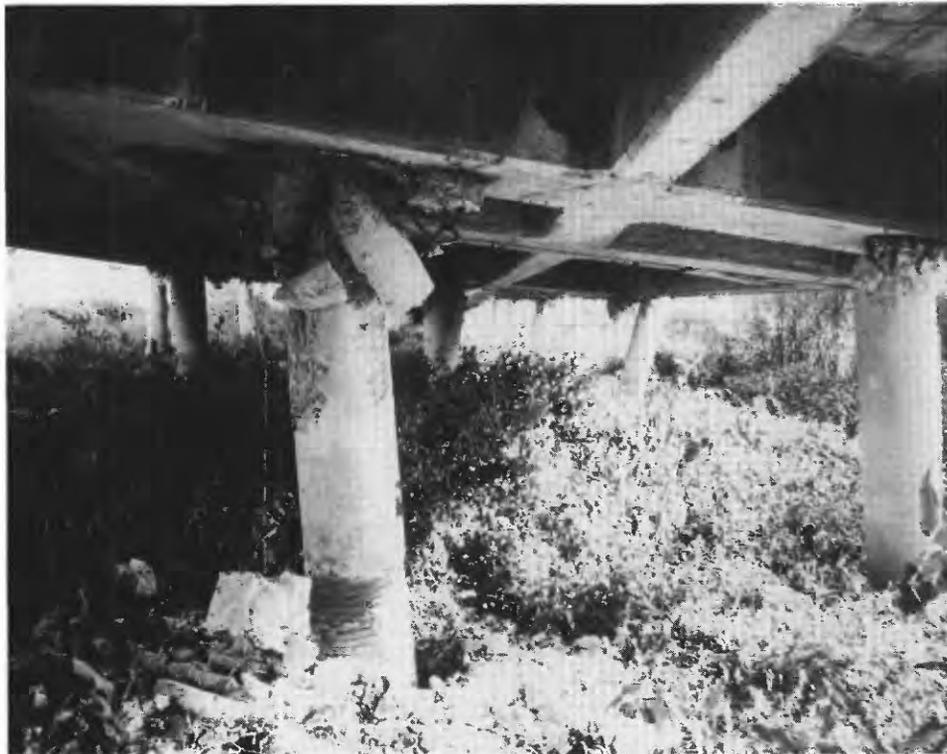
it dragged the pile extensions along with it, causing severe damage to both bridges. The left bridge collapsed from spans 6 to 17. Many of the piles were crushed. Several piles in Bents #14 and #15 were displaced longitudinally, separated from the bent cap, and punched through the bridge deck (figs. 167 to 171).

Figure 167.—Pile damage on Struve Slough Bridges.

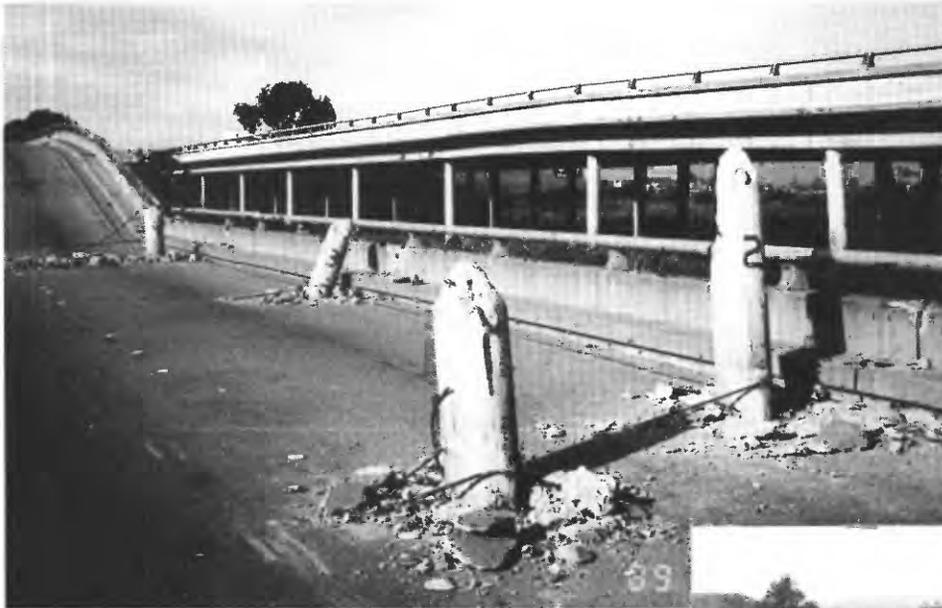
There was some speculation that the high recorded vertical motion may have had an influence on the bridge damage, particularly since several pile tips were driven through the concrete deck slab. However, an analysis of this structure (Saadeghvaziri, 1990) showed that the fundamental vertical period of 0.20 seconds was far from the power component of the ground motion. Also, the vertical mode had a small participation factor.

Figure 170.—Piles penetrating deck of left Struve Slough Bridge (view to south).

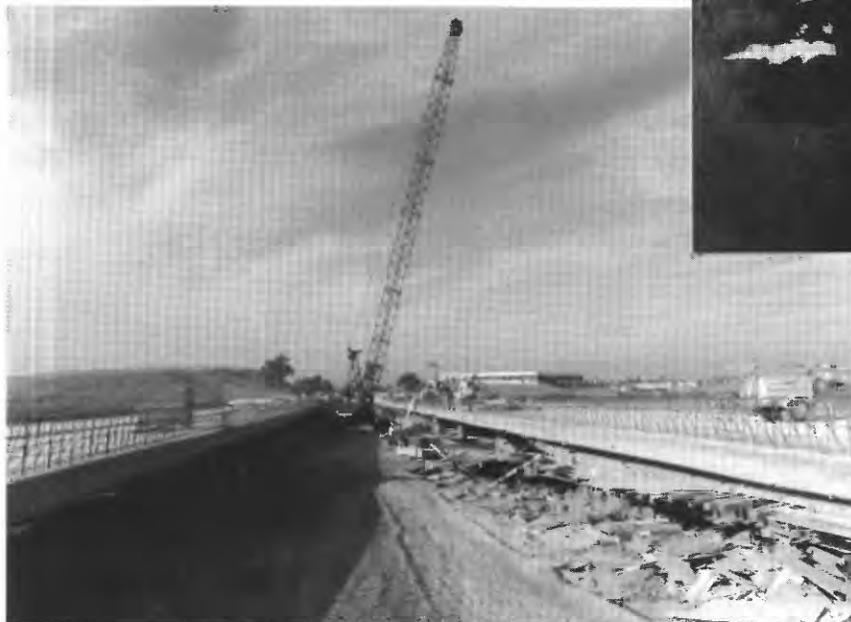
Figure 171.—Reconstruction of Struve Slough Bridges.

Damage to this bridge stopped all traffic from traveling on the Pacific Coast Highway. Because of the severe damage and potential for more damage during the next earthquake, it was decided to replace the damaged bridges with new structures that could survive the large movement of the soft soil during earthquakes. Caltrans Design Section 11 was given the task of coming up with a new design in 8 days. At first they thought they could use the standard design charts for a slab bridge. However, putting in pile extensions that were basically unsupported through 70 feet of soft soil required a dynamic analysis.

The final design called for 24-inch concrete piles cast into driven steel pipe piles and socketed 10 feet into bed-

rock. The superstructure was designed as two continuous flat slabs without joints (figs. 172 to 173). The complete package of plans, specifications, and quantities, was ready for contractors bids on November 15, 1989.

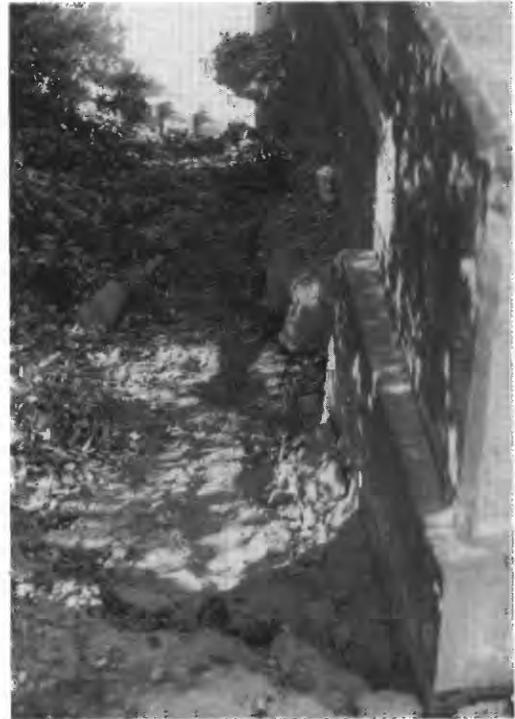
At Abutment 1 the right wingwall broke off. The fill had settled as much as 12 inches on the outside of the wingwalls (figs. 176 and 180). The approach also settled about 6 inches. There was curb and railing damage all along the structure (figs. 178 and 179). At Bent 4, Span 3 moved transversely about 1 inch to the right, spalling the diaphragm and shearing the bearing plate bolts and grout pads. At Abutment 5 the wingwalls moved outward, causing the fill to settle (fig. 177).

Figure 176.—Settlement along abutment of Grant Undercrossing (photograph by Mike Van de Pol).

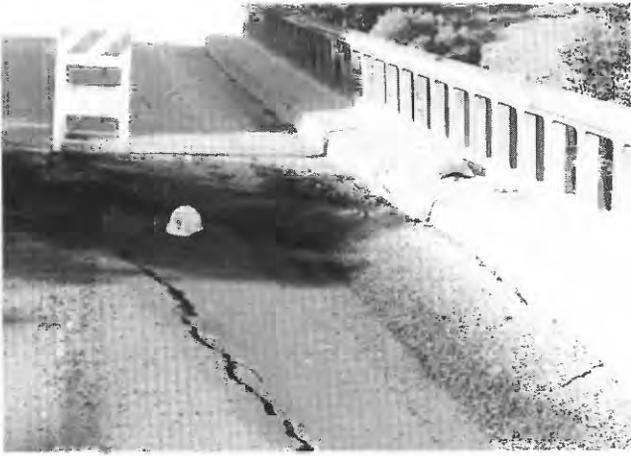
Figure 177.—Abutment 5 approach to Grant Undercrossing (view to west) (photograph by Mike Van de Pol).

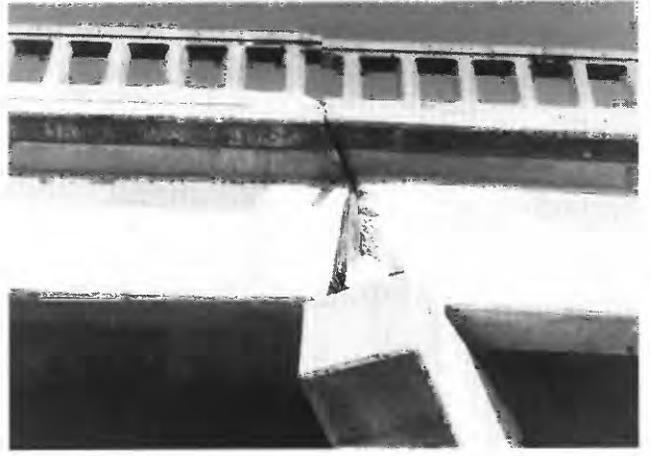
Figure 179.—Exterior spall at Bent 4 of Grant Undercrossing (view to south) (photograph by Mike Van de Pol).

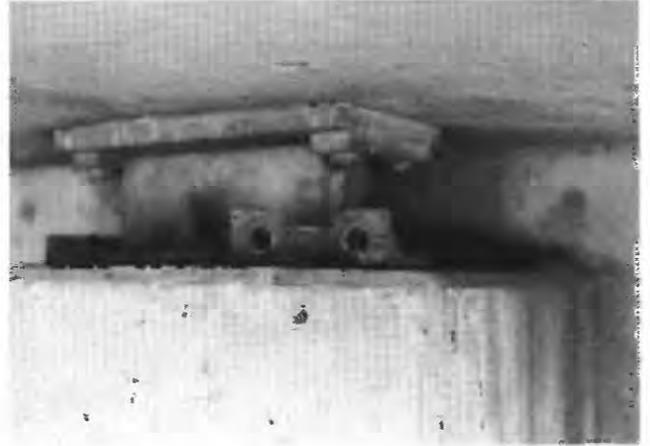
Figure 180.—Broken keeper plate for Abutment 5 of Grant Undercrossing (photograph by Mike Van de Pol).

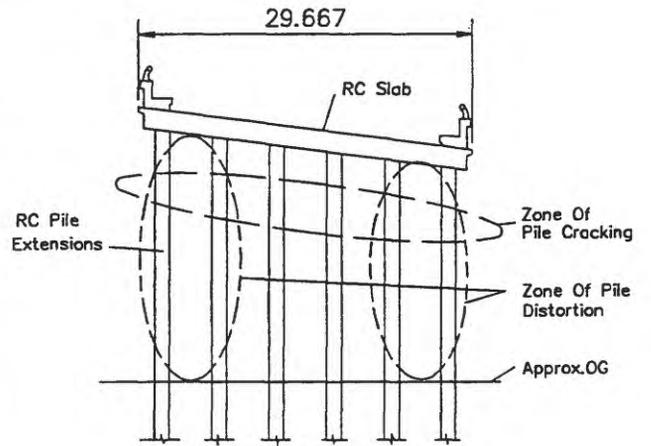
The off-ramp had damage to the hinges (fig. 188) and to some pile extensions (figs. 185 to 187) during the earthquake. The soft soil did not provide enough support for the pile extensions, and they moved enough to have flexural damage at the high moment locations at the bottom and the top of the piles. Most of the piles had some damage, but the most cracks were at Bents 4, 5, and 6, particularly for the exterior piles. The pile with the most damage was on the left side of Bent 4. The bents vary in height, with the shortest bents being closest to the abutment. The taller, more flexible piles had no cracking. However, they showed a permanent deformation in single and a few in double curvature.

Figure 185.—Elevation drawing of damage to pile extensions of Mococo Off-Ramp.

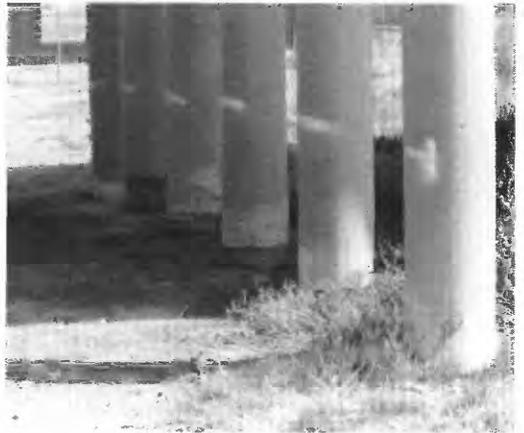
Figure 186.—Damage to Mococo Off-Ramp concrete pile extensions at ground surface.
