The Loma Prieta, California, Earthquake of October 17, 1989— Highway Systems

Professional Paper 1552-B

This paper summarizes the impact of the Loma Prieta earthquake on highway systems. City streets, urban freeways, county roads, state routes, and the national highway system were all affected. There was damage to bridges, roads, tunnels, and other highway structures. The most serious damage occurred in the cities of San Francisco and Oakland, 60 miles from the fault rupture. The cost to repair and replace highways damaged by this earthquake was \$2 billion. About half of this cost was to replace the Cypress Viaduct, a long, elevated double-deck expressway that had a devastating collapse which resulted in 42 deaths and 108 injuries.

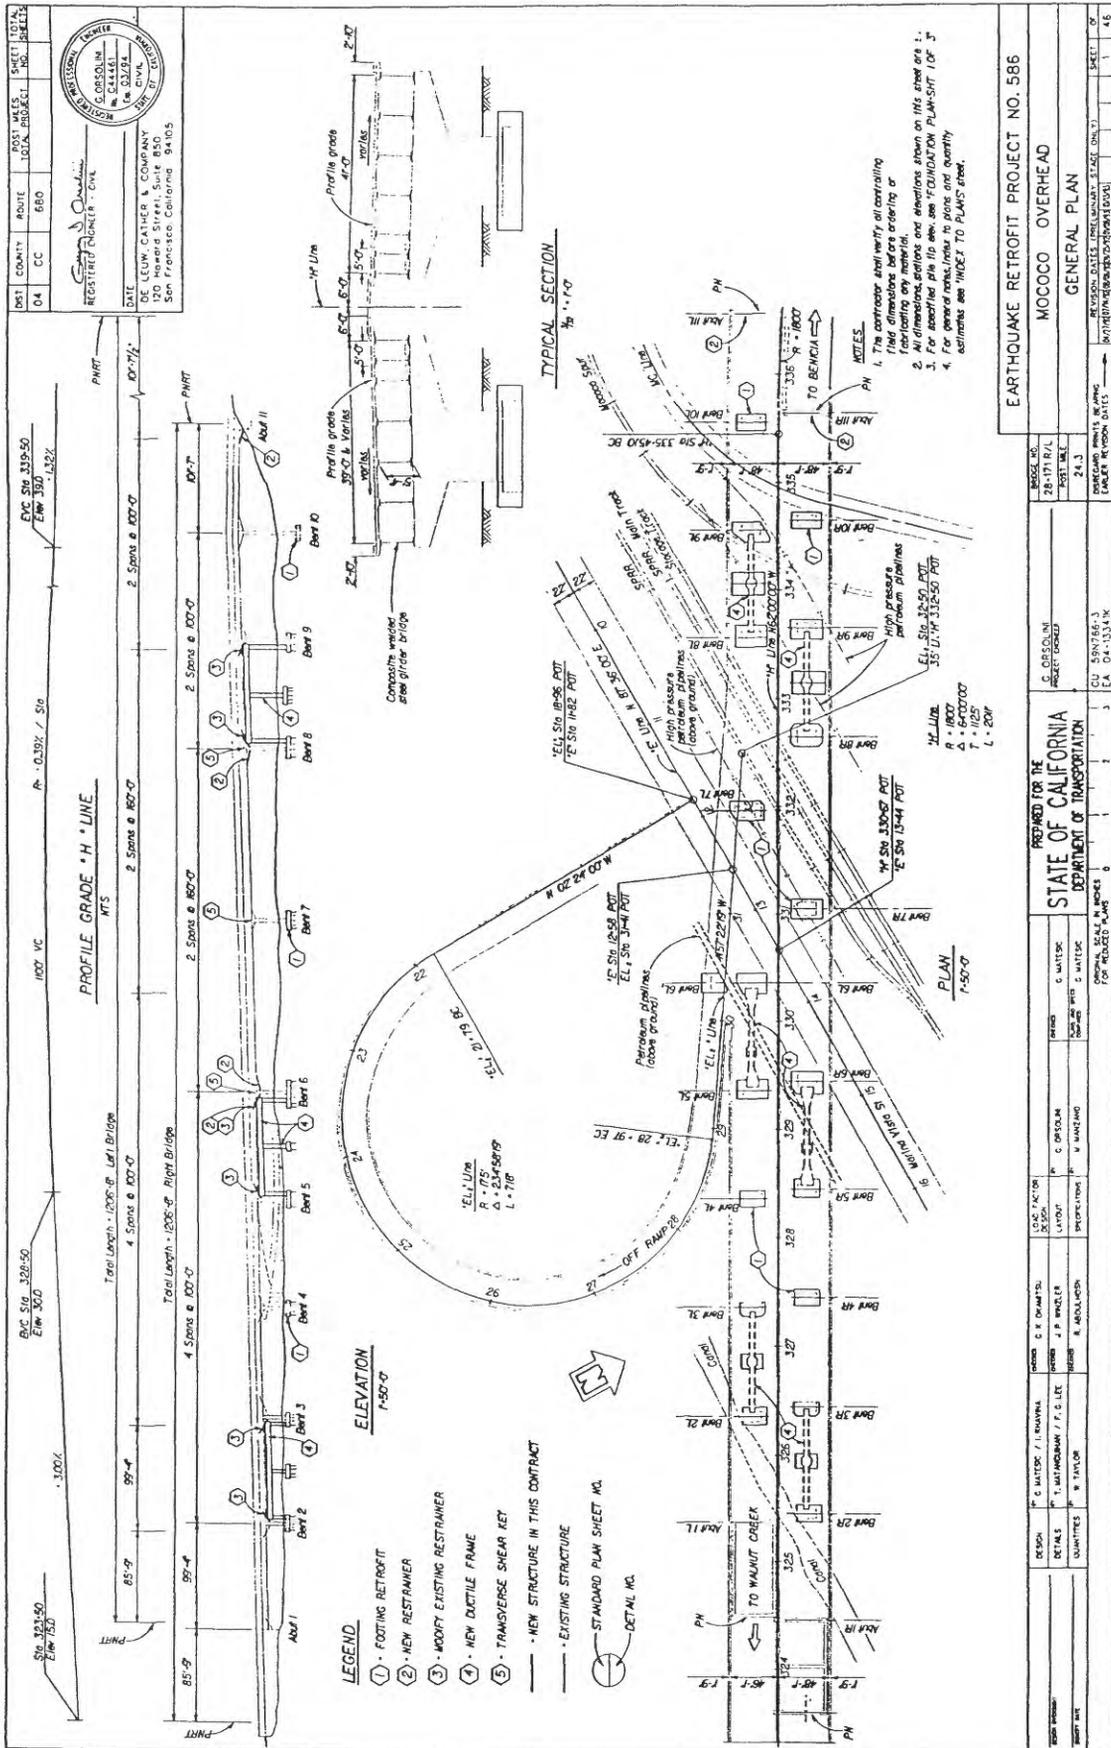
Figure 191.—General Plan drawing for seismic retrofit of Mococo Overhead.

In 1991, a contract was written to design a retrofit for this structure (fig. 191). Surprisingly, only the main-line structure was retrofit.

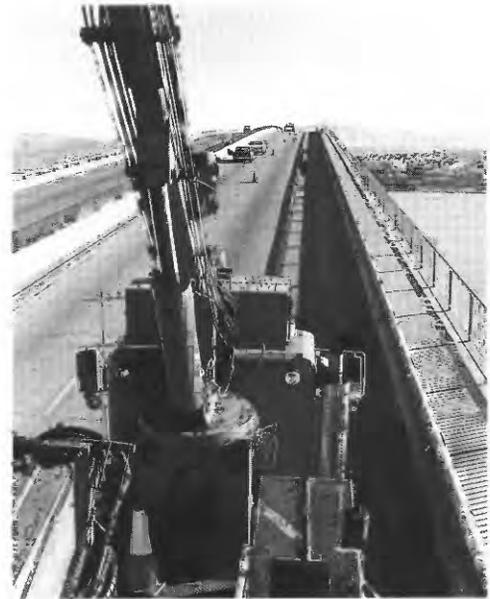
The first investigation of damage was done by a Post Earthquake Investigation Team; however, it is difficult to effectively examine a tall bridge over water without a catwalk or snooper truck. A snooper truck became available on October 30, 1989, and was used on this bridge for 2 days and then again on December 9 (fig. 197).

Figure 197.—Snooper on top of Napa River Bridge.

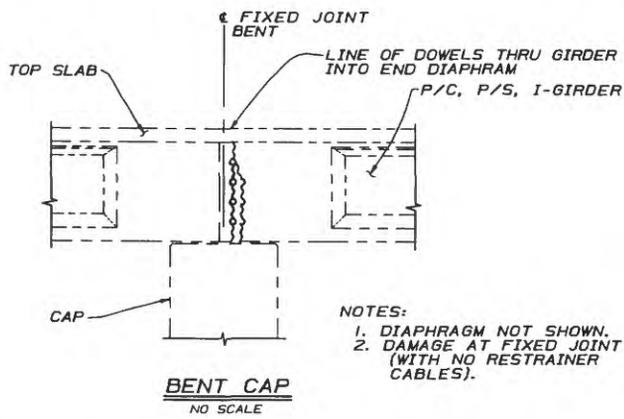
The basis for much of the damage can be seen in figure 198. Almost all the damage was the result of the precast "I" girders pulling out of the diaphragms (figs. 199 to 202). They were tied together with #6 reinforcement that ran transversely through the diaphragms. During the earthquake the girders pulled out, delaminating the concrete behind the #6 reinforcement.

Figure 198.—Detail drawing of typical damage to Napa River Bridge.

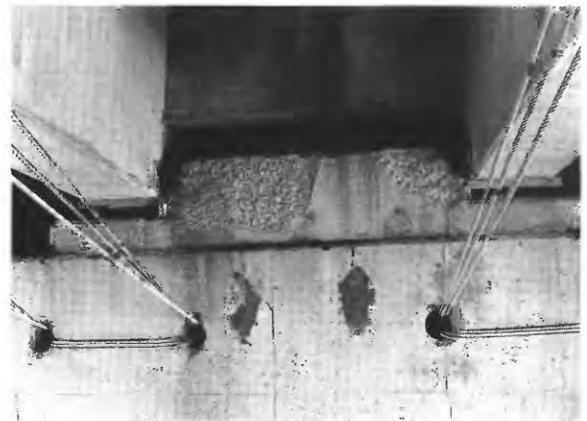
Figure 201.—Spalling on the Span 16 side of Pier 17 at Napa River Bridge.

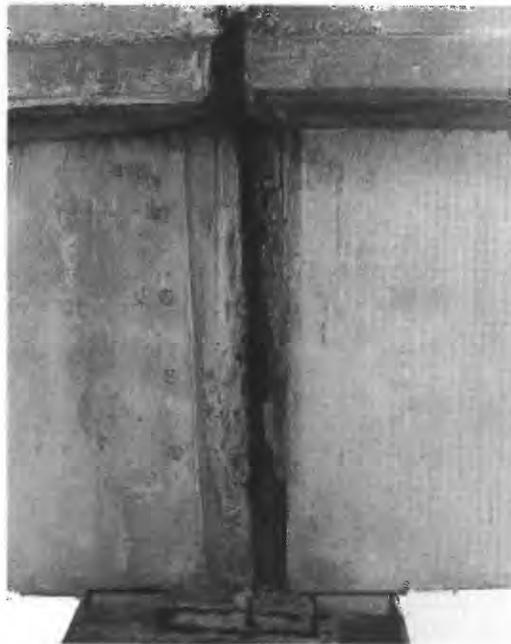
Figure 199.—Diaphragm damage to Napa River Bridge.

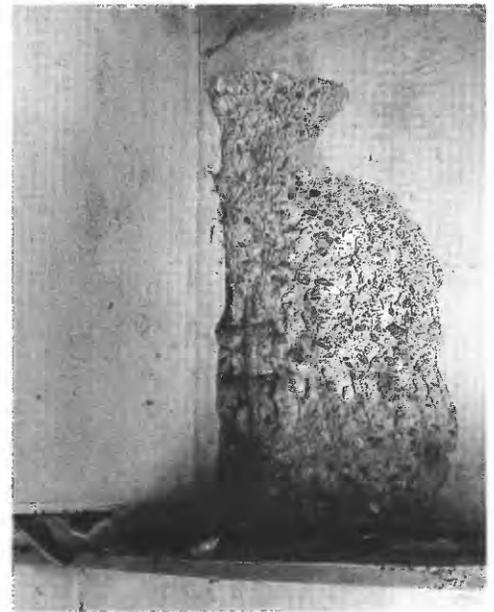
causing the restrainer cables at Pier 13 to hang loosely. There was flutter at the holes for the restrainers at Pier 14 (the restrainers are double wrapped through the holes in the bent caps as shown in fig. 203), and the restrainers were probably damaged. However, they held the superstructure on the bents.

Figure 203.—Bent cap damage to Pier 17 of Napa River Bridge.

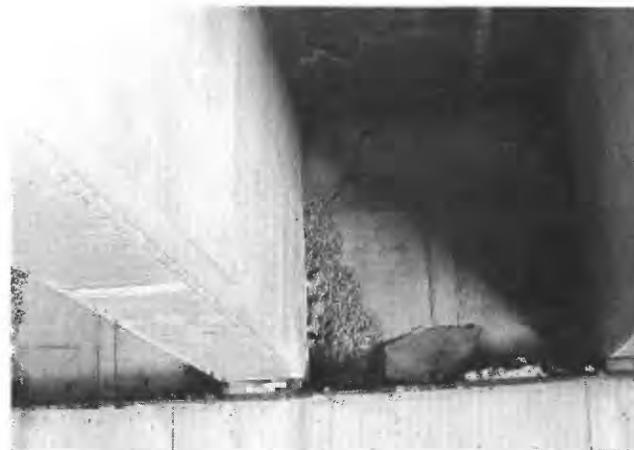
Figure 200.—Spalling at diaphragm of Napa River Bridge.

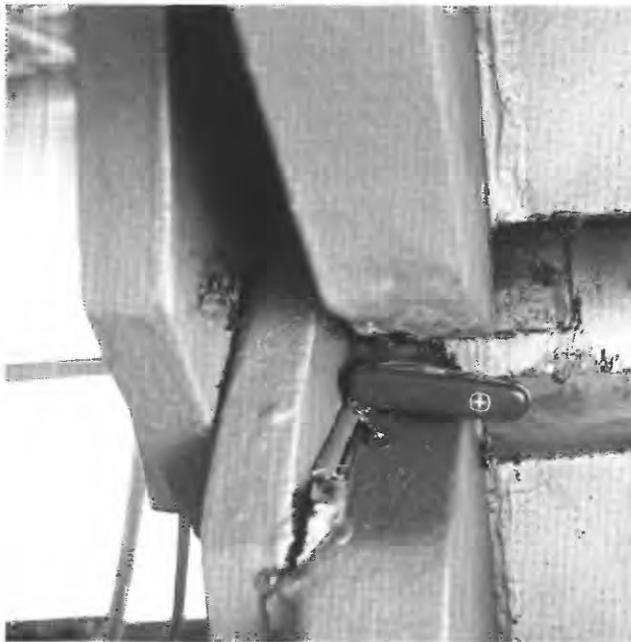
Bearings at Piers 18 and 21.—Bearings supporting the steel box girders had moved 1.5 inches at the north bearing of Pier 18 and 4.5 inches at the south bearing of Pier 21. Six of the eight interior pin caps (1.75-inch screw cap) had broken off. The end keeper plates were bent (figs. 220 to 223).

Figure 222.—Signs of movement at bearing (scraped paint) of San Mateo-Hayward Bridge (courtesy of Earthquake Engineering Research Institute).

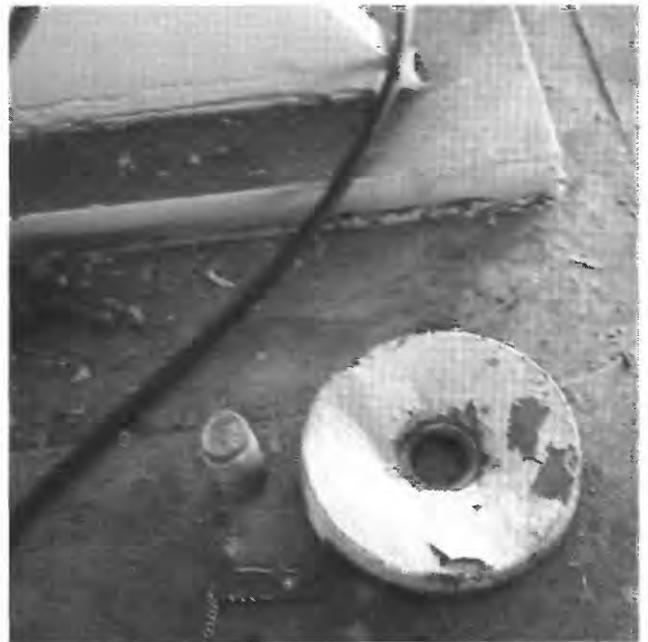
Figure 223.—Broken cap and washer from bearing of San Mateo-Hayward Bridge (courtesy of Earthquake Engineering Research Institute).

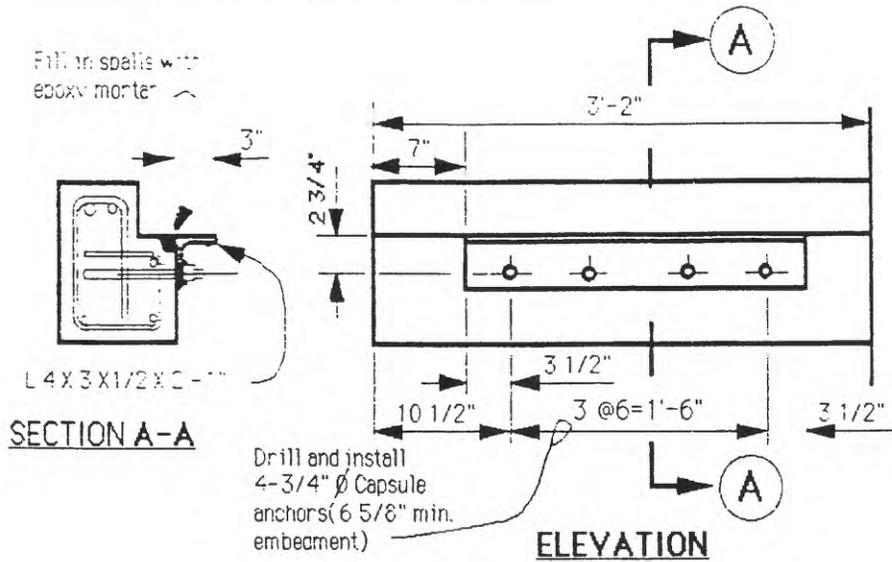
STAIRWAY REINSTALLATION DETAIL

Pier 38.—At the backwall for Pier 38 the trestle earthquake restrainer shelf bearings supporting the first trestle span were damaged. The painters stairway giving access to the walkway behind Pier 38 has fallen into the bay (fig. 224).

Figure 224.—Plan for stairway repair of San Mateo-Hayward Bridge (White, 1990).

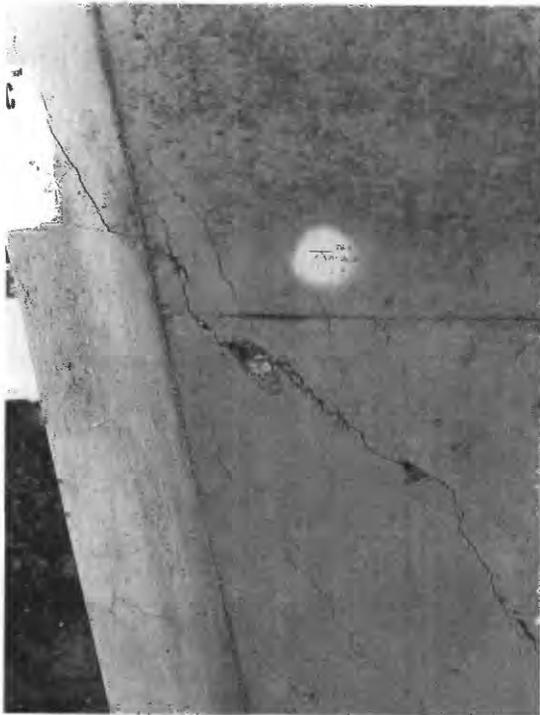
The most serious damage to this bridge was several wide cracks that appeared to go all the way through the column (figs. 229 and 230). These cracks began at the footing on the north side of the column and extended to 10 feet above the footing on the south side of the column. There were also some smaller cracks. Maintenance engineers chipped out about 7 square feet of the cracked portion of the column to a depth of 6 inches. They found some of the reinforcement was heavily corroded. The abutments also showed signs of movement including some concrete spalls where the abutment met the bridge soffit (figs. 231 and 232).

There are several possible explanations for the column damage. The column had only #4 rebar at 12-inch

spacing for transverse reinforcement. It also had a large flare that attracted more shear. The reinforcement was corroded in the area of damage. All these things probably contributed to the damage.

Figure 229.—Damage on northwest side of column at Mora Drive Overcrossing.

After the earthquake, a layer of asphalt was spread behind the abutment to smooth the approach (fig. 233). In 1992 the bridge was repaired and retrofitted with a steel casing for the column that matched the flare (fig. 234). A top layer of reinforcement and concrete was added to the existing column footing to allow it to handle the plastic moment capacity of the column. Also, the cracked soffit concrete was patched near the abutments.

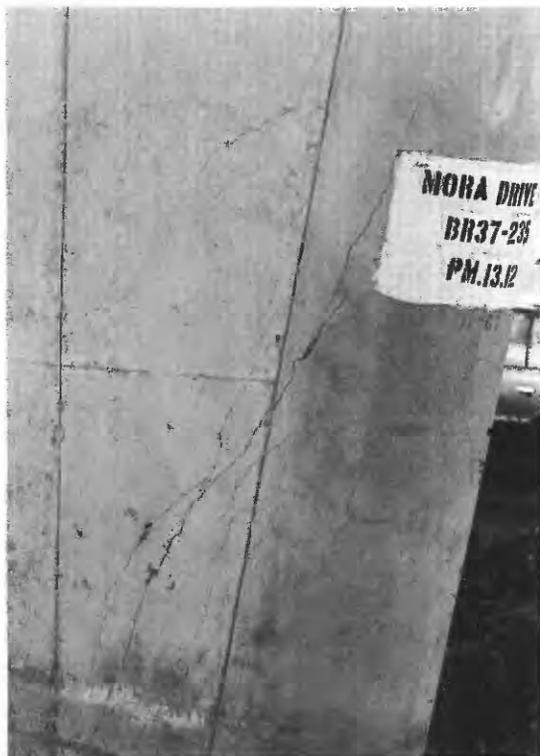
Figure 230.—Damage on southwest side of column at Mora Drive Overcrossing.

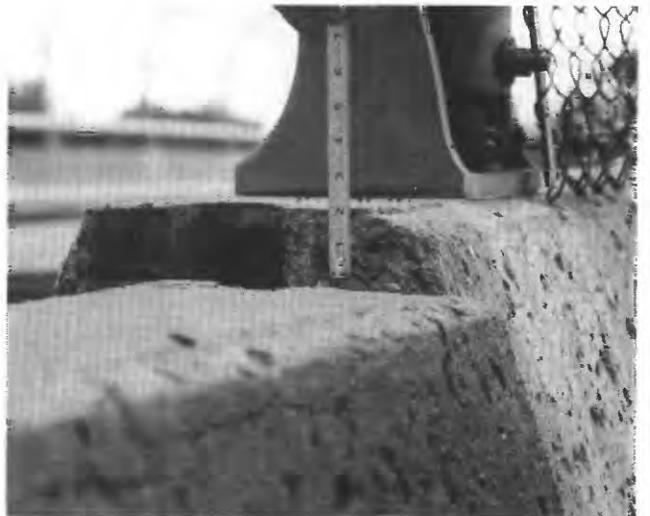
Figure 231.—Vertical offset of west abutment at Mora Drive Overcrossing (courtesy of Earthquake Engineering Research Institute).

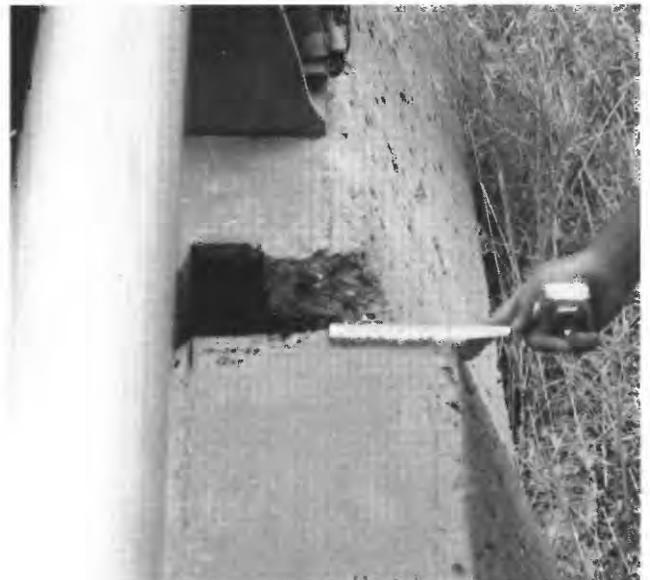
Figure 232.—Horizontal offset of west abutment at Mora Drive Overcrossing (courtesy of Earthquake Engineering Research Institute).

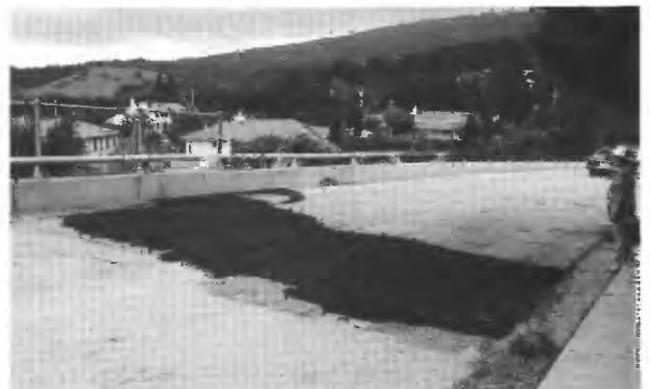
Figure 233.—Repair to approach of Mora Drive Overcrossing (courtesy of Earthquake Engineering Research Institute).

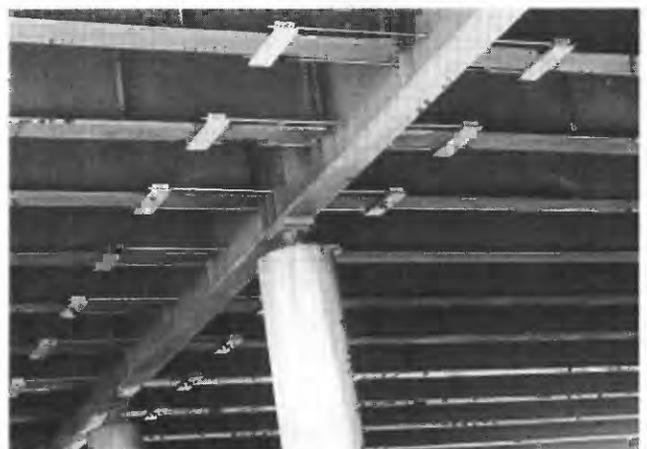
Figure 243.—Existing bearings (before removal) during retrofit of Sierra Point Overhead.

Sierra Point Overhead has undergone two modifications since it was built. In 1967, girders and a deck were added to the center of the bridge to increase the number of traffic lanes (fig. 242). In 1986 the first seismic retrofit in California to include seismic isolation was done on this bridge. The retrofit addressed the two seismic vulnerabilities of this structure, inadequate column capacity and the steel girders falling off the rocker bearings. The replacement of the steel bearings on the columns with lead/rubber isolation bearings and the addition of longitudinal rod restrainers addressed these weaknesses.

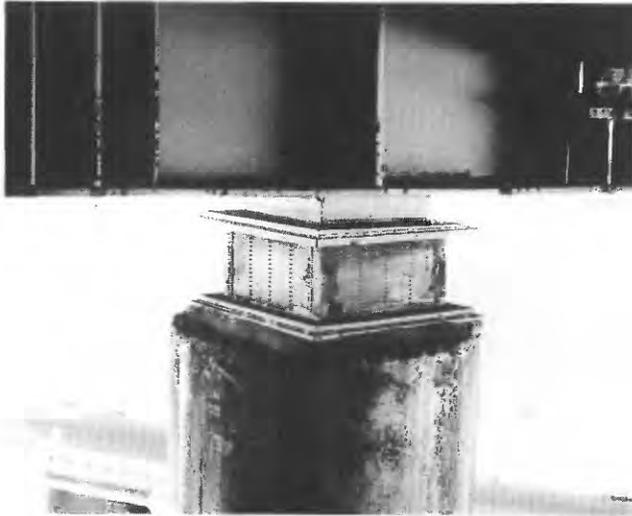
Figure 244.—Newly installed lead/rubber bearing during retrofit of Sierra Point Overhead.

Figure 244 shows a lead/rubber isolation bearing installed on top of a column. All 27 columns for this bridge had the spherical bearings replaced with lead/rubber bearings. Also, as part of the retrofit, the bridge was instrumented with 13 sensors on the structure and three additional sensors nearby on the ground to obtain the free-field motion. Figure 245 shows the instruments mounted on the two westernmost columns of Bent 7 and on that portion of the transverse beam between them.

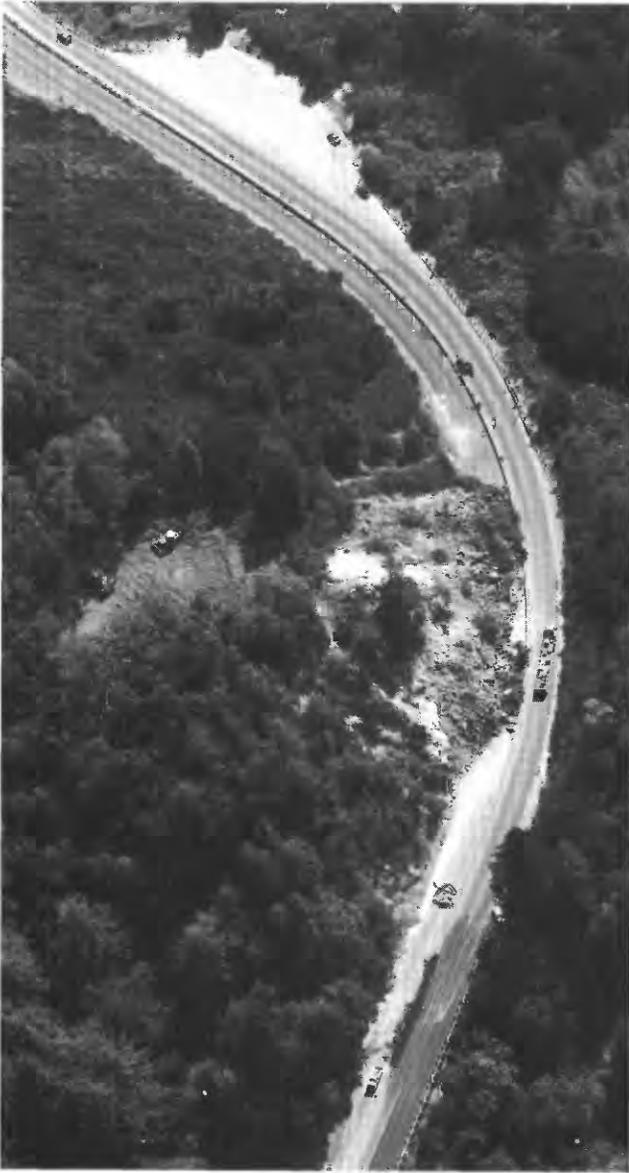
291). This is at a location within a few miles of the epicenter of the earthquake. Some of the damage was rock and land slides that blocked the highway at several locations. In addition, densification of soil at embankments and behind retaining walls caused road settlements and cracked pavements. The concrete median barrier was damaged at several locations. A surface rupture with a vertical uplift of 1.5 feet damaged the roadway near the summit of the Santa Cruz Mountains. Repairs to the roadway left the highway closed to everyone except local residents and carpools for 32 days. The roadway was reopened on November 19. The repairs included excavation and flattening of slopes, grout injection, soil nailing, and rock fences.

Figure 290.—Route 17 landslide.

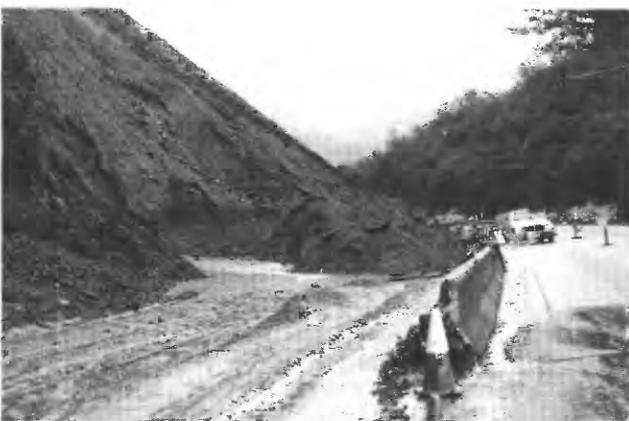
Figure 291.—Route 17 landslide.

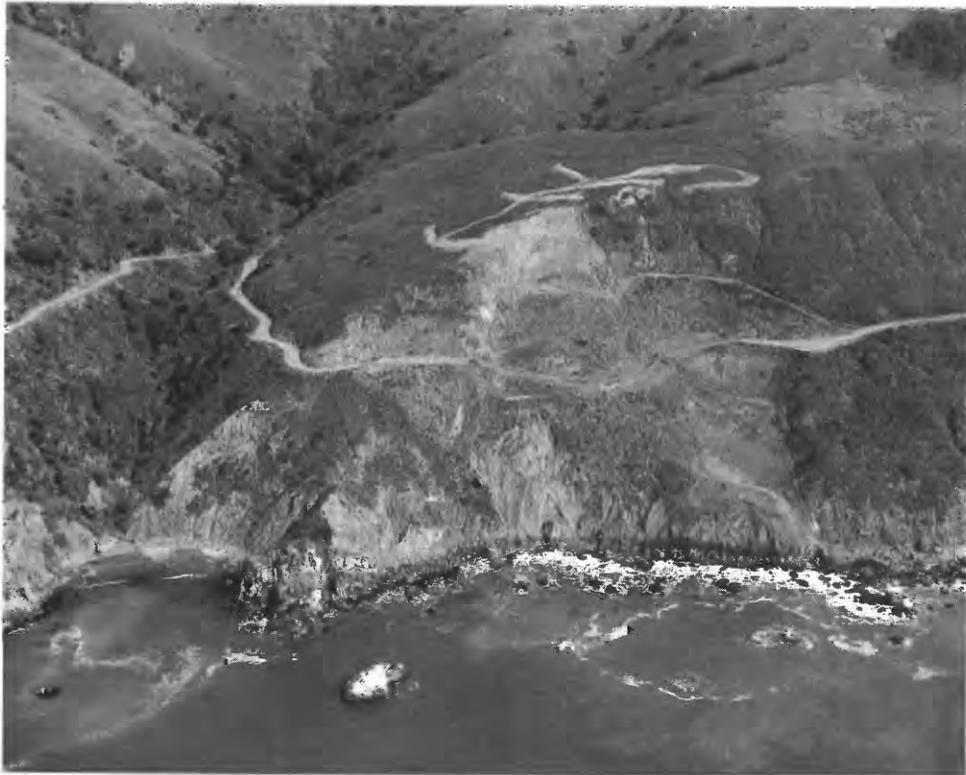
This is an ancient landslide along the coastal bluffs of Marin County. It was remobilized but controlled by Caltrans following very heavy rains of January 1982. However, the Loma Prieta earthquake created a much faster rate of soil movement (figs. 292 to 295), eventually requiring a new road alignment behind the landslide. A detailed report describing this landslide is provided by Van Velsor and Walkenshaw (1992).

Figure 293.—Landslide along Route 1 in Marin County (courtesy of Joan Van Velser).

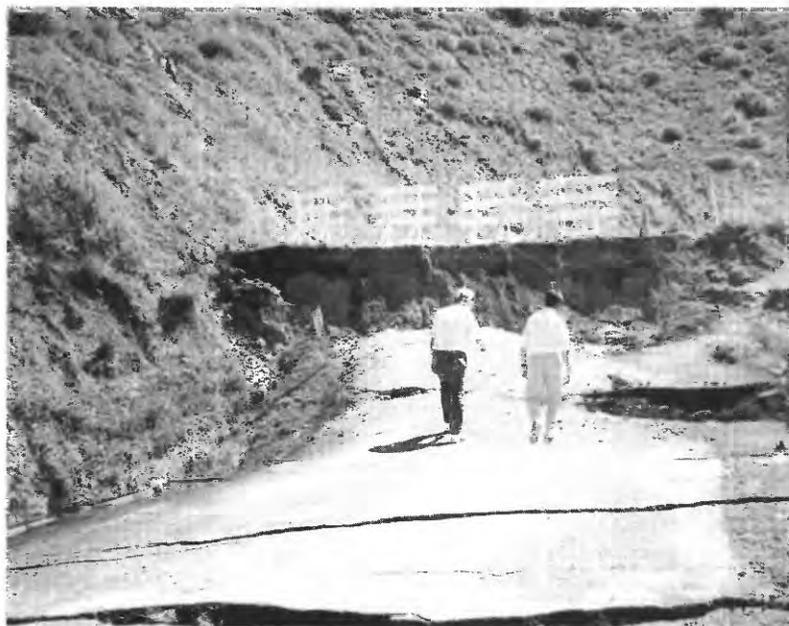
Figure 294.—Landslide damage along the coast (courtesy of Joan Van Velser).

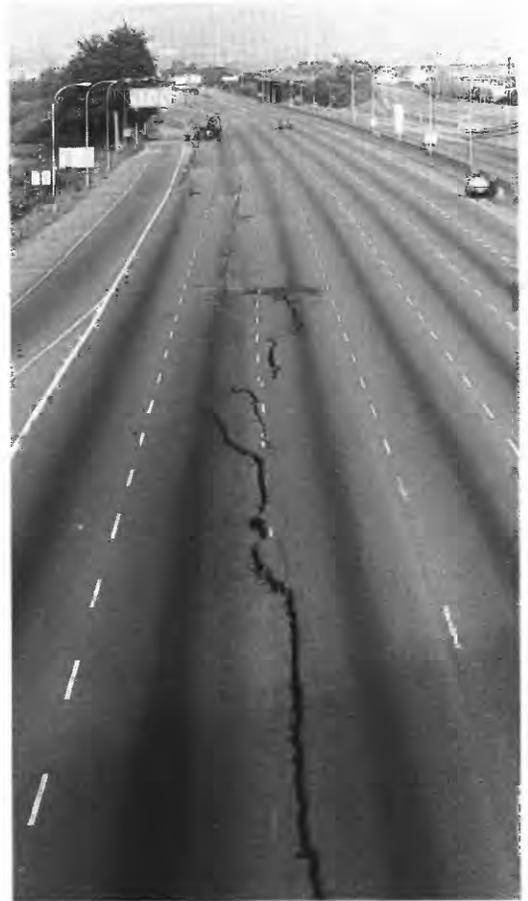
Interstate 80 runs south along the San Francisco Bay in Emeryville and then turns west and widens to become a toll plaza before crossing the Bay. Approximately 2 miles of this roadway from Powell Street to the Bay Bridge was damaged due to heaving, settlement, cracking, and lateral spreading following the earthquake (figs. 295 to 298). This damage did not affect traffic because a dropped span on the Bay Bridge closed this section of roadway. The road was regraded every day for a week before the movement subsided.

Figure 296.—Lateral spreading at Interstate 80.

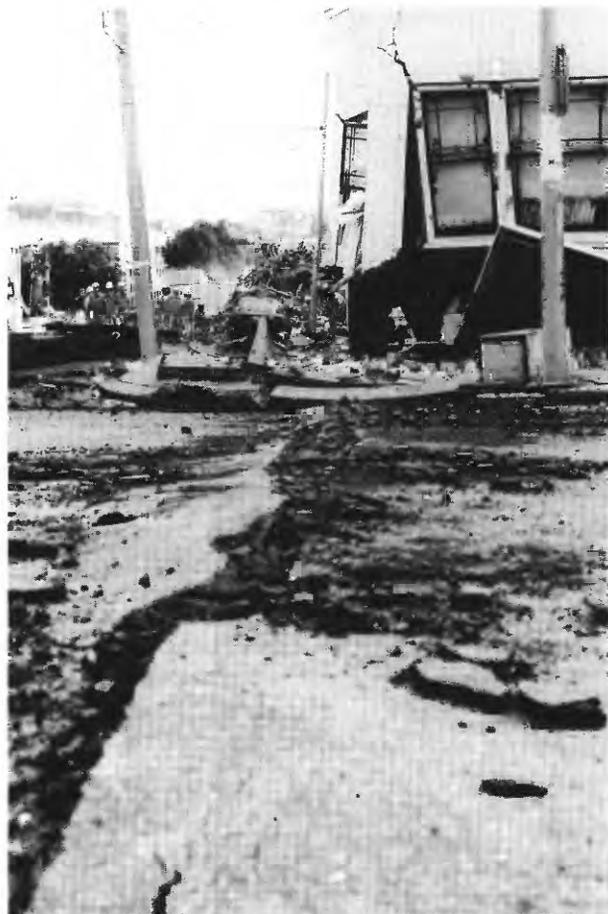
Streets in San Francisco that were built on Bay mud or loose fills were damaged during the earthquake. This damage was often in the very same locations that had sustained damage during the 1906 San Francisco earthquake. Figure 299 was taken at the corner of Divisadero and Jefferson Streets in the Marina District. Differential settlement of the ground with accompanying buckling of asphalt pavement was common throughout the Marina (fig. 300).

Figure 299.—Road damage in San Francisco's Marina District (courtesy of Earthquake Engineering Research Institute).

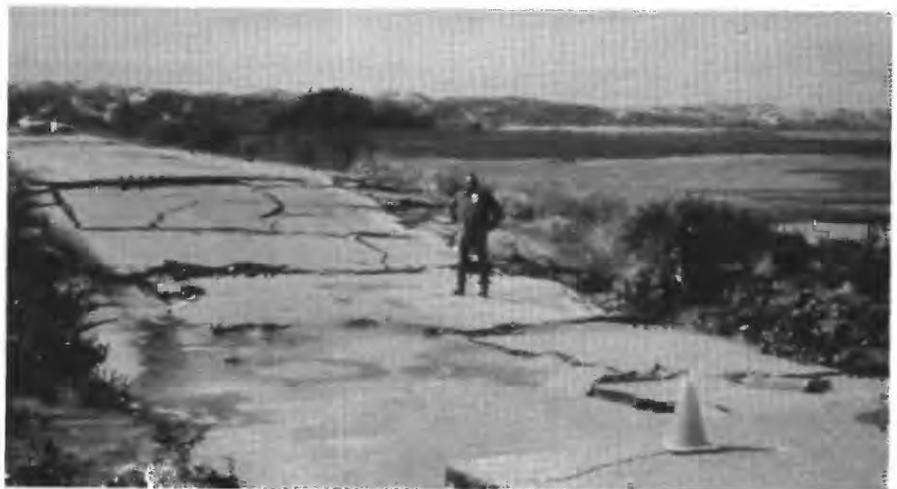
South of the city of Santa Cruz, the approach road to Moss Landing State Beach was damaged due to liquefaction of the soil (figs. 301 and 302). About 300 feet of roadway subsided as much as 3 feet and spread 20 feet laterally.

Figure 301.—Damage to the access road at Moss Landing State Park (courtesy of Earthquake Engineering Research Institute) (view to north).

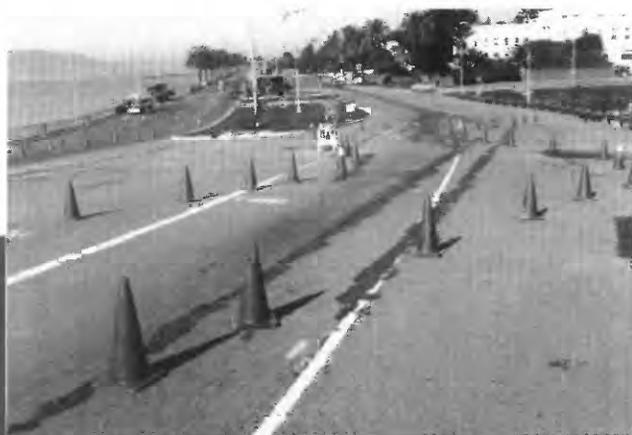
Figure 304.—Lateral spreading damage to roadway at Treasure Island (courtesy of U.S. Geological Survey; photograph by Michael Bennett).

Treasure Island is a Naval Station in the middle of San Francisco Bay. Land access to the island is limited to a causeway from Yerba Buena Island (fig. 303). During the earthquake this causeway (an embankment built over sand and Bay mud) experienced lateral spreading with cracks several inches wide. There was also widespread liquefaction damage to most of the roads on the island (fig. 304).

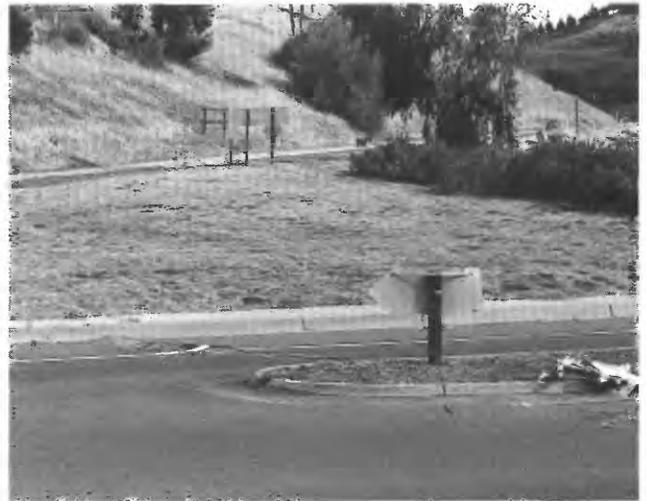
These “second-order tectonic features” caused asphalt pavement to buckle and concrete curbs and sidewalk to break on city streets from Los Gatos north to Los Altos (fig. 305). At Sand Hill Road there was a movement of the ground that pushed a section of the road together until it failed in compression (figs. 306 and 307). Similar damage occurred to State Route 17 and Interstate 280.

Figure 306.—Buckled roadway (by traffic island) at Sand Hill Road.

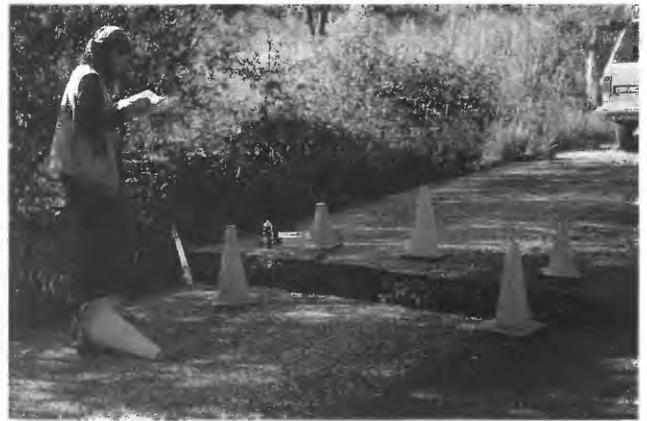
Figure 309.—Damage to Morrill Road from 1989 (Loma Prieta) earthquake.

There were many surface fractures in the Summit Road/Skyline Ridge area near the San Andreas Mountains in Santa Clara County (fig. 308). This resulted in substantial road damage in the area (Ponti, 1990). Damage can occur to roads on good basement material when the pavement is within several miles of an active fault. Morrill Road suffered a transverse crack that closed the road after the earthquake (fig. 309). Surprisingly, a similar crack at the same location closed the road after the 1906 earthquake (fig. 310).

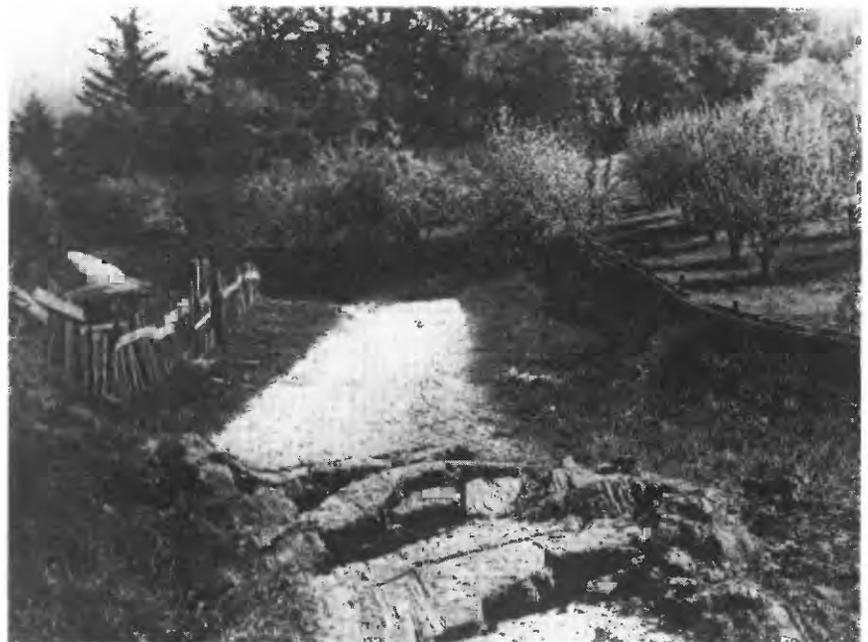
Figure 310.—Similar damage to Morrill Road from 1906 earthquake.

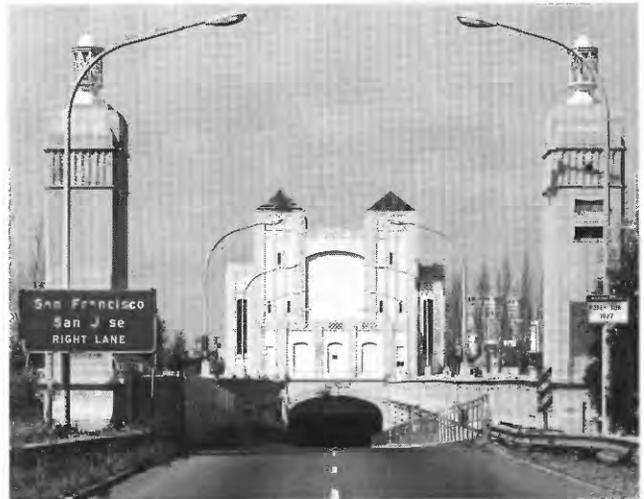
was built in the 1960's. They are reinforced concrete tubes with a bituminous coating for water proofing, and they descend to about 70 feet below sea level. After Loma Prieta, some of the connections between the tube segments began leaking. It was thought that liquefaction of the soil around the tubes caused deformation at the joints. Earthquake repair drawings were made, and the tubes were epoxy injected to stop the leaking. In 1997 a more elaborate retrofit was planned that included (1) creating very strong, water-proof hinges at the joints, (2) compacting the soil, adding stone columns, and building a curtain wall to prevent liquefaction and pore pressure from pushing up the tubes, and (3) jet grouting columns to support the ends of the tube segments.

Figure 311.—Alameda entrance to Posey Street Tube (courtesy of Ben C. Gerwick Inc.)

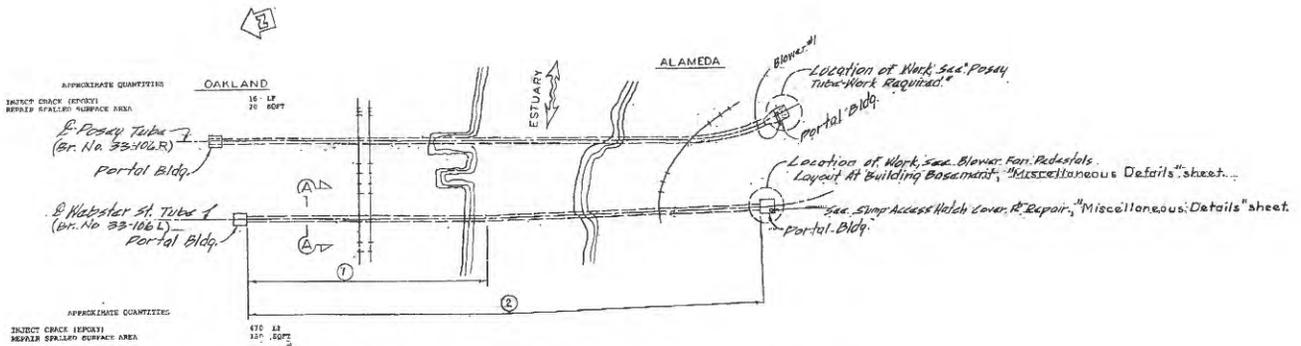
The only significant tunnel damage was to these 4,500-foot-long tubes which carry two lanes of traffic in each direction under the Oakland Estuary between the cities of Alameda and Oakland (figs. 311 and 312). The Posey Street Tube was built in the 1920's, and the Webster Street Tube

Figure 312.—Plan drawing of Posey and Webster Street Tubes showing location under Oakland Estuary.

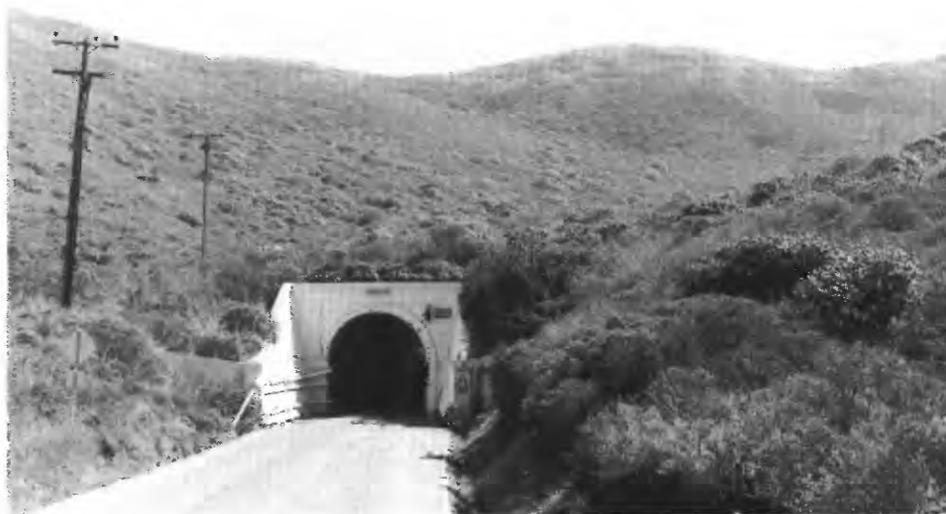
This is an unreinforced concrete arch built in 1954 that allows a single lane of traffic to go under Highway 101 in Marin County. It is 17 feet tall at its crown, 20 feet tall at its base, and 1,109 feet long (fig. 313). Although there were some indications of movement, and the tunnel was briefly closed by the Golden Gate Park Service, there was no earthquake damage to this tunnel.

Figure 313.—Fort Cronkite Tunnel.

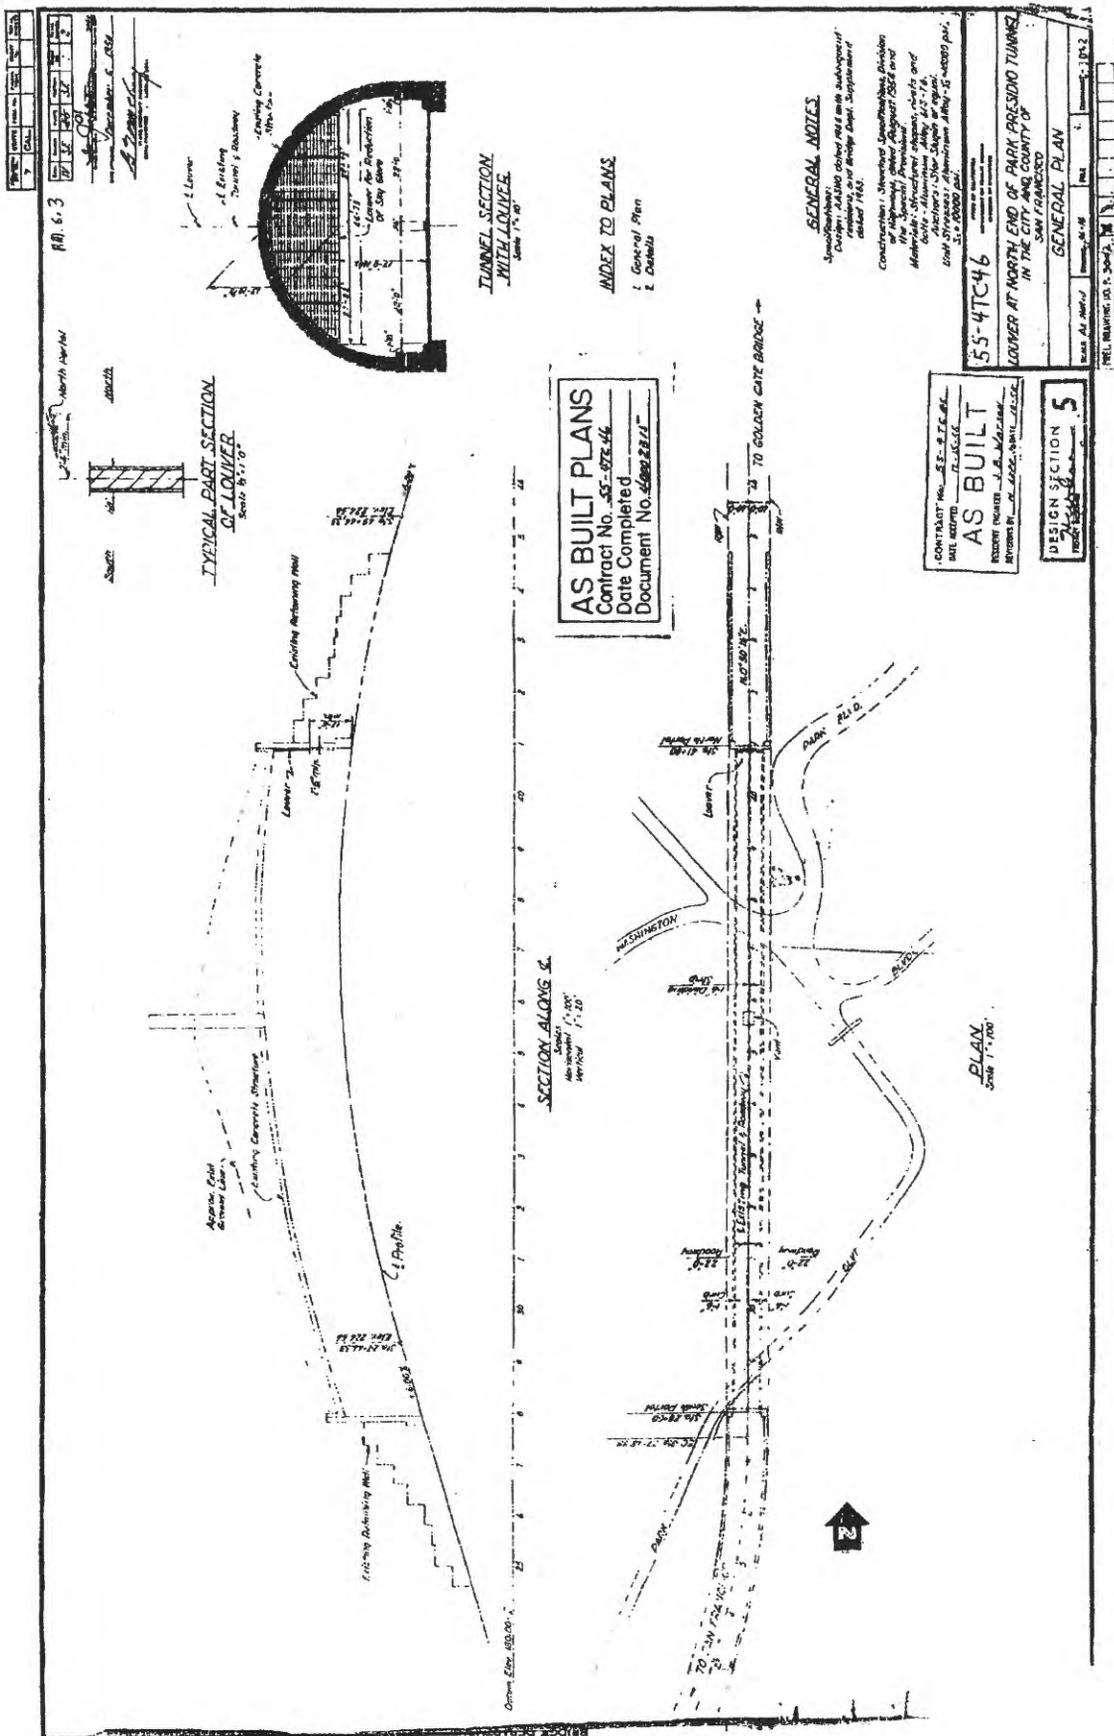
This is a reinforced concrete arch tunnel built in 1955. It carries traffic on State Route 1 north to the Golden Gate Bridge. It is 1,300 feet long, 45 feet wide, 30 feet tall, and has a 17-foot minimum vertical clearance (fig. 314). It had no earthquake damage.

Figure 314.—General Plan drawing of Presidio Park Tunnel.

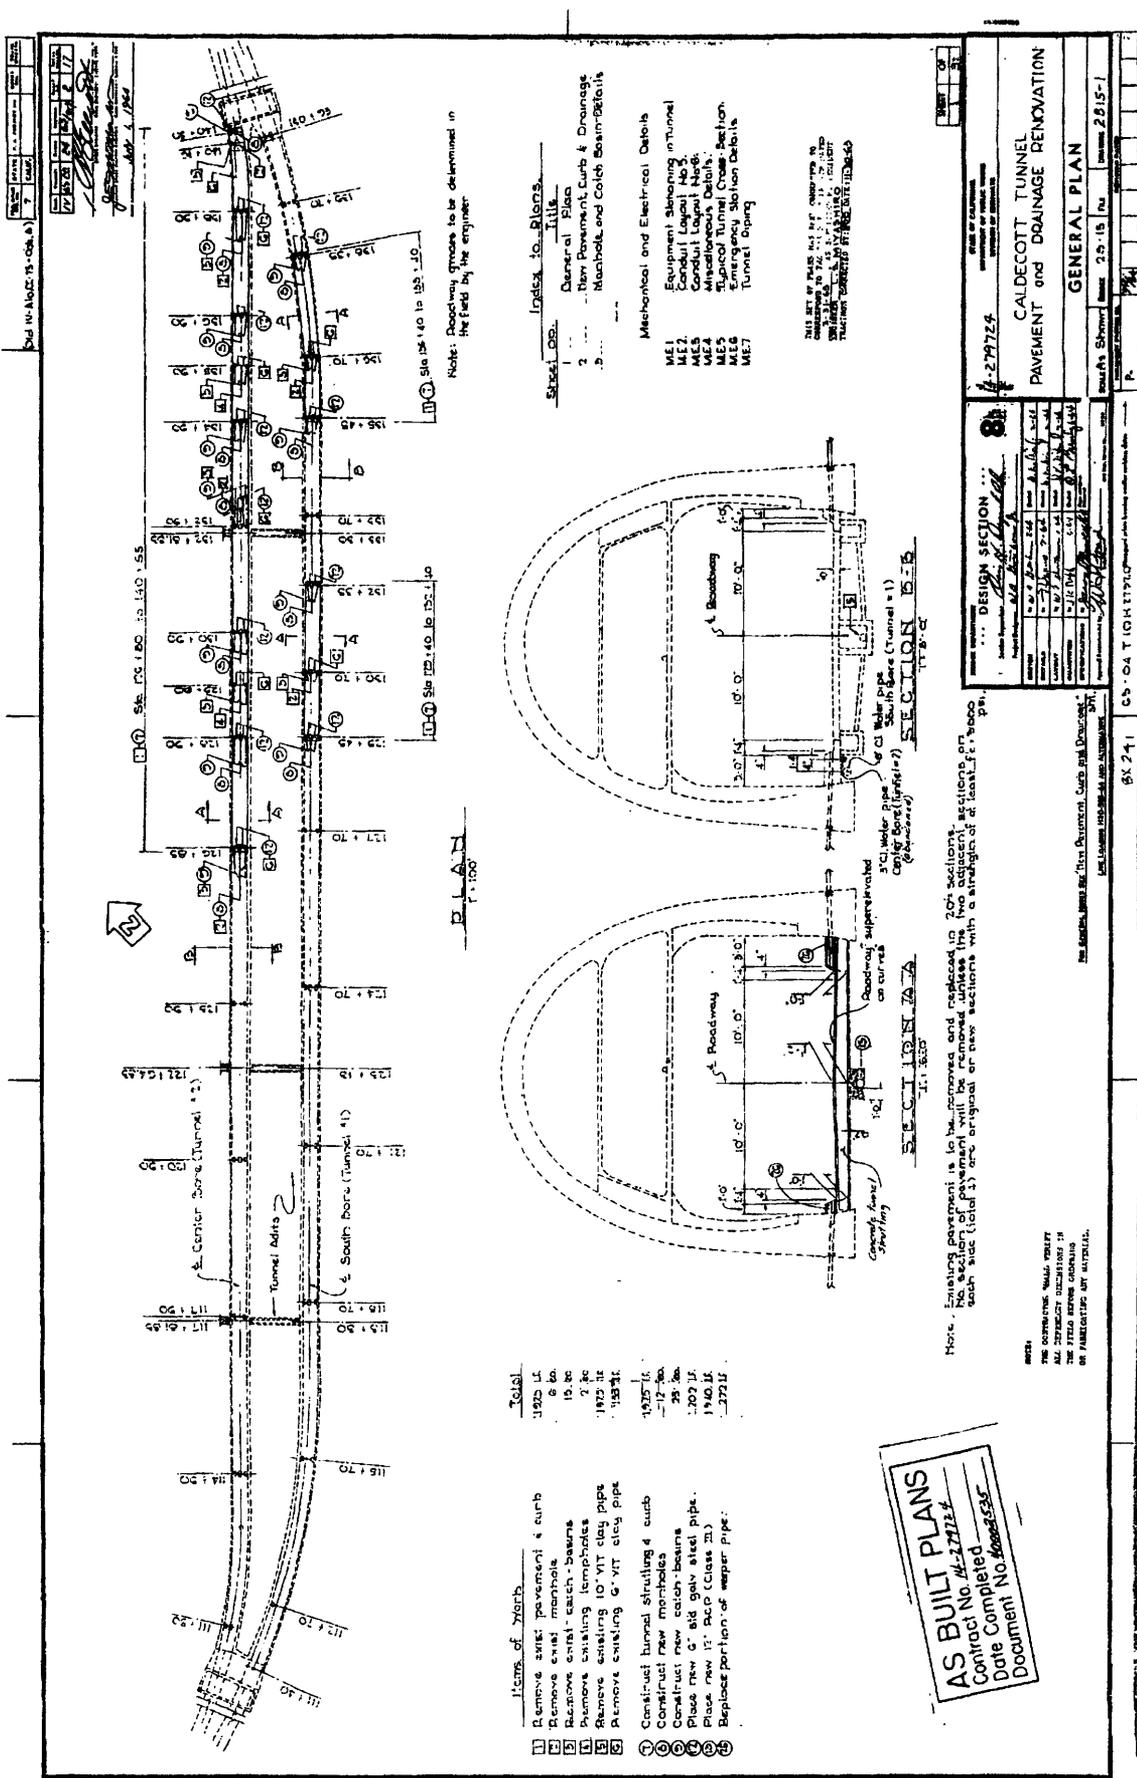
These twin reinforced concrete arch tunnels take Route 24 traffic under the Oakland Hills between the Alameda and Contra Costa Counties (fig. 315). They were built in 1964 and carry two lanes of traffic each. They were inspected and found to be in excellent condition after the earthquake. This tunnel was instrumented and although the records are of low magnitude, they provided the first information on tunnel movement during an earthquake (fig. 316).

Figure 3.15.—General Plan drawing of Caldecott Tunnel.
