The Loma Prieta, California, Earthquake of October 17, 1989— Highway Systems

Professional Paper 1552-B

This paper summarizes the impact of the Loma Prieta earthquake on highway systems. City streets, urban freeways, county roads, state routes, and the national highway system were all affected. There was damage to bridges, roads, tunnels, and other highway structures. The most serious damage occurred in the cities of San Francisco and Oakland, 60 miles from the fault rupture. The cost to repair and replace highways damaged by this earthquake was \$2 billion. About half of this cost was to replace the Cypress Viaduct, a long, elevated double-deck expressway that had a devastating collapse which resulted in 42 deaths and 108 injuries.

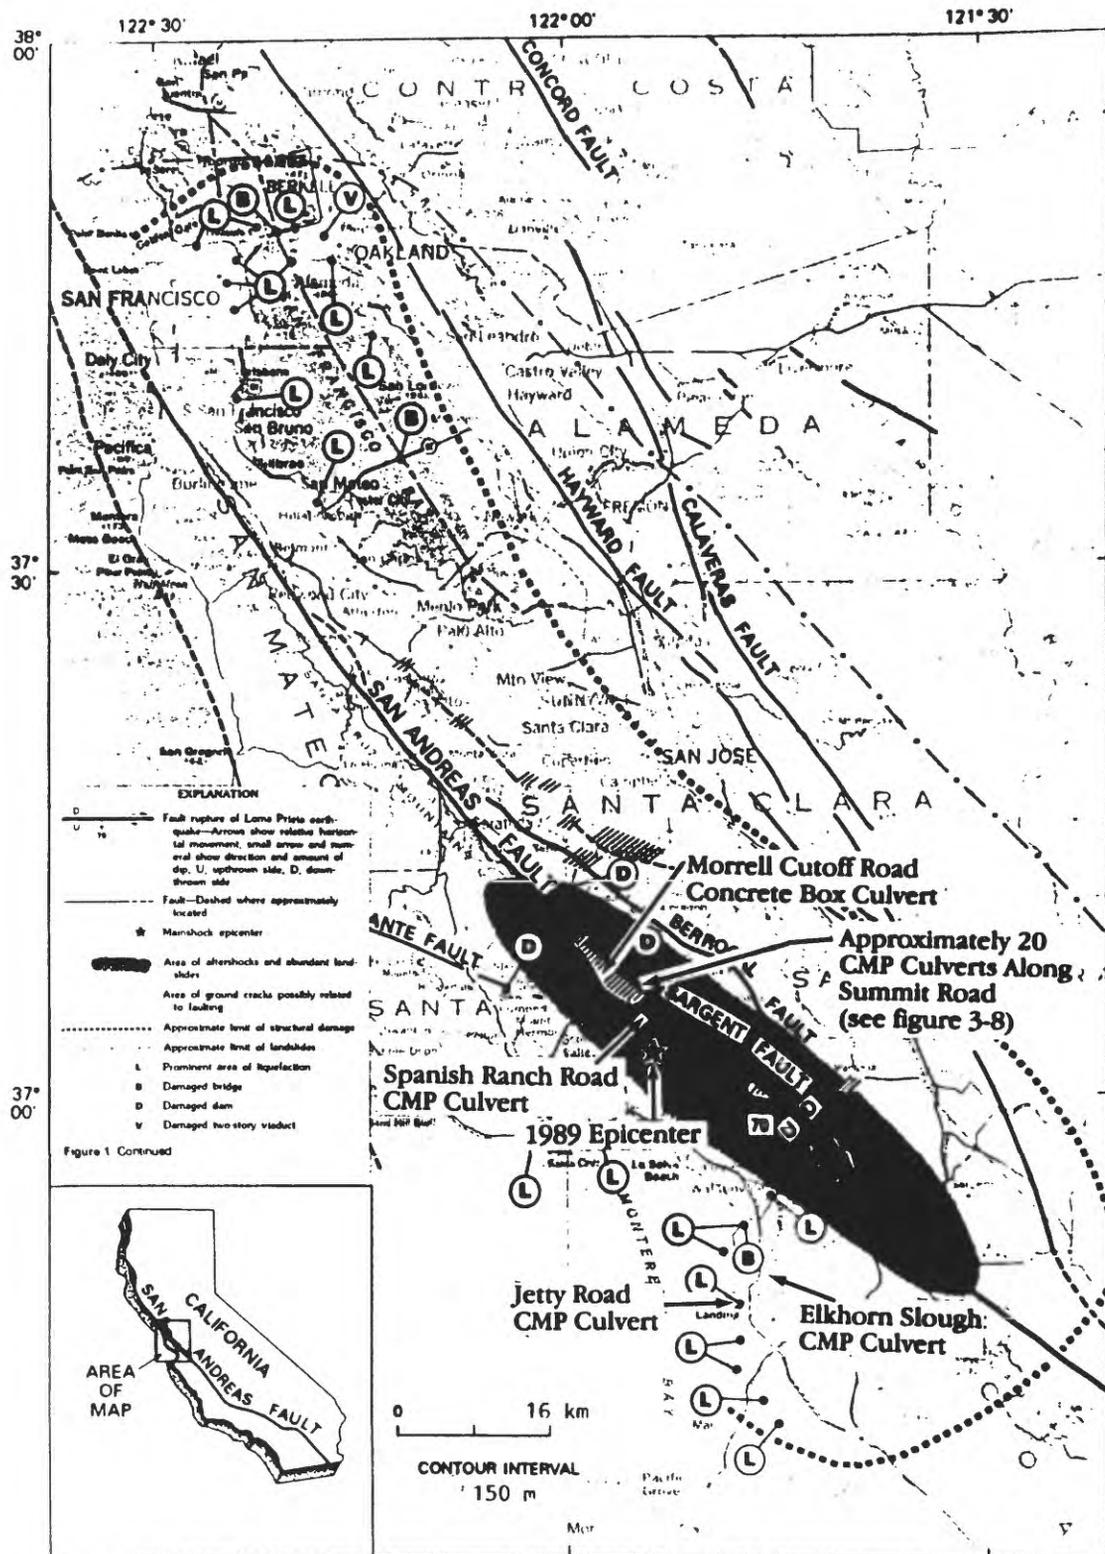
Figure 317.—Location of culvert damage (Youd, 1997).

A few culverts sustained damage during the earthquake (fig. 317). Much of the information on culvert damage comes from Youd (1997). With a few exceptions, the location of culvert damage matches the location of road damage. Usually, where ground deformation, liquefaction, or landslides damaged roads, they also damaged culverts, the exceptions being where structural damage occurred to concrete box culverts or where, surprisingly, the CMP survived roadway damage.

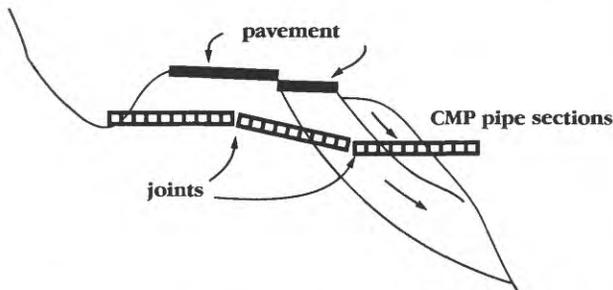
This was the only example of culvert damage as a result of a landslide during the earthquake. This was a 36-inch-diameter CMP consisting of three 20-foot-long segments tied together with a 1- to 2-foot overlap at each joint. During the earthquake, the outer third of the roadway slid down about 3 feet, slightly damaging the roadway (fig. 321). The overlaps at the joints were long enough to prevent the culvert from being pulled apart, although the culvert was slightly displaced and reoriented by the ground movement.

Figure 321.—Spanish Ranch Road culvert.

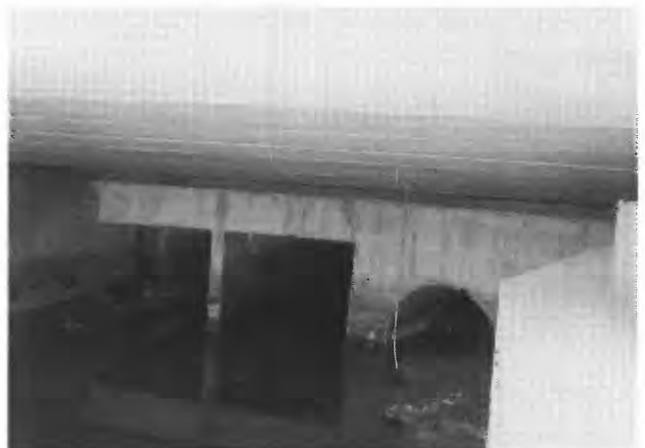
There was damage to a box culvert as a result of the earthquake. Temescal Creek flows under I-80 in Emeryville. The culvert is a double 10 by 10 foot reinforced concrete box, about 220 feet long, built under the freeway (fig. 322). There are also two 96-inch-diameter reinforced concrete pipe culverts immediately to the north. After the earthquake, the northernmost cell was inspected by rowboat. The adjacent cell was filled with mud and could not be accessed by boat (as were the pipe culverts). Cracks ran along the soffit and exterior wall of the north cell, and an expansion joint about 55 feet from the east end opened about 1 foot. This culvert is located where a great deal of liquefaction-related damage occurred to I-80. Apparently, this is another case where liquefaction damaged the roadway and the culvert. Figure 323 shows the general plan for the repair of earthquake damage to this culvert.

Figure 322.—Temescal Creek culverts.

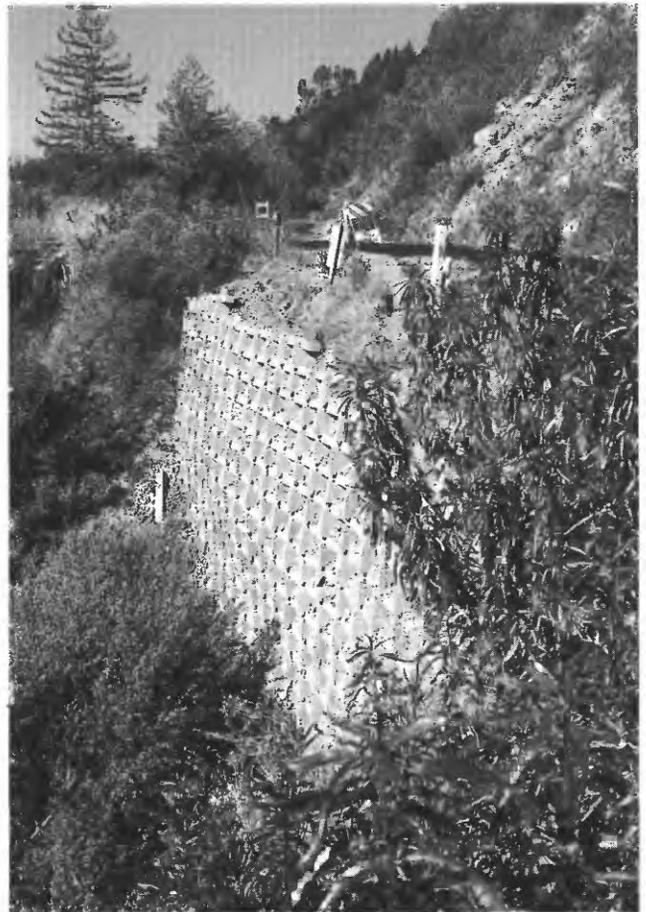
Crib walls are cells made out of precast concrete, metal, or timber elements that are filled with earth. Several crib walls in the Santa Cruz Mountains showed distortions due to settlement of the backfill (behind the wall) and movement of the wall face. The wall shown in figure 324 showed major distress halfway up the face and had backfill settlement of more than a foot. This wall may have been built at a previous landfill site.

Figure 324.—Crib wall (courtesy of Earthquake Engineering Research Institute).

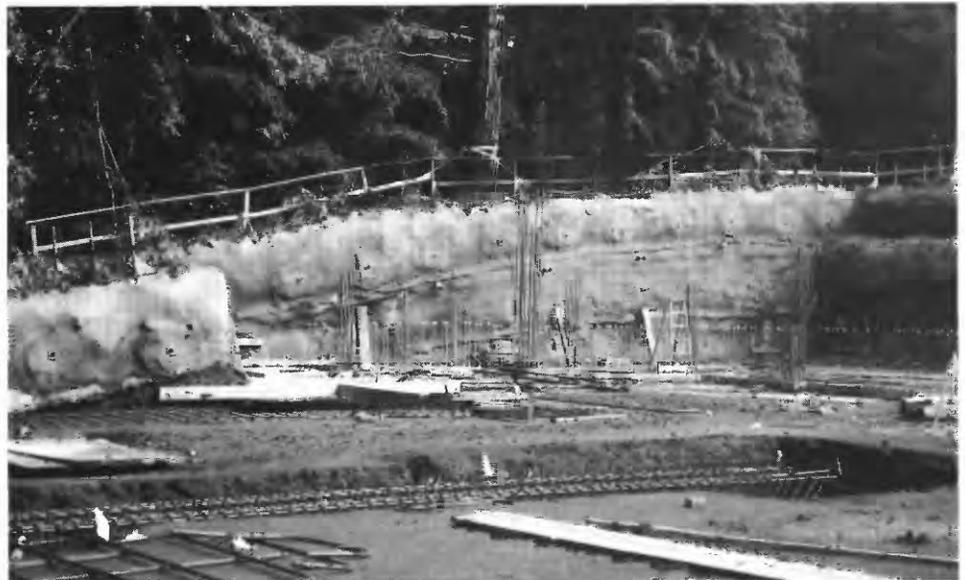
Soil-nail walls are used to temporarily hold back the soil during construction and sometimes as a permanent retaining wall. There were many soil-nail walls in the area of earthquake damage, including one (fig. 325) near the rupture zone. They all performed very well during the earthquake.

Figure 325.—Soil-nail wall (courtesy of Earthquake Engineering Research Institute).
