Streamflow and Streambed Scour in 2010 at Bridge 339, Copper River, Alaska

Professional Paper 1784–C

By Jeffrey S. Conaway and Timothy P. Brabets

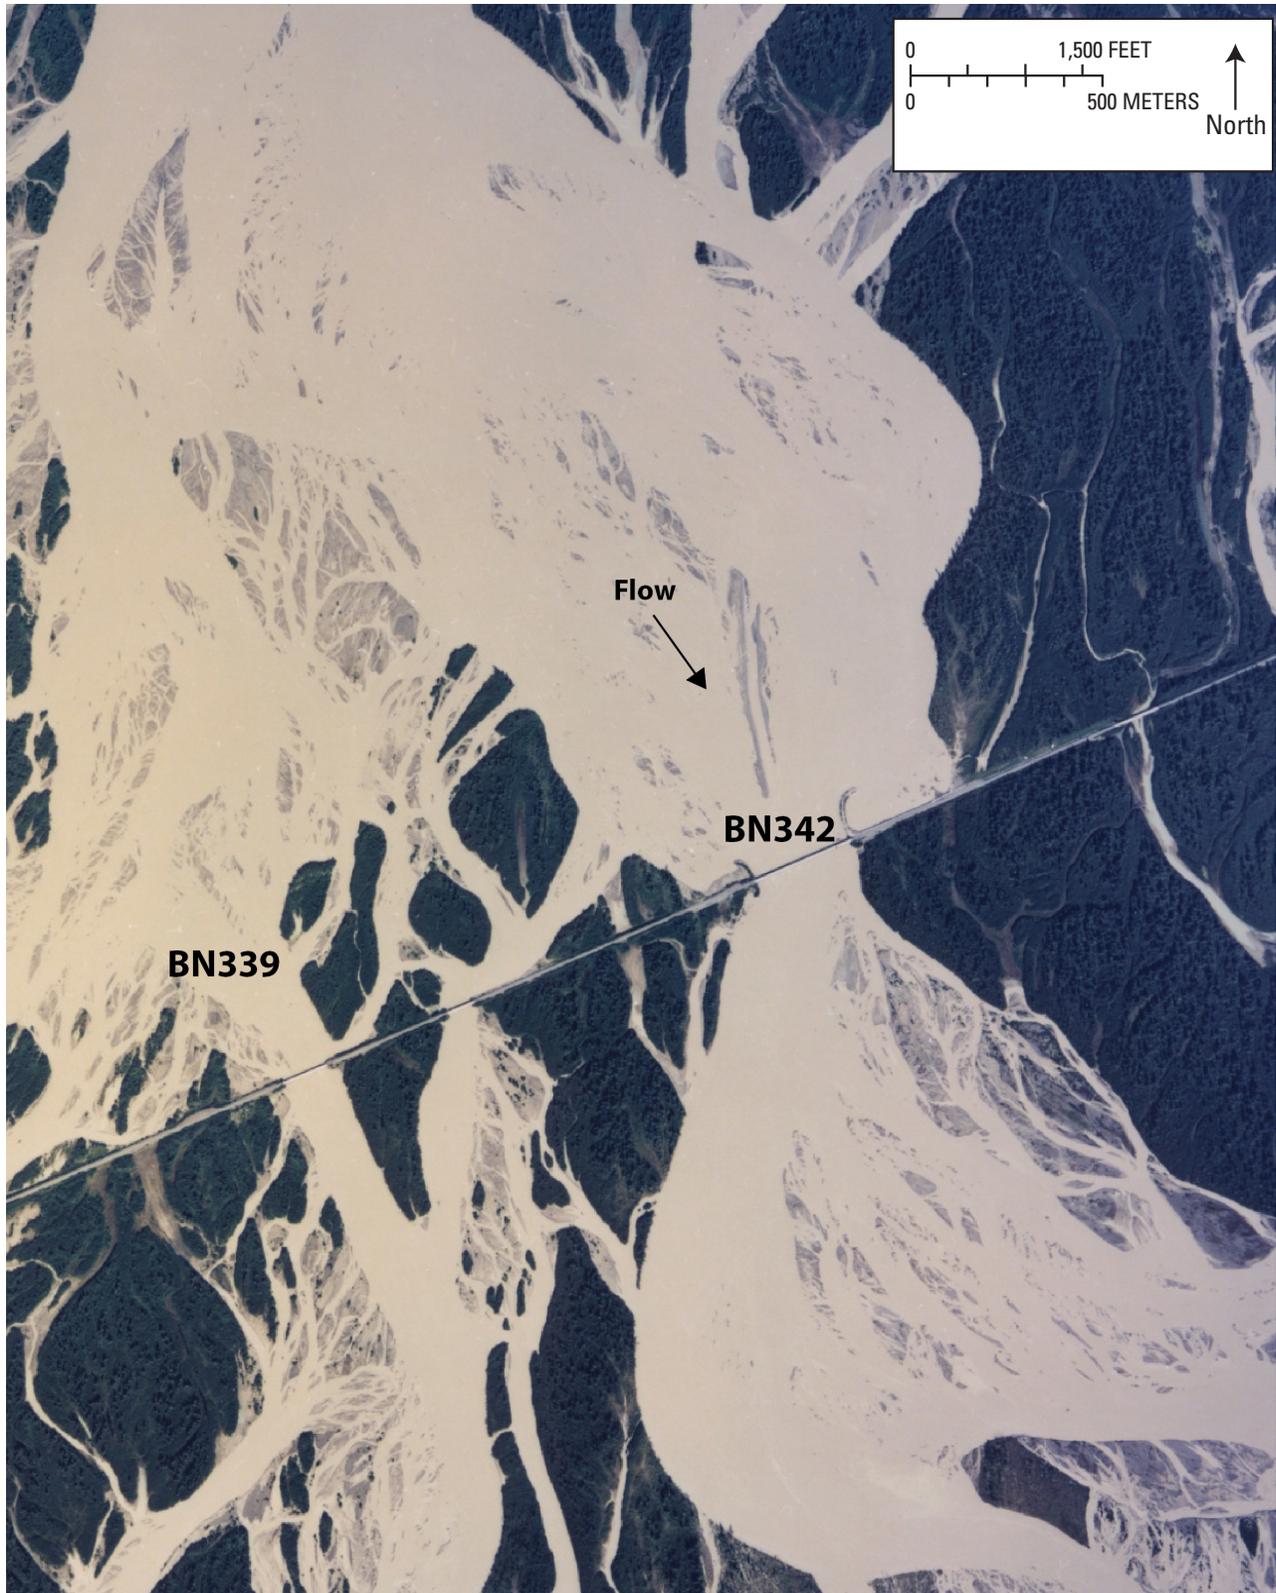
There have been three distinct changes in distribution of flow on the Copper River Delta that notably affect BN 339. The first was the large-scale eastward shift of flow from the Flag Point bridges toward BN 339 and BN 342 that occurred sometime between 1969–70 and 1982. From 1950 to 1995, flow that passed through BN 339 ranged from less than 1 to 5 percent of the total flow—1,000 ft³/s to 14,600 ft³/s—well below the design discharge for the bridge (Brabets, 1997). The second shift in flow occurred sometime between 1995 and 2005. Analysis of discharge measurements indicated that at average flow conditions, flow at the Flag Point bridges shifted from approximately 50 percent of the total during 1991–95 to approximately 5 percent of the total during 2005–7, and flow passing through BN 339 and BN 342 increased from 50 percent of the total during 1991–1995 to 95 percent of the total during 2005–7 (Brabets and Conaway, 2009). Measurements from 2005–10 indicate that the flow toward the Flag Point bridges increases proportionately with increases to the overall discharge of the Copper River.

Figure 3. Aerial photograph of the lower Copper River, Alaska, near bridge numbers (BN) 339 and 342 taken in August 2002. (USGS image.)

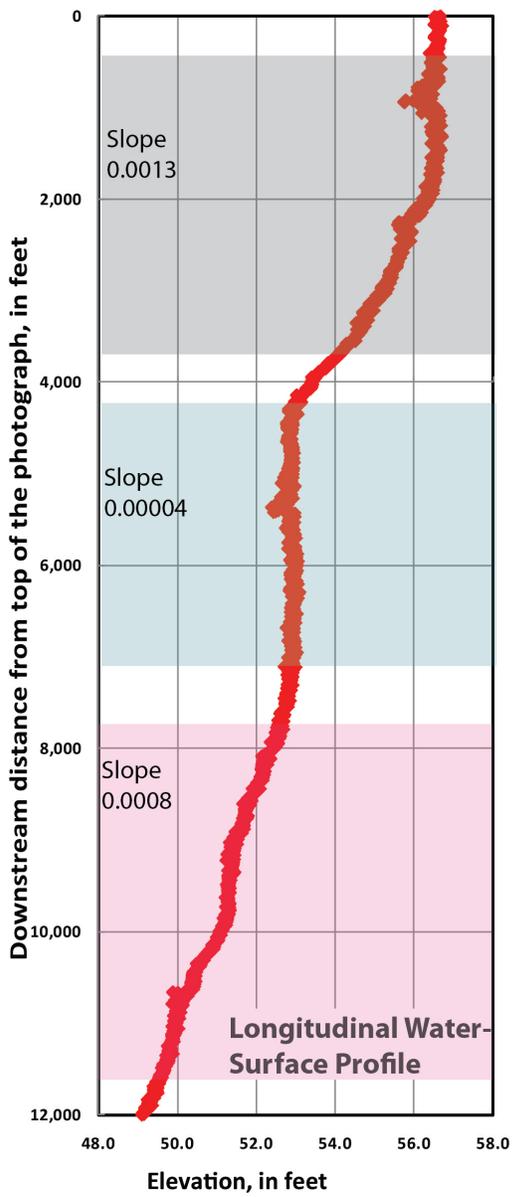
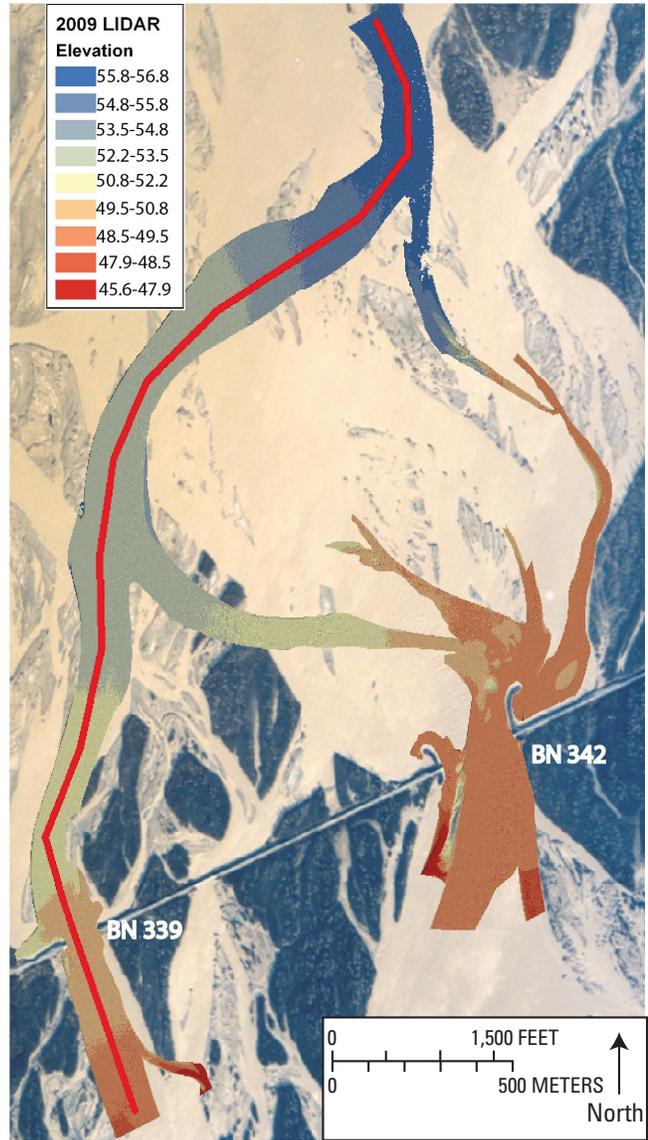
Lidar water surface on November 7, 2009

the deepest channels on the braid plain actively convey water. A sinuous, single-thread channel approaches BN 339 and BN 342 and then bifurcates approximately 3,500 ft upstream of BN 339. There are three distinct water-surface slopes along this channel (fig. 8). The upstream section slope is the greatest at 0.0013 ft/ft and this part of the channel traverses from east to west across the braid plain. The slope of the next section is nearly flat at 0.00004 ft/ft for 3,600 ft until the slope increases to 0.0008 ft/ft through BN 339. Reductions in slope along a river result in decreased sediment transport capacity, deposition of sediment as bars, and diversion of flow toward the outer banks (Leopold and others, 1964). The bifurcation is located near the apex of large curve in the low-flow channel. Migration of this low-flow channel will likely continue west and continue to favor flow toward BN 339.

Figure 8. Copper River, Alaska, water-surface elevations from the November 7, 2009, lidar dataset that was collected at a total discharge of 16,800 ft³/s. (USGS image.)

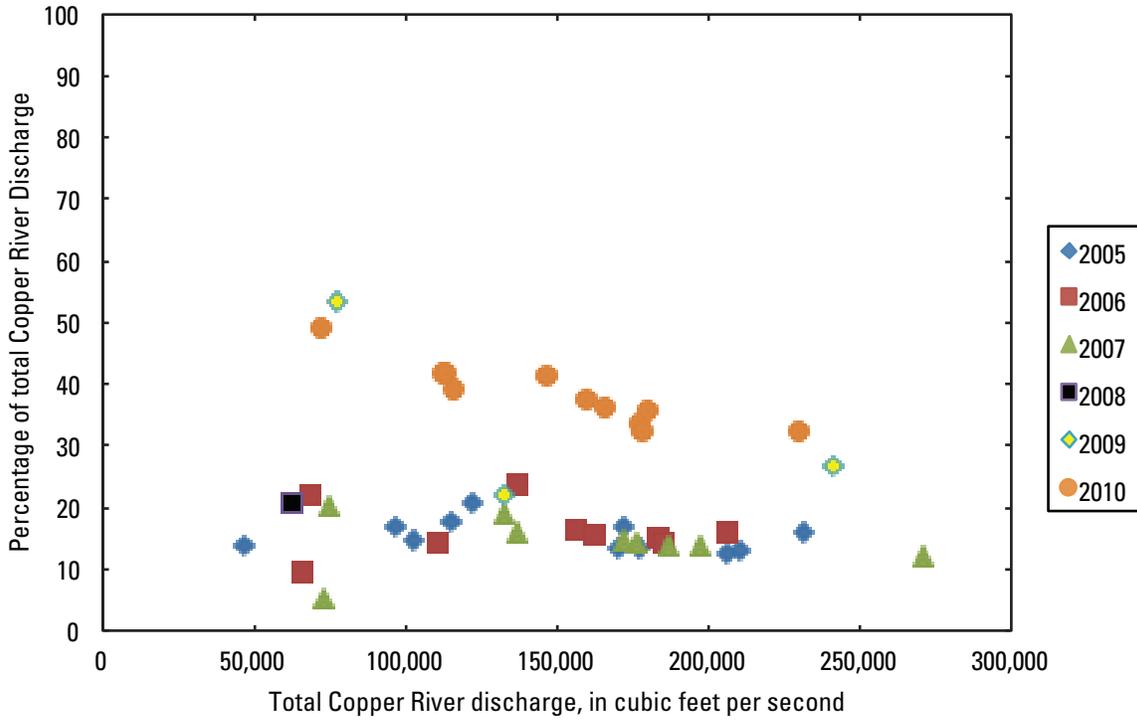
Discharge measurements in 2009 indicated a shift in flow distribution from BN 342 to BN 339. In 2010, as much as 49 percent of the total flow of the Copper River went through BN 339 (fig. 9). However, the discharge at BN 339 remained relatively constant through the open-water season compared with the overall discharge of the Copper River, and the percentage of flow through BN 339 decreased when the overall Copper River discharge increased (fig. 9, table 2). In 2010, flow through BN 339 was never less than 30 percent of the total Copper River discharge. Over the same time period, a decreased percentage of the total Copper River flow passed through BN 342 to the east (fig. 10). The measured discharge at BN 342 from 2005 through September of 2009 was only once less than 50 percent of the total Copper River flow but never exceeded 45 percent in 2010. The percentage of flow passing through BN 339 was higher for the lower discharges in spring and fall of 2010 (49.2 percent on September 22) indicating that this is an established channel. From June to August 2010 streamflow at BN 339 was in excess of 45,000 ft³/s, and the maximum stage was recorded on August 5 (51.8 ft (all elevations in this report are in the datum of the bridge as-built plans) (fig. 11). In 2010, ten discharge measurements were made at BN 339 (table 2), with discharge ranging from 35,700 ft³/s to 74,000 ft³/s.

Figure 9. Discharge measurements from 2005–10 at Copper River, Alaska, bridge number (BN) 339 and their percentage of the total river discharge.

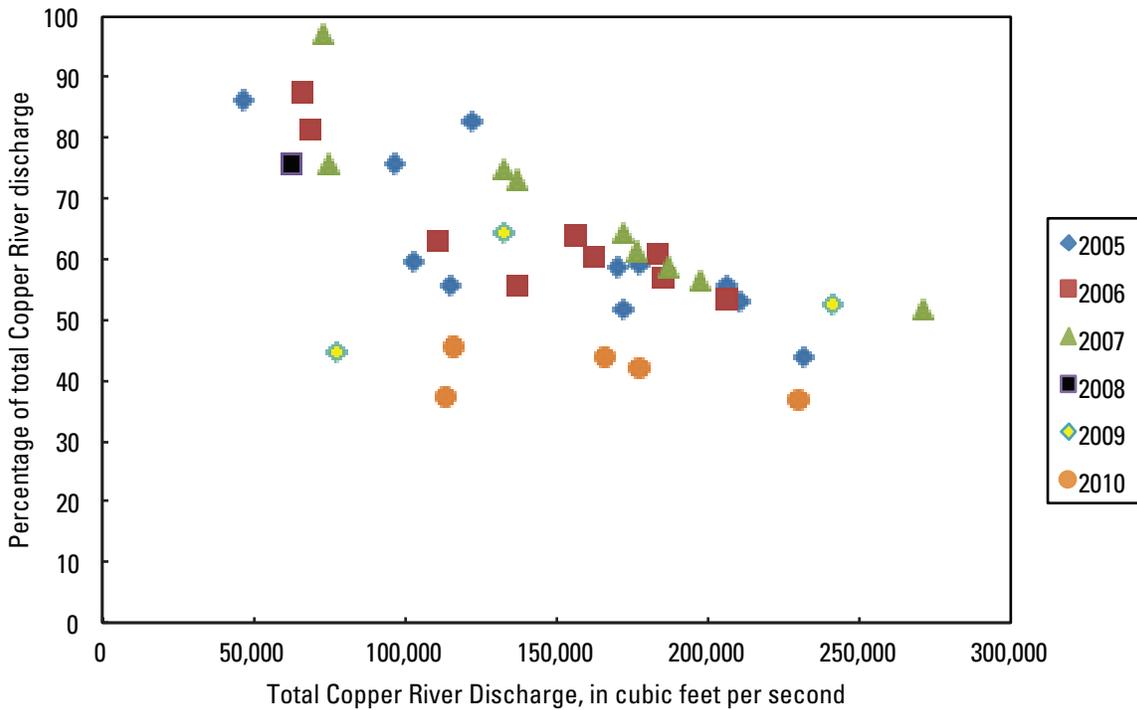
Figure 10. Discharge measurements from 2005–2010 at Copper River, Alaska, bridge number (BN) 342 and their percentage of the total river discharge.

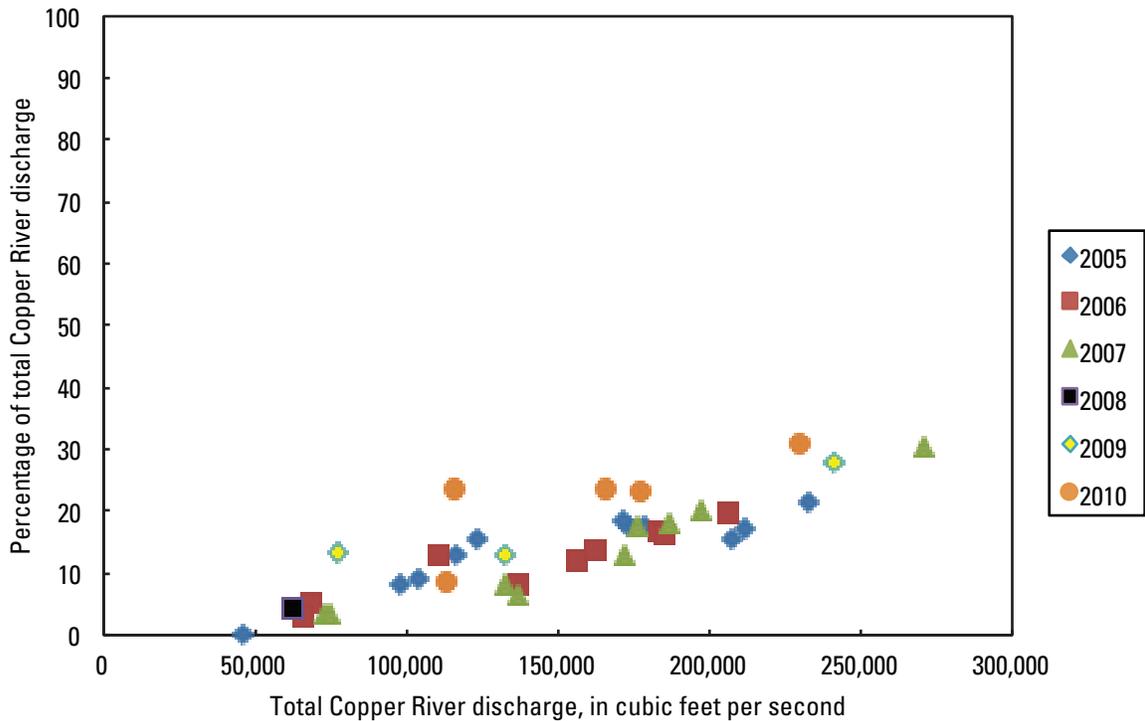
As stage increases, water/flow enters the channels to the Flag Point bridges. The measured discharge at the three Flag Point bridges from 2005 through June 2009 was never greater than 25 percent of the total Copper River discharge (fig. 12). The distribution of flow to the Flag Point bridges—BN 331, BN 332, and BN 1187—has remained consistent from 2005 to 2010 (fig. 12).

Figure 12. Discharge measurements from 2005–10 at Copper River, Alaska, bridge numbers (BN) 331, 1187, and 332, and their percentage of the total river discharge. Discharge represents the combined flow of BN 331, 1187, and 332.

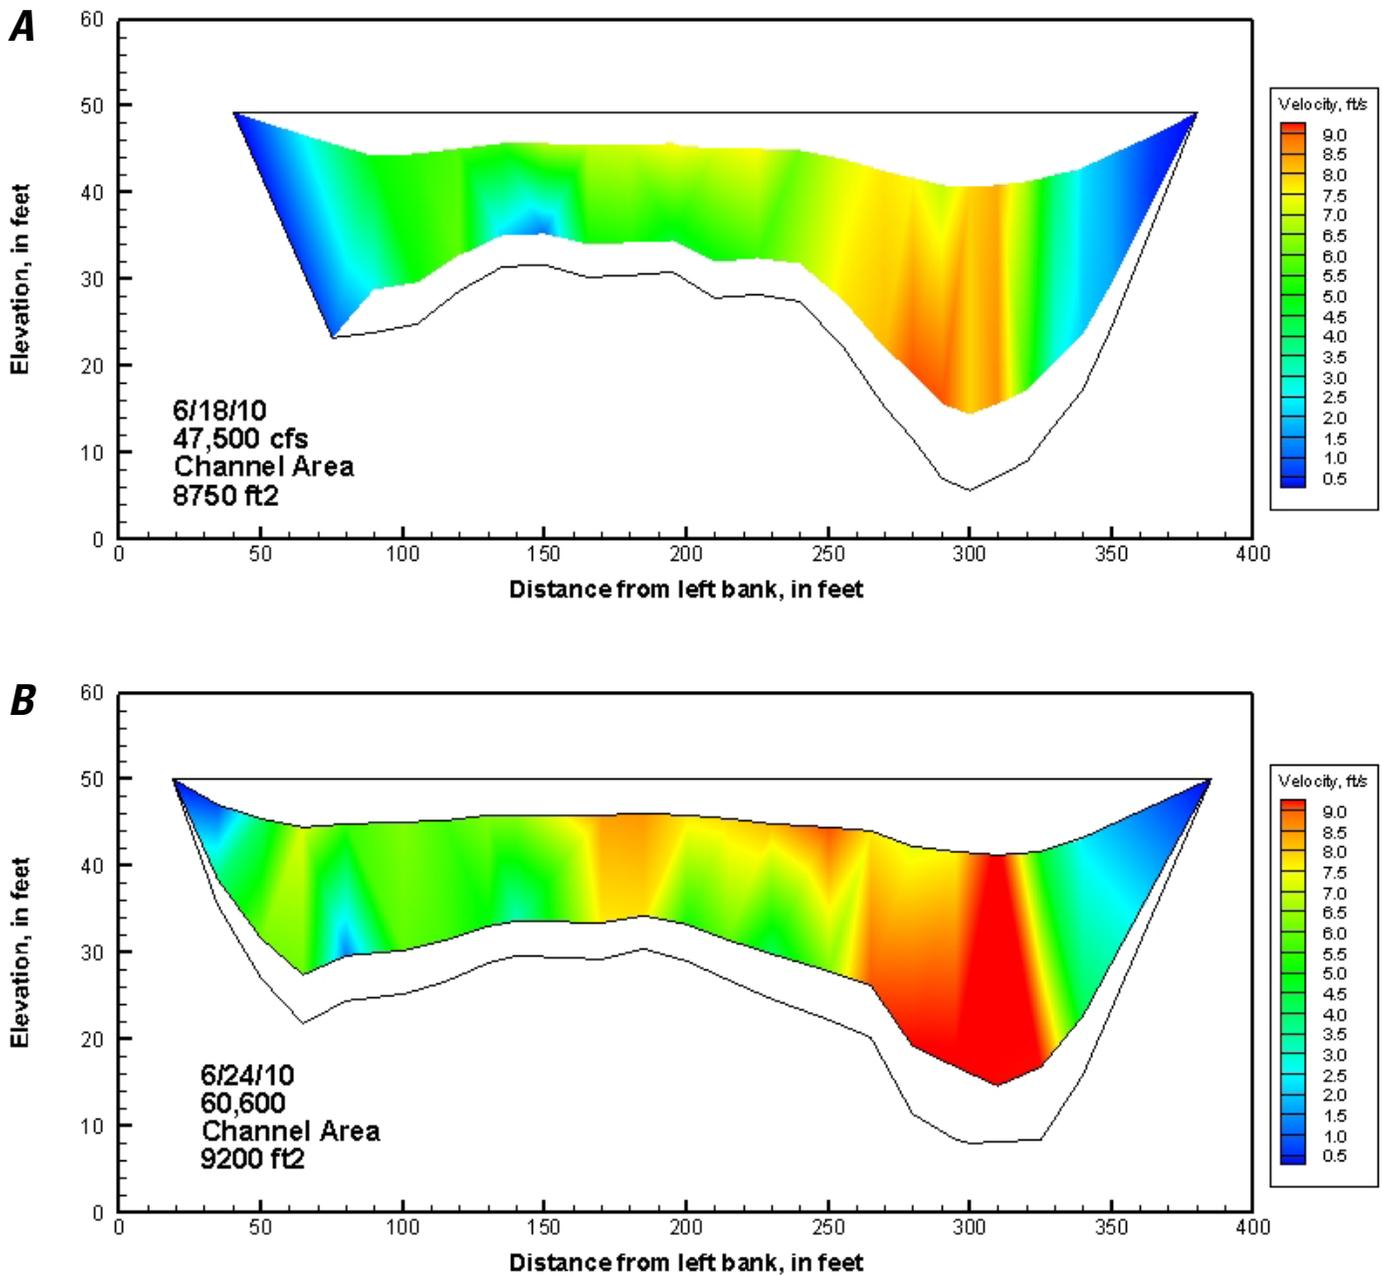
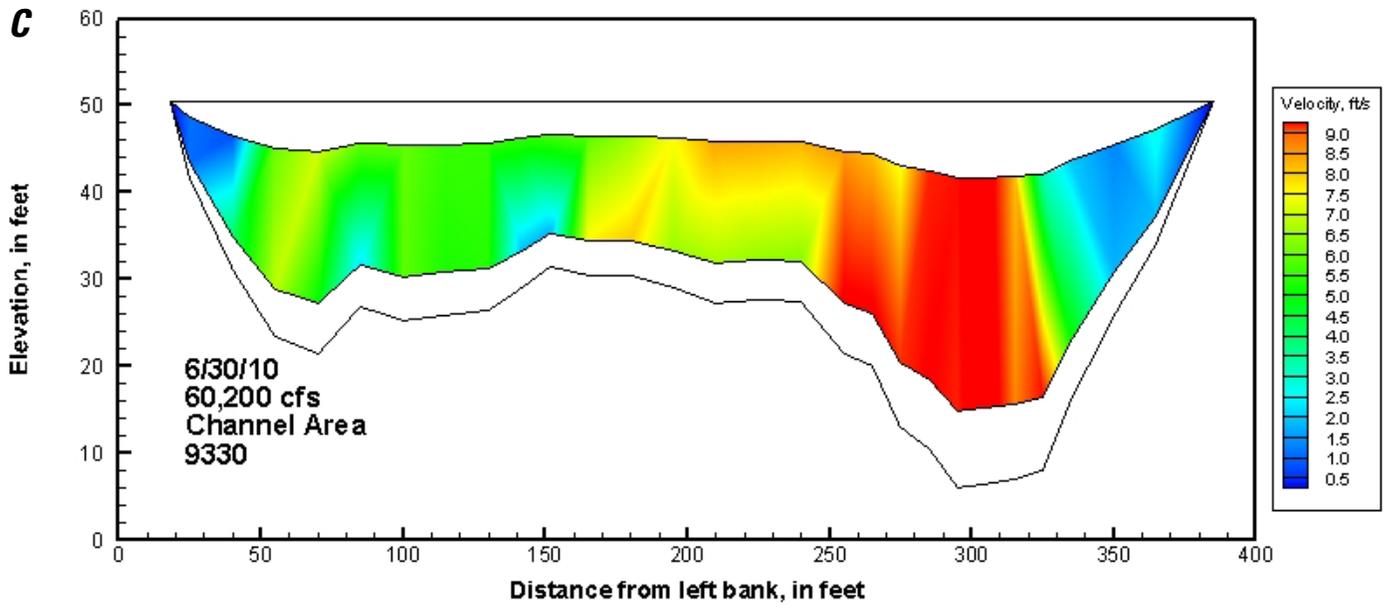
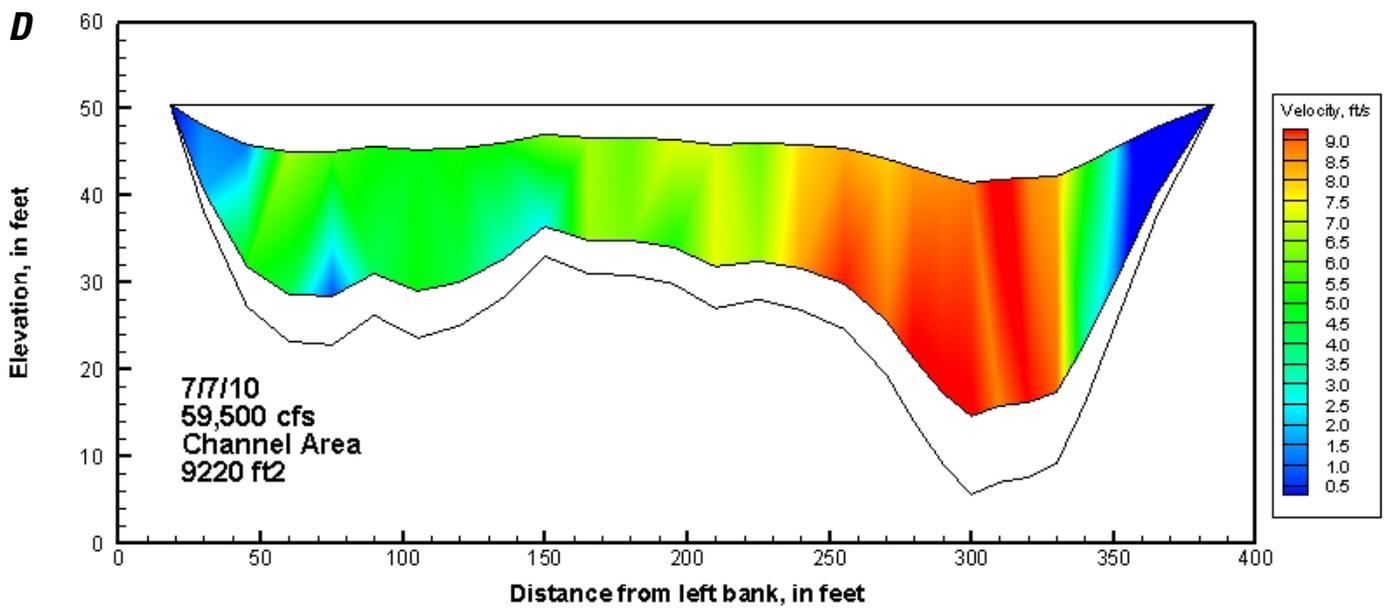
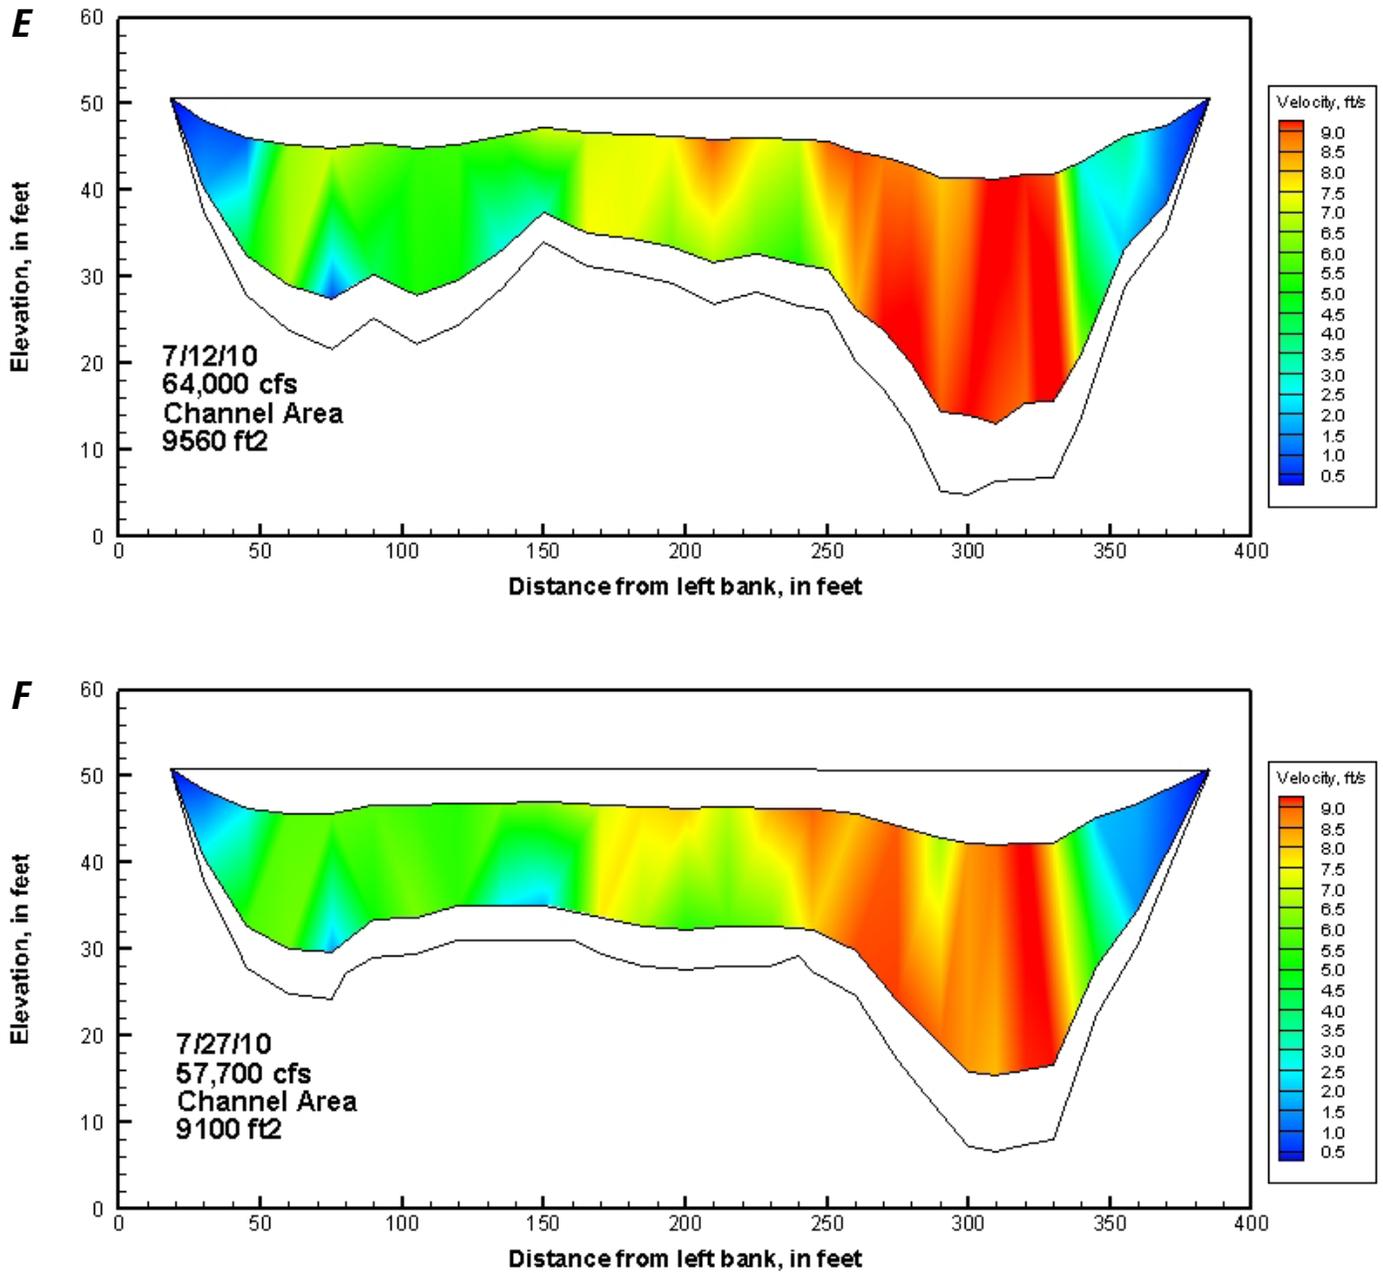
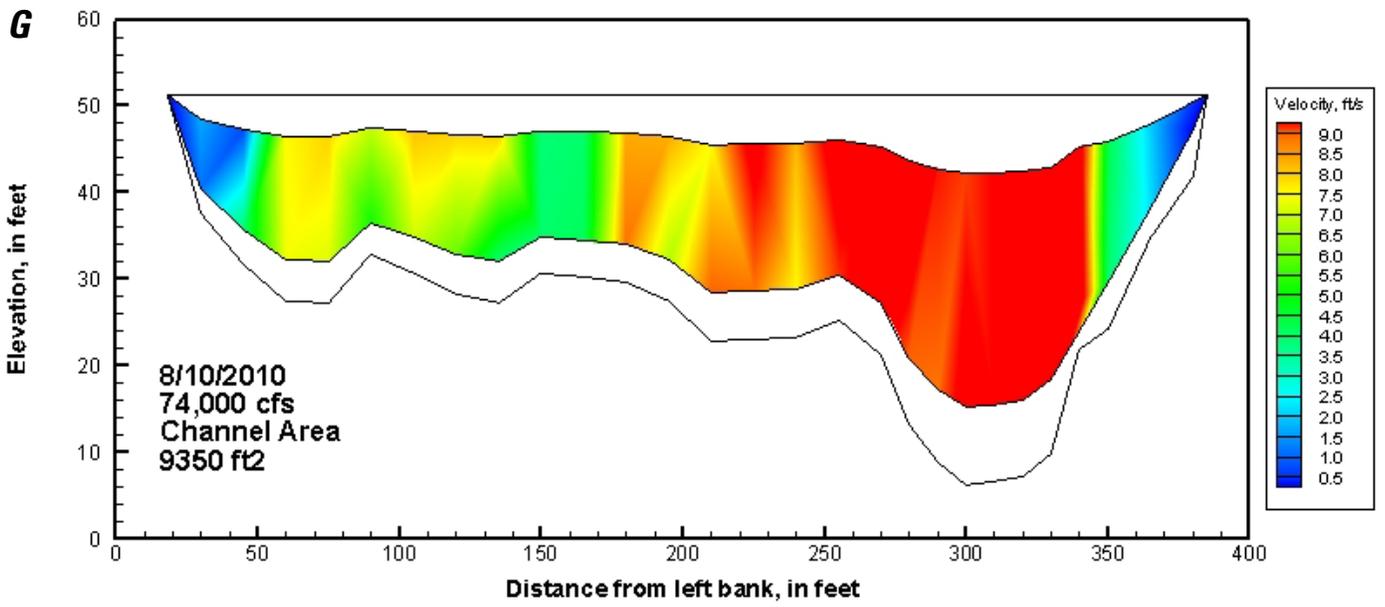
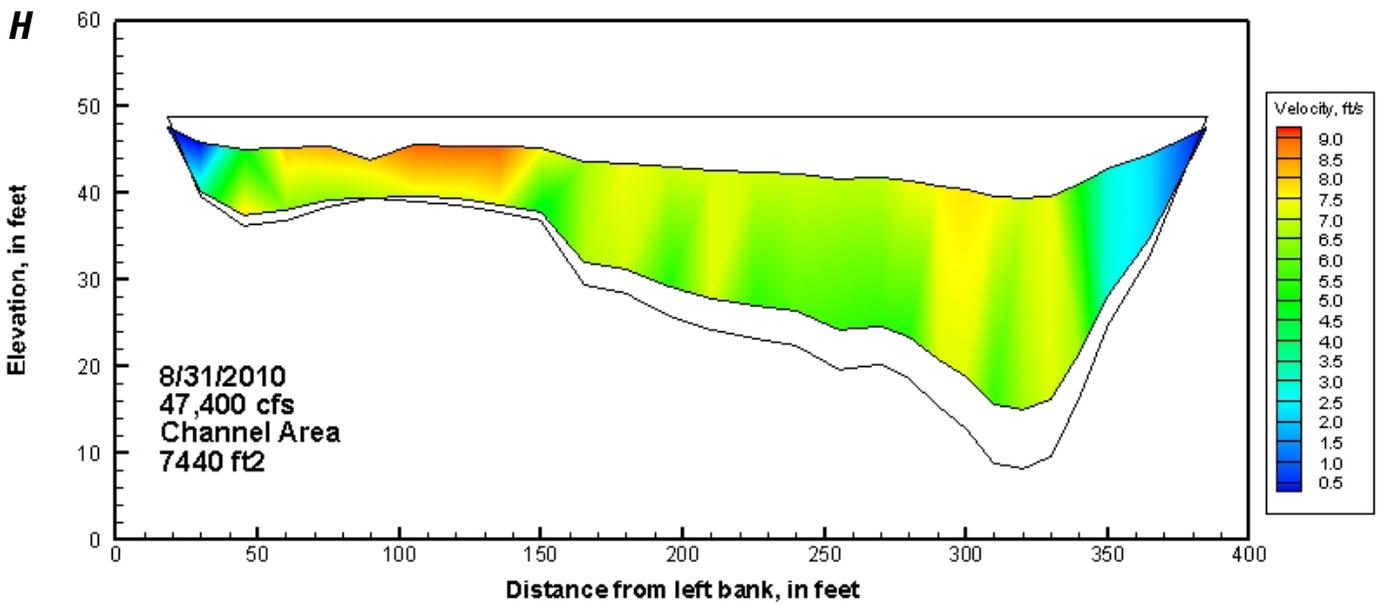
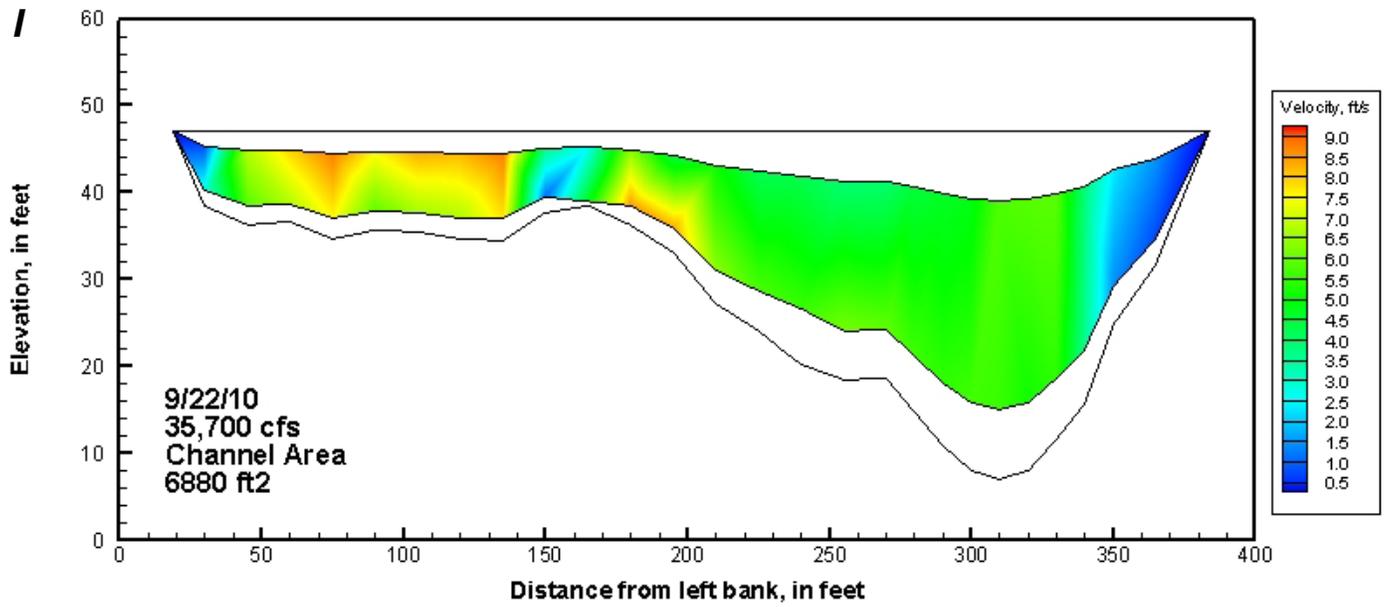
The main channel to BN 339 has changed continuously from 2002 to 2010. Brabets and Conaway (2009) documented the migration of this channel initially toward the west (right bank) and then back toward the east (left bank) in 2008. In 2010, the approach channel was skewed to the bridge opening and directly attacked the right bridge abutment (figs. 13 and 14). This migration reduced undermining and scour along the right bank approach, but increased these processes at the right bank abutment and scoured the streambed across the channel (figs. 15 and 16). Channel area below a datum of 50.0 ft increased from 4,130 ft² on July 1, 2009, to 8,850 ft² on July 6, 2010. This increase in channel area was the result of as much as 20 ft of scour along the left part of the channel as the approach channel became more aligned with the bridge opening. Maximum channel depths were along the right side of the channel, and scour at piers 2 and 3 nearly reached the criterion for minimum embedment.

Figure 16. Velocity contour plots from discharge measurements made during 2010 at Copper River, Alaska, bridge number (BN) 339. A, June 18, 2010; B, June 24, 2010; C, June 30, 2010; D, July 7, 2010; E, July 12, 2010; F, July 27, 2010; G, August 10, 2010; H, August 31, 2010; I, September 22, 2010.
