## STRUCTURAL DAMAGE AND GROUND FAILURES FROM THE NOVEMBER 16, 1983, KAOIKI EARTHQUAKE, ISLAND OF HAWAII

By Jane M. Buchanan-Banks

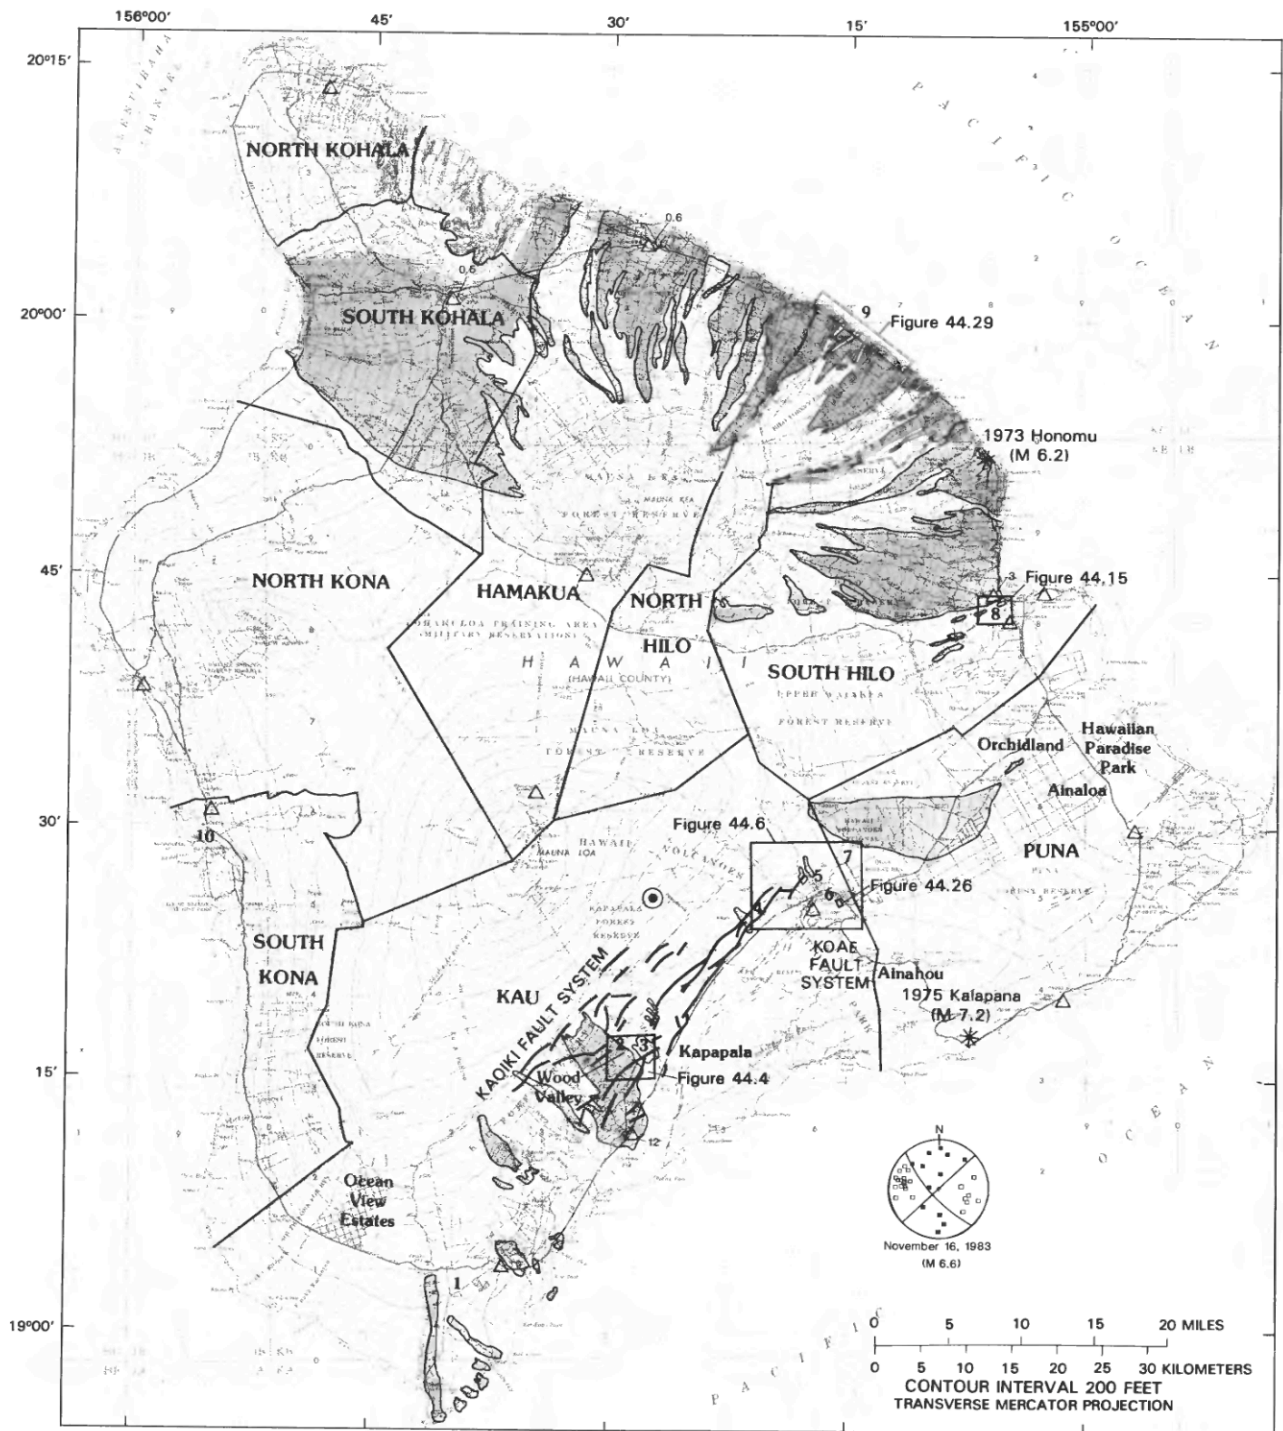
FIGURE 44.1.—The Island of Hawaii showing epicenters of November 16, 1983, Kaoiki earthquake and two earlier damaging earthquakes; also shown are areas of 1983 structural damage and earthquake-related ground failures discussed in text. Additional text figures cited where applicable. Inset shows focal-mechanism solution for 1983 earthquake from Endo (1985, p. 186): *P*-wave first motions plotted on lower hemisphere equal-angle stereonet; open squares, down first motions; solid squares, up first motions. Topography from U.S. Geological Survey Hawaii Island series W532, 1975, 1:250,000.

1 Areas of structural damage or ground failure during 1983 earthquake: 1, Ka Lae Road; 2, Wood Valley; 3, Kapapala Ranch house; 4, Ranch house at east end of Kapapala Ranch; 5, Volcano Golf and Country Club Sub-division and Keauhou Ranch house; 6, Hawaii Volcanoes National Park; 7, Upper Wright Road; 8, Hilo; 9, North Hilo District; 10, Kealekekua Bay

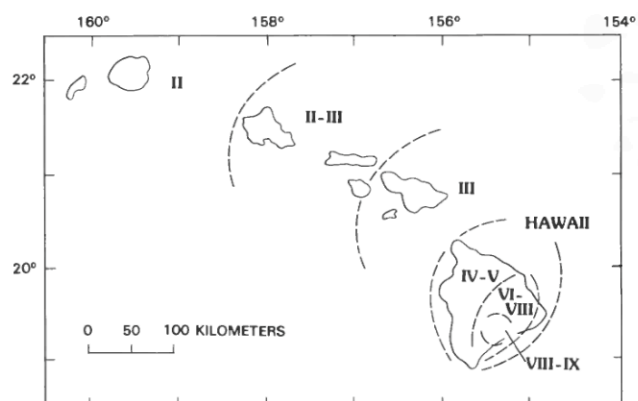
FIGURE 44.2.—Isoseismal map for November 16, 1983, earthquake prepared from observations of damage and felt reports from residents compiled by Hawaii County Civil Defense Agency. Numbers indicate intensity on modified Mercalli scale (from Koyanagi and others, 1984, fig. 3).

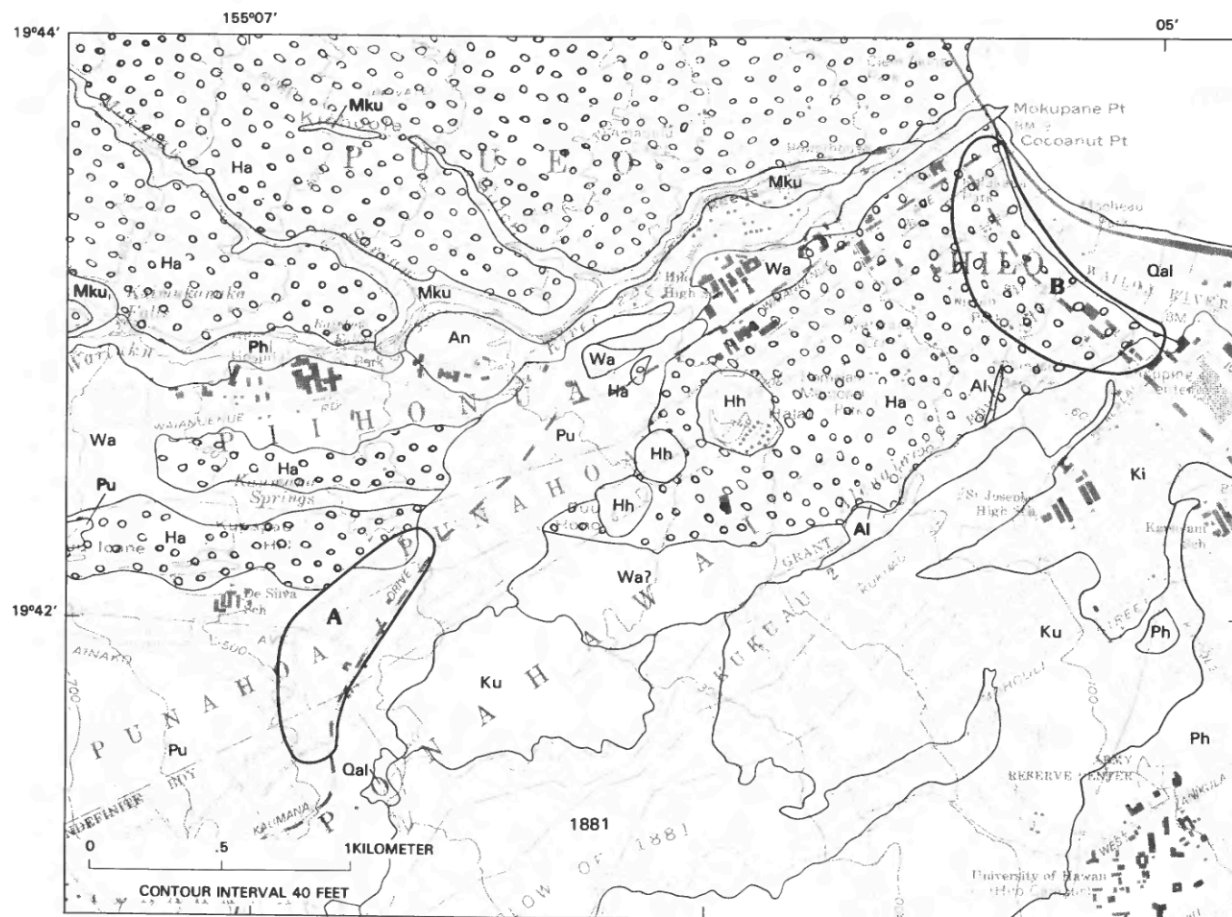
FIGURE 44.15.—Geologic map of Hilo and vicinity showing areas of structural damage from November 1983 earthquake (fig. 44.1, locality 8). Adapted from Buchanan-Banks and Lockwood (1982). Topography from U.S. Geological Survey Hilo 7.5-minute quadrangle, 1981, scale 1:24,000.

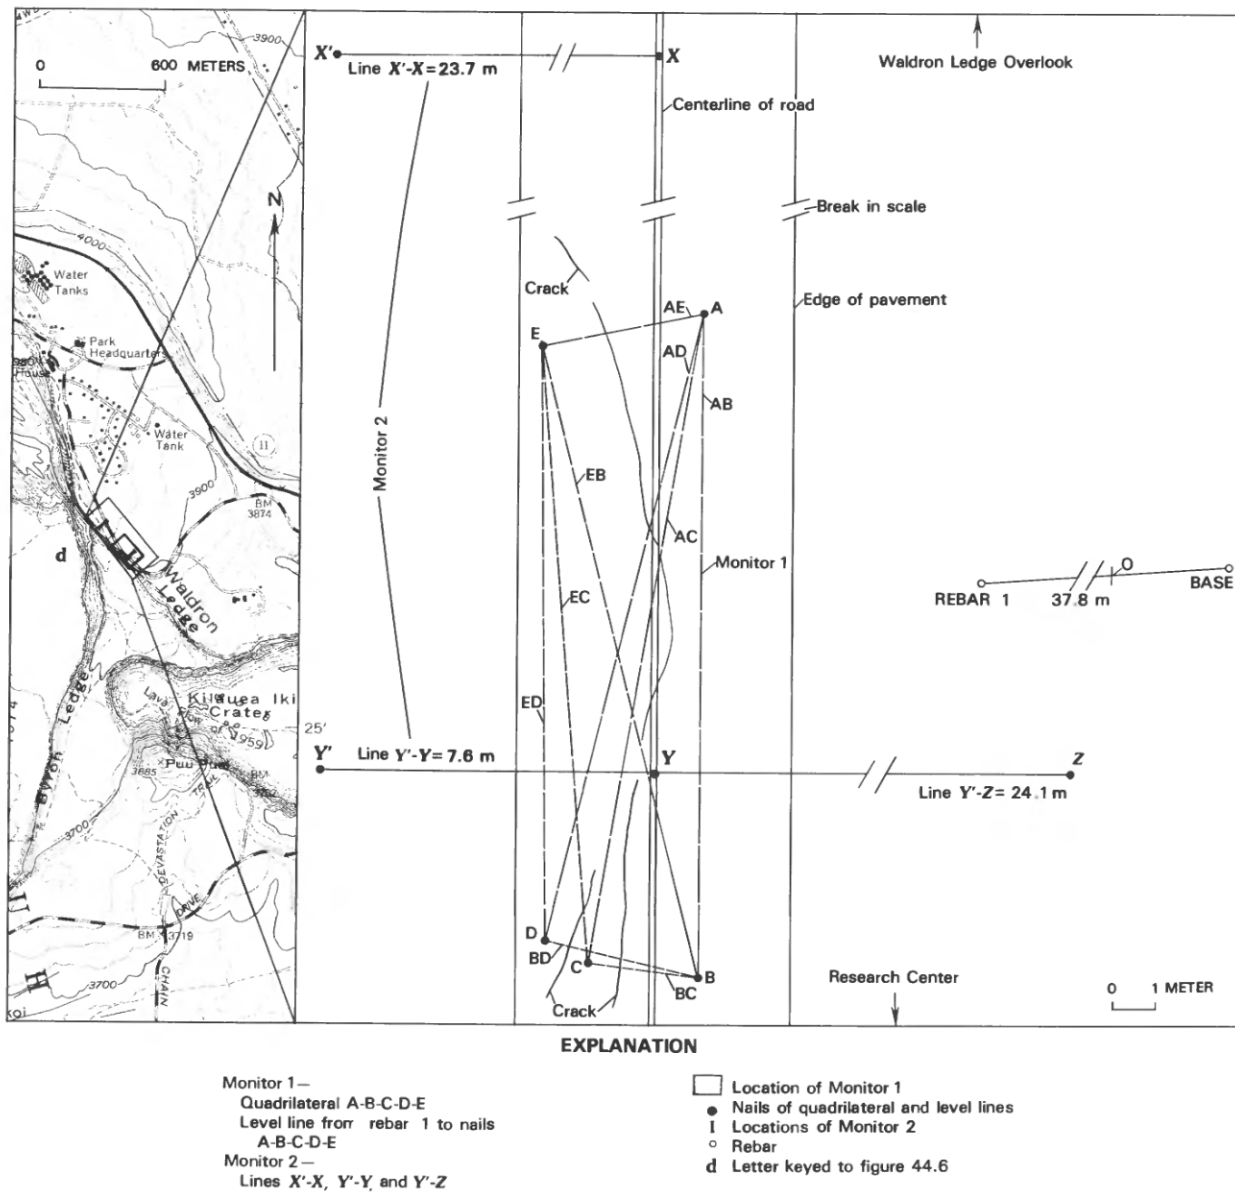
Monitor 1 consisted of five nails set out as a quadrilateral centered over the road cracks (fig. 44.26). The distance between the nails was measured with steel tape once a week for the first month, then once a month for the next few months, and thereafter with lessened frequency (table 44.4). Within the first few months, nearly all the lines began showing measurable and cumulative extension, particularly those normal to the cracks (figs. 44.26, lines AE, BC, BD, 44.27A). In addition, the cracks had lengthened at both ends, and vertical offsets had become apparent.

To assess the rate of vertical change, a leveling line was added to monitor 1 in November 1980; it consisted of two lengths of rebar driven into bedrock, rebar 1 and Base, in a line northeast of, and off, the landslide (fig. 44.26). The level gun was placed at point 0 between the rebars to check their respective stabilities (fig. 44.26, right center); the gun was then moved to rebar 1 and the rod to each nail of the quadrilateral to measure its elevation.

Monitor 2 was added to the program in April 1981 to measure horizontal movement on cracks not crossed by the quadrilateral (fig. 44.26). Line X'-X was established northwest of the quadrilateral beyond the zone of visible cracking; it extended 23.7 m from X', a nail in a tree at the caldera edge to X, a nail in the centerline of the road. A second line was established across the quadrilateral and comprised two segments; one segment, line Y'-Z (24.1 m) was measured from Y', a nail in a tree at the caldera's edge to Z, another nail in a tree northeast of the road, and the second segment, line Y' to Y.

FIGURE 44.26.—Location map and plan of monitors established by USGS across series of cracks in Crater Rim Drive near Waldron Ledge. Topography from USGS Kilauea Crater 7.5-minute quadrangle, 1981, scale 1:24,000.

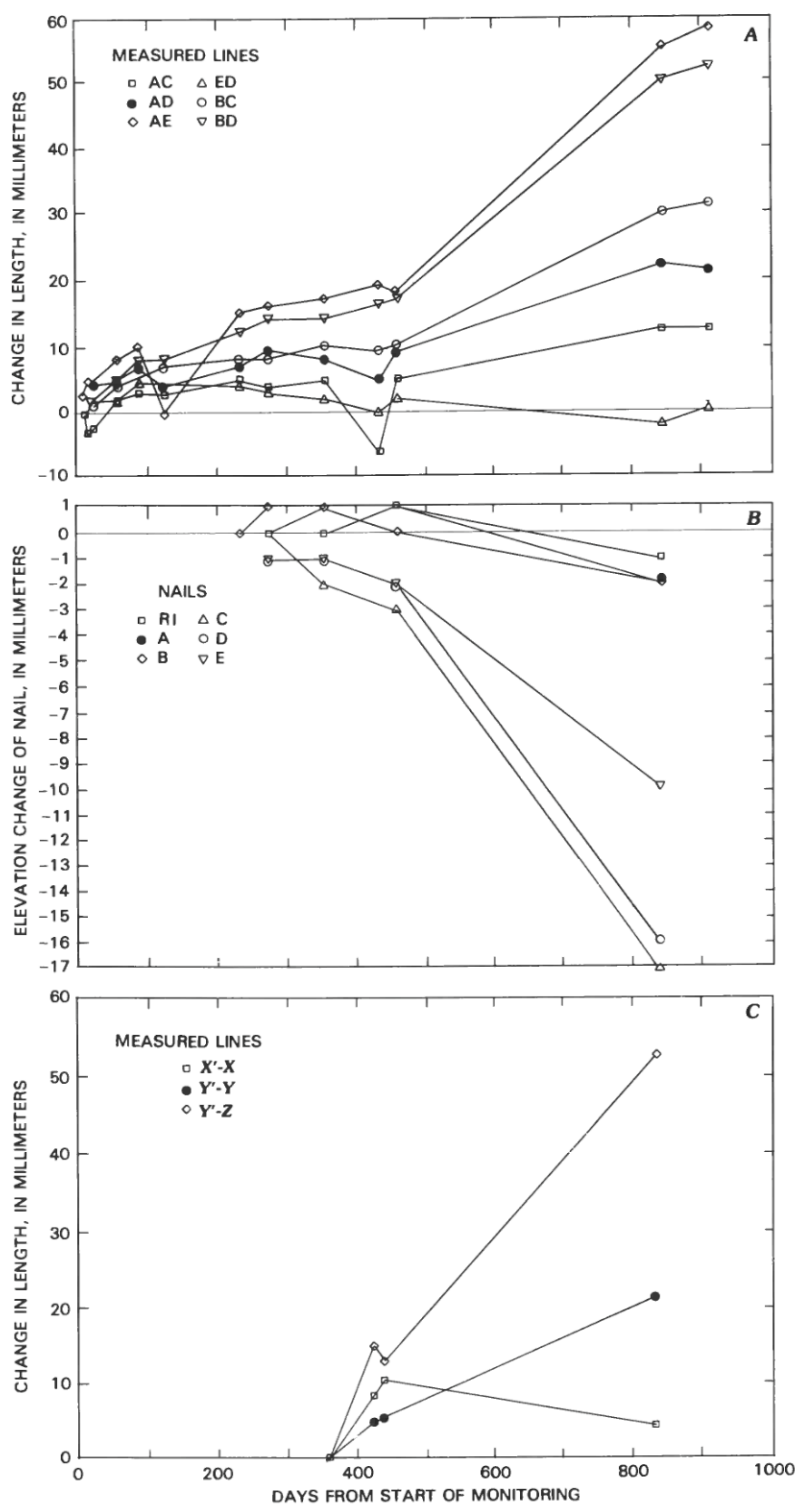
The lines of the quadrilateral were measured 14 times between April 1980 and October 1982 (table 44.4). Cumulative extensions above background level on the lines normal to the cracks (for background level see data for line ED, parallel to the cracks) was detected within a few months of the establishment of monitor 1 (fig. 44.27A). Continued documented movement of the incipient landslide block toward the caldera led to a decision by the Superintendent, Hawaii Volcanoes National Park, to close this section of road to traffic in April 1981 (fig. 44.6, site *d*). Although monitoring frequency decreased after the closing of the road, accelerated movement both laterally and vertically can be seen in the data after July 1981. The largest changes in line lengths within the quadrilateral occurred between July 1981 and July 1982 on lines AC, AD, AE, BC and BD, crossing the cracks (table 44.4, fig. 44.27A). The largest vertical changes also occurred during the same period when nails C, D, and E (the three on the caldera side of the cracks), moved downward with respect to rebar 1 (table 44.4, fig. 44.27B).

Line Y'-Z, which also crossed the cracks curving away from the caldera (see fig. 44.23A, *B*, location B) as well as the cracks monitored by the quadrilateral, extended about 7 mm more than the shorter quadrilateral lines, AE and BD, over the period June 1981 to July 1982 (table 44.4, fig. 44.27C), suggesting that incipient failure was also developing on the cracks curving away from the caldera.

FIGURE 44.27.—Results from monitors established across incipient landslide on Waldron Ledge. **A**, Changes in line lengths recorded by monitor 1, the quadrilateral. **B**, Vertical changes recorded by monitor 1 between nails of quadrilateral and rebar 1 (R1). **C**, Changes in line length recorded by monitor 2, lines measured with steel tape.

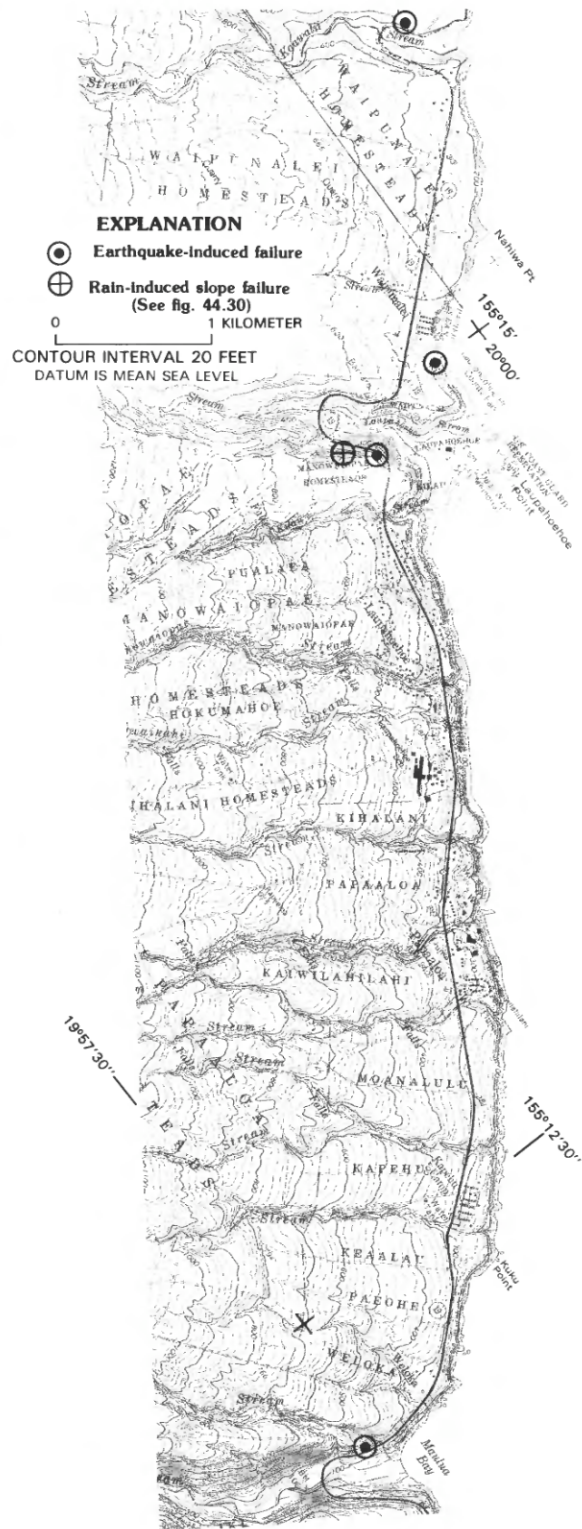
angular rock remnants in a clayey matrix. The rocks are in large part soft and frequently slide during periods of heavy rain. Six landslides with volumes less than 500 m<sup>3</sup> deposited debris on the highway between Maulua Bay and Kaawalii Gulch causing temporary closure of the road (fig. 44.1, locality 9; fig. 44.29). The debris was removed by midday of November 16 and the highway was reopened (Harry Kim, oral commun., 1983).

FIGURE 44.29.—Locations of earthquake-induced and subsequent rain-induced slope failures that occurred in North Hilo District between Maulua Bay and Kaawali Gulch as a result of November 16, 1983, earthquake. Topography from U.S. Geological Survey Keanakolu, Kukaiau, and Papaaloa 7.5-minute quadrangles, 1981, scale 1:24,000.

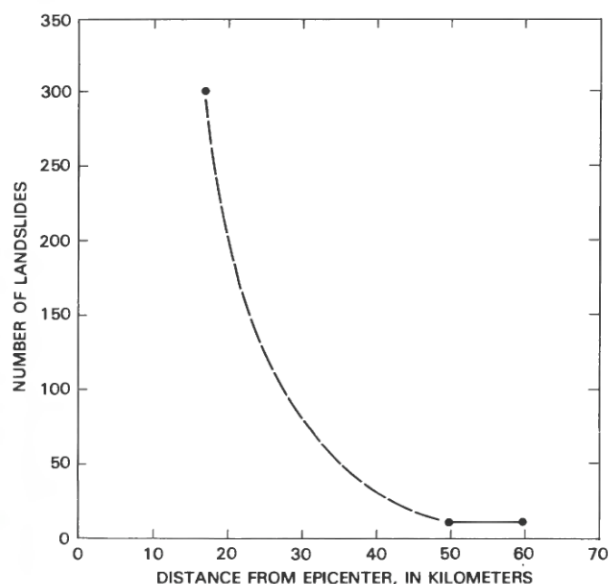
The greatest ground cracking occurred in the epicentral area; most landslides also occurred there, the size and abundance of failures decreasing with distance from the epicenter (fig. 44.33). This localization of ground failures is most probably due to the shallow depth of the earthquake and to the generating mechanism. The strike-slip faulting occurred on a near-vertical fault plane that ruptured the ground surface; the seismic energy released along the fault was thereby transferred to the surface as earthquake waves, and the resulting strong ground shaking in the epicentral area caused abundant ground failures.

FIGURE 44.33.—Number of landslides caused by November 1983 earthquake in relation to distance from epicenter. Dashed line is estimated interpolation.
