# The Loma Prieta, California, Earthquake of October 17, 1989—Liquefaction

STRONG GROUND MOTION AND GROUND FAILURE

U.S. GEOLOGICAL SURVEY PROFESSIONAL PAPER 1551-B

UNITED STATES GOVERNMENT PRINTING OFFICE, WASHINGTON : 1998

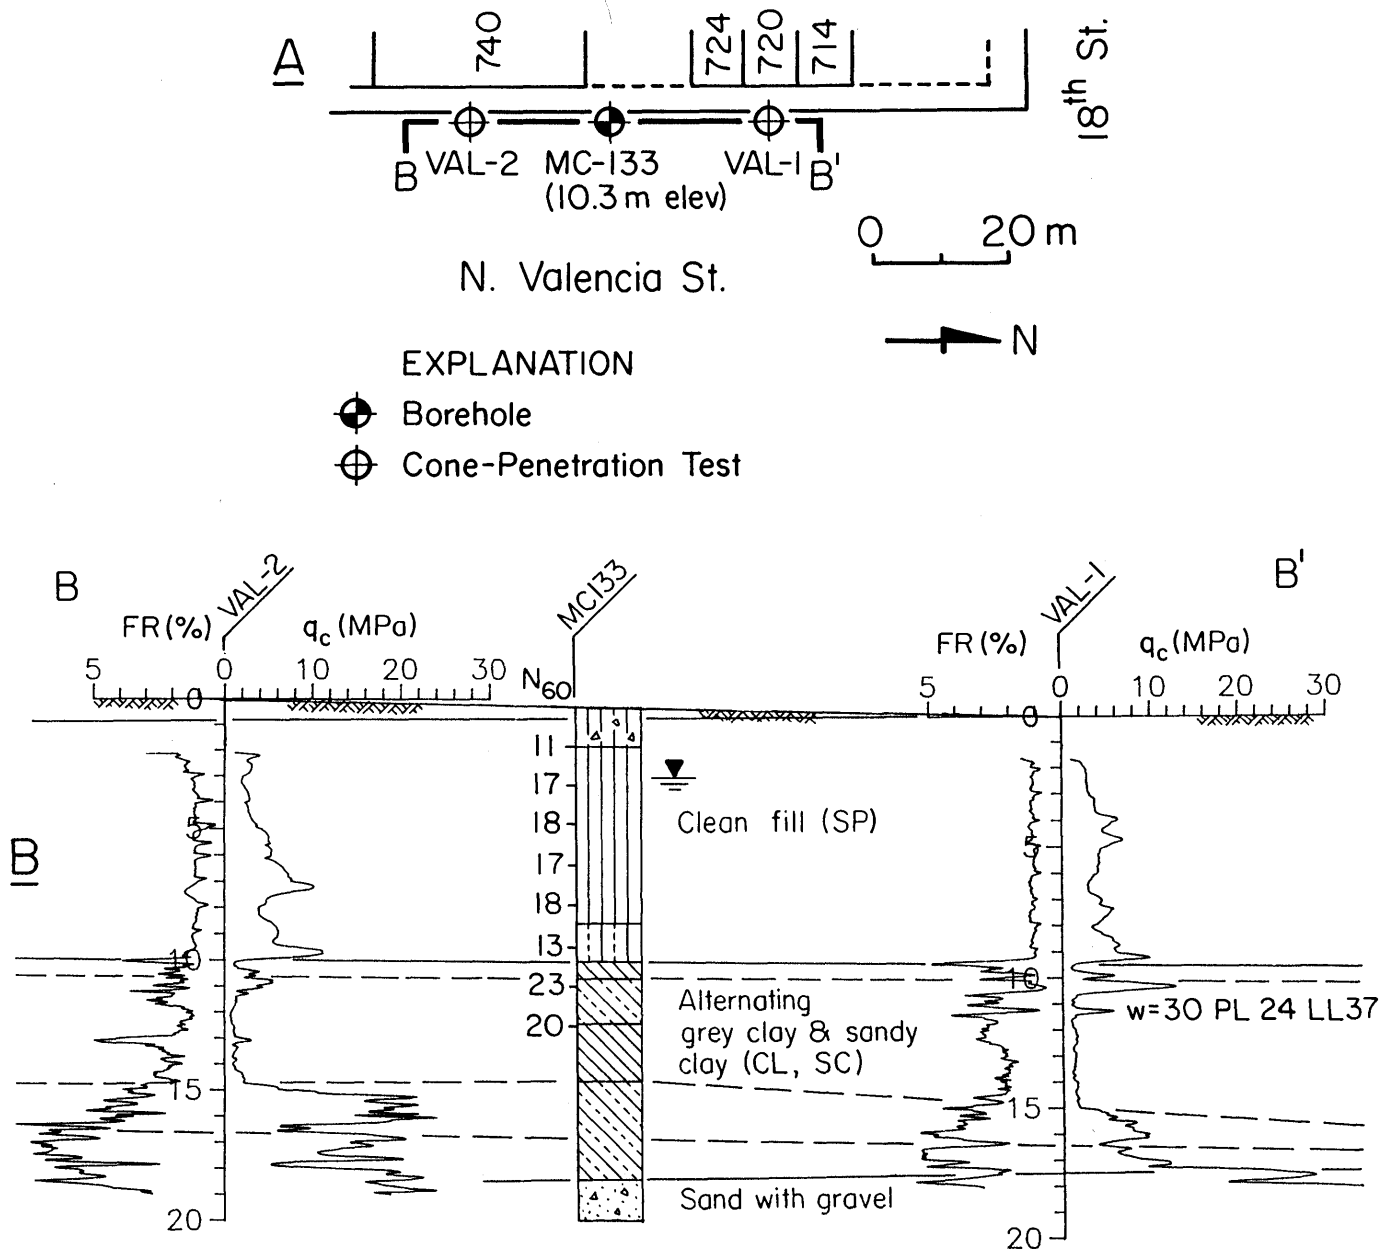
Figure 4.—Schematic map (A) and cross section (B) of Valencia Street site (fig. 1), showing locations of boreholes, cone-penetration tests (CPT's), and soil profile. Soil profile is approximately 55 m long. Depths on cross section are in meters. CPT measurements:  $q_c$ , tip resistance (in megapascals); FR, friction ratio (in percent);  $N_{60}$ , standard-penetration-test blowcount (in blows per foot). Soils are identified by symbols in Unified Soil Classification (American Society for Testing and Materials, 1991b): CL, low-plasticity clay; SC, clayey sand; SP, poorly graded sand. LL, liquid limit; PL, plastic limit; w, natural-water content (in percent).

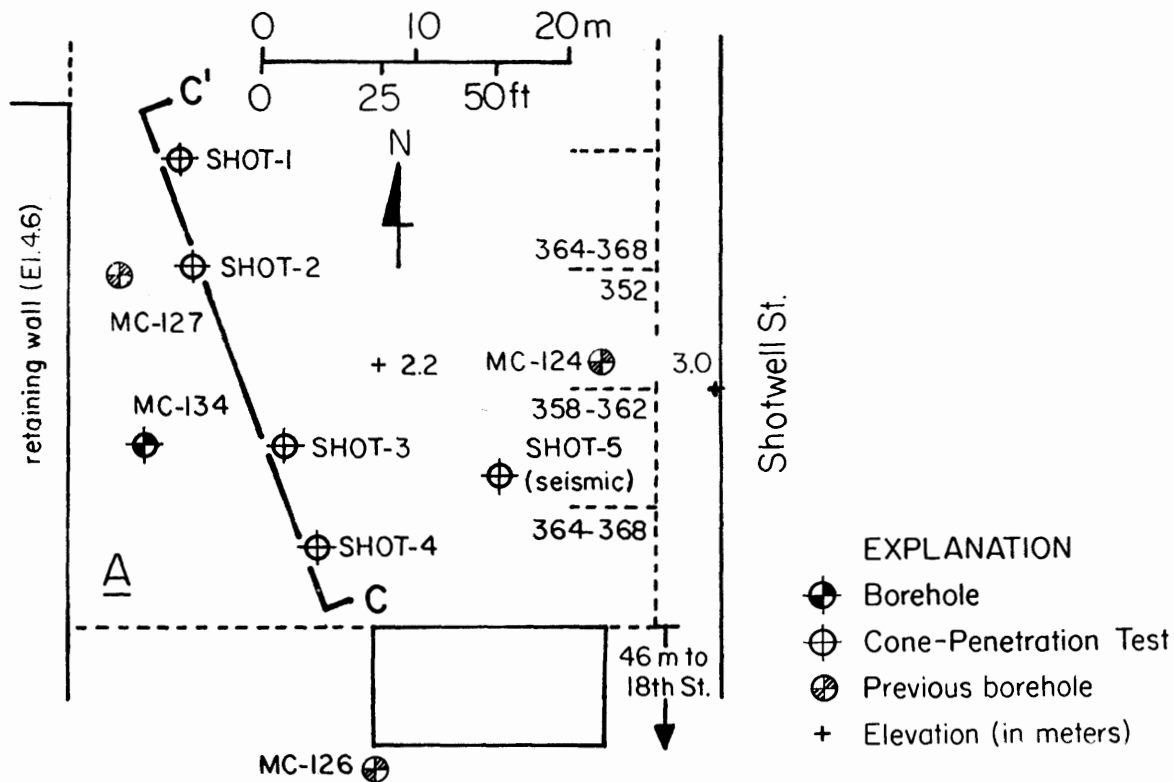
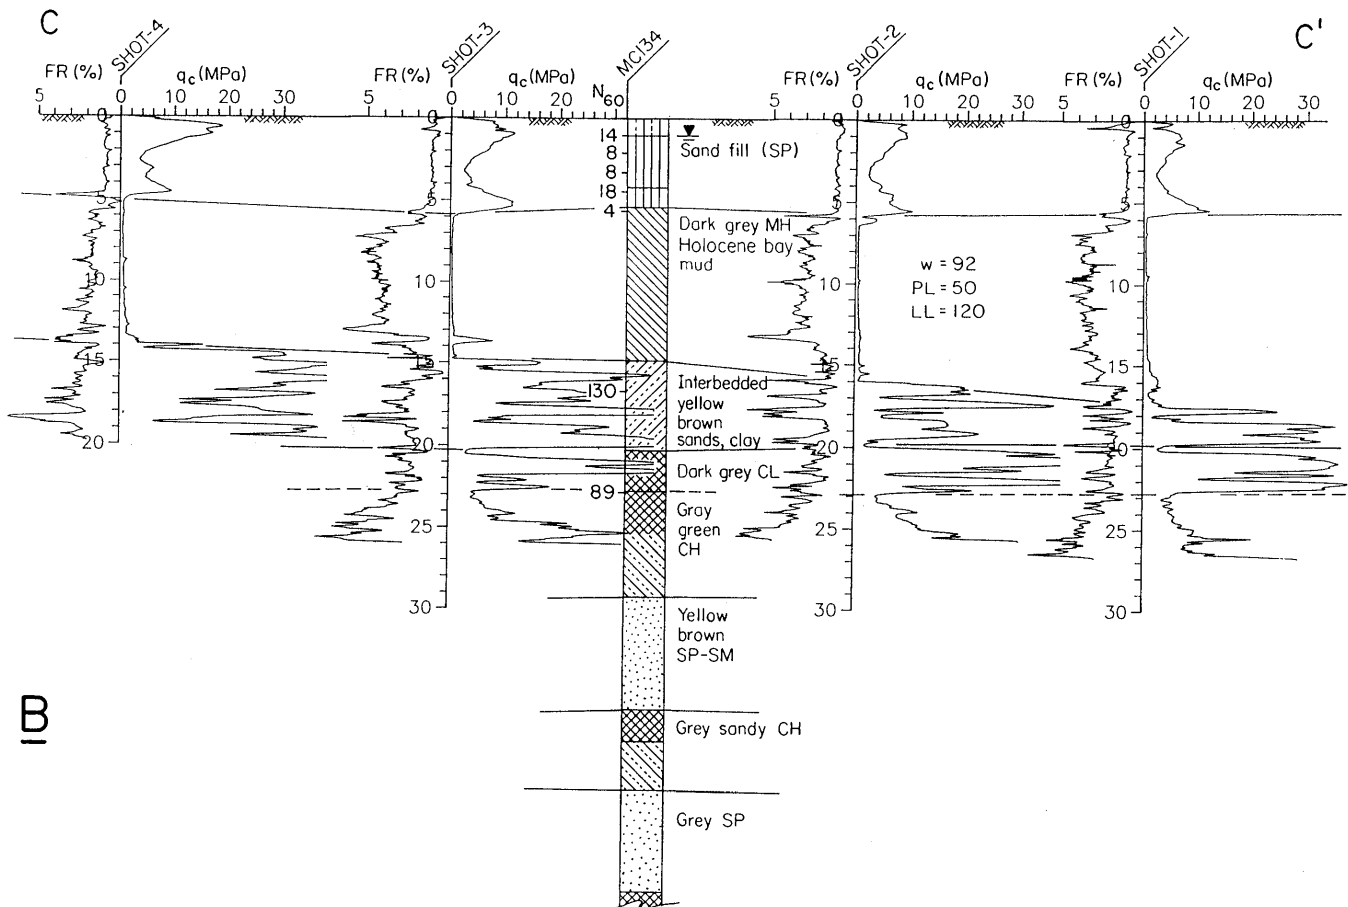
The existing grade of the lots at the time of our investigation was at about 2.0-m elevation. The upper 0.9 m of sandy fill had been removed, replaced, and compacted with a vibratory roller in 1990. The soil profile (fig. 5B) shows a considerable increase in tip resistance above 2- to 3-m depth, probably owing to surface compaction. The fill averages 5.5 m in depth across the site, slightly decreasing in thickness toward the south. As at the other sites, the fill is clean, poorly graded, fine sand containing less than 2 percent fines. The bottom of the fill is at -2.4-m elevation, slightly above mean sea level and within the

Figure 5.—Schematic map (A) and cross section (B) of Shotwell Street site (fig. 1), showing locations of boreholes, cone-penetration tests (CPT's), and soil profile. Soil profile is approximately 30 m long. Depths on cross section are in meters. CPT measurements:  $q_c$ , tip resistance (in megapascals); FR, friction ratio (in percent);  $N_{60}$ , standard-penetration-test blowcount (in blows per foot). Soils are identified by symbols in Unified Soil Classification (American Society for Testing and Materials, 1991b): CH, high-plasticity clay; CL, low-plasticity clay; SM, silty sand; SP, poorly graded sand. LL, liquid limit; PL, plastic limit; w, natural-water content (in percent).

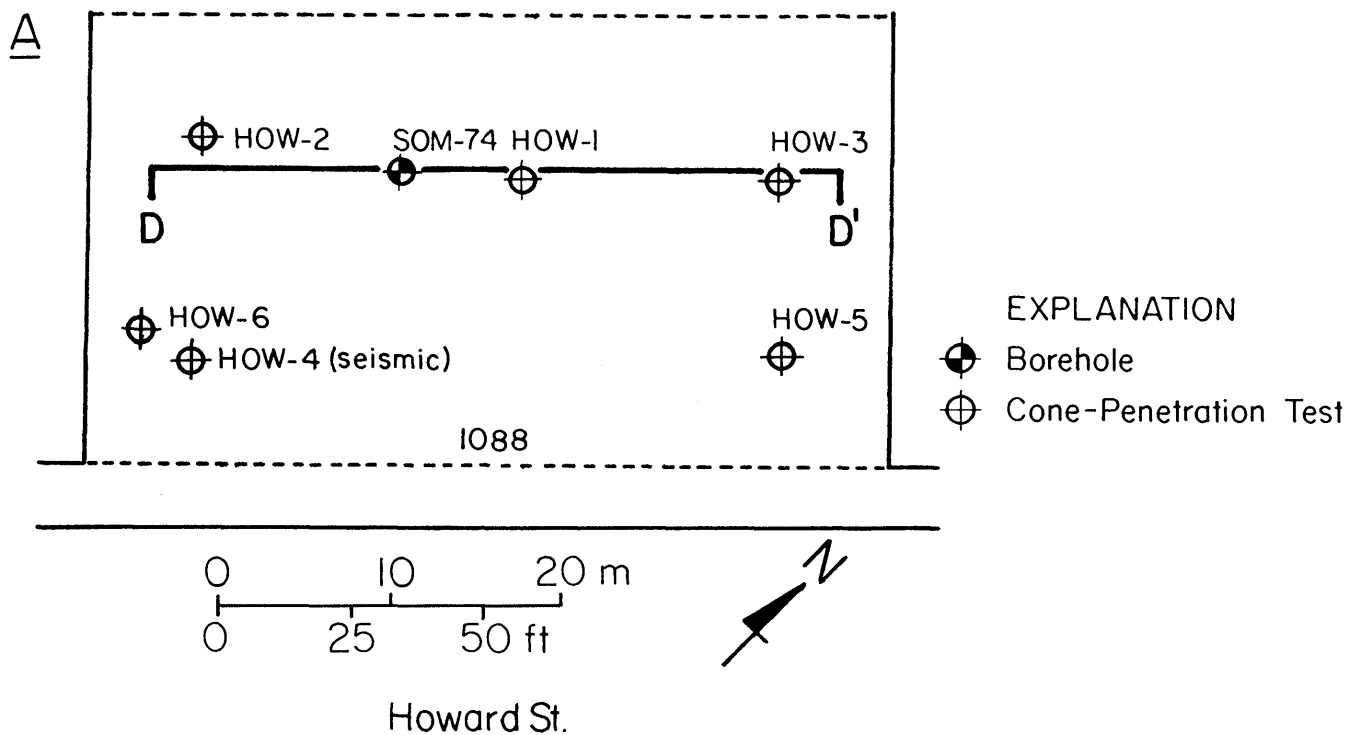
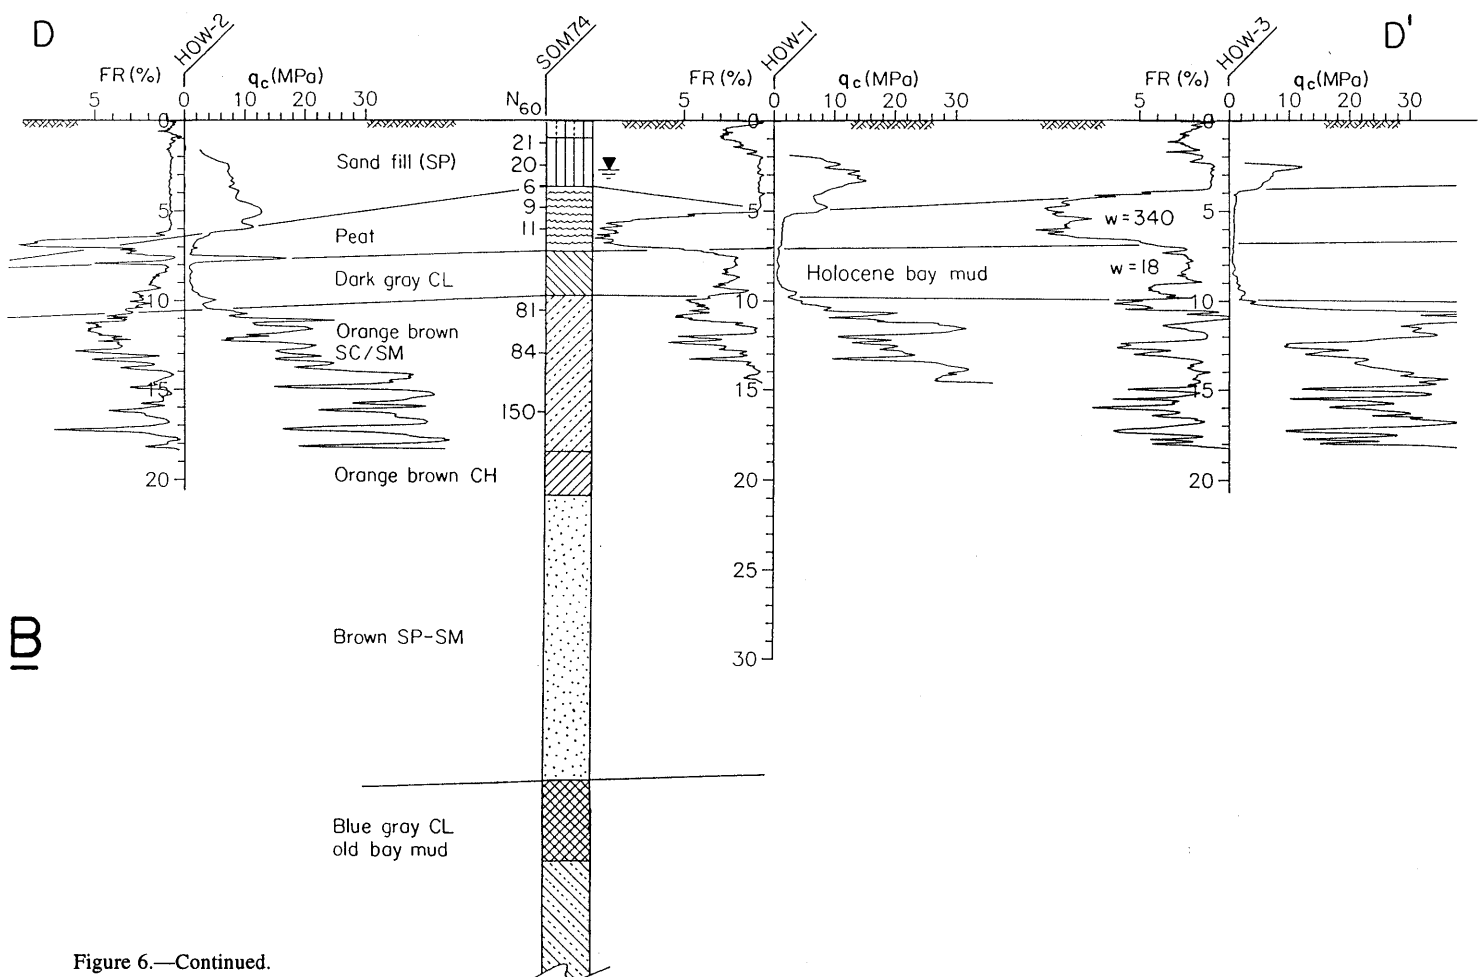
sists of easily penetrable sand, gravel, and rubble. The fill below the surface layer is poorly graded sand containing less than 2 percent fines. The fill at this site appears to be somewhat denser than those at the Mission District sites, on the basis of blowcounts and CPT logs. The water table is at 2.7-m depth. There is a liquefiable layer 1 to 3 m thick at this location.

Figure 6.—Schematic map (A) and cross section (B) of Howard Street site (fig. 1), showing locations of boreholes, cone-penetration tests (CPT's), and soil profile. Soil profile is approximately 34 m long. Depths on cross section are in meters. CPT measurements:  $q_c$ , tip resistance (in megapascals); FR, friction ratio (in percent);  $N_{60}$ , standard-penetration-test blowcount (in blows per foot). Soils are identified by symbols in Unified Soil Classification (American Society for Testing and Materials, 1991b): CH, high-plasticity clay; CL, low-plasticity clay; SM, silty sand; SP, poorly graded sand. LL, liquid limit; PL, plastic limit; w, natural-water content (in percent).

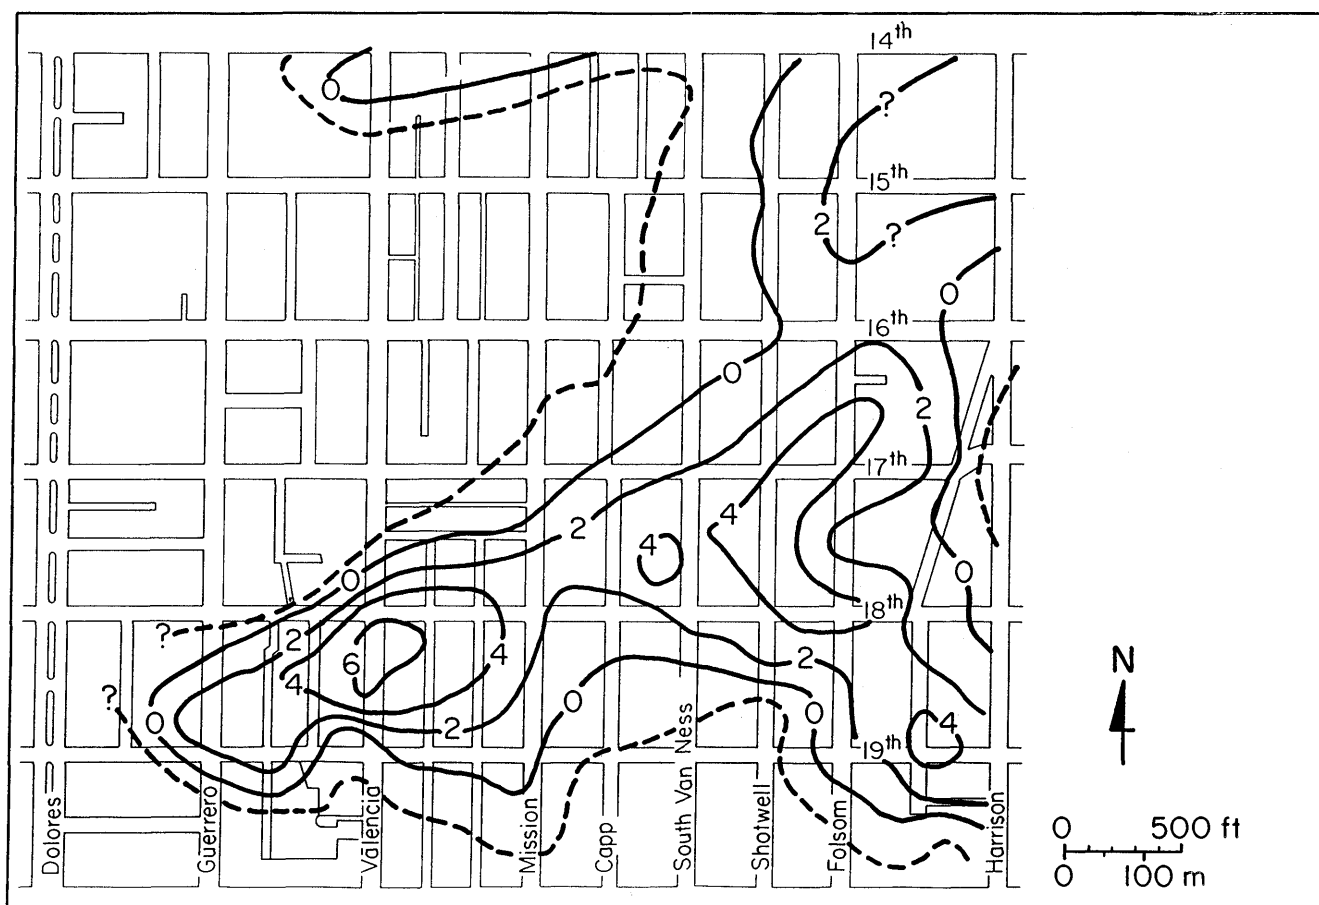
Liquefaction is likely to be most severe in thick layers of submerged fill. In figure 8, 4 to 8 m of submerged fill was observed at both Valencia and Shotwell Streets in former Upper Mission Creek, only 2 to 3 m under Mission Street near 18th Street, and as much as 4 m in former

Figure 8.—Mission District study area, showing thickness of submerged fill (solid contours; interval, 2 m). 0-m contour, which indicates where elevation of water table is at base of fill, represents a theoretical boundary between regions where liquefaction can and cannot occur. Upper-bound

contour (dashed), which delimits area where ground-water level is within 2 m of base of fill, is proposed as a reasonable limit on maximum extent of potential hazard in case of nonuniform changes in fill thickness or unpredictable variations in ground-water level.

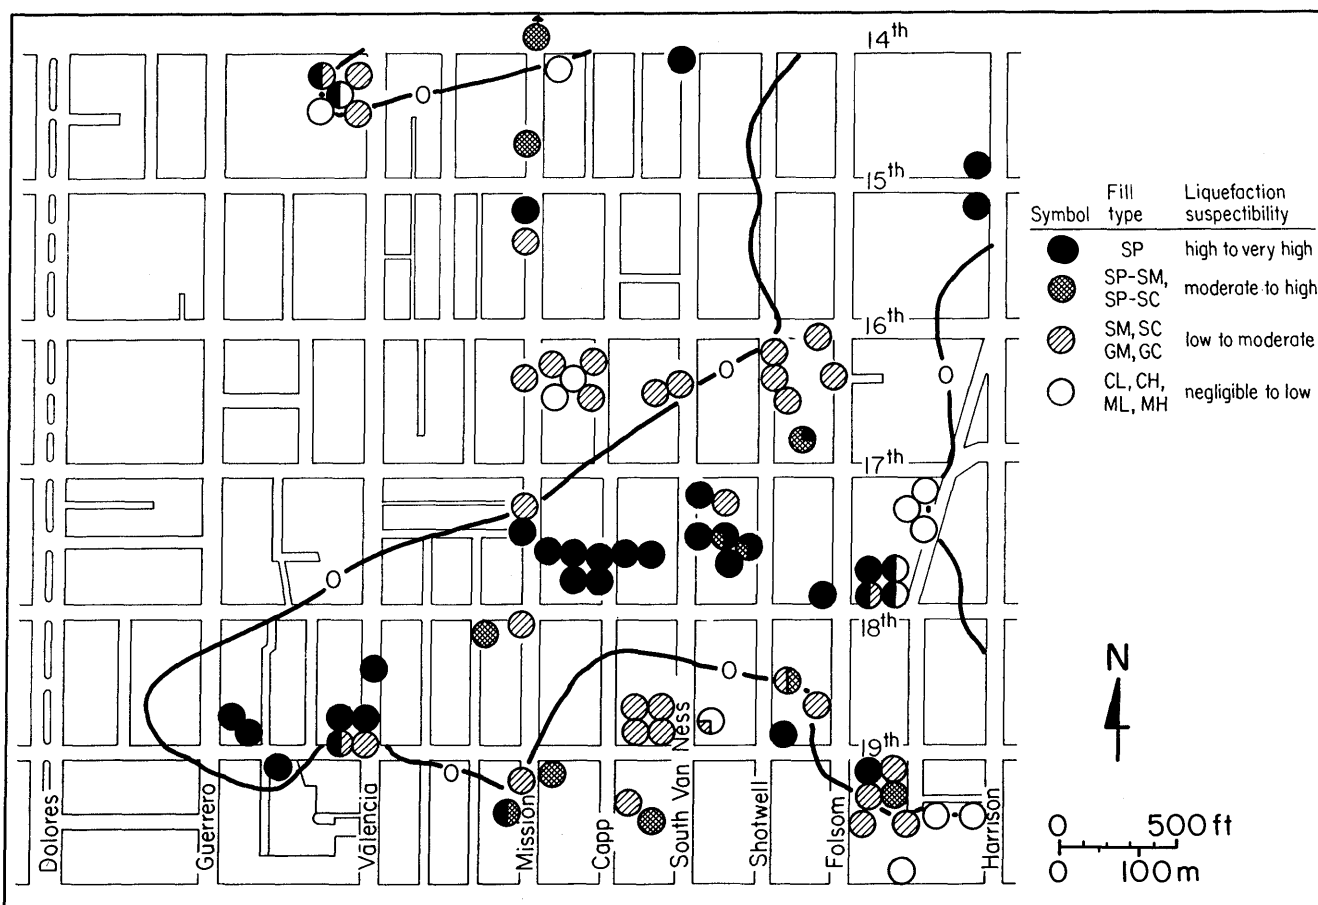
Figure 9.—Mission District study area, showing soil characteristics and liquefaction susceptibility of submerged fill. 0-m contour marks boundary between areas of submerged fill and unsaturated fill, as shown in figure 8. Shaded circles indicate classification of fills based on data from boreholes or cone-penetration-test soundings at each location. Where submerged fill occurs (within bounded area), shading indicates only soil types below water table; where there is no submerged fill below water table or bore-hole terminated above water table, shading indicates only soil type closest to base of fill. Soils are identified by symbols in Unified Soil Classification (American Society for Testing and Materials, 1991b): CH, high-plasticity clay; CL, low-plasticity clay; GC, clayey gravel; GM, silty gravel; MH, high-plasticity silt; ML, low-plasticity silt; SC, clayey sand; SM, silty sand; SP, poorly graded sand. Clays and silts consist of materials of

which more than 50 weight percent passes a No. 200 sieve. Proportion of circle with a particular shading reflects approximate proportion of corresponding soil type below water table at that location. In general, liquefaction susceptibility of soils containing 20 to 50 weight percent fines is considered to be low, and that of fairly clean soils containing less than 20 weight percent fines to be moderate. This classification is considered valid for San Francisco soils on the basis of observations that the fines in these soils (particles smaller than 0.075 mm) are typically clay minerals and that relatively few soil samples contain much low-plasticity or cohesionless silt. Although soils containing more than 20 weight percent fines have been observed to liquefy during earthquakes, such occurrences have been confined to regions where low-plasticity silts are a common constituent of fines (Cao and Law, 1991).

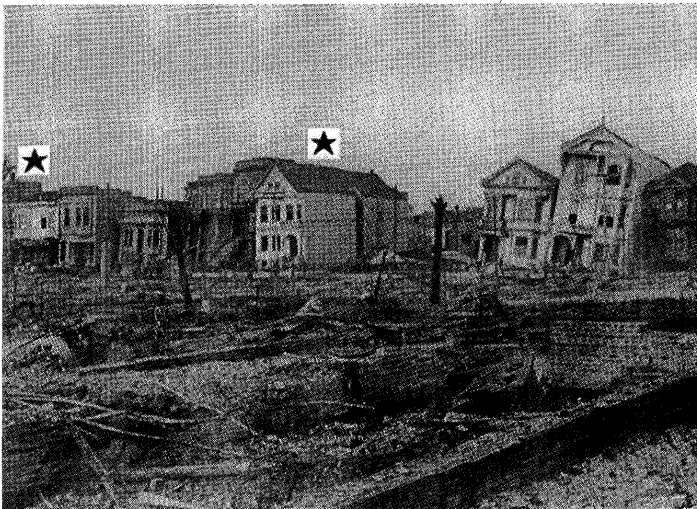
Figure 13.—Buildings on east side of South Van Ness Avenue between 17th and 18th Streets after 1906 San Francisco earthquake and fire. Stars denote structures still standing in 1993. Two buildings to left of center sustained cripplewall failure and were shifted to left (northward) off their foundations. As a result of these failures, they are tilted to right and away from street. Rubble from another building that collapsed into an adjacent vacant lot is visible in center. View from Capp and 18th Streets (see fig. 9 for location).

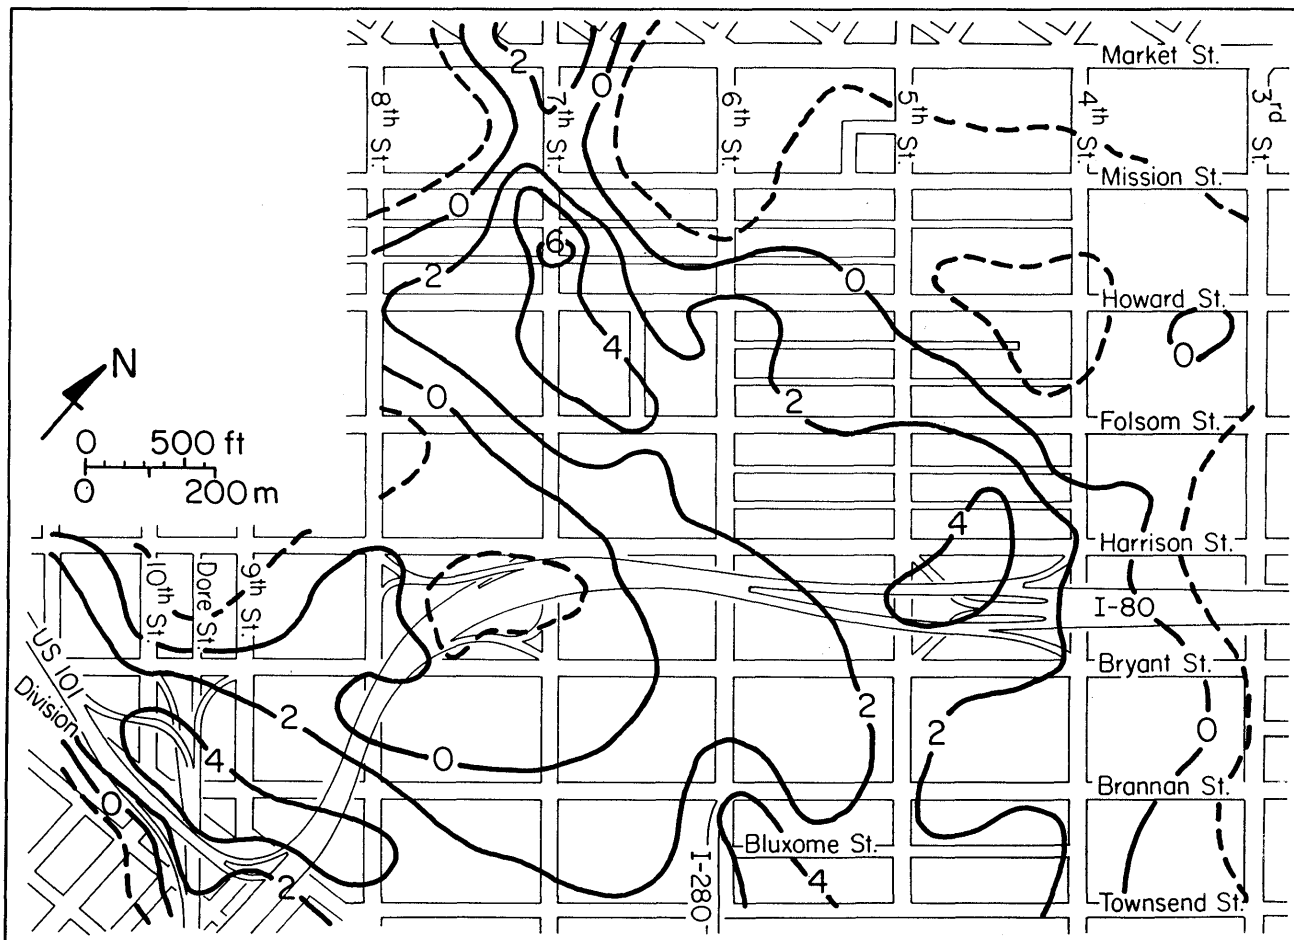
As shown in figure 17, approximately 6 m of saturated loose fill occurs at 7th Street from Mission Street to Howard Street. Submerged fill also is more than 4 m thick along Mission Creek at Dore and Brannan Streets, Fifth and Harrison Streets, and Sixth and Townsend Streets.

These areas overlie buried narrow Holocene bay-mud-filled ravines, as much as 30 m deep, with natural-water contents of 50 to 100 percent, such that additional fill may have been added as major ground settlement occurred because of consolidation. The submerged fill is at least 2 m thick throughout the former marsh area.

Outside the main filled zones, isolated thin layers of submerged fill occur. Within the former dune field, interdune depressions extend close to the water table. One such depression is shown in figure 17 at Howard and Third Streets, and submerged fill more than 2 m thick at Seventh and Market Streets. As noted in the section above entitled "Data Collection and Mapping Procedures," the available subsurface data base may be too coarse to accurately characterize the fill geometry and, thus, the submerged-fill thickness in the former dune landscape of the South of Market area. The occurrence of submerged fill in this area (fig. 17) can be confirmed by individual bore-

Figure 17.—South of Market study area, showing thickness of submerged fill (solid contours; interval, 2 m). 0-m contour, which indicates where elevation of water table is at base of fill, represents a theoretical boundary between regions where liquefaction can and cannot occur. Upper-

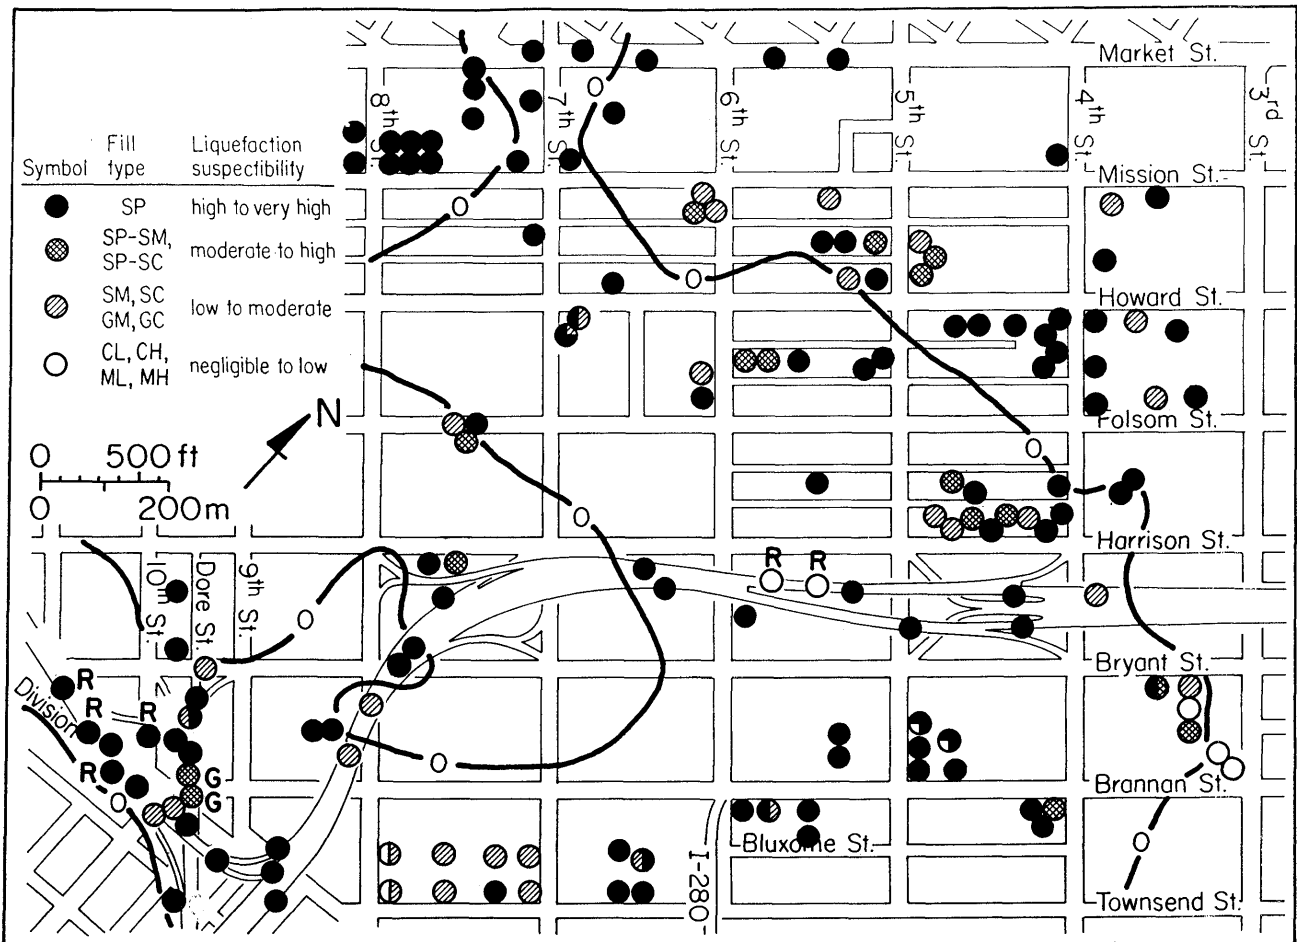
Figure 18.—South of Market study area, showing soil characteristics and liquefaction susceptibility of submerged fill. 0-m contour marks boundary between areas of submerged fill and unsaturated fill, as shown in figure 17. Shaded circles indicate classification of fills based on data from boreholes or cone-penetration-test soundings at each location. Boreholes that penetrated a significant amount of rubble (R) or gravel (G) are so denoted because presence of these materials may influence liquefaction susceptibility. Where submerged fill occurs (within bounded area), shading indicates only soil types below water table; where there is no submerged fill below water table or borehole terminated above water table, shading indicates only soil type closest to base of fill. Soils are identified by symbols in Unified Soil Classification (American Society for Testing and Materials, 1991b): CH, high-plasticity clay; CL, low-plasticity clay; GC, clayey gravel; GM, silty gravel; MH, low-plasticity silt; ML, high-plasticity silt; SC, clayey sand; SM, silty sand;

SP, poorly graded sand. Clays and silts consist of materials of which more than 50 weight percent passes a No. 200 sieve. Proportion of circle with a particular shading reflects approximate proportion of corresponding soil type below water table at that location. In general, liquefaction susceptibility of soils containing 20 to 50 weight percent fines is considered to be low, and that of fairly clean soils containing less than 20 weight percent fines to be moderate. This classification is considered valid for San Francisco soils on the basis of the observation that the fines in these soils (particles smaller than 0.075 mm) are typically clay minerals and relatively few soil samples contain much low-plasticity or cohesionless silt. Although soils containing more than 20 weight percent fines have been observed to liquefy during earthquakes, such occurrences have been confined to regions where low-plasticity silts are a common constituent of fines (Cao and Law, 1991).

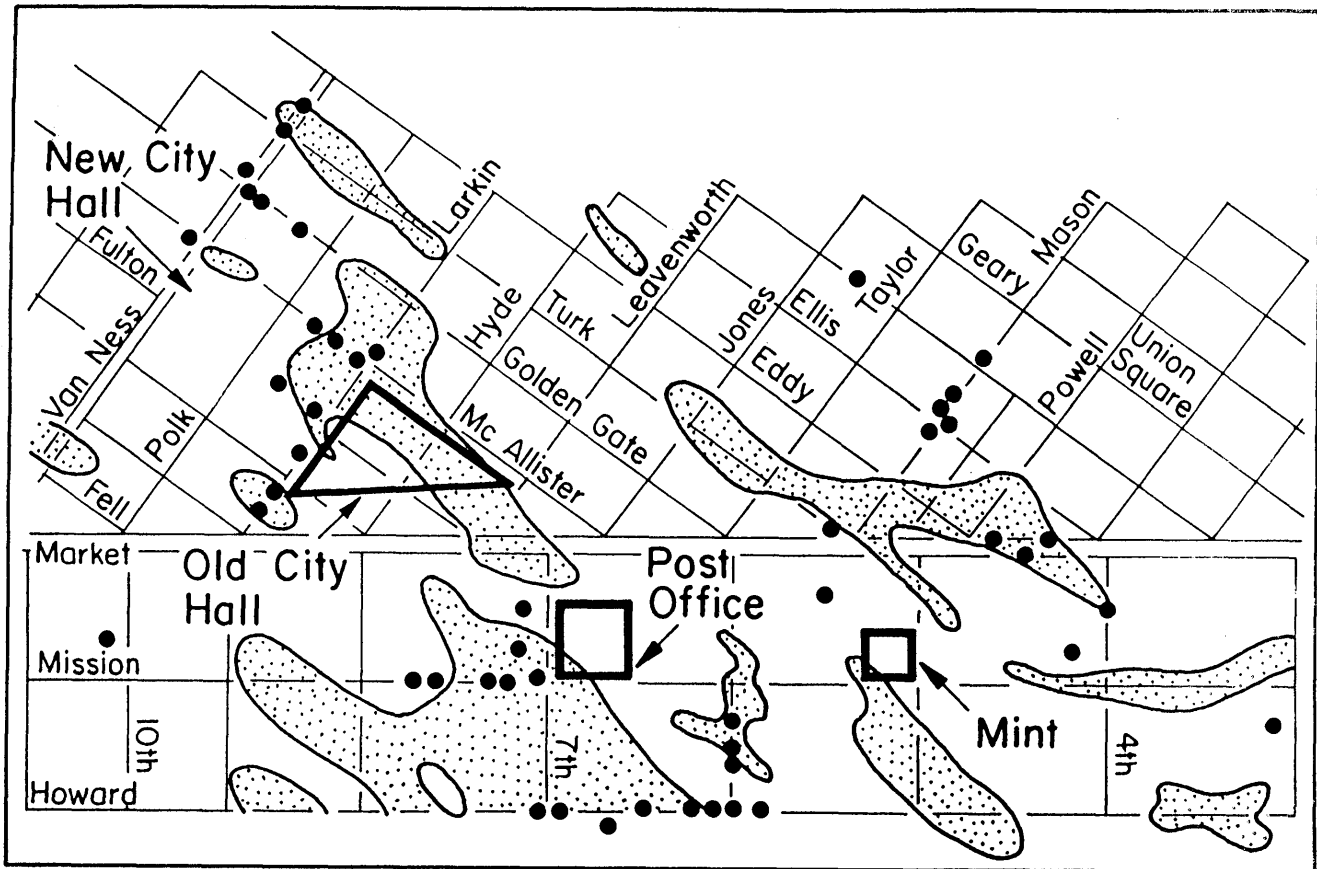
Of the 32 pipeline breaks near Market Street that were located outside former Sullivan Marsh, 16, or 50 percent, occurred in or adjacent to the zones of deep fill (shaded areas, fig. 23). Deep, loose fills may pose a seismic hazard due to consolidation and settlement in response to prolonged shaking. Moreover, subsurface evidence suggests that submerged fills were present at sites near Market Street, and so liquefaction could also have affected ground movement in these areas. These submerged fills are probably no more than 2 m thick and are overlain by 4 to 10 m of unsaturated fill that would have substantially damped and restricted any movement of the liquefiable layer.

Figure 23.—Vicinity of Market Street between Third and 11th Streets, showing locations of zones of probable submerged fill (stippled areas), based on interpretation of historical topography (U.S. Coast Survey, 1853, 1857), and broken water mains (dots). South half of map overlaps with area of figures 17 through 21, 24, and 27.

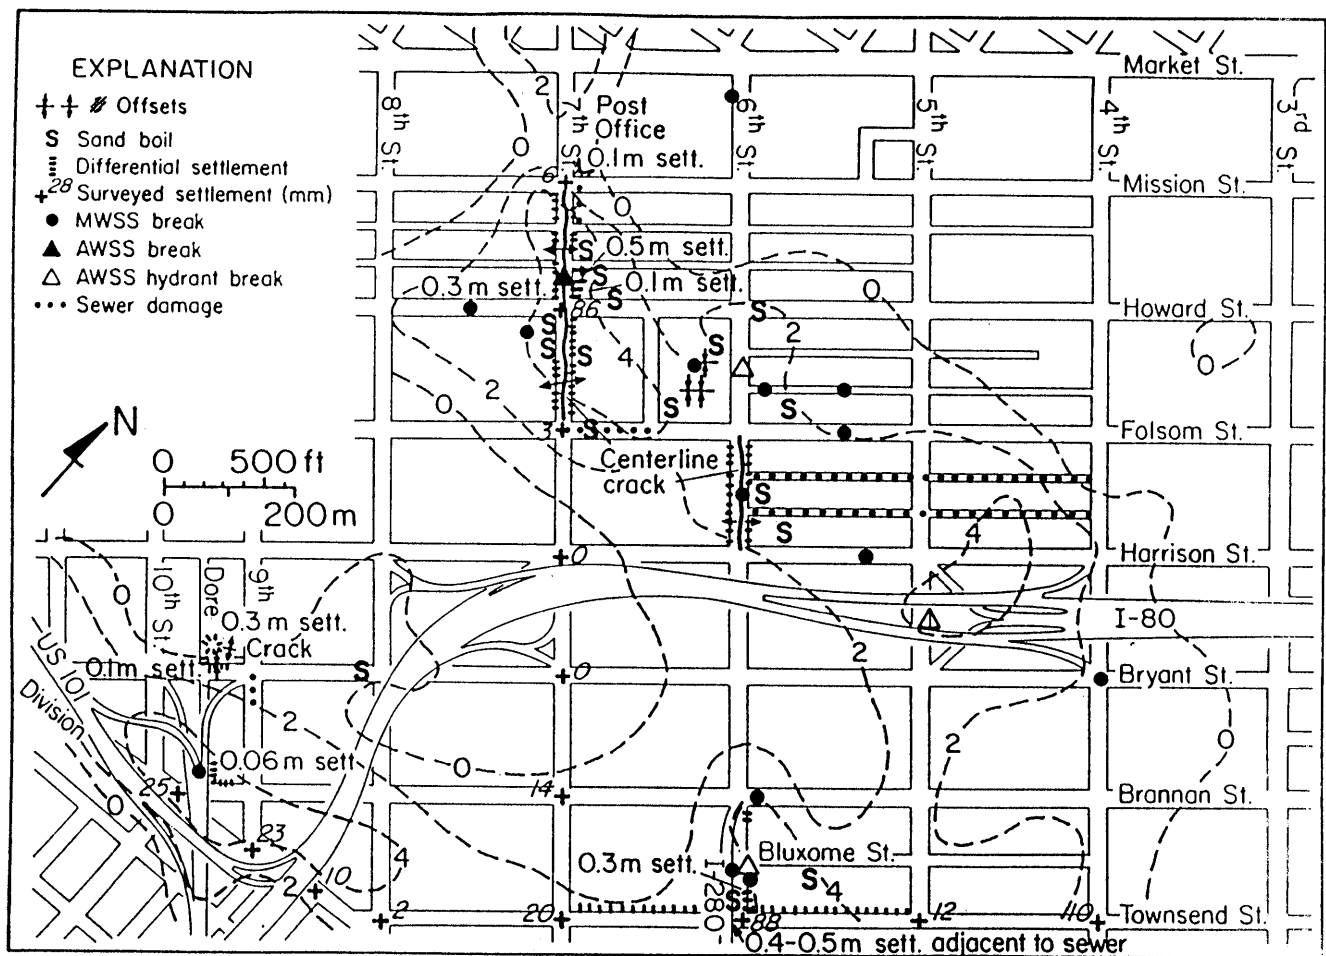
During the 1989 Loma Prieta earthquake, liquefaction resulted in moderate to severe damage associated with sand boils, settlement, pavement damage, strong ground shaking, and pipeline breaks in the South of Market area, as summarized in figure 24. Cracks, 10 to 30 mm wide, and differential settlement were observed down the centerline of Seventh Street between Mission and Folsom Streets. Settlement was noted as far north as the corner of the U.S. Post Office on Mission Street, where large settlements had occurred in 1906. Large differential settlements of 300 to 500 mm were observed adjacent to buildings on Seventh Street just north of Howard Street. Rupture of a 300-mm-diameter water main may have contributed to the damage in this area. Extensional cracks were also observed in Sixth Street between Folsom and Harrison

About 300 mm of localized subsidence and several cracks were observed in a parking lot on Dore Street approximately 30 m northwest of Bryant Street, at the approximate north limit of major lateral spreading in this area in 1906. The sidewalk near the northeast corner of Bryant and Dore Streets was buckled, and a water-service connection was ruptured. Both the buckled pavements and extension cracks paralleled the north boundary of a zone of submerged fill.

Figure 24.—South of Market area, showing thickness of submerged fill (dashed contours; interval, 2 m) and locations of lateral spreading, differential settlement, offsets, and broken water main (dots) in 1989 Loma Prieta earthquake. Surveyed settlements are differential settlements mea-

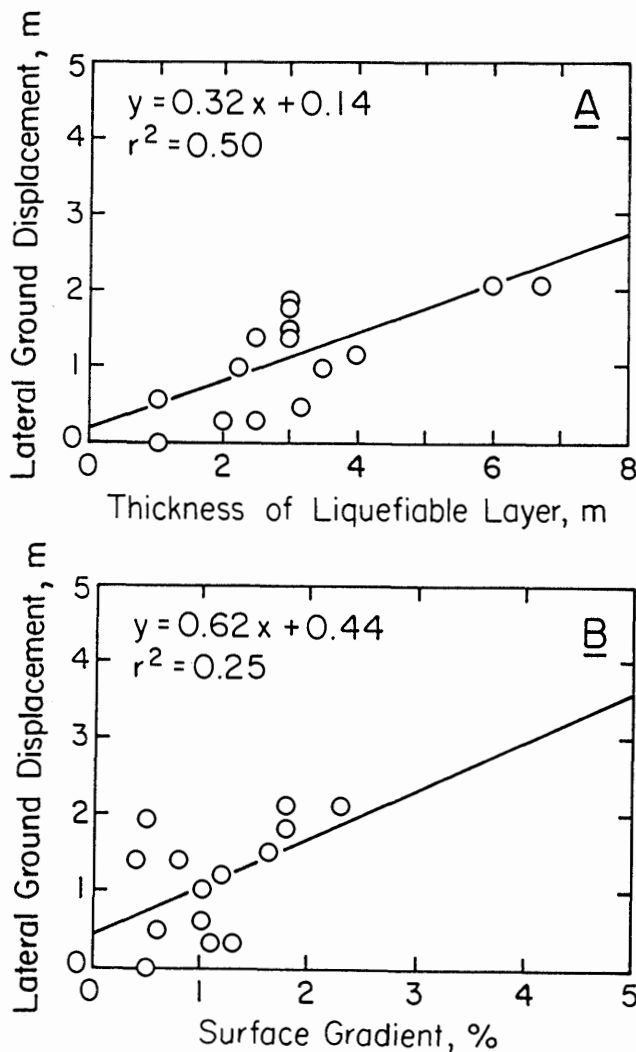
As shown in figure 25A, a reasonable fit exists for the plot of lateral ground displacement versus submerged-fill thickness. About half the variation in displacement data is explainable by the thickness of liquefiable soils ( $r^2=0.50$ ). Lateral displacement is about 30 percent of the thickness of submerged fill, and most data are bounded by ratios corresponding to 15 to 45 percent of submerged-fill thickness.

Surface gradient as a function of lateral ground displacement is plotted in figure 25B. Consistent with observations by the U.S. National Research Council (1985), surface slopes of lateral-spread zones range from 0.5 to 2.5 percent. The best linear fit of the data has  $r^2=0.25$ , which represents a poor correlation for explaining the variation in observations. Single-variable and multiple linear regressions involving surface-layer thickness did not improve the coefficient of determination achieved by regression with only the thickness of liquefiable fill.

The data of Hamada (1992a, b) indicate that lateral spreads in Japan average 125 percent of liquefied thickness, about 4 times greater than the displacement at San Francisco sites plotted in figure 25A. The models of Bartlett and Youd (1992), who included data from the Mission District and South of Market area in their study, significantly overpredict lateral displacement in 1906 by a factor of 5 to 10.

Figure 25.—Linear regressions of thickness of liquefiable layer (A) and surface gradient (B) versus lateral ground displacement in 1906 San Francisco earthquake.

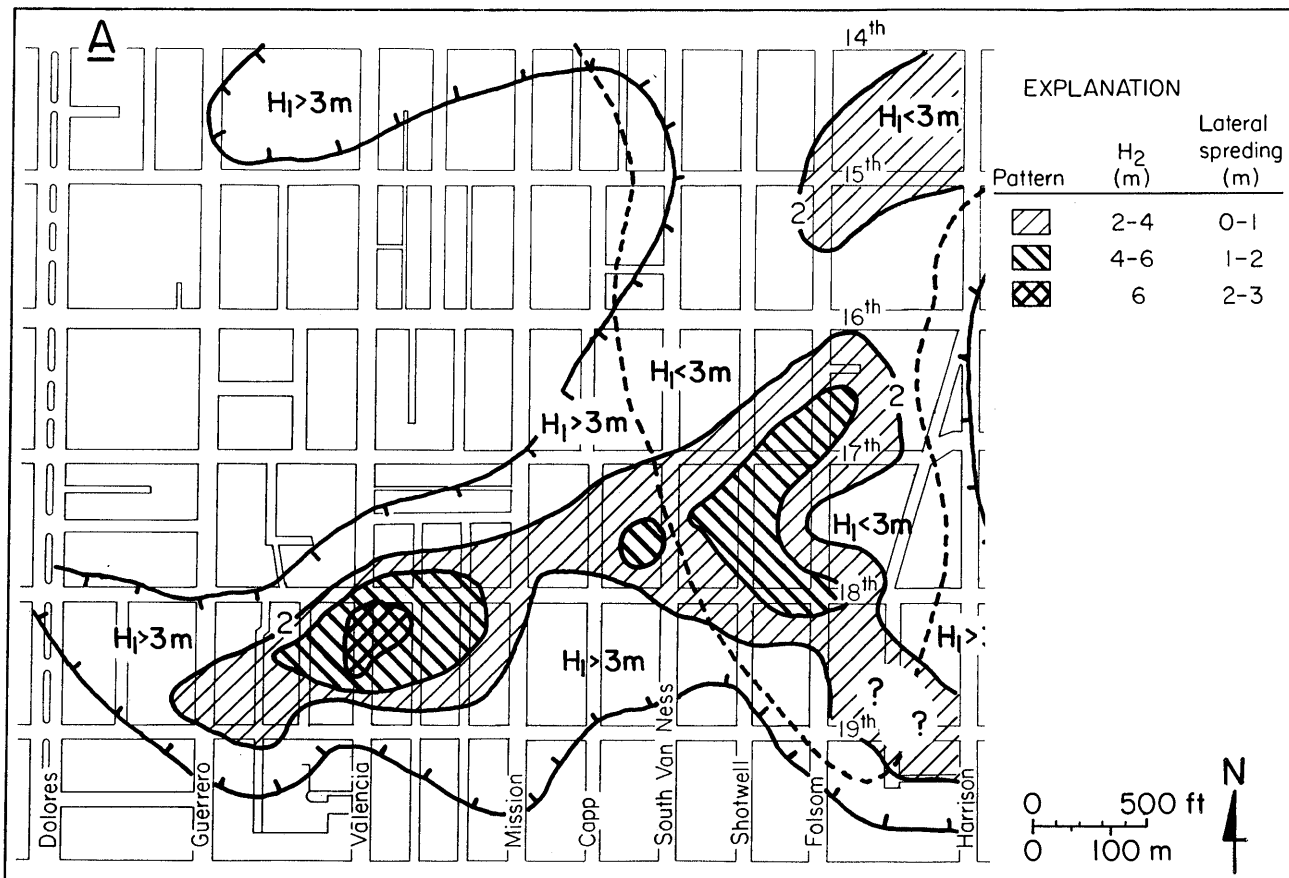
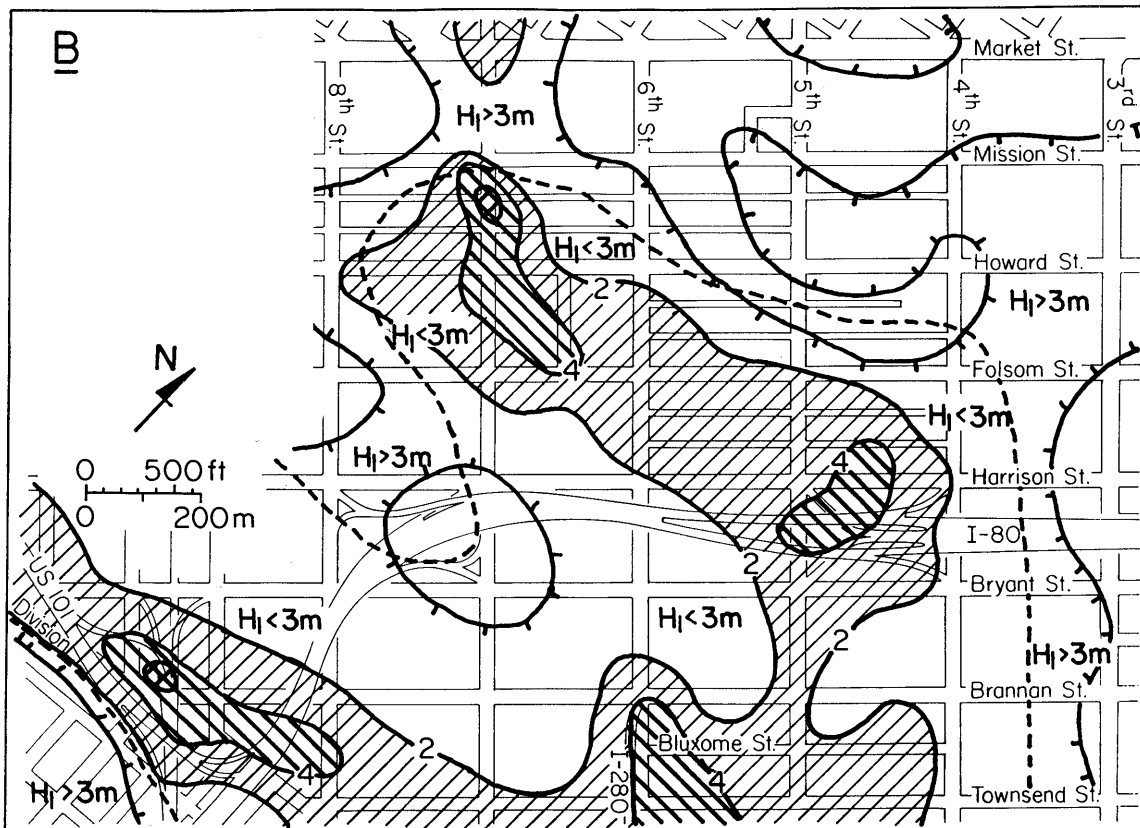
The limits of the liquefaction zone in the Mission District shown in figure 26A approximately coincide with the delineations of liquefaction zones in previous studies (for example, Youd and Hoose, 1978; O'Rourke and others, 1992a). In contrast, the upper bound of the liquefaction zone in the South of Market area shown in figure 26B includes dune depression fills that were not recognized in previous studies and that may increase the extent of the potential hazard.

In the course of our study, we identified other factors that reduce the liquefaction susceptibility in areas of submerged fill. Specifically, any hazard assessment must include consideration of the fines content and plasticity of fill materials. In particular, figure 26 shows that severe liquefaction is unlikely in the vicinity of 19th Street between Folsom and Harrison Streets, despite the presence of submerged fill more than 2 to 4 m thick. Boreholes in this area indicate that the fill has a relatively high fines content, which substantially reduces its liquefaction susceptibility. Similarly, the hazard in other areas may be low because of fill characteristics. Figures 9 and 18 can be used to make preliminary estimates of soil types and their influence on liquefaction susceptibility. We advise caution, however, because liquefiable-sand pockets and seams may occur in the predominantly fine grained fill. Figure 26, supplemented by figures 9 and 18, would best be used to delineate hazards in a general way for planning purposes, whereas site-specific investigations would be needed to provide detailed information for engineering and design decisions.

Figure 26.—Liquefaction-susceptibility maps of the Mission District (A) and South of Market area (B), showing areas of highest potential for damage from lateral spreading, based on submerged-fill thickness.  $H_1$ , thickness of nonliquefiable surface layer;  $H_2$ , thickness of liquefiable deposit. Upper-bound contour (dashed), which delimits area where groundwater level is within 2 m of base of fill, is proposed as a reasonable limit on maximum extent of potential hazard in case of nonuniform changes in fill thickness or unpredictable variations in ground-water level. Patterned

areas, where  $H_2 > 2$  m, are associated with estimates of expected lateral spreading for an event similar in magnitude to 1906 San Francisco earthquake. Dashed line, contour of  $H_1 = 3$  m; in areas where  $H_1 < 3$  m, liquefaction-induced damage is more likely to be observed during smaller events, such as 1989 Loma Prieta earthquake. In figure 26A, fill in area of 19th Street between Folsom and Harrison Streets contains much clay, which reduces its liquefaction susceptibility.

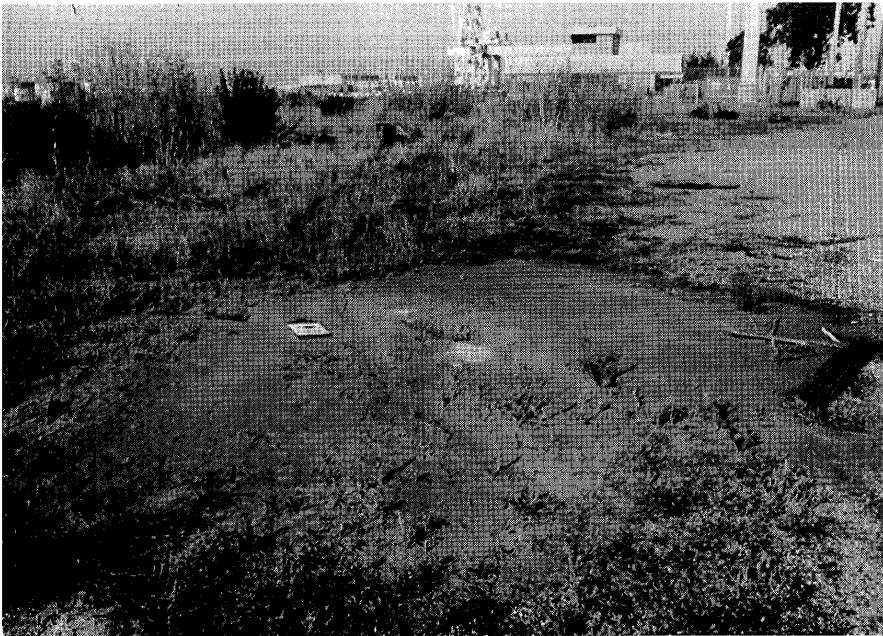
Figure 3.—Sand boils on undeveloped land at end of Harbor Way Road in the Port of Richmond.

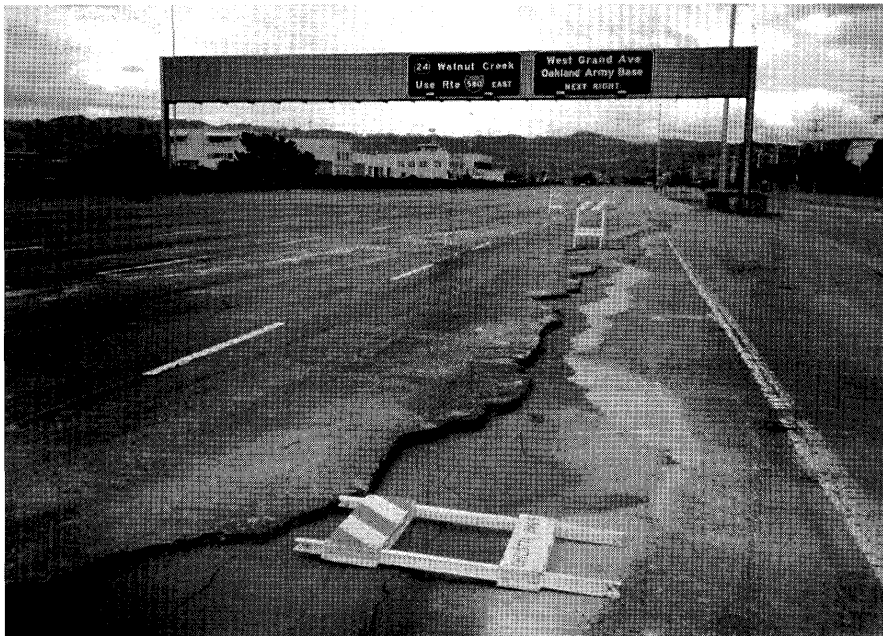
Settlements of the mole and the elevated structures of Interstate Highway 580 and West Grand Avenue were severe, resulting, at each site, in pavement collapse and open fissures, as much as 0.3 m wide, at the soil-structure interface. The approach mole also settled below the bridge- and ramp-structure road level by as much as 0.5 m. The fissures and uneven pavement surface interrupted ground transportation in the interchange areas after the earthquake. Soil liquefaction was also observed adjacent to the piers of elevated-highway distribution structures (fig. 8)

Figure 6.—Fissure in pavement caused by settlement in rightmost eastbound lane of Interstate Highway 80 west of San Francisco-Oakland Bay Bridge Toll Plaza administration building (visible in distance).
