# The Loma Prieta, California, Earthquake of October 17, 1989—Liquefaction

STRONG GROUND MOTION AND GROUND FAILURE

U.S. GEOLOGICAL SURVEY PROFESSIONAL PAPER 1551-B

UNITED STATES GOVERNMENT PRINTING OFFICE, WASHINGTON : 1998

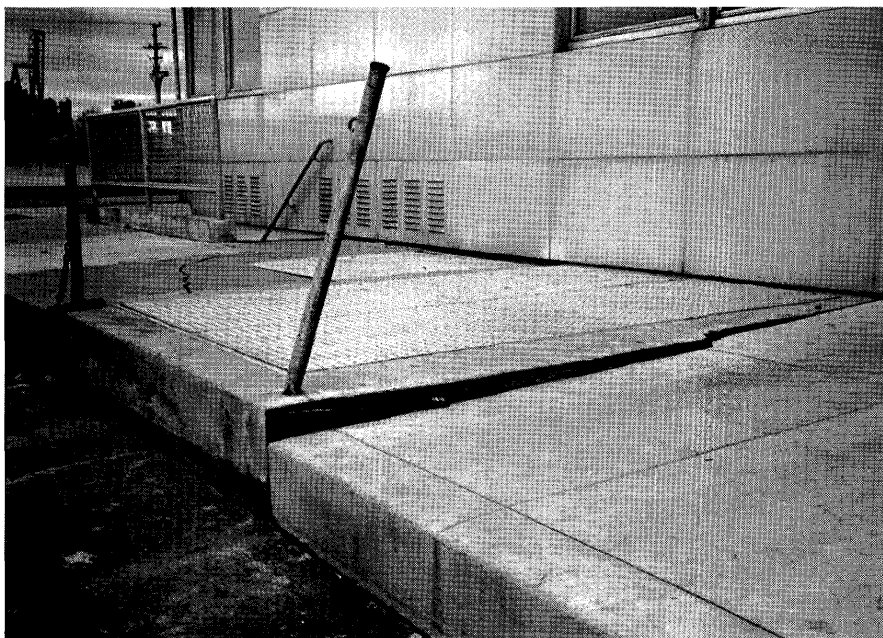
Figure 7.—Settlement at the east side of the San Francisco-Oakland Bay Bridge Toll Plaza administration building.

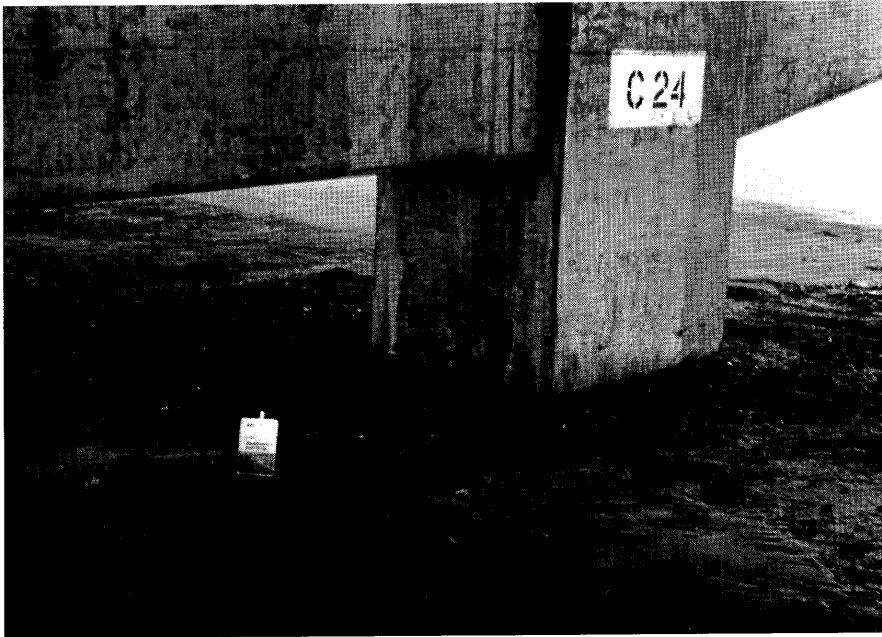
Settlements of the mole and the elevated structures of Interstate Highway 580 and West Grand Avenue were severe, resulting, at each site, in pavement collapse and open fissures, as much as 0.3 m wide, at the soil-structure interface. The approach mole also settled below the bridge- and ramp-structure road level by as much as 0.5 m. The fissures and uneven pavement surface interrupted ground transportation in the interchange areas after the earthquake. Soil liquefaction was also observed adjacent to the piers of elevated-highway distribution structures (fig. 8)

Figure 8.—Sand boils beneath elevated West Grand Avenue distribution structure adjacent to Interstate Highway 80 east of San Francisco Oakland Bay Bridge Toll Plaza.

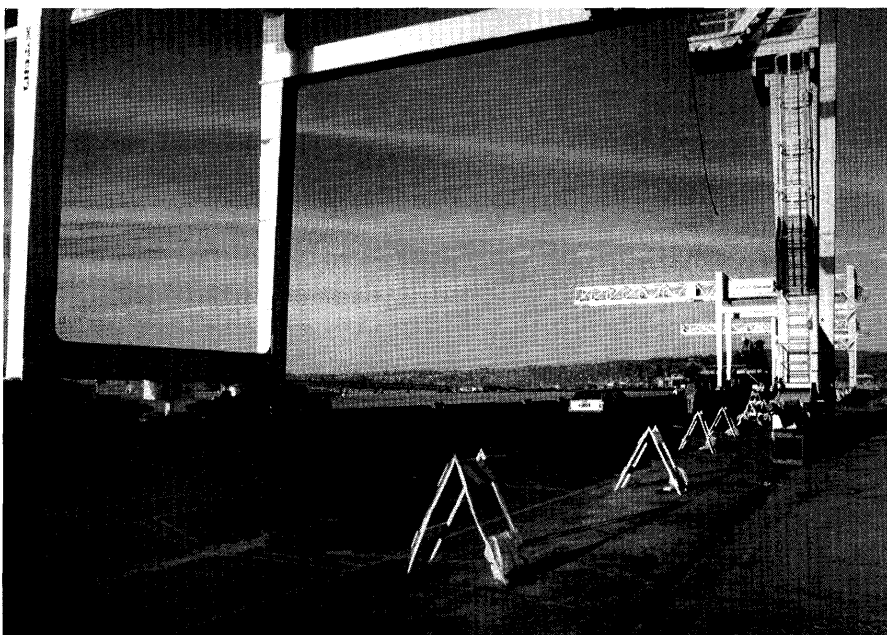
Two of the large cranes operating along the north edge of the Marine Container Terminal at Berths 35 and 36 are shown in figure 11. A closeup of the pavement damage

Figure 11.—Wharf of Port of Oakland's Marine Container Terminal at Seventh Street (viewed from Berth 37), showing shipping-container cranes, damaged pavement, and extruded sand.

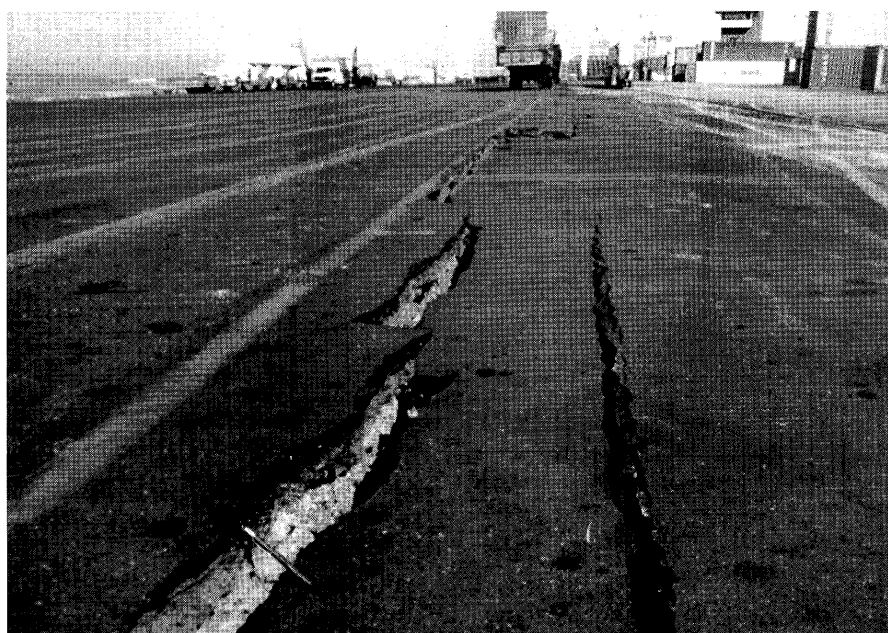
and approximately 0.15 m of settlement beneath the crane nearest to the camera in figure 11 is shown in figure 12. The observed settlement, which occurred in the vicinity of the inboard crane rail (fig. 16), resulted in severe distress to the crane system. In fact, one crane jumped the inboard rail at this site. Similar cracks and fissures occurred along much of the terminal. A 10-m-diameter, 0.3-m-high sand boil in the paved container yard south of the C.F.S. Building (now removed) near Berth 38 is shown in figure 13.

Figure 12.—Closeup of damaged pavement near boreholes POO7-5 and POO7-6 at Port of Oakland Berths 36 and 37 (see fig. 5 for locations), showing differential settlement, open fissures, and lateral spreading.

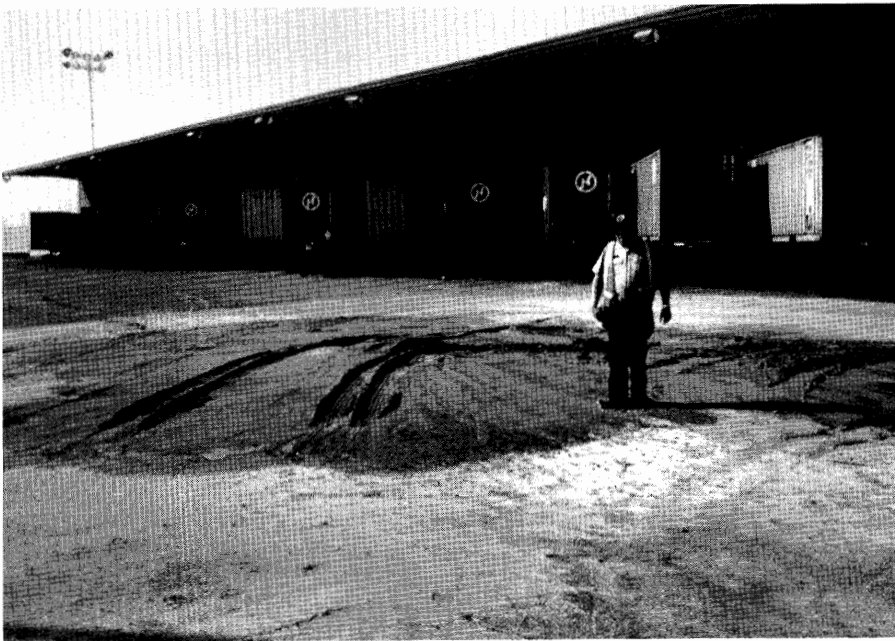
Figure 13.—Sand boil near borehole POO7-1 at Port of Oakland Berth 38 and Port View Park (see fig. 5 for locations).

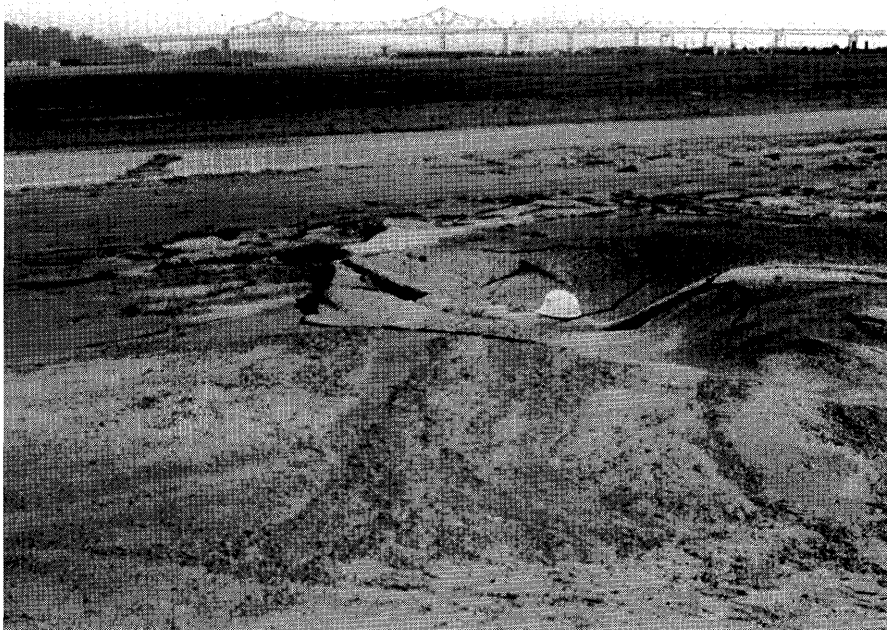
two runways and two taxiways were significantly damaged and inoperable after the earthquake. A large sand boil and vent on the taxiway of the two runways at ANAS is shown in figure 16. Pavement damage consisted of heaving, settlement, and minor lateral spreading, resulting in separation at joints. Maximum crack and joint openings were about 10 cm, and maximum vertical offsets were approximately 5 cm.

Figure 16.—Liquefaction-induced damage to taxiway pavement at Alameda Naval Air Station.

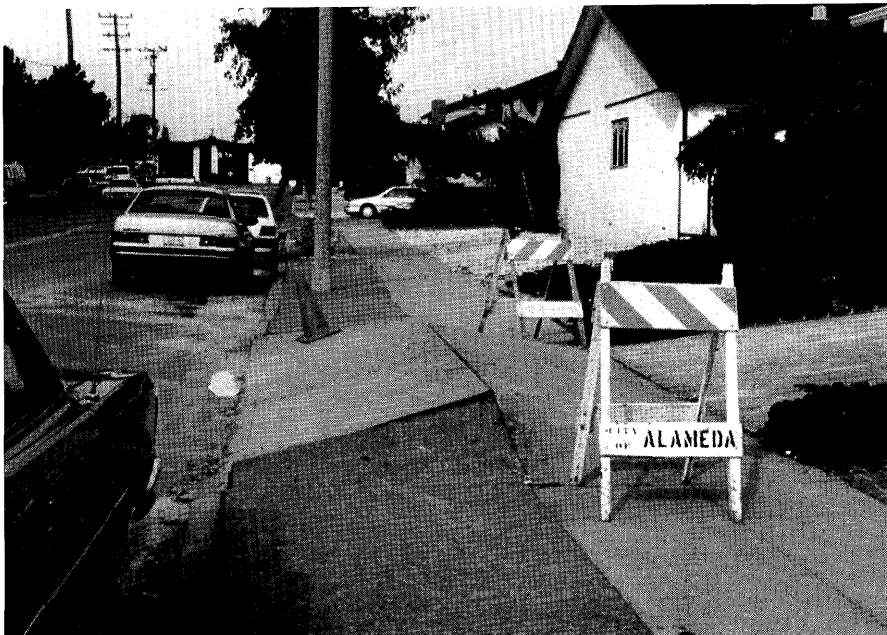
Figure 17.—Minor settlement and buckling of pavement at southwest edge of the Alameda (fig. 1).

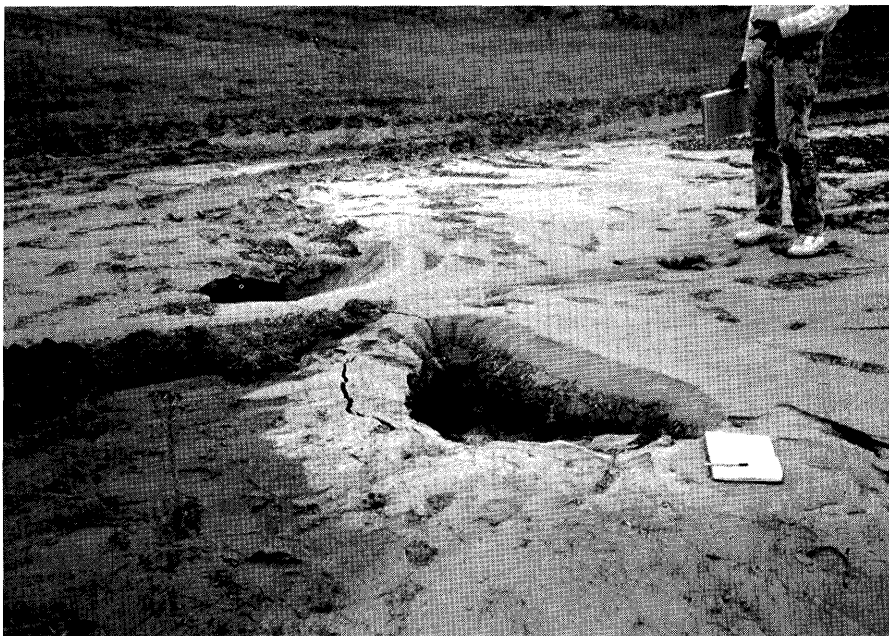
Figure 19.—Sand boils west of Aughinbaugh Way near borehole HBI-CPT1 on Bay Farm Island (see fig. 18 for locations).

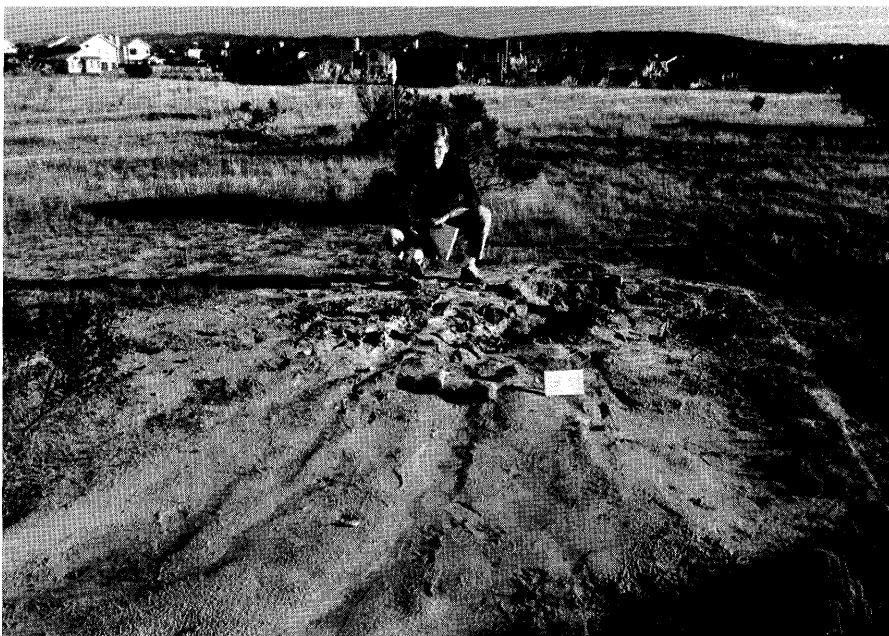
Fill in the perimeter dike was densified by dynamic compaction. Densification appears to have successfully prevented soil liquefaction of the western-perimeter dike during the earthquake. In contrast, in an area of unimproved fill, damage to roadway and parking-lot pavements occurred at the Harbor Bay Plaza business park (fig. 18). Numerous sand boils, many relatively large (more than 3 m in diameter), erupted in this area (fig. 20).

Figure 20.—Sand boil near Harbor Bay Plaza on west side of Bay Farm Island.

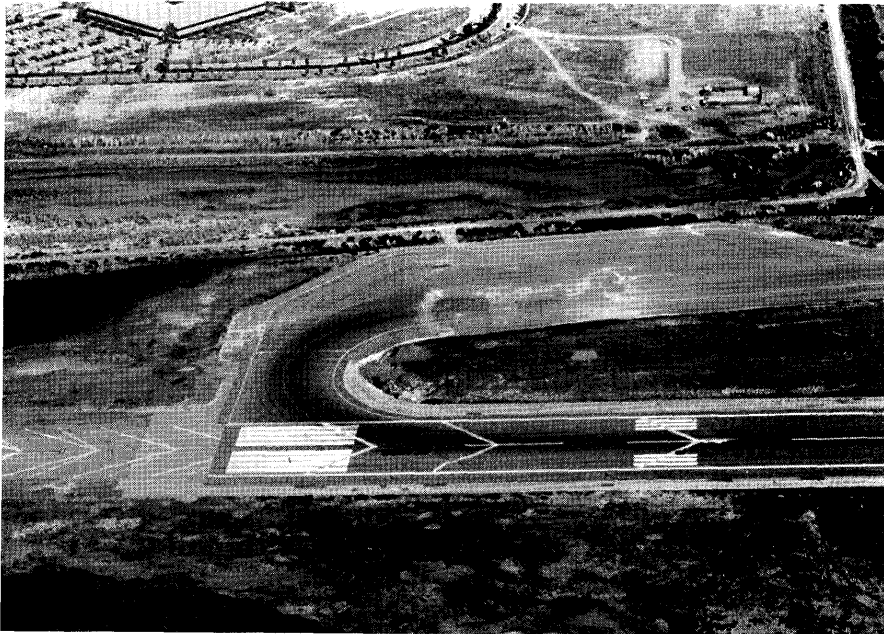
Figure 22.—Northwest end of main runway (bottom) and adjacent taxiway (top) at Oakland International Airport (fig. 1). Photograph taken October 18, 1989.

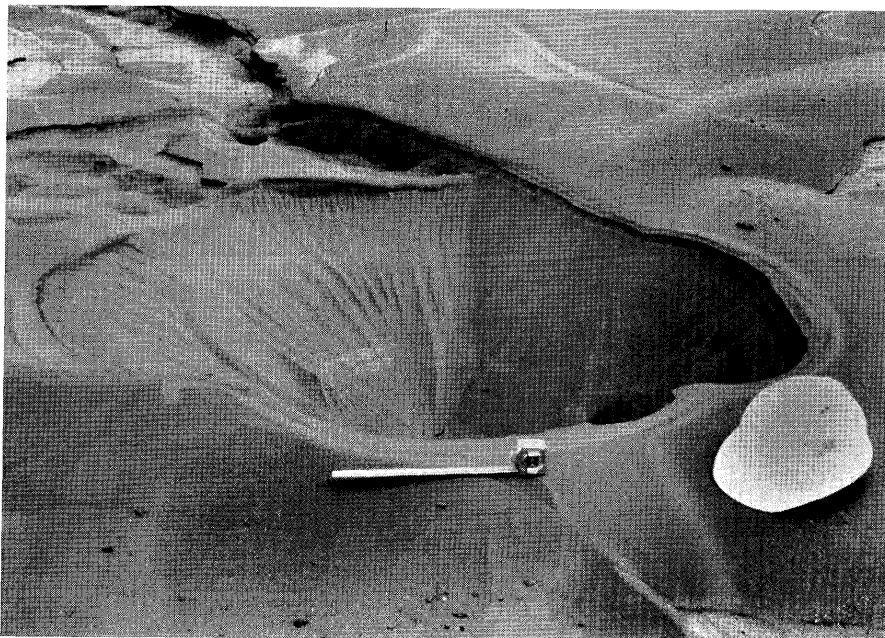
Figure 23.—Large sand boil near north end of main runway at Oakland International Airport (fig. 1).

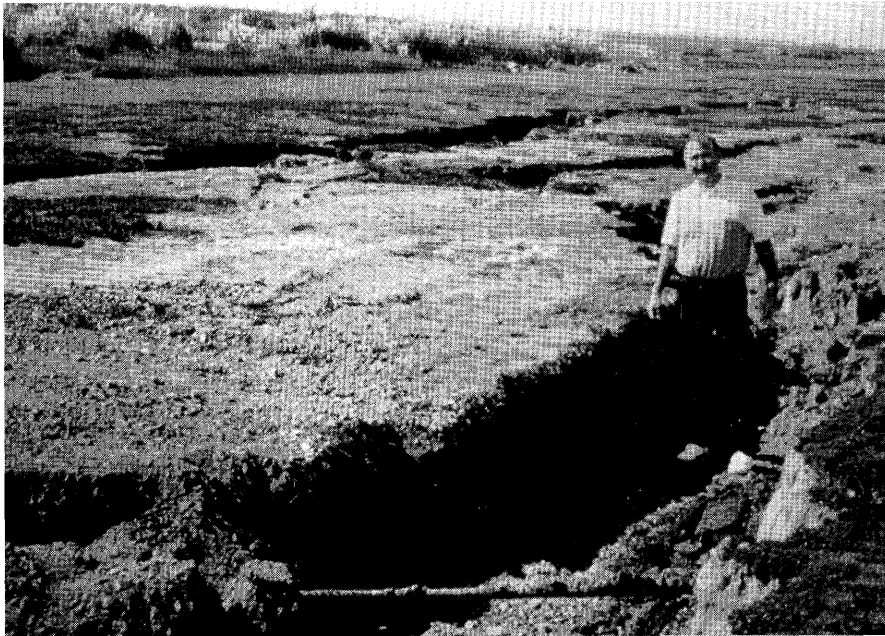
Figure 24.—Fissures, sand boils, and grabens associated with lateral spreading near northwest end of main runway at Oakland International Airport. Photograph courtesy of B.A. Vallerga.

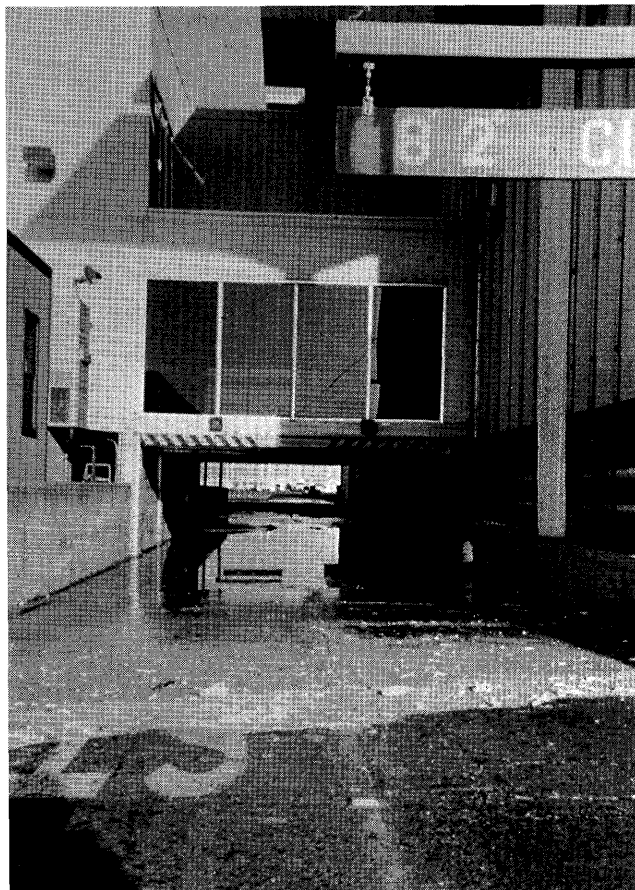
Liquefaction-induced ground deformations also damaged an undeveloped area of fill to the north and northeast of the main runway. Sand boils and major fissures caused by lateral spreading in this area are shown in figure 30. Liquefaction was also observed near the main terminal buildings, which are supported on deeper foundations and were not significantly damaged, although settlements of as much as 8 cm were observed in several places in the surrounding soils. In addition, a below-ground tramway, which allows service vehicles carrying passengers' luggage to pass under part of one of the main terminal buildings, filled to a depth of 2 m with exuded sand and water, as shown in figure 25.

Figure 25.—Below-grade tramway, filled with as much as 1.8 m of extruded sand, at Oakland International Airport Terminal Building. Photograph courtesy of B.A. Vallerga.

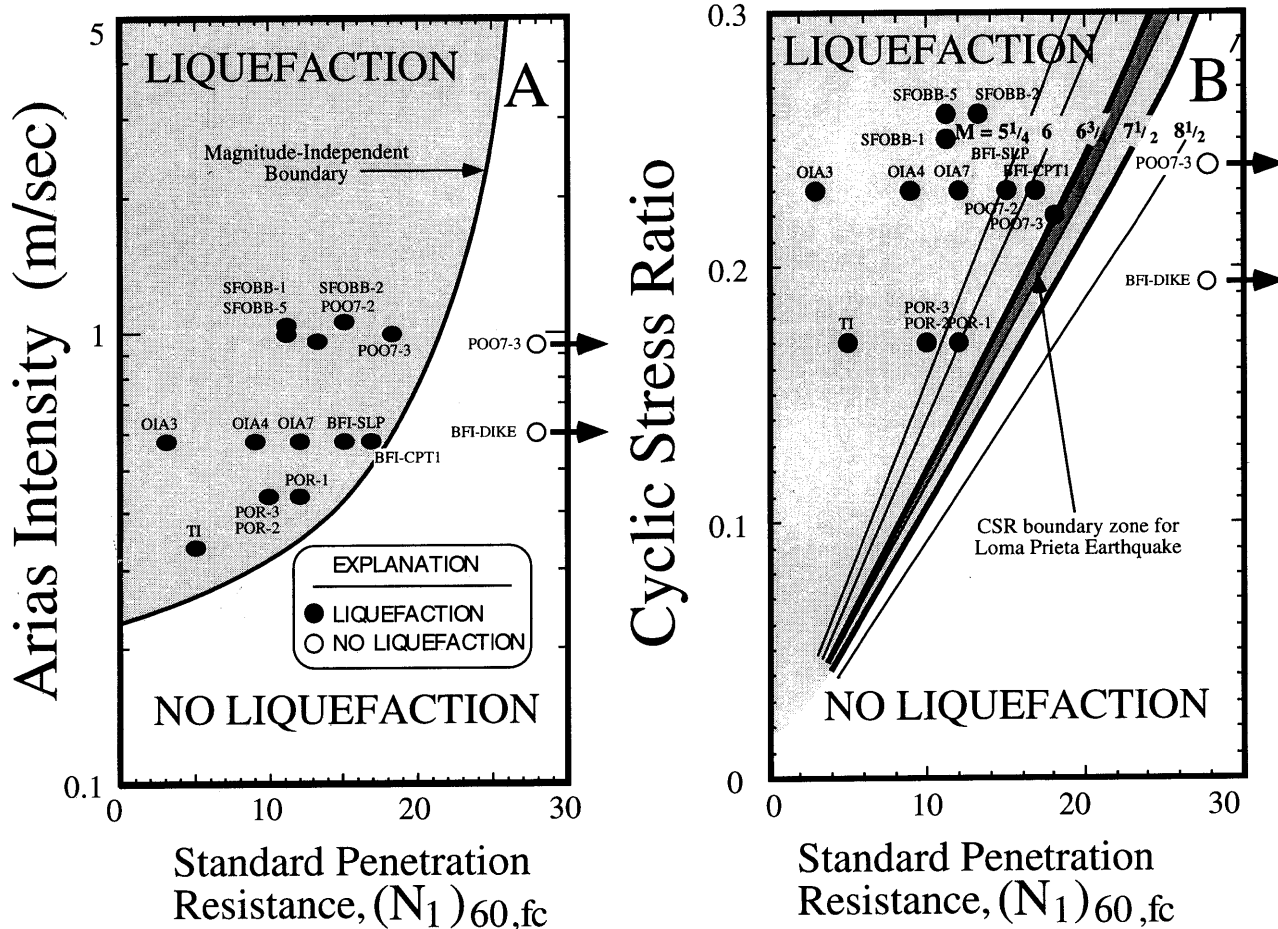
In our study, we associate CSR and  $I_{hb}$  profiles with the liquefaction field-performance data ( $N_1$ )<sub>60</sub> and  $q_{c1}$  from our study sites. The CSR and  $I_{hb}$  values used in the analyses of critical soil layers at the east-bay study sites (fig. 1) are summarized in table 1. Two SPT boundary-curve sets for the assessment of soil-liquefaction potential based on  $I_{hb}$  (Kayen and Mitchell, in press) and CSR (Seed and others, 1984) for soils with low-plasticity fines content of less than 5 percent are shown in figure 28. The CSR by itself does not account for earthquake magnitude and du-

The  $I_{hb}$  and CSR values at the liquefaction boundary in figure 28 represent the minimum threshold seismic intensity ( $I_{hb,l}$  and  $CSR_l$ , respectively) required to induce liquefaction in soil with a given  $(N_1)_{60}$  or  $q_{c1}$  value. We compared  $I_{hb,l}$  and  $CSR_l$  with the corresponding seismic-shaking-intensity function induced by the earthquake, using equations for Arias intensity at depth ( $I_{hb,eq}$ ) and cyclic-stress ratio ( $CSR_{eq}$ ), to determine profiles of factor of safety against liquefaction. The Arias intensity-based factor of safety  $F_{hb}$  against liquefaction occurrence is defined as the ratio of the Arias intensity required to cause liquefaction to the Arias intensity imparted by the earthquake:

Figure 28.—Assessment of soil-liquefaction potential from Arias intensity versus cyclic-stress-ratio method. A, Arias intensity within soil column versus normalized 60-percent-hammer-efficiency blowcount for sites in the United States and Japan, with fines-content correction to equivalent “clean sand.” B, Cyclic-stress ratio versus normalized 60-percent-hammer-efficiency blowcount for Loma Prieta study sites.

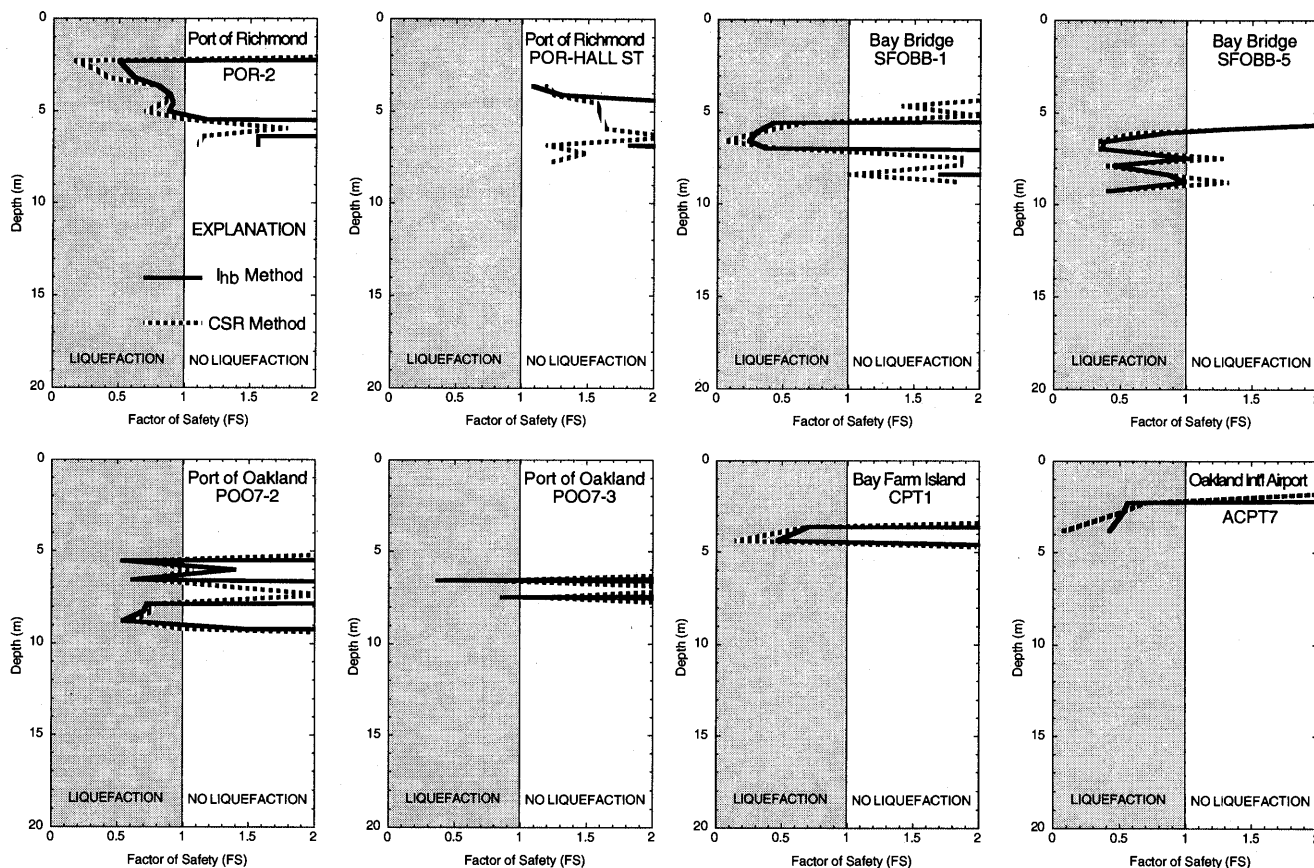
We converted the  $N$  profiles from figures 4, 9, 10, 14, 15, 21, and 26 into factor-of-safety profiles for both  $F_{CSR}$  and  $F_{hb}$  in figure 29, on the basis of the calculated CSR and  $I_{hb}$  values for the study sites. At the Port of Richmond study site, the  $F_{hb}$  and  $F_{CSR}$  profiles accurately identify the liquefaction zone between 4- and 5-m depth in profile POR-1. At borehole POR-Hall St. (log not shown), both profiles accurately indicate no liquefaction. Profiles of  $F_{CSR}$  and  $F_{hb}$  for the San Francisco-Oakland Bay Bridge study site correctly indicate that liquefaction occurred principally between approximately 5.5- and 7.5-m depth at borehole SFOBB-1 and between 6.0- and 9.0-m depth at borehole SFOBB-5, on the basis of field observations. The profiles for borehole POO7-2 are in agreement and identify the zone of liquefaction between 5- and 8-m depth, and borehole POO7-3 indicates thin seams of loose potentially liquefiable material at 6.5- and

Figure 29.—Comparison of factor of safety against liquefaction ( $FS \leq 1.0$  = liquefaction;  $FS > 1.0$  = no liquefaction) for study sites on east side of San Francisco Bay, using Arias intensity and cyclic-stress-ratio methods.

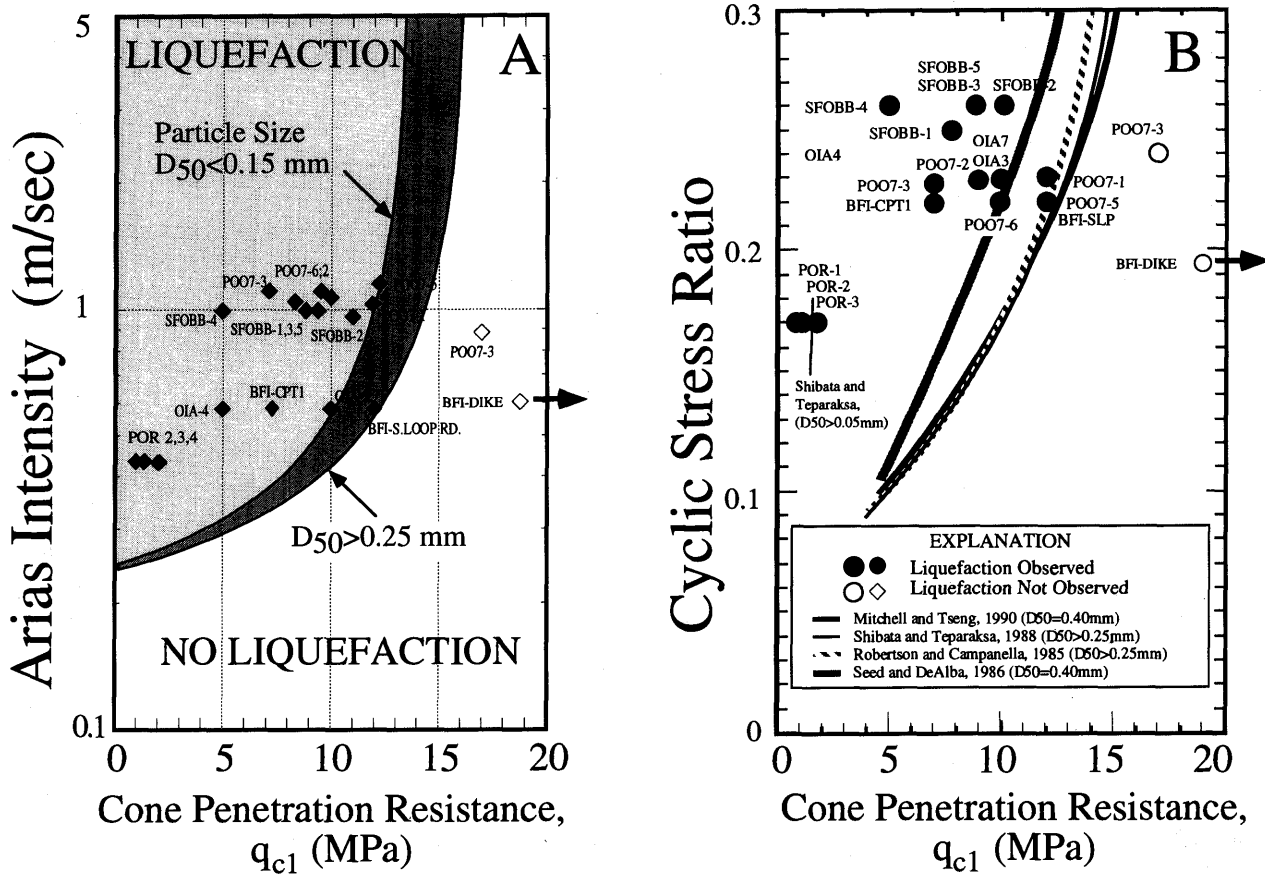
The CPT data used to construct the plot of  $I_{hb}$  versus  $q_{c1}$  in figure 30A are almost exclusively from the Loma Prieta data set.  $q_{c1}$  is plotted against CSR in figure 30B with respect to the boundary curves proposed by Robertson and Campanella (1985), Seed and de Alba (1986), Shibata and Teparaksa (1988), and Mitchell and Tseng (1990). The boundary curves proposed by Robertson and Campanella (1985) and Seed and de Alba (1986) are based on  $q_c/N$  ratios rather than direct field investigations of liquefaction test sites. The method of Shibata and Teparaksa (1988) is based on a limited data set of direct measurements at liquefaction sites for earthquakes in Japan, China, and the United States. Mitchell and Tseng (1990) proposed boundary curves developed from the  $q_c$ - $D_r$  (relative density)-CSR relation at a given effective confining stress, which are based on cavity-expansion theory and cone-chamber test results.

The data points for sandy-fill deposits in the east bay observed to have liquefied plot on or to the left of the boundary curves proposed by Robertson and Campanella (1985), Shibata and Teparaksa (1988), and Mitchell and Tseng (1990) for medium sand. The dense layers at borehole POO7-3 and the Bay Farm Island dike (fig. 24), which are not believed to have liquefied, plot to the right of all the boundary curves. One boundary curve proposed by Seed and de Alba (1986) did not fully capture the observed occurrences of liquefaction for several soil layers and appears to be somewhat unconservative. The boundary curve for  $D_{50}=0.05$  mm proposed by Shibata and Teparaksa (1988) falls to the left of the data points for the Port of Richmond study site and appears to be somewhat unconservative for fine-sand material.

Figure 30.—Assessment of soil-liquefaction potential from Arias intensity versus cyclic-stress-ratio method, showing plots of Arias intensity within soil column (A) and cyclic-stress ratio (B) versus normalized cone-penetration resistance for Loma Prieta study sites listed in table 1.

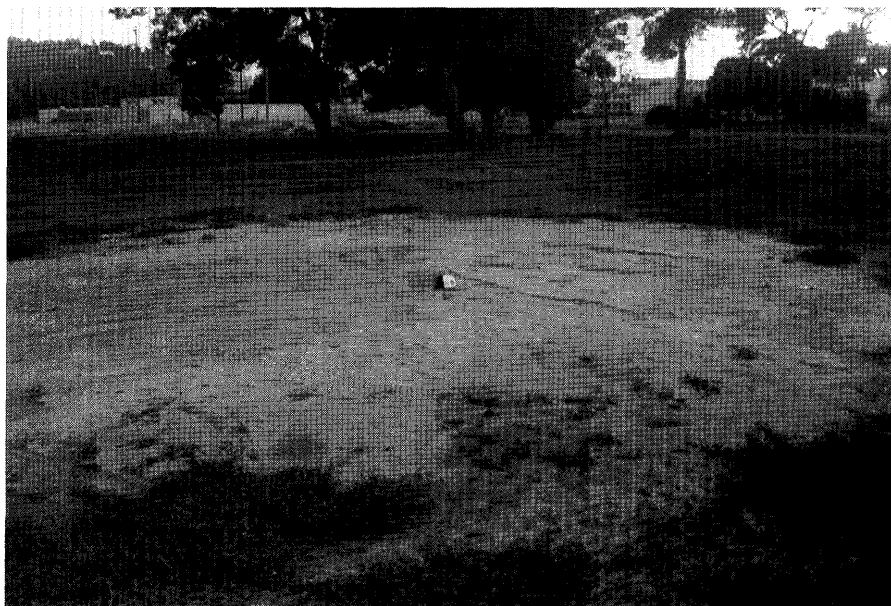
Figure 12.—Sand boil on Treasure Island. Photograph courtesy of Michael J. Bennett, U.S. Geological Survey.

As previously discussed, sand boils were observed in many places across the island, substantiating that subsur-

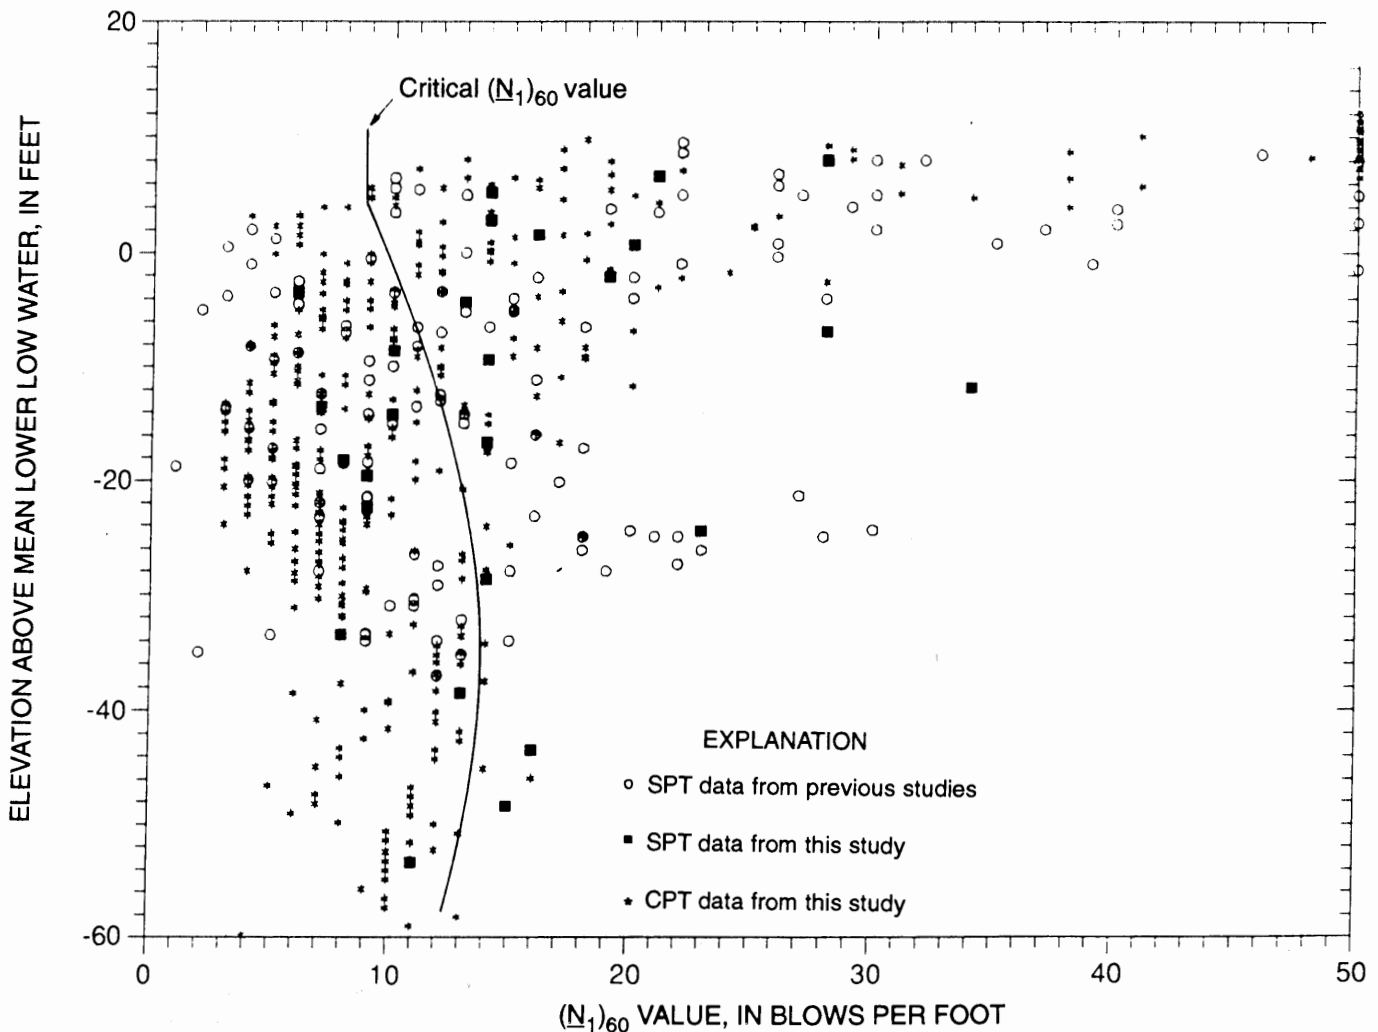
For a peak acceleration of 0.16 g, the seismically induced cyclic-stress ratio was computed as a function of elevation, and the corresponding critical  $(N_1)_{60}$  value was determined. These critical  $(N_1)_{60}$  values were then compared with the  $(N_1)_{60}$  values from boreholes and CPT soundings located close to the perimeter of the island. Comparisons were made for four different sections or reaches of the perimeter dike (Geomatrix Consultants, 1990b). The comparison for Section II (fig. 5), which is the reach located from 4,950 to 8,500 ft from the entry gate, proceeding clockwise around the island's perimeter, is shown in figure 18; the comparisons are similar for the other three reaches. As can be seen, a substantial number of the  $(N_1)_{60}$  data fall below the critical value, indicating that much of the sand below the ground-water level probably liquefied during the 1989 Loma Prieta earthquake. However, because some of the data below the ground-water level also fall above the critical  $(N_1)_{60}$  value, liquefaction probably did not occur in some zones within the sand fill and shoal sand.

The spatial distribution of expected occurrence and nonoccurrence of liquefaction can be illustrated by examining the contours of  $(N_1)_{60}$  data for typical island cross sections, such as those in figure 10. As shown in figure 18, the critical  $(N_1)_{60}$  value was estimated at 10 to 15 blows/ft. Figure 10 indicates that substantial proportions of the island's subsurface materials have an  $(N_1)_{60}$  value less than 10 and so could reasonably be expected to have liquefied during the 1989 Loma Prieta earthquake. For the zones of material in figure 10 with an  $(N_1)_{60}$  value of 10 to 15 blows/ft, the occurrence of liquefaction was only marginal, and materials with an  $(N_1)_{60}$  value greater than

Figure 18.— $(N_1)_{60}$  value versus elevation, based on SPT and CPT data. Curve shows critical  $(N_1)_{60}$  value at various elevations.

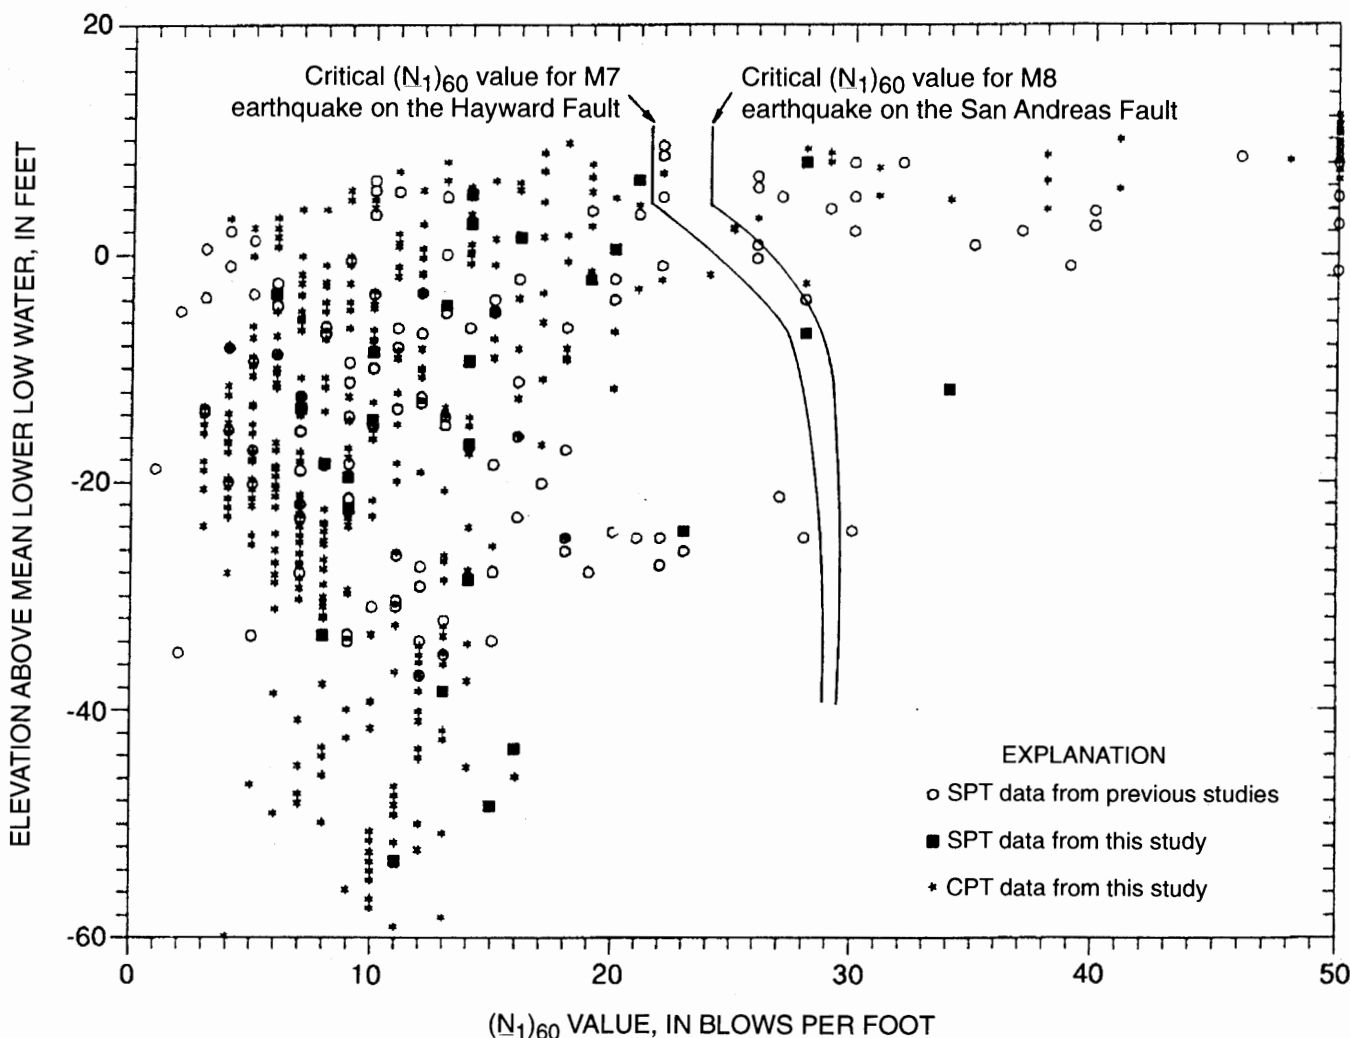
for liquefaction for potential future earthquakes of  $M=7$  on the Hayward fault and  $M=8$  on the San Andreas fault. A typical comparison of the critical  $(N_1)_{60}$  values for these earthquakes with that for the sand deposits on Treasure Island is shown in figure 21, which illustrates that essentially complete liquefaction of the sand would be expected during these earthquakes.

Figure 21.— $(N_1)_{60}$  value versus elevation, based on SPT and CPT data. Curves show critical  $(N_1)_{60}$  values for hypothetical  $M=7$  earthquake on the Hayward fault and  $M=8$  earthquake on the San Andreas fault.

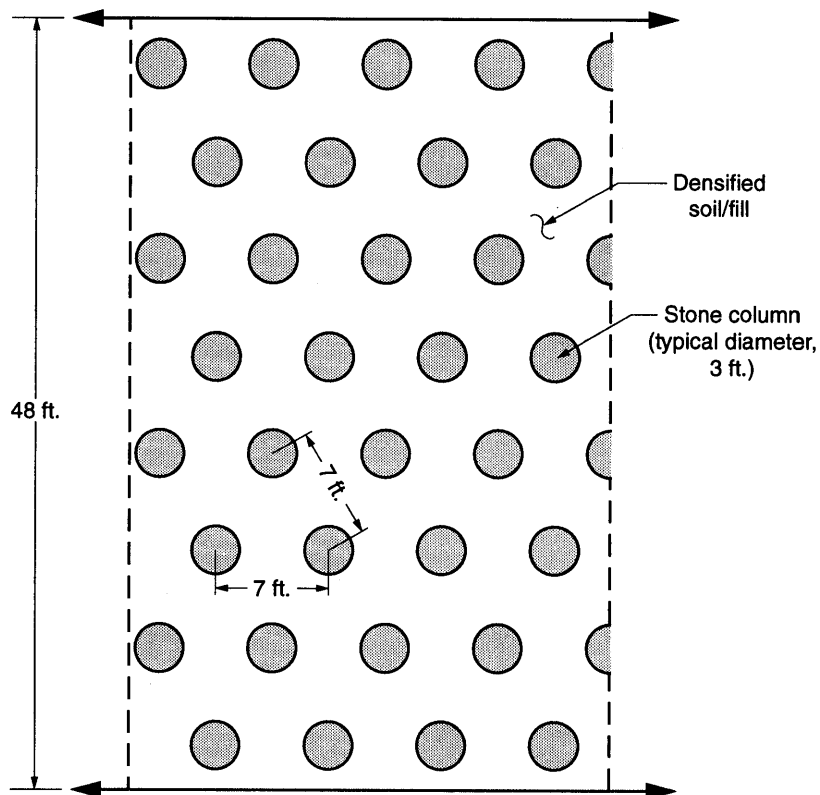
Figure 23.—Plan view of stone-column configuration for remedial scheme to mitigate liquefaction-induced lateral spreading.

earthquakes. Creation of a buttressing, stabilized area of sand adjacent to the perimeter slope by the vibro-replacement method was found to be the most cost effective means of mitigating the hazard. By this method, the sand would be densified by vibroflotation at approximately 7 ft on center, and stone columns approximately 3 ft in diameter would be constructed at the vibroflotation locations. Analysis indicated that a stabilized buttressing zone approximately 50 ft wide extending back from the top of the perimeter slope would be enough to effectively retain any liquefied sand behind (landward of) this zone and thus reduce lateral-spreading displacements through the sand to less than approximately 1 ft. A plan view of the stone-column configuration is shown in figure 23, and a cross section of the stabilized zone is shown in figure 24.

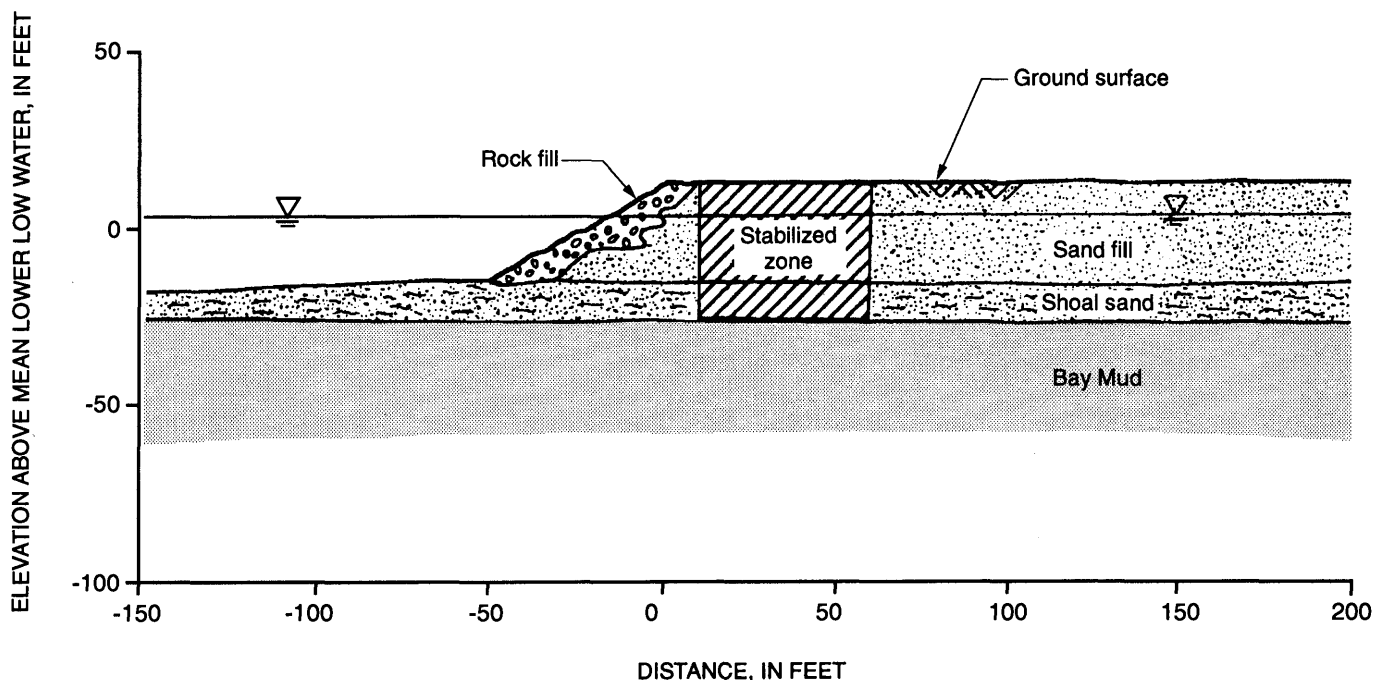
relatively soft material that could be further reduced in strength and deform during strong earthquake shaking. With the sand-stabilization measures in place, the area susceptible to lateral-spreading movements then shifts below the stabilized zone into the bay mud (fig. 24). Larger movements might occur on sliding surfaces that pass through the bay mud below the stabilized zone than on sliding surfaces passing through this zone. Within the scope of our studies, we could not assess in detail the potential for such movements through the bay mud around the perimeter of Treasure Island. Preliminary analyses using the method of Newmark (1965) indicate that movements of several feet might occur and that therefore more detailed consideration of this potential hazard would be desirable.

Figure 24.—Cross section of remedial scheme to mitigate liquefaction-induced lateral spreading.

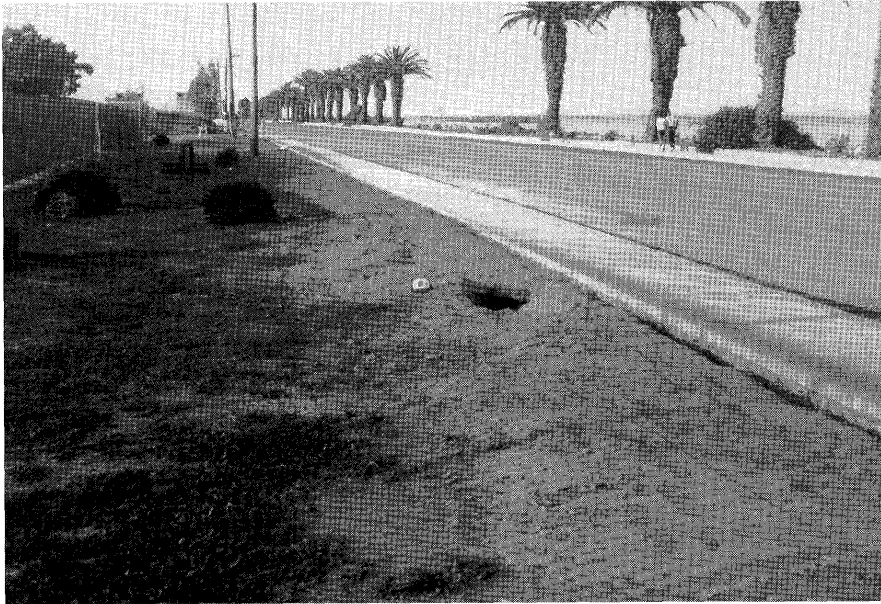
Figure 5.—Sand boil on east side of Treasure Island at locality 5 (fig. 4).

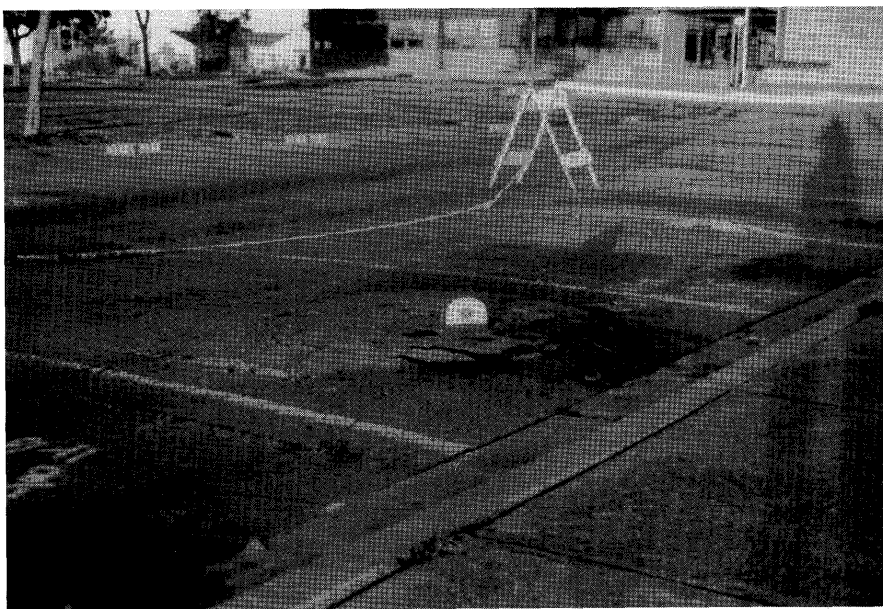
Figure 6.—Differential settlement (approx 90 mm) on Treasure Island where piles erupted through pavement in parking lot near Building 450 (loc. 28, fig. 4).

18	60	Building 2, paint overlap on awning.
19	80	Building 2, pull down of pipe brace.
20	35	Building 3, fence damaged when floor settled.
21	50	Building 3, northeast corner.
22	50	Building 3, floor and foundation.
23	65	Building 3, around structural support.
24	70	Building 3, settlement due to heavy equipment (?).
25	90	Building 3, ground and building outside.
26	65	Building 3, floor.
27	5-50	Piles, Avenue D.
28	90	Piles, parking lot near Building 450.

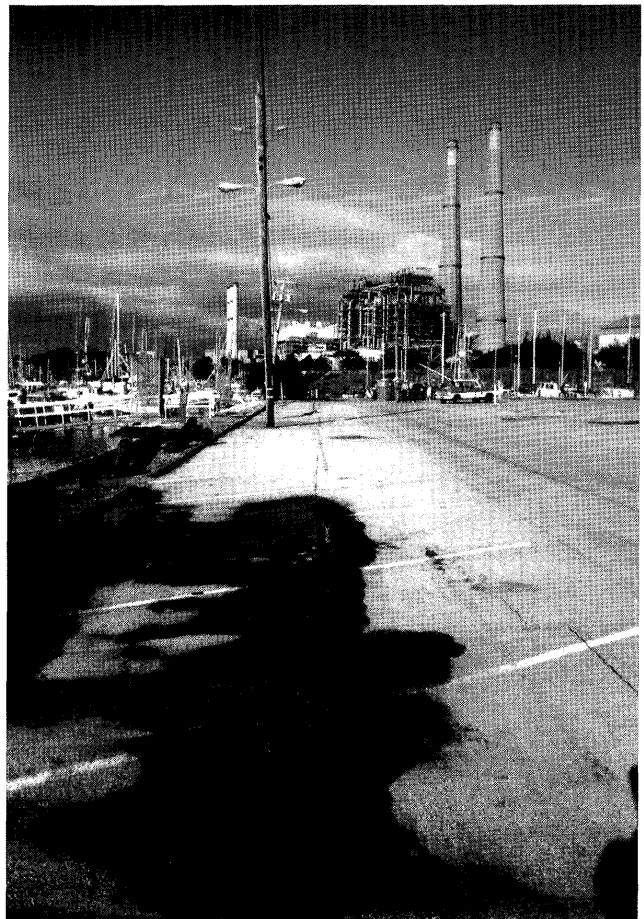
Figure 4.—Sand boils in Moss Landing Harbor District parking lot. Smokestacks for Units 6 and 7 of Pacific Gas & Electric powerplant are visible in background.

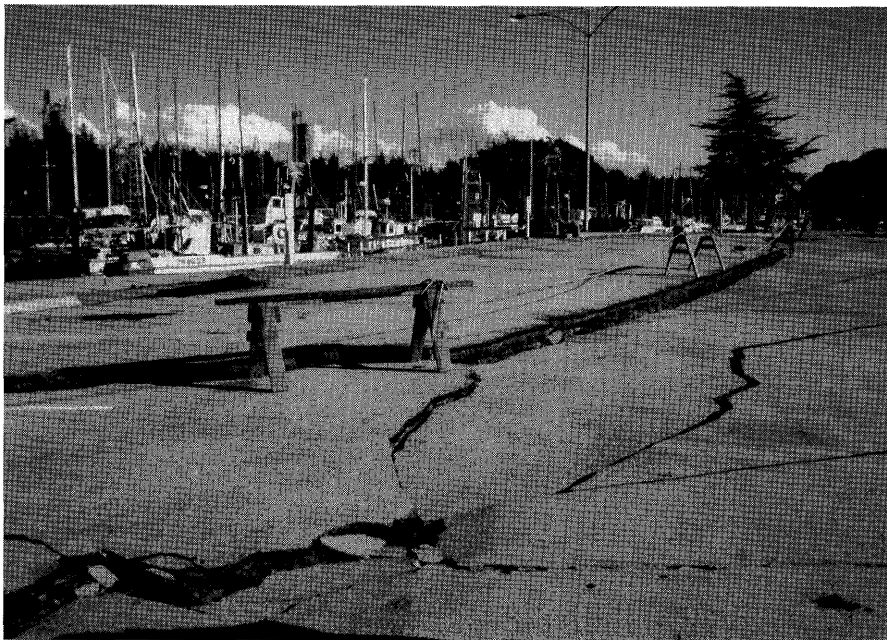
Figure 5.—Ground cracks at north end of Moss Landing Harbor District parking lot.

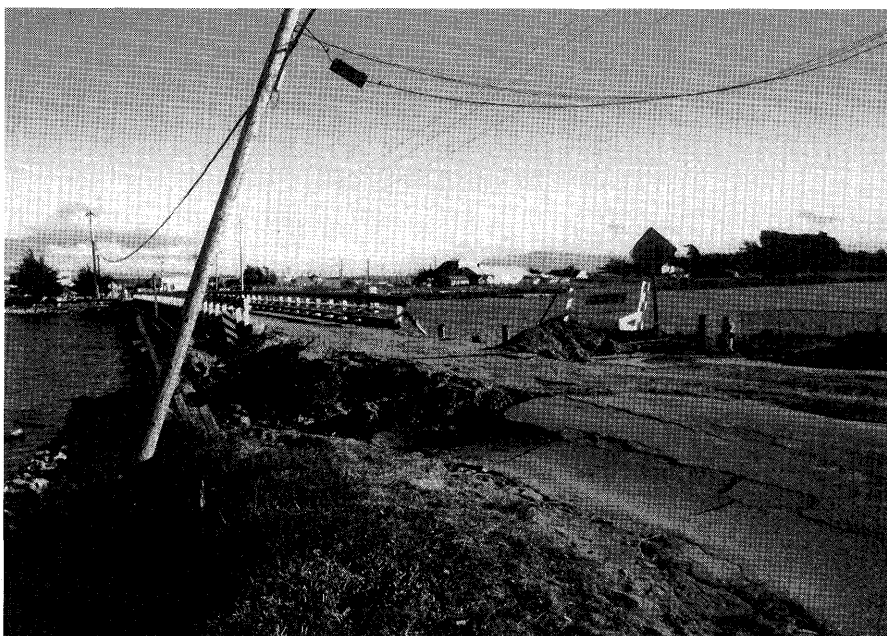
Figure 6.—West approach to single-lane timber bridge across the Old Salinas River (see fig. 2 for locations).
