# The Loma Prieta, California, Earthquake of October 17, 1989—Liquefaction

STRONG GROUND MOTION AND GROUND FAILURE

U.S. GEOLOGICAL SURVEY PROFESSIONAL PAPER 1551-B

UNITED STATES GOVERNMENT PRINTING OFFICE, WASHINGTON : 1998

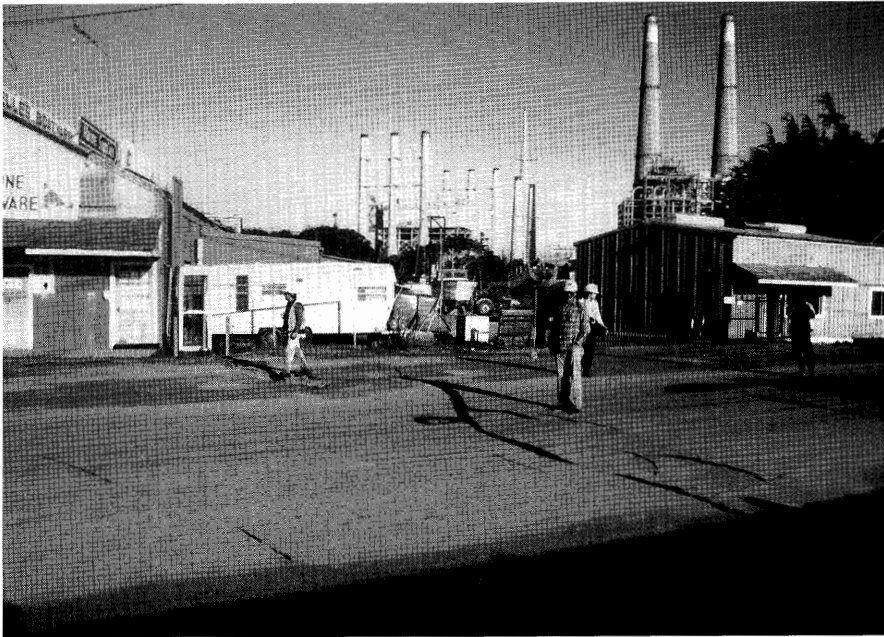
Figure 7.—Settlement across Sandholdt Road near north end of Moss Landing spit (see fig. 2 for locations).

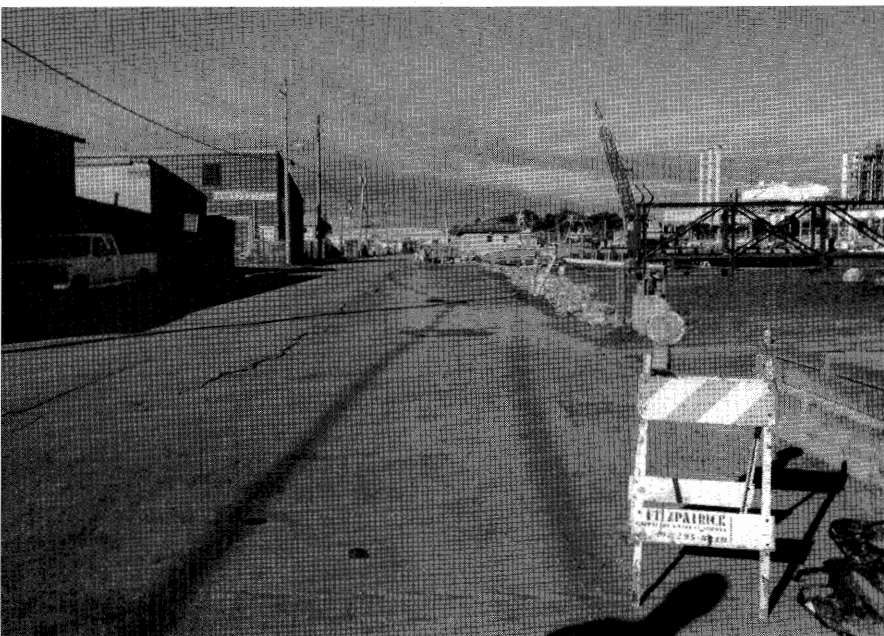
As shown in figure 8, lateral deformations of the road were accompanied by settlements of 2 to 3 in. and cracking of the road surface approximately 15 to 20 ft landward of the slope crest. No evidence of significant deformation of the road was observed farther west at this site. Assuming that the observed cracks represent the sur-

Figure 8.—Sandholdt Road halfway between timber bridge and Monterey Bay Aquarium Research Institute facilities (see fig. 2 for locations). Photograph taken 3 days after earthquake. View northward.

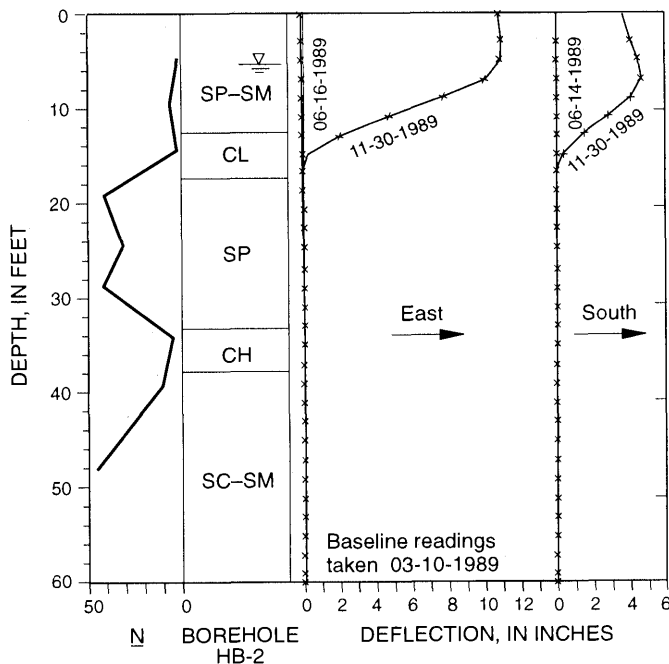
Horizontal deflections measured after the earthquake with a slope inclinometer on the east edge of Sandholdt Road within 10 ft of borehole HB-2 (fig. 9) are plotted in figure 10. This inclinometer and two others farther to the north were installed in early 1989 by Harding Lawson Associates to monitor slope movements associated with riprap filling of the waterfront slopes (Kevin Tillis, oral commun., 1991). These inclinometer measurements indicate that the edge of the road moved about 11 in. toward the harbor and about 4 in. southward nearly parallel to the waterfront. Clearly, the deformations resulted from liquefaction of the saturated part of the upper sand layer, and no permanent deformations occurred below. These deformations correspond to an approximately uniform shear strain of about 10 percent over a depth interval of about 10 ft.

Figure 10.—Slope-inclinometer deflections on east edge of Sandholdt Road midway between timber bridge and Monterey Bay Aquarium Research Institute facilities (see fig. 2 for locations). CH, fat clay; CL, lean clay; SC, clayey sand; SM, silty sand; SP, poorly graded sand.

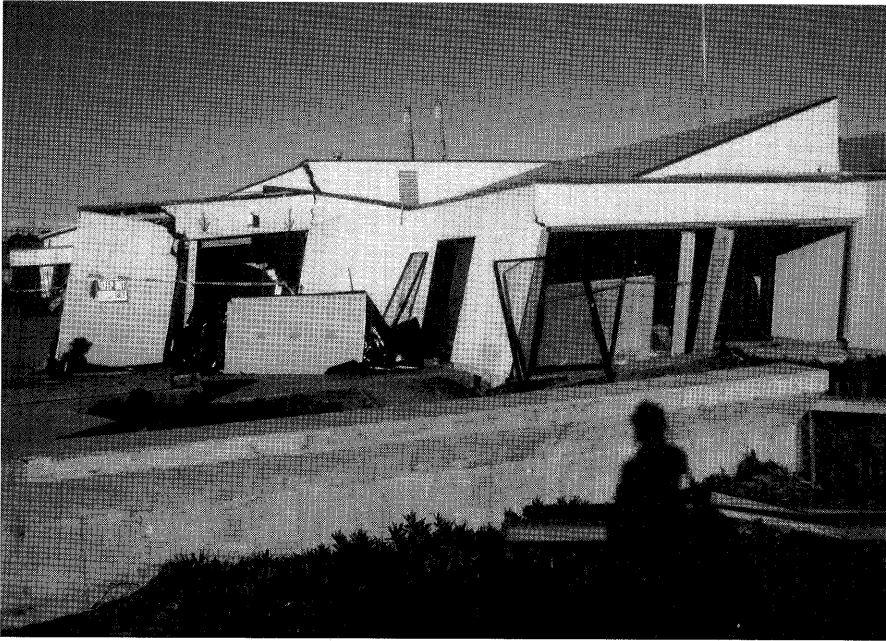
Figure 12.—Racking of director's office at southwest corner of Moss Landing Marine Laboratory (fig. 11).

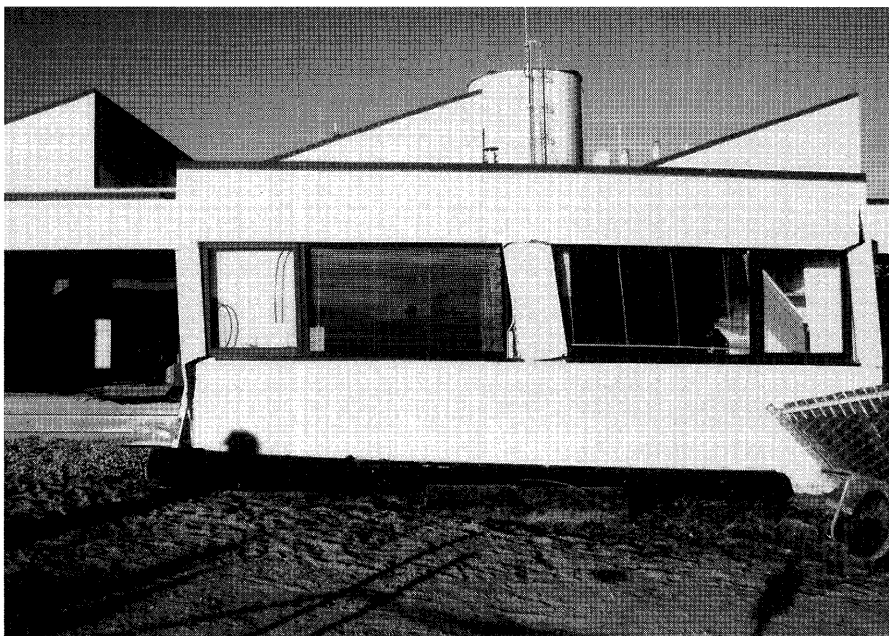
Racking of the southeast corner of the MLML is shown in figure 13; this corner of the facility moved laterally

toward the river about 1.5 ft and settled about 1 foot. Similar displacements were observed at the northeast corner. Measured lateral displacements on the east side of Sandholdt Road were 2.5 to 4.5 ft toward the river (fig. 11). Thus, the total extension of the spit due to lateral spreading at the site appears to have ranged from about 4.5 ft on the north side of the MLML to 7 ft on the south side. This difference in displacement appears to be related mainly to slight differences in topography between the north and south sides of the site and to slight differences in soil conditions.

Figure 13.—Racking of southern building at southeast corner of Moss Landing Marine Laboratory (fig. 11).

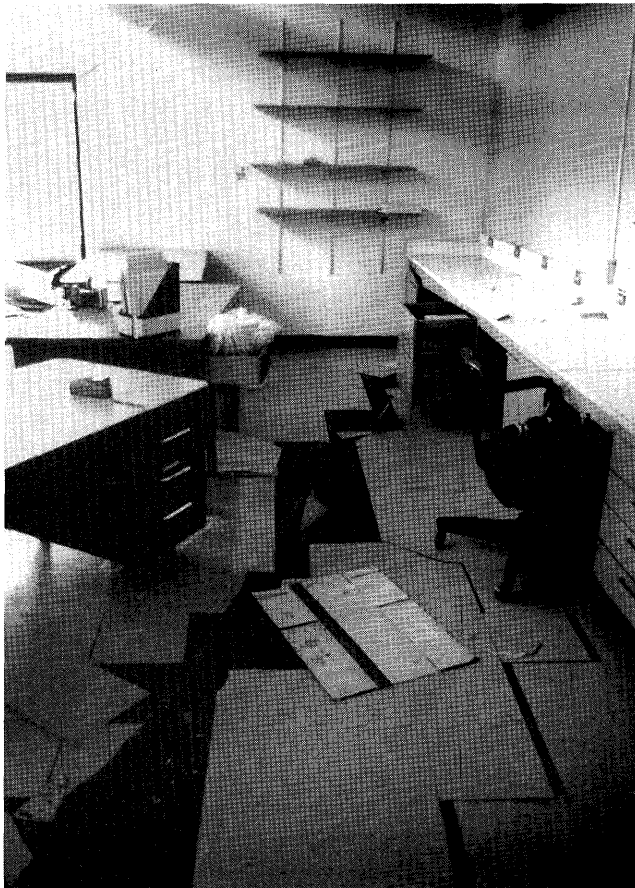
As shown in figure 11, lateral spreading resulted in extensive cracking throughout the site and formation of an approximately 15-ft-wide, 1-ft-deep graben south of the MLML. The southern building sustained severe cracking in the foundation and slab floor; cracks as much as 6 in. wide formed in the slab, and separations of as much as 10 in. occurred between building floors and walls. Cracking of the concrete floor in the southern building, just north of the graben, is shown in figure 14. The northern

building also sustained severe cracking at the roof and foundation levels, and separations of more than 18 in. in some places.

Figure 14.—Cracks in concrete floor in southern building of Moss Landing Marine Laboratory (fig. 11).

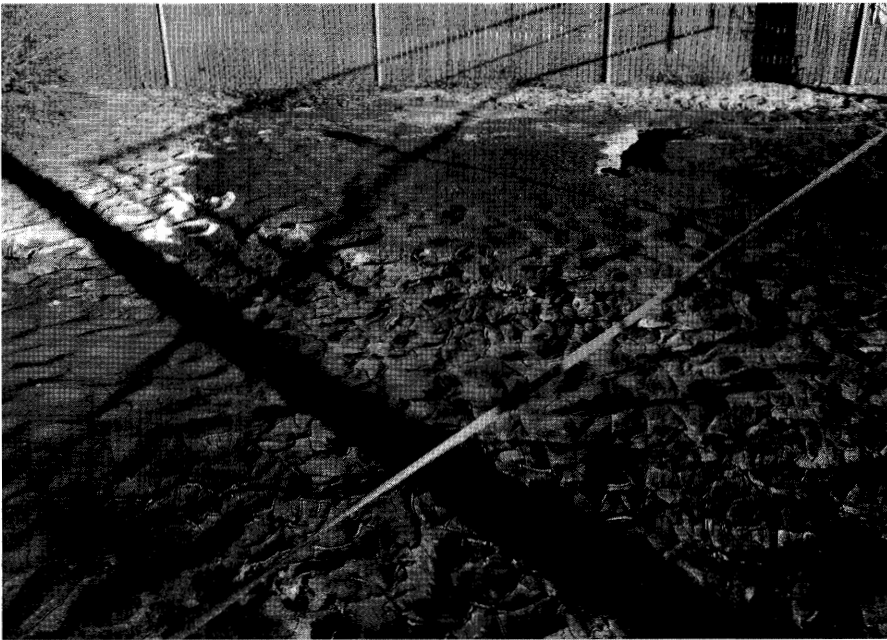
Soil boils, which geysered as much as 3 ft high, flowed for 30 to 45 minutes after the earthquake at the volleyball court south of the MLML (Greene and others, 1991). As shown in figure 15, the soil-boil ejecta consisted of predominantly fine clayey silt, although medium sand also flowed to the surface at this site. Sand boils of

The soil-boil ejecta at the volleyball court indicates that the clayey silt underlying the dune sand in this area also appears to have developed high excess pore pressures (fig. 15). Several liquefaction vents through the dune sand were carefully examined in an 8-ft-deep test pit at this site. The appearance of the clayey silt in these vents suggests that the silt flowed to the surface in a liquefied state. An LL value of 38 percent, a PI value of 17 percent, a fines content of 78 percent, and a minus-5- $\mu\text{m}$  fraction of 24 percent were measured in a sample of the soil ejecta at the surface.

Figure 15.—Sand-boil ejecta in volleyball court of Moss Landing Marine Laboratory (fig. 11).

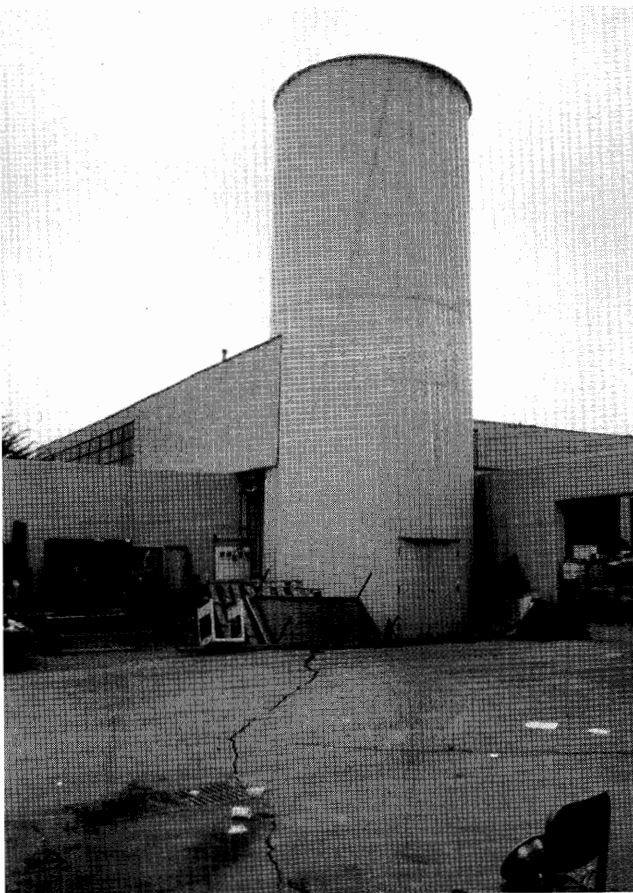
curred through cracks in the corporation-yard pavement shown in figure 16. The pavement heaved upward about 2 ft and resettled as muddy water erupted through the cracks,

Figure 16.—Cracks in corporation-yard pavement of Moss Landing Marine Laboratory (fig. 11). Seawater-storage tank in background settled differentially 2 to 3 in.

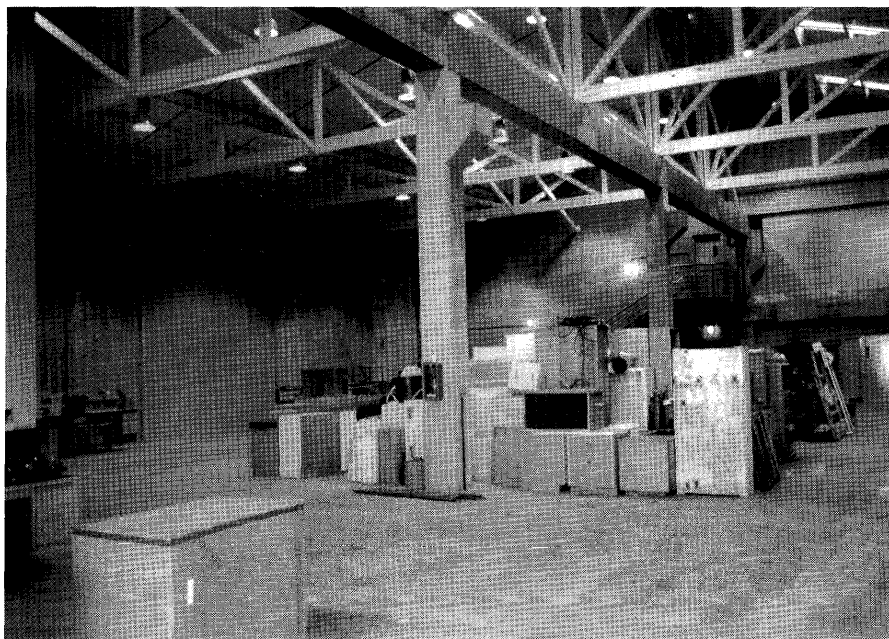
Figure 20.—Appearance of Monterey Bay Aquarium Research Institute technology building 3 days after earthquake. A, Building exterior. B, Building interior.

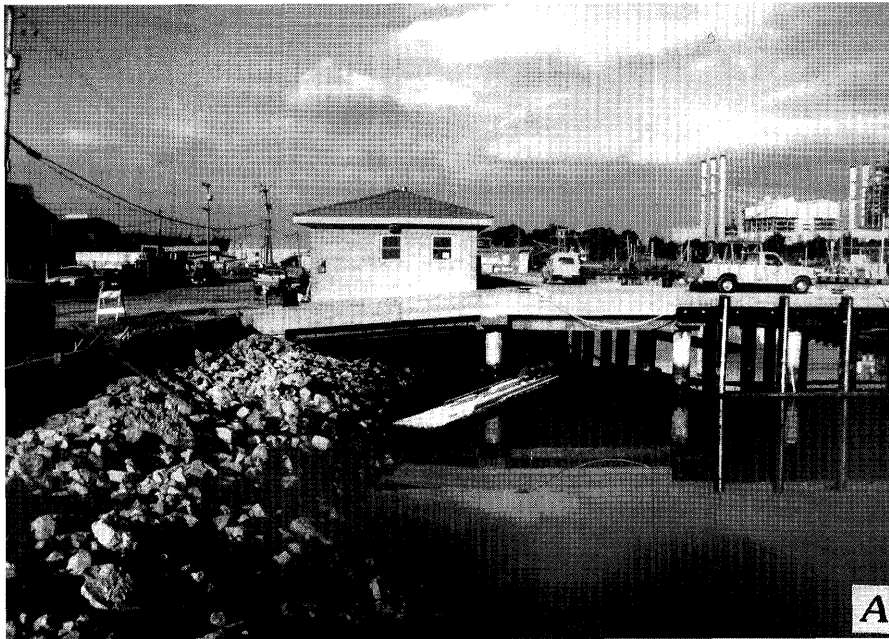
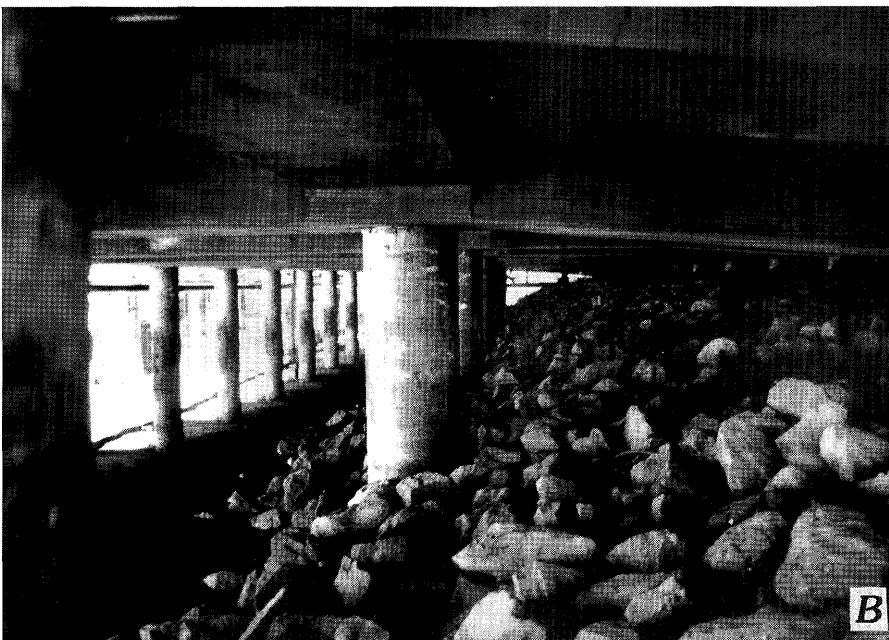
of the concrete deck on the north side of the pier are shown in figures 21A and 21B, respectively. Evidence of small movements in the form of minor concrete spalling was observed at the joints between some of the piles and the deck. Lateral displacements of the edge of the road toward the harbor were about 10 in. and 3 in. just north and south of the pier, respectively; however, the pier appears to have been displaced laterally toward the harbor less than about 1 in.

Figure 21.—Appearance of Monterey Bay Aquarium Research Institute pier 3 days after earthquake. *A*, South side of pier. *B*, Underside of concrete deck.

The sand boils and deformations observed along Sandholdt Road indicate that liquefaction occurred in the near-surface loose to medium-dense sand underlying the road. On the basis of the observed difference in lateral displacements of the pier and the waterfront slopes to the

north and south, the pier apparently buttressed the liquefied soils and prevented larger lateral deformations from occurring on Sandholdt Road in front of the pier and, possibly, at the building sites across the road.

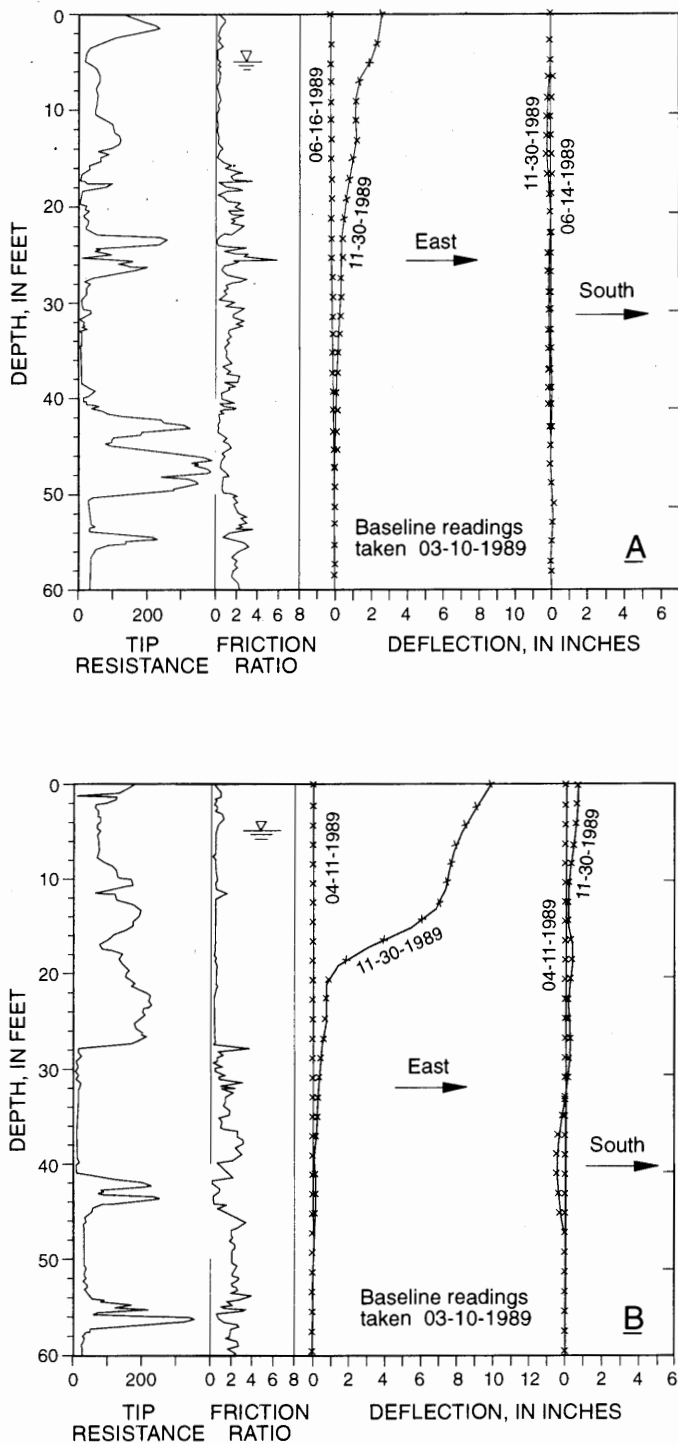
The horizontal deflections measured after the earthquake with a slope inclinometer (SI-5, fig. 19) located on the east edge of Sandholdt Road, about 20 ft north of the MBARI pier, are plotted in figure 24A, along with the log of a CPT sounding by Rutherford and Chekene (1988) located within about 10 ft of the inclinometer. The deflections measured with another slope inclinometer (SI-4, fig. 19) located about 20 ft south of the pier, within about 5 ft of another Rutherford and Chekene CPT sounding, are plotted in figure 24B. The edge of the road north of the pier moved about 10 in. towards the harbor, and south of the pier about 3 in. Movements parallel to the road were small.

The movements north of the MBARI pier appear to have resulted primarily from liquefaction of a medium-dense lens of sand at 13- to 19-ft depth. The observed deformations correspond to an approximately uniform shear strain of about 8 percent over a depth interval of 6 ft. Interestingly, the slope-inclinometer deflections suggest that deformation also occurred in the clayey silt and silty sand at about 28- to 36-ft depth. South of the pier, liquefaction appears to have occurred in the loose to medium-dense sand immediately below the water table at 5- to 7-ft depth, and in the clayey silt and silty sand at about 15- to 22-ft and 28- to 40-ft depth. No deformations occurred in the soils below 40-ft depth.

Figure 24.—Cone-penetration resistance (in tons per square foot), friction ratio (in percent), and deflection measured in slope inclinometers SI-4 (A) and SI-5 (B) (see fig. 19 for locations) versus depth at east edge of Sandholdt Road north (B) and south (A) of Monterey Bay Aquarium Research Institute pier.

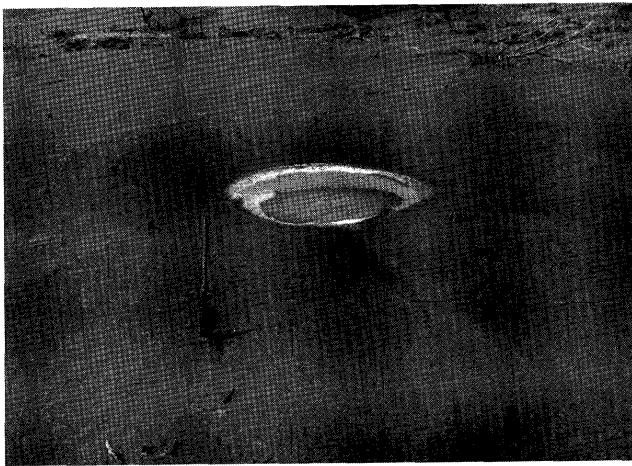
Figure 4.—Sandblow reactivated by March 23, 1991,  $M=4.6$  aftershock. Surface is smooth in comparison with eroded and vegetated cones shown in figures 5 and 7. Diameter of vent between arrows is approximately 30 cm. Photograph taken March 26, 1991.

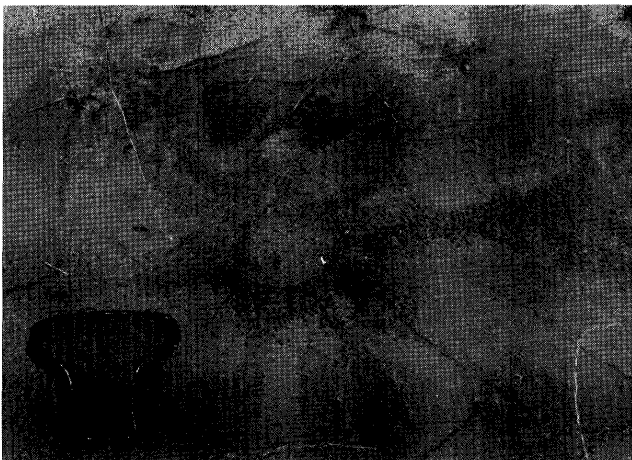
Figure 5.—Photograph of eroded and vegetated cone first formed in October 17, 1989, Loma Prieta earthquake and reactivated in April 18, 1990, aftershock but not in March 23, 1991, aftershock. Photograph taken March 26, 1991.

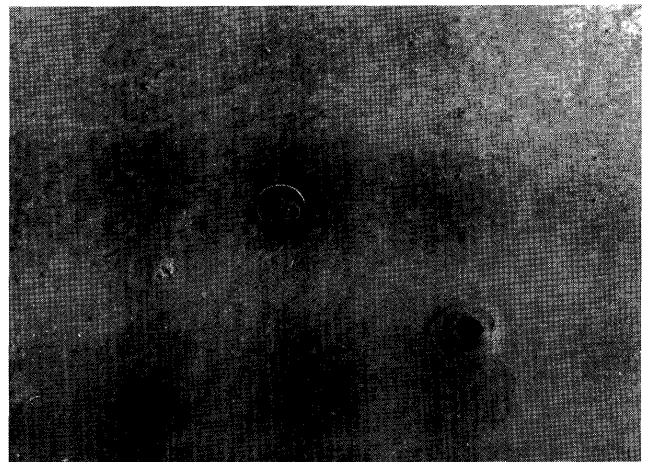
Figure 6.—Microvent on flank of cone reactivated in March 23, 1991, aftershock. Diameter of microvent is approximately 1 cm. Photograph taken March 26, 1991.

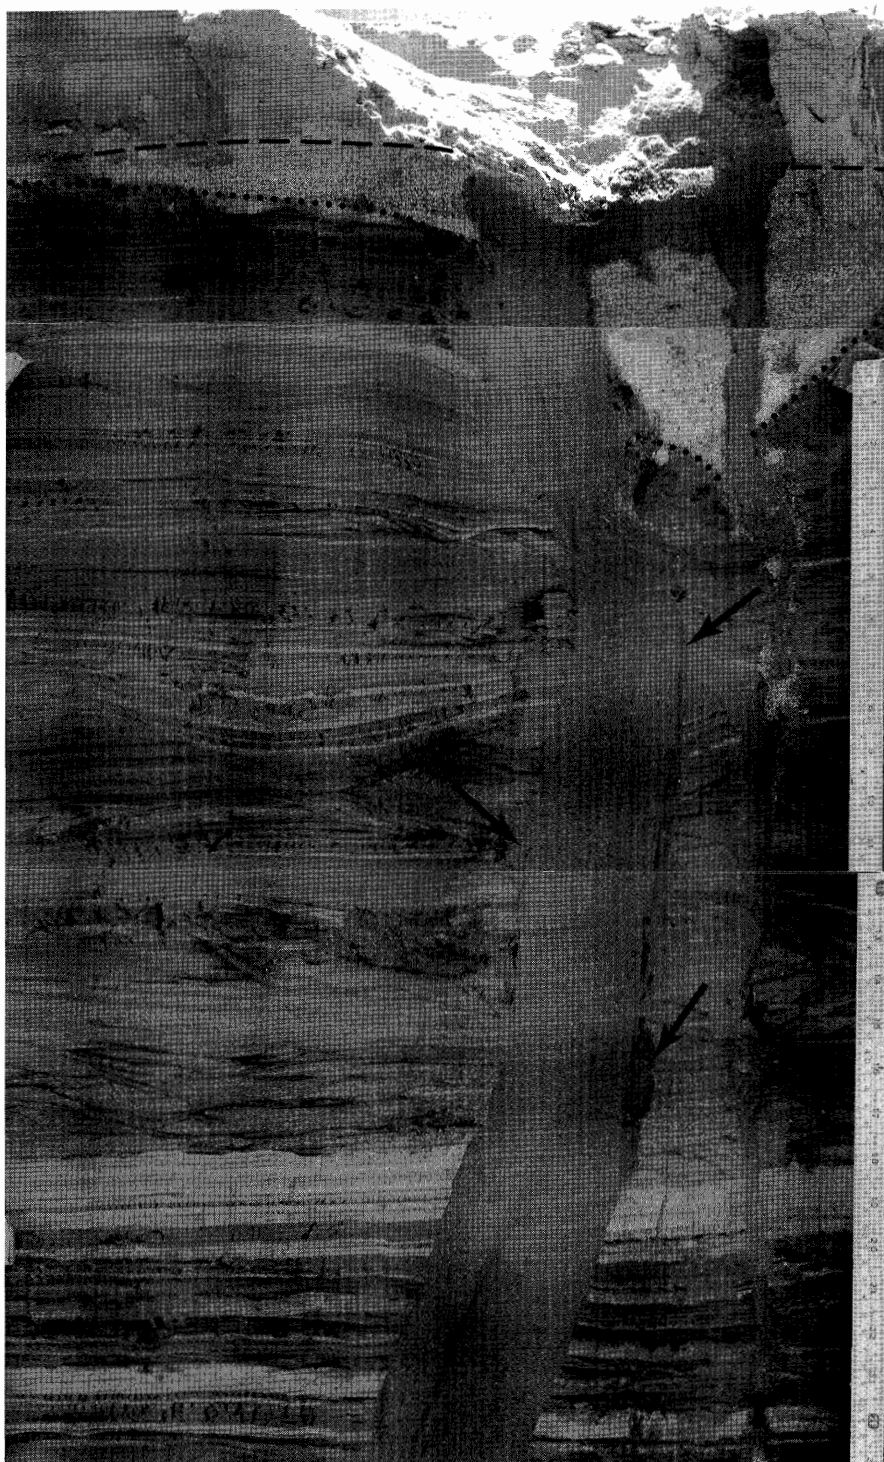
Sand dikes are subsurface deposits of dewatered liquefied sediment that fill fissures. The dikes are composed of well-sorted, fine to medium sand (fig. 10). Some of the sand-dike deposits contain laminations subparallel to parallel to the fissure wall (fig. 11). In cross section, the walls of sand dikes are undulatory, and most of the con-

Figure 11.—Vertical section through sand dike and sandblow, showing internal lamination subparallel to dike walls in sand dike. Dike walls are undulatory, and most concave sections are filled with lenses of darker silt- and clay-rich sediment (arrows). Note details of stratigraphy of host sediment. Dotted line, contact between finely laminated host sediment and erupted sand of sandblow surface shield; dashed line, upper contact of basal subunit of coarse sand that was first material erupted from fissure.

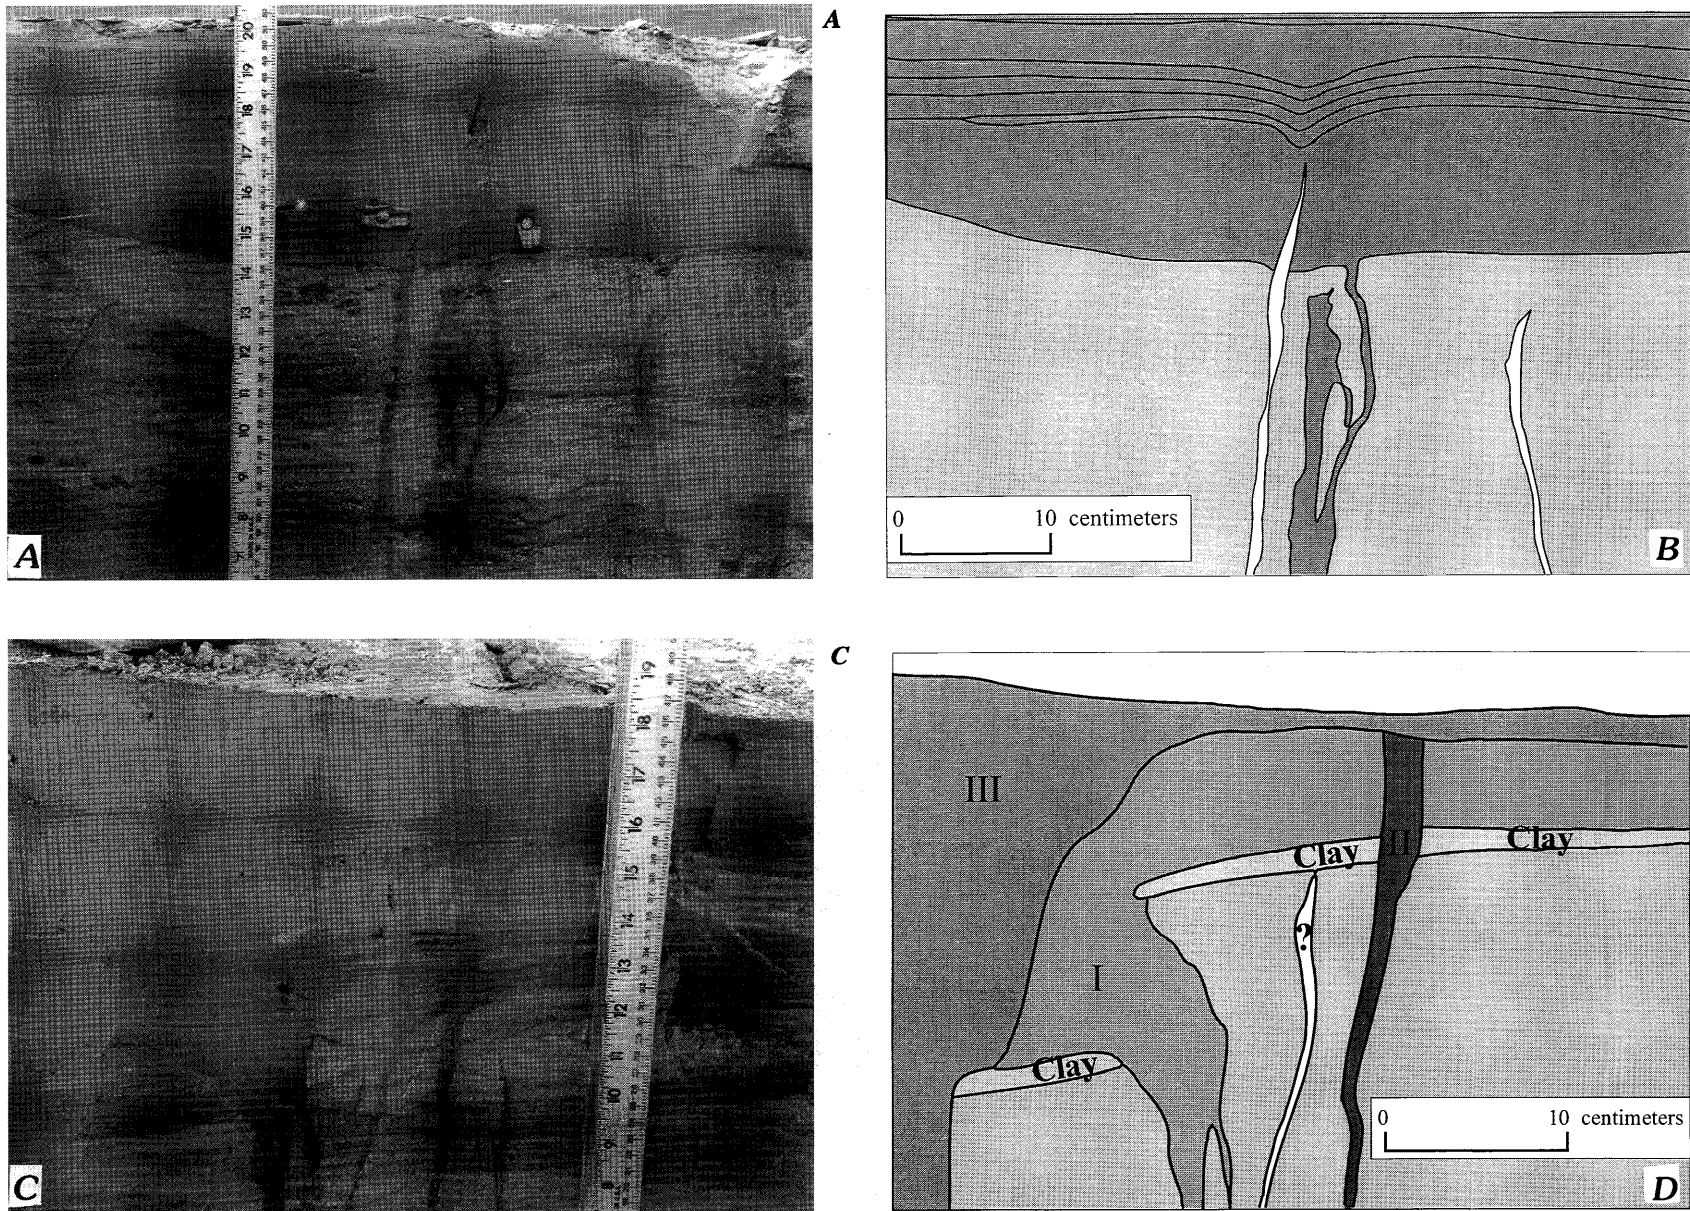
Figure 12.—Sediment exposed in trenches 3 (A) and 4 (C) (see fig. 3 for locations), with sketches illustrating stratigraphic relations (B and D, respectively). Photograph in figure 12A shows small sand dikes, terminating at different stratigraphic levels, that formed on either October 17, 1989, or April 18, 1990. Photograph in figure 12C shows three crosscutting liquefaction structures, I through III, and a small sand dike that terminates at a clay layer.

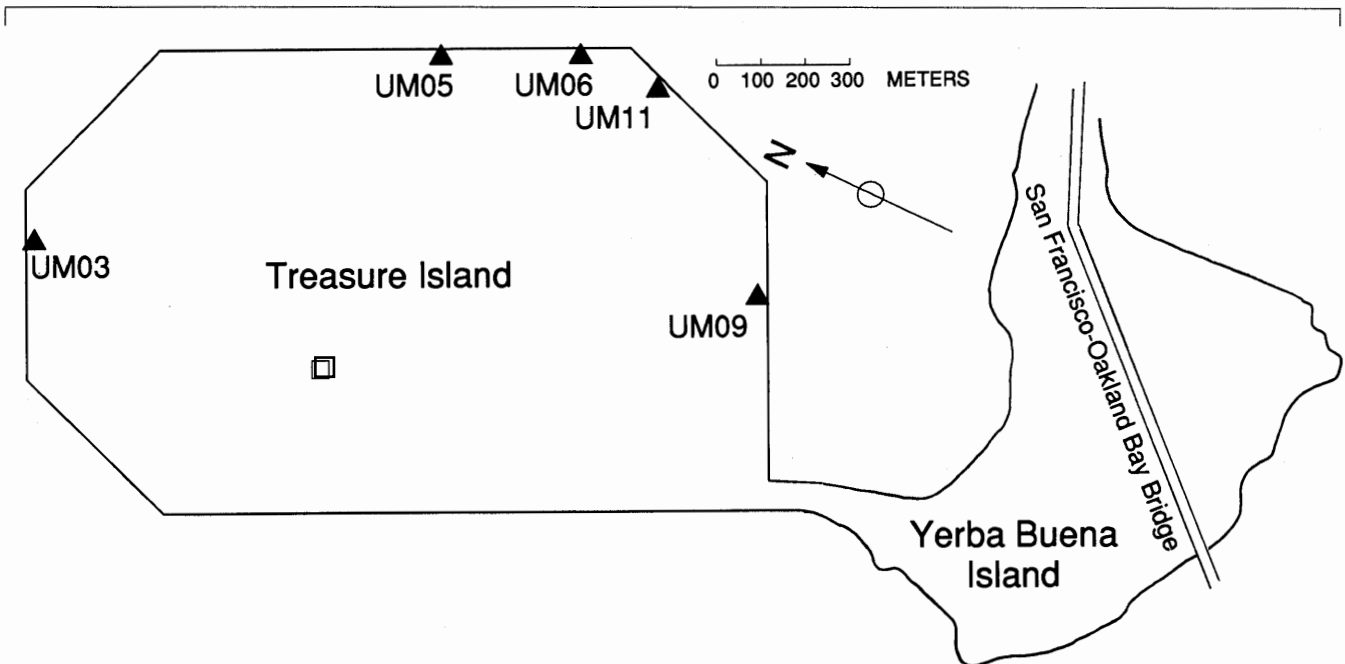
The best performance of the retaining systems was on the west and north sides of the island. No damage was evident at site UM03 (fig. 7), although some liquefaction did occur in adjacent inland areas and a large slump of the retaining system occurred northeast of site UM03. As much as 9 cm of vertical settlement was observed adjacent to a building approximately 60 m inland from site UM09. At site UM05, some 9 cm of horizontal dis-

placement of the soil was observed. In addition, 5 cm of vertical settlement was observed 30 m away. At site UM06, sand boils and 12 to 15 cm of horizontal movement of the levee were observed. Liquefaction was observed at site

UM11; however, soils in an area immediately south of site UM11 has been improved by vibroflotation and were undamaged. We were unable to perform any tests in this area.

Figure 7.—Sketch map of Yerba Buena Island and Treasure Island, showing locations of test sites.

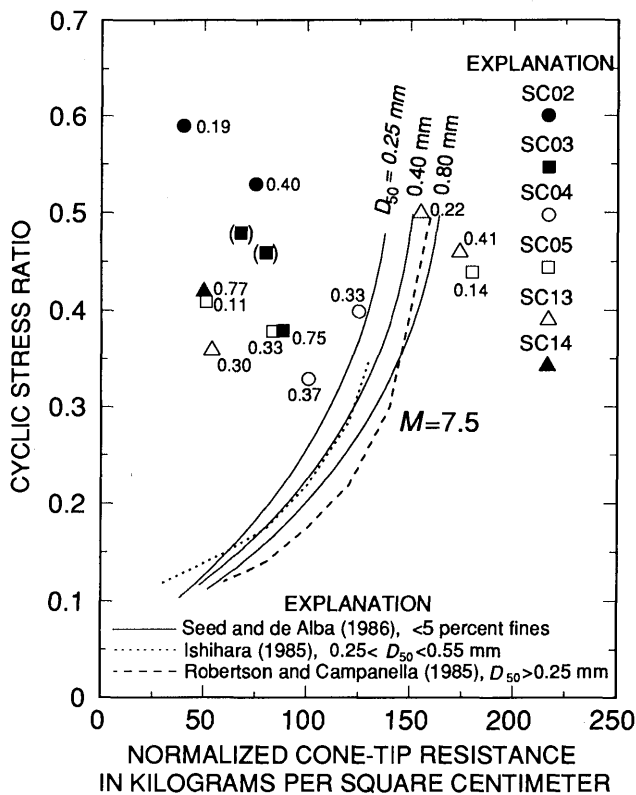
The estimated cyclic-stress ratio is plotted against the normalized cone-tip resistance,  $q_{c1}$ , for the test sites in Santa Cruz in figure 8. On the basis of liquefaction criteria, liquefaction or, at least, cyclic mobilization should have occurred at all six test sites; however, no surface evidence of liquefaction was observed at site SC04, SC05, or SC13 (fig. 5). The liquefiable layers at these three test sites are generally characterized by  $t/z < 0.40$ . Conversely, at the three sites where sand boils formed, the maximum  $t/z$  ratios were 0.40, 0.75, and 0.77.

Figure 8.—Cone-penetration-test results at sites in Santa Cruz (see fig. 5 for locations). Solid data points denote sites with surface evidence of liquefaction. Values near data points indicate ratio of thickness of liquefiable layer to its center depth ( $t/z$ ); data points in parentheses denote sites where  $t/z < 0.1$ .

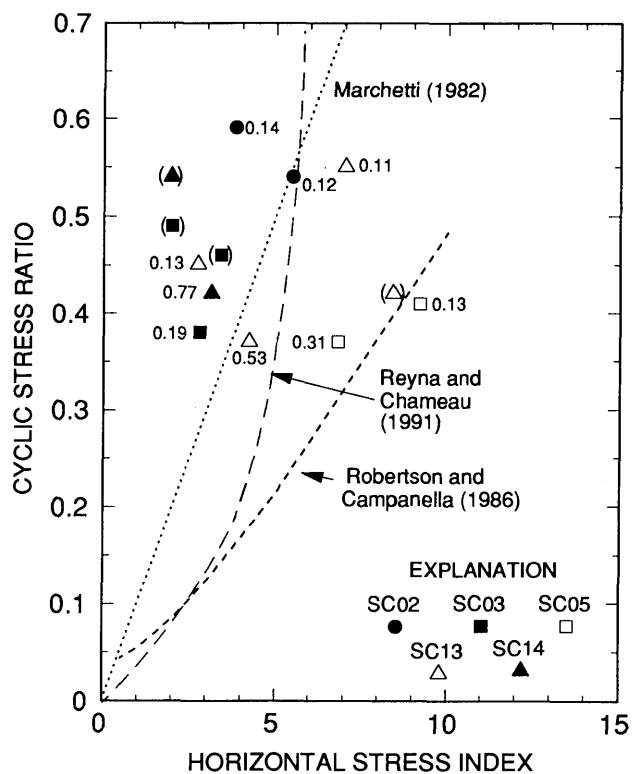
The  $K_D$ -based data for the test sites in Santa Cruz are plotted in figure 9. Considering the low  $t/z=0.13$  of the outlying point for site SC13 and the fact that the higher- $K_D$  layer at site SC02 is not a critical layer, both the criteria of Marchetti (1982) and Reyna and Chameau (1991) appear to have performed well in the cyclic-stress range 0.35–0.60. Although the criterion of Robertson and Campanella (1985) appears to be somewhat conservative, we again emphasize that the absence of ground damage does not exclude the possibility of subsurface liquefaction.

Figure 9.—Flat-plate-dilatometer-test results at sites in Santa Cruz (see fig. 5 for locations). Solid data points denote sites with surface evidence of liquefaction. Values near data points indicate ratio of thickness of liquefiable layer to its center depth ( $t/z$ ); data points in parentheses denote sites where  $t/z < 0.1$ .

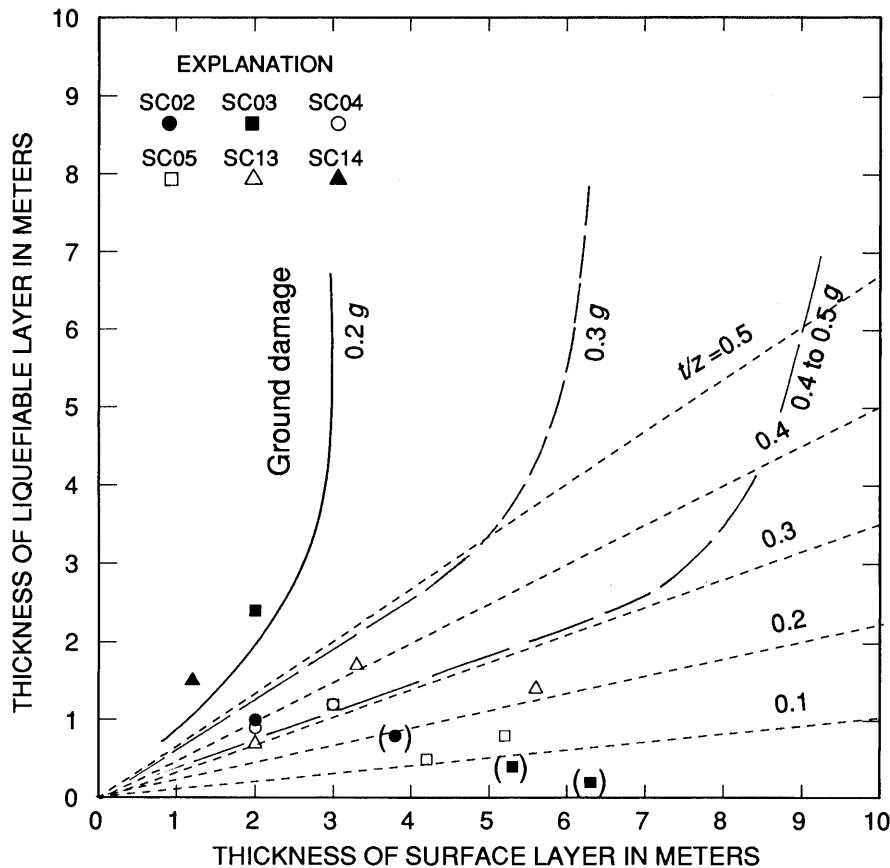
Ishihara (1985) studied the effects of nonliquefiable surface layers. He suggested that the ground damage at sites with nonliquefiable surface layers is also related to the peak accelerations. Ishihara compared the thickness of the liquefiable layer with that of the surface layer, as shown in figure 14, rather than using a  $t/z$  ratio. Nevertheless, the  $t/z$  ratio is easily convertible to Ishihara's approach, as shown in figure 14. The test data for Santa Cruz are also plotted in figure 14. We note that the observed  $t/z=0.4$  threshold for ground damage corresponds to a suggested peak acceleration slightly smaller than that believed to have occurred in Santa Cruz. Therefore, an upward shift of the lower part of Ishihara's 0.4- to 0.5- $g$  line may be warranted.

Figure 14.—Comparison of criterion of Ishihara (1985) for ground damage with observed  $t/z$  ratios at sites in Santa Cruz (fig. 5). Solid data points denote sites where ground damage occurred; data points in parentheses denote sites where ground damage was probably not attributable to secondary liquefiable layers. Three sloping curves illustrate approximate peak accelerations suggested by Ishihara.

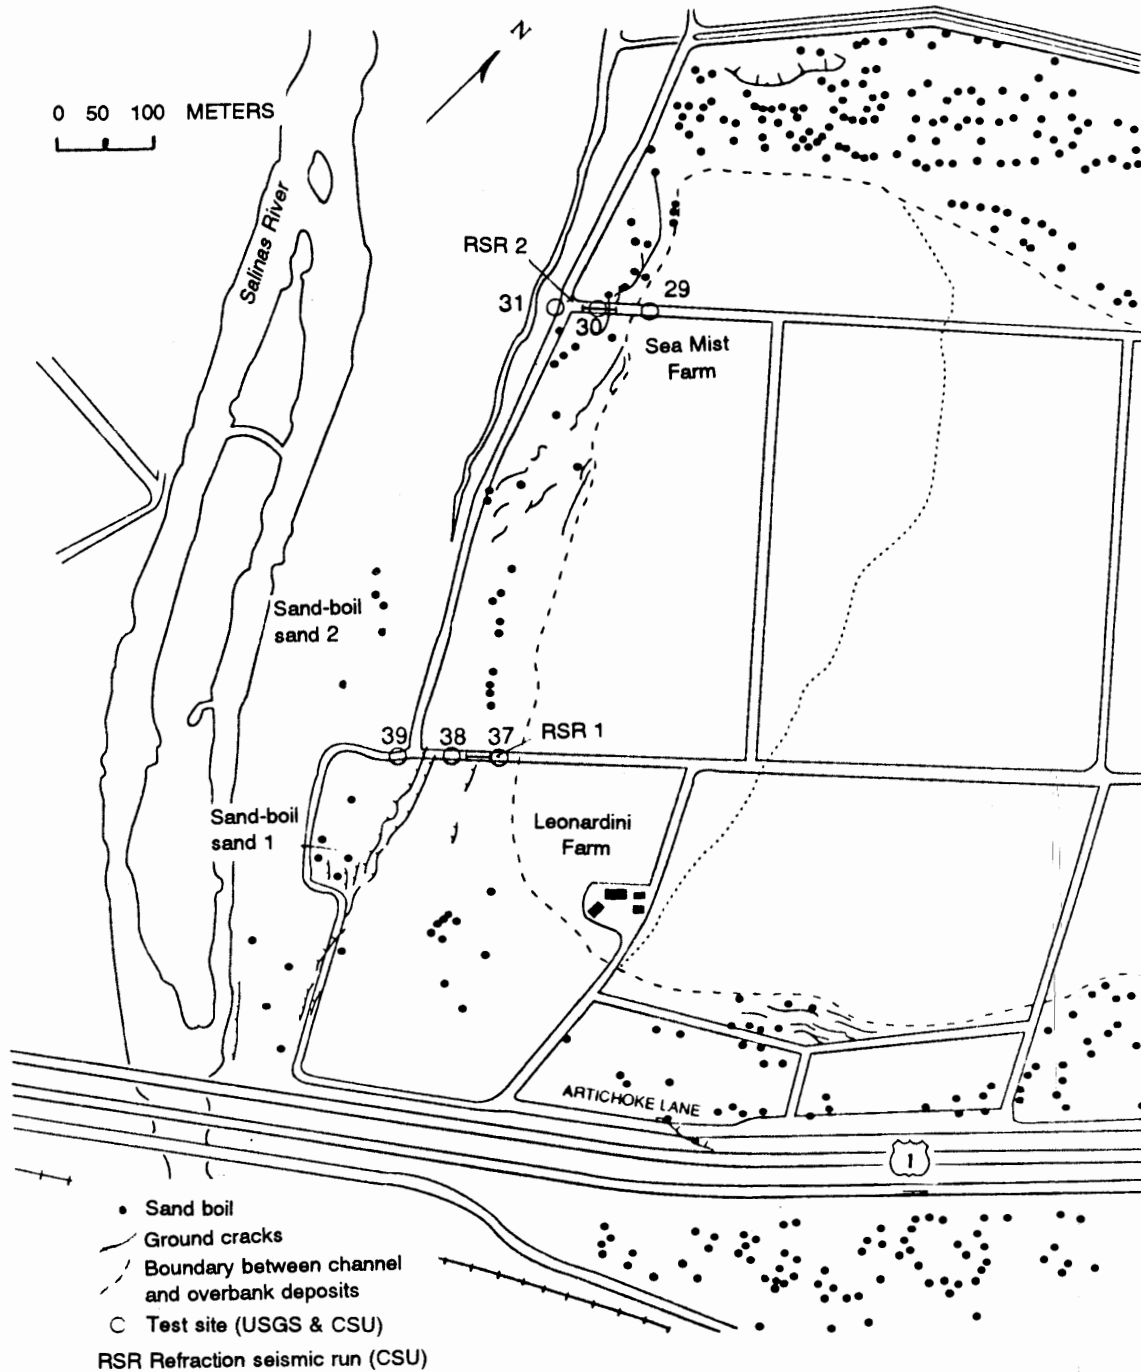
Figure 8.—Sea Mist-Leonardini Farms study site (fig. 7), showing locations of liquefaction features and tests by Colorado State University (CSU) and U.S. Geological Survey (USGS).

three study sites, indicating the presence of liquefiable soils. At the Sea Mist-Leonardini Farms study site (figs. 8, 13), extensive lateral spreads, ground cracks, and sand boils were confined to sedimentary deposits within a paleochannel meander bend. Sand boils, ground cracking, and lateral spreading at the Miller Farm (figs. 13, 14) decreased away from the Pajaro River where fine-grained sedimentary deposits are present. Sand layers that appear susceptible to liquefaction are interpreted as fluvial or estuarine in origin. Overbank deposits consist of silt and clay that did not liquefy. The channel sand layers shown

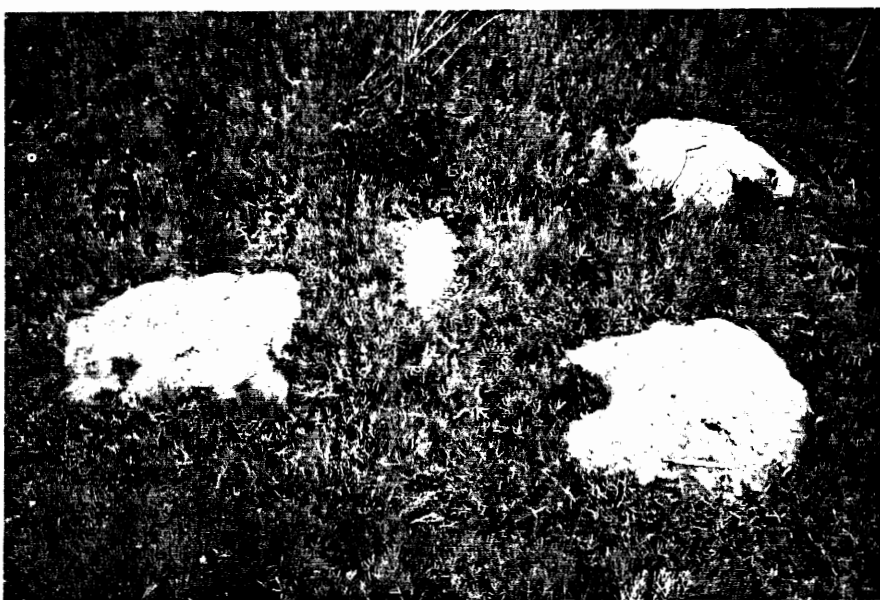
Figure 12.—Sand boils on the Leonardini Farm (fig. 7). Pen is 15 cm long.

study site was erupted from small-diameter (0.3–1 m) isolated vents (figs. 8, 12). Sand-boil material from the Miller Farm study site was deposited on the surface in massive amounts from long ground fissures (locs. 5, 6, fig. 14). At several boreholes, sand samples near the water table were collected with a sand-bucket auger before inserting the Piezovane; the samples were analyzed for grain-size distribution, mineral contents, and color.

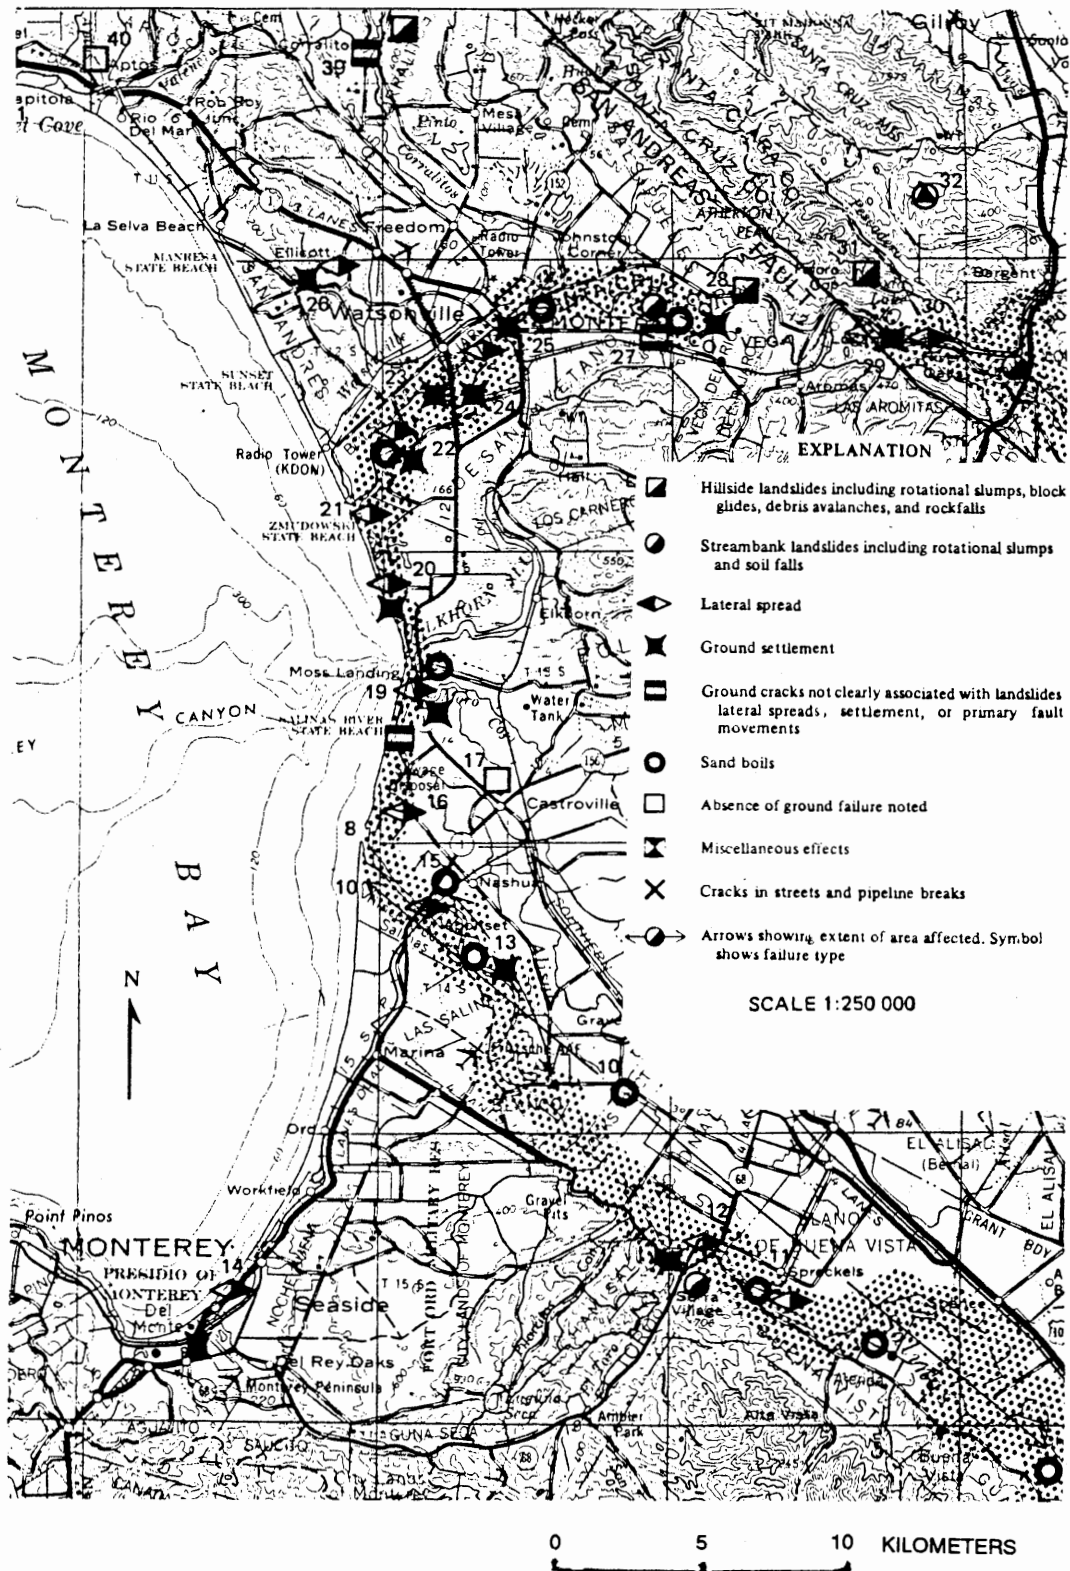
Figure 13.—Monterey Bay area, Calif., showing locations of ground failures induced by 1906 San Francisco earthquake. From Youd and Hoose (1978).
