# The Loma Prieta, California, Earthquake of October 17, 1989—Liquefaction

STRONG GROUND MOTION AND GROUND FAILURE

U.S. GEOLOGICAL SURVEY PROFESSIONAL PAPER 1551-B

UNITED STATES GOVERNMENT PRINTING OFFICE, WASHINGTON : 1998

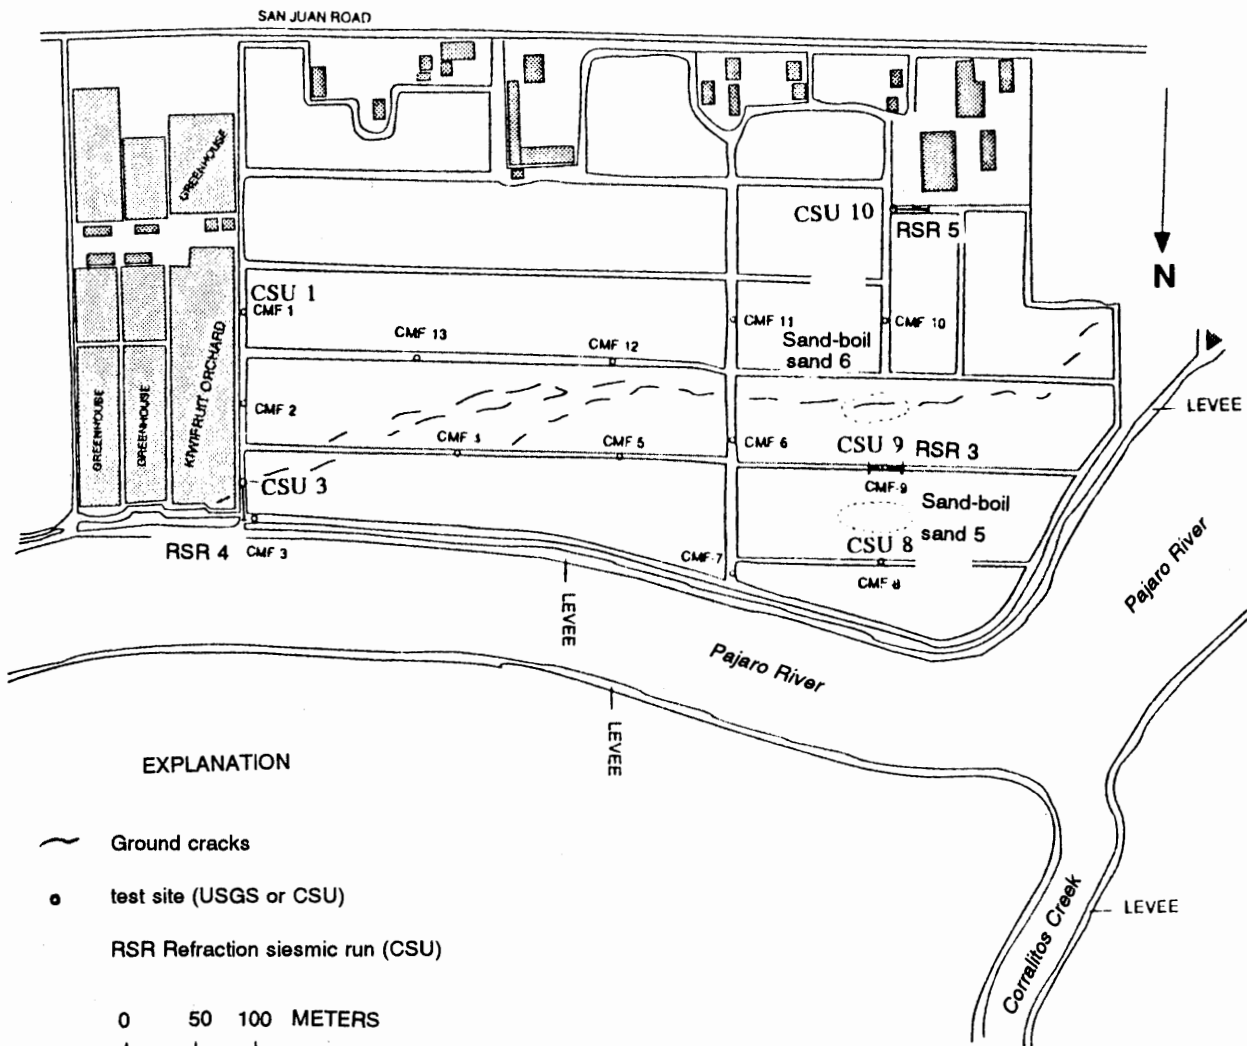
study site was erupted from small-diameter (0.3–1 m) isolated vents (figs. 8, 12). Sand-boil material from the Miller Farm study site was deposited on the surface in massive amounts from long ground fissures (locs. 5, 6, fig. 14). At several boreholes, sand samples near the water table were collected with a sand-bucket auger before inserting the Piezovane; the samples were analyzed for grain-size distribution, mineral contents, and color.

Figure 14.—Miller Farm study site (fig. 7), showing locations of liquefaction features and tests by Colorado State University (CSU) and U.S. Geological Survey (USGS).

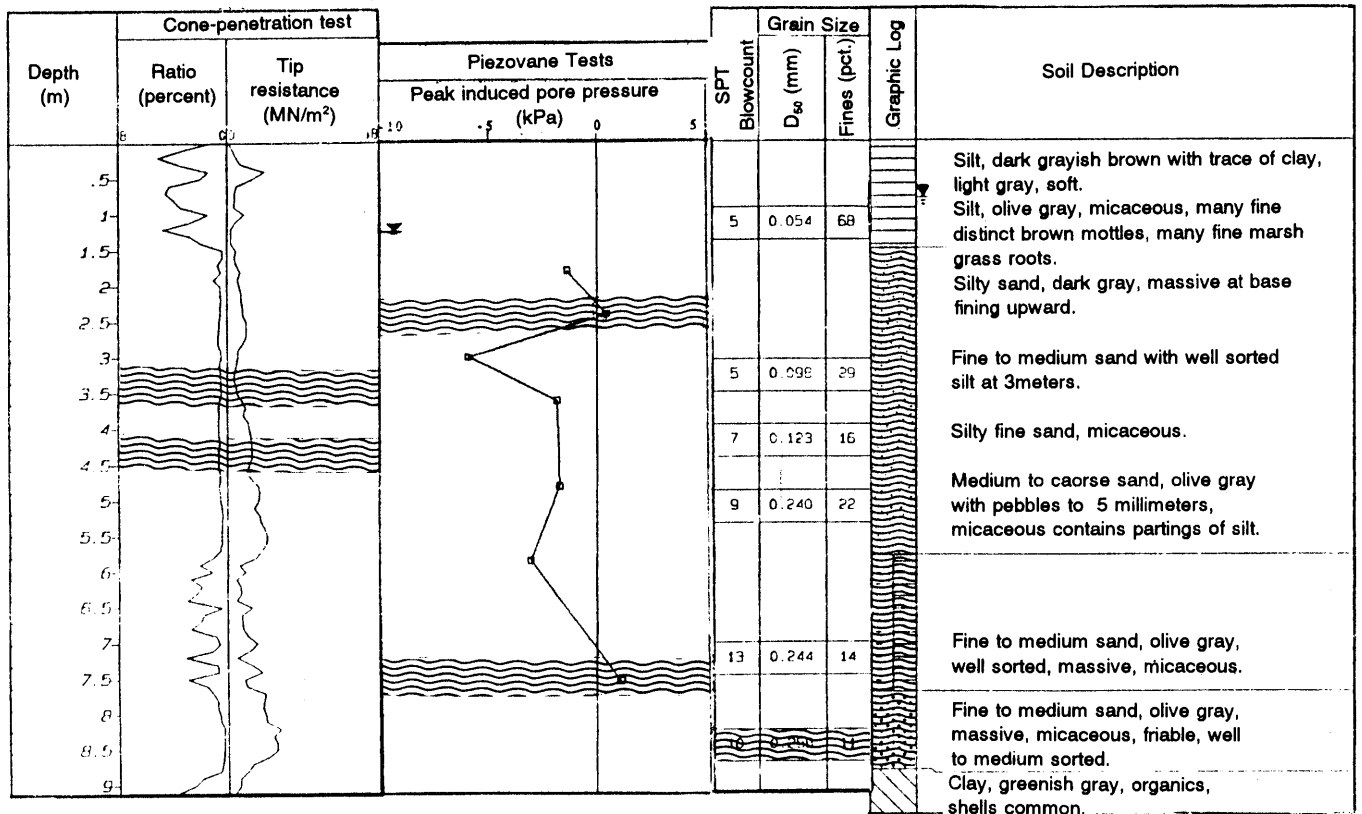
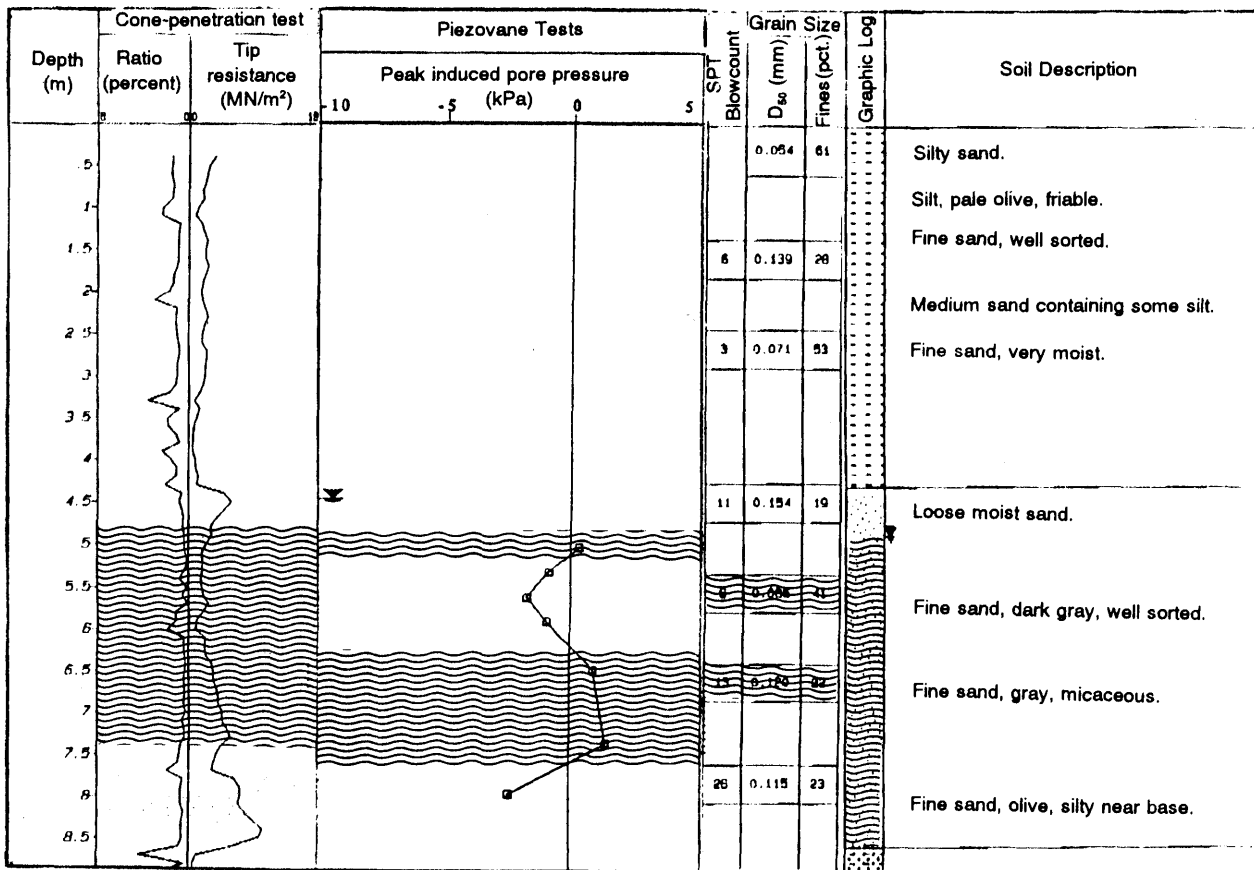
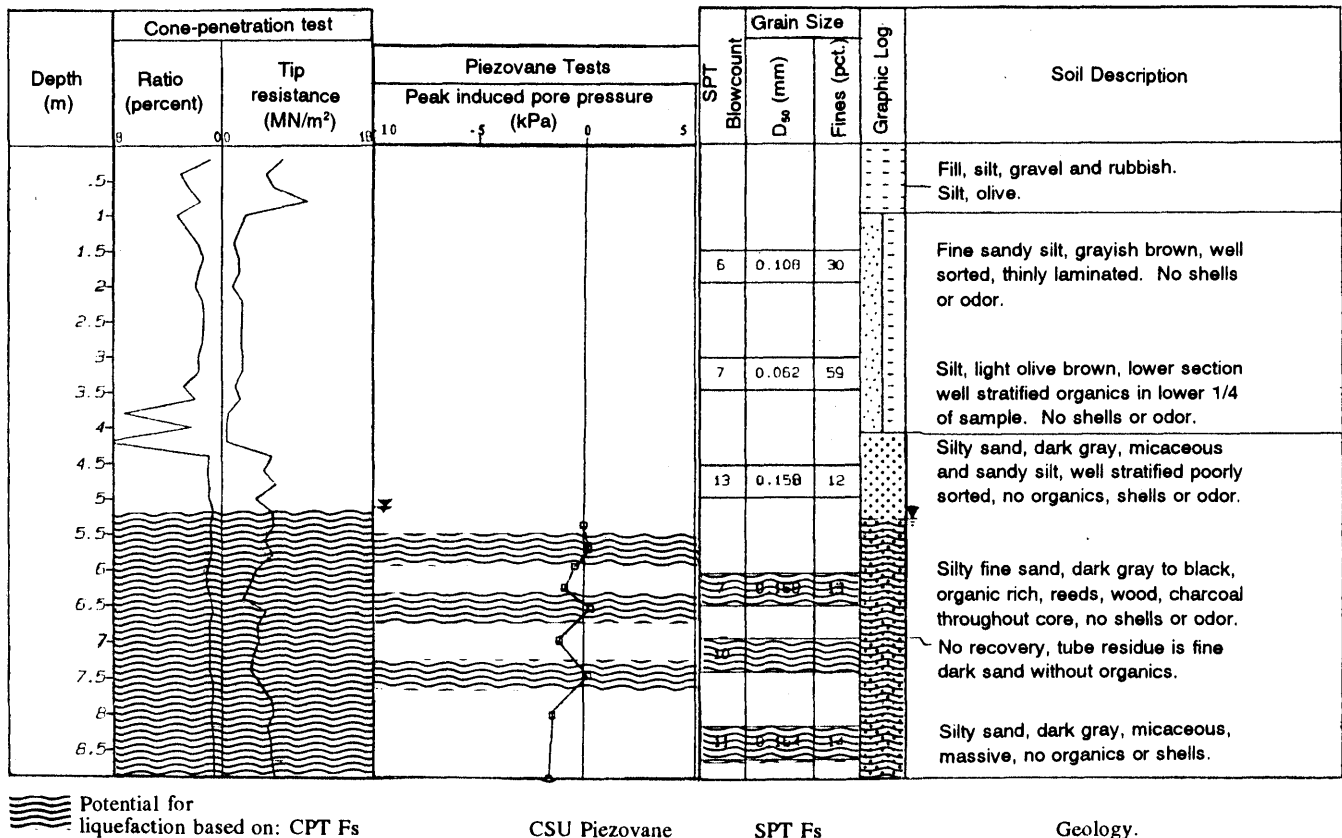
of safety against liquefaction was calculated from the site SPT blowcounts, using estimates of soil conditions and earthquake ground motion. We used estimated peak accelerations of 0.14 *g* for the Sea Mist-Leonardini Farms study site and 0.39 *g* for the Miller Farm and Southern Pacific Railroad Bridge study sites. The data, assumptions, and methods used for factor-of-safety calculations are summarized below in the section entitled "Supplementary Information," and details were given by Brislawn (1992). Zones with SPT factors of safety against liquefaction of less than 1 are shown in figure 18.

Figure 18.—Pore-pressure logs of U.S. Geological Survey cone-penetration tests (CPT's) (left), Colorado State University Piezovane tests (middle), and U.S. Geological Survey standard penetration tests (SPT's) (right) (A) on the Sea Mist Farm (site CSU 31, fig. 8), (B) on the Miller Farm (site CSU 3, fig. 14), and (C) on the Southern Pacific Railroad

CSU 48, fig. 16). Shading denotes zones with liquefaction potential based on factors of safety; inverted solid triangle, depth to water table. CPT and SPT data from Tinsley and others (this chapter); soil descriptions from U.S. Geological Survey.

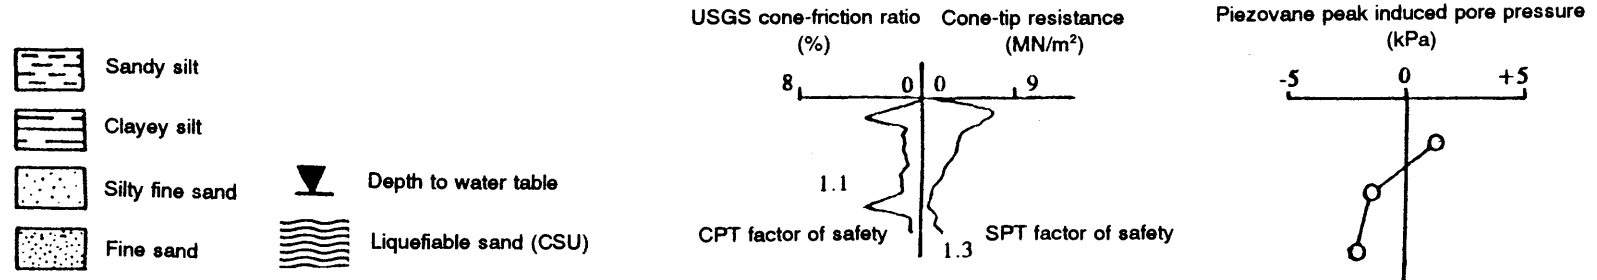
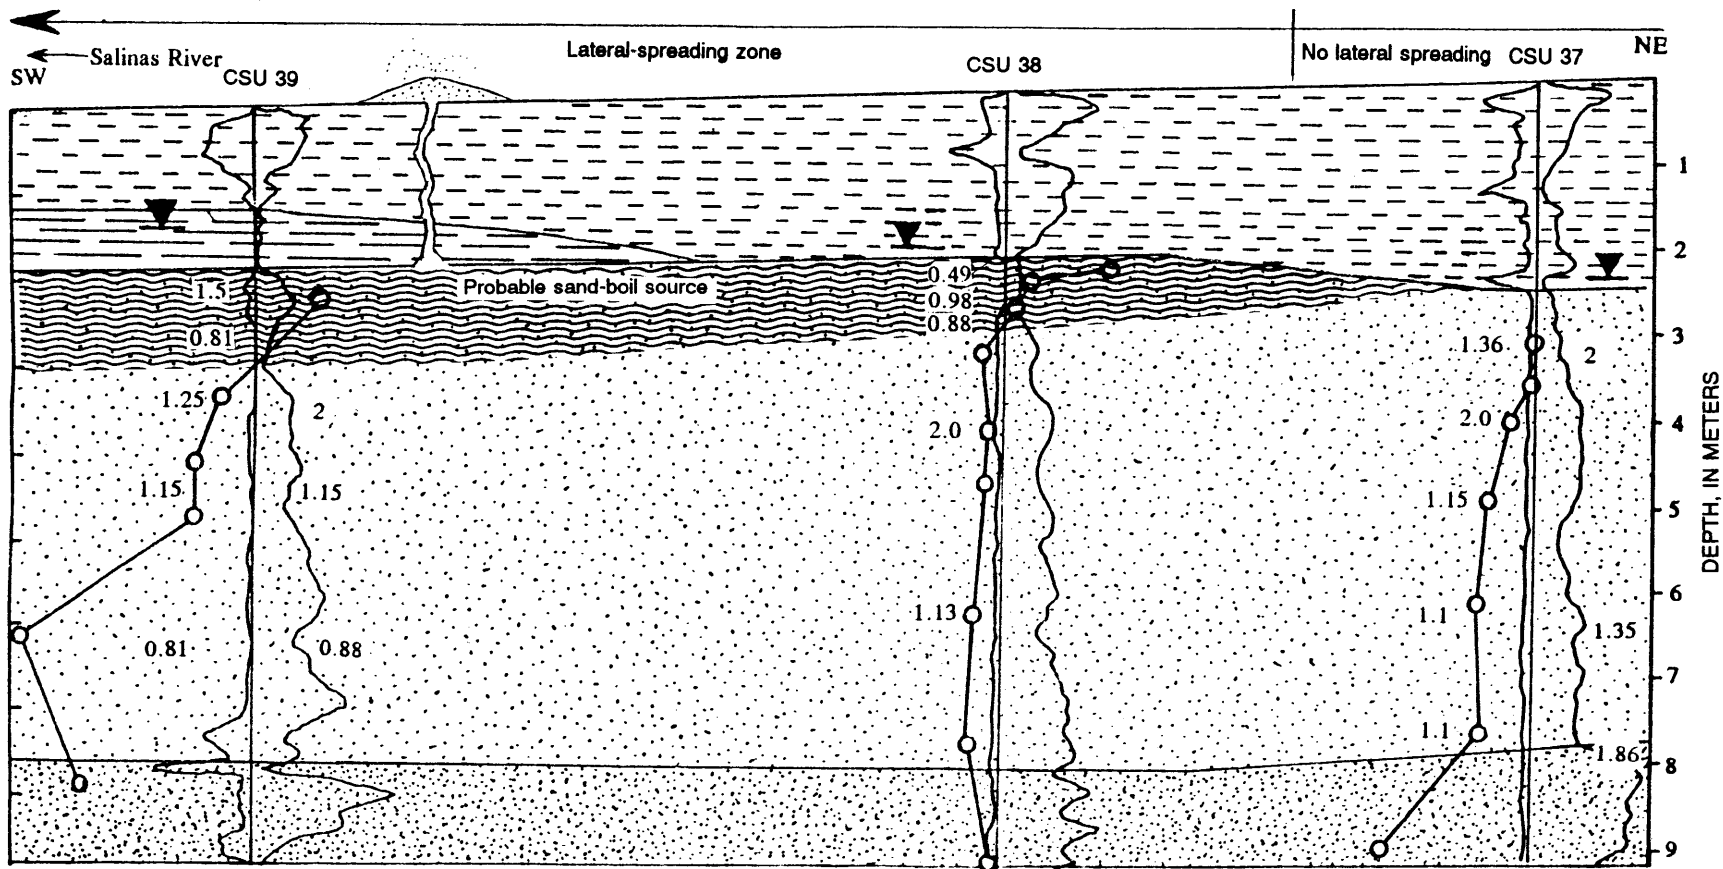
Figure 20.—Soil profile along line of Piezovane test sites CSU 37 through 39 (fig. 8) on the Leonardini Farm (fig. 7). CPT, cone-penetration test; CSU, Colorado State University; SPT, standard penetration test; USGS, U.S. Geological Survey.

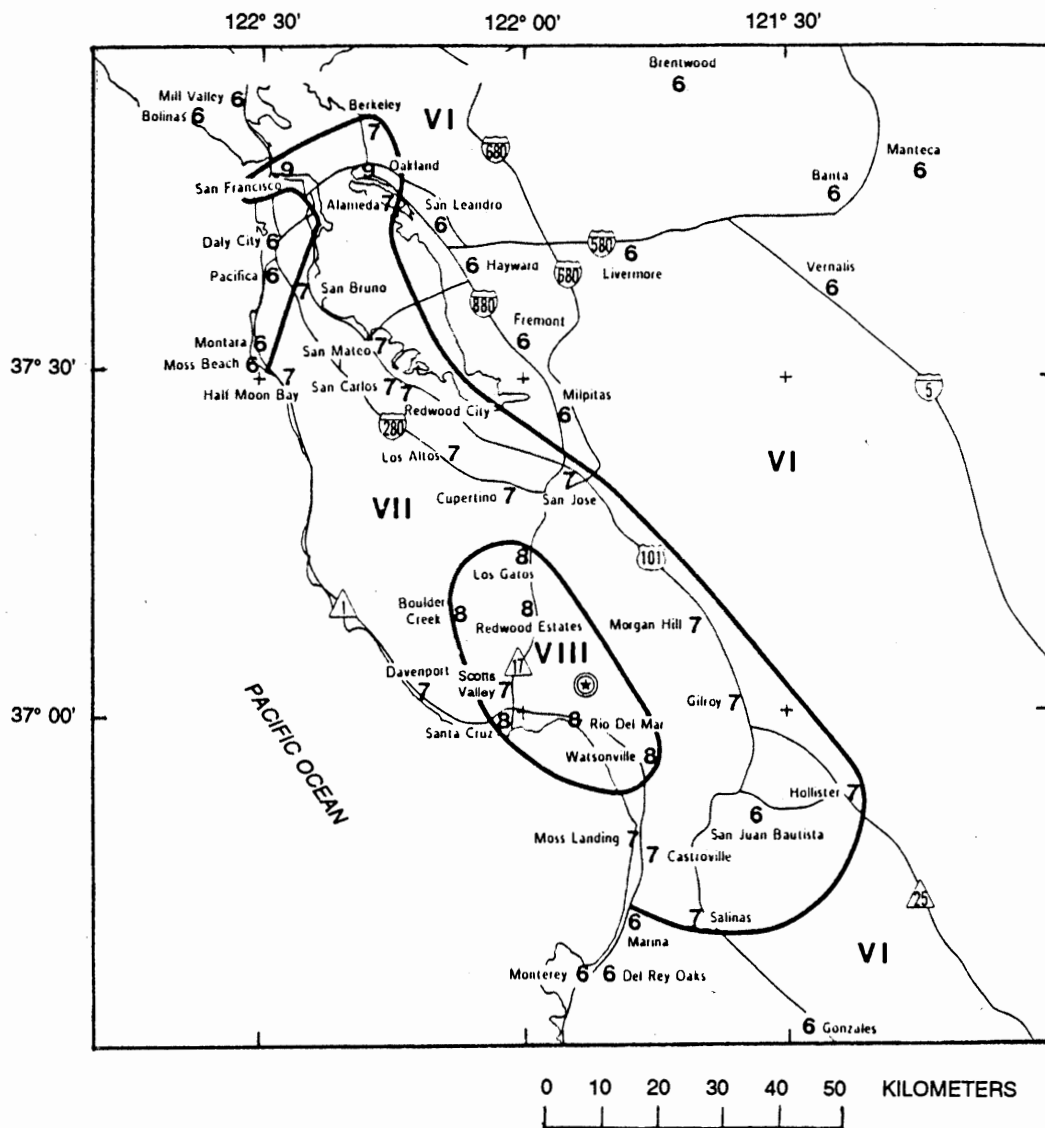
The ground motion measured closest to the Sea Mist-Leonardini Farms study site was a peak acceleration of 0.12 *g* at a station located 14.6 km away in the town of Salinas. Modified Mercalli intensities (fig. 21; Plafker and Galloway, 1989) and soil/rock attenuation relations reported by the U.S. Department of the Navy (1983, p. 22–34) were used to independently estimate peak accelerations at the three study sites. Modified Mercalli intensities of VIII and IX for the Miller Farm and Southern Pacific Railroad Bridge study sites correspond to a peak acceleration of 0.21 to 0.39 *g*, which agrees with the 0.39 *g* recorded in Watsonville. The modified Mercalli intensity at the Sea Mist-Leonardini Farms study site is almost VII, which corresponds to a peak acceleration of 0.07 to 0.13 *g*. We used distance and soil/rock attenuation relations to estimate a peak acceleration of 0.16 *g* for the Sea Mist-Leonardini Farms study site. We used peak accelerations of 0.39 *g* for the Miller Farm and Southern Pacific Railroad Bridge study sites and 0.14 *g* for the Sea Mist-Leonardini Farms study site for this study, on the basis of the information described above.

Figure 21.—San Francisco-Monterey Bay region, showing distribution of modified Mercalli intensities (Roman and Arabic numerals) from 1989 Loma Prieta earthquake. After Plafker and Galloway (1989).

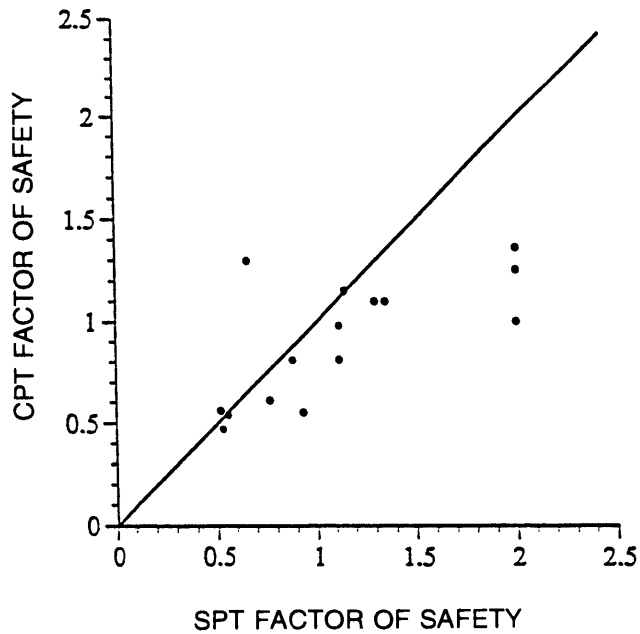
Figure 22.—Cone-penetration-test (CPT) versus standard-penetration-test (SPT) factors of safety against liquefaction, calculated from data of this study.

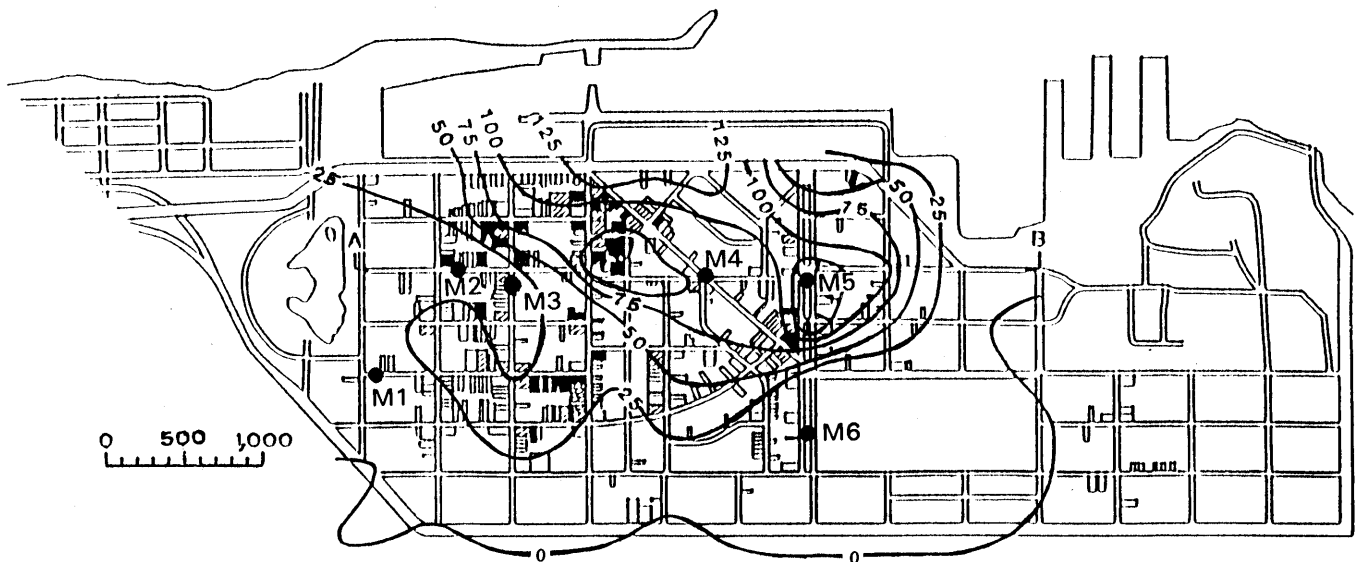
in the Marina District. These data allow calculation of settlement contours from measurements between 1974 and November 1989 (fig. 13). Most of this settlement resulted from liquefaction during the earthquake, although a small fraction may be due to other sources. The settlement ranges

Figure 13.—Marina District of San Francisco, showing contours of settlement (in millimeters) and locations of boreholes drilled by the U.S. Geological Survey (Bennett, 1990).

from less than 25 mm at the margins of the hydraulic fill to more than 125 mm in certain places within the fill. After the earthquake, the U.S. Geological Survey drilled six test borings to depths of approximately 40 ft at locations shown in figure 13, and SPT's were conducted at each site. The soil profiles and SPT results for each borehole are shown in figure 14.

The variation in settlement calculated for the different soil profiles is significant. The range of settlement calculated for boreholes M4 and M5 is 10 times larger than that for boreholes M3 and M6 (fig. 13). The sites with low blowcounts (boreholes M4, M5) vary widely in calculated settlement, whereas the sites with higher blowcounts (boreholes M3, M6) vary much less. This trend is inherent in the computation procedure for settlement in saturated sand. For low  $(N_1)_{60}$  values (1–7 blows/ft), the volumetric strain can range from 0 to 10 percent; for moderate  $(N_1)_{60}$  values (8–14 blows/ft), the volumetric strain is less than 3 percent; and for high  $(N_1)_{60}$  values (greater than 15 blows/ft) the volumetric strain can be no greater than 2 percent.

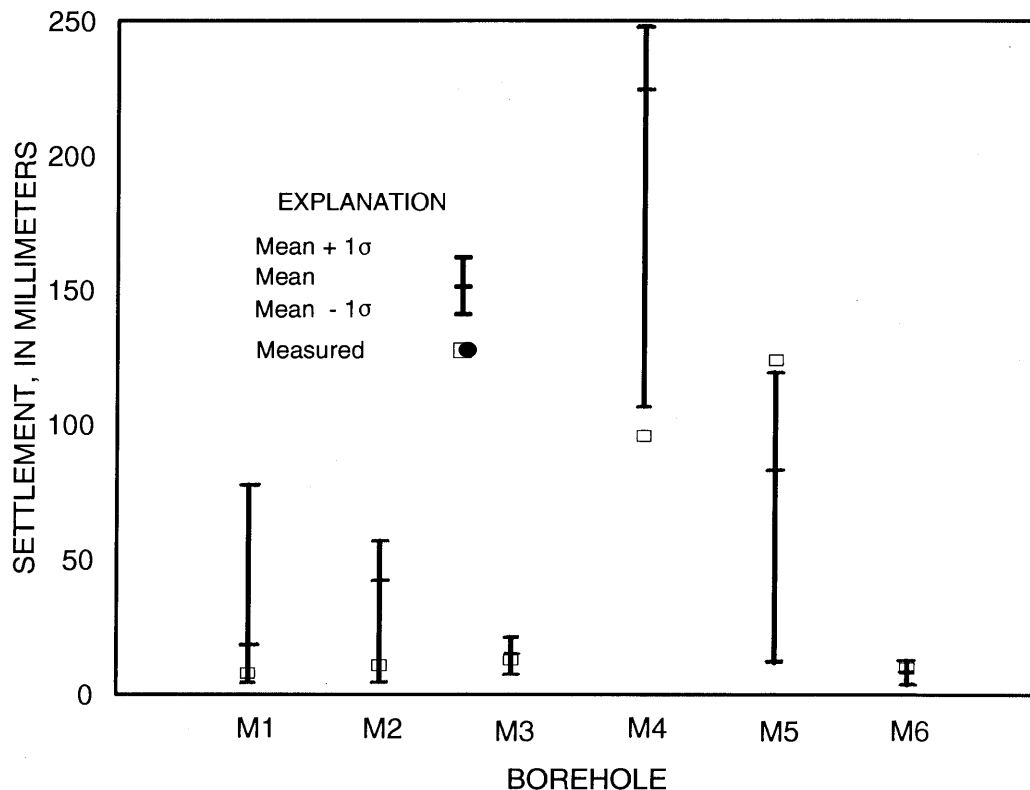
Overall, the measured settlements are generally within about  $1\sigma$  of the mean settlements calculated by the procedure of Tokimatsu and Seed (1987). Estimates were less accurate for sites where large settlements (>80 mm) had occurred. The ratio of the measured settlement to the calculated settlement ranges from 0.4 to 1.6. We can gain some perspective on the success of this procedure by noting the accuracy and reliability of equations for predicting settlement of structures built on sand under static conditions. Tan and Duncan (1991) proposed that the most accurate static-settlement prediction be multiplied by 1.7 to ensure that 85 percent of the measured settlements would be less than the computed settlements. Considering these results, the agreement here between measured and computed settlements for earthquake shaking is encouraging.

Figure 17.—Comparison of measured and calculated settlement at U.S. Geological Survey boreholes (see fig. 13 for locations) in the Marina District.

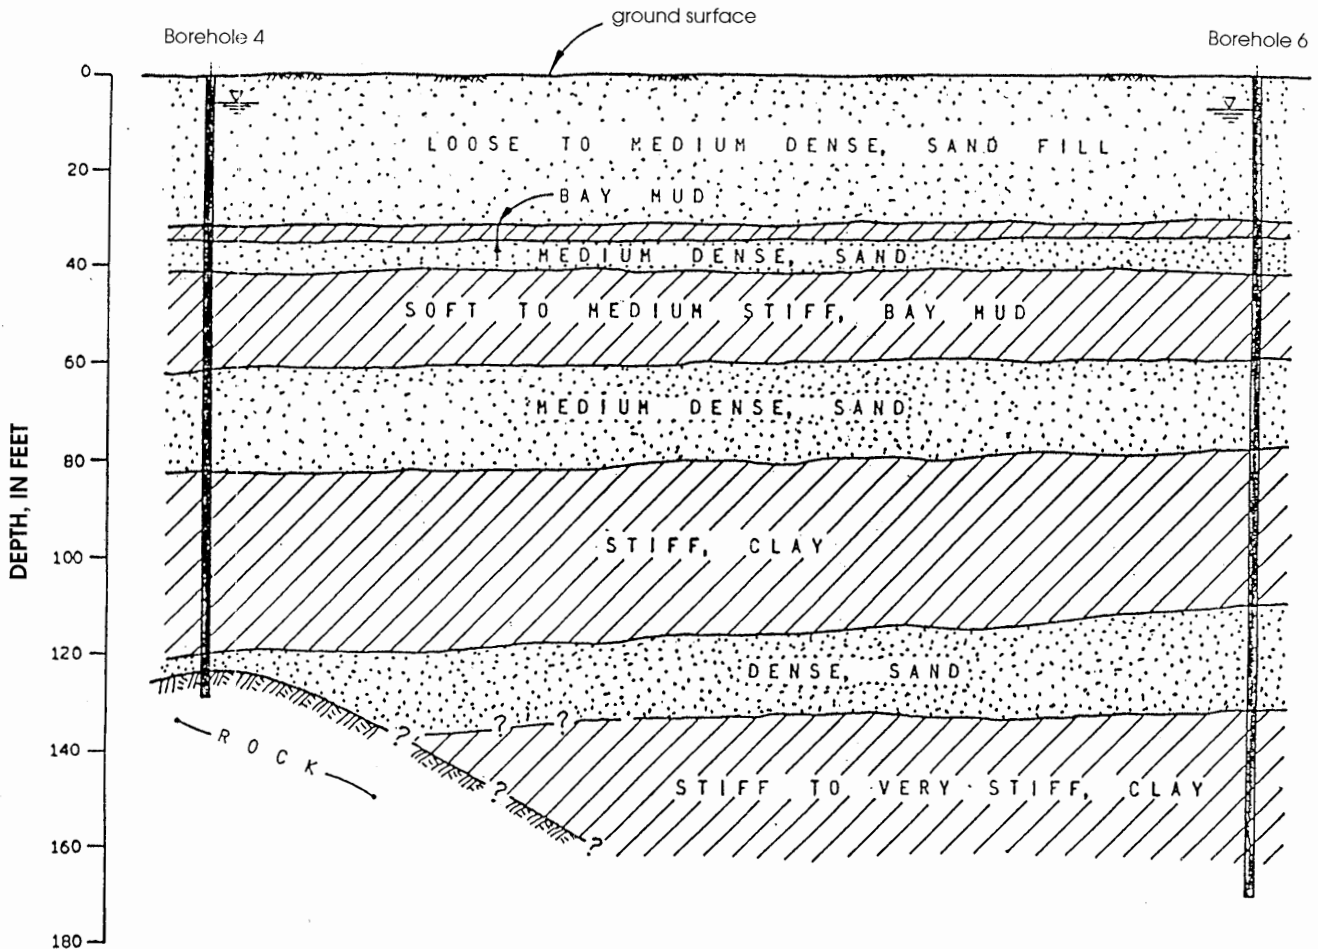
On the basis of data from a CDMG strong-motion-recording instrument located on Treasure Island, the study site was subjected to a peak acceleration of approximately 0.16 g within a bracketed duration of about 2.5 s during the earthquake. A formal building inspection performed soon after the earthquake indicated no evidence of damage. Some lateral spreading, sand boils, and localized settlement were observed outside of the improved ground areas adjacent to the buildings, suggesting that had densi-

Figure 7.—Soil profile at Office Building 450, Treasure Island (fig. 5). From Woodward-Clyde-Sherard and Associates (1966).

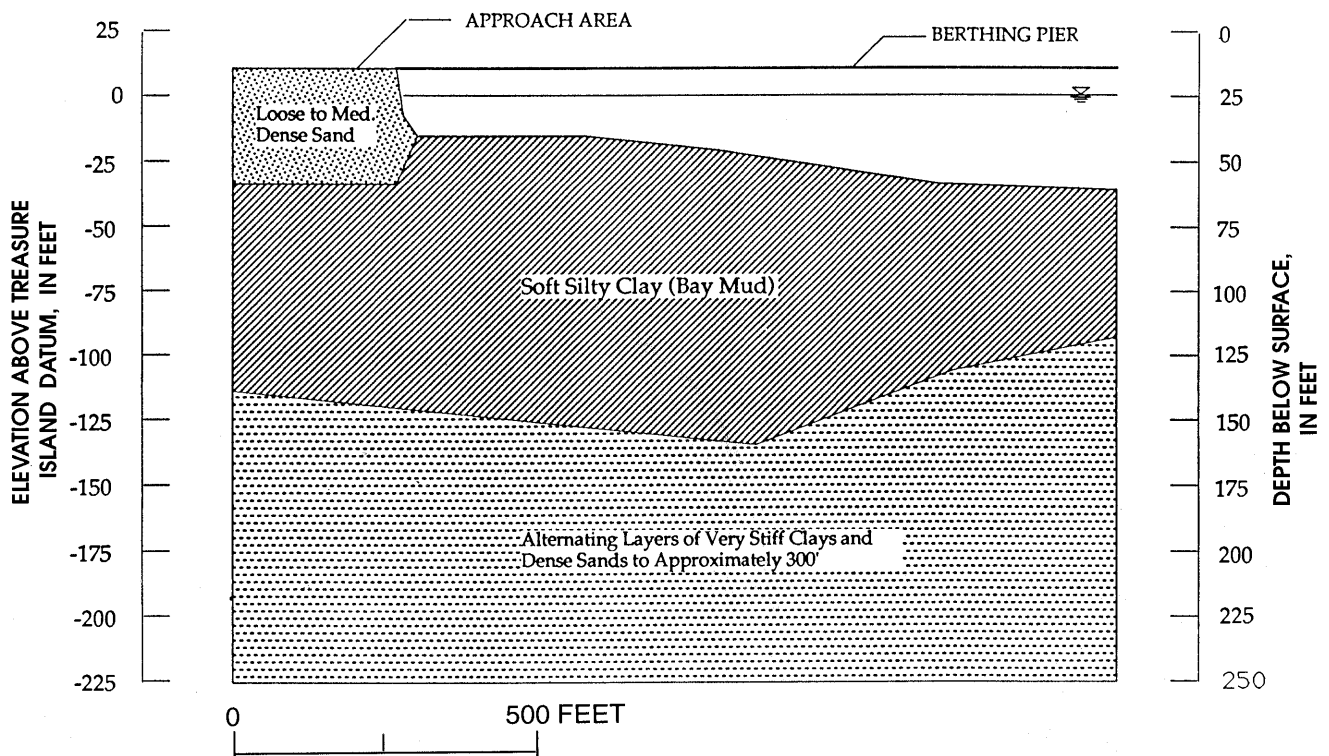
On the basis of data from a CDMG strong-motion-recording instrument located on Treasure Island, the study site was subjected to a peak acceleration of approximately 0.16  $g$  within a bracketed duration of about 2.5 s during the earthquake. A formal inspection of the pier approach performed shortly after the earthquake revealed no signs of ground movement in the improved areas; however, several sinkholes and sand boils were observed in the adjacent, unimproved areas.

Figure 9.—Soil profile at approach to berthing pier, Treasure Island (fig. 5).

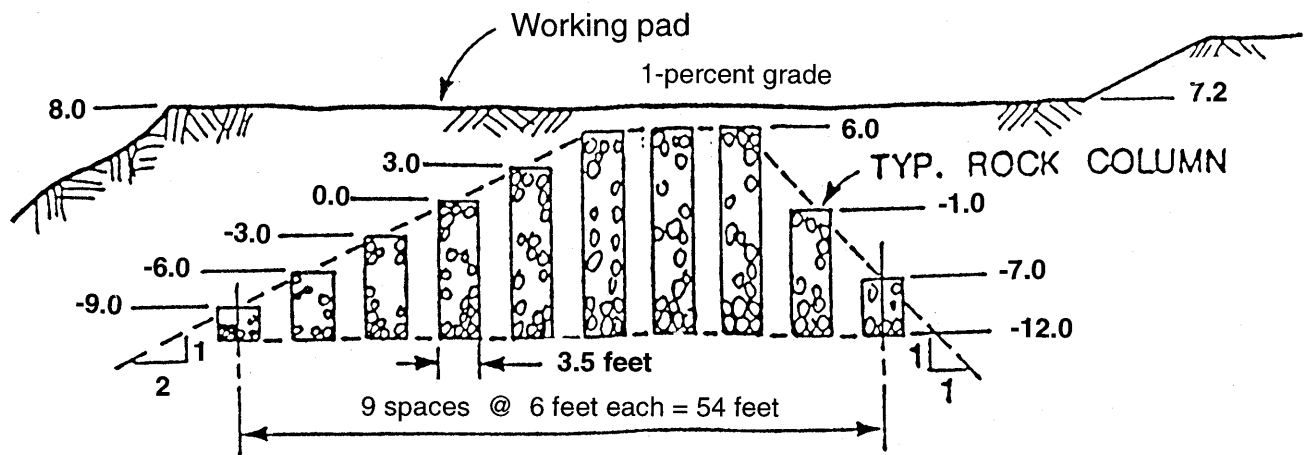
For the first several days of construction, the cranes were working from a pad excavated to an elevation of 8 ft and frequently became stuck in the soft subgrade soils. Therefore, the cranes were moved to the paved area just east of the buttress alignment. Minor slope failures and settlement occurred in the asphalt-paved area north of the Penterra office building (fig. 12), owing to construction-induced vibrations. In addition, tension cracks appeared in several areas behind the vertical slope parallel to the centerline of the buttress. Because of a concern that construction-induced vibrations might damage the Yacht Club at the north end of the buttress, the northernmost row of columns was eliminated. In addition, the vibrators were unable to penetrate the ground surface at five locations

Figure 13.—Typical cross section of buttress on Marina Bay Esplanade, Richmond (study site 6, fig. 1). Numbers are elevations in feet above National Geodetic Vertical Datum. From Harding Lawson Associates (1987).

along the westernmost row of columns because of concrete debris in the fill. Therefore, the entire row of columns was shifted 6 ft eastward at these locations.

acent to Marina Bay and lateral spreading during an earthquake was predictable, a significant risk to inland development existed. Both the city of Richmond and the developer agreed that it would be uneconomical to eliminate the liquefaction potential of the entire deposit under the study site. Therefore, it was decided to construct a "buttress" through the liquefiable deposit along the shoreline boundary to resist lateral spreading.

The stone columns were constructed by using two 1 1/2-ft-diameter, 12-ft-long downhole vibrators suspended from cranes. The vibrators were advanced into the ground dry, primarily by their vibratory energy. The hole created by the vibrator was backfilled with 3/8-in. by 1-in. crushed rock placed in about 3-ft-thick lifts, using a bottom-feed system. The amount of crushed rock required for each lift was determined by assuming an in-place relative density and computing the weight of rock required to achieve a 42-in.-diameter column at this density.

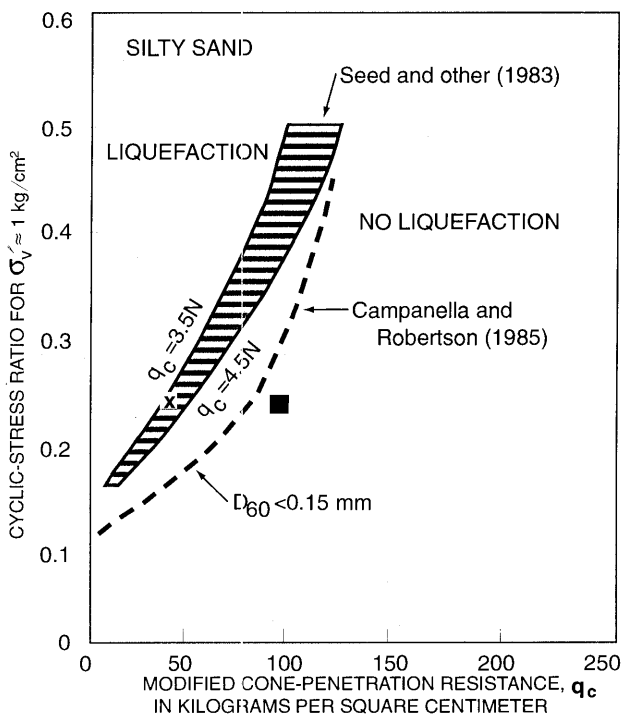
Average preconstruction and postconstruction  $q_{c1}$  values are plotted in figure 14. The liquefaction potential of the deposits before densification was moderate to high, using the correlation of Seed and others (1983), and high, using the correlation of Robertson and Campanella (1985). The average  $q_{c1}$  value increased by approximately 45 kg/cm<sup>2</sup> after column installation. It was concluded, on the basis of CPT correlations, that the postconstruction liquefaction potential of the hydraulic fill between the stone columns was low for the design earthquake. Increases in cone-tip resistance were greatest in zones with lower silt contents.

Figure 14.—Comparison of preconstruction (x) and postconstruction (square) cone-penetration-test data for an  $M=6.5$  earthquake at Marina Bay Esplanade, Richmond (study site 6, fig. 1). From Rinne and others (1988).

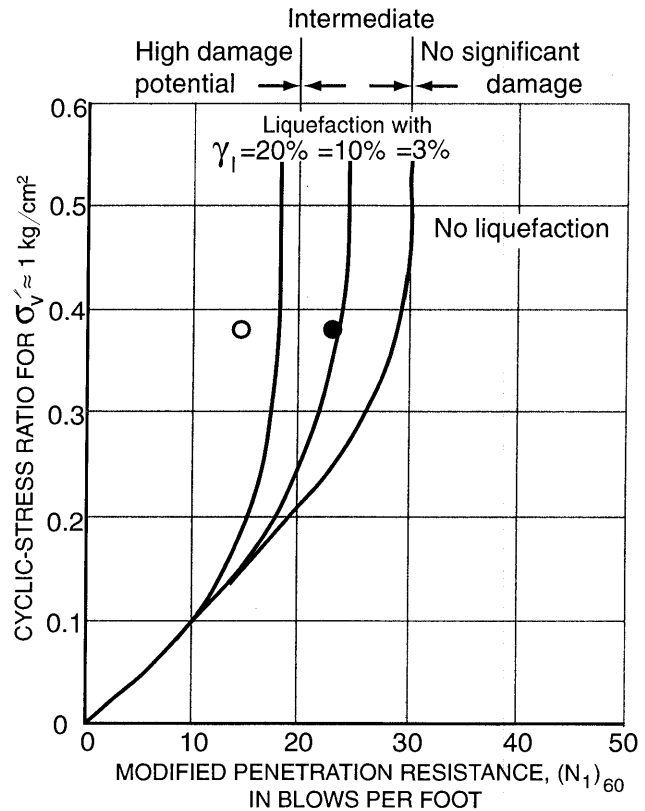
Average preconstruction and postconstruction  $(N_1)_{60}$  values are plotted in figure 15, which shows the correlation between liquefaction resistance and  $(N_1)_{60}$  values for the maximum credible earthquake ( $M=7.5$ ). As shown, the average  $(N_1)_{60}$  value increased by 7 blows/ft. Despite this increase, some liquefaction potential exists for the soil between the stone columns during a maximum credible earthquake. The estimated shear-strain potential of the liquefiable deposits, however, decreased from more than 20 percent to approximately 10 percent as a result of ground improvement. Overall, the combination of stone-

Figure 15.—Comparison of preconstruction (circle) and postconstruction (dot) standard-penetration-test data for an  $M=7.5$  earthquake at Marina Bay Esplanade, Richmond (study site 6, fig. 1). From Rinne and others (1988).

column reinforcement and the increase in liquefaction resistance of the soil between the columns was judged to be sufficient to prevent lateral spreading into the bay in the event of liquefaction of the unimproved ground on the inland side of the buttress.

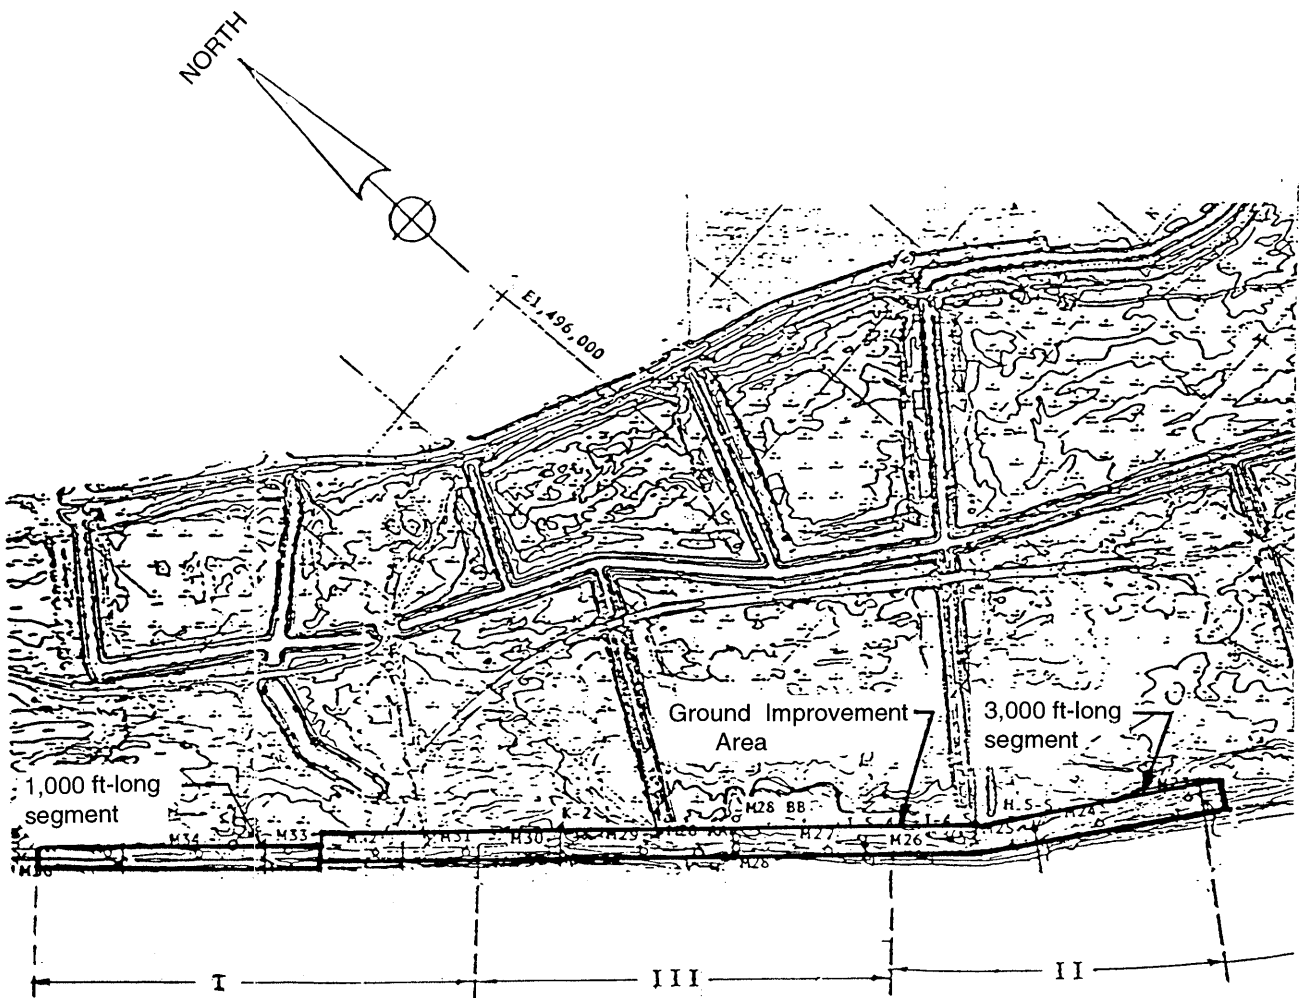
Figure 16.—Perimeter sand dikes at Harbor Bay Isle Development, Alameda (study site 8, fig. 1), showing locations of sections I through III in figure 17. From Hallenbeck and Associates (1985).

On the basis of the results of extensive geotechnical studies, the 4,000 ft of dikes can be divided into three different sections, as shown in figure 16; an idealized subsurface profile of each section is shown in figure 17. Section I consists of a 5- to 7-ft-thick upper layer of medium-dense to dense sand, with SPT blowcounts ranging from 15 to 35 blows/ft. This sand layer is underlain by a layer of loose to medium-dense silty sand, approximately 12 ft thick, with SPT blowcounts ranging from 3 to 10 blows/ft. Both the surface medium-dense to dense sand and the underlying loose sand consist of hydraulically placed fill. Medium-dense to dense silty and clayey sand, with SPT blowcounts of more than 25 blows/ft, was penetrated at 17-ft depth.

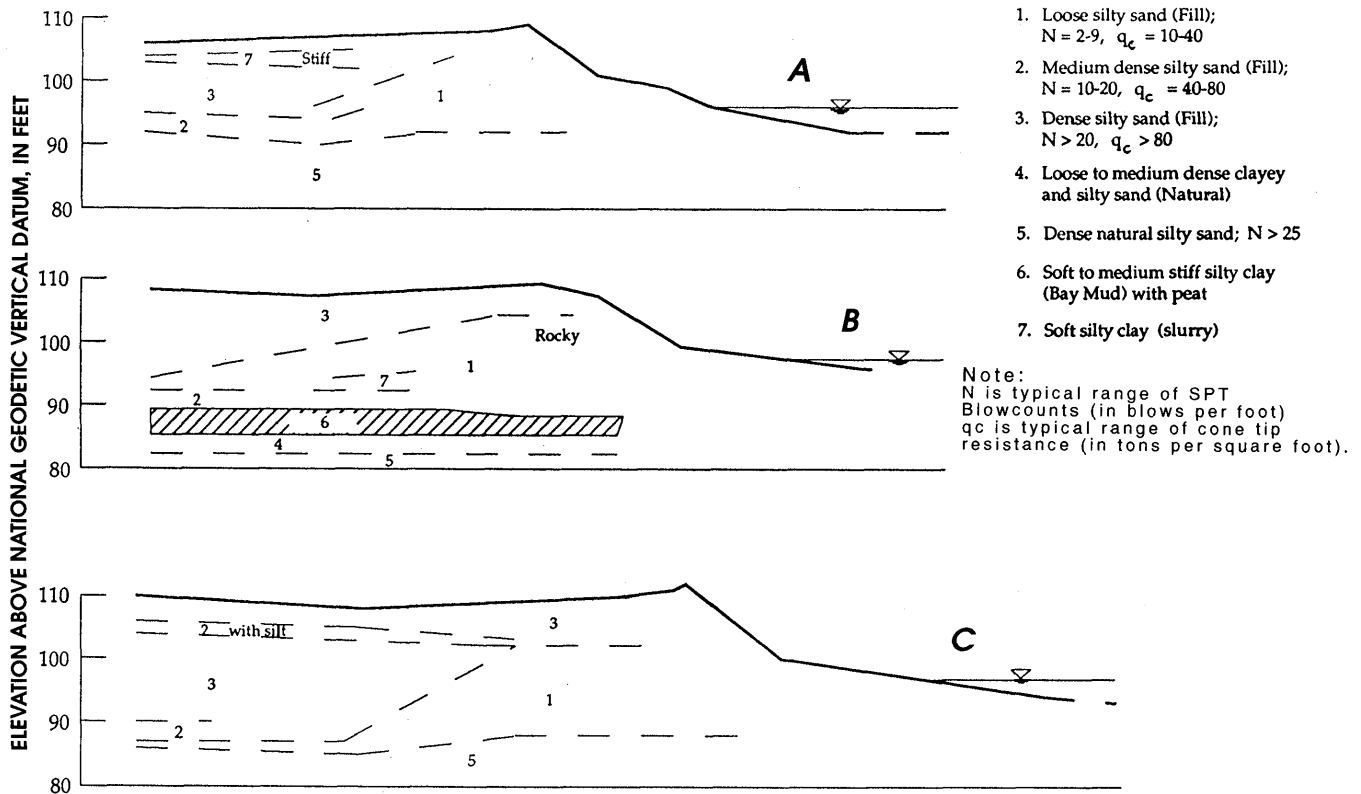
Section II similarly consists of 5 to 12 ft of medium-dense sand crust over a layer of loose sand fill; the medium-dense sand has SPT blowcounts ranging from 10 to 20 blows/ft. The loose sand layer is approximately

6 to 13 ft thick and is interspersed with thin clay lenses; this sand layer has SPT blowcounts ranging from 3 to 8 blows/ft. The loose sand is underlain by a layer of soft bay mud, approximately 3 ft thick. The bay mud, in turn, is underlain by a layer of natural loose to medium-dense sand extending to a maximum depth of 26 ft below the ground surface; this sand layer has SPT blowcounts ranging from 8 to 15 blows/ft. Below 26-ft depth, the sand is denser, with SPT blowcounts of more than of 30 blows/ft.

Section III consists of a surface fill layer of 10 to 16 ft of dense sand, with SPT blowcounts ranging from 30 to 40 blows/ft. The dense sand is underlain by a layer of loose to medium dense sand, 6 to 12 ft thick, with SPT blowcounts ranging from 5 to 10 blows/ft. The lower 5 ft of the loose sand layer consists of natural sand. Below 22-ft depth, the natural sand is denser, with SPT blowcounts of more than 30 blows/ft. The hydraulic sand fill is everywhere generally fine grained and contains an average of less than 11 percent of material finer than a No. 200 sieve. The natural sand also is generally fine grained, with an average fines content of about 22 percent. The ground-water level at the study site was at approximately the same elevation as mean sea level at the time of drilling.

Figure 17.—Subsurface profiles of sections I (A), II (B), and III (C) (see fig. 16 for locations) of perimeter sand dikes at Harbor Bay Isle Development, Alameda (study site 8, fig. 1).

The liquefaction potential of the loose hydraulic sand fill was evaluated by using an analytical-empirical procedure based on SPT  $N$  values corrected for fines content (Seed, 1987). An  $M=8.25$  earthquake occurring on the San Andreas fault was used as the design earthquake. The results of this analysis showed that the liquefaction potential of the loose and medium-dense sand fill in the dikes was high, and it was concluded that the dikes could undergo excessive yielding or slope failure during a major earthquake. Such yielding or failure would reduce confinement of the interior soils and might allow lateral spreading in the interior of the Harbor Bay Isle development. On the basis of these conclusions, it was recommended that the loose sand fill in the dikes be densified to minimize its liquefaction potential.

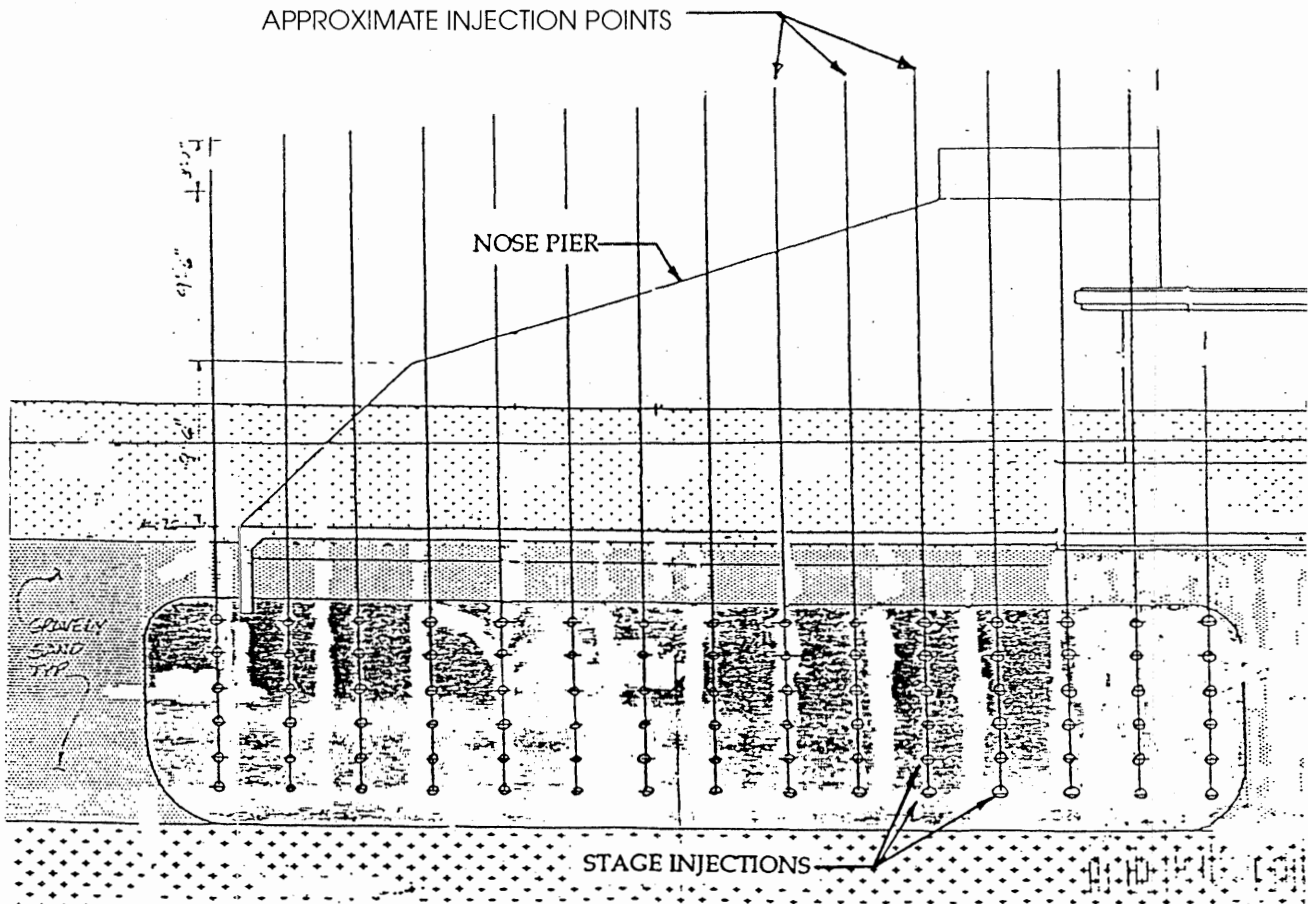
The granular bearing soils underneath the south nose pier were being eroded by the river, thereby undermining the pier. The resulting settlement of the pier was damaging the bridge decking above. Over time, the erosion and resulting settlement appeared to be increasing, and so it

Figure 20.—Cross section of Riverside Avenue Bridge, Santa Cruz (study site 11, fig. 1), showing typical grouting pattern. From Georesource Consultants (1986).

was decided that some method of improving the granular soils to prevent further erosion must be implemented.

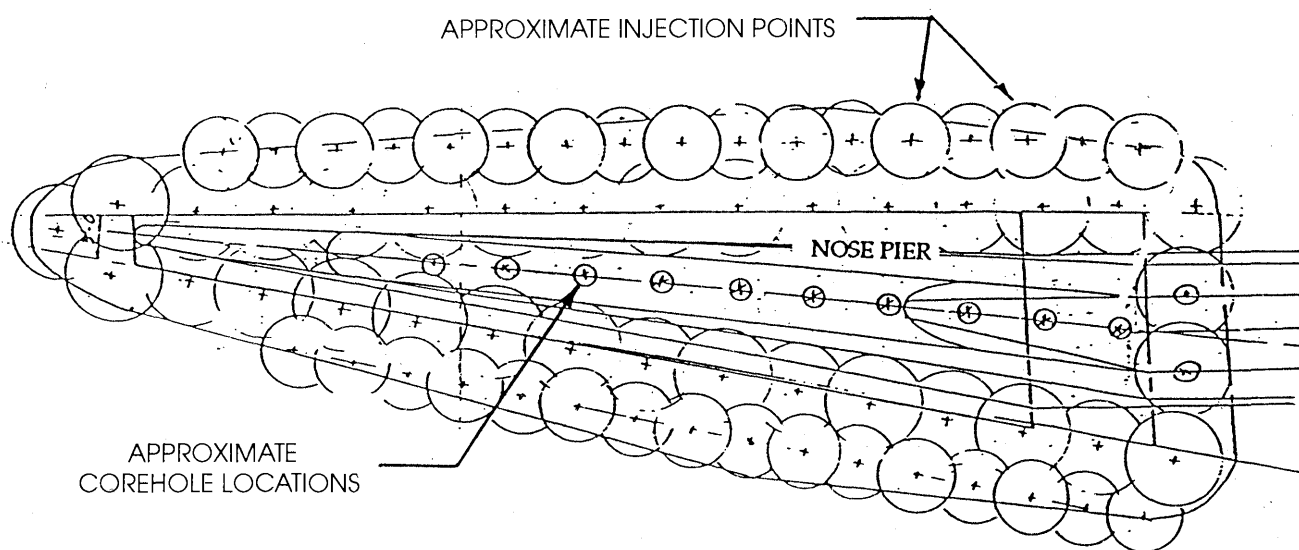
Figure 21.—Plan view of Riverside Avenue Bridge, Santa Cruz (study site 11, fig. 1), showing typical grouting pattern. From Georesource Consultants (1986).

eted duration of 15 s during the earthquake. According to the Santa Cruz city engineer, no settlement of the bridge pier or other detrimental ground movements were observed.
