# The Loma Prieta, California, Earthquake of October 17, 1989—Liquefaction

STRONG GROUND MOTION AND GROUND FAILURE

U.S. GEOLOGICAL SURVEY PROFESSIONAL PAPER 1551-B

UNITED STATES GOVERNMENT PRINTING OFFICE, WASHINGTON : 1998

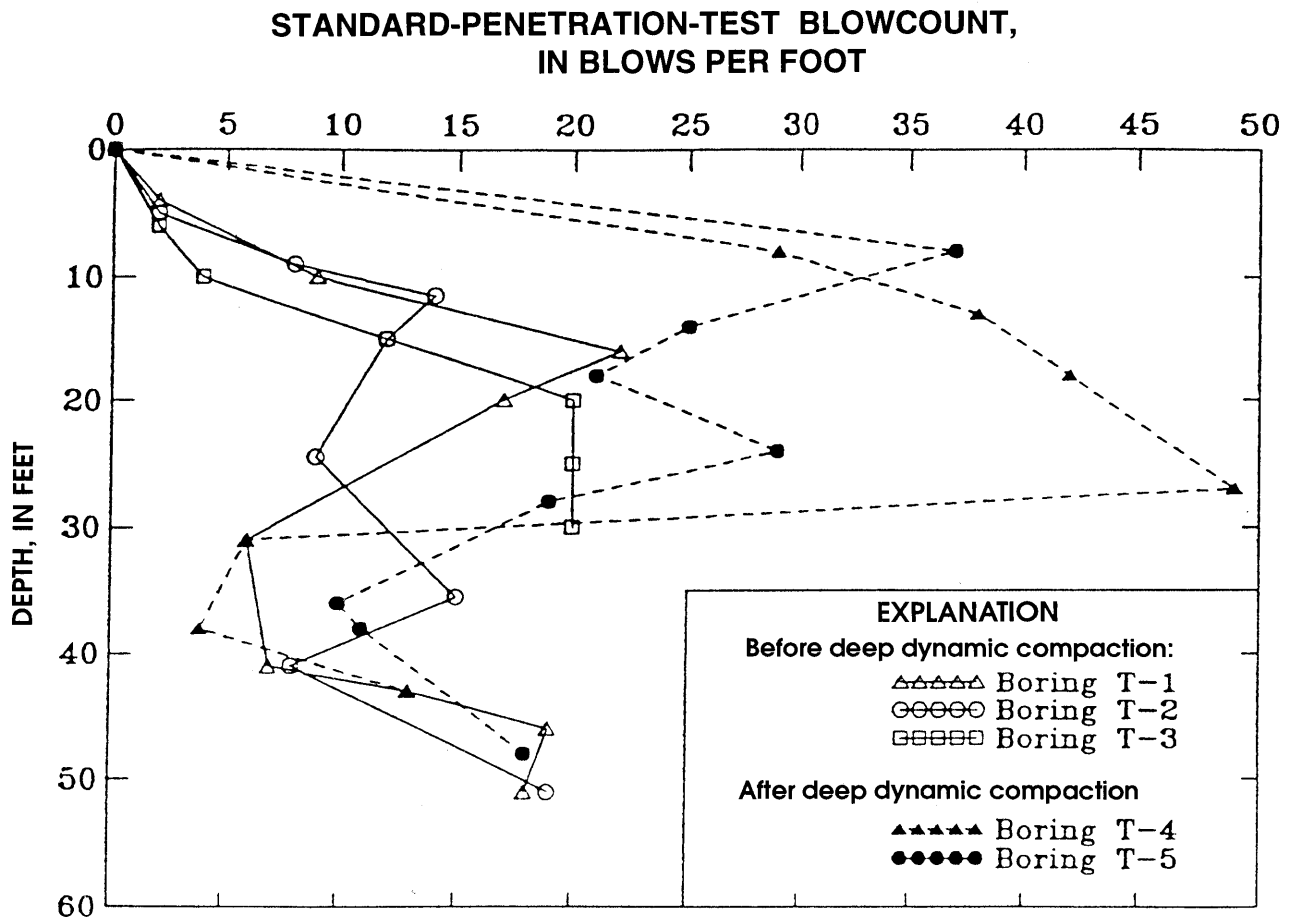
A comparison of the subsurface profile in the test area before and after improvement, indicating that a substantial amount of densification was achieved in the layers above about 25- to 30-ft depth, is shown in figure 23. A significant increase in SPT blowcounts was achieved in the silty-sand layer above about 30-ft depth (fig. 24). Overall, it was concluded that the liquefiable layer in the test area had been adequately densified.

Figure 24.—Comparison of standard-penetration-test blowcount before and after dynamic deep compaction at Santa Cruz County Detention Facility, Santa Cruz (study site 12, fig. 1). See figure 22 for locations of boreholes T-1 through T-5. From Peter Kaldveer and Associates (1977).

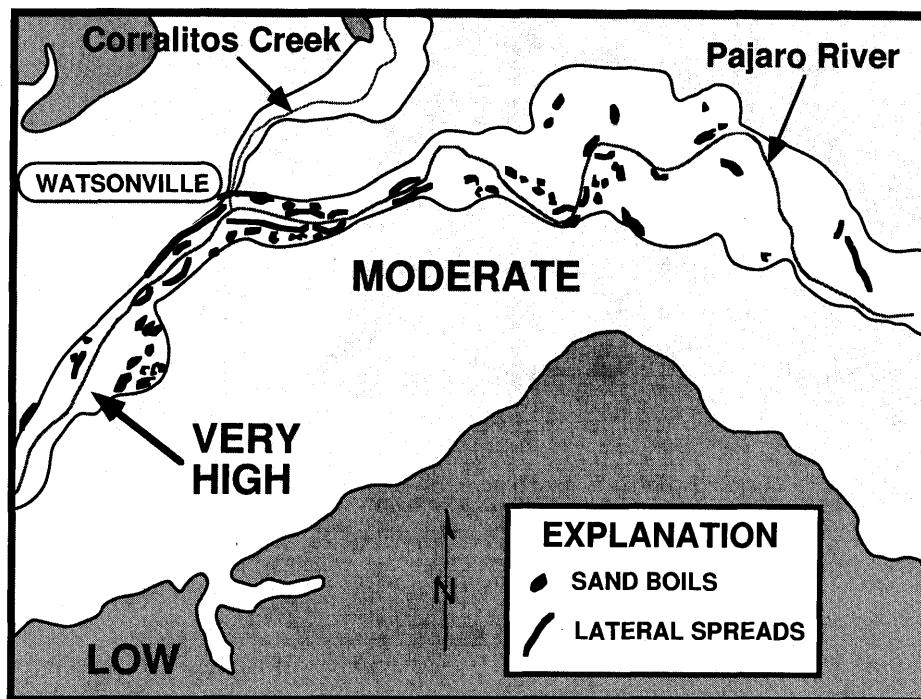
Figure 3.—Watsonville, Calif., area (see fig. 1 for location), showing distribution of liquefaction effects from 1989 Loma Prieta earthquake in relation to zones of predicted susceptibility as determined by Dupré and Tinsley (1980).

were not zoned by Dupré and Tinsley (1980) as having a high or very high liquefaction susceptibility. Minor sand boils occurred at two of these localities zoned as moderate (sites 100, 101) in basin deposits, along the lower part of the Pajaro Valley.

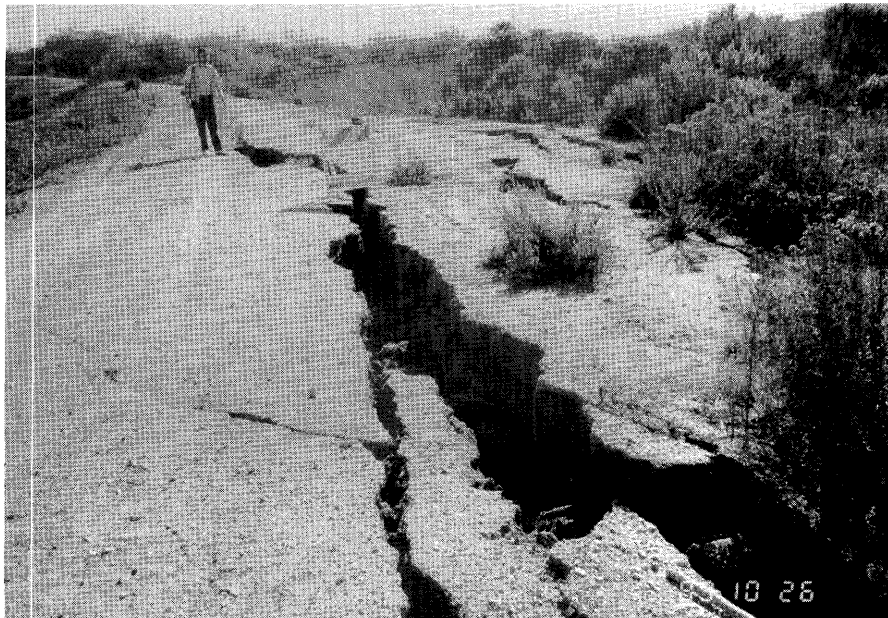
A

The lateral-spread failures (figs. 4A–4D) typically occurred within 150 m of channel margins characterized by a free face or gently sloping point bar 3 to 5 m high. Some failures, however, occurred along the margins of abandoned channels filled with organic-rich sediment, where the free face was less than 1 m high but where the compressible material filling the channel readily accommodated the laterally displaced mass. Lateral displacements ranged from a few millimeters to as much as 2 m, measured cumulatively across a failure from its head to its toe; vertical displacements were similar but generally less than 0.3 m. Failure commonly occurred on both sides of the modern channel, and zones of failure were mappable for distances of as much as 2 km along the channel margins.

Figure 4.—Liquefaction features from 1989 Loma Prieta earthquake in Monterey Bay region. *A*, Lateral spread in channel and point-bar deposits beneath flood-control levee near mouth of the Pajaro River (fig. 1; site 103 of Tinsley and others, this chapter). Extension was from left to right, toward free face formed by river channel. *B*, Lateral spread along margin of lower course of the Pajaro River (fig. 1; site 99 of Tinsley and others, this chapter). Partial view emphasizes nearly 2 m of differential settlement of narrow strip of land adjacent to channel. Extension was right to left by nearly 1 m. *C*, Lateral spread in estuarine and overlying artificial fill deposits at the entrance to Moss Beach (MB, fig. 1; site 116 of Tinsley and others, this chapter). Extension was from right to left, toward tidal inlet north of Elkhorn Slough. *D*, Lateral spread in estuarine deposits and overlying dunes at Moss Beach (MB, fig. 1; site 116 of Tinsley and others, this chapter). Extension was from right to left, including differential settlement of about 0.4 m. *E*, Sand boils along paleochannel within younger fluvial deposits in the Pajaro Valley (PV, fig. 1; site 91 of Tinsley and others, this chapter).

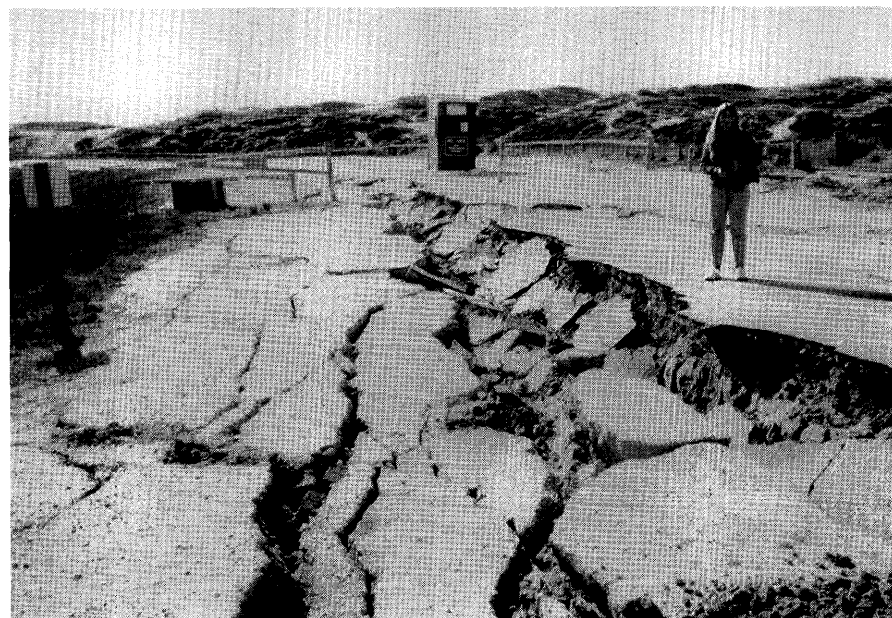
**C**

In addition, **dune deposits** (unit Qd of Dupré and Tinsley, 1980), exhibited ground failure only where underlain by young estuarine or tidal-channel deposits; failure actually occurred within the underlying deposits (figs. 4C, 4D). The discontinuous patterns of failure in the Moss Landing area (ML, fig. 1; Tuttle and others, 1990; Greene and others, 1991), and at the mouth of the Pajaro River

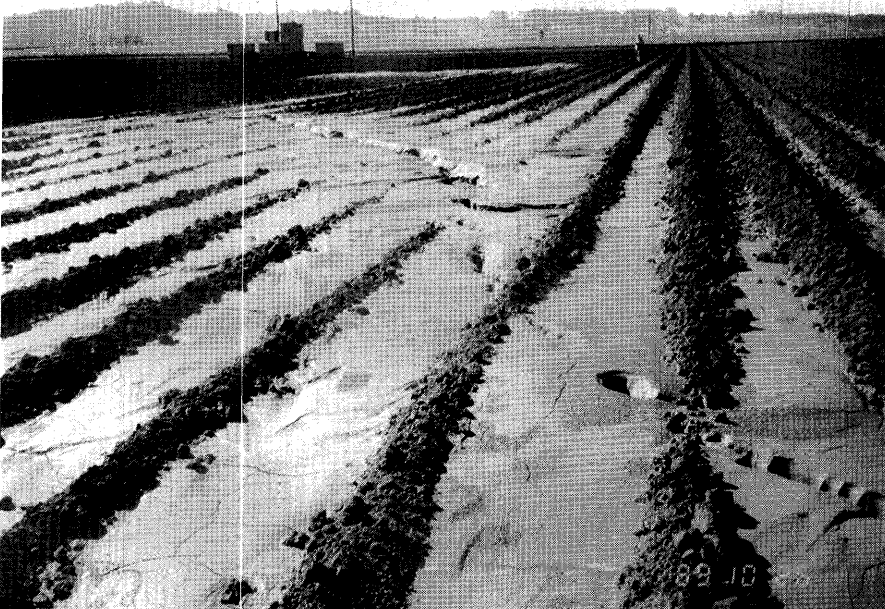
**E**

Differential settlement, fracturing, and sand boils were especially common over abandoned channels within the late Holocene flood plain (fig. 4E). For example, as part of a larger lateral failure in the town of Pajaro, just south of Watsonville (W, fig. 1), extensive fracturing and as much as 0.5 m of subsidence occurred over a filled chan-

nel approximately 15 m wide. The zone of deformation associated with this paleochannel extended approximately 2 km parallel to the river, as evidenced by sand boils, fractured ground, condemned buildings, and the damaged abutments of the Main Street and Southern Pacific bridges that cross the Pajaro River at Watsonville (see Tinsley and others, this chapter).

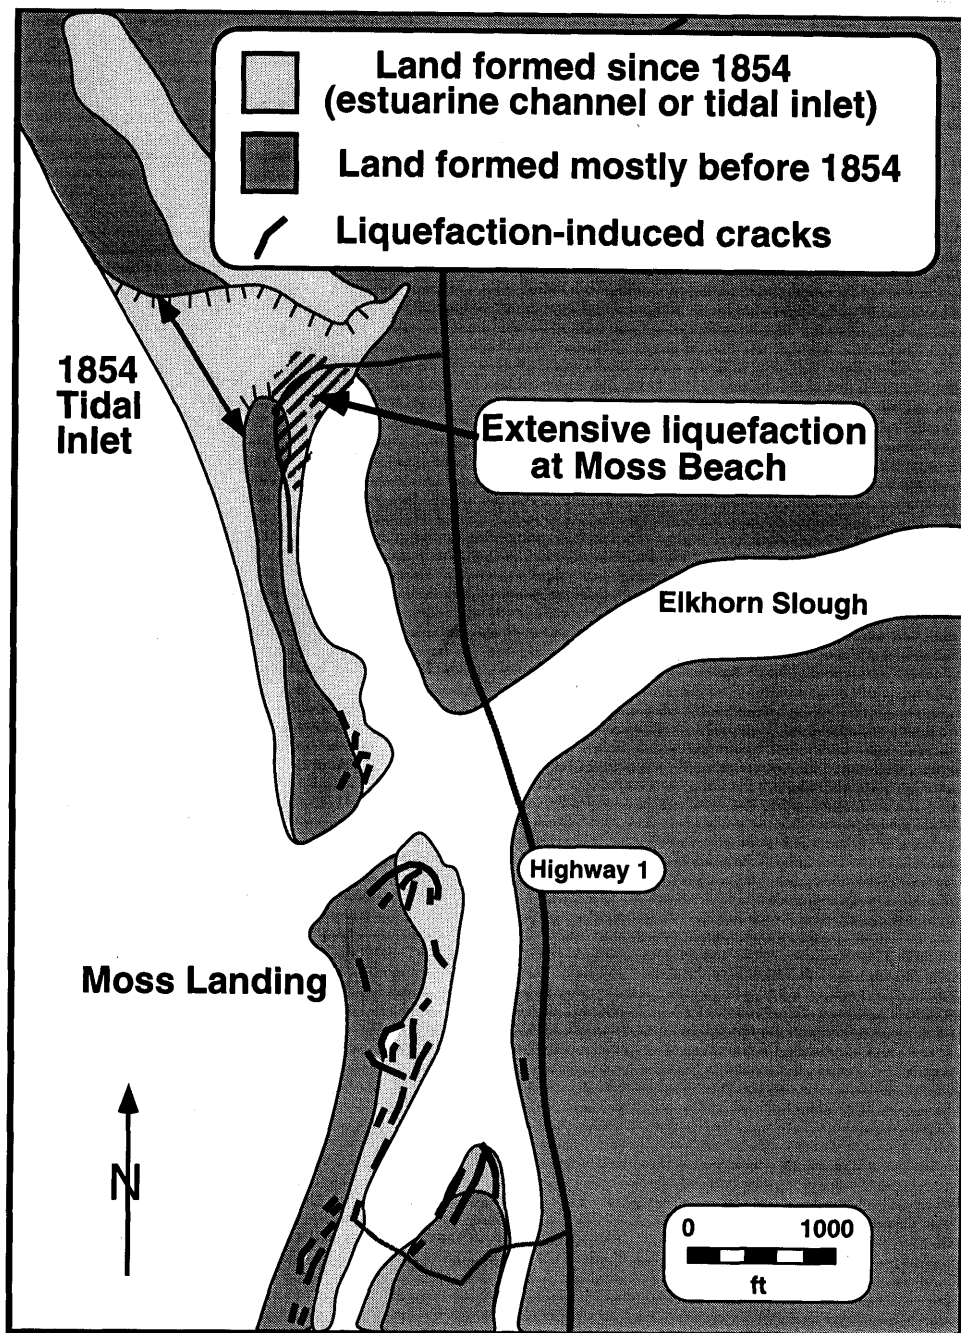
Most failures along the coast occurred in areas underlain by estuarine and tidal-channel deposits subsequently buried by channel migration, washover deposits, and landward-migrating dune deposits, as was particularly evident between the mouth of the Pajaro River and Moss Landing (fig. 5).

(sites 109 and 108 of Tinsley and others, this chapter) coincide largely with areas that were originally tidal inlets or estuaries which had been filled within the last 150 years (fig. 5). The geologic units as mapped at the surface, such as dunes and washover deposits, do not reflect these differences in subsurface stratigraphy. These differences become readily apparent, however, when historical maps of the shoreline are superimposed on the modern map (fig. 5).

Figure 5.—Moss Landing area, Calif. (see fig. 1 for location), showing distribution of liquefaction-induced deformation (modified from Greene and others, 1991). Areas of young deposits (post-1854 estuarine-channel or tidal-inlet fill), are mapped on basis of comparisons with historical shoreline changes (modified from Hans Nielsen, unpub. data, 1991).
