The Loma Prieta, California, Earthquake of October 17, 1989—Landslides

STRONG GROUND MOTION AND GROUND FAILURE
THOMAS L. HOLZER, *Coordinator*

U.S. GEOLOGICAL SURVEY PROFESSIONAL PAPER 1551-C

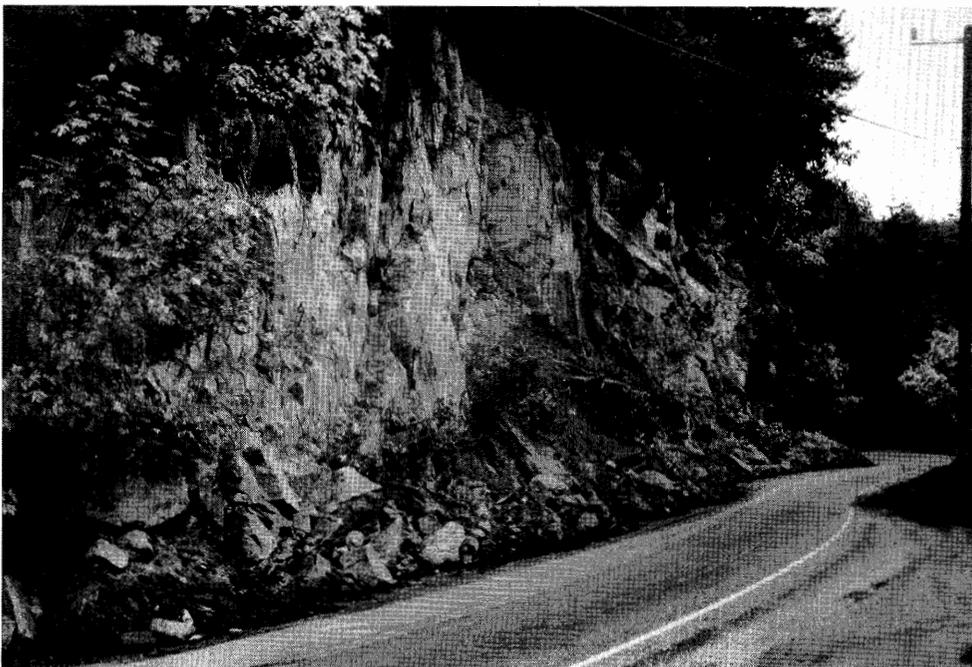
Figure 3.—Rock fall from near-vertical cut along Old San Jose Road, about 0.9 km northwest of Sugarloaf Mountain (see pl. 2 for location). Source rock is weakly to moderately cemented sandstone, broken by conspicuous, through-going joints. Estimated volume of deposit is 500 to 1,000 m³.

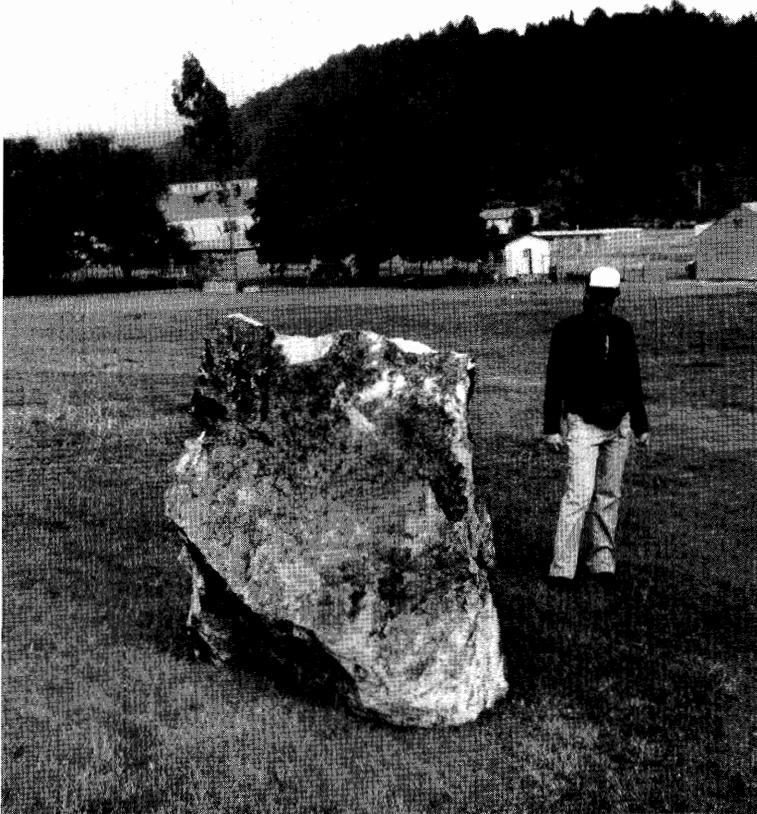
Figure 4.—Boulder, approximately 1.5 m in maximum diameter, from earthquake-induced rock fall near conference ground about 2.5 km north of Soquel (see pl. 2 for location). Several boulders of nearly comparable size bounced and rolled into gently sloping field from steep slope above.

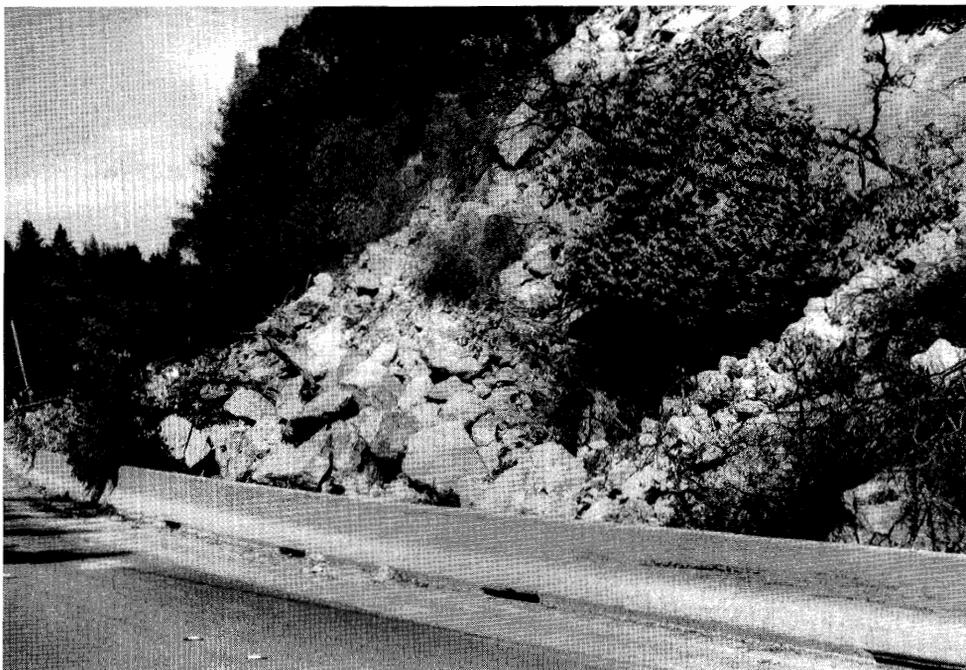
Figure 5.—Part of rock-fall deposit from cut slope above California Highway 17 in Glenwood area (see pl. 2 for location).

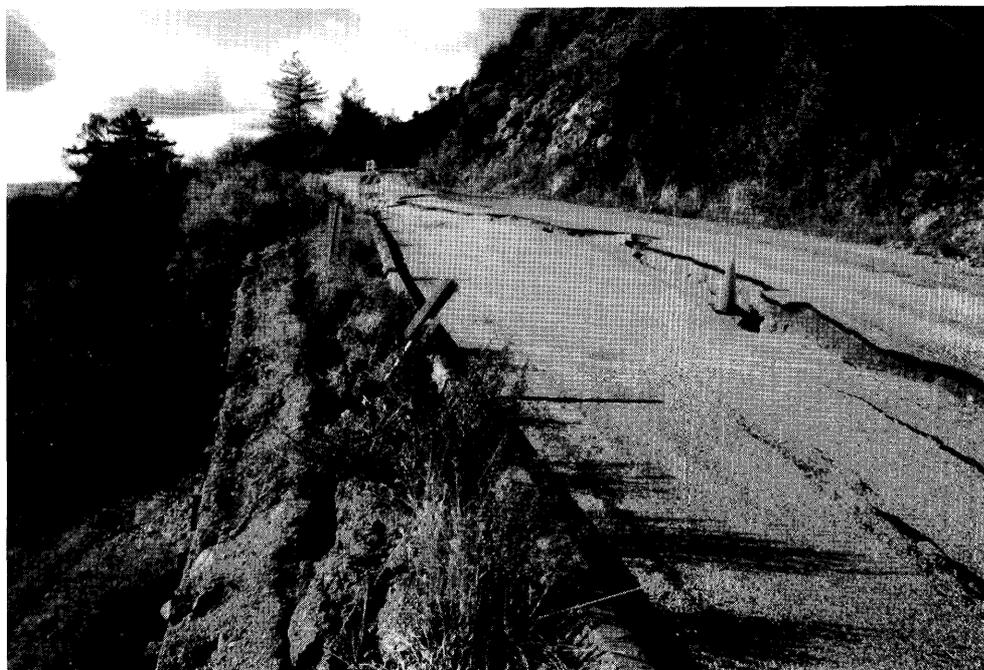
Figure 7.—Small slump in road fill near Bean Hill (see pl. 2 for location). Note arcuate, concave-downslope main scarp nearly parallel to long axis of road. Slumps in fill were most common type of category II landslides in the southern Santa Cruz Mountains. Photograph by David M. Peterson, U.S. Geological Survey.

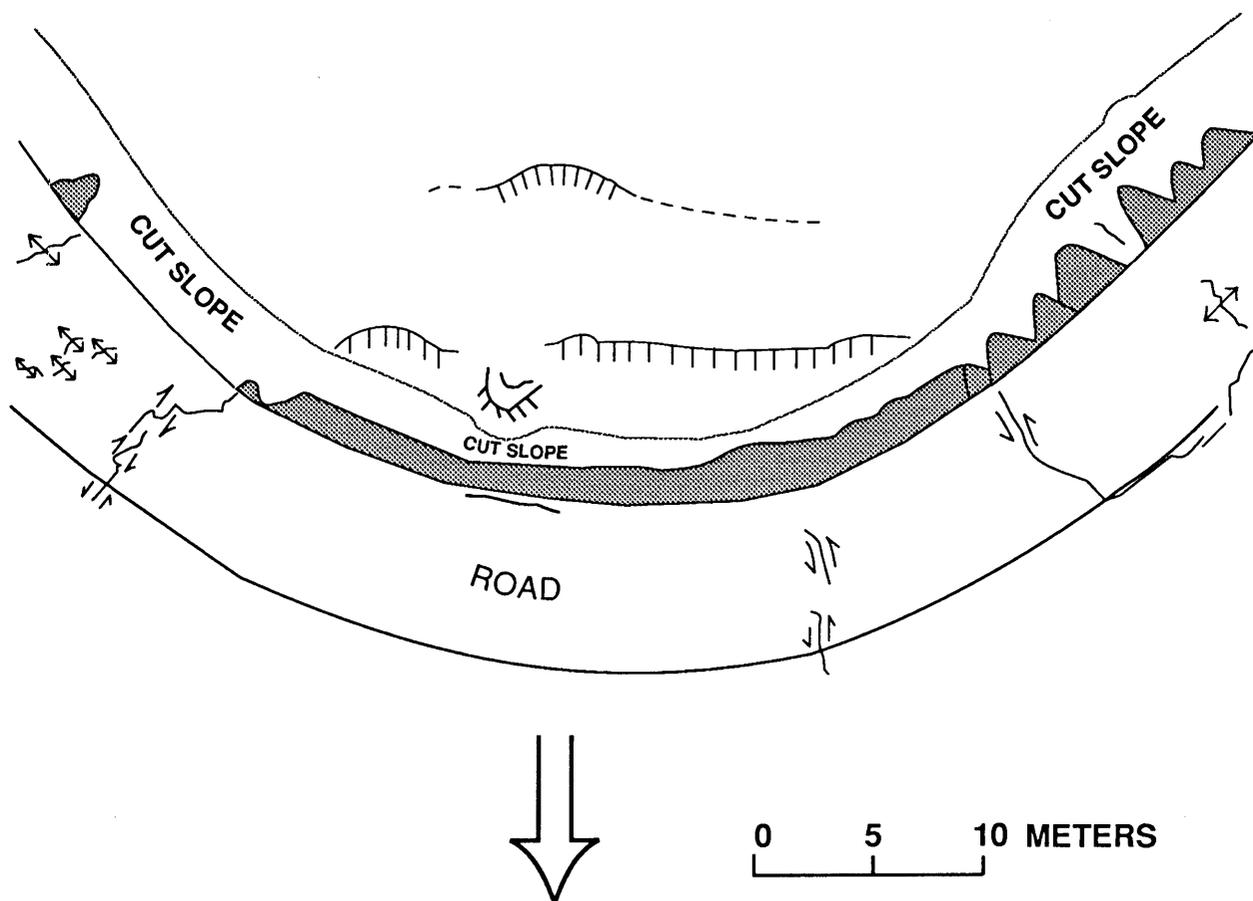
Figure 10.—Sketch map showing rock fall and block slide from end of ridge in Big Basin Redwoods State Park (see pl. 1 for location). Road curves around end of ridge in mid-slope position. Prominent scarps on ridgecrest above road (hachured on down-dropped side, dashed where approximately located) showed as much as 6 cm of downslope displacement. Small arrows denote relative senses of motion on cracks in road, which typically trend perpendicular to long axis of roadway. Maximum local lateral displacement was 1.5 cm. Large arrow indicates approximate, inferred direction of movement of slide. No compressional features were found in heavily vegetated area downslope from road. Rock and soil falls (shaded areas) occurred on cut slope above road.

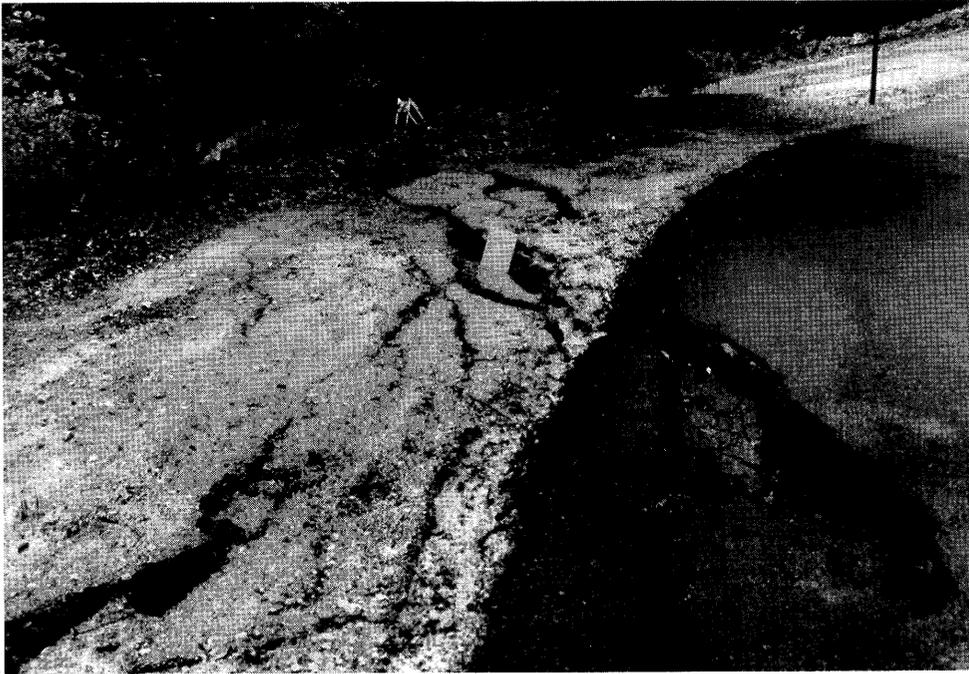
Figure 11.—Part of main scarp of rock block slide on end of ridge near Laurel (see pl. 2 for location). Notebook is 20 by 27 cm.

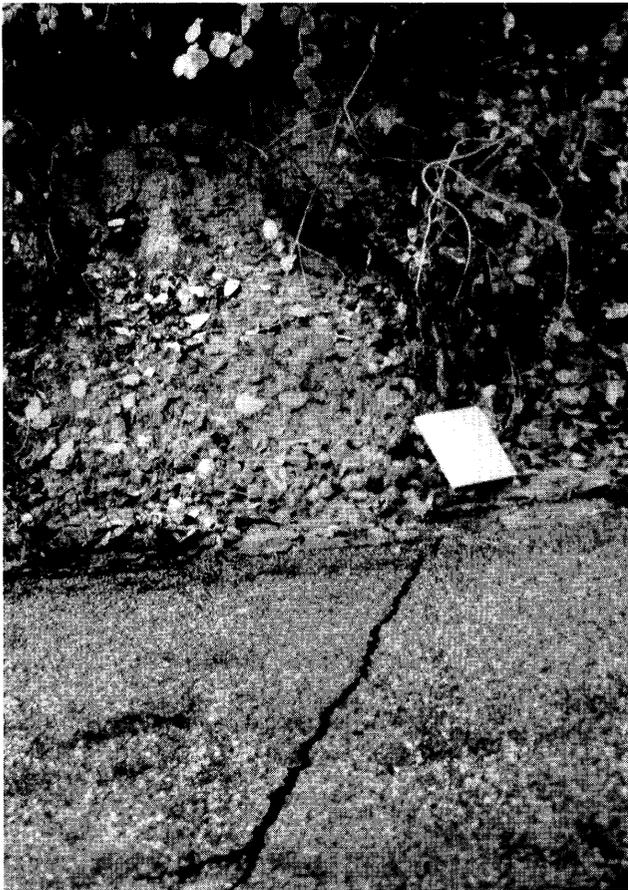
Figure 12.—Lateral margin (left flank) of block slide near Laurel (see pl. 2 for location) defined by crack across road, showing left-lateral movement. Note small rock fall where crack intersects steep cut slope across road.

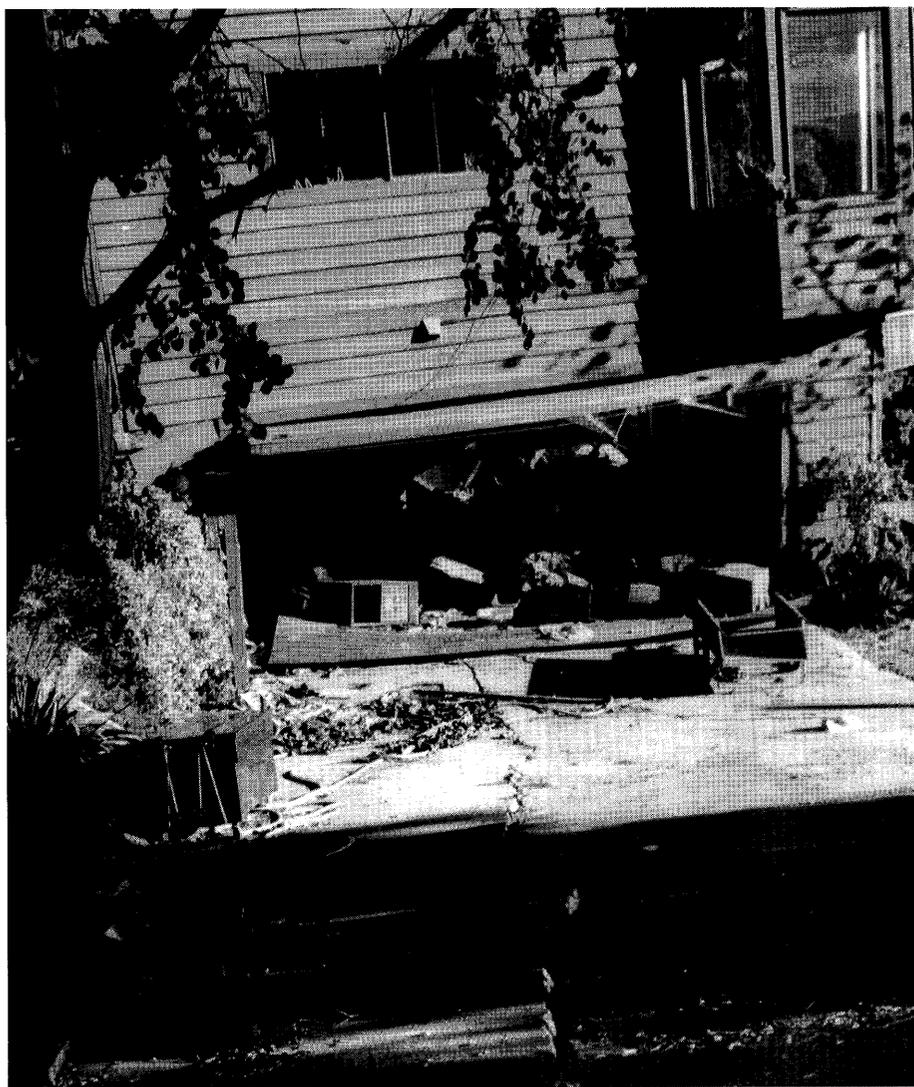
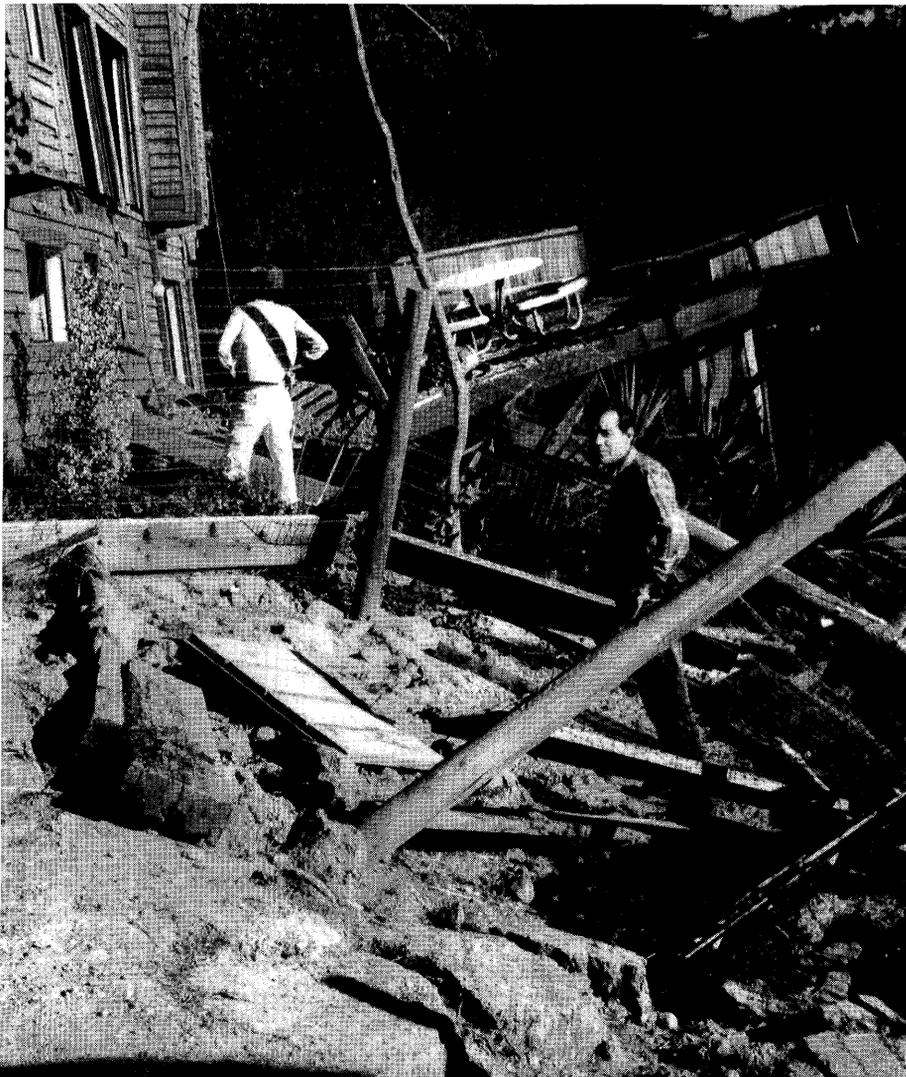
Figure 13.—Ridgecrest fissure and associated landslide along Robinwood Way (see pl. 2 for location). *A*, Ground crack, also breaking pavement and foundation slab. Crack is nearly linear, trends parallel to long axis of steep, high, narrow ridge, and is immediately upslope from slump shown in figure 13*B*. Downslope direction is toward right. *B*, Rotational slump originating on edge of ridgecrest, immediately below ground crack shown in figure 13*A*. Position and orientation of crack and relation to slump indicate that crack is an incipient landslide feature.

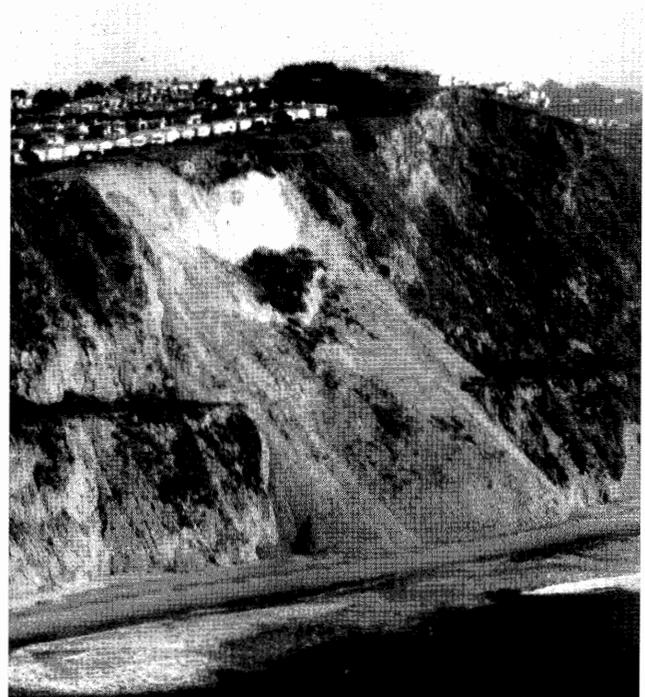
Figure 6.—Large coastal landslide near Daly City (fig. 4) resulting from 1989 Loma Prieta earthquake. Note proximity of cliff-top houses to headscarp.

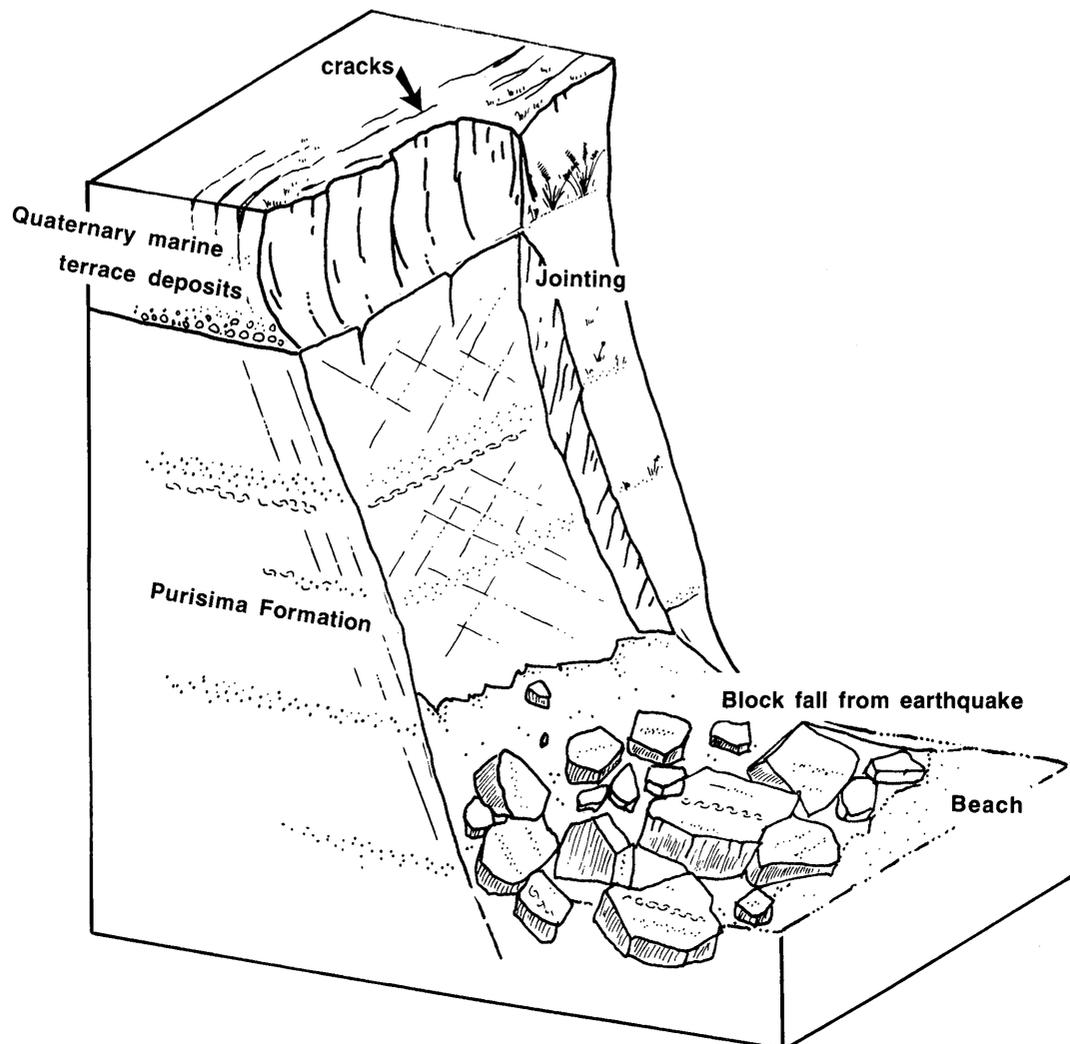
ries toppled downslope, blufftop terrace deposits collapsed, and weakened bedrock failed. Horizontal and downslope separation along joint surfaces allowed large blocks to separate from more intact rock (fig. 7). The size of these failures was a function of joint spacing and orientation, frictional or cohesive strength along the joint surface, cliff height, and toe support. High cliffs with widely spaced, subvertical joints and poor toe support sustained the largest instantaneous and incipient failures in weakened or undercut sedimentary rocks.

Figure 7.—Geologic structure and style of typical rockfall in seacliffs underlain by well-jointed siltstone of the Purisima Formation. Note undercut cliff and tension cracks in Pleistocene terrace deposits.

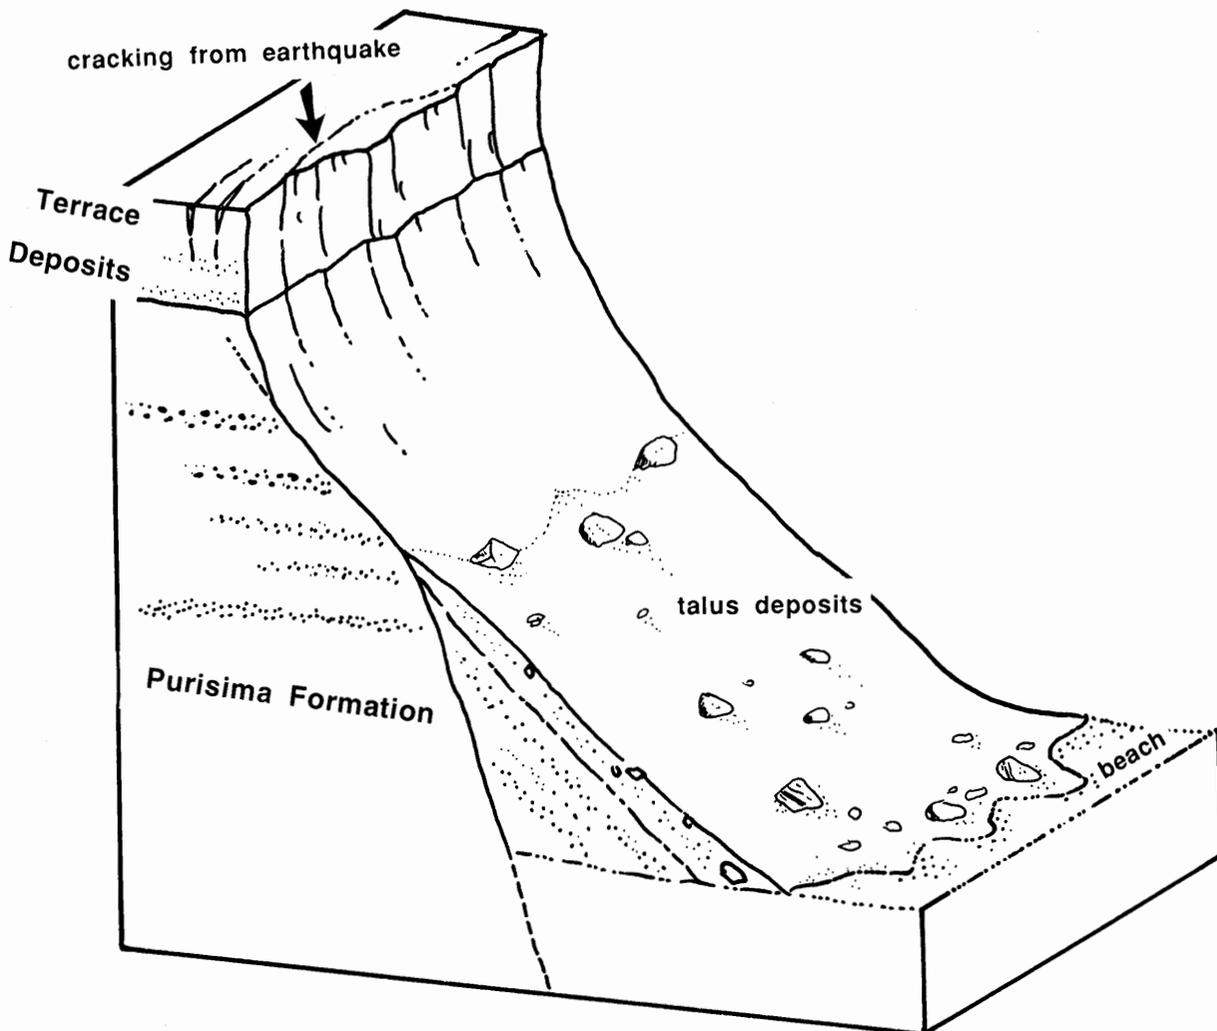
Figure 8.—Geologic structure and typical debris slide in seacliffs underlain by sandstone of the Purisima Formation.

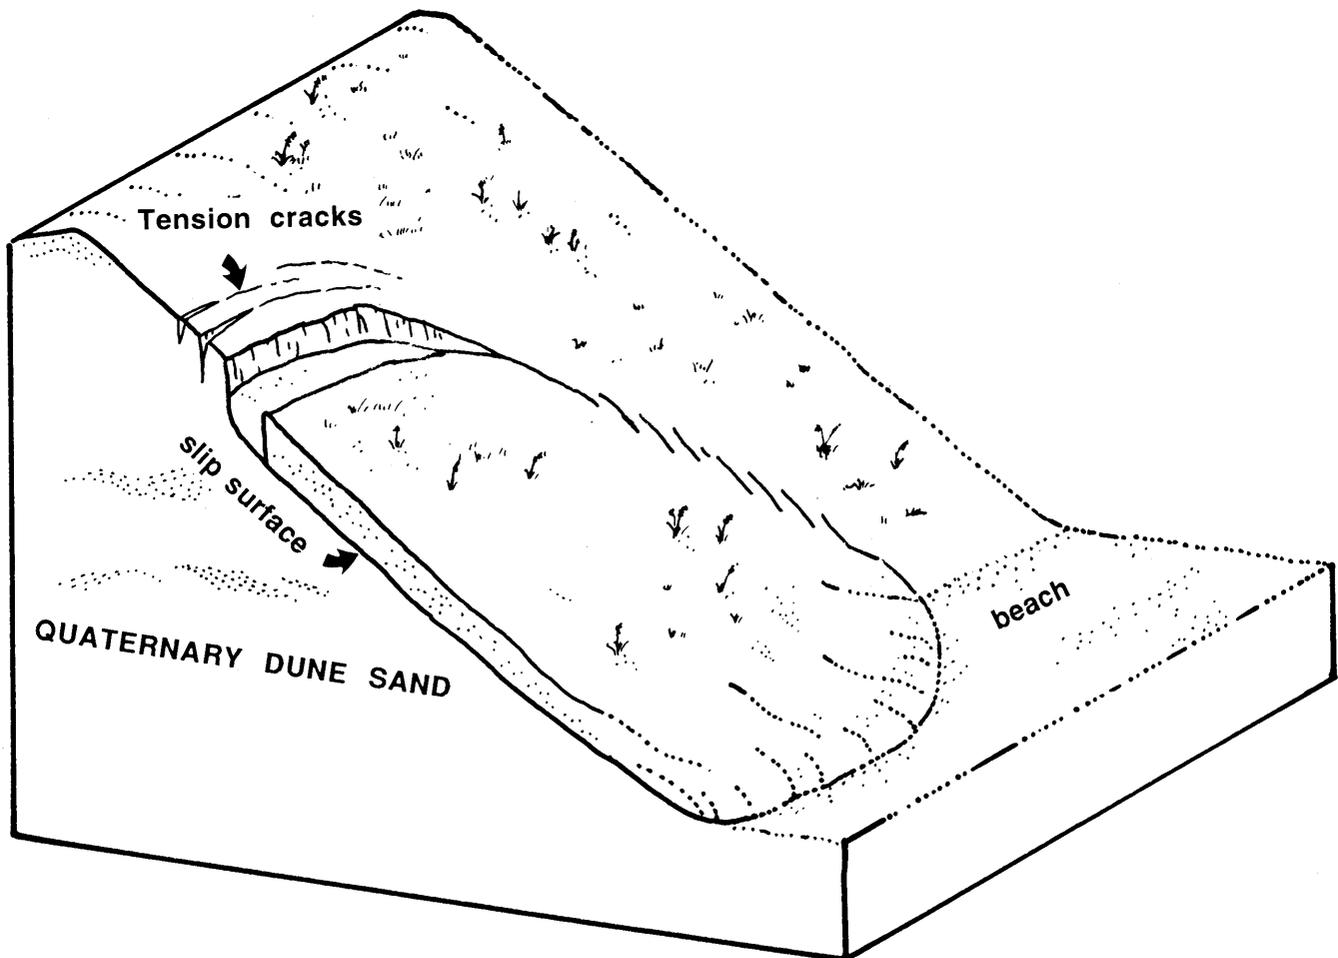
Figure 9.—Dry sandflow in uncemented eolian deposits. Note tension cracks in overlying, more cohesive surficial soils.

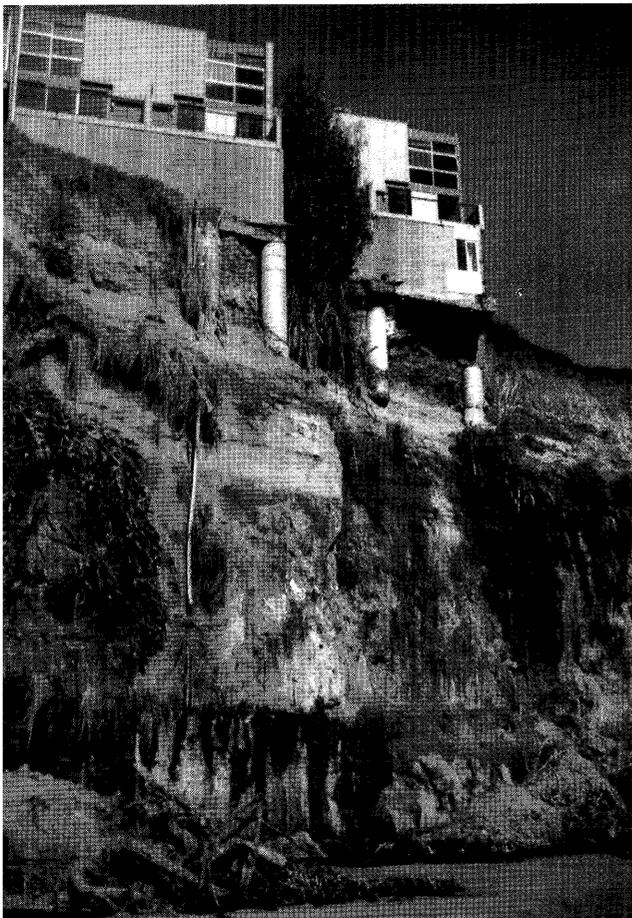
Damage to private property and public infrastructure was minimal along the cliffs in this area, except for those immediately east of Capitola (fig. 4). An apartment complex that was already overhanging the seacliff was additionally undermined as both bedrock and terrace deposits toppled to the beach below (fig. 11). Earthquake-induced failure led to partial loss of concrete caisson support and cracking of the foundation slab and perimeter wall of six apartments. Tension cracks were visible as far as 10 m inland of the cliff edge.

Figure 11.—Collapse of terrace deposits and underlying jointed bedrock of the Purisima Formation at Capitola (fig. 5) as a result of the 1989 Loma Prieta earthquake. These six apartment units were subsequently demolished, owing to blufftop cracking and loss of foundation support.

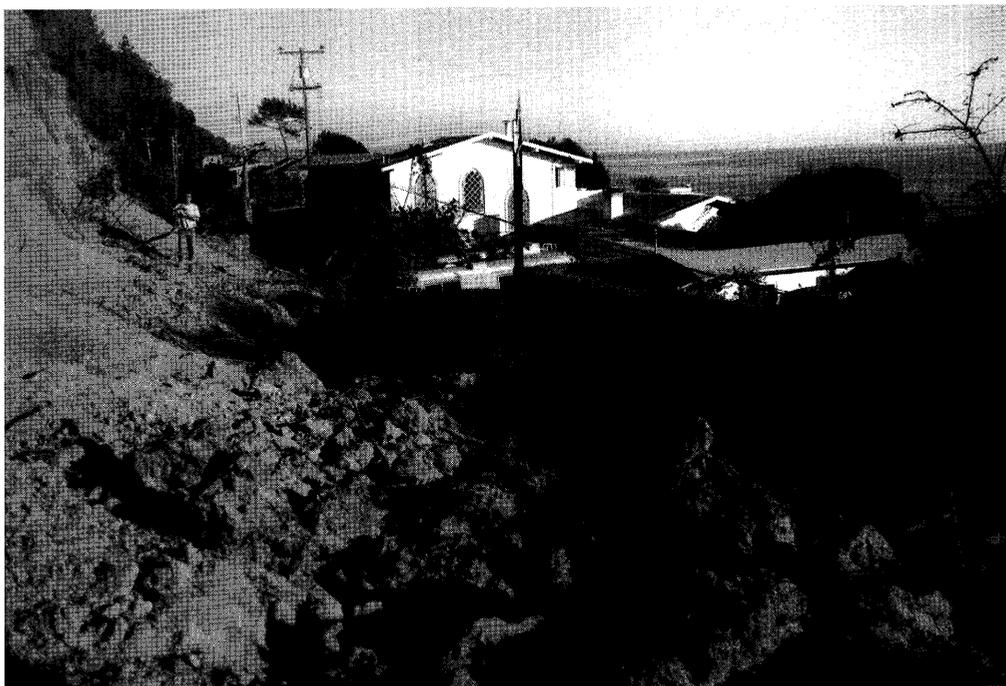
Figure 14.—Base of seacliff in area of figure 12 where material from bluff failure has blocked access to beach-front homes.

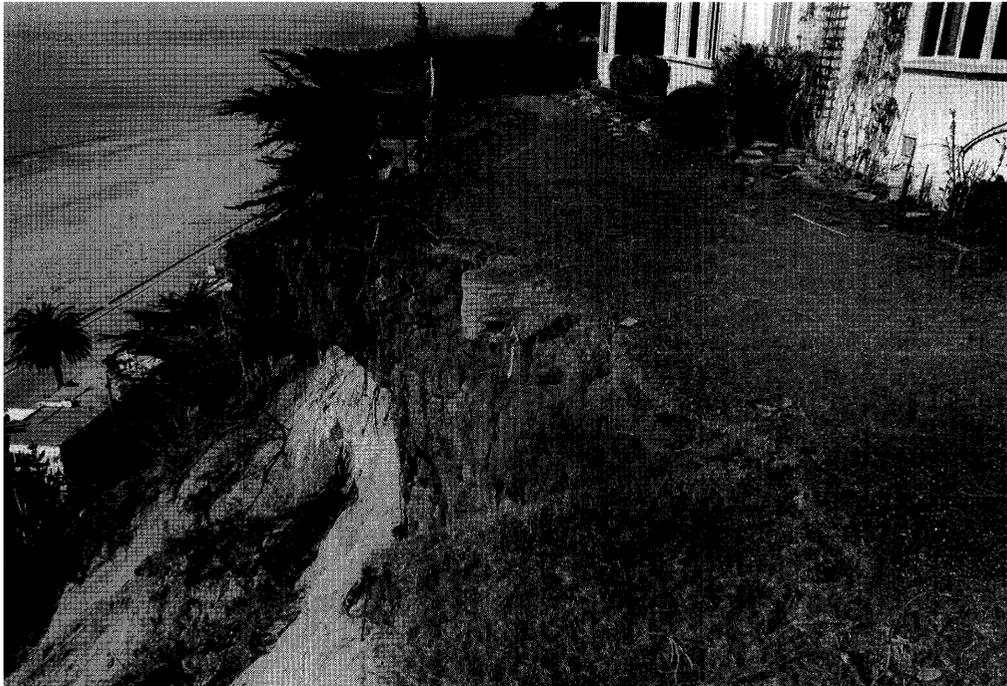
Translational failure along joints or weathering surfaces produced many large (30–60 m wide) concave upward scarps in the upper 12 to 15 m of the cliff in this area (figs. 8, 12). These scarps tended to cut vertically through the terrace deposits and then flatten to parallel the slope as they approached the Purisima Formation. Deep tension cracks cut through the upper terrace deposits and soils as far as 6 m landward of many of the scarps; this distance tended to increase with the size of the scarp and the height of the cliff. Coherent blocks overlying loose soil disintegrated as they cascaded down the cliff face. Talus piles, as much as 12 m high, blocked access to homes (fig. 14) and partly buried automobiles. Two blufftop homes ultimately were demolished because of such failures, which produced deep tension cracks through the building sites

(fig. 15). Both homesites were on narrow, steep-sided peninsulas along the crest of the coastal bluff, locations where seismic shaking appears to have been particularly severe.

Figure 15.—Deep tension cracks (arrows) in terrace deposits in Rio Del Mar (fig. 5). Cracks cut through house foundation and indicate potential extent of future failure. At this site, house was demolished, and unstable material was removed to stabilize site.

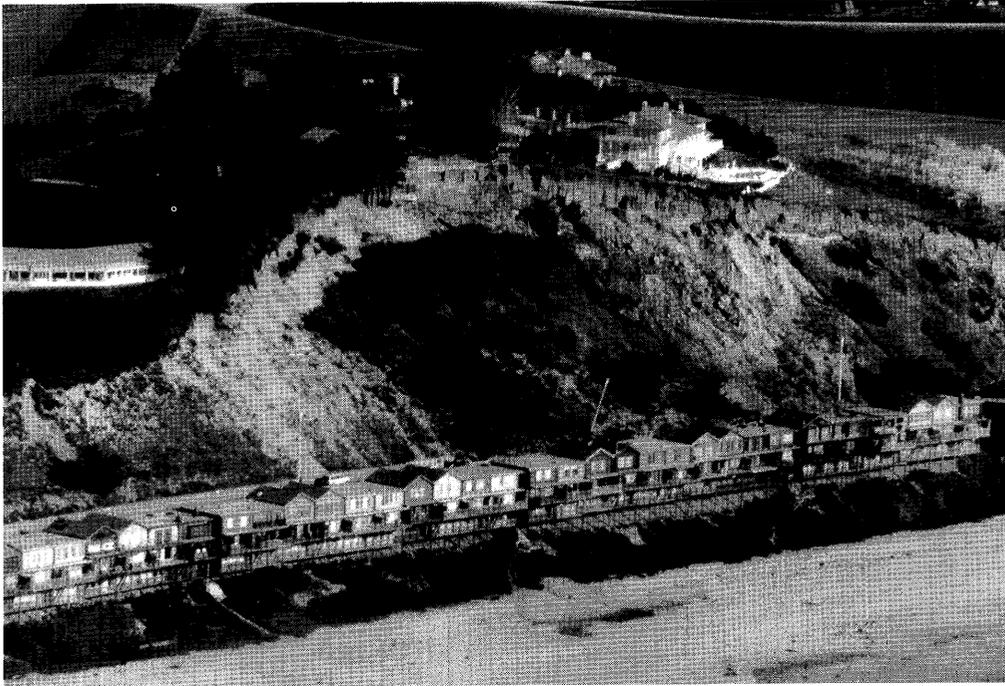
Several types of earthquake-induced failures were typical along this stretch of coastal bluffs. The first type consisted of shallow (1–3 m deep), large (max 100 m wide) translational slides (figs. 8, 16, 17). At one site, such a failure undermined 5 to 10 m of the cliff top, leading to collapse and toppling of large cohesive blocks of soil. These detached masses rolled downslope and blocked access to condominiums built on the talus slope at the base of the bluff (fig. 18). This same failure also undermined a blufftop home that was subsequently demolished.

Figure 17.—Large translational slide above condominium development south of Rio Del Mar (fig. 5). One house at top of bluff had to be demolished; homes at base of bluff were threatened, and access partly blocked (see fig. 18).

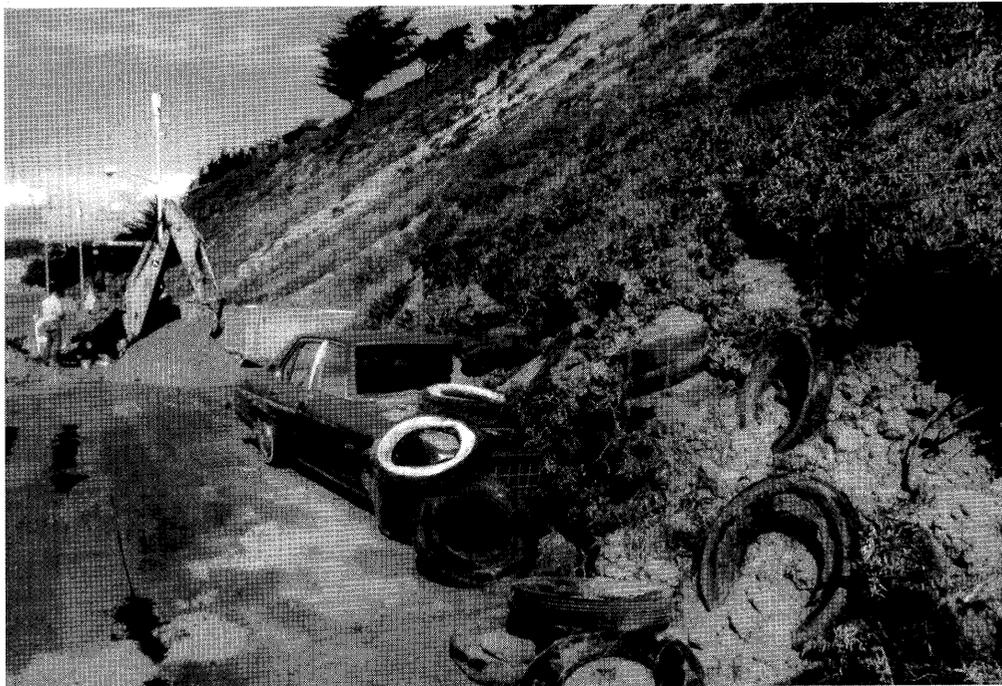
Figure 18.—Weakly consolidated sand of the Aromas Sand disintegrated and flowed downhill to block access and threaten condominiums at base of bluff (see fig. 16). Tires had been placed on slope in an attempt to control erosion.

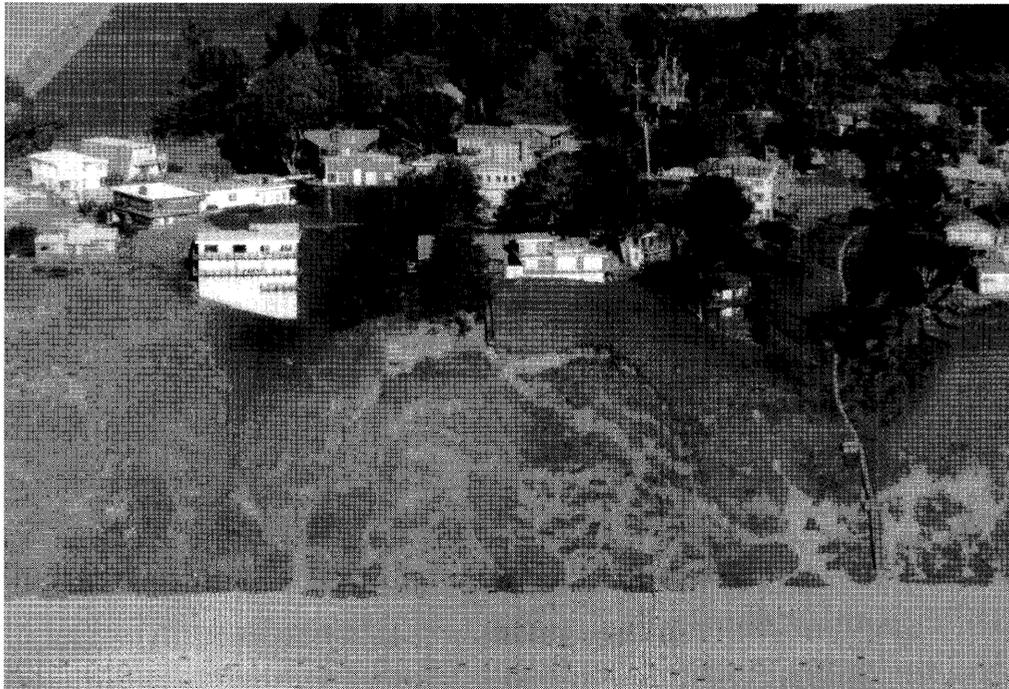
Another type of failure occurred in weakly consolidated Pleistocene dune sand near Sunset Beach (fig. 4) that has been partially stabilized by vegetation. Homes have been built on the edge of this ancient, partially vegetated dune complex. Slope failure took the form of shallow (max 1 m thick), dry sandflows that initiated well below the blufftop (figs. 9, 19). A vertical scarp cut through a thin, cohesive soil layer to a failure surface that paralleled the bluff face. Loose sand or small blocks of more cohesive material, commonly held together by roots, slid downslope along this surface and then ramped over the less steep talus deposits at the base of the bluff. The foundations of several homes were threatened, and one home was relocated.

Figure 19.—Large sandflows above Sunset State Beach (fig. 5). One blufftop house was to be relocated.

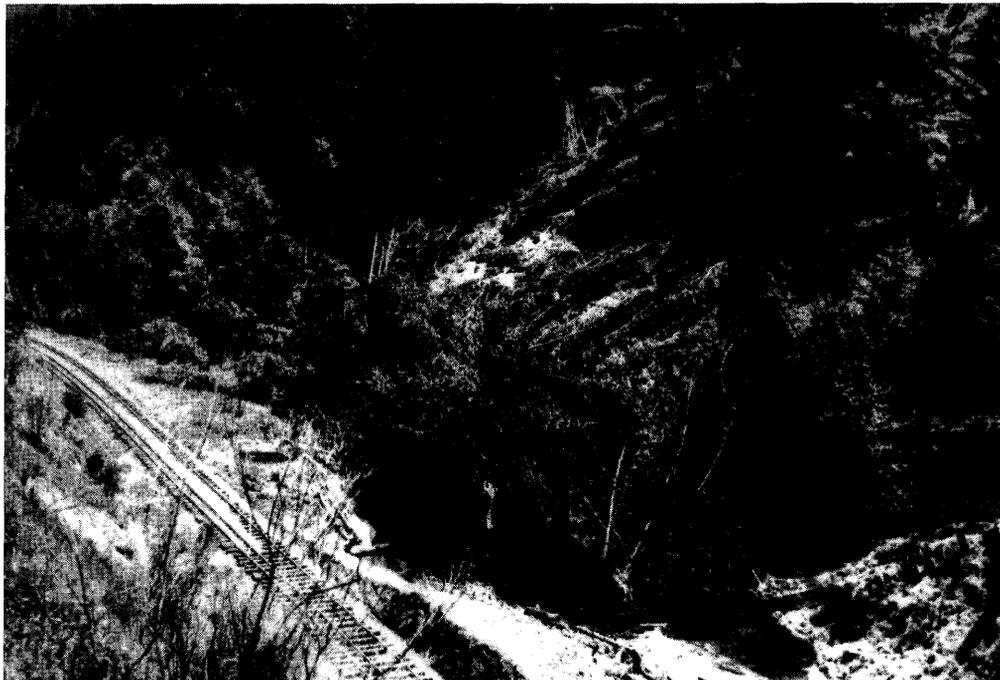
Figure 2.—Landslide that dammed Los Gatos Creek, Santa Clara County, Calif. (fig. 1), as a result of 1906 San Francisco earthquake. Photograph courtesy of J.C. Branner Papers, Stanford University Archives.

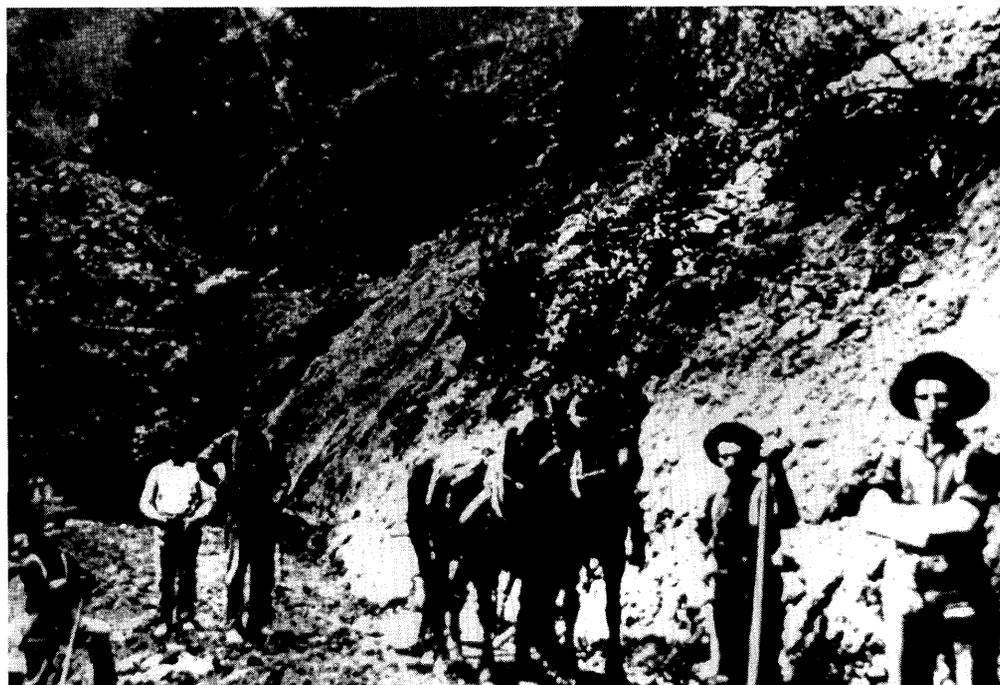
Figure 3.—Workers removing toe of earthquake-induced landslide that dammed Hinckley Creek at Olive Springs sawmill in 1906 (see fig. 4 for location). Landslide killed nine workers at Olive Springs and formed a 20-m-deep impoundment where it dammed the creek. Photograph courtesy of California Department of Parks and Recreation.

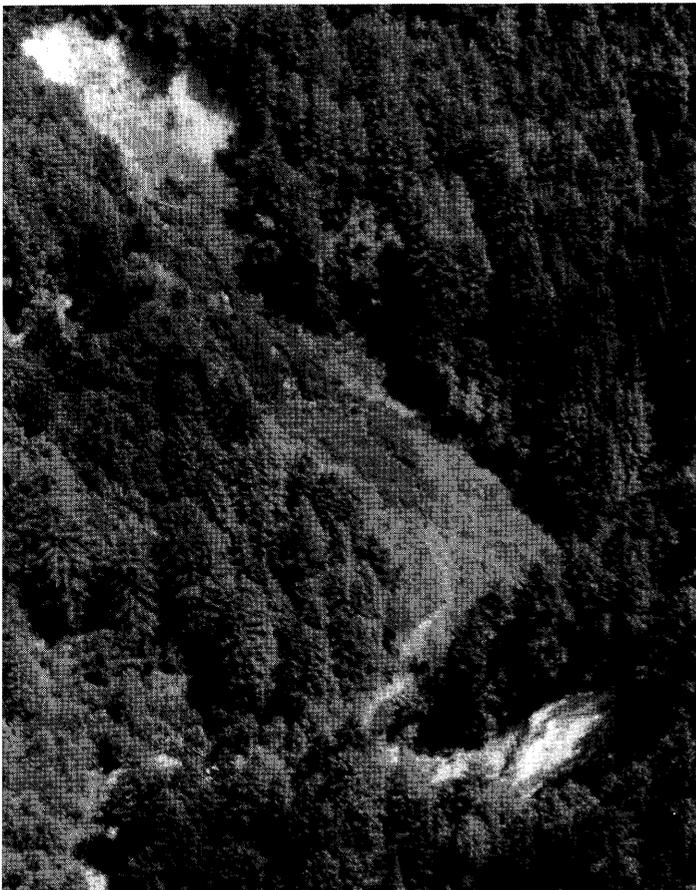
Figure 6.—Toe of this 50,000-m³-volume earthquake-induced slide dammed West Branch Soquel Creek (see fig. 4 for location). Dam failed in December 1989, 61 days after 1989 Loma Prieta earthquake. Photograph taken in May 1992.

and mudstone at the site of a spring on the valley wall. Initial failure probably occurred in a weak layer of silt or clay in the Purisima Formation. The slide crosses the Zayante fault (Clark and others, 1989) on a slope averaging 26° , and its toe lies on rocks of the Eocene Butano sandstone in the valley bottom. The existing, nearly vertical headscarp in Purisima Formation rocks is 12 m high and 30 m long and has a spring issuing from its base. As indicated by Clark and others, the strike of the Purisima Formation beds at this site approximately parallels West Branch Soquel Creek, and the dip is back into the valley wall. Thus, this slide was not a dip-slope failure; instead, failure probably was related to the low shear strength of mudstone and siltstone that had been saturated locally by ground water from the spring.

Although this slide is much larger than the others discussed here, it barely crossed the creek, forming only a low dam and a resulting small impoundment. The minimum crest height of the blockage formed by the toe of the slide was 4 m. The original landslide dam was 10 m long (perpendicular to the stream) by 55 m wide (parallel to the stream); it impounded an $1,800\text{-m}^3$ -volume lake. The dam was composed of a heterogeneous, fairly impervious mass of clay, silt, sand, and small blocks of sandstone. On December 17, 1989, 61 days after the earthquake, the landslide dam failed, causing minor downstream flooding and deposition of $5,000\text{ m}^3$ of sediment in the streambed.

On the day after the earthquake, the landslide dam on West Branch Soquel Creek (fig. 6) was noted from the air (Capt. Dennis Smith, Santa Cruz County Sheriff's Office, oral commun., 1989). However, because this landslide dam was in an unpopulated, untraveled area and its impoundment was small, no mitigative measures were undertaken.

Then, 61 days after the earthquake, the dam failed, causing minor downstream flooding in the channels of West Branch Soquel Creek and Soquel Creek. Channel capacity was not exceeded; thus, no damage occurred as a result of flooding.

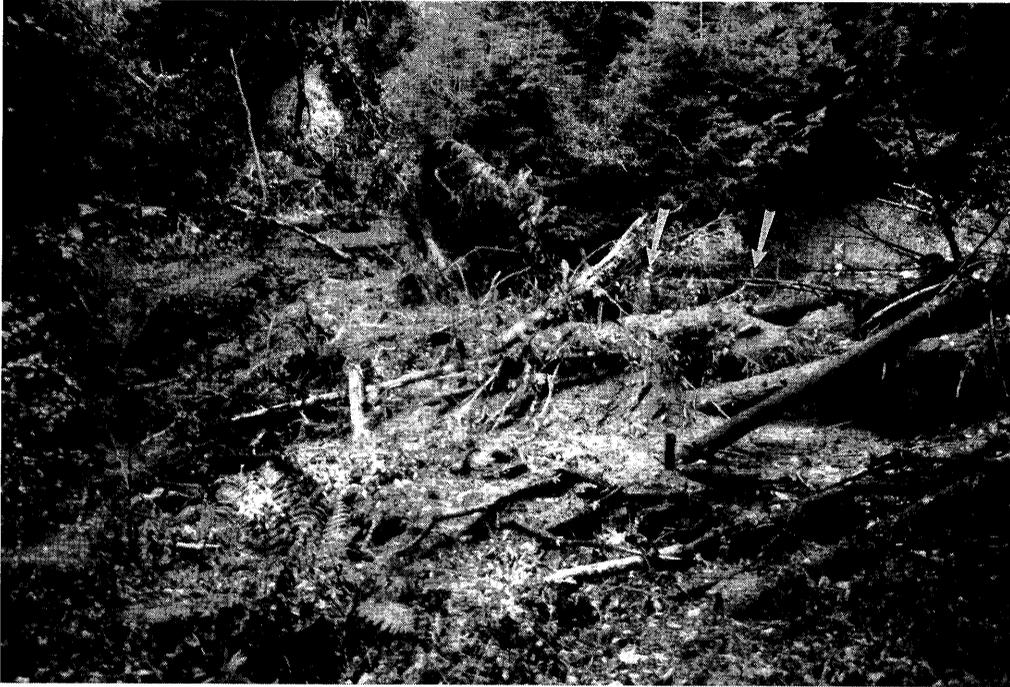
The 1989 Hinckley Creek rock fall occurred near Olive Springs (fig. 4) on a 60° slope in weathered sandstone of the Purisima Formation, 60 m high, about 800 m downstream from the 1906 Hinckley Creek "Sawmill slide" (table 1). As shown by Clark and others (1989), the Purisima Formation strikes nearly normal to Hinckley Creek at this site and dips about 20° upstream; thus, the attitude of the formation had little influence on the 1989 slope failure. Weathering and joints at the surface of the sandstone probably were the important elements in failure of the slope. The 1989 rock fall had an estimated volume of $1,600\text{ m}^3$, consisting mainly of broken blocks of soft sandstone that disintegrated to silt and fine sand in the valley bottom. This broken-up sandstone, combined with timber debris, dammed Hinckley Creek to a depth of 4 m, impounding a lake 160 m long with an estimated volume of $3,500\text{ m}^3$. The blockage, which was 20 m long (normal to the creek) by 15 m wide (parallel to the creek), breached in February 1992 after heavy rain.

Figure 8.—Rock-fall and timber debris forming dam on Hinckley Creek (see fig. 4 for location). Arrows denote downstream end of impoundment. Photograph taken on October 25, 1989, 1 week after 1989 Loma Prieta earthquake.

The 4-m-high Hinckley Creek landslide dam was naturally reinforced by timber debris (logs and limbs) within the landslide, and so, because it was thought to be stable, it was not removed, as both the Corralitos Creek landslide dams were. During heavy rain in February 1992, however, the soil matrix of the dam was removed by erosion, resulting in rapid drainage of the impoundment (fig. 9) and minor downstream flooding that did not exceed channel capacity. Most of the interwoven logs, branches, and brush that had held the dam together remained in place (fig. 10).

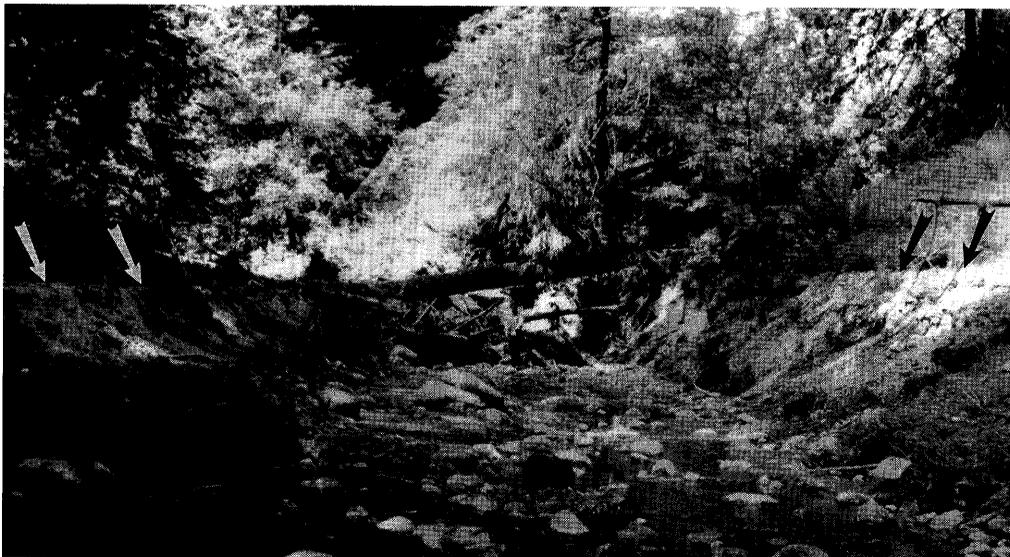
Figure 9.—Downstream view of remnants of 1989 Hinckley Creek landslide dam after it had failed in February 1992. Arrows denote previous shoreline of now-drained 4-m-deep impoundment. Photograph taken May 1992.

When the soil matrix of the rest of the Hinckley Creek landslide dam eroded away in February 1992, the effect on downstream water quality was similar to that from the failure of the landslide dam on West Branch Soquel Creek, except that only about 1,000 m³ of sediment was washed downstream. The coarse materials were deposited within 200 m of the dam, but a significant amount of silt and fine sand was carried as far as the confluence of Hinckley and Soquel Creeks, 1 km downstream (fig. 4).

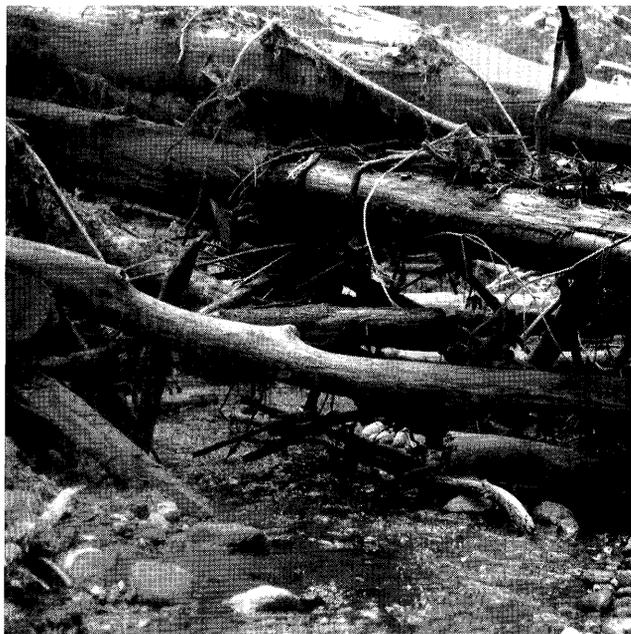
Figure 10.—Closeup of log/brush remnant of 1989 Hinckley Creek landslide dam after soil matrix of dam had eroded away in February 1992. Photograph taken May 1992.
