The Loma Prieta, California, Earthquake of October 17, 1989—Landslides

STRONG GROUND MOTION AND GROUND FAILURE
THOMAS L. HOLZER, *Coordinator*

U.S. GEOLOGICAL SURVEY PROFESSIONAL PAPER 1551-C

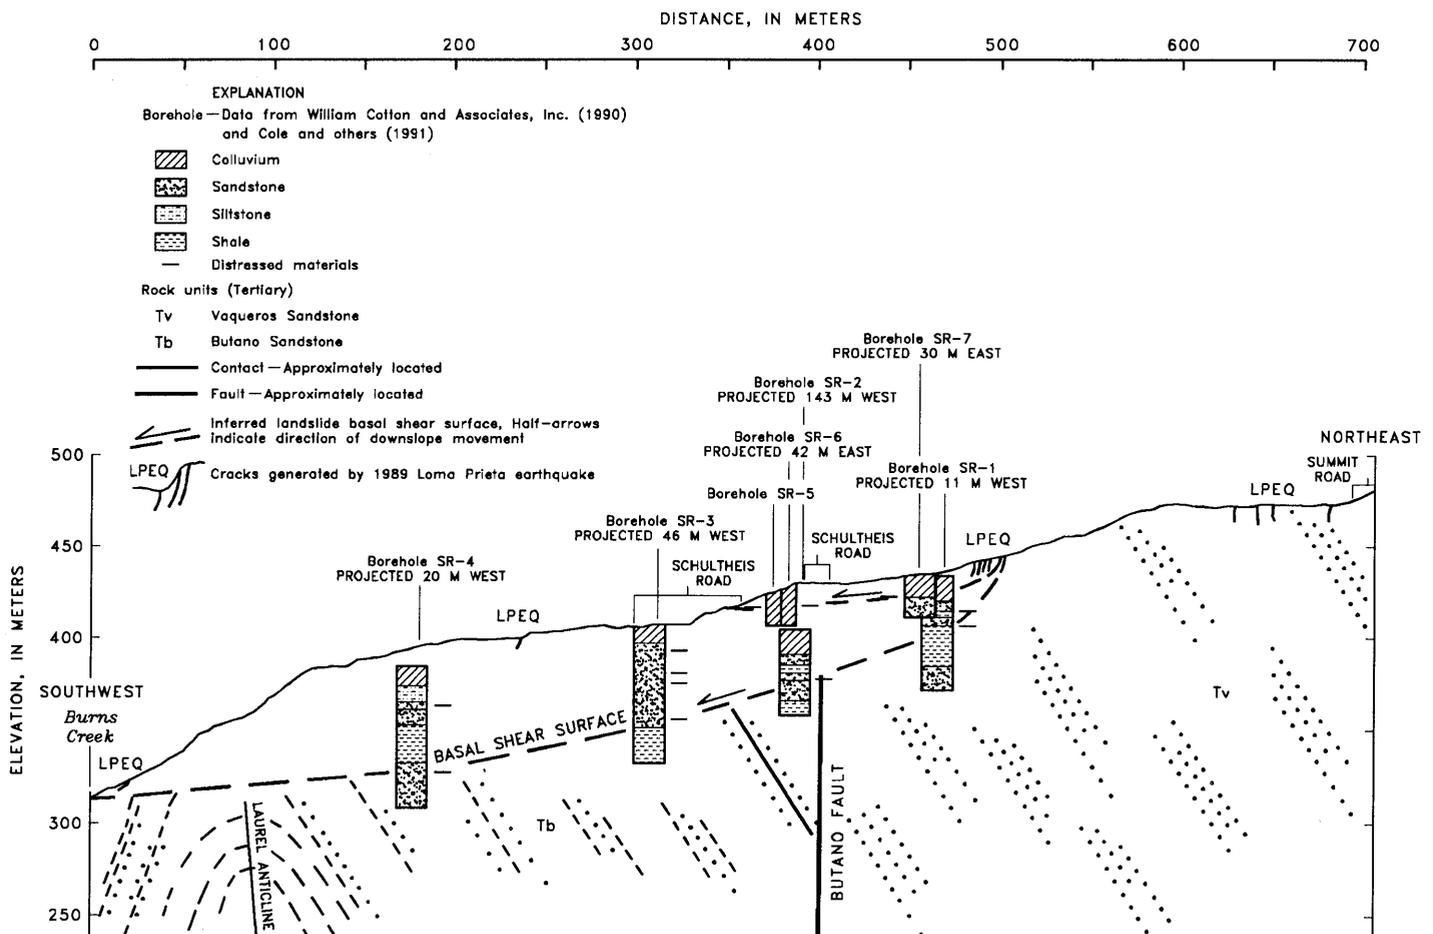
Figure 11.—Geologic cross section through Upper Schultheis Road landslide (fig. 9B). Locations of landslide basal shear surfaces inferred from borehole data of William Cotton and Associates, Inc. (1990), and Cole and others (1991).

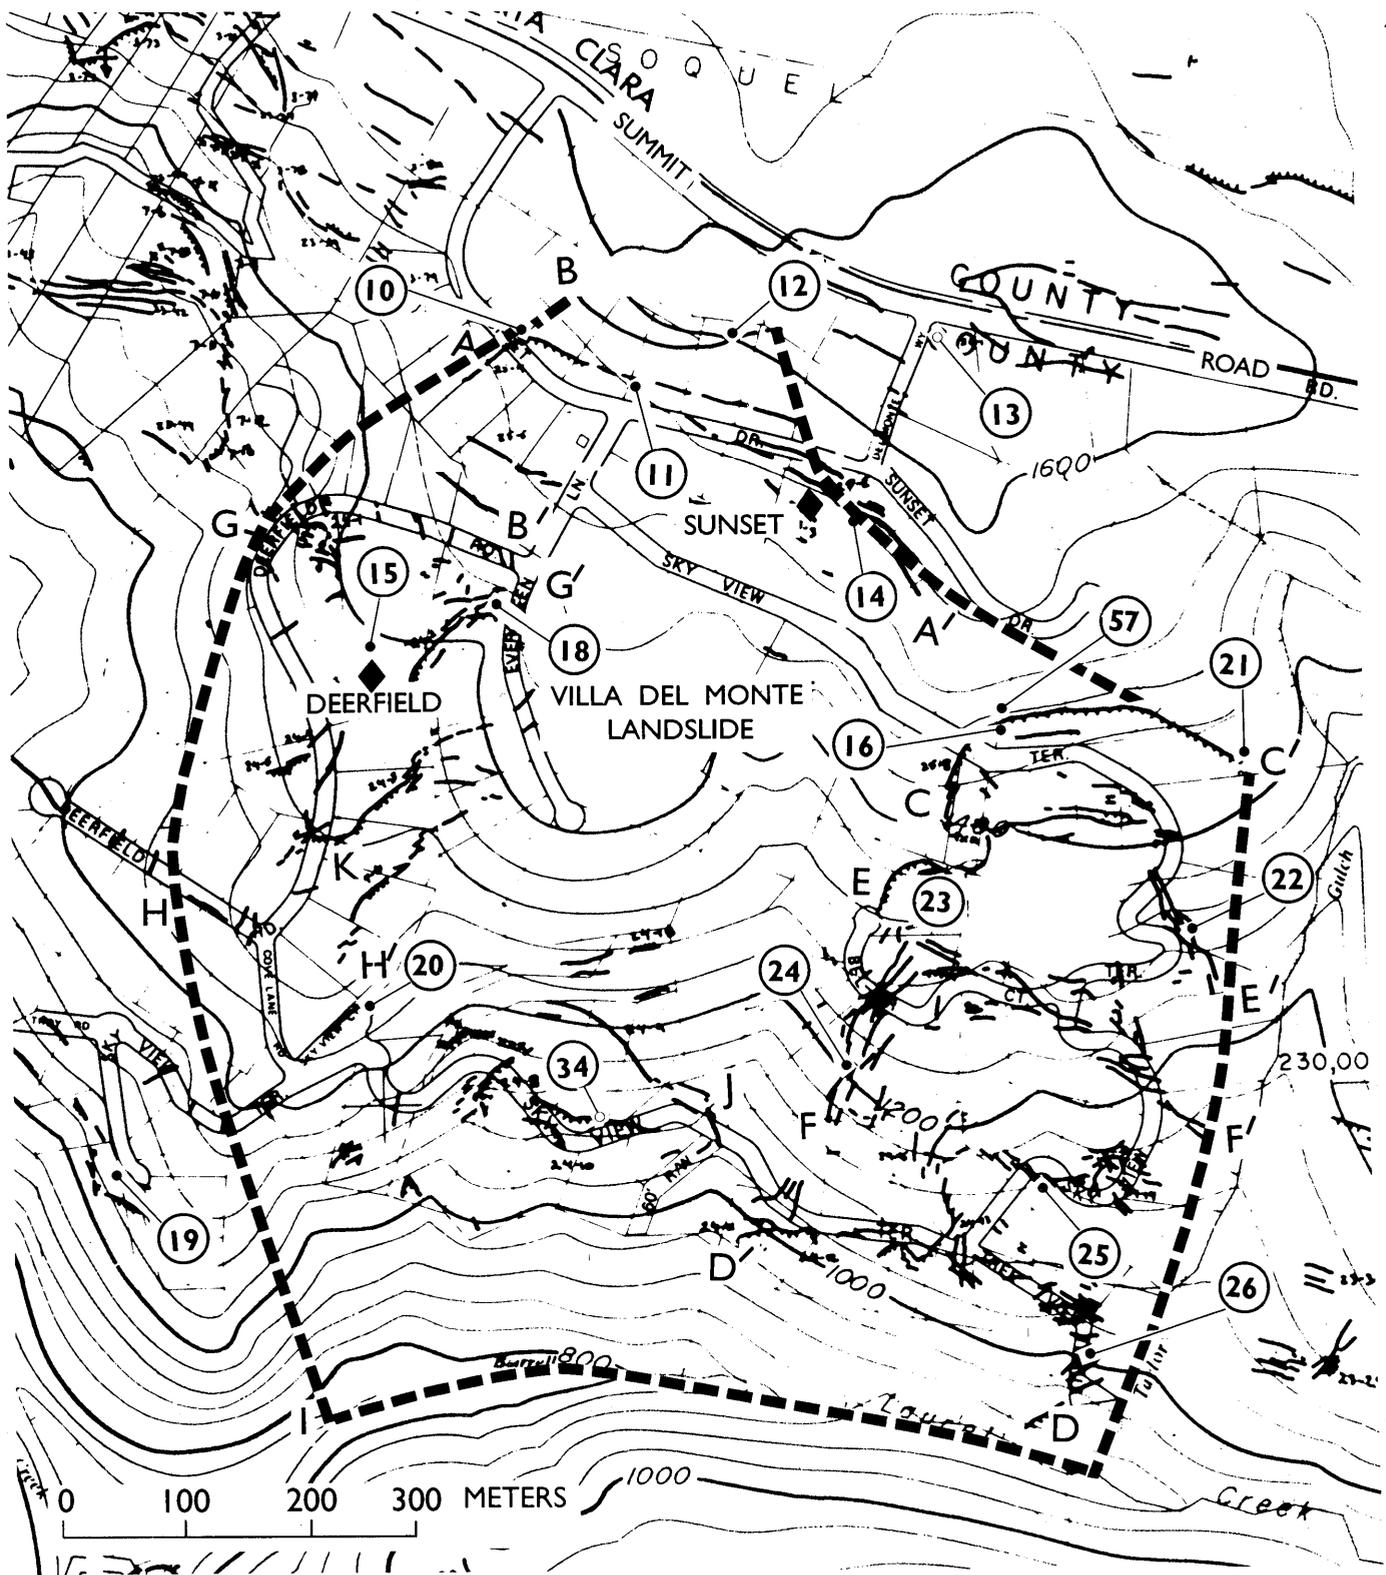
The ground cracks and scarps in the Sunset Drive area (figs. 12, 13) extend approximately 420 m across the slope (leg A-A', fig. 12A) and 210 m down the slope (leg B-B', fig. 12A). For parts of their lengths, these cracks and scarps cross a gentle slope downslope from a 3- to 5-m-high bedrock scarp composed of intensely fractured sandstone. A few northwest-striking ground cracks in this area are subparallel to local faults (see pl. 3), indicating that their

formation was controlled by bedrock structures. Displacements measured across individual cracks and scarps were from 8 to 53 cm, downslope toward the southwest and southeast.

Six wells in this area (wells 71, 74, 75, 82, 83, 88, fig. 12B) were reportedly damaged. The damage to wells 74 and 75, which involved collapsed casings at 5- and 23-m depth (Brumbaugh, 1990), suggests that the ground crack immediately upslope from them marks the upslope boundary of the landslide.

The upper Skyview Terrace-Bel Air Court area, in the eastern part of the Villa Del Monte neighborhood, is the second zone of concentrated and pervasive ground cracking (figs. 12, 14). The cracks and scarps in this area extend approximately 300 m across the slope and 670 m downslope, from immediately above upper Skyview Terrace (leg C-C', fig. 12A) to Laurel Creek (leg D-D', fig.

12A). At the upslope margin of this zone is a scarp (leg C-C', fig. 12A), 240 m long, that is arcuate and concave downslope, toward the south. The ground cracks between upper Skyview Terrace and Bel Air Court (leg E-E', fig. 12A), along Bel Air Court and middle Skyview Terrace (leg F-F', fig. 12A), and along Tree View Trail and lower Skyview Terrace (leg D-D', fig. 12A) also form arcuate-downslope patterns subparallel to the upper scarp zone. In addition, the area contains several small pressure ridges.

In the western part of the Villa Del Monte area, another major zone of ground cracks, scarps, and pressure ridges occurs along Deerfield Road and between Deerfield Road and Evergreen Lane (area G-G'-H-H', fig. 12A). This zone extends approximately 240 m from west to east and 370 m downslope (fig. 12). The cracks and scarps (fig. 15) in the zone strike predominantly northeast, oblique to the main structural elements in the bedrock (see pl. 3). Displacement measurements show predominantly southeastward to locally southwestward movement of 5 to 41 cm. Both the strike of the main ground cracks and the predominantly southeastward direction of displacements indicate that this zone forms the west (or right) flank of the landslide.

Figure 12.—Villa Del Monte landslide, showing boundary of landslide and locations of (A) surficial features, surface-monitoring stations, and localities discussed in text and of (B) boreholes (from William Cotton and Associates, 1990, and Cole and others, 1991), cross section in figure 16, and water wells (from Brumbaugh, 1990). Ground cracks and compressional features from Spittler and Harp (1990); landslide boundaries modi-

Air Court area (leg C'-D, fig. 12A). Thus, the overall width of the landslide is 870 m, and its surface area is about 68 ha. Displacements measured across individual ground cracks and scarps throughout the Villa Del Monte landslide ranged from 5 to 107 cm; most local displacements ranged from 33 to 53 cm.

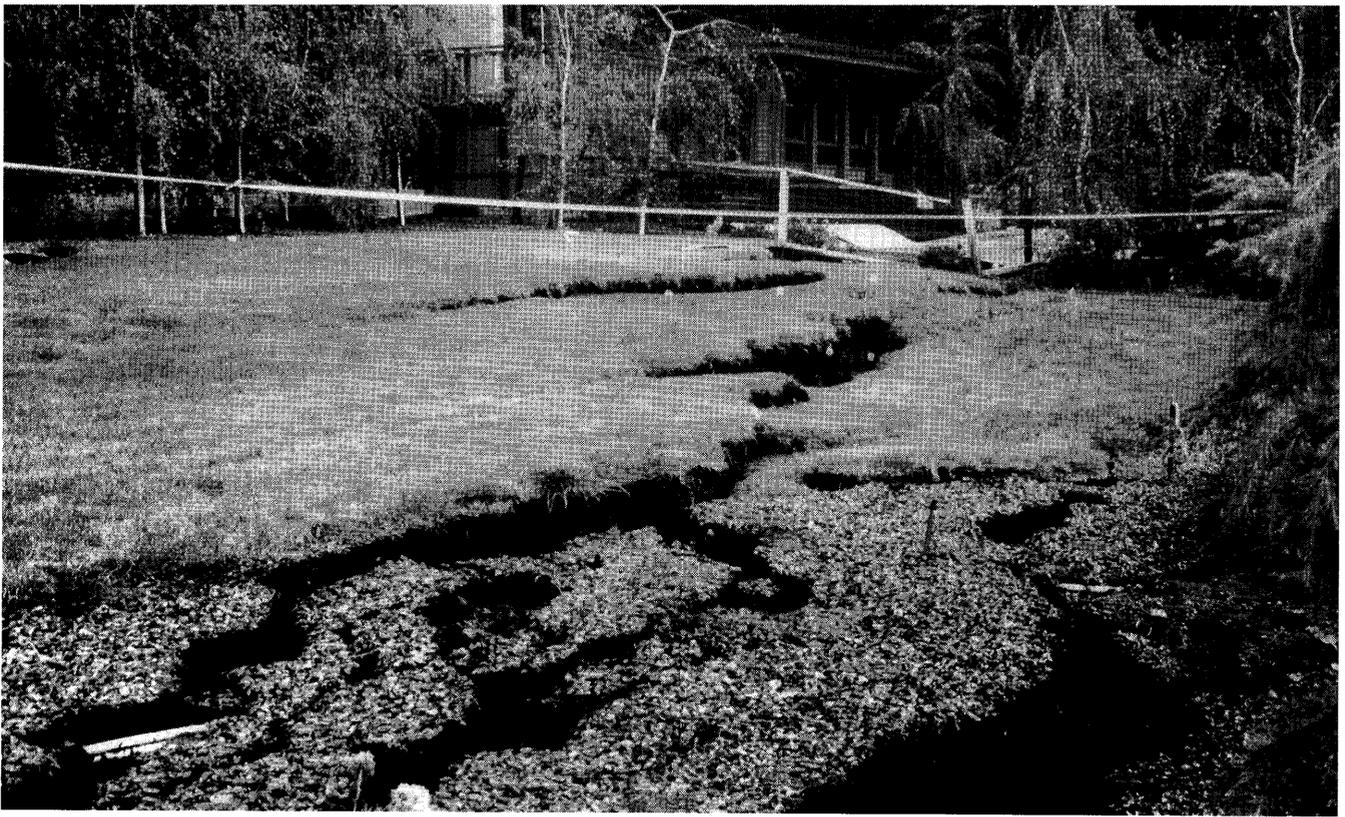
A

Figure 15.—Internal scarps and compressional features of Villa Del Monte landslide in Deerfield Road area. *A*, Internal scarps, which are part of a zone about 200 m long. View northeastward from just east of Deerfield Road (loc. K, fig. 12A). *B*, Internal ridge, consisting of compressed ground, marked by broken and buckled pavement. View northwestward from near east end of Deerfield Road (loc. *B'* on fig. 12A).

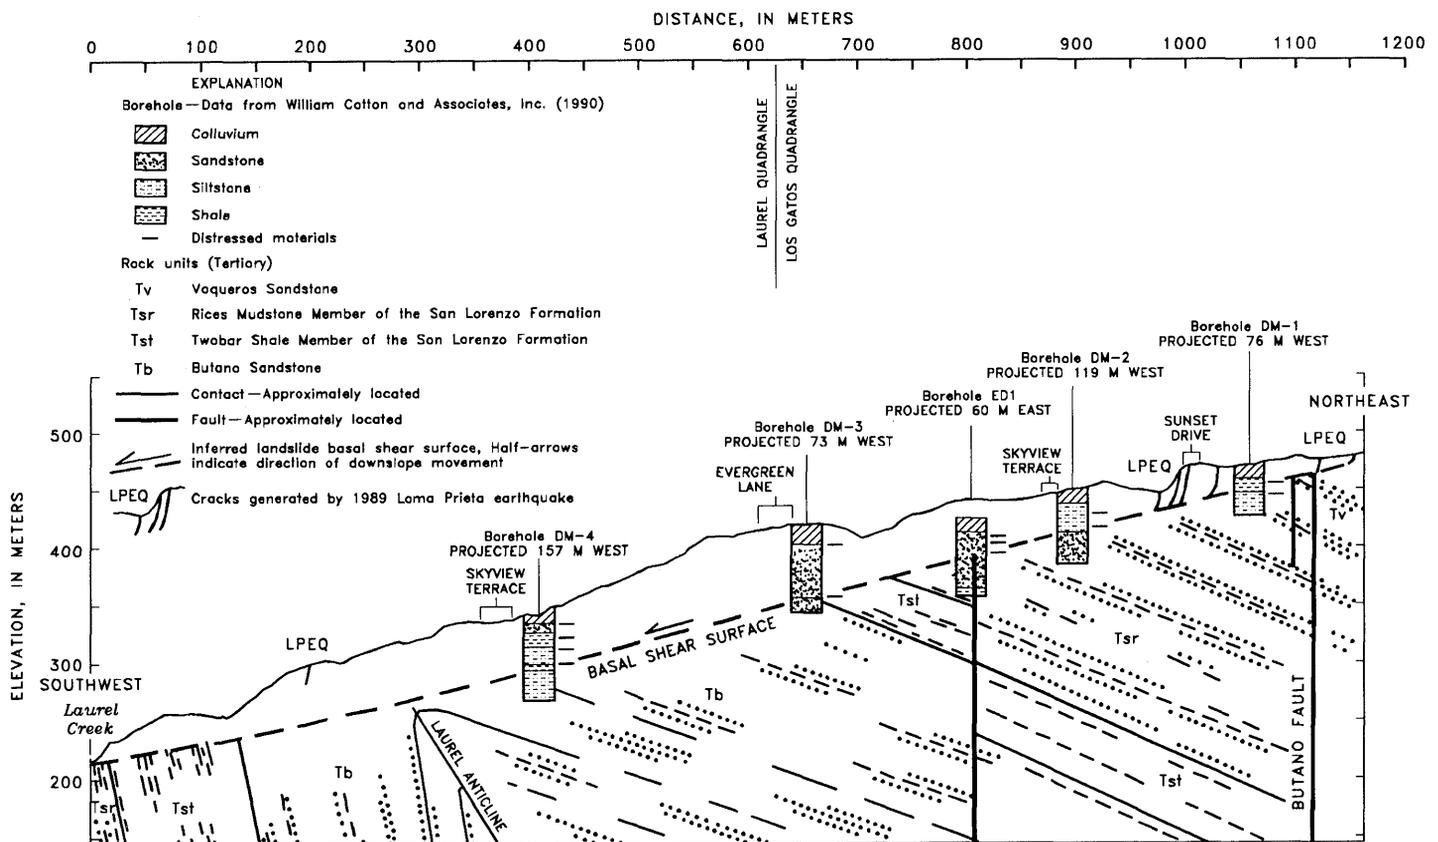
The soil, weathered rock, and bedrock contained approximately 45 intervals in the boreholes with indications of distressed materials—sheared, intensely fractured, or faulted rocks; very soft zones; crushed materials; intervals of collapsing or caving of the boreholes; or zones of lost circulation (fig. 16; William Cotton and Associates, Inc., 1990). These zones occurred in all rock types at depths from near the surface to near the maximum depth of drilling. However, the small diameters, discontinuous sampling, and absence of geophysical logging of the boreholes made identification of landslide shear surfaces within the boreholes uncertain. The numerous zones with indications of disturbance and reports of water well damage at various depths (fig. 12B) indicate that localized internal shearing occurred at several depths during landslide movement. An inferred deep basal shear surface, which is compatible with the drilling and surface data, is shown in figure 16. If the average landslide thickness is assumed to be half of the maximum thickness shown on this cross section, the landslide volume is $27 \times 10^6 \text{ m}^3$.

Figure 16.—Geologic cross section through Villa Del Monte landslide (see fig. 12B for location). Basal shear surface inferred from borehole data of William Cotton and Associates, Inc. (1990). See figure 11 for explanation.

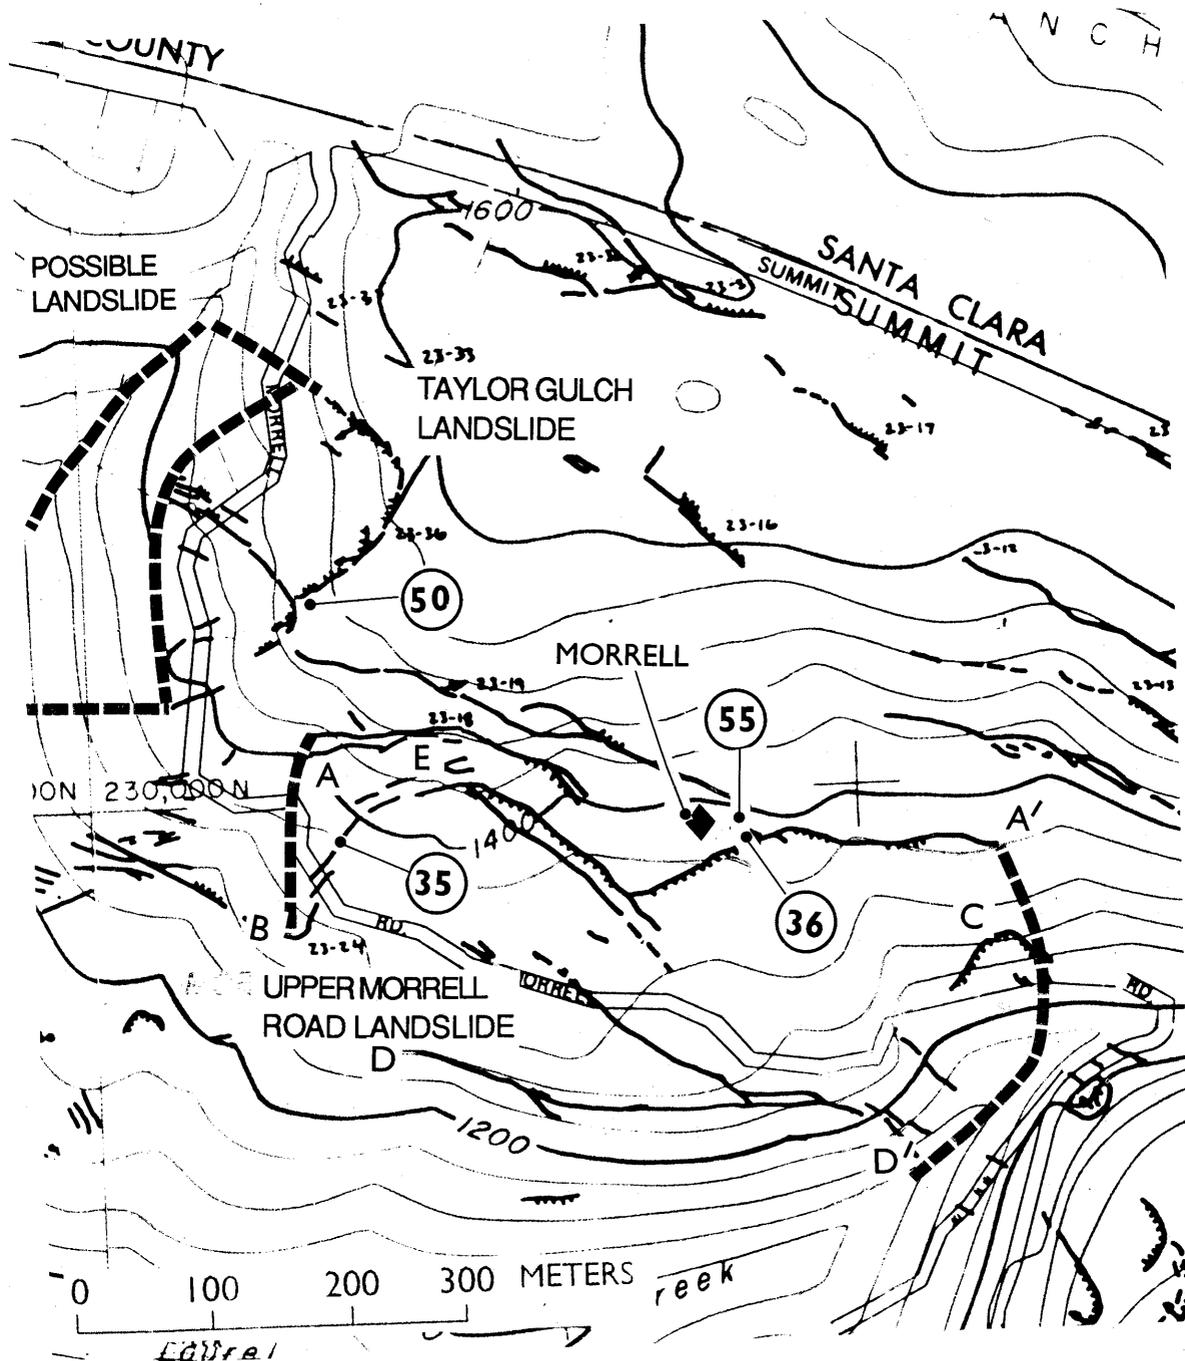
The Upper Morrell Road landslide is on the south flank of Summit Ridge east of Taylor Gulch (area 7, pl. 3). The main scarp of the landslide is made up of two adjoining zones of ground cracks and scarps, each of which is arcuate, concave downslope in plan view (leg A-A', fig. 17). Together, these zones extend approximately 550 m across the slope. The orientation of ground cracks in these zones

and the relation of these cracks to other northwest-striking cracks nearby (leg B-B', fig. 17) suggest significant control by bedrock structures. Displacement measurements across the main zones of cracks (fig. 18) indicate downslope movement of as much as 2.01 m. Southeast of the main scarp, a shorter scarp is inferred to mark part of the east flank of the landslide (loc. C, fig. 17).

Figure 17.—Taylor Gulch and Upper Morrell Road landslides. Ground cracks and compressional features from Spittler and Harp (1990); landslide boundaries from Keefer (1991). See figure 7 for explanation and figure 12 for base-map information.

downslope from the main scarp. A zone of fractures and grabens along the crest of this bulge is evidence of local extension of the ground that accompanied upward bulging of the landslide toe. Between the crown cracks and the toe, the landslide encompasses an area of approximately 14 ha.

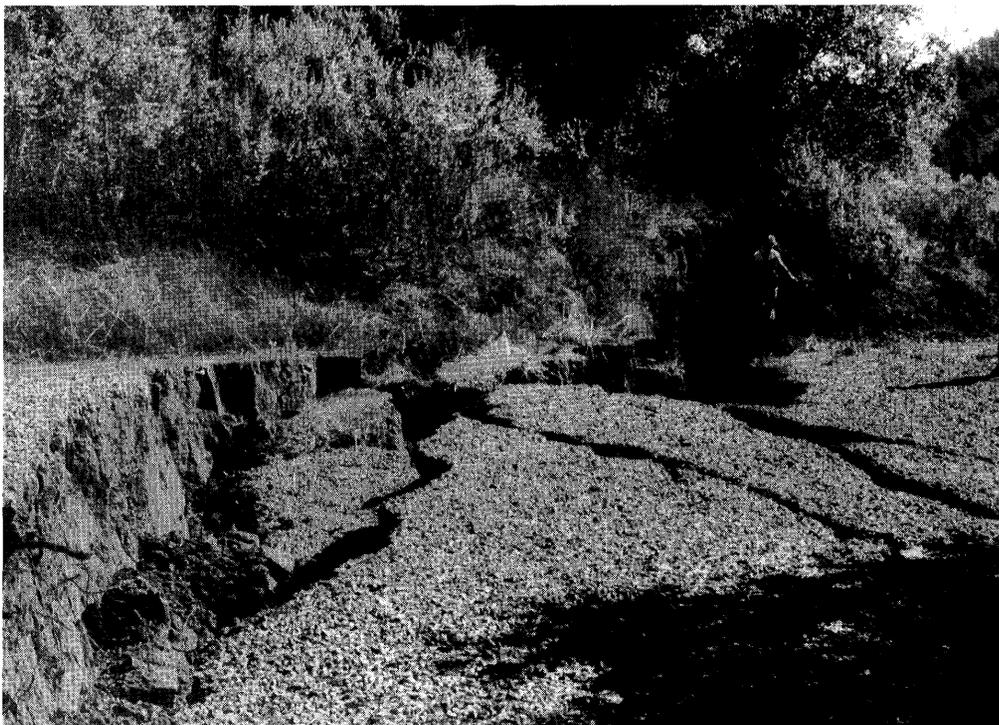
Figure 18.—Part of main scarp of Upper Morrell Road landslide where scarp crosses gravel road. View northeastward from just east of Morrell Road (loc. E, fig. 17).

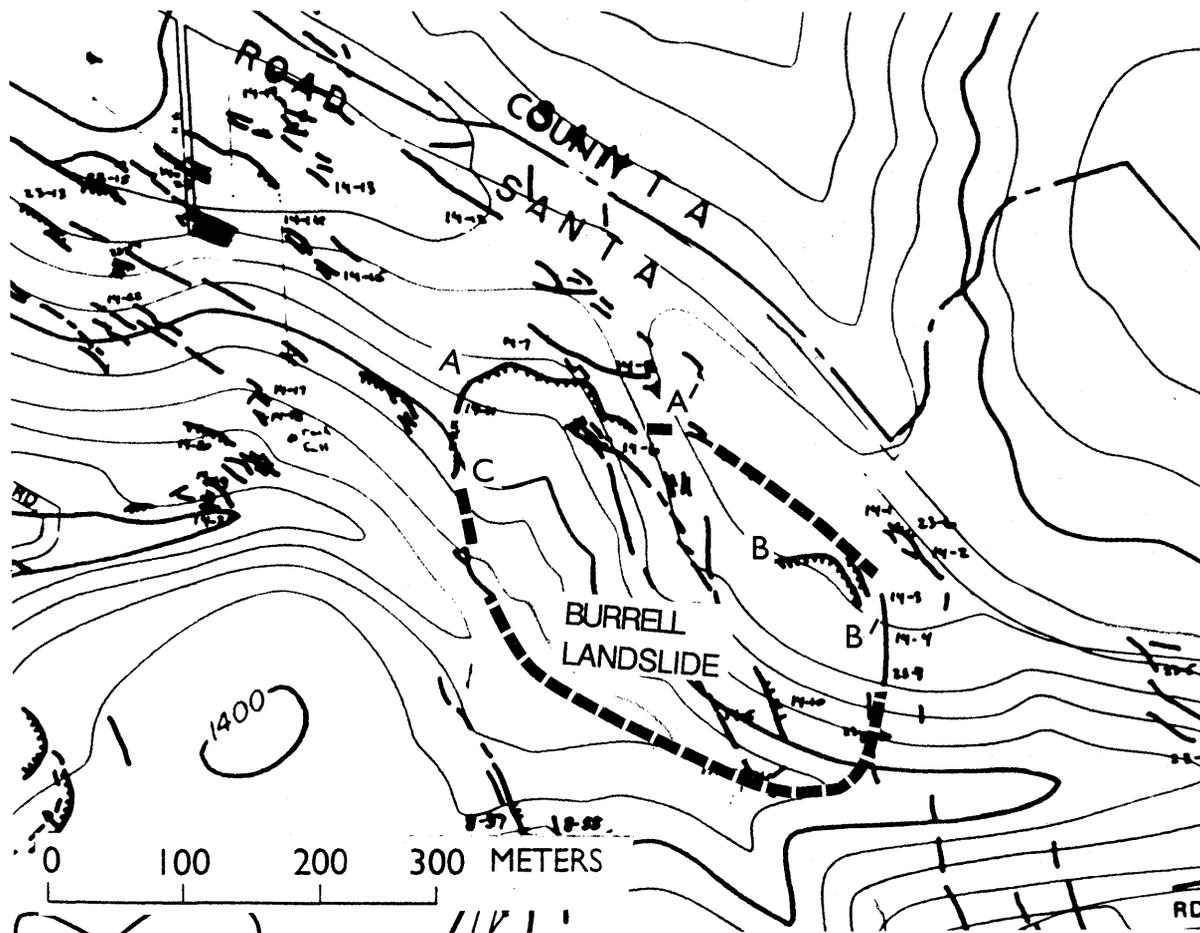
of two landslide blocks (legs A-A', B-B', fig. 19) were differentiated from other ground cracks in the area on the basis of their arcuate forms, their location at the upslope margin of a gently sloping topographic bench, and the occurrence of a pressure ridge downslope from one of them, which partly delineates the landslide toe (loc. C, fig. 19). These two main scarps were separated by a zone of discontinuous cracks. The landslide is approximately 230 m long by 460 m wide and encompasses an area of about 9 ha. Downslope displacements measured across the main scarps were from 28 to 71 cm. The slope averages 15°–20°, and bedrock is the Butano Sandstone (see pl. 3), which dips east to northeast, oblique to the slope direction.

Figure 19.—Burrell landslide. Ground cracks and compressional features from Spittler and Harp (1990); landslide boundaries from Keefer (1991). Base from Towill, Inc., prepared using topography from U.S. Geological Survey Laurel, Calif., 7.5-minute quadrangle and culture from County of Santa Cruz planimetric base and interpretation of aerial photographs flown July 24, 1990. See figure 7 for explanation. Contour interval, 40 ft.

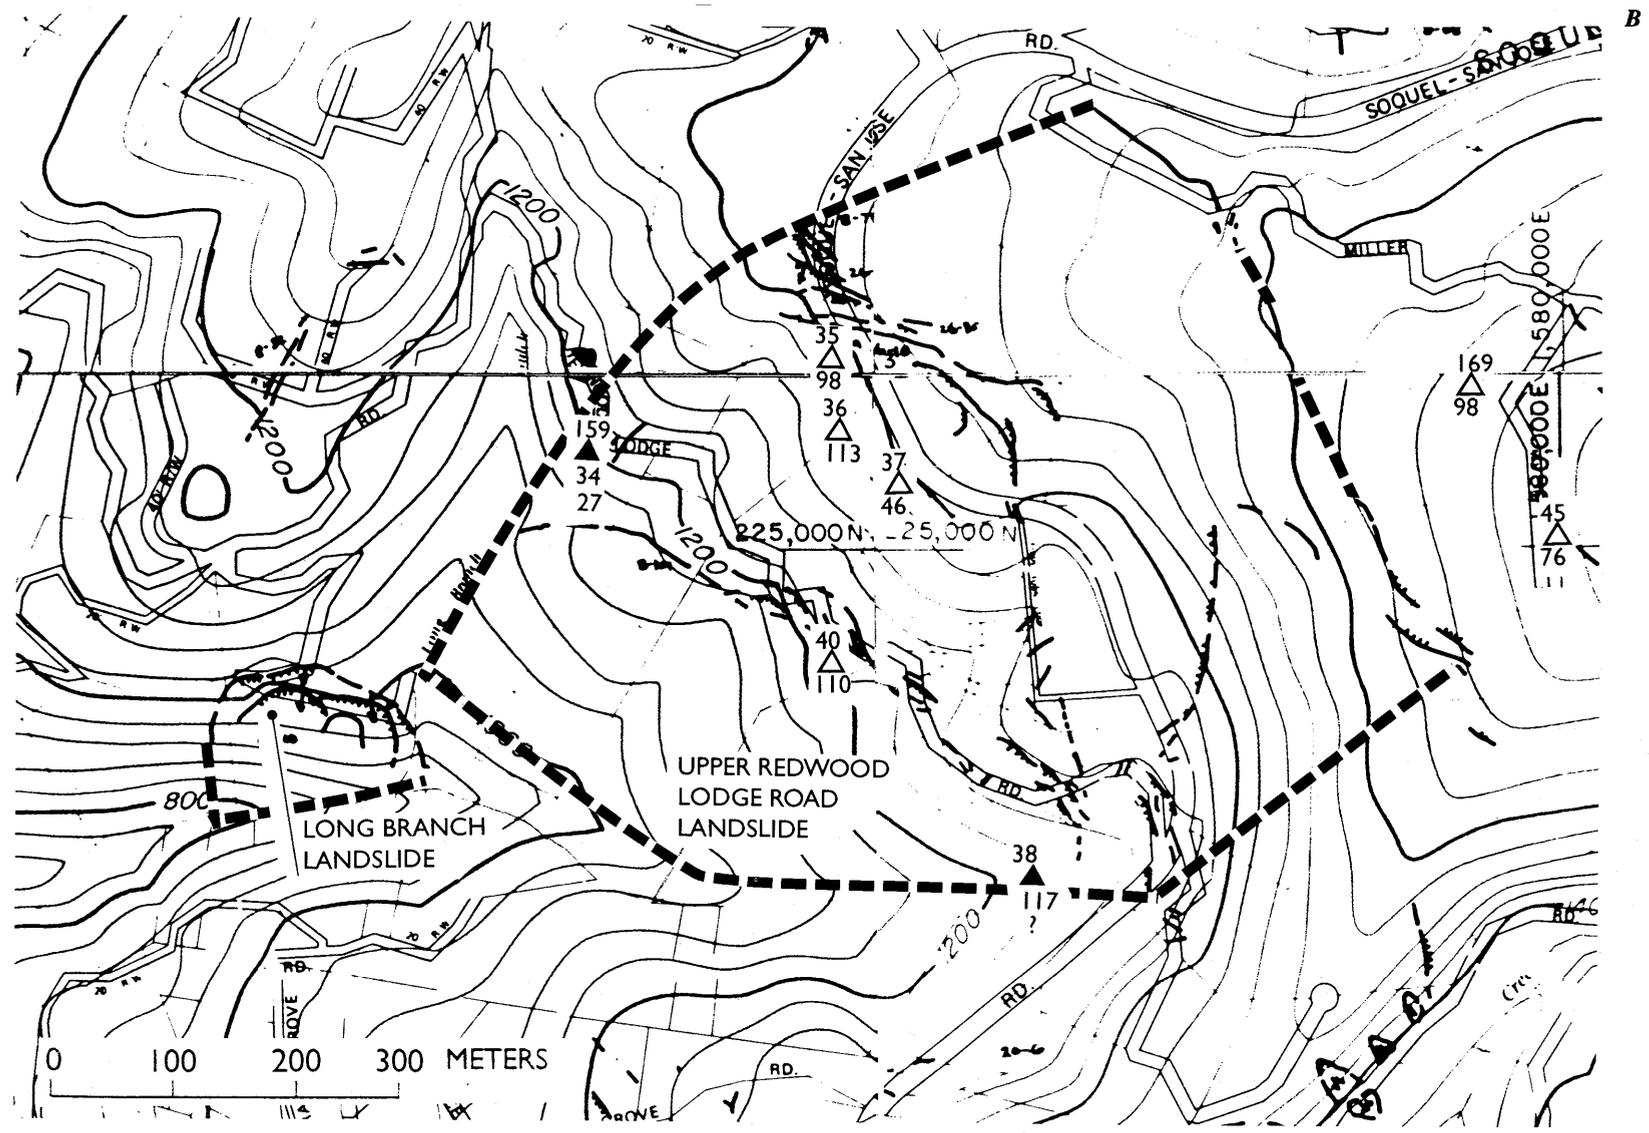
main scarp of the landslide is a series of discontinuous, straight to slightly arcuate cracks and scarps approximately 580 m long, that strikes about N. 30° W. (leg A-A', fig. 20A). The linearity and strike direction suggest that crack formation was controlled by bedrock structures (Keefer, 1991; Harp, this chapter). The most conspicuous ground cracks and scarps are in a nearly flat meadow, at the base of a steep stretch of slope; for part of their length, they are associated with a preexisting graben, about 30 m long, a few meters wide, and about 1 m deep. These relations indicate that the area is the head both of a large landslide that moved during the 1989 Loma Prieta earthquake and of a large preexisting landslide. Earthquake-induced displacements across the ground cracks and scarps were as great as 25 cm.

A second conspicuous zone of ground cracks and scarps crosses Soquel-San Jose Road ("Old San Jose Road") north of its intersection with Redwood Lodge Road (leg B-B', fig. 20A). This zone is arcuate and concave downslope in

cracks and scarps (fig. 20); the landslide is thus at least 640 m wide. The southwest (downslope) boundary is likewise not marked by any surface features, but the position and pattern of the westernmost cracks and scarps suggest that the landslide extends to the creek at the base of the slope (fig. 20). The landslide is thus about 820 m long and at least 37 ha in area. The slope through the landslide averages 15°–20°.

Two wells within the landslide were reportedly damaged by the earthquake—well 159, at a depth of 27 m and well 38, at undetermined depth—and four wells (35–37, 40, fig. 20B), with depths of 45 to 113 m, were reportedly undamaged (Brumbaugh, 1990). The two damaged wells are both located near the margins of the landslide. The four reportedly undamaged wells are farther from these margins, and the absence of reported damage could indicate either a basal shear surface locally deeper than the wells or local displacements too small to cause damage.

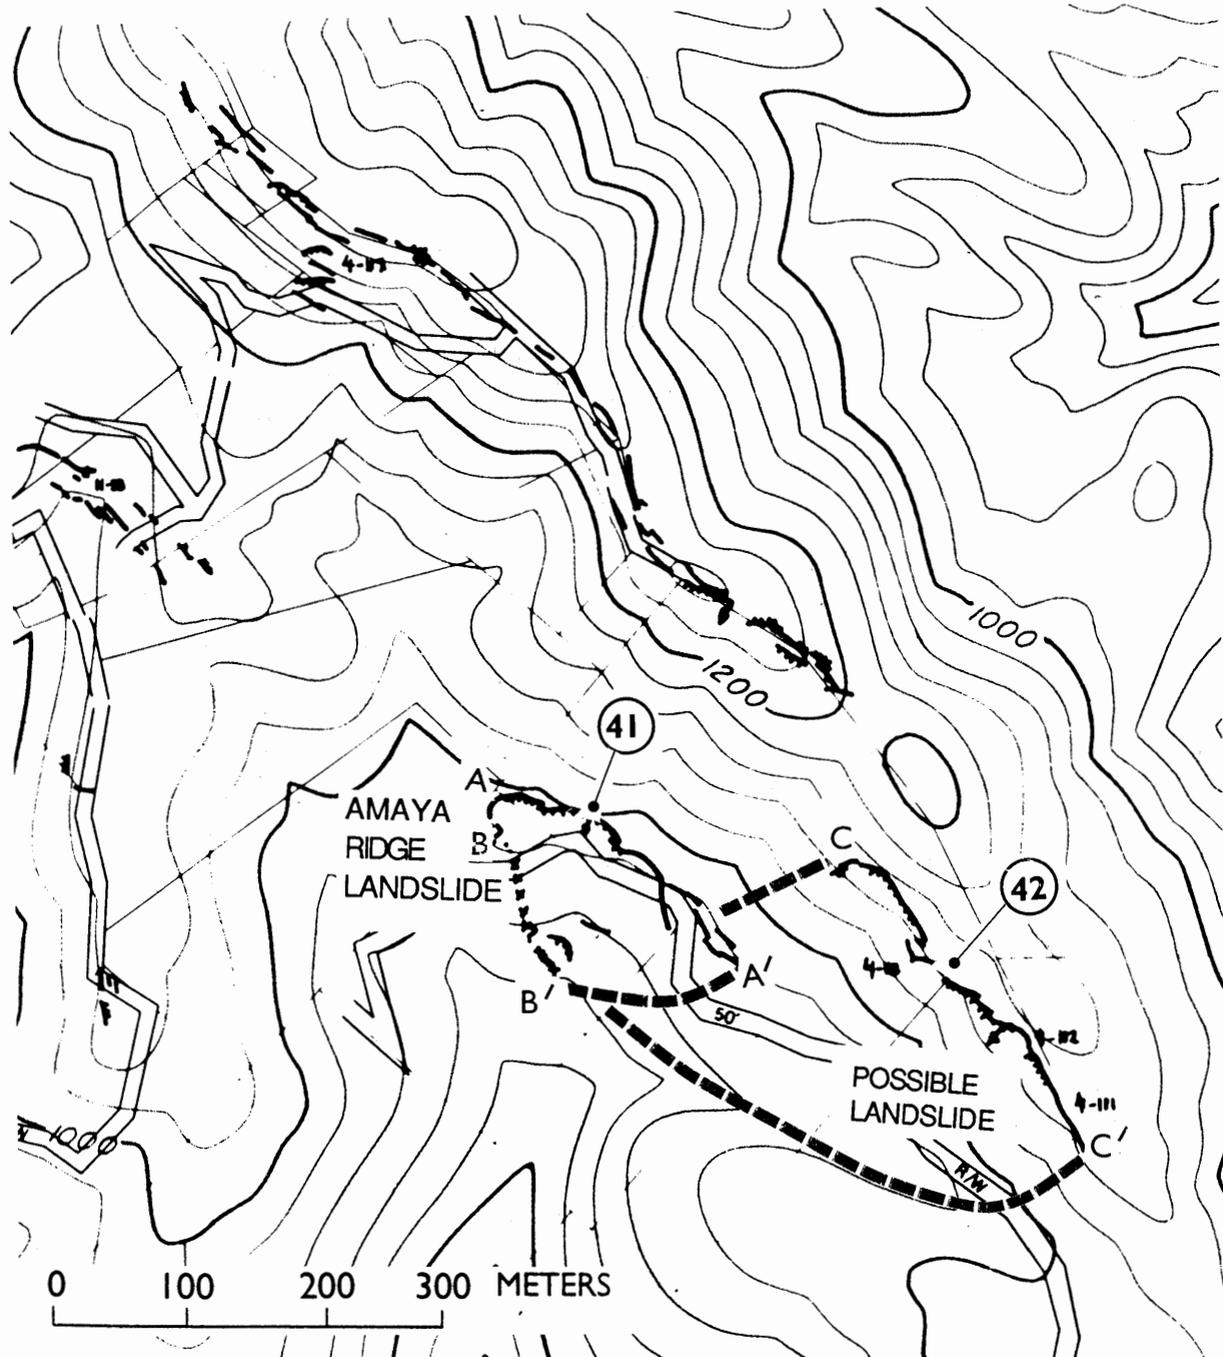
The Amaya Ridge landslide is on the southwest flank of Amaya Ridge, in the southern part of the study area (area 13, pl. 3). Two sets of ground cracks and associated features are present (fig. 21). The northwestern set consists of a relatively continuous, arcuate zone of ground cracks that are concave downslope in plan view (leg A–A', fig. 21), and a nearly straight compression feature farther downslope (leg B–B', fig. 21). These features are interpreted to be, respectively, the main scarp and toe of a landslide, approximately 120 m long, 240 m wide, and 1.6 ha in area. Measurements across the main scarp indicated local downslope displacements of 8 to 100 cm or more.

southwest. The area between this set of ground cracks and scarps and the base of the slope is 4.5 ha.

Figure 21.—Amaya Ridge landslide. Ground cracks and compressional features from Spittler and Harp (1990); landslide boundaries from Keefer (1991). See figure 7 for explanation and figure 19 for base-map information.

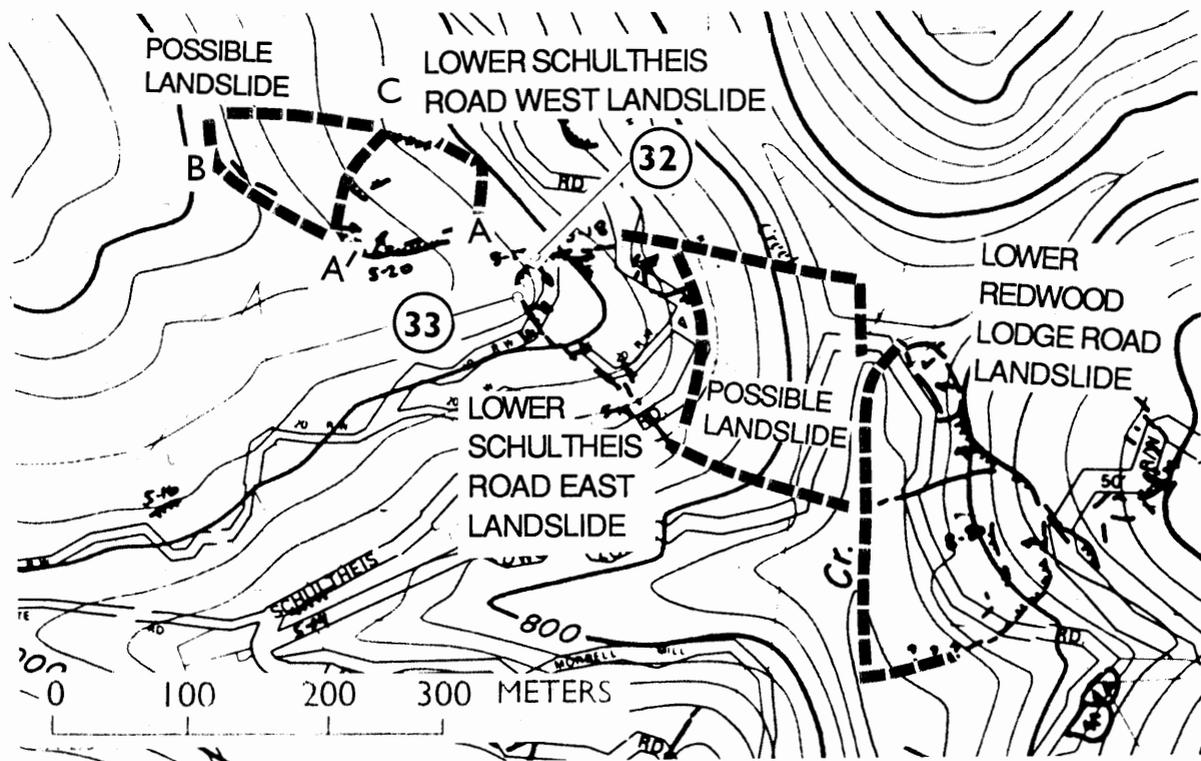
The Lower Schultheis Road West landslide is near Laurel, on a short ridge immediately south of Summit Ridge (area 18, pl. 3). The main scarp of the landslide is a 90-m-long series of slightly arcuate cracks and a graben (leg A–A', fig. 22). For part of its length, this main scarp is south of the ridge crest (fig. 23), and so part of the ridge crest is involved in the landslide, having been displaced to the north. Measurements along the scarp showed 30 to 65 cm of northward displacement.

A set of discontinuous ground cracks (leg A'–B, fig. 22) west of the scarp indicates that the landslide may extend an additional 90 m in that direction. These ground cracks also nearly parallel the bedrock strike (see pl. 3), suggesting that they and, by extension, the better developed main scarp to the east probably are structurally controlled. An elongate bulge in the ground about 110 m downslope from the main scarp marks part of the landslide toe (loc. C, fig. 22). The landslide defined by this bulge and the main scarp is at least 110 m long, 110 m wide, and 1.2 ha in area; if the landslide also encompasses the zone of ground cracking to the north and also extends there as far downslope as the bulge, its area may be as large as 2 ha. The slope through the landslide averages 15°–20°.

Figure 22.—Lower Redwood Lodge Road, Lower Schultheis Road East, and Lower Schultheis Road West landslides. Ground cracks and compressional features from Spittler and Harp (1990); landslide boundaries from Keefer and others (1991). See figure 7 for explanation and figure 19 for base-map information.

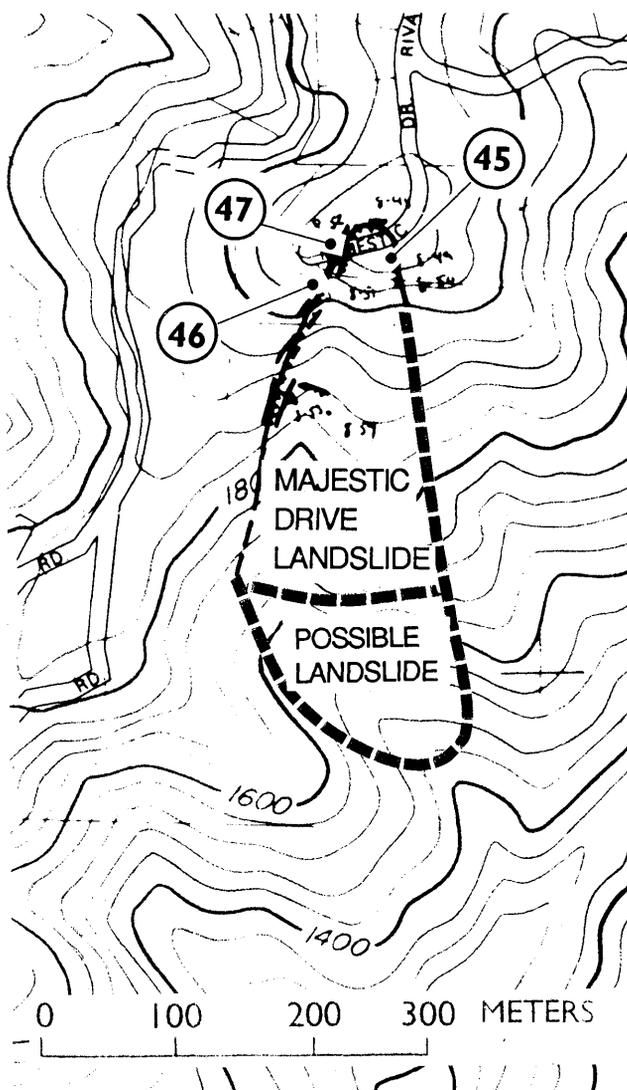
Figure 24.—Majestic Drive landslide. Ground cracks and compressional features from Spittler and Harp (1990); landslide boundaries from Keefer (1991). See figure 7 for explanation and base-map information.

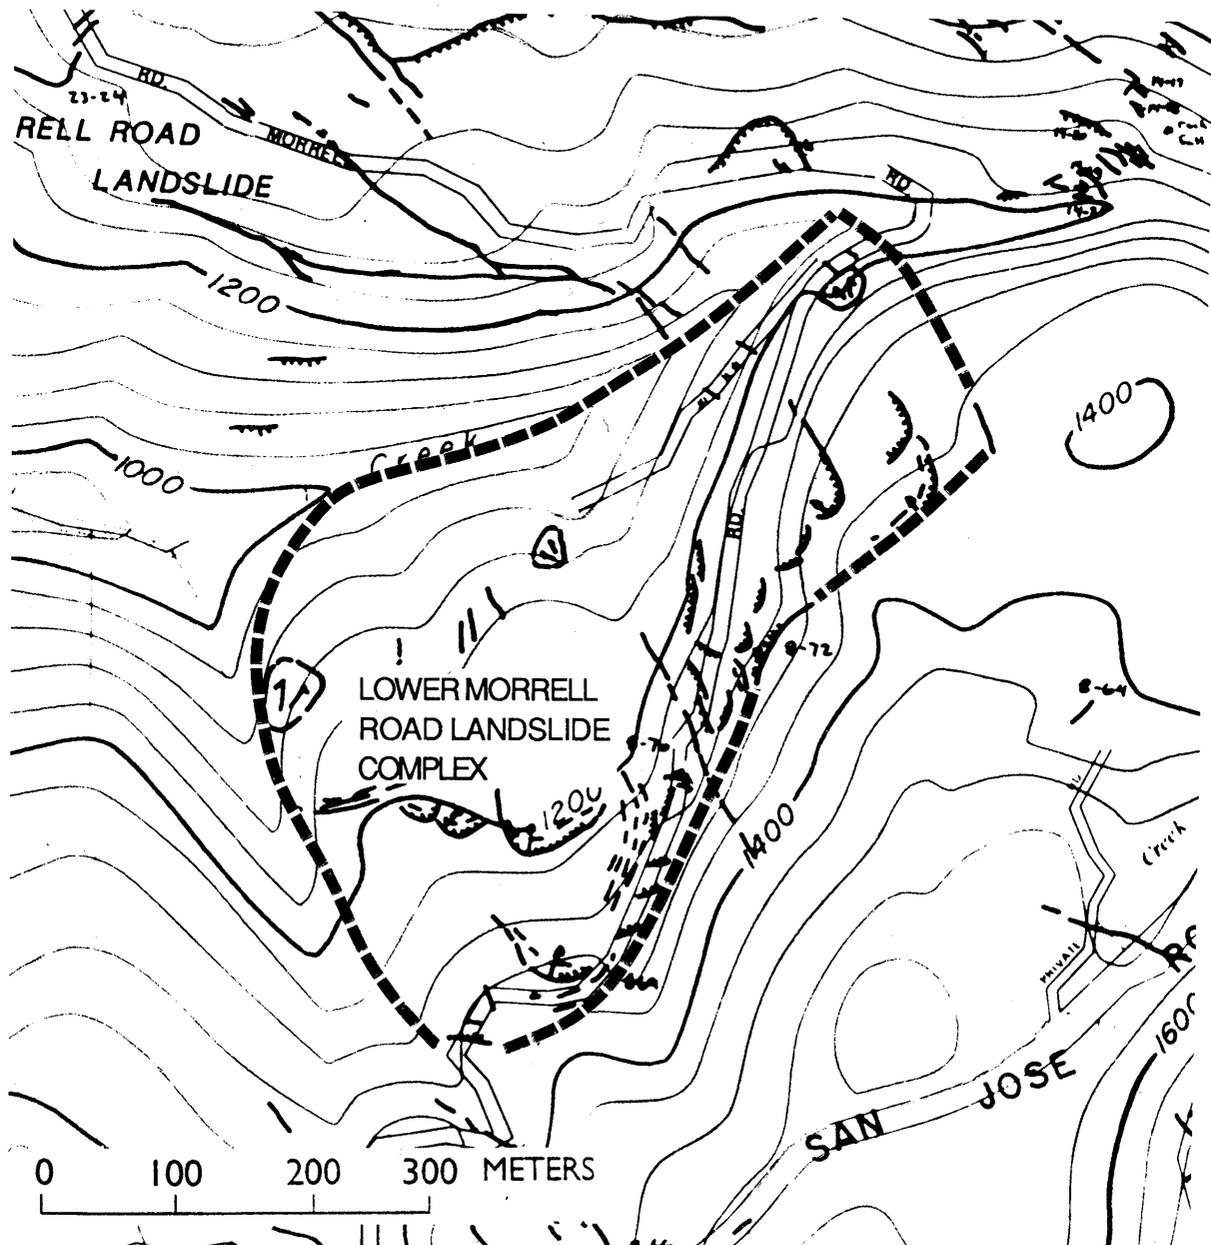
Figure 25.—Lower Morrell Road landslide complex. Ground cracks and compressional features from Spittler and Harp (1990); landslide boundaries from Keefer (1991). See figure 7 for explanation and figure 19 for base-map information.

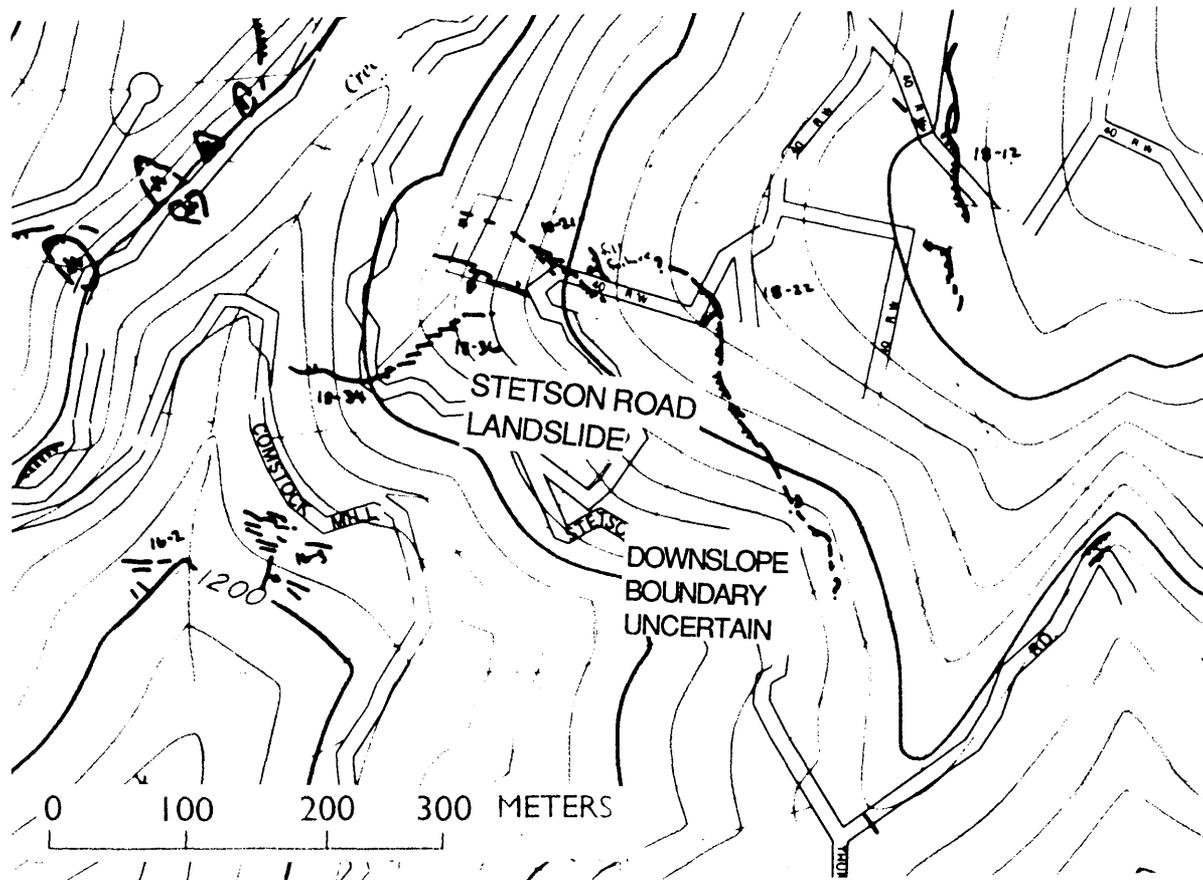
Figure 26.—Stetson Road landslide. Ground cracks and compressional features from Spittler and Harp (1990); landslide boundaries from Keefer (1991). See figure 7 for explanation and figure 19 for base-map information.

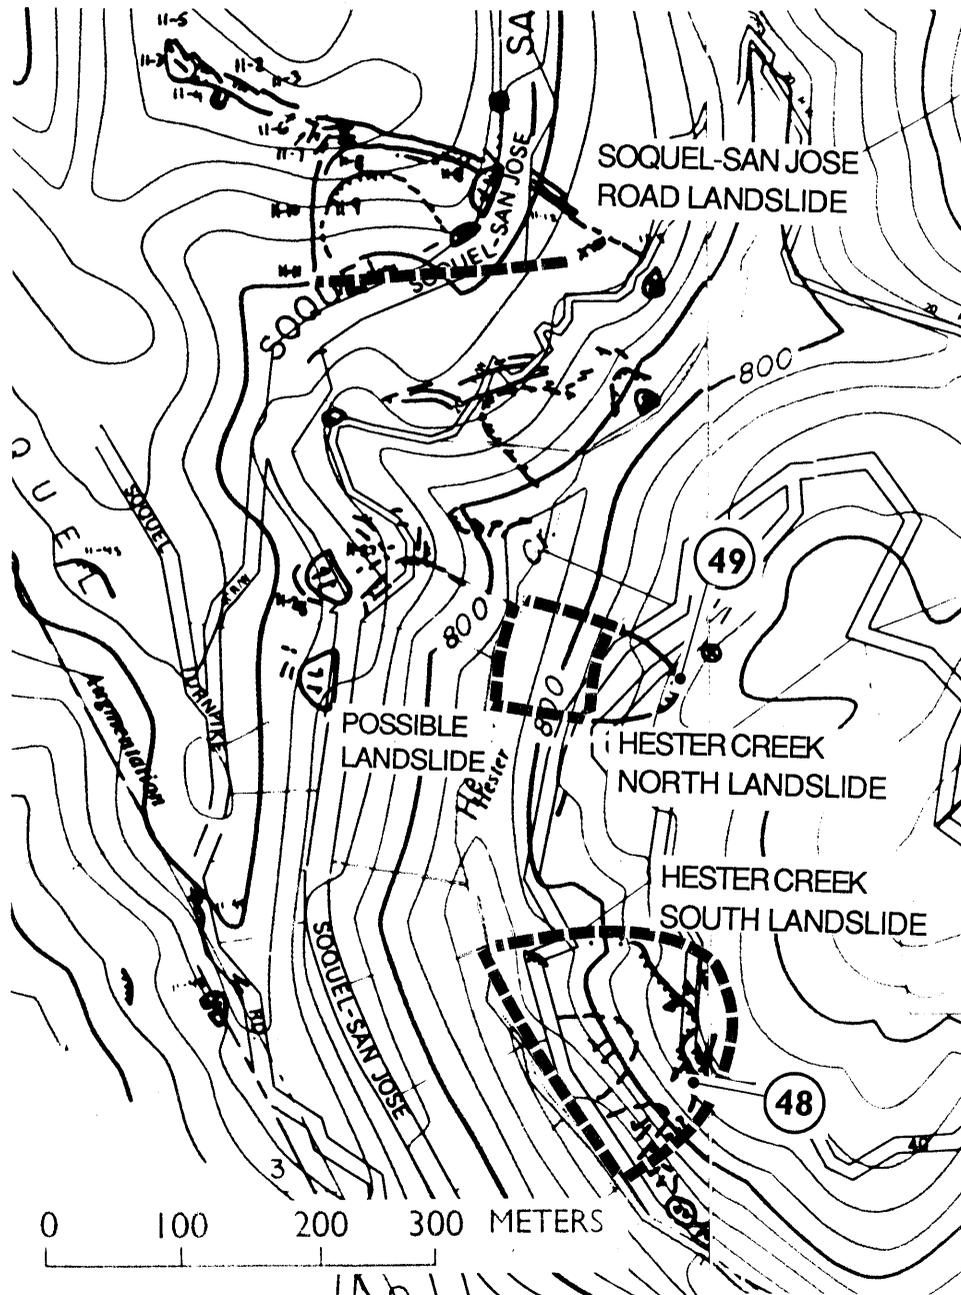
Renewed displacement was first detected along the main scarp of the Hester Creek North landslide on March 19, 1991. Measurements at quadrilateral array 49 (fig. 27) indicated 2 cm of extension between March 15 and 19,

and on March 25, measurements at the site revealed an additional 2 cm of extension. During the March 25 survey, renewed minor cracking was also observed across the unpaved access road, downslope from quadrilateral array 49 (fig. 27), at both localities where the road crossed the main scarp. Those cracks were 1 to 2 cm wide and showed slight vertical displacements.

Figure 27.—Hester Creek North, Hester Creek South, and Soquel-San Jose Road landslides. Ground cracks and compressional features from Spittler and Harp (1990); boundaries of Hester Creek North and South landslides from Keefer (1991). See figure 7 for explanation and figure 19 for base-map information.
