The Loma Prieta, California, Earthquake of October 17, 1989—Landslides

STRONG GROUND MOTION AND GROUND FAILURE
THOMAS L. HOLZER, *Coordinator*

U.S. GEOLOGICAL SURVEY PROFESSIONAL PAPER 1551-C

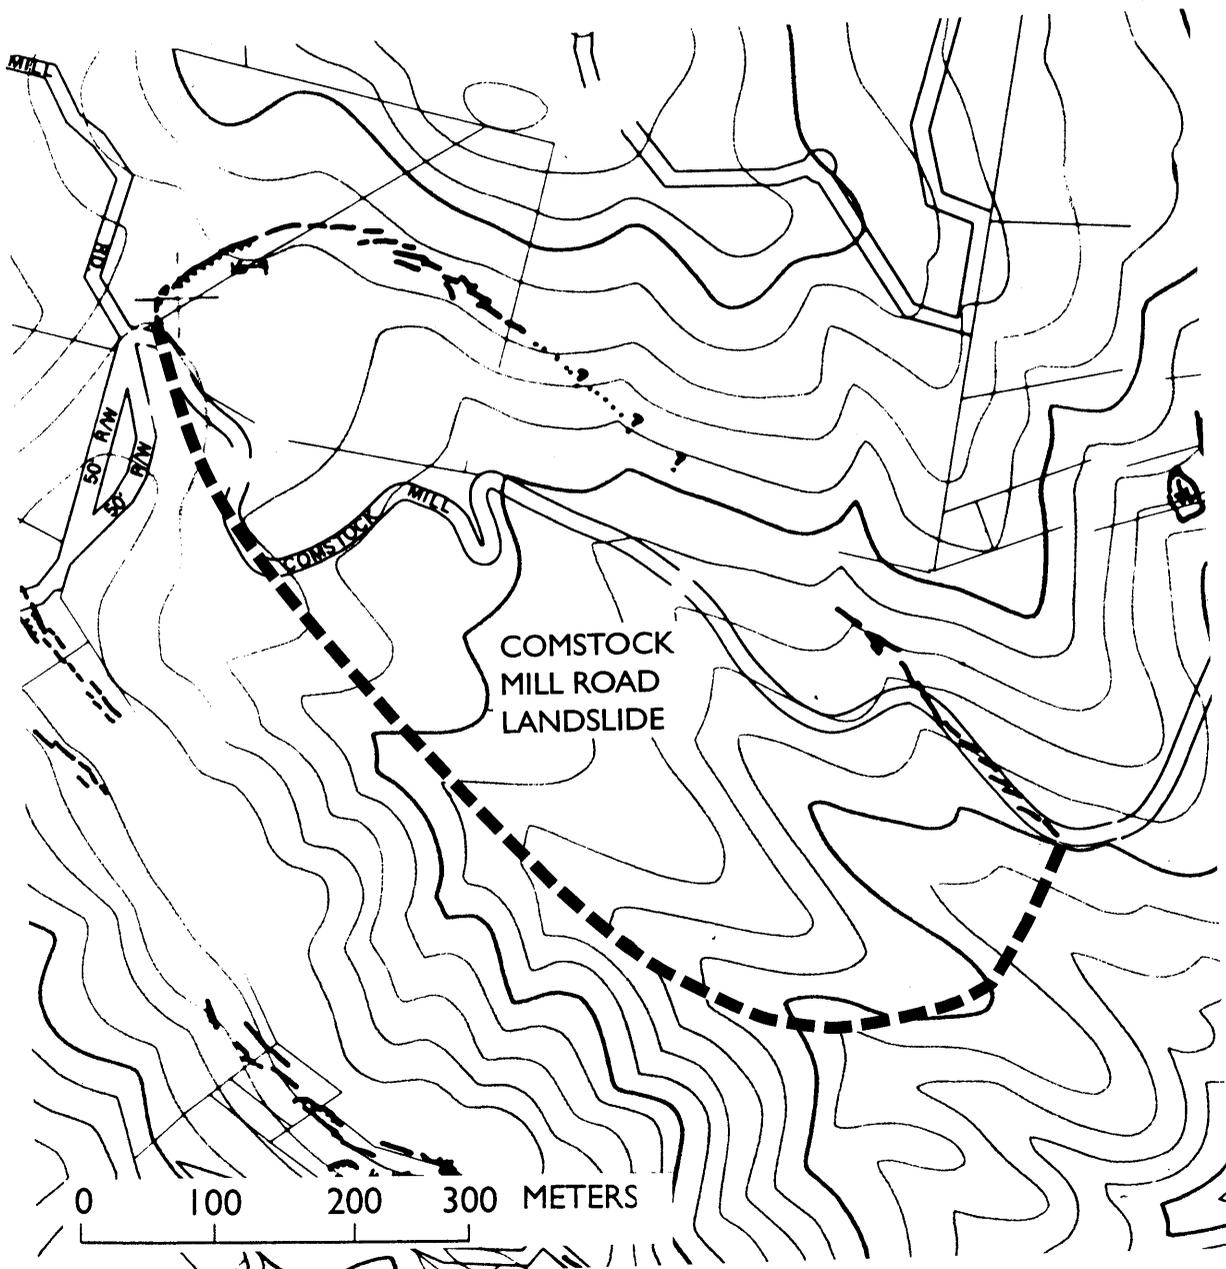
Figure 28.—Comstock Mill Road landslide. Ground cracks and compressional features from Spittler and Harp (1990). See figure 7 for explanation and figure 19 for base-map information.

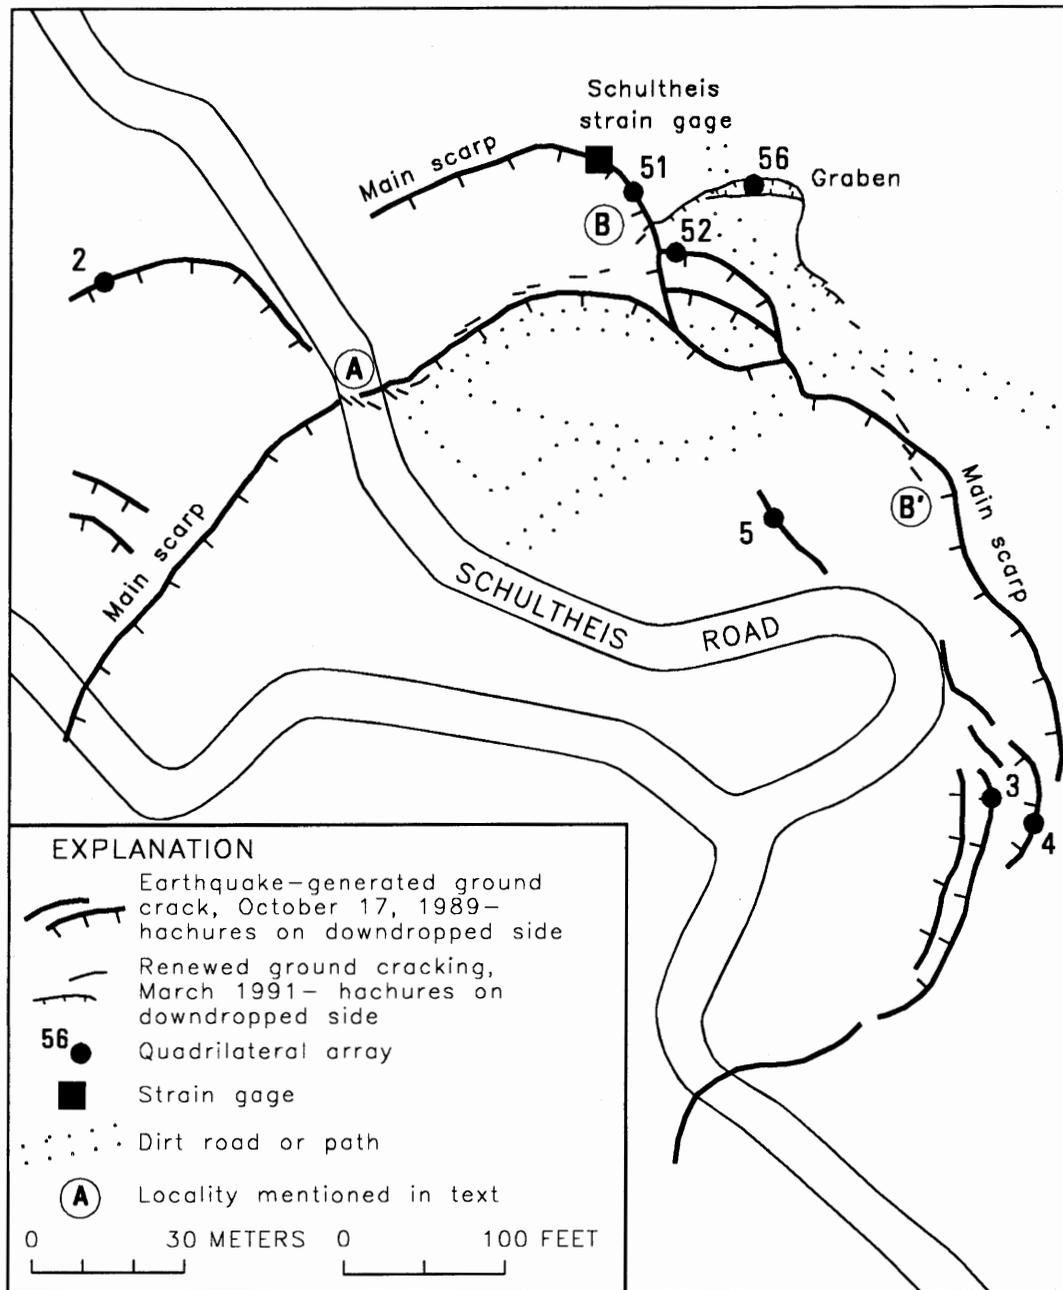
On March 25, a new set of cracks was observed upslope from the main scarp that formed during the earthquake (leg B–B', fig. 29). Because these new cracks did not occur along the traces of the preexisting, earthquake-induced cracks, associated displacements were not detected at nearby quadrilateral arrays 51 or 52 or by the adjacent

Schultheis strain gage (fig. 29). The new set of cracks extended eastward and southeastward from a point (B, fig. 29) on the earthquake-generated main scarp. From there eastward, a new crack was virtually continuous for about 50 m. This crack was arcuate and concave downslope in plan view, and along part of the crack was a graben, 15 m long, 2 to 3 m wide, and 0.5 m deep, that showed 20 to 30 cm of net vertical displacement between its upslope and downslope margins. Elsewhere, the crack was 5 to 10 cm wide and showed 5 to 10 cm of vertical displacement. Southeast of the continuous crack, shorter echelon cracks continued for an additional 50 m (to loc. B', fig. 29). These shorter cracks were 10 to 20 cm wide and showed

A new quadrilateral array (56, figs. 9A, 29) was installed on March 27, 1991, across the newly formed graben. Measurement of this array 2 weeks later, on April 11, showed 3 cm of additional downslope displacement. Subsequent measurements on April 18, 23, and 30, May 8, and July 17 indicated no additional displacements, but field observations during those surveys showed that minor ground cracking had occurred in several places along the main scarp (between locs. A and B, fig. 29).

Figure 29.—Area around main scarp of Upper Schultheis Road landslide, showing ground cracks and scarps that resulted from earthquake; ground cracks, scarps, and grabens formed during period of heavy rainfall in March 1991; and locations of quadrilateral arrays and strain gage.

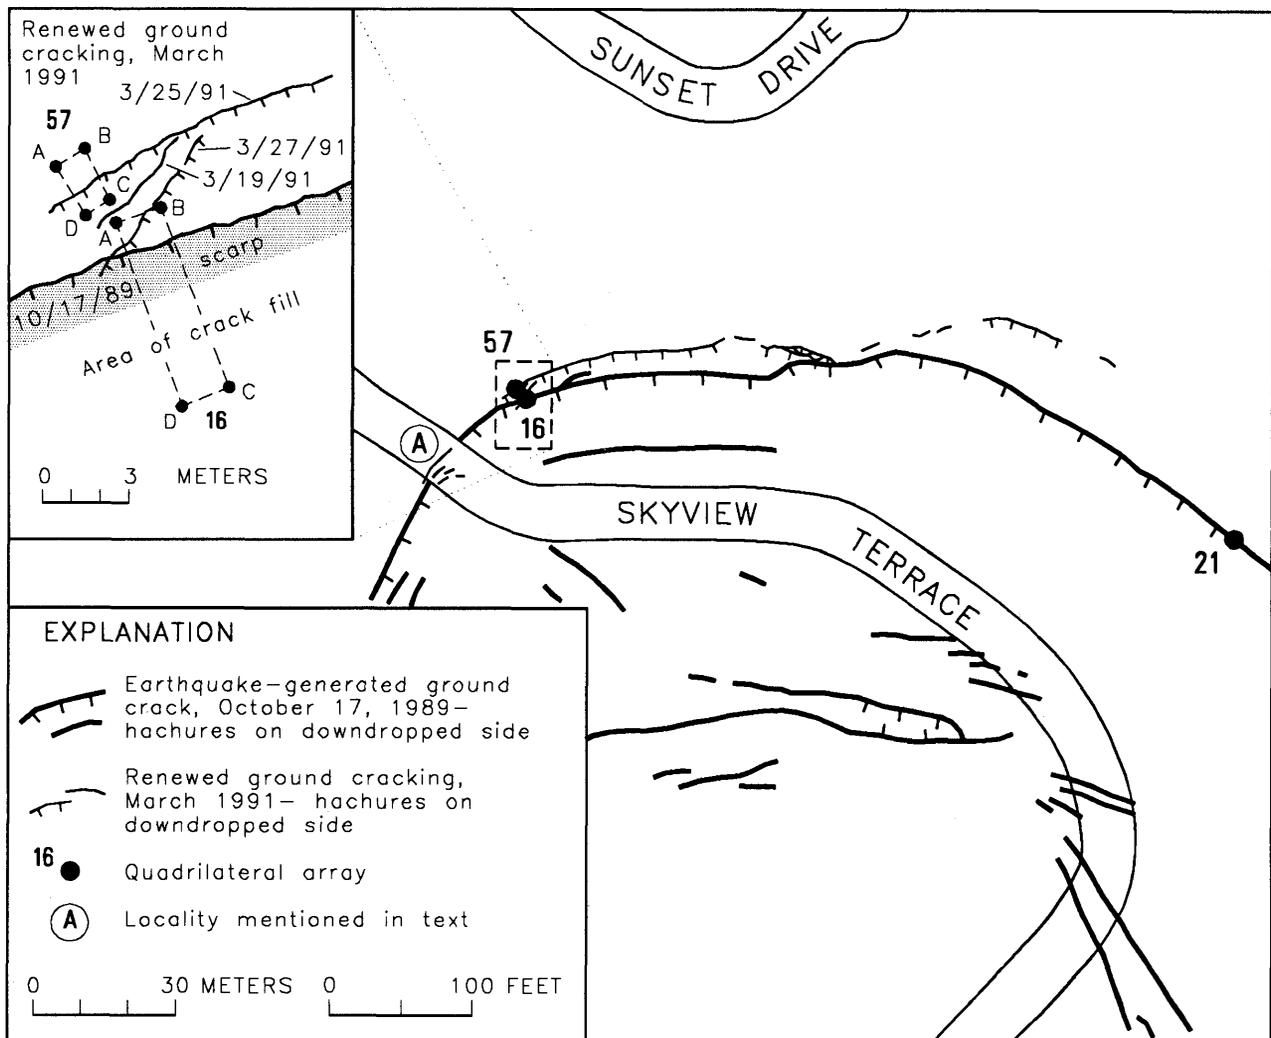
Renewed ground cracking and displacement along the major scarp near upper Skyview Terrace was detected on March 19, 1991, when a survey of quadrilateral array 16 (figs. 12, 30), showed 1 to 2 cm of contraction. Field inspection revealed that the contraction was associated with extension across a new crack, less than 1 m upslope from the site (inset, fig. 30). This crack, which formed sometime between March 15 and 19, was 2 to 5 cm wide and showed no vertical displacement. The crack was traceable 10 m eastward from the array, until lost beneath thick vegetation. Small cracks, less than 1 cm wide, also broke the pavement of upper Skyview Terrace near quadrilateral array 16 (point A, fig. 30).

and traceable continuously approximately 40 m eastward. From that point east, a series of shorter cracks were traceable an additional 70 to 80 m. These shorter cracks were 5 to 15 cm wide and showed vertical displacements of as much as 15 cm. The cracks in Skyview Terrace (loc. A, fig. 30) had also become larger by March 25.

On March 27, another new crack was observed, trending obliquely upslope, northeast from the earthquake-generated scarp (inset, fig. 30). This crack, which averaged 5 cm in width and showed as much as 5 cm of vertical displacement, was traceable for 4 m and passed between two of the stakes in quadrilateral array 16 (stakes A, B, inset, fig. 30). The March 27 survey showed 11 cm of cross-crack contraction on the two legs involving stake B (that is, legs B-C, B-D) and no significant change on the two legs involving stake A (that is, legs A-C, A-D). On March 27, a new quadrilateral array (57, figs. 12A, 30) was installed across the new crack observed on March 25 (fig. 30). Subsequent measurements made at both quadrilateral arrays 16 and 57 on April 11, 18, and 23 and May 8, 1991, showed that no additional displacements had occurred.

Figure 30.—Area around part of upper Skyview Terrace on Villa Del Monte landslide, showing ground cracks and scarps that resulted from earthquake; ground cracks and scarps formed during period of heavy rainfall in March 1991; and locations of quadrilateral arrays.

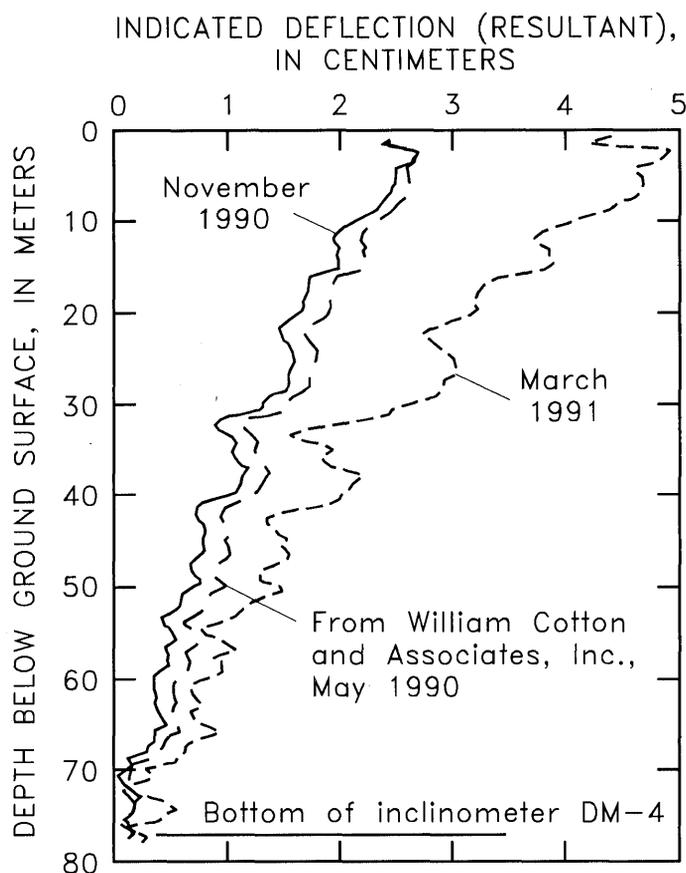
Figure 31.—Deflections measured by inclinometer in borehole DM-4 on Villa Del Monte landslide (see fig. 12B for location).

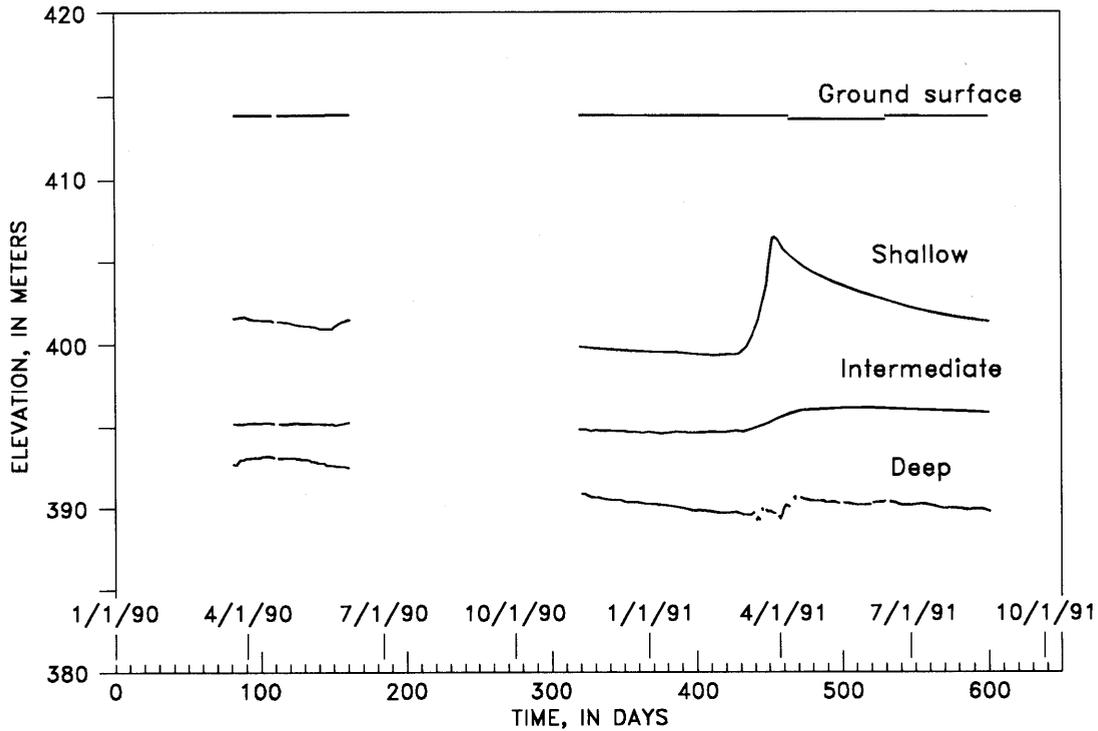
1991 (figs. 32, 33; table 6). The dates and times of rise in ground-water levels due to the spring 1991 rains are listed in table 7. These times reflect a relatively rapid ground-water response to the rainfall, particularly to that in February and early March. Complete plots of the piezometric records were presented by Keefer (1991).

Figure 32.—Elevation of piezometric surface versus time for piezometers in borehole SR-3 on Upper Schultheis Road landslide (see fig. 9B for location).

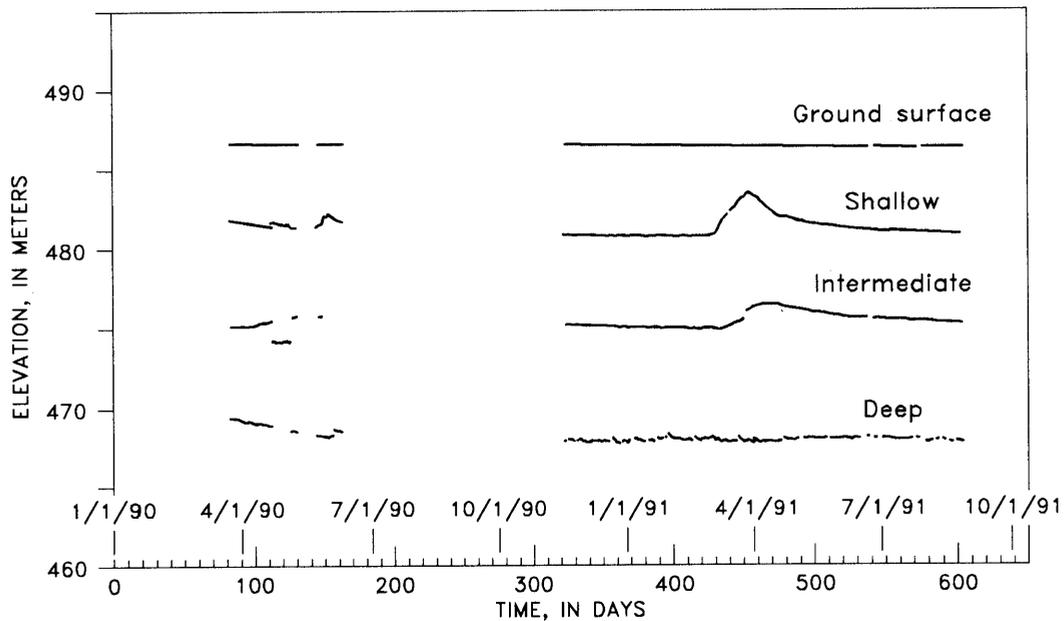
Figure 33.—Elevation of piezometric surface versus time for piezometers in borehole DM-1 on Villa Del Monte landslide (see fig. 12B for location).

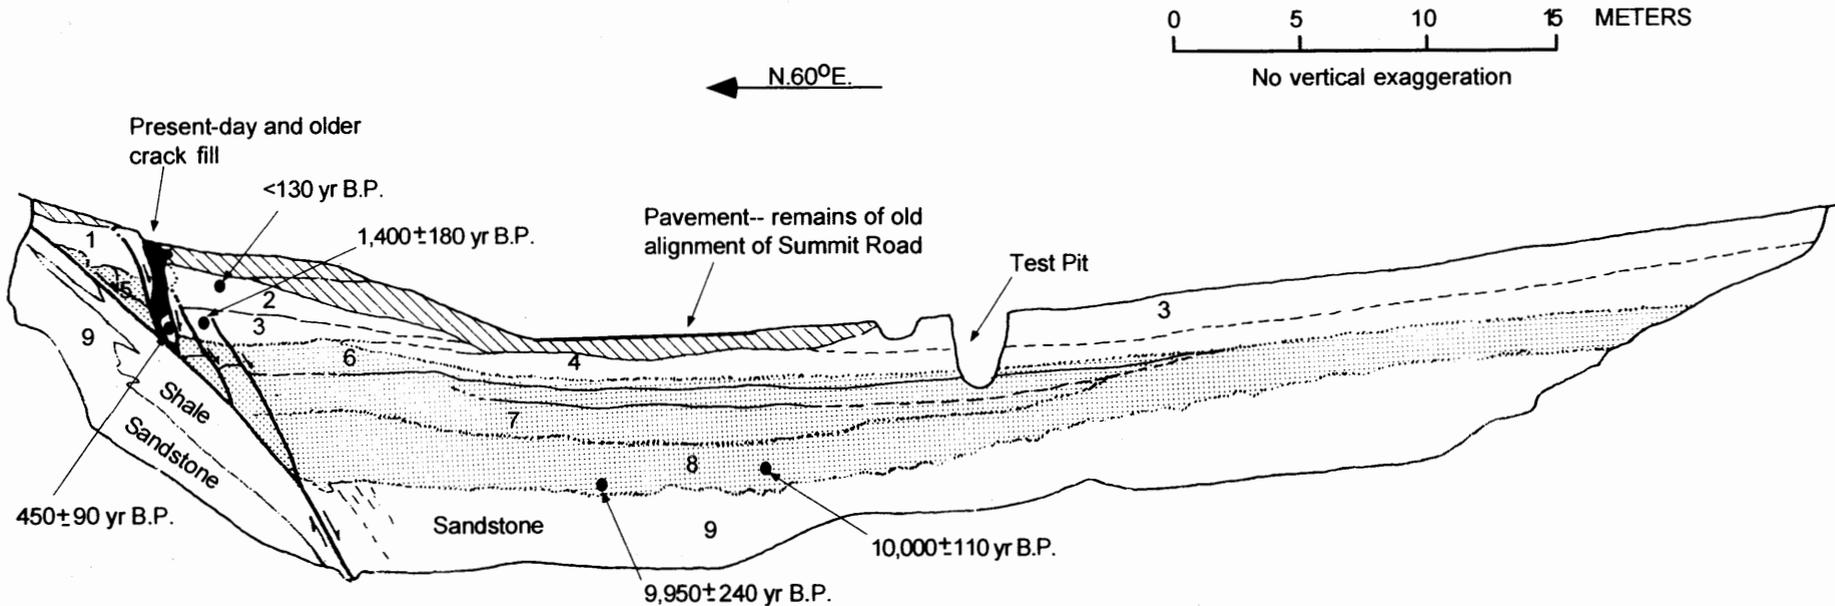
The trench revealed Vaqueros Sandstone and shale offset in a normal sense by a southwest-dipping shear surface, possibly aligned with bedding (fig. 2). A sequence of colluvial deposits, 3.6 m thick, overlies the downdropped block. The shear surface is a sharply defined parting lined with a 3- to 4-mm-thick layer of gray clay and a band of iron oxide staining. Slickensides observed on the shear surface have rakes of 76° – 77° SE. Movement therefore is dominantly normal, dip slip, with a slight left-lateral component.

Four discrete displacements are recorded by the most recent colluvial deposits. Although earlier events are likely to have occurred, they are not preserved as discrete stratigraphic offsets in the sedimentary record. The first recorded episode of movement offset the uppermost layer of older colluvium (unit 4, fig. 2). Cumulative vertical separation on the two shears that offset the base of this layer is about 0.4 m, but total throw during the displacement event(s) may be obscured by later ground cracking and (or) subsequent soil-forming processes. This movement was followed by the deposition of unit 3. The shears that offset unit 4 extend into unit 3, indicating some secondary movement, but do not visibly offset the unit 3/4 contact, indicating that unit 3 postdates most of the observed displacement of unit 4. A ^{14}C age of $1,400 \pm 180$ yr B.P. (sample CAMS 843, table 1) on soil from the upper part of unit 3 (fig. 2) indicates a latest date for the first recorded episode of movement. A tentative date for this event of about 2 ka was estimated by considering average sedimentation rates in the colluvial section (Nolan, 1992).

Figure 2.—Log of trench 1, which was excavated across a ground crack along base of a 0.5-km-long, northwest-trending scarp at summit of the Santa Cruz Mountains. Trench exposed a southwest-dipping slip surface and a 4-m-thick colluvial wedge overlying downdropped block. Earliest Holocene ¹⁴C ages on soil from basal part of colluvium and offset stratigraphic layers indicate that movement on this slip surface has been ongoing throughout the Holocene, including at least three discrete events in the past approximately 2,000 years.

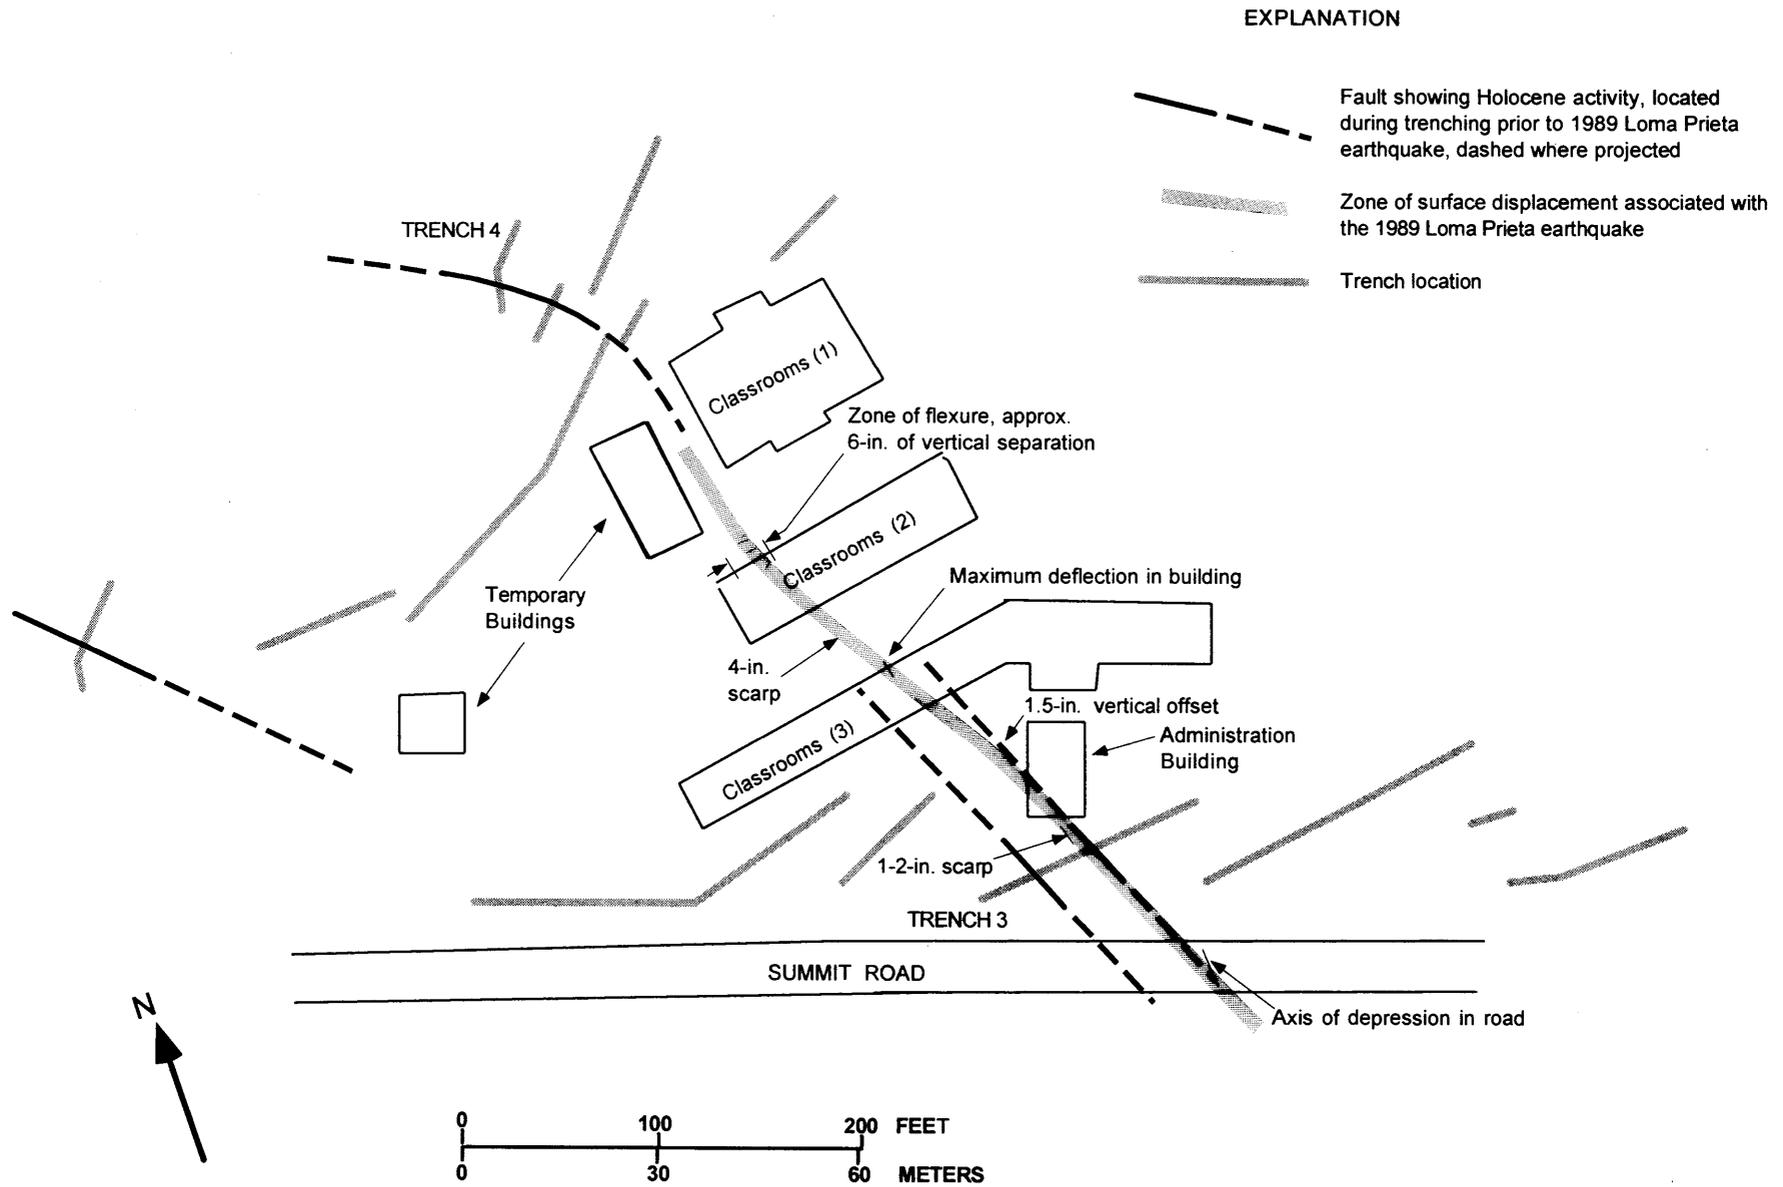
Figure 4.—Simplified site plan for Loma Prieta Elementary School, showing locations of paleoseismic trenches excavated before 1989 Loma Prieta earthquake, suspected active faults identified in trenches, and ground displacement that occurred during the earthquake. Modified from Rogers E. Johnson and Associates (1989).

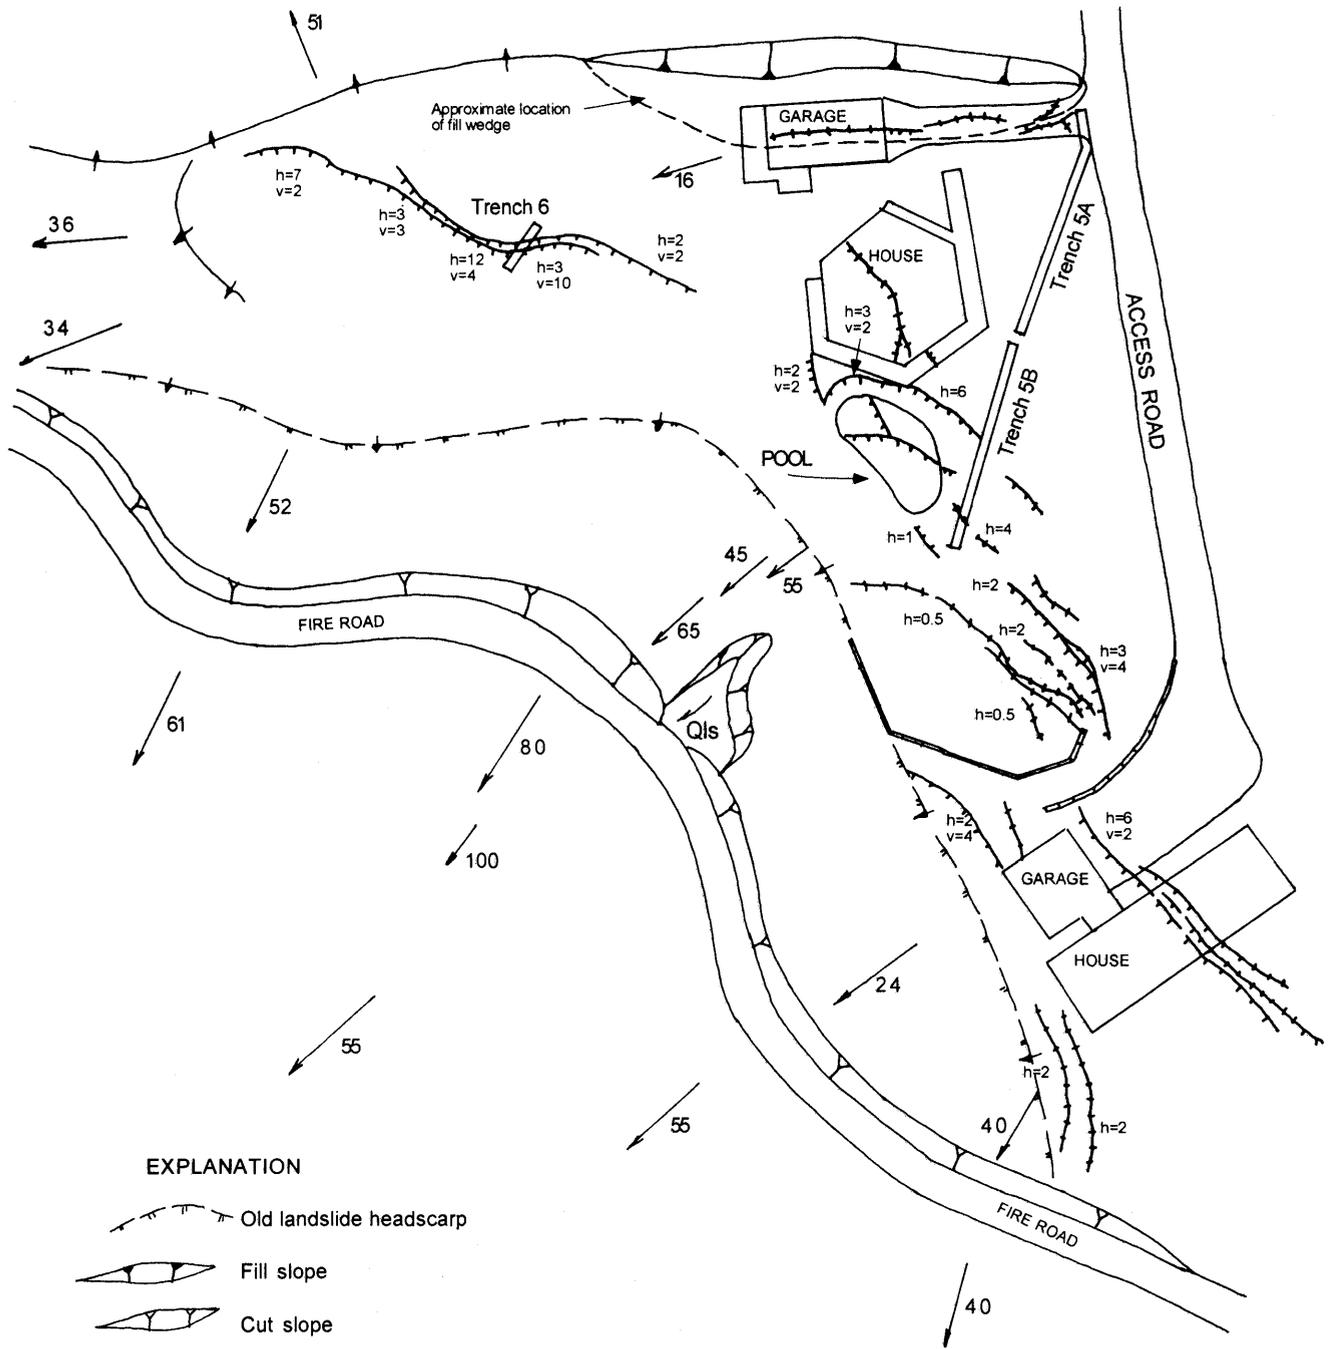
Figure 6.—Area of case history 2 (see pl. 5 for location), showing pattern and dimensions of ground cracking that occurred during 1989 Loma Prieta earthquake. Trenches across ground-cracks showed evidence for many previous episodes of ground cracking in the same places. From G.E. Weber and Associates (1990a).

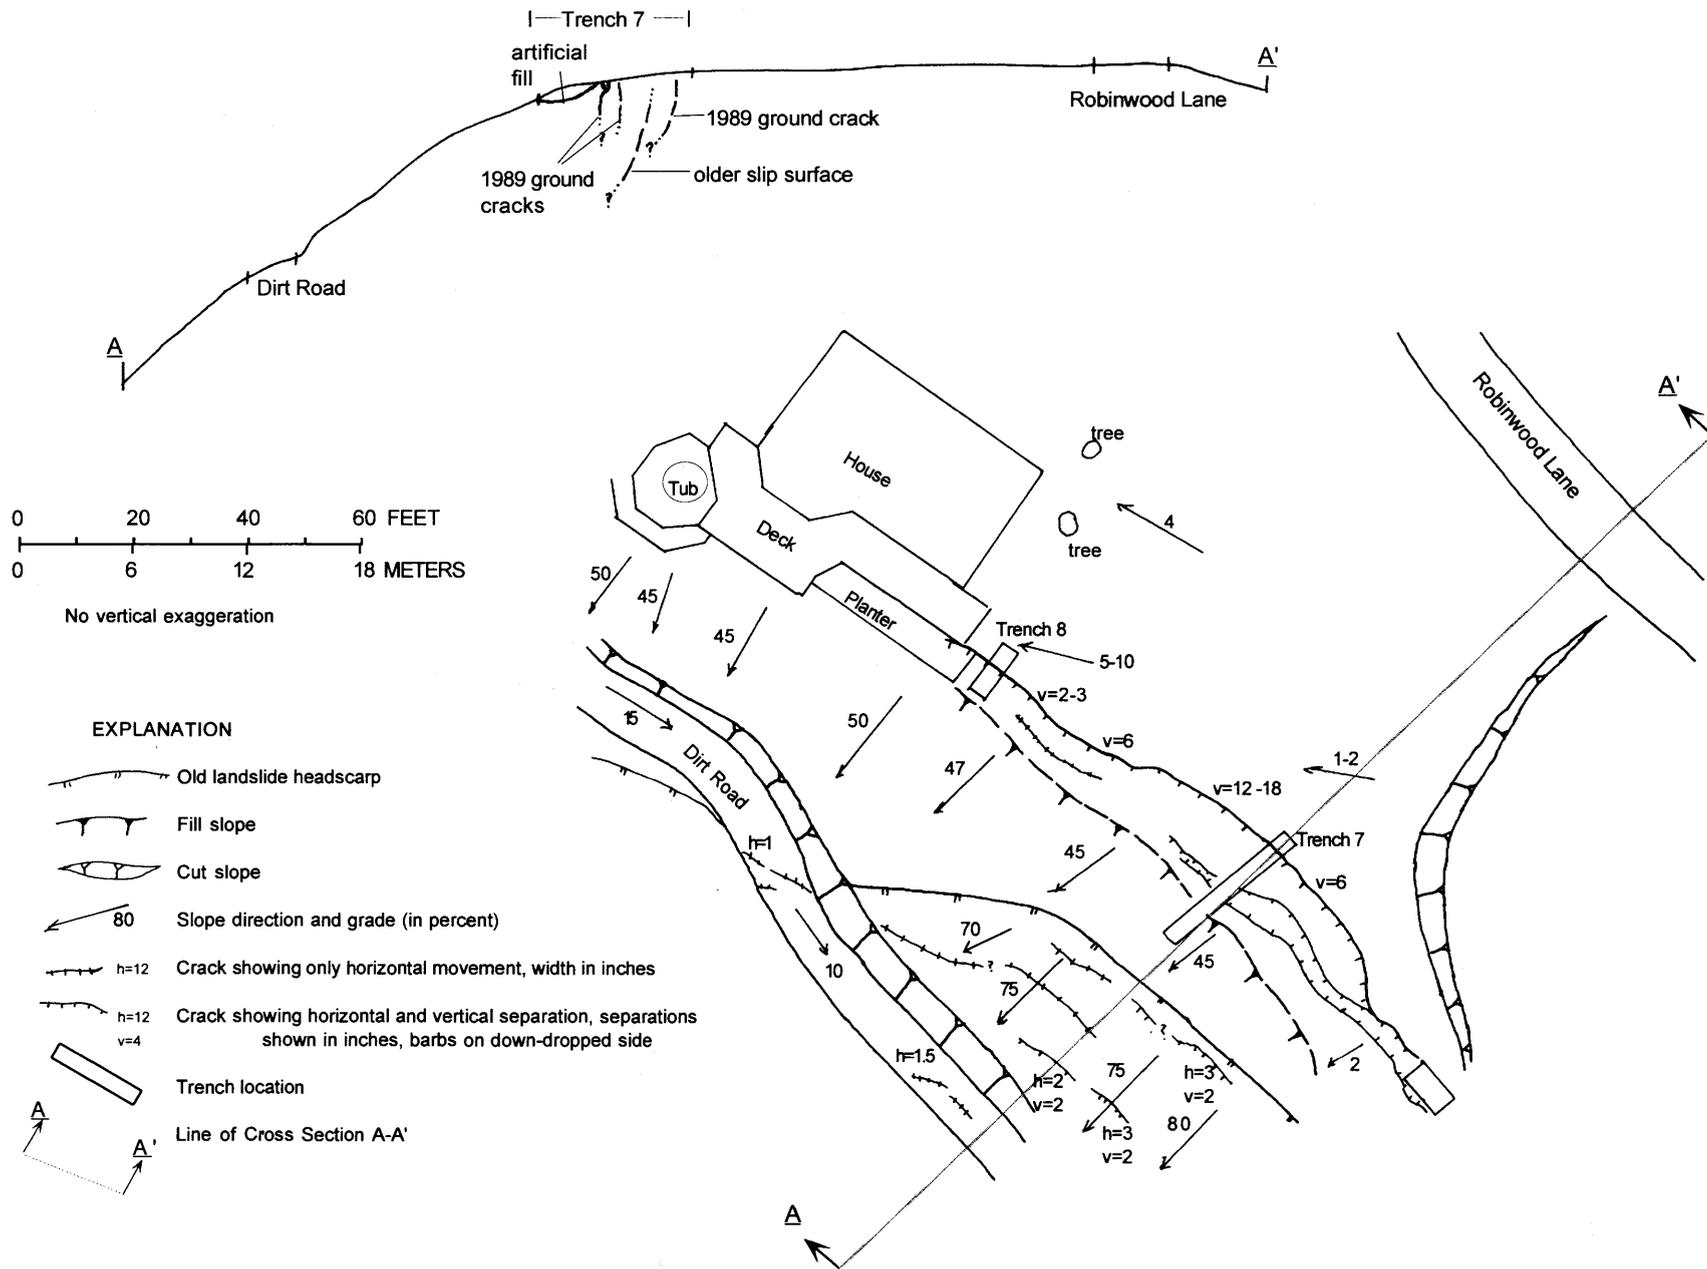
Figure 8.—Area of case history 3 (see pl. 5 for location), at the crest of a narrow, steep-sided ridge, and cross section A-A'. Ground cracking occurred continuously along crest and southwest facing flank of ridge for a distance of more than 0.5 km. A total of 12 trenches across this series of cracks revealed evidence for multiple earlier movements on 1989 ground cracks but also several previous ground cracks that were not reactivated by 1989 Loma Prieta earthquake. From G.E. Weber and Associates (1990b).

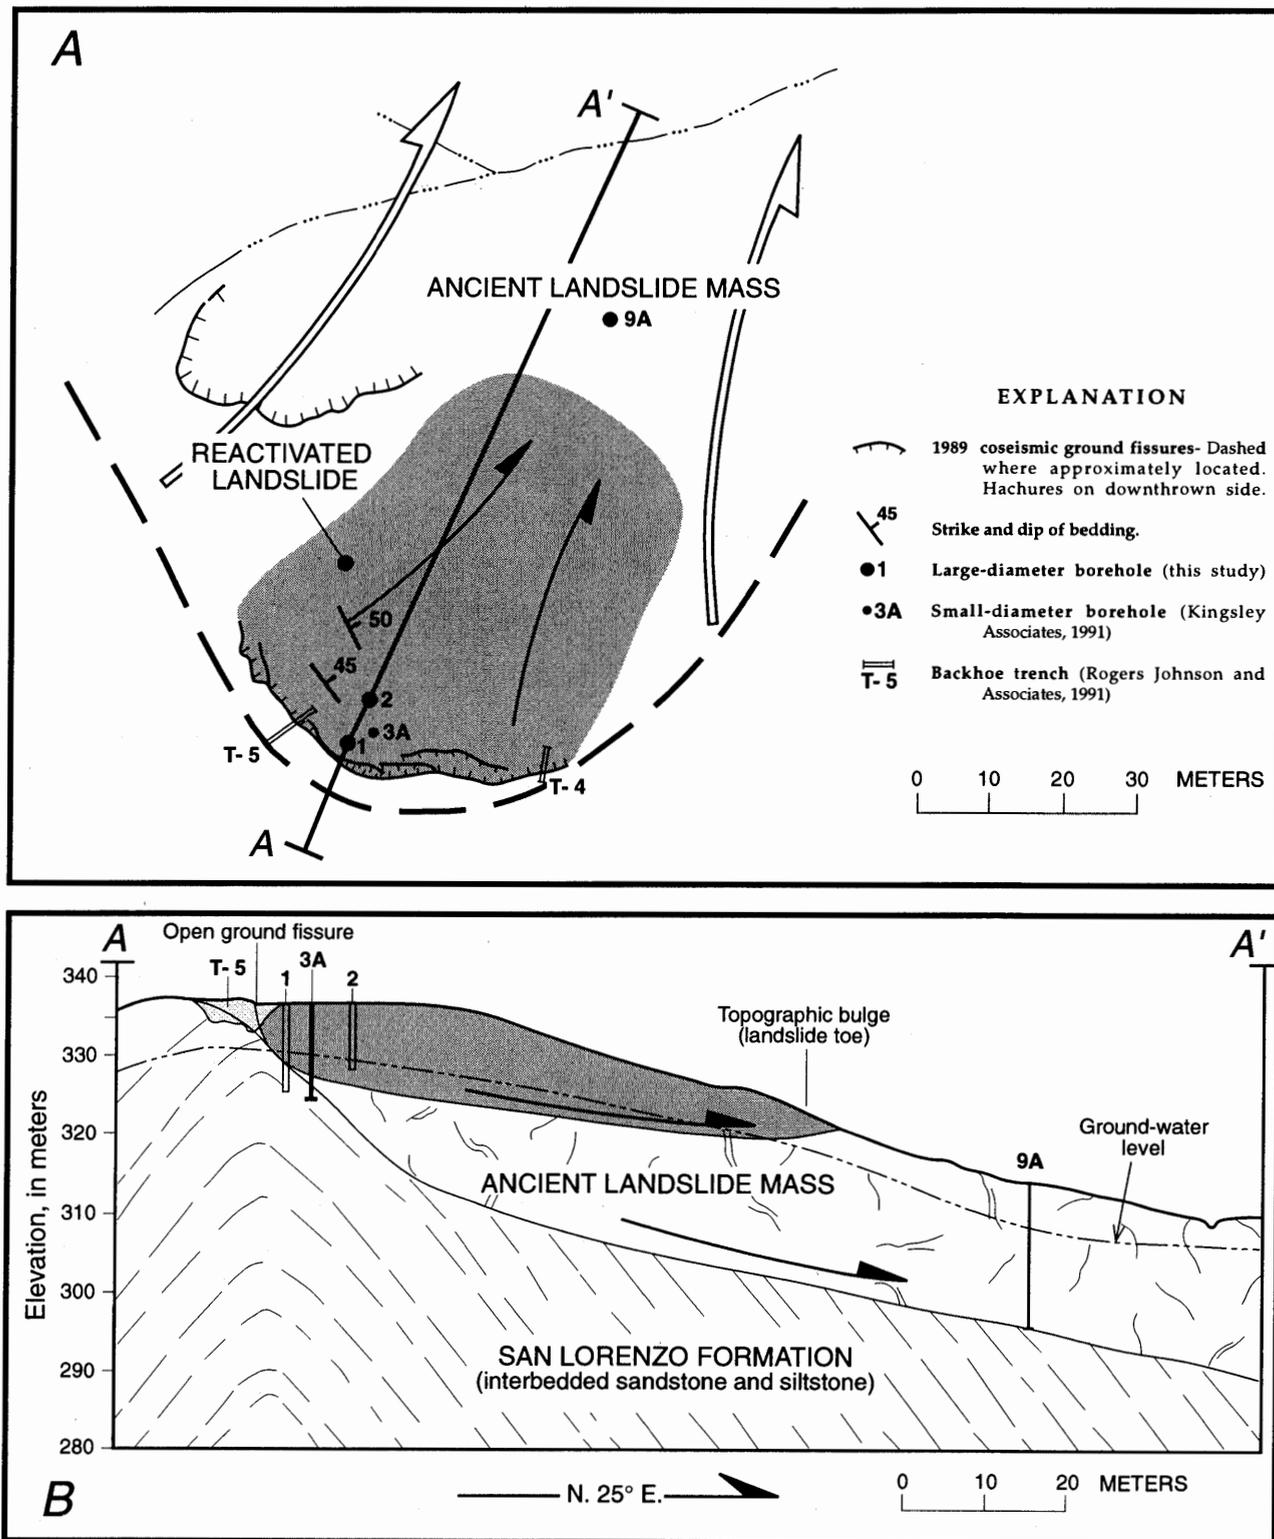
Figure 3.—Simplified geologic map (A) and cross section (B) of Lower Schultheis Road West landslide (see fig. 2 for location). Half-arrows indicate direction of downslope movement.

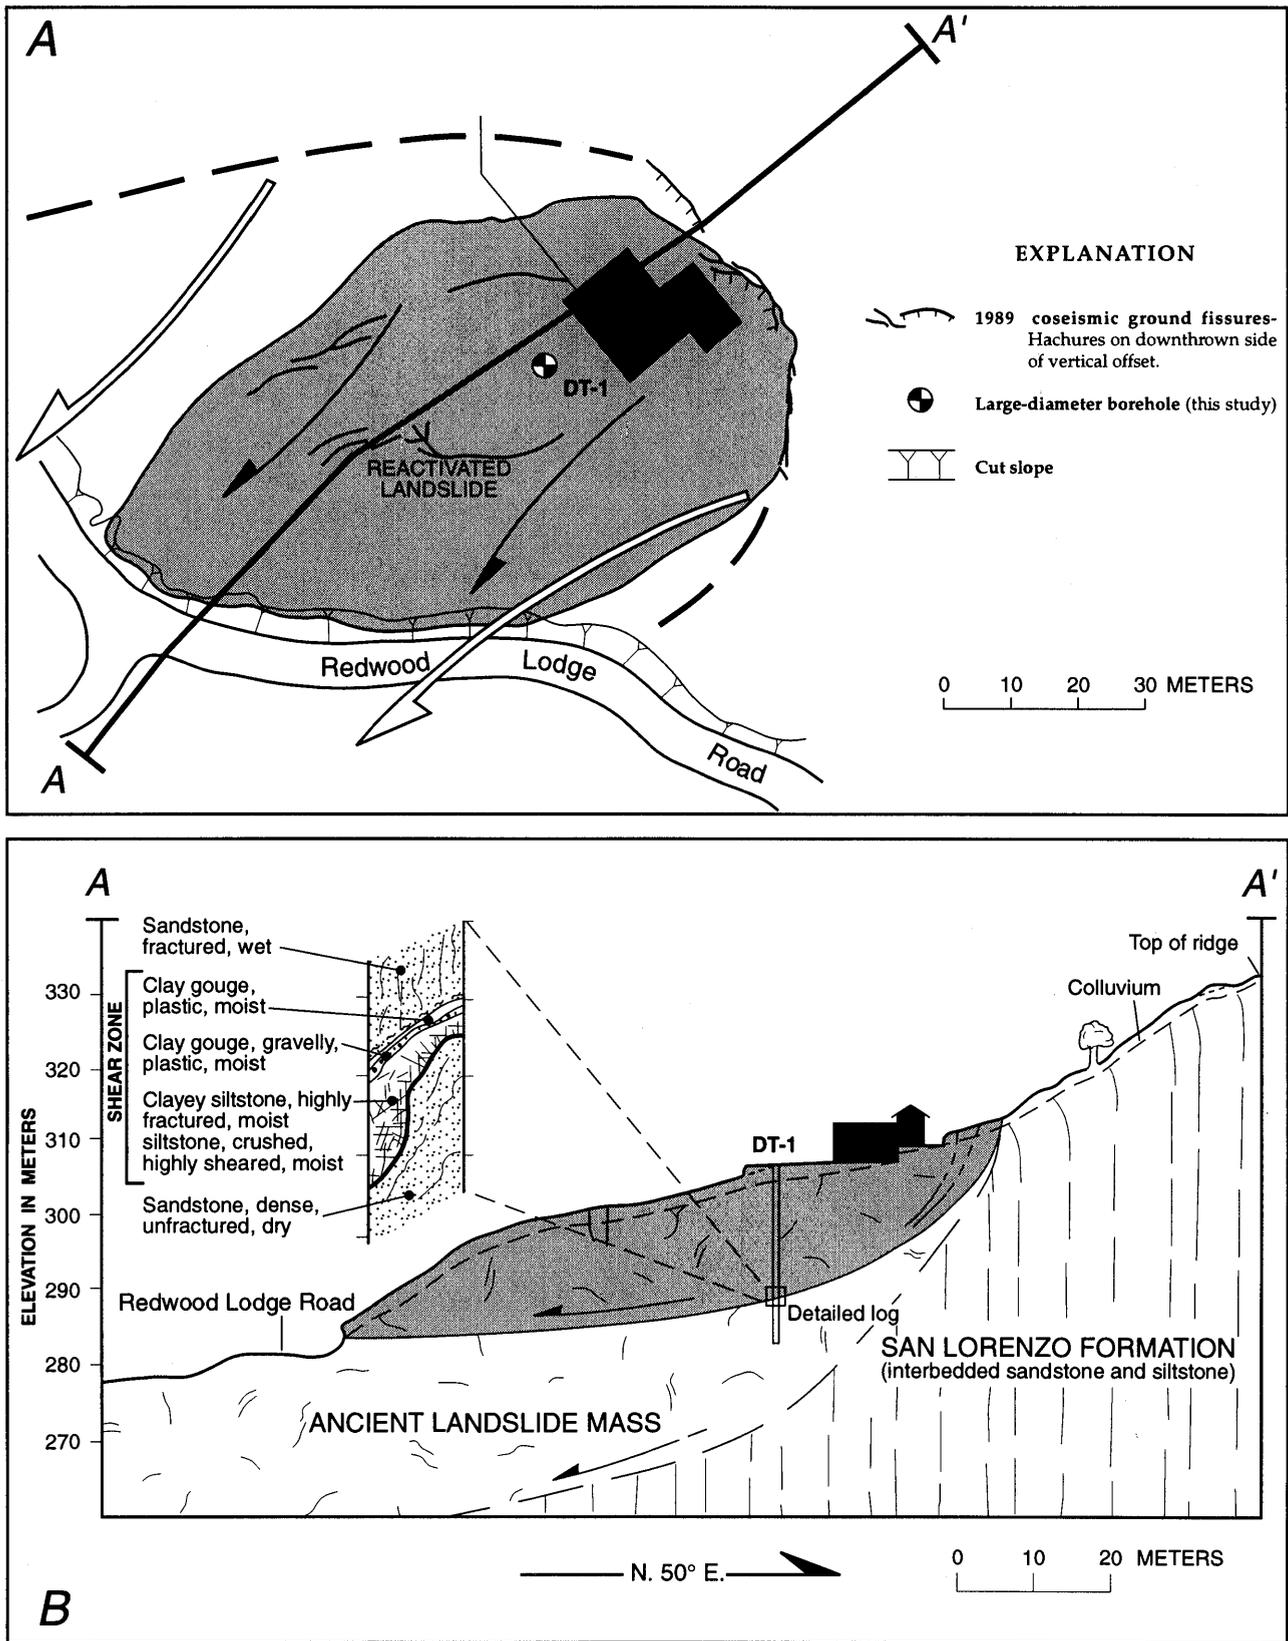
Figure 4.—Simplified geologic map (A) and cross section (B) of Ditullio landslide (see fig. 2 for location). Half-arrows indicate direction of downslope movement.

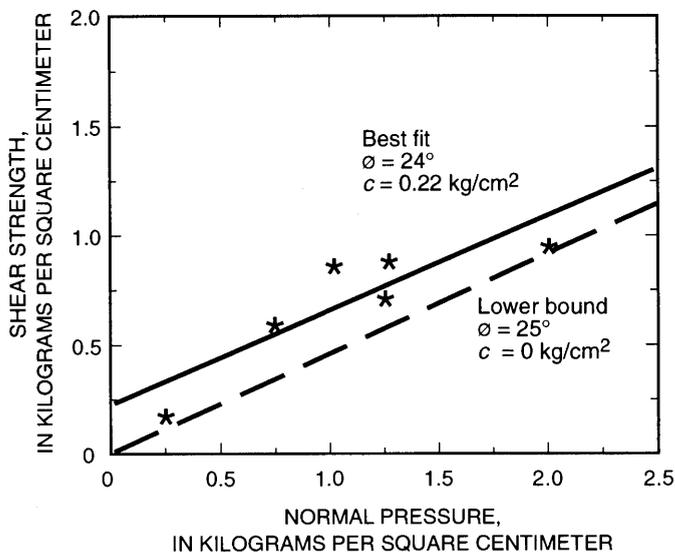
The residual shear strengths measured in direct shear tests are approximately 70 to 75 percent of the peak values. This result approximates the reduction to 80 percent of peak shear strength estimated by Makdisi and Seed (1977) and recommended by Hynes-Griffin and Franklin (1984), owing to cyclic-loading effects. Therefore, we used the residual shear strengths to characterize the cyclic strength of the basal rupture surfaces. Two measures of residual shear strength, lower-bound and average or "best fit" curves, were drawn by linear regression through the data points (fig. 6). The shear-strength parameters, in terms of angle of internal friction (ϕ) and cohesion (c), that describe the lower-bound and best-fit values are $\phi=25^\circ$, $c=0$ kg/cm² and $\phi=24^\circ$, $c=0.22$ kg/cm², respectively.

Figure 6.—Residual shear strength versus normal pressure in laboratory consolidated-undrained tests on landslide rupture surface material.

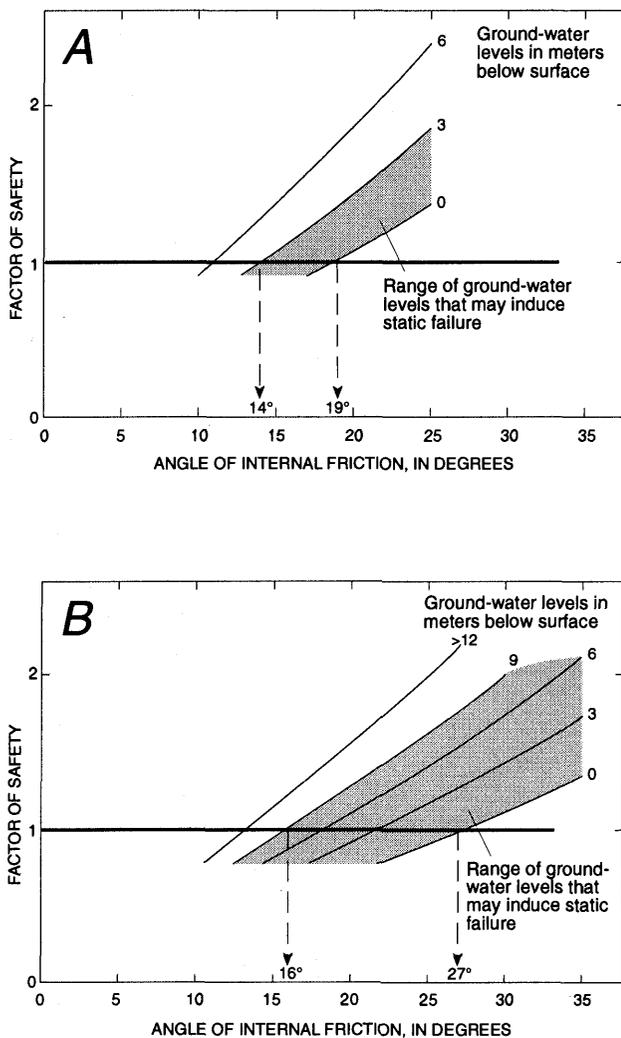
Figure 7.—Factor of safety versus shear strength (expressed as angle of internal friction) at various ground-water levels in Lower Schultheis Road West (A) and Ditullio (B) landslides (see fig. 2 for locations).

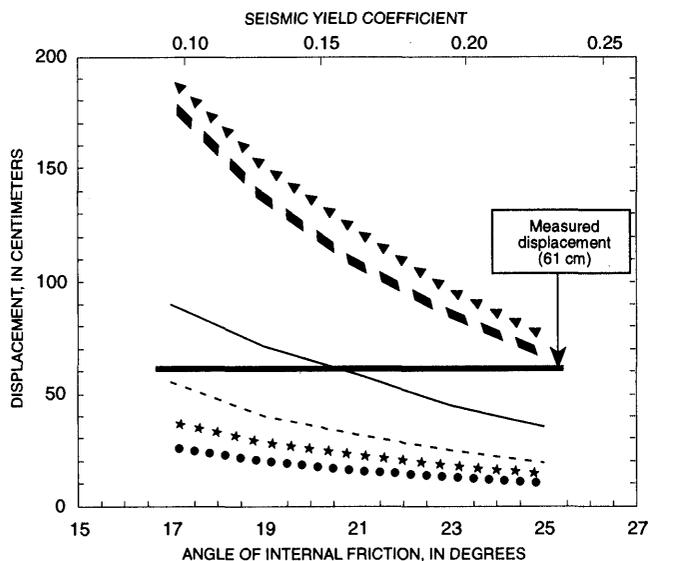
The displacements that can be calculated for an $M=7.0$ earthquake, using the three curves of Makdisi and Seed (1977) and Hynes-Griffin and Franklin (1984) for the Lower Schultheis Road West landslide, are plotted in figure 10. Because of the bilateral rupture, the 1989 Loma Prieta earthquake was of considerably shorter duration than most other earthquakes of similar magnitude. Therefore, we might expect the measured displacements to fall in the lower part of the range of calculated displacements. Figure 10 shows, however, that they do so only for the smallest ϕ values. If we assume that the appropriate ϕ value should be about 21° , then the measured displacements fall in the middle of the range of displacements in the data sets of both Makdisi and Seed (1977) and Hynes-Griffin and Franklin (1984).

Figure 10.—Predicted displacement versus shear strength (expressed as angle of internal friction) calculated by two cumulative-displacement methods for Lower Schultheis Road West landslide (see fig. 2 for location).
