The Loma Prieta, California, Earthquake of October 17, 1989—Marina District

STRONG GROUND MOTION AND GROUND FAILURE
THOMAS L. HOLZER, *Coordinator*

U.S. GEOLOGICAL SURVEY PROFESSIONAL PAPER 1551-F

MARINA DISTRICT

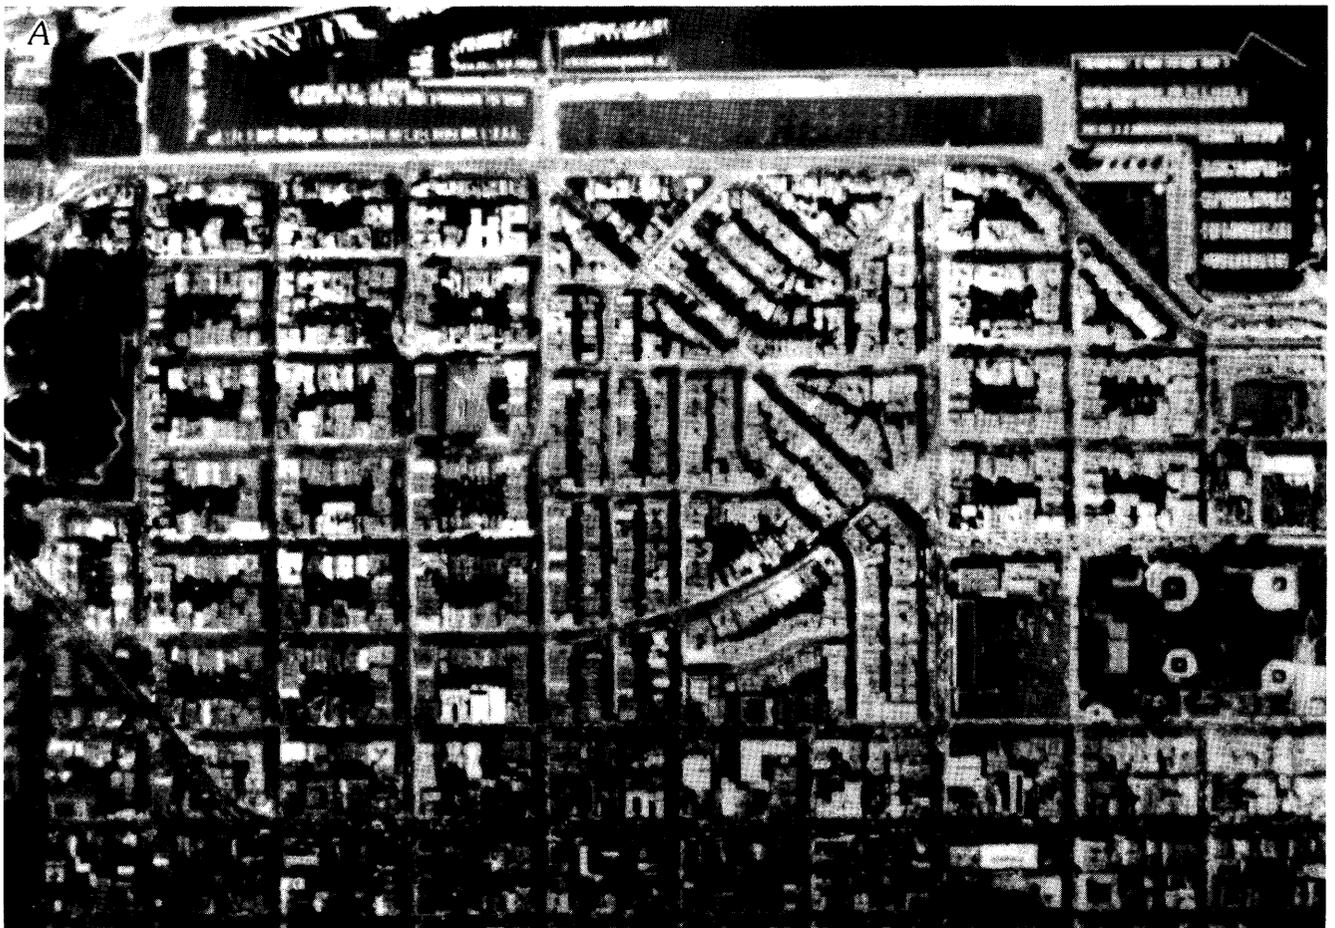
Figure 1.—Marina District of San Francisco. A, Marina District 2 days after the earthquake, showing areas of conspicuous damage and earthquake effects. Photograph taken from a height of 2,000 m; courtesy of Pacific Aerial Surveys, Oakland, Calif. B, Sketch maps showing locations of the Marina District within San Francisco and of areas of figure 1A.

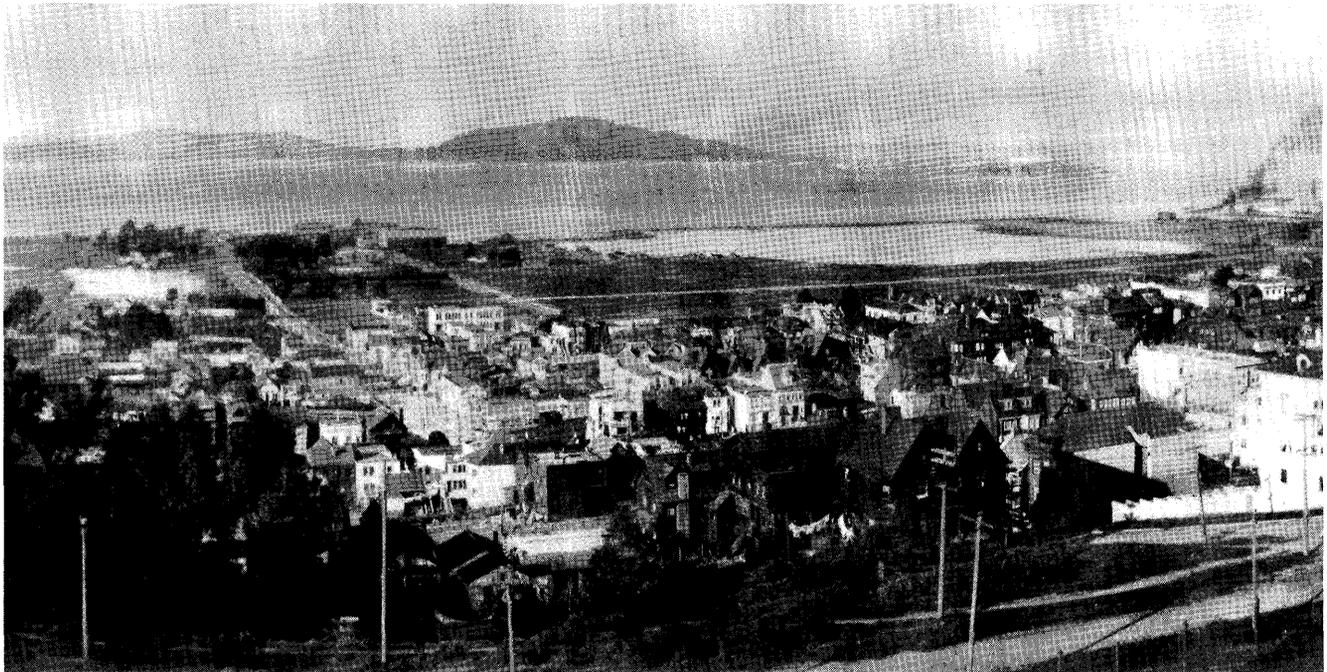
Figure 14.—Marina area in April(?) 1912. Shortly after this photograph was taken, cove in right center was hydraulically filled for the Panama-Pacific International Exposition. Sand was pumped from the bottom of the bay, transported by pipeline, and discharged into the cove. Pond to left is now part of lagoon at the Palace of Fine Arts. Next to pond is Baker Street and then Broderick Street. Photograph courtesy of Archives, San Francisco Main Library.

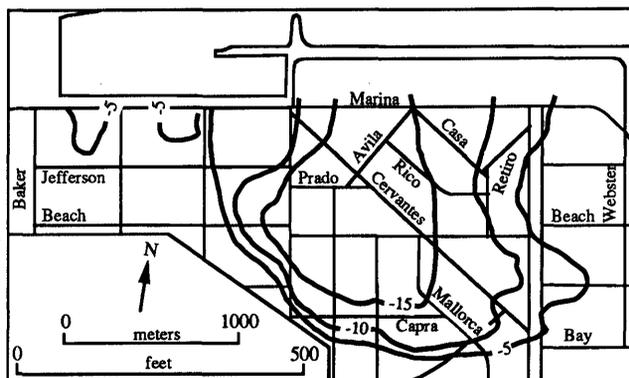
Figure 15.—Contours on bottom of Marina Cove in 1912, before modifications for the Panama-Pacific International Exposition, in relation to modern streets. Contours in feet, based on San Francisco city datum, which is approximately 8.6 ft above mean sea level datum. After Leurey (1914, fig. 3).

The position of the bottom of the hydraulic fill is probably irregular and is poorly known. A map showing the approximate elevation of the lagoon bottom about 1912, before the filling (fig. 15; Leurey, 1914, fig. 3), indicates only its general position because Leurey (1914, p. 250) stated that the fill pushed its way 0.6 to 1.5 m (2–5 ft) into the soft ooze of the lagoon bottom, and postexposition borehole logs also show artificial fills extending below the 1912 bottom. As noted before, the area of 1912–17 fills also includes scraper fill, post-1915 hydraulic fill of unknown dimensions, and public dumps, all related to the exposition.

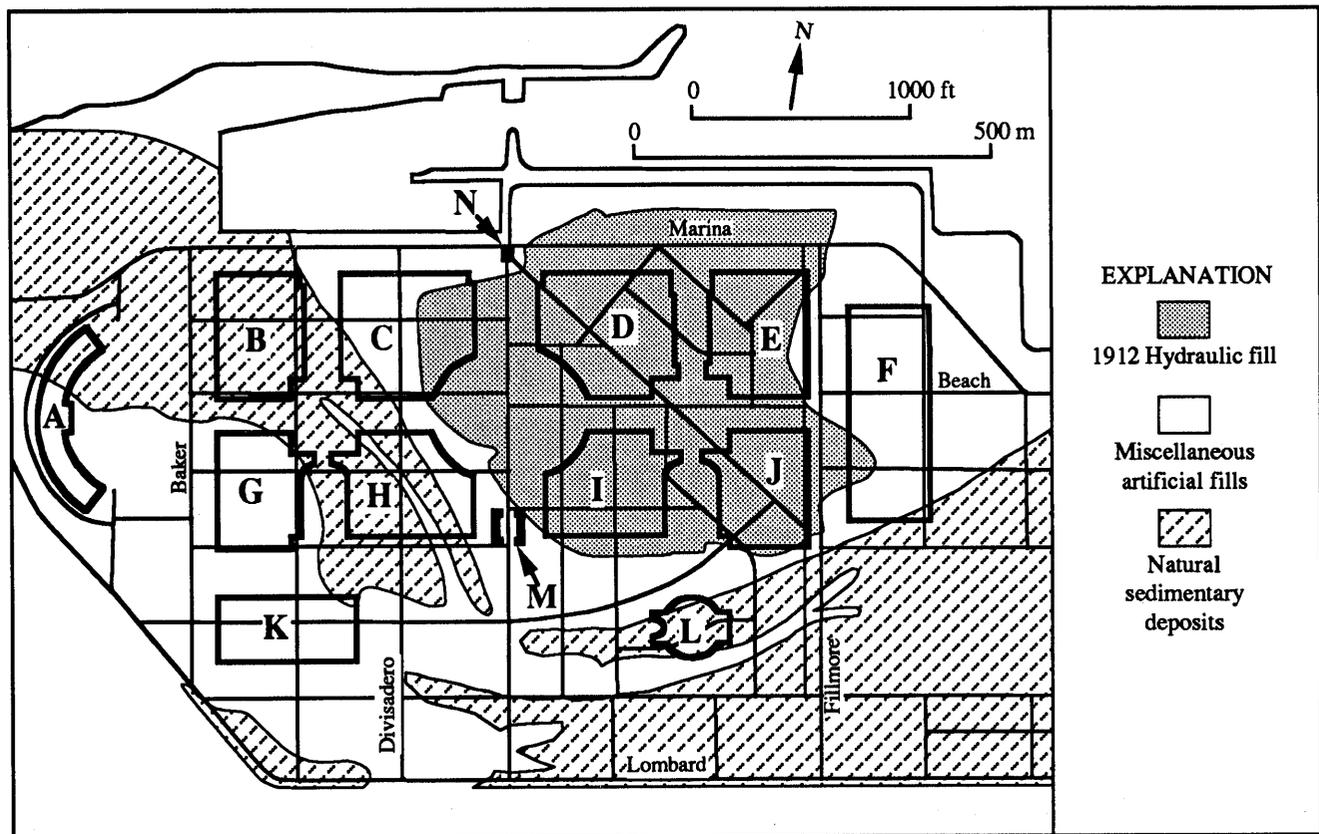
Figure 16.—Principal buildings of the 1915 Panama-Pacific International Exposition (letters; see table 2 for names), in relation to modern streets and simplified geology. Locations of exposition buildings from Todd (1921). Locations of buildings with respect to modern streets are based on location of Scott Street, the only exposition street that was centered on existing San Francisco streets (Markwart, 1915a, p. 75), and on location of the Palace of Fine Arts.

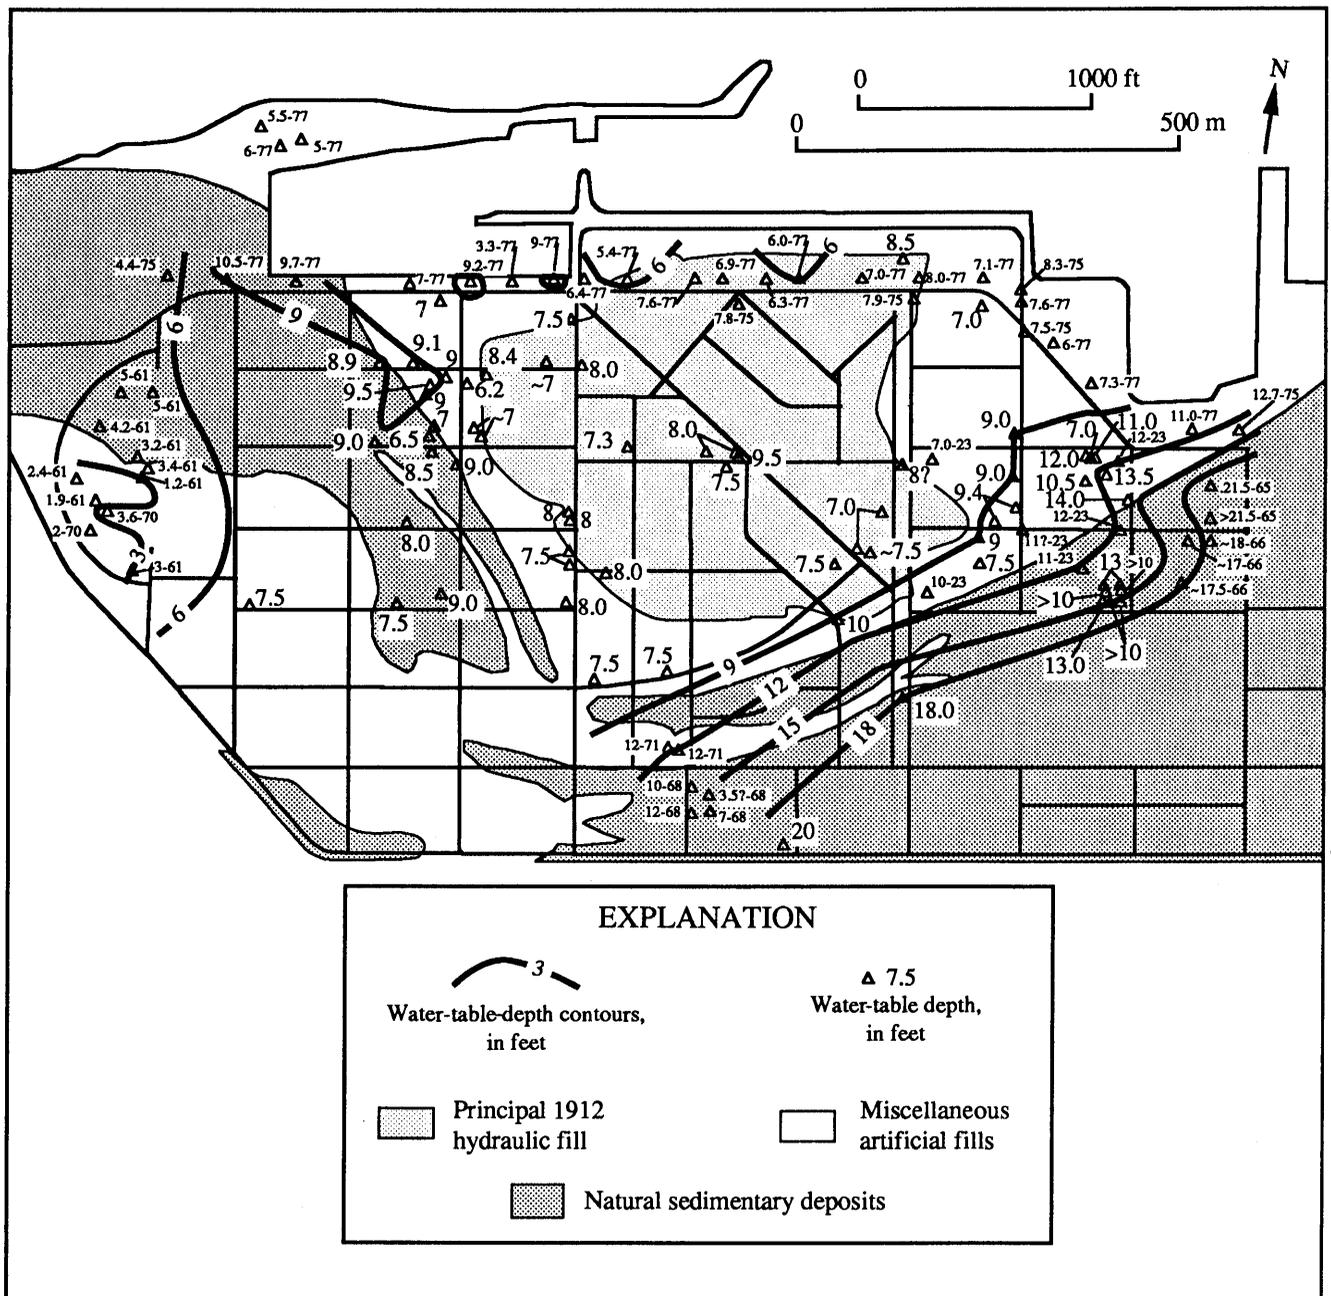
Depth to ground water is shown in figure 17. Because data are scarce, some water depths measured as long ago as 1923 are included; however, where both pre- and post-1980 depths are close together, they do not differ greatly, suggesting that water levels have changed very little. Pre-1980 measurements are identified in figure 17, which shows that ground-water depths are generally less than 2.7 m (9 ft) except in the southeastern part of the map area and a few other isolated areas.

Figure 17.—Marina District, showing depth to water table. Depths measured before 1980 are in smaller type, with last two digits of year of measurement following hyphen.

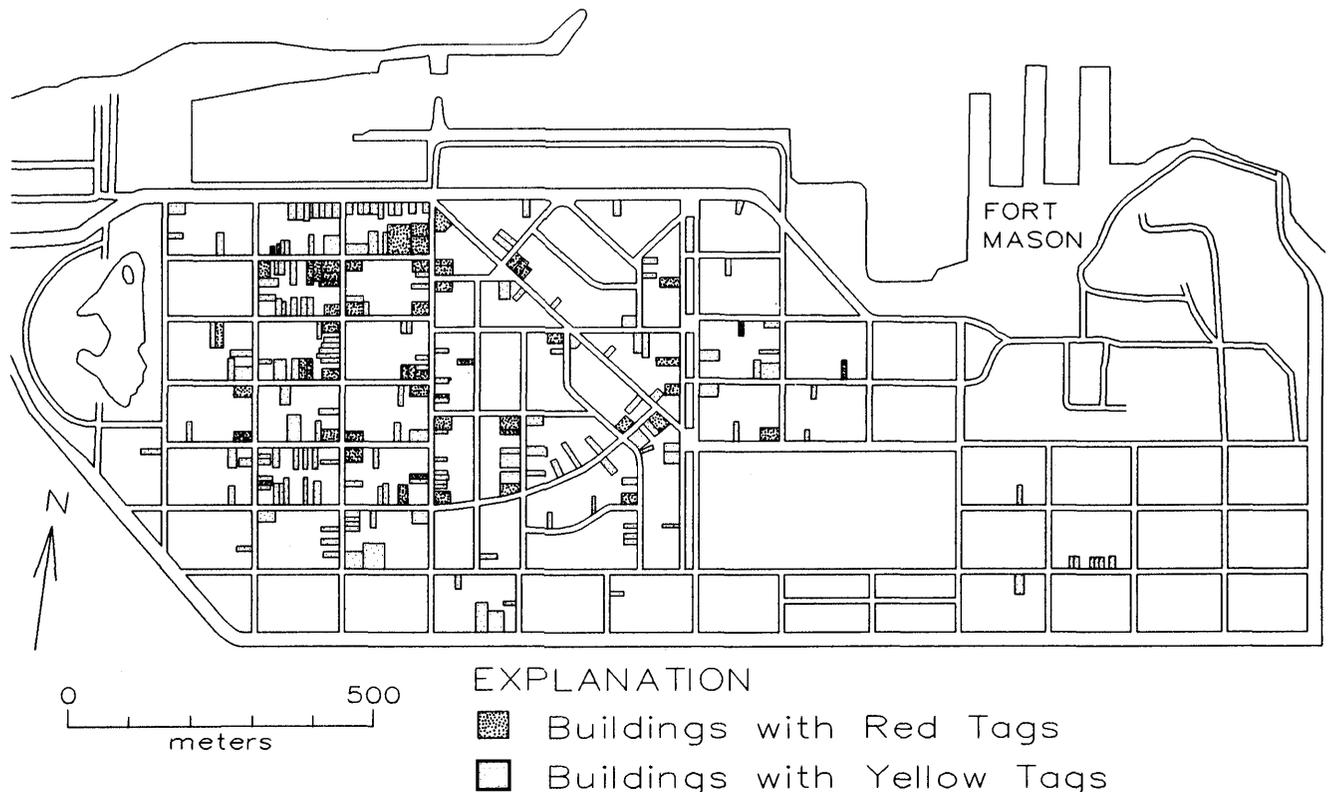
The extensive damage in the Marina District caused by the earthquake, as detailed in figure 1, suggests that the ground motion was significantly amplified relative to that in such nearby areas as Pacific Heights or Russian Hill. To investigate this amplification, the U.S. Geological Survey deployed seismometers with General Earthquake Observation System (GEOS) event recorders (Borcherdt and others, 1985) at 12 sites inside and just outside the Marina District for 3 weeks after the main shock. Despite the large epicentral distances (~100 km) and the relatively noisy urban environment, 14 aftershocks ranging in local magnitude (M_L) from 3 to 5 were recorded in the Marina District; two smaller earthquakes were recorded at epicentral distances of 20 and 35 km.

Figure 1.—Marina District of San Francisco, showing locations of red (unsafe for occupancy)- and yellow (dangerous)-tagged buildings. The set of tagged buildings was revised and updated by the City and County of San Francisco in fall 1990. Many red and yellow tags were originally issued to buildings for perceived danger from broken gas mains, asbestos, or possible collapse of a nearby building and were later upgraded; these buildings are plotted using the later tags. Red- and yellow-tagged buildings that were upgraded to yellow or green (no restriction on use) after repair work are plotted as originally tagged. A few demolished buildings are also included as red-tagged buildings.

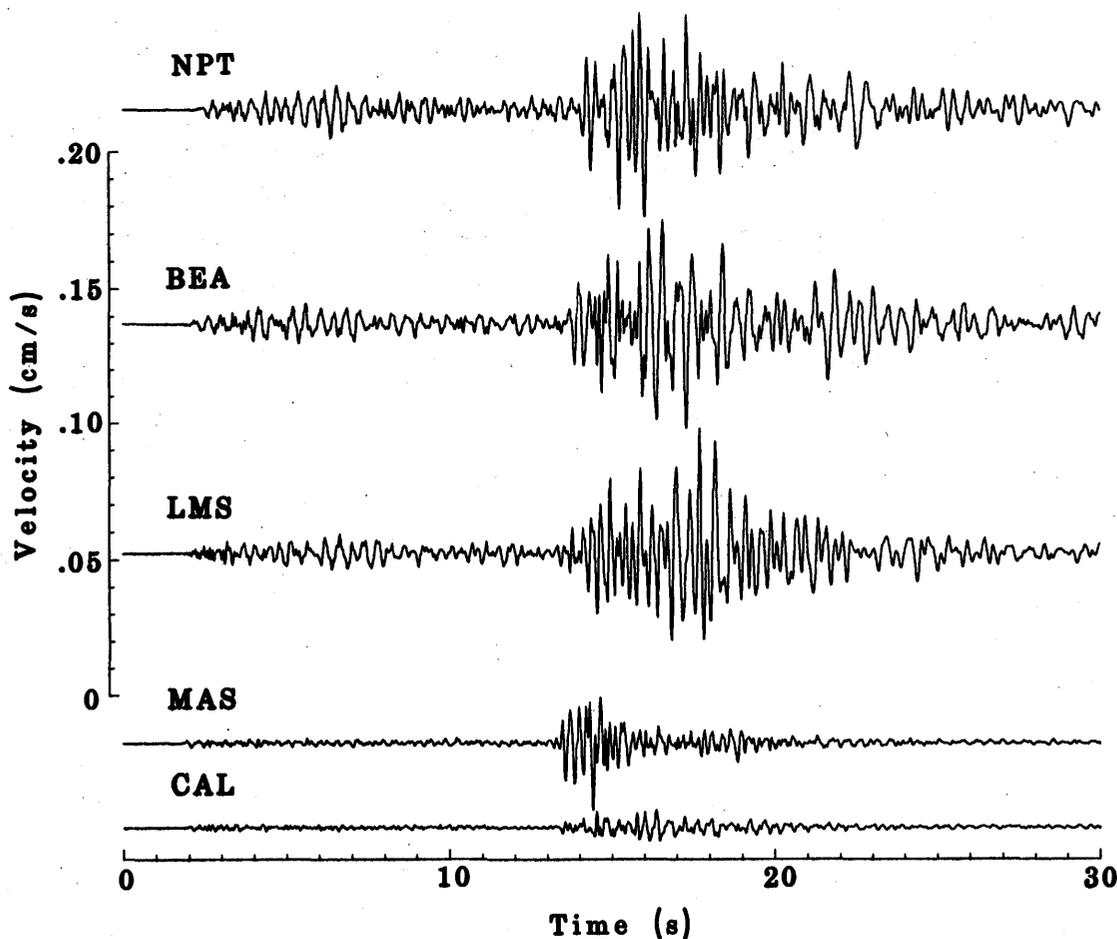
Figure 3.—East-west (EW) ground velocity for an $M_L=3.6$ aftershock (event 2990901, table 1) recorded at stations in the Marina District. *S* waves are strongest on east-west component, whereas *P* waves are weakest. Spectral amplitudes plotted in figure 4 are determined from 20-s samples starting approximately 2 s before *S*-wave arrival.

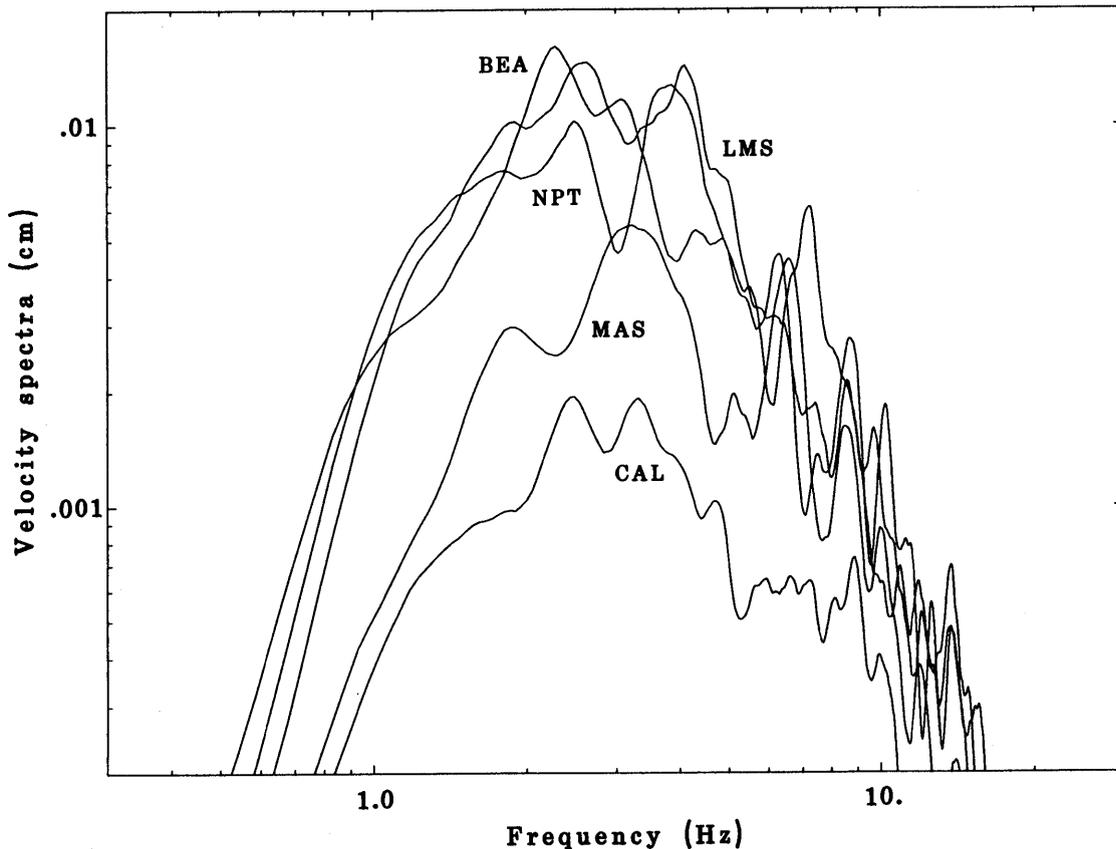
The spectral amplitudes of the shear waves are plotted in figure 4. The relative seismic amplification apparent in figure 3 is clearly delineated in the frequency domain. In particular, the spectral amplitudes of the shear waves recorded at station CAL are consistently the smallest among the five stations. Station MAS exhibits spectral amplitudes intermediate to those at station CAL on Pacific Heights and at stations in the Marina District. Station BEA

has a marked spectral peak at 2.2 Hz, whereas stations NPT and LMS have spectral peaks near 4.0 Hz, which is approximately the fundamental frequency for a three-story building with a wood frame.

Figure 4.—Spectral amplitudes of shear waves plotted in figure 3. Note that the spectra from the Marina District stations (NPT, BEA, LMS) are similar in overall amplitude, as the relative amplitudes of the recorded velocities suggest. For this event and this component, station MAS is amplified by a factor of 3 at 3 Hz relative to station CAL.

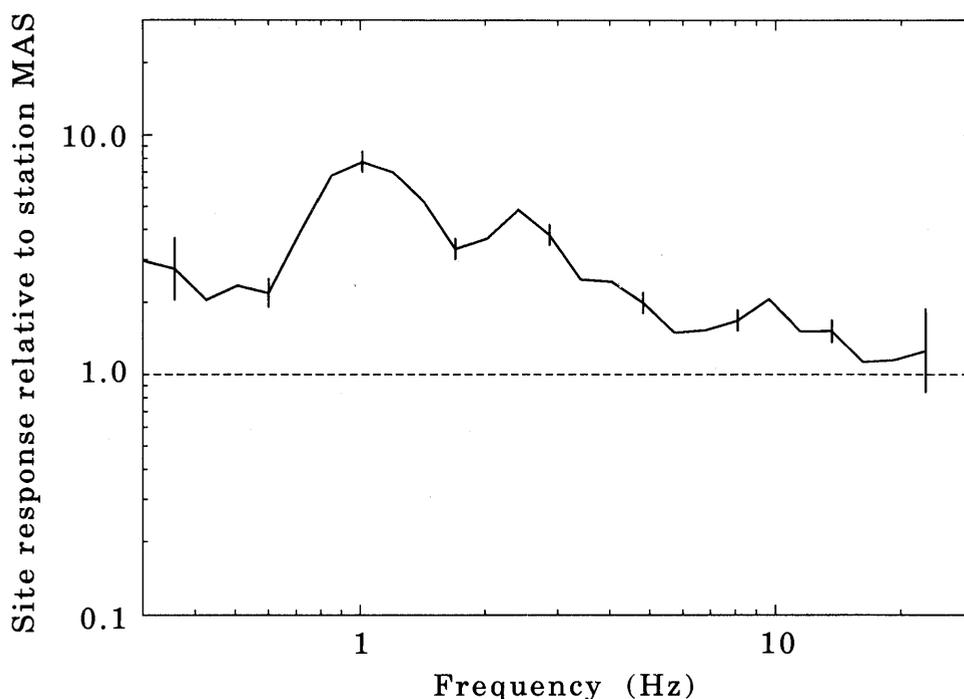
Figure 5.—Average site-response spectrum for shear waves at station NPT, relative to station MAS. Vertical bars show 68-percent confidence interval for spectral estimates. Relative site response is well determined from 0.7 to 15 Hz. At low frequencies, relative amplification is slightly larger than a factor of 2; it peaks around 1 Hz and decreases gradually with increasing frequency up to 15 Hz, where there is little relative amplification.

that was heavily damaged during the main shock (fig. 1). The relative site response, which is well determined within the frequency band from 0.6 Hz (1.6 s) to 15 Hz, is amplified by a factor of 7 near 1 Hz and decreases gradually with increasing frequency up to 15 Hz. At the lowest frequencies, the amplification is approximately a factor of 2 but is poorly resolved.

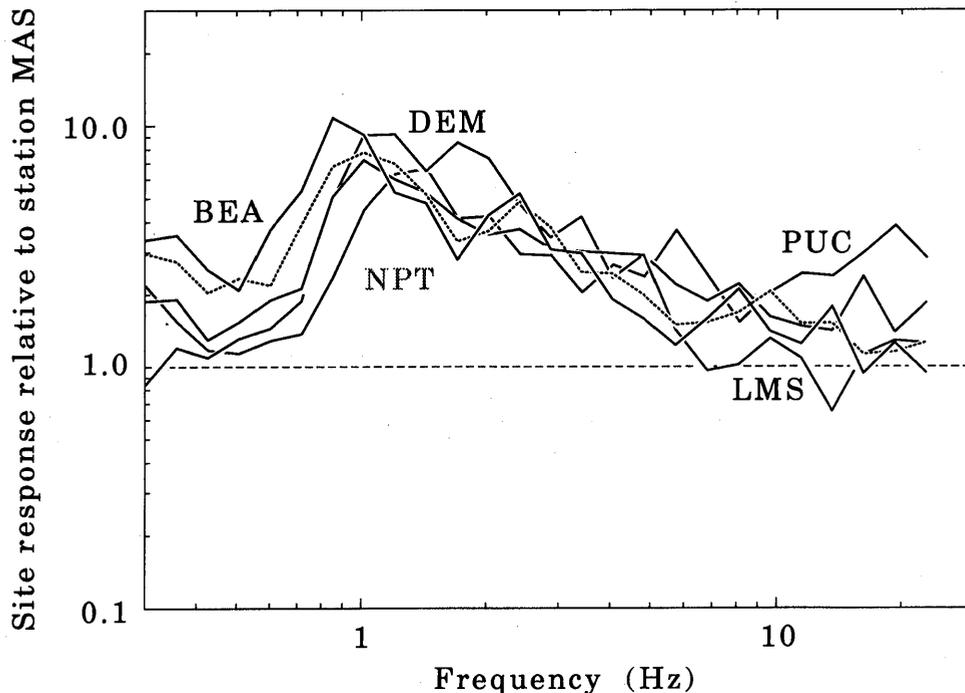
Figure 6.—Site-response spectra for shear waves at five stations in central part of the Marina District, relative to station MAS. Dotted line shows site response for station NPT. Although there is some variation between stations, the overall amplification is remarkably consistent, with a peak amplification of a factor of 7 to 10 near 1.0 Hz that gradually decreases with increasing frequency. Station PUC has the most amplification, and station LMS the least amplification, at high frequencies.

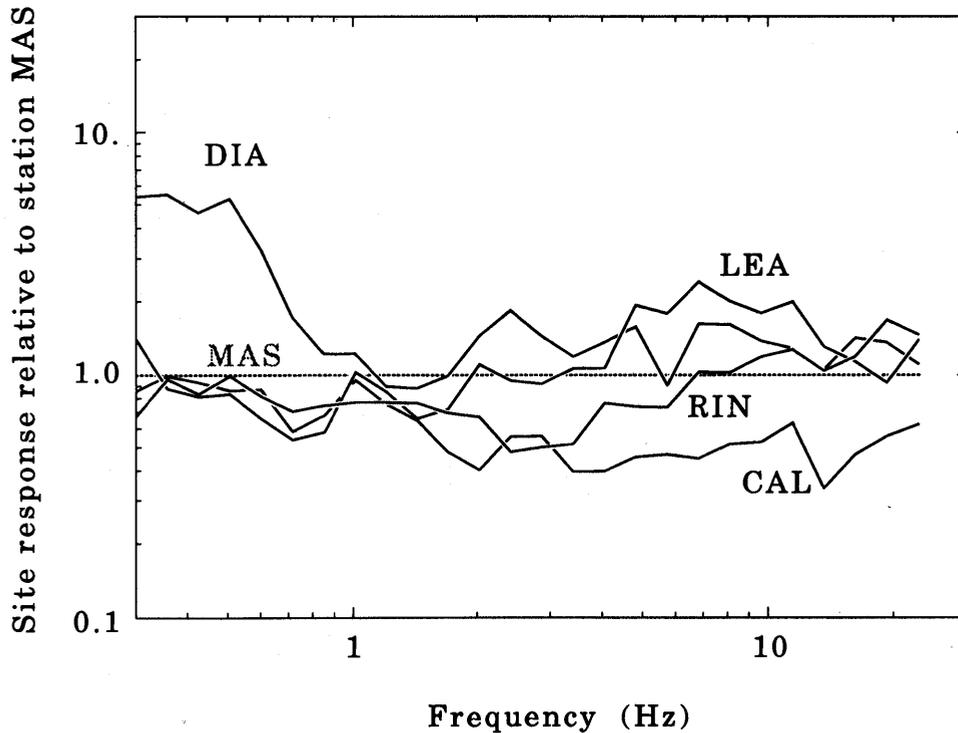
The site response at the hard-rock stations (fig. 7) indicates the significance of the seismic amplification in the Marina District. On average, these stations show no relative amplification within the frequency band from 0.3 to 20 Hz. At 5.0 to 15 Hz, the amplification at station LEA increases to a factor of 2, whereas the amplification at station CAL is approximately half that at station MAS at 2.0 to 20 Hz. Overall, the median amplification at these five stations is remarkably close to 1, justifying the description of station MAS as an "average" hard-rock station. The increase in the relative site response at low frequencies at station DIA is the result of a malfunctioning recorder: Gary Glassmoyer (oral commun., 1990) identified, but could not correct, a baseline offset in the recording of event 3112342 (table 1).

Figure 7.—Site-response spectra for shear waves at five hard-rock stations in San Francisco, relative to station MAS. Constraining station MAS yields a flat amplification of 1.0 (dotted line), close to the median site response for the other stations. Station CAL has the least amplification, and stations RIN and LEA the most amplification, reaching 2. Apparent amplification at low frequencies for station DIA is due to a malfunctioning recorder.

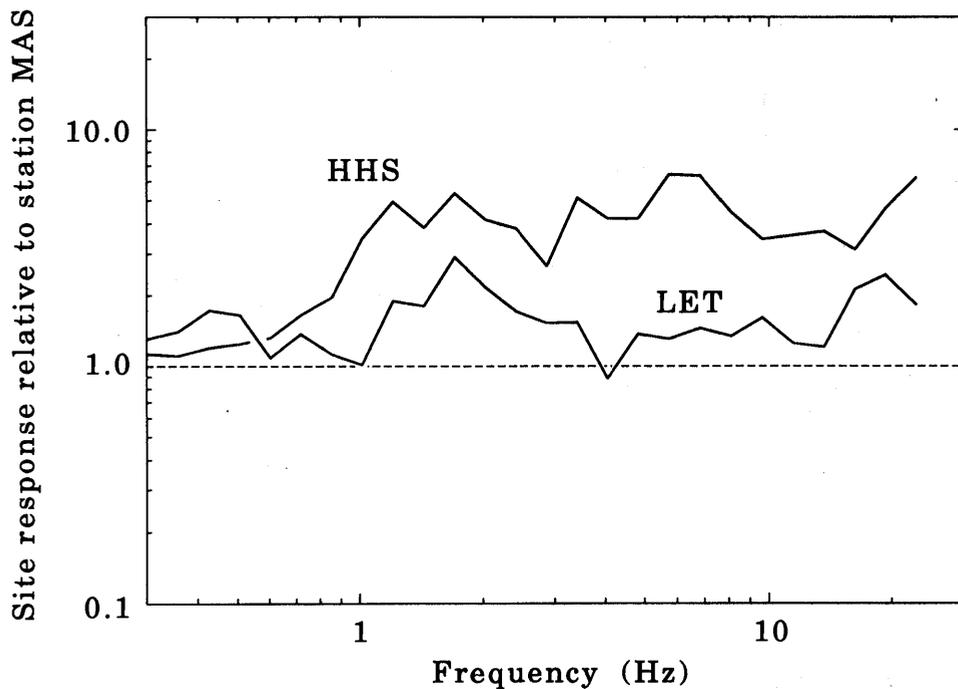
The site response at stations HHS and LET is plotted in figure 8. Comparison with figure 6 indicates a pronounced difference in the response between these stations and the five stations in the central part of the Marina District: Stations HHS and LET, located on dune sand and sediment, respectively, show little relative amplification at low frequencies; the amplification increases to 2–4 above 1 Hz. We note that the difference in

Figure 8.—Site-response spectra relative to station MAS for shear waves at two stations sited on dune sand and undivided sedimentary deposits inside and just outside the Marina District. Station LET is located at Letterman Army Medical Center in the Presidio, and station HHS in eastern part of the Marina District. Bedrock contours drawn by Bonilla (this chapter) indicate that the sedimentary basin underlying the Marina District is about 35 m thick beneath station HHS but does not extend westward beneath station LET.

relative amplification between stations HHS and LET correlates with the relative amount of damage in these two areas. There was little damage in the Presidio (LET), whereas the area near the Heritage House (HHS) sustained moderate damage (see fig. 1). Because Letterman Army Medical Center is a large (six story) building, the relative site response plotted in figure 8 is also conditioned by the building response.

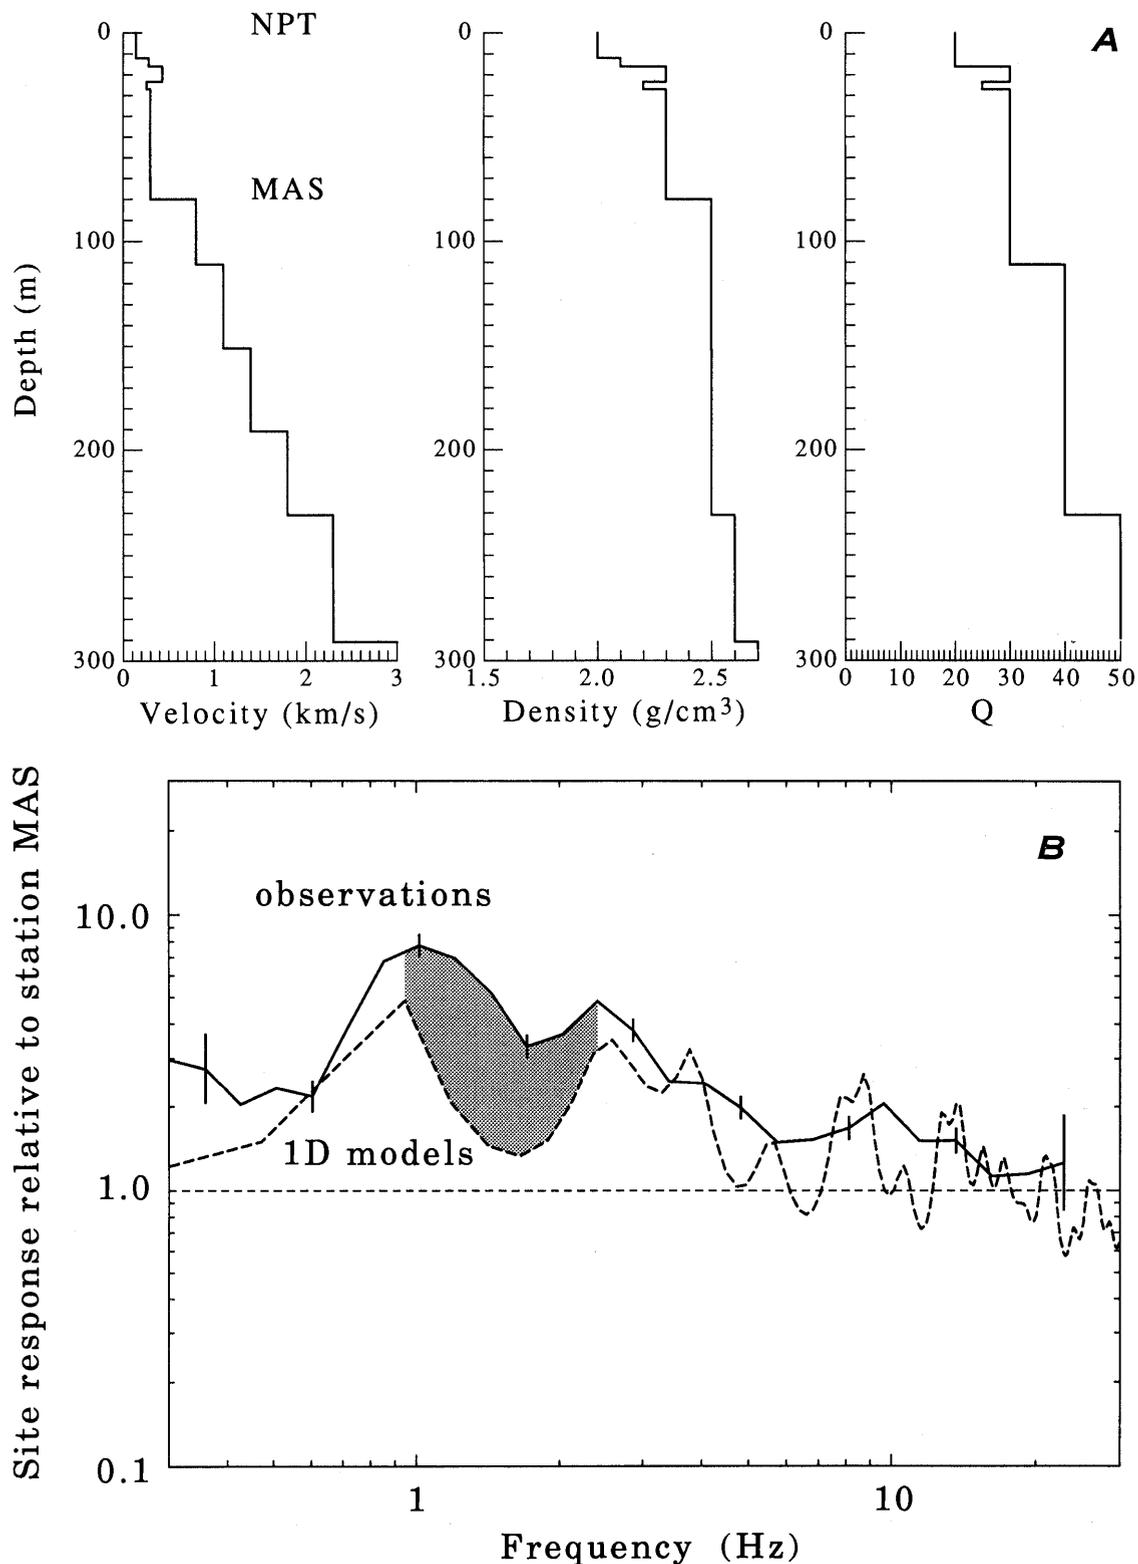
Figure 9.—One-dimensional model for ground-motion amplification. A, Distributions of shear-wave velocity, density, and Q values inferred for station NPT. Shear-wave velocity was logged by Kayen and others (1990) to a depth of 25 m, then extrapolated to Franciscan serpentine at 80 m, assuming a velocity of 300 m/s. Stepped increase in shear-wave velocity in the basement rock was chosen arbitrarily, as were the densities. Q structure was adjusted to fit observed spectral ratio at high frequencies. Velocity, density, and Q structure used to model station MAS were obtained by stripping the upper 80 m of structure used for station NPT. B, Observed spectral ratio compared to predicted amplification at station NPT, relative to station MAS. Fit at frequencies above 2.5 Hz was obtained by adjusting cumulative attenuation in the sedimentary deposits. Misfit between 1 and 2.5 Hz (shaded area) could be caused by seismic-focusing effects due to the shape of sedimentary basin; varying the velocity structure below 80-m depth does not improve this misfit.

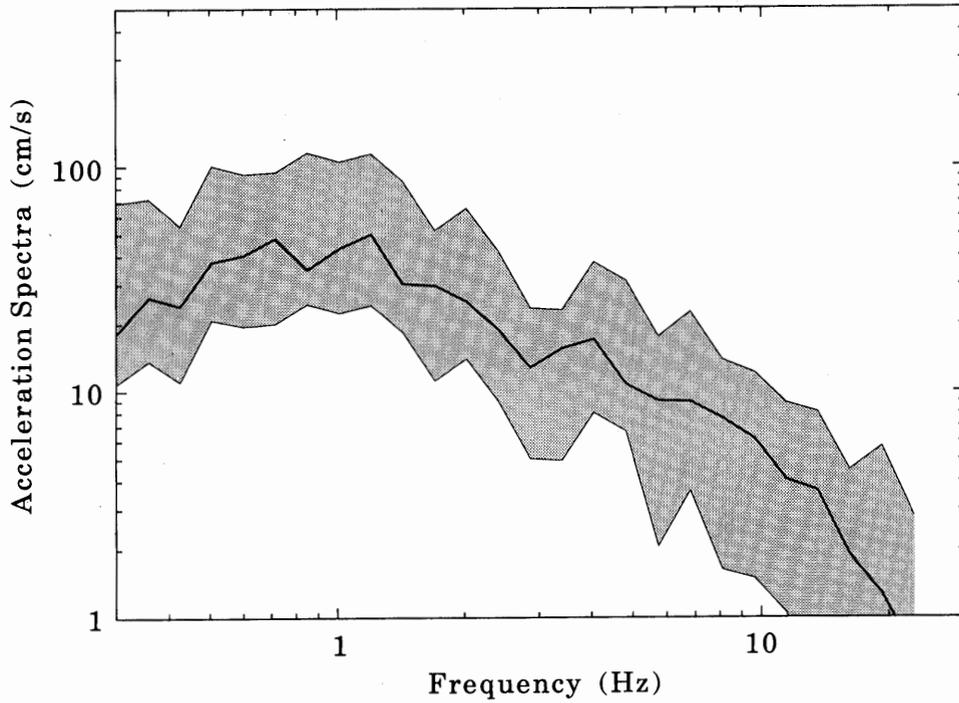
To test this procedure, we incorporate the main-shock spectrum at station CAL into the data set and extrapolate for station RIN. The recorded spectrum and the 68-percent-confidence limits for the extrapolated spectrum are plotted in figure 10. The recorded main-shock spectrum falls well within the confidence interval for this extrapolation, as determined from the variance defined in equation 3 and the number of main-shock accelerograms.

Figure 10.—Extrapolated acceleration spectrum, plotted as a 68-percent-confidence interval (shaded area), compared to acceleration spectrum for main shock from station RIN (heavy curve). Extrapolation was obtained using only the main-shock recording from station CAL, together with the set of aftershock recordings.

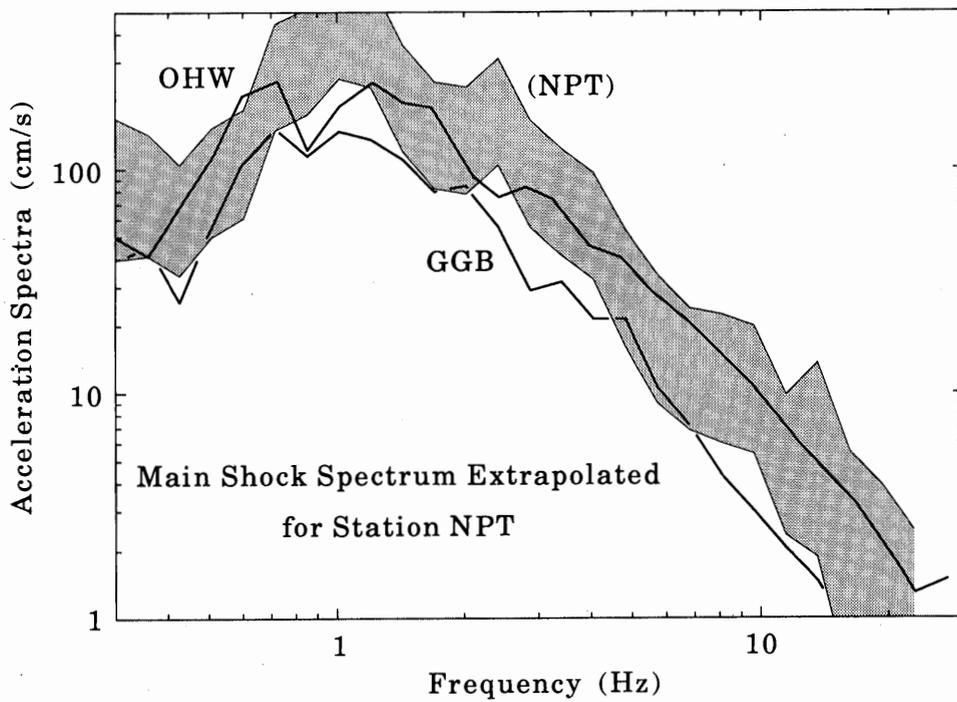
To extrapolate the ground motions in the central part of the Marina District for the main shock, we incorporate the main-shock spectra at stations CAL and RIN into the data set and extrapolate for station NPT. The extrapolated acceleration spectrum is plotted in figure 11. As shown in figure 5, the amplification at station NPT has a broad peak at 1 Hz and a "side lobe" at 2.3 Hz; these peaks are similarly evident in the extrapolated acceleration spectrum. Two main-shock acceleration spectra are also plotted in figure 11. The spectrum labeled "GGB" was obtained at a station located 2 km west of the Marina District, sited on Franciscan serpentine below the Toll Plaza of the Golden Gate Bridge. Station GGB recorded a peak ground acceleration of 0.25 *g*. The main-shock spectrum at station

Figure 11.—Extrapolated acceleration spectrum, plotted as 68-percent-confidence interval (shaded area), for main shock at station NPT, compared to acceleration spectra from two accelerograph sites that recorded the main shock. Station GGB is sited on Franciscan serpentine below the Toll Plaza of the Golden Gate Bridge; station OHW is sited on older bay clay and sand at the Outer Harbor Wharf in Oakland. These two stations recorded peak accelerations of 0.25 and 0.29 g, respectively.

GGB is a factor of 3 smaller than the extrapolated spectrum for station NPT near 1 Hz, and a factor of 2 smaller at most other frequencies. The spectrum labeled "OHW" was obtained at a station sited on sand and older bay deposits near the Outer Harbor Wharf in Oakland. Station OWH recorded a peak ground acceleration of 0.29 *g*, the largest acceleration of any station north of the San Francisco Airport. The extrapolated spectrum for station NPT exceeds the main-shock spectrum for station OHW at 1 and 2 to 3 Hz; the two spectra are similar at frequencies above 4 Hz.

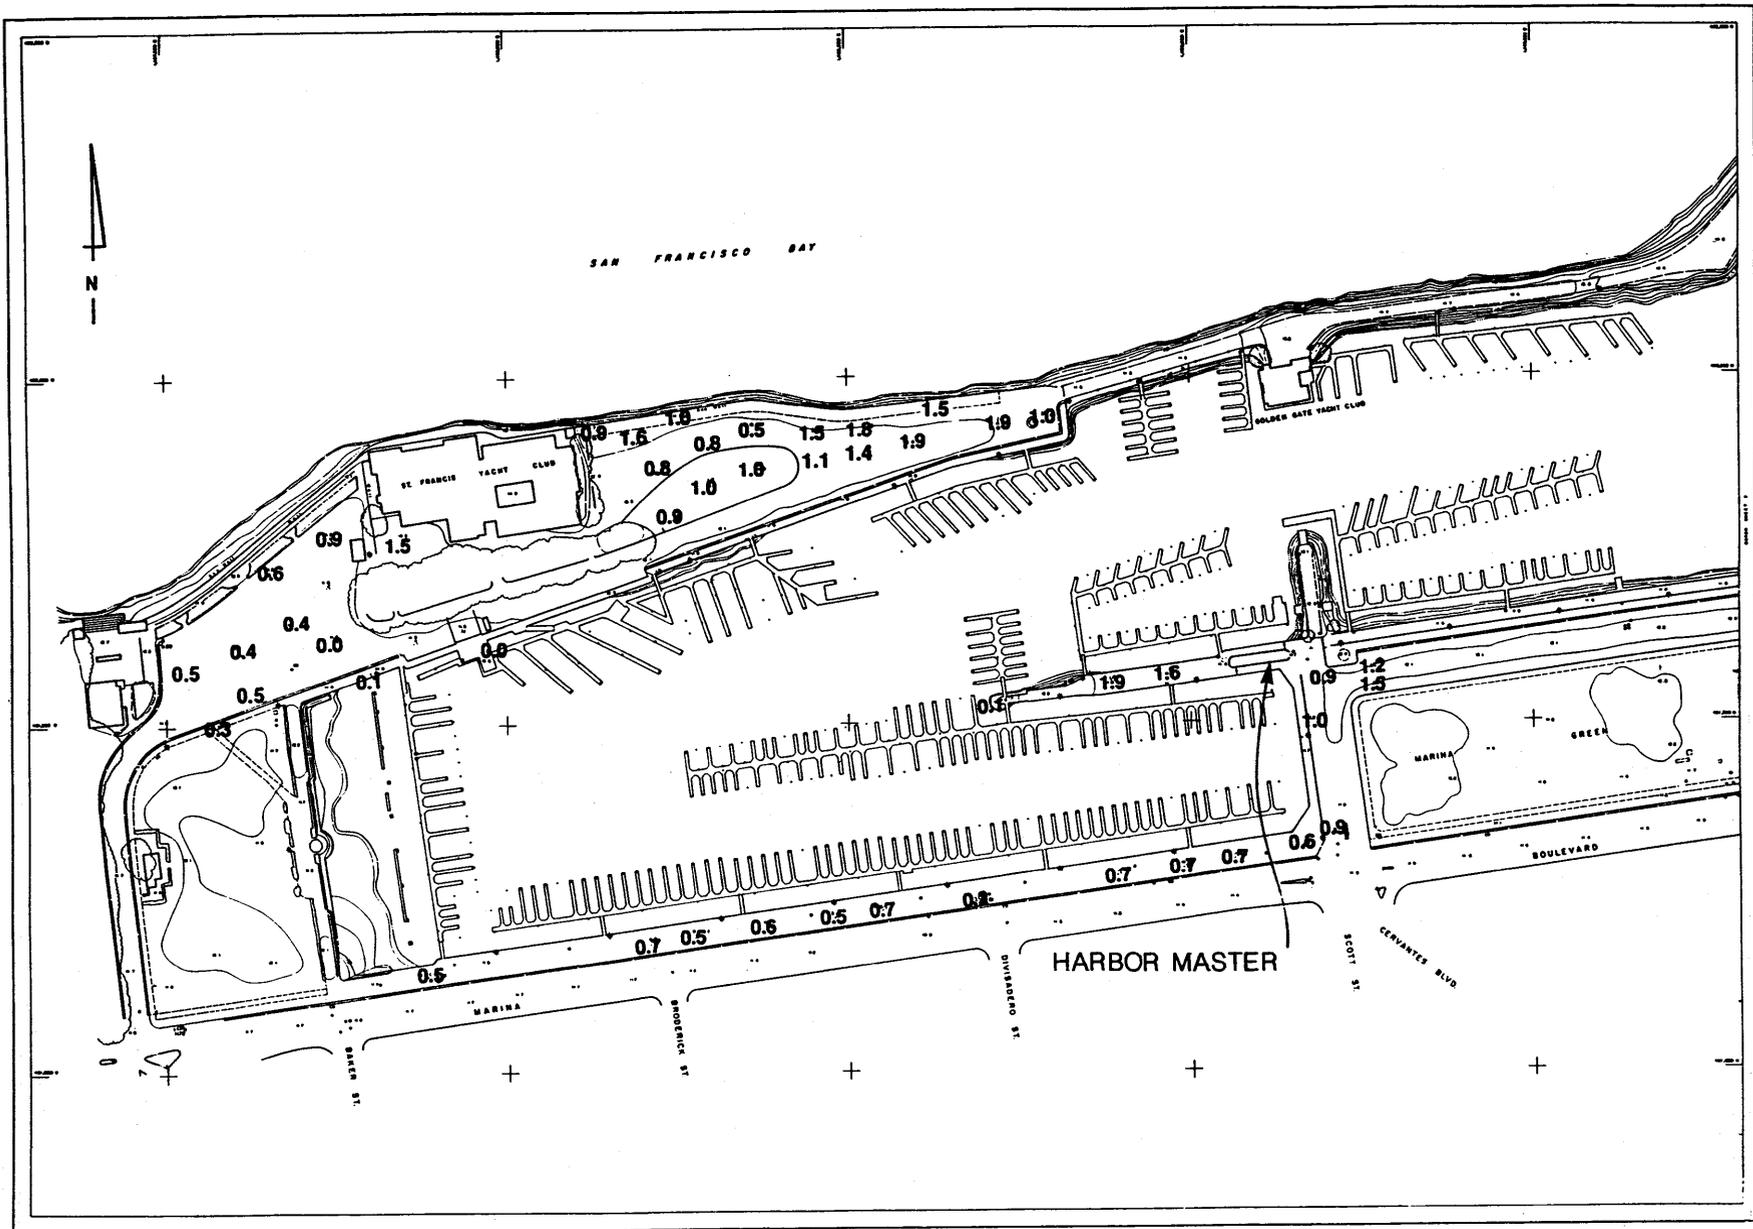
The approximate amounts of settlement along the shoreline between the two surveys are shown in figures 3 and 4. From 0.5 to almost 2 ft of settlement seems to have occurred in the vicinity of the St. Francis Yacht Club. On the basis of information obtained from the contractors who repaired the St. Francis Yacht Club, the maximum settlement of the ground at the yacht club was 0.5 to 1.0 ft. The pile-supported building, however, settled less than 1 in. In addition, visual inspection of those areas where large settlement is indicated does not appear to correlate with these high values. We cannot explain the discrepancies between the observed and calculated amounts of settlement in the vicinity of the St. Francis Yacht Club.

Figure 3.—Computed settlements of west side of Marina shoreline (in feet) between November 1987 and December 1989 surveys.

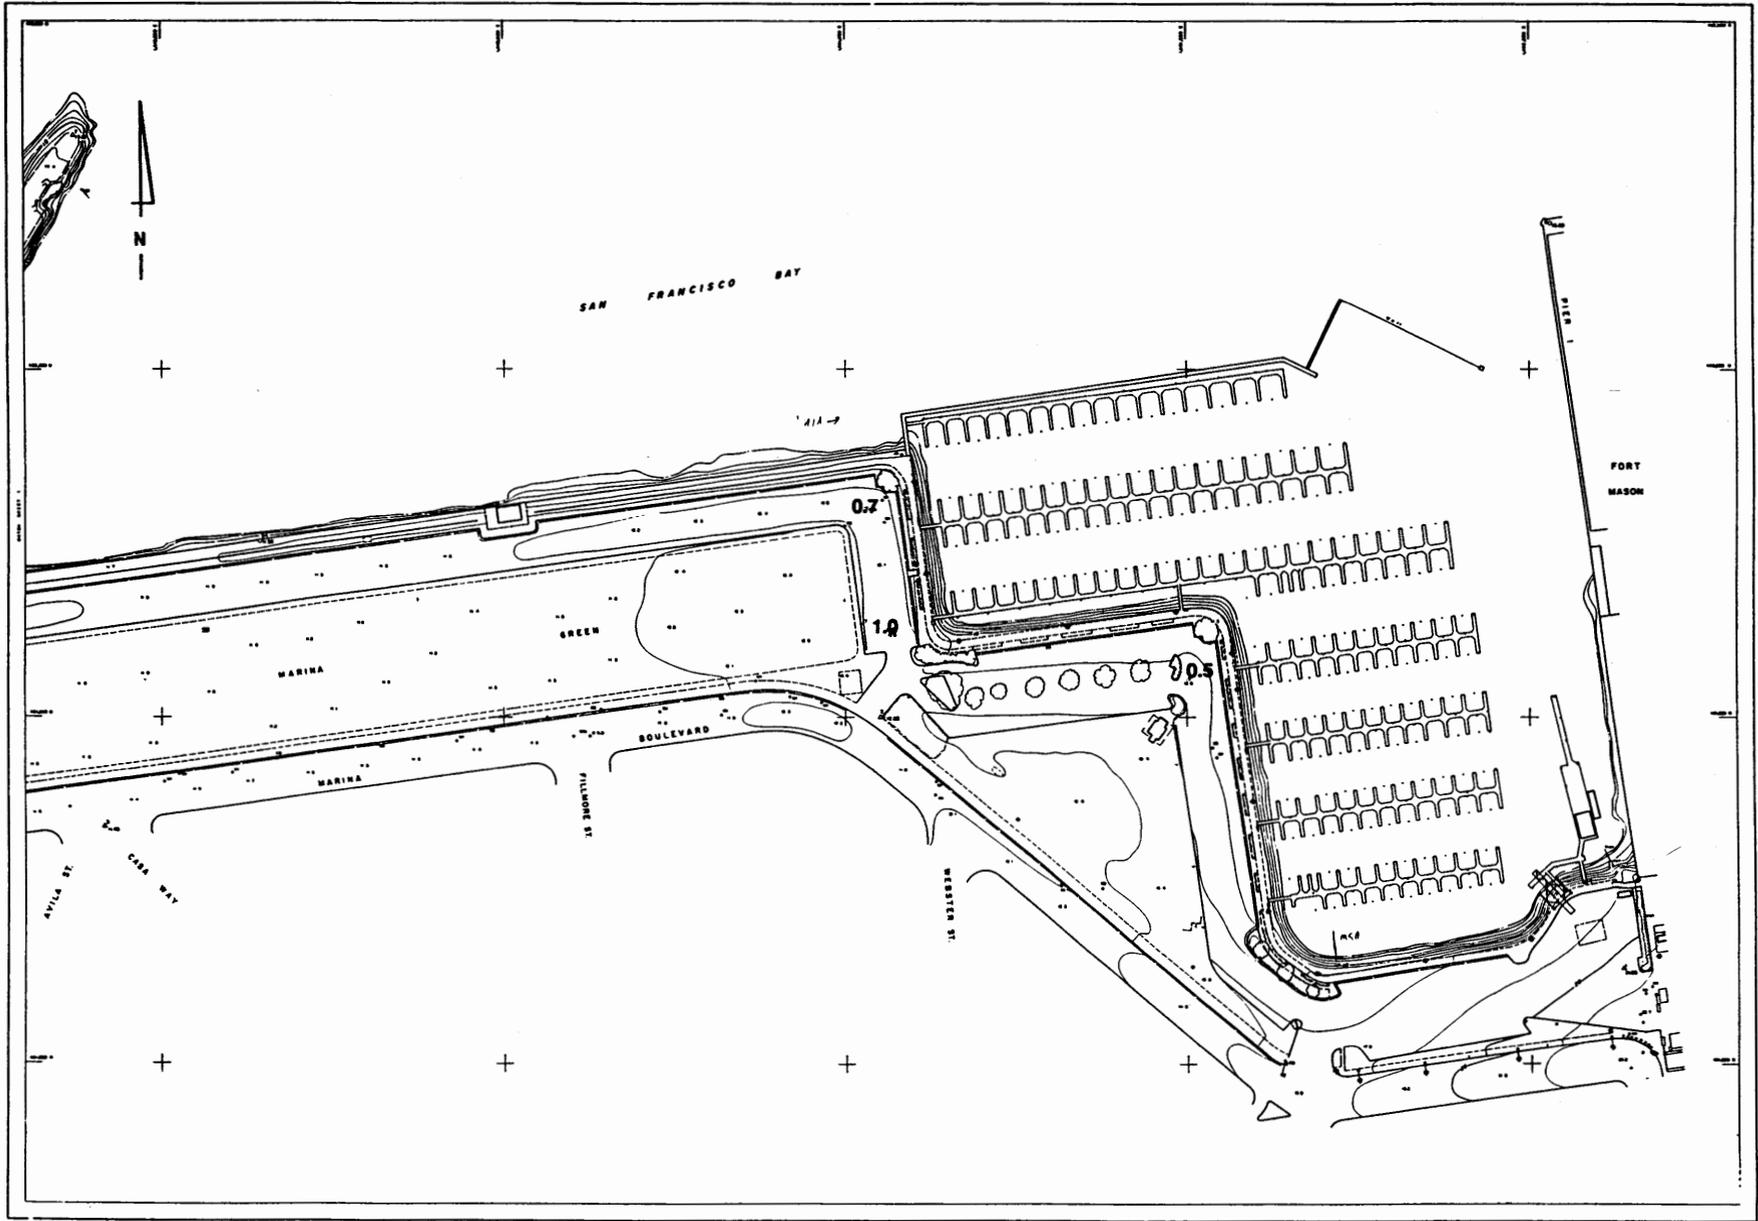
Figure 4.—Computed settlements of east side of Marina shoreline (in feet) between November 1987 and December 1989 surveys.
