The Loma Prieta, California, Earthquake of October 17, 1989—Marina District

STRONG GROUND MOTION AND GROUND FAILURE
THOMAS L. HOLZER, *Coordinator*

U.S. GEOLOGICAL SURVEY PROFESSIONAL PAPER 1551-F

MARINA DISTRICT

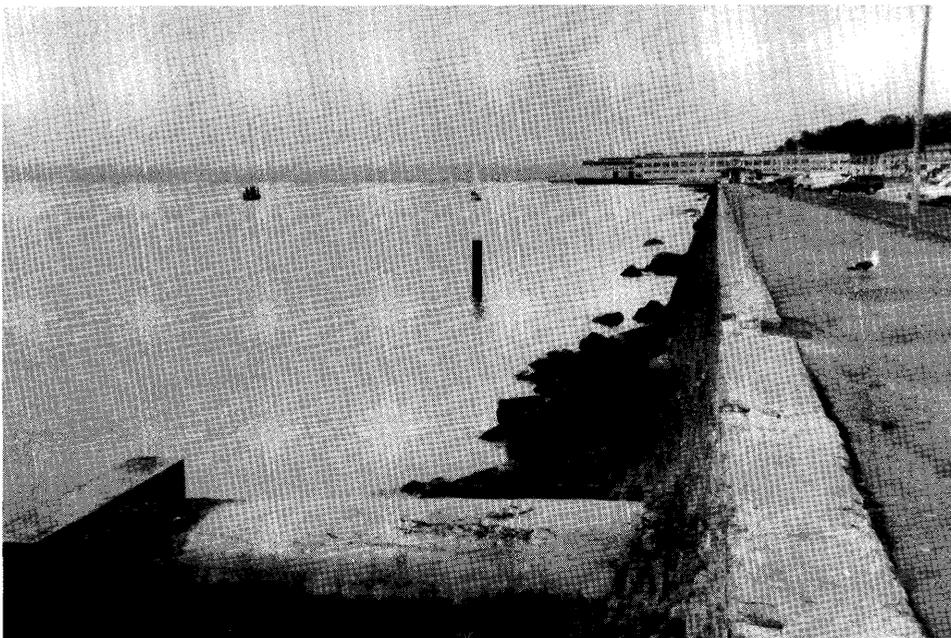
Boulevard showed no evidence of any significant horizontal movement. The masonry seawall along San Francisco Bay just north of the Marina Green is believed to be supported on spread-footing foundations on top of Fair's seawall. This masonry seawall showed no evidence of uneven lateral movement or settlement (fig. 9), but there was a crack a few inches wide parallel to, and about 30 to 50 ft behind, the seawall. There was no evidence of lateral

Figure 9.—Masonry wall above Fair's seawall. Note storm-sewer outfall in foreground. Photograph taken in 1991.

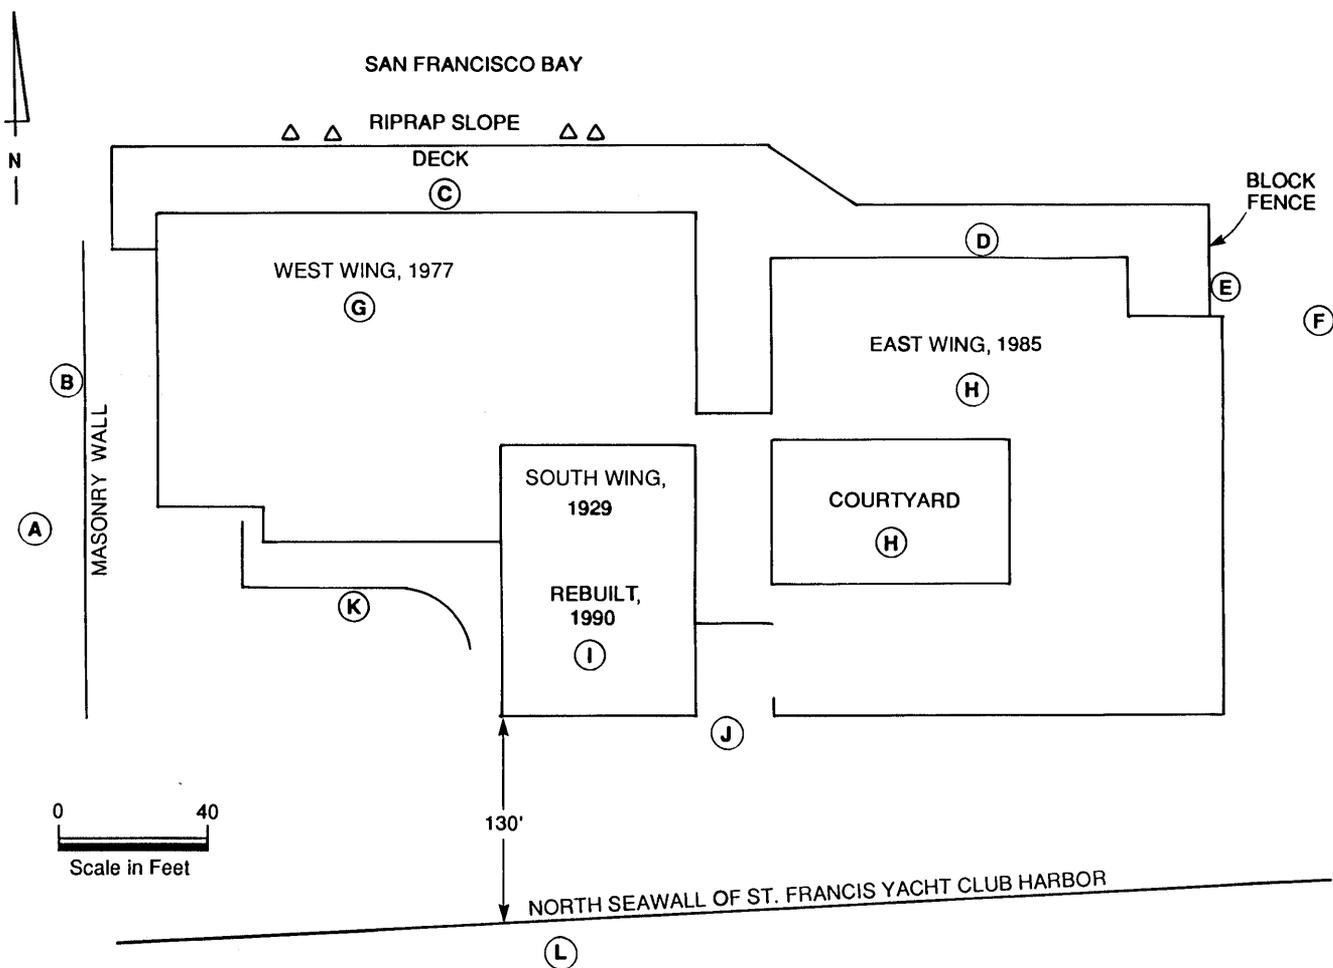
Because most of the St. Francis Yacht Club building is a relatively new structure supported on long concrete pilings, it is a reference point for judging both lateral spreading and vertical settlement. Observed movements are mapped in figure 10 and detailed below:

| G--- | West wing built in 1977 after original building was destroyed by fire. New 16-in.-square prestressed piles 85 to 90 ft long were driven. Floor slab was poured on top of old wood-pile-supported deck, leaving about 2 ft of clearspace above ground surface. Moderate damage to utilities supported on ground. Building within 1 in. of level but estimated to have shifted northward 2 to 4 in. |
| J --- | Slabs on ground settled about 4 in. more than adjacent building and moved southward from building 4 to 6 in. |
| K--- | Soil adjacent to pile-supported entrance slab indicated 6 to 8 in. of vertical and lateral movement. |

Figure 10.—Sketch plan of the St. Francis Yacht Club. Letters denote locations referred to in text.

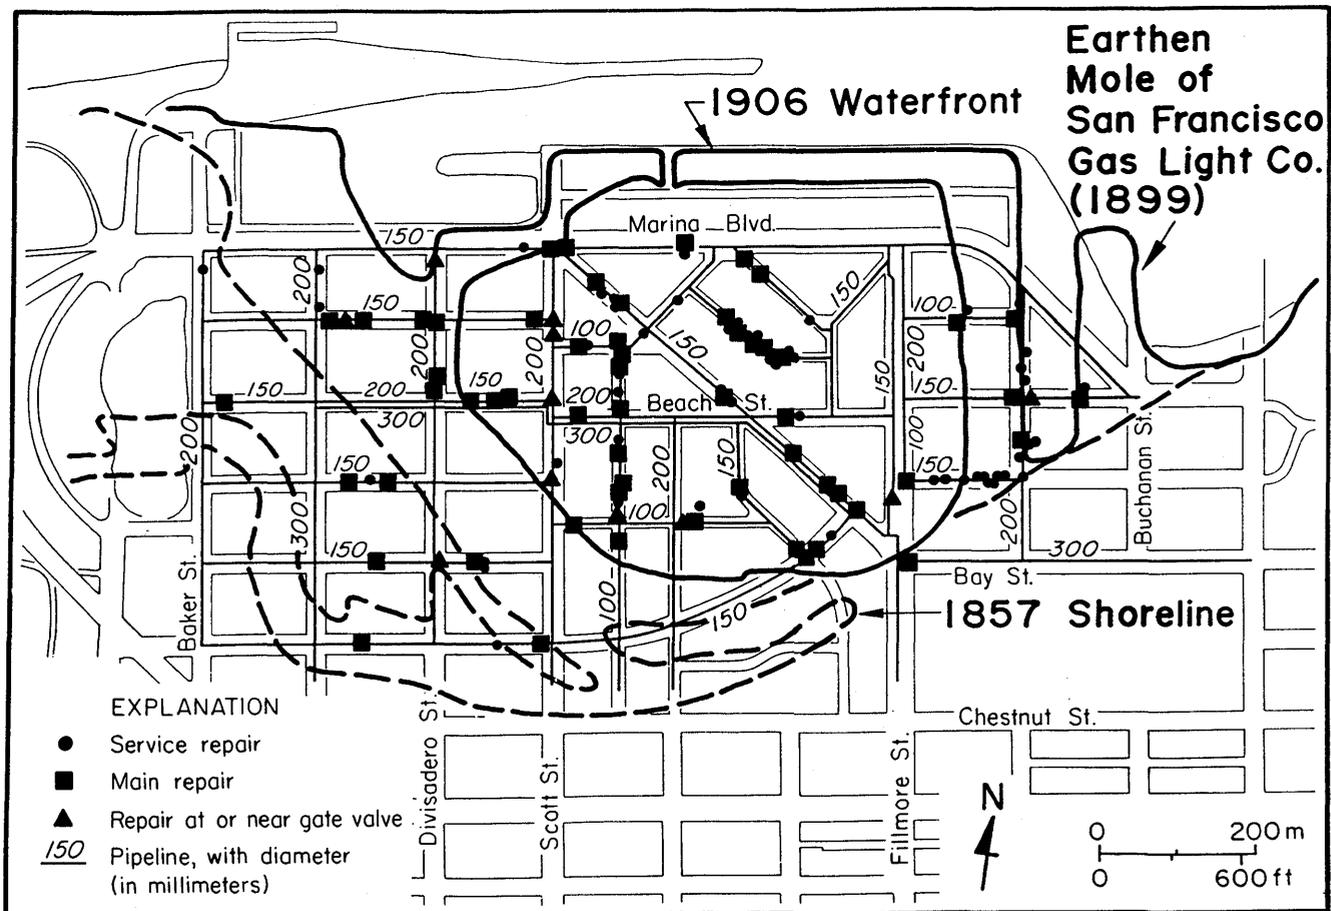
times the number in the entire MWSS elsewhere. A total of 69 repairs were made to mains, including those at or near gate valves; more than 80 percent of these repairs were attributed to flexural round cracks. In contrast, only one leaking joint was found in a 300-mm-diameter AWSS pipeline out of 2,290 m of 250- and 300-mm-diameter pipelines within the area of MWSS damage described above, resulting in a repair rate of only 0.43 per kilometer.

Figure 3.—Marina District, showing locations of repairs to MWSS mains, service lines, and sections at or near gate valves as of November 1, 1989.

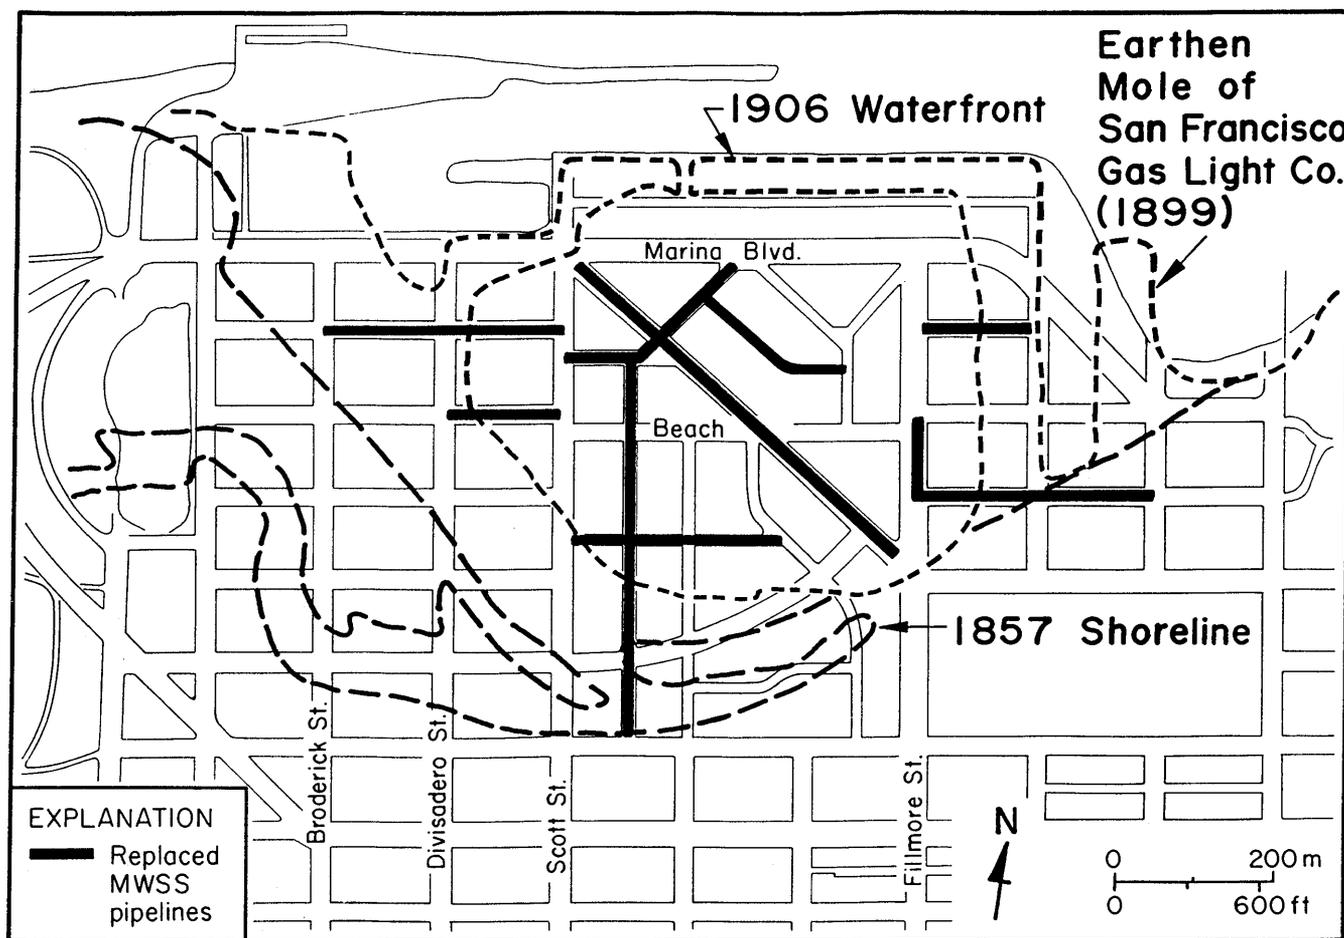
most heavily damaged in areas of greatest surface settlement and so are most likely to be subject to continuing rupture and maintenance difficulties in the future. Approximately 2.7 km of mains was replaced, primarily in or immediately adjacent to areas underlain by hydraulic fill.

Figure 4.—Marina District, showing locations of MWSS pipelines replaced about 6 months after initial repairs illustrated in figure 3.

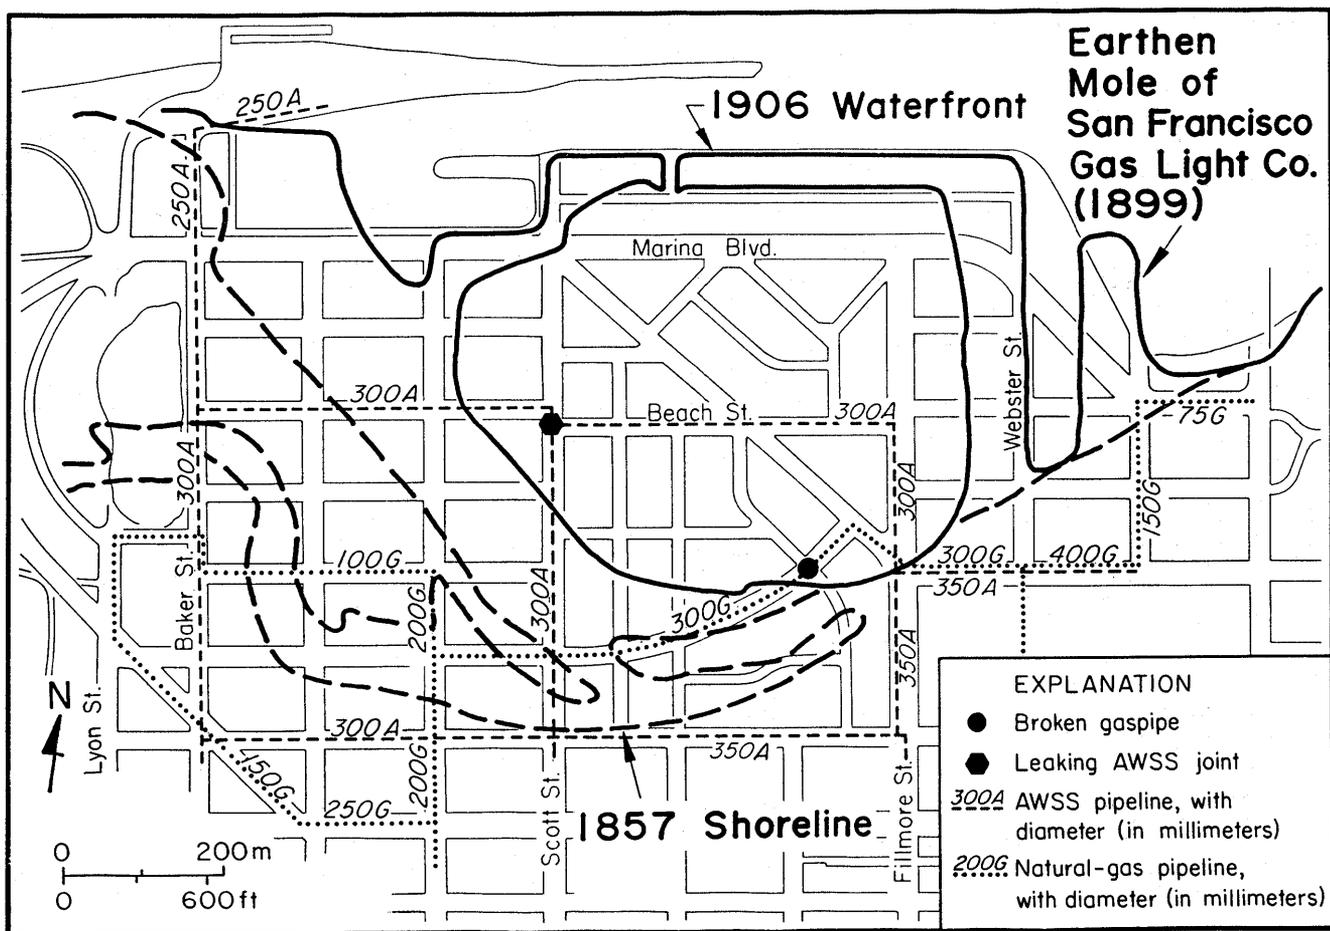
Even though the MWSS was substantially damaged in the Marina District, the AWSS was repaired at only one place, at a leaking joint at Scott and Beach Streets (fig. 5). The MWSS pipeline damage reported by the San Francisco Water Department as of November 1, 1989, is summarized in table 1. Service connections typically are made with pipe substantially smaller than the main, and in many places, the performance of service connections cannot be linked directly with the diameter of the main. Thus, the service repairs listed in table 1 are omitted from the repair rate based on pipe diameter but are included in the total

Figure 5.—Marina District, showing locations of damage to AWSS and high-pressure gas-distribution system. Approximately 13.6 km of low-pressure gas-distribution mains that were replaced after the earthquake is omitted for simplicity.

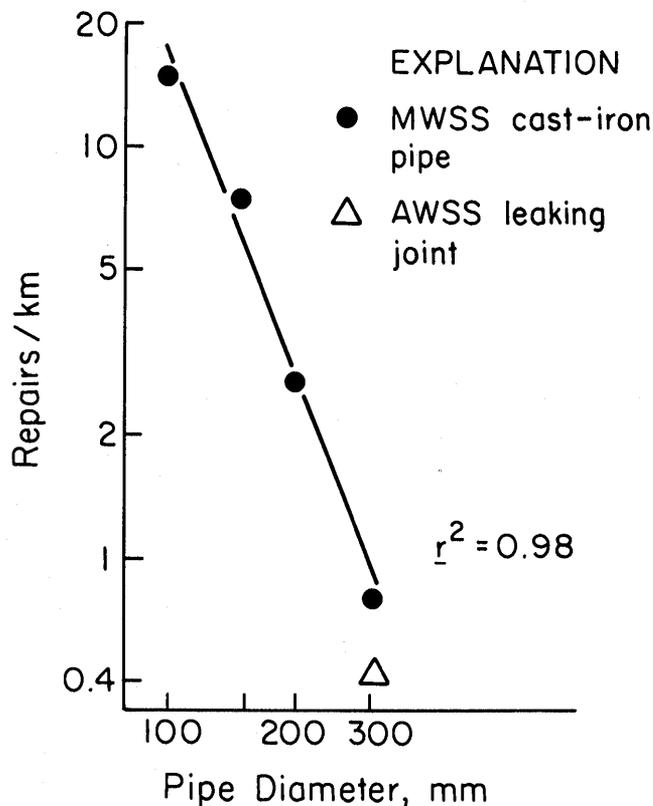
The repair rates for MWSS and AWSS pipelines are plotted on a logarithmic scale as a function of nominal pipe diameter in figure 6. The slope of the linear regression is approximately -3, implying that pipeline repair was inversely proportional to the cube of the pipe diameter. Because the moment of inertia of a given pipe is a function of the cube of its diameter, the regression analysis indicates that damage was influenced strongly by the longitudinal bending resistance of the pipelines. Thus, it appears that bending stress caused by differential settlement of the underlying soil was the main cause of pipe failure and that resistance to such stress, resulting from

Figure 6.—Linear regression of repair rate versus nominal pipe diameter for MWSS and AWSS mains in the Marina District. Only repairs to MWSS mains, including sections at or near gate valves, were used in regression analysis.

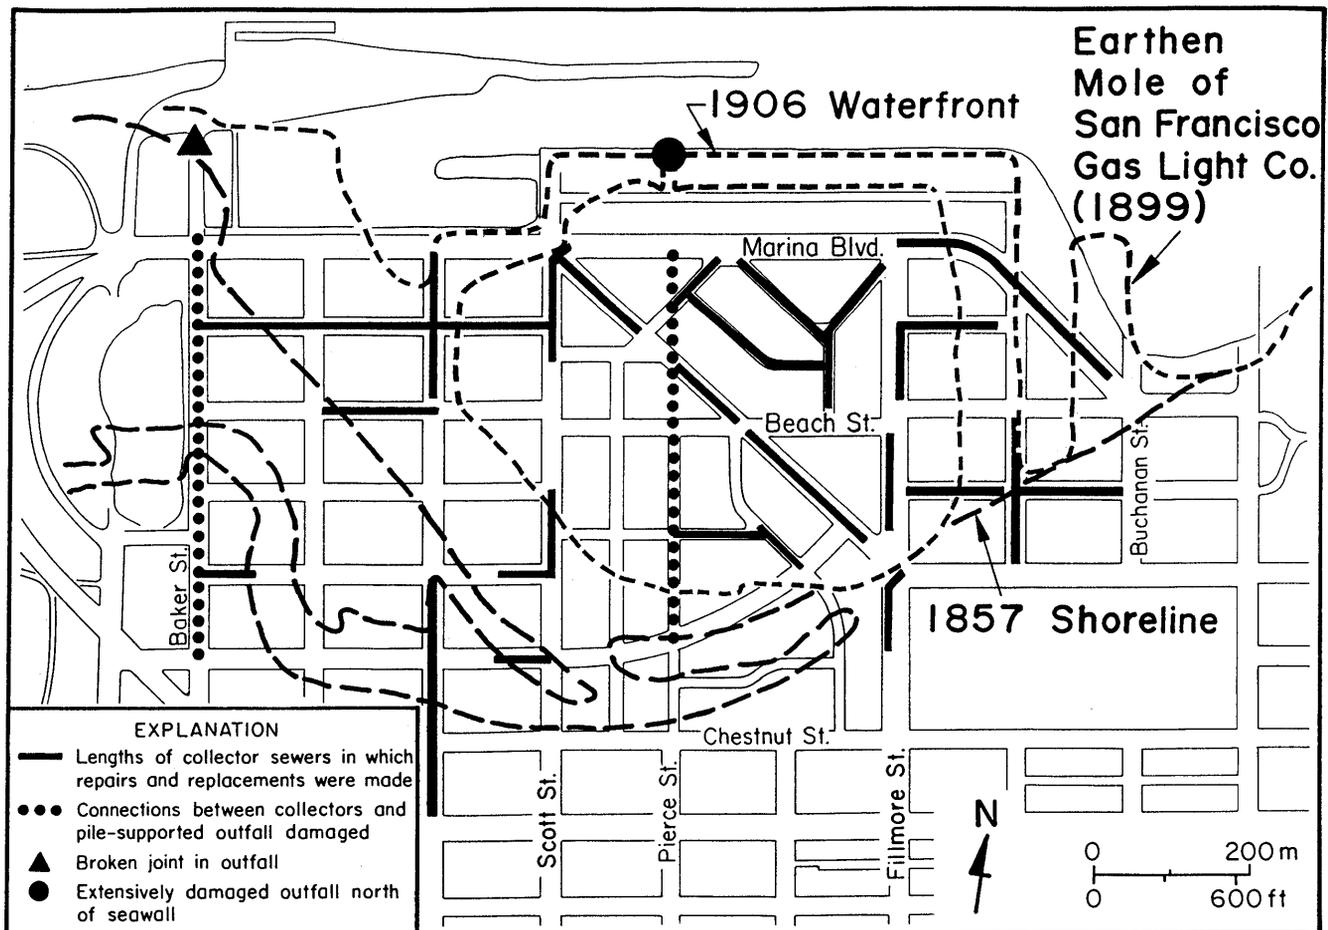
Figure 7.—Marina District, showing locations of damage to wastewater-conveyance pipelines.

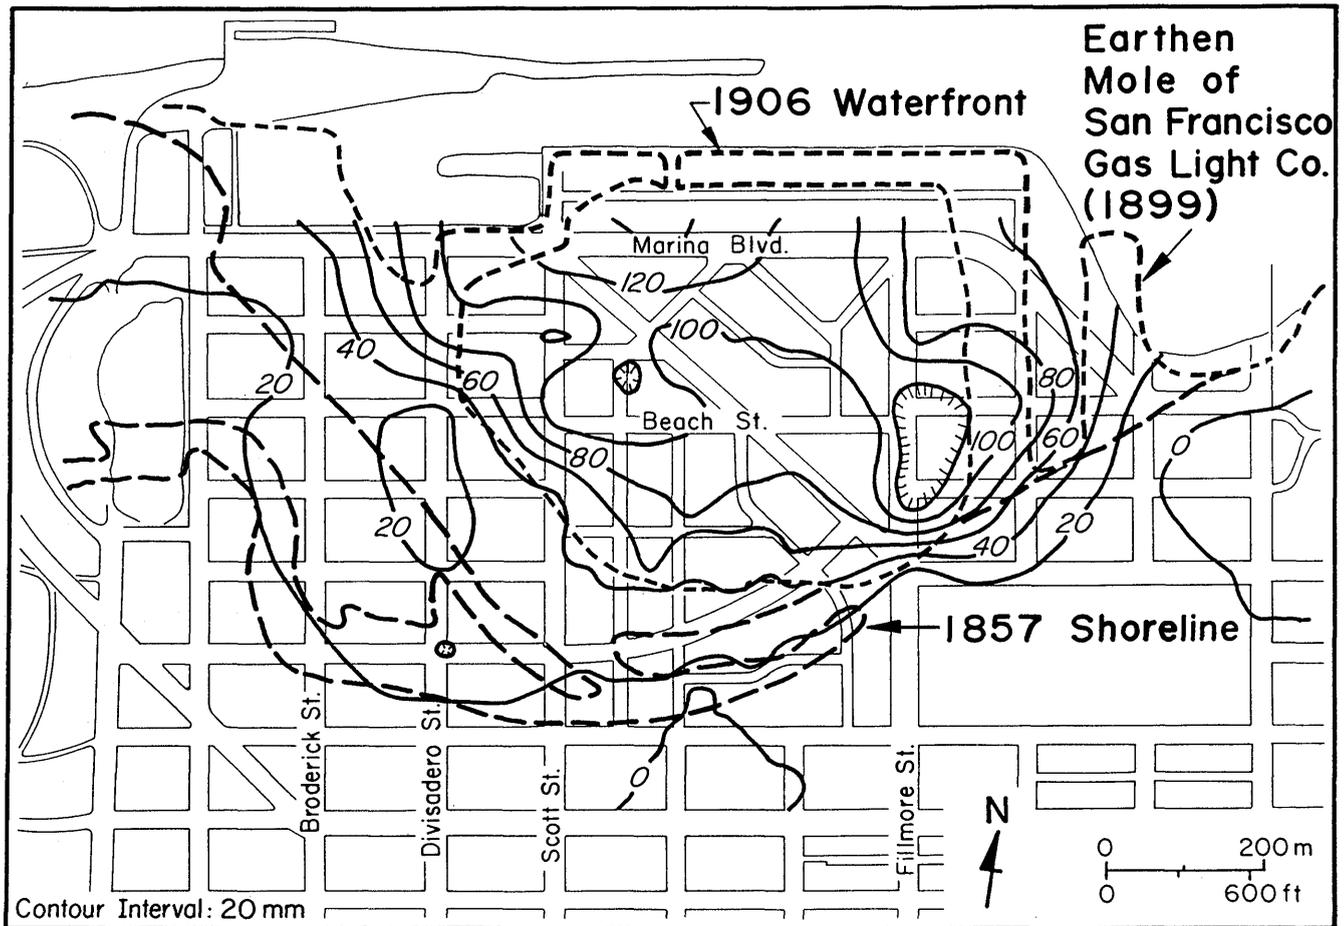
Figure 8.—Marina District, showing contours of settlement caused by the earthquake, calculated from 1961, 1974, and 1989 survey data reported by Bennett (1990). Settlements were adjusted for secondary compression between 1974 and 1989 of underlying Holocene bay mud, as inferred from 1961–74 settlement measurements. Hachures indicate area of closed low.

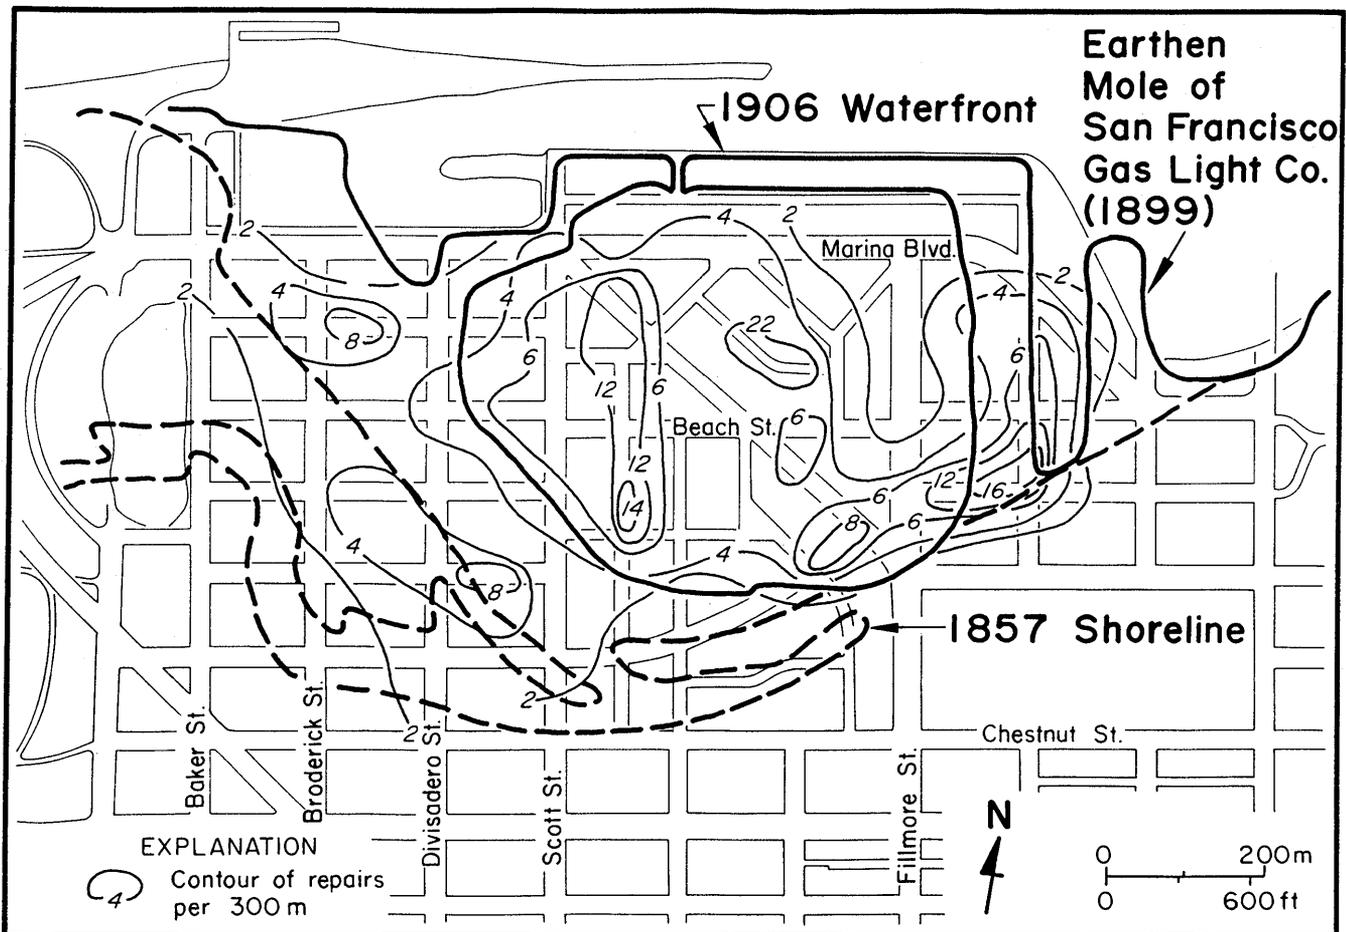
Figure 9.—Marina District, showing contours of MWSS repair rates per 300 m, including damage to mains, service lines, and sections at or near gate valves. Anomolously high contour of 22 per 300 m represents a pipeline installed along a relatively sharp curve on Rico Way, thus vulnerable to earthquake effects because of installation stresses and constraints imposed at joints.

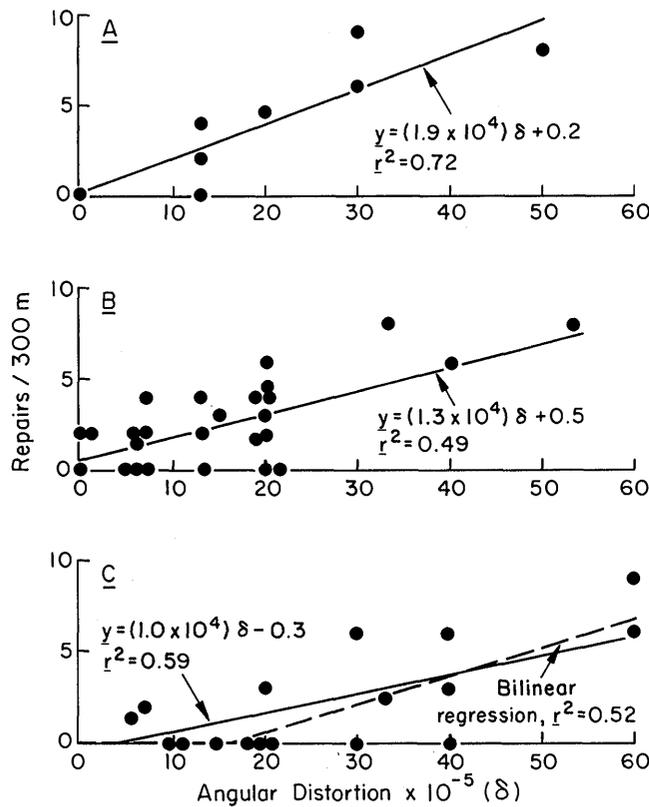
Figure 10.—Linear regressions of MWSS repair rate versus angular distortion (local slope of settlement profile) for water mains 100 (A), 150 (B), and 200 mm in diameter (C).

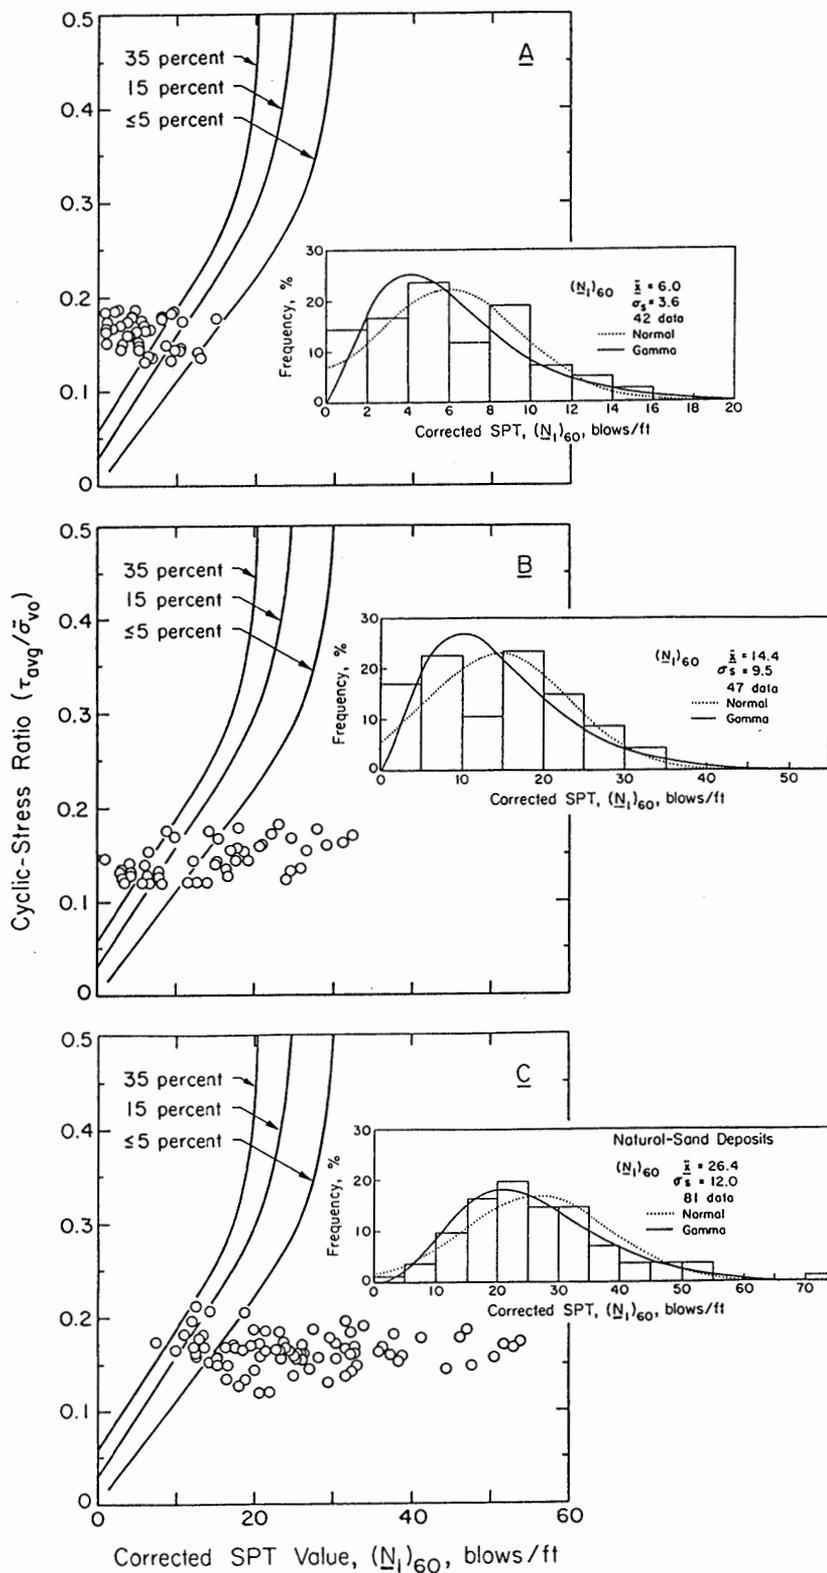
The most striking feature of the plots in figure 18 is the relatively high liquefaction potential of the hydraulic fill. The corrected SPT values for at least half of the measurements in the sample are less than 6, implying that the hydraulic fill would have a very low undrained residual shear strength, perhaps lower than 5 kPa, based on the empirical relations suggested by Seed (1987). In contrast, both the land-tipped fills and natural-sand deposits show increasing

Figure 18.—Cyclic-stress ratio versus corrected SPT value at different fines contents for hydraulic fill (A), land-tipped fills (B), and natural-sand deposits (C). Fines content is defined as proportion (in weight percent) of soil that is silt size or smaller (≤ 0.075 mm). Curves show boundaries of liquefaction potential for an $M=7.1$ earthquake, according to procedure of Seed and others (1985); data points to left of curves indicate increasing susceptibility to liquefaction. Histograms, showing normal and gamma frequency distributions of corrected SPT values, provide a measure of variation in soil density. \bar{x} , mean; σ , standard deviation.

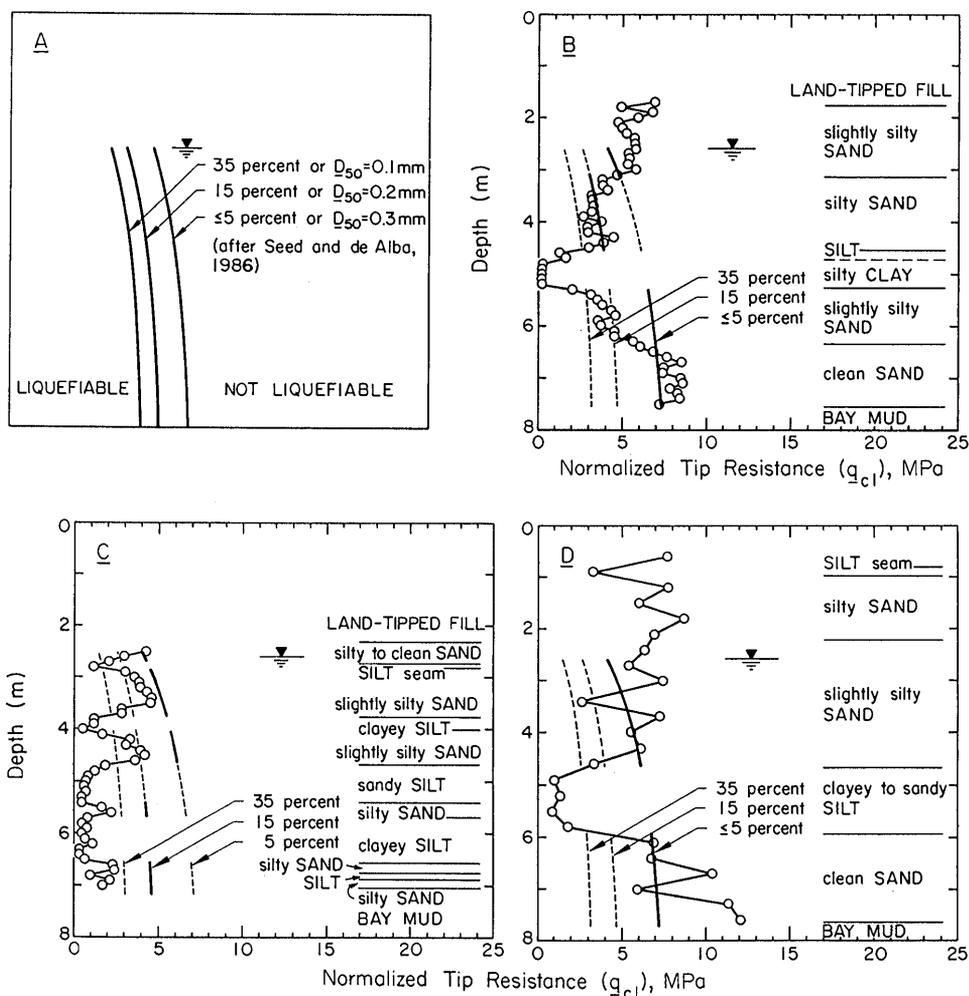
The CPT profiles for three soundings in the hydraulic fill, from north to south designated as C-8, C-4, and C-15 (see fig. 11), are shown in figures 20B through 20D, respectively. For example, sounding C-8 indicates liquefiable sand and silty sand between depths of 3 and 4.5 m and again at 5.5 to 6.5 m. Between 4.5 and 5.5 m, the cone penetrated silt and silty clay, which can be interpreted as not susceptible to liquefaction, and so no heavy curve is drawn for this depth interval. Sounding C-4 (fig. 20C) shows liquefiable sand and silty sand generally between depths of 2.6 to 7 m, with thin intervening layers of clayey silt that can be interpreted as not susceptible to liquefaction. Sounding C-15 (fig. 20D) shows only a few thin seams of sand and silty sand that are clearly susceptible to liquefaction.

Figure 20.—Depth versus normalized tip resistance at different fines contents for hydraulic fill (A) and for CPT soundings C-8 (B), C-4 (C), and C-15 (D) (see fig. 11 for locations). Fines content is defined as proportion (in weight percent) of soil that is silt size or smaller (≤ 0.075 mm). Profiles in figure 20A were calculated for an $M=7.1$ earthquake, according to procedure of Seed and others (1985); profiles in figures 20B through 20D were plotted according to procedure of Seed and de Alba (1986). In figures 20B through 20D, solid curves denote appropriate liquefaction potential for specific depths and soil types, and dashed curves are shown for reference. Data points to left of curves indicate increasing susceptibility to liquefaction; breaks in curves indicate that a particular soil layer is not readily susceptible to liquefaction. Inverted triangles denote depth to water table.

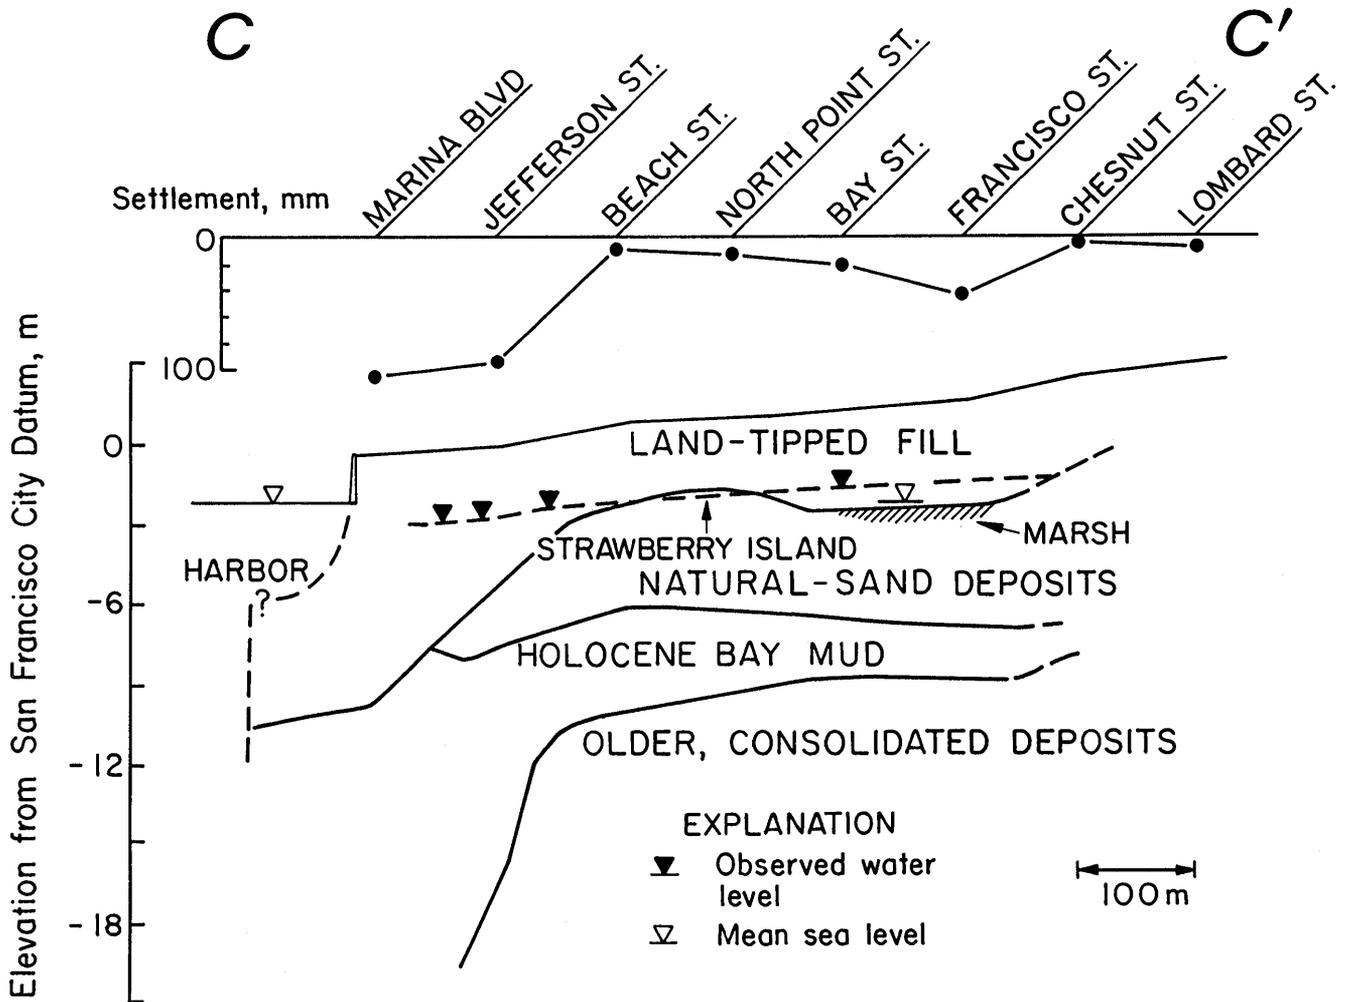
The relation between settlement and fill thickness is illustrated in figure 22, which shows a simplified cross section along Divisadero Street (C-C', fig. 11). Note that some of the most extensive damage to pipelines and the heaviest concentration of building damage were on Divisadero Street, primarily in the area from Beach Street to Marina Boulevard.

Street are also the locations of greatest damage to MWSS pipelines and collector sewers along Divisadero Street.

Figure 22.—Cross section C-C' along Divisadero Street, showing settlement profile, water table, and stratification of underlying soils. See figure 11 for location.

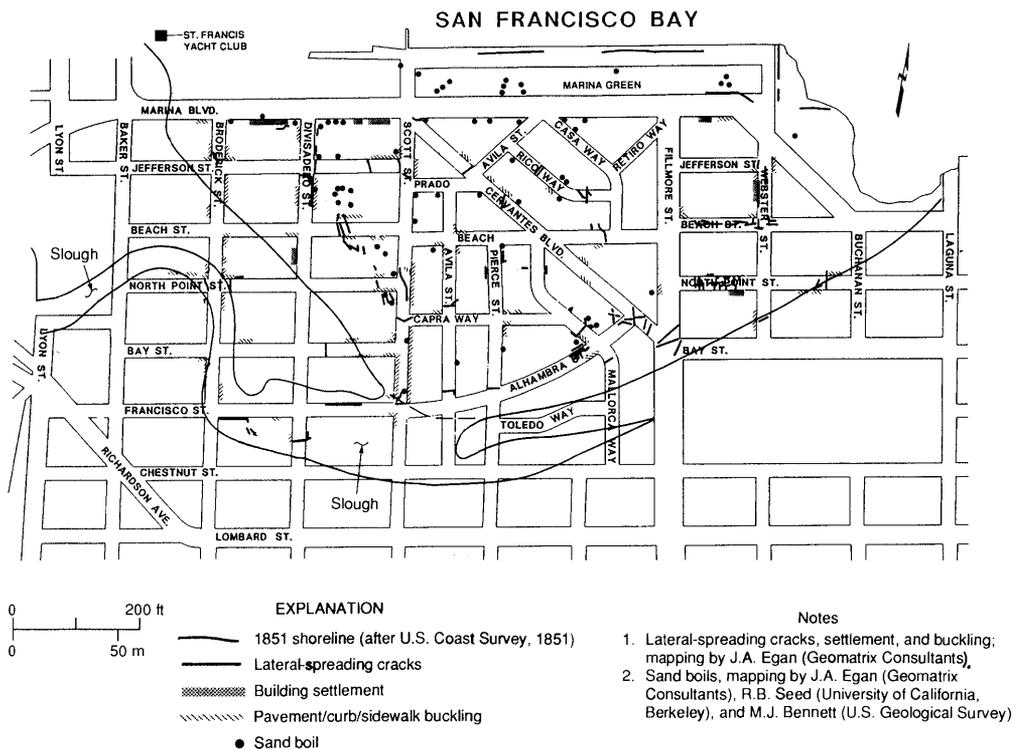
soil; areal subsidence; settlement; distortion of residential buildings; compressional buckling of sidewalks and curbs; and utility-line breaks. Street-by-street mapping of geotechnical effects was conducted, and the more significant of these observations are summarized in figure 4, with the

location of the original shoreline (U.S. Coast Survey, 1851) drawn for reference. Examination of the pattern of observations shown in figure 4 indicates that the areas of lateral-spreading cracks, liquefaction sand boils, settlement, and buckling coincide well and define what may be considered as the ground-failure zone. This zone lies bayward of the old shoreline, extending about 3,000 ft (900 m) along Marina Boulevard between Webster and Broderick Streets and inland as far as about the intersection of Alhambra and Avila Streets. Note that a close spatial correlation exists between the ground-failure zone identified in figure 4 and the area of fill placed after 1906. Geotechnical effects did occur outside of the postulated ground-failure zone but appeared to consist primarily of differential building settlements and local subsidence near the old shoreline and in the filled slough channel (fig. 4). For example, a house on Francisco Street near Divisadero Street sustained 1.7 ft (0.5 m) of differential settlement; and farther west along Francisco Street, near Broderick Street, sidewalks and backyard soils exhibited cracks with horizontal widths as large as half an inch (0.01 m) and vertical offsets as large as 1.25 in. (0.03 m). In areas landward of the old shoreline and former slough boundaries, negligible geotechnical effects were observed.

Figure 4.—Marina District, showing locations of earthquake-related liquefaction and ground failure and of 1851 shoreline.

in this area were racked by settlement and lateral movement. Horizontal displacement was also evident along Beach and North Point Streets near Webster Street, where cracks as much as 3 in. (0.08 m) wide opened in the street, and separations between curb and street pavement as great as 5 in. (0.15 m) developed. Several inches of areal subsidence occurred within the ground-failure zone. Subsidence of as much as 5 in. (0.15 m) was observed around a 60-ft (18 m)-diameter inground pump station on the Marina Green near Avila Street. Such vertical and lateral displacements caused broken waterlines and fractured manholes throughout the Marina District; near the seawall and at the St. Francis Yacht Club, lateral-spreading cracks and deformation were quite evident. At the yacht club, differential settlement of 8 in. (0.2 m) was observed between the pile-supported part of the structure and that part supported on spread footings. Finally, a phenomenon observed throughout the ground-failure zone was buckling of sidewalks and curbs, including heave and override of driveway and sidewalk slabs. Although some of this buckling was associated with lateral spreading, we believe that much of it was caused by large, spatially nonuniform displacements.

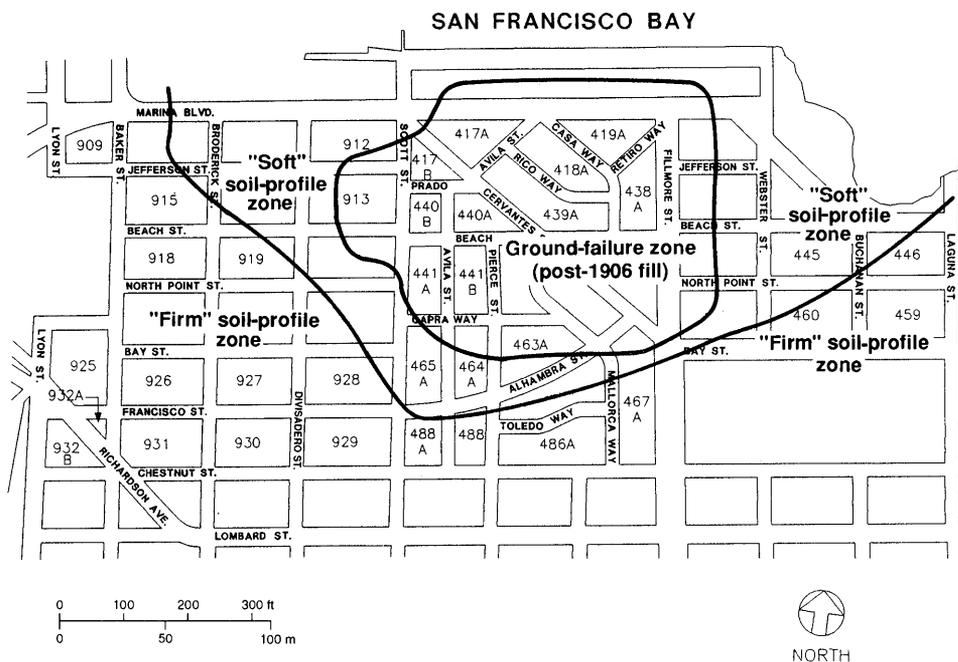
In examining the ground performance mapped in figure 4, three soil-profile zones can be defined (fig. 5): first, the ground-failure zone; second, a zone between the ground-failure zone and the old shoreline within which relatively minor ground-failure effects were observed; and third, a zone landward of the old shoreline within which ground-failure effects were essentially absent. Ground conditions

Figure 5.—Marina District, showing locations of three soil-profile zones differentiating relative ground performance during the earthquake. Numbers shown are city block numbers, which are referenced in table 2.

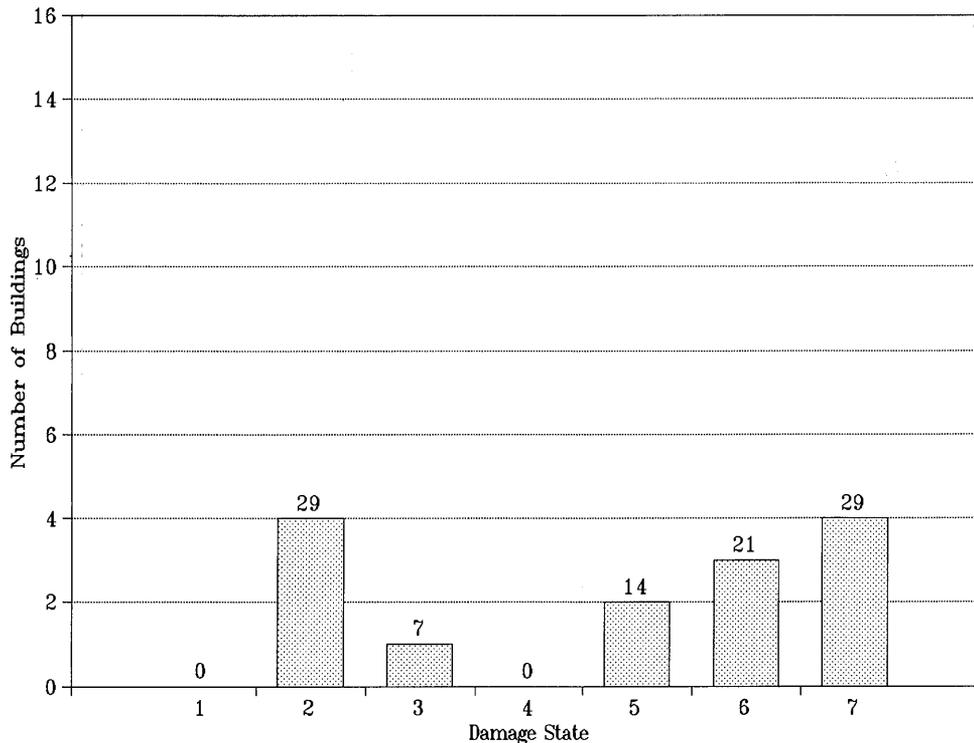
Figure 6.—Number of buildings in "soft"-soil-profile zone versus damage state. Most (64 percent of) buildings were assigned to damage states 5 (heavy) through 7 (destroyed). Numbers at top of bars indicate percentage of total.

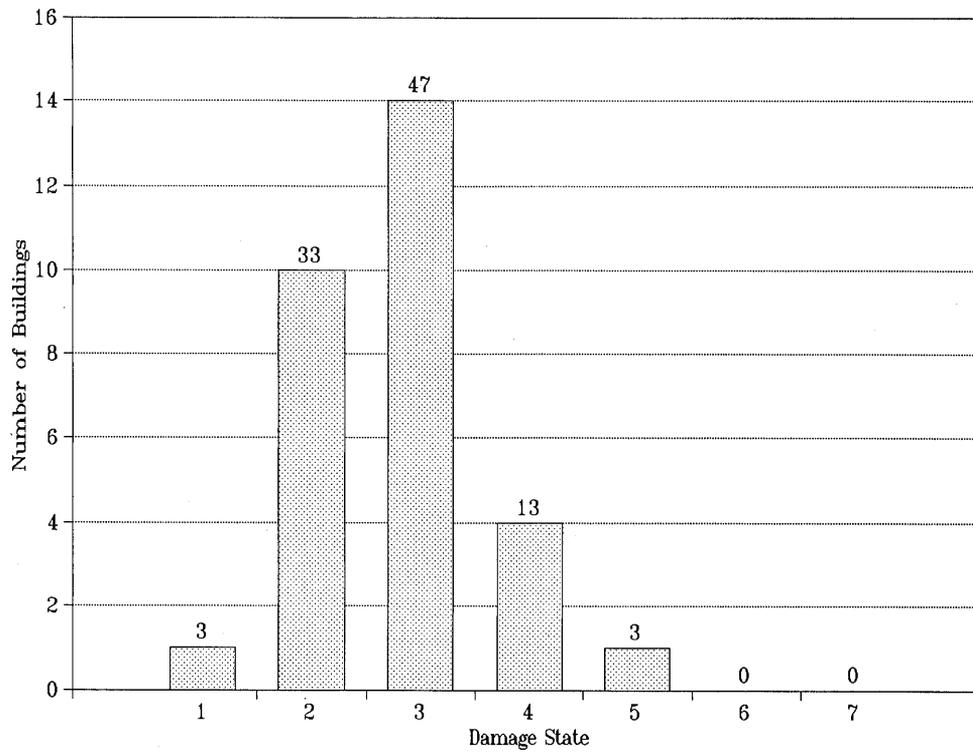
Figure 7.—Number of buildings in “firm”-soil-profile zone versus damage state. All buildings except one were assigned to damage states 4 (moderate) and below. Numbers at top of bars indicate percentage of total.

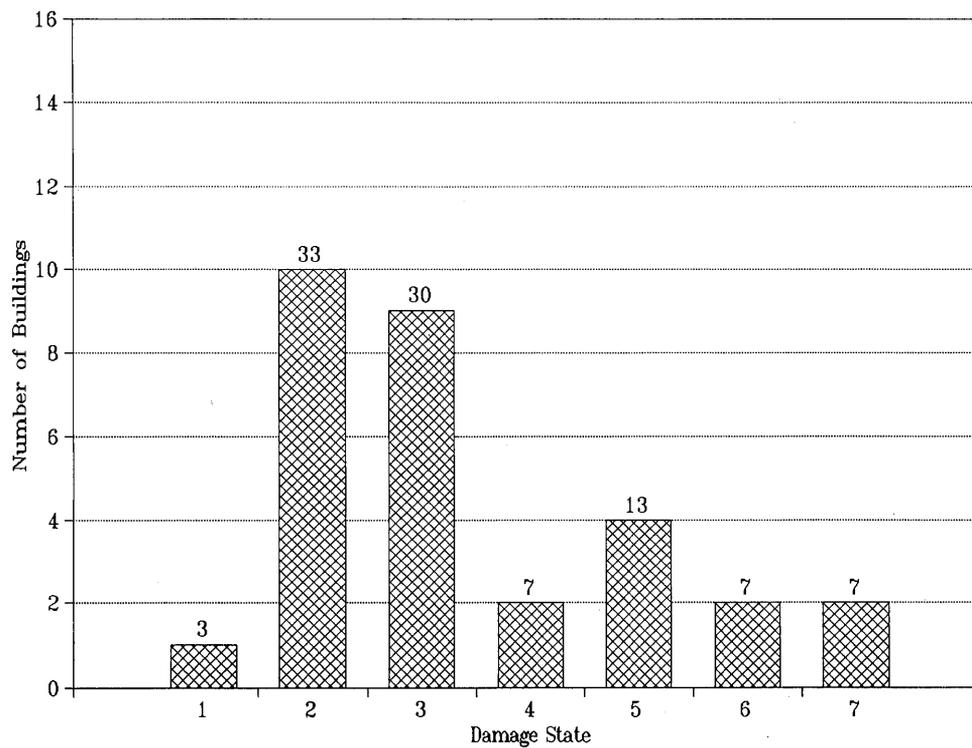
Figure 8.—Number of buildings in ground-failure zones versus damage state. Buildings are spread across all damage states but are concentrated at lower end. Numbers at top of bars indicate percentage of total.

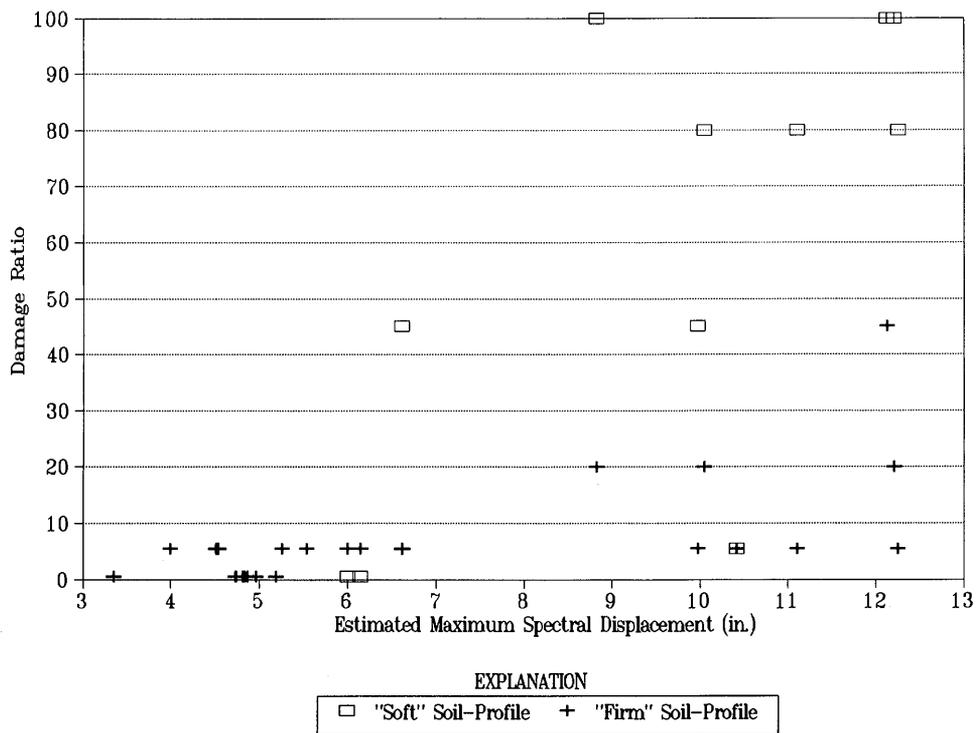
1. The maximum spectral displacement for buildings 80 percent damaged (which leaned over but did not collapse) is about 1 ft (0.3 m). The buildings 100 percent damaged show similar, if slightly more varied, results.

2. The data in figure 13 appear to suggest an upper bound for the damage ratio, given the spectral displacement, that may indicate the presence (in some buildings) of structural attributes invisible from the exterior, such as diagonal wall sheathing or first-story walls with interior stucco, that would significantly increase building strength and stiffness.

Figure 13.—Damage ratio versus estimated maximum spectral displacement for all corner buildings studied except those within ground-failure zone. Spectral displacements of buildings 80 to 100 percent damaged are about 1 ft (0.3 m), approximately equal to permanent lateral deformation observed in heavily damaged buildings that did not collapse.
