The Loma Prieta, California, Earthquake of October 17, 1989—Marina District

STRONG GROUND MOTION AND GROUND FAILURE
THOMAS L. HOLZER, *Coordinator*

U.S. GEOLOGICAL SURVEY PROFESSIONAL PAPER 1551-F

MARINA DISTRICT

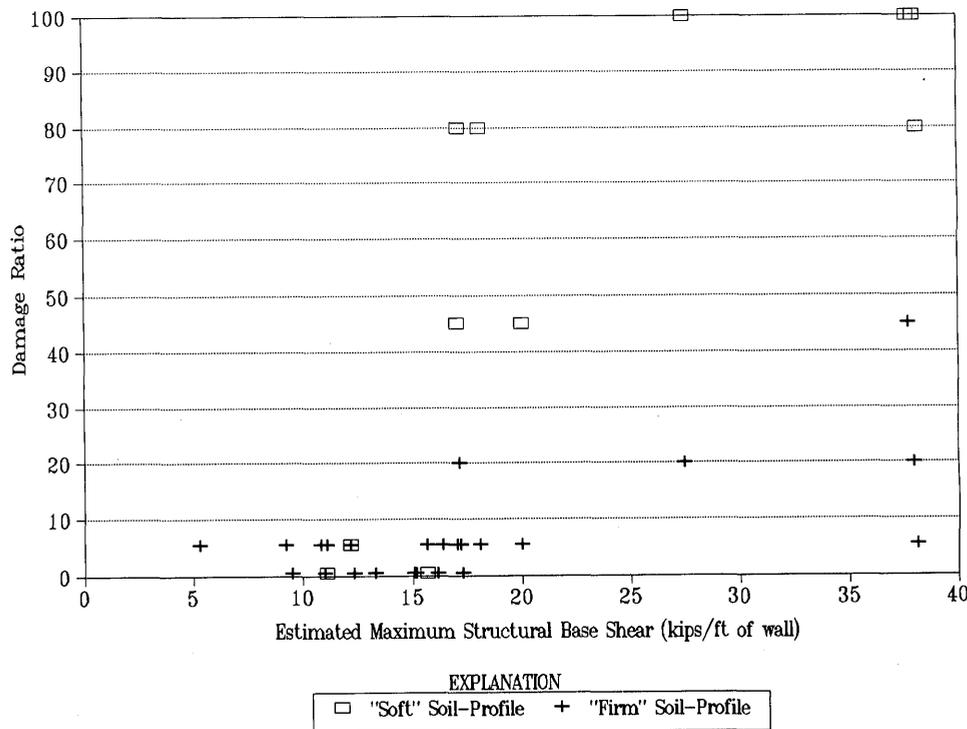
(225-300 kN/m), whereas those in the "soft"-soil-profile zone generally indicate a higher shear that appears to be an approximate lower bound for the large permanent lateral deformation observed in the heavily damaged corner buildings.

Figure 14.—Damage ratio versus estimated maximum structural base shear for all corner buildings studied except those within ground-failure zone. Base shear of about 15 to 20 kips/ft (225-300 kN/m) appears to be approximate lower bound of permanent lateral deformation observed in heavily damaged buildings.

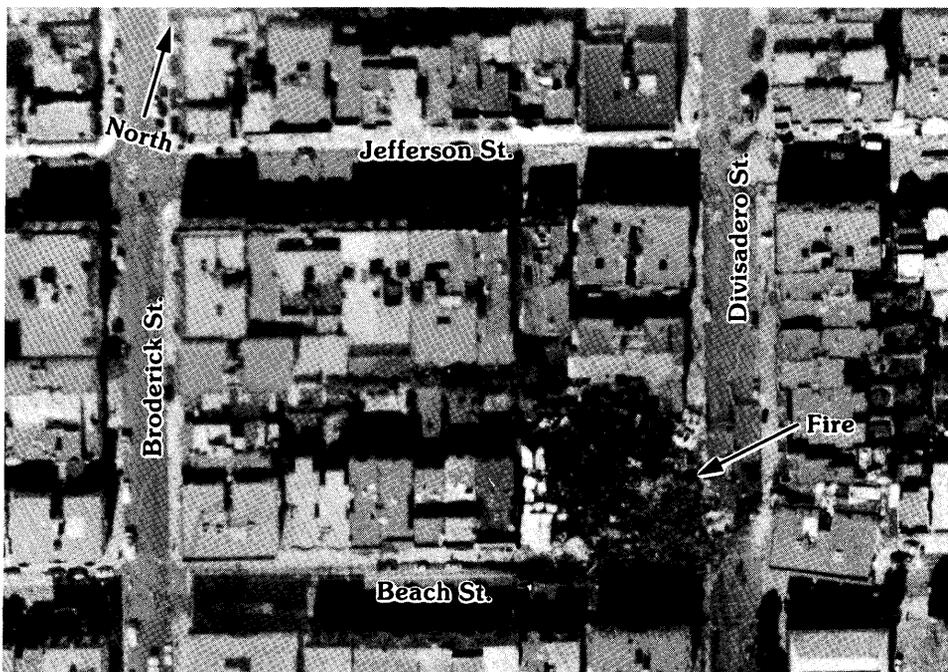
Figure 16.—Northwestern part of Marina District, showing area near Beach and Divisadero Streets. Fire destroyed corner building, another immediately to west, and two more immediately to north.
