The Loma Prieta, California, Earthquake of October 17, 1989—Highway Systems

By MARK YASHINSKY

U.S. GEOLOGICAL SURVEY PROFESSIONAL PAPER 1552-B

HIGHWAY SYSTEMS

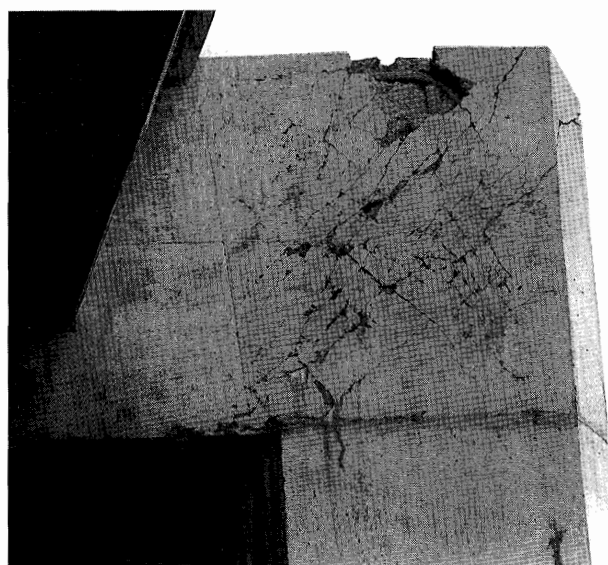
Almost all of the serious bridge damage was the result of problems in transferring forces between vertical and horizontal elements. This was a problem for both steel and reinforced concrete members. Outrigger joints cracked, pinned connections shattered, moment connections sheared, bolted connections broke, and development rebar pulled out (fig.

Figure 4.—Damage to outrigger knee-joint on Route 980 Southbound Connector.

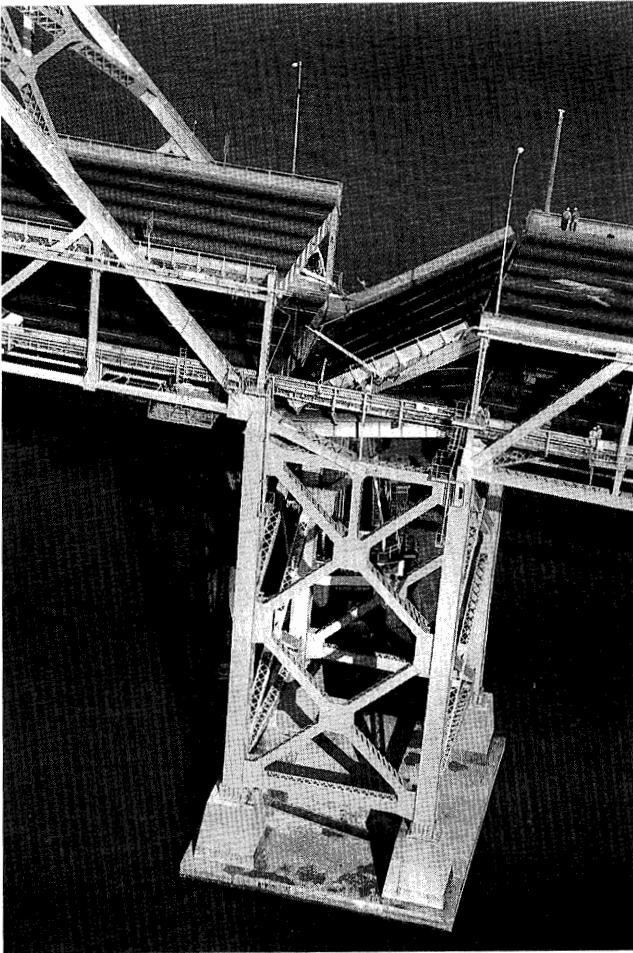
Except for a few minor problems on the West Bay Crossing, all of the earthquake damage occurred on the East Bay Crossing. The most significant damage was at Pier E9 where the top and bottom decks were pulled off their seats, causing them to fall onto a platform and electrical building near the top of the pier (fig. 12). The rest of the damage occurred from Piers E17 to E23 where anchor bolts failed, earthquake restrainers were damaged, stringers moved on their seats, the concrete pedestal at E17 rocked, and expansion joints spalled.

Figure 12.—Fallen decks at Pier E9 of the East Bay Crossing.

age was the dropping of the 50-foot span at Pier E9, which resulted in an unfortunate loss of life. Since the peak ground acceleration from the maximum credible earthquake at this bridge is at least 0.5 g, a substantial retrofit is required to prevent severe bridge damage from a rupture on the San Andreas or Hayward faults, which are near this site.

After the earthquake, an emergency contract was given to the Smith-Rice Company, who had the biggest derrick barge in the area to repair the bridge. Rigging International was the prime subcontractor. The fallen decks at Pier E9 were removed, new girders put in place, and precast concrete deck sections (fig. 19)

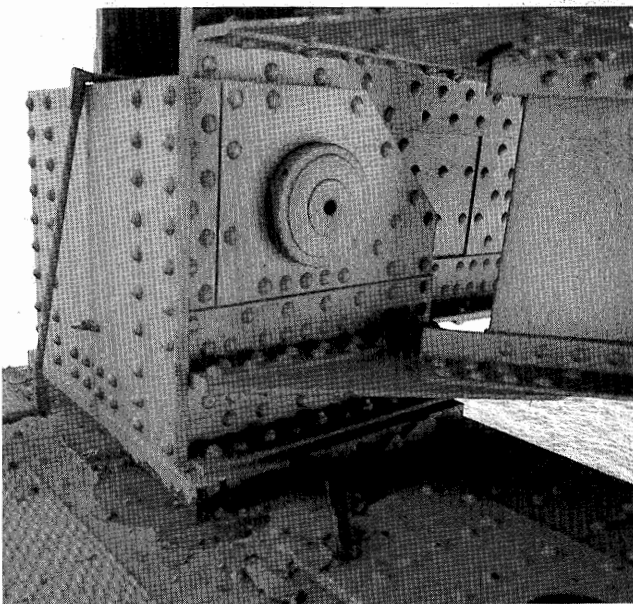
The movement of the decks at Pier E9 was the result of all 20 high-strength bolts at each of the east truss shoes breaking (fig. 13). This allowed the superstructure trusses on the east side of Pier E9 to move approximately 10 inches to the east and 5 inches to the north. The decks at Pier E9 are supported on steel stringers that rest on 6-inch steel angles bolted to large floor beams. When the trusses moved to the east, the stringers were pulled off the angles on the west end. The stringers remained on the bearing seats at the east end, which were bent as the west side fell.

Figure 13.—Truss shoe at Pier E9 of the East Bay Crossing showing broken bolts and shoe movement after earthquake.

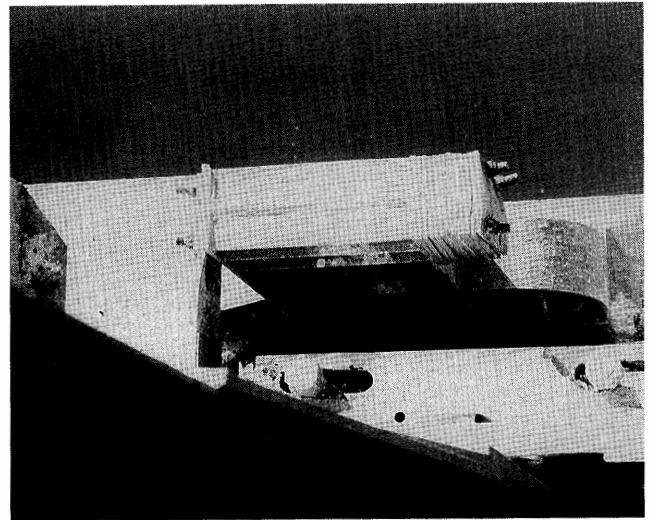
The north and south fixed truss shoes at Piers E18 to E22 had all 12 one-inch-diameter bolts broken at each pier connection to the concrete pedestals. When the fixed shoes broke free, the expansion side of the trusses slammed into the steel girder restrainers (fig. 14). These restrainers apparently prevented the trusses from falling off the concrete pedestals, at least for the moderate forces generated from this earthquake. Elastomeric pads absorbed the impact when the truss shoes slammed into the restrainer beams. These dam-

Figure 14.—Steel girder restrainer on East Bay Crossing with damage to rods and elastomeric pads after the earthquake.

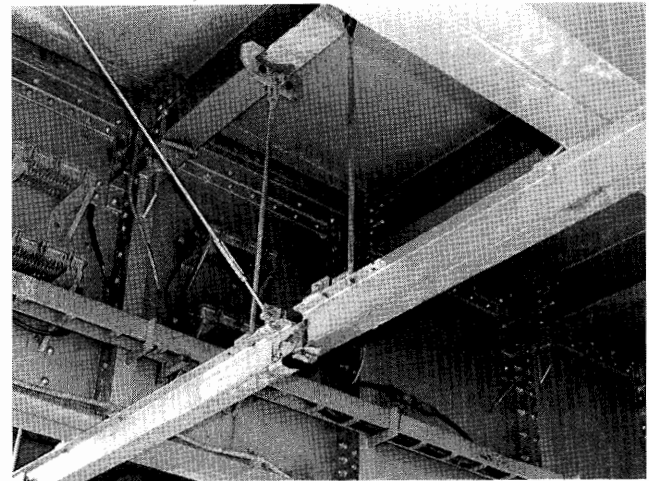
At Pier E23 the rivets connecting the bottom flange of the floor beam (fig. 15) to the concrete pier were sheared off, allowing the span between Pier E23 and E24 to move. A 9-foot drop-in span for the top deck at Pier E23 (figs. 16 and 17) rested on seats attached to this floor beam in a manner similar to that described for Pier E9 (fig. 18). When the floor beam moved, the steel stringer webs were pulled out of the guide angles at Pier E23 (similar to Pier E9) and to within one-quarter inch of the edge of the bearing seat.

Figure 15.—Pier E23 floor beam with small girder seat that almost dropped this span during the earthquake (photograph by Erik Zechlin).

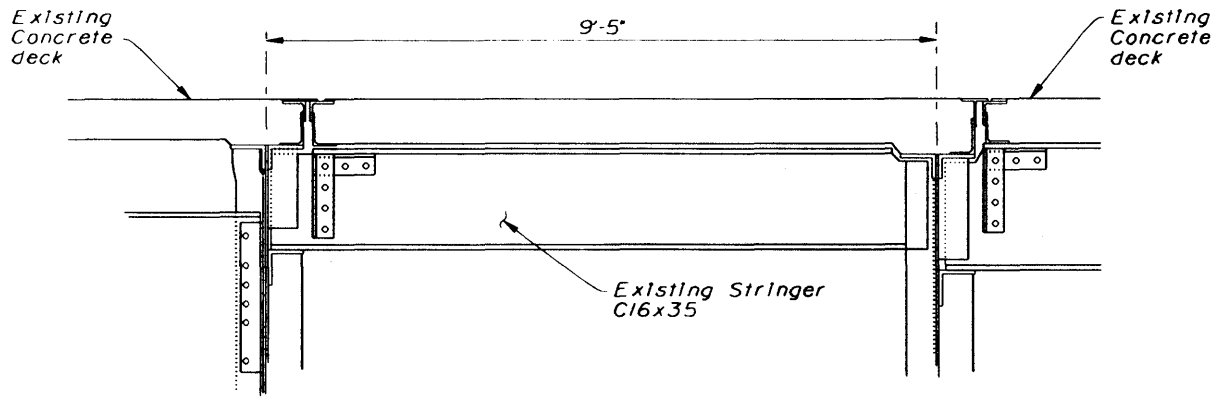
UPPER DECK JOINTS AT E23

Figure 16.—Plan drawing of steel girders, floor beams, and girder seats at Pier E23 of the East Bay Crossing.

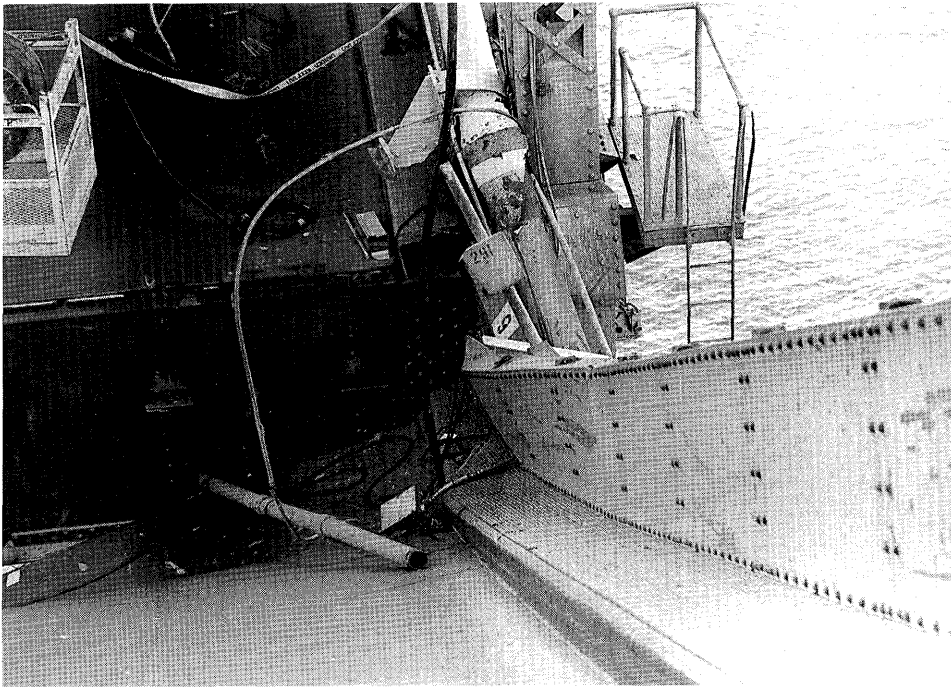
Figure 18.—Collapsed lower deck at Pier E9 of the East Bay Crossing showing short girder seats attached to floor beam.

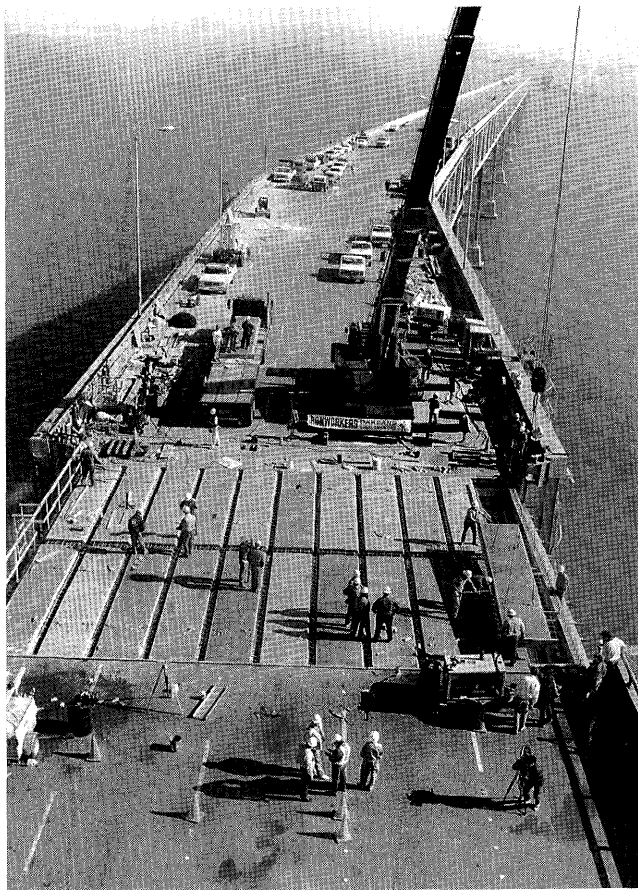
Figure 19.—Installing new, precast deck panels at Pier E9 on East Bay Crossing after the earthquake.

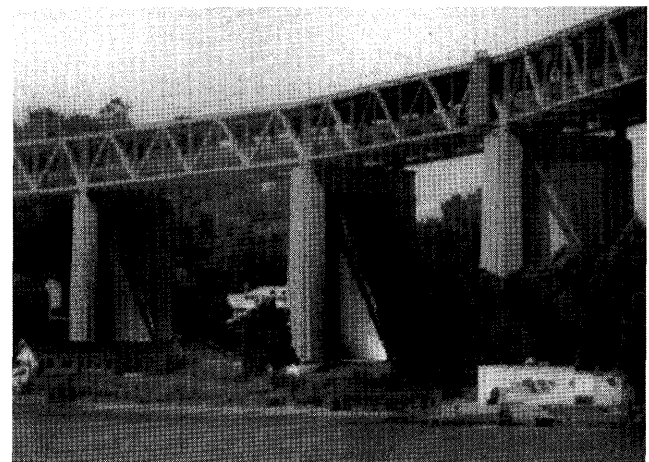
Figure 20.—Proposed retrofit of encasing steel towers in concrete for East Bay Crossing (currently (1997) superseded by plans to replace this structure).

Since that time, Caltrans has been busy assessing the vulnerabilities of this bridge and devising a retrofit strategy to prevent major damage from the maximum credible earthquake. The retrofit strategy (fig. 20) that eventually emerged was to use reinforced concrete bents embedded around the existing steel piers with special bearings to isolate and dampen the earthquake motions from the superstructure. The cantilever portion was to have two additional piers and an exterior frame to strengthen the structure. However, the cost of this retrofit was so high that a replacement structure is now being planned instead.

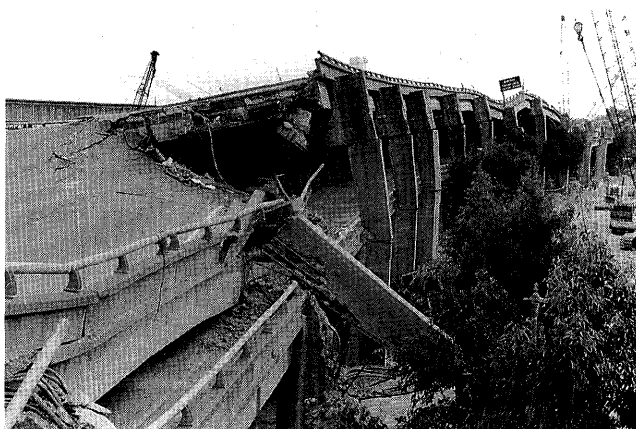
The Cypress Street Viaduct suffered the most catastrophic damage of any structure during the Loma Prieta earthquake. A large portion of the upper deck collapsed (fig. 27). This was from Bent 63 in the south all the way to Bent 112 in the north. Only Bents 96 and 97 remained standing. This collapse was a result of the weak pin connections at the base of the columns of the upper frame. Figure 28 clearly shows that there was inadequate confinement around the four #10 bars to restrain them during the earthquake. Also, the strong ground motion was probably influenced by the site conditions, as shown in figure 25. The sequence of collapse was as shown in figure 29. Although this was the most common collapse mechanism, there were several other types of failure as well. At some bents, the top and bottom decks both collapsed. Just south of Bent 113, the roadway sheared off, and at some bents where columns were supported by a cantilevered girder, the girder collapsed. Figures 30 shows an aerial view of that portion of the structure where the top deck collapsed. Figures 31 to 33 provide details of the damage. Table 9 lists all the significant damage that occurred. References to several papers that provide a complete description of earthquake damage for the Cypress Street Viaduct can be found at the end of this section.

Figure 27.—Pin connection failure at Cypress Viaduct.

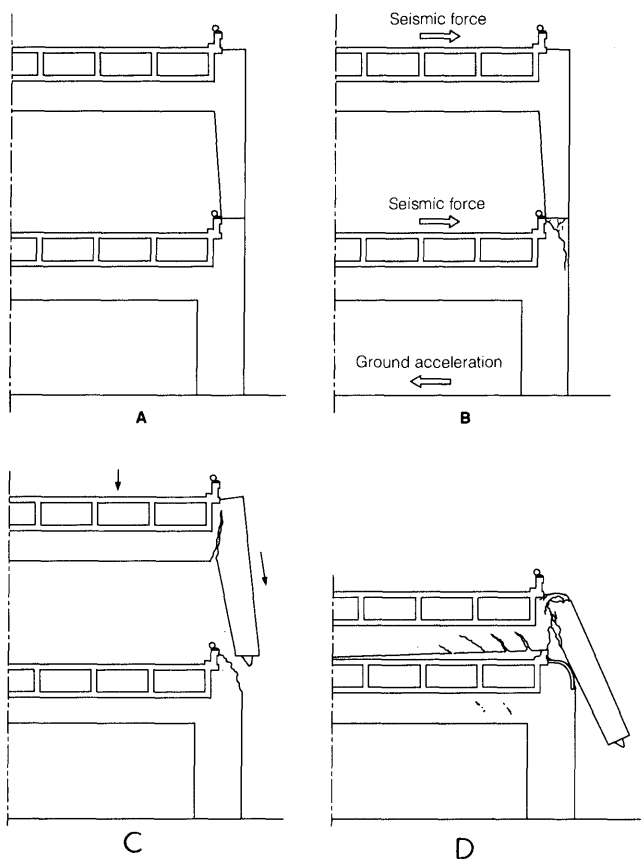
Figure 29.—Cypress Viaduct collapse sequence for bent type B1 (from Thiel, 1990).

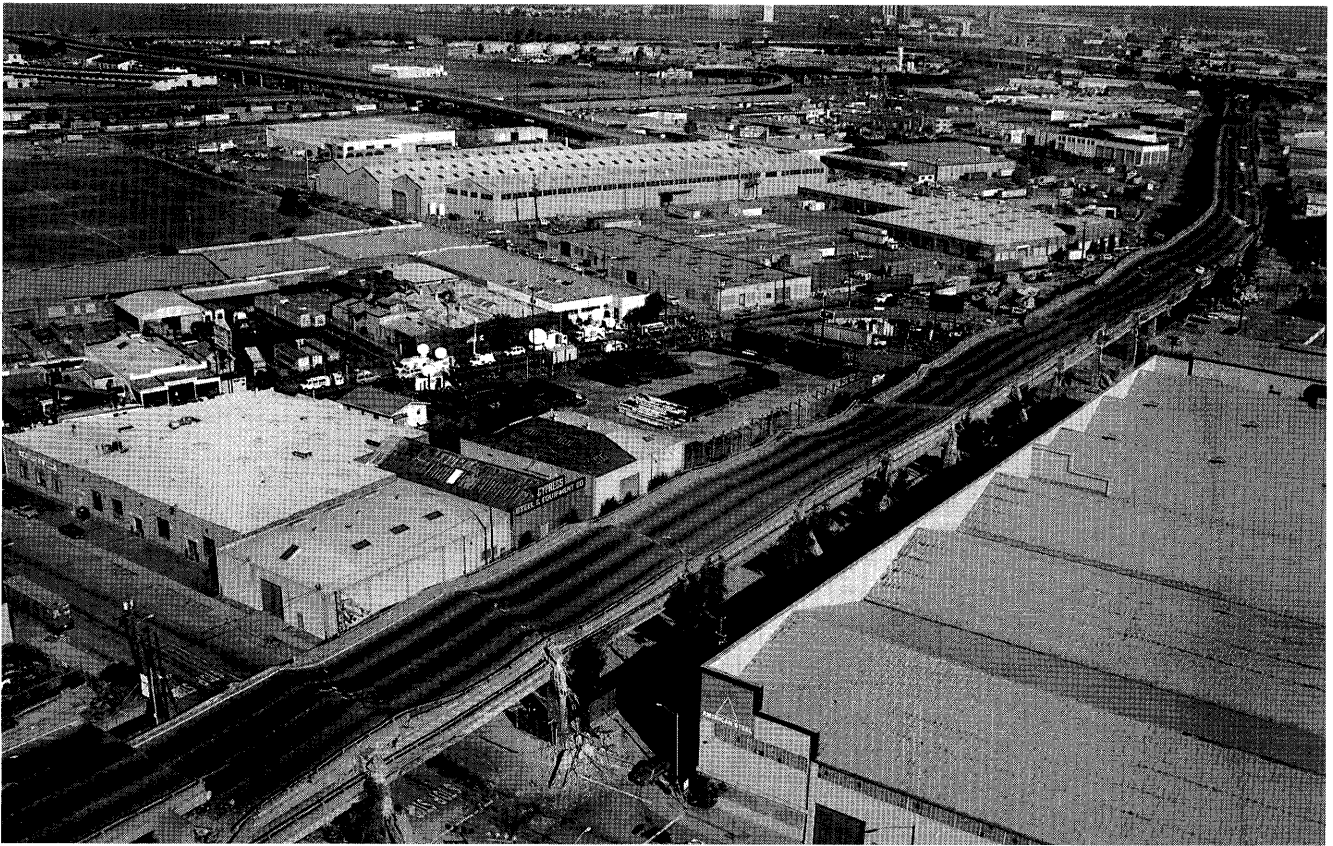
Figure 30.—Collapse of Cypress Viaduct between Bent 62 and Bent 113.

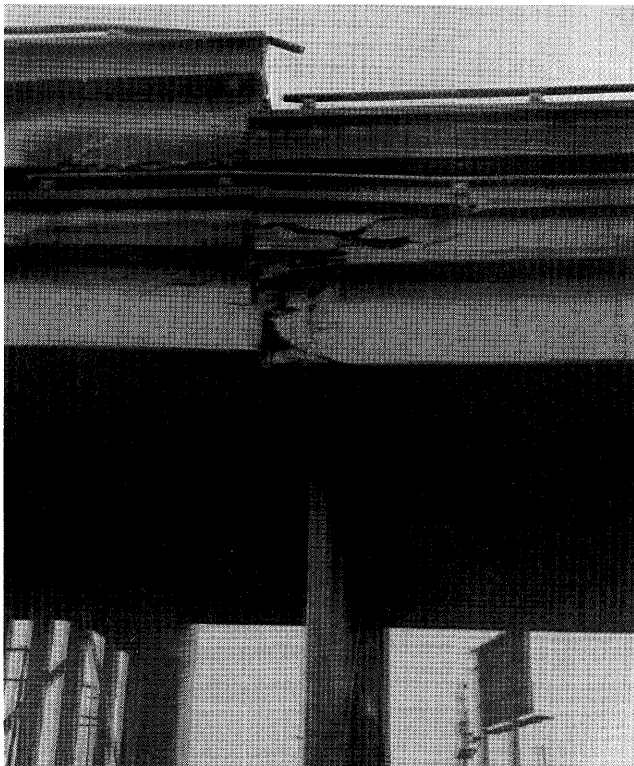
Figure 31.—Hinge damage at Cypress Viaduct.

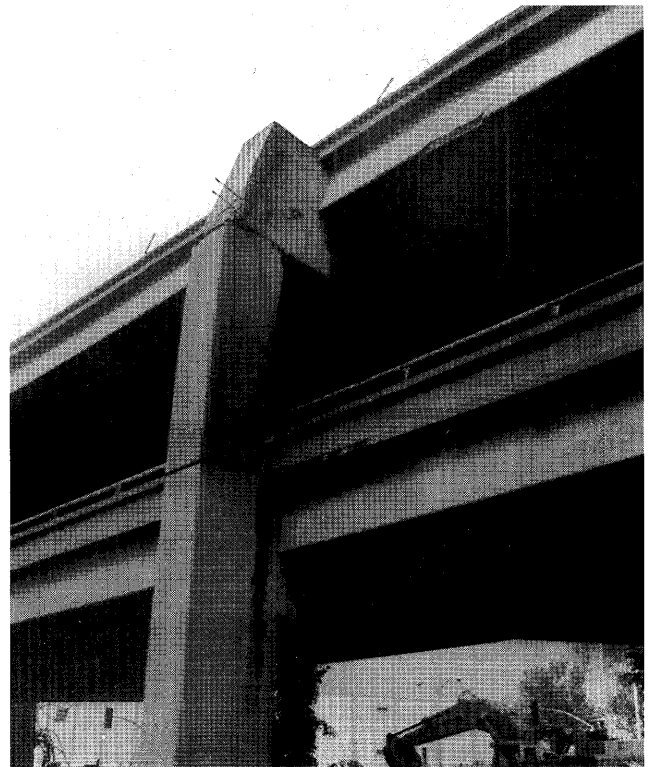
Figure 32.—Rotation at Bent 76 of Cypress Viaduct (note prestressing tendons).

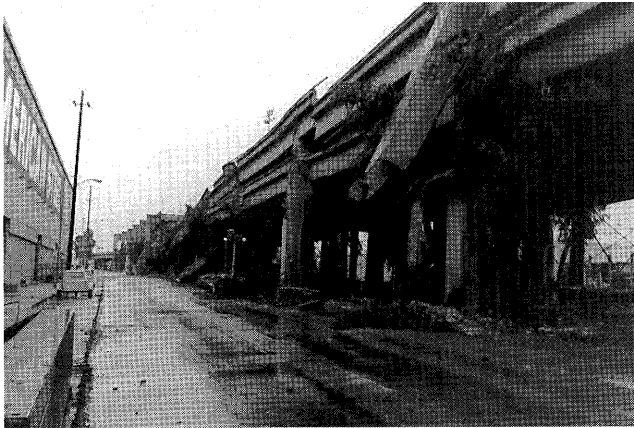
Figure 33.—Bent 70 of the Cypress Viaduct (view to south).

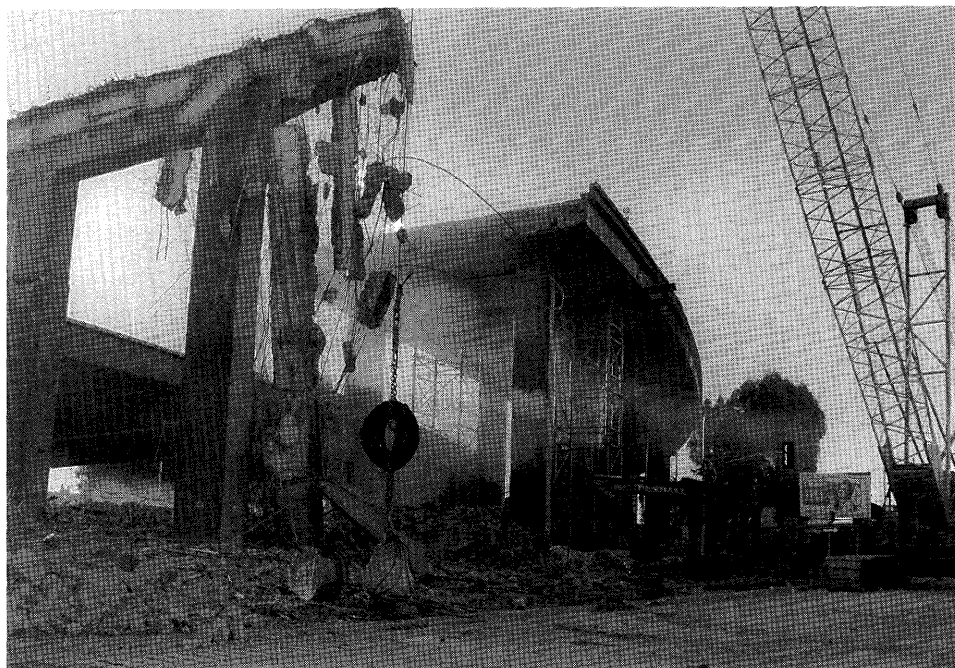
After the last human remains and vehicles were removed from the site, the task switched to the expeditious removal of the freeway (fig. 37). The biggest problem was finding a place to dispose of the debris. The city of Oakland passed an ordinance prohibiting disposal of the rubble in the city. It was hoped that the debris could be recycled and used as construction material. However, there were difficulties in removing the reinforcement from the concrete and obtaining the necessary permits; in the end, almost all the material was hauled by trucks and disposed of along the Route 580 right of way in Castro Valley.

Figure 37.—Removal of the Cypress Viaduct.

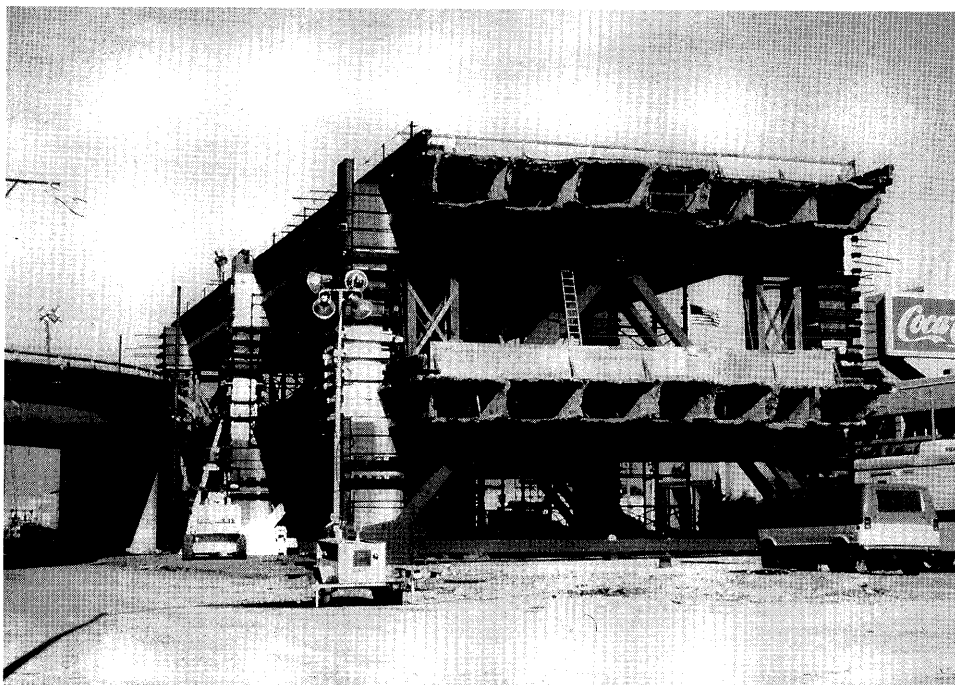
Figure 38.—Retrofit strategy being tested with jacking frame on section of the Cypress Viaduct.

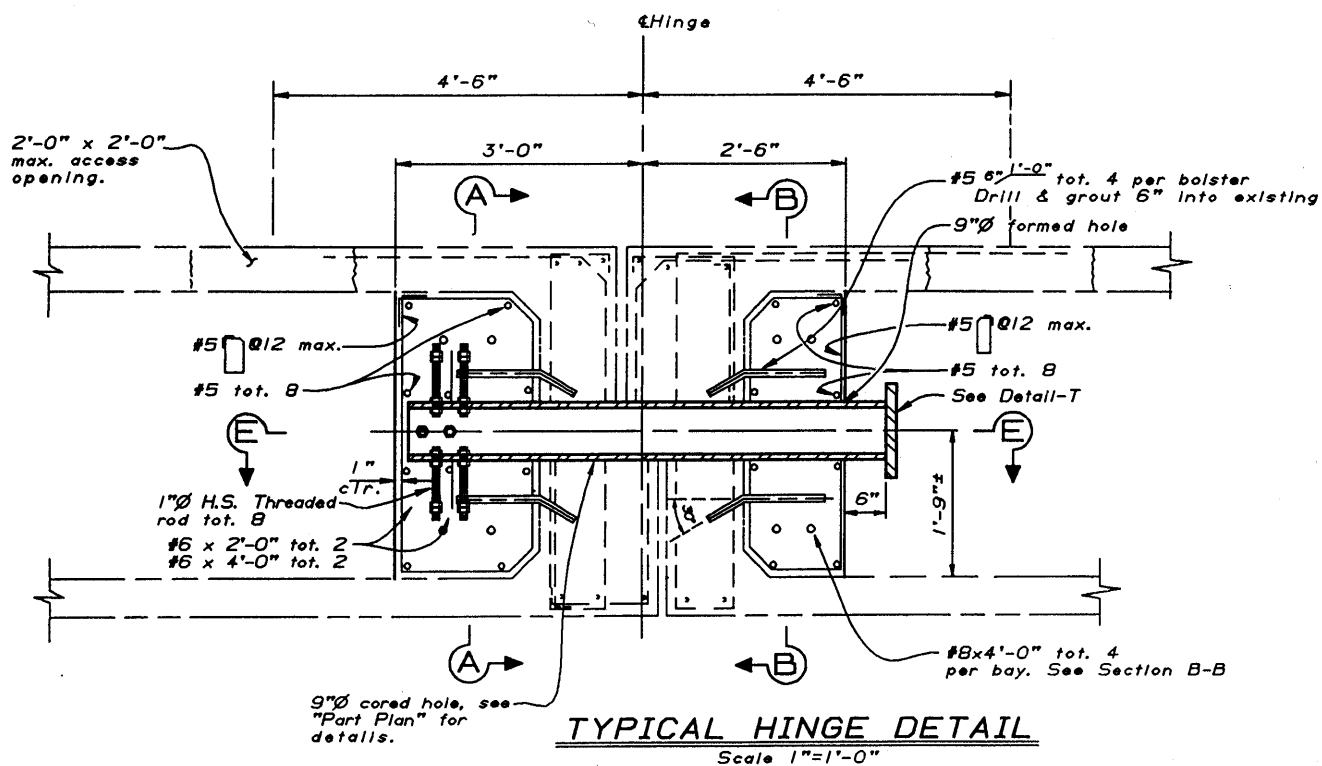
Finally, the portion of this viaduct that was still standing afforded researchers a rare opportunity to do (1) destructive testing to help understand the collapse, the behavior of pile groups to failure, and new retrofit schemes and (2) testing to compare computed deflection and damage to actual bridge behavior. These tests were carried out by the University of California at Berkeley and Caltrans' Division of Structures. Steel jacking platforms were built (fig. 38). The bents were modified with different retrofits to provide confinement to vulnerable members. Then vibration tests were done as well as transverse loading to failure. However, due to time constraints to complete the testing, most of these confinement retrofit schemes were of limited value. Of more importance was the pipe seat extender testing. High-strength pipes were inserted in hinges to pre-

vent unseating (fig. 39). This retrofit scheme has since become very popular.

Figure 39.—Pipe seat extender test for the Cypress Viaduct

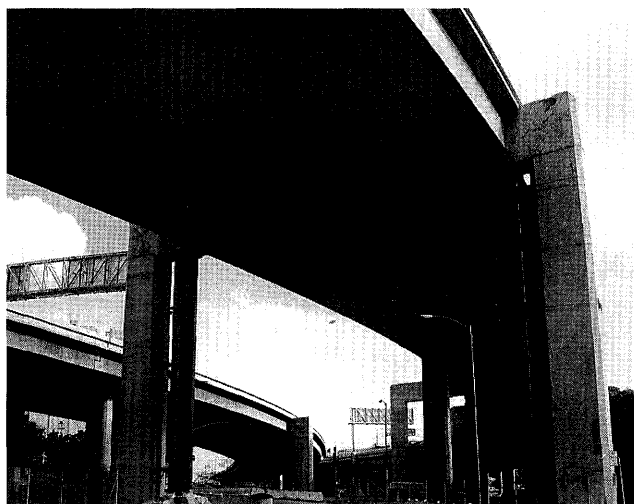
moved transversely, the main restraints were the moment-resisting cap/column joints at Bent 38. Both joints were cracked, the west joint most severely, with the cracks, more severe on the hinge side of the bent. Also, the bridge deck over the bent sustained some cracks suggesting high stresses to the extreme fibers of the bent cap in bending.

Bent 38's west outrigger knee joint was confined with W5 spiral wire which broke along with a #18 vertical reinforcing bar in the joint. Whatever moment capacity this joint had was severely reduced by cracking and spalling of the concrete after the confinement reinforcement broke. The #18 "X" reinforcement in this joint was tested in the materials lab after the quake. It was found that the broken rebar was of grade 75 steel, while the other bars were grade 60 steel. Moreover, the broken rebar had a curve radius of 11 3/8 inches, while the plans showed a bend radius of 18 inches. It is believed that the difference in grade and the sharp bend in the bar caused the failure. The difference in grade made the rebar much stronger, causing most of the load to be transferred to the stiffer bar. Other bridge damage including spalling of concrete at the wingwall and shear keys of the north abutment. There were column cracks at Bents 35 to 37 that appear to have occurred prior to but were widened by the earthquake. There was damage to the sidewalk, asphalt, and soil around the base of these columns, indicating that they experienced a lot of movement during the earthquake. The expansion joints at the abutment and hinges all showed signs of banging and large movements.

Figure 45.—Bent 38 of Route 980 Southbound Connector after the earthquake.

As mentioned previously, this connector was essential to move traffic from I-880 to I-80 after the collapse of the Cypress Street Viaduct. The connector was closed immediately after the earthquake. Subsequently, structural personnel examined the bridge and determined a temporary and permanent repair to allow traffic back on the roadway. Emergency repairs began on the bridge on October 20, 1989. They consisted of timber cribbing under the cap, supported by 24-inch-diameter steel pipe shoring capped with steel plates and braced with diagonal cables for lateral support. This allowed traffic back on the bridge. Then heavy-duty structural steel falsework frames were installed, and the pipe shoring was removed. Traffic was

shifted to the east half of the roadway, and work was begun to strengthen the cap/column joints on the west side by adding reinforcement and increasing the size of the joints. After the concrete was cured, traffic was shifted to the west side, and the same procedure was done to the east side of the bridge. Then the falsework was removed, the surface streets below the connector were given minor repairs, and traffic was allowed back on the streets below the bridge. All the work was completed as of November 7, 1989. The total cost of this repair was just under \$100,000. Since the only deficiencies to this modern structure were the weak cap/column joints, this repair was considered sufficient to protect the bridge from the maximum credible earthquake.

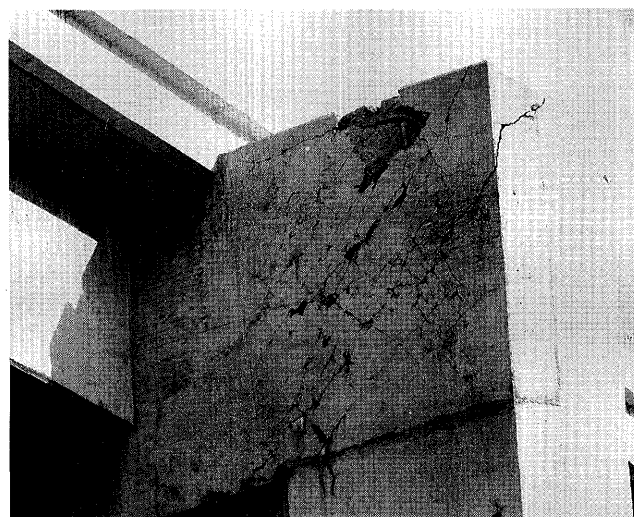
Figure 46.—Closer view of knee joint damage to Bent 38 of Route 980 Southbound Connector.

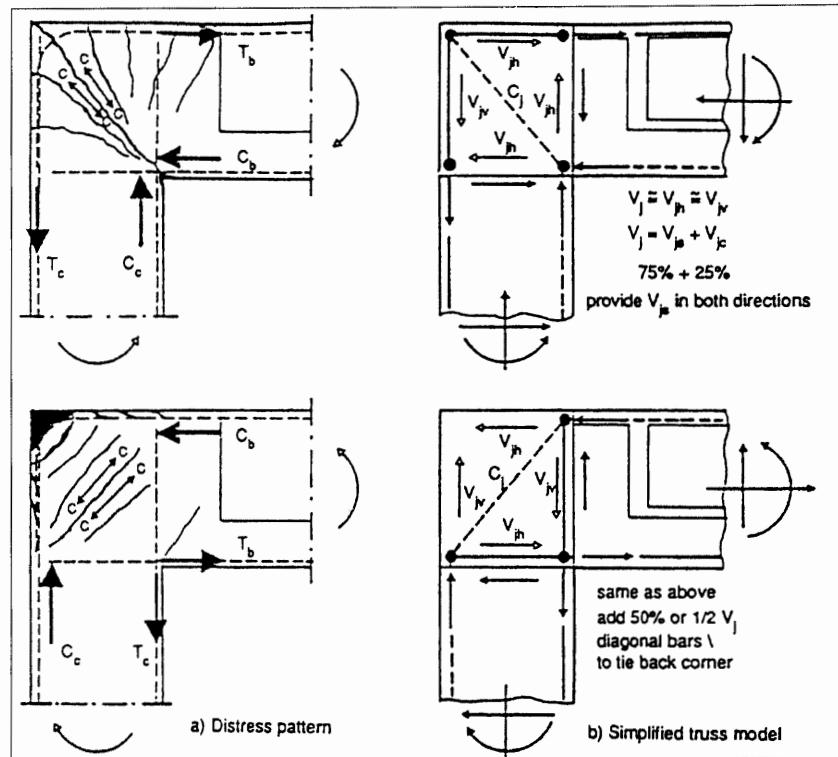
The vulnerability of knee joints from opening and closing moments had been studied before this bridge was built (Park and Paulay, 1975). Caltrans' philosophy has been to design very strong joints and bent caps that force the damage to occur in the ductile columns. This bridge had very ductile columns, but the joints were underdesigned. Joint damage to this and other bridges has resulted in a major research and testing effort at the University of California, San Diego, to come up with better joint details and a coherent philosophy for joint design.

Figure 47.—Distress pattern for closing and opening of knee joints (Seible and Priestley, 1991).

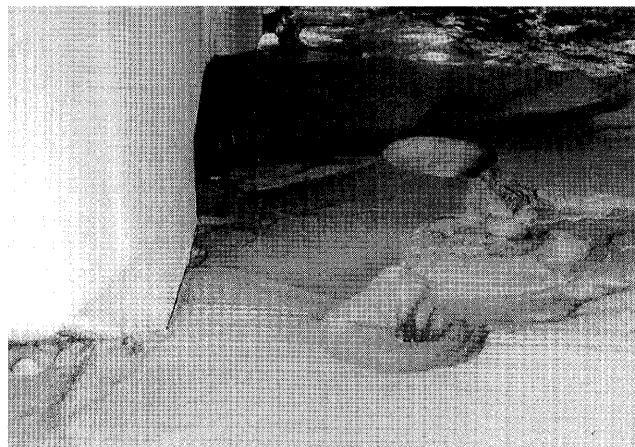
The most noticeable evidence that a strong earthquake had occurred was the quantity of ejected sand around the columns at the north end of the bridge (fig. 53). There was substantial minor damage to this bridge during the earthquake. Anchor bolts that held the bottom steel girder flange to the bent cap were broken at a few locations. Also, some anchor bolts that held the steel bent caps to the columns were damaged. Mortar pads under girders had been broken. Keeper plates that held the steel bearings in place had been knocked loose at many locations. Some girders had moved sideways up to 14 inches, buckling the crossbracing. Surprisingly, cable restrainers had yielded at several locations (fig. 54). Steel girder flanges had buckled at two locations. There was also some concrete damage. The deck overhang had spalled from banging at expansion joints. There was some shear cracking at bent caps. The most serious damage was spalling at the base of some of the reinforced concrete single column bents (fig. 55). Table 11 summarizes the visual inspection of damage for each alignment. All the evidence suggests that the bridge moved primarily in an east-west (transverse) direction during the earthquake. After the earthquake, this bridge was used to haul heavy timber for shoring at the nearby Cypress Street Viaduct. However, it was later decided to close the structure for a few days while some repairs were made.

Figure 53.—Sand boil at Bent 3 of the O line at Port of Oakland Overcrossing (view to south) (photograph by Li Hong Sheng).

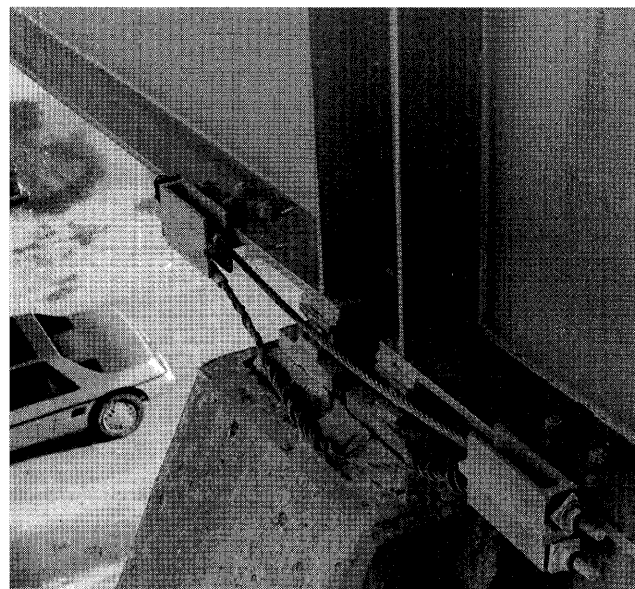
Figure 54.—Restrainer damage at Port of Oakland Overcrossing (Photograph by Philip Stolarski).

Because of the damage to anchor bolts, welds, etc., the first order of business was to bring in a snooper (a truck with an articulated arm and large basket) and do a thorough ultrasonic inspection of steel girders and steel connecting elements. After the extent of damage was ascertained, repairs were initiated. Concrete cracks were repaired by epoxy injection. Concrete spalls were repaired with dry pack (fig. 56). For the spalling at some column bases, additional reinforcement was added to the repair. Because of the decision to replace this structure as part of the I-880 replacement project (fig. 40), repairs were done only to bring this structure back to its condition before the earthquake but not to retrofit it to survive a stronger event. However, all the existing bolts at the steel bent caps were replaced with high strength bolts, all the cable restrainers were replaced, and the other extensive repairs to this structure probably have improved its seismic performance. Because of the extent of minor damage to this long structure, the cost of repairs was almost \$1 million.

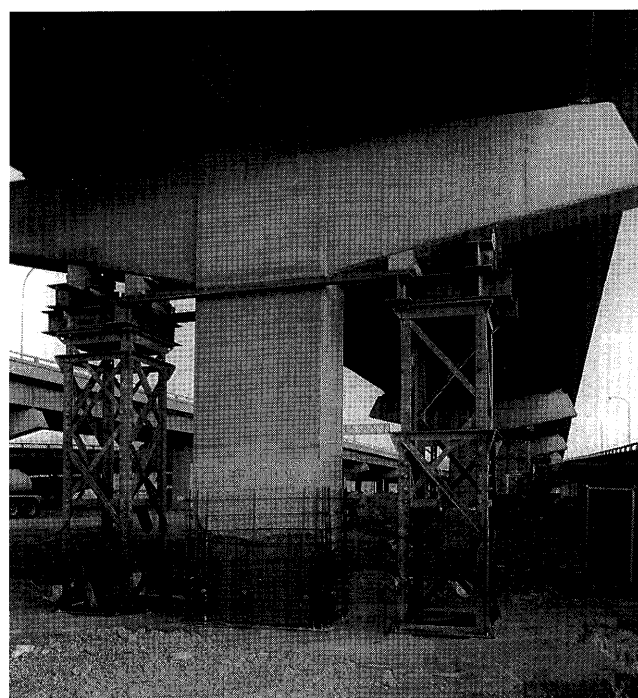
JR line	Bents JR28 to JR34 have soil cracks around footings and concrete spalls at column bottoms, indicative of flexural yielding in east-west direction.

Figure 56.—Column damage and repair at Port of Oakland Overcrossing.

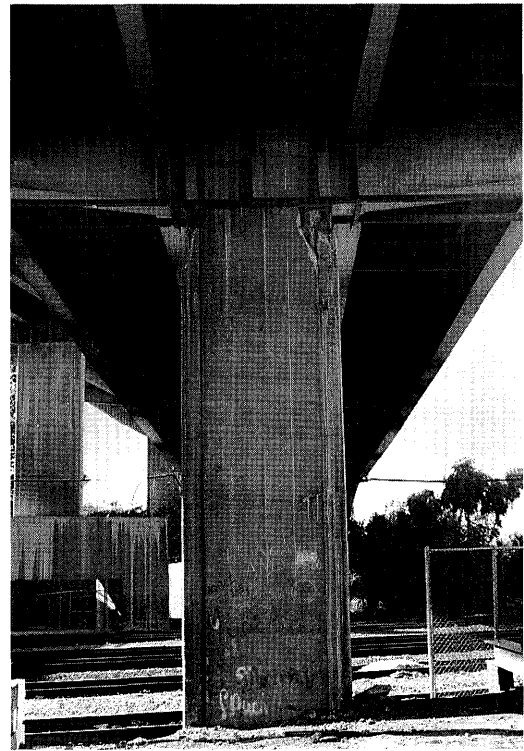
There was a great deal of minor and moderate damage to this structure. There was substantial damage to keeper plates, anchor bolts, and other steel hardware that kept the bearings in place. There was some minor cracking at the bottom of columns. Figures 61 and 62 show the results of transverse rocking of bents which caused concrete to spall and anchor bolts to deform at the column-to steel-bent-cap connection. The MB alignment had the most damage. The backwall for Abutment MB1 was severely cracked. The most significant damage was at Bent MB25, where there were many cracks at the bottom of the column, the bearing keeper plates were knocked off, the girder ends were bent, the bent cap web had a bow, and the superstructure shifted 3 inches to the north. Figure 63 shows the keeper plate damage. Table 13 summarizes the structural damage.

Figure 61.—Spalls and anchor bolt damage at Bent BC8 of the Distribution Structure.

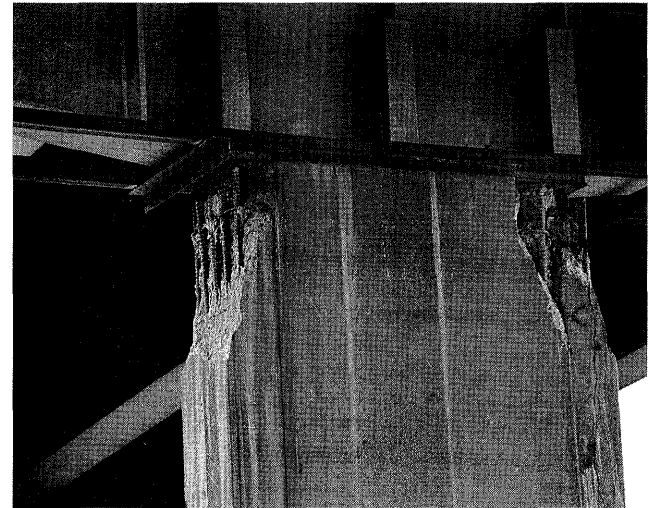
Figure 62.—Closer view of damage at top of Bent BC8 of the Distribution Structure.

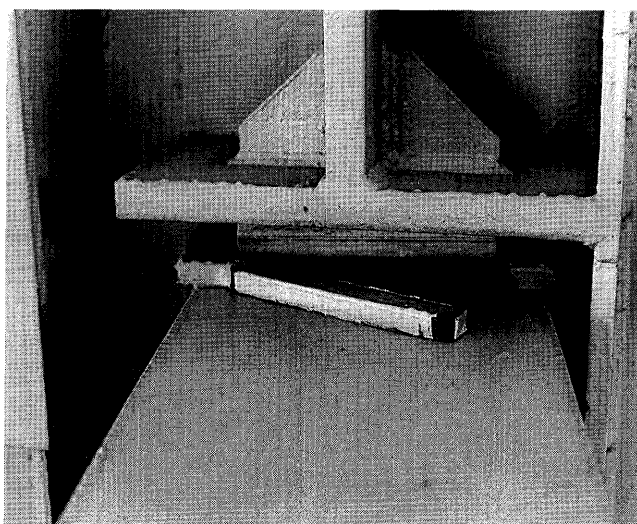
Alignment	Damage
CB	Bents CB2 and CB3 have the two interior steel girder keeper plates sheared off. Bent CB4 has at least one interior steel girder keeper plate sheared off.
CS	At Abut 1, Bent CS2, and Bent CS3, the structure has moved 2 inches in the east-west direction. Soil dropped 4 inches around the column at Bent CS2. Signs of foundation movement (soil cracks) from Bent CS2 to Bent CS5. Gap at Abutment 1 is about 4 inches wide and more than 3 feet deep at west side. Pavement crack along west side curb of approach.
BM	Approach has settled 6 inches. Pavement buckled at end of approach slab. Roadway shifted 2 inches to north.
MB	Footings rocking can be seen from the soil cracks around the footing. Series of soil cracks follow structure alignment. Concrete spalled at bottom of pinned bearing pad and above hole of restrainers at Bent MB9. Several bearing plates at Bent MB25 moved and fell.
CM	Roadway crack follows alignment of CM line toward Toll Plaza. Liquefaction can be seen along roadside and cracks. North side of roadway shifted 4 inches to north and has 6 inches settlement.

Figure 63.—Keeper Plate Damage on the Distribution Structure (photograph by Li Hong Sheng).

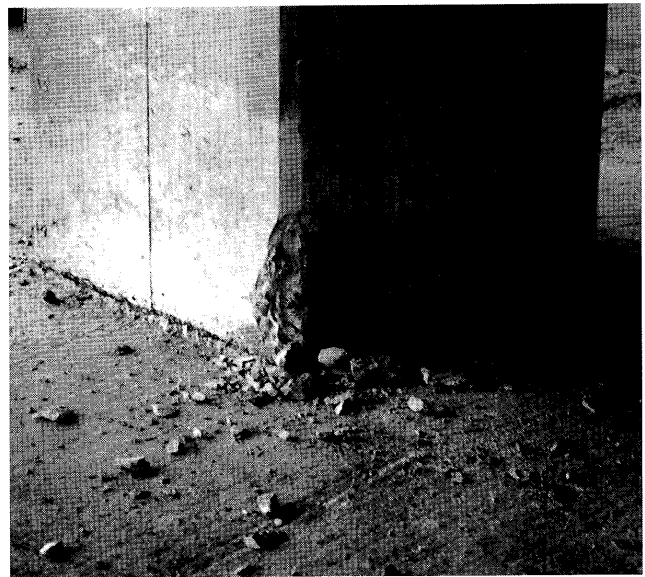
Figure 71.—Spall at column base for Bent 35 of Fifth Avenue Overhead (courtesy of Earthquake Engineering Research Institute).

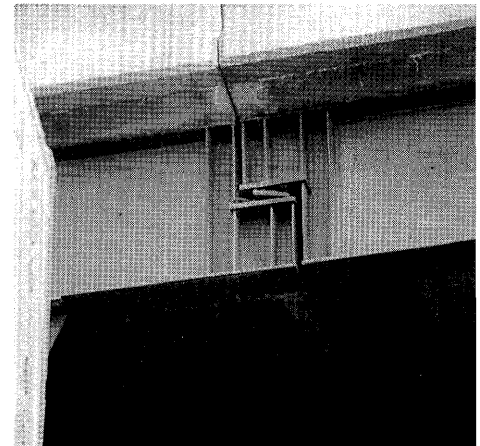
Figure 74.—Damaged hinge at Bent 36 of Fifth Avenue Overhead (courtesy of Earthquake Engineering Research Institute).

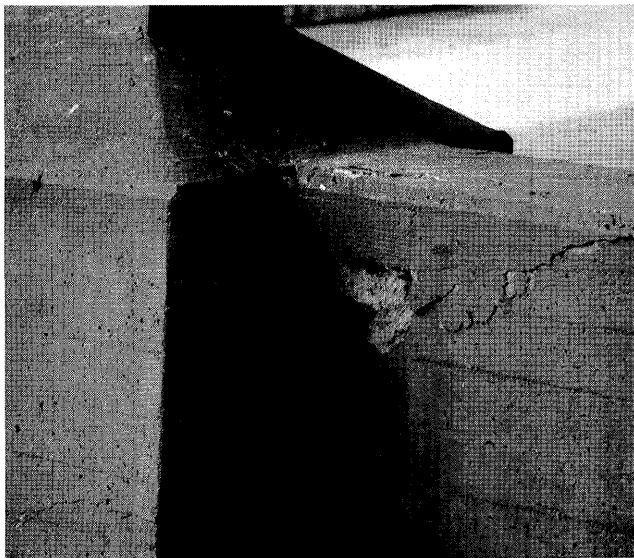
Location	Damage
Abut 1 to Bent 24	No damage.
Bent 25	Cracks to railroad collision wall. Deck spall at hinge in Span 24.
Bent 26	Cracked collision wall. Hairline crack of Column 3 at top of wall.
Bent 27	Hairline crack in Column 1 similar to Bent 26.
Bent 30	1/4" opening in soil around Column 7 and diagonal crack in concrete pad at bottom of column.
Bent 31	Spalls on all faces of Column 8 about 6" above ground line.
Bent 32	Column 8 cracked and spalled near ground and at bent cap.
Bent 33	Columns have cracks near the ground and near the cap.
Bent 34	Similar to Bent 33 but more severe.
Bent 35	Similar to Bent 34 but even more severe.
Bent 36 to 39	At this location there are steel three-column bents embedded in concrete pedestals and connected to skewed railroad collision walls. There was damage at the column to cap connections, and plastic hinging of some of the steel columns above the pedestals.
Bent 40 to 42	These columns sit in Merritt Lake Canal. The earthquake spalled concrete previously loosened by corrosion damage.

Figure 72.—Damage to railroad collision wall of Fifth Avenue Overhead (courtesy of Earthquake Engineering Research Institute).

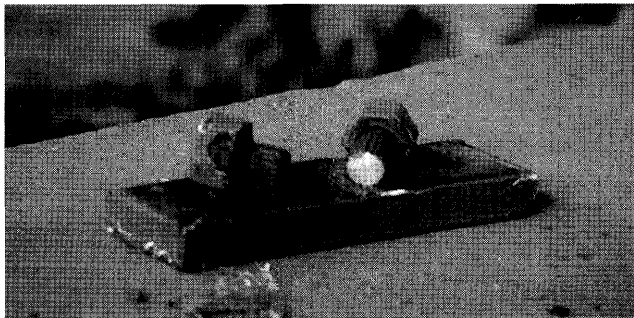
Figure 73.—Broken keeper plate at Bent 35 of Fifth Avenue Overhead (courtesy of Earthquake Engineering Research Institute).

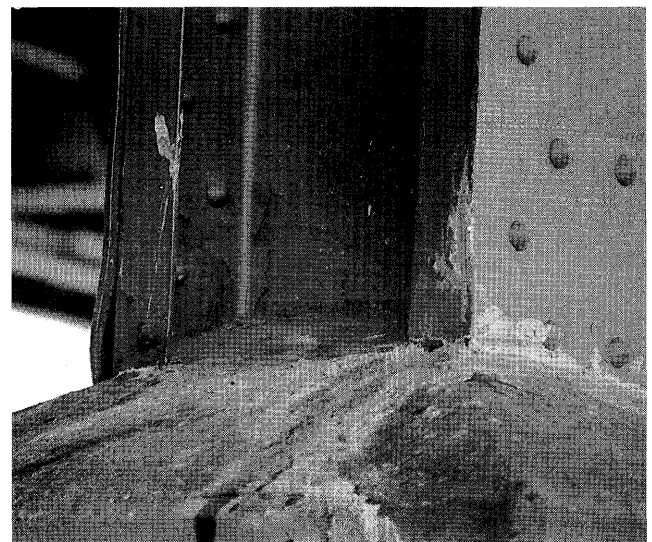
Figure 76.—Steel column damage at Fifth Avenue Overhead (courtesy of Abolhassan Astaneh-Asl).

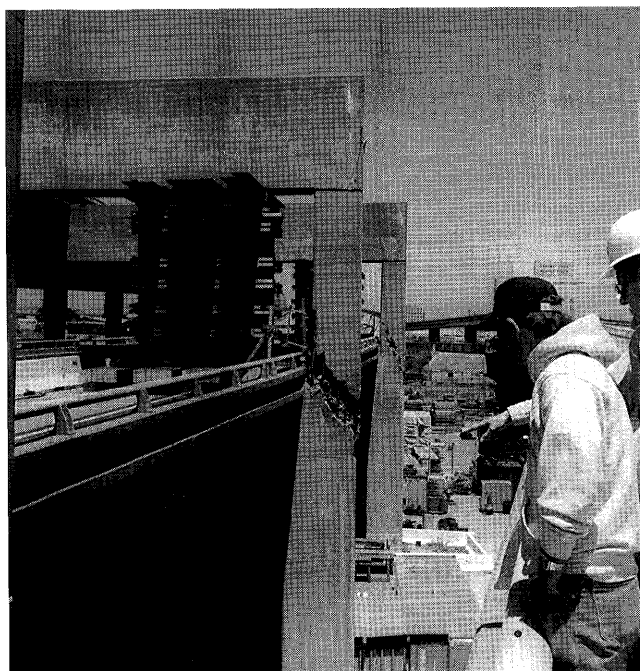
Bent 51 Right Column.—Diagonal cracks formed where the column frames into the bent caps (fig. 80, 86).

Bent 52 Right Column.—Similar to Bent 51, a shear transfer crack formed at the bottom bent cap.

Figure 80.—Damage to Bents 51 and 52 of Southern Freeway Viaduct.

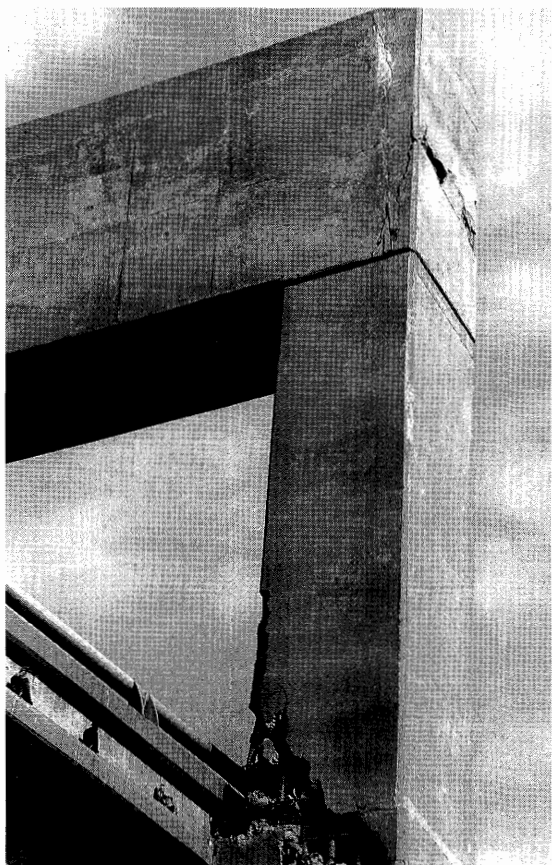
Figure 86.—Damage at Bent 51 of Southern Freeway Viaduct.

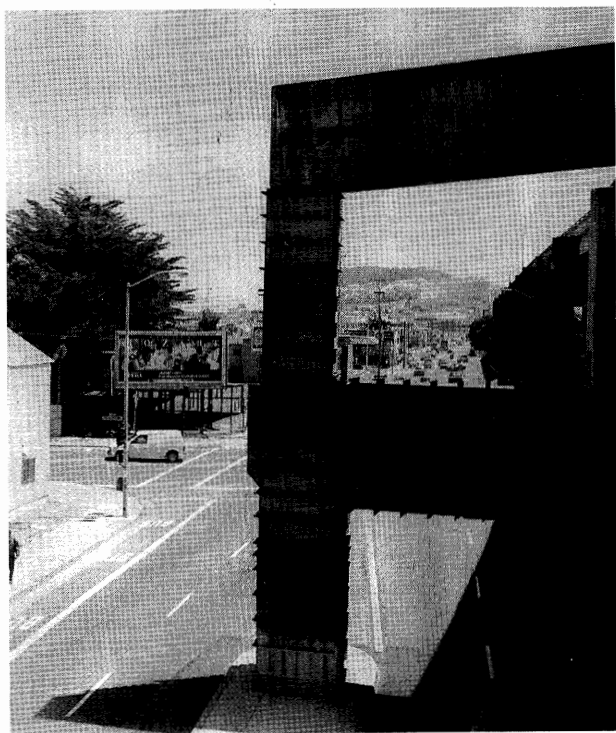
Figure 87.—Retrofit of the Southern Freeway Viaduct later rejected by the Peer Review Panel.

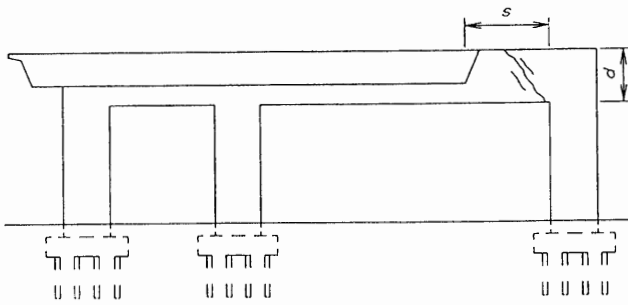
Bent A-32.—This bent is similar to A-31 except that the right column here supports an outrigger bent cap. The outrigger cap had significant diagonal cracks that extended

from the column up to bridge deck, possibly due to longitudinal movement of the superstructure (fig. 94).

Figure 94.—Damage to Bent A-32 of China Basin Viaduct.

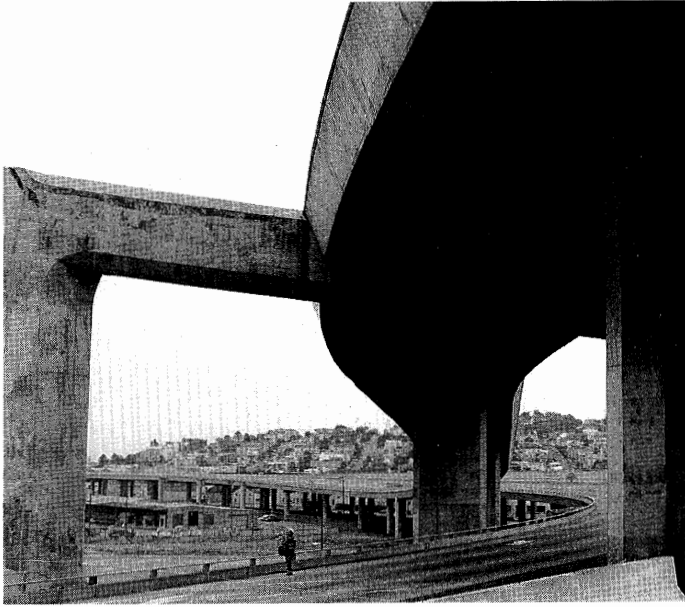
Bent N-35.—This outrigger bent had significant diagonal cracks where the columns frame into the cap and where the cap frames into the superstructure. It is reported that the cracks from the superstructure to the cap had existed since construction but may have worsened due to the earthquake. The cracks around the columns were the result of transverse movement during the earthquake. There were 2 inches of longitudinal movement to the hinge just north of this bent. Also one could see the outline of the column footings in the soil and pavement around these columns (fig. 95).

Figure 95.—Damage to knee joints at Bent N1-35 of China Basin Viaduct.

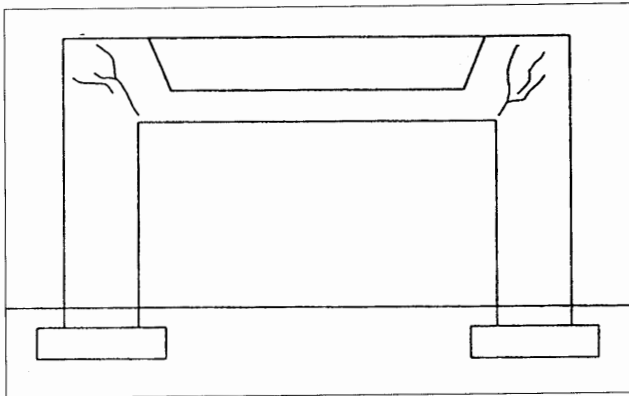
Bent S2-41.—This bent has a shorter outrigger cap with two fixed columns and precast I-girders framed to the cap. Again, there was cracking that began where the bottom of the cap joined the column and extended to the bottom of the exterior girder (fig. 96).

Figure 96.—Damage at Bent S2-41 of China Basin Viaduct.

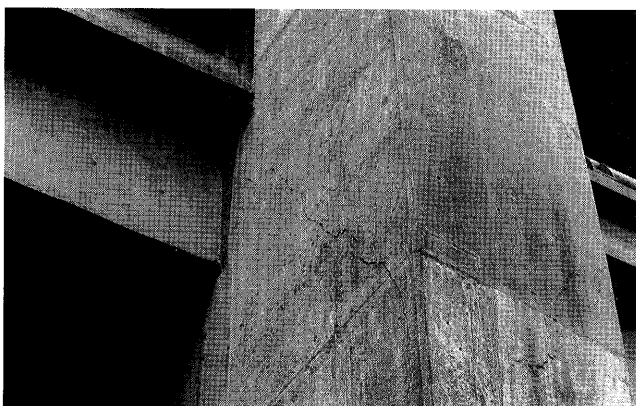
Figure 114.—Column damage to west side of Bent 75 at Embarcadero Viaduct.
