The Loma Prieta, California, Earthquake of October 17, 1989—Highway Systems

By MARK YASHINSKY

U.S. GEOLOGICAL SURVEY PROFESSIONAL PAPER 1552-B

HIGHWAY SYSTEMS

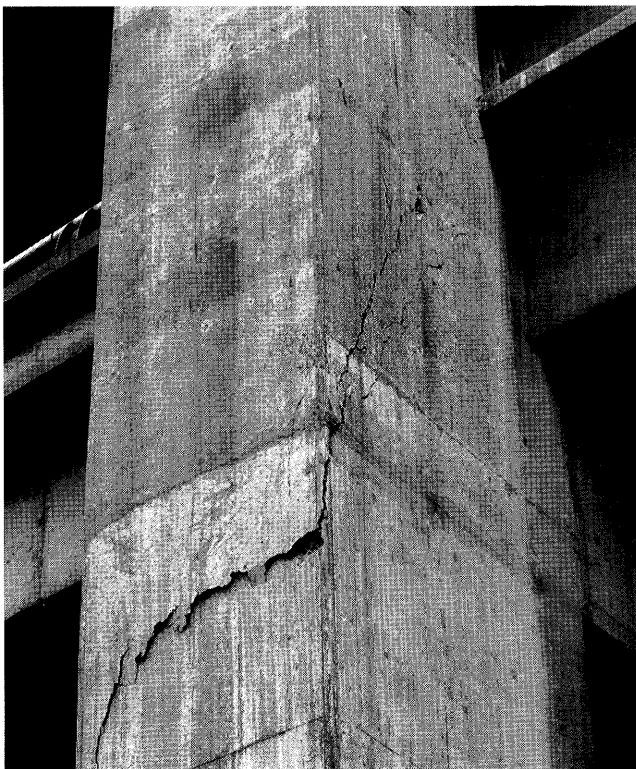
Figure 115.—Column damage to west side of Bent 76 at Embarcadero Viaduct.

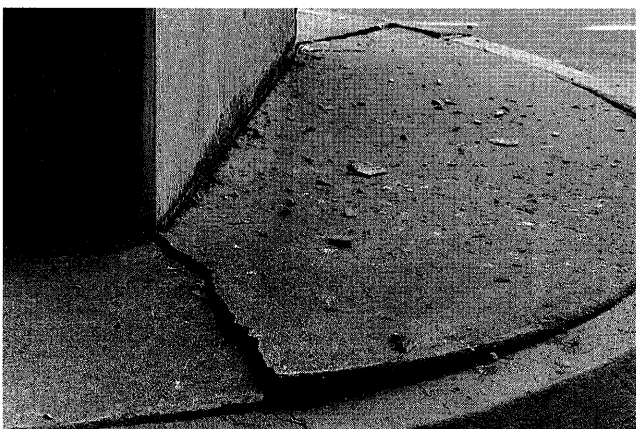
Figure 116.—Damage to sidewalk under Bent 77 of Embarcadero Viaduct.

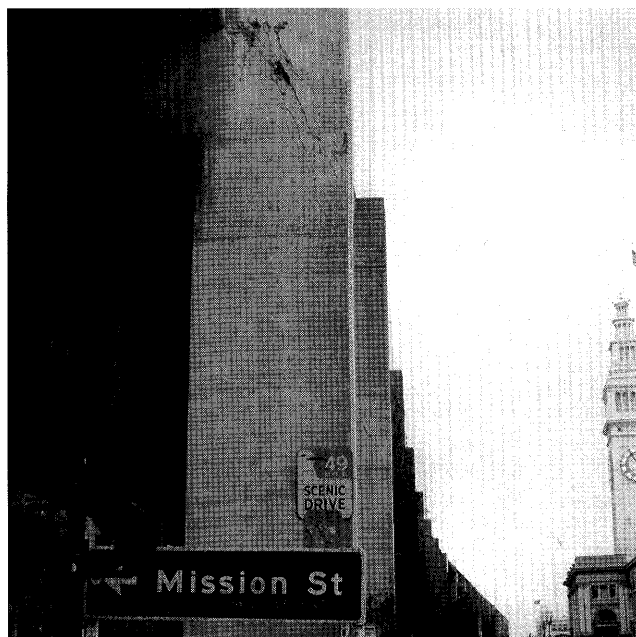
Figure 118.—Column damage on east side of Bent 79 at Embarcadero Viaduct.

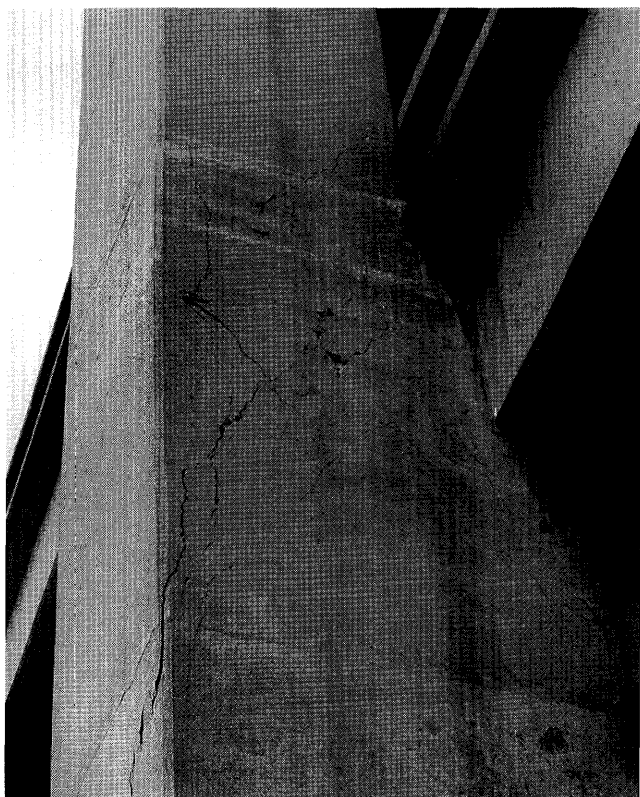
Figure 119.—Column damage to west side of Bent 79 at Embarcadero Viaduct.

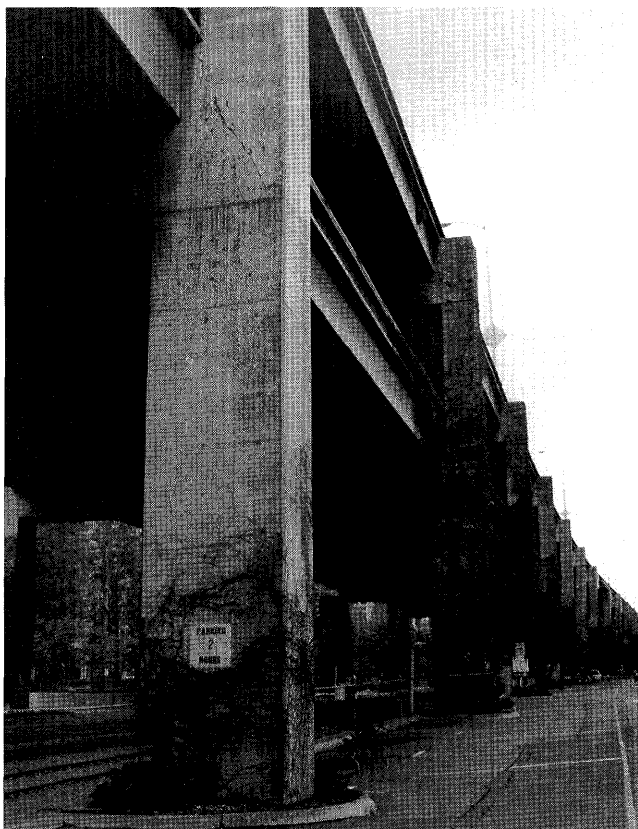
Figure 120.—Damage to west side of Bent 80 at Embarcadero Viaduct.

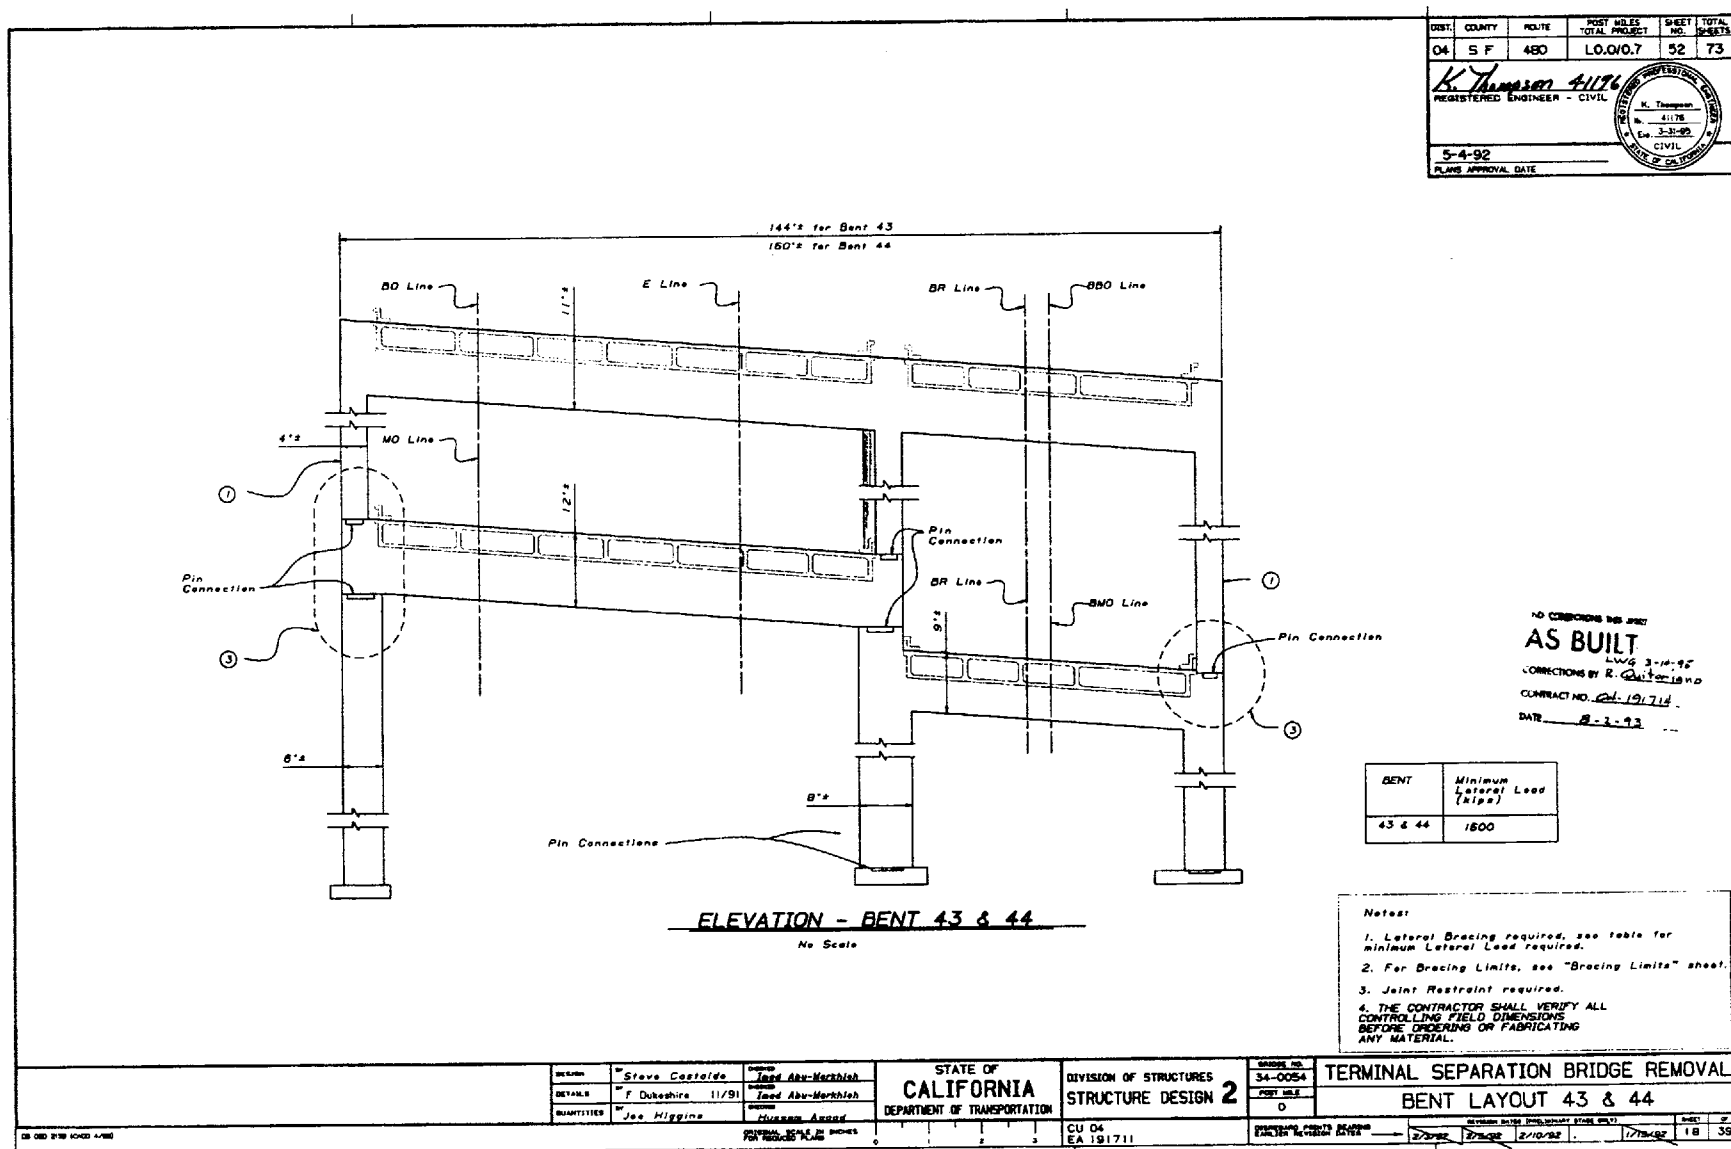
Figure 127.—Elevation drawing of Bent 43 and 44 at Terminal Separation.

Bent 44 (Column 2).—The lower outrigger bent cap was completely fractured with $\geq 1/4$ -inch cracks extending transversely across the top of the bent cap approximately 6 feet back from the face of the column and extending down both sides to the bottom of the bent cap at the column face (fig. 127). Concrete was removed using a hammer, which showed fracturing extending into the core of the bent cap. The condition of the fractured concrete was rubble. Concrete in this area was lightweight Portland Cement Concrete. Estimated cost to repair this damage was \$250,000.

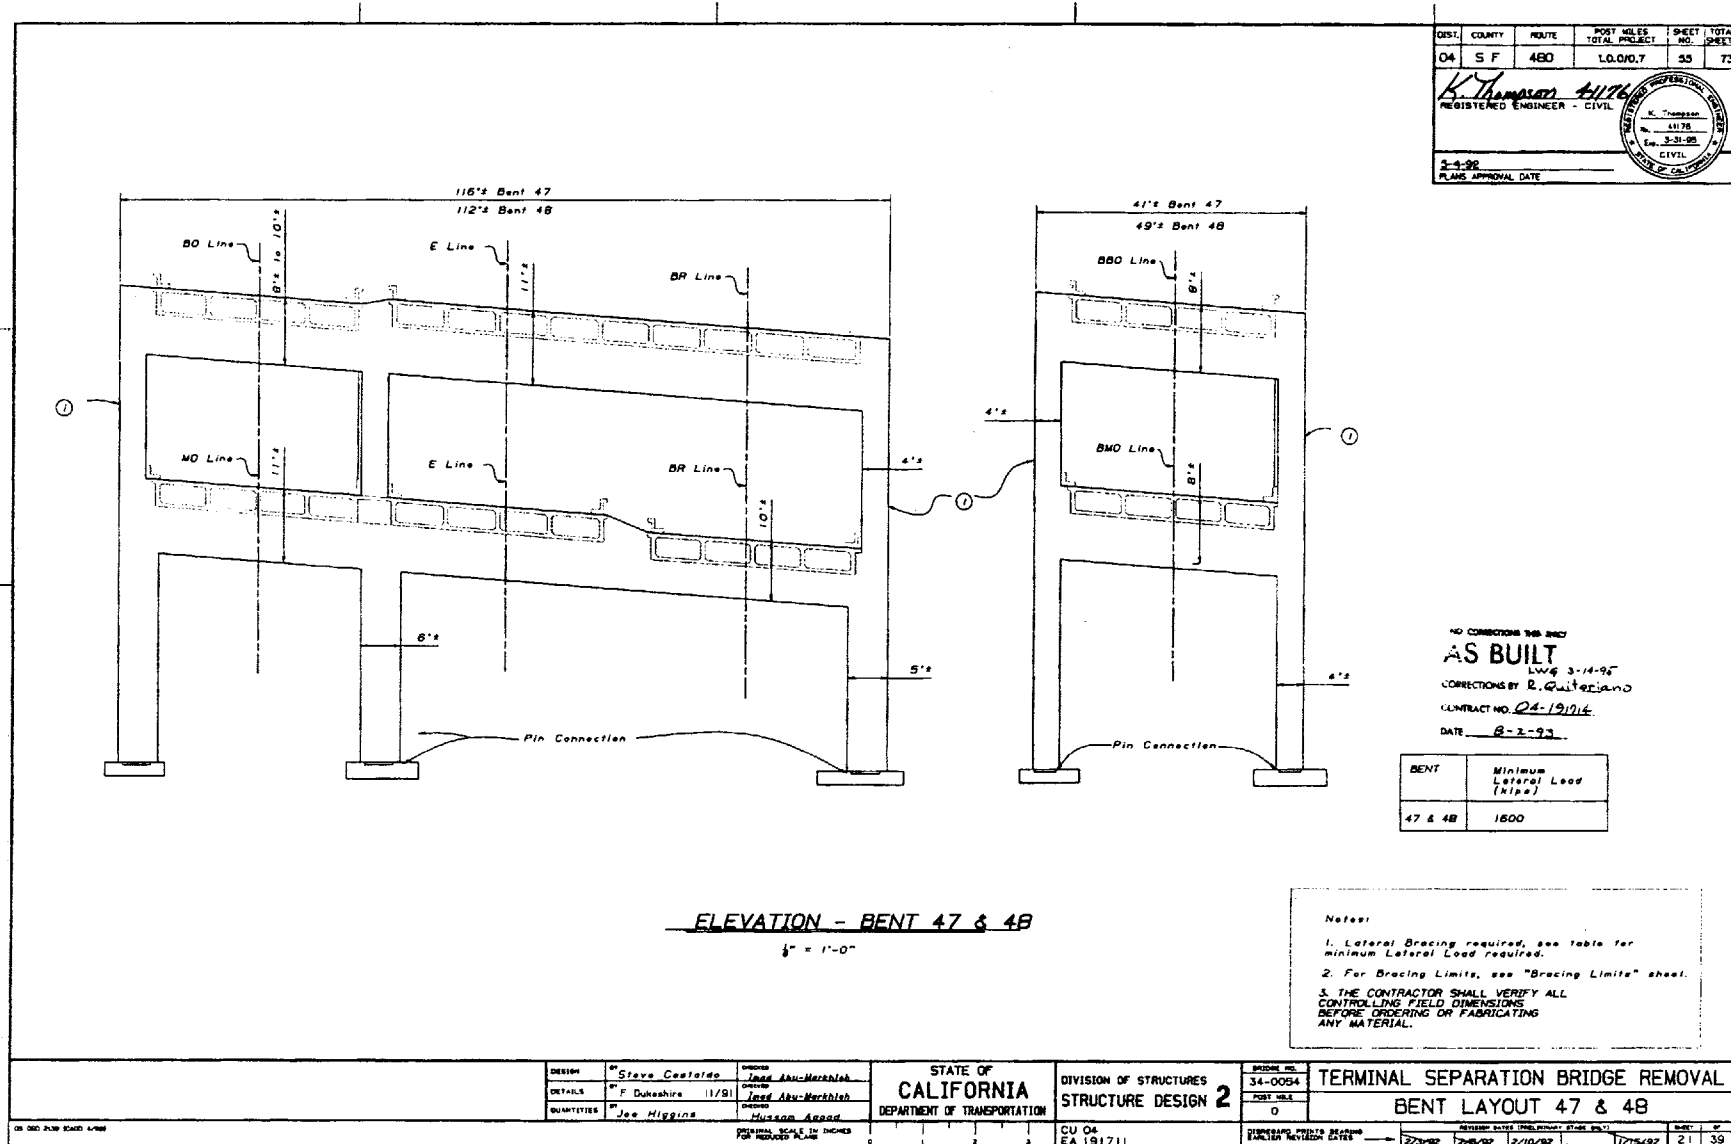
Figure 128.—Elevation drawing of Bent 47 and 48 at Terminal Separation.

Bent 48.—The bent cap between Columns 2 and 3 (fig. 128) was cracked vertically at midspan, with the cracks extending into the soffit. At Column 3 the bent cap was cracked, extending from the bottom of the cap at the column inward and upward at 45° . The bent cap at Column 4 was cracked at the column similarly to that described for Column 3. Repair cost at this bent was estimated to be about \$50,000.

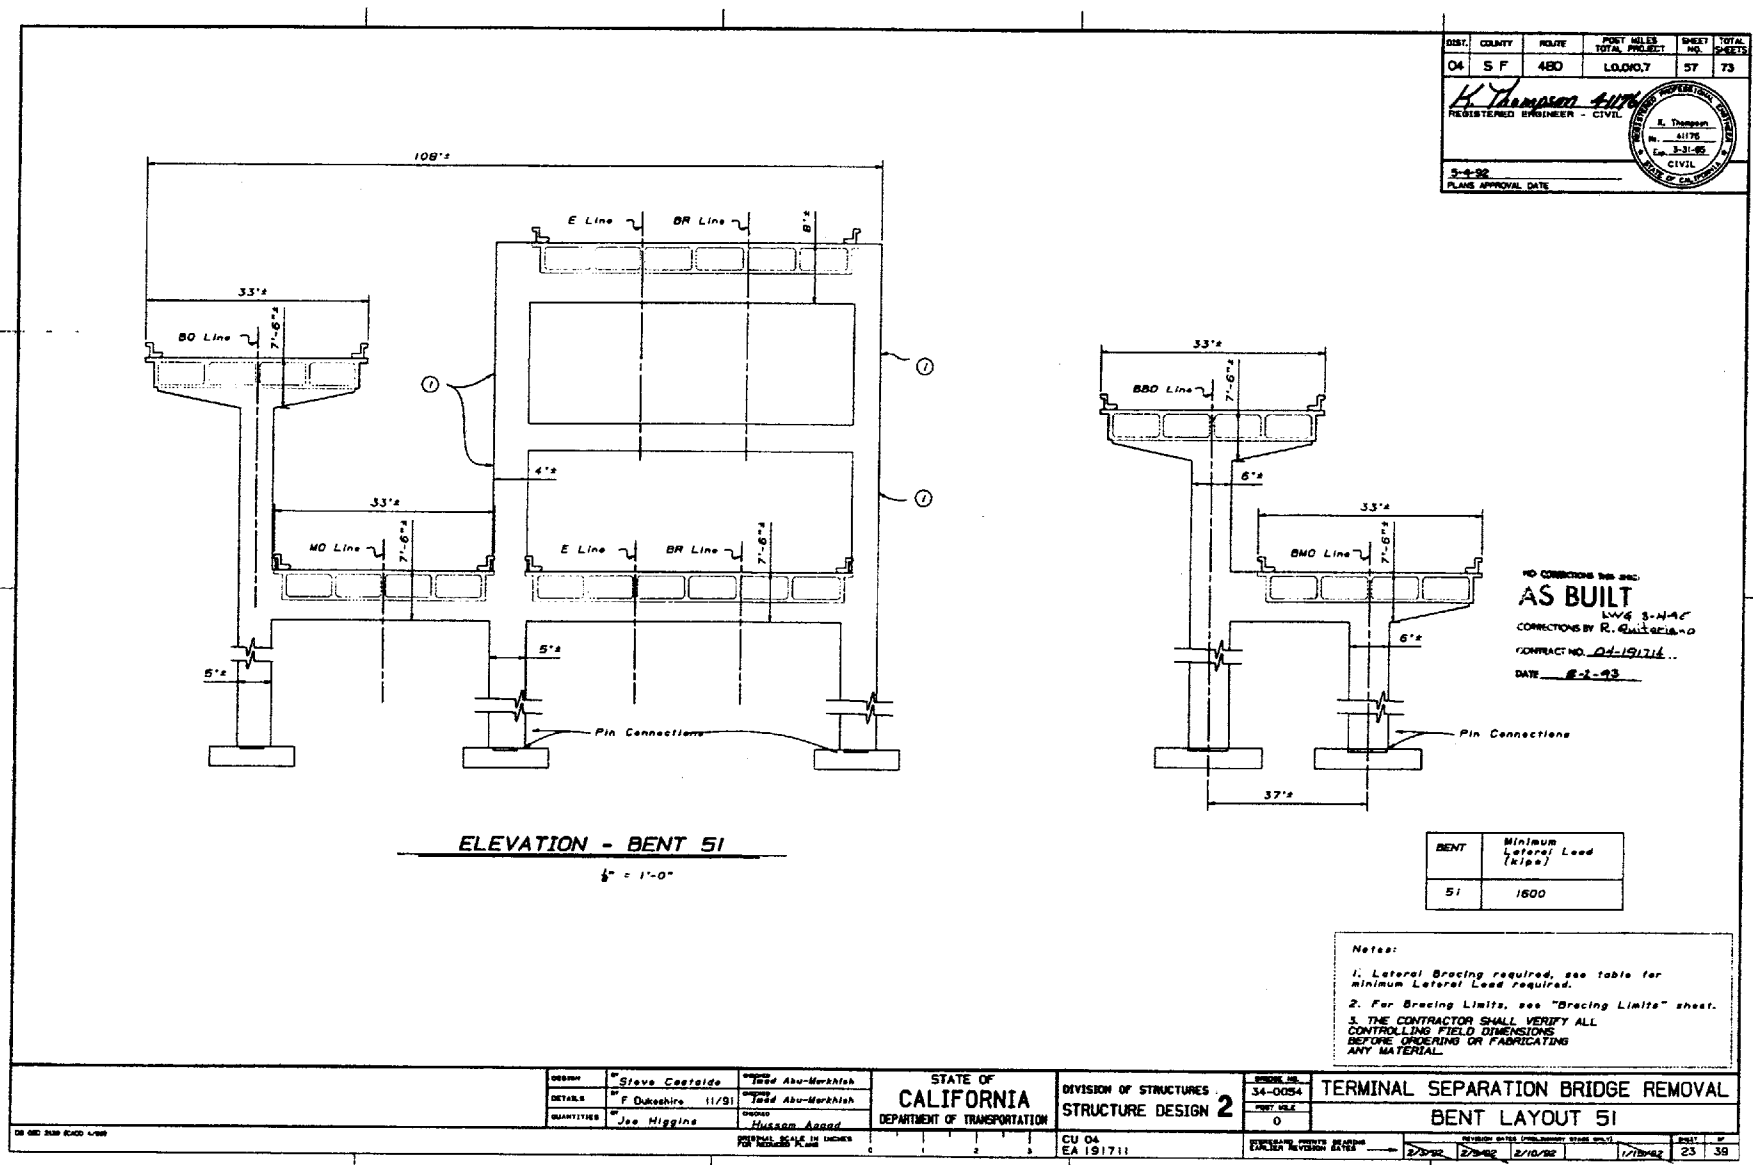
Figure 130.—Elevation drawing of Bent 51 at Terminal Separation.

Bent 51.—The bent cap at Column 1 was vertically cracked at the column face, with exposed rebar (fig. 130). Total estimated cost of repair for this bent was estimated as \$50,000.

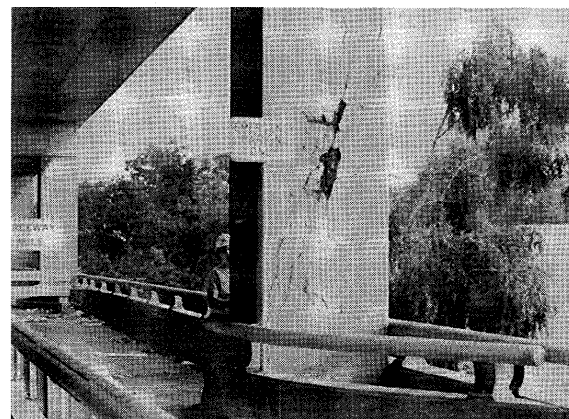
forcement (figs 139 to 141). In all cases the cracks appeared to extend through the entire column cross section. At street level, Column 3 of Bent 48 and Column 2 of Bent 49 had the same damage as mentioned above, indicating it was distressed and only partially functional. Figure 142 shows all the significant damage that occurred at Central Viaduct during the earthquake.

Figure 140.—Damage to Column 2 of Bent 43 at Central Freeway Viaduct (photograph by Mike Van de Pol).

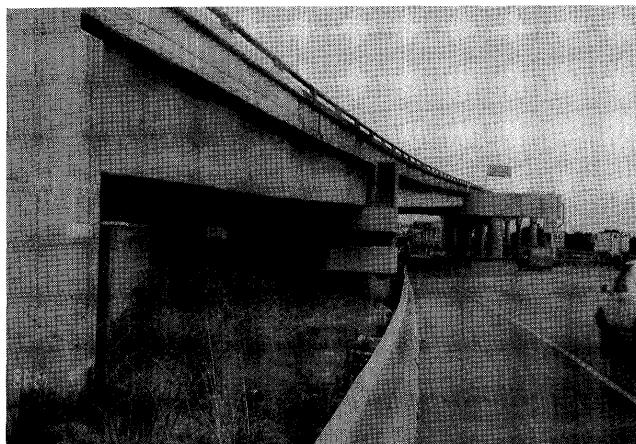
This viaduct also had a proposed retrofit that was rejected by the Peer Review Panel. However, a very innovative retrofit was done in 1992. This structure, like so many bridges, begins on very short bents and gradually ascends on very tall columns. To prevent substructure damage on the short, stiff bents and to prevent superstructure damage on the tall, strong bents, isolators were installed to give the substructure a uniform response along its entire length and to prevent large plastic moments from forming on the tall columns (fig. 145).

Figure 145.—Completed retrofit for Alemany Interchange.

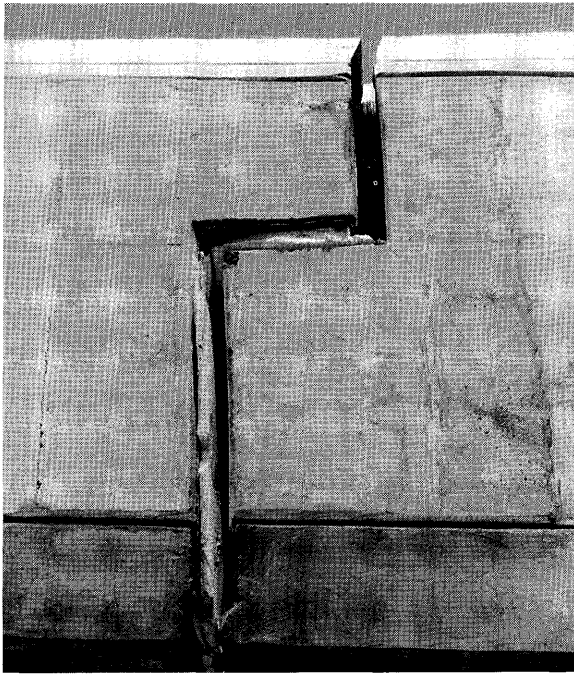
The most significant damage to this structure was failure of elastomeric pads at the hinge for Span 19 of the Northwest Connector (fig. 151; table 18). It had been assumed that the greased plates above and below the bearing would allow the hinge to move during the earthquake. Apparently the grease and neoprene pads harden over time and the pads can fail in shear since they are not designed for earthquakes. Replacing bearings at hinges is a difficult and expensive procedure. Large jacking frames had to be built on the ground that reached the superstructure soffit. A better hinge design is needed that will allow maintenance crews to reach the bearings from inside the cells of the box girder superstructures. A report was prepared by Structural Maintenance on November 17, 1989, that

Figure 151.—Hinge opening at Northwest Connector of Route 92/101 Interchange due to earthquake.

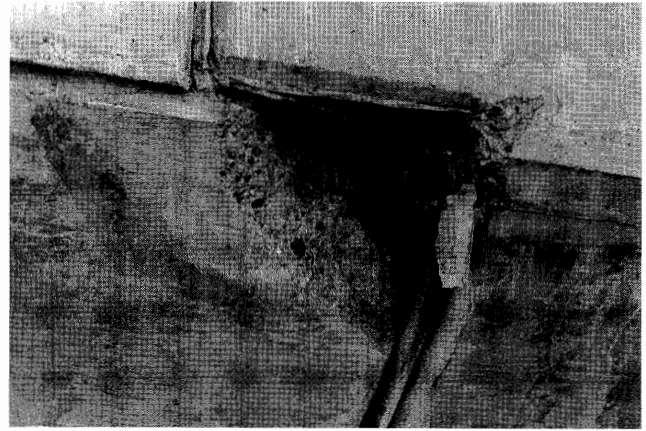
The hinge at the center frame suffered serious damage due to relative movement between the three frames during the earthquake (fig. 155). The elastomeric bearing pads did not delaminate, but certain layers were compressed and worn down. Inspection of the joints showed that the suspended side of the Span 19 hinge was 1.5 inches lower than the support side. On October 25, 1989, work began to replace the elastomeric pads at Span 19. The superstructure was jacked up, new elastomeric pads and restrainers were placed in the hinge, and the bridge was reopened to traffic on November 2, 1989. The Span 16

Figure 155.—Spall at Northwest Connector of Route 92/101 Interchange.

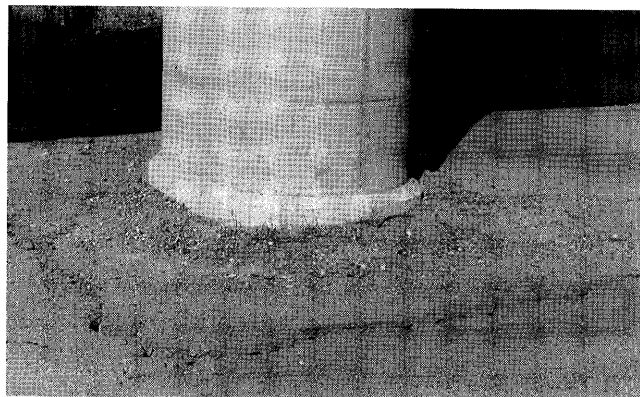
The soil around the base of most of the columns of this structure in the vicinity of Bent 12SE and 13SE had consolidated because of the October earthquake. There is a small crack in the soil around these single column bents, outlining the shape of the footing (fig. 157). The consolidation is not severe, only an inch or two in some locations. At other locations, only a small crack is visible in the soil, outlining the edges of the footing. In most locations, the cover over the footing block concrete is only 2 to 3 inches.

Figure 157.—Foundation movement at Southeast Connector of Route 92/101 Interchange.

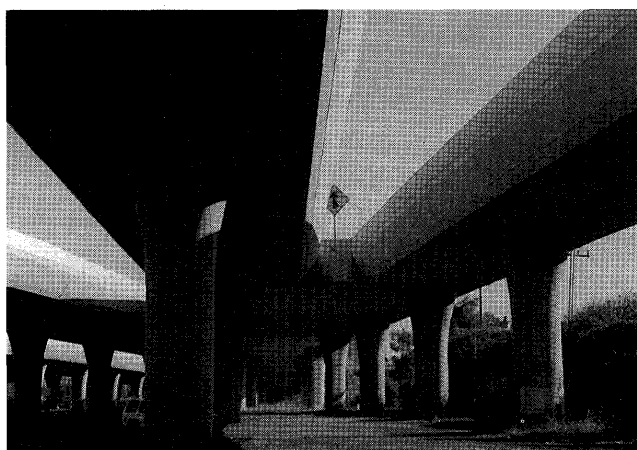
In 1991, Professors Saidi and Maragakis from the University of Nevada at Reno made a study of several wide soffit cracks near the hinge of the Northeast Connector (figs. 158 and 159). These cracks were reported after the earthquake, but an investigation had to wait until access holes were cut into the soffit (November 21, 1991). The cracks, along with some damage to the barrier rails at the hinge, suggested that they were caused by the earthquake (figs. 160 to 162). Because the cracks were vertical along the webs, they could not have been caused by shear. Because the cracks were near the hinge, they could not be caused by flexure. Therefore, it was felt that the cracks were caused by tension. The eccentric location of the restrainers could possibly have produced a flexural moment which may have caused these cracks. Also, the role of prestressing tendons combined with cable restrainers needs more study.

Figure 159.—Portion of Northeast Connector of Route 92/101 Interchange where soffit cracks were investigated.

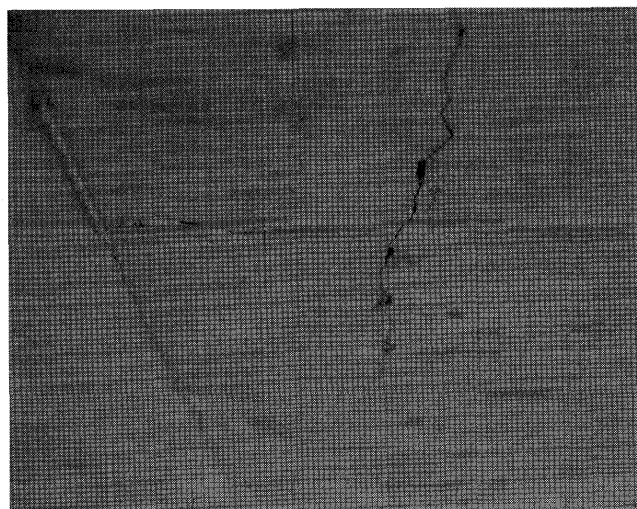
Figure 160.—Soffit cracks on Northeast Connector of Route 92/101 Interchange.

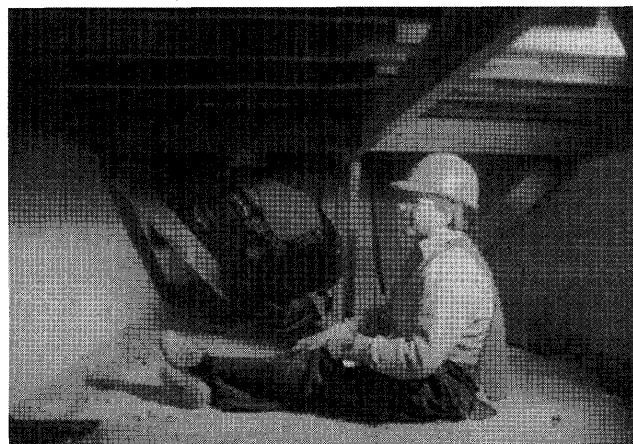
Figure 161.—M. "Saiid" Saidi investigating cracks in interior bay of Northeast Connector of Route 92/101 Interchange.

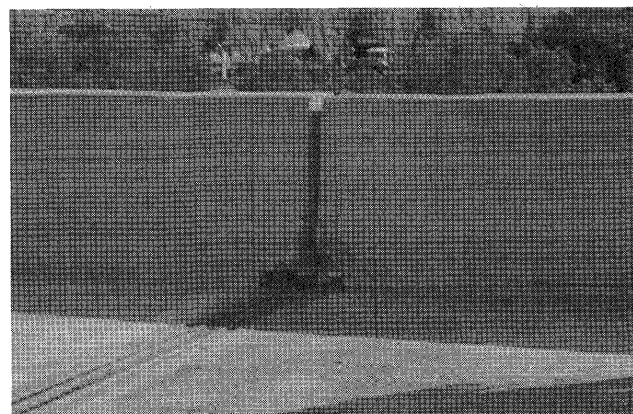
Figure 162.—Barrier rail damage at hinge of Northeast Connector of the Route 92/101 Interchange.

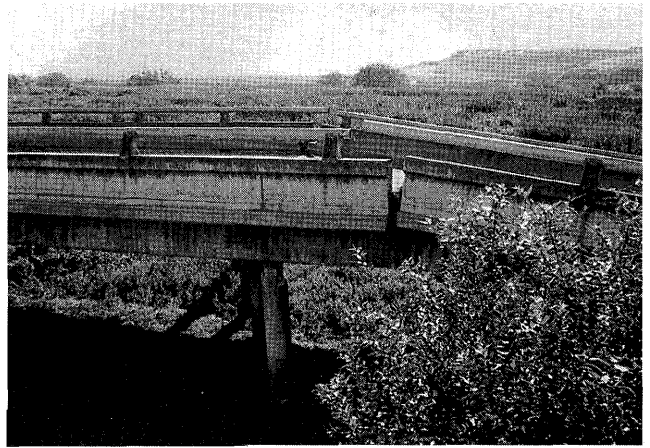
The restrainers performed surprisingly well during the earthquake, holding the hinges together even on the collapsed portion of the bridge. There was a great deal of displacement. Abutment 1 of the left bridge moved 6 inches longitudinally, and the approach fill settled 3 inches behind the abutment. The bridge superstructure displaced up to 2 feet at midspan. Almost all the pile extensions were damaged. There

Figure 168.—Cable restrainers holding hinge together on Struve Slough Bridges (superstructure was unsupported beyond this point).

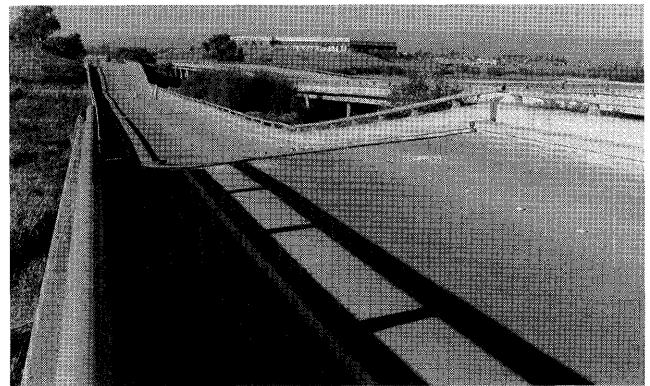
Figure 169.—South abutment of left Struve Slough Bridge (view to north).

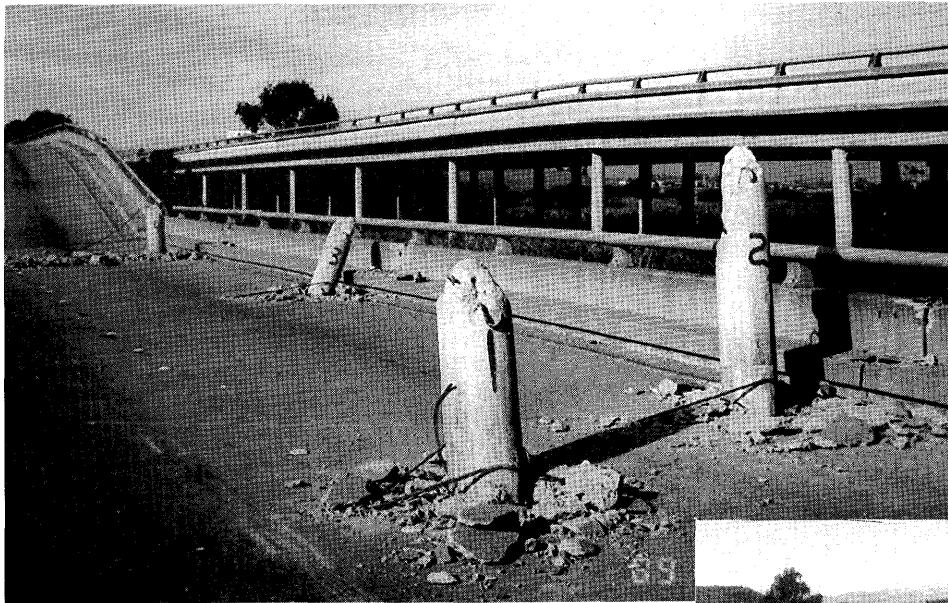
it dragged the pile extensions along with it, causing severe damage to both bridges. The left bridge collapsed from spans 6 to 17. Many of the piles were crushed. Several piles in Bents #14 and #15 were displaced longitudinally, separated from the bent cap, and punched through the bridge deck (figs. 167 to 171).

Figure 170.—Piles penetrating deck of left Struve Slough Bridge (view to south).

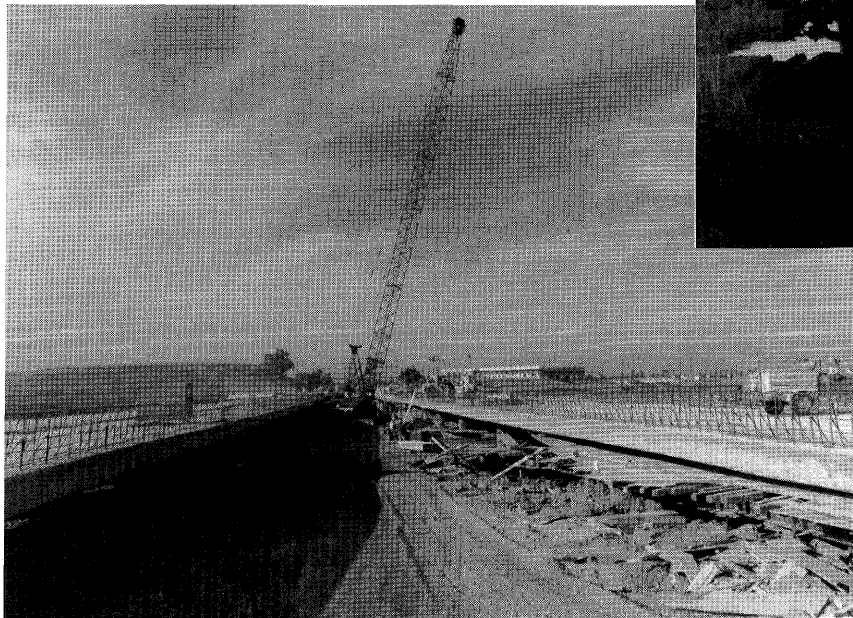
Figure 171.—Reconstruction of Struve Slough Bridges.

Damage to this bridge stopped all traffic from traveling on the Pacific Coast Highway. Because of the severe damage and potential for more damage during the next earthquake, it was decided to replace the damaged bridges with new structures that could survive the large movement of the soft soil during earthquakes. Caltrans Design Section 11 was given the task of coming up with a new design in 8 days. At first they thought they could use the standard design charts for a slab bridge. However, putting in pile extensions that were basically unsupported through 70 feet of soft soil required a dynamic analysis.

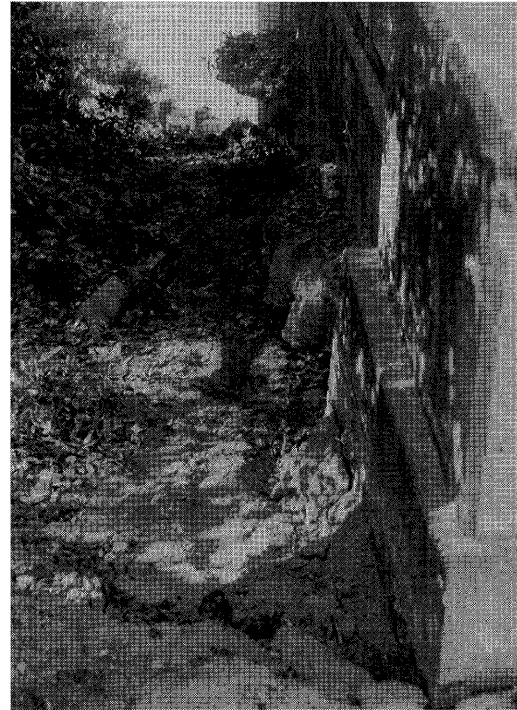
At Abutment 1 the right wingwall broke off. The fill had settled as much as 12 inches on the outside of the wingwalls (figs. 176 and 180). The approach also settled about 6 inches. There was curb and railing damage all along the structure (figs. 178 and 179). At Bent 4, Span 3 moved transversely about 1 inch to the right, spalling the diaphragm and shearing the bearing plate bolts and grout pads. At Abutment 5 the wingwalls moved outward, causing the fill to settle (fig. 177).

Figure 176.—Settlement along abutment of Grant Undercrossing (photograph by Mike Van de Pol).

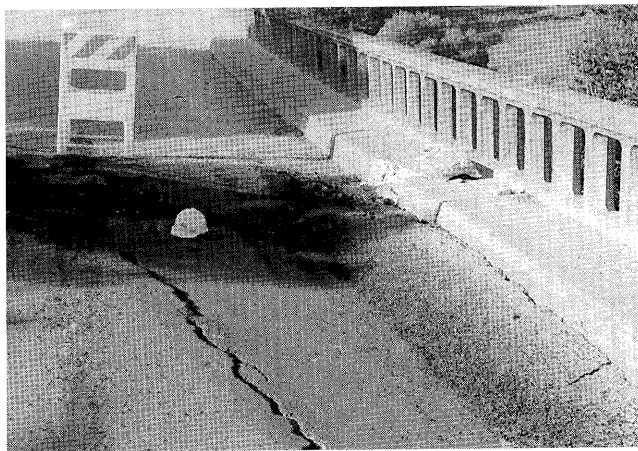
Figure 177.—Abutment 5 approach to Grant Undercrossing (view to west) (photograph by Mike Van de Pol).

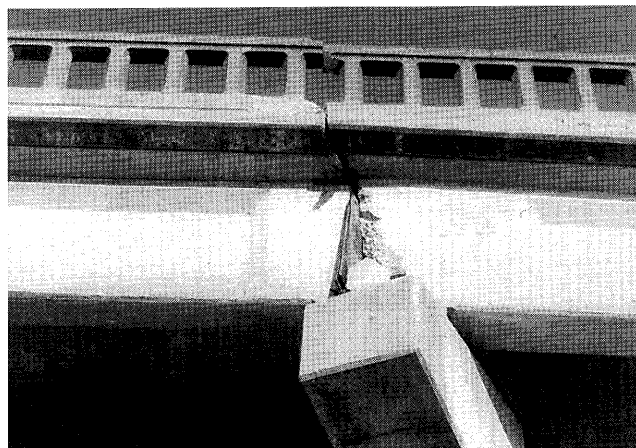
Figure 179.—Exterior spall at Bent 4 of Grant Undercrossing (view to south) (photograph by Mike Van de Pol).

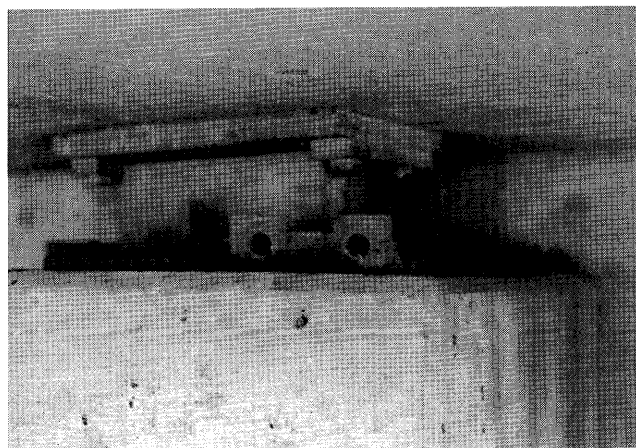
Figure 180.—Broken keeper plate for Abutment 5 of Grant Undercrossing (photograph by Mike Van de Pol).

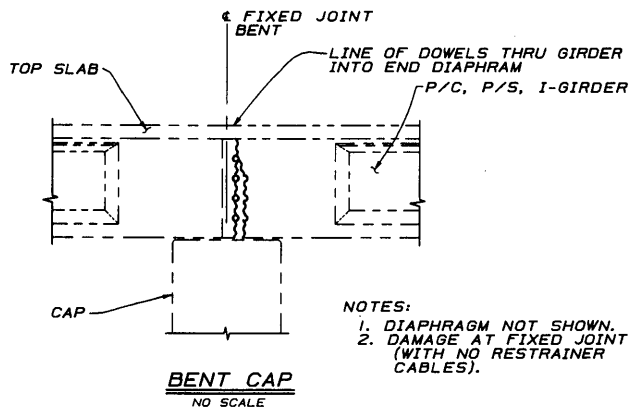
The basis for much of the damage can be seen in figure 198. Almost all the damage was the result of the precast "T" girders pulling out of the diaphragms (figs. 199 to 202). They were tied together with #6 reinforcement that ran transversely through the diaphragms. During the earthquake the girders pulled out, delaminating the concrete behind the #6 reinforcement.

Figure 198.—Detail drawing of typical damage to Napa River Bridge.

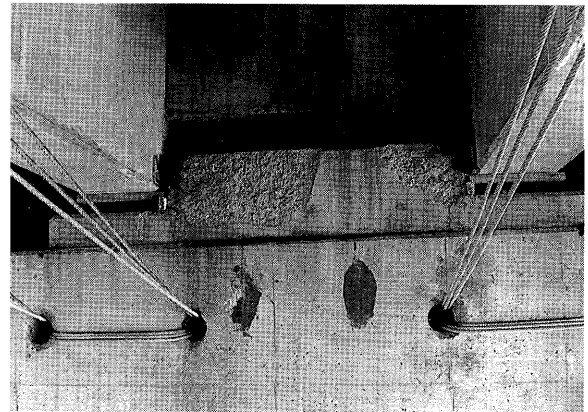
Figure 201.—Spalling on the Span 16 side of Pier 17 at Napa River Bridge.

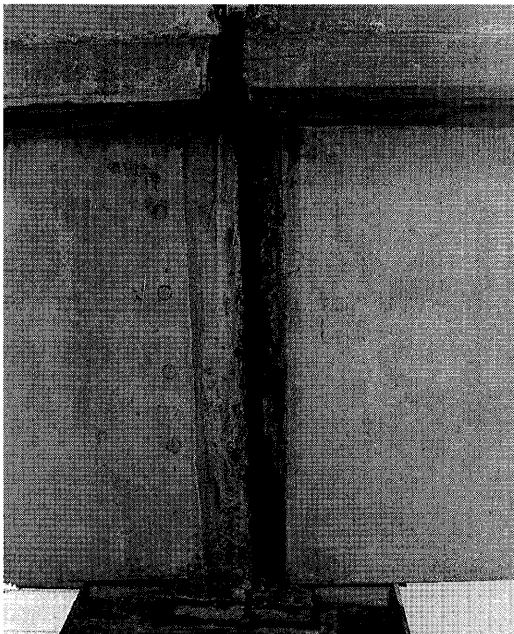
There were small to large spalls in the concrete diaphragms between the girders at the following locations. Pier 9 (Span 8 side), Pier 10 (both sides), Tower 11a (Span 10), Pier 12 (both sides), Pier 15 (both sides), Tower 16 (both sides), Pier 18 (both sides), Pier 19 (both sides), Tower 20 (both sides), Pier 21 and 22 (on the span 21 side). The diaphragms for Pier 12 at Span 11 and Pier 15 on both sides had major spalls and shear key failures.

Figure 199.—Diaphragm damage to Napa River Bridge.

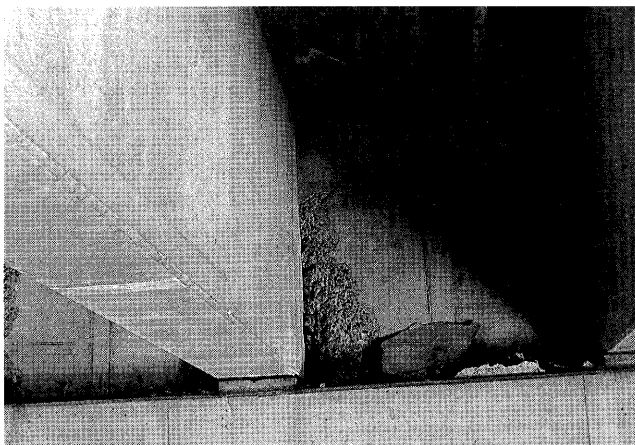
Figure 200.—Spalling at diaphragm of Napa River Bridge.

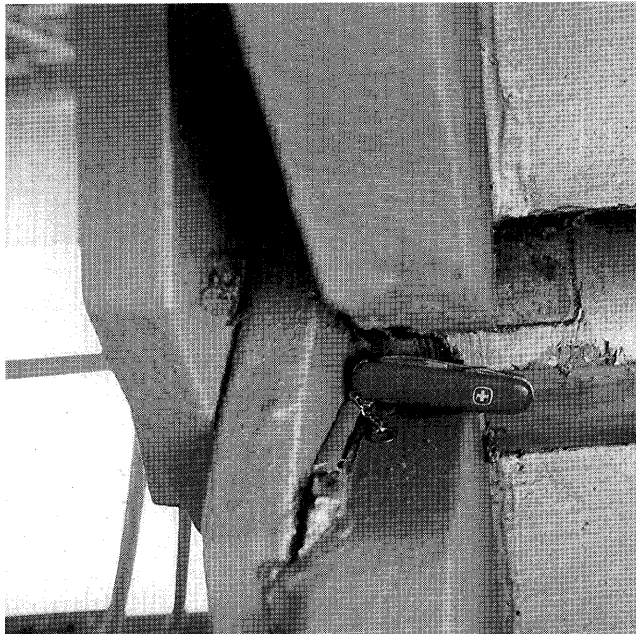
Bearings at Piers 18 and 21.—Bearings supporting the steel box girders had moved 1.5 inches at the north bearing of Pier 18 and 4.5 inches at the south bearing of Pier 21. Six of the eight interior pin caps (1.75-inch screw cap) had broken off. The end keeper plates were bent (figs. 220 to 223).

Figure 222.—Signs of movement at bearing (scraped paint) of San Mateo-Hayward Bridge (courtesy of Earthquake Engineering Research Institute).

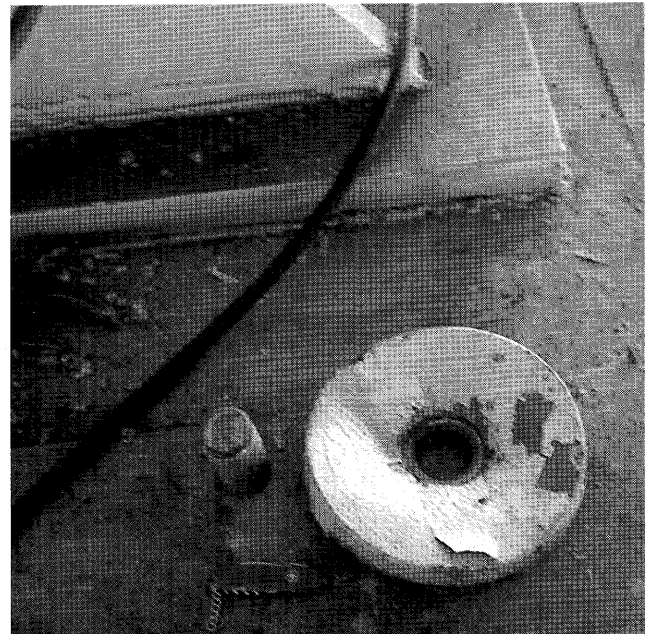
Figure 223.—Broken cap and washer from bearing of San Mateo-Hayward Bridge (courtesy of Earthquake Engineering Research Institute).

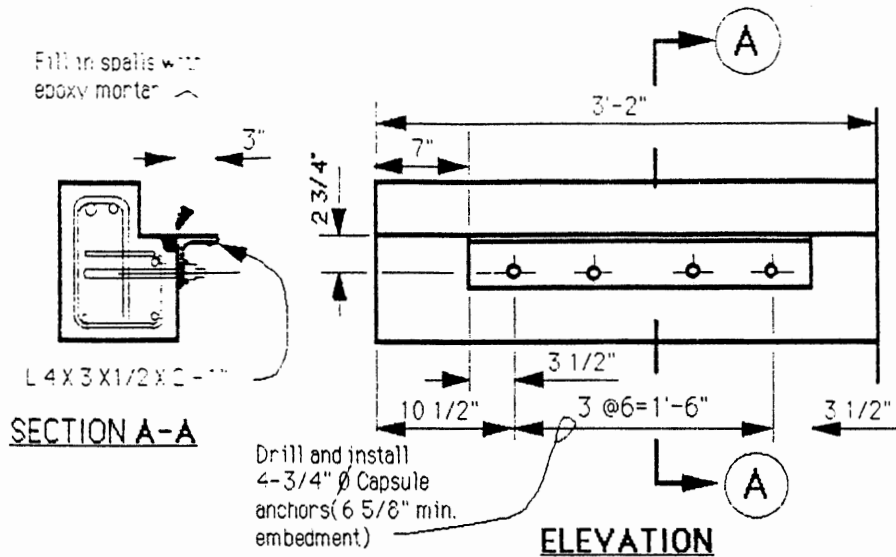
Figure 224.—Plan for stairway repair of San Mateo-Hayward Bridge (White, 1990).

Pier 38.—At the backwall for Pier 38 the trestle earthquake restrainer shelf bearings supporting the first trestle span were damaged. The painters stairway giving access to the walkway behind Pier 38 has fallen into the bay (fig. 224).

STAIRWAY REINSTALLATION DETAIL

BOTTOM BRACKET REPAIR DETAIL

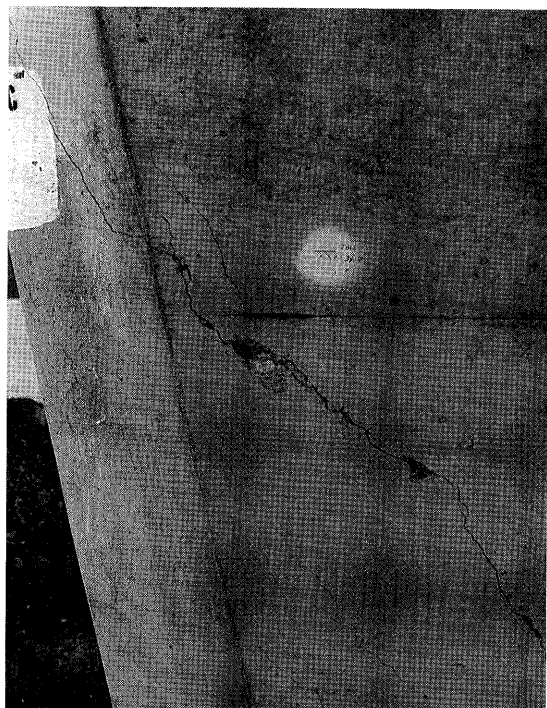
The most serious damage to this bridge was several wide cracks that appeared to go all the way through the column (figs. 229 and 230). These cracks began at the footing on the north side of the column and extended to 10 feet above the footing on the south side of the column. There were also some smaller cracks. Maintenance engineers chipped out about 7 square feet of the cracked portion of the column to a depth of 6 inches. They found some of the reinforcement was heavily corroded. The abutments also showed signs of movement including some concrete spalls where the abutment met the bridge soffit (figs. 231 and 232).

There are several possible explanations for the column damage. The column had only #4 rebar at 12-inch

spacing for transverse reinforcement. It also had a large flare that attracted more shear. The reinforcement was corroded in the area of damage. All these things probably contributed to the damage.

Figure 229.—Damage on northwest side of column at Mora Drive Overcrossing.

After the earthquake, a layer of asphalt was spread behind the abutment to smooth the approach (fig. 233). In 1992 the bridge was repaired and retrofitted with a steel casing for the column that matched the flare (fig. 234). A top layer of reinforcement and concrete was added to the existing column footing to allow it to handle the plastic moment capacity of the column. Also, the cracked soffit concrete was patched near the abutments.

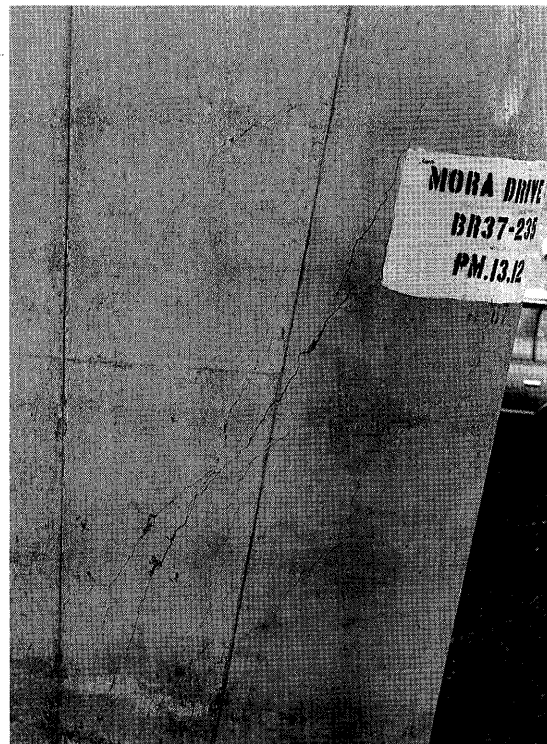
Figure 230.—Damage on southwest side of column at Mora Drive Overcrossing.

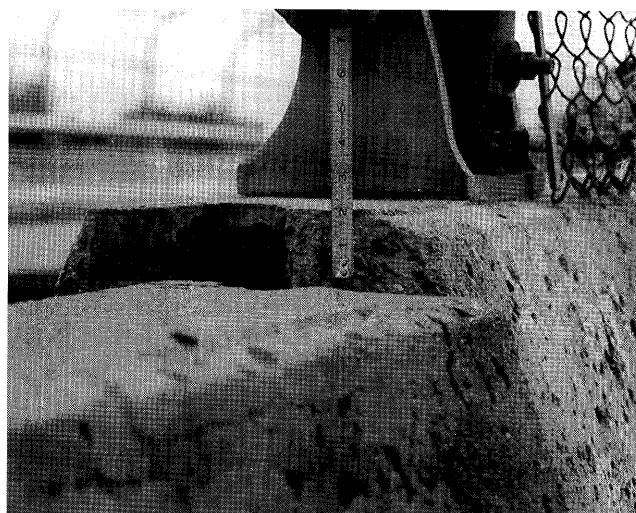
Figure 231.—Vertical offset of west abutment at Mora Drive Overcrossing (courtesy of Earthquake Engineering Research Institute).

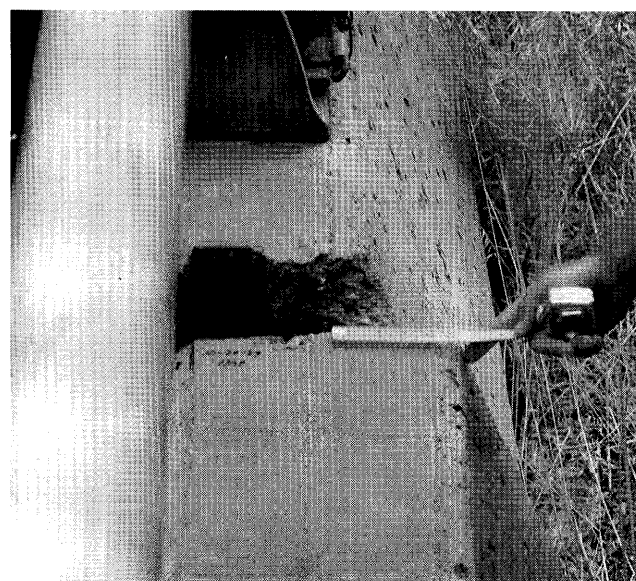
Figure 232.—Horizontal offset of west abutment at Mora Drive Overcrossing (courtesy of Earthquake Engineering Research Institute).

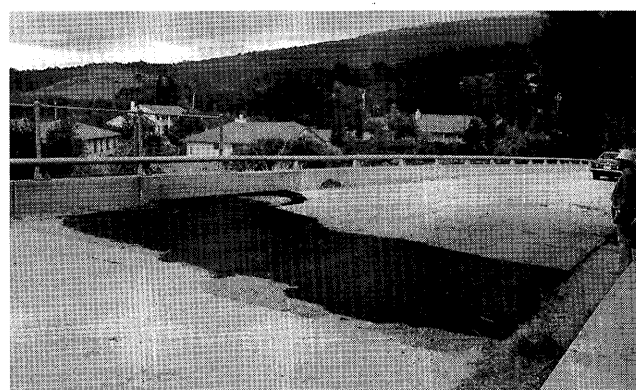
Figure 233.—Repair to approach of Mora Drive Overcrossing (courtesy of Earthquake Engineering Research Institute).

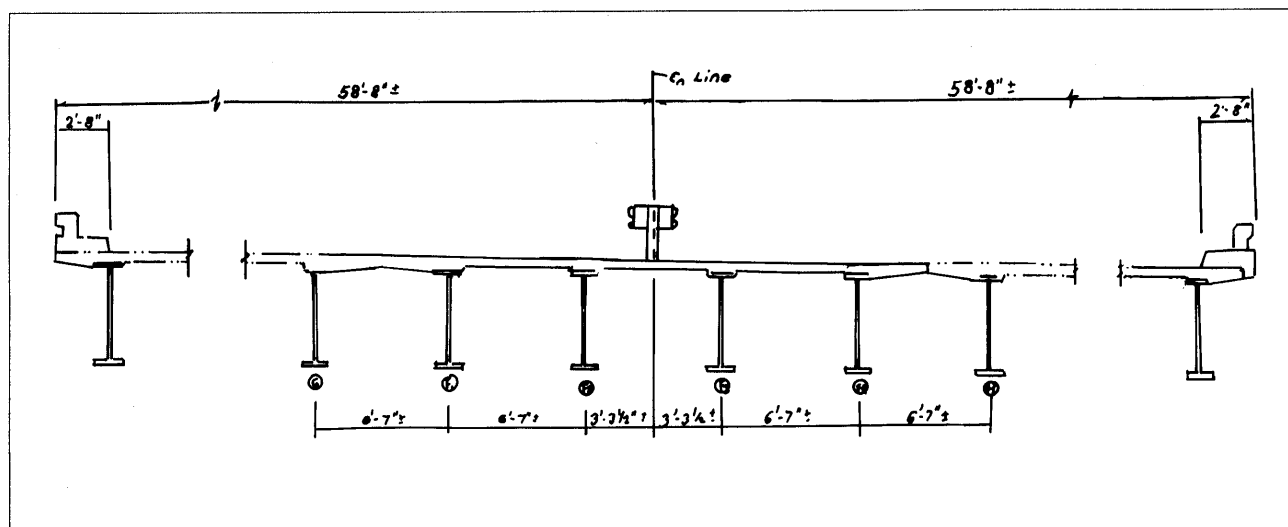
Figure 242.—Section drawing for widening of Sierra Point Overhead.

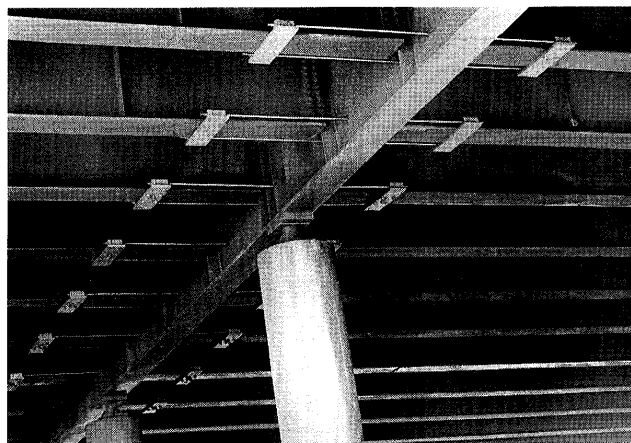
Figure 243.—Existing bearings (before removal) during retrofit of Sierra Point Overhead.

Sierra Point Overhead has undergone two modifications since it was built. In 1967, girders and a deck were added to the center of the bridge to increase the number of traffic lanes (fig. 242). In 1986 the first seismic retrofit in California to include seismic isolation was done on this bridge. The retrofit addressed the two seismic vulnerabilities of this structure, inadequate column capacity and the steel girders falling off the rocker bearings. The replacement of the steel bearings on the columns with lead/rubber isolation bearings and the addition of longitudinal rod restrainers addressed these weaknesses.
