The Loma Prieta, California, Earthquake of October 17, 1989—Highway Systems

By MARK YASHINSKY

U.S. GEOLOGICAL SURVEY PROFESSIONAL PAPER 1552-B

HIGHWAY SYSTEMS

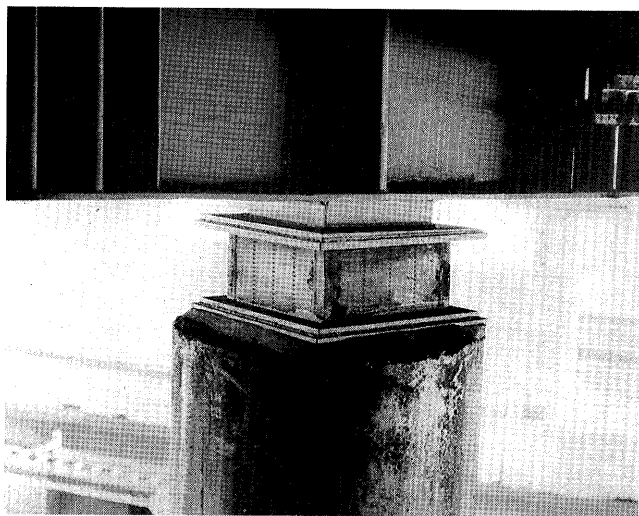
Figure 244 shows a lead/rubber isolation bearing installed on top of a column. All 27 columns for this bridge had the spherical bearings replaced with lead/rubber bearings. Also, as part of the retrofit, the bridge was instrumented with 13 sensors on the structure and three additional sensors nearby on the ground to obtain the free-field motion. Figure 245 shows the instruments mounted on the two westernmost columns of Bent 7 and on that portion of the transverse beam between them.

Figure 244.—Newly installed lead/rubber bearing during retrofit of Sierra Point Overhead.

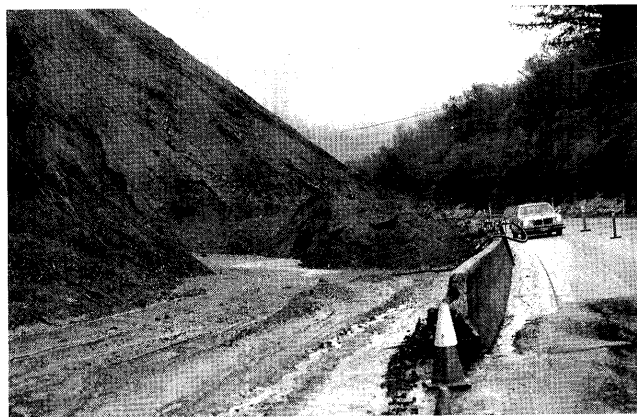
291). This is at a location within a few miles of the epicenter of the earthquake. Some of the damage was rock and land slides that blocked the highway at several locations. In addition, densification of soil at embankments and behind retaining walls caused road settlements and cracked pavements. The concrete median barrier was damaged at several locations. A surface rupture with a vertical uplift of 1.5 feet damaged the roadway near the summit of the Santa Cruz Mountains. Repairs to the roadway left the highway closed to everyone except local residents and carpools for 32 days. The roadway was reopened on November 19. The repairs included excavation and flattening of slopes, grout injection, soil nailing, and rock fences.

Figure 291.—Route 17 landslide.

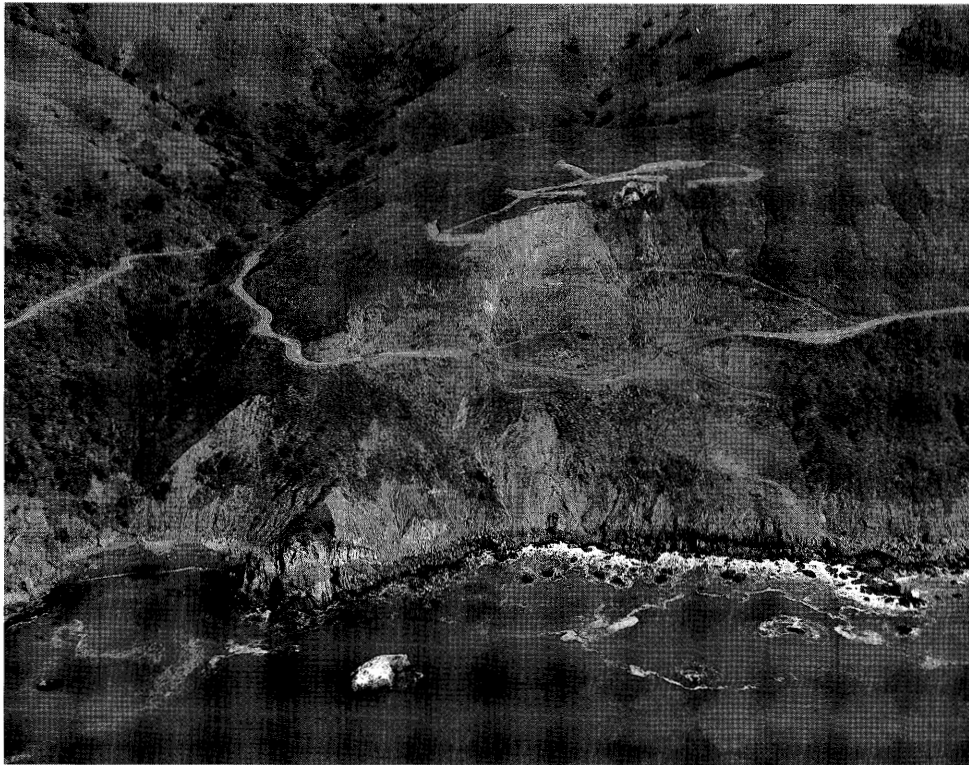
This is an ancient landslide along the coastal bluffs of Marin County. It was remobilized but controlled by Caltrans following very heavy rains of January 1982. However, the Loma Prieta earthquake created a much faster rate of soil movement (figs. 292 to 295), eventually requiring a new road alignment behind the landslide. A detailed report describing this landslide is provided by Van Velsor and Walkenshaw (1992).

Figure 293.—Landslide along Route 1 in Marin County (courtesy of Joan Van Velser).

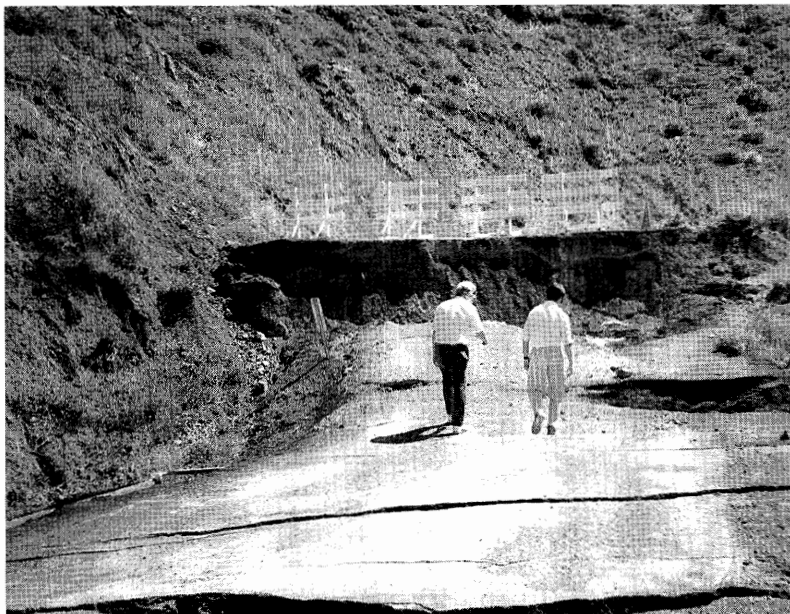
Figure 294.—Landslide damage along the coast (courtesy of Joan Van Velser).

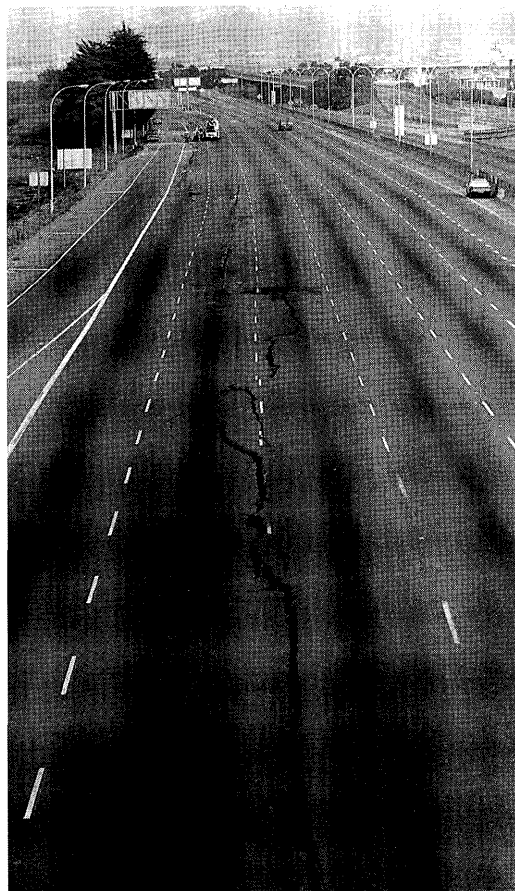
Figure 296.—Lateral spreading at Interstate 80.

Interstate 80 runs south along the San Francisco Bay in Emeryville and then turns west and widens to become a toll plaza before crossing the Bay. Approximately 2 miles of this roadway from Powell Street to the Bay Bridge was damaged due to heaving, settlement, cracking, and lateral spreading following the earthquake (figs. 295 to 298). This damage did not affect traffic because a dropped span on the Bay Bridge closed this section of roadway. The road was regraded every day for a week before the movement subsided.

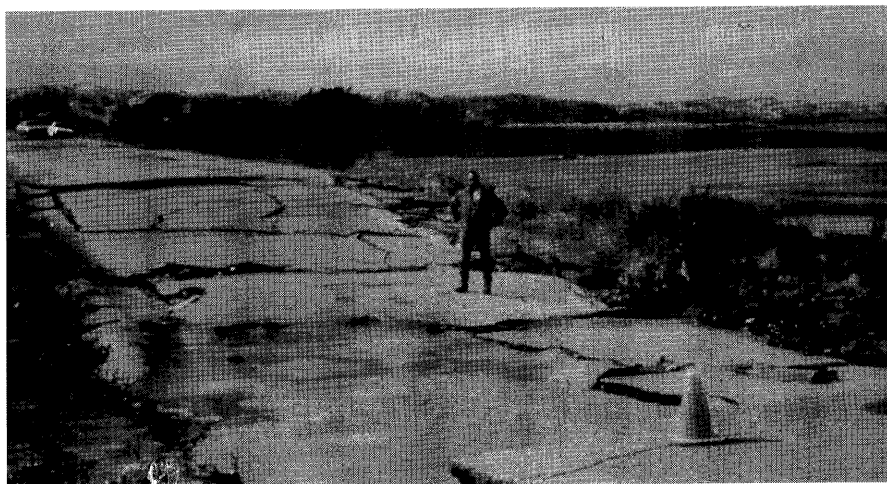
South of the city of Santa Cruz, the approach road to Moss Landing State Beach was damaged due to liquefaction of the soil (figs. 301 and 302). About 300 feet of roadway subsided as much as 3 feet and spread 20 feet laterally.

Figure 301.—Damage to the access road at Moss Landing State Park (courtesy of Earthquake Engineering Research Institute) (view to north).

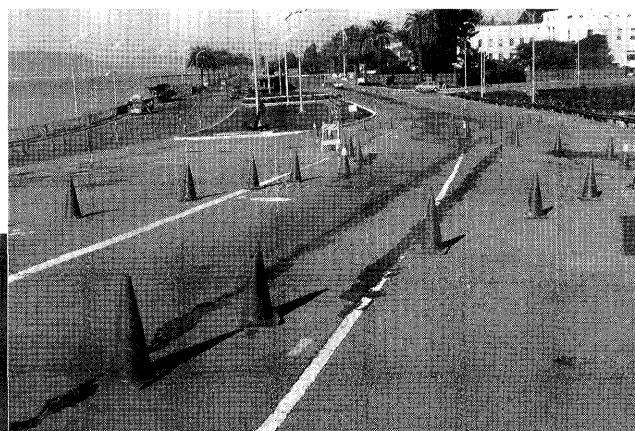
Figure 304.—Lateral spreading damage to road way at Treasure Island (courtesy of U.S. Geological Survey; photograph by Michael Bennett).

Treasure Island is a Naval Station in the middle of San Francisco Bay. Land access to the island is limited to a causeway from Yerba Buena Island (fig. 303). During the earthquake this causeway (an embankment built over sand and Bay mud) experienced lateral spreading with cracks several inches wide. There was also widespread liquefaction damage to most of the roads on the island (fig. 304).

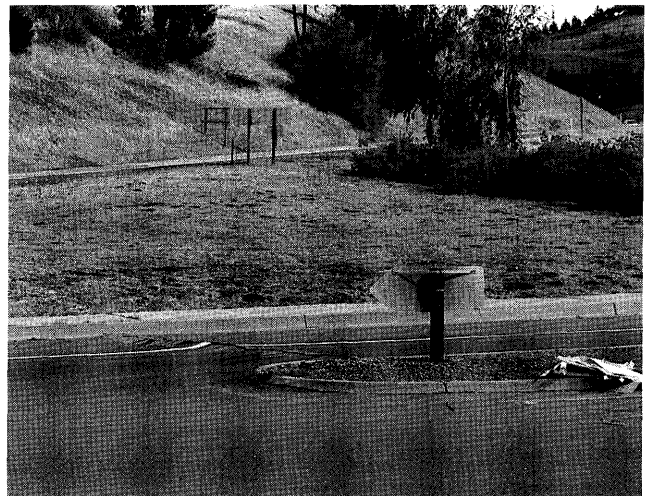
These "second-order tectonic features" caused asphalt pavement to buckle and concrete curbs and sidewalk to break on city streets from Los Gatos north to Los Altos (fig. 305). At Sand Hill Road there was a movement of the ground that pushed a section of the road together until it failed in compression (figs. 306 and 307). Similar damage occurred to State Route 17 and Interstate 280.

Figure 306.—Buckled roadway (by traffic island) at Sand Hill Road.

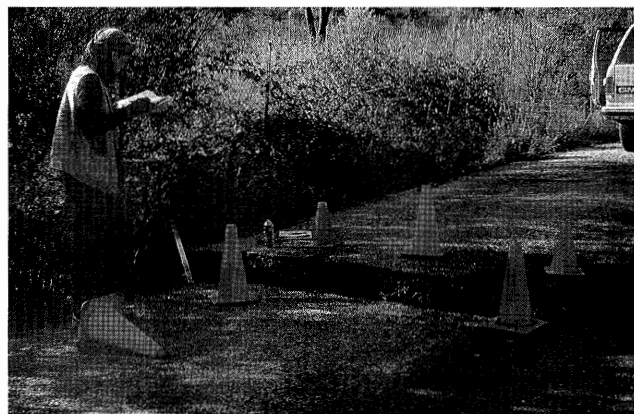
Figure 309.—Damage to Morrill Road from 1989 (Loma Prieta) earthquake.

There were many surface fractures in the Summit Road/Skyline Ridge area near the San Andreas Mountains in Santa Clara County (fig. 308). This resulted in substantial road damage in the area (Ponti, 1990). Damage can occur to roads on good basement material when the pavement is within several miles of an active fault. Morrill Road suffered a transverse crack that closed the road after the earthquake (fig. 309). Surprisingly, a similar crack at the same location closed the road after the 1906 earthquake (fig. 310).

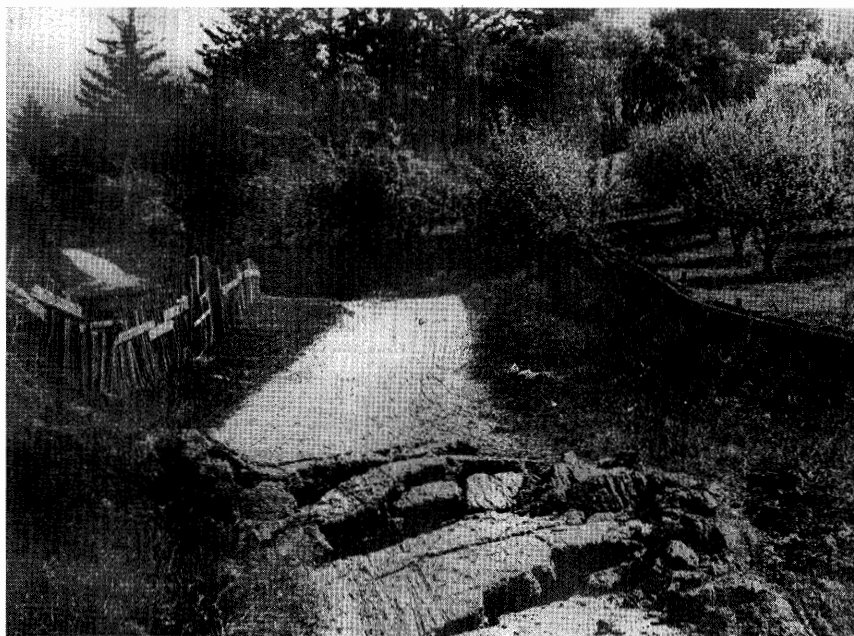
Figure 310.—Similar damage to Morrill Road from 1906 earthquake.

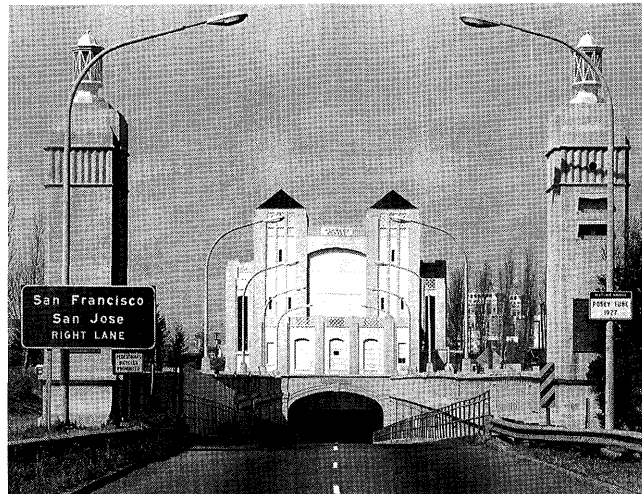
was built in the 1960's. They are reinforced concrete tubes with a bituminous coating for water proofing, and they descend to about 70 feet below sea level. After Loma Prieta, some of the connections between the tube segments began leaking. It was thought that liquefaction of the soil around the tubes caused deformation at the joints. Earthquake repair drawings were made, and the tubes were epoxy injected to stop the leaking. In 1997 a more elaborate retrofit was planned that included (1) creating very strong, water-proof hinges at the joints, (2) compacting the soil, adding stone columns, and building a curtain wall to prevent liquefaction and pore pressure from pushing up the tubes, and (3) jet grouting columns to support the ends of the tube segments.

Figure 311.—Alameda entrance to Posey Street Tube (courtesy of Ben C. Gerwick Inc.)

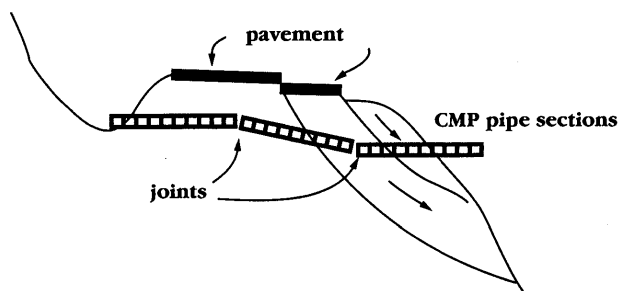
This was the only example of culvert damage as a result of a landslide during the earthquake. This was a 36-inch-diameter CMP consisting of three 20-foot-long segments tied together with a 1- to 2-foot overlap at each joint. During the earthquake, the outer third of the roadway slid down about 3 feet, slightly damaging the roadway (fig. 321). The overlaps at the joints were long enough to prevent the culvert from being pulled apart, although the culvert was slightly displaced and reoriented by the ground movement.

Figure 321.—Spanish Ranch Road culvert.

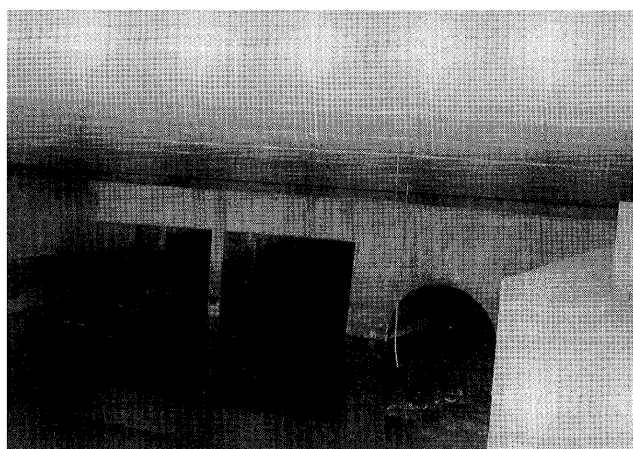
There was damage to a box culvert as a result of the earthquake. Temescal Creek flows under I-80 in Emeryville. The culvert is a double 10 by 10 foot reinforced concrete box, about 220 feet long, built under the freeway (fig. 322). There are also two 96-inch-diameter reinforced concrete pipe culverts immediately to the north. After the earthquake, the northernmost cell was inspected by rowboat. The adjacent cell was filled with mud and could not be accessed by boat (as were the pipe culverts). Cracks ran along the soffit and exterior wall of the north cell, and an expansion joint about 55 feet from the east end opened about 1 foot. This culvert is located where a great deal of liquefaction-related damage occurred to I-80. Apparently, this is another case where liquefaction damaged the roadway and the culvert. Figure 323 shows the general plan for the repair of earthquake damage to this culvert.

Figure 322.—Temescal Creek culverts.

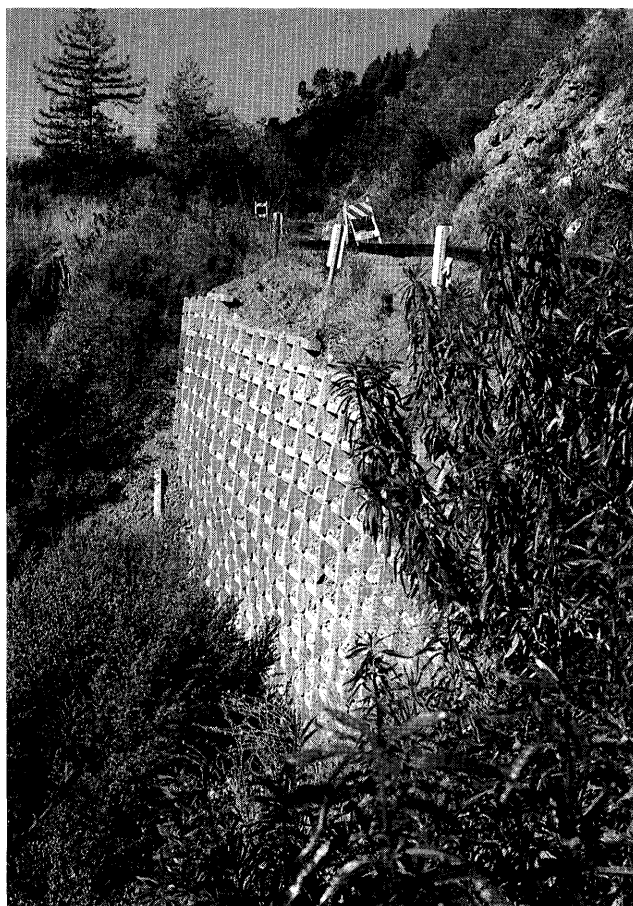
Crib walls are cells made out of precast concrete, metal, or timber elements that are filled with earth. Several crib walls in the Santa Cruz Mountains showed distortions due to settlement of the backfill (behind the wall) and movement of the wall face. The wall shown in figure 324 showed major distress halfway up the face and had backfill settlement of more than a foot. This wall may have been built at a previous landfill site.

Figure 324.—Crib wall (courtesy of Earthquake Engineering Research Institute).

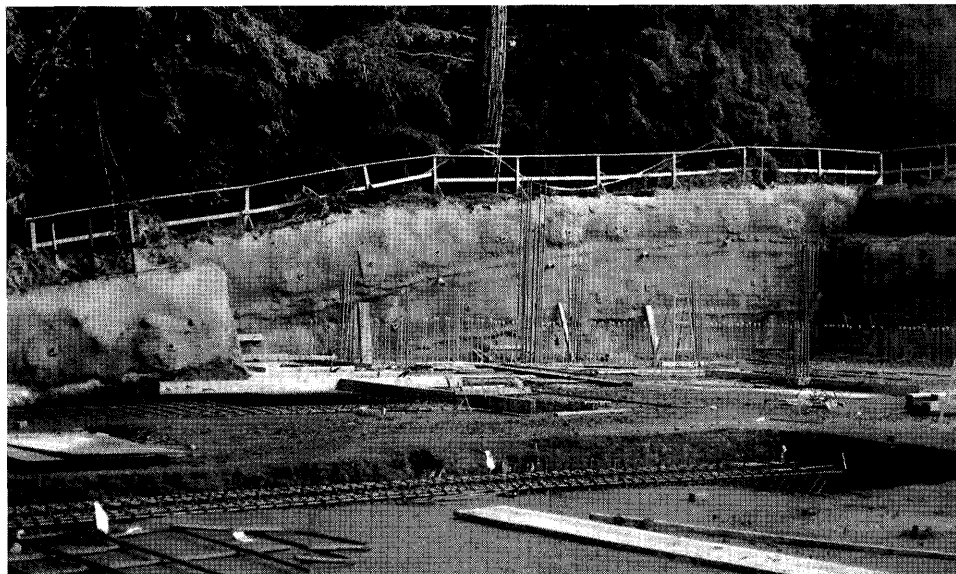
Soil-nail walls are used to temporarily hold back the soil during construction and sometimes as a permanent retaining wall. There were many soil-nail walls in the area of earthquake damage, including one (fig. 325) near the rupture zone. They all performed very well during the earthquake.

Figure 325.—Soil-nail wall (courtesy of Earthquake Engineering Research Institute).
