Monitoring Channel Morphology and Bluff Erosion at Two Installations of Flow-Deflecting Vanes, North Fish Creek, Wisconsin, 2000–03

Scientific Investigations Report 2004–5272

By Faith A. Fitzpatrick, Marie C. Peppler, Heather E. Schwar, John A. Hoopes,
and Matthew W. Diebel

U.S. Department of the Interior
U.S. Geological Survey

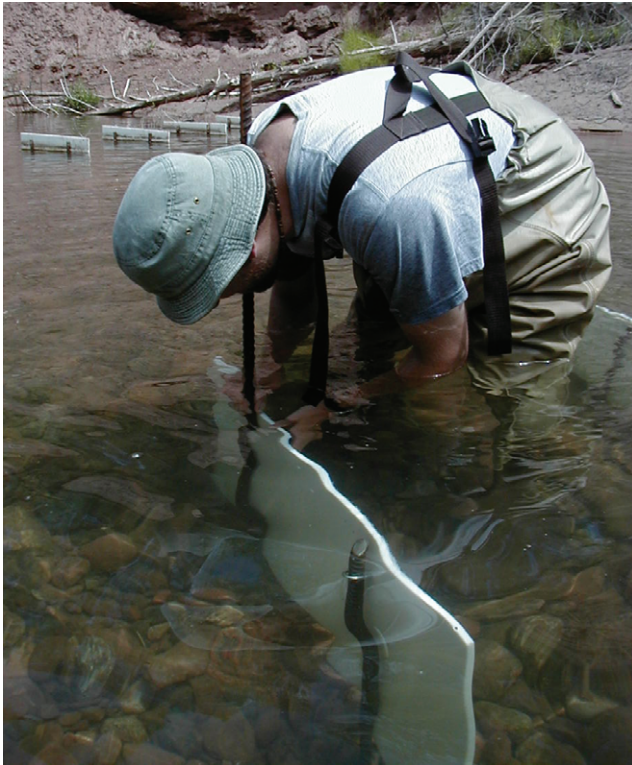
Figure 7. Vanes being installed at site 16.4, summer 2000, North Fish Creek, Wis. (Installer is David Poggi, University of Wisconsin-Madison).

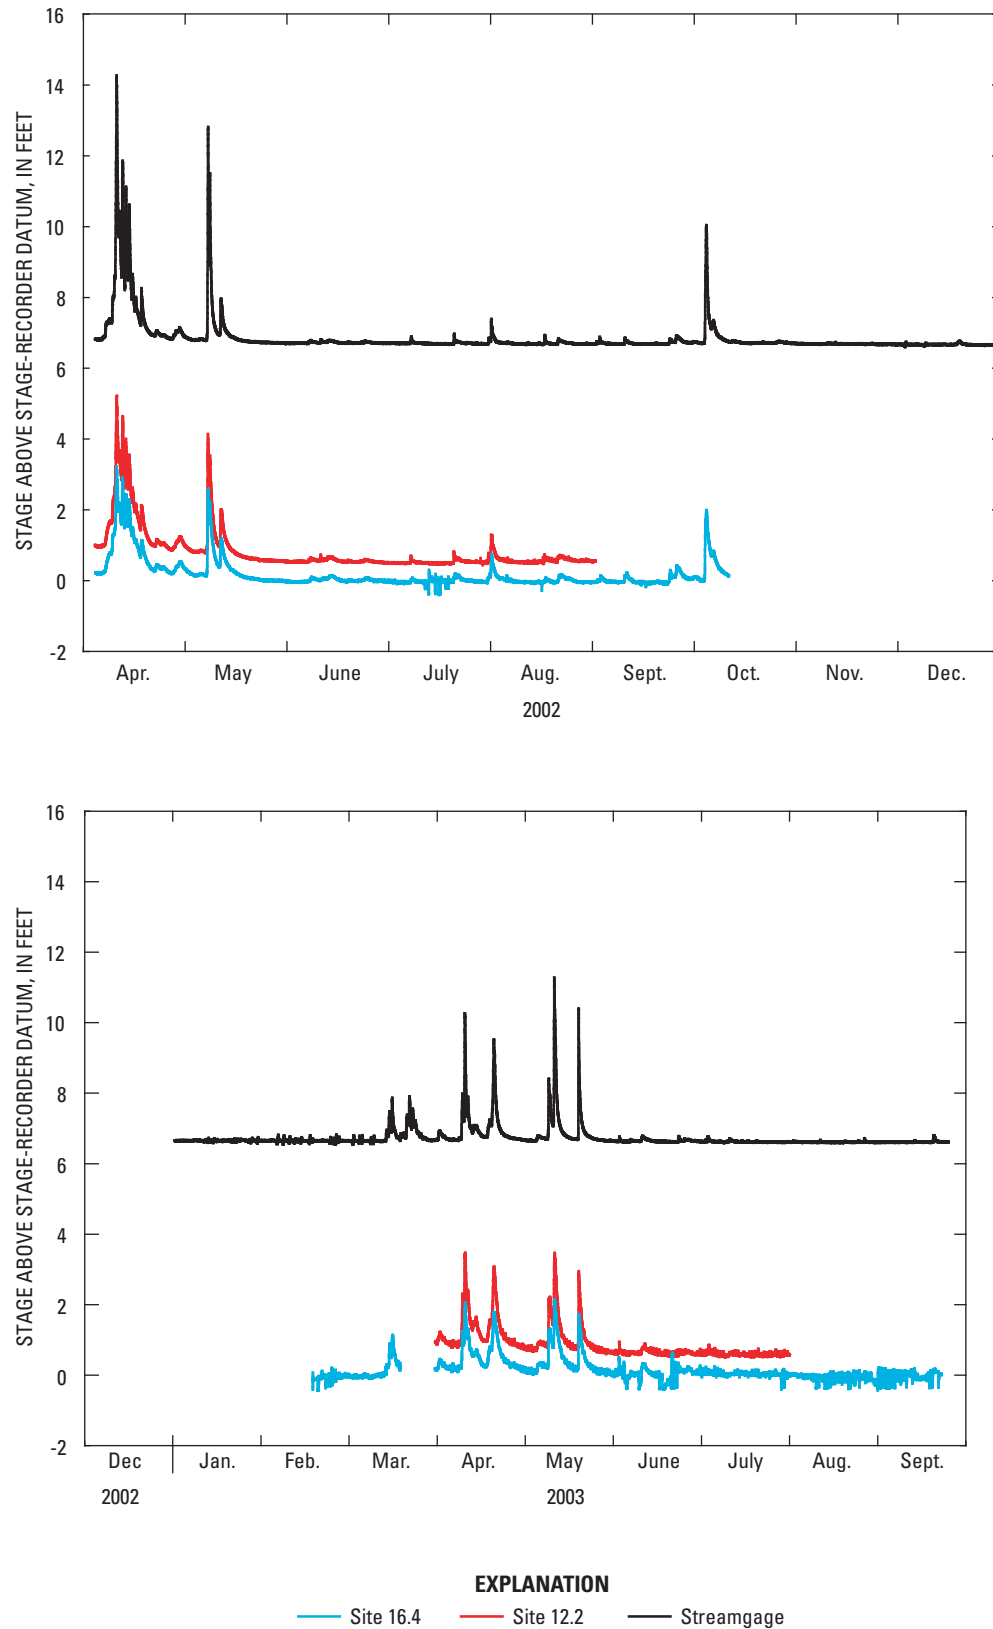
Figure 13. Stage data from the streamgage and from the stage recorders at sites 16.4 and 12.2, April 2002 to September 2003, North Fish Creek, Wis.

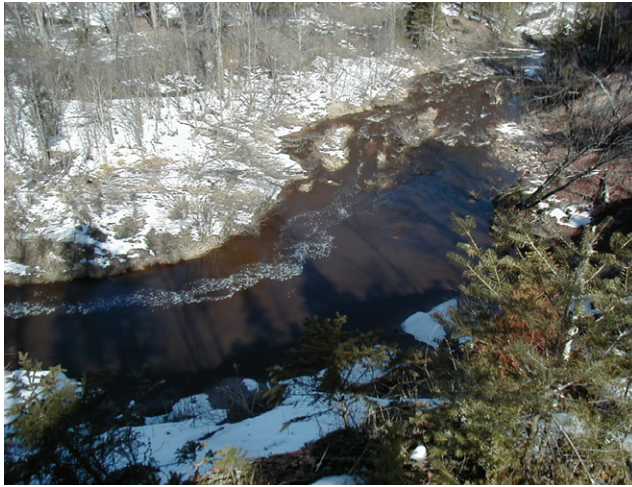
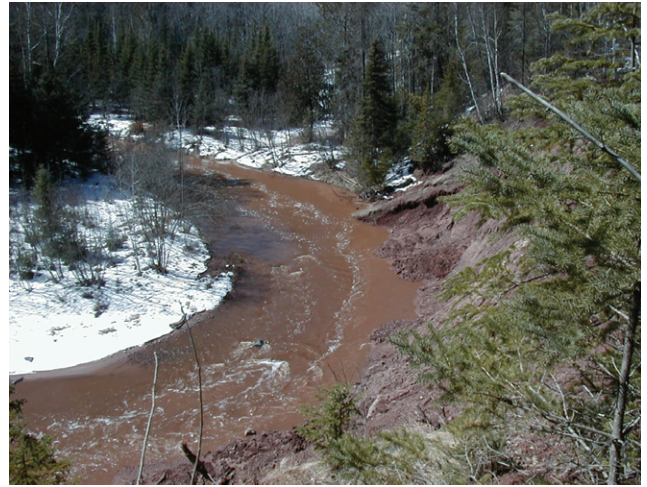
Figure 14. North Fish Creek at sites 16.4 and 12.2 during the April 2003 snowmelt, North Fish Creek, Wis. Photograph of site 16.4 is from the bluff top on the upstream end of the bend looking downstream. Photograph of site 12.2 is from the bluff top on the downstream end of the bend looking upstream.
