Scientific Investigations Report 2010–5259

# **Flash Floods of August 10, 2009, in the Villages of Gowanda and Silver Creek, New York**

By Carolyn O. Szabo, William F. Coon, and Thomas A. Niziol

Prepared in cooperation with the Federal Emergency Management Agency

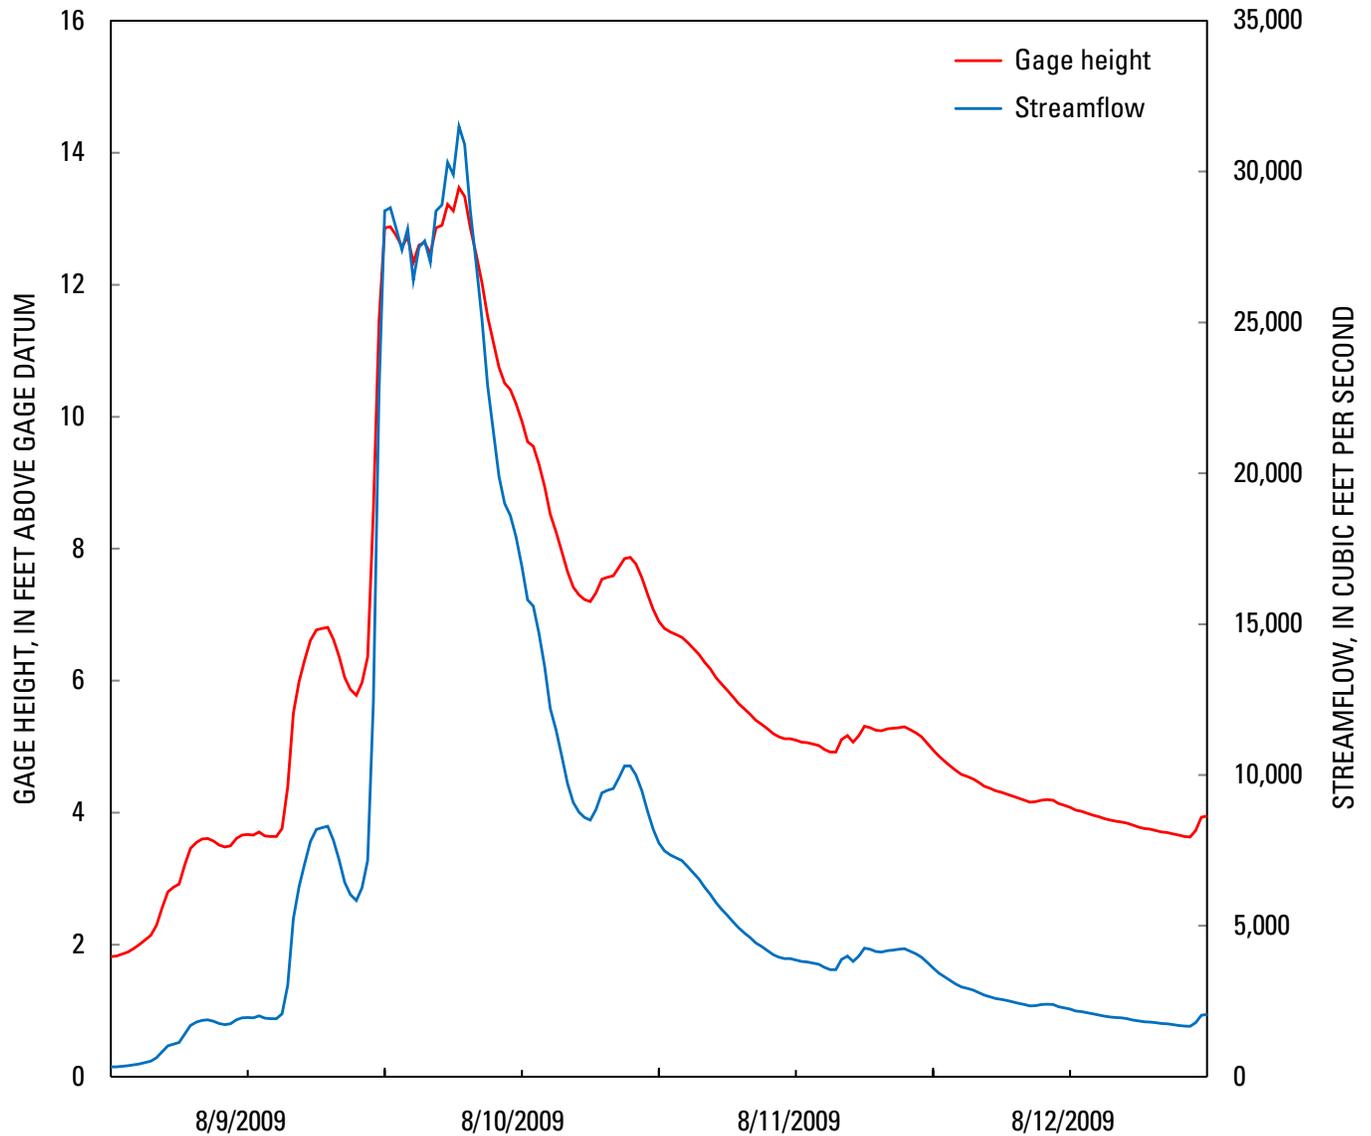
Cattaraugus Creek at Gowanda (station 04213500) rose 5 ft in 1 hr between 11:35 p.m. and 12:35 a.m. EDT (10:35 to 11:35 p.m. Eastern Standard Time (EST) on August 9) and had an initial peak of 12.88 ft at 1:35 a.m. EDT (12:35 a.m. EST) on August 10 (fig. 4). The creek receded slightly, then rose to its maximum recorded gage height of 13.47 ft at 7:35 a.m. EDT (6:35 a.m. EST) on August 10.

**Figure 4.** Streamflow and gage-height for Cattaraugus Creek at Gowanda, New York, U.S. Geological Survey station 04213500, August 9-12, 2009.

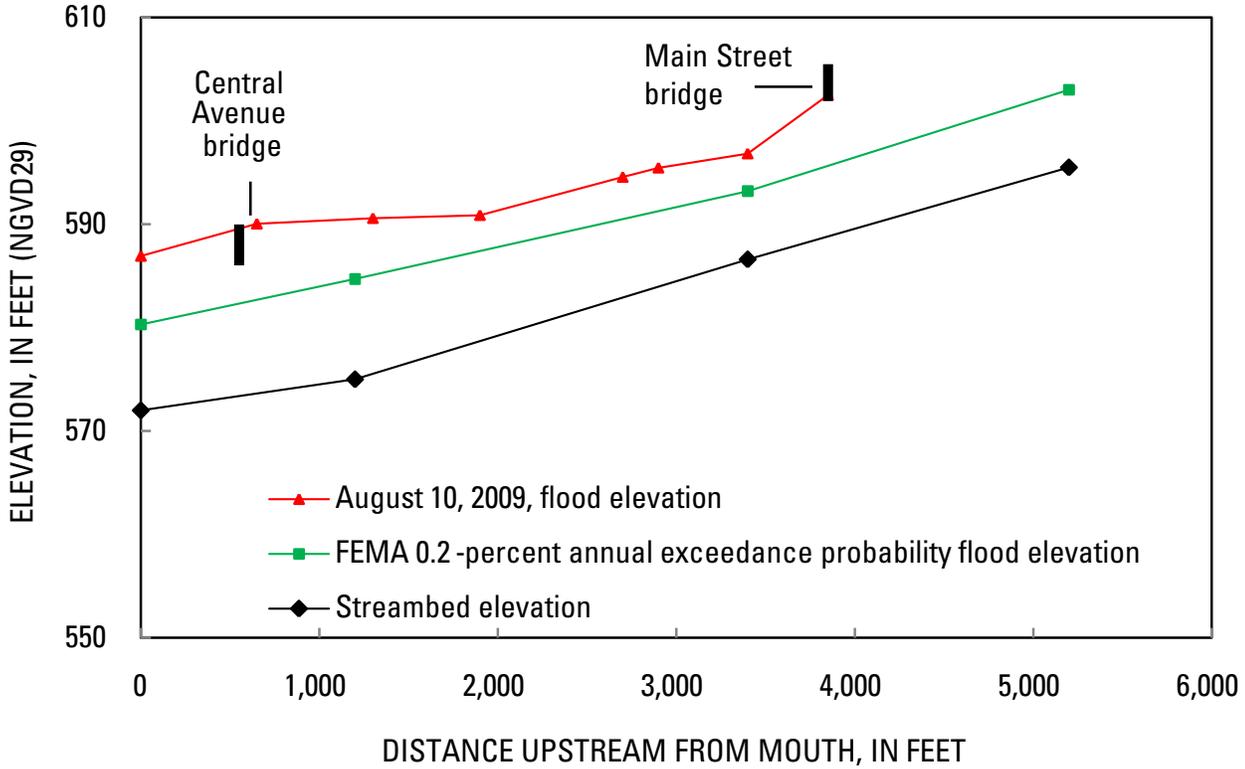
Figure 8. Water-surface elevations for the August 10, 2009, flood and the FEMA 0.2-percent annual exceedance probability flood for Walnut Creek at Silver Creek, N.Y.

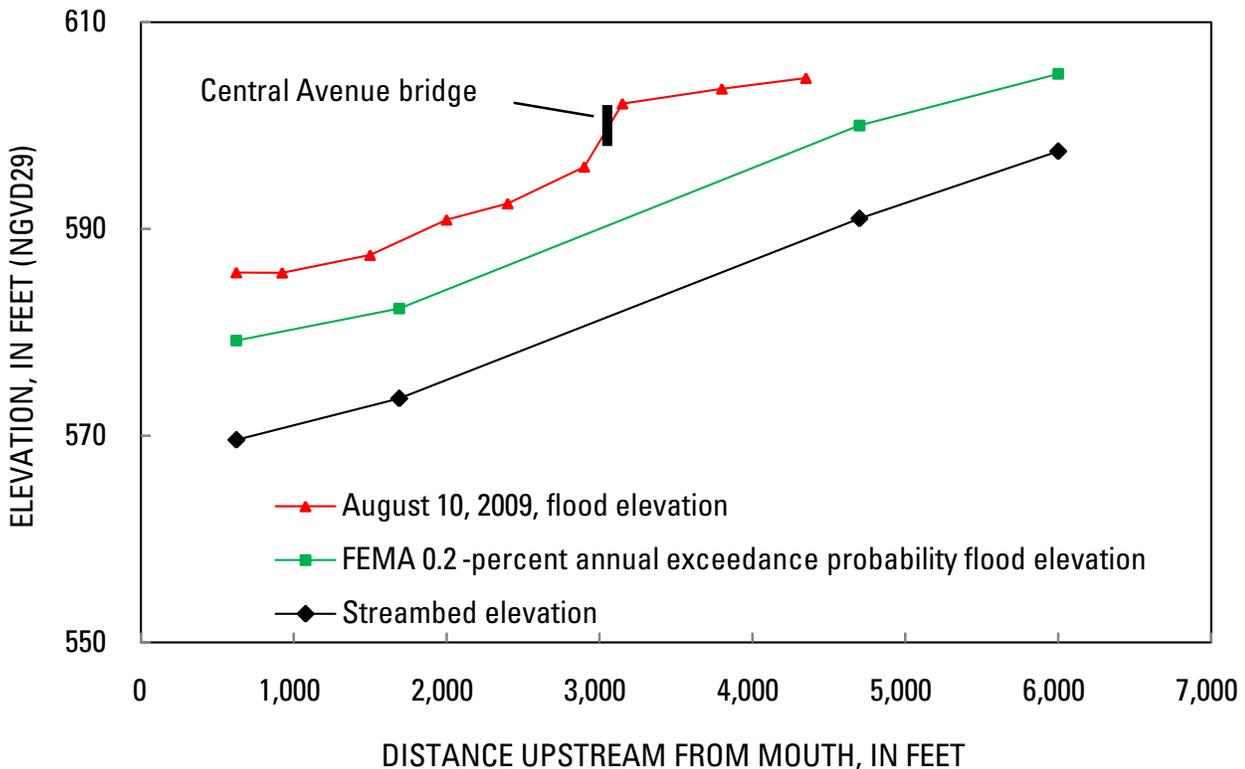
Figure 9. Water-surface elevations for the August 10, 2009, flood and the FEMA 0.2-percent annual exceedance probability flood for Silver Creek at Silver Creek, N.Y.
