Geomorphology and Bank Erosion of the Matanuska River, Southcentral Alaska

Scientific Investigations Report 2011–5214

By Janet H. Curran and Monica L. McTeague

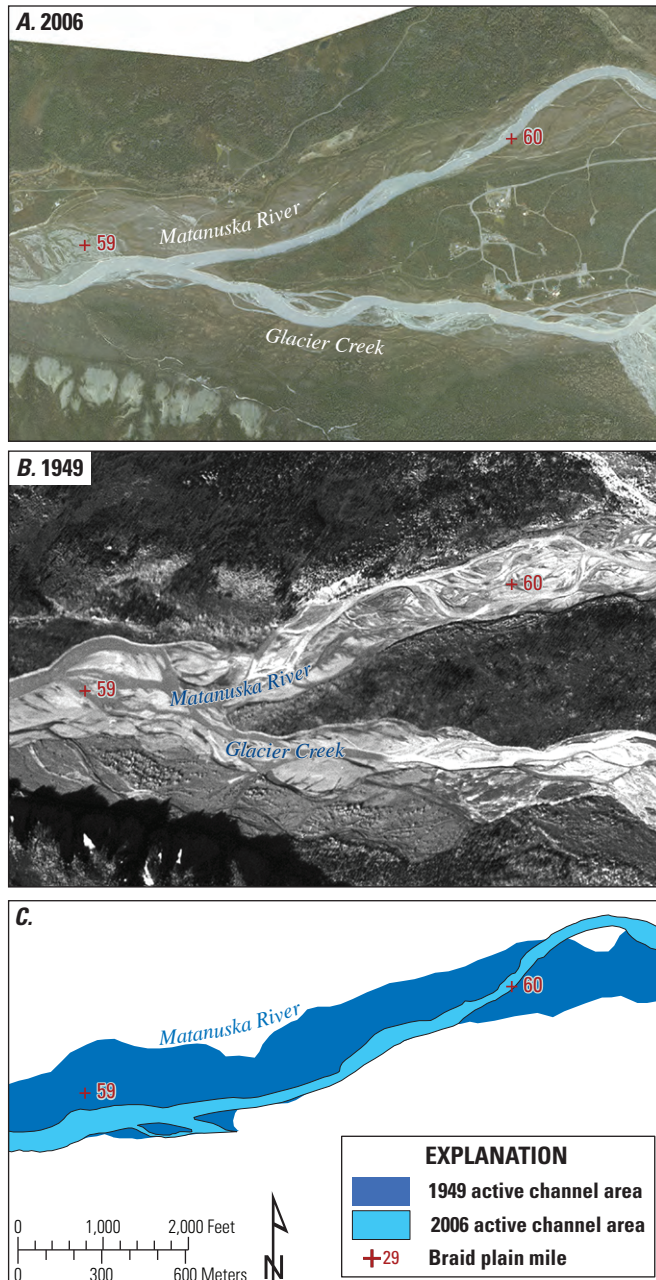
Figure 16. Channel pattern changes near the Matanuska Glacier terminus, southcentral Alaska. Progression from a braided channel in 1949 (A) to a single-thread channel in 2006 (B) and narrowing of the active channel belt (C). Only Matanuska River area is mapped, but changes are similar in Glacier Creek.

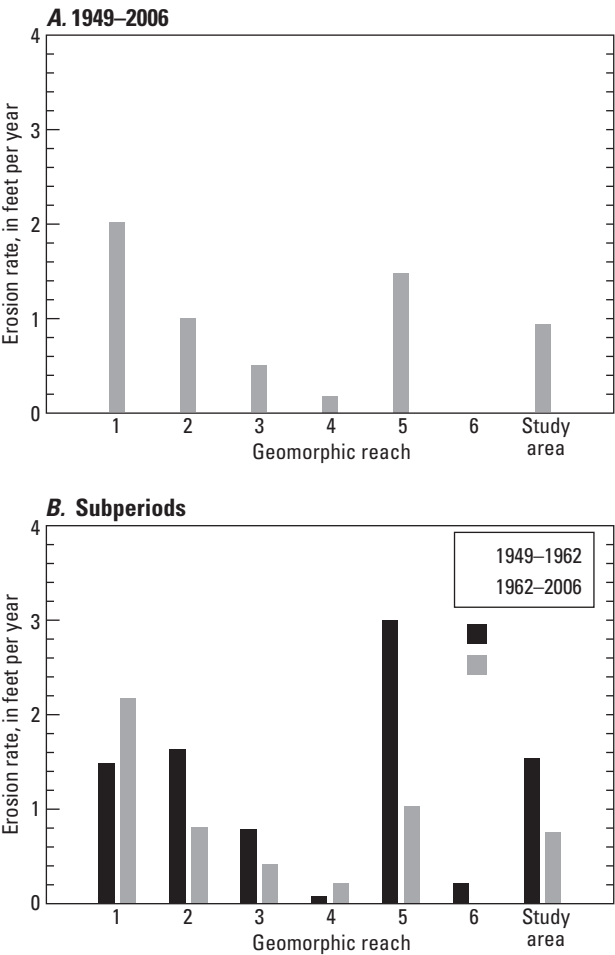
Bank erosion along the 133 mi of braid plain margins within the erosion analysis area converted a total of 861 acres to braid plain between 1949 and 2006, but the distribution of erosion was localized. Erosion detectable with the project methods occurred at an average rate of 0.9 ft/yr (fig. 19A) from 1949 to 2006 but affected only 23 percent of the banks. Severe erosion accounted for 64 percent of all erosion but occurred at only 8 percent of the banks.

Compiling erosion by reach helped quantify the variable distribution of erosion (figs. 19 and 20). Reaches 4 and 6 were relatively stable, affected by only minor erosion on 6 percent or fewer banks. Severe erosion was most concentrated in Reach 1, affecting 20 percent of the banks. Although a small amount of severe erosion occurred in Reach 3, minor erosion was as prevalent there as in the reaches with more severe erosion.

Figure 19. Bank erosion rates by geomorphic reach, Matanuska River, southcentral Alaska, for (A) the entire study period 1949–2006 and (B) the subperiods 1949–1962 and 1962–2006.

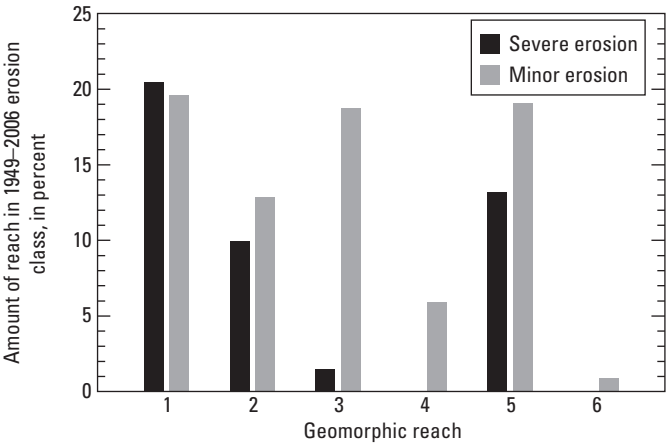
Figure 20. Minor and severe bank erosion by geomorphic reach, Matanuska River, southcentral Alaska, 1949–2006.

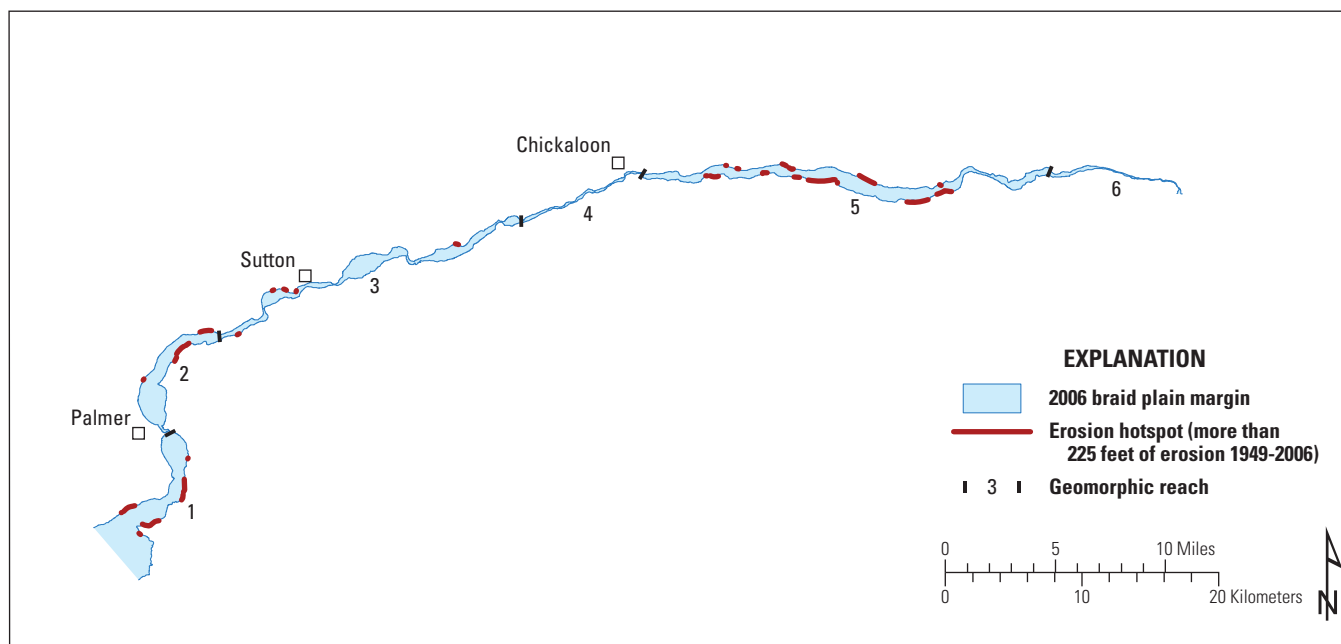
Severe erosion was clustered into 20 erosion hotspots totaling 10.8 mi of bank (fig. 21). Two additional areas were present but omitted from the following analysis because shadowing on orthophotography limited confidence in their interpretation. Left bank erosion hotspots were longer (an average of 4,300 ft compared to 1,600 ft) and more severe than right bank erosion hotspots. Manual identification of eroded features, which varied from mapped feature identification if the feature was eroded away, showed hotspots most often impacted modern fluvial terraces (45 percent of hotspots) and tributary fans (40 percent), followed by glacial terraces (15 percent). This indicates that the river is actively eroding older features (tributary fans and glacial terraces) as well as reworking modern fluvial deposits.

Figure 21. Erosional hotspots along the Matanuska River, southcentral Alaska, 1949–2006.

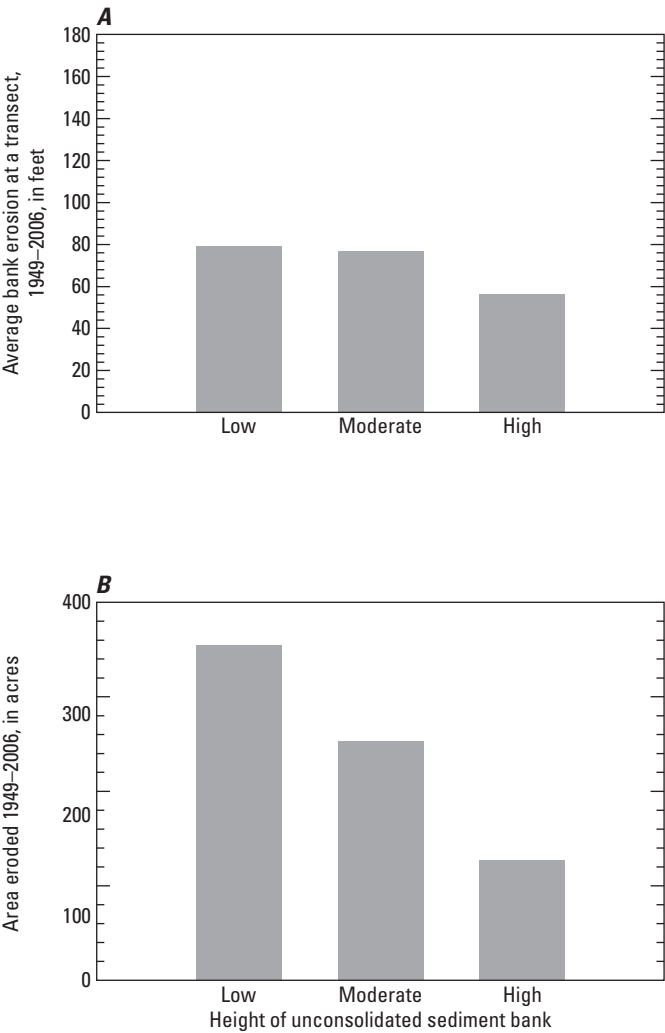
A summary of erosion statistics by height category for unconsolidated sediments shows that the average erosion value at a transect on low-height banks was similar to erosion at moderate-height banks ([fig. 22A](#)), but about one-half of the area eroded occurred at low-height banks ([fig. 22B](#)). This confirms that the abundance of low-height banks and their higher erosion rates places them in the highest risk category for the entire river corridor, but suggests that moderate-height banks offer only modest additional erosion resistance when erosion at a particular location is considered. Similarly, several high banks in Reach 1 had confirmed measurable erosion, demonstrating the lack of significant erosion resistance of unconsolidated banks in the 20–30 ft height range.

Figure 22. Erosion of braid plain margins by height category, Matanuska River, southcentral Alaska, 1949–2006. (A) Average braid plain margin change (bank erosion) at a transect, and (B) net area eroded.

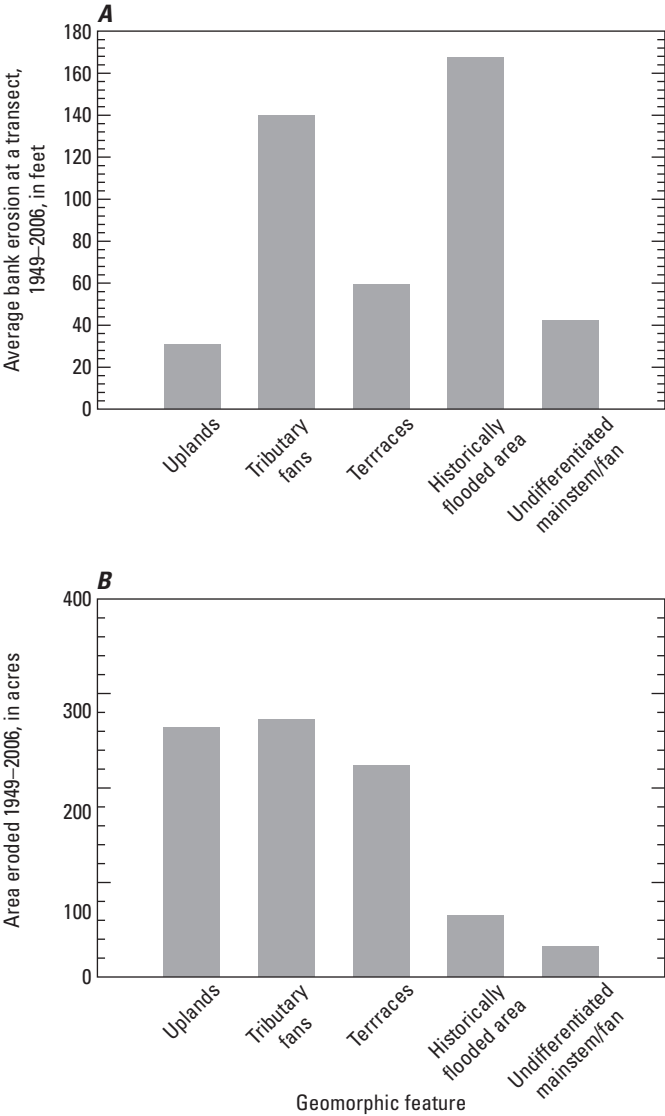
The distribution of all magnitudes of erosion by geomorphic feature category indicated that the average erosion at a transect was 1.4 to 6.5 times greater (fig. 23A) and the total area of erosion was 2.3 times as great along fluvial deposits (primarily tributary fans and terraces) as along uplands (older features including glacial terraces) (fig. 23B).

Figure 23. Erosion of braid plain margins by geomorphic feature, Matanuska River, southcentral Alaska, 1949–2006. (A) Average bank erosion at a transect, and (B) net area eroded.

Fluvial deposits of all ages accounted for 43 percent of the bank length but 69 percent of the erosion between 1949 and 2006. Of the fluvial deposits, fans eroded 2.3 times the rate of terraces (fig. 23A) but were less abundant, resulting in a similar total amount of erosion (fig. 23B). Eroded uplands were more common in the lower half of the river, particularly in Reach 1 where glacial terraces were extensively eroded.

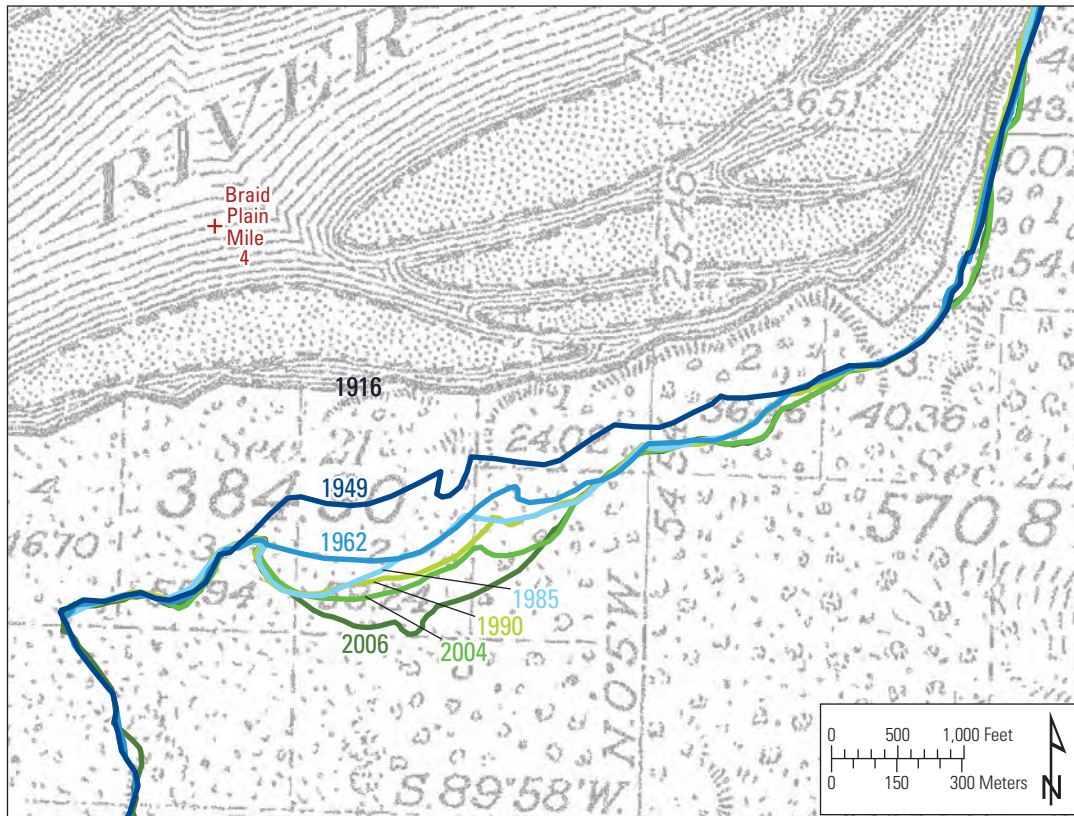
erosion at Circle View Subdivision (fig. 24), where erosion has been persistent and severe since at least 1916. The variability of timing of historical erosion indicates a poor correlation between erosion and flooding.

Figure 24. Braid plain margin position between 1916 and 2006 near Circle View Subdivision, Braid Plain Mile 4 of the Matanuska River, southcentral Alaska.

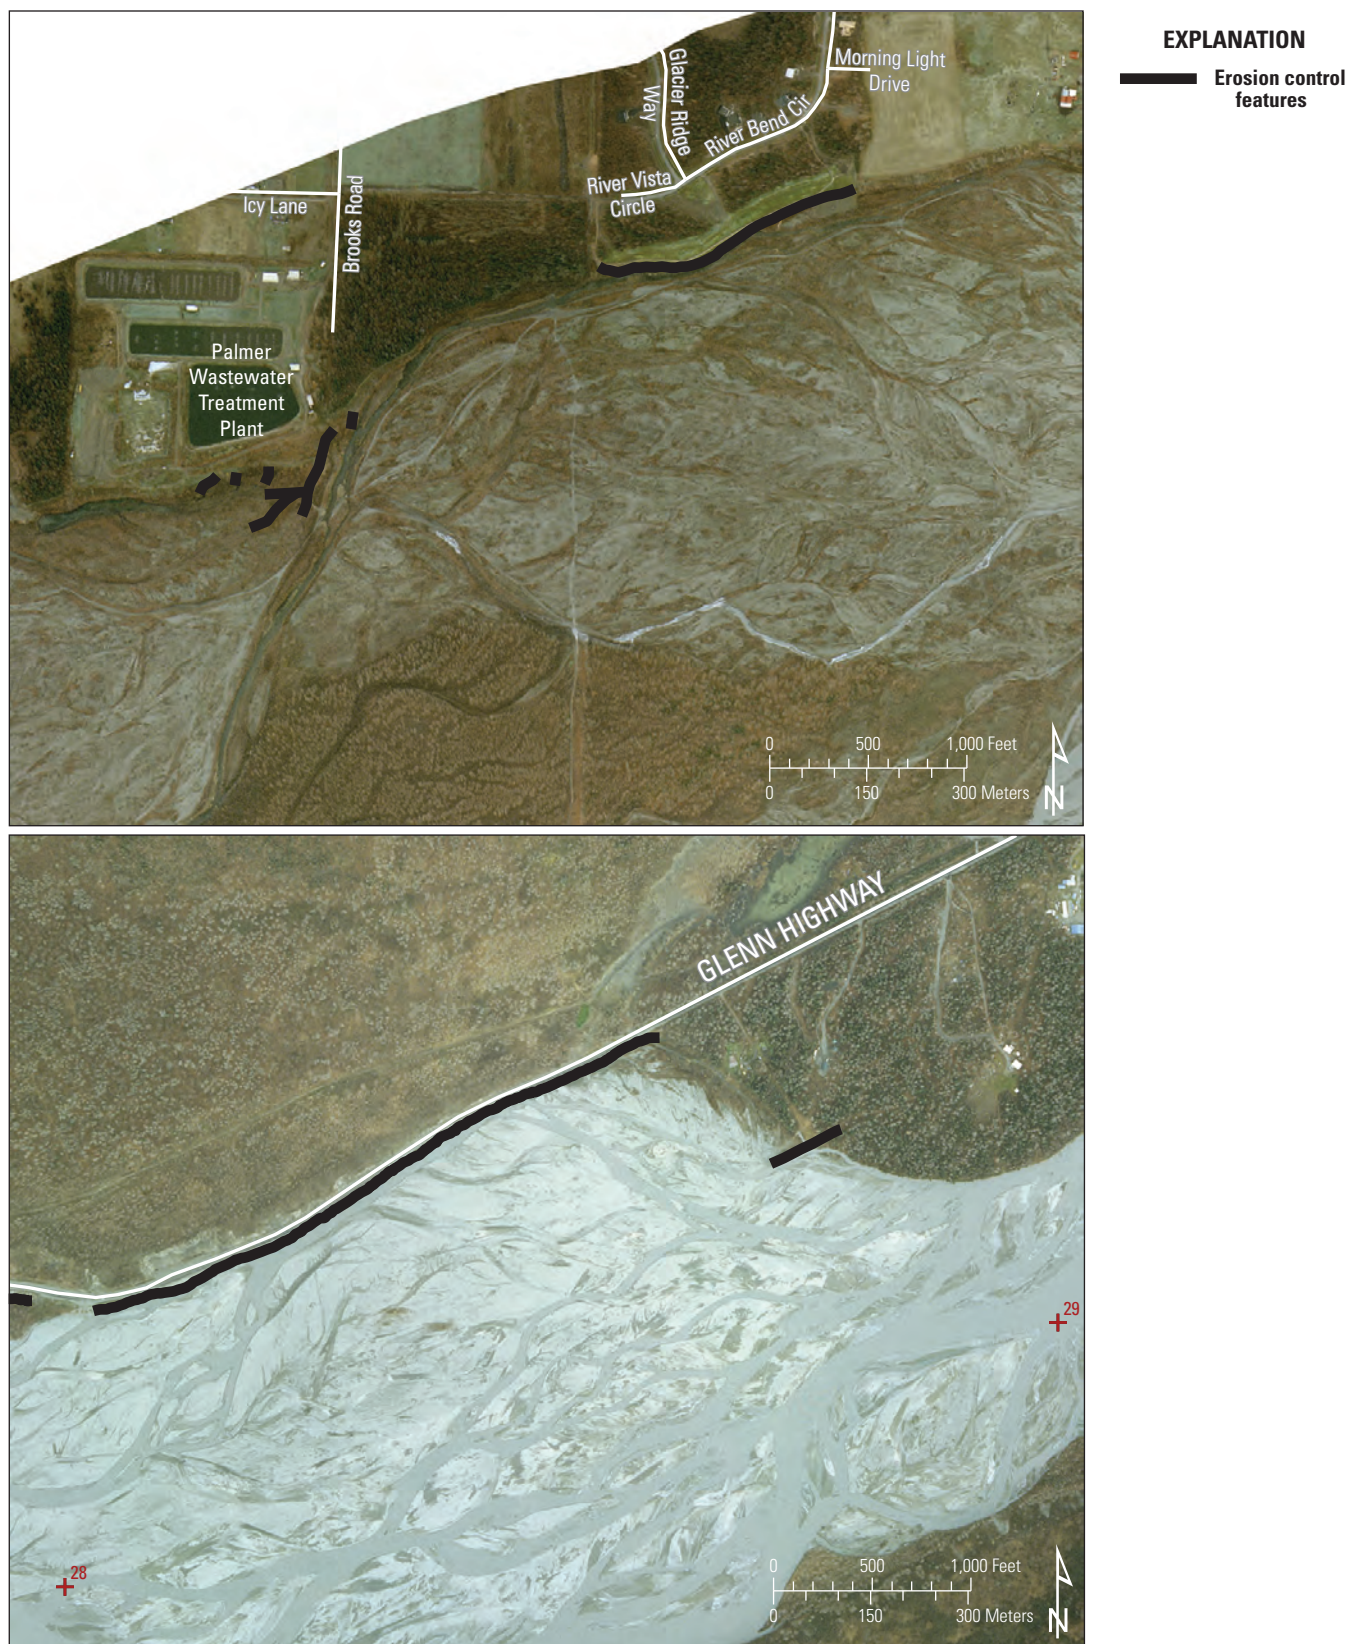
Figure 26. Examples of mapped erosion control, Matanuska River, southcentral Alaska. (A) Dikes at a public facility and buried riprap at a residential subdivision. (B) Riprap along a Glenn Highway embankment and a dike provide erosion control near Glenn Highway Mile 69.

The inventory of 2006 conditions shows that the length of protected banks is relatively small, totaling 5.6 percent of the 138 mi of project area banks. Bank armoring was more extensive than dikes, consisting of 23 riprapped banks ranging in length from less than 100 ft to 0.7 mi for a total of 6 mi of bank protection. Dikes and levees were clustered into 11 groups of 1–7 structures, collectively totaling 2 mi in length. An additional 14 mi of bank is adjacent to the abandoned railroad bed, a portion of which is fill that contains coarse clasts likely to reduce erosion. Although not documented, the total length of informal bank protection (car bodies, rocks, tires, or placed trees) is estimated from field observations to be less than the length of the documented erosion control measures.

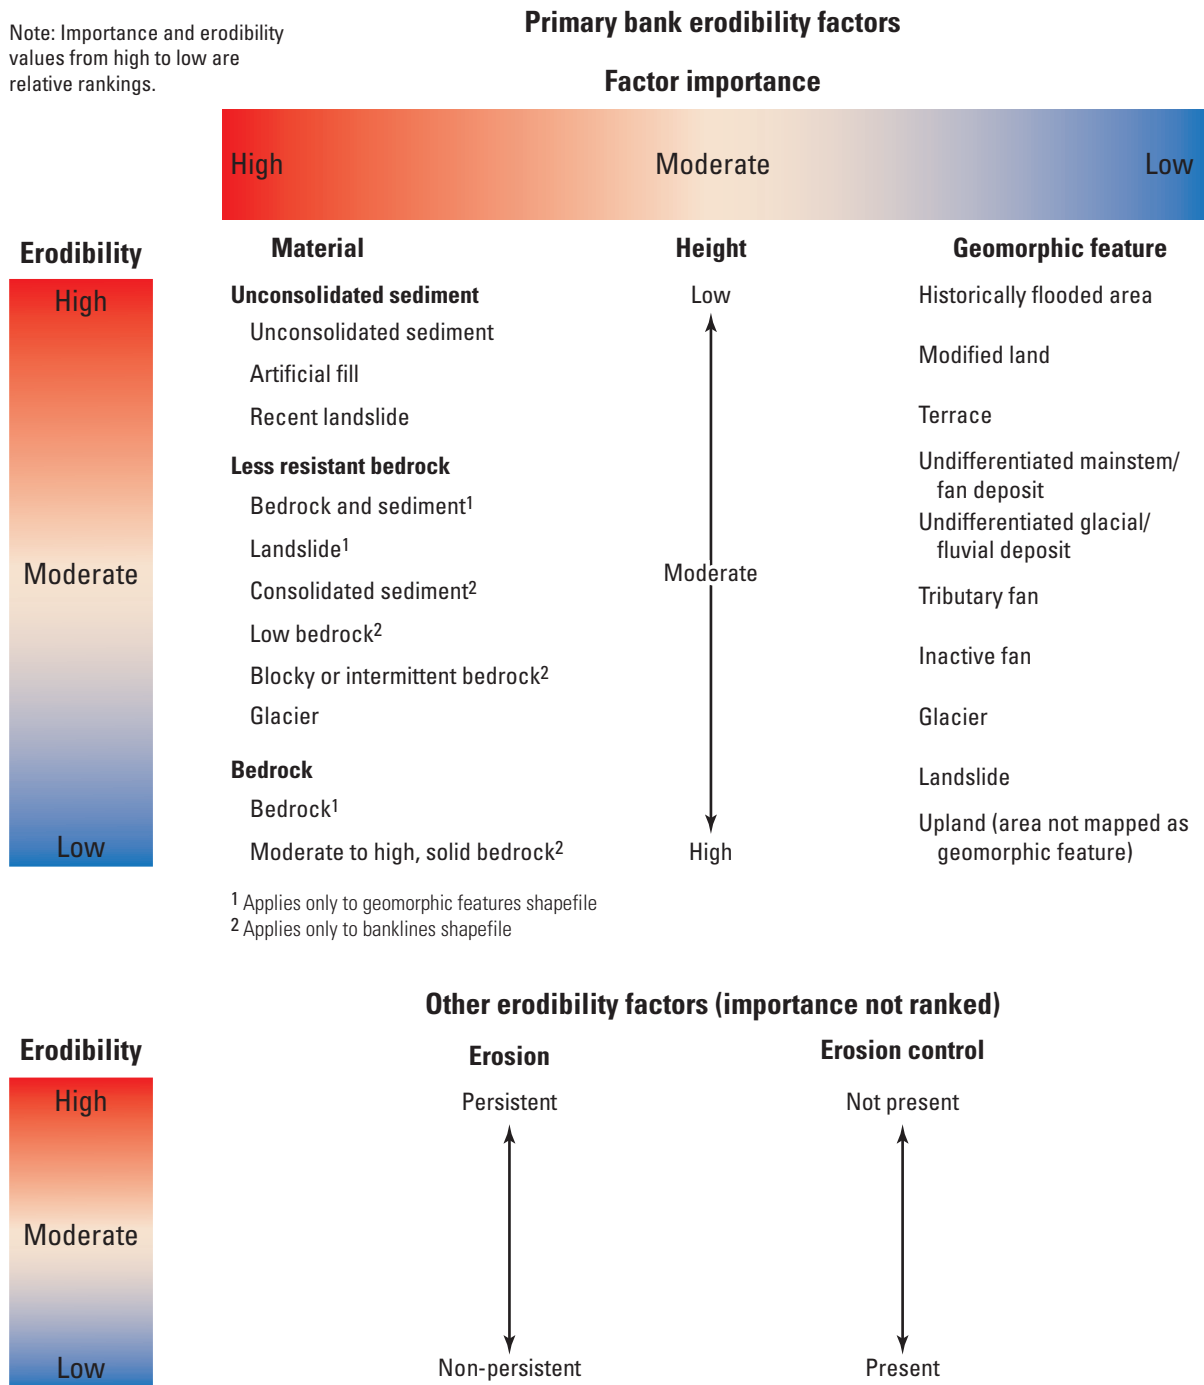
The relative importance of erodibility factors for the Matanuska River that can be drawn from the mapping for this report can be shown in a qualitative way ([fig. 28](#)). Relative erodibility within a factor was ranked using basic principles for the physical factors of bank material and height. Materials were grouped into categories termed unconsolidated sediment, less-resistant bedrock (which included non-bedrock features that provided significant erosion resistance), and bedrock on the basis of their erodibility. Geomorphic features were ranked on the basis of results of historical erosion, which showed more erosion at modern fluvial deposits than uplands, and more erosion at terraces than fans. The obviously high erosion resistance of bedrock makes bank material the most important erodibility factor, but the importance of bank height relative to geomorphic feature is difficult to discern. All features within the braid plain are subject to clear riverine hazards including flooding, as well as erosion, and are removed from consideration of braid plain margin erosion.

Figure 28. Ranking of variables and characteristics associated with bank erosion along the Matanuska River, southcentral Alaska.

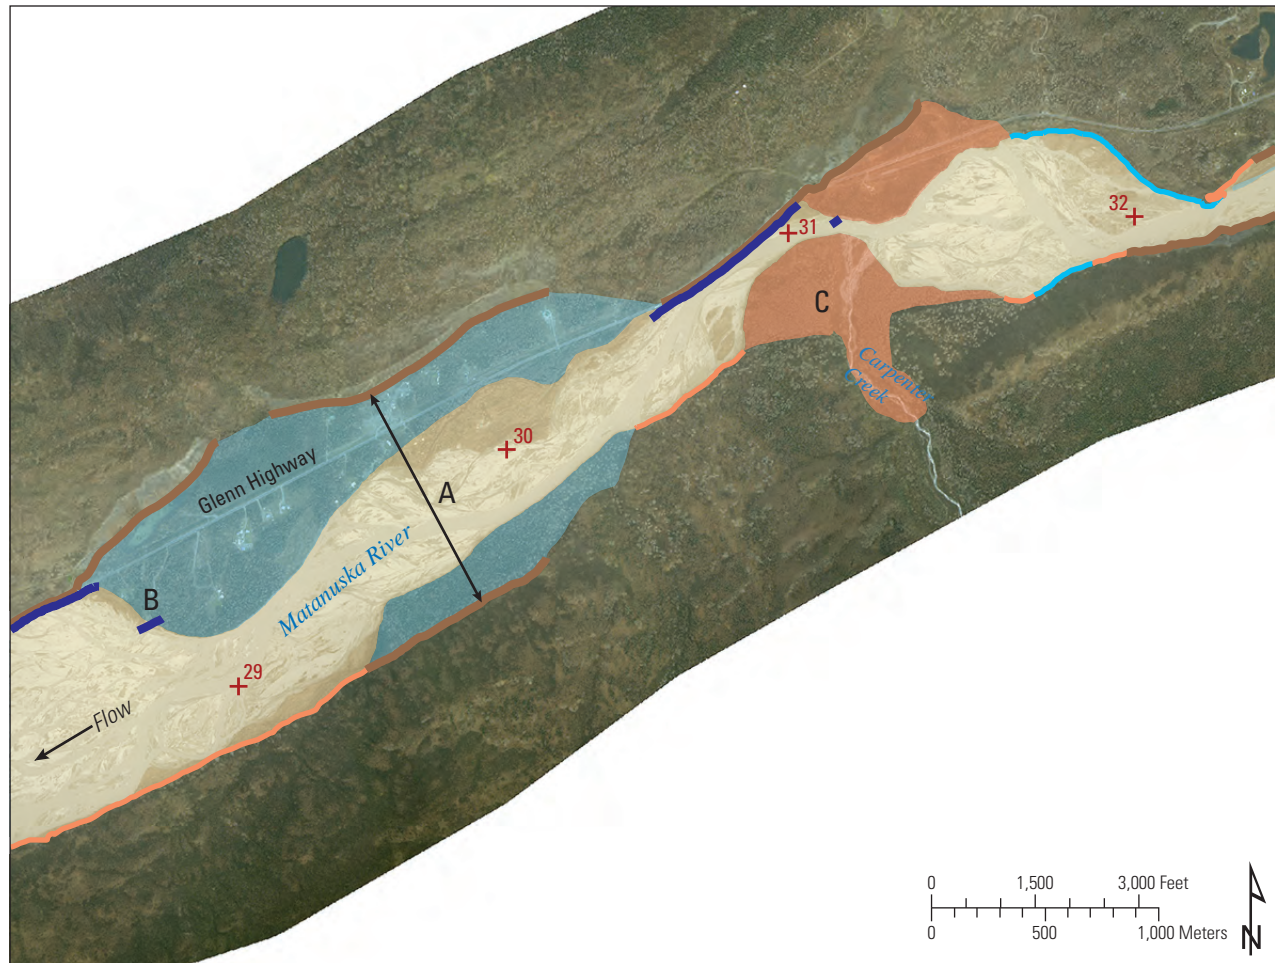
Erosion statistics computed for this report provide estimates of the extent of erosion concerns. Erosion detectable with aerial photographs (61 ft or more), occurred at 23 percent (31 mi) of the banks between 1949 and 2006, providing an estimate of the length of bank that might be affected by erosion in any given 50-year period. An analysis of the sensitivity of banks to erosion (for example, developed or undeveloped) would be required to estimate the length of banks that would require protecting in that period. A very coarse estimate of this can be obtained by the length of erosion control features installed by the time of this study. More than 8 mi of bank were sufficiently sensitive to erosion to require erosion control by formal or informal means. Persistent erosion was identified at selected locations, but at many others the river eroded enough to trigger action (for example, construction of dikes) and then moved away. This suggests that the persistently, severely eroded areas, such as along the left bank near the Old Glenn Highway and near Circle View Subdivision, can be identified as areas likely to require attention, but that other areas can appear suddenly.
