# Bathymetric and Velocimetric Surveys at Highway Bridges Crossing the Missouri River between Kansas City and St. Louis, Missouri, April–May 2013

By Richard J. Huizinga

Scientific Investigations Report 2014–5116

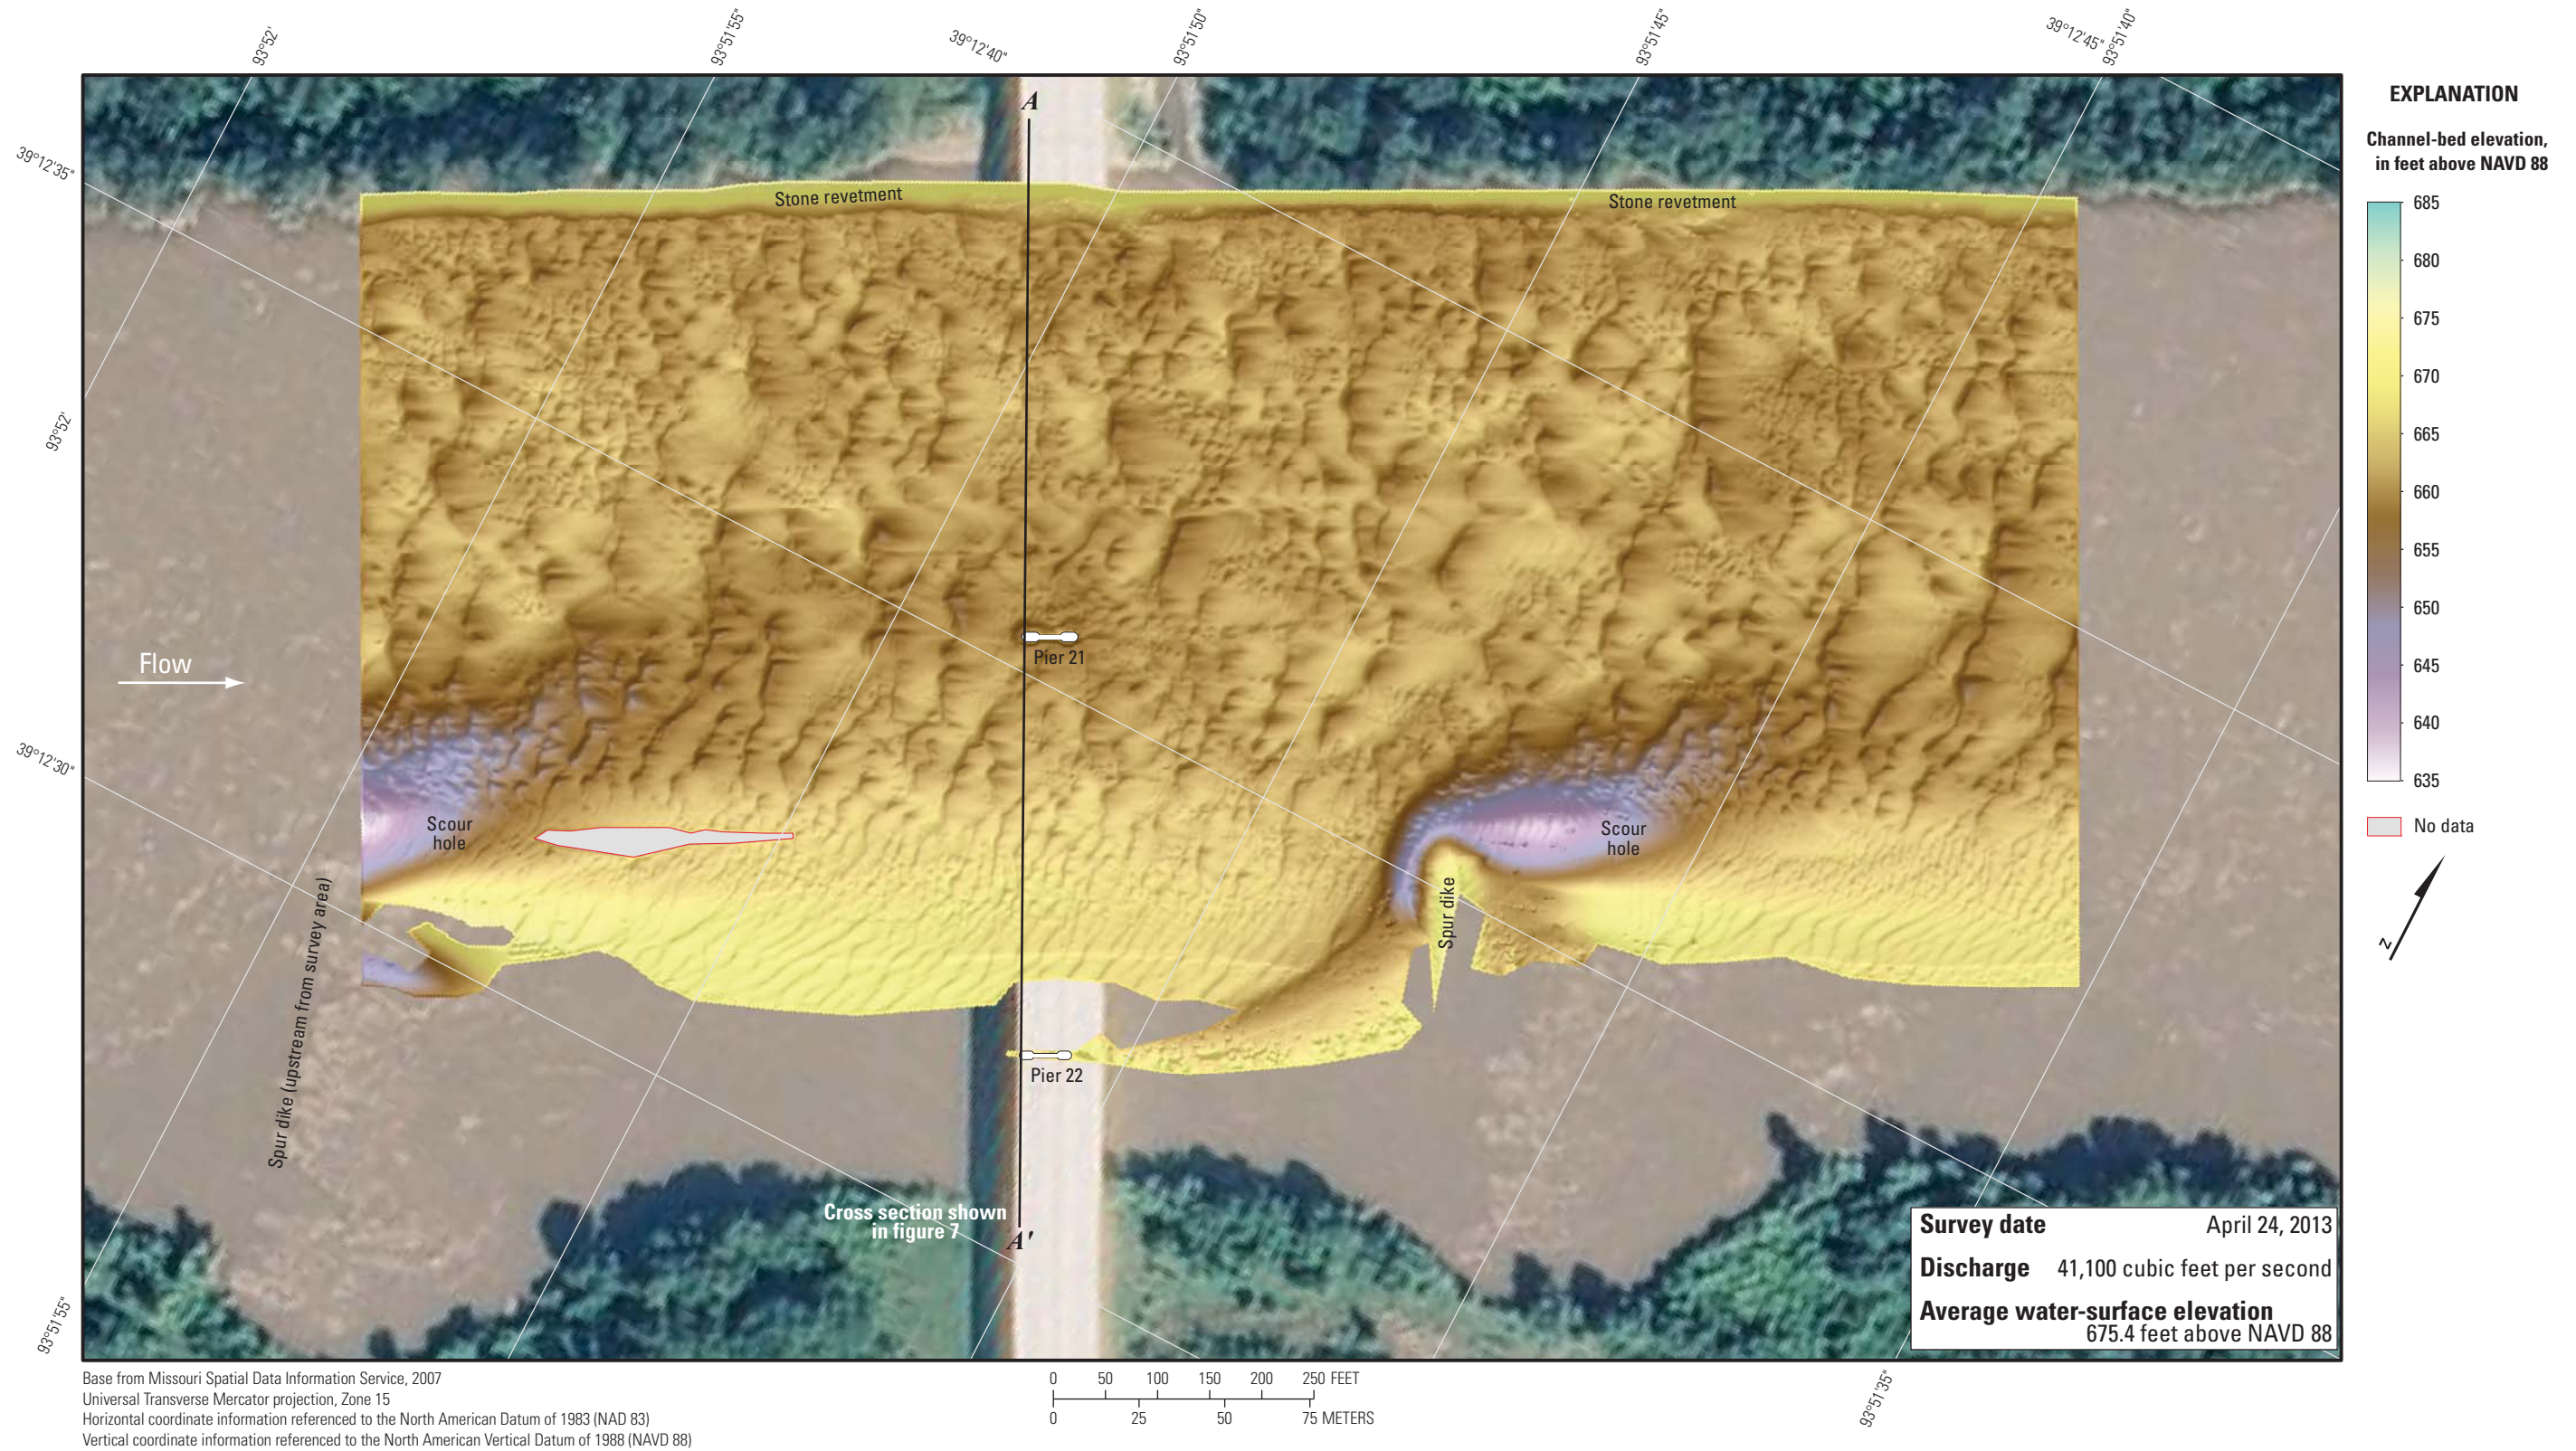
Figure 6. Bathymetric survey of the Missouri River channel in the vicinity of structure A5664 on State Highway 13 at Lexington, Missouri.

The survey area was about 1,640 ft long and about 800 ft wide, extending from the left (north) bank to about 150 ft to the right of the tips of the spur dikes on the right (south) side of the main channel (fig. 6). The upstream end of the survey area was about 670 ft upstream from the centerline of structure A5664, and pier 21 and 22 were in the water and away from the banks (fig. 6); however, pier 22 was in shallow water (fig. 6). The channel-bed elevations ranged from about 655 to 666 ft for most of the surveyed area (5 to 95 percentile range of the bathymetric data), except in the vicinity of the spur dikes on the right (south) bank (fig. 6; table 2). The channel bed between the left bank and the spur dikes was filled with small and medium dune features, and small dunes and ripples were present in the area between the spur dikes on the right side of the channel (fig. 6). Large scour holes were present downstream from the spur dikes on the right side (fig. 6).

The minor scour hole in the vicinity of main channel pier 21 was difficult to discern from nearby dunes and ripples (fig. 6). Information from bridge plans indicates that piers 21

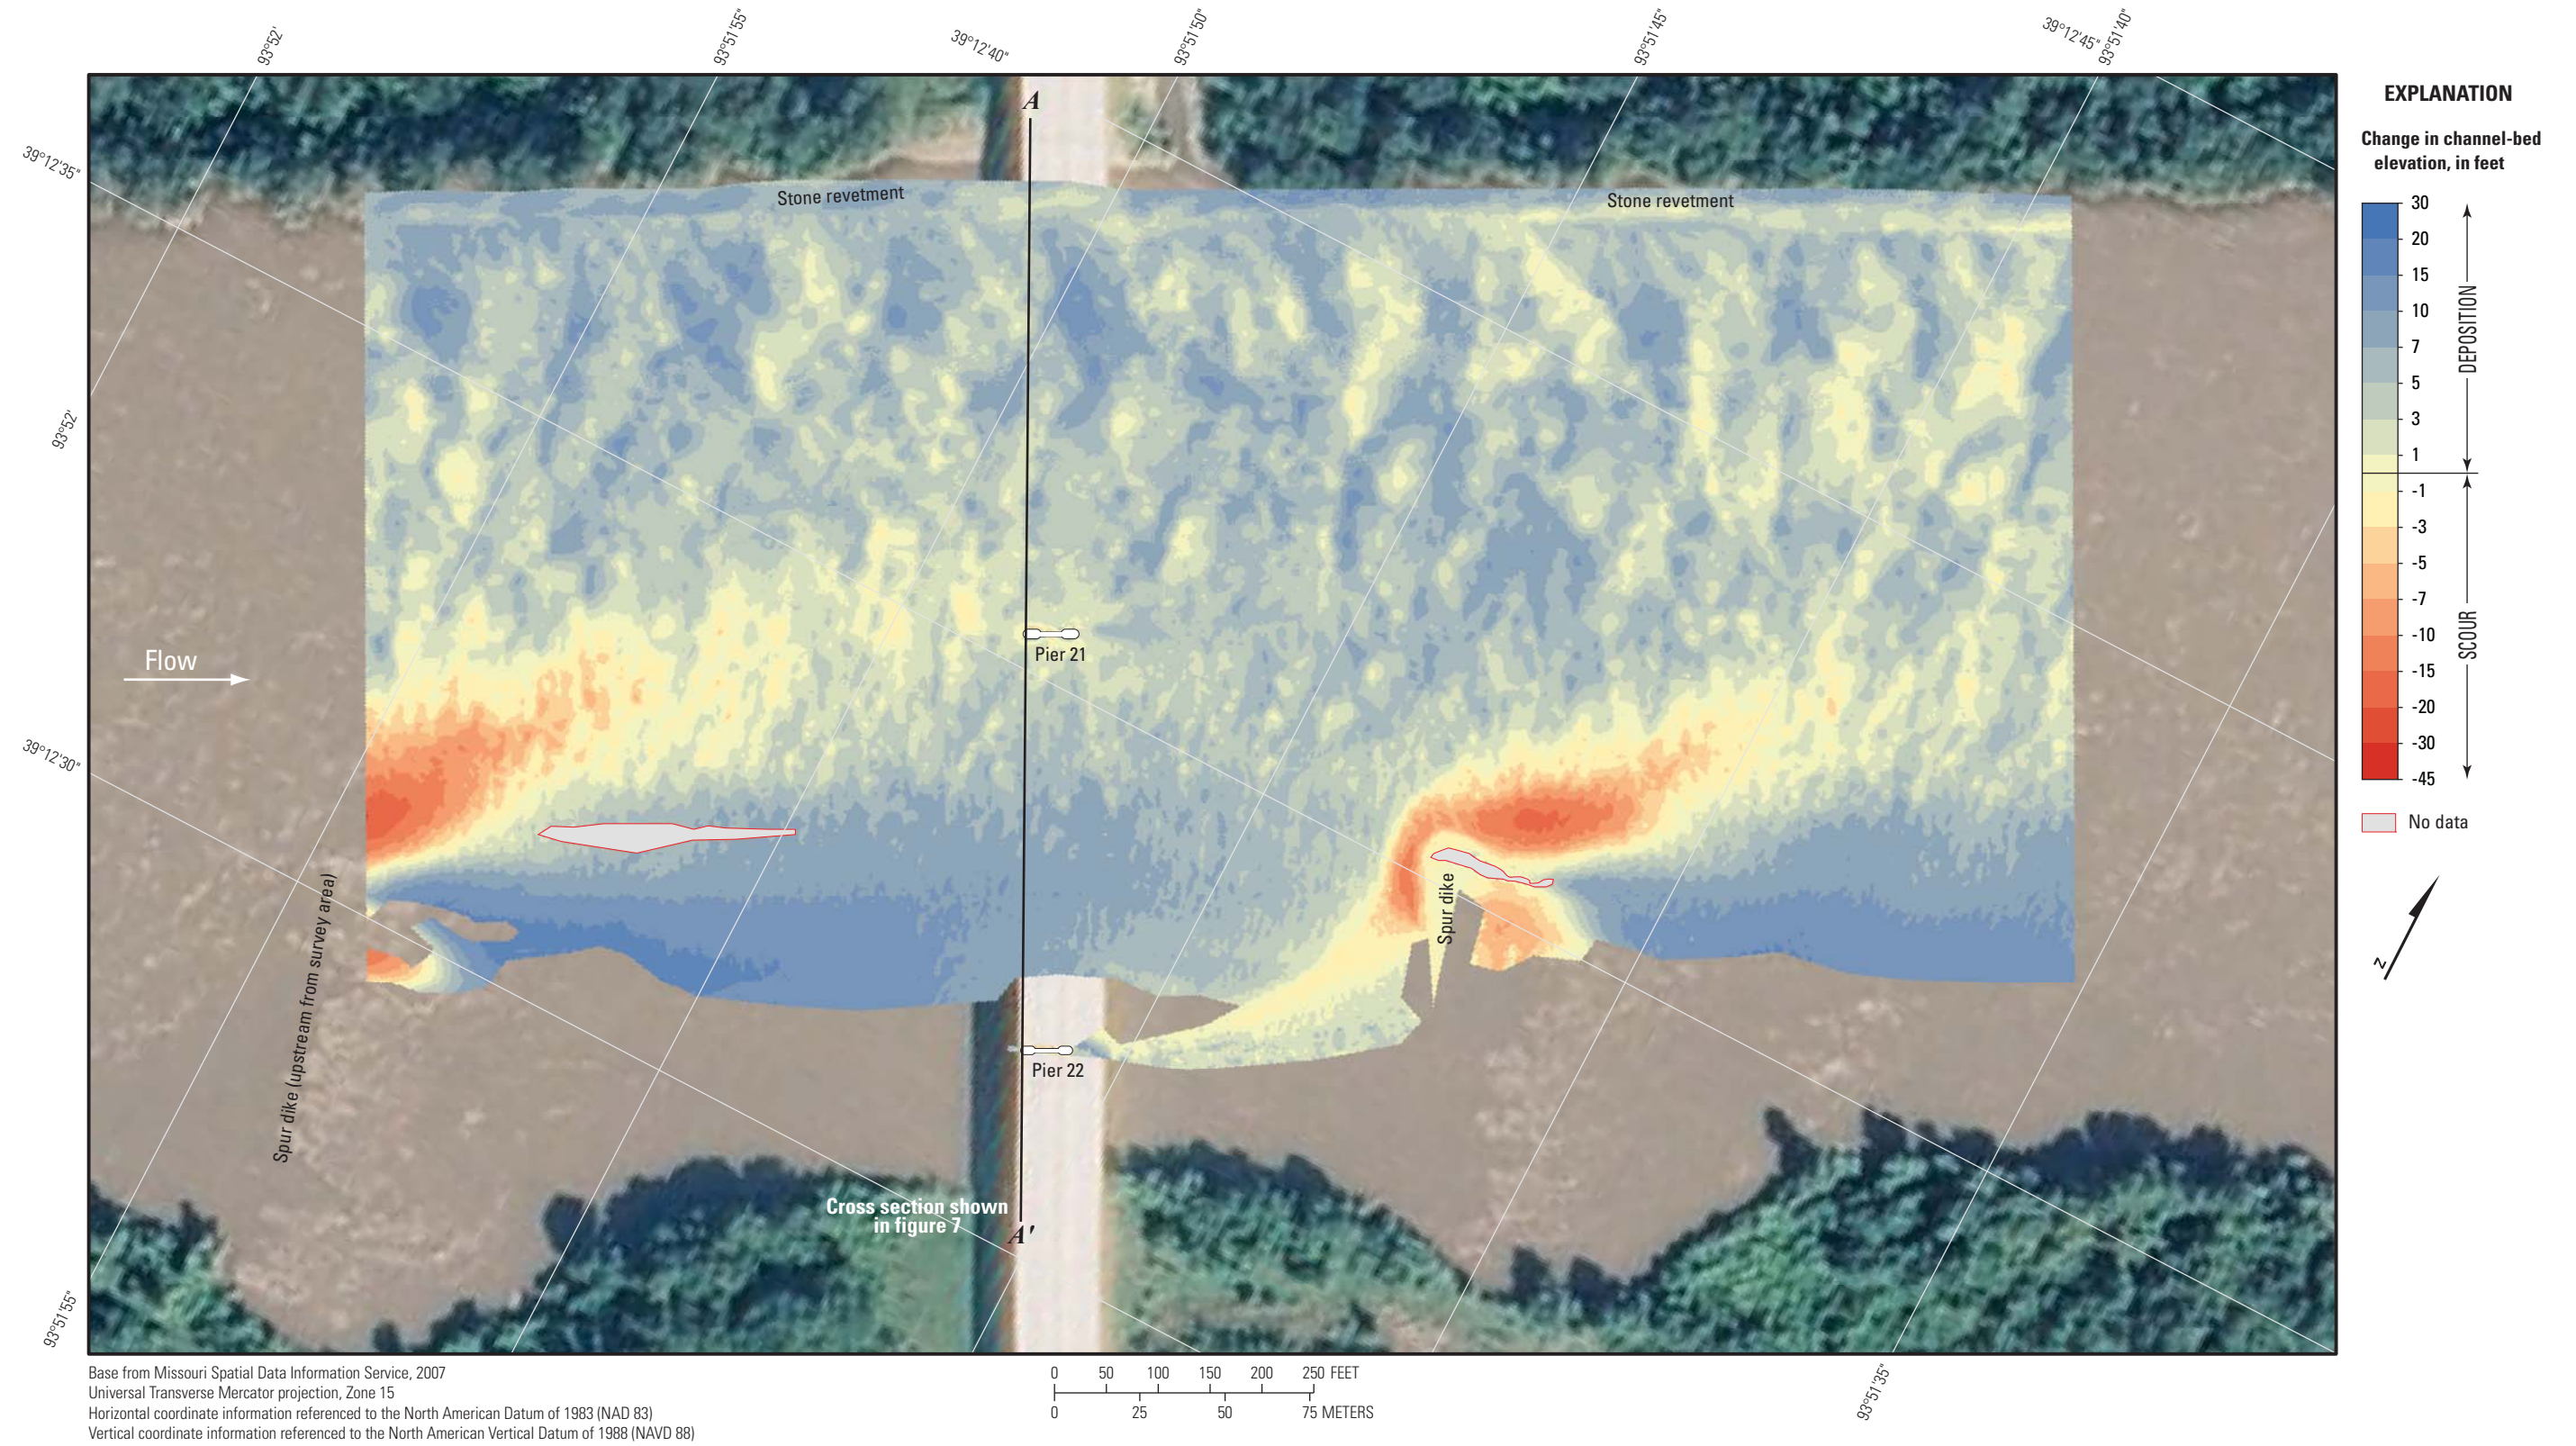
Figure 8. Difference between bathymetric surfaces created from surveys of the Missouri River channel in the vicinity of structure A5664 on State Highway 13 at Lexington, Missouri, on April 24, 2013, and July 20, 2011.

The difference between the bathymetric surfaces from the surveys on April 24, 2013, and July 20, 2011 (fig. 8), indicates substantial deposition of as much as 15 ft has occurred throughout the channel, but having small areas of scour near the tips of the spur dikes on the right (south) side of the channel. The mean difference between the July 2011 and April 2013 bathymetric surfaces (4.35 ft; table 7) indicates moderate to substantial deposition overall, as evident in the difference map (fig. 8). There was as much as 15 ft of deposition on the right bank downstream from the spur dikes, and as much as 20 ft of scour near the tips of the spur dikes (fig. 8). About 5 ft of deposition was observed on the stone revetment on the left bank (fig. 8).

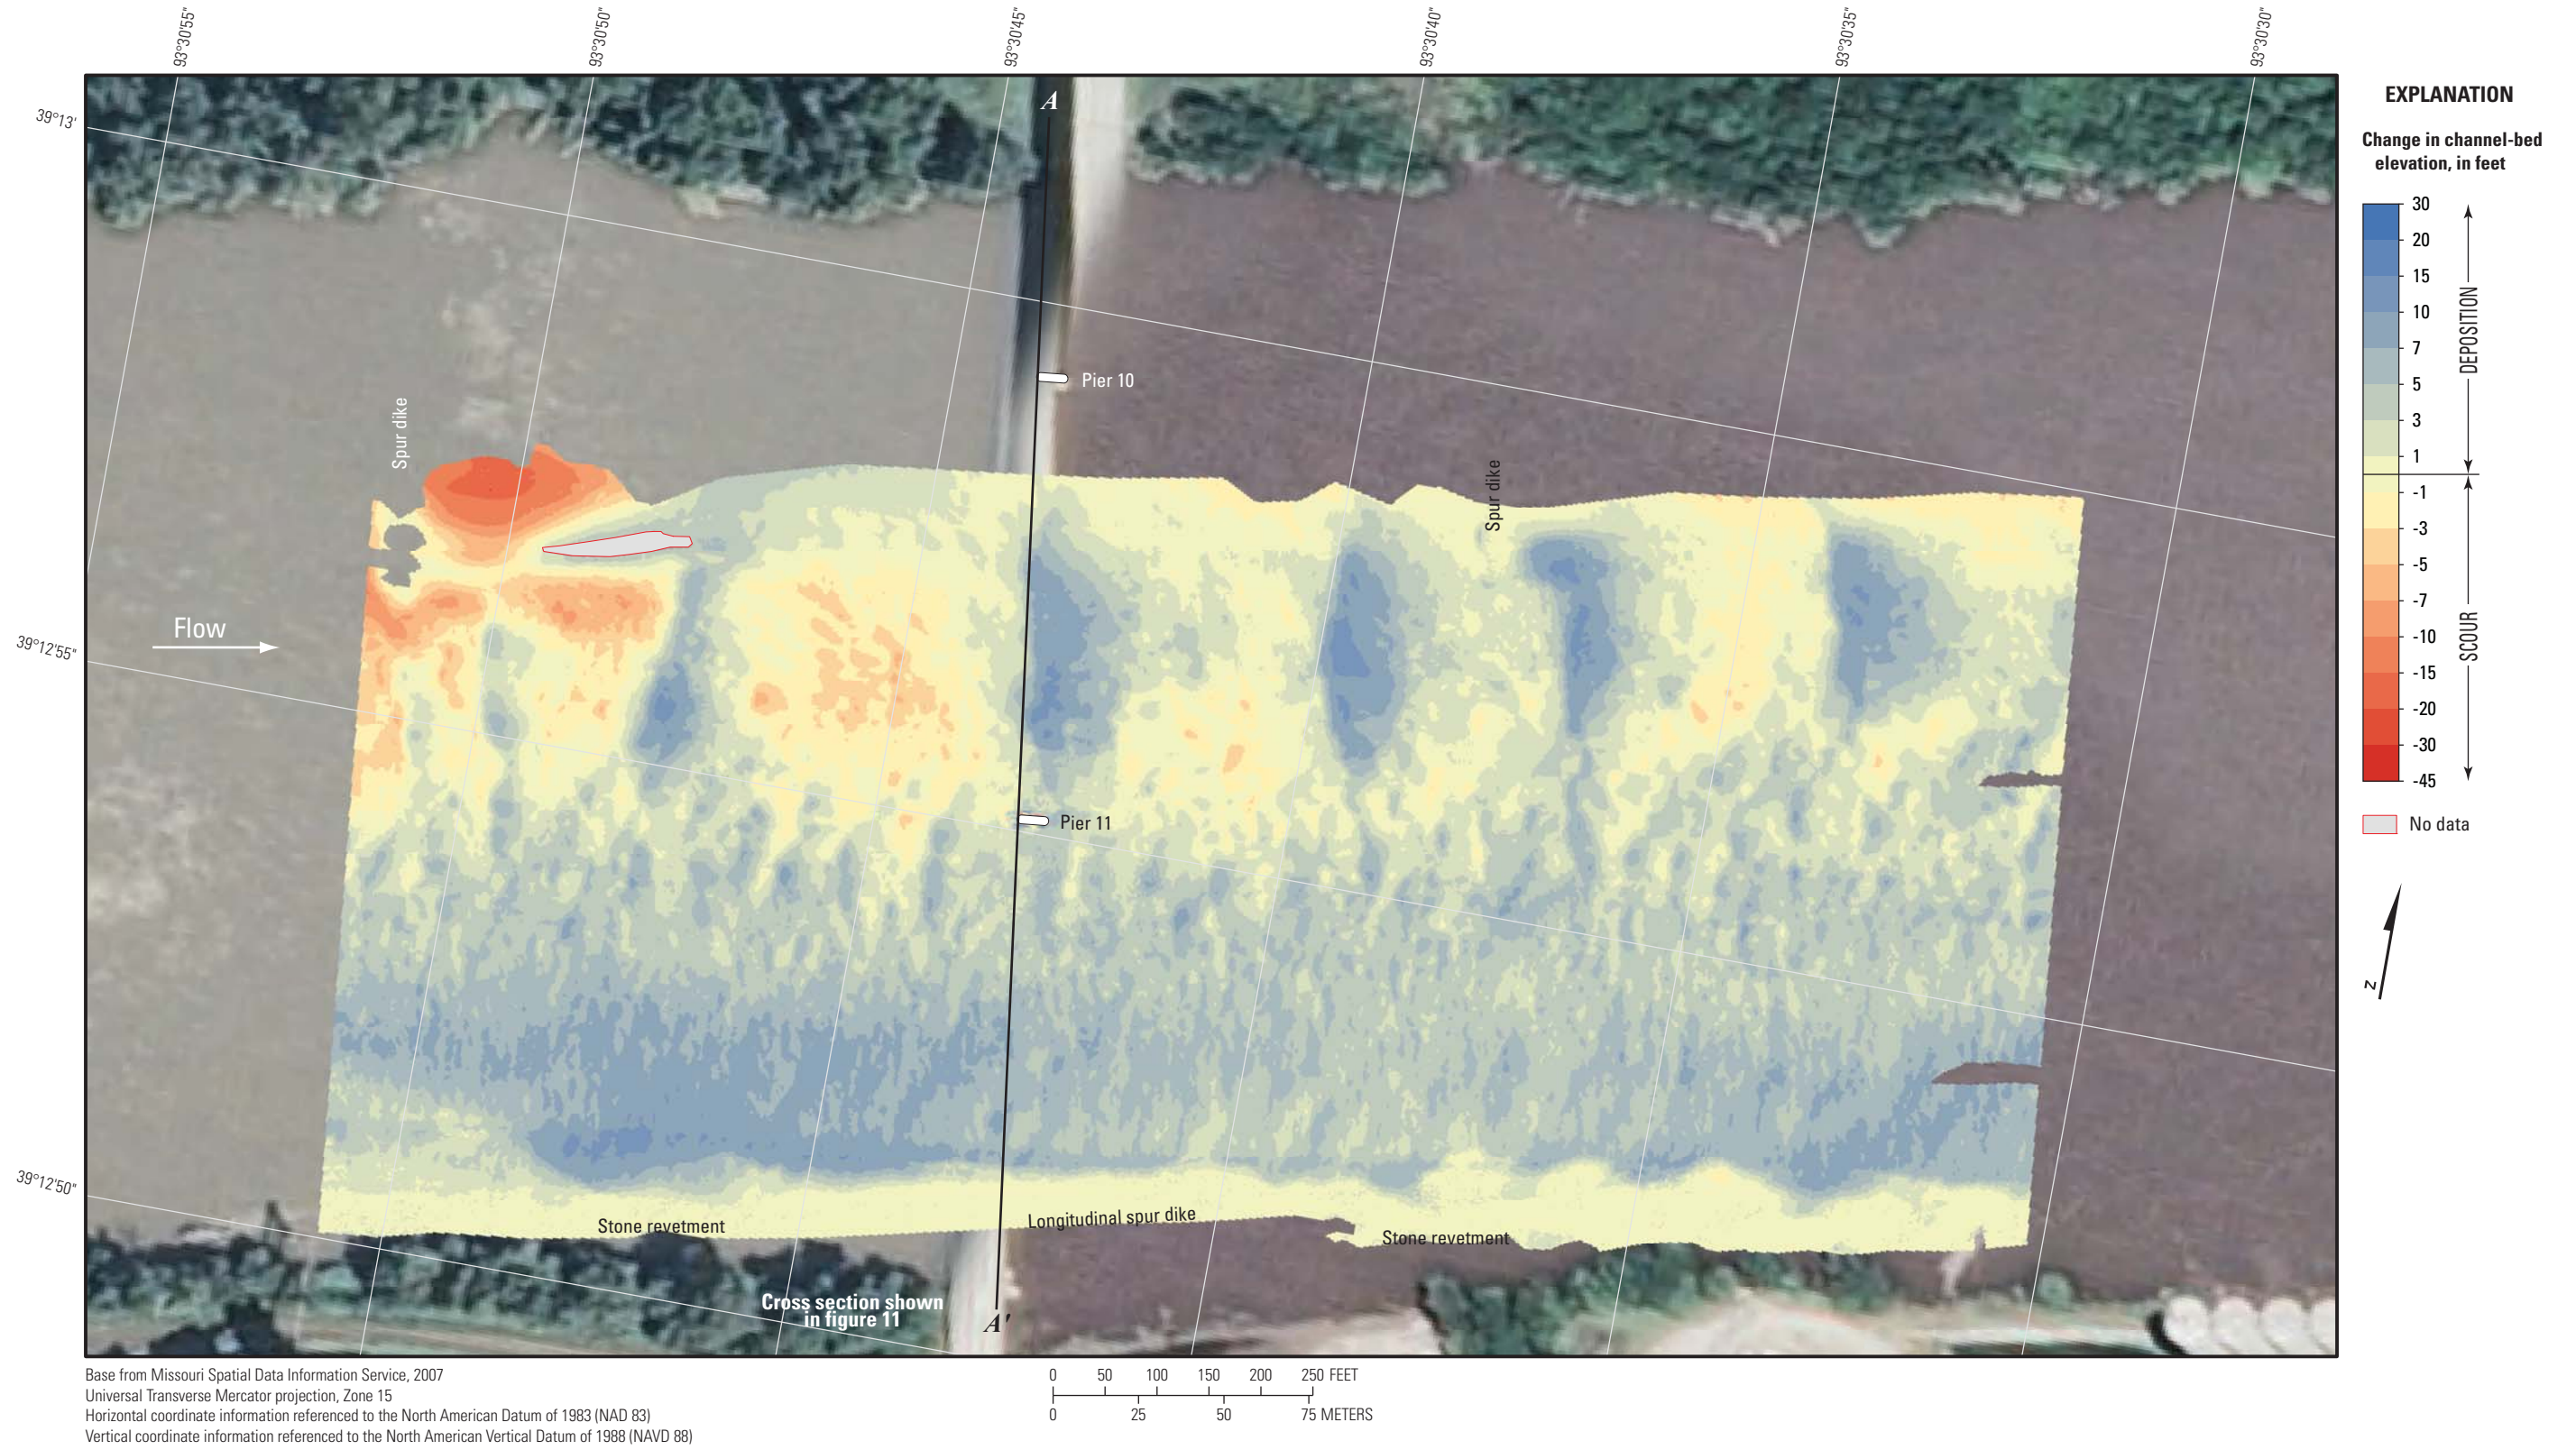
**Figure 12.** Difference between bathymetric surfaces created from surveys of the Missouri River channel in the vicinity of structure A5910 on U.S. Highway 24 at Waverly, Missouri, on April 25, 2013, and July 21, 2011.

The difference between the surveys on April 25, 2013, and July 21, 2011 (fig. 12), indicates moderate deposition of as much as 15 ft has occurred particularly in the thalweg along the right bank, with small areas of scour near the tip and downstream from the spur dike on the upstream left side of the channel. The mean difference between the July 2011 and April 2013 bathymetric surfaces (2.75 ft; table 7) indicates moderate deposition overall, as evident in the difference map (fig. 12). The series of large dunes evident in the July 2011 survey is indicated by a series of alternating scour and deposition patches along the left side of the channel (fig. 12). As much as 20 ft of scour was observed near the upstream spur dike (fig. 12). No deposition was observed on the stone revetment or the longitudinal spur dike on the right bank (fig. 12).

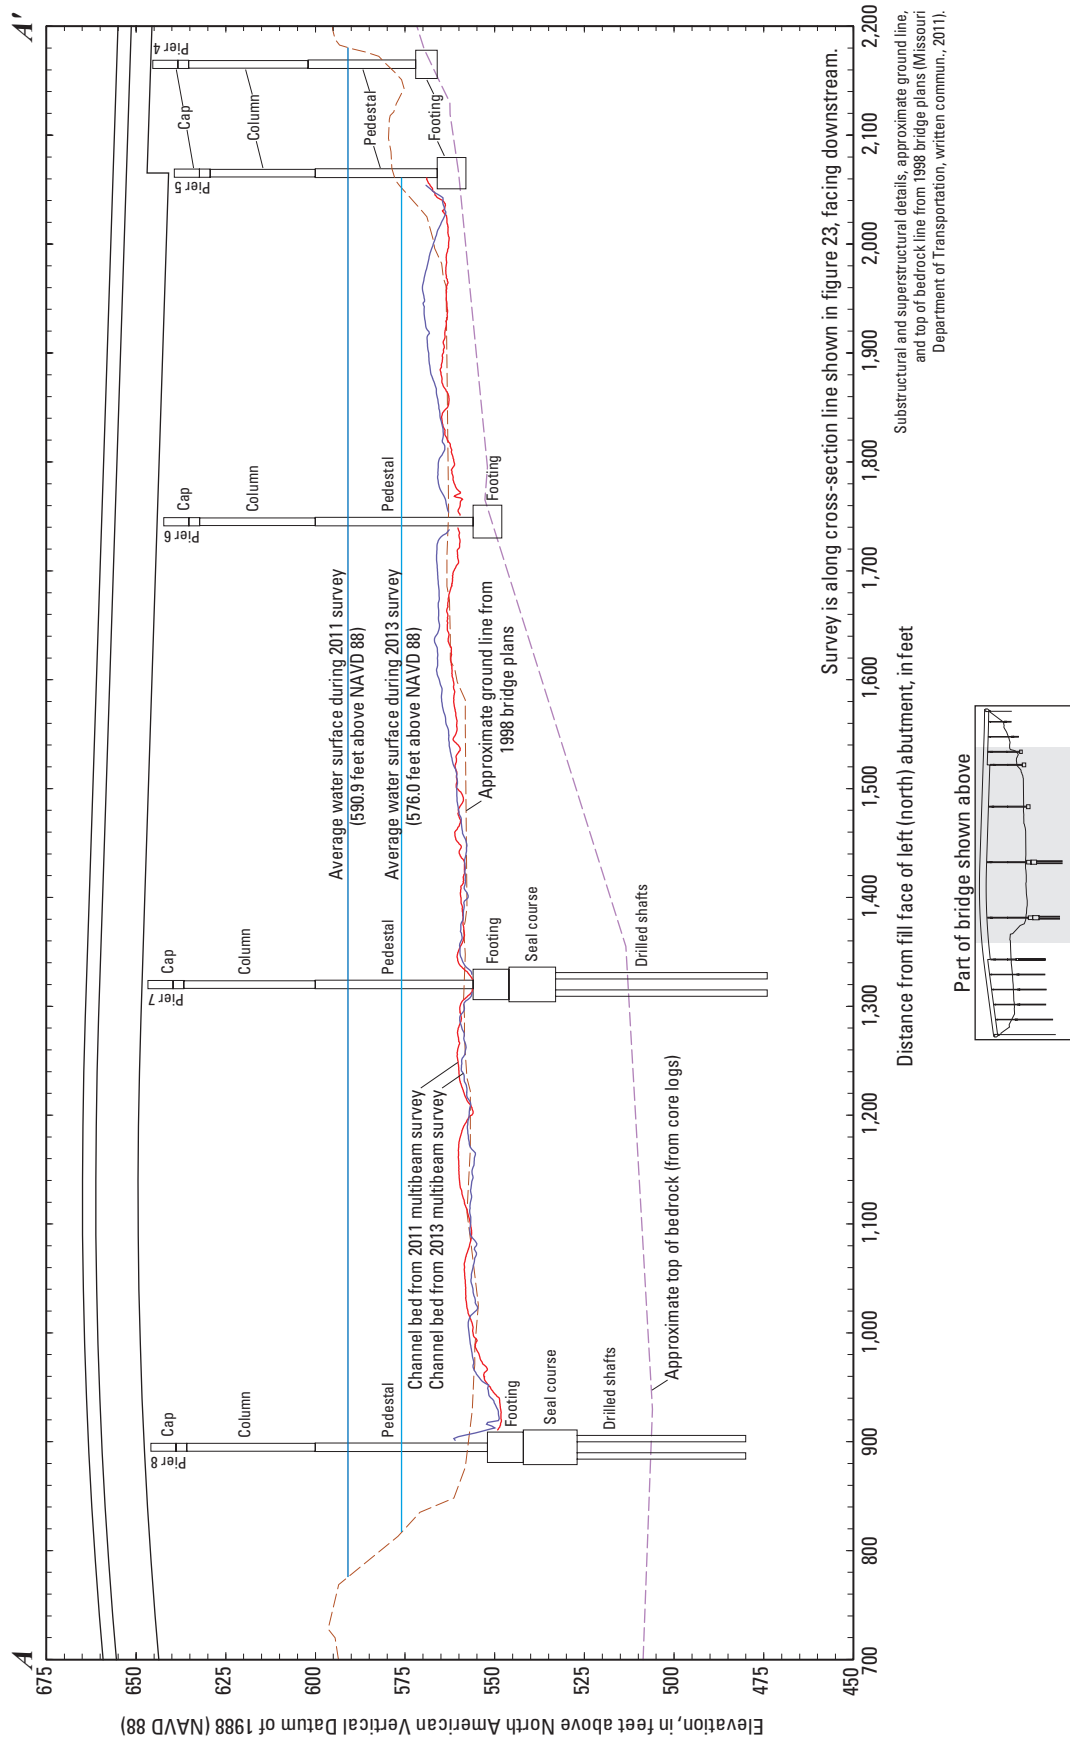
**Figure 24.** Key features, substructural and superstructural details, and surveyed channel bed of structure A4574 on State Highway 5 over the Missouri River at Boonville, Missouri.

10 ft higher than the previous multibeam survey from the middle of the channel to the right bank (fig. 24).

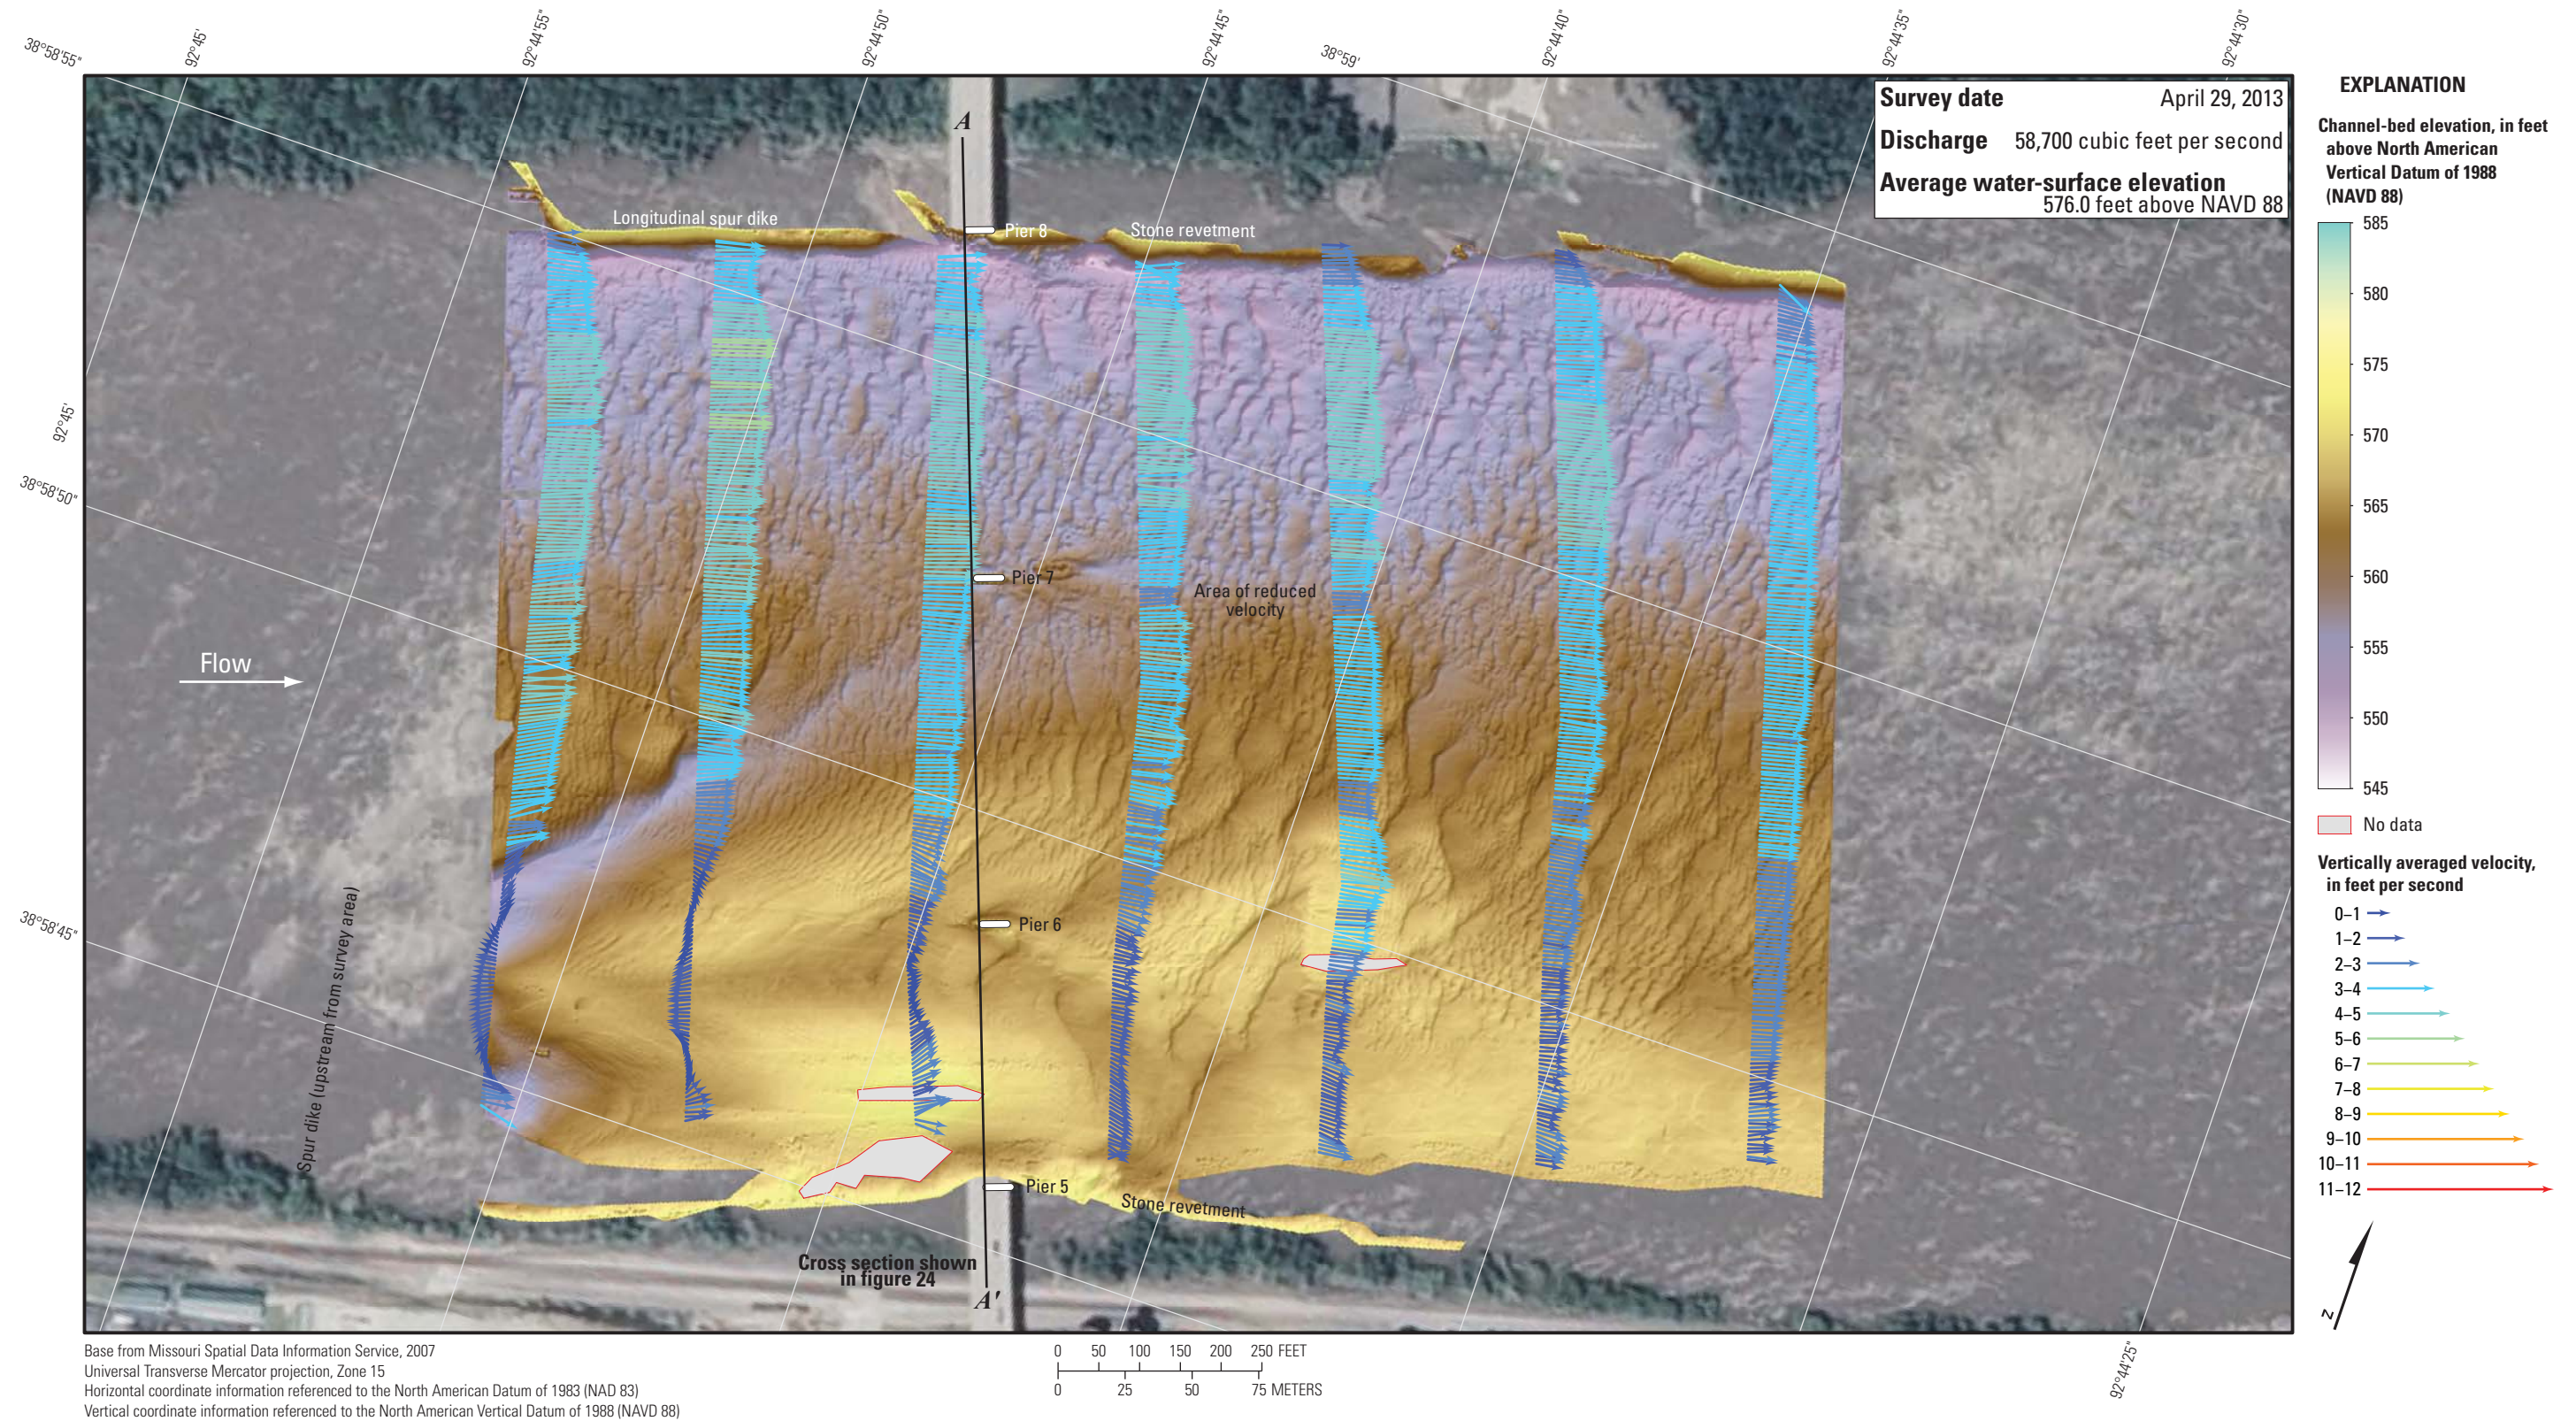
Figure 26. Bathymetry and vertically averaged velocities of the Missouri River channel in the vicinity of structure A4574 on State Highway 5 at Boonville, Missouri.

The vertically averaged velocity vectors indicate mostly uniform flow throughout most of the channel, ranging from about 2 to 6 ft/s (fig. 26). Flow reversal and minor turbulence was observed on the right side of the channel downstream from the spur dike just upstream from the reach (fig. 26). The bridge piers were aligned with flow, causing little to no turbulence downstream (fig. 26) despite a reduction in velocity downstream from pier 7 (fig. 26).

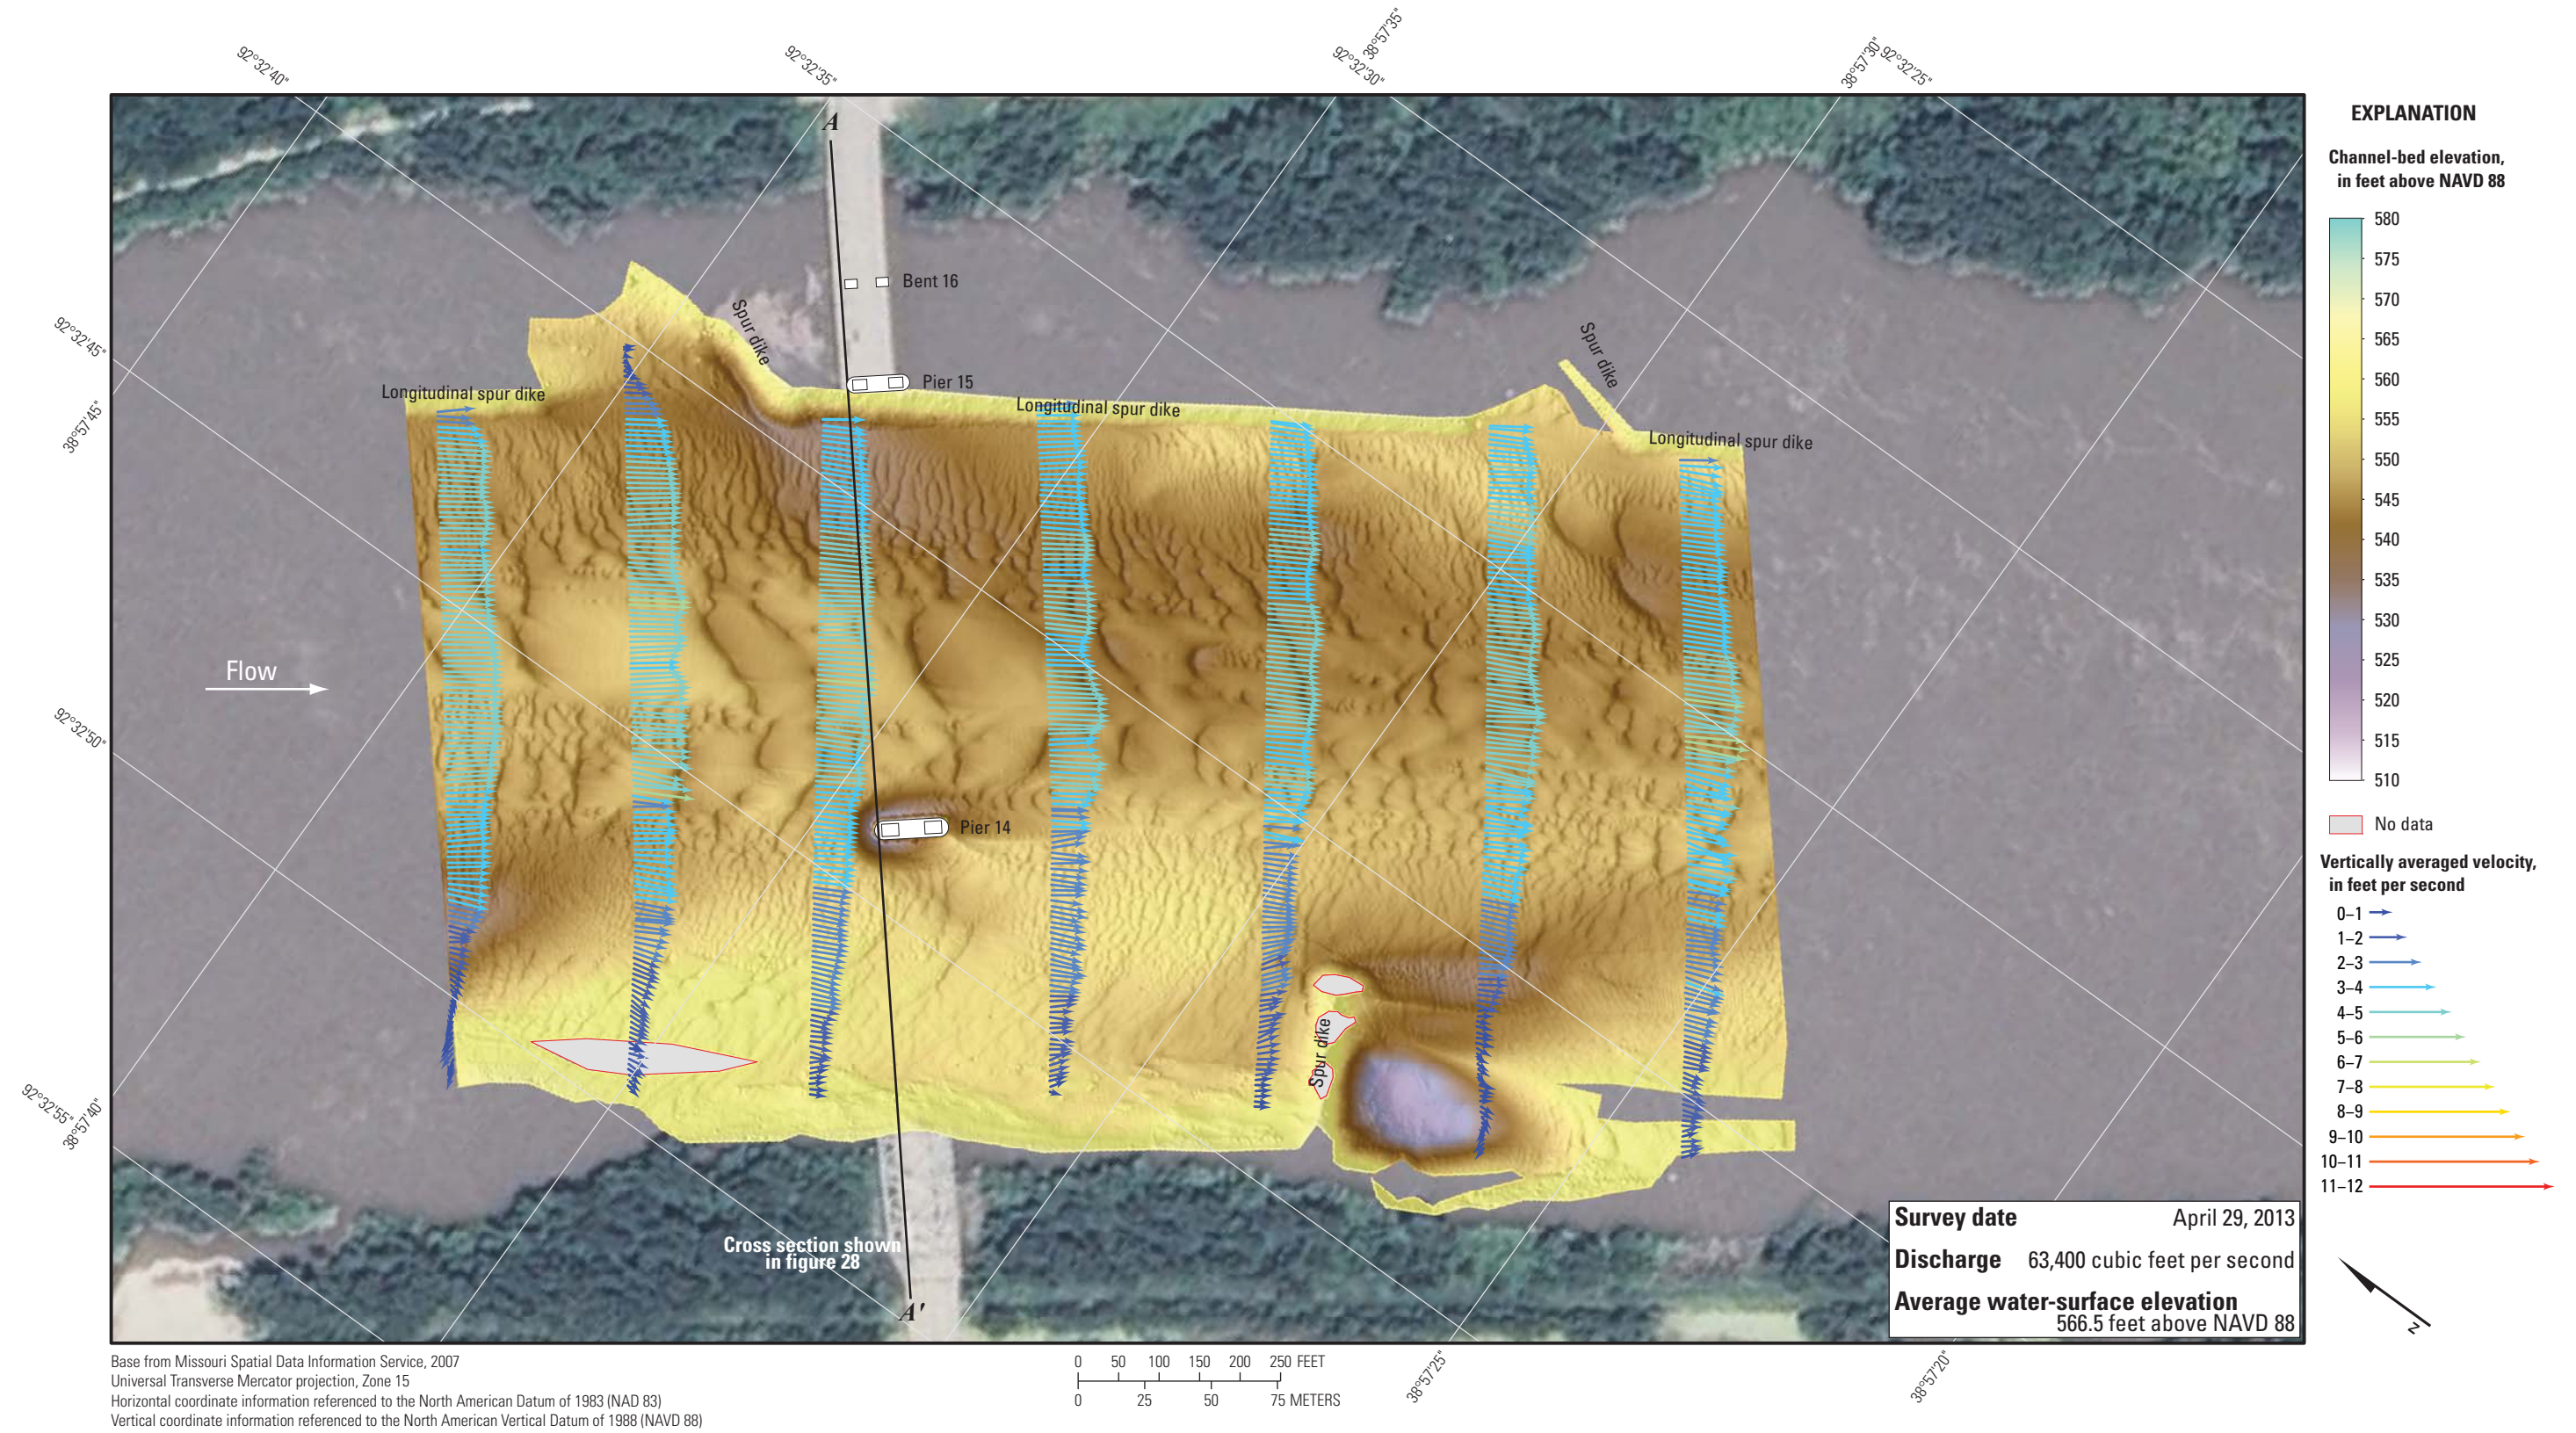
Figure 30. Bathymetry and vertically averaged velocities of the Missouri River channel in the vicinity of structure L0962 on Interstate 70 near Rocheport, Missouri.

The vertically averaged velocity vectors indicate mostly uniform flow in the thalweg, with areas of turbulence along the right bank (fig. 30). Velocities ranged from about 3 to 6 ft/s for most of the channel (fig. 30), with locally lower velocities and flow reversal along the right bank and between the longitudinal spur dikes on the upstream left bank (fig. 30). Pier 14 was mostly aligned with flow, causing minimal turbulence downstream (fig. 30); however, flow approached pier 14 from the left, causing an asymmetric scour hole that is longer and slightly deeper on the left side (fig. 30).
