# Bathymetric and Velocimetric Surveys at Highway Bridges Crossing the Missouri River between Kansas City and St. Louis, Missouri, April–May 2013

By Richard J. Huizinga

Scientific Investigations Report 2014–5116

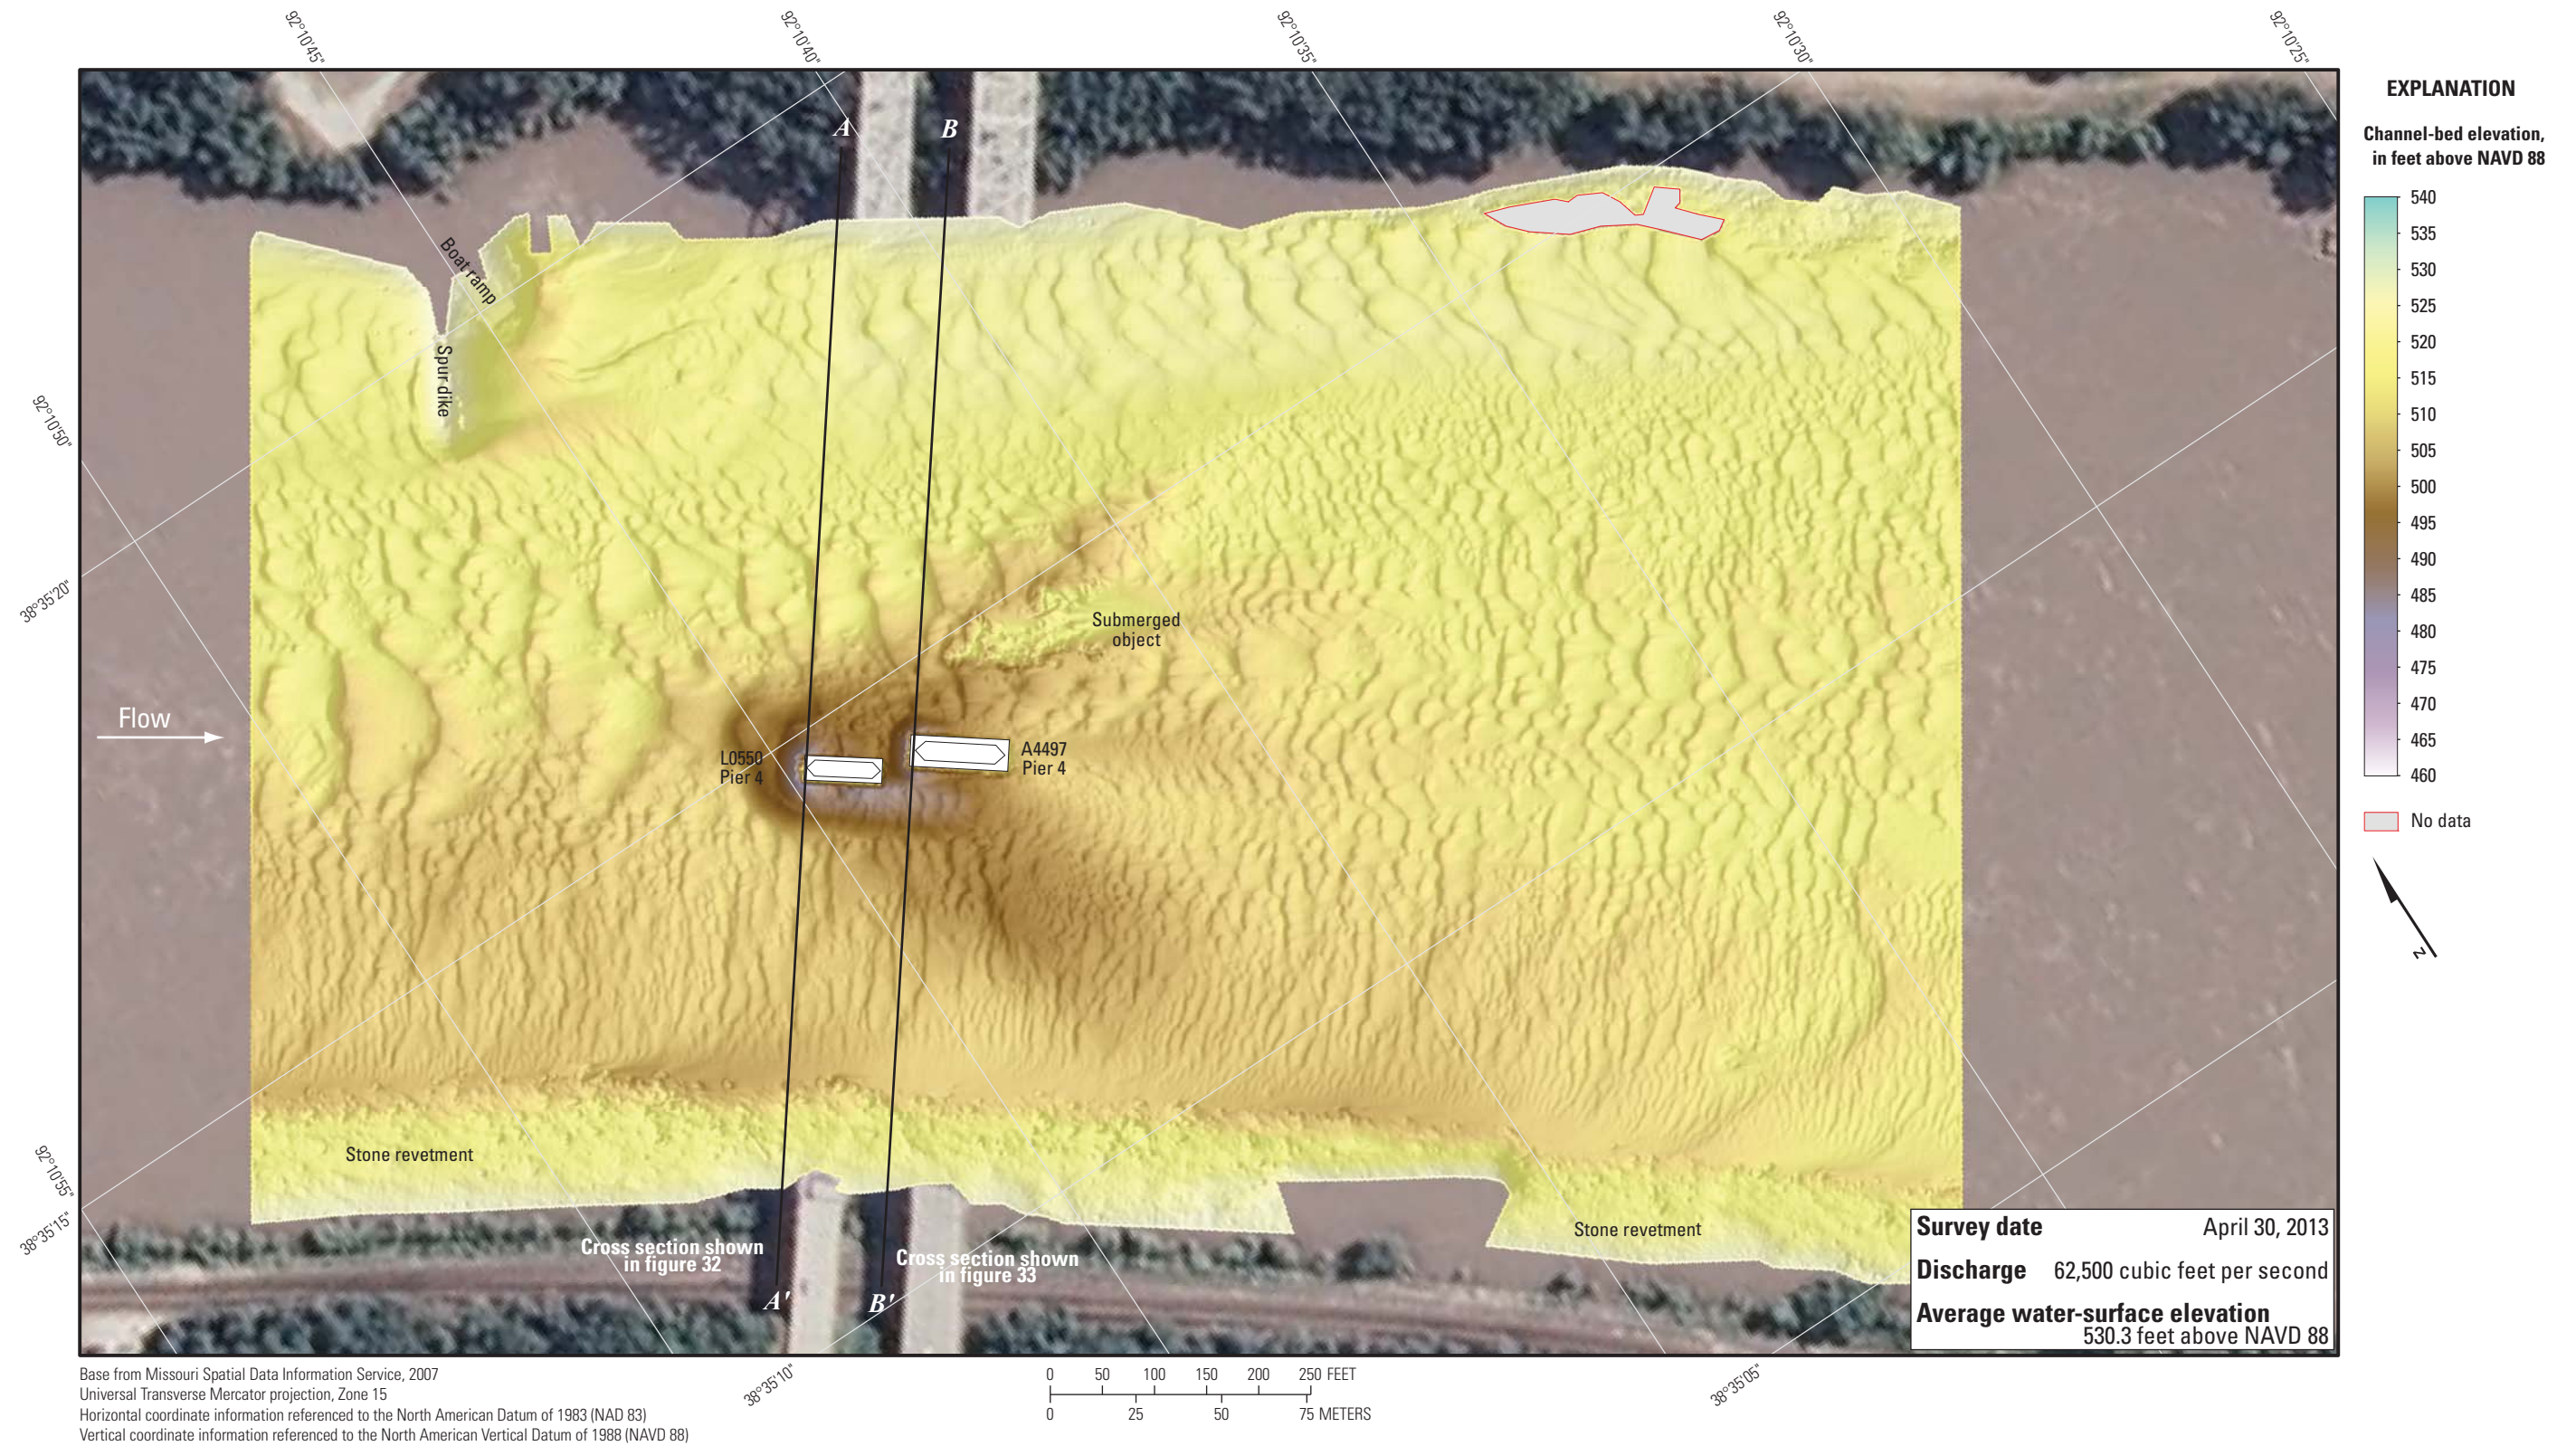
Figure 31. Bathymetric survey of the Missouri River channel in the vicinity of structures L0550 and A4497 on U.S. Highway 54 at Jefferson City, Missouri.

In the previous studies in the Kansas City, Mo., and St. Louis, Mo., areas (Huizinga, 2010, 2011), the movement of bed material affected the bathymetric data and the shape of the scour holes at several of the bridges, such that several of the scour holes displayed subtle “steps” and waves in the front of or along the sides of the holes. These “steps” were more pronounced in the Kansas City, Mo., area bridges than in the area bridges in the previous studies, presumably because the nonflood flow conditions during the St. Louis, Mo., area surveys would result in less dynamic movement of bed material than the moderate flood conditions during the Kansas City, Mo., area surveys; subsequently, the scour holes were presumed to be less likely to have lateral or longitudinal sand input in the St. Louis, Mo., surveys. However, during the 2011 flood study (Huizinga, 2012), the Missouri River was in moderate- to high-flow conditions at all of the bridges that resulted in substantial and dynamic movement of bed material, yet “steps” and waves were observed at only a few bridges. No such “steps” or waves were observed in the current study, which was in low to moderate flow conditions. In the earliest previous survey at structures L0550 and A4497 at Jefferson City, Mo., on January 26, 2010, the “steps” and waves caused the scour hole to be nearly rectangular (apparent in the difference map; fig. 36C), whereas there were no such features apparent in the most-recent survey on April 30, 2013 (fig. 31).

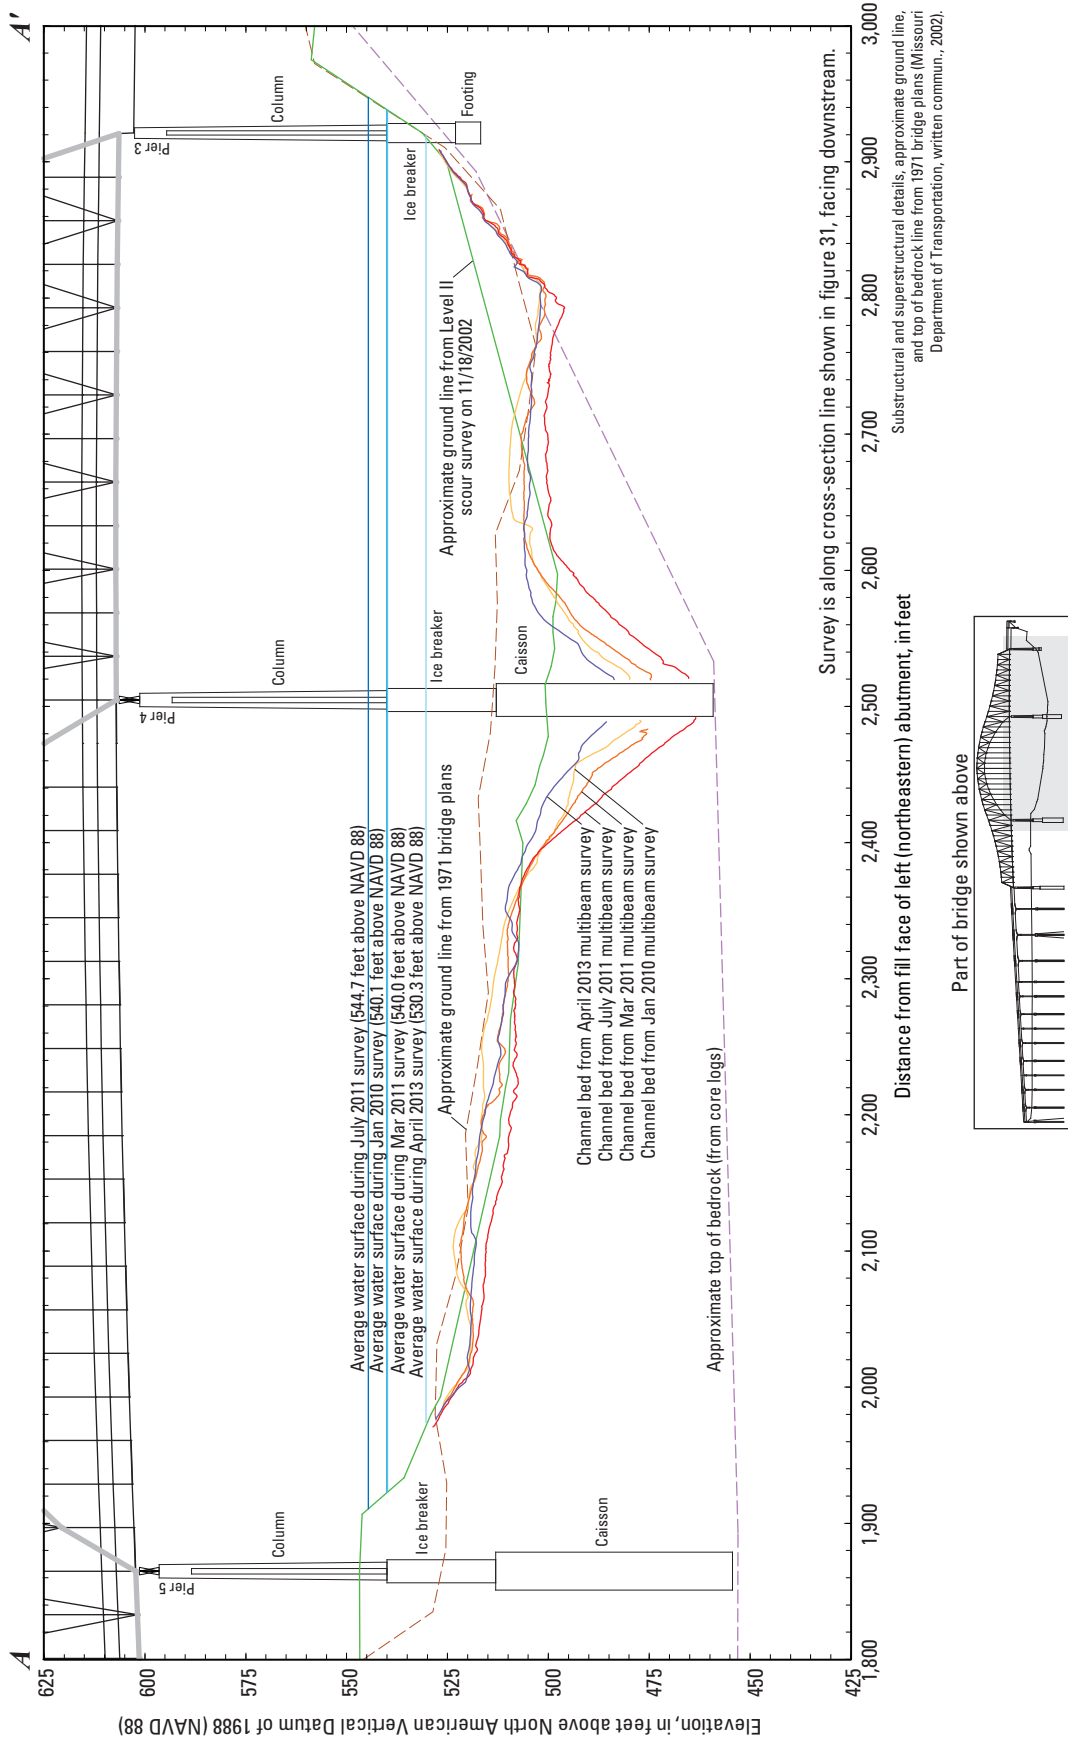
Figure 32. Key features, substructural and superstructural details, and surveyed channel bed of structure L0550 on U.S. Highway 54 over the Missouri River at Jefferson City, Missouri.

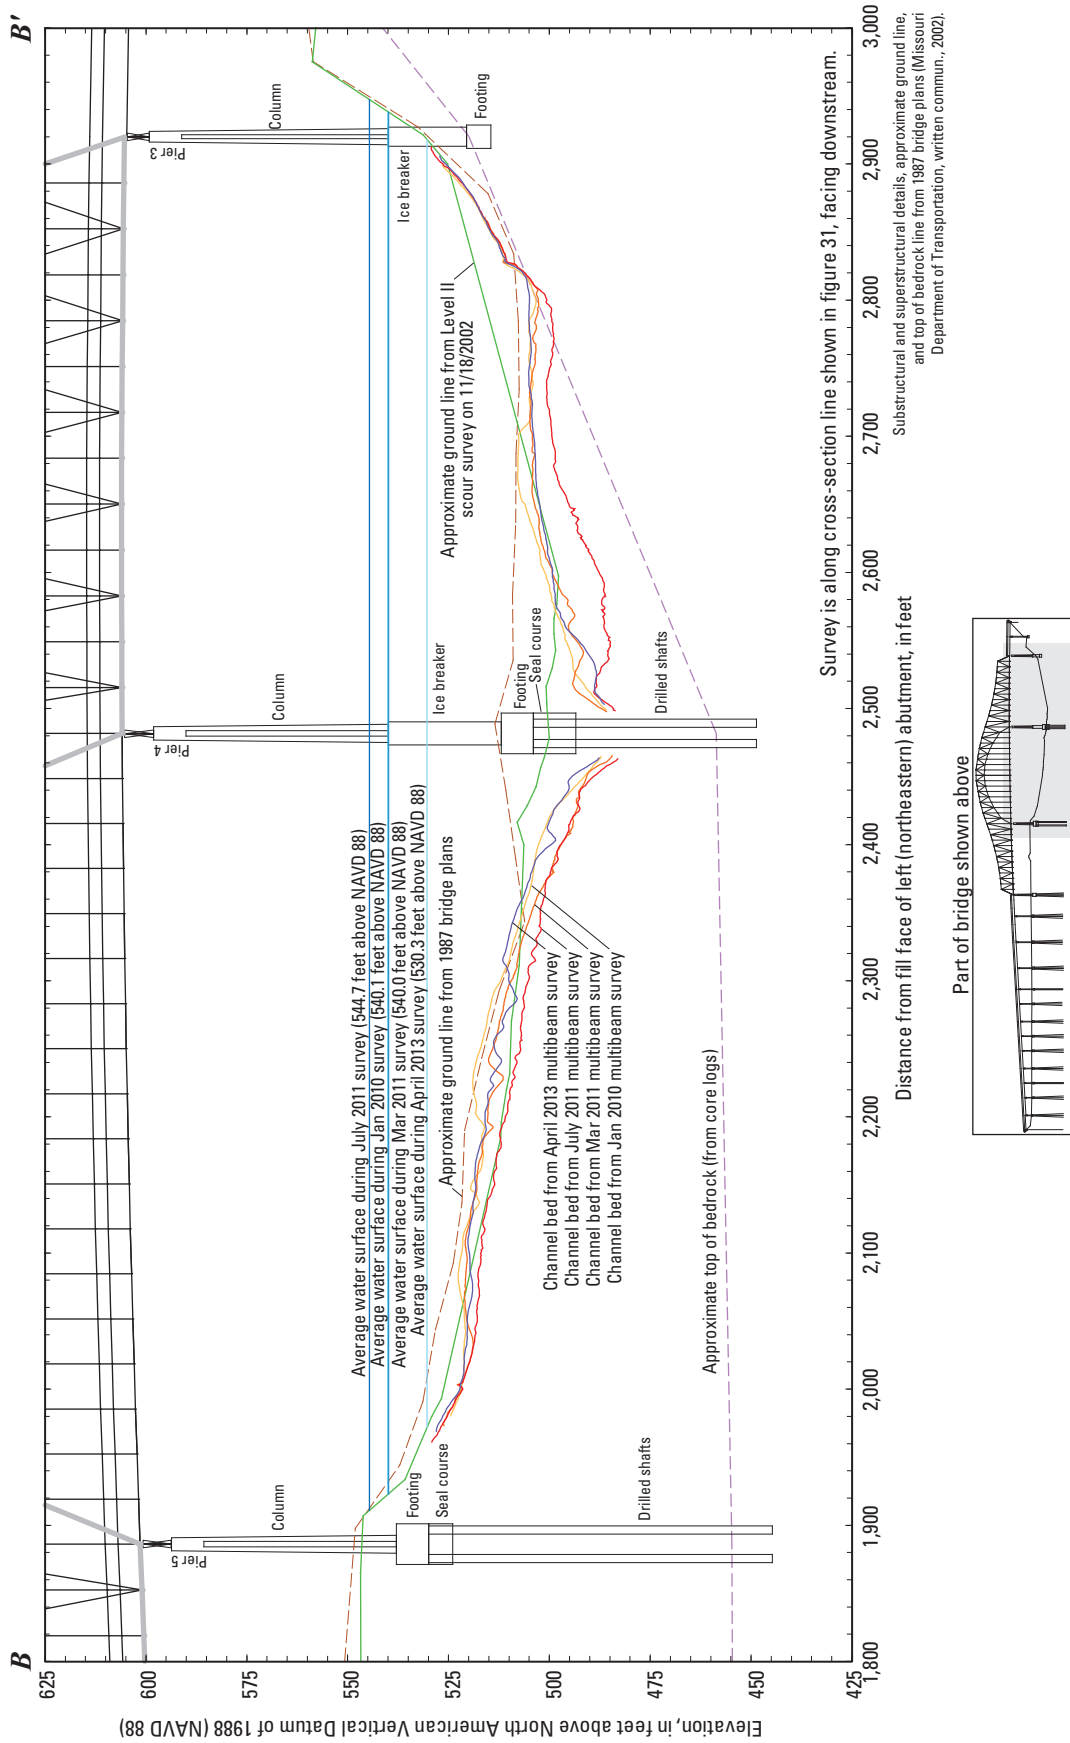
**Figure 33.** Key features, substructural and superstructural details, and surveyed channel bed of structure A4497 on U.S. Highway 54 over the Missouri River at Jefferson City, Missouri.

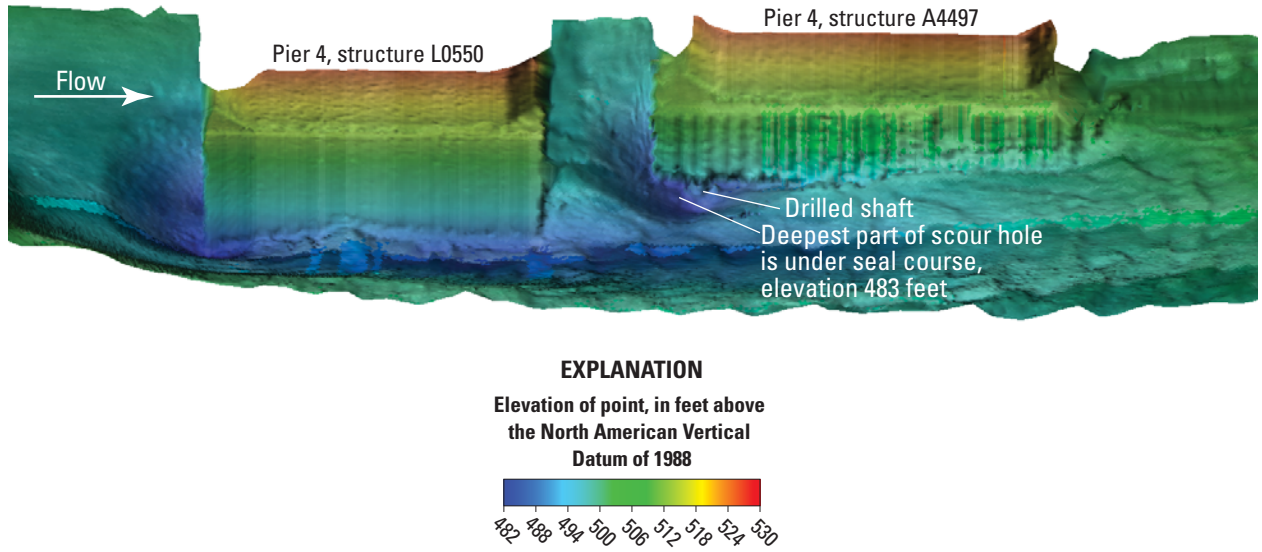
**Figure 34.** Shaded triangulated irregular network (TIN) visualization of the channel bed and right (southwest) side of main channel piers of structures L0550 and A4497 on U.S. Highway 54 over the Missouri River at Jefferson City, Missouri.

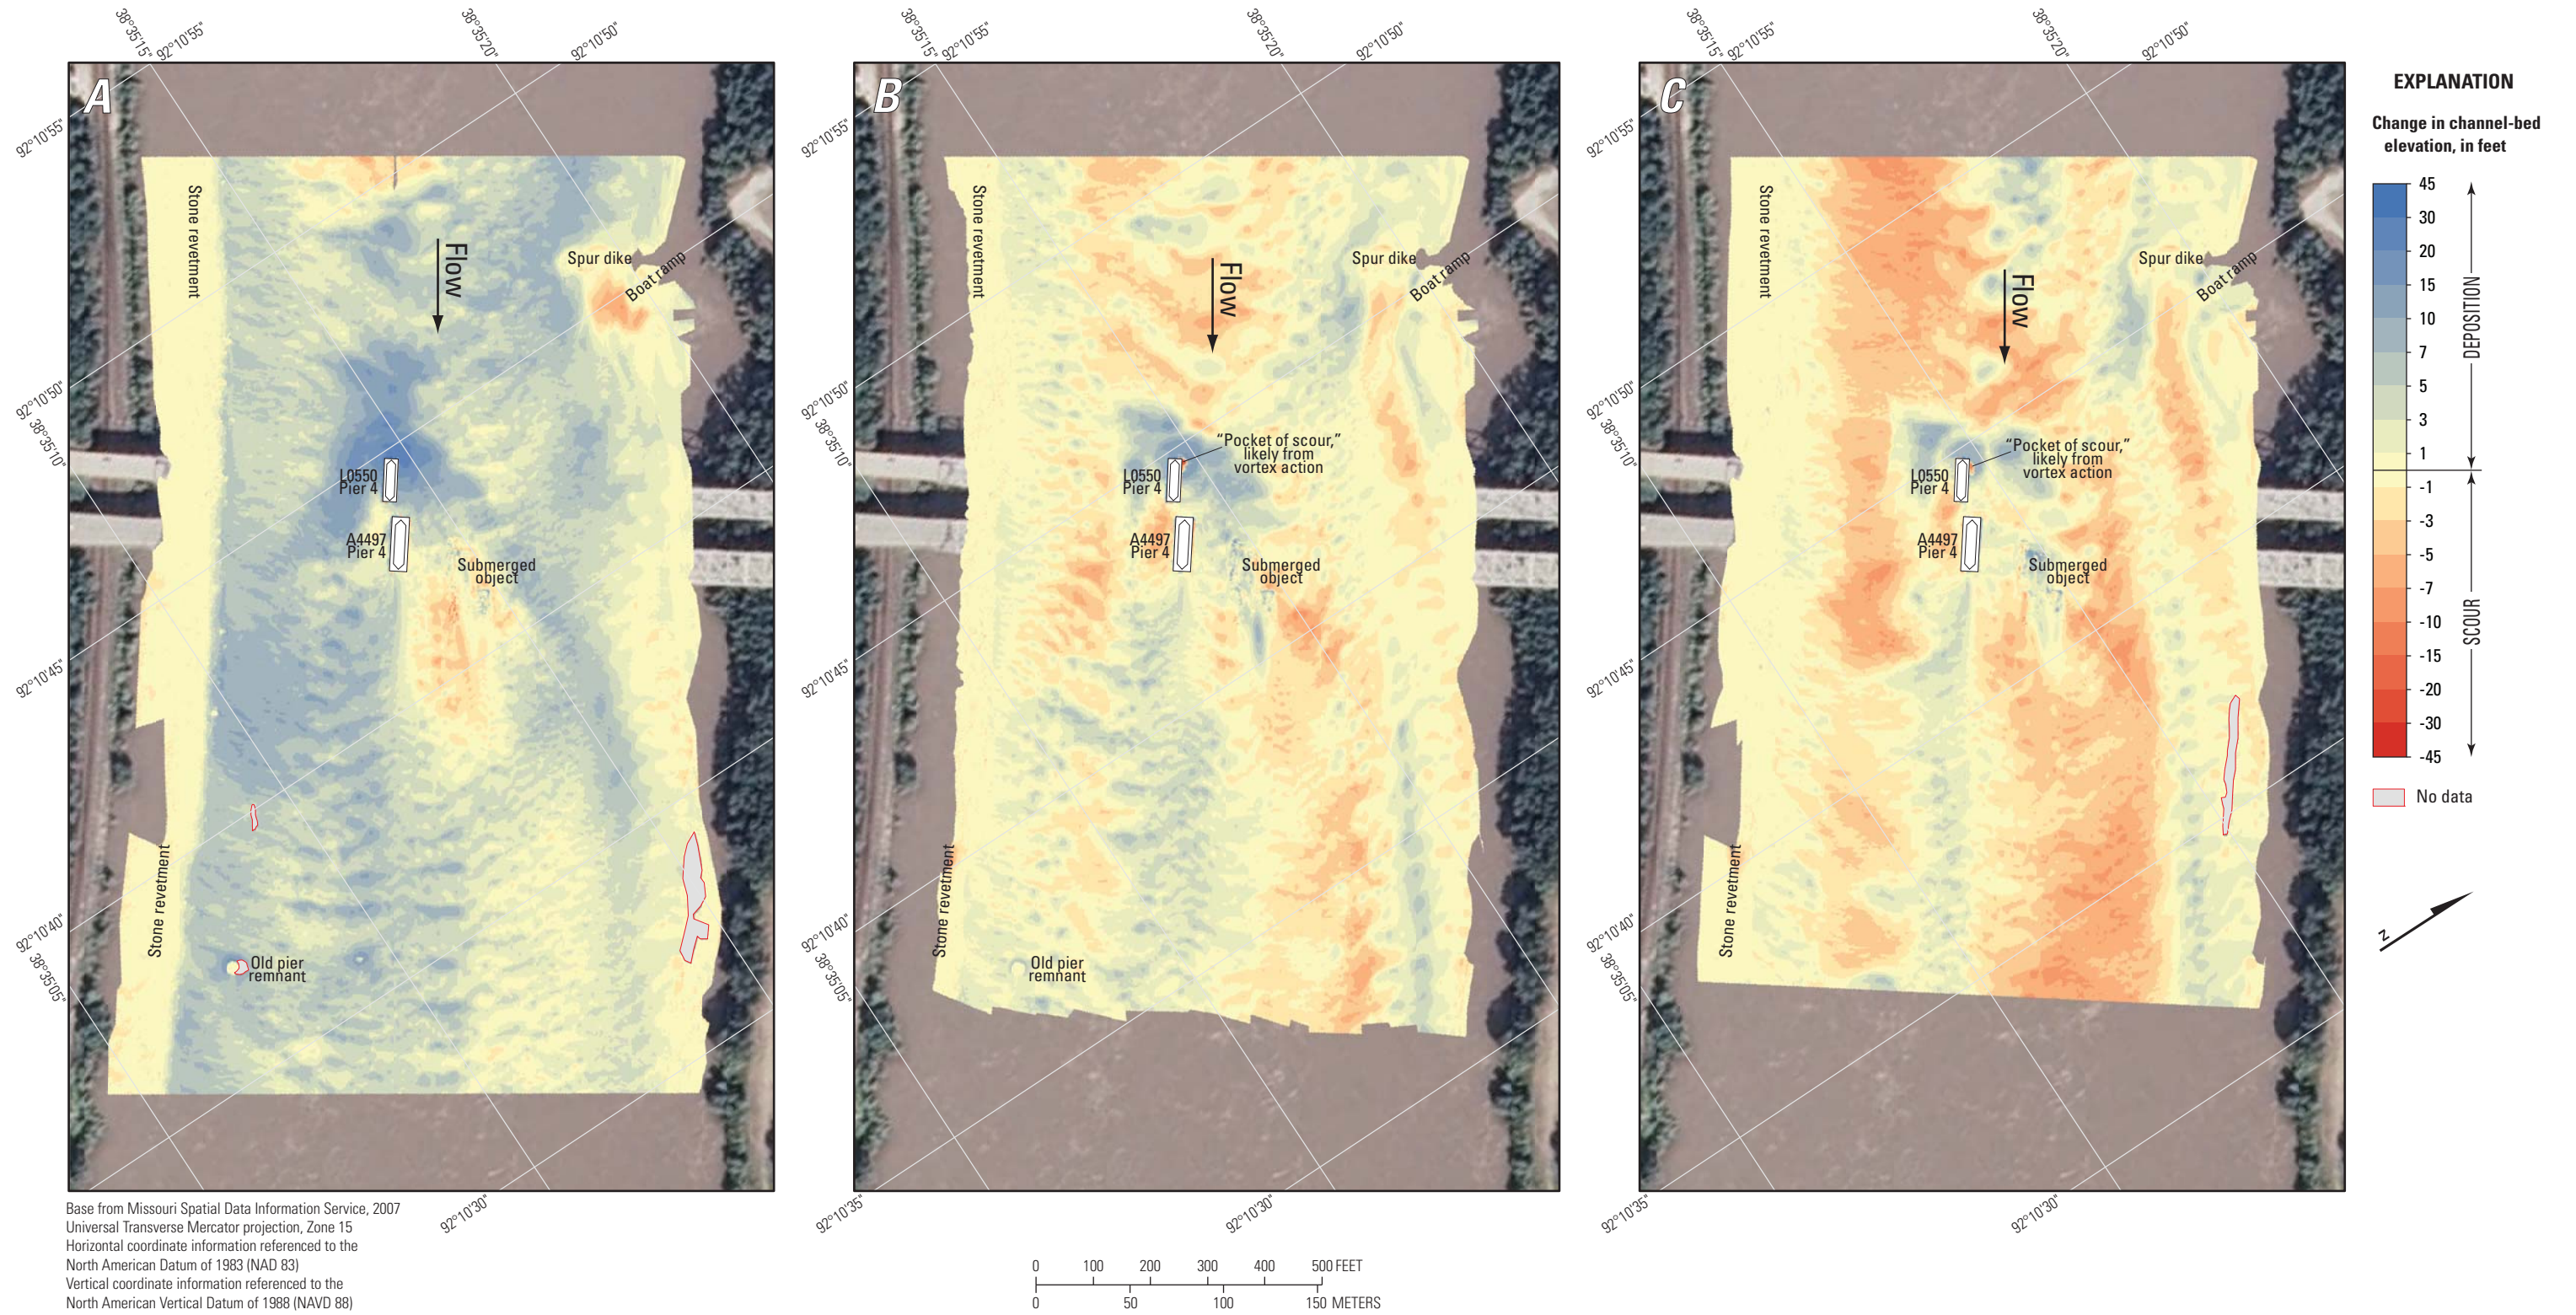
The difference between the surveys on April 30, 2013, and during the spring flooding on March 1, 2011 (fig. 36B), indicates an apparent balance between areas of mild to moderate scour and mild to moderate deposition, whereas the difference between the surveys on April 30, 2013, and January 26, 2010 (fig. 36C), indicates more scour overall, with strips of mild to moderate deposition near and downstream from the piers and along the left bank. The mean difference between the March 2011 and April 2013 bathymetric surfaces (0.21 ft; table 7) indicates minor deposition overall, despite the substantially different flow rates (82,500 ft<sup>3</sup>/s difference; table 7). The mean difference between the January 2010 and April 2013 bathymetric surfaces (-1.23 ft; table 7) indicates moderate scour overall, and is more consistent with the higher flow rate observed in 2010 (92,500 ft<sup>3</sup>/s difference; table 7). In all of the difference maps (fig. 36), the appearance of substantial deposition or scour near the piers results from minor horizontal positional variances between the surveys; however, there was as much as 30 ft of deposition near the upstream pier of upstream structure L0550 between the July 2011 and April 2013 surveys (fig. 36A), and as much as 20 ft of deposition between the March 2011 and January 2010 surveys, and the April 2013 survey (figs. 36B and 36C). A pocket of entrained air or dense suspended sediment was observed on the left side of the upstream end of the upstream pier in the January 2010 and March 2011 surveys (likely caused by vortex action from the blunt nose of the pier). This pocket of air or sediment appears as a pocket of scour in the difference maps (figs. 36B and 36C).

**Figure 36.** Difference between bathymetric surfaces created from surveys of the Missouri River channel in the vicinity of structures L0550 and A4497 on U.S. Highway 54 at Jefferson City, Missouri, on April 20, 2013, and (in reverse chronological order) A, July 27, 2011, B, March 1, 2011, and C, January 26, 2010.

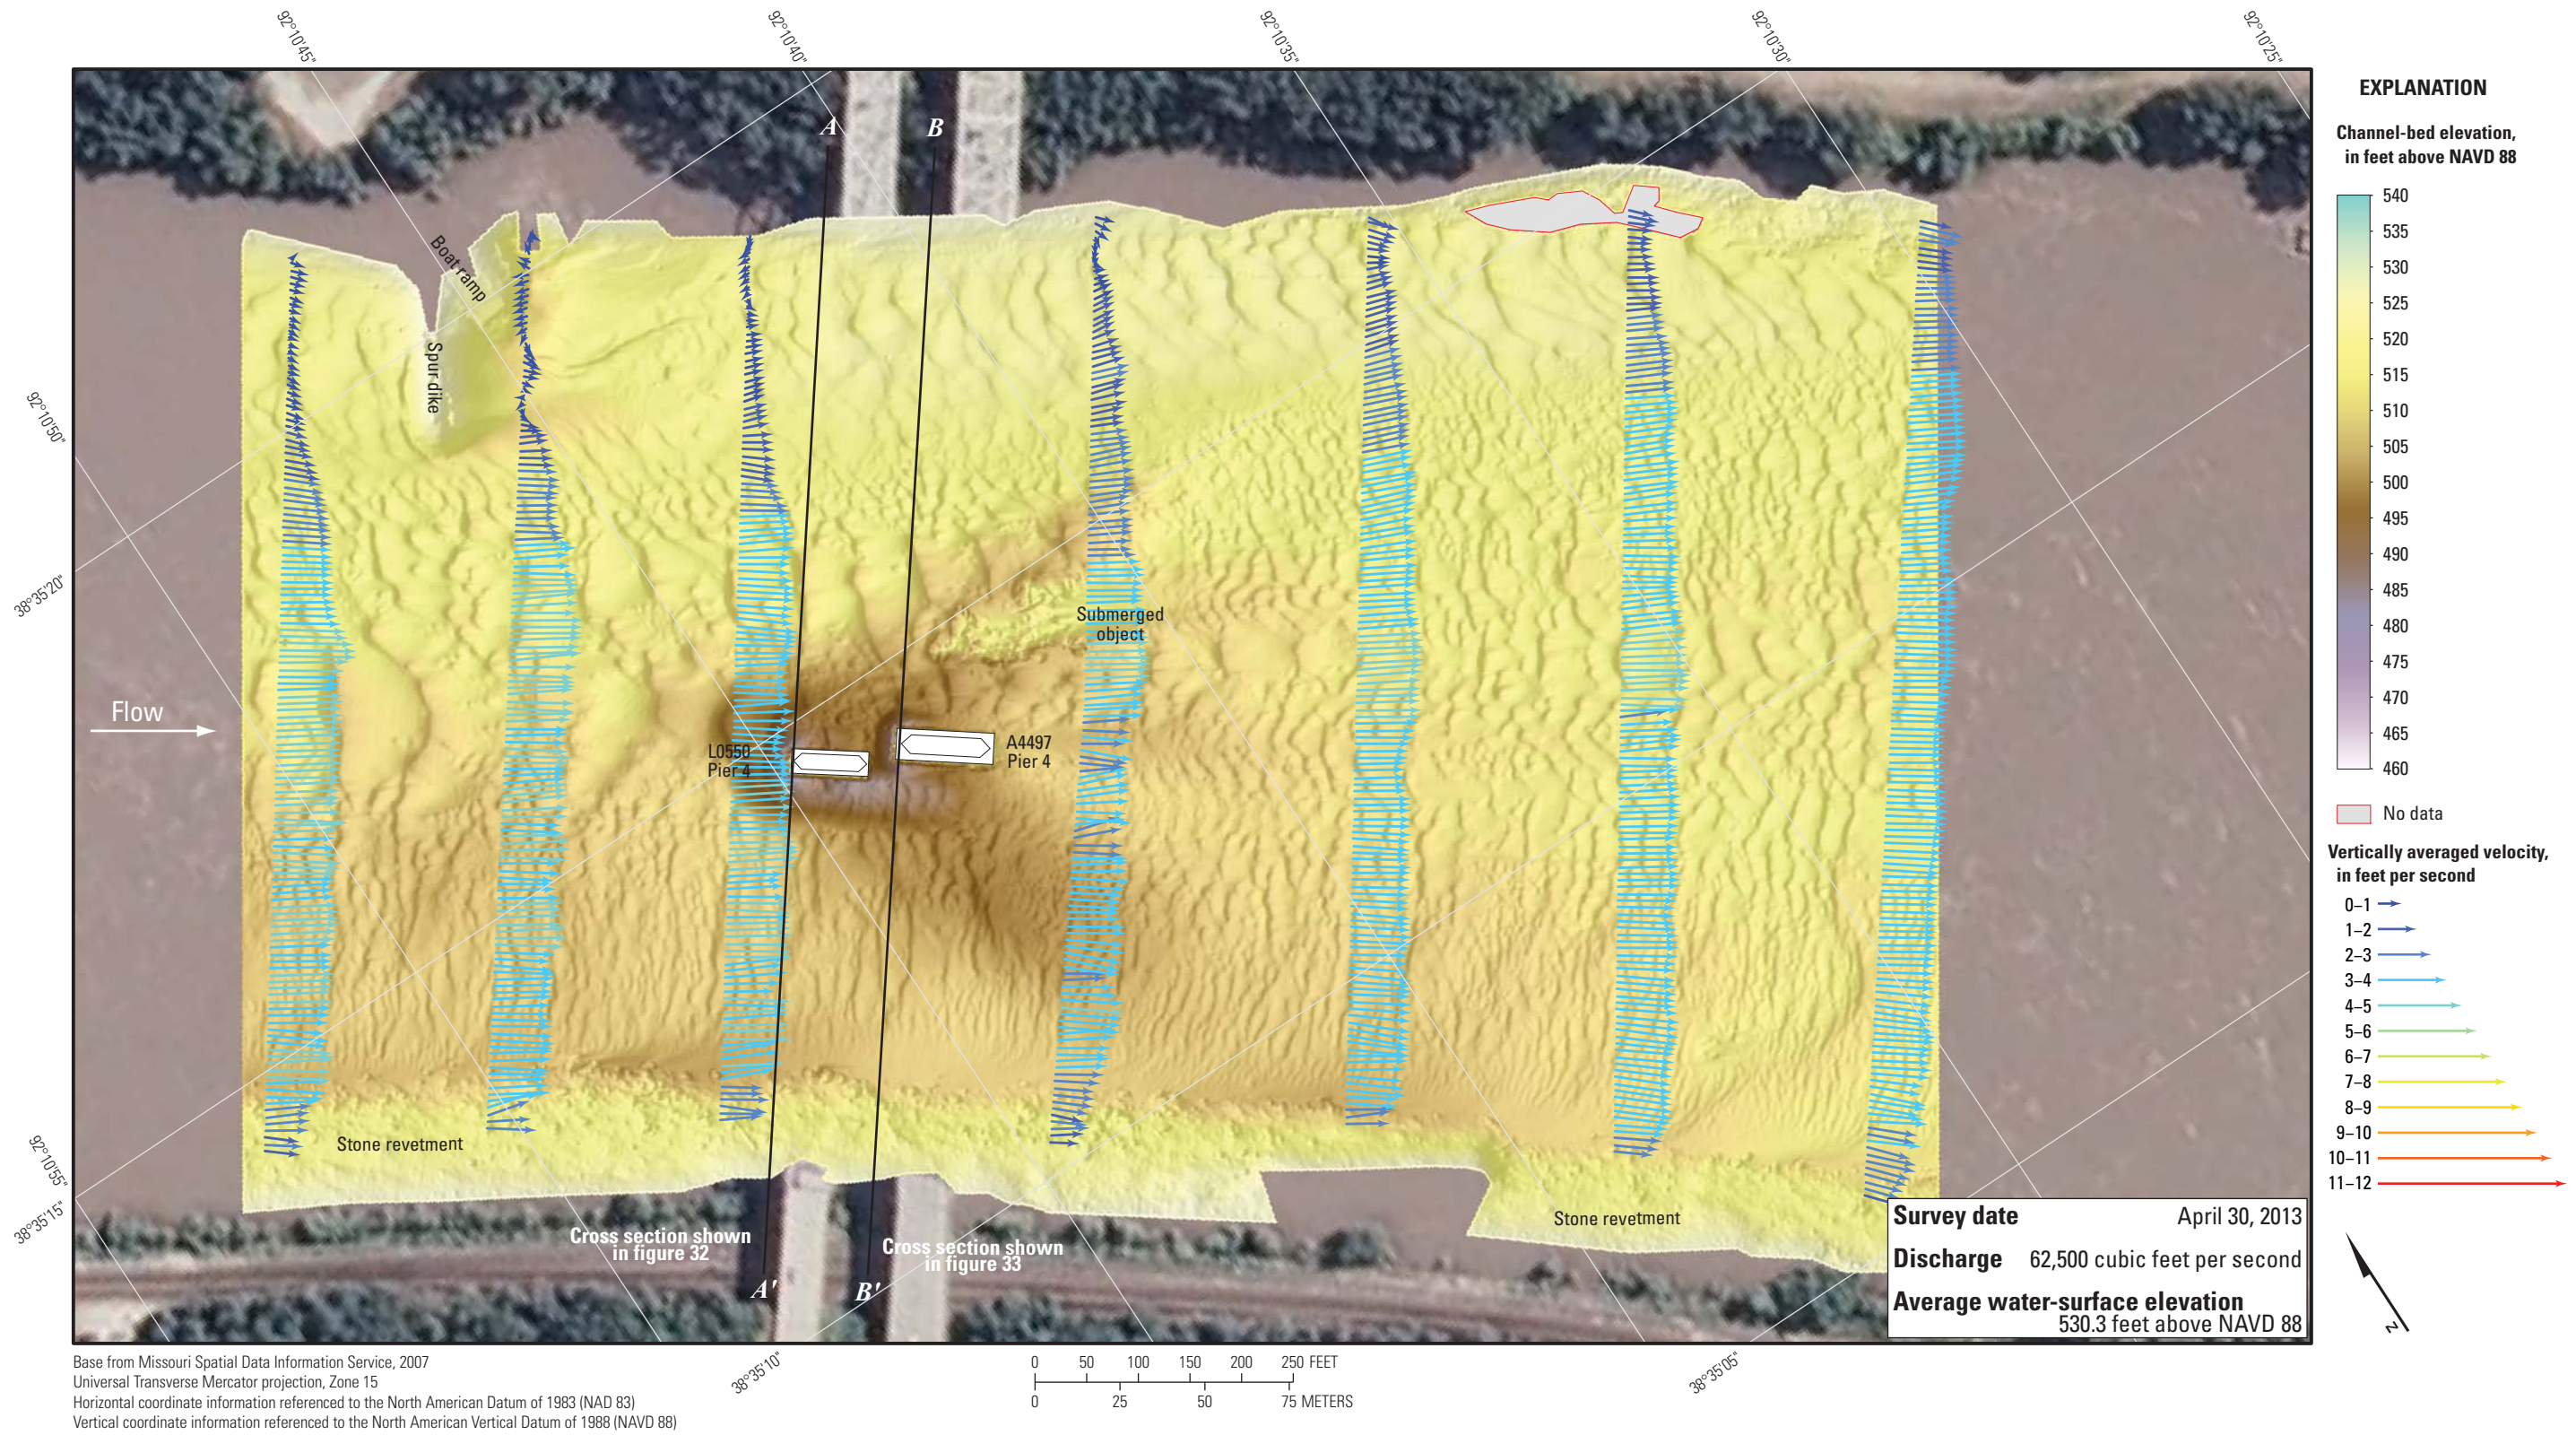
The vertically averaged velocity vectors indicate uniform flow throughout most of the reach, with small areas of turbulence, particularly along the banks and near the spur dike on the upstream left bank (fig. 37). Velocities ranged from about 3 to 6 ft/s for most of the channel (fig. 37), except in the vicinity of the spur dike, where low velocities and flow reversals were observed. The piers of both bridges generally were aligned with flow, but minor turbulence was observed downstream (fig. 37).

Figure 37. Bathymetry and vertically averaged velocities of the Missouri River channel in the vicinity of structures L0550 and A4497 on U.S. Highway 54 at Jefferson City, Missouri.

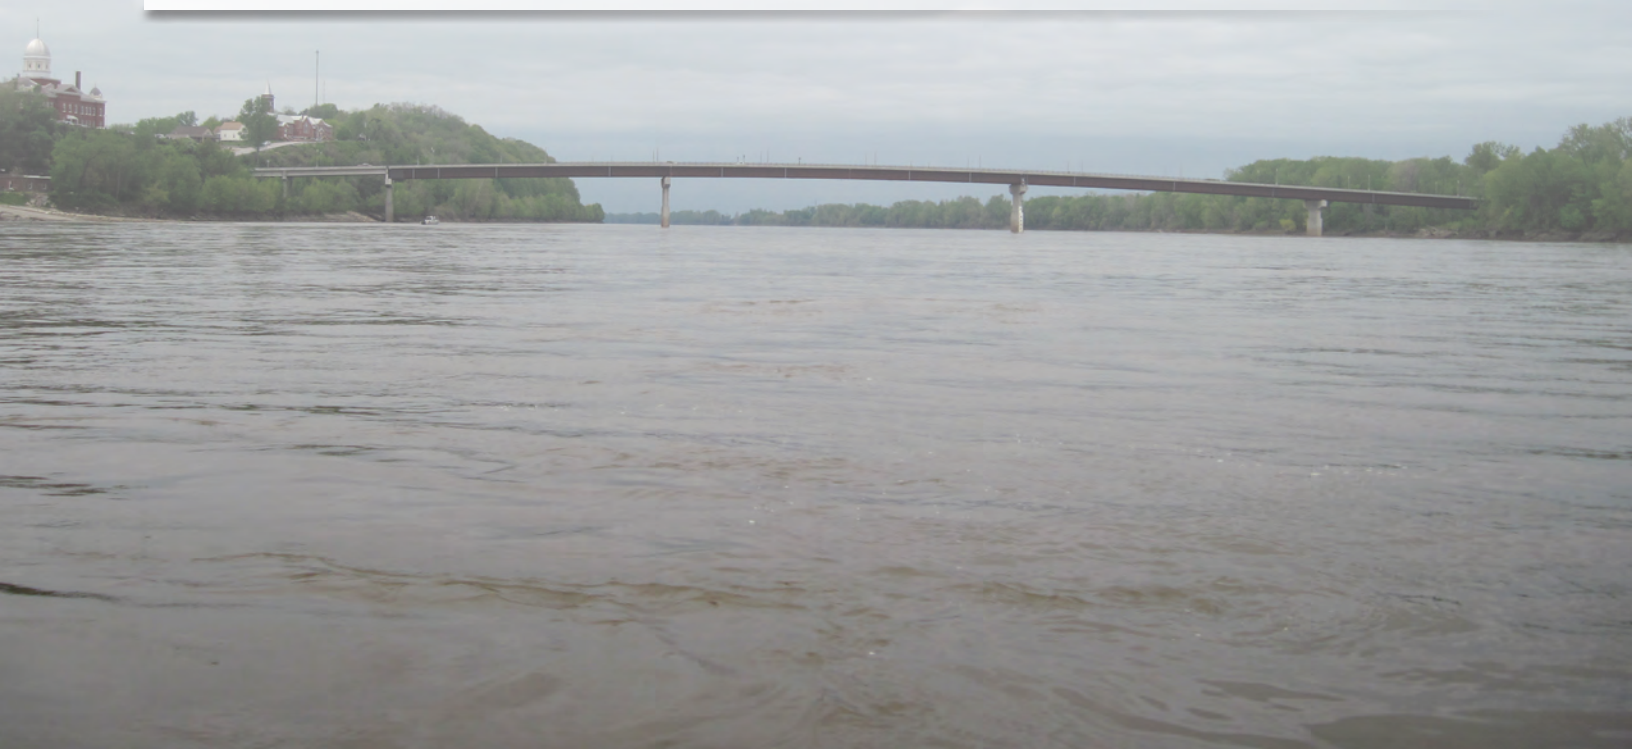
The survey area was about 1,840 ft long and about 1,120 ft wide, generally extending from the longitudinal spur dikes on the left (north) bank to the right (south) bank in the main channel (fig. 38). The upstream end of the survey area was about 690 ft upstream from the centerline of structure A6288 at pier 5 (fig. 38), and piers 4 through 6 were in the water. The channel-bed elevations ranged from about 467 to 481 ft for most of the surveyed area (5 to 95 percentile range of the bathymetric data), except near the upstream toe of the downstream left longitudinal spur dike that had a local minimum channel-bed elevation of 458 ft (fig. 38; table 2). A poorly defined thalweg was present along the left bank, and numerous small dunes and ripples were present throughout the channel (fig. 38). The part of the channel bed between the longitudinal spur dikes on the upstream left bank was surveyed using the tilted head configuration of the MBES (fig. 38); however, a shallow area behind the longitudinal spur dike prevented surveying near pier 6 (fig. 38).

Minor scour holes were observed near both of the piers in the main channel (fig. 38). The minor scour hole near pier 5 had a minimum channel-bed elevation of about 468 ft

Figure 38. Bathymetric survey of the Missouri River channel in the vicinity of structure A6288 on State Highway 19 at Hermann, Missouri.

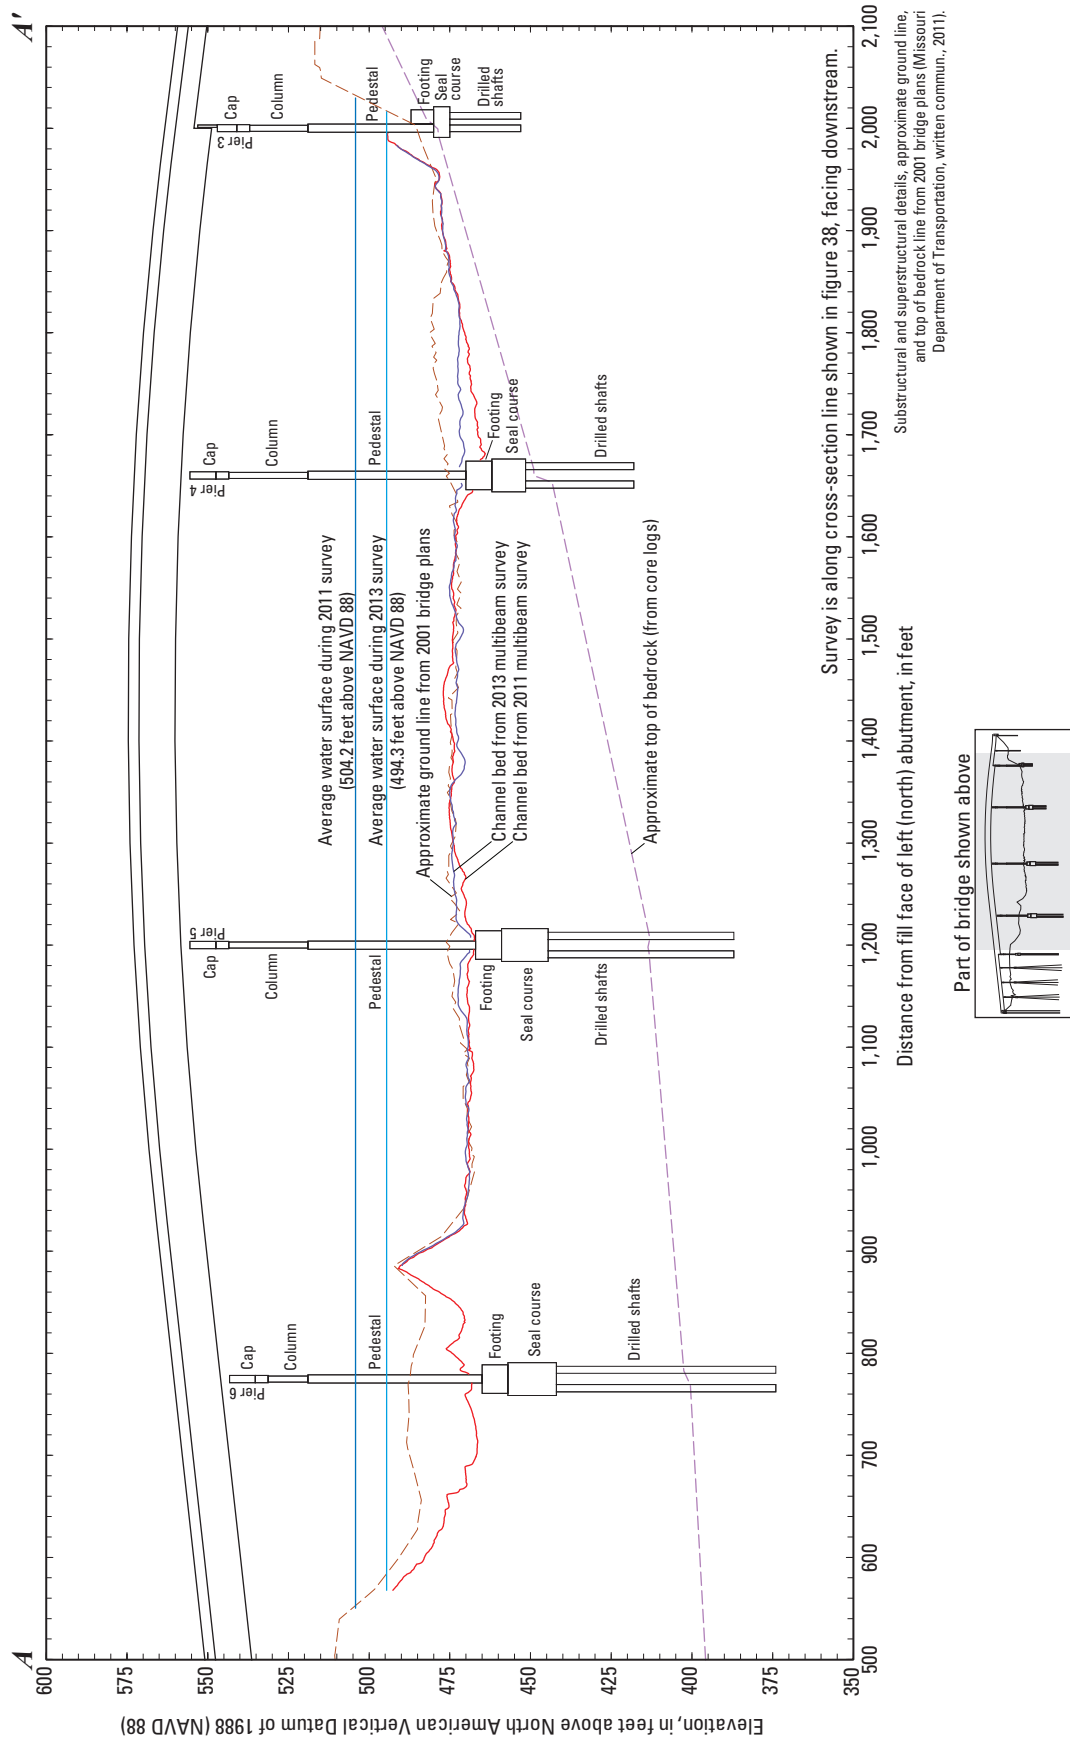
(table 6), which is about 24 ft above the elevation of the bottom of the pier seal course of 444.50 ft (fig. 39; table 6). The minor scour hole near pier 4 had a minimum channel-bed elevation of about 469 ft (table 6), which is about 18 ft above the elevation of the bottom of the pier seal course of 451.50 ft (fig. 39; table 6). Both scour holes were difficult to discern from nearby dunes and ripples. Information from bridge plans indicates that piers 4 and 5 are founded on shafts drilled as much as 26 ft into bedrock, having about 54 ft of bed material between the bottom of the scour hole and bedrock at pier 5, and about 26 ft of material at pier 4 (fig. 39; table 6). The surveyed bed generally was similar to the previous multibeam survey in 2011, which was similar to the original ground line in 2001 from bridge plans (fig. 39).

**Figure 39.** Key features, substructural and superstructural details, and surveyed channel bed of structure A6288 on State Highway 19 over the Missouri River at Hermann, Missouri.
