# Bathymetric and Velocimetric Surveys at Highway Bridges Crossing the Missouri River between Kansas City and St. Louis, Missouri, April–May 2013

By Richard J. Huizinga

Scientific Investigations Report 2014–5116

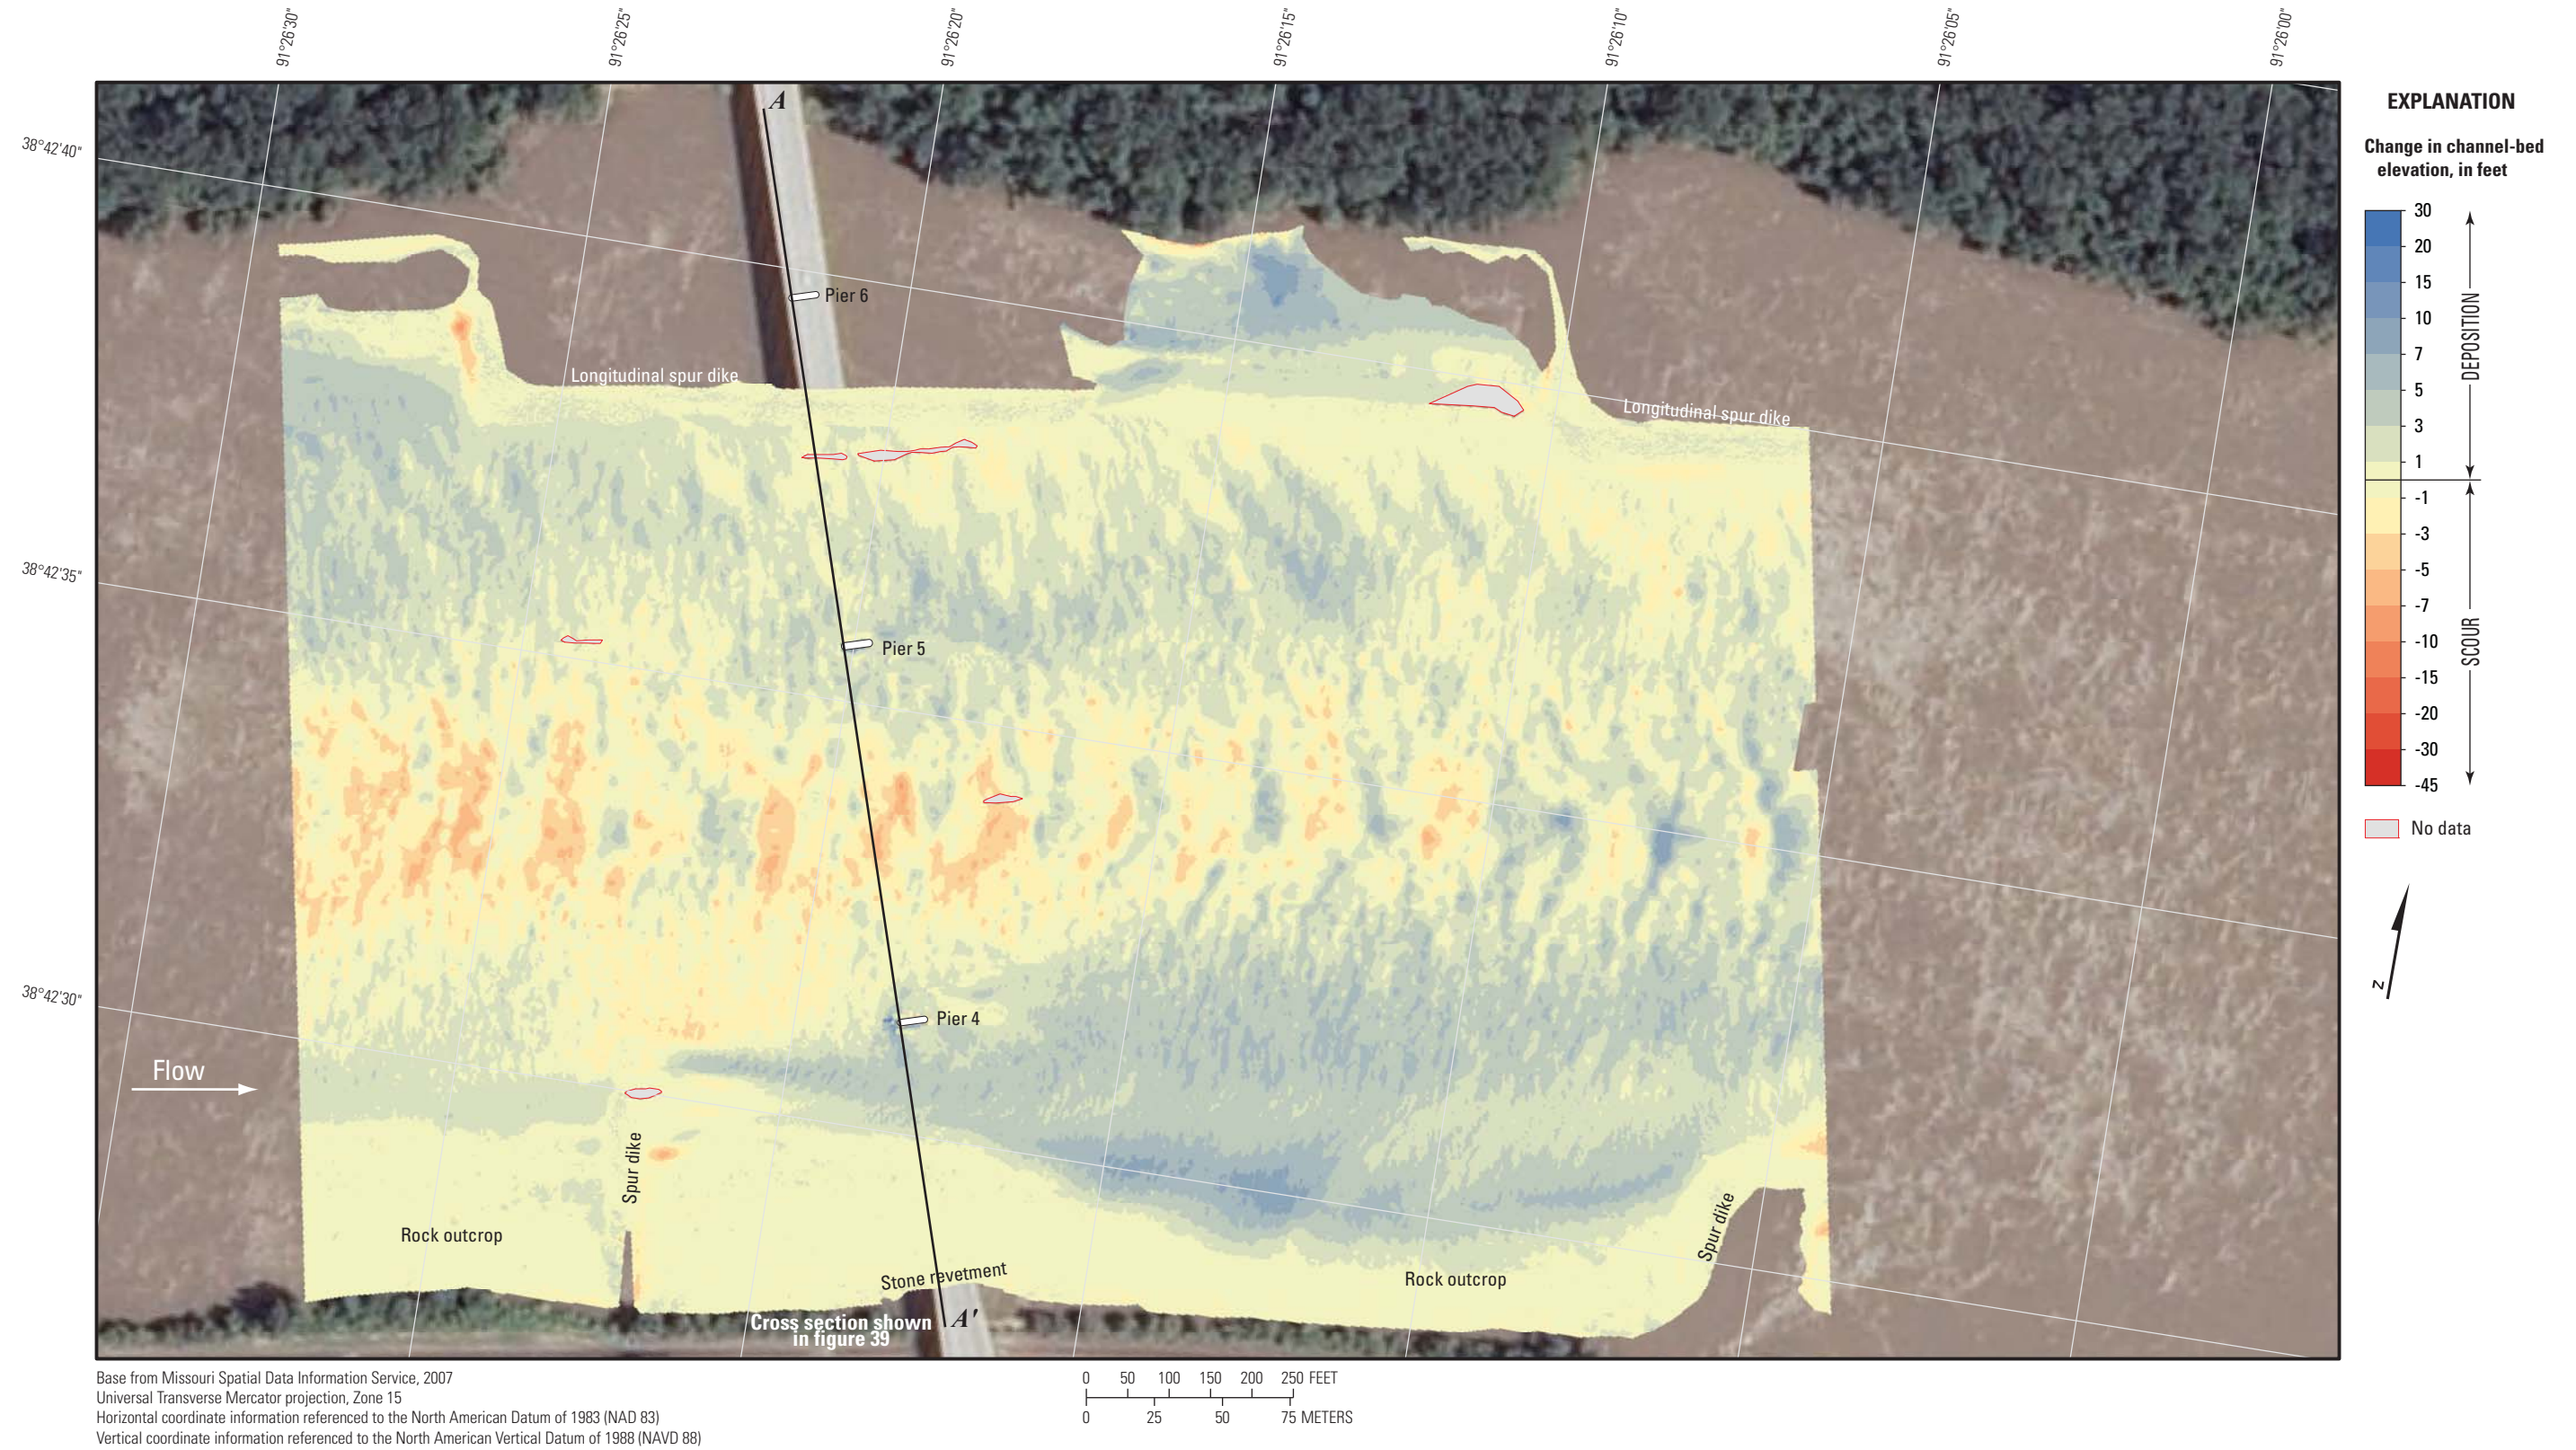
The difference between the surveys on May 2, 2013, and July 28, 2011 (fig. 40), indicates minor deposition throughout the channel. Moderate deposition of as much as 10 ft has occurred throughout much of the channel, except for scour at the upstream face of the upstream left longitudinal spur dike, and the series of alternating scour and deposition patches along the middle of the channel from the series of medium and large dunes in the July 2011 survey (fig. 40). The mean difference between the July 2011 and May 2013 bathymetric surfaces (1.18 ft; table 7) indicates minor to moderate deposition overall.

Figure 40. Difference between bathymetric surfaces created from surveys of the Missouri River channel in the vicinity of structure A6288 on State Highway 19 at Hermann, Missouri, on May 2, 2013, and July 28, 2011.

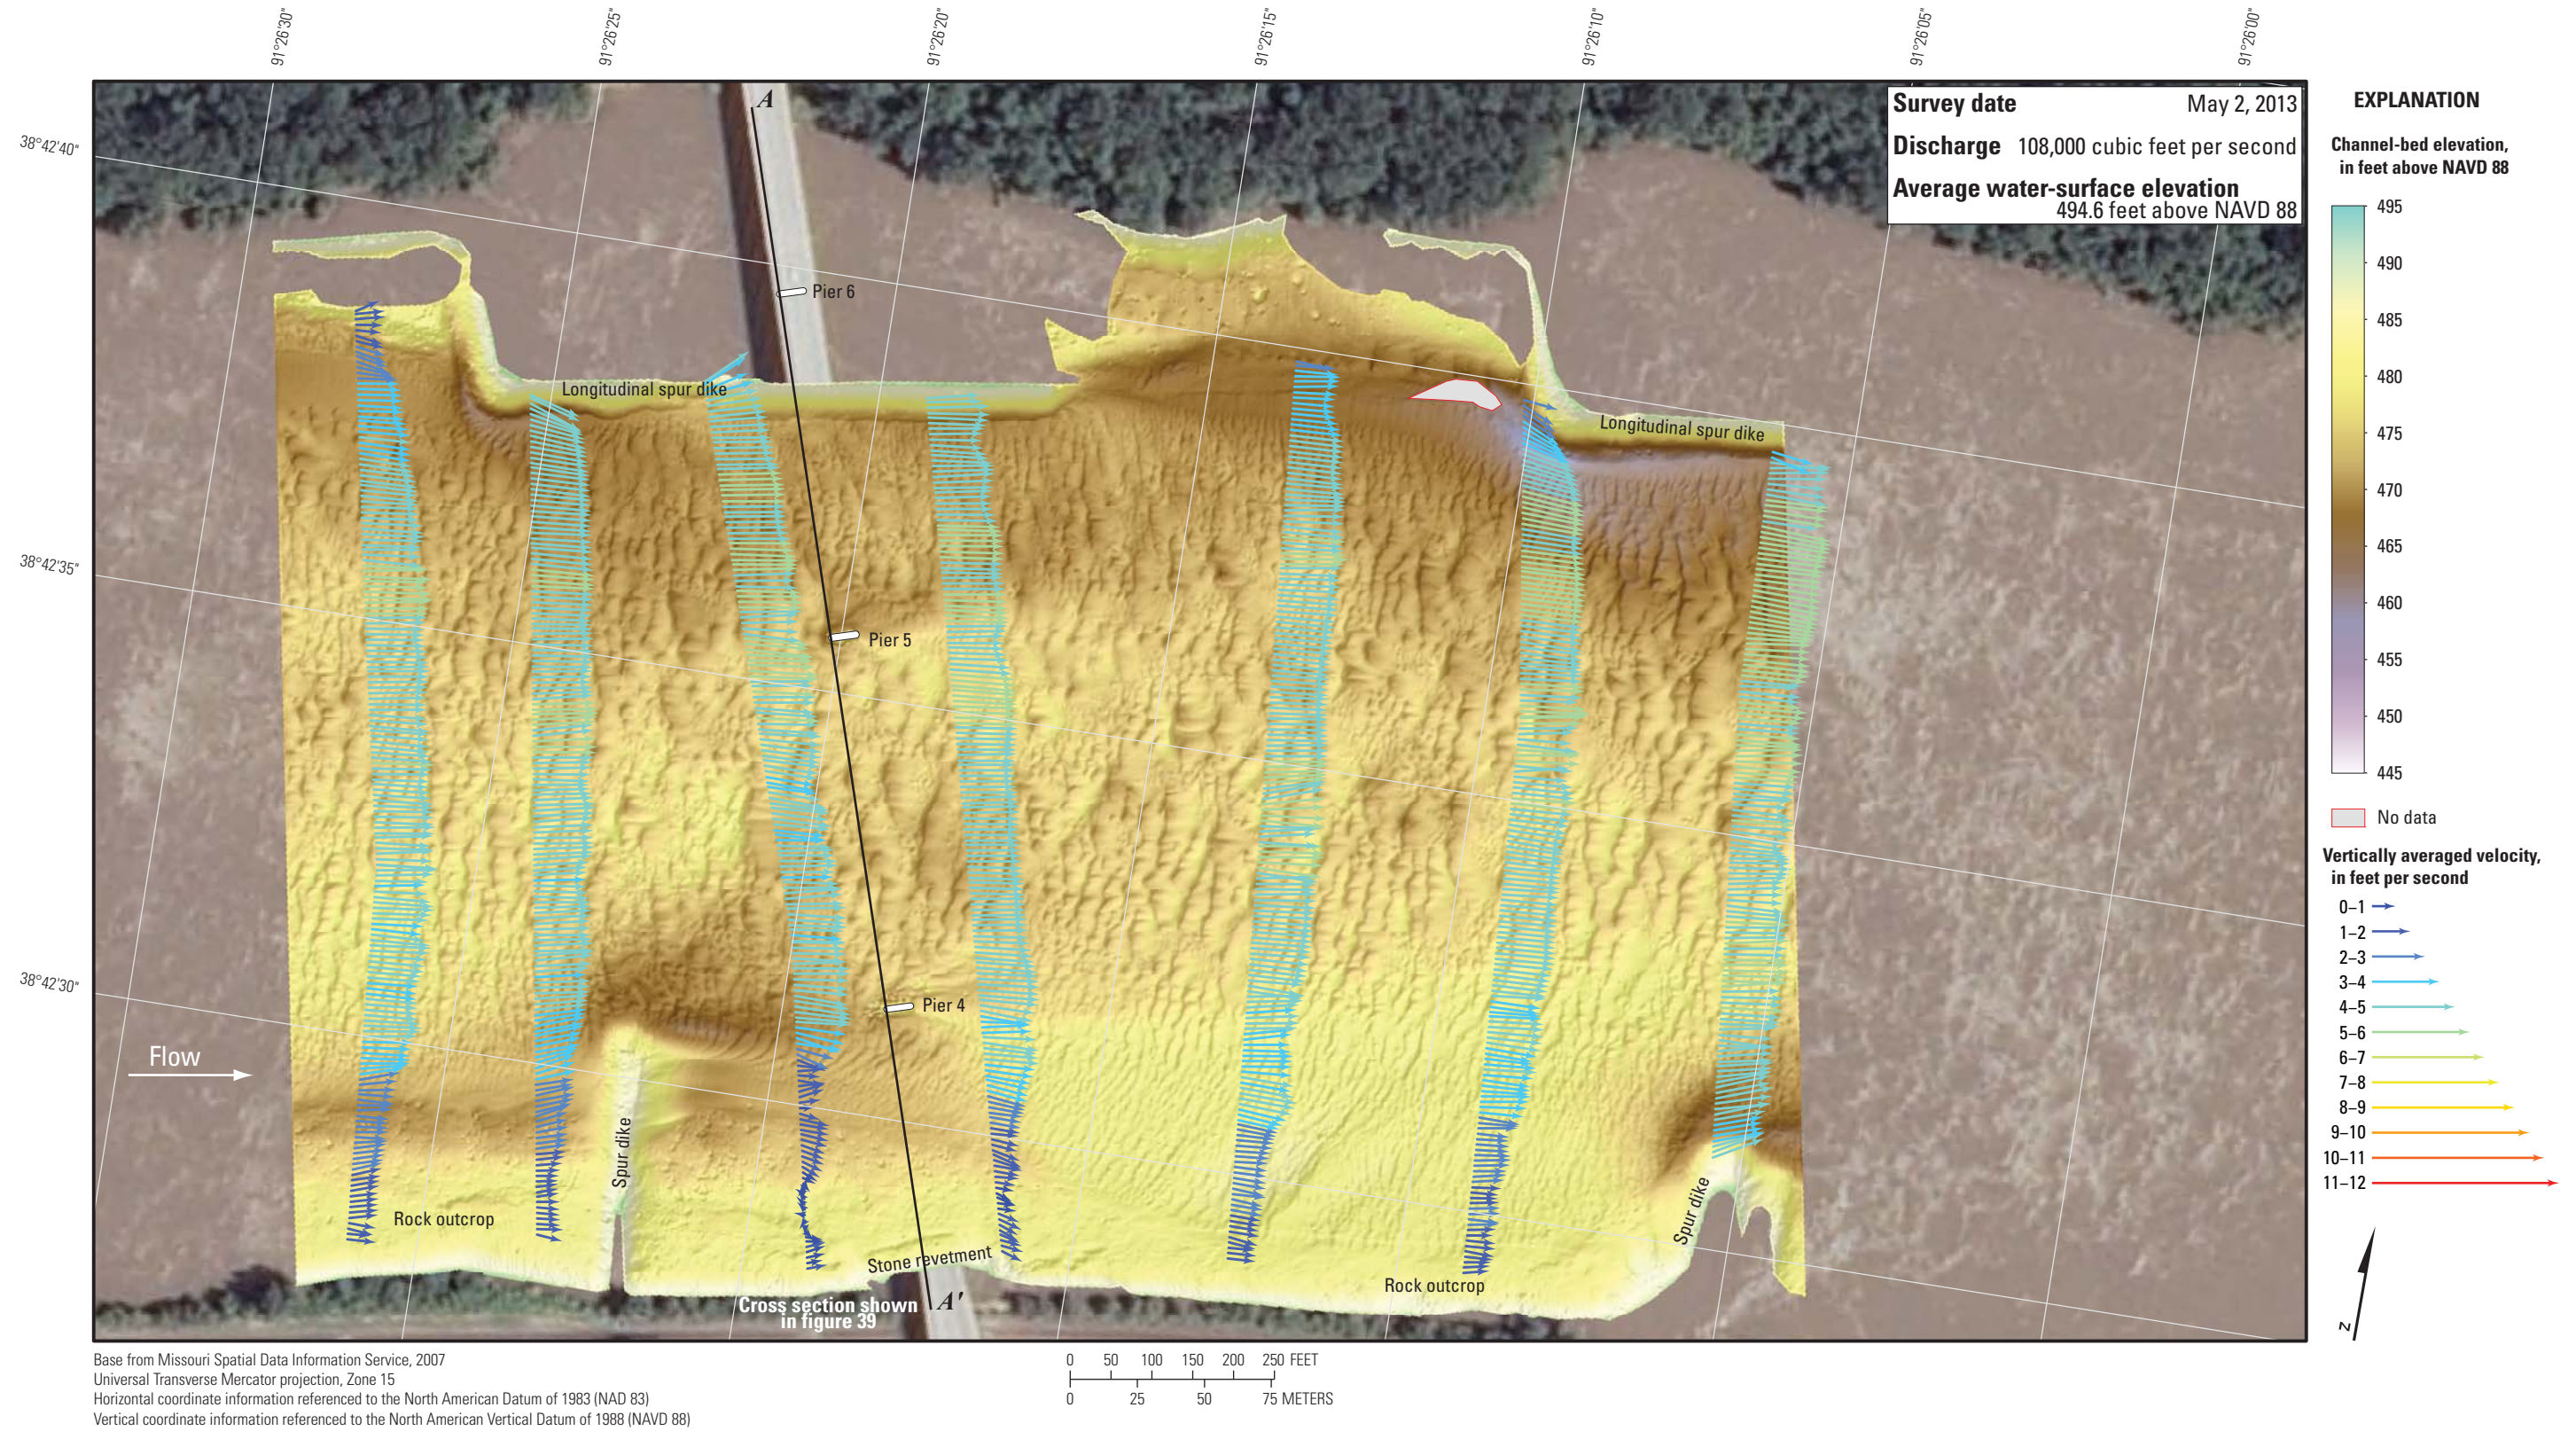
The vertically averaged velocity vectors indicate mostly uniform flow throughout the middle of the channel, ranging from about 4 to 6 ft/s (fig. 41). Moderate turbulence was observed along the right side of the channel and upstream from the upstream left longitudinal spur dike (fig. 41). The bridge piers were skewed to flow, but caused only minor turbulence downstream (fig. 41).

Figure 41. Bathymetry and vertically averaged velocities of the Missouri River channel in the vicinity of structure A6288 on State Highway 19 at Hermann, Missouri.

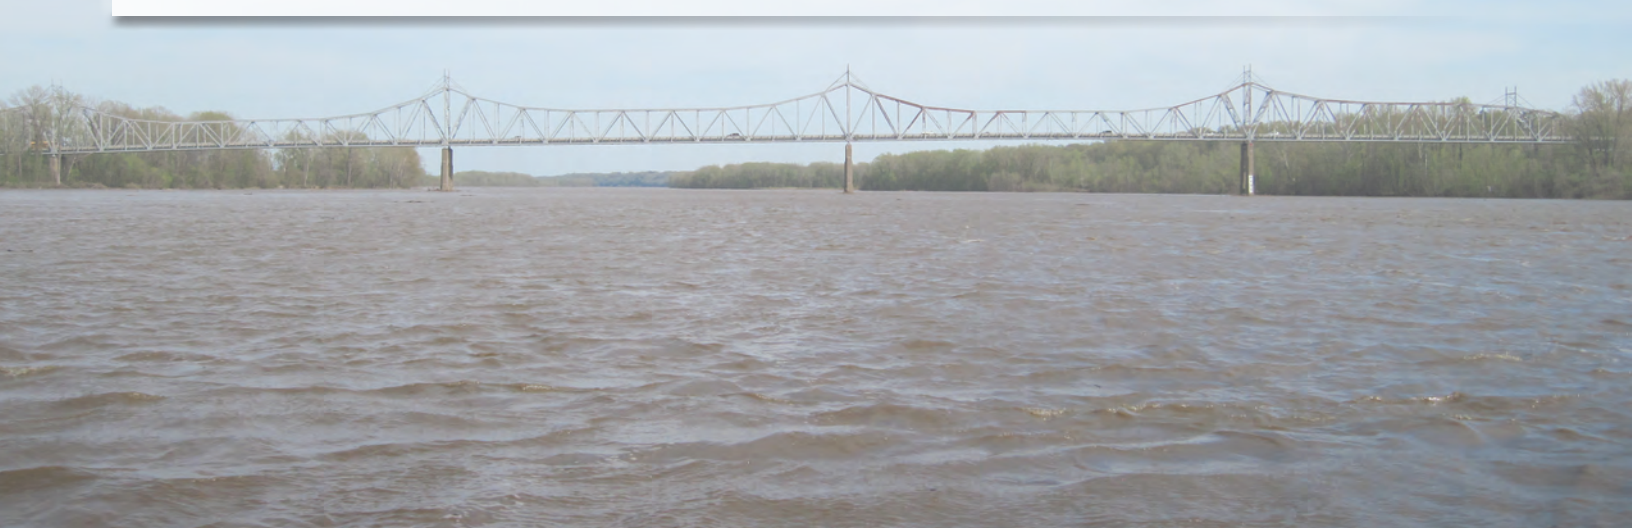
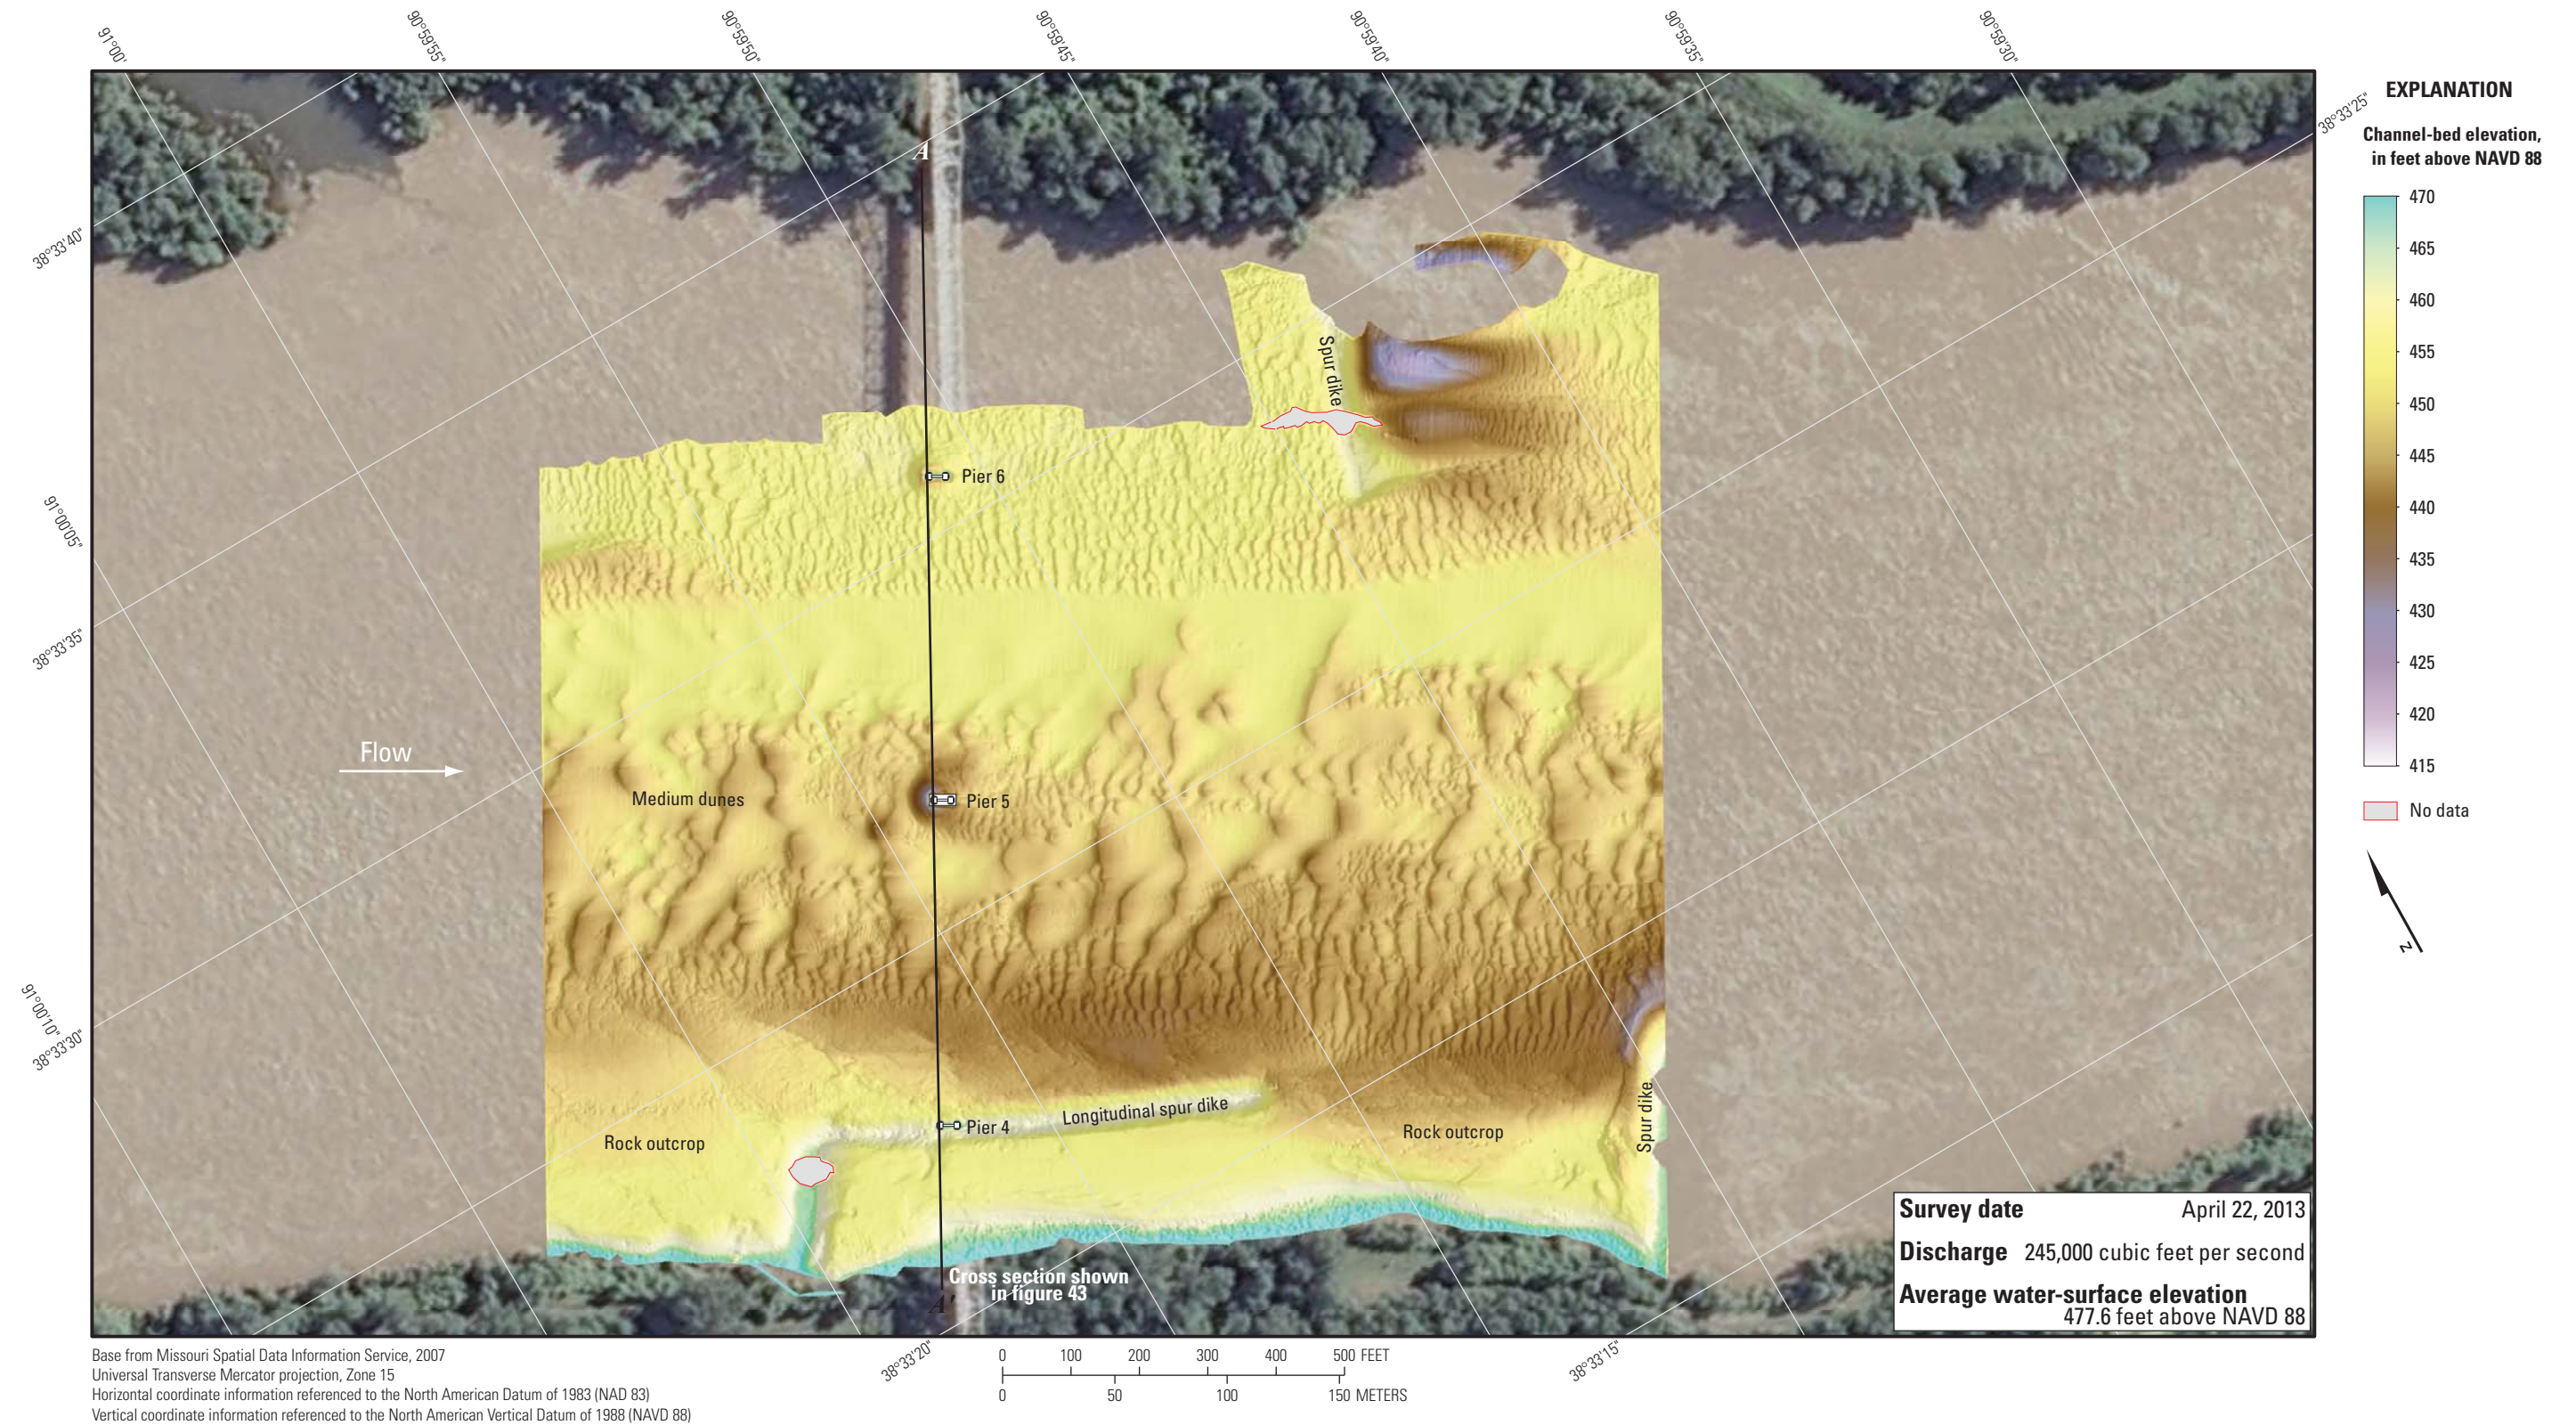
The survey area was about 1,640 ft long and about 1,250 ft wide for most of the area, extending from about 250 ft to the right of the left (north) bank to the right (south) bank; an attempt was made to survey along the left bank, but substantial amounts of floating debris prevented this except for the downstream one-third of the survey area (fig. 42). The upstream end of the survey area was about 570 ft upstream from the centerline of structure K0969 (fig. 42), and piers 4 through 6 were in the water. The channel-bed elevations ranged from about 440 to 457 ft for most of the surveyed area (5 to 95 percentile range of the bathymetric data), except in the scour hole at pier 5 and downstream from the downstream left (north) spur dike that had a local minimum channel-bed elevation of about 427 ft (fig. 42). A thalweg was present along the right (south) bank and deepened in a downstream direction throughout the reach (fig. 42). A series of medium dunes were present in the middle of the channel, and numerous small dunes and ripples were present throughout the rest of the channel (fig. 42). An unusual, nearly planar area was present between piers 5 and 6 (fig. 42).

Scour holes were observed near piers 5 and 6 (fig. 42). There was a substantial scour hole in the vicinity of main channel pier 5 (fig. 42), having a minimum channel-bed elevation of about 429 ft (table 6), which is about 15 ft below the average channel-bed elevation upstream from the pier (fig. 43; table 6). The moderate scour hole near pier 6 (fig. 42) had a minimum channel-bed elevation of about 444 ft (table 6),

Figure 42. Bathymetric survey of the Missouri River channel in the vicinity of structure K0969 on State Highway 47 at Washington, Missouri.

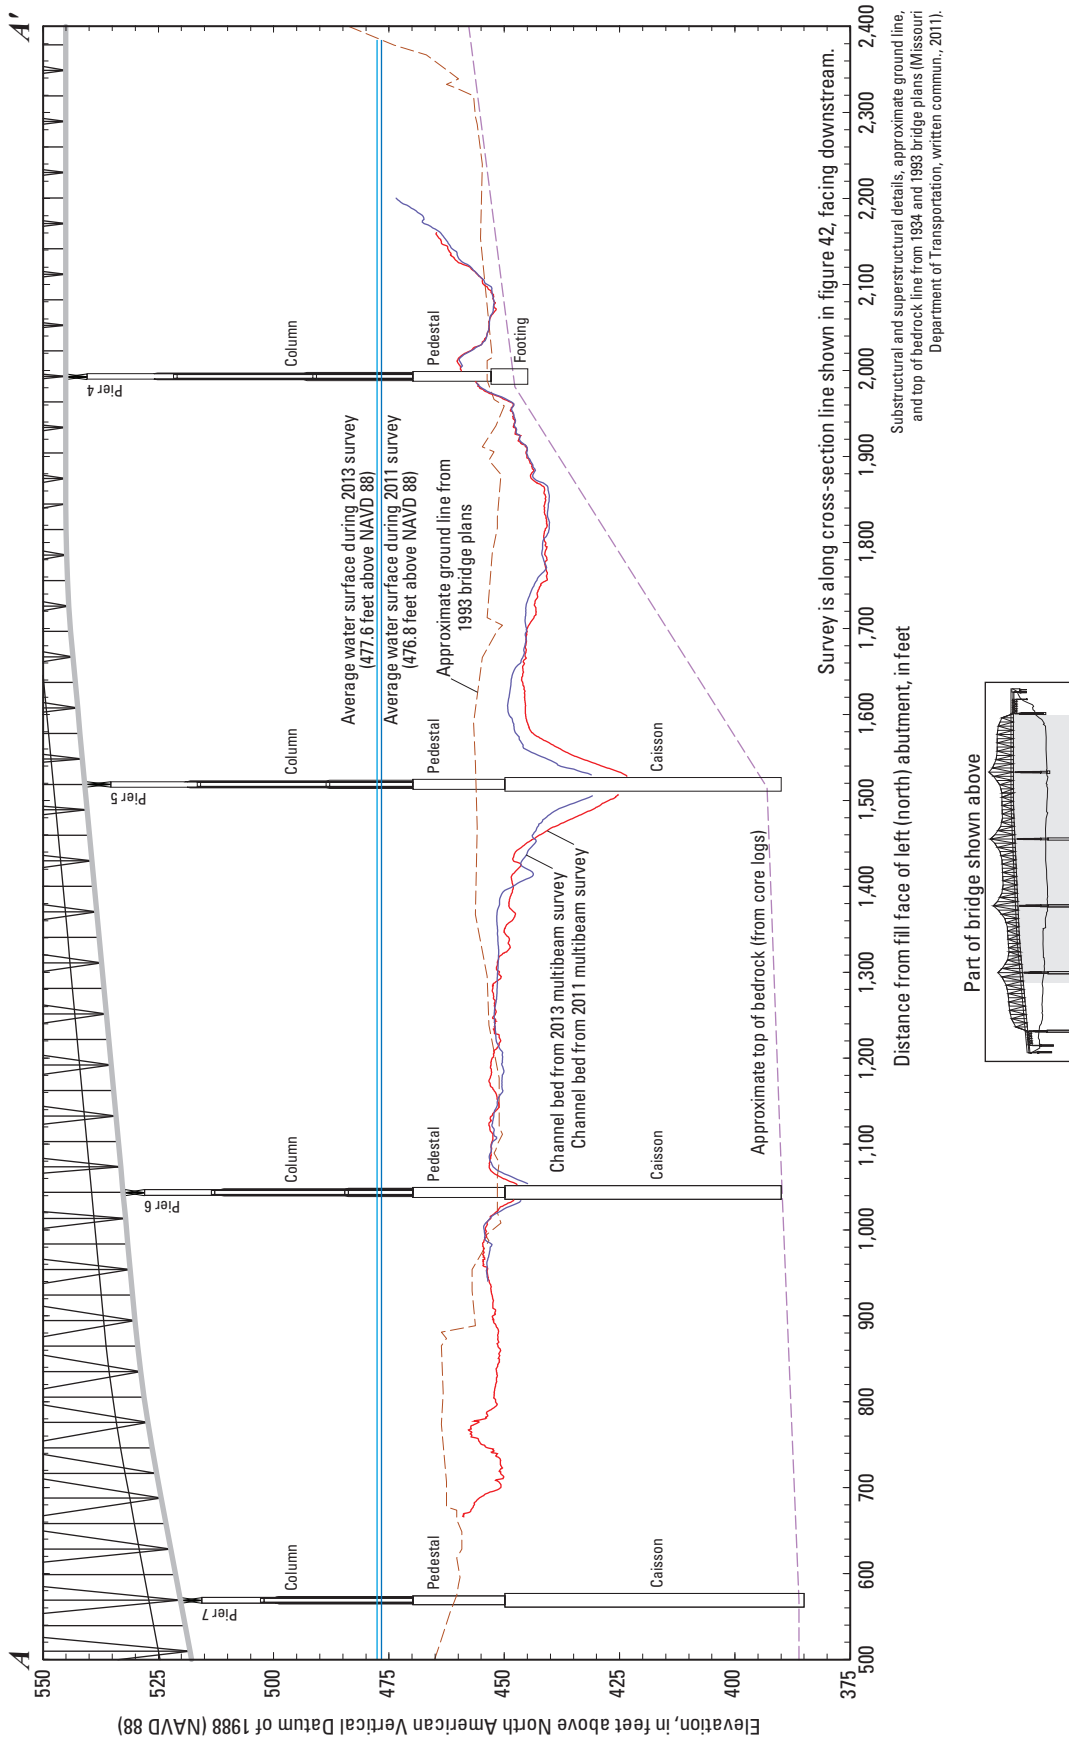
which is about 12 ft below the average channel-bed elevation upstream from the pier (fig. 43; table 6). Information from bridge plans indicates that piers 5 and 6 are founded on caissons on bedrock, having about 54 ft of bed material between the bottom of the scour hole and bedrock at pier 6, and about 36 ft of material at pier 5 (fig. 43; table 6). Pier 4 was embedded in the longitudinal spur dike, and the minimum channel elevation at the toe of the dike was about 448 ft (figs. 42 and 43; table 6). Pier 4 is founded on a footing on bedrock, and bedrock was exposed at the toe of the spur dike (fig. 43; table 6); however, the rock of the spur dike likely will limit or prevent a local scour hole near pier 4. The surveyed bed generally was similar to the previous multibeam survey in July 2011, except near pier 5 where there was 5 to 10 ft of deposition (fig. 43) that caused the scour hole near that pier to be smaller and shallower in 2013 than in 2011.

Figure 43. Key features, substructural and superstructural details, and surveyed channel bed of structure K0969 on State Highway 47 over the Missouri River at Washington, Missouri.

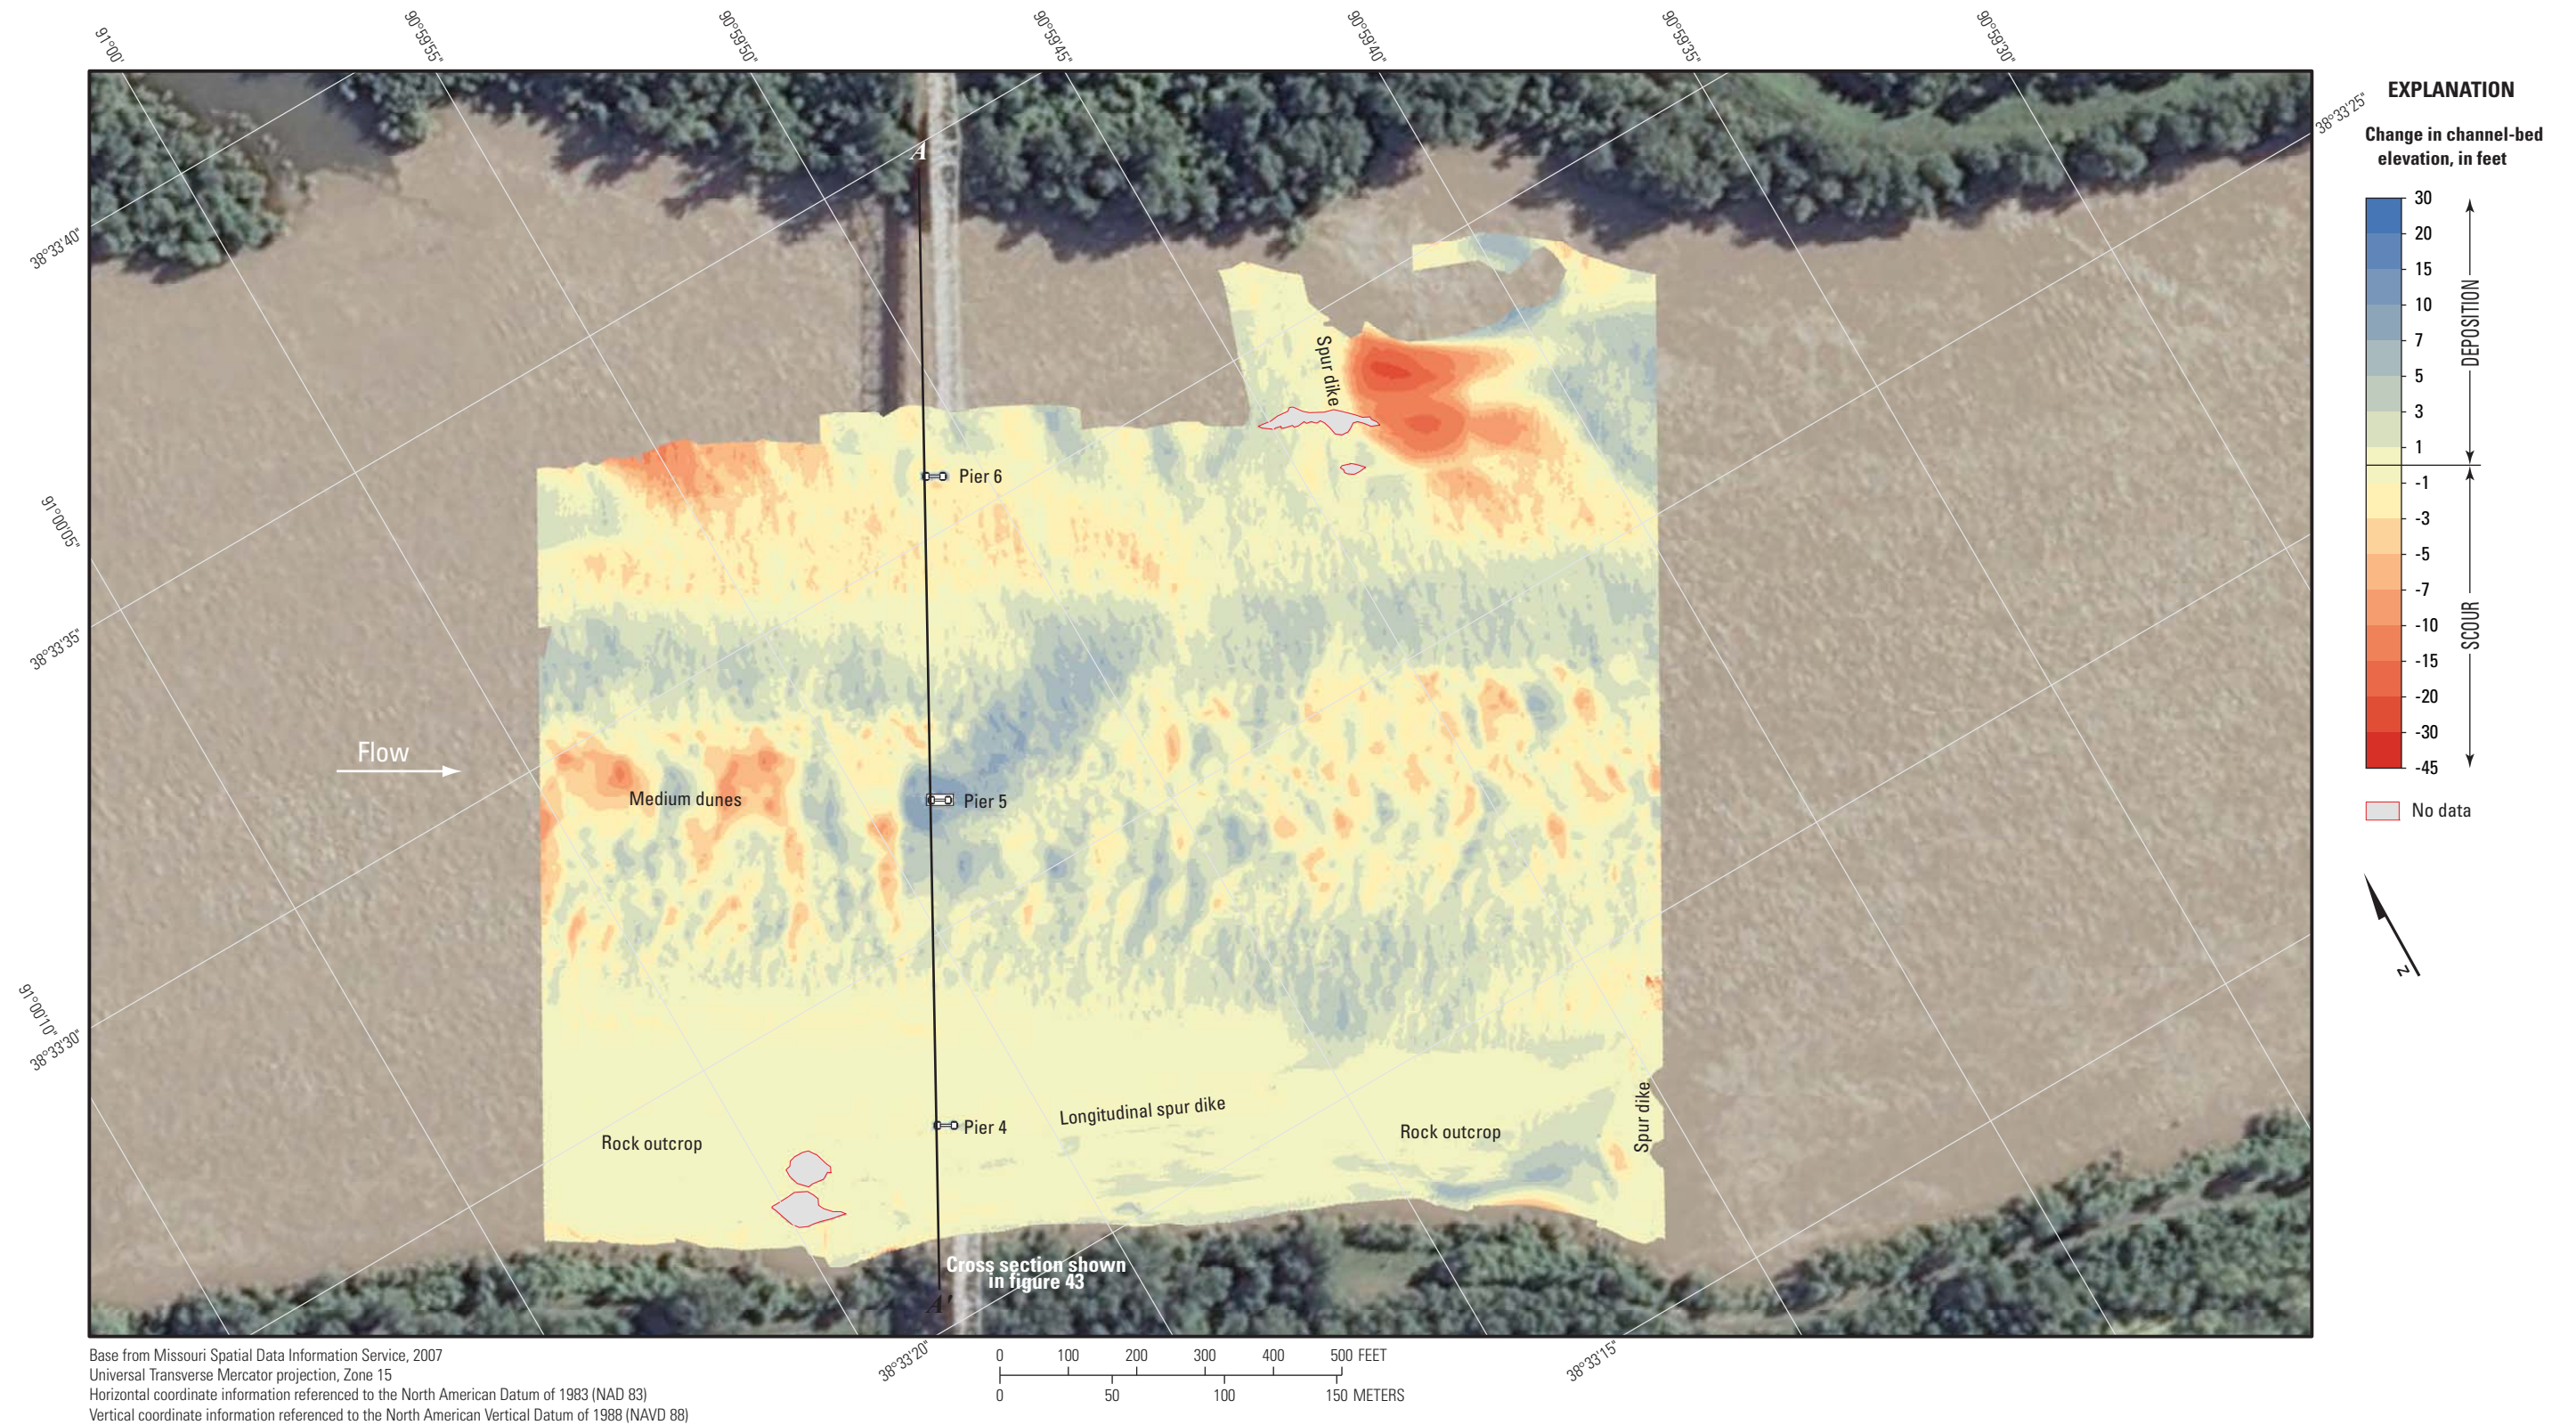
The difference between the surveys on April 22, 2013, and July 27, 2011 (fig. 44), indicates a rough balance between scour and deposition throughout the channel. Moderate to substantial scour of as much as 20 ft has occurred downstream from the spur dike on the left bank and on the left side of the channel near the upstream end of the reach, whereas moderate deposition of as much as 15 ft has occurred in the middle of the channel and near pier 5 (fig. 44). The mean difference between the July 2011 and April 2013 bathymetric surfaces (0.15 ft; table 7) indicates essentially no net change overall, as evident in the difference map (fig. 44). The series of medium dunes evident in the July 2011 survey is indicated by a series of alternating scour and deposition patches upstream from pier 5 (fig. 44). Minor deposition was observed on the rock outcrop between the right (south) longitudinal spur dike and the right bank and downstream (fig. 44).

Figure 44. Difference between bathymetric surfaces created from surveys of the Missouri River channel in the vicinity of structure K0969 on State Highway 47 at Washington, Missouri, on April 22, 2013, and July 27, 2011.

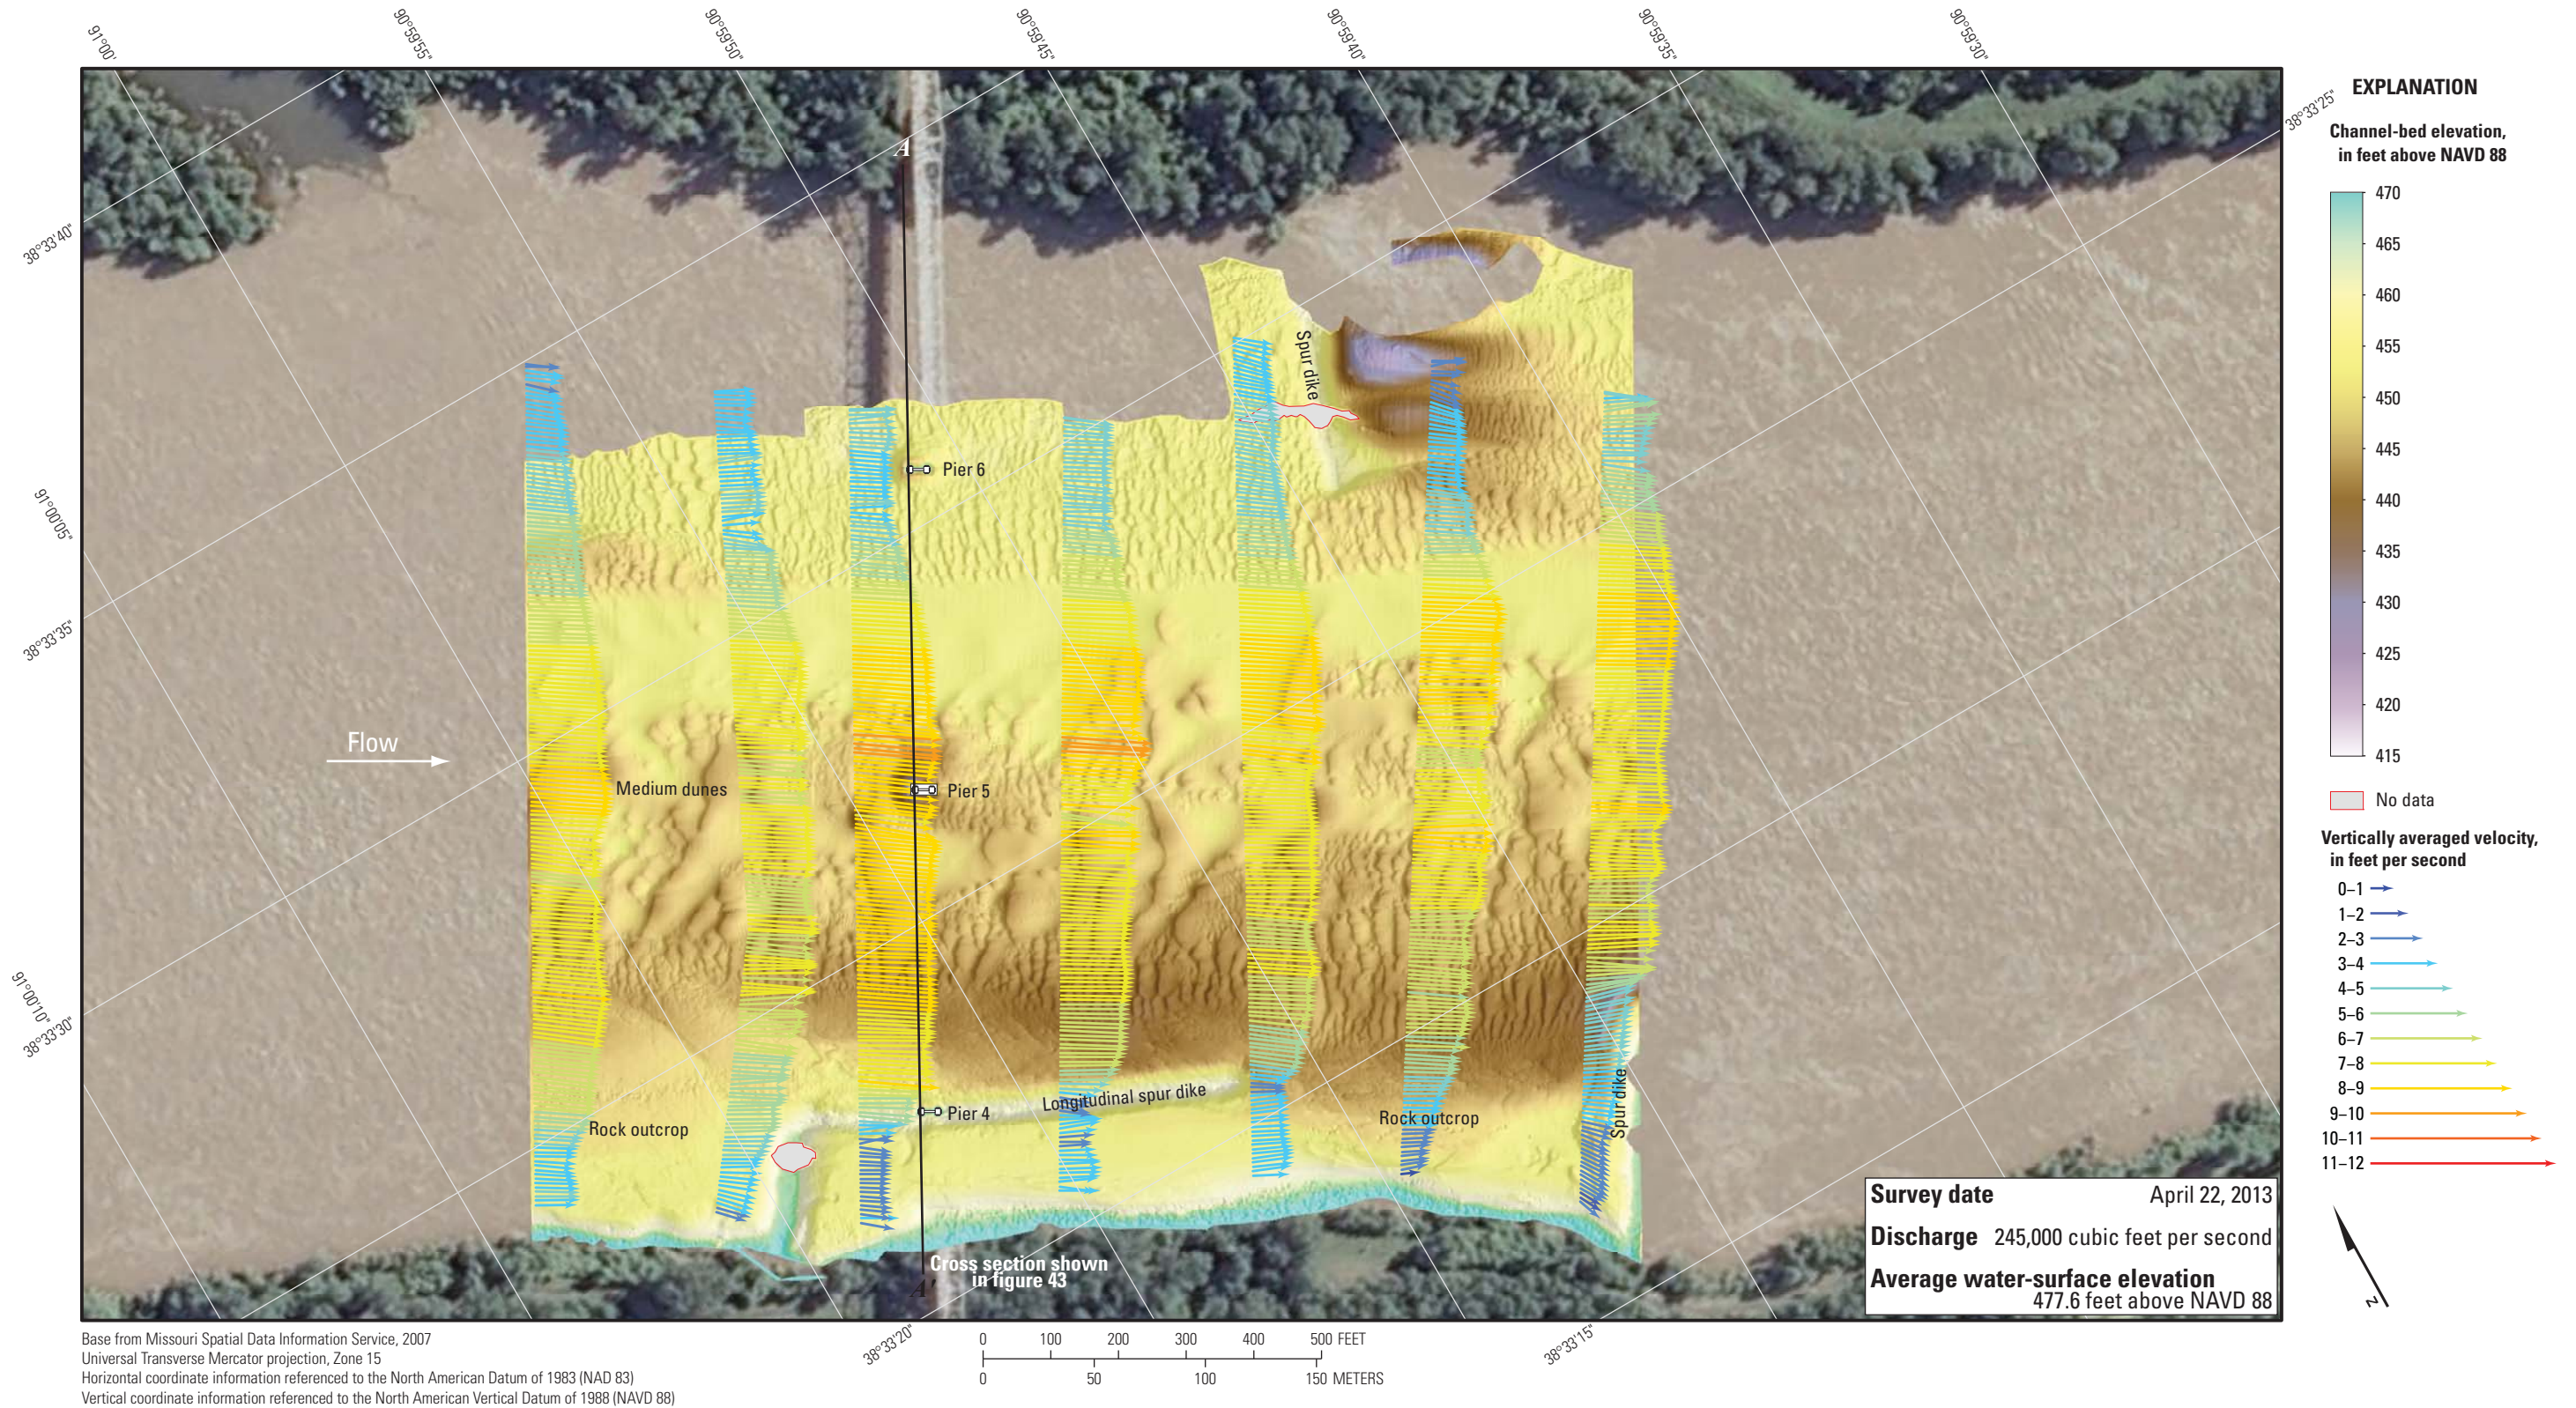
The vertically averaged velocity vectors indicate mostly uniform flow in the middle of the channel, with velocities ranging from about 4 to 10 ft/s (fig. 45). Local lower velocities and turbulence were observed downstream from the various spur dikes on both banks (fig. 45). The bridge piers were aligned with flow, and caused little to no evident turbulence downstream (fig. 45).

Figure 45. Bathymetry and vertically averaged velocities of the Missouri River channel in the vicinity of structure K0969 on State Highway 47 at Washington, Missouri.
