# Bathymetric and Velocimetric Surveys at Highway Bridges Crossing the Missouri River between Kansas City and St. Louis, Missouri, April–May 2013

By Richard J. Huizinga

Scientific Investigations Report 2014–5116

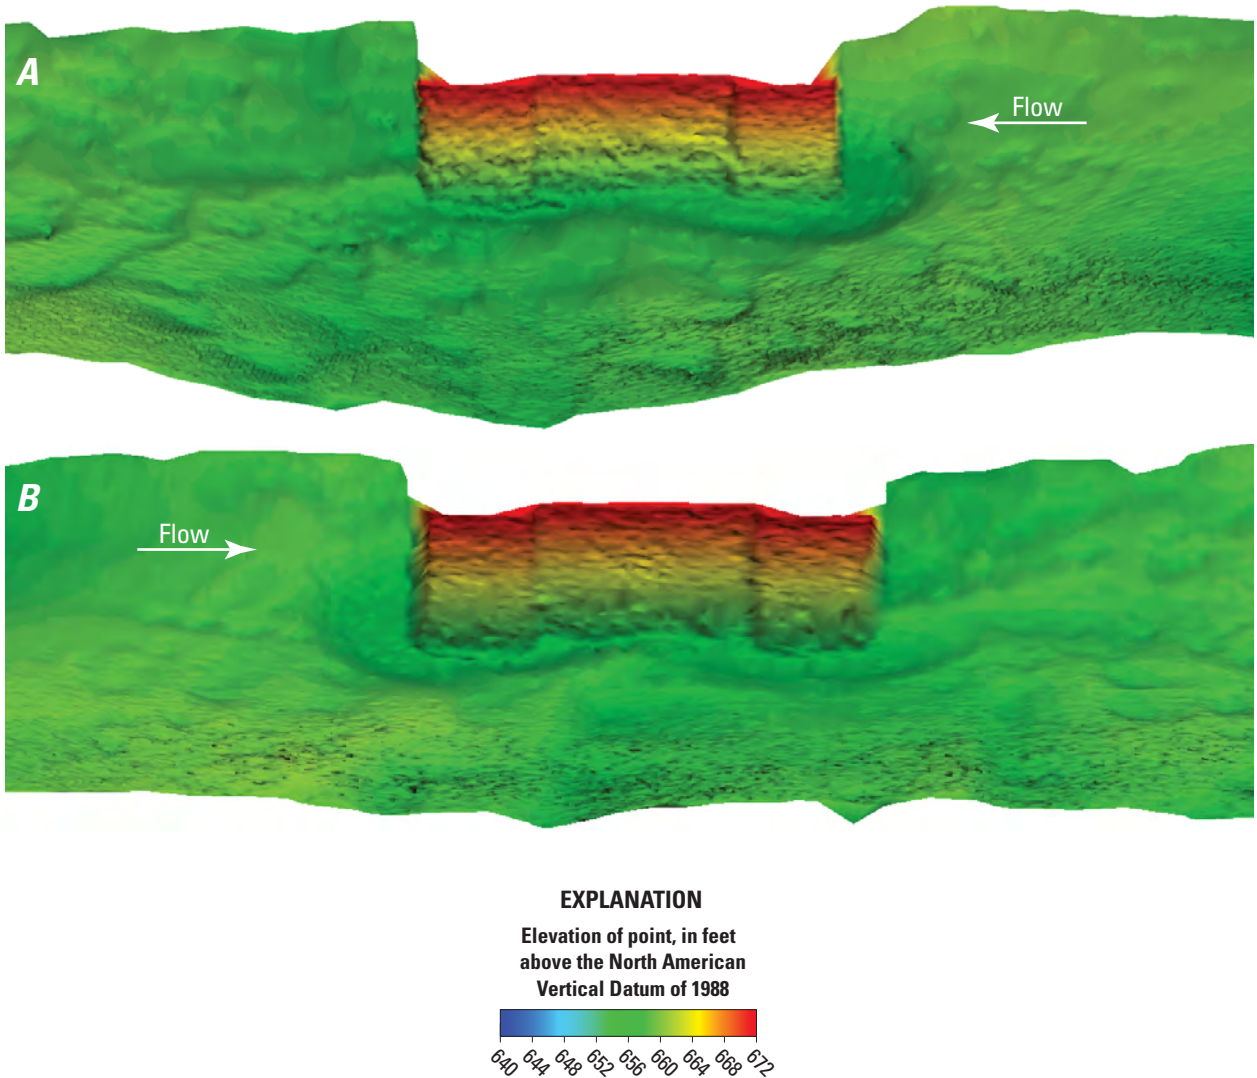
**Figure 1–1.** Shaded triangulated irregular network (TIN) visualization of the channel bed and *A*, left (northwest) side, and *B*, right (southeast) side of main channel pier 21 of structure A5664 on State Highway 13 over the Missouri River at Lexington, Missouri.

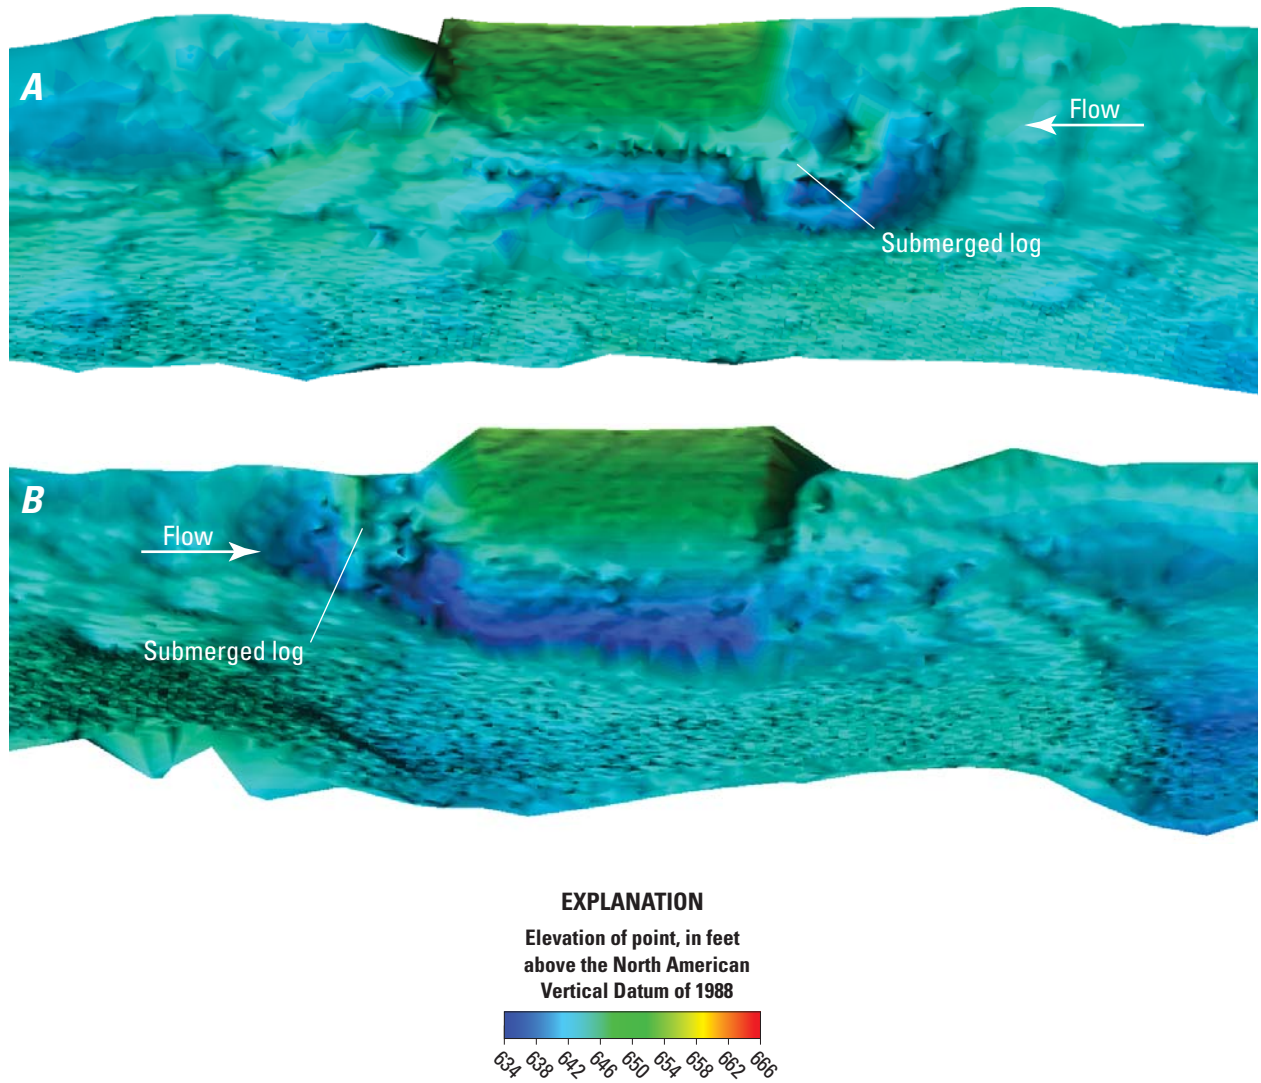
**Figure 1–2.** Shaded triangulated irregular network (TIN) visualization of the channel bed and *A*, left (north) side, and *B*, right (south) side of main channel pier 11 of structure A5910 on U.S. Highway 24 over the Missouri River at Waverly, Missouri.

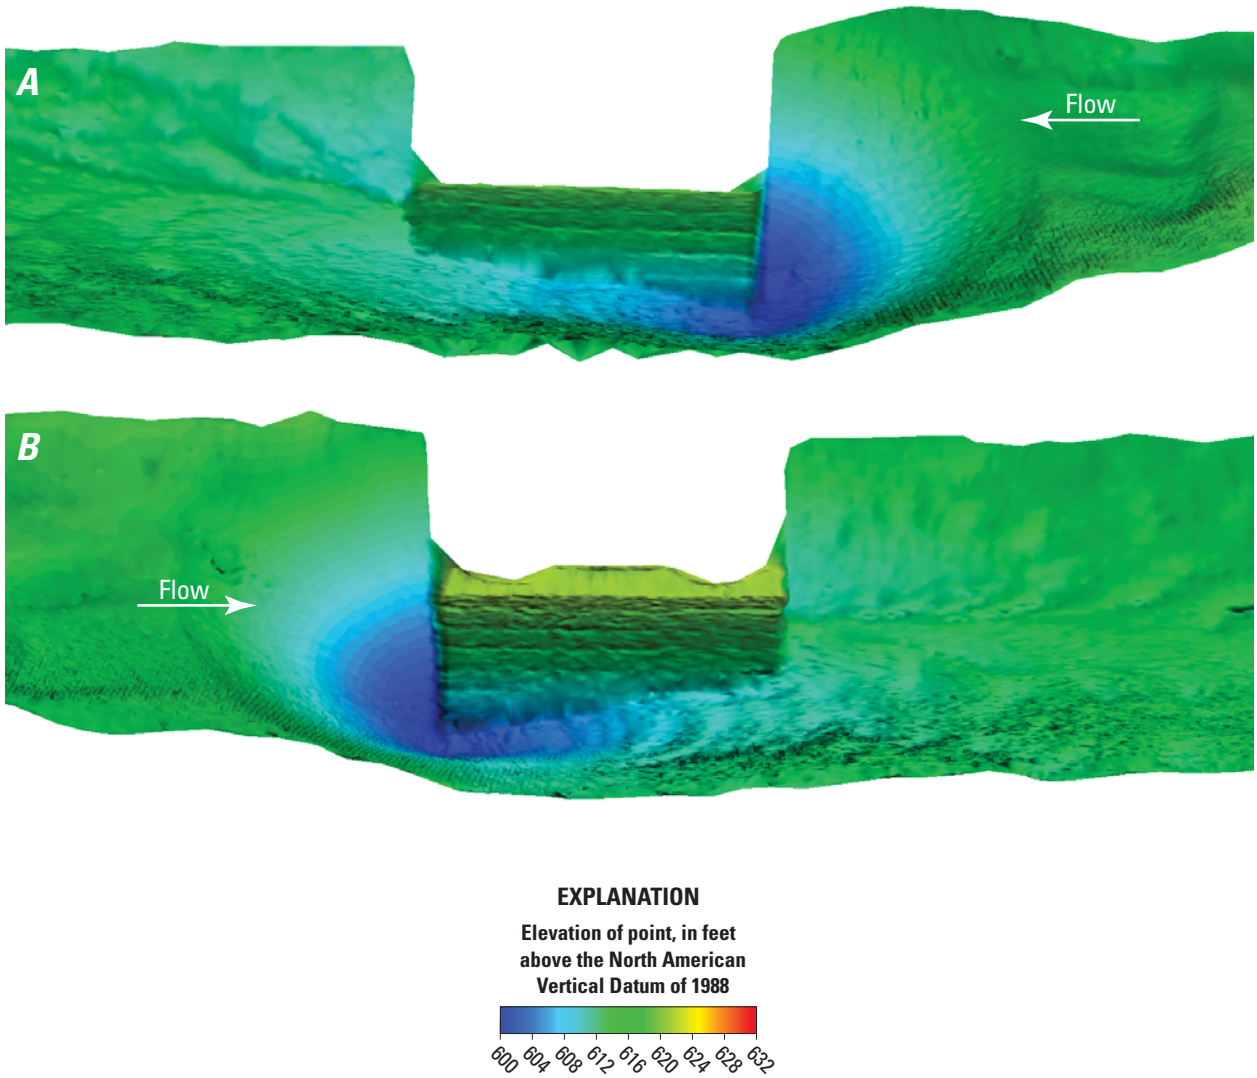
**Figure 1-3.** Shaded triangulated irregular network (TIN) visualization of the channel bed and *A*, left (northwest) side, and *B*, right (southeast) side of main channel pier 5 of structure K0999 on State Highway 41 over the Missouri River at Miami, Missouri.

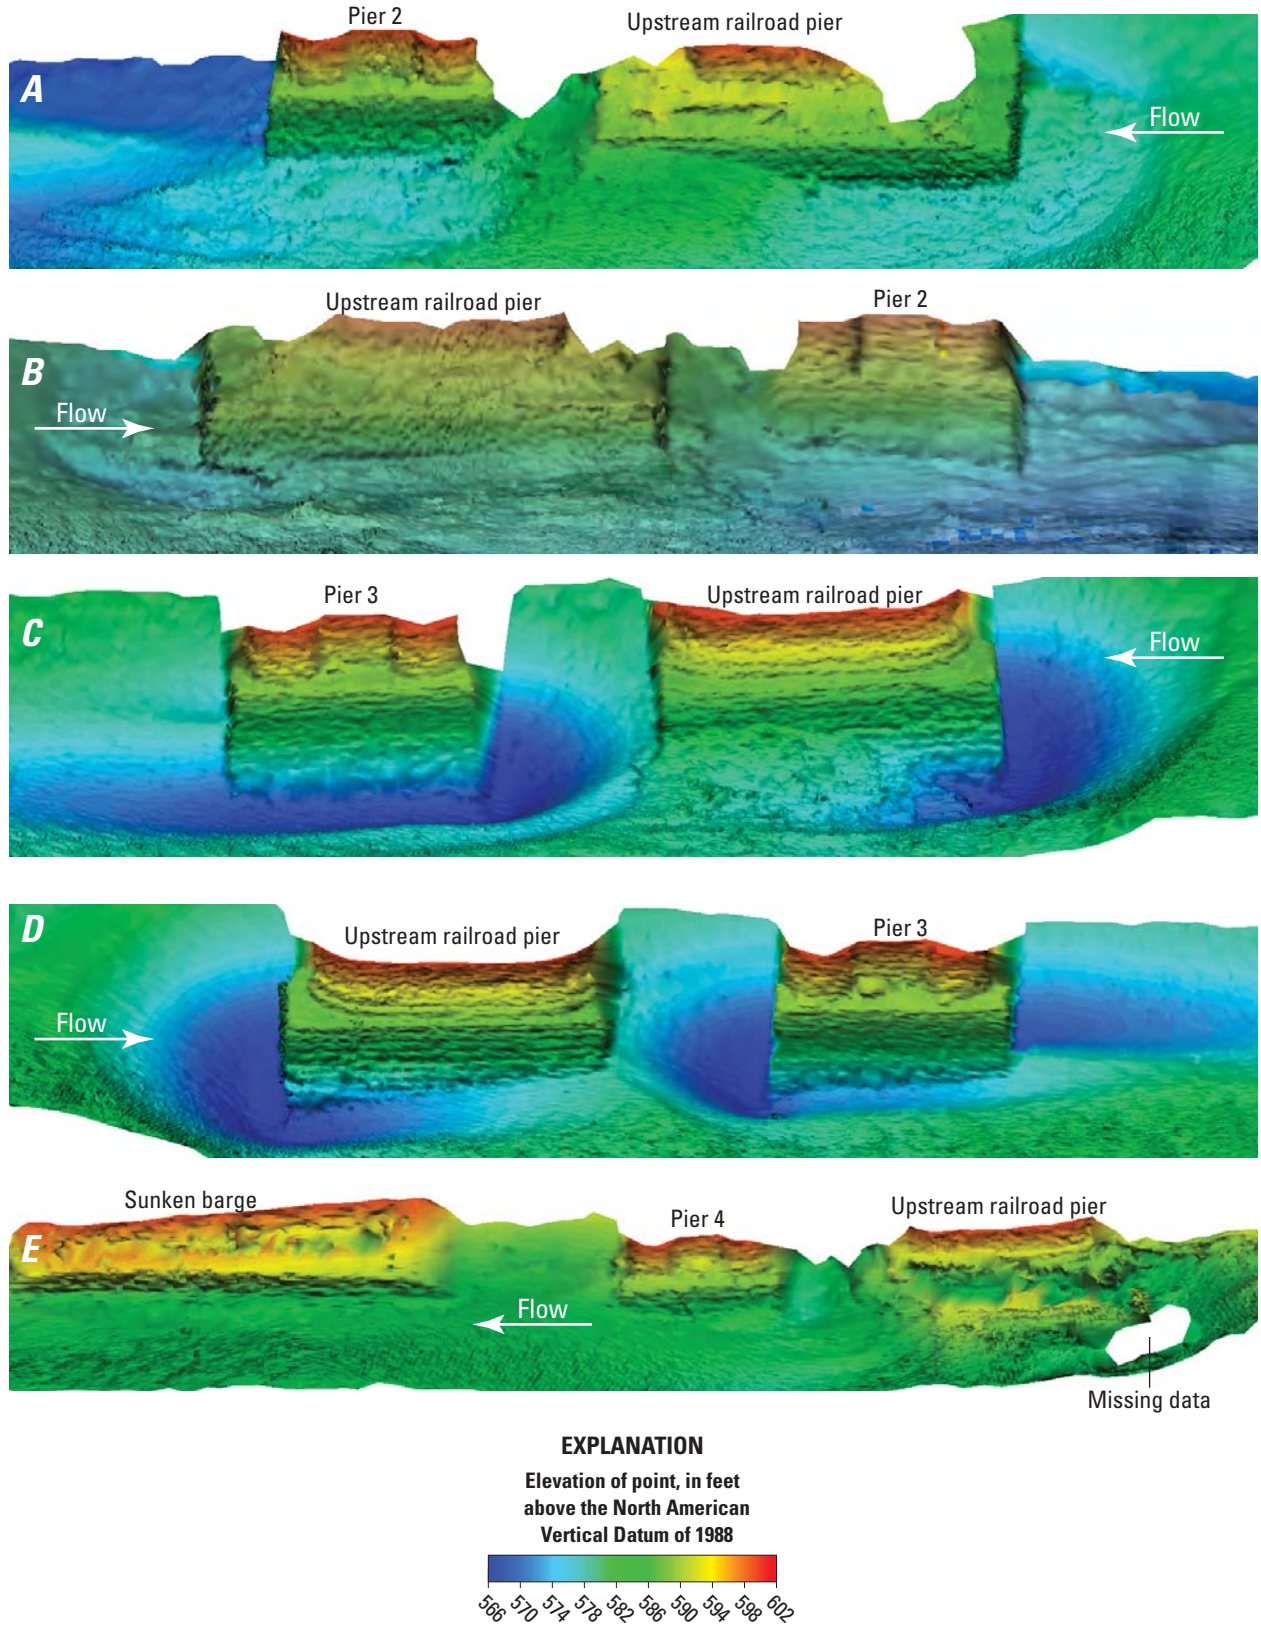
**Figure 1–4.** Shaded triangulated irregular network (TIN) visualization of the channel bed and *A*, left (east) side, and *B*, right (west) side of main channel pier 2; *C*, left (east) side, and *D*, right (west) side of main channel pier 3; and *E*, left (east) side of main channel pier 4 of structure G0069 on State Highway 240 over the Missouri River at Glasgow, Missouri.

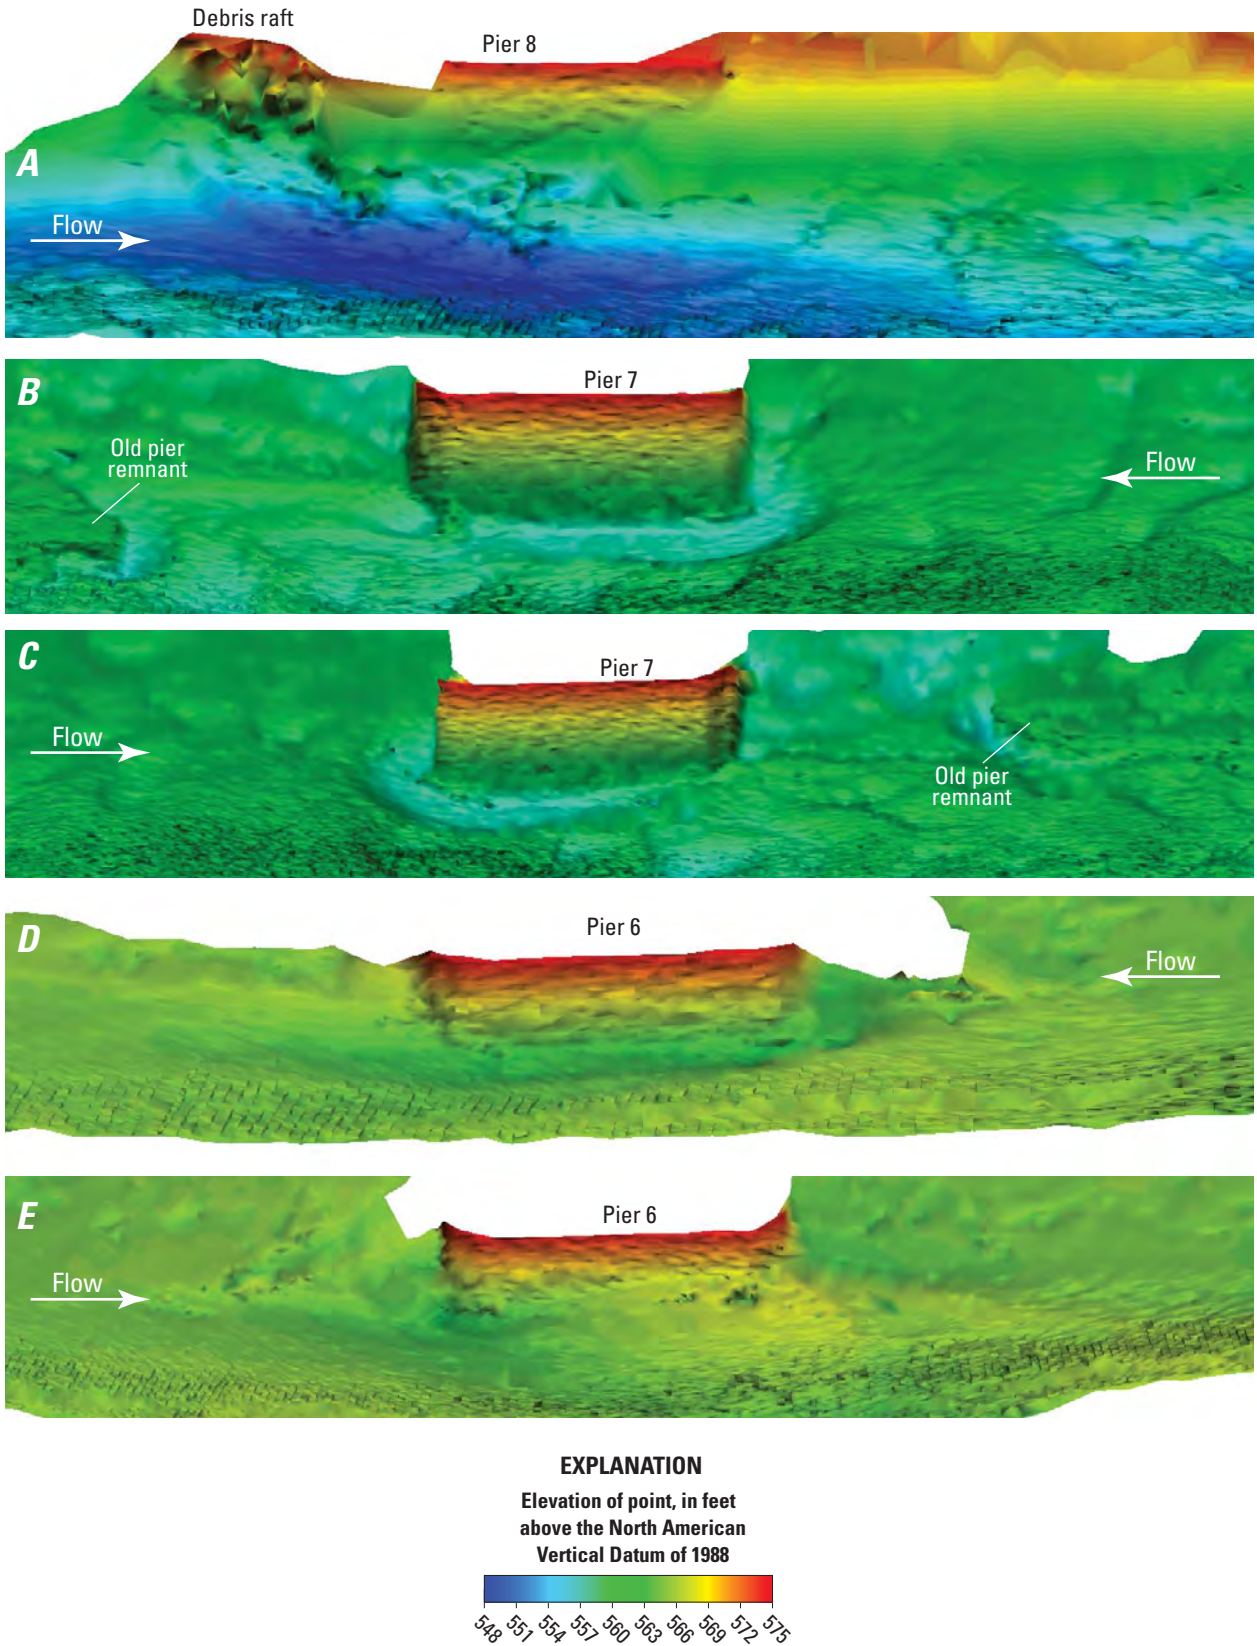
**Figure 1-5.** Shaded triangulated irregular network (TIN) visualization of the channel bed and A, right (south) side of main channel pier 8; B, left (north) side, and C, right (south) side of main channel pier 7; and, D, left (north) side, and E, right (south) side of main channel pier 6 of structure A4574 on State Highway 5 over the Missouri River at Boonville, Missouri.

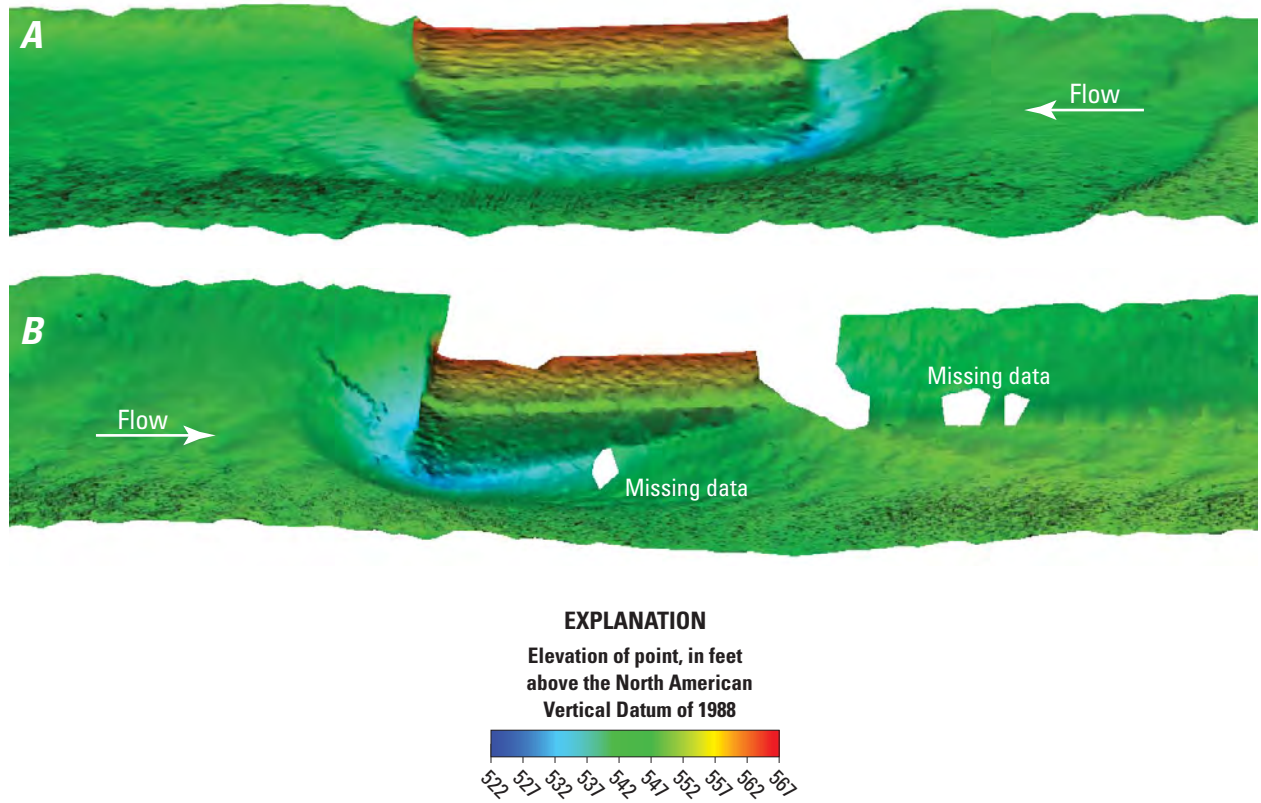
**Figure 1-6.** Shaded triangulated irregular network (TIN) visualization of the channel bed and *A*, left (northeast) side, and *B*, right (southwest) side of main channel pier 14 of structure L0962 on Interstate 70 over the Missouri River near Rocheport, Missouri.

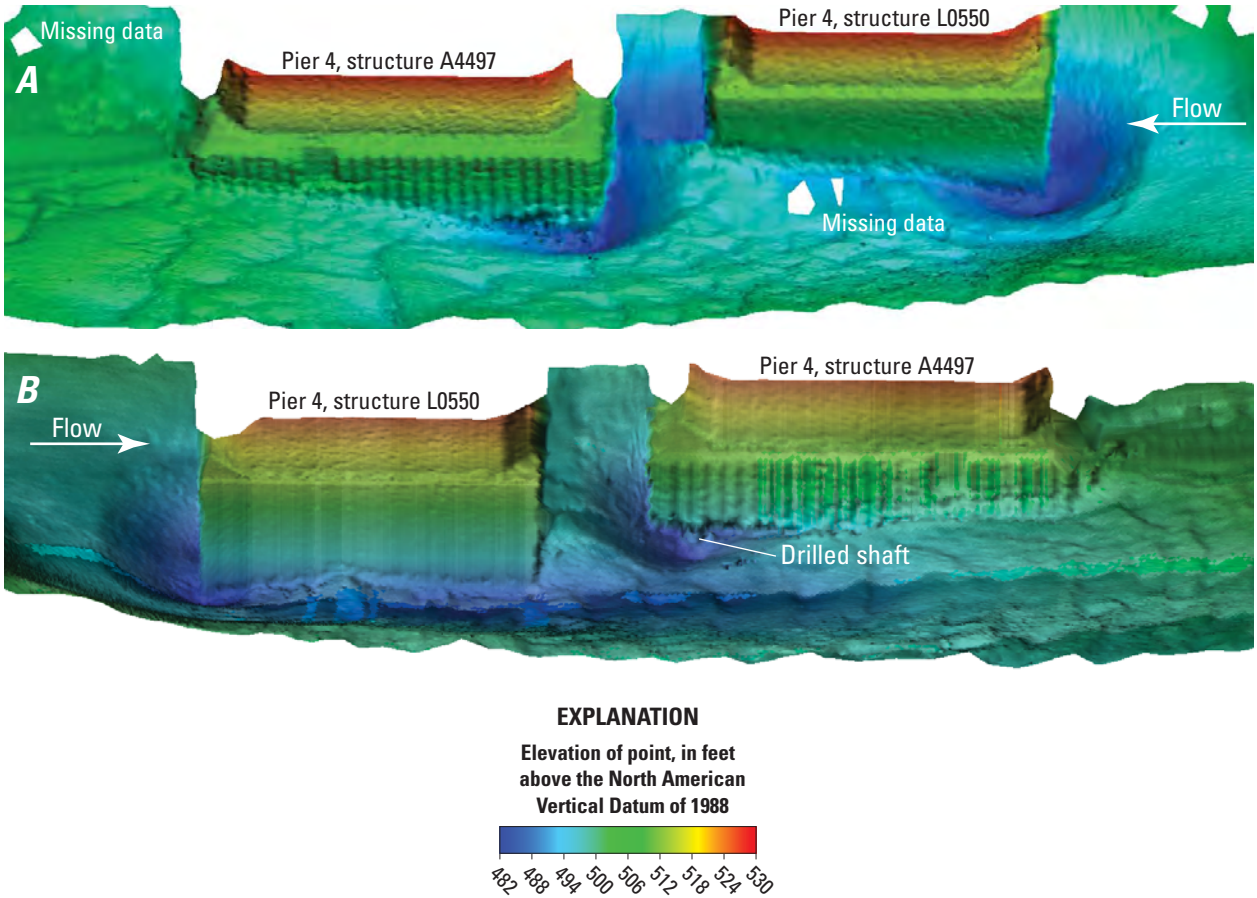
**Figure 1–7.** Shaded triangulated irregular network (TIN) visualization of the channel bed and *A*, left (northeast) side, and *B*, right (southwest) side of main channel pier 4 of structures L0550 and A4497 on U.S. Highway 54 over the Missouri River at Jefferson City, Missouri.

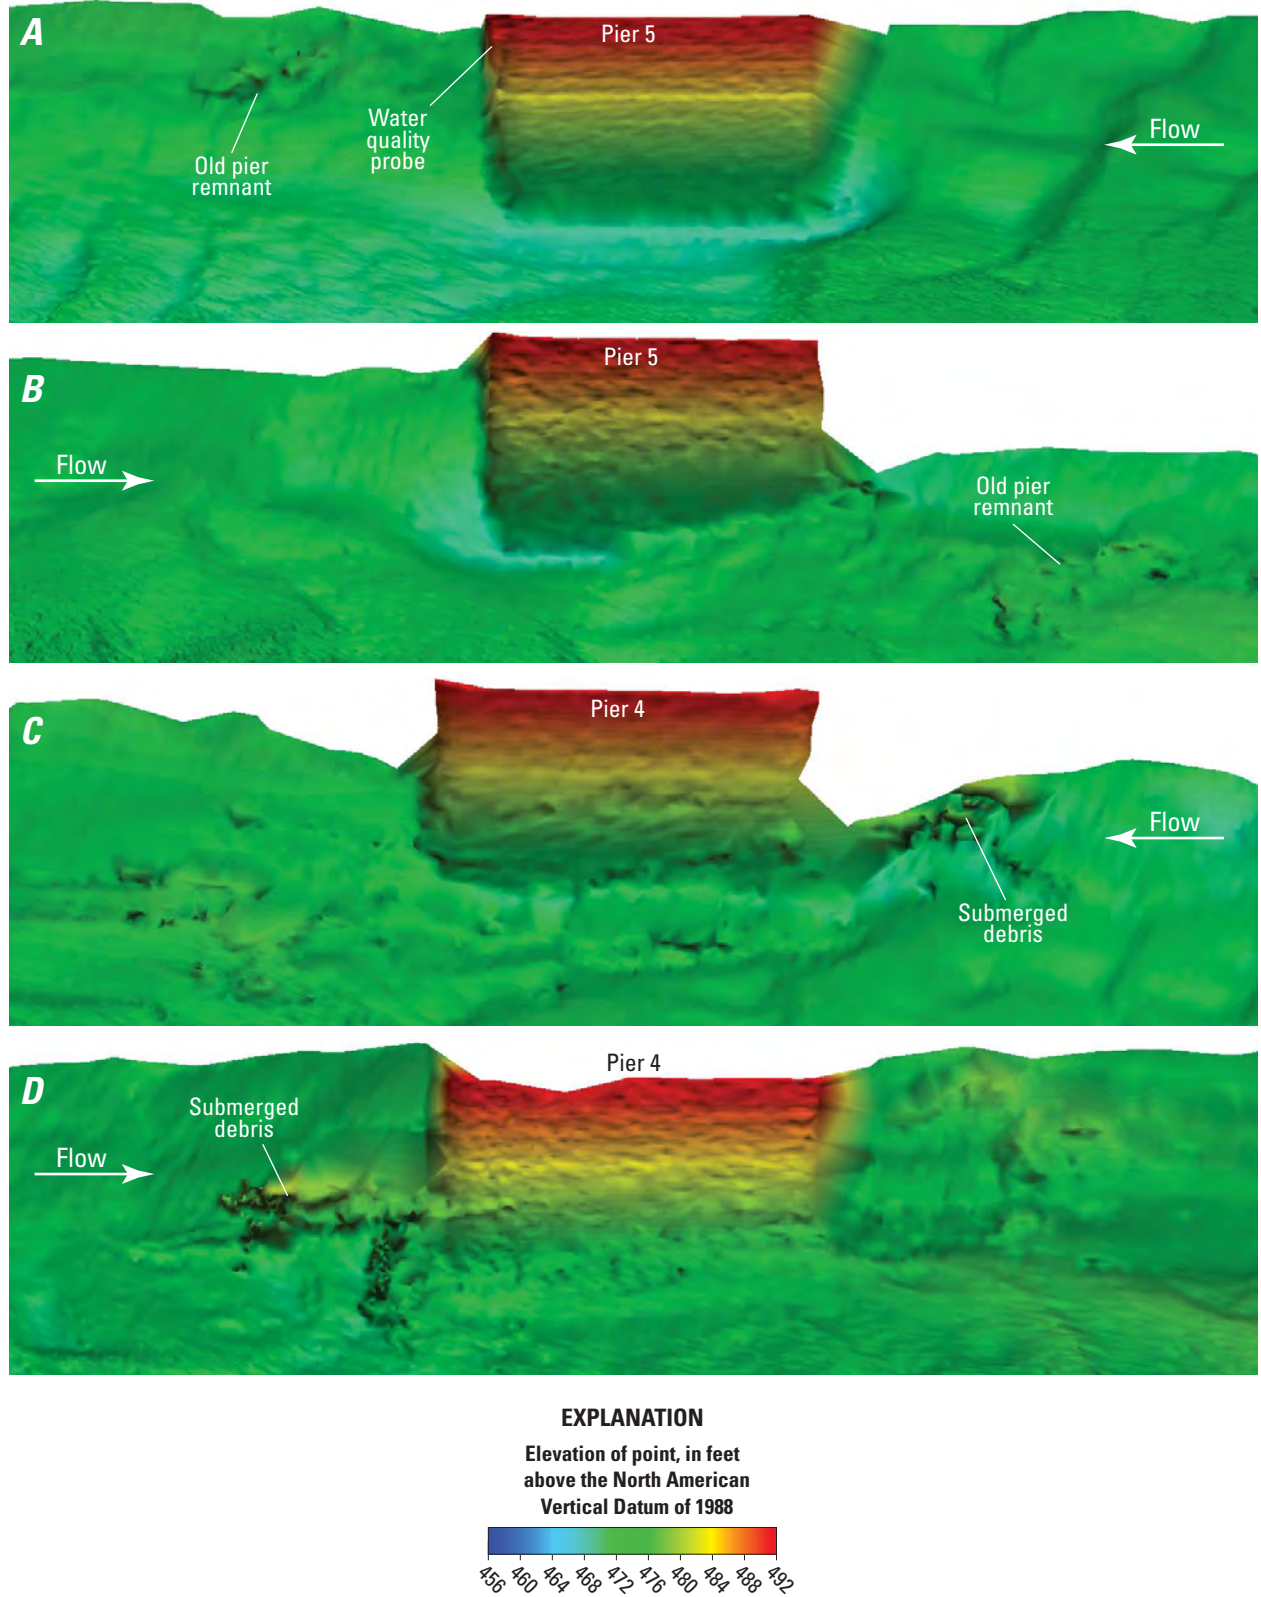
**Figure 1-8.** Shaded triangulated irregular network (TIN) visualization of the channel bed and *A*, left (northwest) side, and *B*, right (southeast) side of main channel pier 5; and *C*, left (northwest) side, and *D*, right (southeast) side of main channel pier 4 of structure A6288 on State Highway 19 over the Missouri River at Hermann, Missouri.

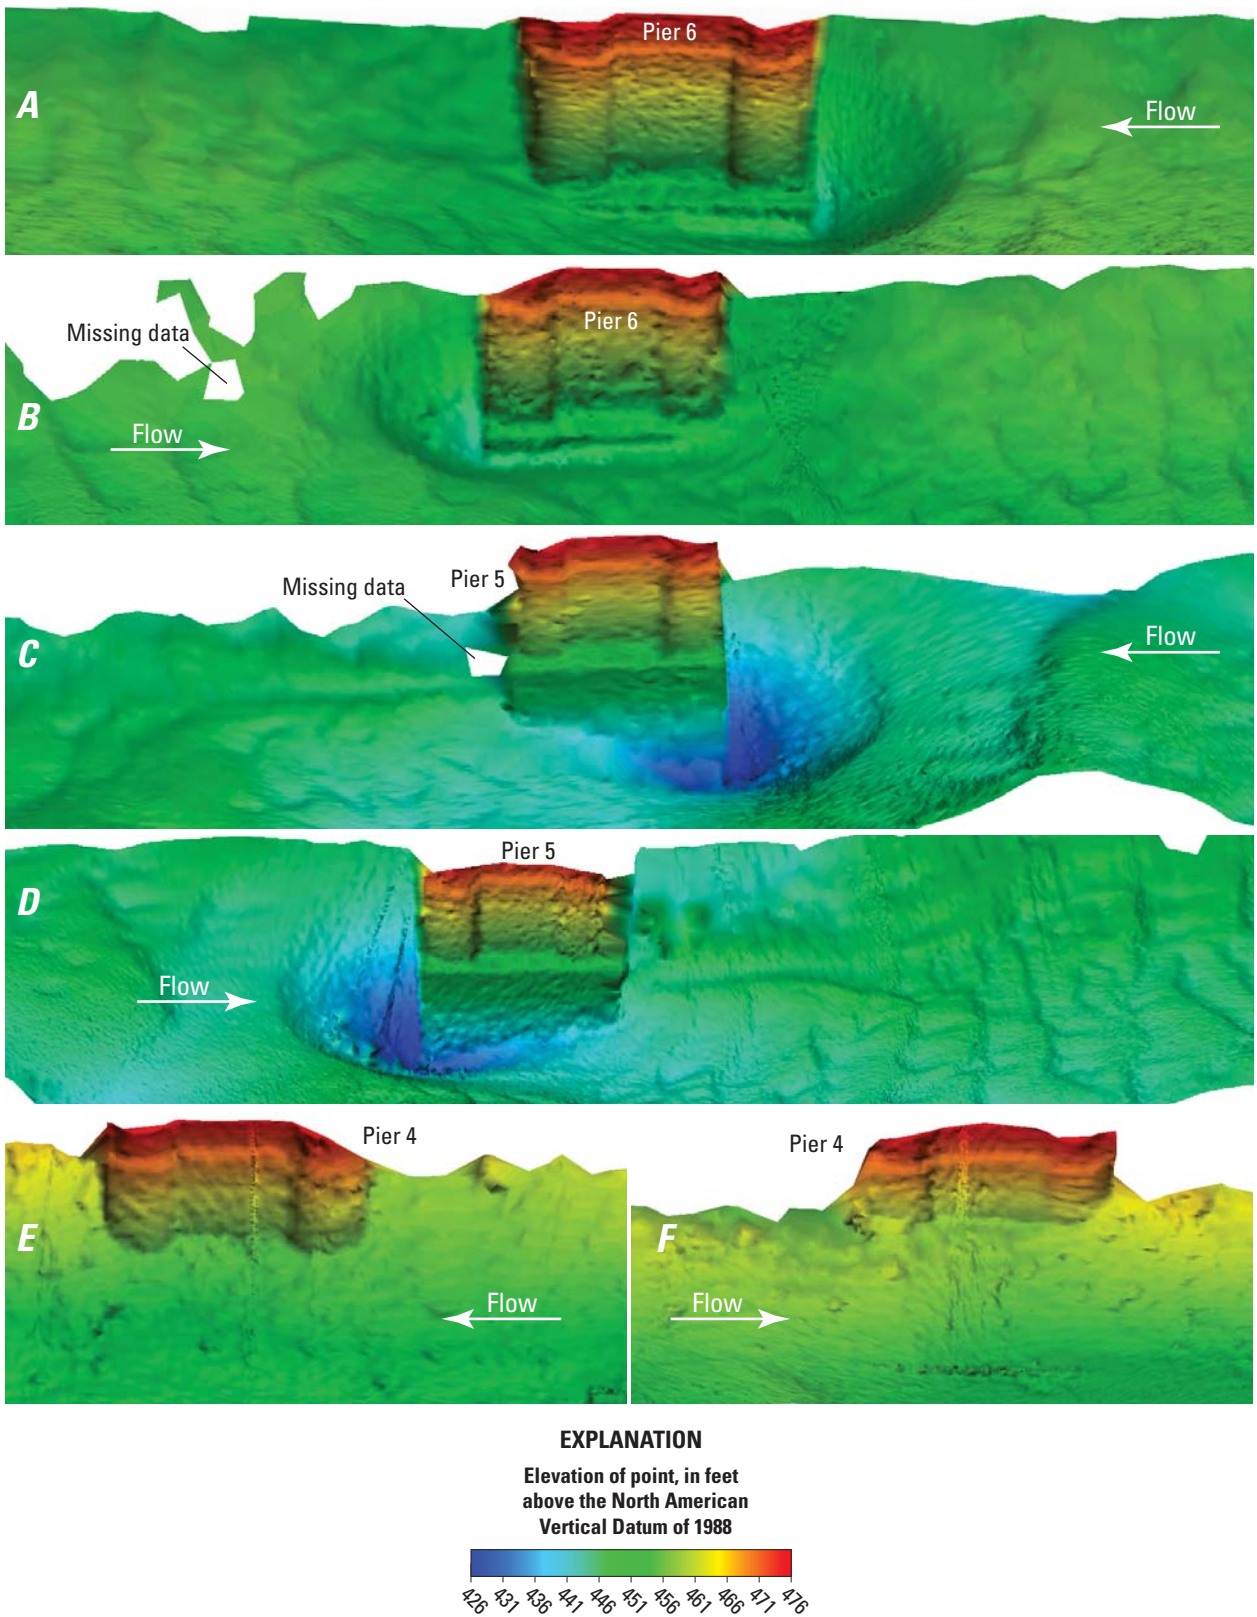
**Figure 1-9.** Shaded triangulated irregular network (TIN) visualization of the channel bed and *A*, left (northeast) side, and *B*, right (southwest) side of main channel pier 6; *C*, left (northeast) side, and *D*, right (southwest) side of main channel pier 5; and *E*, left (northeast) side, and *F*, right (southwest) side of main channel pier 4 of structure K0969 on State Highway 47 over the Missouri River at Washington, Missouri.
