Bathymetric and Velocimetric Surveys at Highway Bridges Crossing the Missouri River near Kansas City, Missouri, June 2–4, 2015

Scientific Investigations Report 2016–5061

By Richard J. Huizinga

Prepared in cooperation with the Missouri Department of Transportation

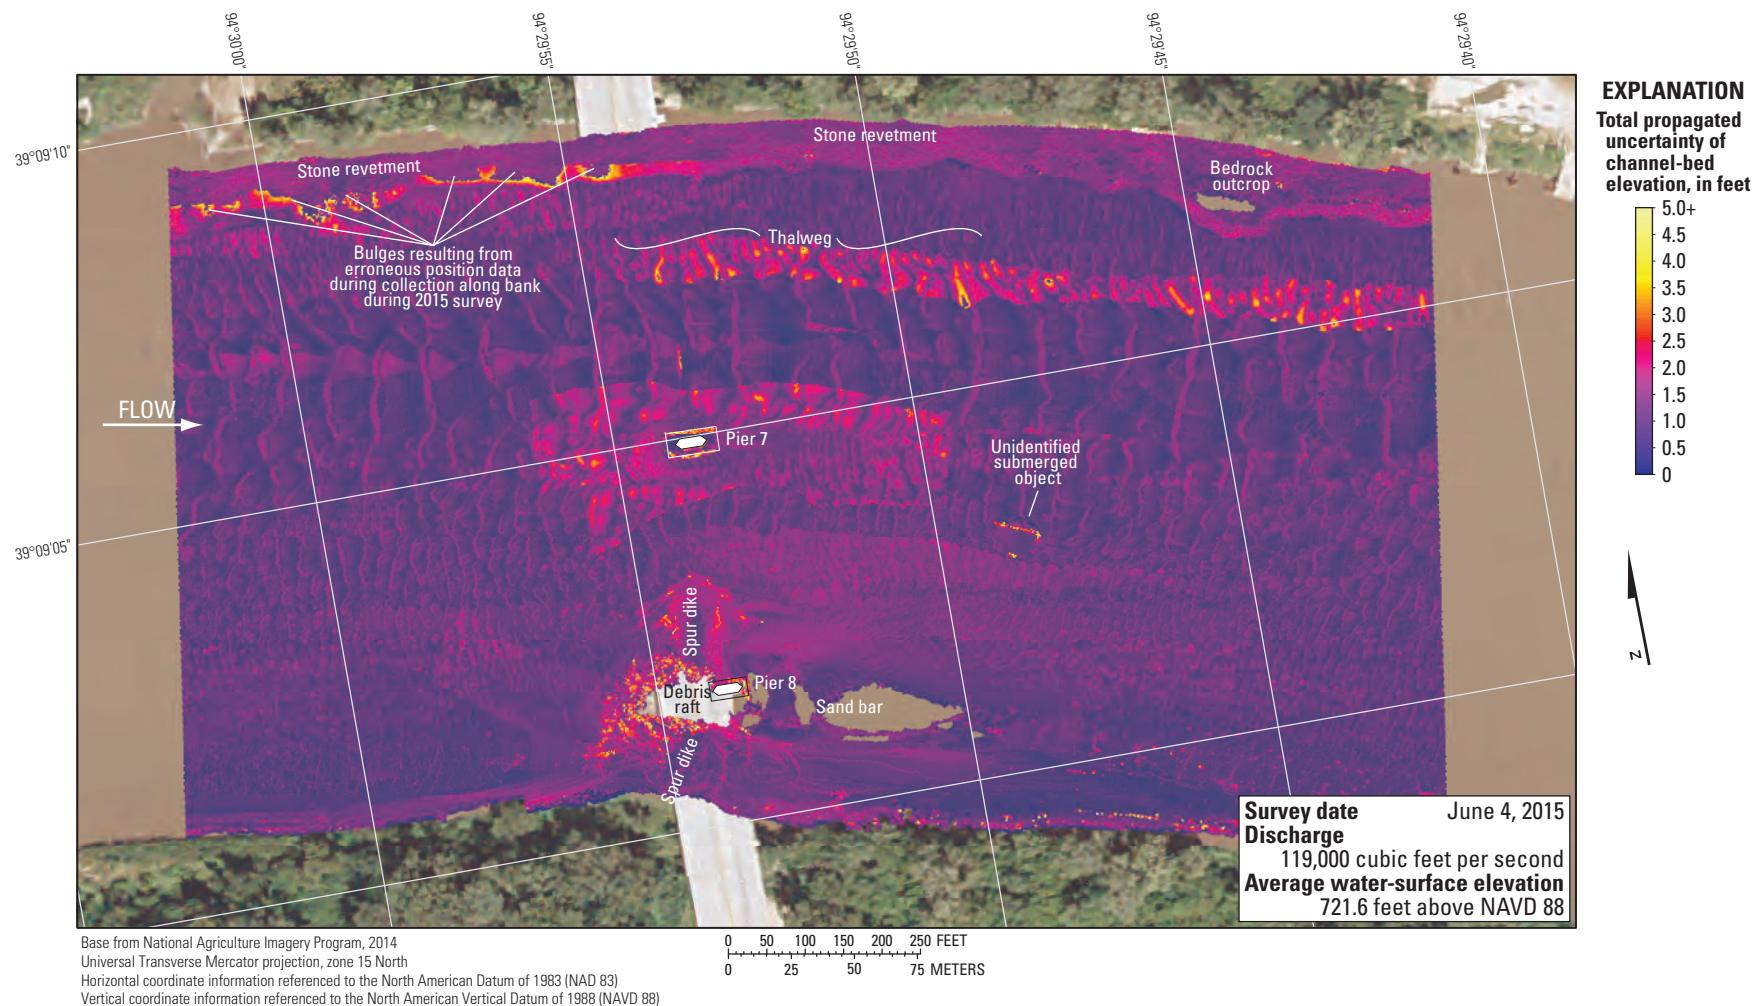
Figure 5. Total propagated uncertainty of bathymetric data from the Missouri River channel near structure A0767 on Interstate 435 in Kansas City, Missouri.

Similar to the previous studies of bathymetry in Missouri (Huizinga, 2010, 2011, 2012, 2013, 2014, 2015), uncertainty in the surveys was estimated by computing the total propagated uncertainty (TPU) for each survey-grid cell in the bathymetric surface of each survey area, using the CUBE method (Calder and Mayer, 2003). The CUBE method allows all random system component uncertainties and resolution effects to be combined and propagated through the data processing steps, which provides a robust estimate of the spatial distribution of possible uncertainty within the survey area (Czuba and others, 2011); thus, the TPU of a point is a measure of the accuracy to be expected for such a point when all relevant error sources are taken into account (Czuba and others, 2011). Statistics of TPU for each of the survey areas are shown in table 4, and an example of the spatial distribution of TPU typically observed in the survey data is shown in figure 5 for the bathymetric data at structure A0767 on Interstate 435.

The largest TPU in this group of surveys was about 11.97 ft (table 4); however, as noted in previous studies, TPU values of this magnitude typically happened near high-relief

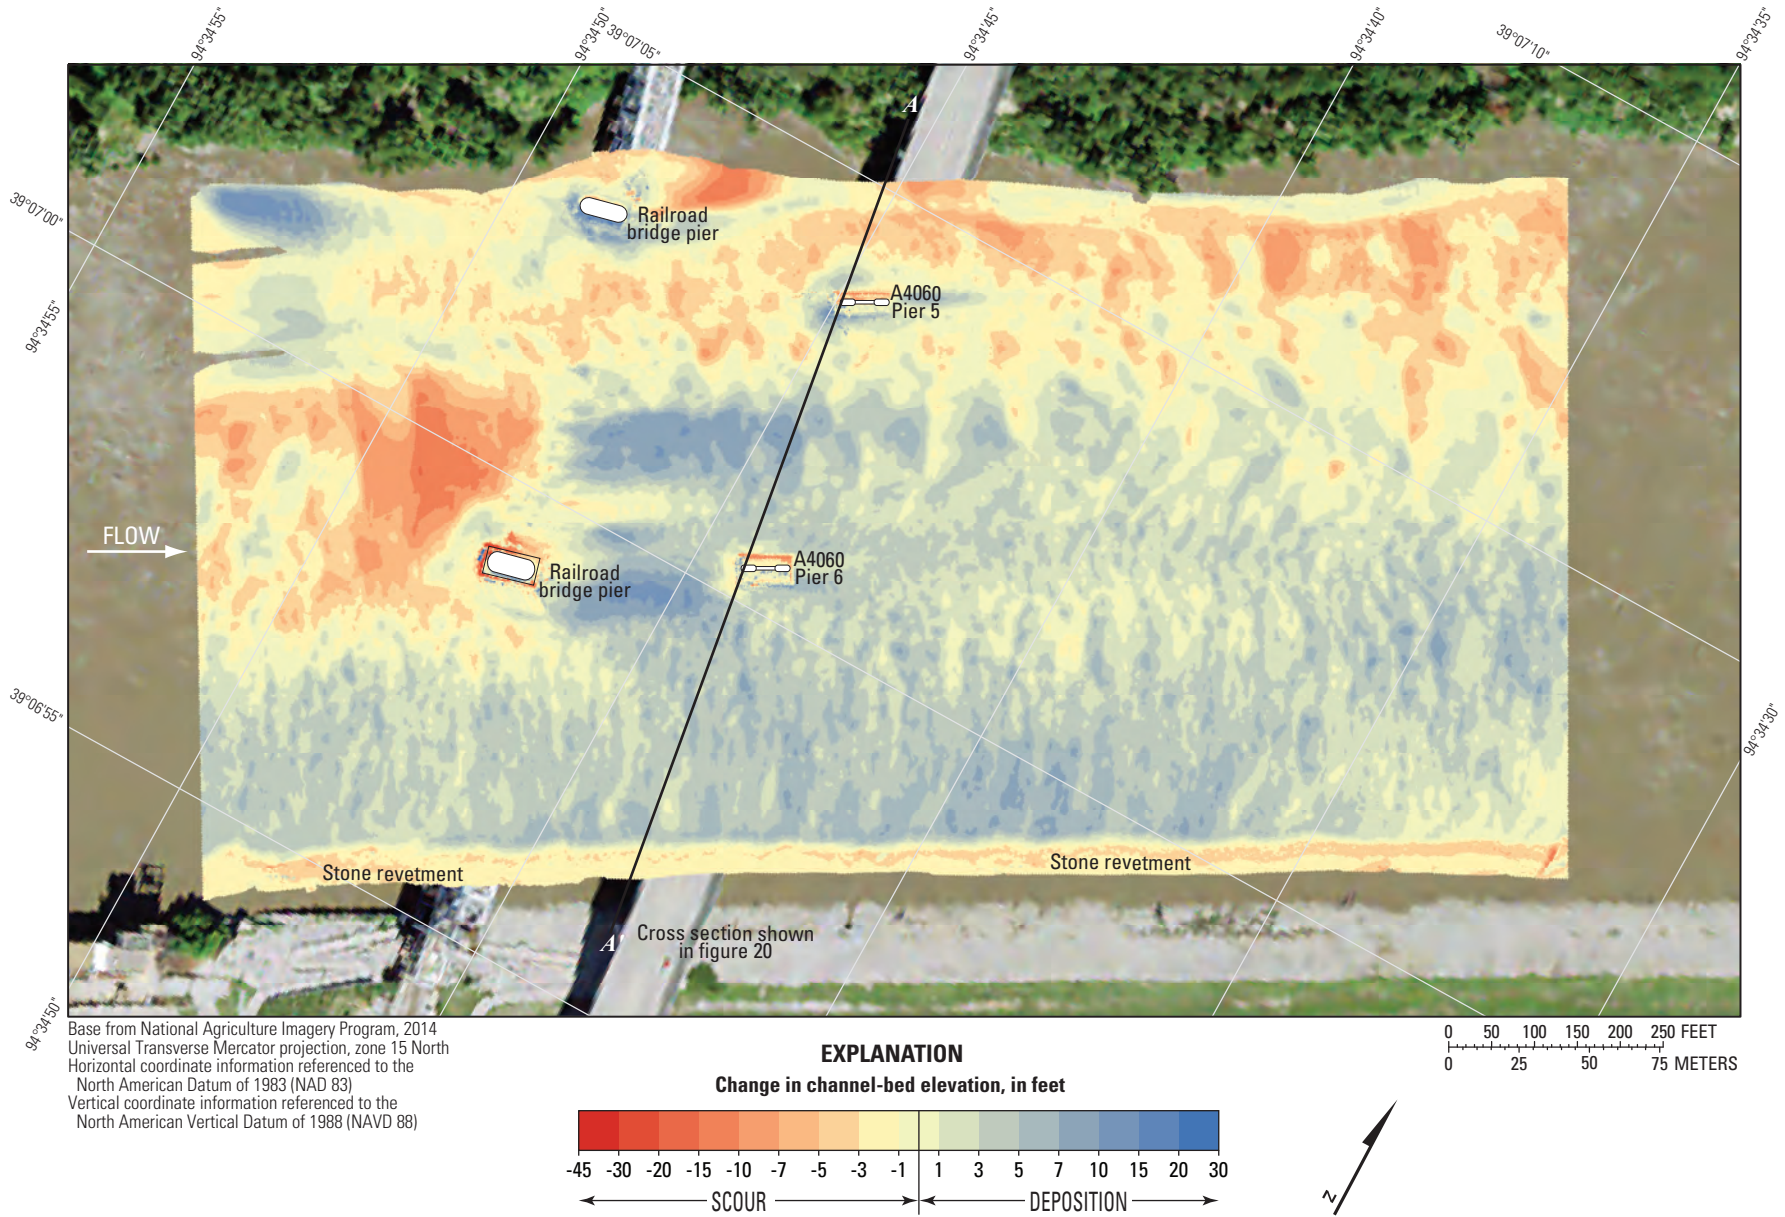
Figure 22. Difference between surfaces created from bathymetric surveys of the Missouri River channel near structure A4060 on State Highway 9 in Kansas City, Missouri, on June 3, 2015, and March 16, 2010.

The difference between the survey on June 3, 2015, and the previous nonflood survey on March 16, 2010 (fig. 22), indicates minor deposition throughout the reach from 2010 to 2015, with an average difference of +0.75 ft between the bathymetric surfaces (table 7). The net volume of cut in the reach from 2010 to 2015 was about 57,500 yd³, and the net volume of fill was about 93,700 yd³, resulting in a net gain of about 36,200 yd³ of sediment between 2010 and 2015. Substantial scour was observed in the middle of the upstream channel in 2015, and minor to moderate scour was observed along the left (north) bank; however, deposition was observed throughout most of the reach (fig. 22). The cross sections from the two surveys further indicate the deposition except to the left of pier 5 (fig. 20). The frequency distribution of bed elevations was substantially narrower in 2015 than in 2010, with a

greater percentage of survey-grid cells at a higher elevation than 2010 (fig. 19). The localized scour observed on the stone revetment on the right (south) bank in 2011 (Huizinga, 2012) is present in the difference between the 2015 and 2010 surveys (fig. 22). As with all difference maps in this report, substantial deposition or scour apparent at the faces of the piers results from minor horizontal positional variances between the surveys (see “Uncertainty Estimation” section).

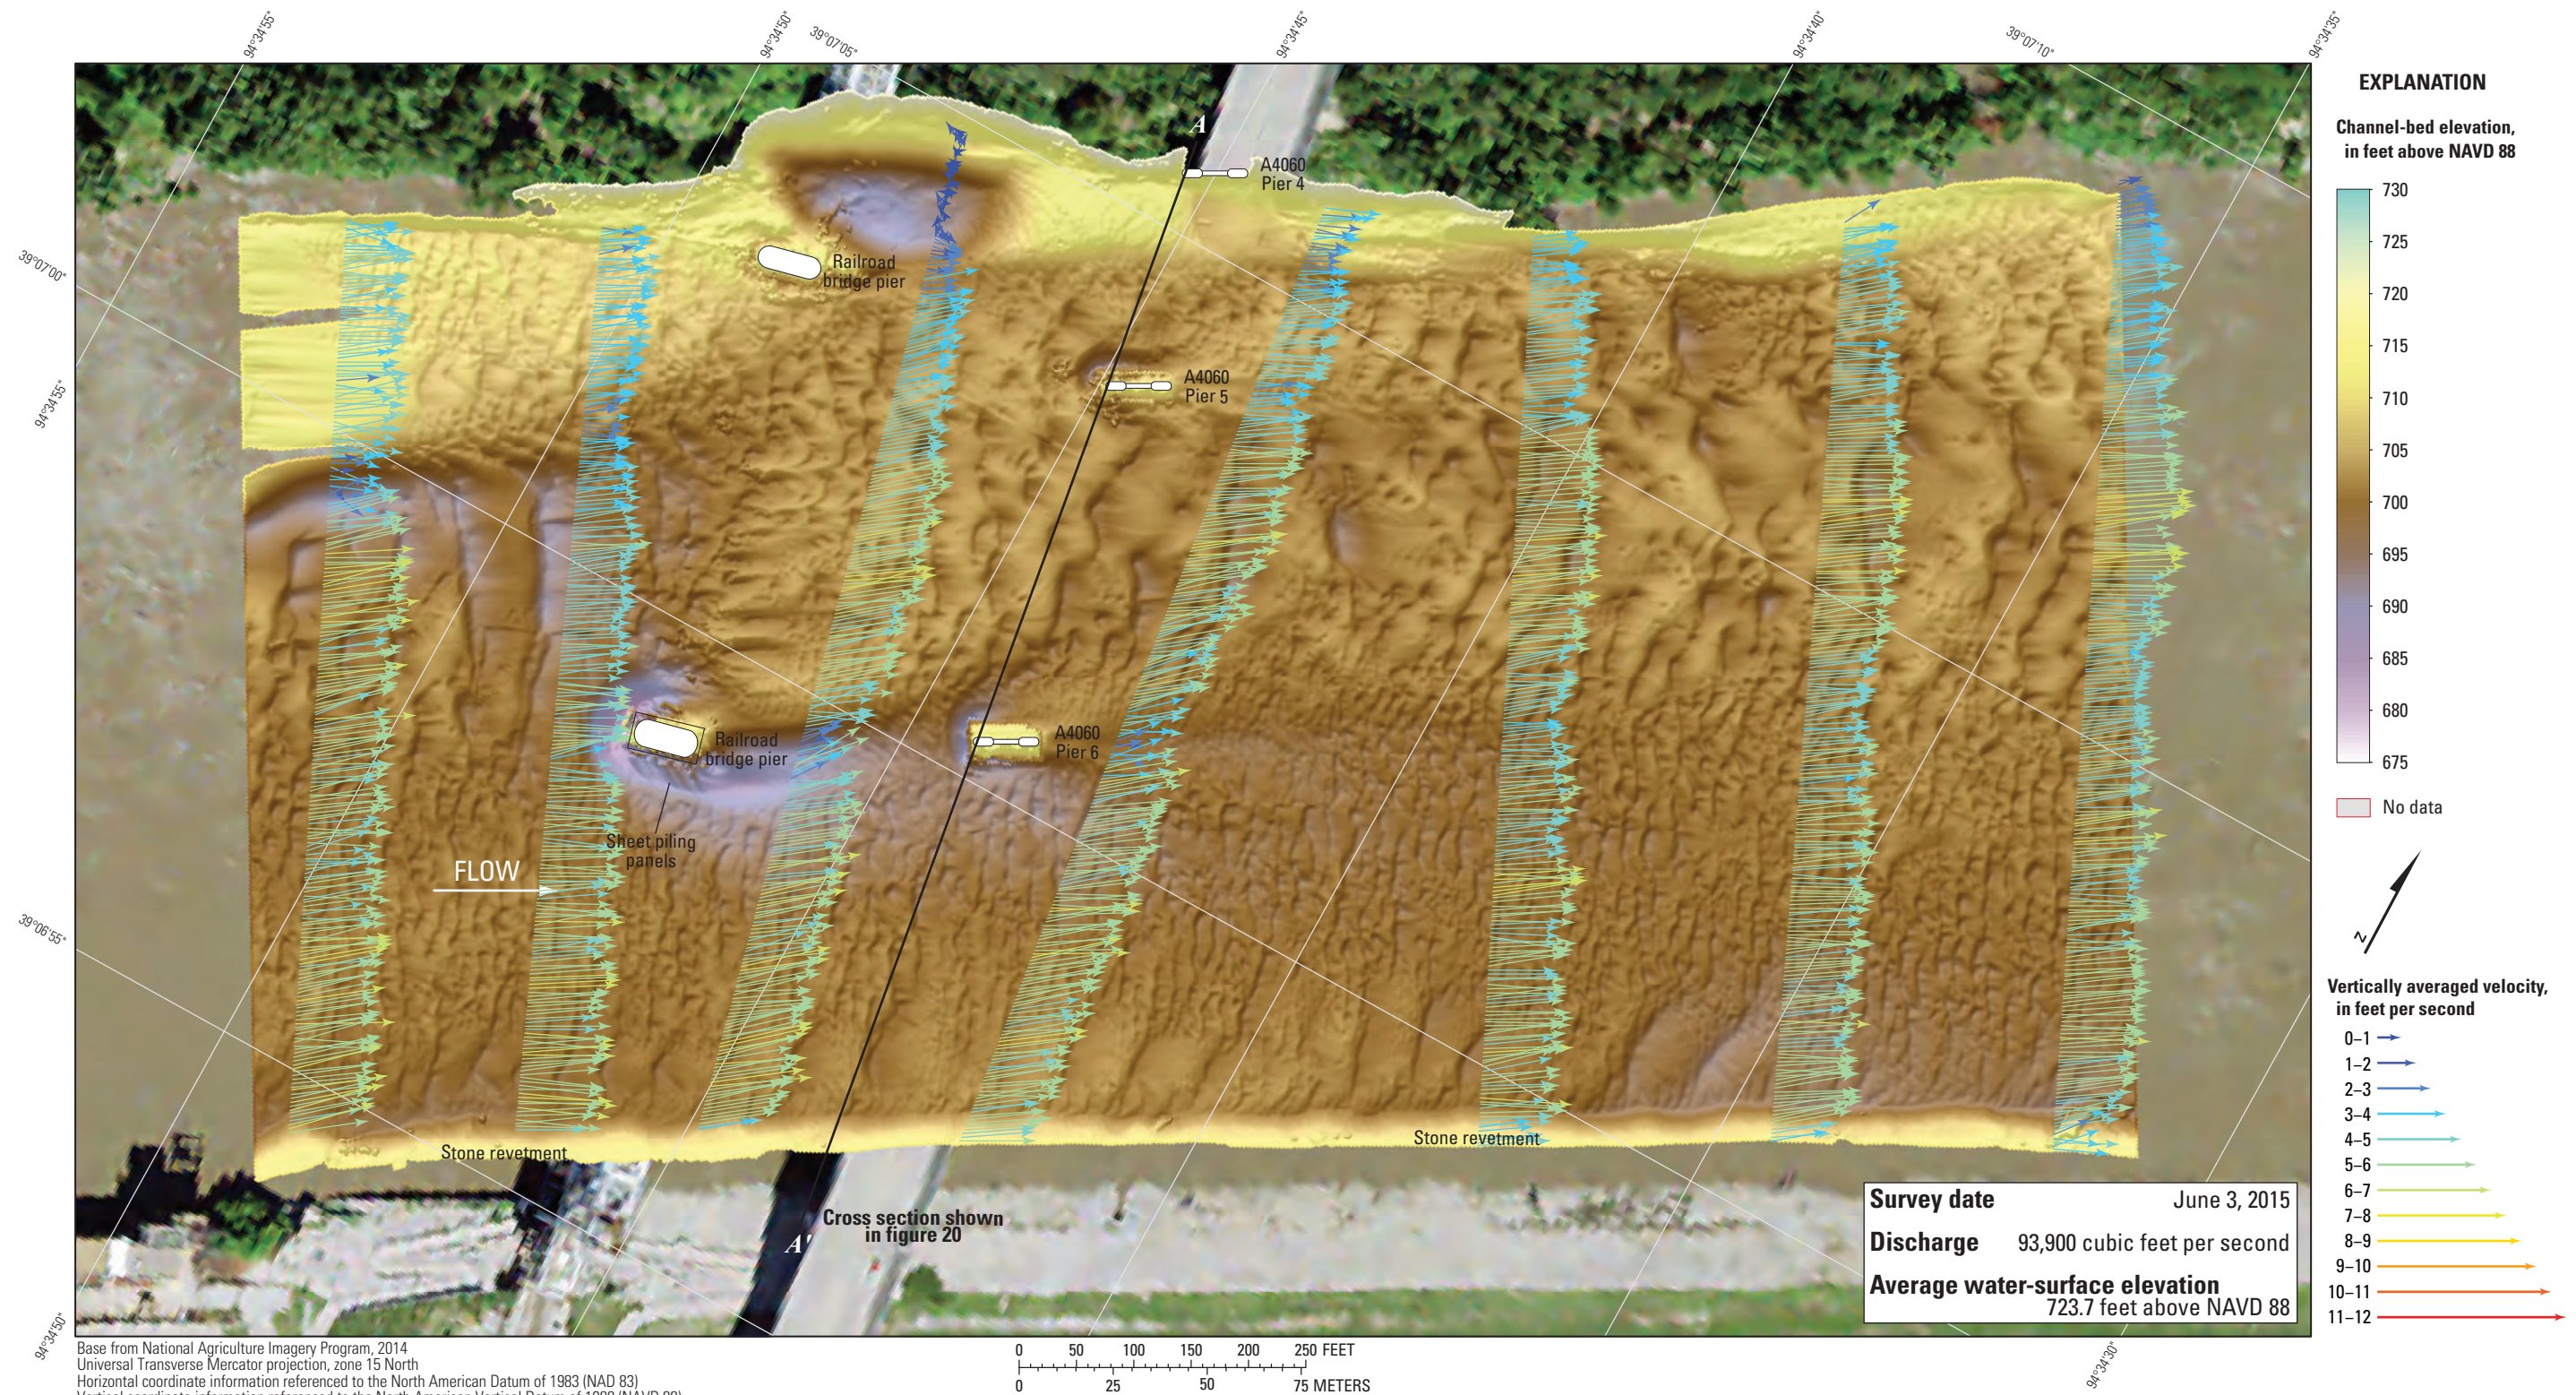
Figure 23. Bathymetry and vertically averaged velocities of the Missouri River channel near structure A4060 on State Highway 9 in Kansas City, Missouri.

The vertically averaged velocity vectors indicate mostly uniform flow throughout the channel, ranging from about 3 to 8 ft/s (fig. 23). Exceptions to uniform conditions include flow reversal observed in the area downstream from the left (north) railroad bridge pier (fig. 23). Substantial turbulence also was observed downstream from the right (south) piers of the railroad bridge and structure A4060 (fig. 23).

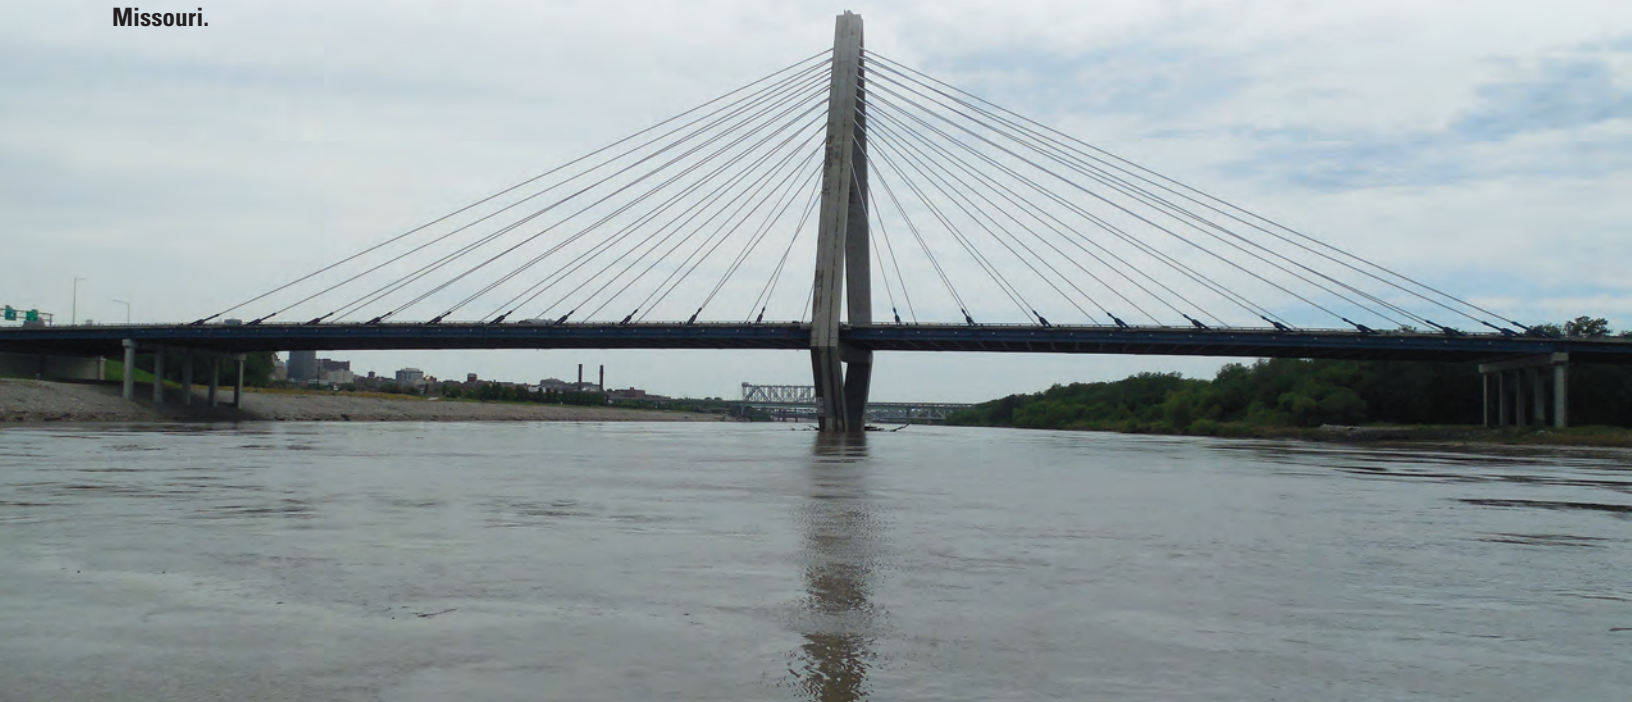
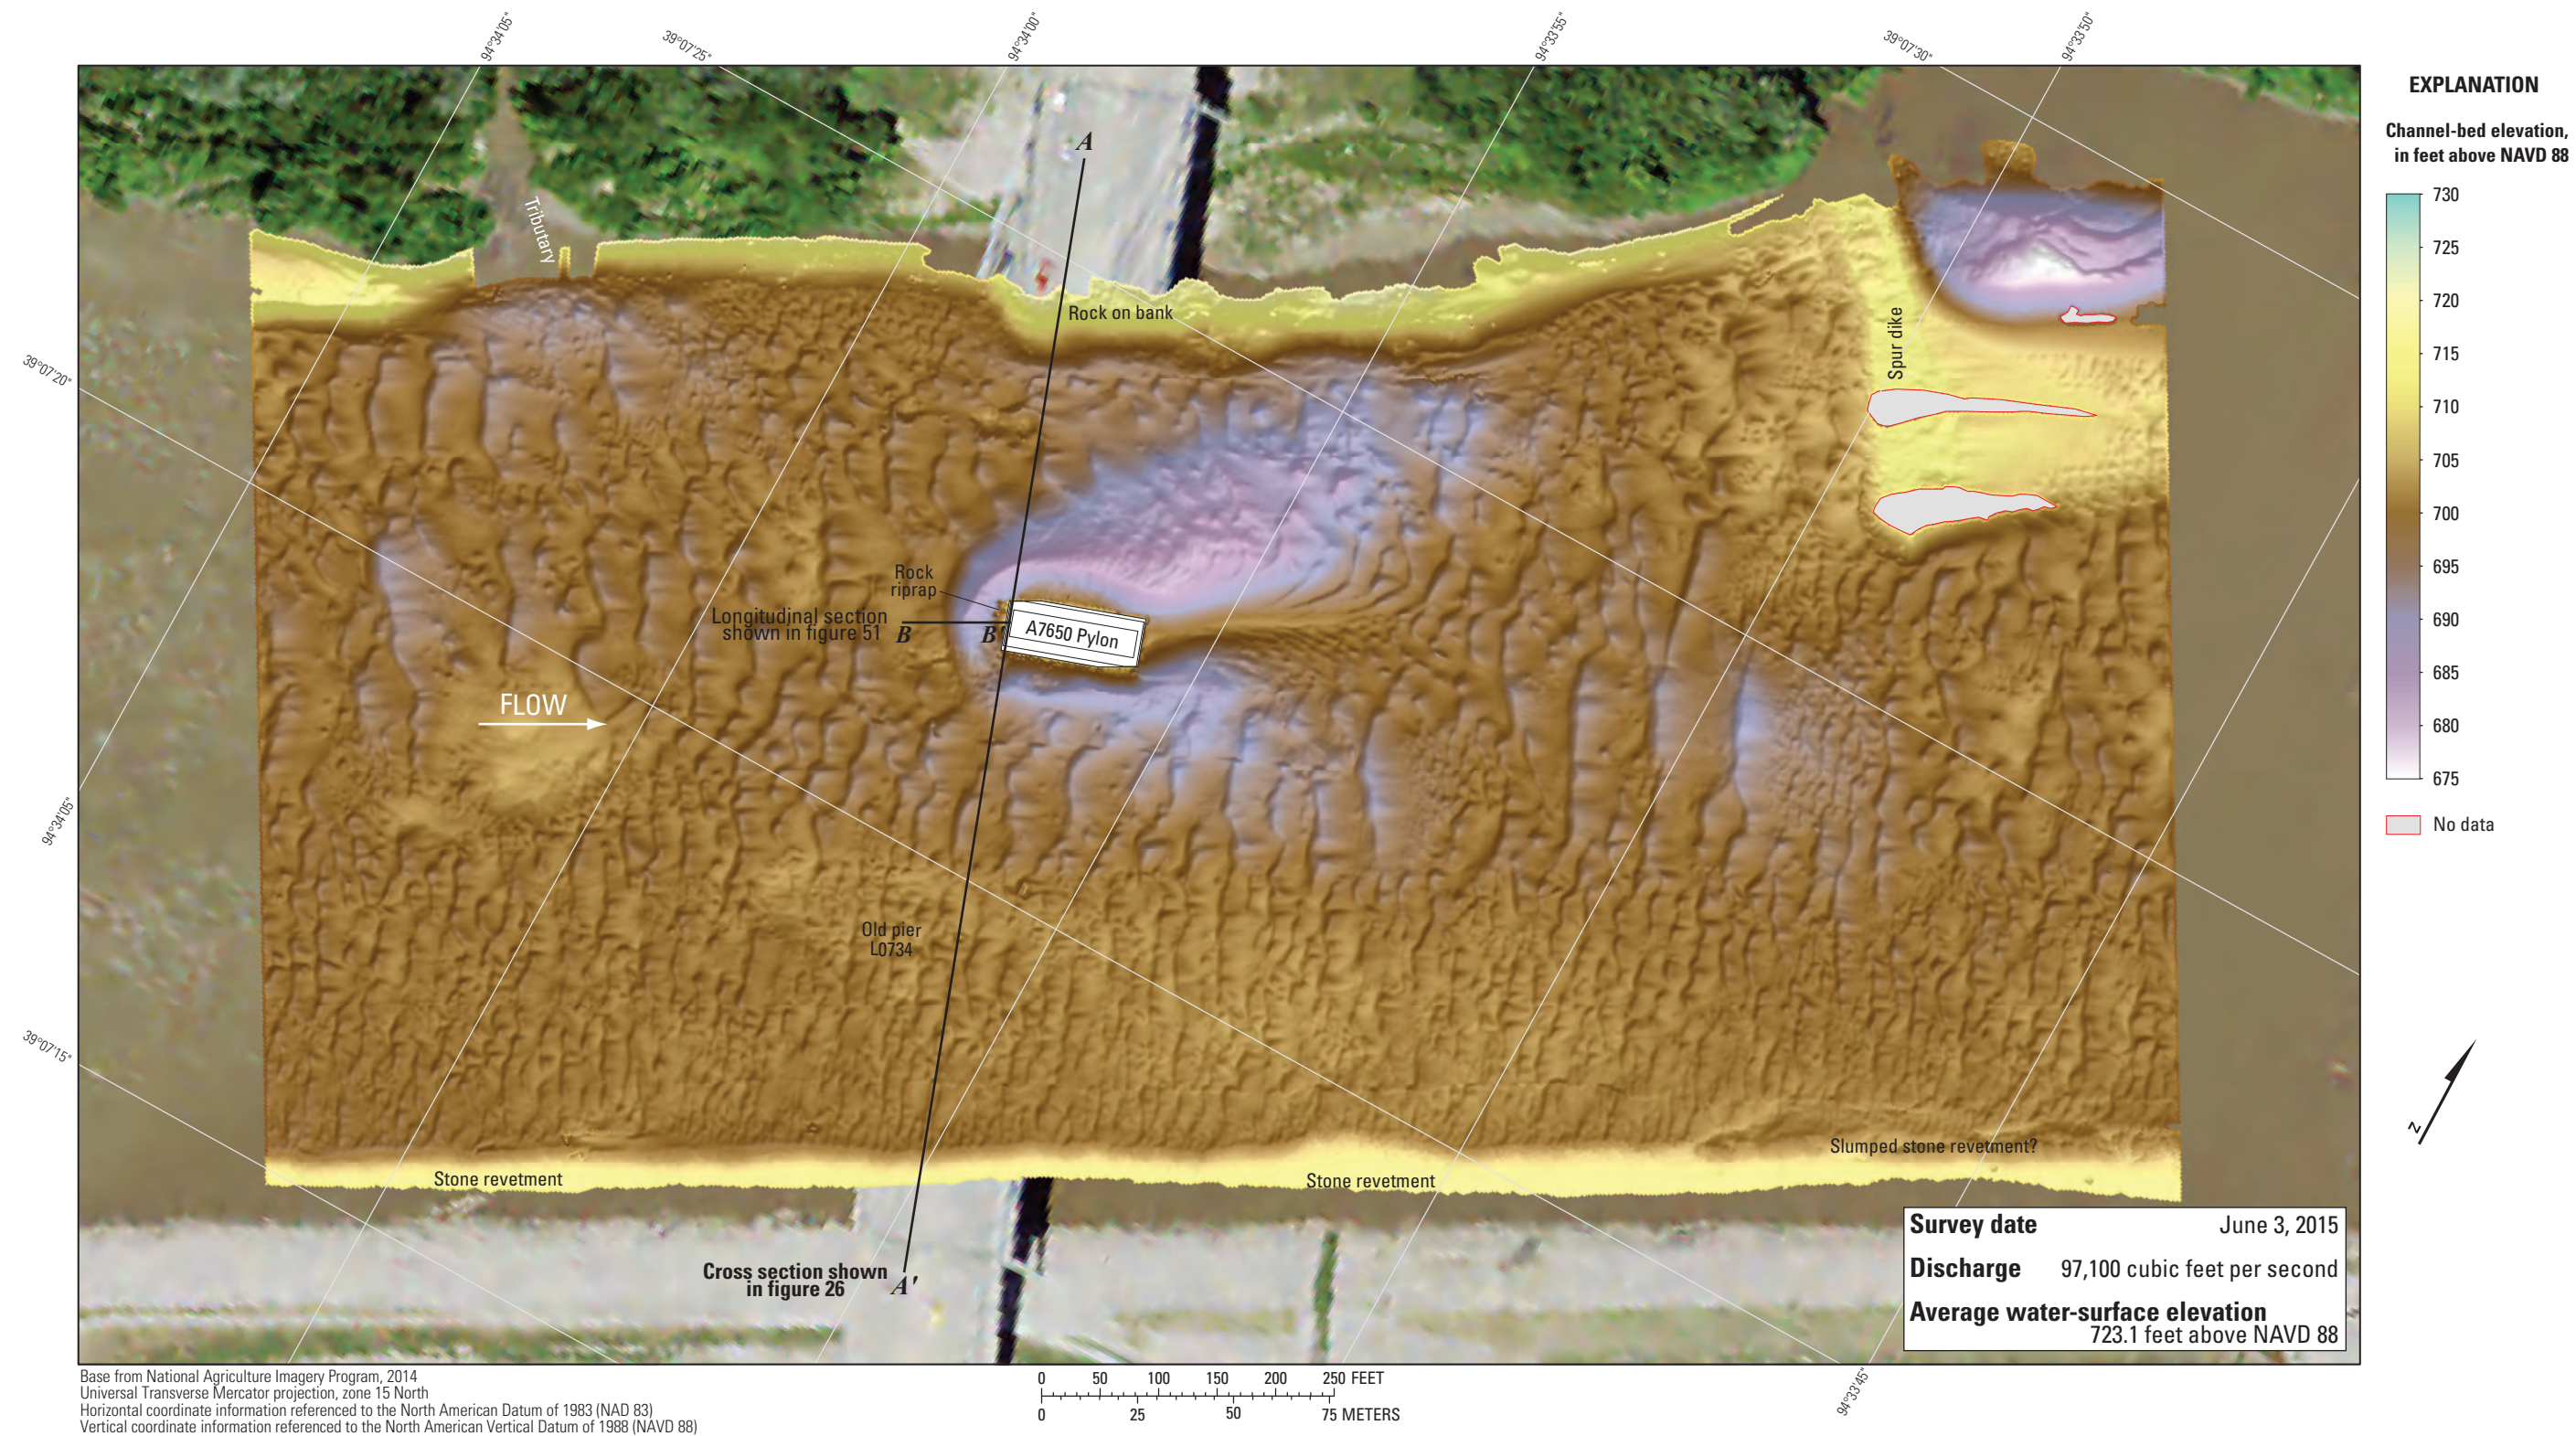
Figure 24. Bathymetric survey of the Missouri River channel near structure A7650 on Interstate 35 in Kansas City, Missouri.

The survey area was about 1,640 ft long and about 805 ft wide, extending from bank to bank in the main channel (fig. 24). The upstream end of the survey area was about 700 ft upstream from the centerline of structure A7650 at the main channel pylon (fig. 24). The channel-bed elevations ranged from about 692 to 709 ft for most of the surveyed area (5 to 95 percentile range of the bathymetric data; table 5; fig. 25), except near the pylon and downstream from the spur dike on the downstream left (north) bank (fig. 24). Similar to upstream structure A4060, there was no definitive thalweg along either side of the channel (fig. 24). Numerous medium and small dunes and ripples were present throughout the channel (fig. 24). Downstream from the spur dike on the left (north) side of the downstream reach, the minimum channel-bed elevations of 676 ft was observed (fig. 24; table 5). Stone revetment was present on the right (south) bank throughout the reach (fig. 24) and seemed to have an area where it had slumped near the downstream end of the reach.

The main channel pylon seemed to be surrounded by a mound of rock riprap, with a local minimum channel-bed elevation of about 681 ft near the downstream left (north) corner (fig. 24; table 6). The top of the riprap around the upstream face of the pylon was at an elevation of about 697 ft, which is slightly below the elevation of the bottom of the pylon seal

course of 699.50 ft (table 6); the top of the riprap along the sides of the pylon is lower than at the upstream face (figs. 24 and 26). The minimum channel-bed elevation near the pylon was about 19 ft below the elevation of the bottom of the pylon seal course (fig. 24; table 6). Information from bridge plans indicates that the pylon is founded on shafts drilled 32 ft into bedrock, with about 34 ft of bed material between the bottom of the scour hole and bedrock (fig. 26; table 6).

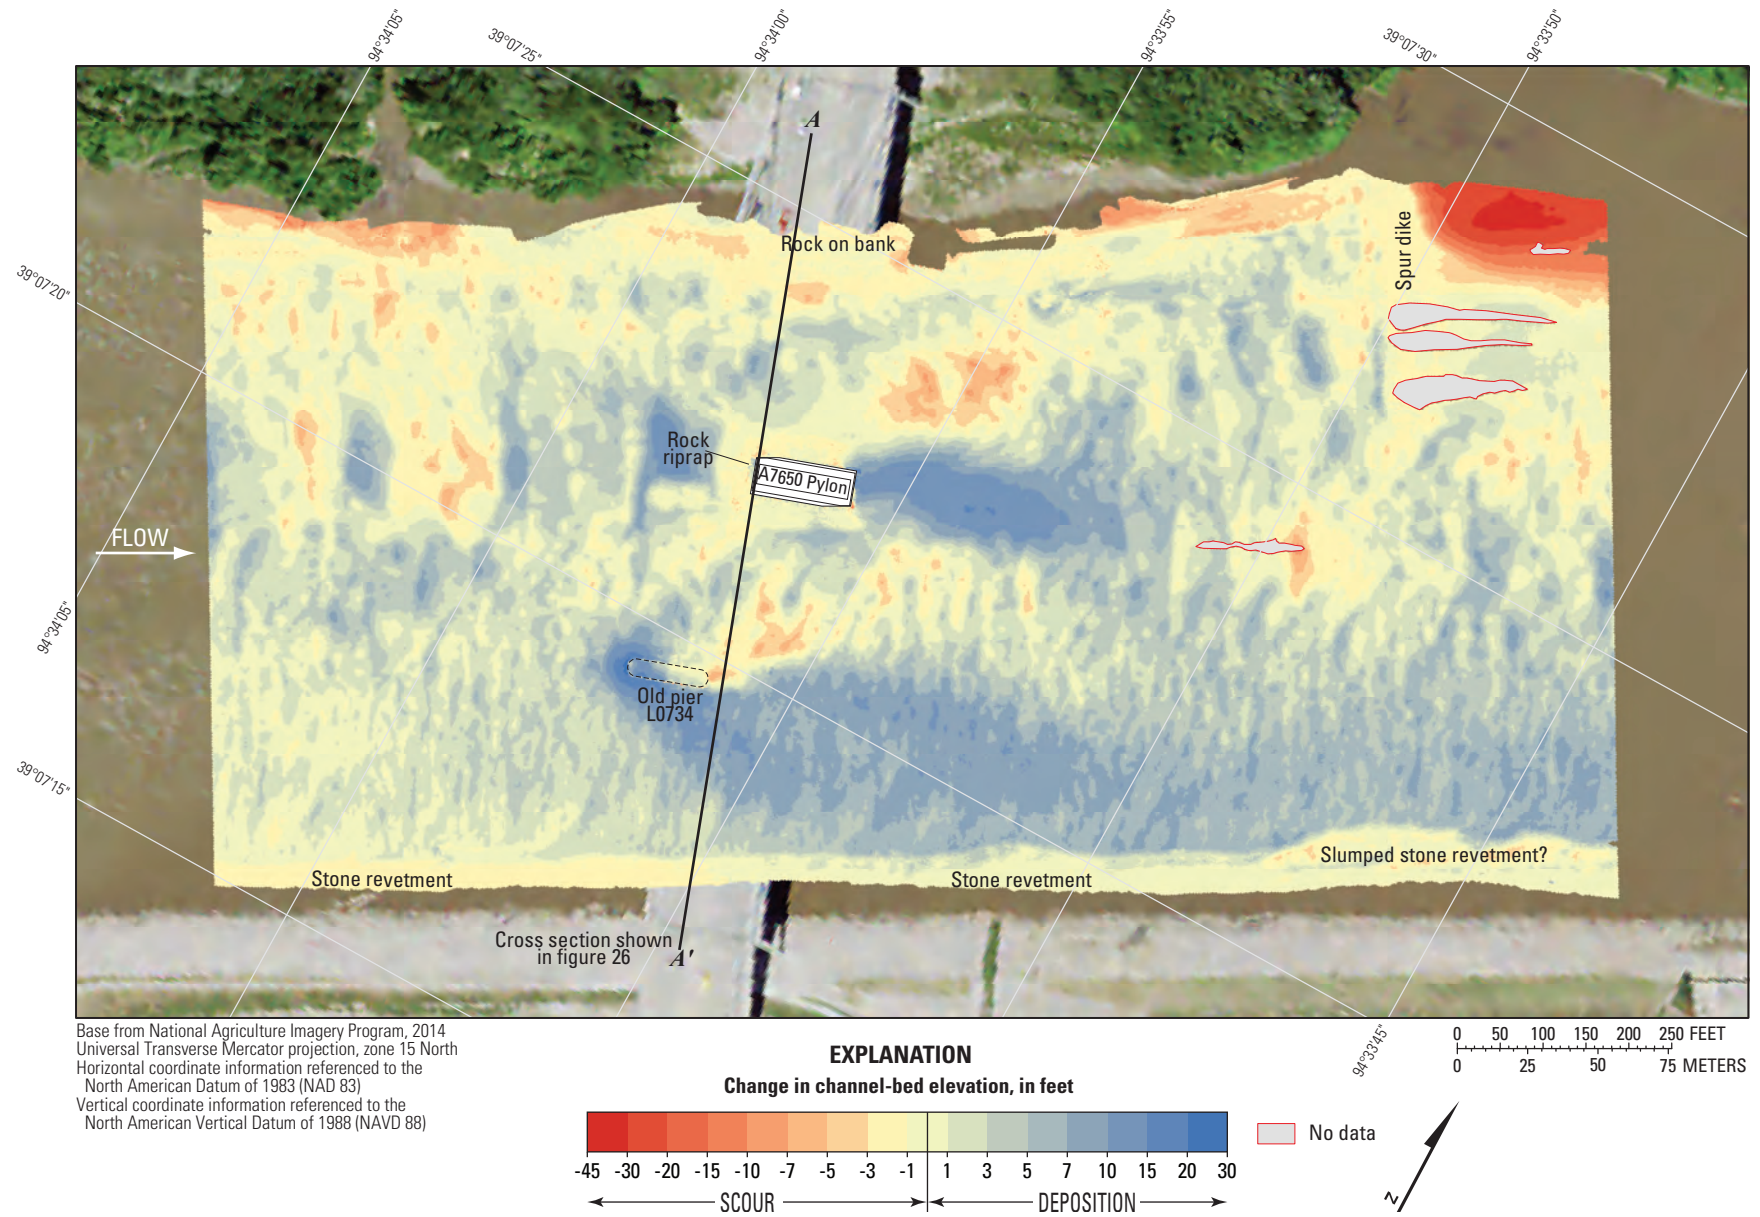
Figure 27. Difference between surfaces created from bathymetric surveys of the Missouri River channel near structure A7650 on Interstate 35 in Kansas City, Missouri, on June 3, 2015, and July 17, 2011.

The difference between the survey on June 3, 2015, and the previous survey on July 17, 2011 (fig. 27), indicates moderate deposition throughout the reach from 2011 to 2015, with an average difference of +1.84 ft between the bathymetric surfaces (table 7). The net volume of cut in the reach from 2011 to 2015 was about 37,100 yd³, and the net volume of fill was about 124,600 yd³, resulting in a net gain of about 87,500 yd³ of sediment between 2011 and 2015. There were areas of substantial deposition in 2015, particularly downstream from the main channel pylon and in the area of a scour hole present in the 2011 survey near the old pier of structure L0734 (fig. 27); however, there also was an area of substantial scour (of nearly 35 ft) downstream from the spur dike on the downstream left (north) bank, and smaller areas of moderate scour scattered throughout the reach (fig. 27). The cross sections from the two surveys were similar to one another except in the area downstream from the old pier of structure L0734 about 1,250 ft from the fill face of the left (north) abutment (fig. 26). The frequency distribution of bed elevations was of a similar shape but narrower in 2015 than in 2011, with a greater percentage of survey-grid cells at a higher elevation than 2011 (fig. 25). The scour hole near the main channel pylon in 2015 was of a similar size and shape to that in 2011, albeit shallower on the outer side edges (figs. 26 and 27). The stone revetment on the right (south) bank seemed to have several areas of localized deposition and scour (fig. 27).

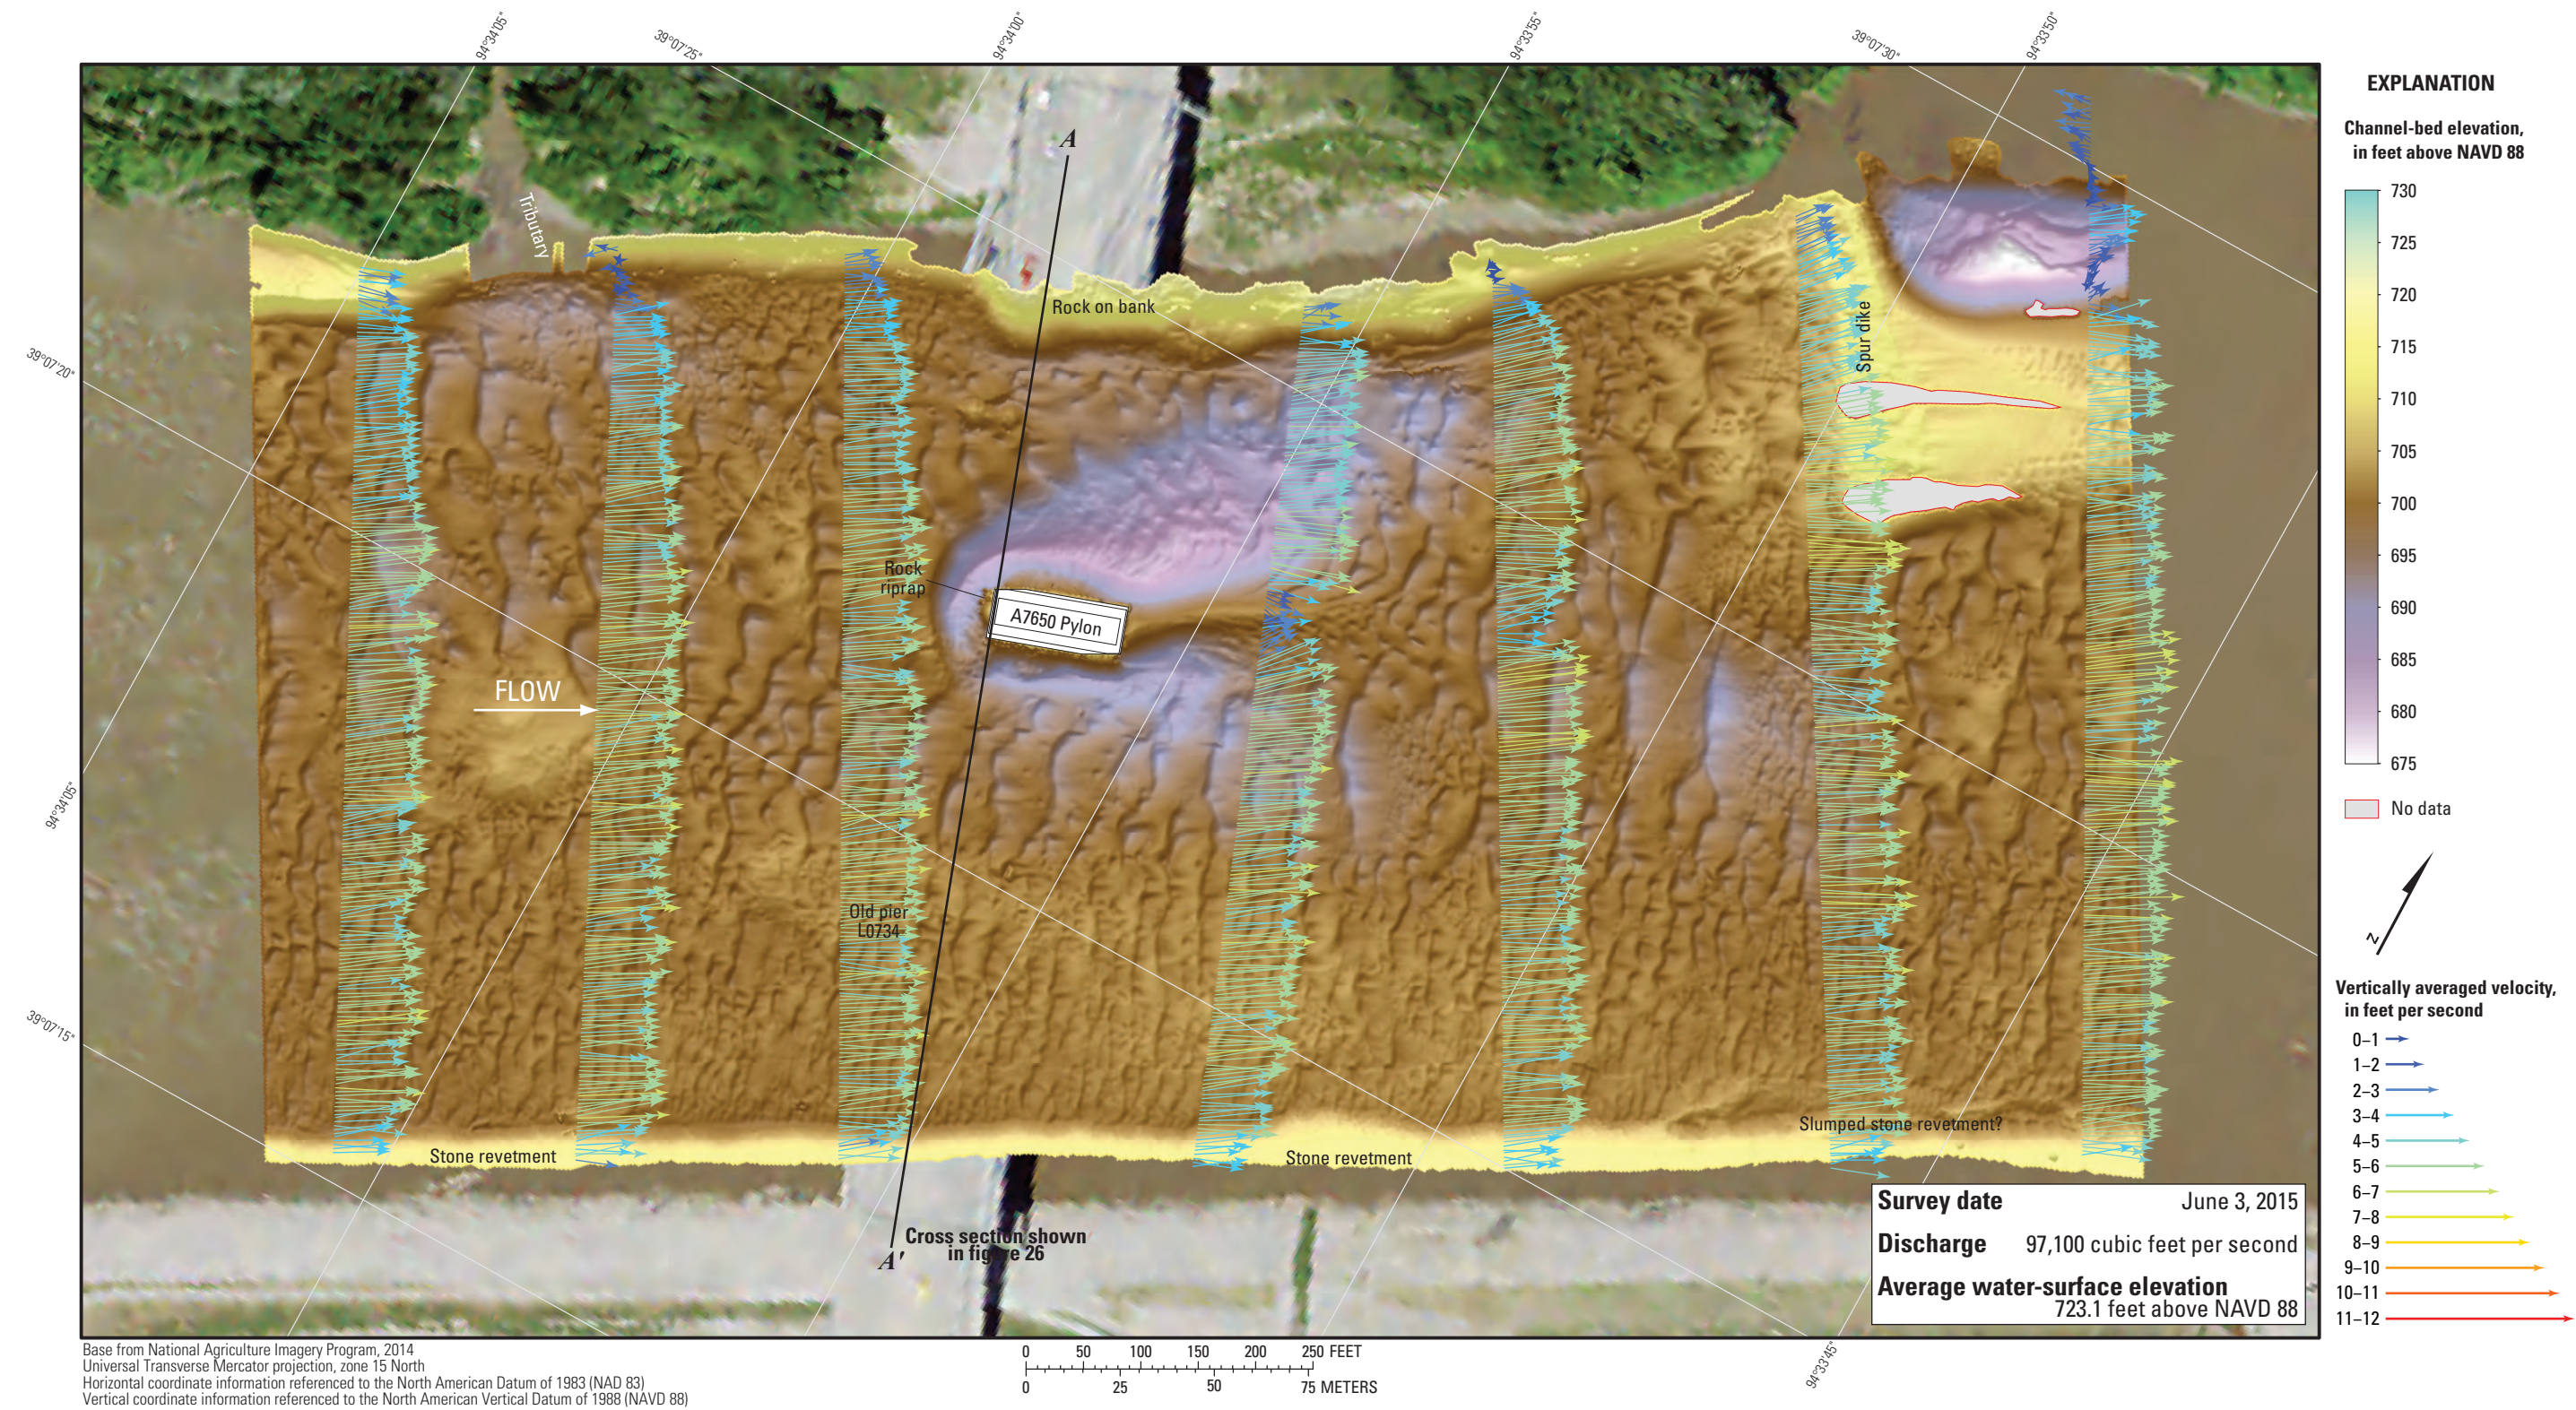
Figure 28. Bathymetric survey of the Missouri River channel near structure A7650 on Interstate 35 in Kansas City, Missouri.

The vertically averaged velocity vectors indicate mostly uniform flow throughout most of the reach, with velocities ranging from about 3 to 8 ft/s (fig. 28). Exceptions to uniform conditions include flow reversal on the left (north) bank near the upstream tributary and in the pool downstream from the

spur dike (fig. 28). Substantial turbulence also was observed downstream from the main channel pylon (fig. 28), likely as a result of the pylon being skewed to flow. The velocities do not seem to be higher near the bulge in the left bank at the bridge, but a velocity cross section was not taken in the constriction.
